MONITORING YEAR 4 ANNUAL REPORT Final

LITTLE TROUBLESOME CREEK MITIGATION SITE
Rockingham County, NC
NCDEQ Contract 003267
NCDMS Project Number 94640

Data Collection Period: May 2015-November 2015
Draft Submission Date: November 30, 2015
Final Submission Date: January 28, 2016

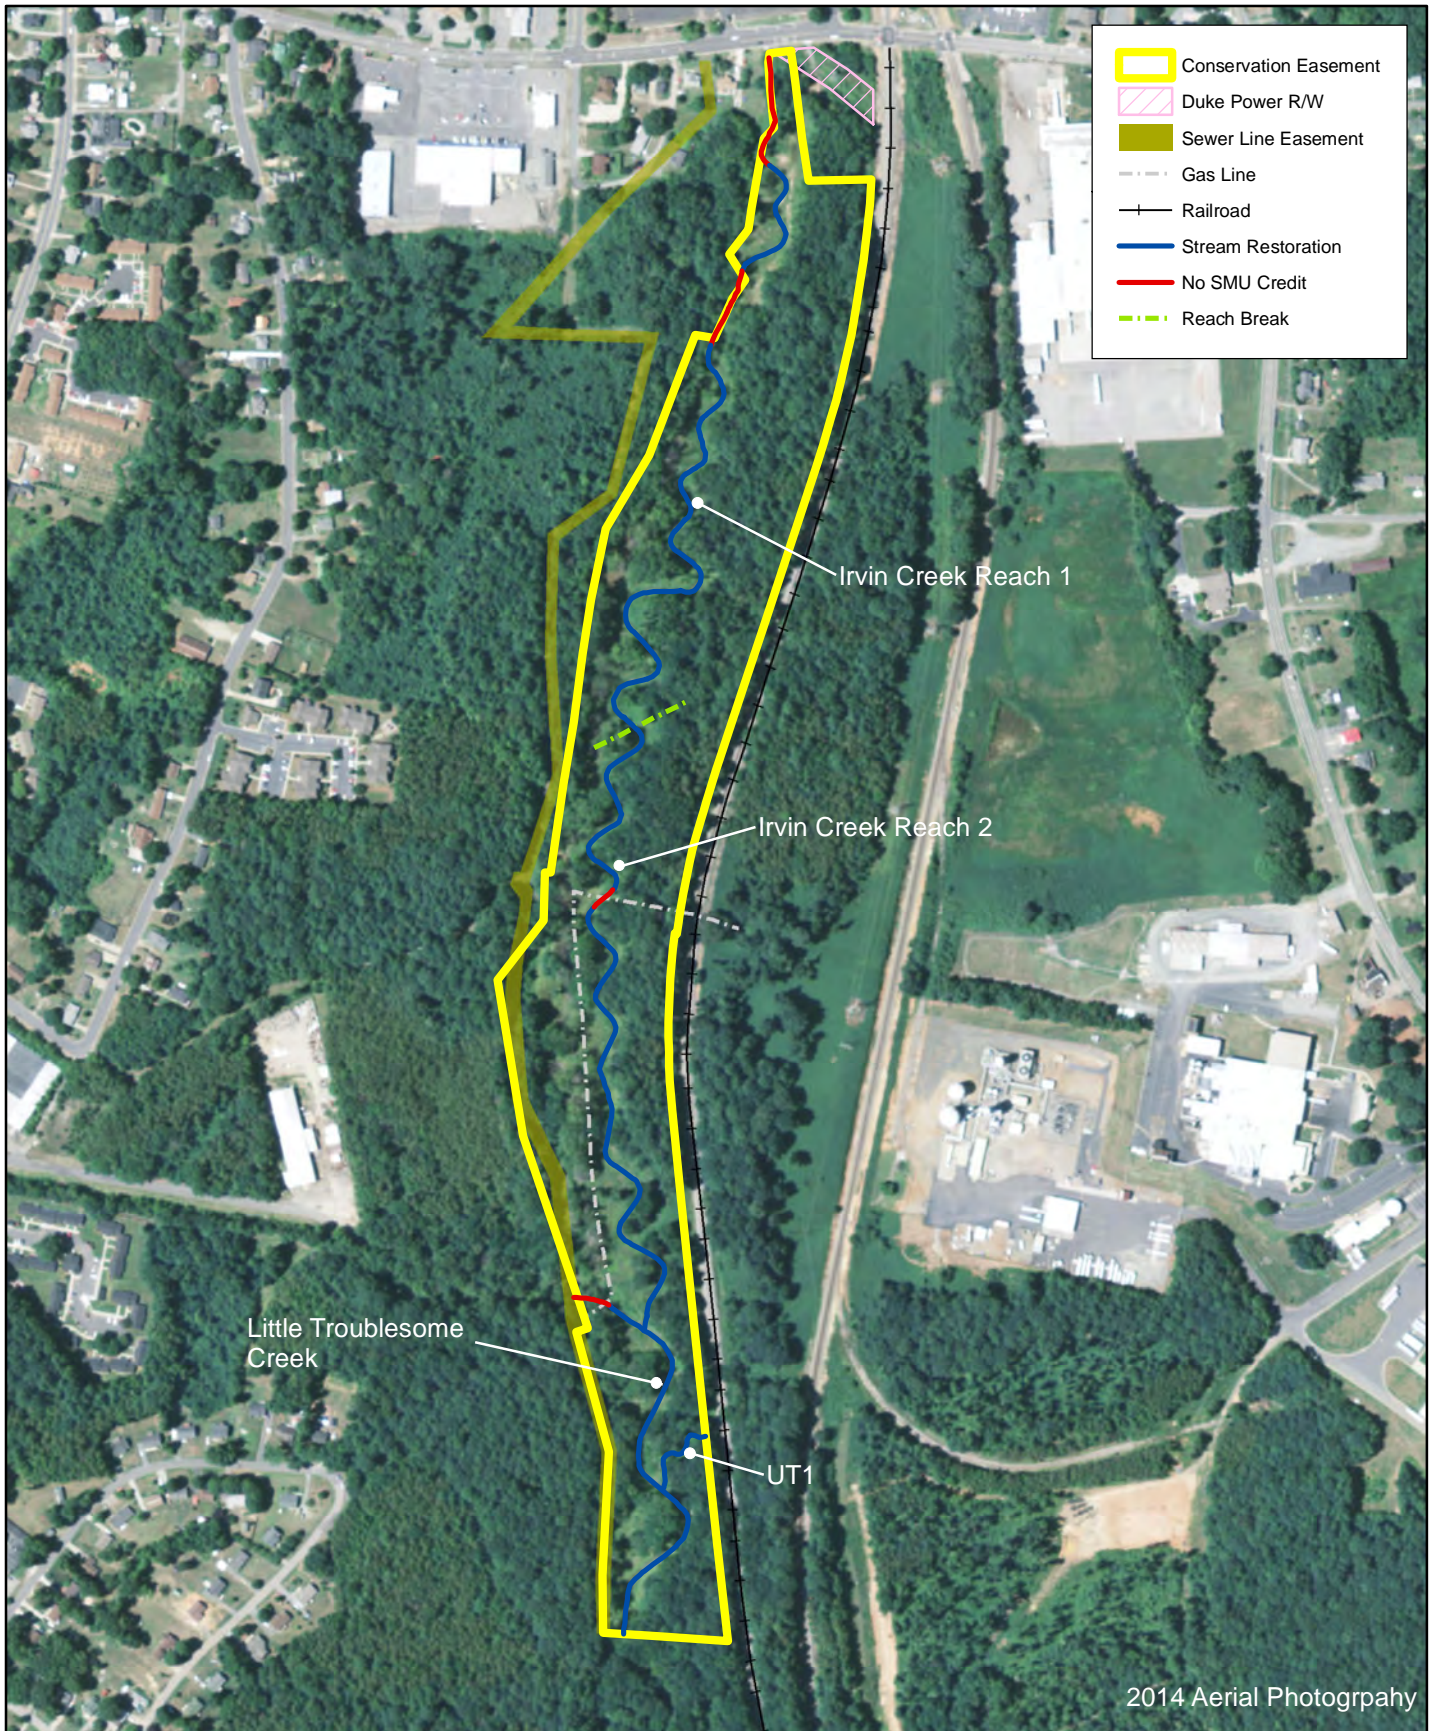
Figure 2a Project Component/Asset Map
 Little Troublesome Creek Mitigation Site
 Stream Site
 NCDMS Project Number 94640
 Monitoring Year 4 - 2015
 Rockingham County, NC

- Conservation Easement
- Duke Power R/W
- Sewer Line Easement
- Gas Line
- Railroad
- Stream Restoration
- No SMU Credit
- Reach Break

The project stream reaches consist of Little Troublesome Creek, Irvin Creek, and one unnamed tributary (UT1) to Little Troublesome Creek (stream restoration approach). Mitigation work within the Sites included restoring 4,968 linear feet (LF) of perennial and intermittent stream channel and restoring, enhancing, and creating 17.2 acres (ac) of riparian wetland. The Stream and Wetland Sites were also planted with native vegetation to improve habitat and protect water quality. Conservation easements have been recorded on the Sites and are in place along the stream and wetland riparian corridors to protect them in perpetuity; 33.0 ac (Deed Book 1411, Page Number 2458) owned by Wildlands Little Troublesome Creek Holdings, LLC and 19.0 ac (Deed Book 1412, Page Number 1685) owned by Jerry Apple. Directions and maps of the Sites are provided in Figure 1 and project components are illustrated for the Sites in Figures 2a and 2b.

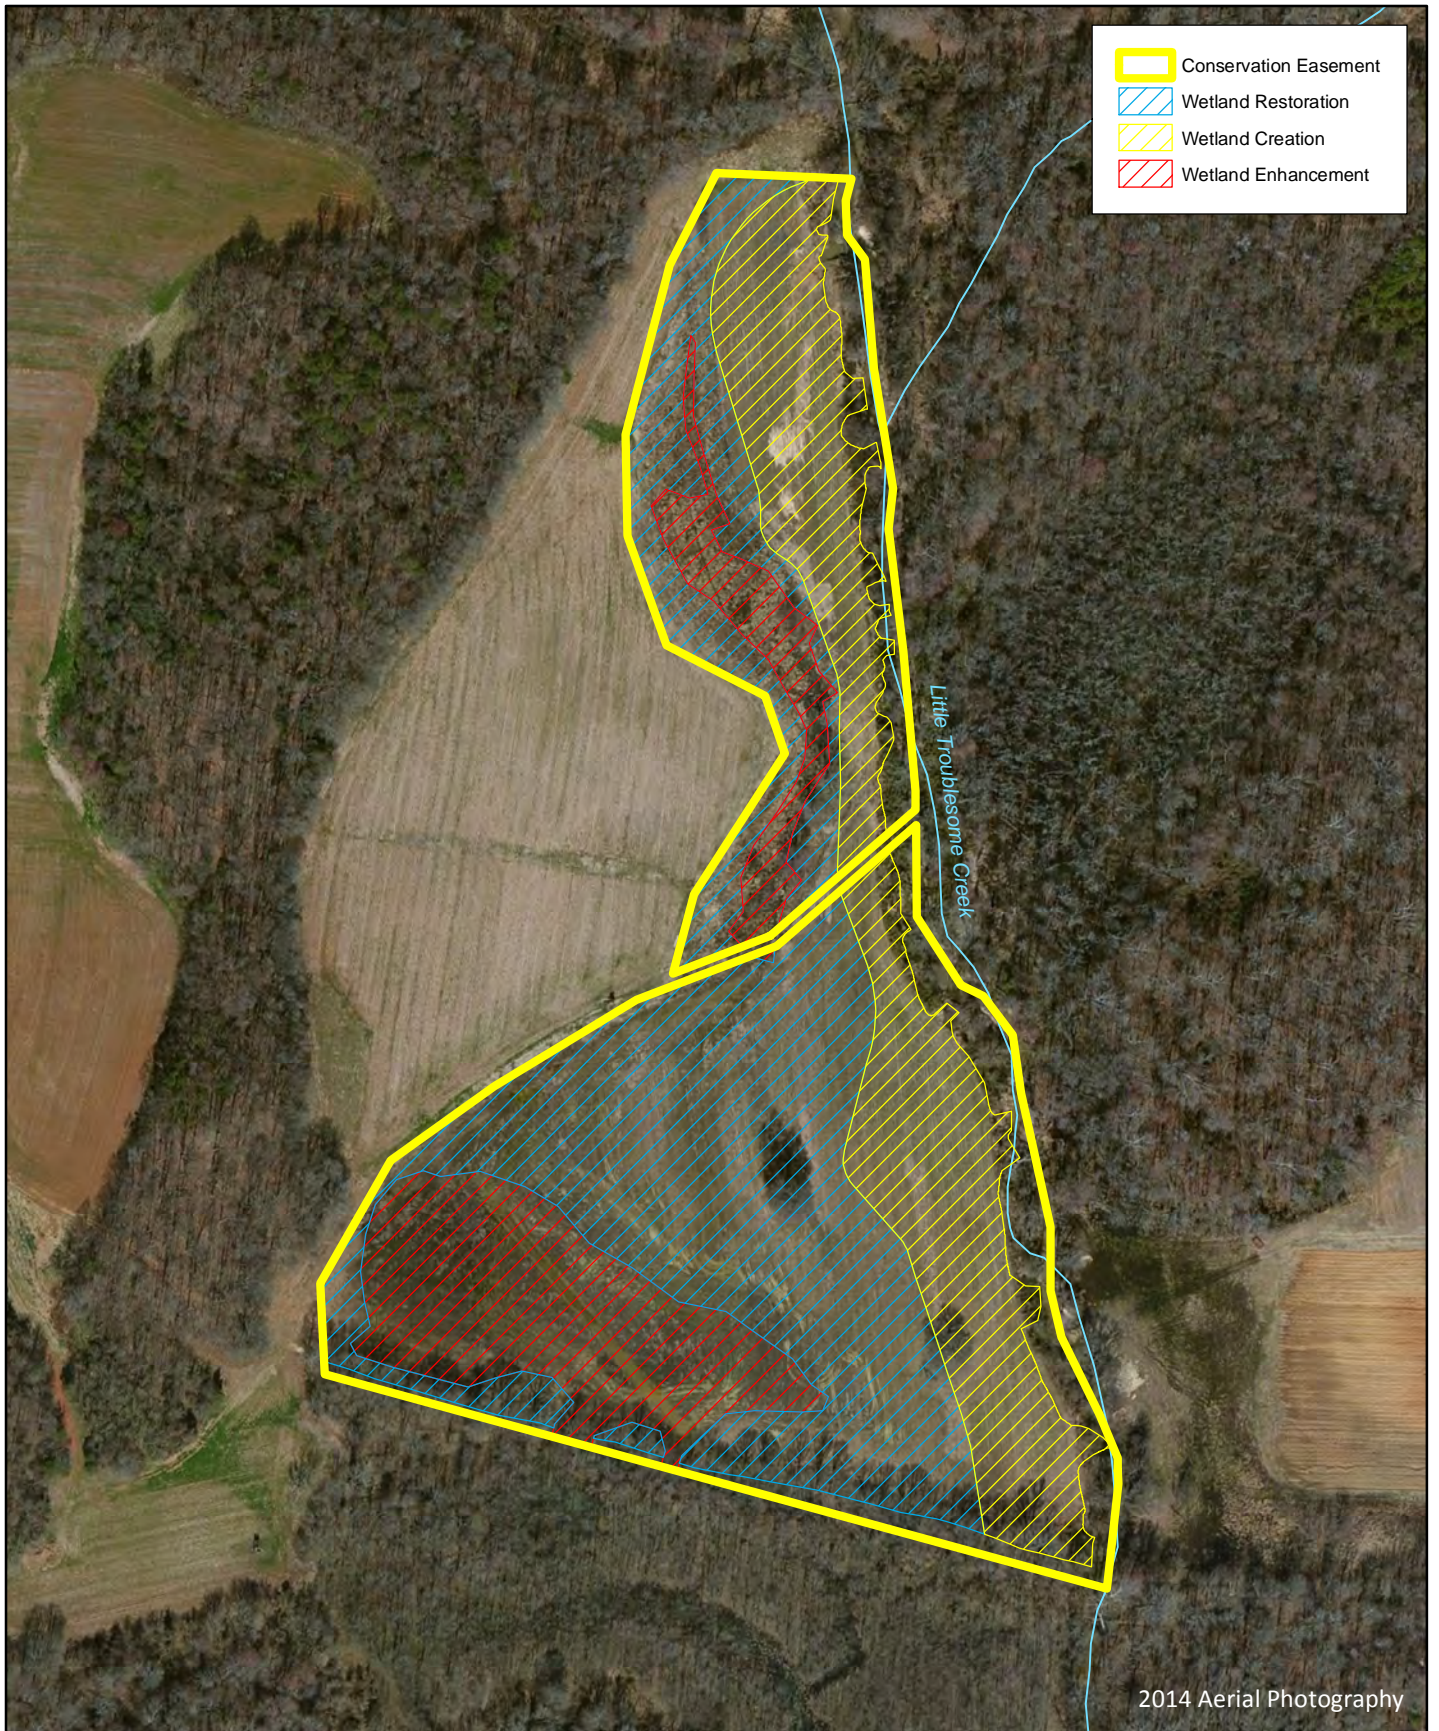
Figure 2b Project Component/Asset Map
 Little Troublesome Creek Mitigation Site
 Wetland Site
 NCDMS Project Number 94640
 Monitoring Year 4 - 2015
 Rockingham County, NC

-   Conservation Easement
-   Wetland Restoration
-   Wetland Creation
-   Wetland Enhancement

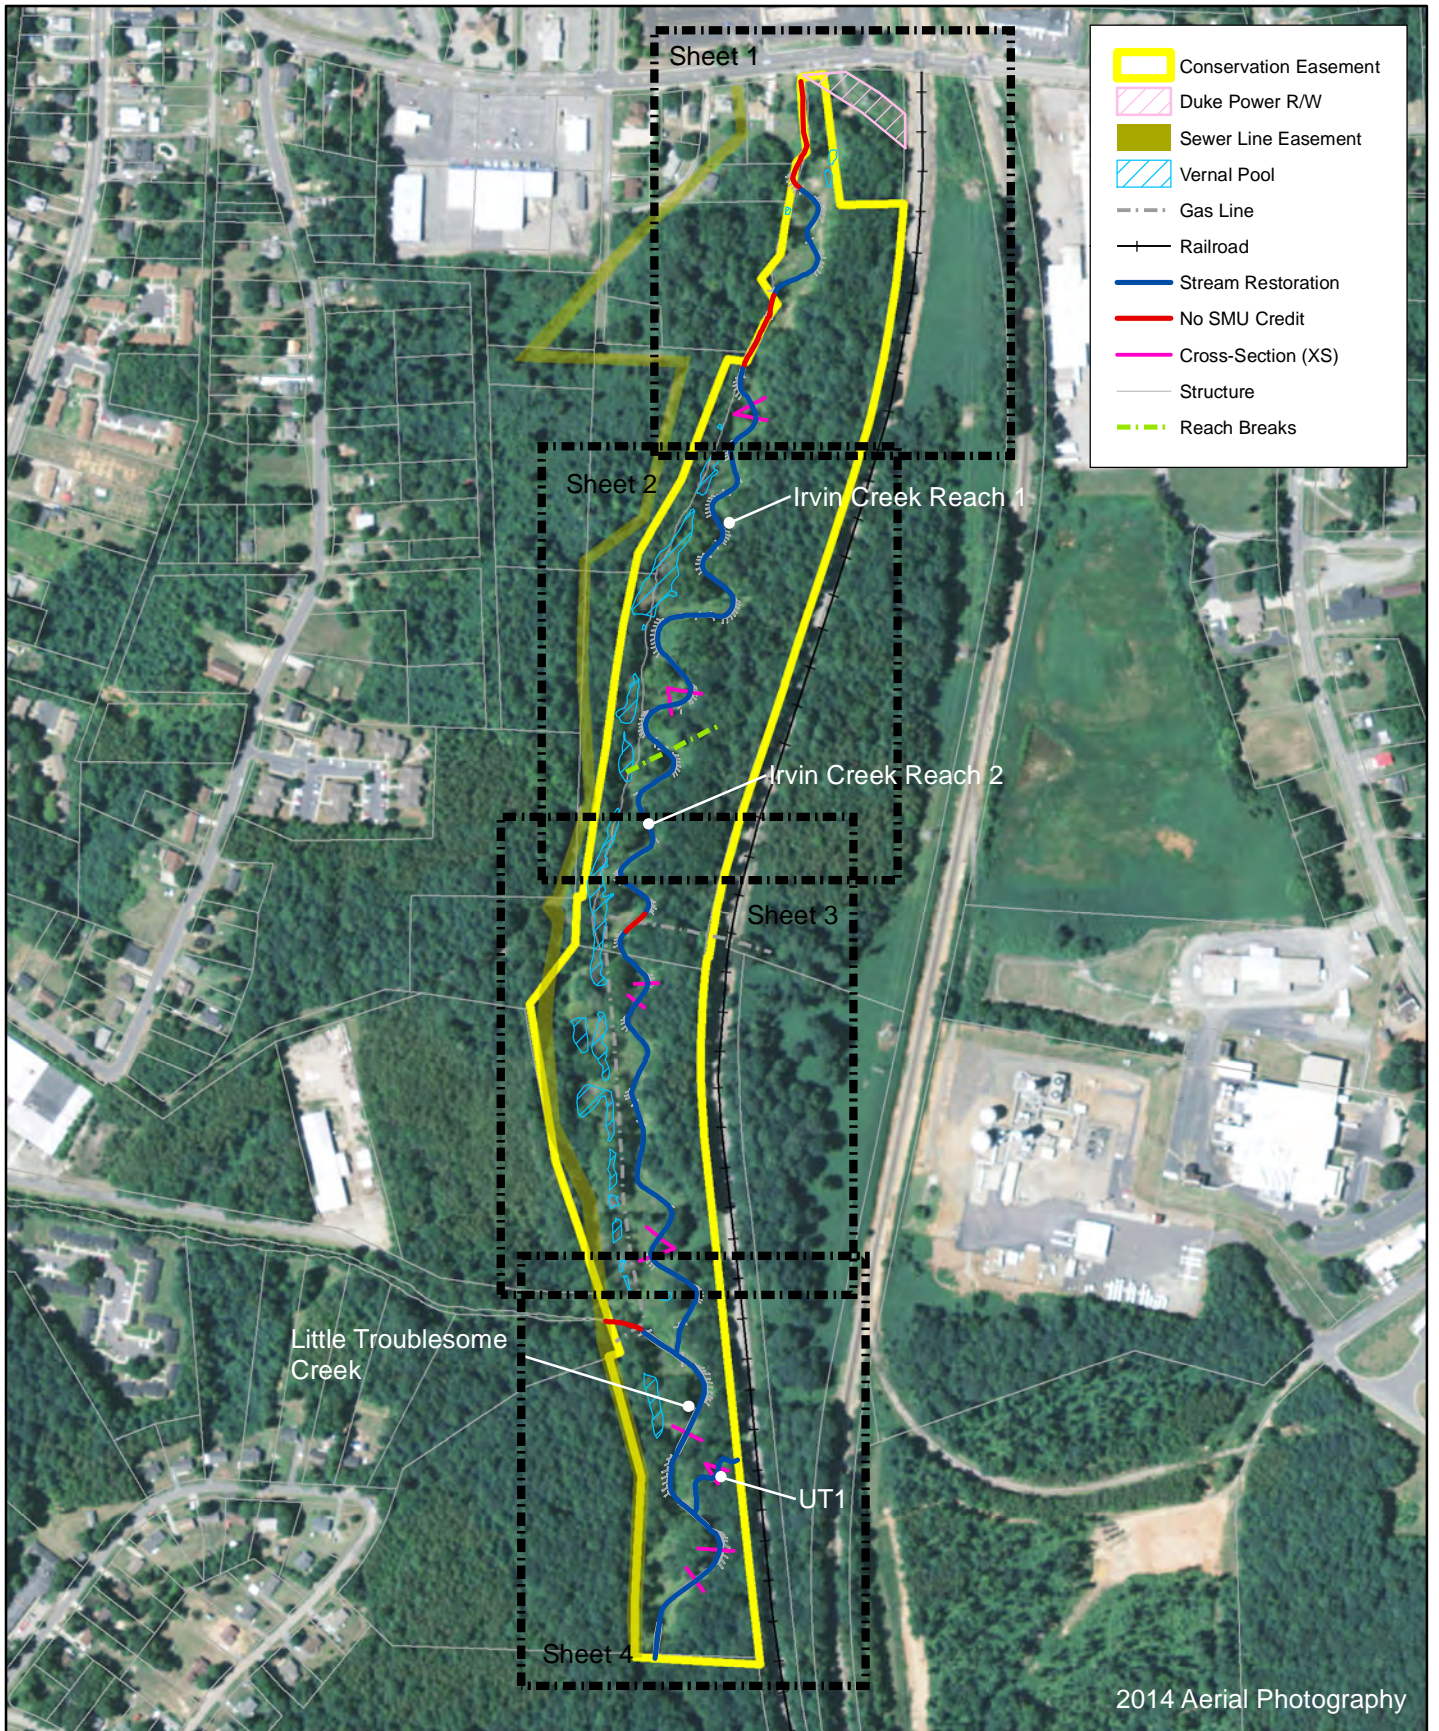
Figure 3.0 Integrated Current Condition Plan View (Key)

Little Troublesome Creek Mitigation Site
 Stream Site
 NCDMS Project Number 94640
 Monitoring Year 4 - 2015

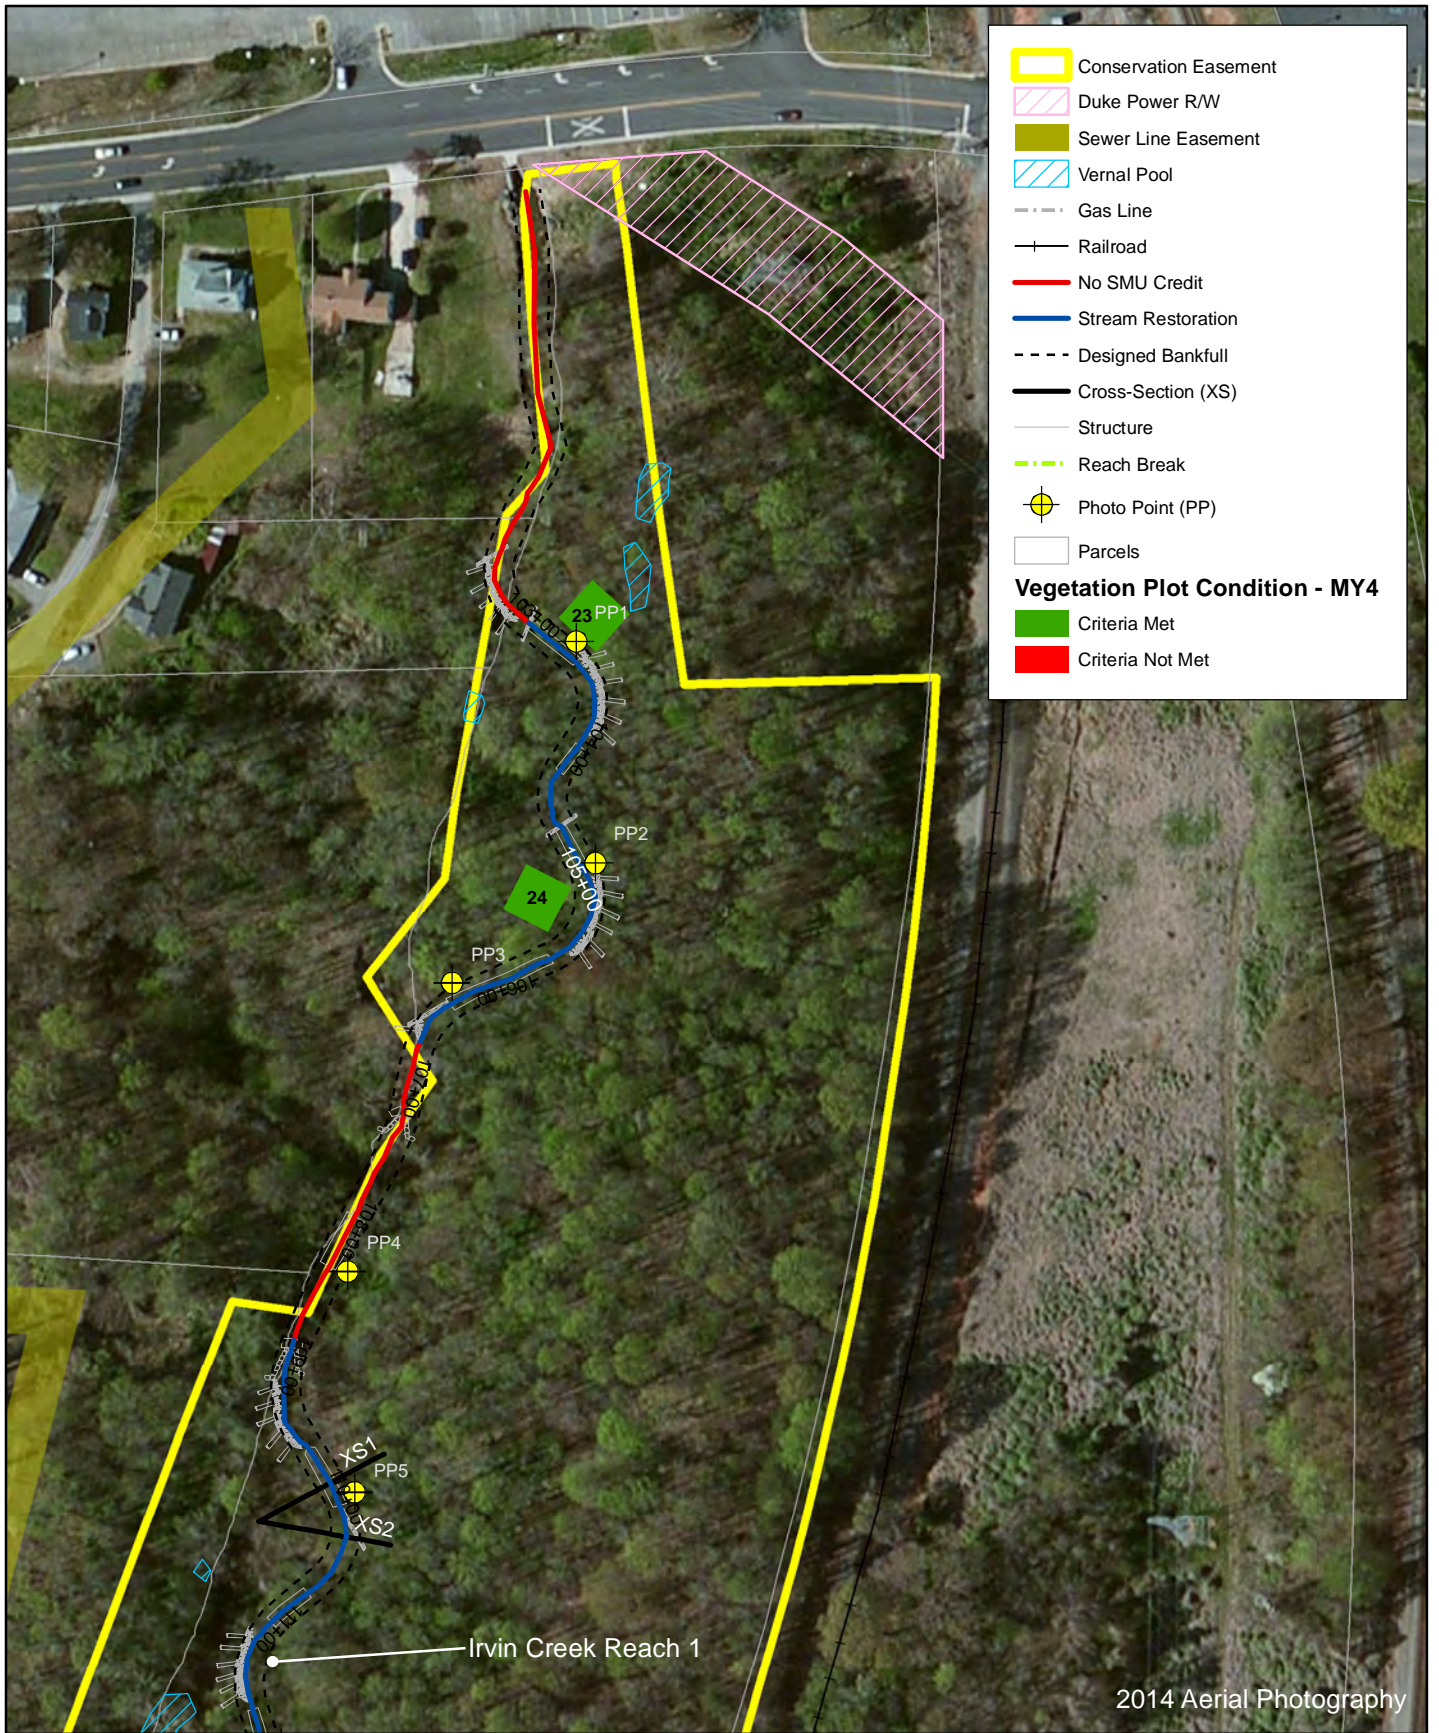
Figure 3.1 Integrated Current Condition Plan View
(Sheet 1 of 4)

Little Troublesome Creek Mitigation Site
Stream Site
NCDMS Project Number 94640
Monitoring Year 4 - 2015

vegetation condition assessment table, and the Current Condition Plan View Map, and Appendix 3 for vegetation data tables.

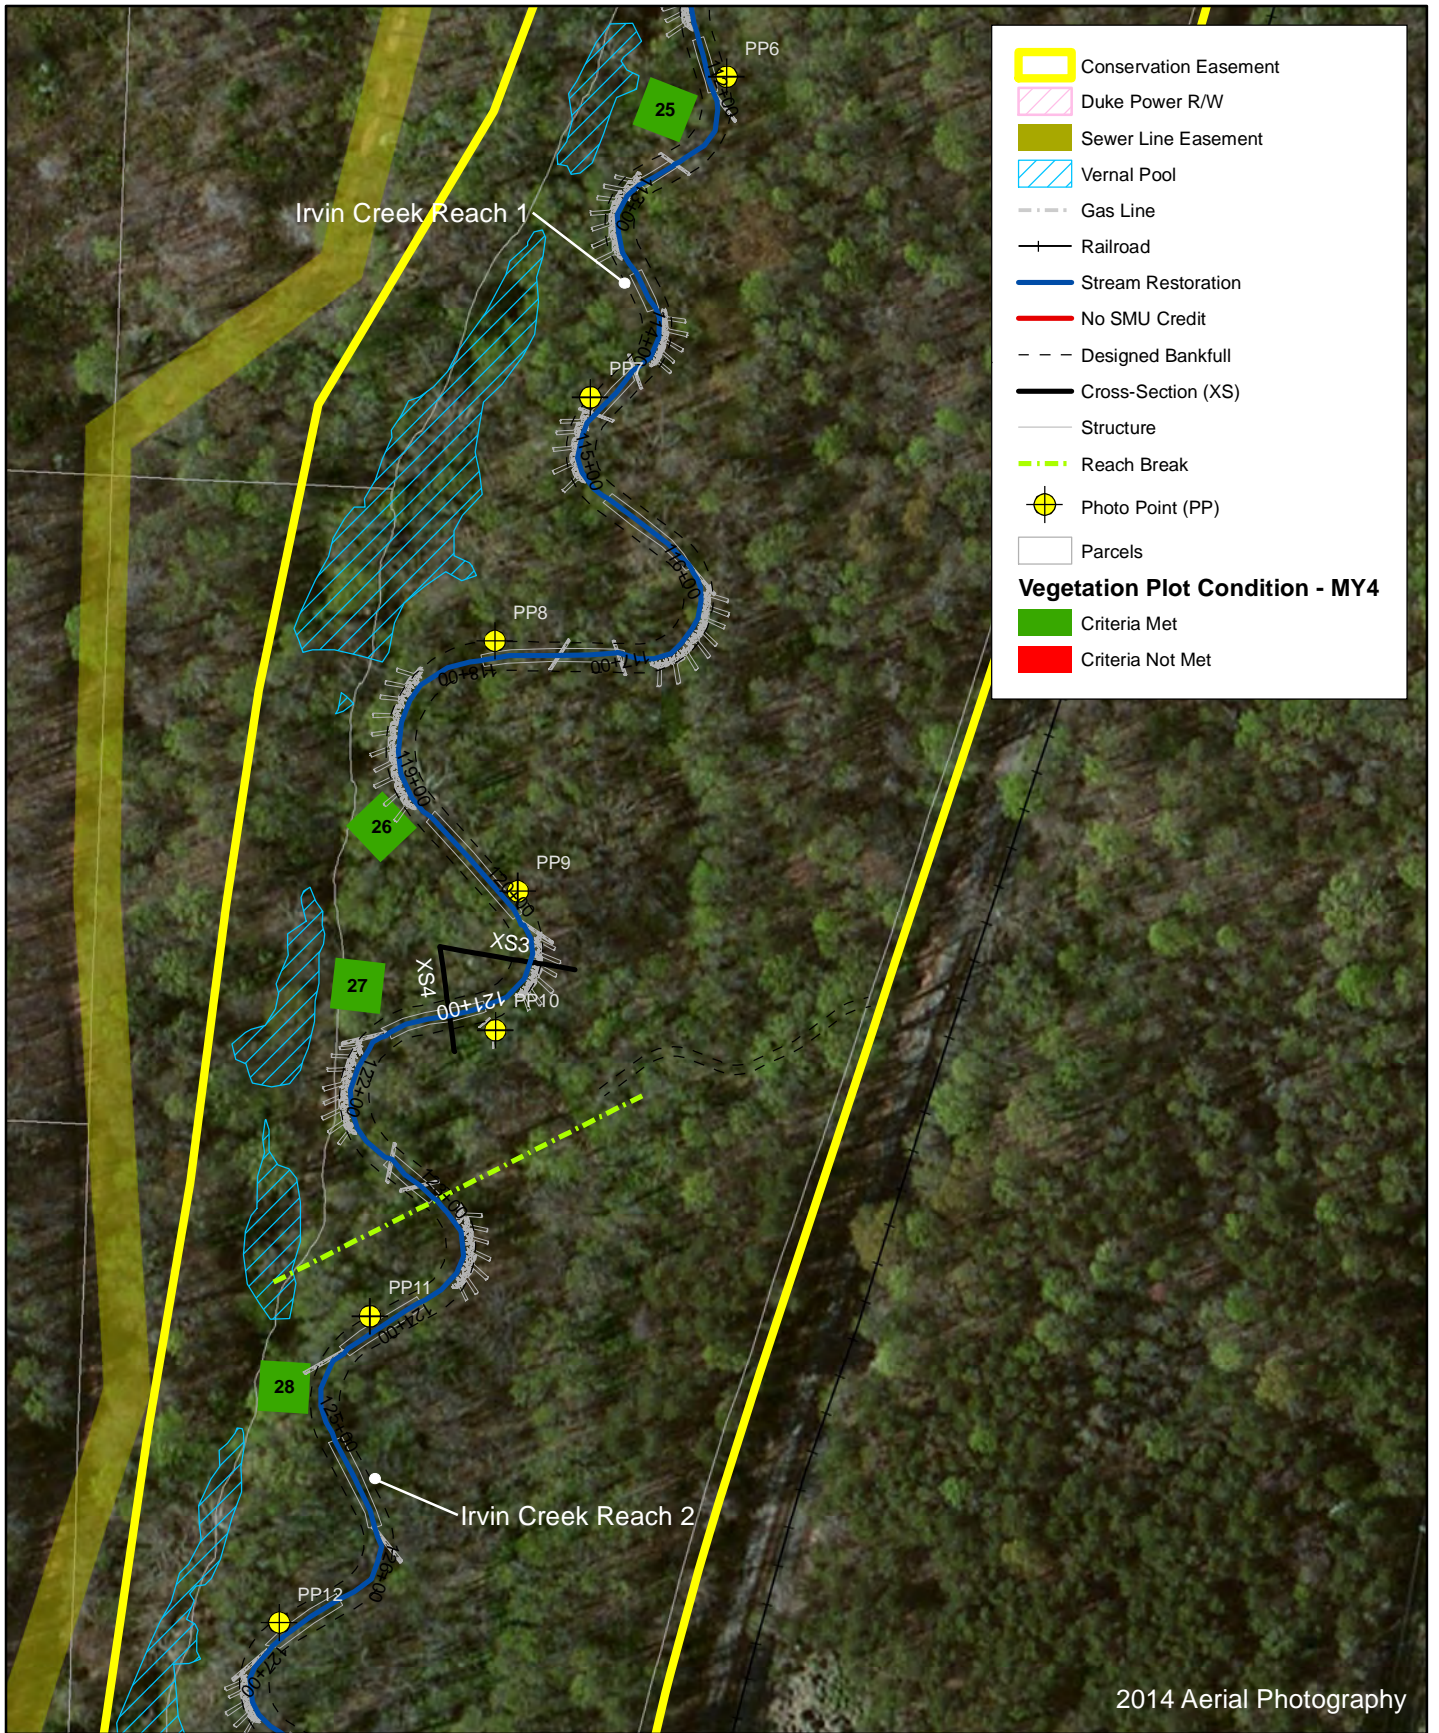
Figure 3.2 Integrated Current Condition Plan View
(Sheet 2 of 4)

Little Troublesome Creek Mitigation Site
Stream Site
NCDMS Project Number 94640
Monitoring Year 4 - 2015

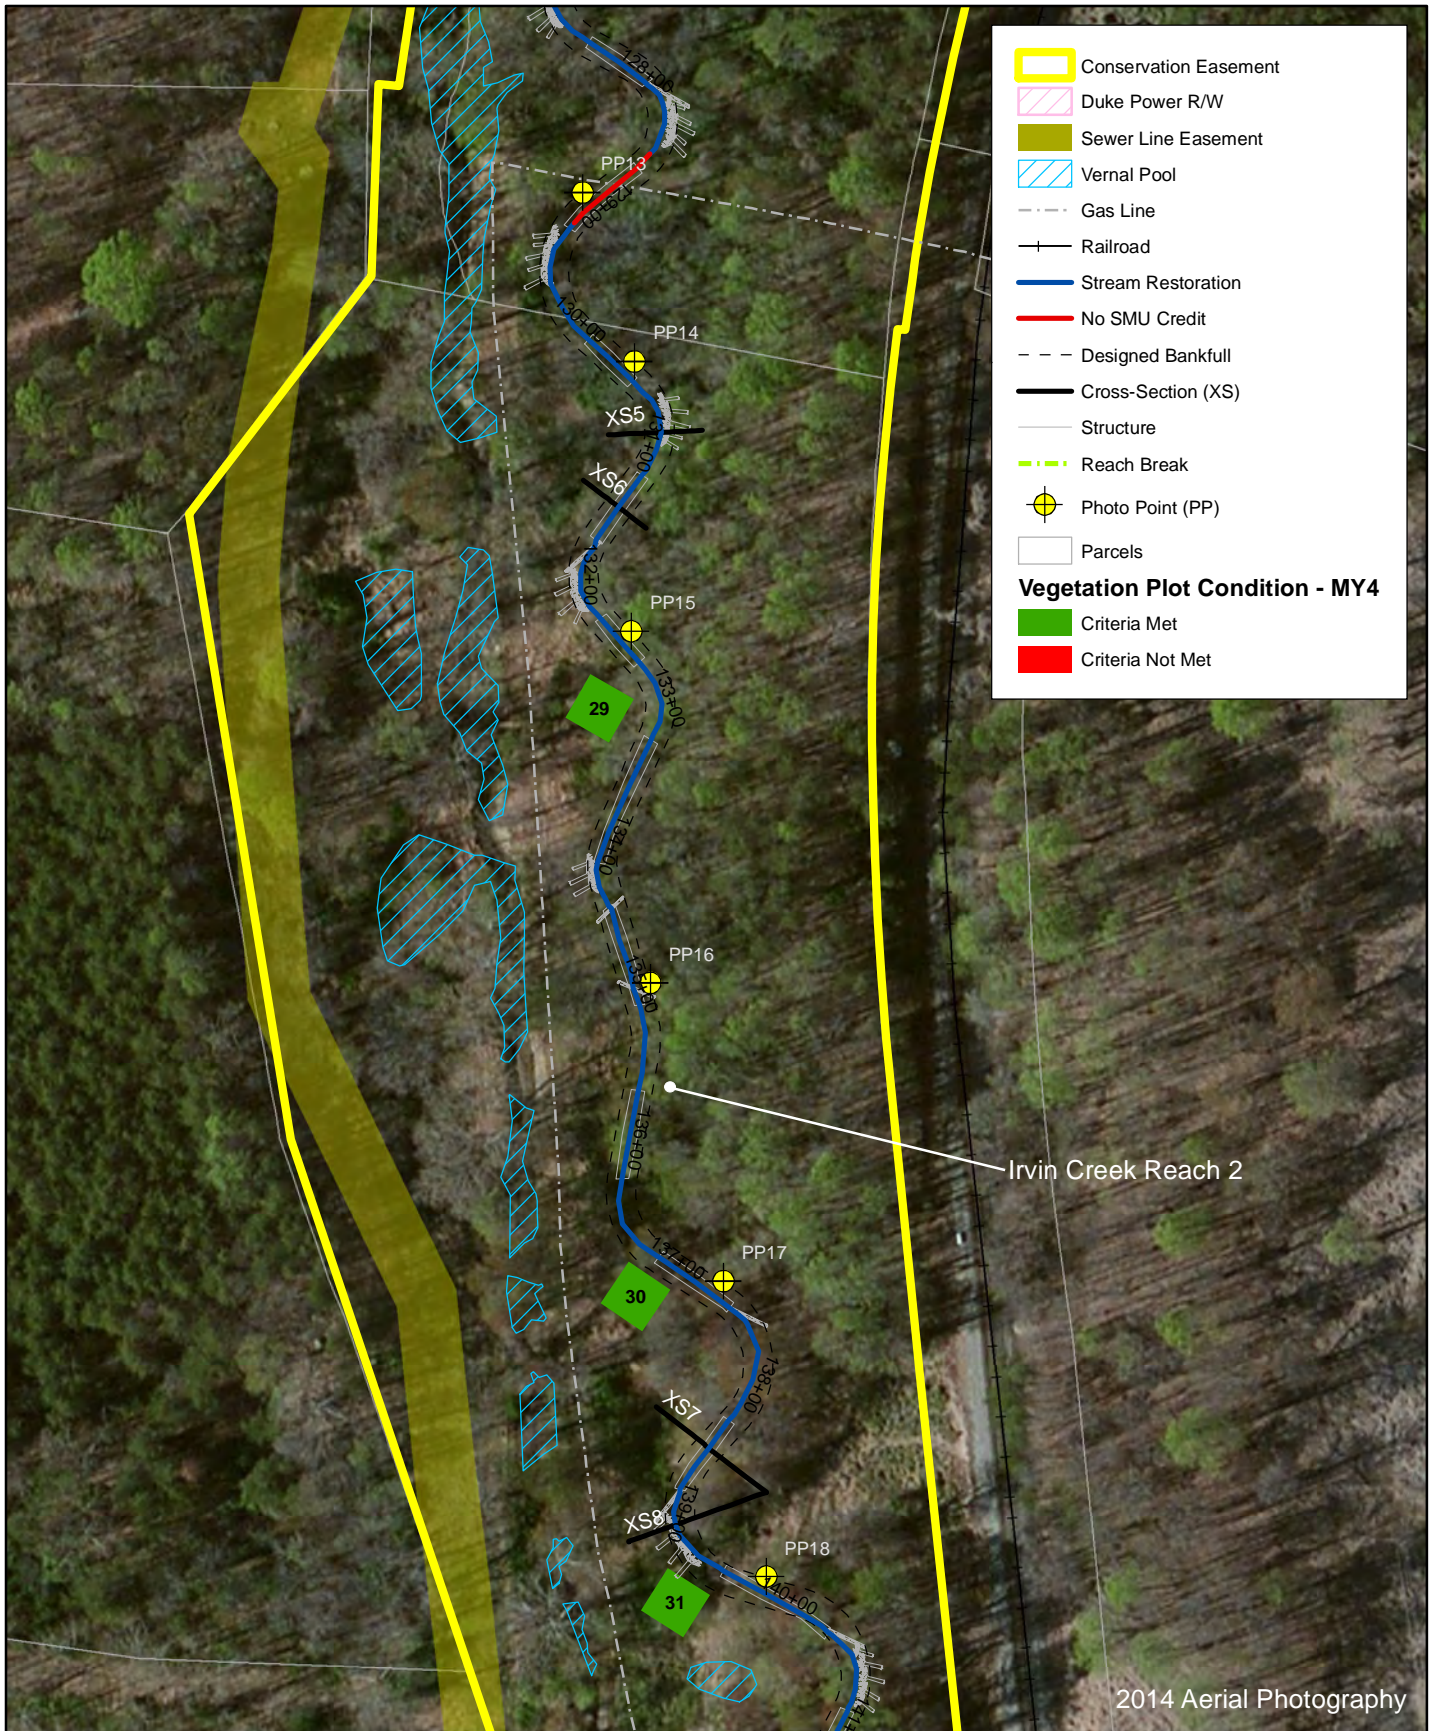
Figure 3.3 Integrated Current Condition Plan View
(Sheet 3 of 4)

Little Troublesome Creek Mitigation Site
Stream Site
NCDMS Project Number 94640
Monitoring Year 4 - 2015

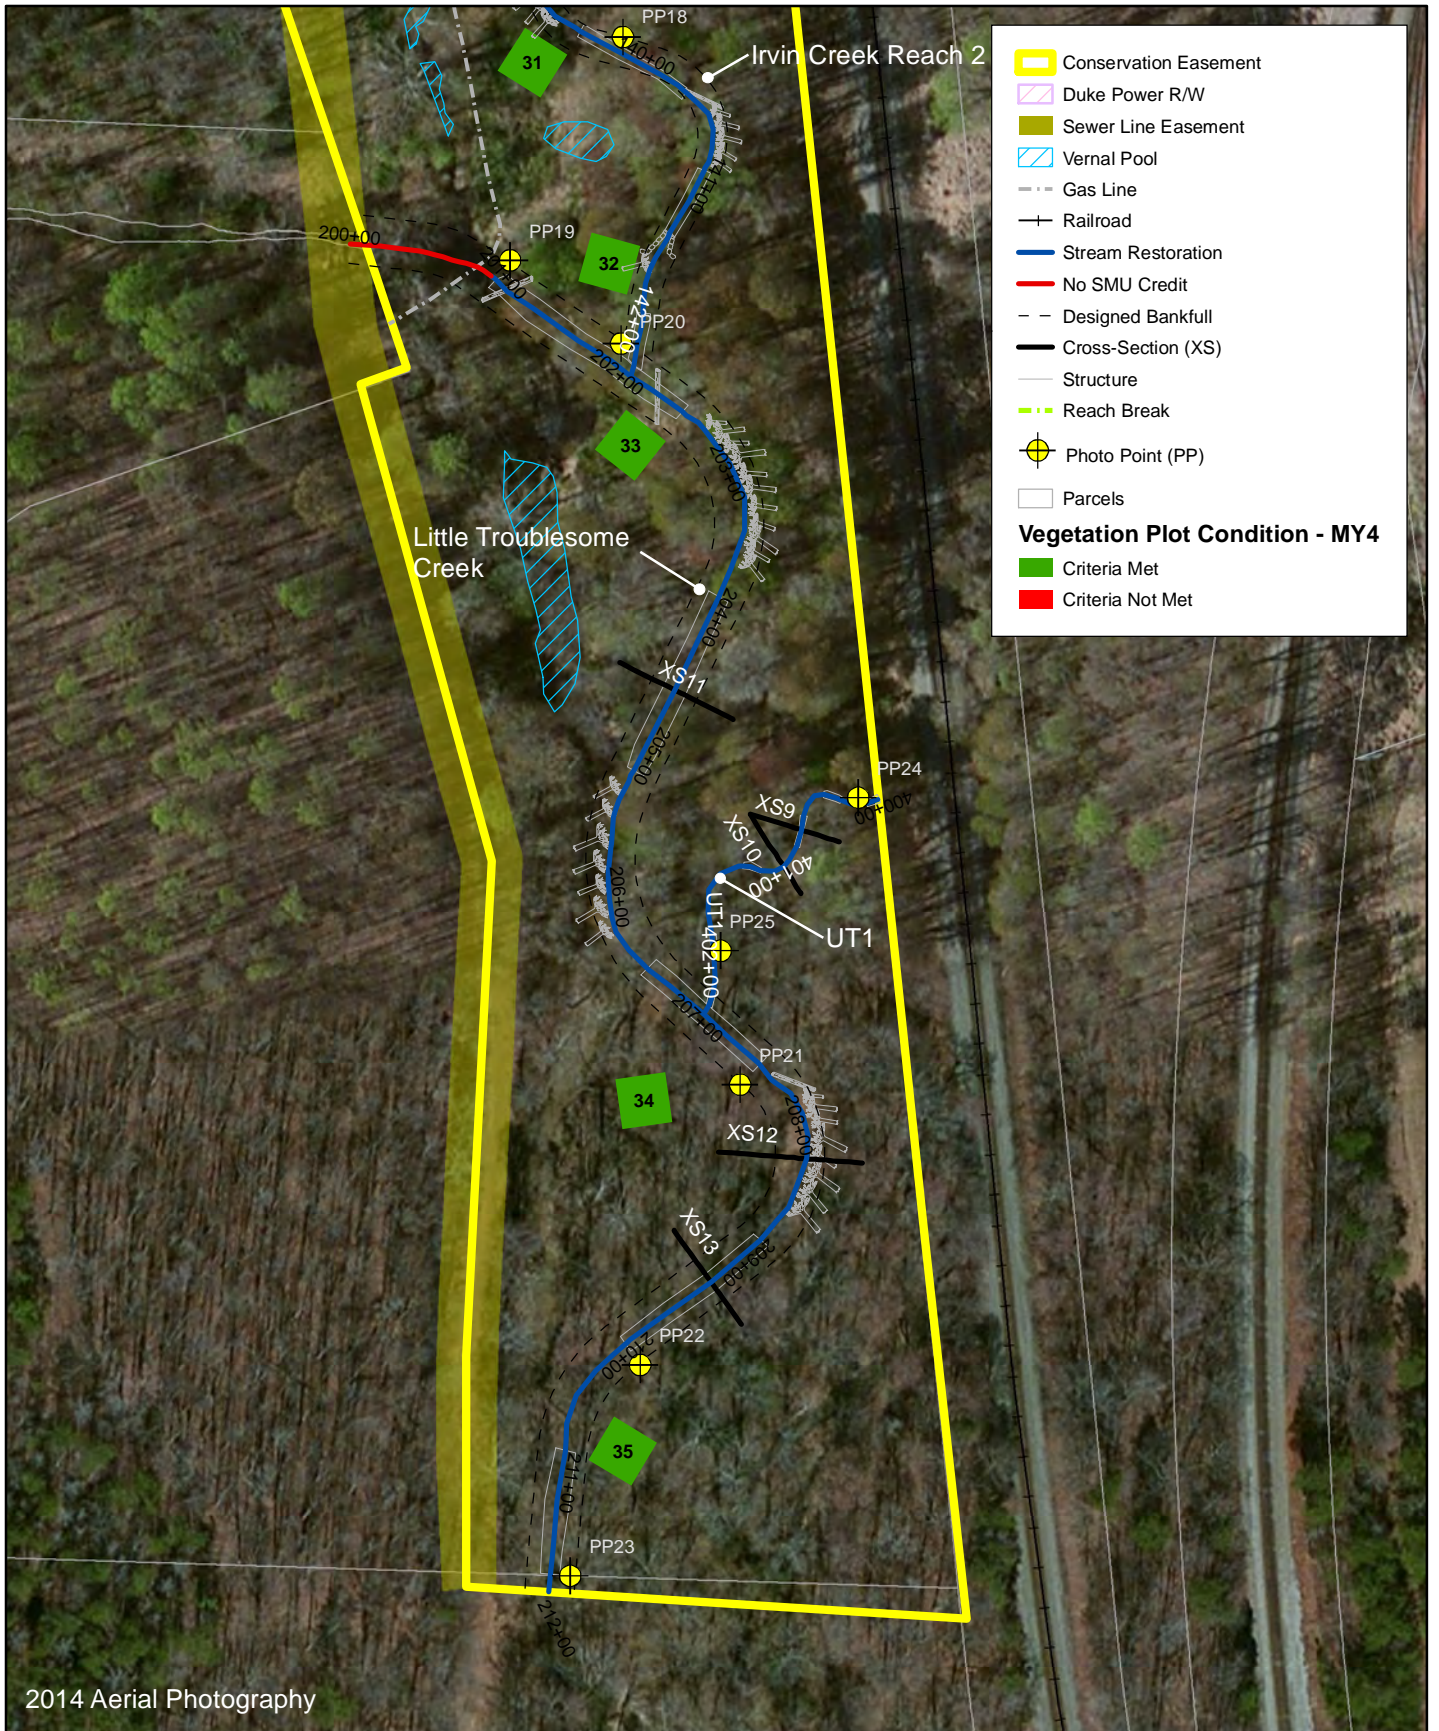
Figure 3.4 Integrated Current Condition Plan View
(Sheet 4 of 4)

Little Troublesome Creek Mitigation Site
Stream Site
NCDMS Project Number 94640
Monitoring Year 4 - 2015

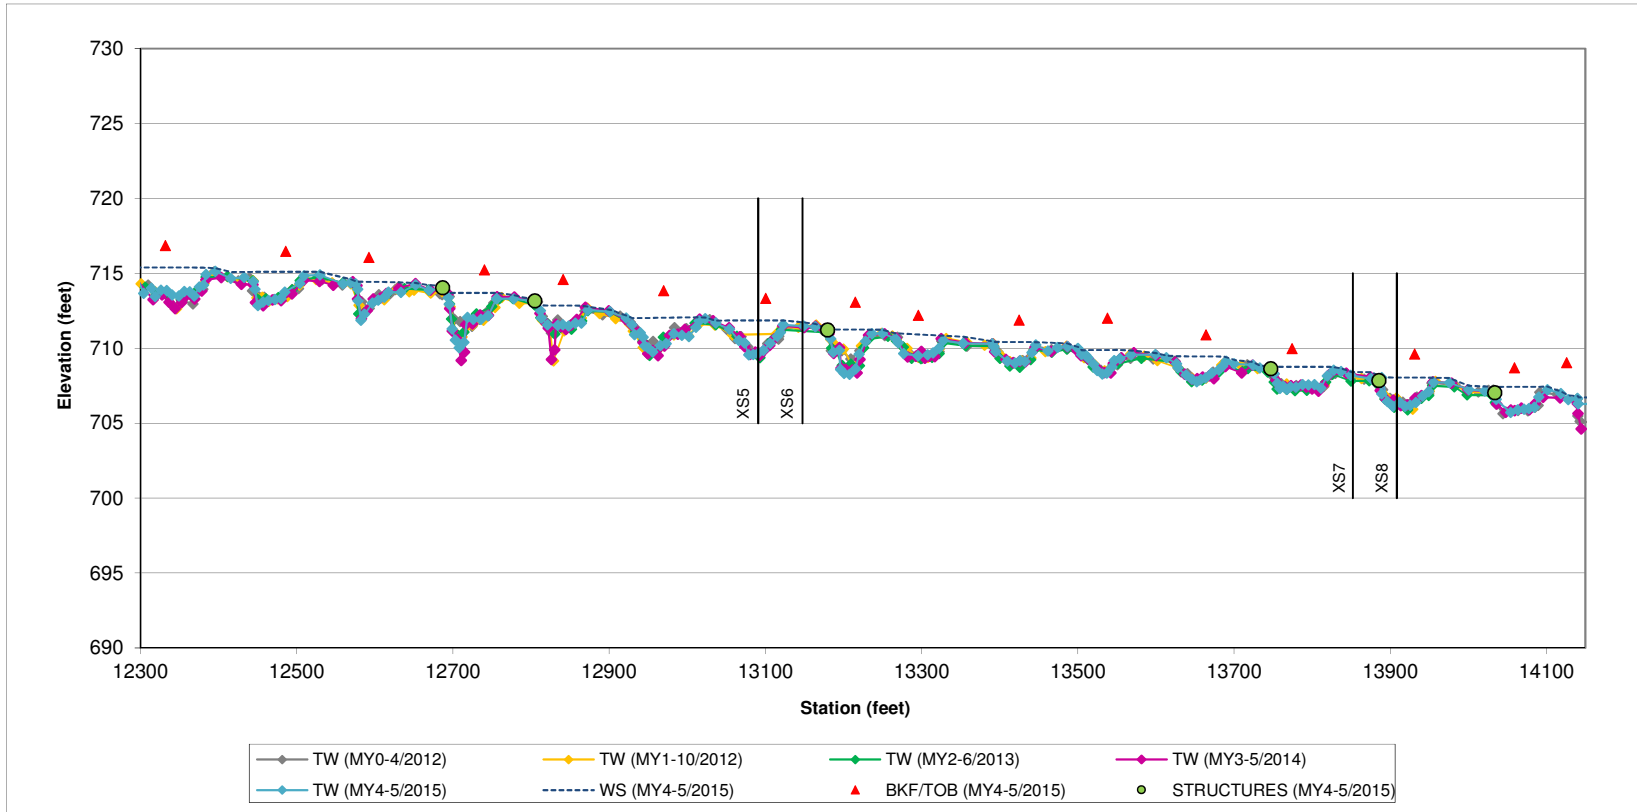
Irvin Creek Reach 2

Monitoring Year 4 - 2015

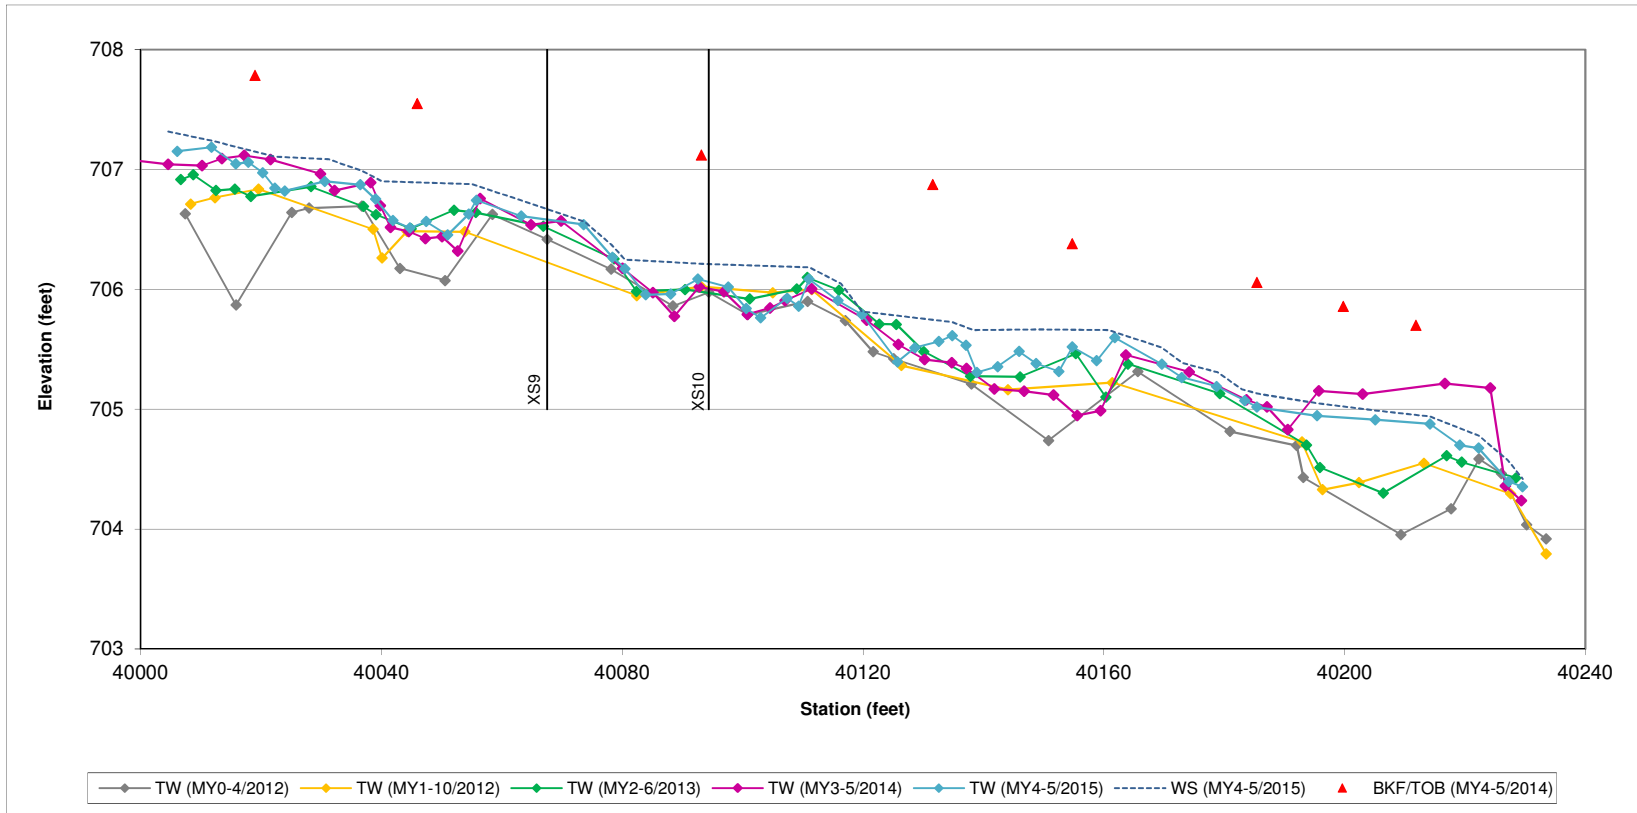
UT1

Longitudinal Profile Plots

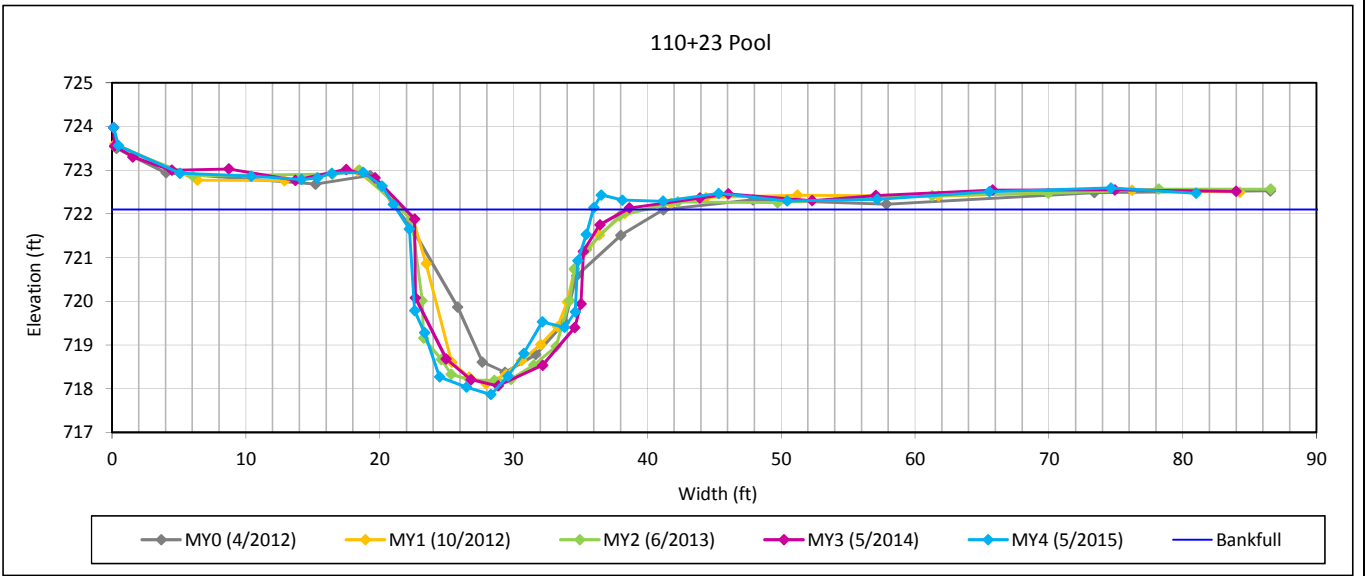
Cross Section 2 - Irvin Creek Reach 1

Bankfull Dimensions

42.7	x-section area (ft.sq.)
14.7	width (ft)
2.9	mean depth (ft)
4.2	max depth (ft)
18.8	wetted perimeter (ft)
2.3	hyd radi (ft)
5.0	width-depth ratio

Survey Date: 5/2015
 Field Crew: Wildlands Engineering

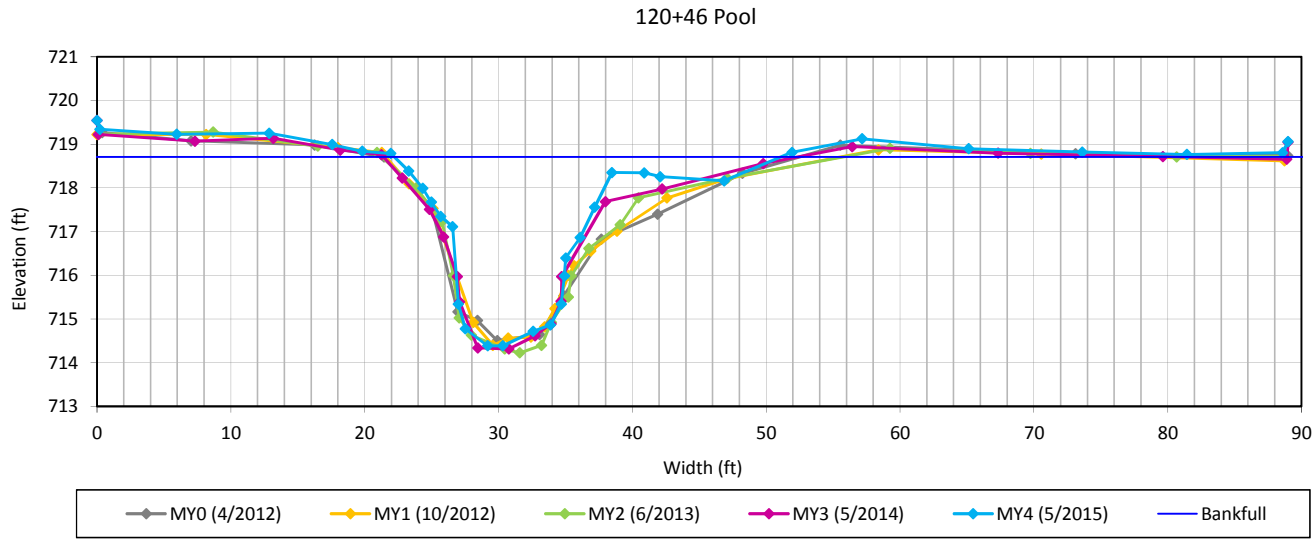
Cross Section 3 - Irvin Creek Reach 1

Bankfull Dimensions

46.4	x-section area (ft.sq.)
28.9	width (ft)
1.6	mean depth (ft)
4.3	max depth (ft)
32.4	wetted perimeter (ft)
1.4	hyd radi (ft)
18.0	width-depth ratio

Survey Date: 5/2015
 Field Crew: Wildlands Engineering

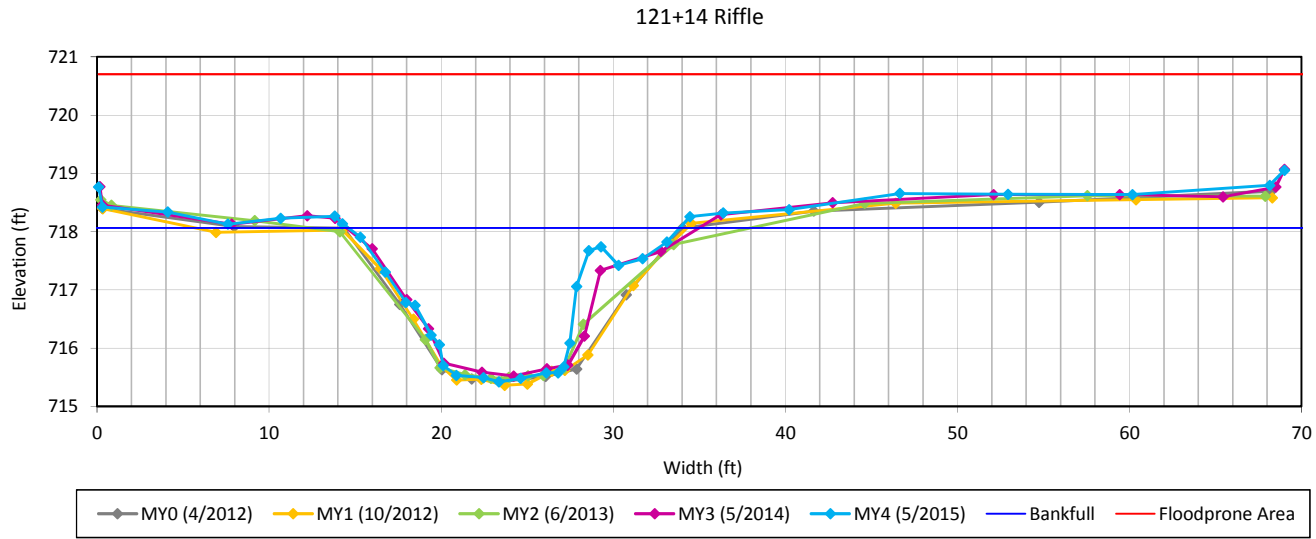
Cross Section 4 - Irvin Creek Reach 1

Bankfull Dimensions

27.3	x-section area (ft.sq.)
19.3	width (ft)
1.4	mean depth (ft)
2.6	max depth (ft)
21.1	wetted perimeter (ft)
1.3	hyd radi (ft)
13.6	width-depth ratio
200.0	W flood prone area (ft)
10.4	entrenchment ratio
1.0	low bank height ratio

Survey Date: 5/2015
 Field Crew: Wildlands Engineering
