MONITORING YEAR 4 ANNUAL REPORT Final

LITTLE TROUBLESOME CREEK MITIGATION SITE
Rockingham County, NC
NCDEQ Contract 003267
NCDMS Project Number 94640

Data Collection Period: May 2015-November 2015
Draft Submission Date: November 30, 2015
Final Submission Date: January 28, 2016

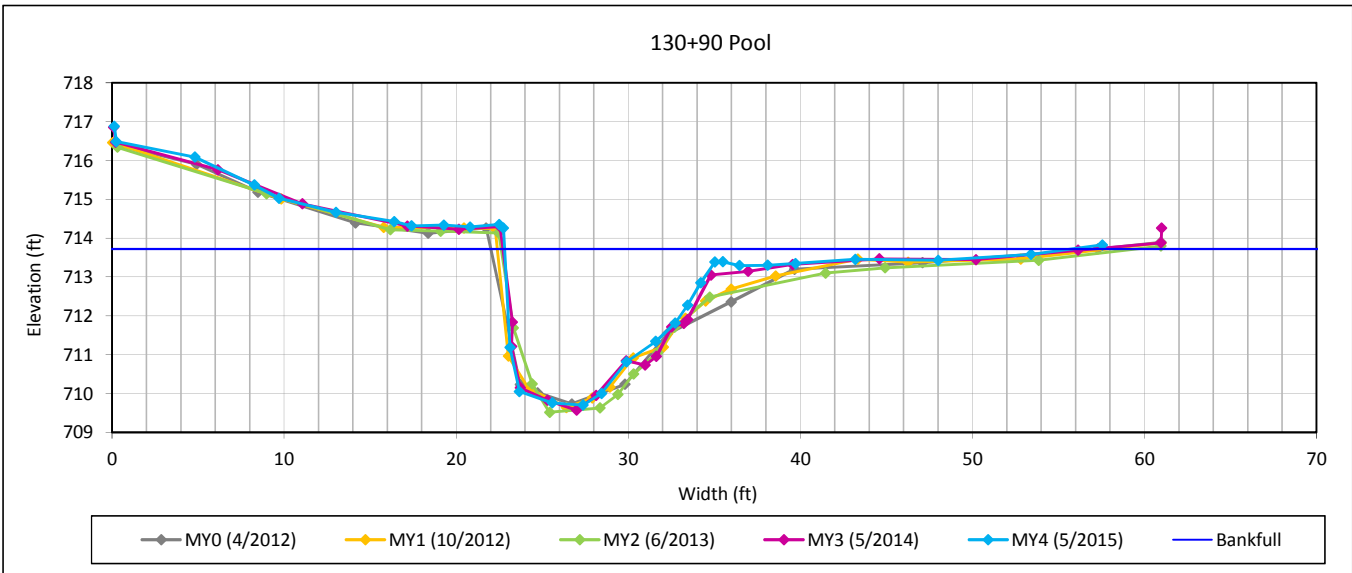
Cross Section 5 - Irvin Creek Reach 2

Bankfull Dimensions

40.6	x-section area (ft.sq.)
32.9	width (ft)
1.2	mean depth (ft)
4.0	max depth (ft)
36.8	wetted perimeter (ft)
1.1	hyd radi (ft)
26.7	width-depth ratio

Survey Date: 5/2015
 Field Crew: Wildlands Engineering

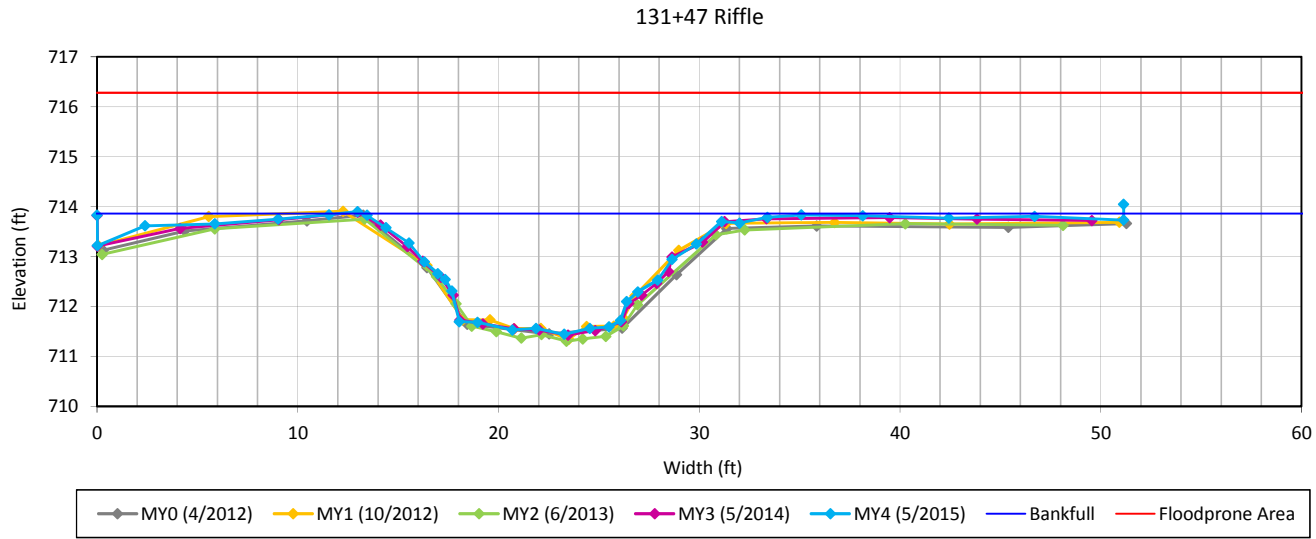
Cross Section 6 - Irvin Creek Reach 2

Bankfull Dimensions

27.1	x-section area (ft.sq.)
17.9	width (ft)
1.5	mean depth (ft)
2.4	max depth (ft)
19.0	wetted perimeter (ft)
1.4	hyd radi (ft)
11.8	width-depth ratio
200.0	W flood prone area (ft)
11.2	entrenchment ratio
1.0	low bank height ratio

Survey Date: 5/2015
 Field Crew: Wildlands Engineering

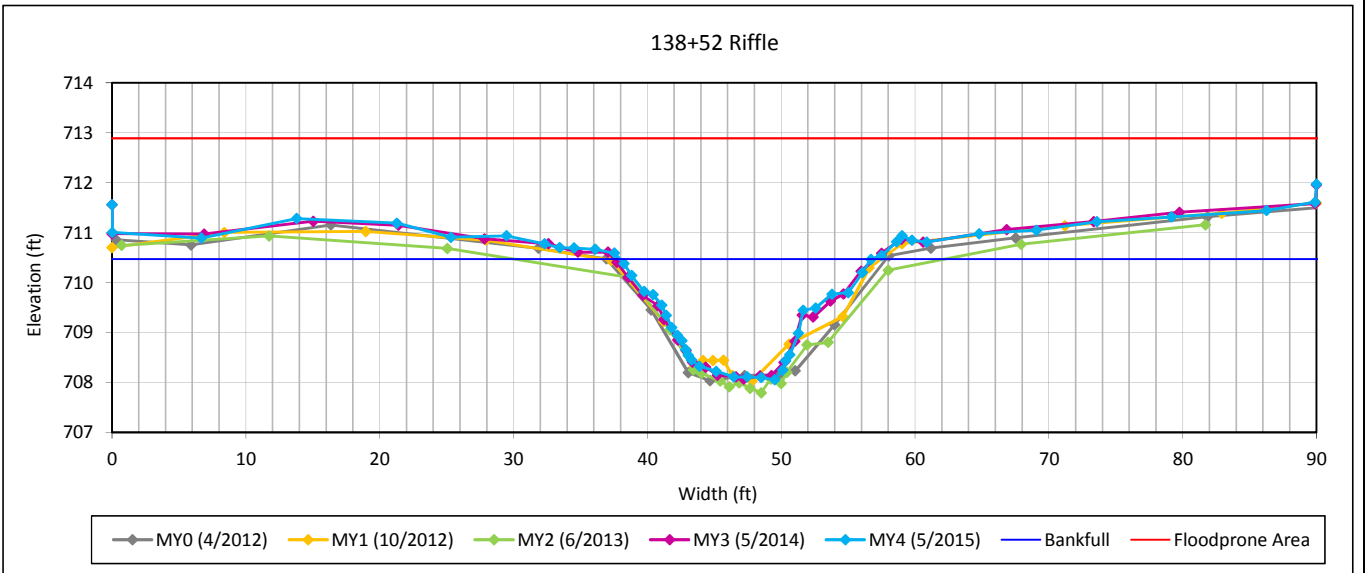
Cross Section 7 - Irvin Creek Reach 2

Bankfull Dimensions

26.6	x-section area (ft.sq.)
18.8	width (ft)
1.4	mean depth (ft)
2.4	max depth (ft)
19.9	wetted perimeter (ft)
1.3	hyd radi (ft)
13.3	width-depth ratio
200.0	W flood prone area (ft)
10.6	entrenchment ratio
1.0	low bank height ratio

Survey Date: 5/2015
 Field Crew: Wildlands Engineering

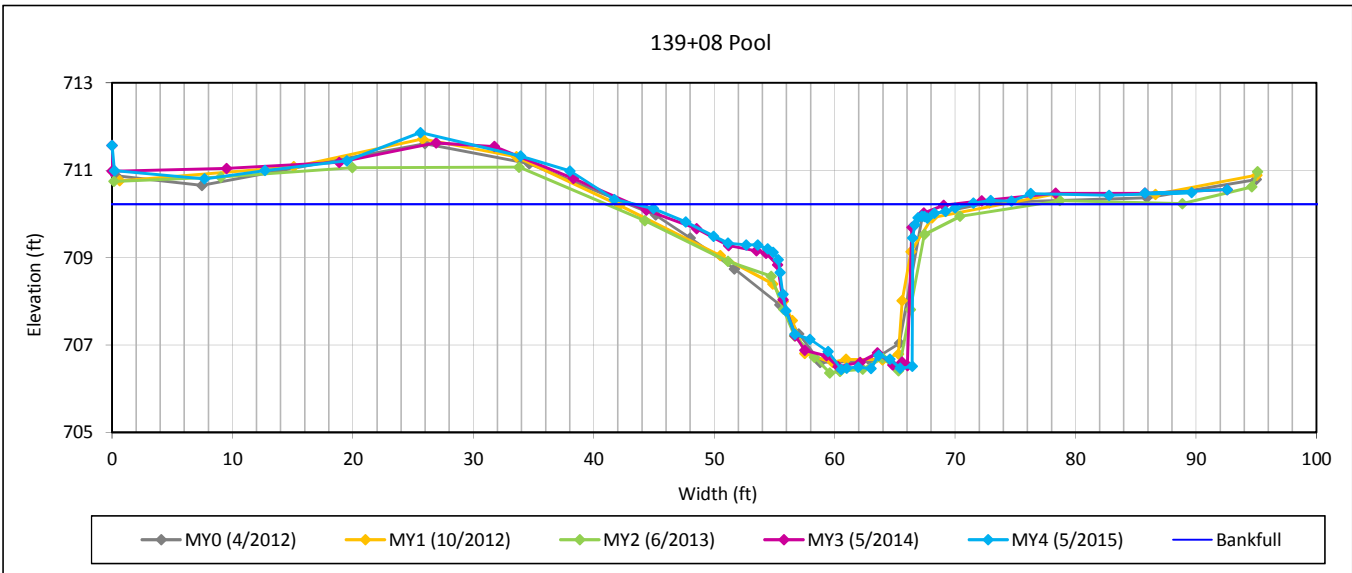
Cross Section 8 - Irvin Creek Reach 2

Bankfull Dimensions

45.5	x-section area (ft.sq.)
27.8	width (ft)
1.6	mean depth (ft)
3.8	max depth (ft)
32.1	wetted perimeter (ft)
1.4	hyd radi (ft)
16.9	width-depth ratio

Survey Date: 5/2015
 Field Crew: Wildlands Engineering

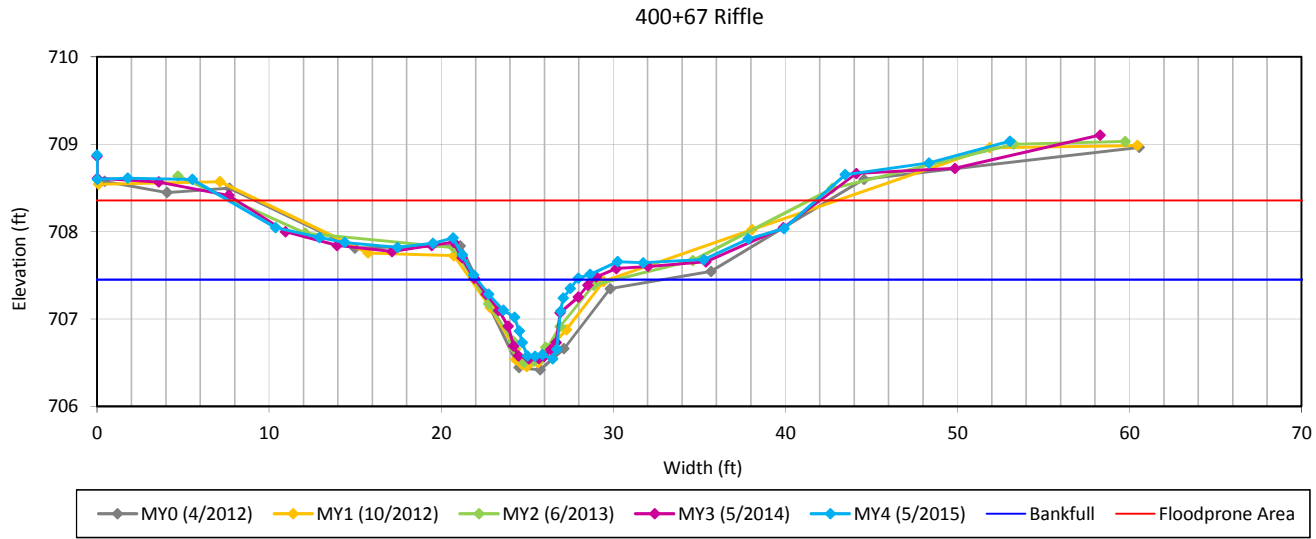
Cross Section 9 - UT1

Bankfull Dimensions

2.8	x-section area (ft.sq.)
5.8	width (ft)
0.5	mean depth (ft)
0.9	max depth (ft)
6.4	wetted perimeter (ft)
0.4	hyd radi (ft)
12.2	width-depth ratio
34.0	W flood prone area (ft)
5.9	entrenchment ratio
1.0	low bank height ratio

Survey Date: 5/2015
 Field Crew: Wildlands Engineering

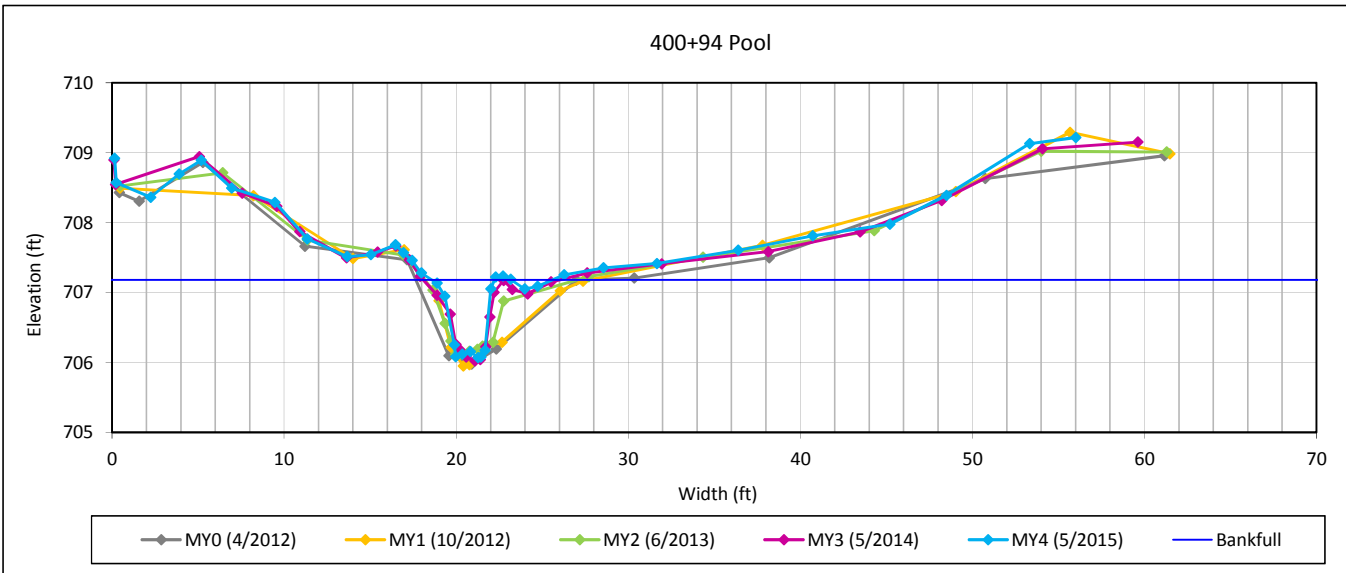
Cross Section 10 - UT1

Bankfull Dimensions

- 2.7 x-section area (ft.sq.)
- 6.0 width (ft)
- 0.4 mean depth (ft)
- 1.1 max depth (ft)
- 7.2 wetted perimeter (ft)
- 0.4 hyd radi (ft)
- 13.5 width-depth ratio

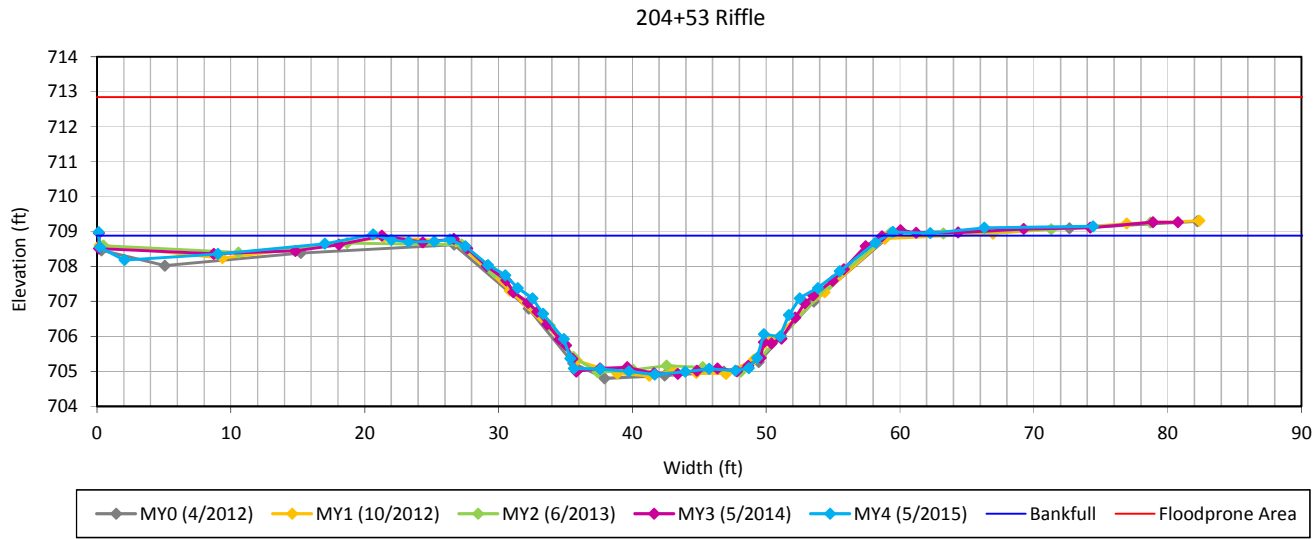
Cross Section 11 - Little Troublesome Creek

Bankfull Dimensions

80.7	x-section area (ft.sq.)
32.6	width (ft)
2.5	mean depth (ft)
4.0	max depth (ft)
34.6	wetted perimeter (ft)
2.3	hyd radi (ft)
13.2	width-depth ratio
200.0	W flood prone area (ft)
6.1	entrenchment ratio
1.0	low bank height ratio

Survey Date: 5/2015
 Field Crew: Wildlands Engineering

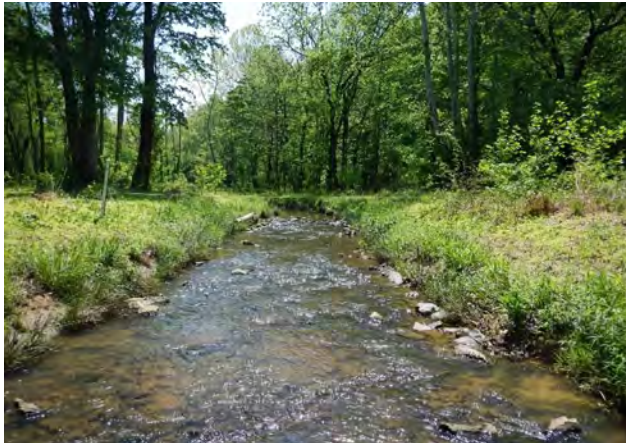
View Downstream

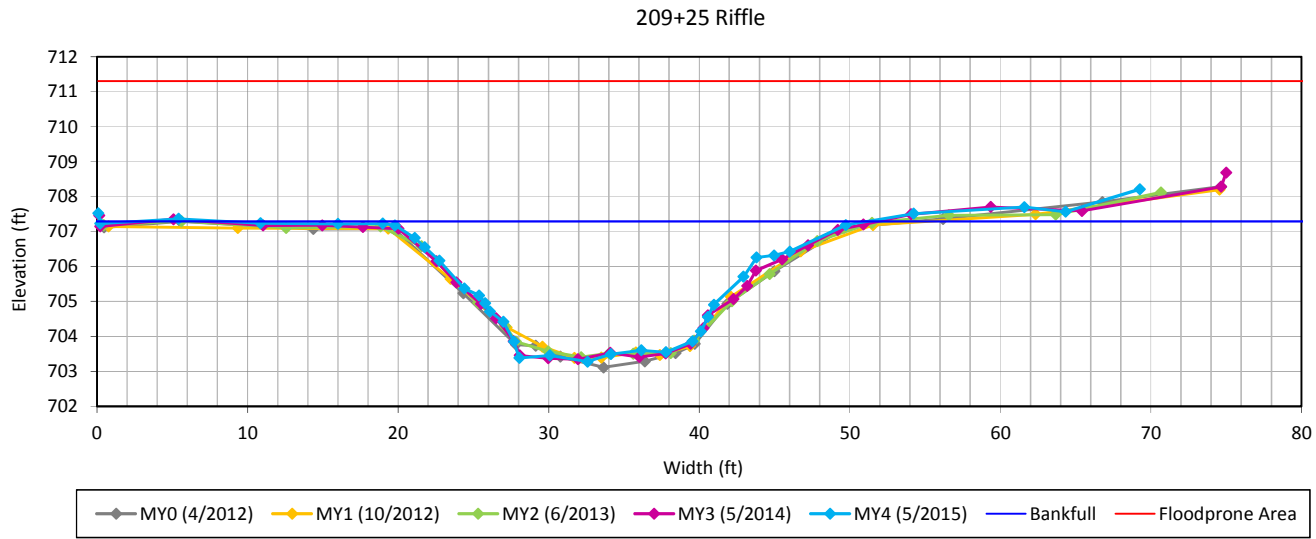
Cross Section 13 - Little Troublesome Creek

Bankfull Dimensions

70.7	x-section area (ft.sq.)
31.4	width (ft)
2.3	mean depth (ft)
4.0	max depth (ft)
33.2	wetted parimeter (ft)
2.1	hyd radi (ft)
13.9	width-depth ratio
200.0	W flood prone area (ft)
6.4	entrenchment ratio
1.0	low bank height ratio

Survey Date: 5/2015
 Field Crew: Wildlands Engineering

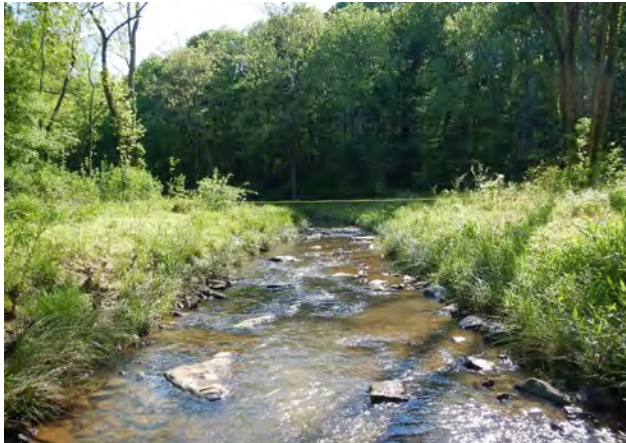
View Downstream

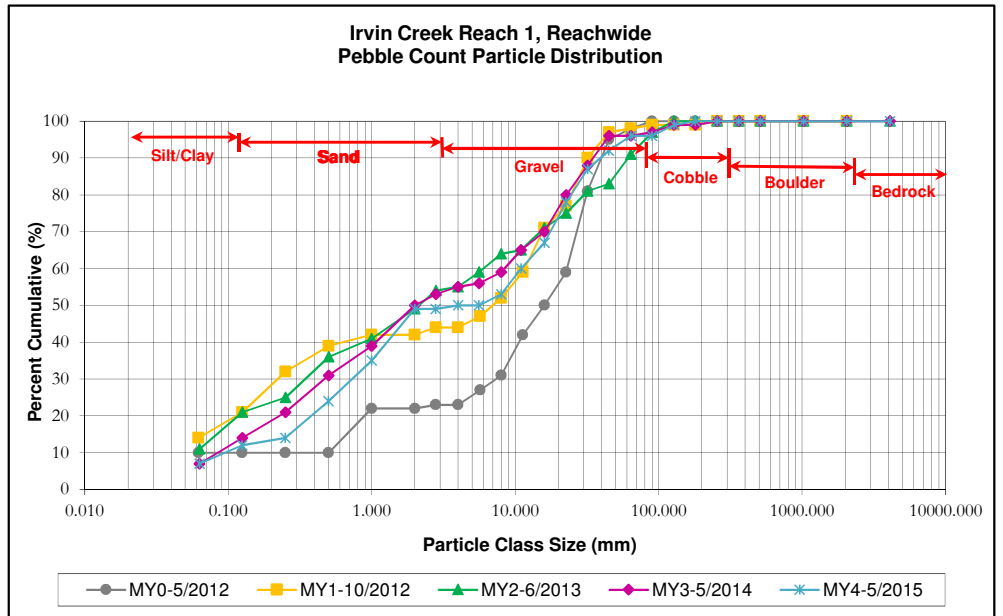
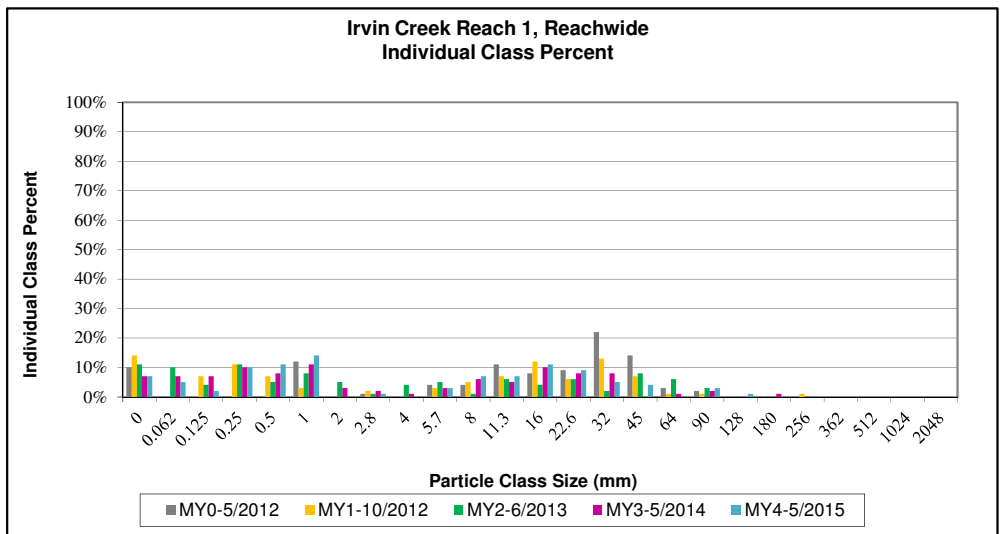
Particle Class		Diameter (mm)		Particle Count			Irvin Creek Reach 1 Summary	
		min	max	Riffle	Pool	Total	Class Percentage	Percent Cumulative
SILT/CLAY	Silt/Clay	0.000	0.062		7	7	7	7
SAND	Very fine	0.062	0.125		5	5	5	12
	Fine	0.125	0.250		2	2	2	14
	Medium	0.250	0.500	1	9	10	10	24
	Coarse	0.5	1.0	1	10	11	11	35
	Very Coarse	1.0	2.0	4	10	14	14	49
GRAVEL	Very Fine	2.0	2.8					49
	Very Fine	2.8	4.0	1	1	1	1	50
	Fine	4.0	5.7					50
	Fine	5.7	8.0	3	3	3	3	53
	Medium	8.0	11.3	6	1	7	7	60
	Medium	11.3	16.0	4	3	7	7	67
	Coarse	16.0	22.6	11		11	11	78
	Coarse	22.6	32	7	2	9	9	87
	Very Coarse	32	45	5		5	5	92
Very Coarse	45	64	4		4	4	96	
COBBLE	Small	64	90					96
	Small	90	128	3	3	3	3	99
	Large	128	180	1	1	1	1	100
	Large	180	256					100
BOULDER	Small	256	362					100
	Small	362	512					100
	Medium	512	1024					100
	Large/Very Large	1024	2048					100
BEDROCK	Bedrock	2048	>2048					100
Total				50	50	100	100	100

Reachwide Channel materials (mm)	
D ₁₆ =	0.29
D ₃₅ =	1.00
D ₅₀ =	4.0
D ₈₄ =	28.5
D ₉₅ =	58.6
D ₁₀₀ =	180.0

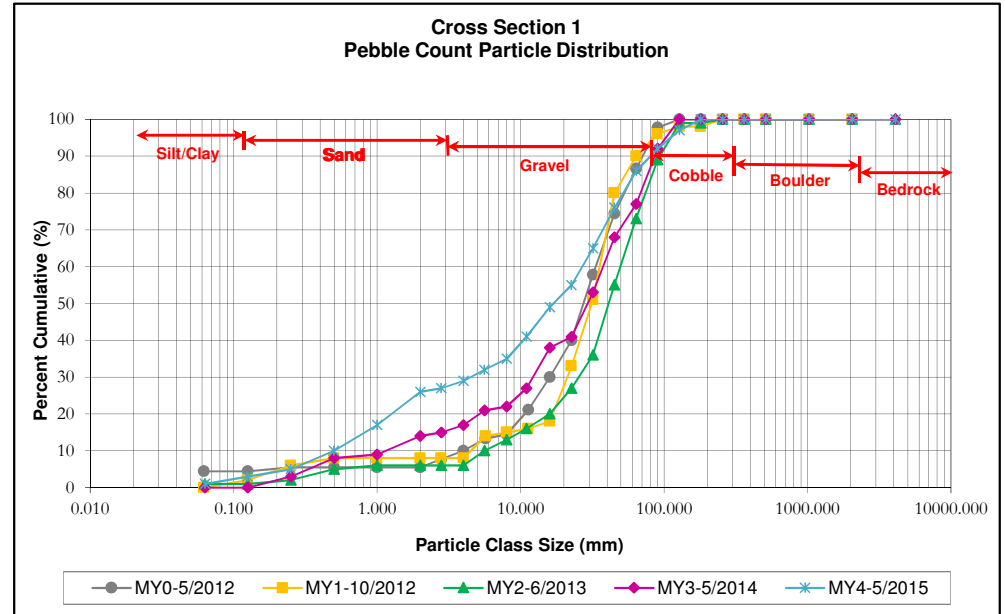
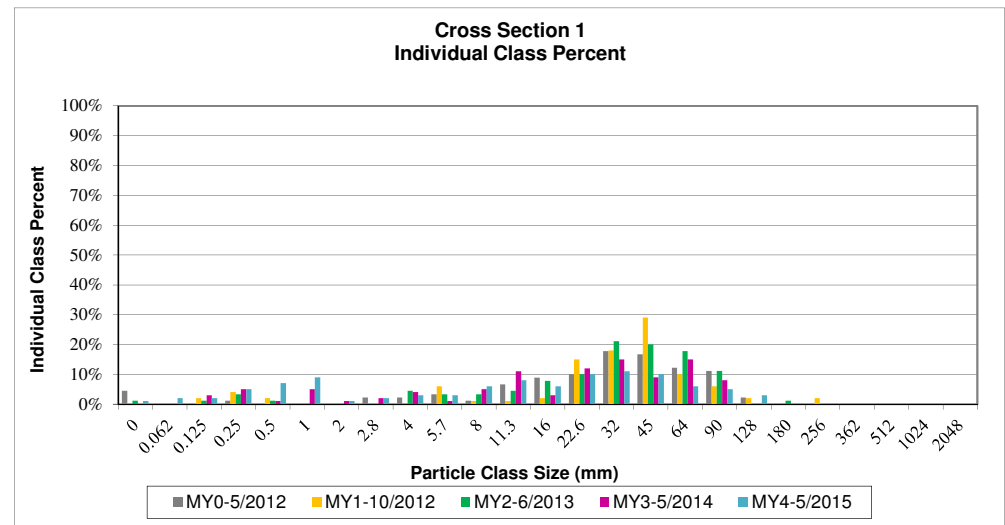
Particle Class		Diameter (mm)		Particle Count	Cross Section 1 Summary	
		min	max		Class Percentage	Percent Cumulative
SILT/CLAY	Silt/Clay	0.000	0.062	1	1	1
SAND	Very fine	0.062	0.125	2	2	3
	Fine	0.125	0.250	2	2	5
	Medium	0.250	0.500	5	5	10
	Coarse	0.5	1.0	7	7	17
	Very Coarse	1.0	2.0	9	9	26
GRAVEL	Very Fine	2.0	2.8	1	1	27
	Very Fine	2.8	4.0	2	2	29
	Fine	4.0	5.7	3	3	32
	Fine	5.7	8.0	3	3	35
	Medium	8.0	11.3	6	6	41
	Medium	11.3	16.0	8	8	49
	Coarse	16.0	22.6	6	6	55
	Coarse	22.6	32	10	10	65
	Very Coarse	32	45	11	11	76
	Very Coarse	45	64	10	10	86
COBBLE	Small	64	90	6	6	92
	Small	90	128	5	5	97
	Large	128	180	3	3	100
	Large	180	256			100
BOULDER	Small	256	362			100
	Small	362	512			100
	Medium	512	1024			100
	Large/Very Large	1024	2048			100
BEDROCK	Bedrock	2048	>2048			100
Total				100	100	100

Cross Section 1 Channel materials (mm)	
D ₁₆ =	0.9
D ₃₅ =	8.0
D ₅₀ =	16.9
D ₈₄ =	59.6
D ₉₅ =	111.2
D ₁₀₀ =	180.0

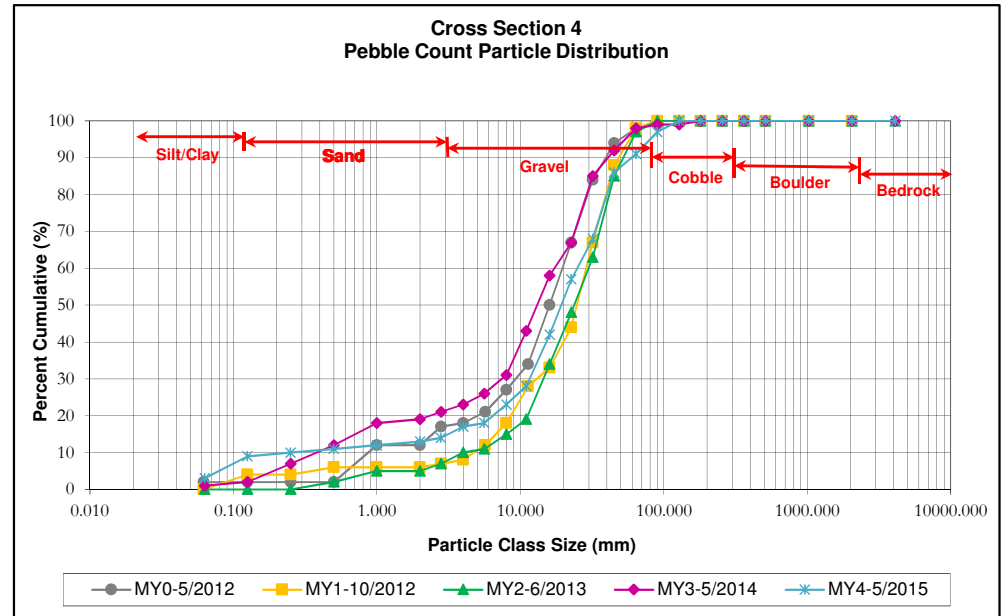
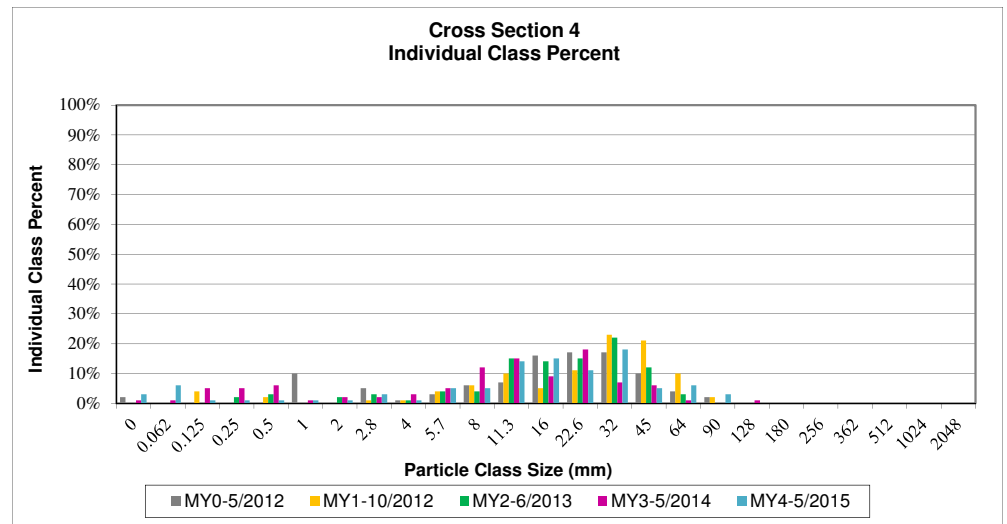
Particle Class		Diameter (mm)		Particle Count	Cross Section 4 Summary	
		min	max		Class Percentage	Percent Cumulative
<i>SILT/CLAY</i>	Silt/Clay	0.000	0.062	3	3	3
<i>SAND</i>	Very fine	0.062	0.125	6	6	9
	Fine	0.125	0.250	1	1	10
	Medium	0.250	0.500	1	1	11
	Coarse	0.5	1.0	1	1	12
	Very Coarse	1.0	2.0	1	1	13
<i>GRAVEL</i>	Very Fine	2.0	2.8	1	1	14
	Very Fine	2.8	4.0	3	3	17
	Fine	4.0	5.7	1	1	18
	Fine	5.7	8.0	5	5	23
	Medium	8.0	11.3	5	5	28
	Medium	11.3	16.0	14	14	42
	Coarse	16.0	22.6	15	15	57
	Coarse	22.6	32	11	11	68
	Very Coarse	32	45	18	18	86
	Very Coarse	45	64	5	5	91
<i>COBBLE</i>	Small	64	90	6	6	97
	Small	90	128	3	3	100
	Large	128	180			100
	Large	180	256			100
<i>BOULDER</i>	Small	256	362			100
	Small	362	512			100
	Medium	512	1024			100
	Large/Very Large	1024	2048			100
<i>BEDROCK</i>	Bedrock	2048	>2048			100
Total				100	100	100

Cross Section 4 Channel materials (mm)	
D ₁₆ =	3.6
D ₃₅ =	13.3
D ₅₀ =	19.2
D ₈₄ =	43.3
D ₉₅ =	80.3
D ₁₀₀ =	128.0

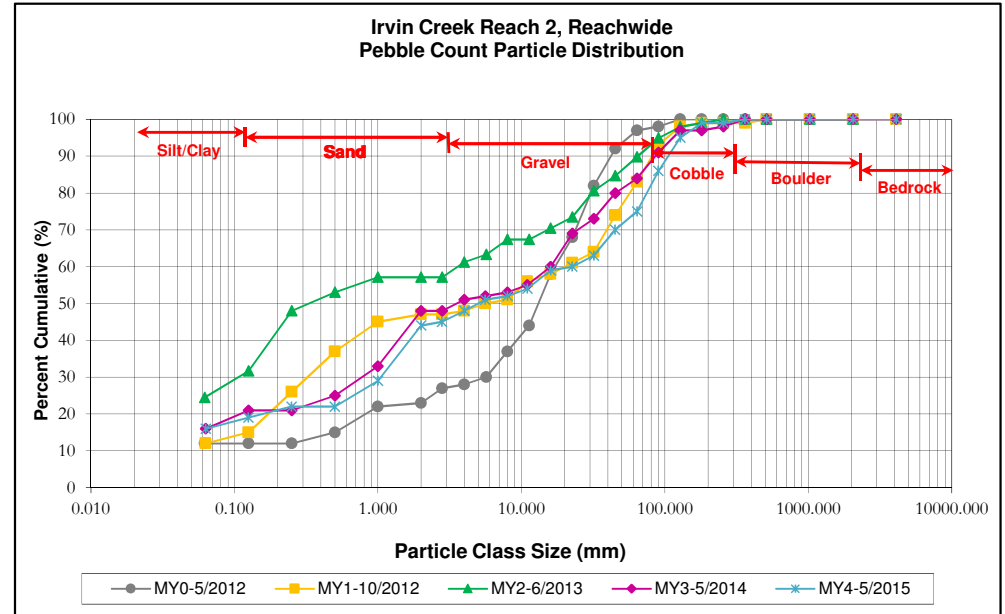
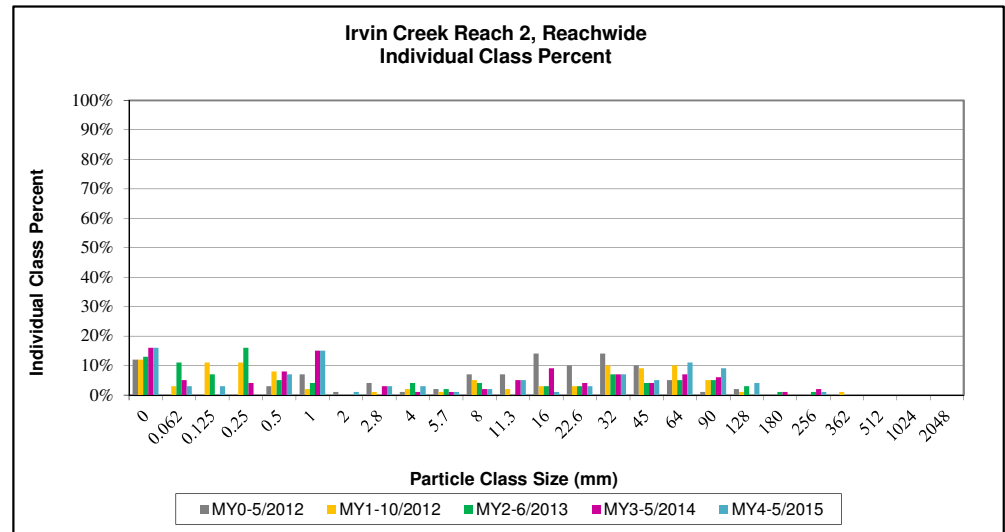
Particle Class		Diameter (mm)		Particle Count			Irvin Creek Reach 2 Summary	
		min	max	Riffle	Pool	Total	Class Percentage	Percent Cumulative
SILT/CLAY	Silt/Clay	0.000	0.062	1	15	16	16	16
SAND	Very fine	0.062	0.125		3	3	3	19
	Fine	0.125	0.250		3	3	3	22
	Medium	0.250	0.500					22
	Coarse	0.5	1.0		7	7	7	29
	Very Coarse	1.0	2.0	3	12	15	15	44
GRAVEL	Very Fine	2.0	2.8		1	1	1	45
	Very Fine	2.8	4.0	1	2	3	3	48
	Fine	4.0	5.7	2	1	3	3	51
	Fine	5.7	8.0		1	1	1	52
	Medium	8.0	11.3	2		2	2	54
	Medium	11.3	16.0	4	1	5	5	59
	Coarse	16.0	22.6	1		1	1	60
	Coarse	22.6	32	3		3	3	63
	Very Coarse	32	45	5	2	7	7	70
	Very Coarse	45	64	5		5	5	75
COBBLE	Small	64	90	10	1	11	11	86
	Small	90	128	9		9	9	95
	Large	128	180	4		4	4	99
	Large	180	256					99
BOULDER	Small	256	362	1		1	1	100
	Small	362	512					100
	Medium	512	1024					100
	Large/Very Large	1024	2048					100
BEDROCK	Bedrock	2048	>2048					100
Total				51	49	100	100	100

Reachwide Channel materials (mm)	
D ₁₆ =	Silt/Clay
D ₃₅ =	1.3
D ₅₀ =	5.0
D ₈₄ =	84.6
D ₉₅ =	128.0
D ₁₀₀ =	362.0

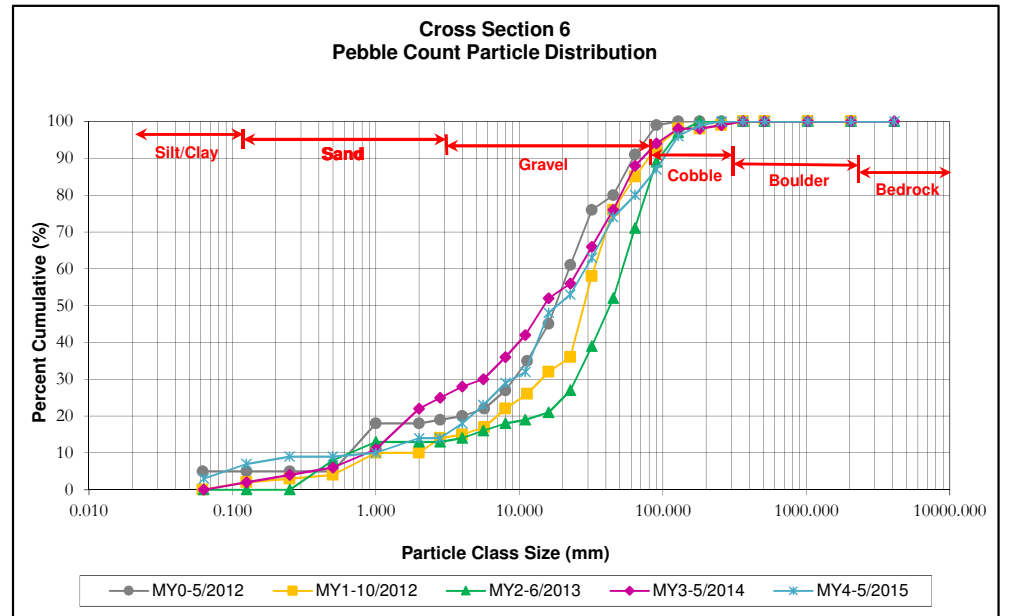
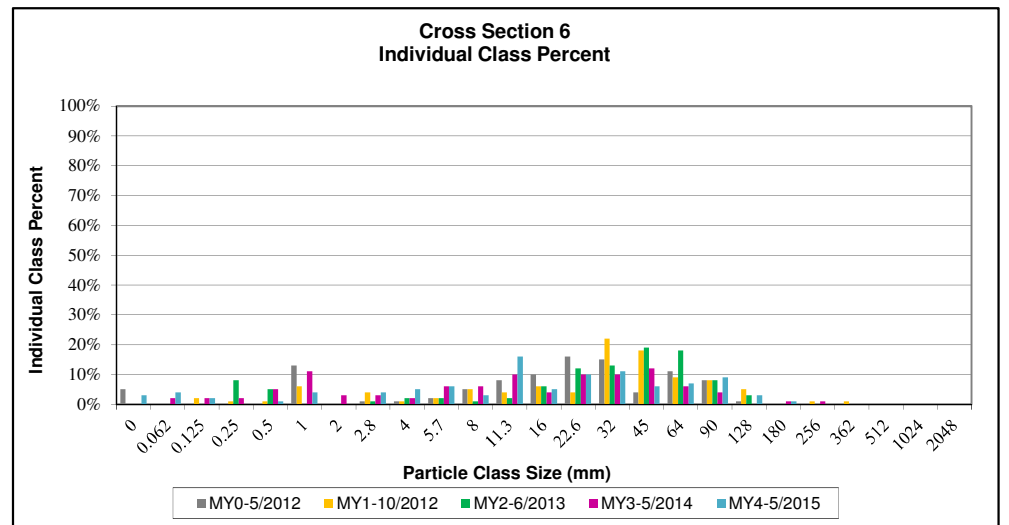
Particle Class		Diameter (mm)		Particle Count	Cross Section 6 Summary	
		min	max		Class Percentage	Percent Cumulative
<i>SILT/CLAY</i>	Silt/Clay	0.000	0.062	3	3	3
<i>SAND</i>	Very fine	0.062	0.125	4	4	7
	Fine	0.125	0.250	2	2	9
	Medium	0.250	0.500			9
	Coarse	0.5	1.0	1	1	10
	Very Coarse	1.0	2.0	4	4	14
<i>GRAVEL</i>	Very Fine	2.0	2.8			14
	Very Fine	2.8	4.0	4	4	18
	Fine	4.0	5.7	5	5	23
	Fine	5.7	8.0	6	6	29
	Medium	8.0	11.3	3	3	32
	Medium	11.3	16.0	16	16	48
	Coarse	16.0	22.6	5	5	53
	Coarse	22.6	32	10	10	63
	Very Coarse	32	45	11	11	74
Very Coarse	45	64	6	6	80	
<i>COBBLE</i>	Small	64	90	7	7	87
	Small	90	128	9	9	96
	Large	128	180	3	3	99
	Large	180	256	1	1	100
<i>BOULDER</i>	Small	256	362			100
	Small	362	512			100
	Medium	512	1024			100
	Large/Very Large	1024	2048			100
<i>BEDROCK</i>	Bedrock	2048	>2048			100
Total				100	100	100

Cross Section 6	
Channel materials (mm)	
D ₁₆ =	3.3
D ₃₅ =	11.8
D ₅₀ =	18.4
D ₈₄ =	77.8
D ₉₅ =	123.1
D ₁₀₀ =	256.0

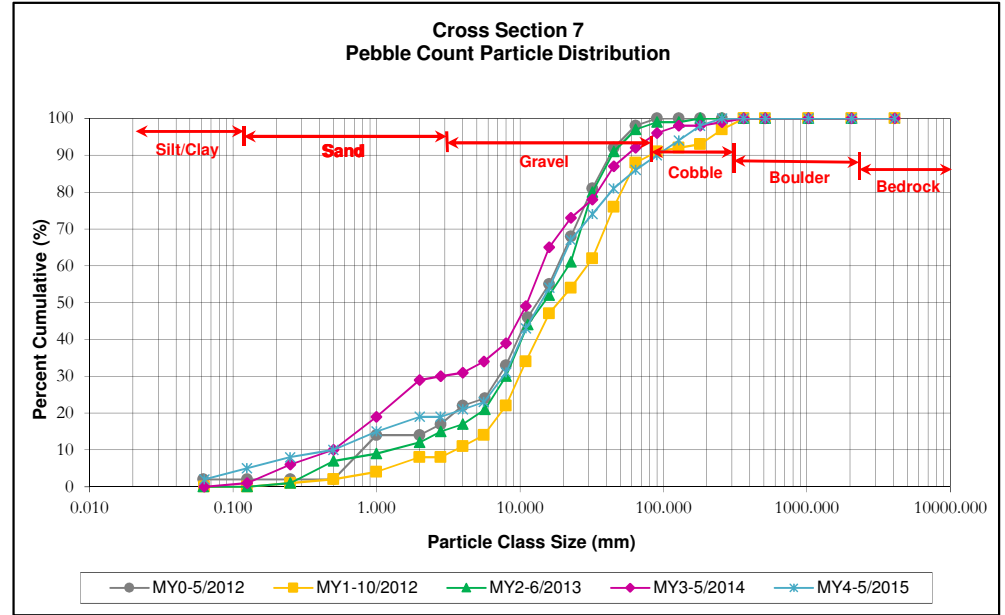
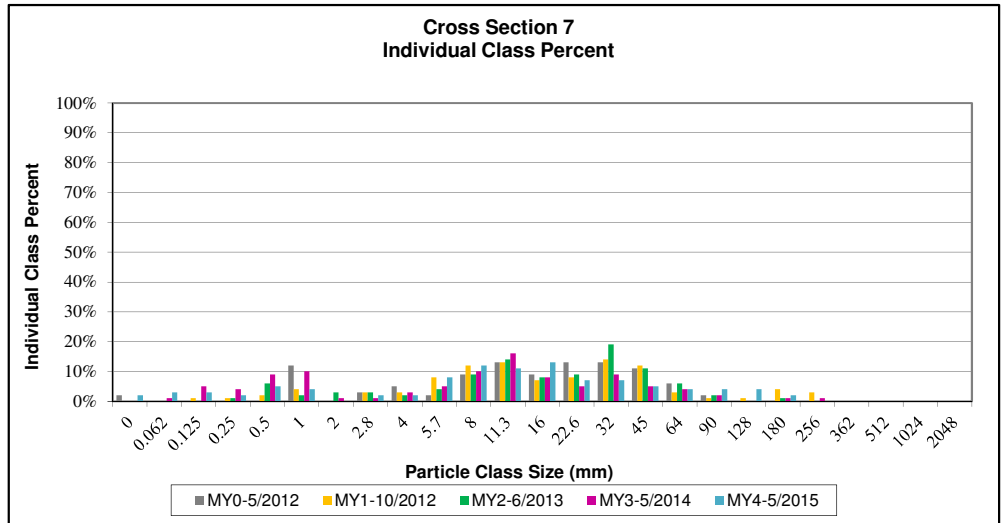
Particle Class		Diameter (mm)		Particle Count	Cross Section 7 Summary	
		min	max		Class Percentage	Percent Cumulative
SILT/CLAY	Silt/Clay	0.000	0.062	2	2	2
SAND	Very fine	0.062	0.125	3	3	5
	Fine	0.125	0.250	3	3	8
	Medium	0.250	0.500	2	2	10
	Coarse	0.5	1.0	5	5	15
	Very Coarse	1.0	2.0	4	4	19
GRAVEL	Very Fine	2.0	2.8			19
	Very Fine	2.8	4.0	2	2	21
	Fine	4.0	5.7	2	2	23
	Fine	5.7	8.0	8	8	31
	Medium	8.0	11.3	12	12	43
	Medium	11.3	16.0	11	11	54
	Coarse	16.0	22.6	13	13	67
	Coarse	22.6	32	7	7	74
	Very Coarse	32	45	7	7	81
	Very Coarse	45	64	5	5	86
COBBLE	Small	64	90	4	4	90
	Small	90	128	4	4	94
	Large	128	180	4	4	98
	Large	180	256	2	2	100
BOULDER	Small	256	362			100
	Small	362	512			100
	Medium	512	1024			100
	Large/Very Large	1024	2048			100
BEDROCK	Bedrock	2048	>2048			100
Total				100	100	100

Cross Section 7 Channel materials (mm)	
D ₁₆ =	1.2
D ₃₅ =	8.9
D ₅₀ =	14.0
D ₈₄ =	55.6
D ₉₅ =	139.4
D ₁₀₀ =	256.0

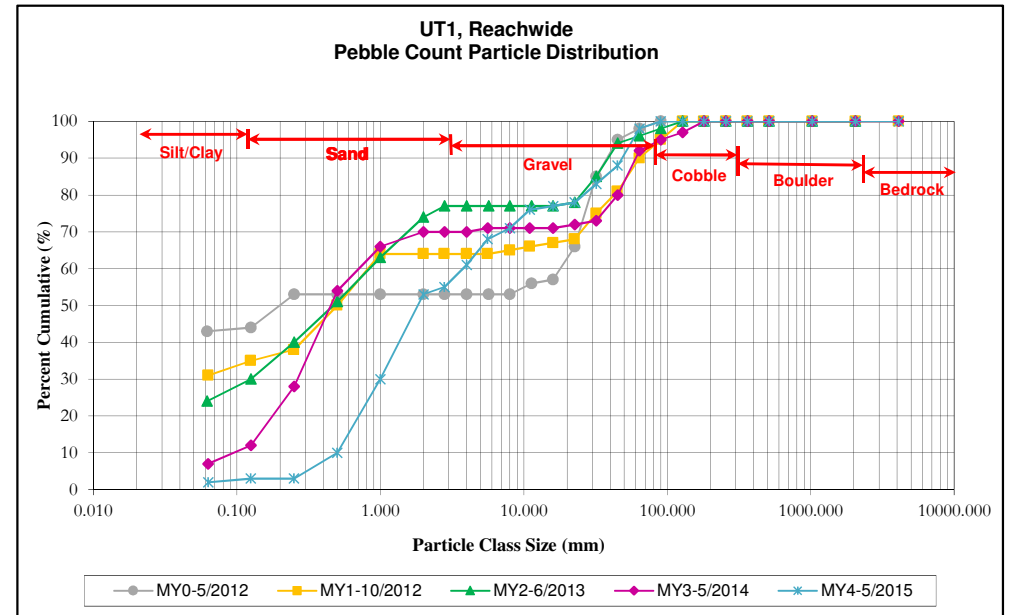
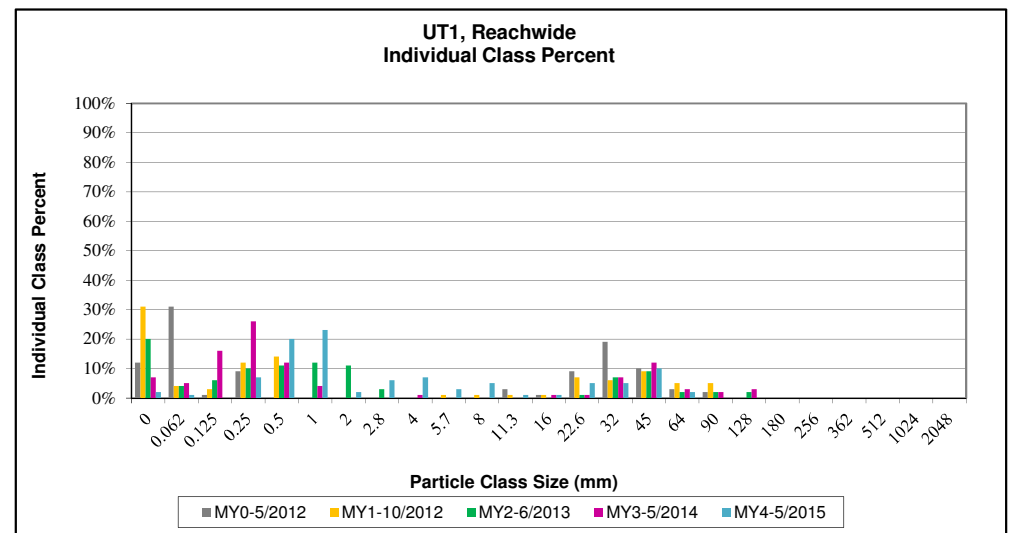
Particle Class		Diameter (mm)		Particle Count			UT1 Summary	
		min	max	Riffle	Pool	Total	Class Percentage	Percent Cumulative
SILT/CLAY	Silt/Clay	0.000	0.062		2	2	2	2
SAND	Very fine	0.062	0.125		1	1	1	3
	Fine	0.125	0.250					3
	Medium	0.250	0.500	1	6	7	7	10
	Coarse	0.5	1.0	3	17	20	20	30
	Very Coarse	1.0	2.0	8	15	23	23	53
GRAVEL	Very Fine	2.0	2.8	1	1	2	2	55
	Very Fine	2.8	4.0	3	3	6	6	61
	Fine	4.0	5.7	2	5	7	7	68
	Fine	5.7	8.0	3		3	3	71
	Medium	8.0	11.3	5		5	5	76
	Medium	11.3	16.0	1		1	1	77
	Coarse	16.0	22.6	1		1	1	78
	Coarse	22.6	32	5		5	5	83
	Very Coarse	32	45	5		5	5	88
	Very Coarse	45	64	10		10	10	98
COBBLE	Small	64	90	2		2	2	100
	Small	90	128					100
	Large	128	180					100
	Large	180	256					100
BOULDER	Small	256	362					100
	Small	362	512					100
	Medium	512	1024					100
	Large/Very Large	1024	2048					100
BEDROCK	Bedrock	2048	>2048					100
Total				50	50	100	100	100

Reachwide Channel materials (mm)	
D ₁₆ =	0.6
D ₃₅ =	1.2
D ₅₀ =	1.8
D ₈₄ =	34.3
D ₉₅ =	57.6
D ₁₀₀ =	90.0

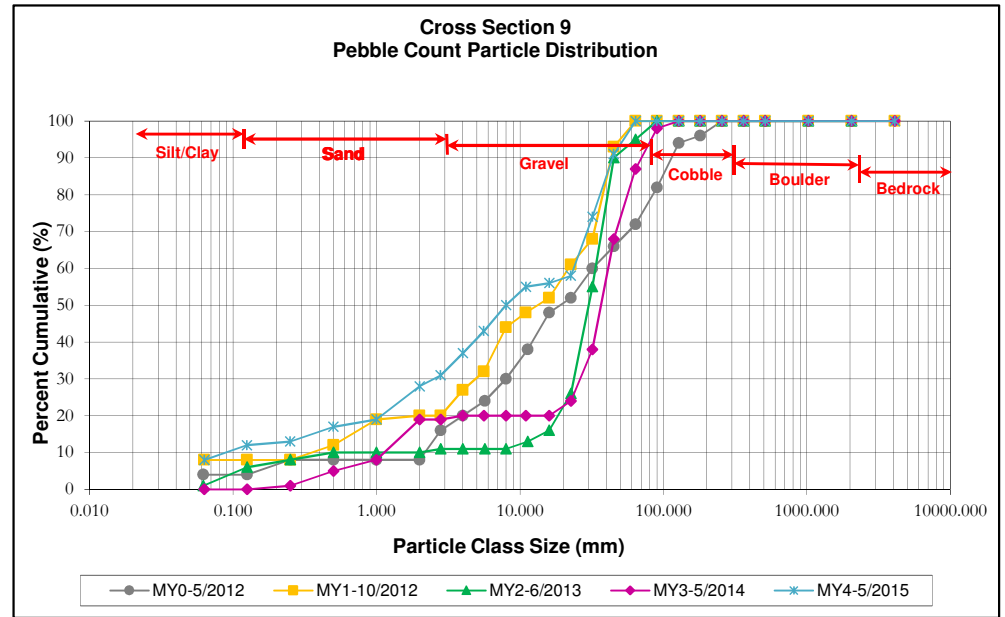
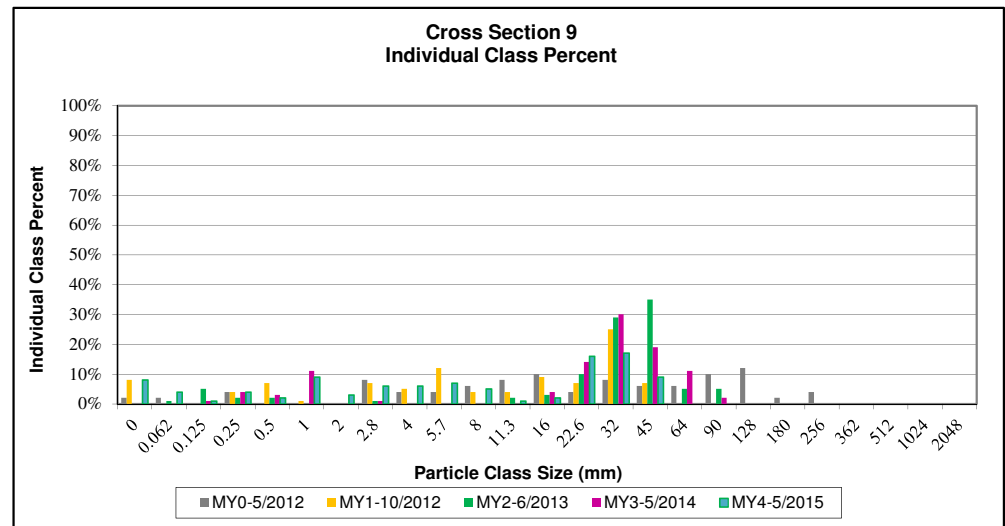
Particle Class		Diameter (mm)		Particle Count	Cross Section 9 Summary	
		min	max		Total	Class Percentage
SILT/CLAY	Silt/Clay	0.000	0.062			0
SAND	Very fine	0.062	0.125			0
	Fine	0.125	0.250	1	1	1
	Medium	0.250	0.500	4	4	5
	Coarse	0.5	1.0	3	3	8
	Very Coarse	1.0	2.0	11	11	19
GRAVEL	Very Fine	2.0	2.8			19
	Very Fine	2.8	4.0	1	1	20
	Fine	4.0	5.7			20
	Fine	5.7	8.0			20
	Medium	8.0	11.3			20
	Medium	11.3	16.0			20
	Coarse	16.0	22.6	4	4	24
	Coarse	22.6	32	14	14	38
	Very Coarse	32	45	30	30	68
	Very Coarse	45	64	19	19	87
COBBLE	Small	64	90	11	11	98
	Small	90	128	2	2	100
	Large	128	180			100
	Large	180	256			100
BOULDER	Small	256	362			100
	Small	362	512			100
	Medium	512	1024			100
	Large/Very Large	1024	2048			100
BEDROCK	Bedrock	2048	>2048			100
Total				100	100	100

Cross Section 9 Channel materials (mm)	
D ₁₆ =	1.7
D ₃₅ =	29.7
D ₅₀ =	36.7
D ₈₄ =	60.5
D ₉₅ =	82.0
D ₁₀₀ =	128.0

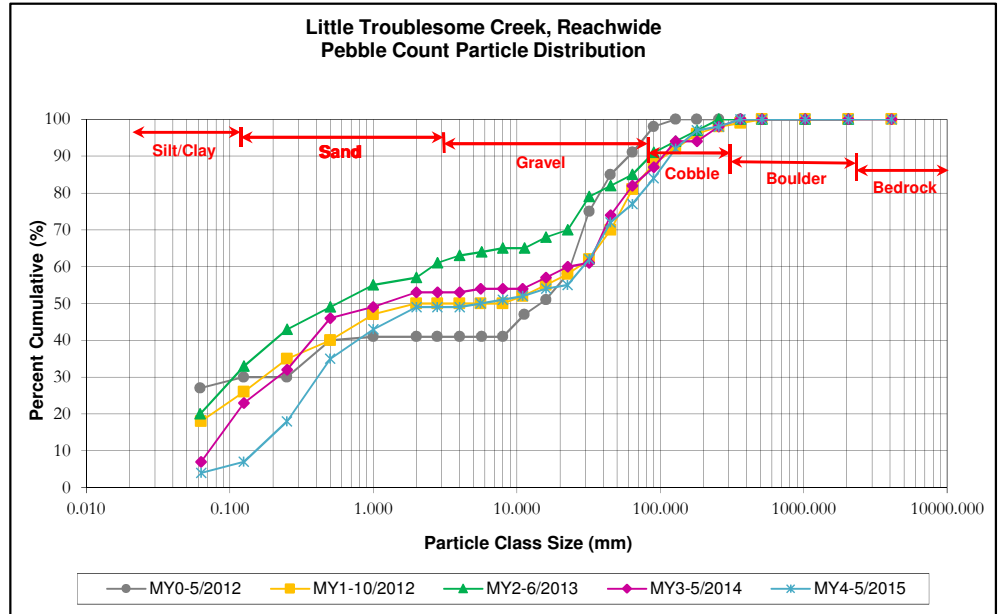
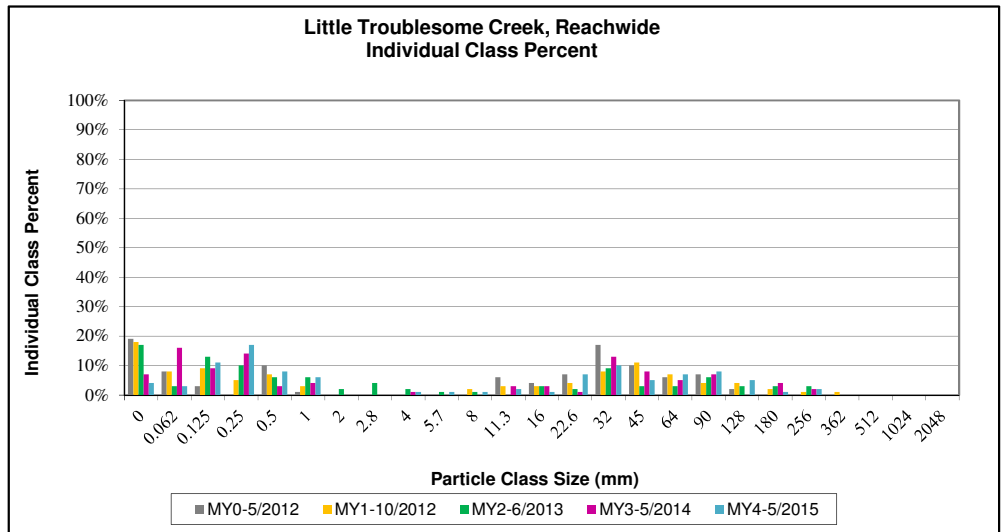
Particle Class		Diameter (mm)		Particle Count			Little Troublesome Creek Summary	
		min	max	Riffle	Pool	Total	Class Percentage	Percent Cumulative
SILT/CLAY	Silt/Clay	0.000	0.062		4	4	4	4
SAND	Very fine	0.062	0.125		3	3	3	7
	Fine	0.125	0.250		11	11	11	18
	Medium	0.250	0.500		17	17	17	35
	Coarse	0.5	1.0		8	8	8	43
	Very Coarse	1.0	2.0	3	3	6	6	49
GRAVEL	Very Fine	2.0	2.8					49
	Very Fine	2.8	4.0					49
	Fine	4.0	5.7	1		1	1	50
	Fine	5.7	8.0	1		1	1	51
	Medium	8.0	11.3	1		1	1	52
	Medium	11.3	16.0	2		2	2	54
	Coarse	16.0	22.6		1	1	1	55
	Coarse	22.6	32	6	1	7	7	62
	Very Coarse	32	45	8	2	10	10	72
	Very Coarse	45	64	5		5	5	77
COBBLE	Small	64	90	7		7	7	84
	Small	90	128	8		8	8	92
	Large	128	180	5		5	5	97
	Large	180	256	1		1	1	98
BOULDER	Small	256	362	2		2	2	100
	Small	362	512					100
	Medium	512	1024					100
	Large/Very Large	1024	2048					100
BEDROCK	Bedrock	2048	>2048					100
Total				50	50	100	100	100

Reachwide Channel materials (mm)	
D ₁₆ =	0.2
D ₃₅ =	0.5
D ₅₀ =	5.7
D ₈₄ =	90.0
D ₉₅ =	157.1
D ₁₀₀ =	362.0

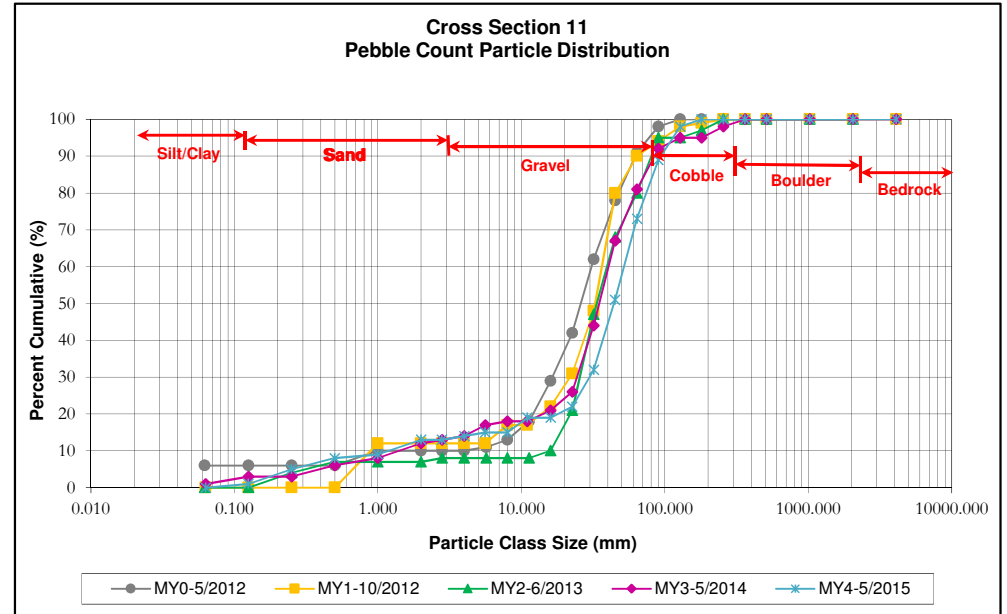
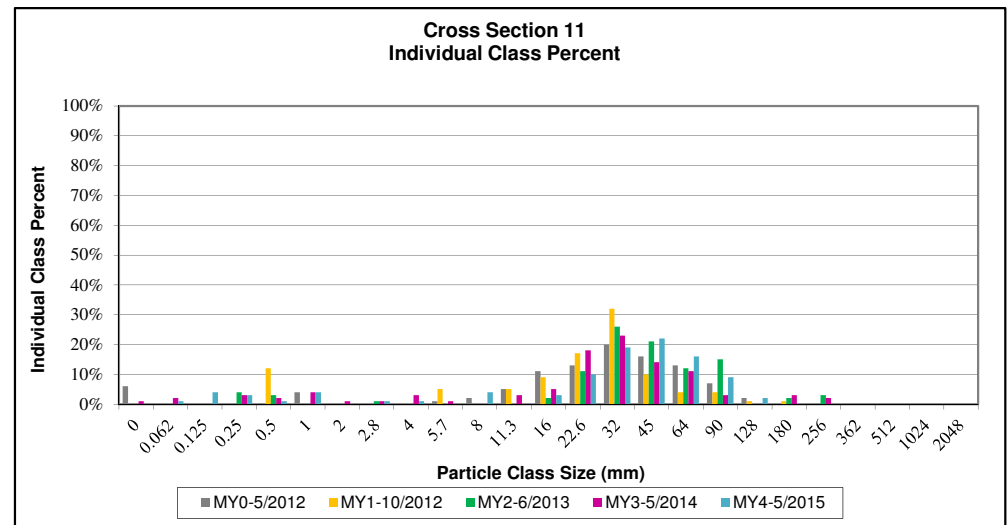
Particle Class		Diameter (mm)		Particle Count	Cross Section 11 Summary	
		min	max		Class Percentage	Percent Cumulative
SILT/CLAY	Silt/Clay	0.000	0.062			0
SAND	Very fine	0.062	0.125	1	1	1
	Fine	0.125	0.250	4	4	5
	Medium	0.250	0.500	3	3	8
	Coarse	0.5	1.0	1	1	9
	Very Coarse	1.0	2.0	4	4	13
GRAVEL	Very Fine	2.0	2.8			13
	Very Fine	2.8	4.0	1	1	14
	Fine	4.0	5.7	1	1	15
	Fine	5.7	8.0			15
	Medium	8.0	11.3	4	4	19
	Medium	11.3	16.0			19
	Coarse	16.0	22.6	3	3	22
	Coarse	22.6	32	10	10	32
	Very Coarse	32	45	19	19	51
	Very Coarse	45	64	22	22	73
COBBLE	Small	64	90	16	16	89
	Small	90	128	9	9	98
	Large	128	180	2	2	100
	Large	180	256			100
BOULDER	Small	256	362			100
	Small	362	512			100
	Medium	512	1024			100
	Large/Very Large	1024	2048			100
BEDROCK	Bedrock	2048	>2048			100
Total				100	100	100

Cross Section 11 Channel materials (mm)	
D ₁₆ =	8.7
D ₃₅ =	33.8
D ₅₀ =	44.2
D ₈₄ =	80.9
D ₉₅ =	113.8
D ₁₀₀ =	180.0

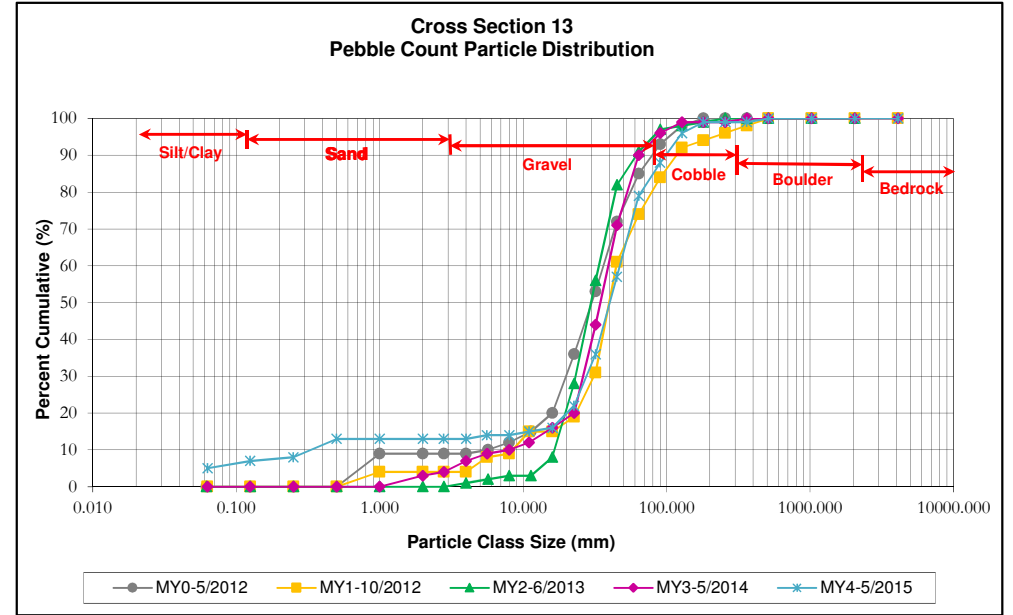
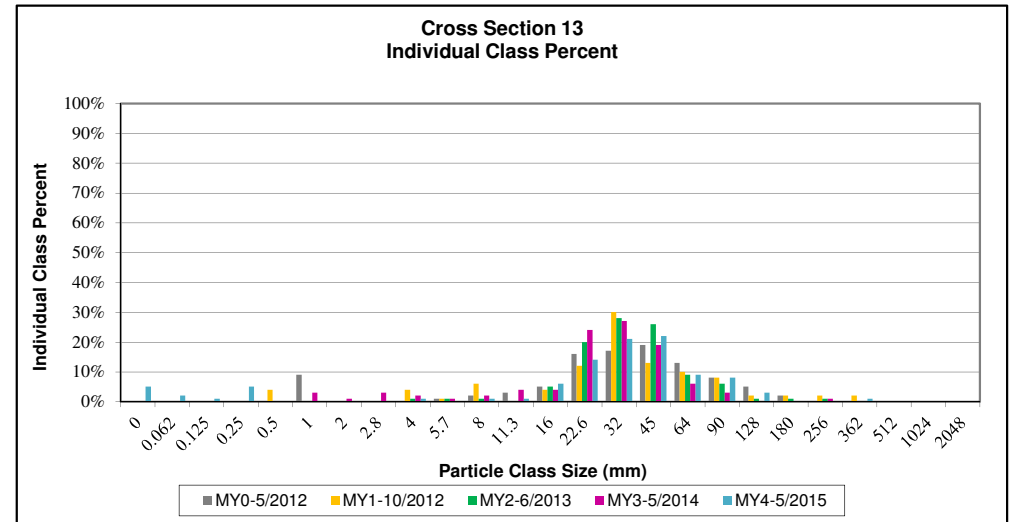
Particle Class		Diameter (mm)		Particle Count	Cross Section 13 Summary	
		min	max		Class Percentage	Percent Cumulative
SILT/CLAY	Silt/Clay	0.000	0.062	5	5	5
SAND	Very fine	0.062	0.125	2	2	7
	Fine	0.125	0.250	1	1	8
	Medium	0.250	0.500	5	5	13
	Coarse	0.5	1.0			13
	Very Coarse	1.0	2.0			13
GRAVEL	Very Fine	2.0	2.8			13
	Very Fine	2.8	4.0			13
	Fine	4.0	5.7	1	1	14
	Fine	5.7	8.0			14
	Medium	8.0	11.3	1	1	15
	Medium	11.3	16.0	1	1	16
	Coarse	16.0	22.6	6	6	22
	Coarse	22.6	32	14	14	36
	Very Coarse	32	45	21	21	57
	Very Coarse	45	64	22	22	79
COBBLE	Small	64	90	9	9	88
	Small	90	128	8	8	96
	Large	128	180	3	3	99
	Large	180	256			99
BOULDER	Small	256	362			99
	Small	362	512	1	1	100
	Medium	512	1024			100
	Large/Very Large	1024	2048			100
BEDROCK	Bedrock	2048	>2048			100
Total				100	100	100

Cross Section 13 Channel materials (mm)	
D ₁₆ =	16.0
D ₃₅ =	31.2
D ₅₀ =	40.2
D ₈₄ =	77.3
D ₉₅ =	122.5
D ₁₀₀ =	512.0
