MONITORING YEAR 4 ANNUAL REPORT Final

LITTLE TROUBLESOME CREEK MITIGATION SITE
Rockingham County, NC
NCDEQ Contract 003267
NCDMS Project Number 94640

Data Collection Period: May 2015-November 2015
Draft Submission Date: November 30, 2015
Final Submission Date: January 28, 2016

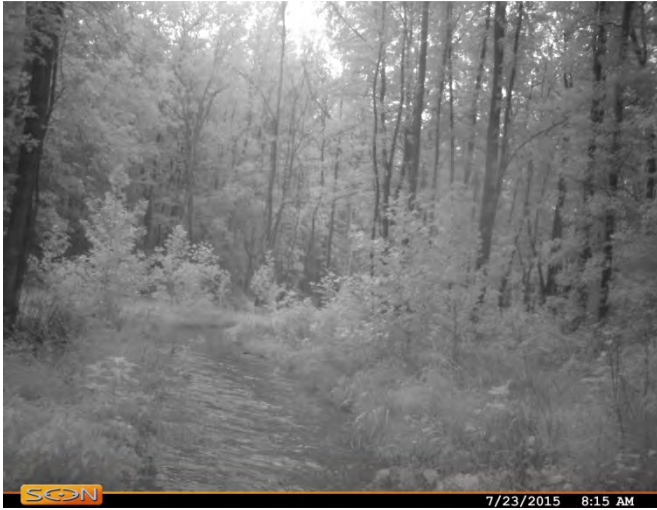
Bankfull Event 1 – Irvin Creek (7/23/2015 8:15am)

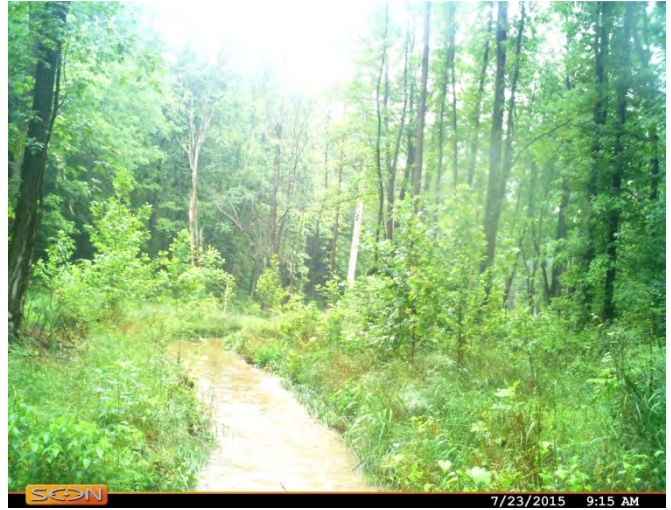
Bankfull Event 1 – Irvin Creek (7/23/2015 9:15am)

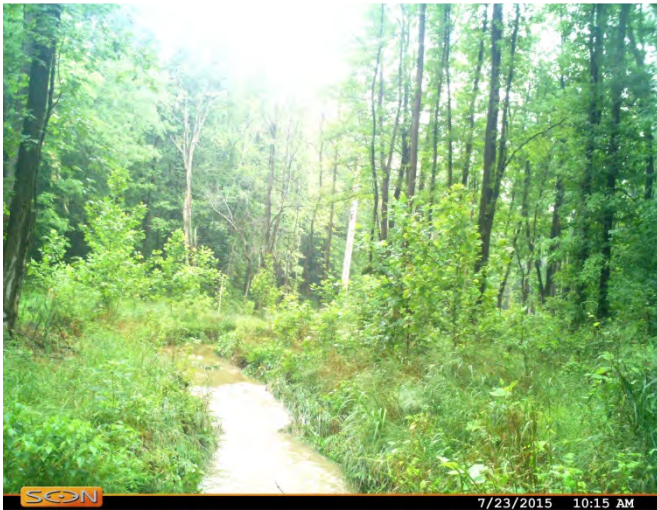
Bankfull Event 1 – Irvin Creek (7/23/2015 10:15am)

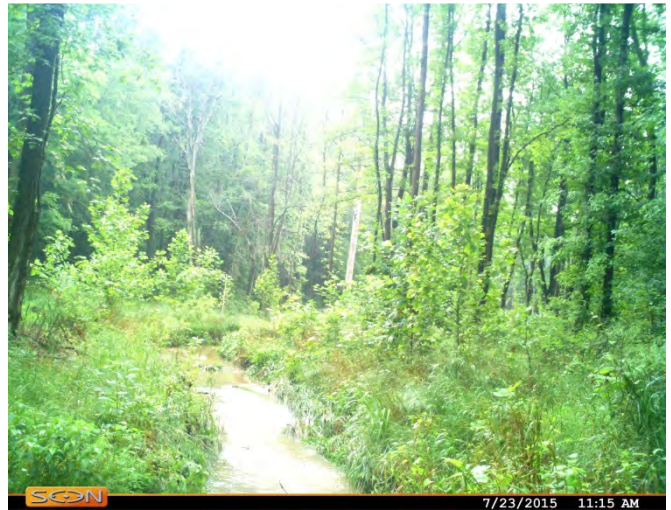
Bankfull Event 1 – Irvin Creek (7/23/2015 11:15am)

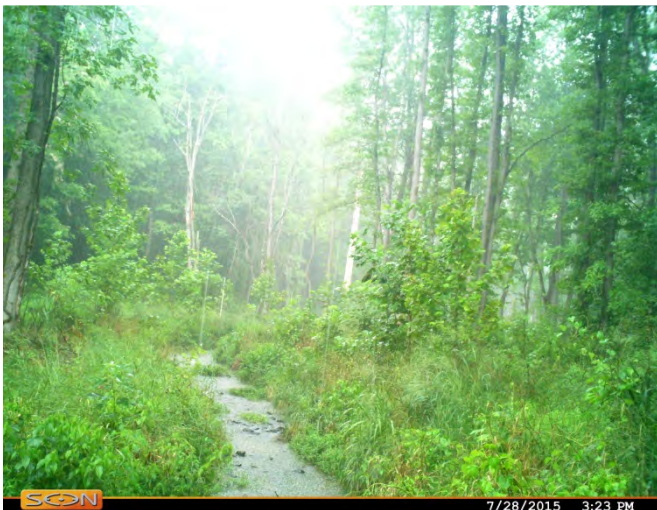
Bankfull Event 2 – Irvin Creek (7/28/2015 3:23pm)

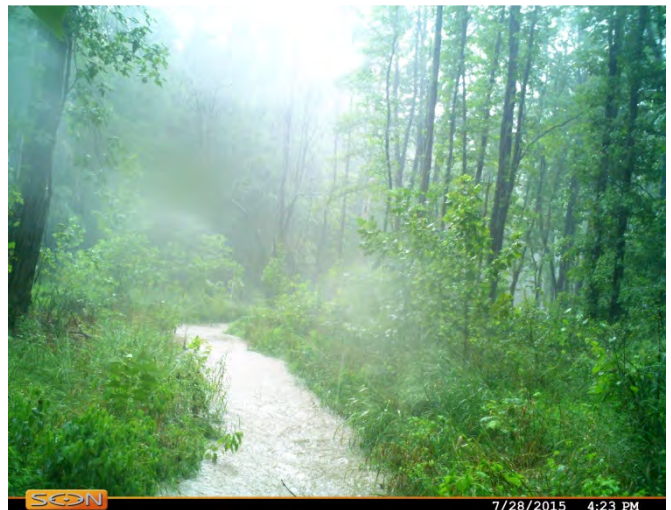
Bankfull Event 2 – Irvin Creek (7/28/2015 4:23pm)

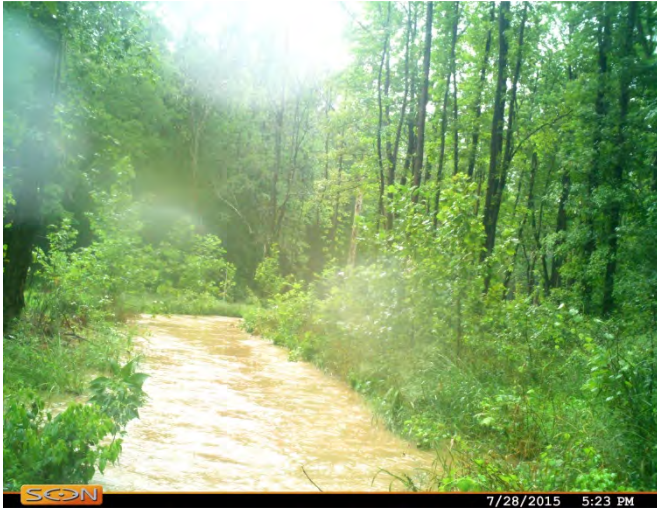
Bankfull Event 2 – Irvin Creek (7/28/2015 5:23pm)

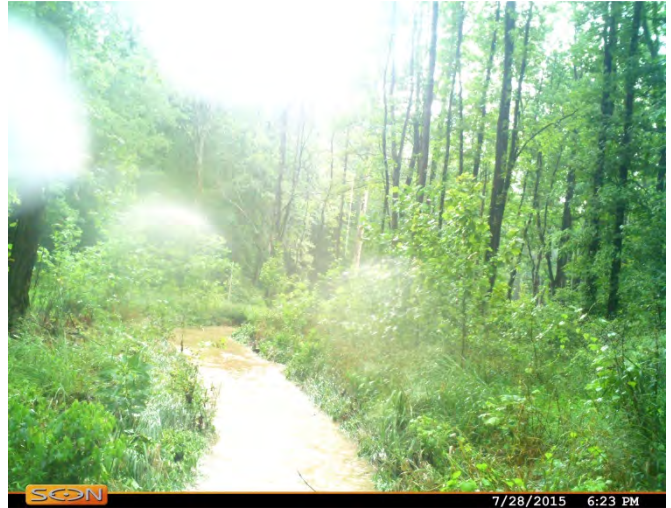
Bankfull Event 2 – Irvin Creek (7/28/2015 6:23pm)

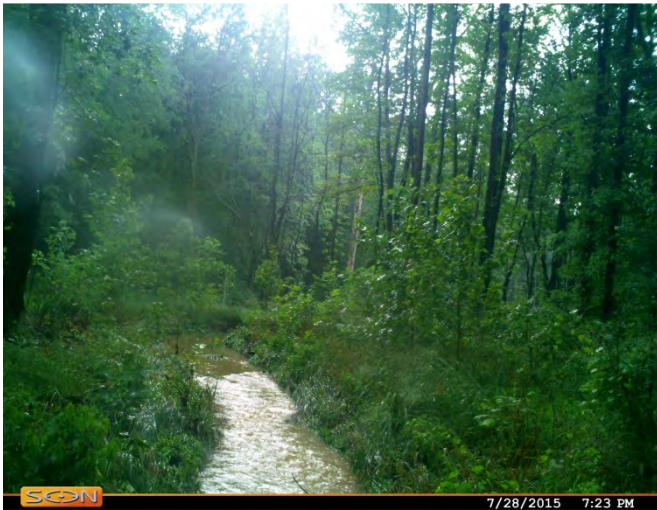
Bankfull Event 2 – Irvin Creek (7/28/2015 7:23pm)

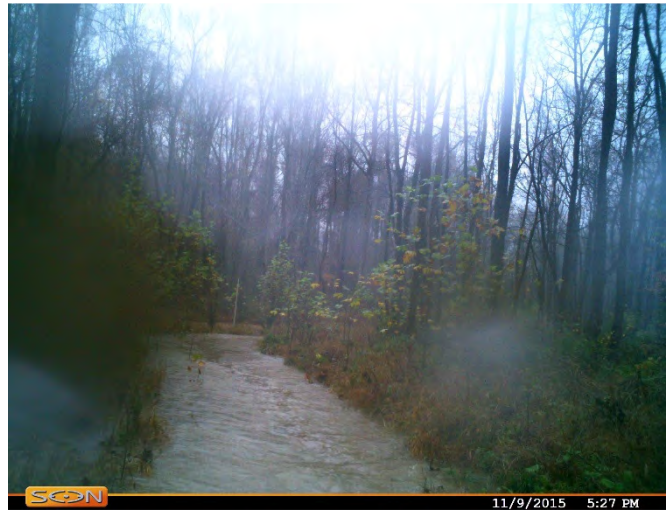
Bankfull Event 3 – Irvin Creek (11/9/2015 5:27pm)

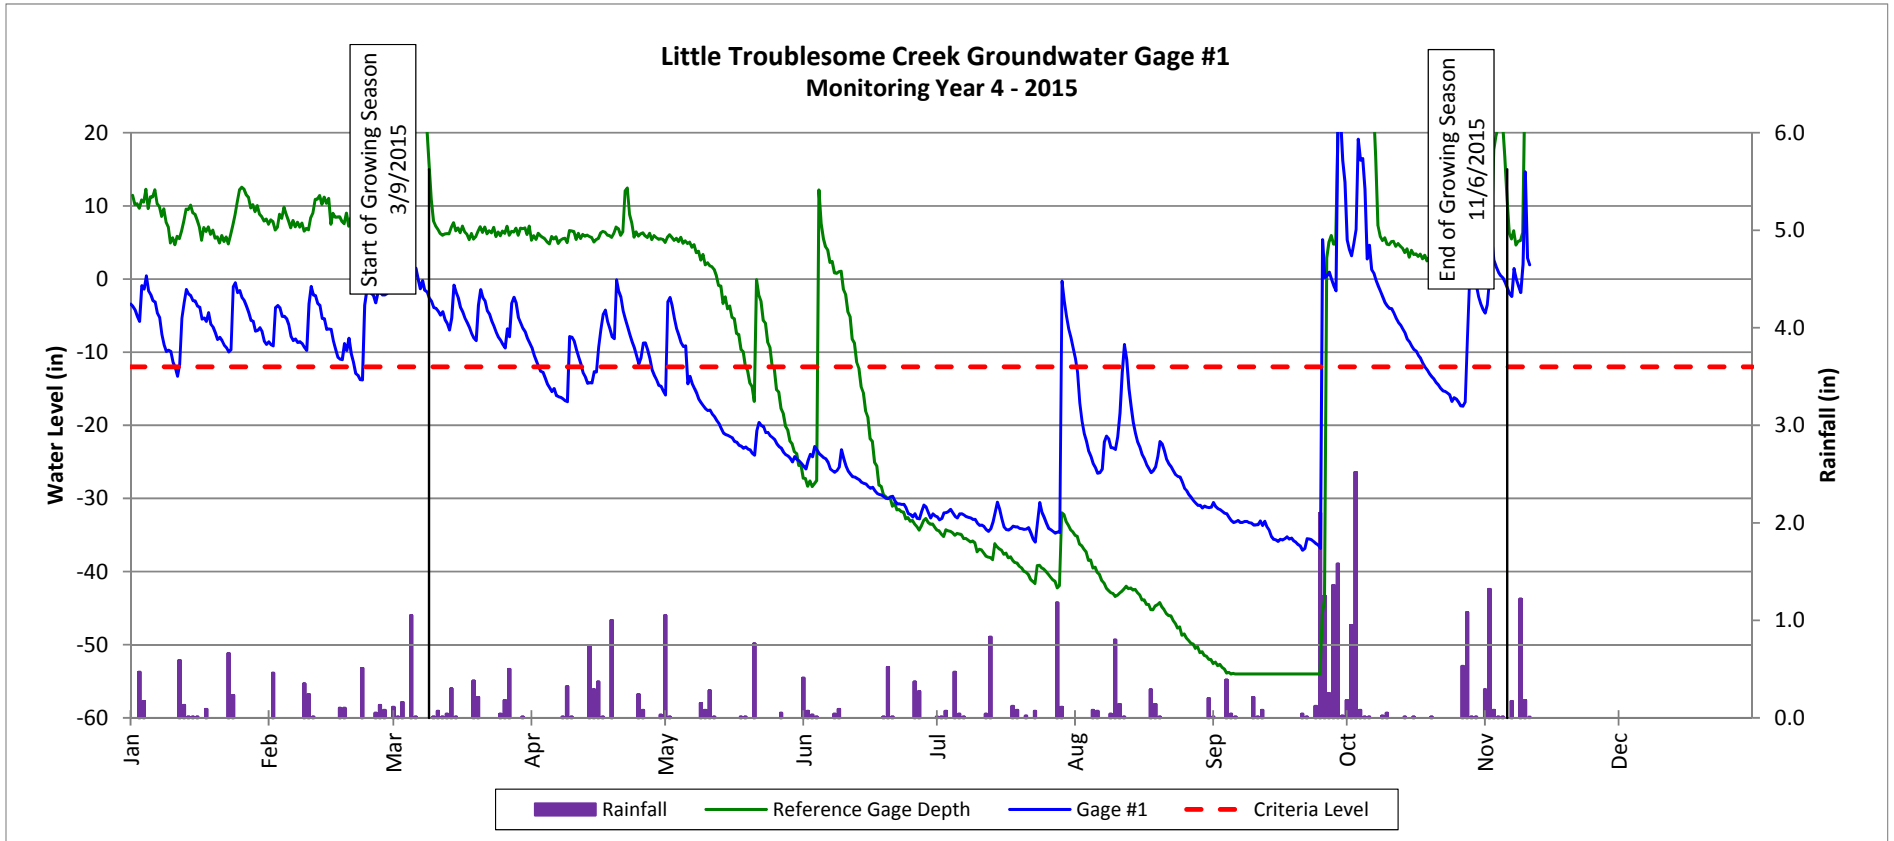
Wetland RW1

Groundwater Gage Plots

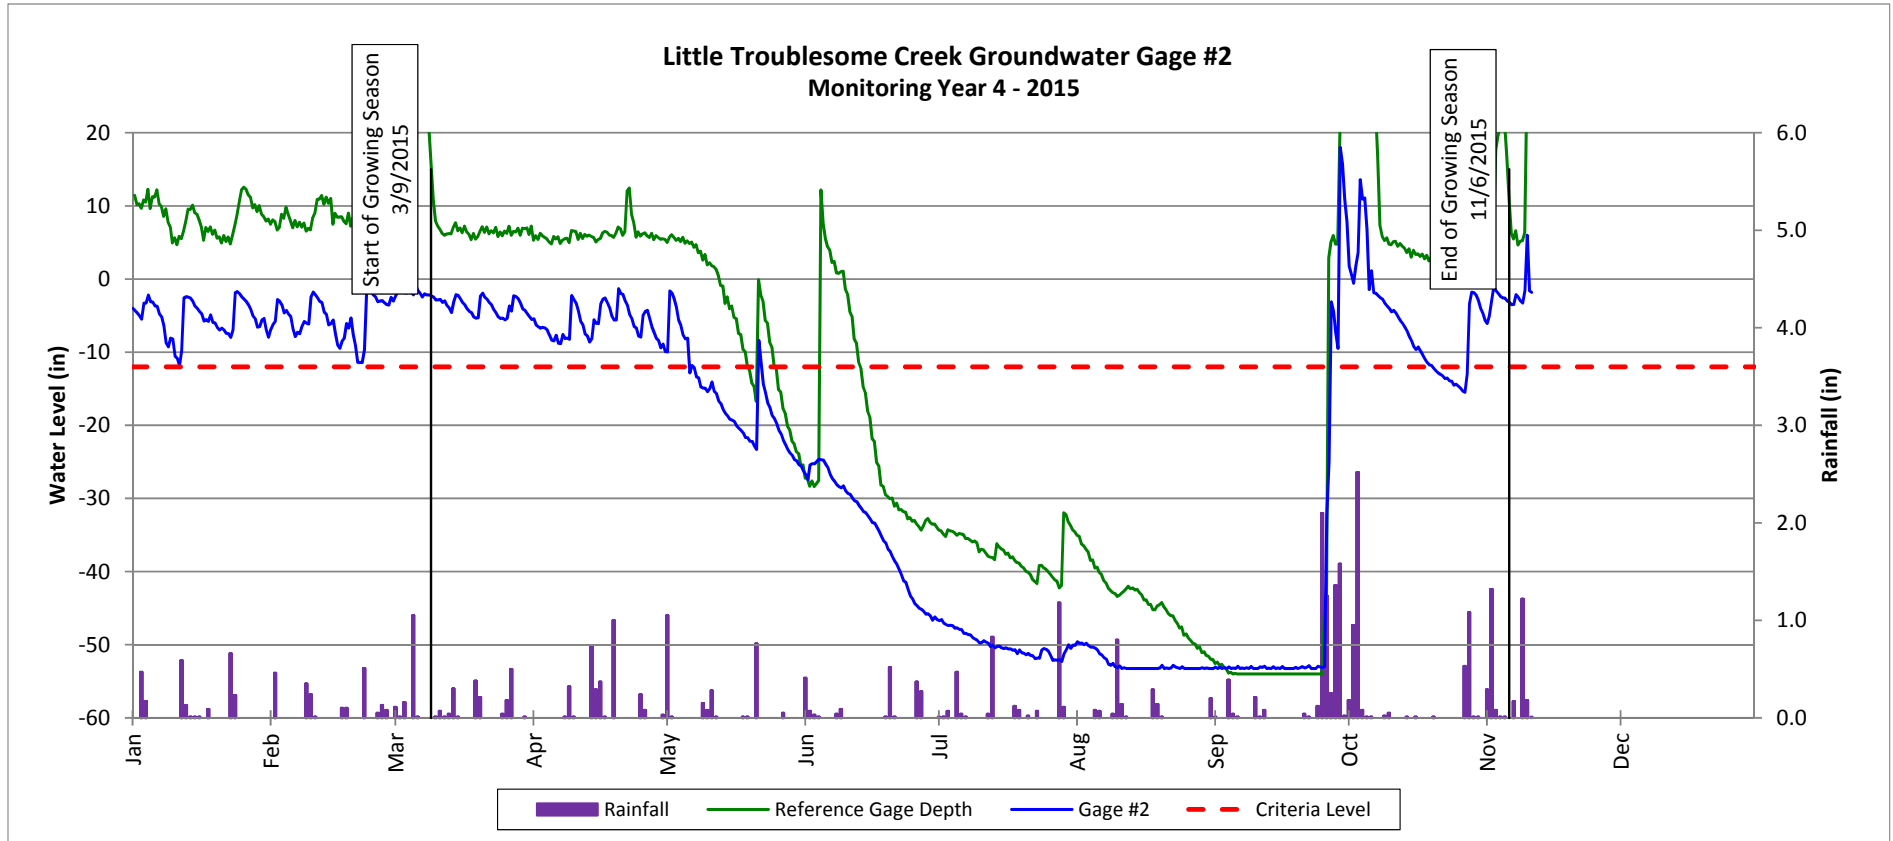
Wetland RW1

Groundwater Gage Plots

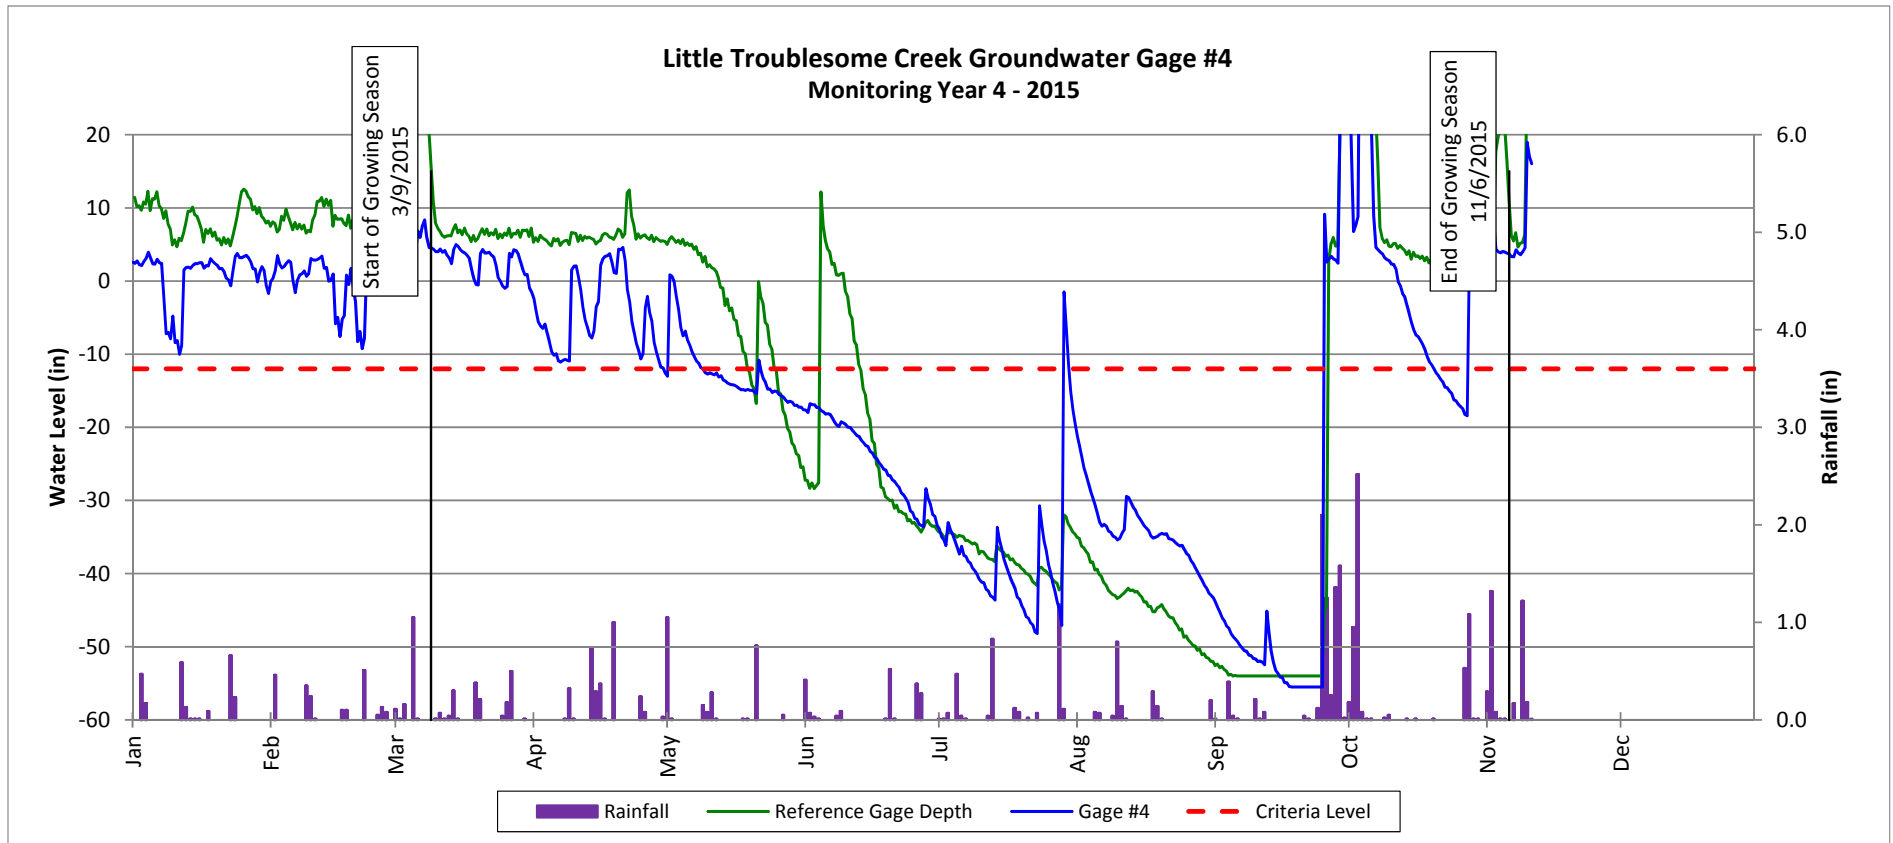
Wetland RW1

Groundwater Gage Plots

Little Troublesome Creek Wetland (NCDMS Project No. 94640)

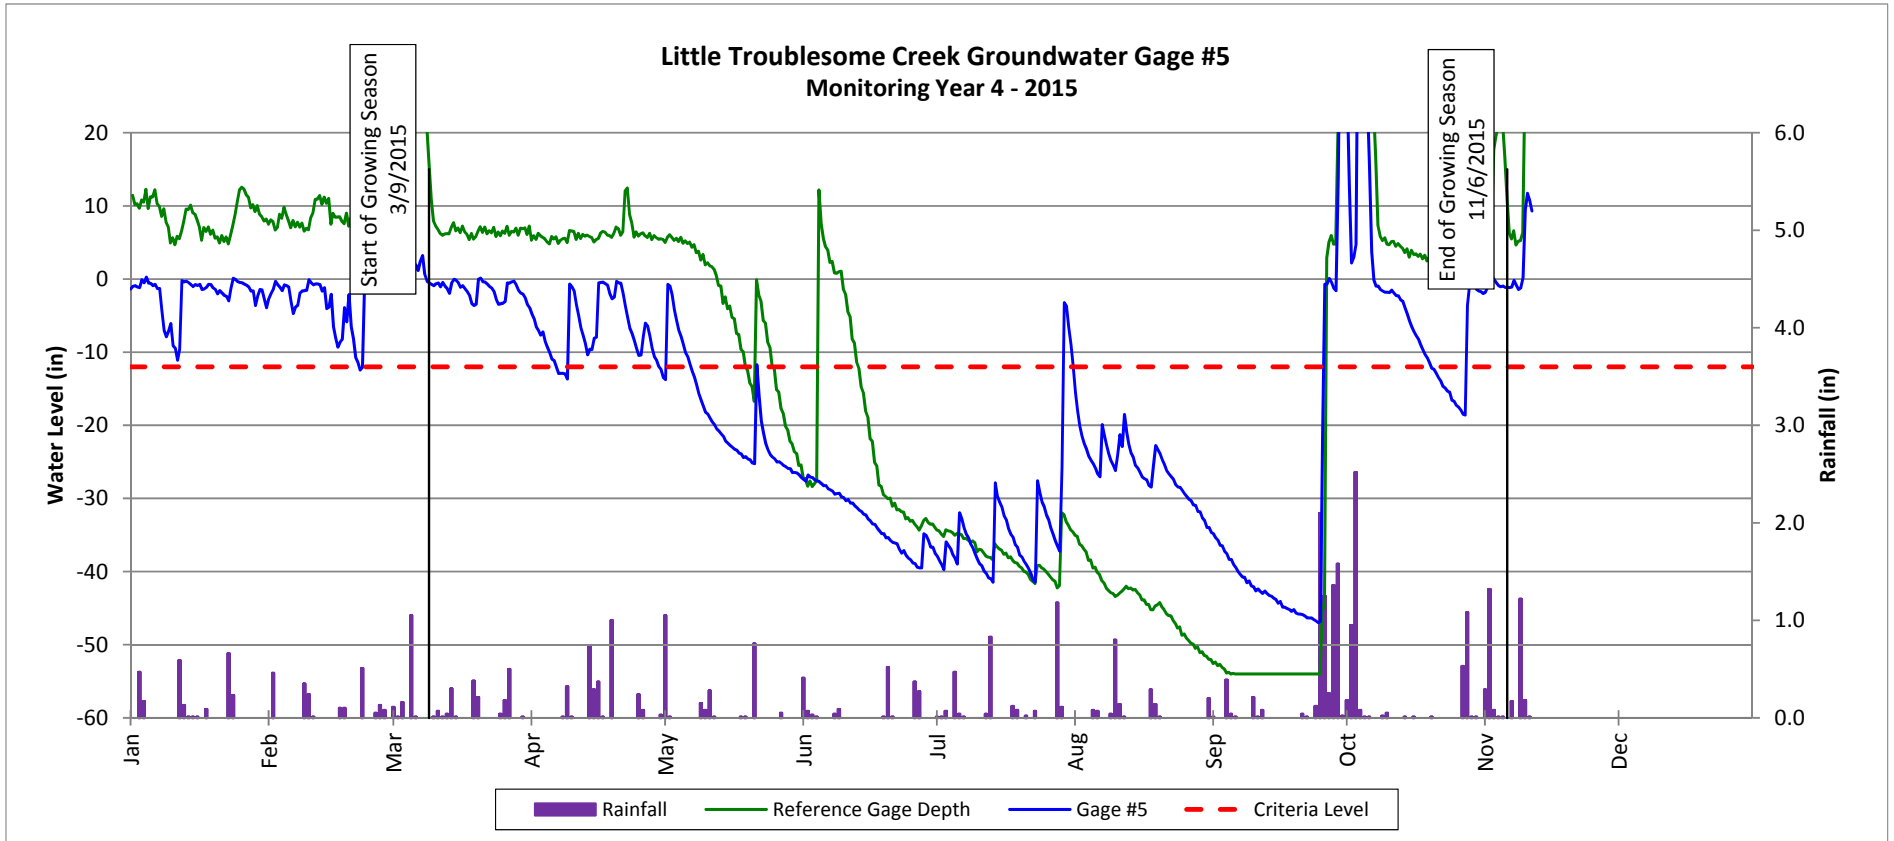
Wetland RW1

Groundwater Gage Plots

Little Troublesome Creek Wetland (NCDMS Project No. 94640)

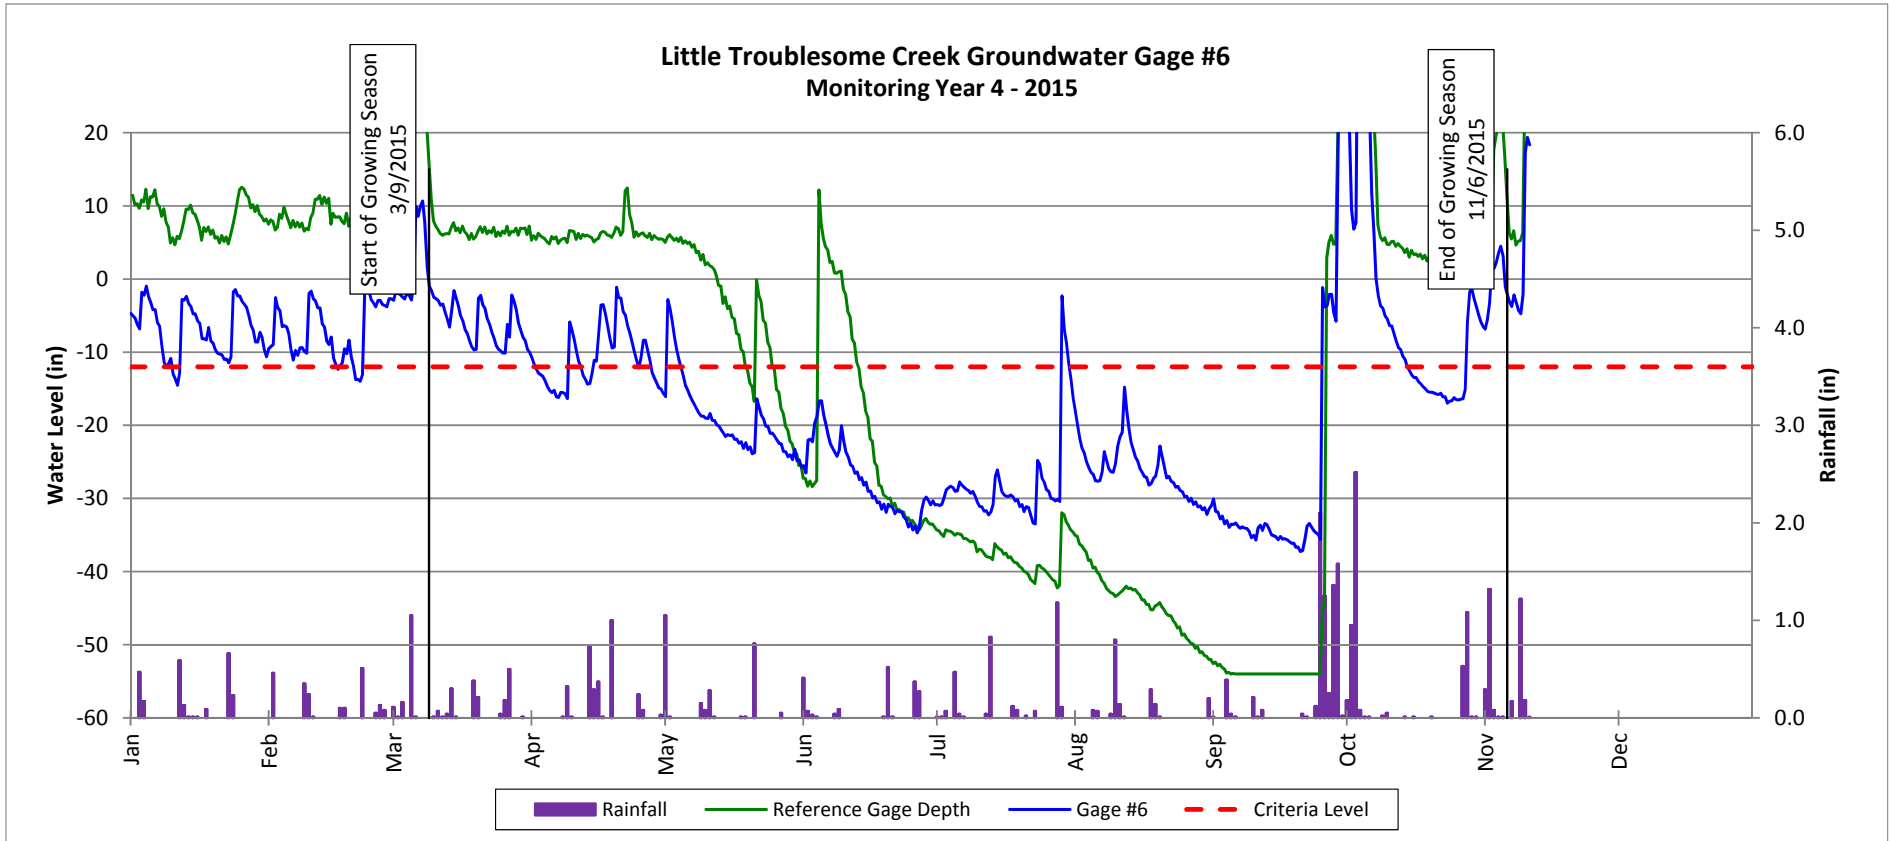
Wetland RW1

Groundwater Gage Plots

Little Troublesome Creek Wetland (NCDMS Project No. 94640)

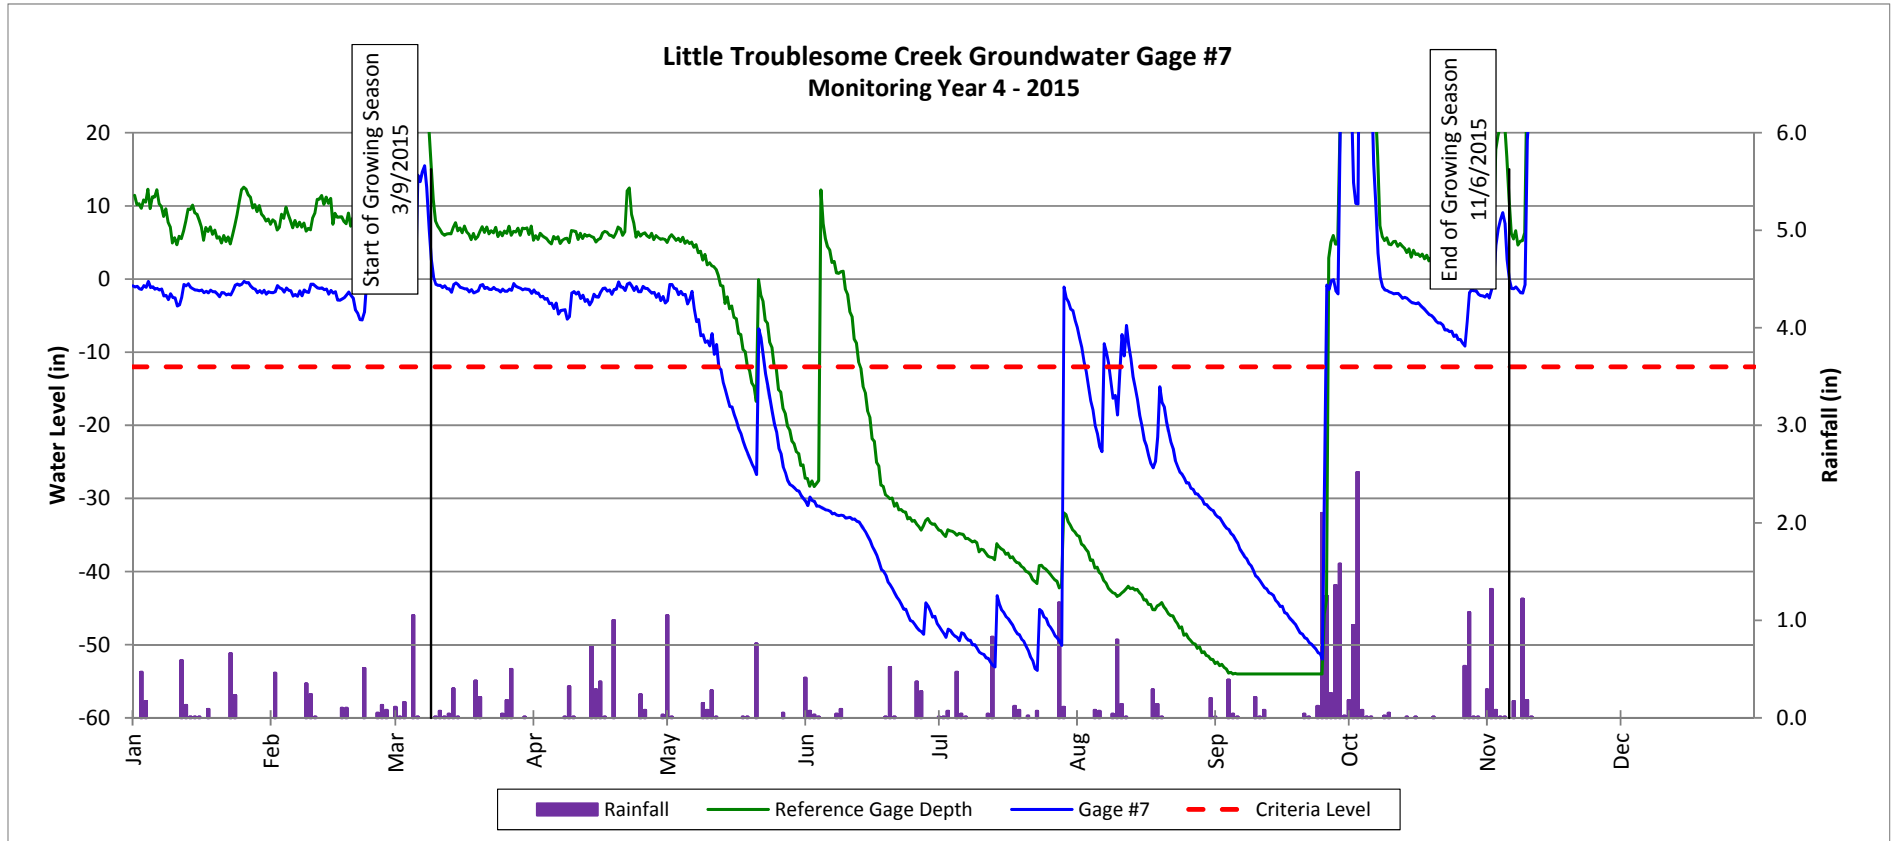
Wetland RW1

Groundwater Gage Plots

Little Troublesome Creek Wetland (NCDMS Project No. 94640)

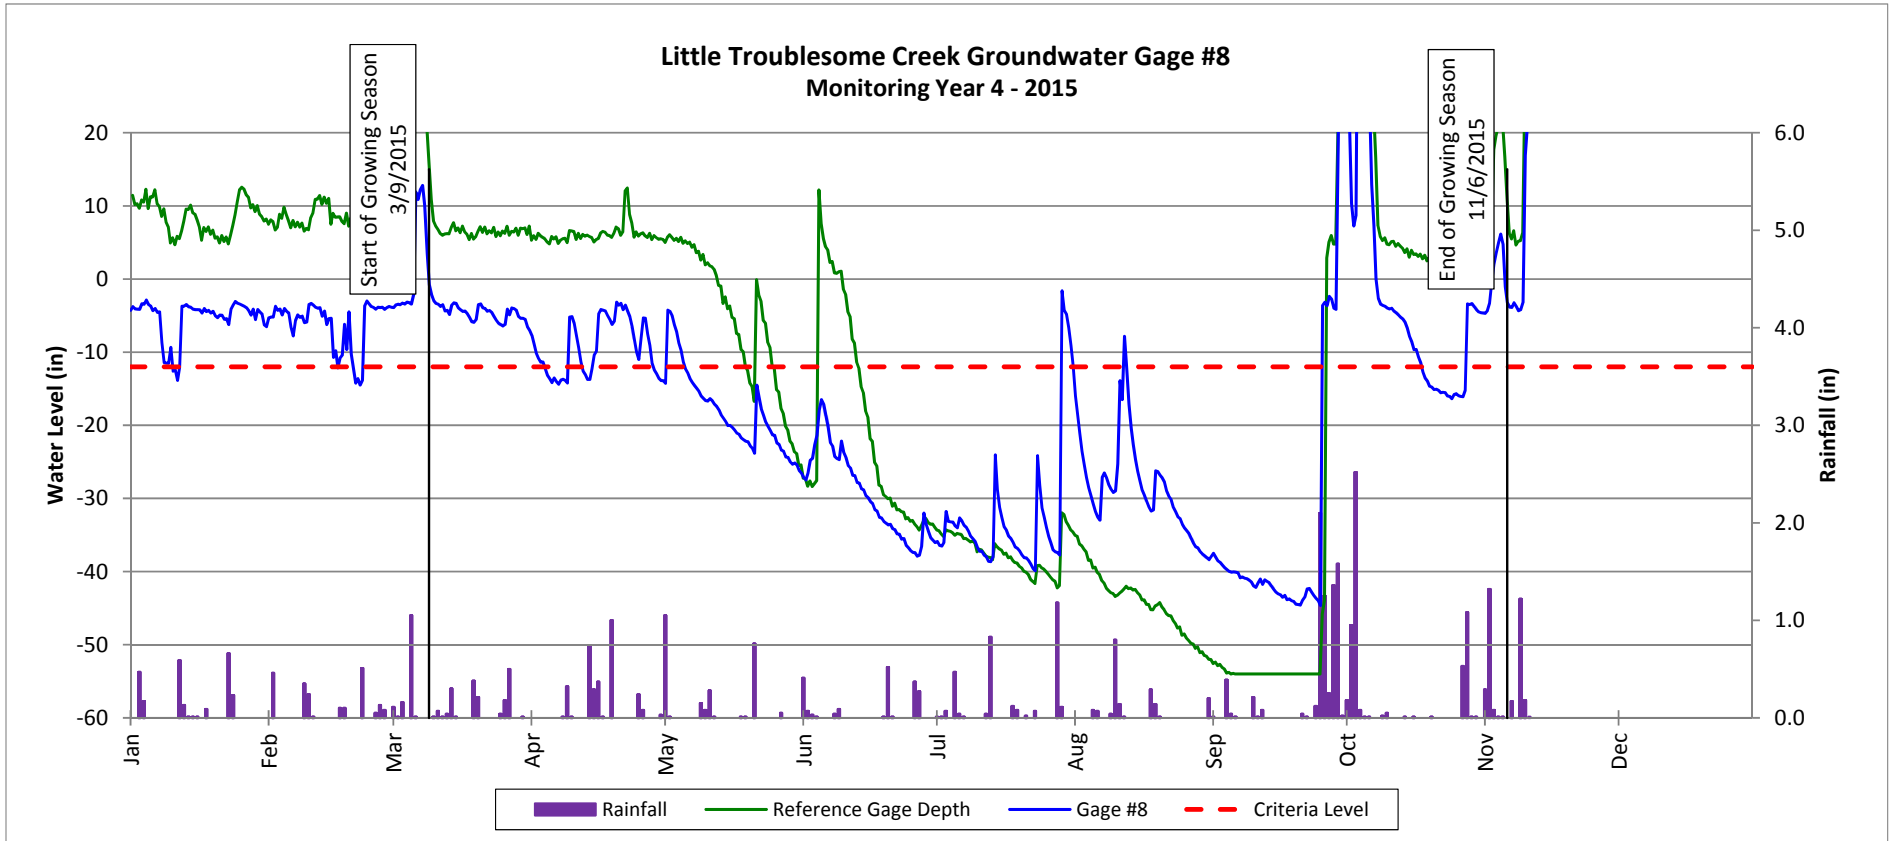
Wetland RW1

Groundwater Gage Plots

Little Troublesome Creek Wetland (NCDMS Project No. 94640)

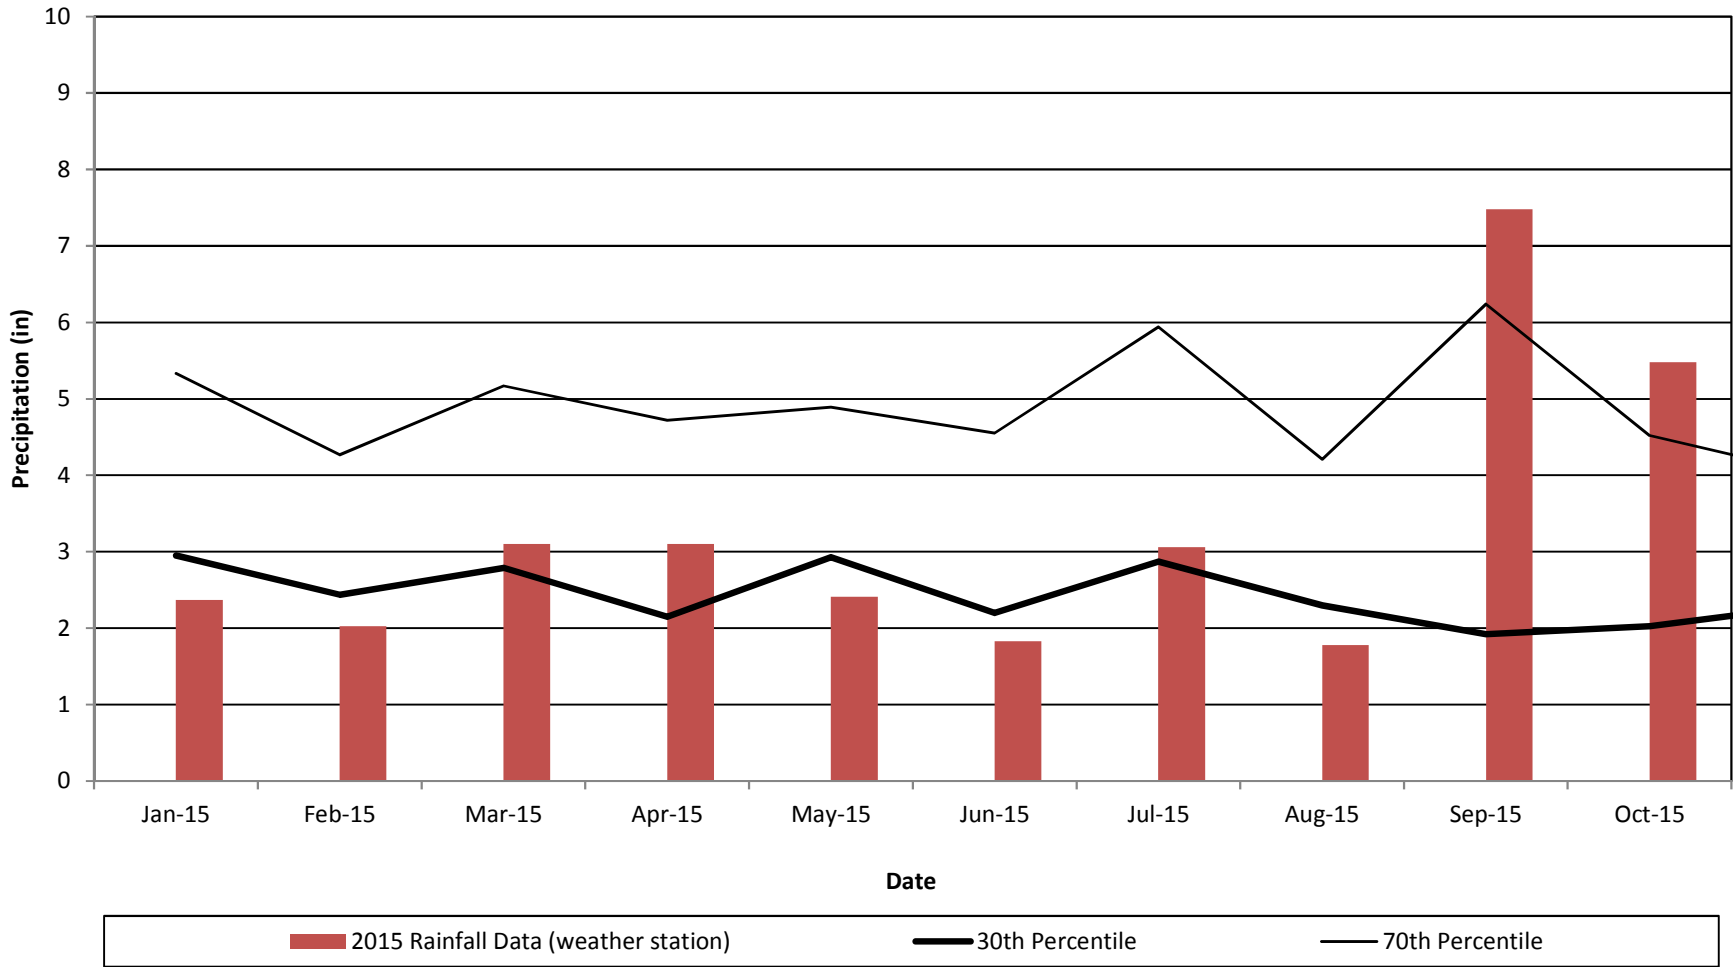
Little Troublesome Creek 30-70 Percentile Graph for Rainfall in 2015 Reidsville, NC

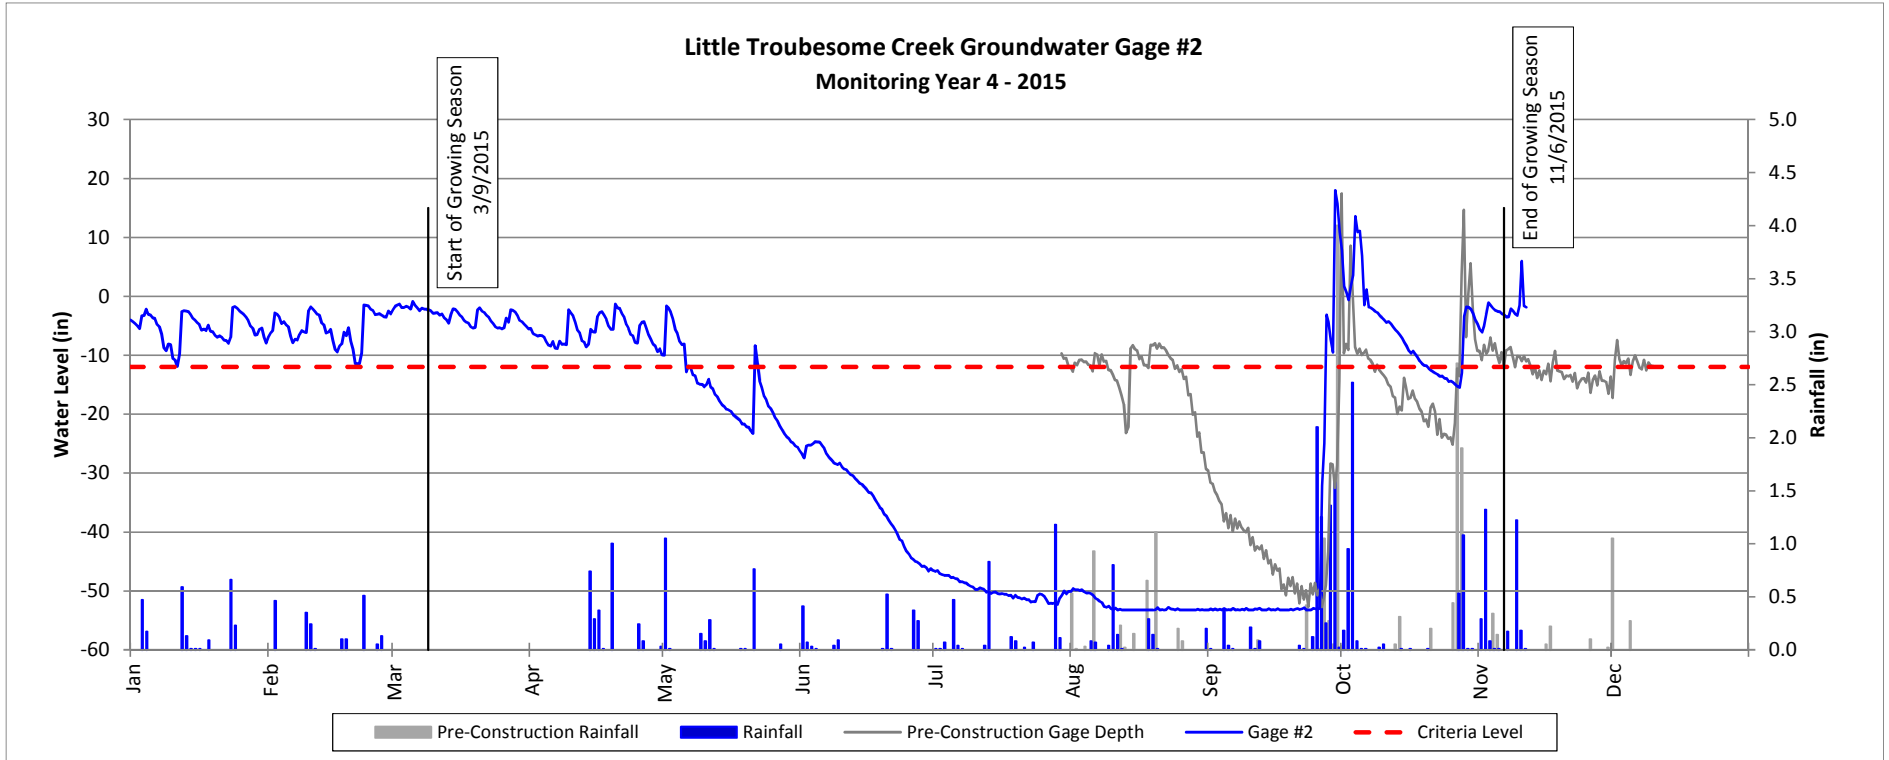
Wetland RW1

Pre and Post Construction Groundwater Gage Comparison Plots

Little Troublesome Creek Mitigation Site (NCDMS Project No. 94640)

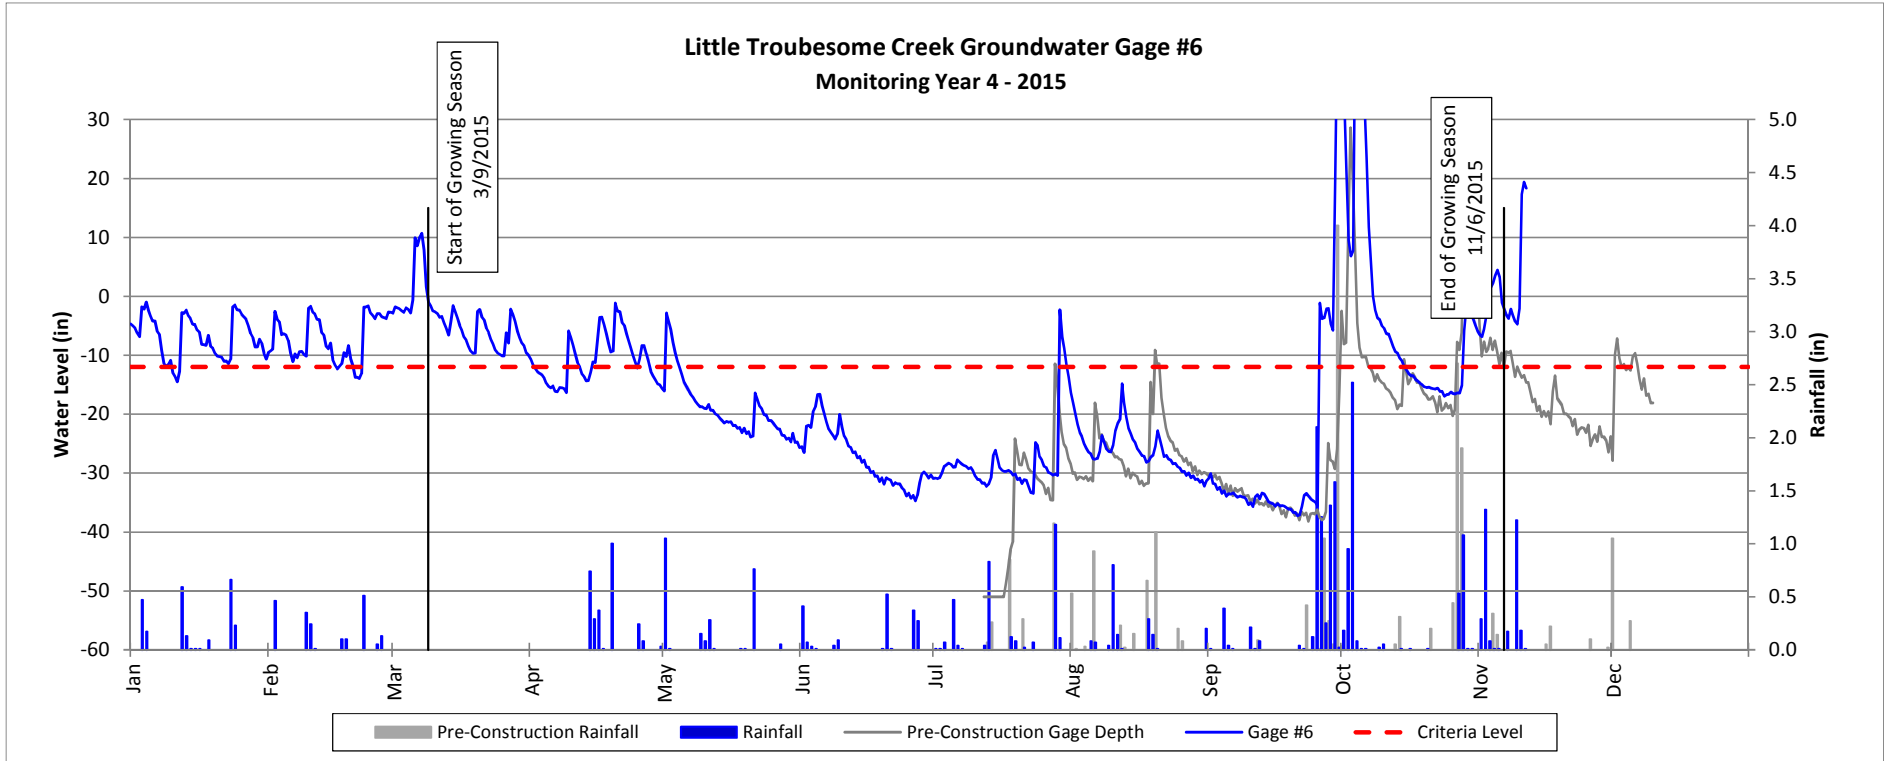
Wetland RW1

Pre and Post Construction Groundwater Gage Comparison Plots

Little Troublesome Creek Mitigation Site (NCDMS Project No. 94640)

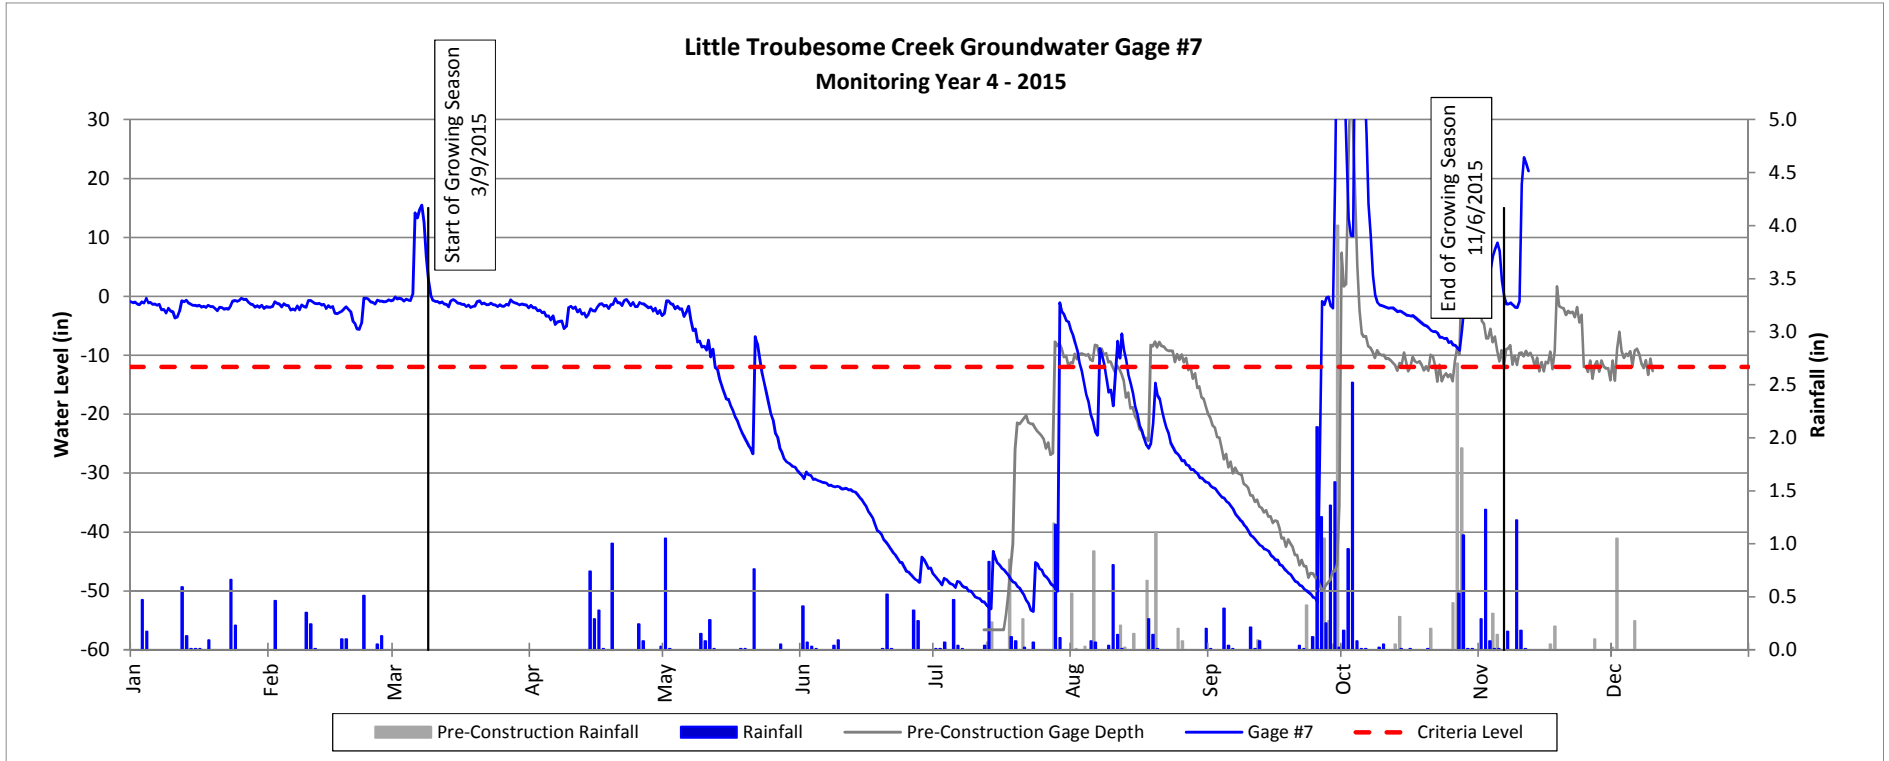
Wetland RW1

Pre and Post Construction Groundwater Gage Comparison Plots

Little Troublesome Creek Mitigation Site (NCDMS Project No. 94640)
