LITTLE WHITE OAK CREEK STREAM RESTORATION

POLK COUNTY, NORTH CAROLINA

ANNUAL MONITORING REPORT (YEAR 3 OF 5)

DECEMBER 2010

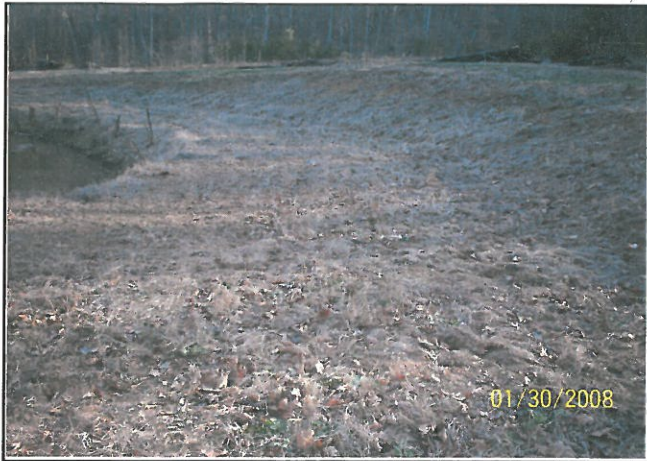
Vegetation Plot 1

As-built Survey: January 2008

established in Section 3.1.2. Similar to Monitoring Year 1, no significant volunteer woody species were observed at any of the 24 vegetation plots. The comparison of the Monitoring Year 2 photos to those previously collected at both the 24 vegetation plot photo reference points and the 14 permanent photo reference points suggested the vegetation was growing exceptionally well. Live stake vegetation has exceeded growth expectations and the bare root material is starting to overcome the weedy vegetation. A further review of the vegetation through the project-wide visual assessment validated this positive trend, as no concerns, problems, or negative trends were documented. Based on the results of the vegetation monitoring for Monitoring Year 2 at LWOC, Mulkey did not propose any additional recommendations or actions other than to proceed with the annual vegetation monitoring.

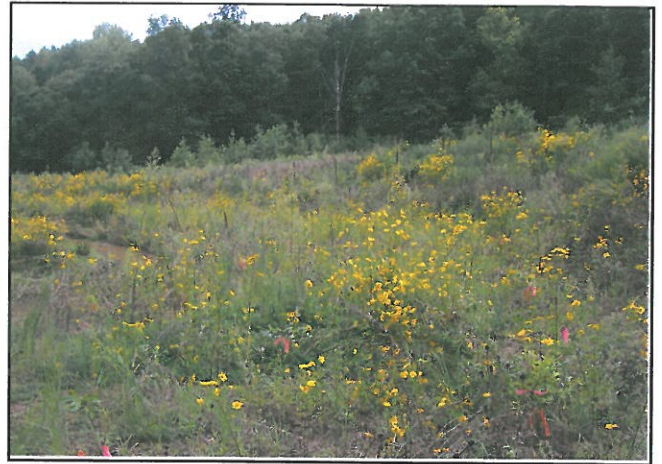
Year 1 Monitoring: September 2008

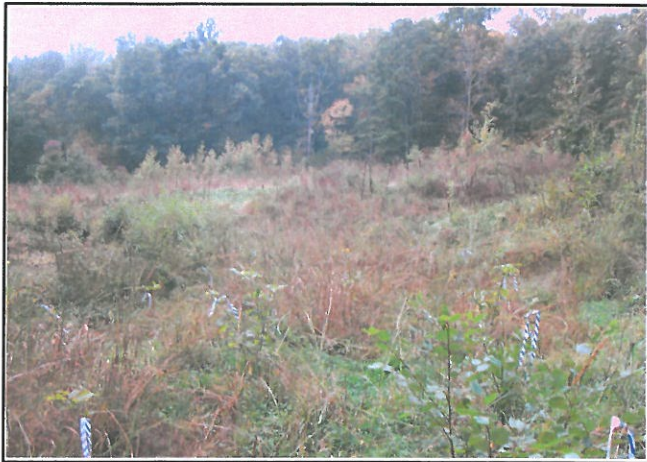
Year 2 Monitoring: October 2009

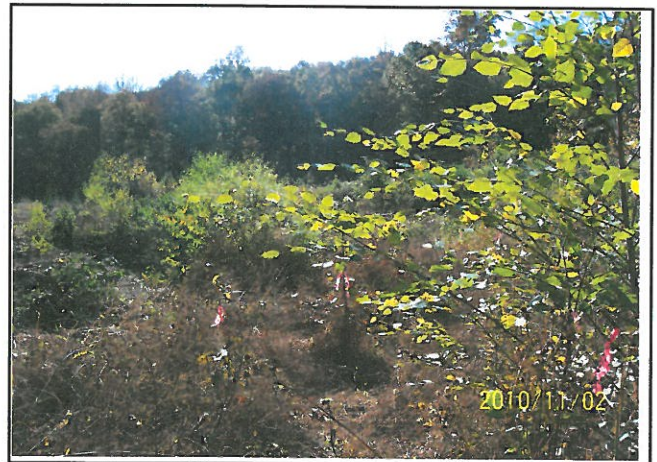
Year 3 Monitoring: November 2010

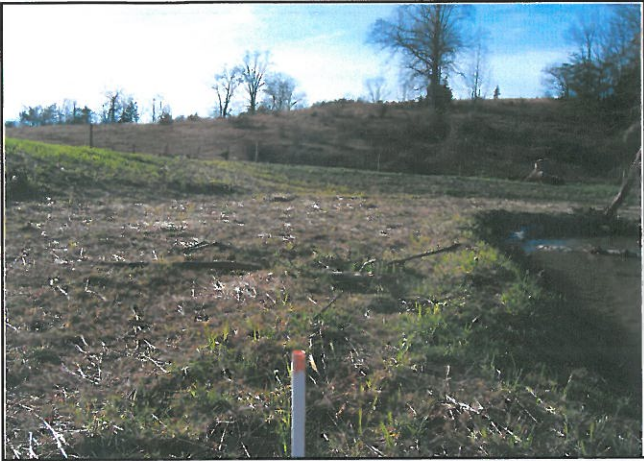
As-built Survey: January 2008

Vegetation Plot 22

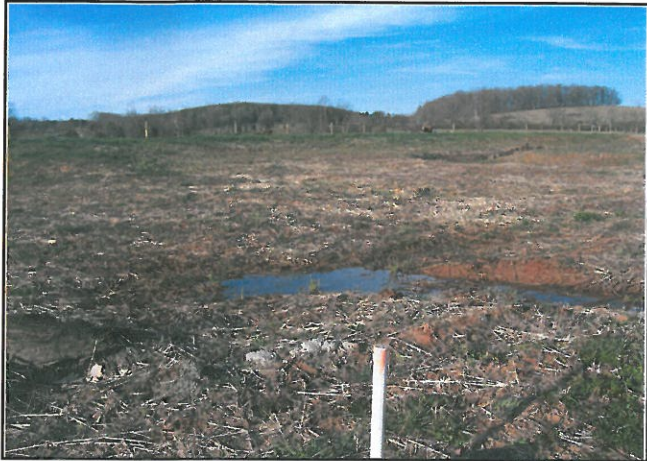
As-built Survey: January 2008

Vegetation Plot 23

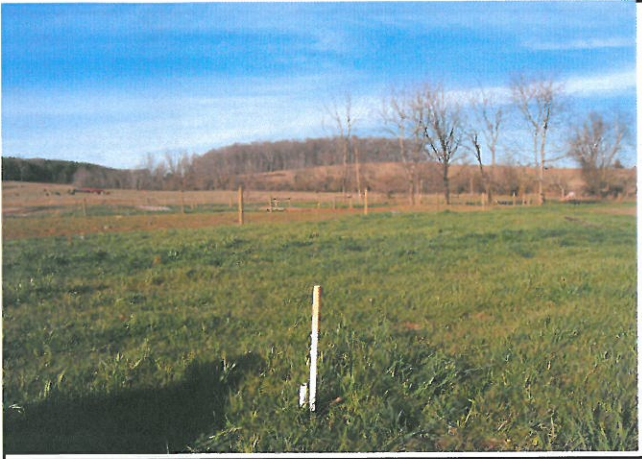
As-built Survey: January 2008

Vegetation Plot 24

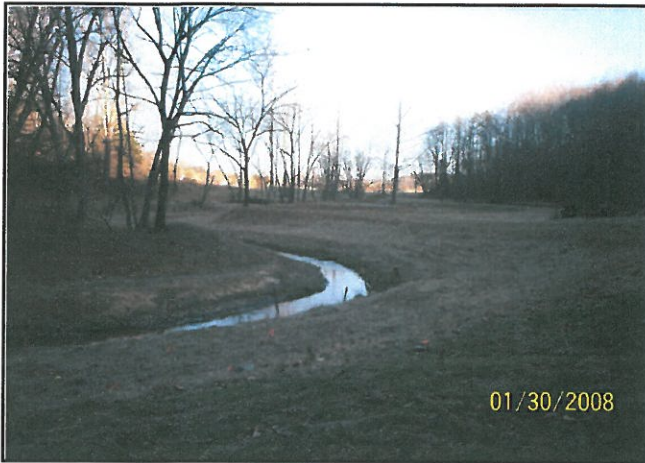
As-built Survey: January 2008

Photo Point 1; Looking Downstream on Reach R2

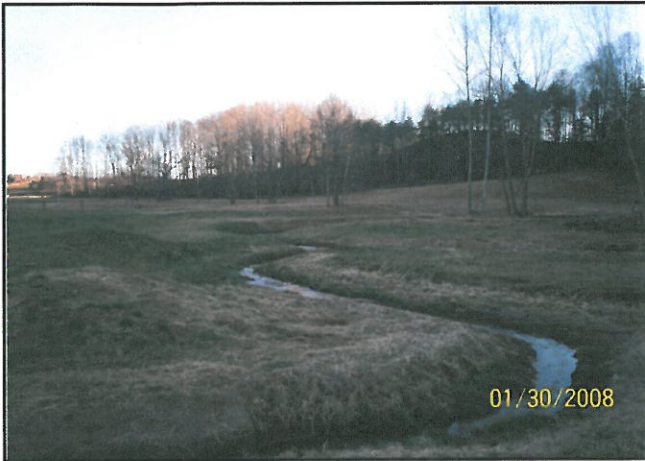
As-built Survey: January 2008

Photo Point 2; Looking Downstream on Reach R2

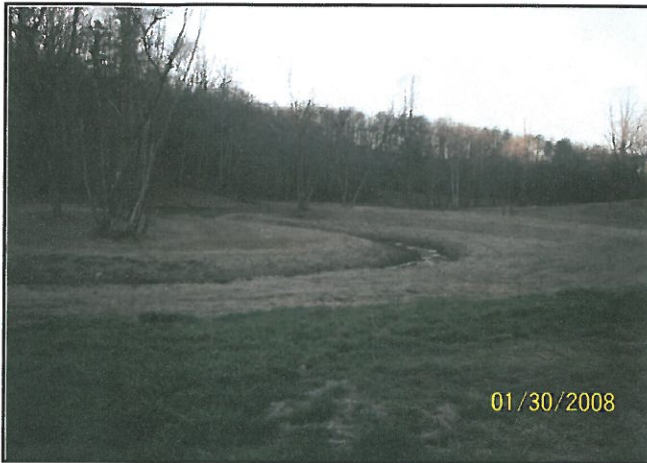
As-built Survey: January 2008

Photo Point 2; Looking Upstream on Reach R2

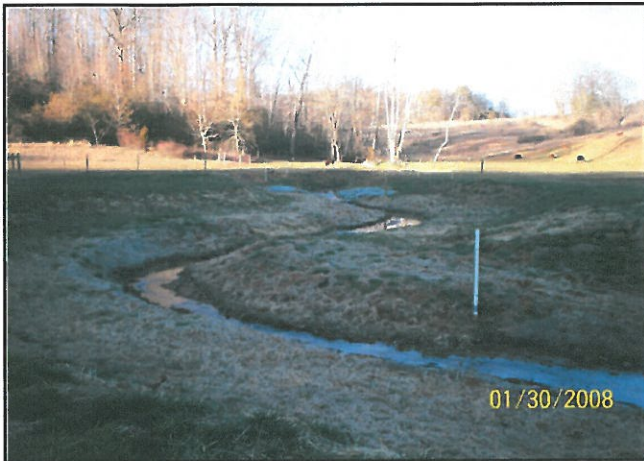
As-built Survey: January 2008

Photo Point 2; Looking upstream on Reach R2A

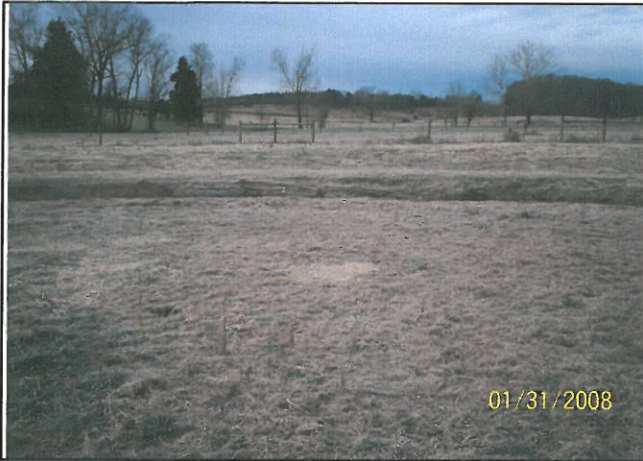
As-built Survey: January 2008

Permanent Cross Section 5

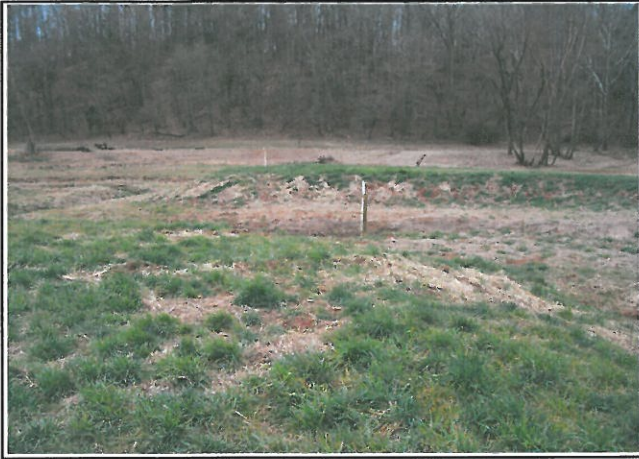
As-built Survey: January 2008

Permanent Cross Section 6

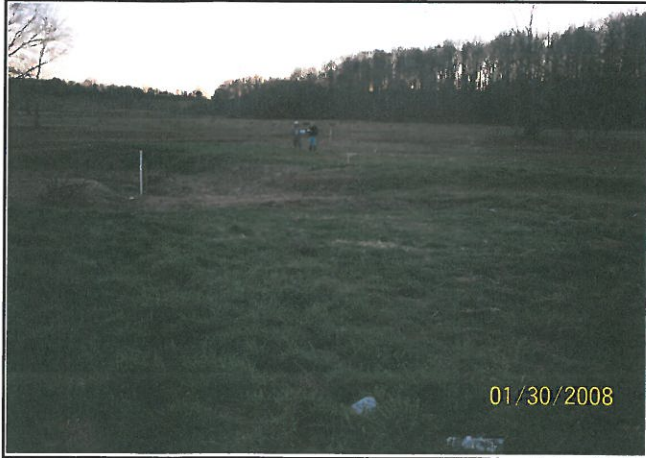
As-built Survey: January 2008

Permanent Cross Section 7

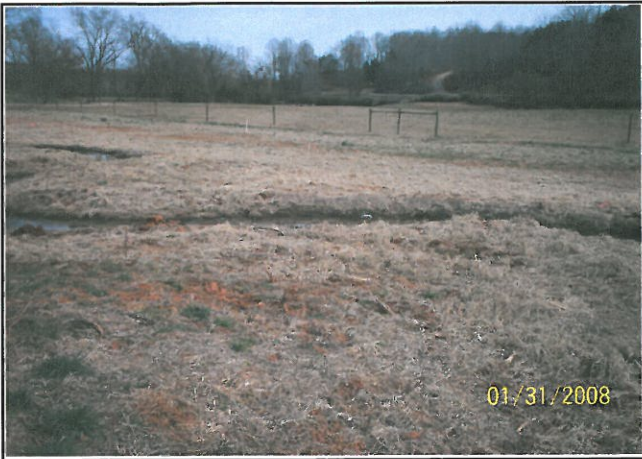
As-built Survey: January 2008

Permanent Cross Section 8

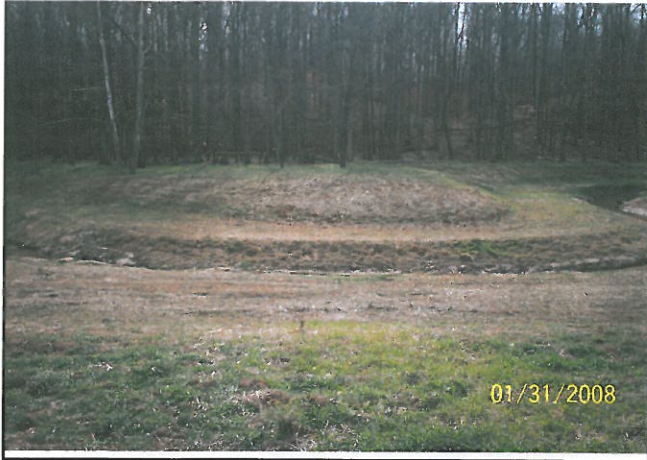
As-built Survey: January 2008

Permanent Cross Section 9

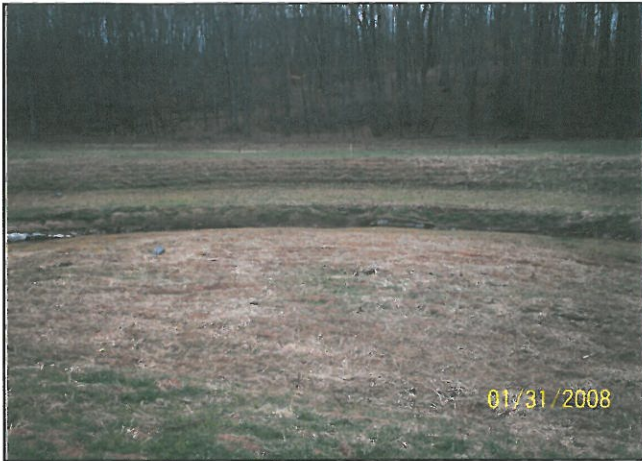
As-built Survey: January 2008

Permanent Cross Section 10

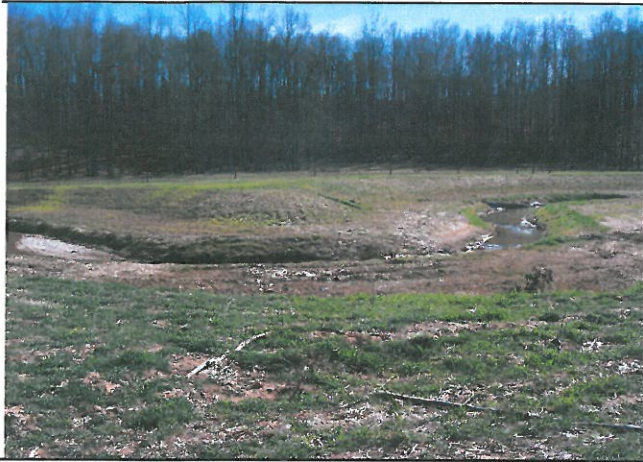
As-built Survey: January 2008

Permanent Cross Section 11

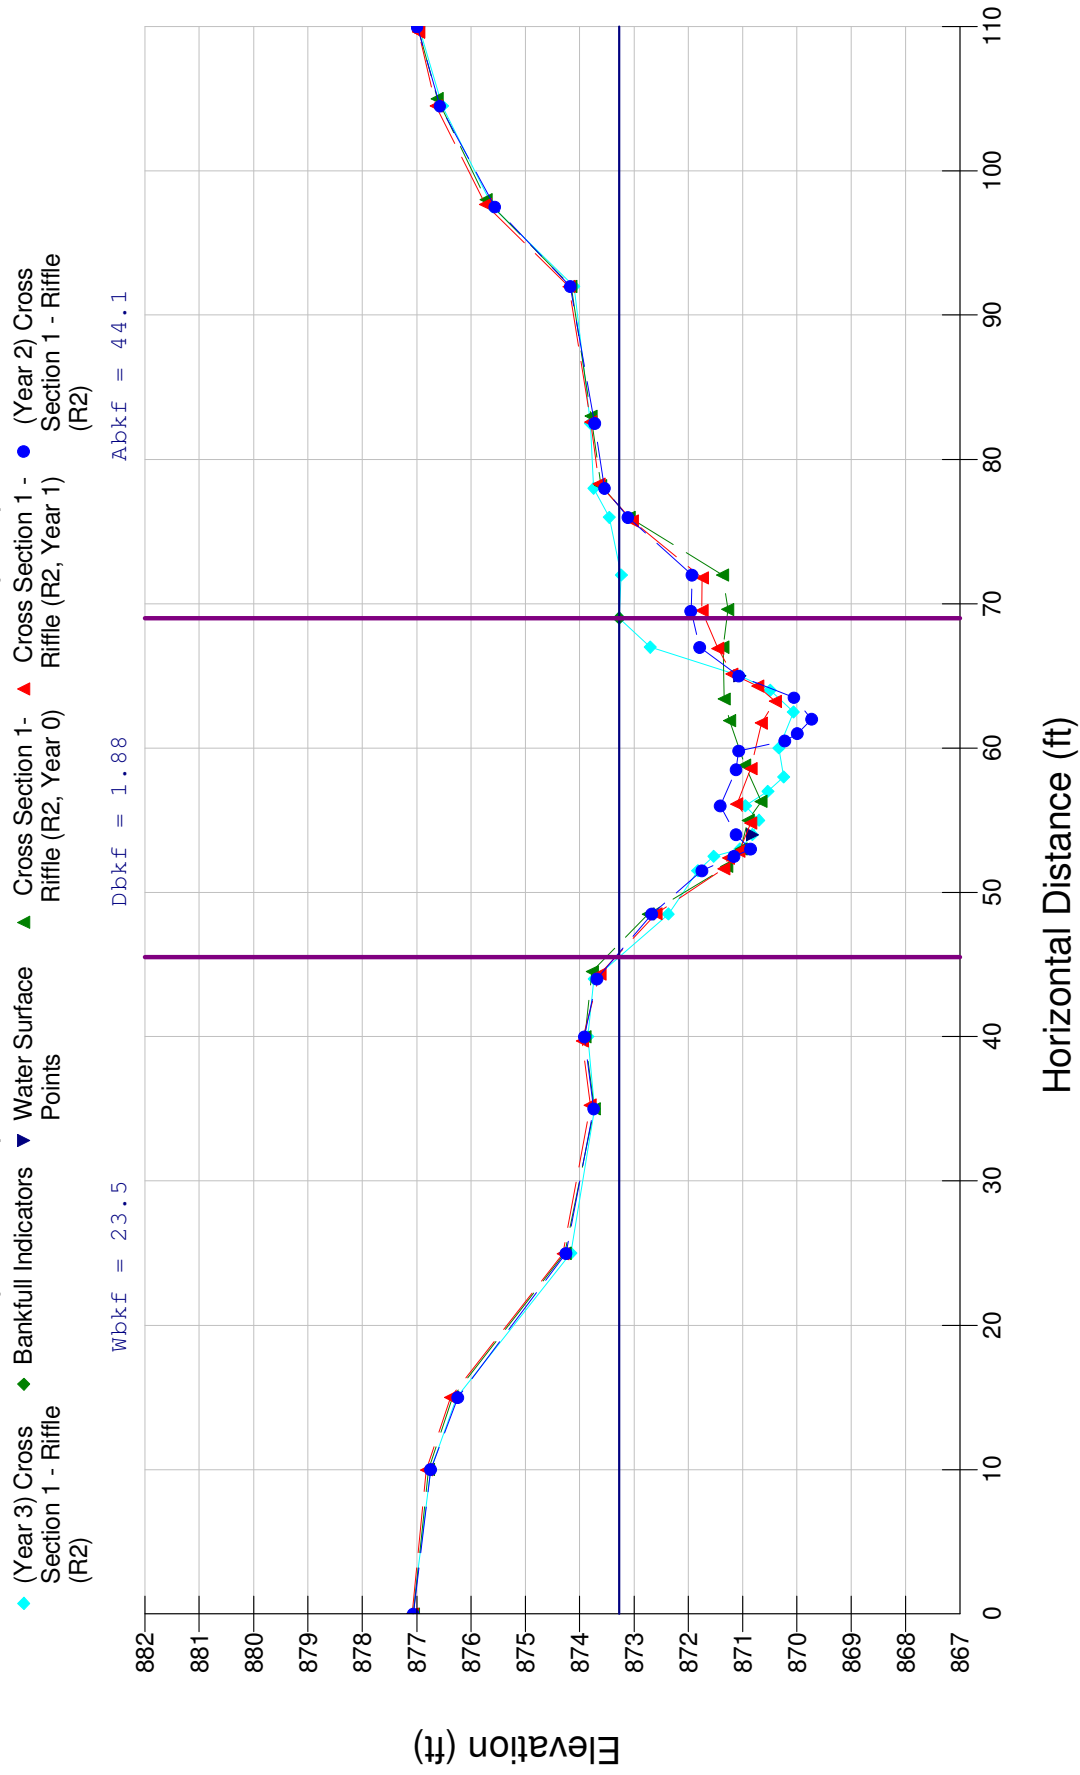
RIVERMORPH CROSS SECTION SUMMARY

River Name: Little White Oak Creek (Year 3)
 Reach Name: R2
 Cross Section Name: (Year 3) Cross Section 1 - Riffle (R2)
 Survey Date: 11/09/2010

All of the 13 cross sections were surveyed to measure the bankfull width, floodprone width, bankfull cross sectional area, bankfull mean depth, bankfull max depth, width to depth ratio, entrenchment ratio, wetted perimeter, and hydraulic radius. The results of the cross section surveys are presented in Table VIII. Appendix D compares photos taken during Monitoring Year 2 with the initial baseline photos and the previous monitoring photos taken at each of the 13 cross sections. Appendix E provides an overlay of the Monitoring Year 2, the previous monitoring periods, and baseline conditions along with the raw data for each cross section. The comparison of Monitoring Year 2 to the previous surveys for stream dimension data for each of the project stream reaches showed very positive results, all of which were comparable to the originally proposed design parameters. Throughout all the cross sections, the bankfull cross sectional area and entrenchment ratios remained consistent indicating the channels were able to contain and convey all the flows experienced during Monitoring Year 2. However, the main channels R1 and R2 displayed typical signs of adjustment in their channel geometries. Both of these reaches have recently been impacted by beavers and some of these adjustments can be attributed to this recent development. In particular on R1, cross section 11 had a significant increase in the width to depth ratio due to the backwater of a downstream beaver dam causing the pool to experience siltation. On the other end, cross section 12 experienced the reverse because a beaver dam was located directly upstream and the cascading water created scour ultimately decreasing the width to depth ratio. Similarly, cross sections along R2 exhibited localized changes in channel geometries, some attributable to beaver activity and others to natural fluctuations, but all within the acceptable ranges of the design parameters. The one exception was cross section 1, with a width to depth ratio climbing up to 22 and the bankfull cross sectional area remaining consistent, a cursory analysis raised concern. However, the overlay of cross section 1 clearly demonstrated the channel developing opposing inner berms to better accommodate the low flow capacity. This effectively allowed the channel to deepen without creating a change in the cross sectional area causing the width to depth ratio to increase instead of decrease due to the derivation being based on the calculated value of mean depth. The results of the smaller tributaries R1A, R2A, R2B, and R2D consistently exhibited minor natural adjustments typical of stable C type streams. The comparisons of the Monitoring Year 2 overlays and

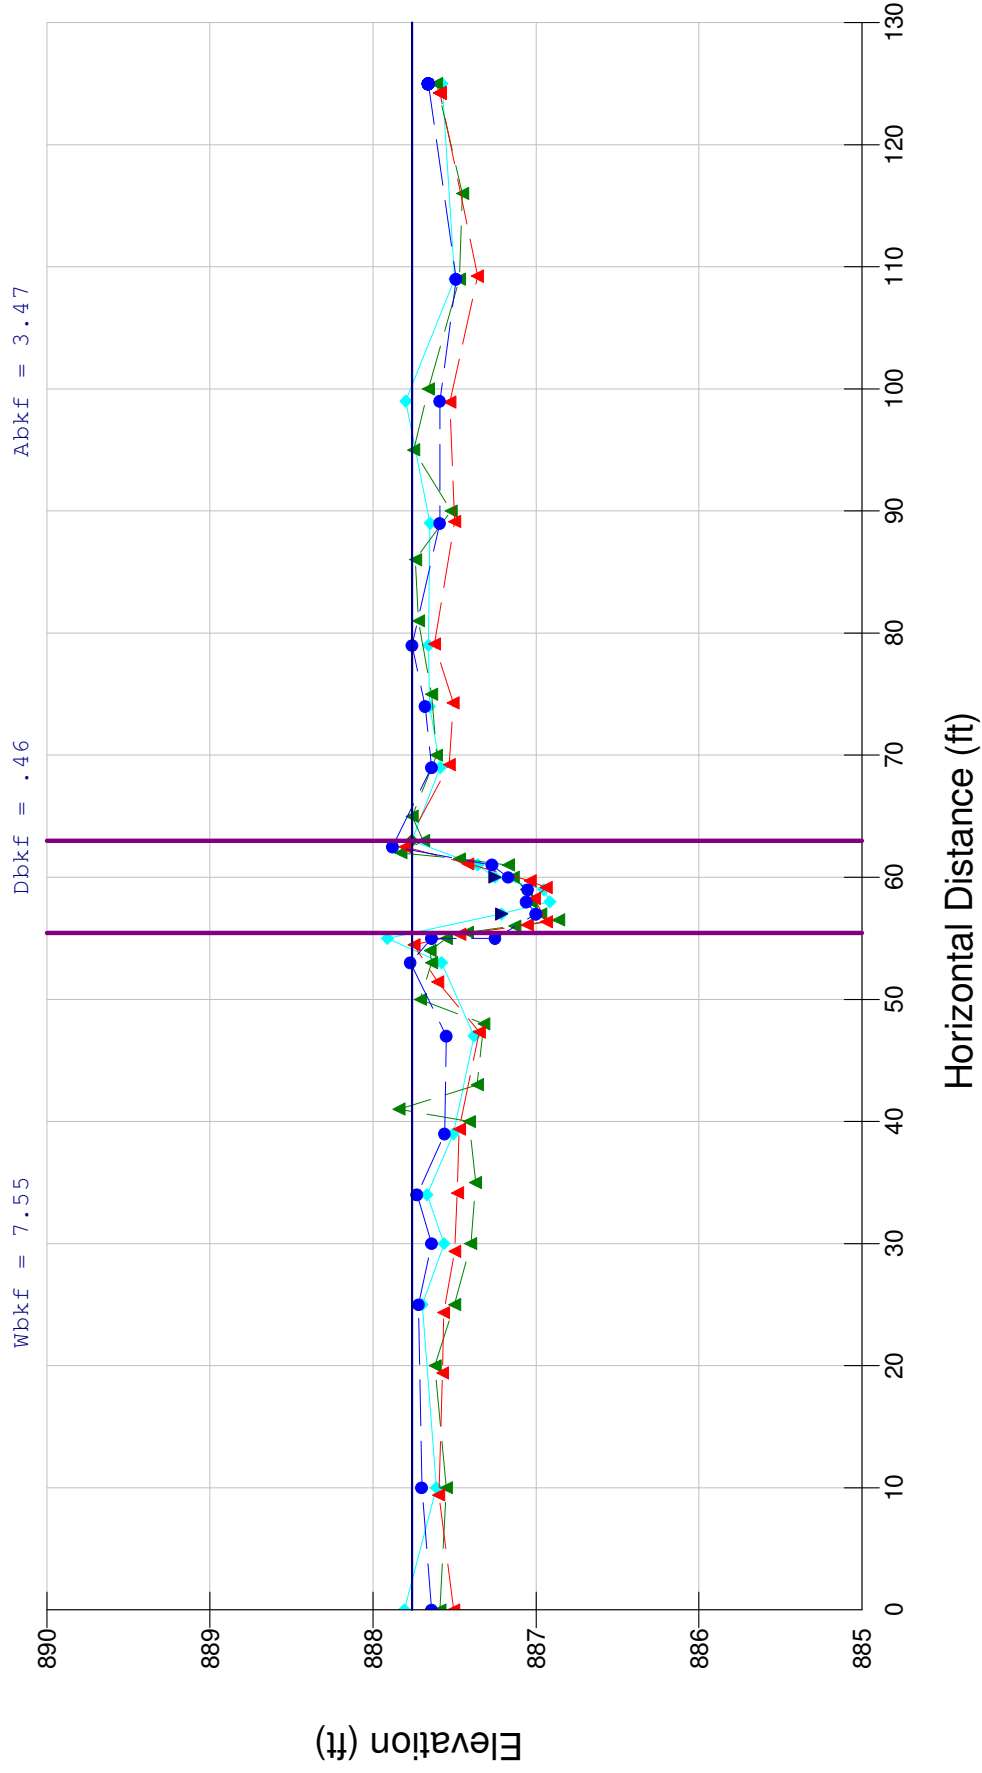
- ◆ (Year 3) Cross Section 13 - Rifle (R1A)
- ◆ Bankfull Indicators
- ▼ Water Surface Points
- ▲ Cross Section 13 - Rifle (R1A, Year 0)
- ▲ Cross Section 13 - Rifle (R1A, Year 1)
- (Year 2) Cross Section 13 - Rifle (R1A)

RIVERMORPH CROSS SECTION SUMMARY

River Name: Little White Oak Creek (Year 3)
 Reach Name: R1A
 Cross Section Name: (Year 3) Cross Section 13 - Riffle (R1A)
 Survey Date: 11/08/2010

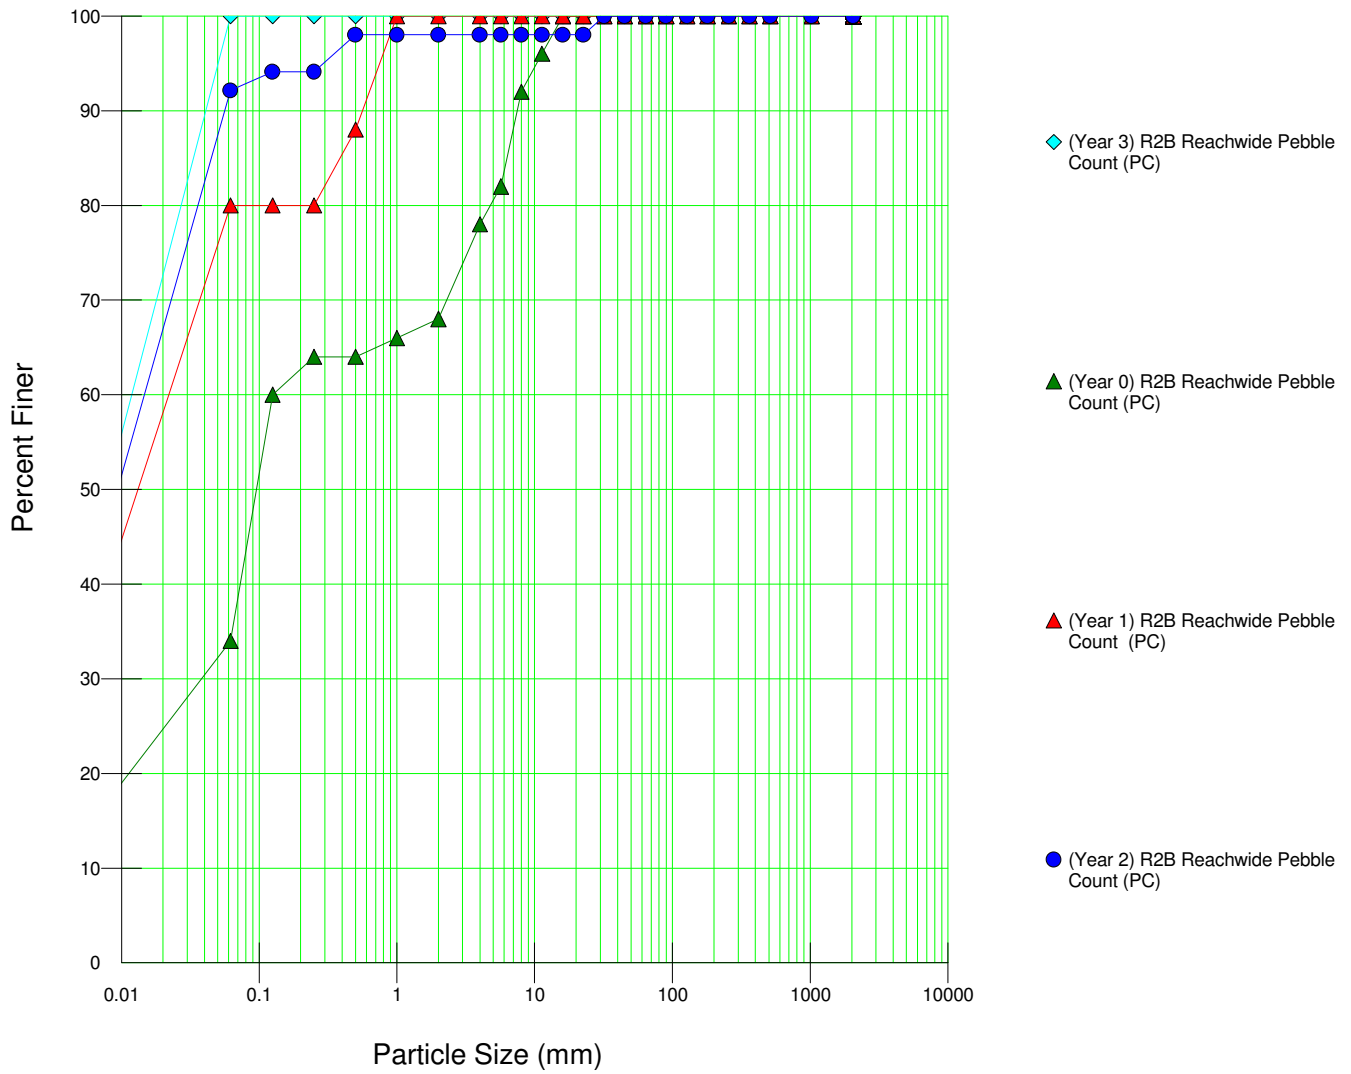
RIVERMORPH PARTICLE SUMMARY

River Name: Little White Oak Creek (Year 3)
Reach Name: R2B
Sample Name: (Year 3) R2B Reachwide Pebble Count
Survey Date: 11/03/2010

Modified Wolman pebble counts were repeated at each of the project stream reaches to classify the stream bed materials and for comparison to the previous years' conditions. The results of the pebble counts are presented in Table VIII while the raw data and overlays of the percent accumulation graphs can be viewed in Appendix E. Fluctuations in bed materials were expected to occur during the early years following construction. Over time the expectation was for the stream to eventually coarsen, however, Monitoring Year 1 and Year 2 have shown the opposite to be true. Specifically, the bed material d50 and d84 for each of the stream reaches decreased. Therefore it is believed that the original assumption that the stream bed materials would coarsen after restoration may have been incorrect. The stream systems at LWOC appear to be sand-dominated and therefore coarsening of the bed may not occur. Nonetheless, the monitoring results do suggest on-site sediment supply from LWOC was reduced as a result of the restoration. As noted earlier, the success criteria for the bed material will be determined at the end of the five-year monitoring period when data can be reviewed and compared to the proposed channel material types. Fluctuations in bed materials will likely continue to occur and several years may be needed to observe a consistent bed material.
