As-Built Baseline Monitoring Report

Logan Creek Stream Restoration Project

Jackson County, North Carolina

DMS Project ID No. 92515, Contract No. D06046

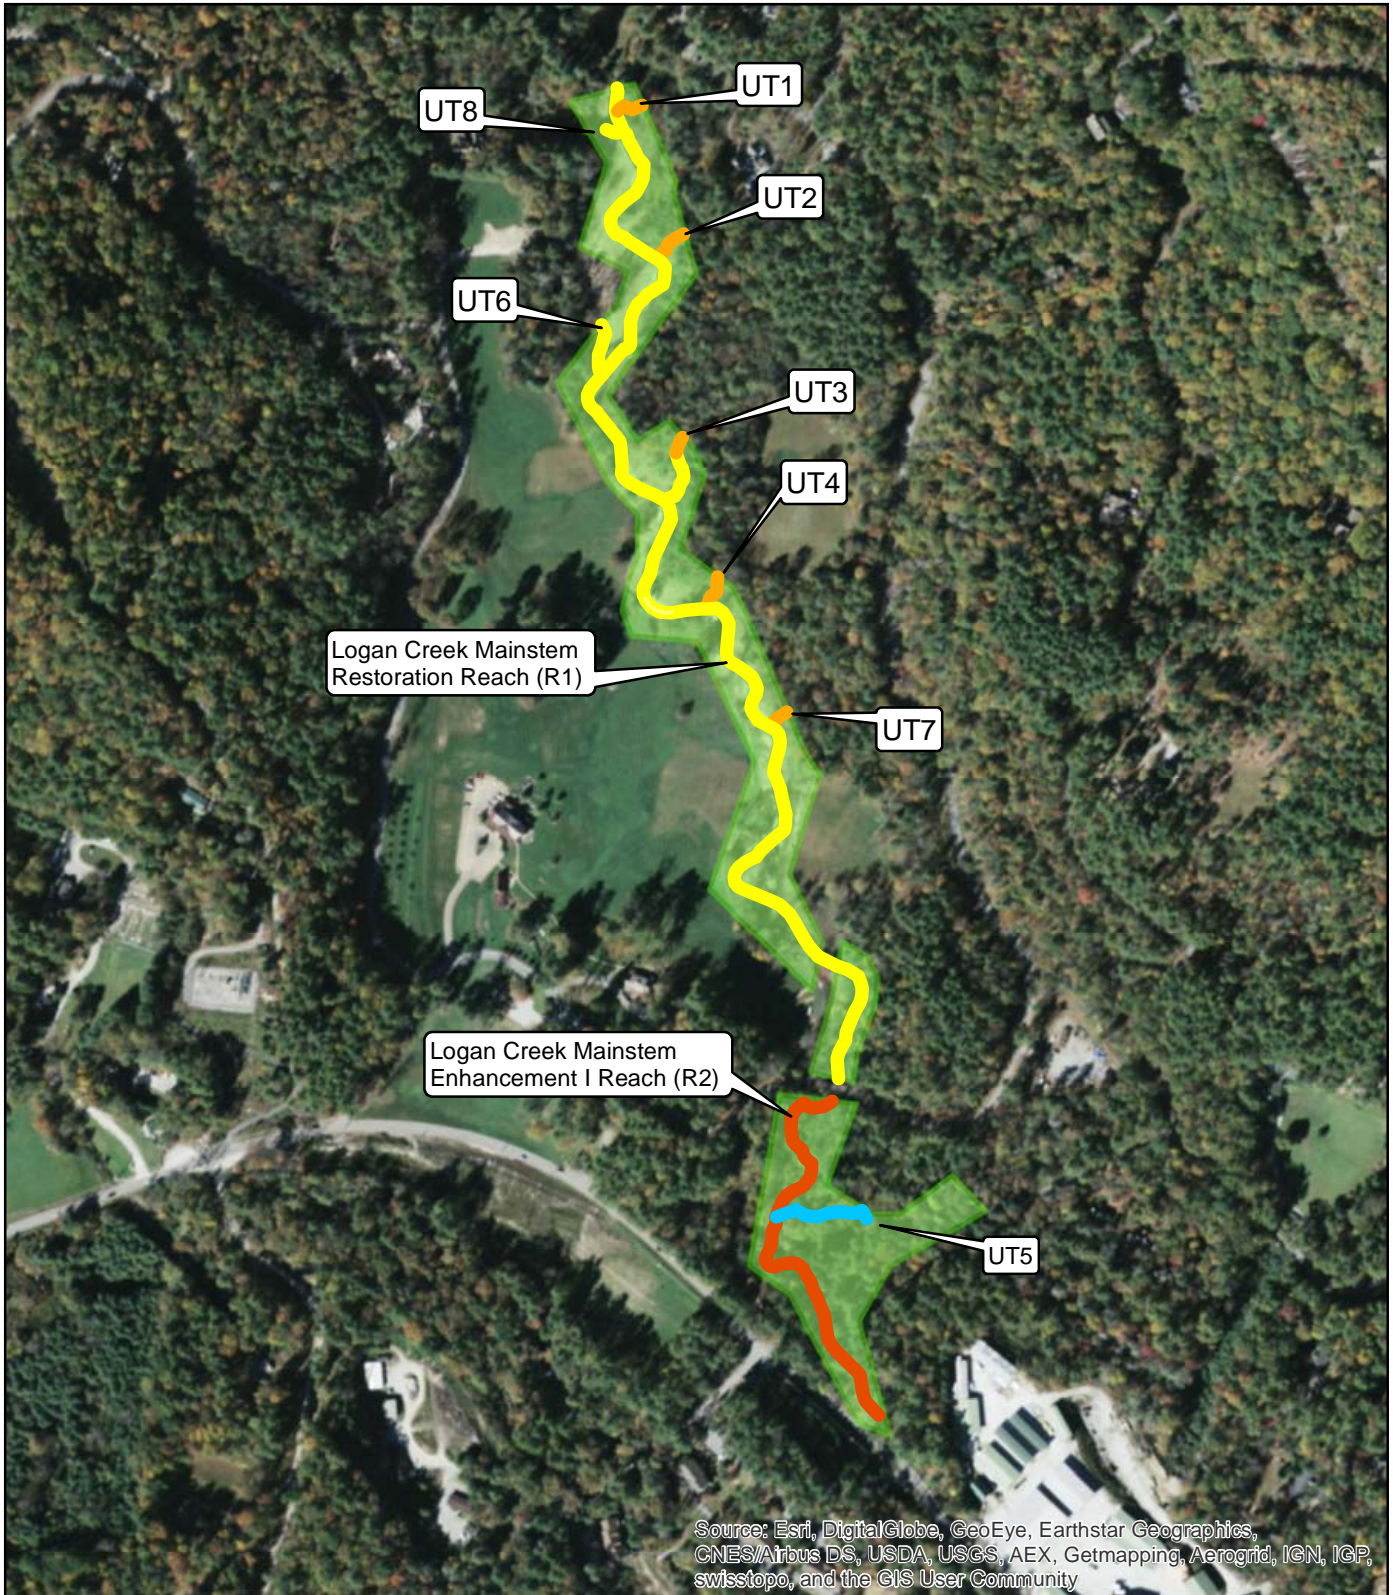
Fig 2. Asset Map showing existing project reaches, tributaries and type of restoration.

Within the project area, a segment of Logan Creek and eight unnamed tributaries to Logan Creek were restored, enhanced or preserved. For design purposes, Logan Creek through the project site was divided into two reaches, with a longer upstream Reach 1 that was improved using a Restoration approach and a shorter downstream Reach 2 that was improved using an Enhancement I approach. Each unnamed tributary was designated as a UT and named UT1 to UT8. Only UT3 was divided into two reaches designated as Reach 1 (Enhancement II) and Reach 2 (Restoration). UT1, UT2, UT4 and UT7 were all improved using an Enhancement II approach. UT5 is a high quality stream that is being preserved. UT6 and UT8 both require Restoration to connect them to the new mainstem channel. Additionally, there are small areas of jurisdictional wetlands and vernal pools within the easement; however, we are not requesting mitigation credit for these areas. Figure 2 in Appendix A illustrates the locations of these streams.

Streambanks were stabilized using a combination of erosion control matting, temporary and permanent seeding, live staking and bare-root planting. The site is planted with native vegetation (as shown in Table 7, Appendix C) and is protected through a permanent conservation easement. Table 1 and Figure 2 (Appendix A) provide a summary of the project components.

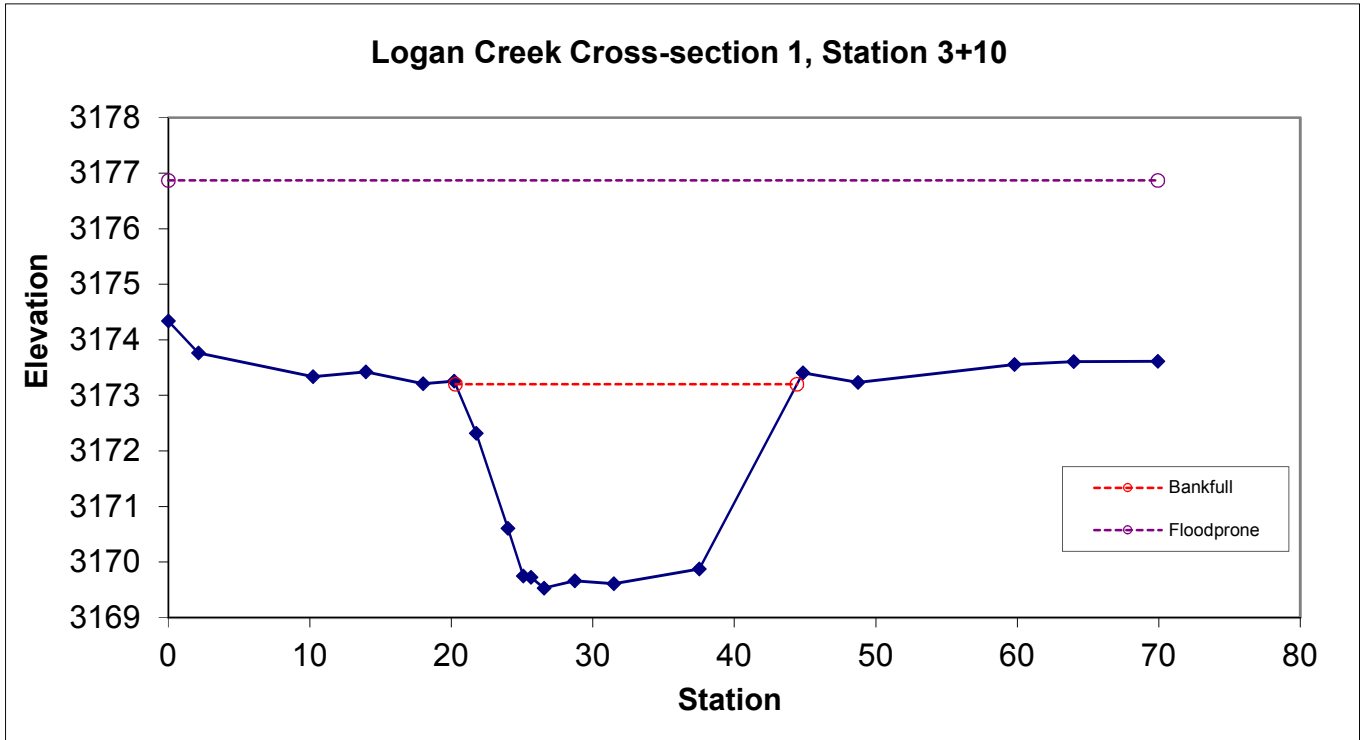
Permanent Cross-section 1
 (As-Built Data - collected May, 2015)

Feature	Stream Type	BKF Area	BKF Width	BKF Depth	Max BKF Depth	W/D	BH Ratio	ER	BKF Elev	TOB Elev
Riffle	E	63	24.12	2.61	3.67	9.23	1	2.9	3173.2	3173.26

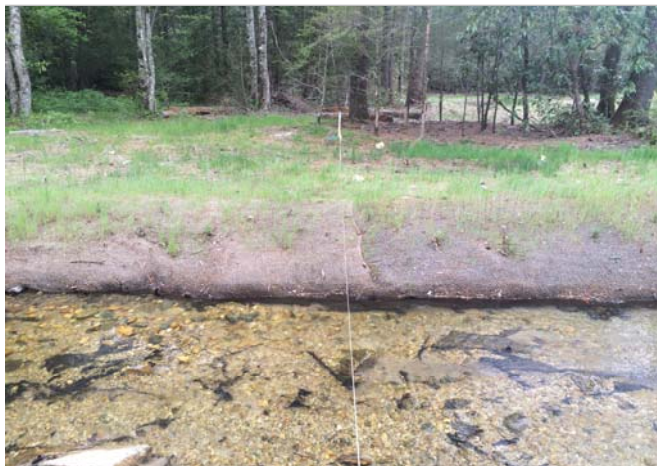
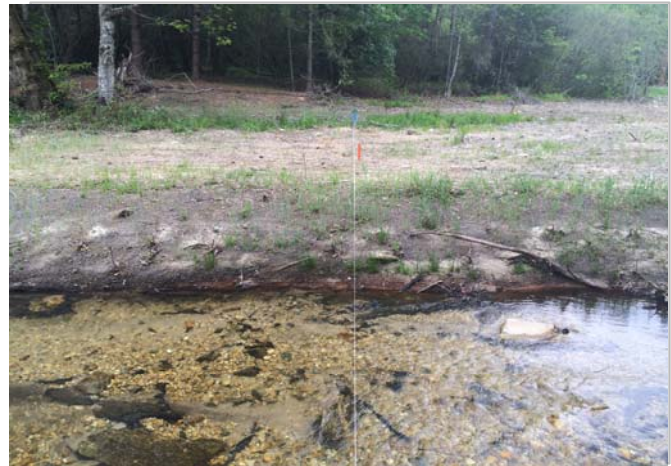
Looking at the Left Bank

Looking at the Right Bank

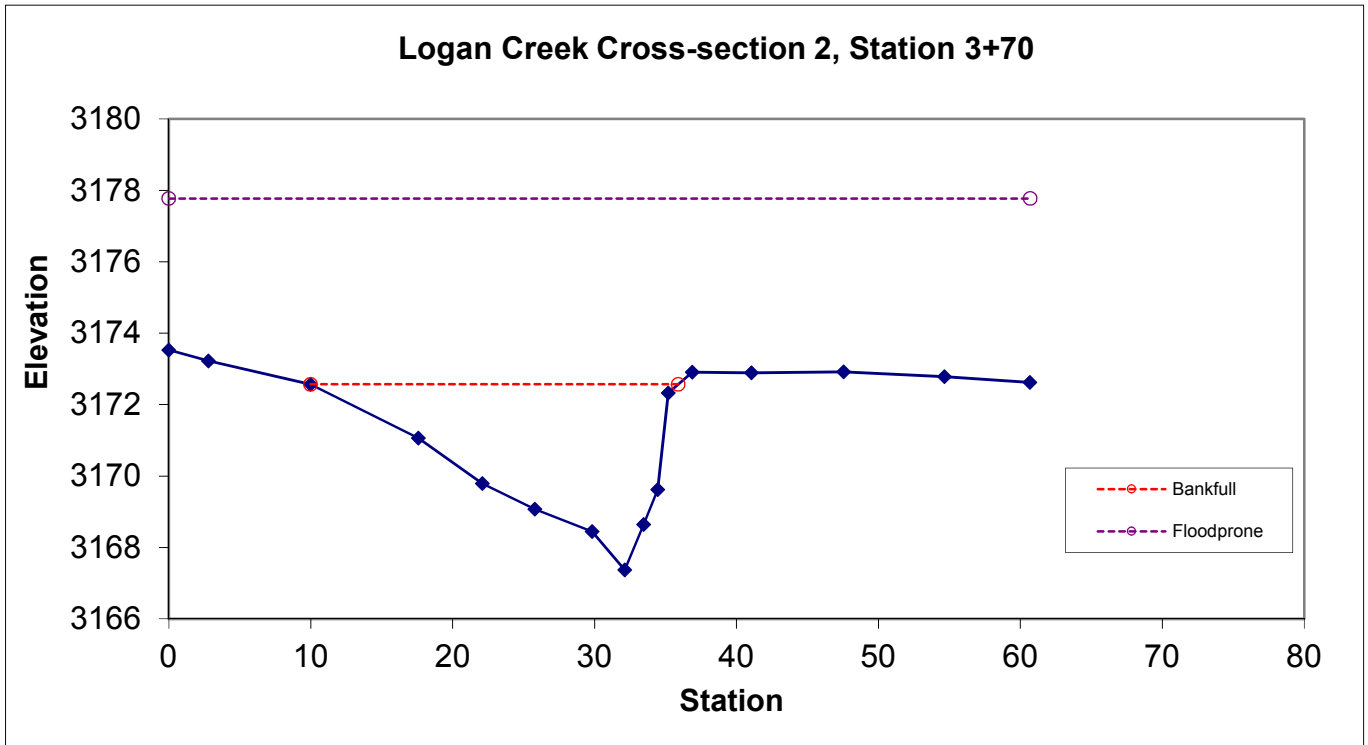
Permanent Cross-section 2
 (As-Built Data - collected May, 2015)

Feature	Stream Type	BKF Area	BKF Width	BKF Depth	Max BKF Depth	W/D	BH Ratio	ER	BKF Elev	TOB Elev
Pool		63.9	25.91	2.47	5.2	10.5	1.1	2.3	3172.57	3172.91

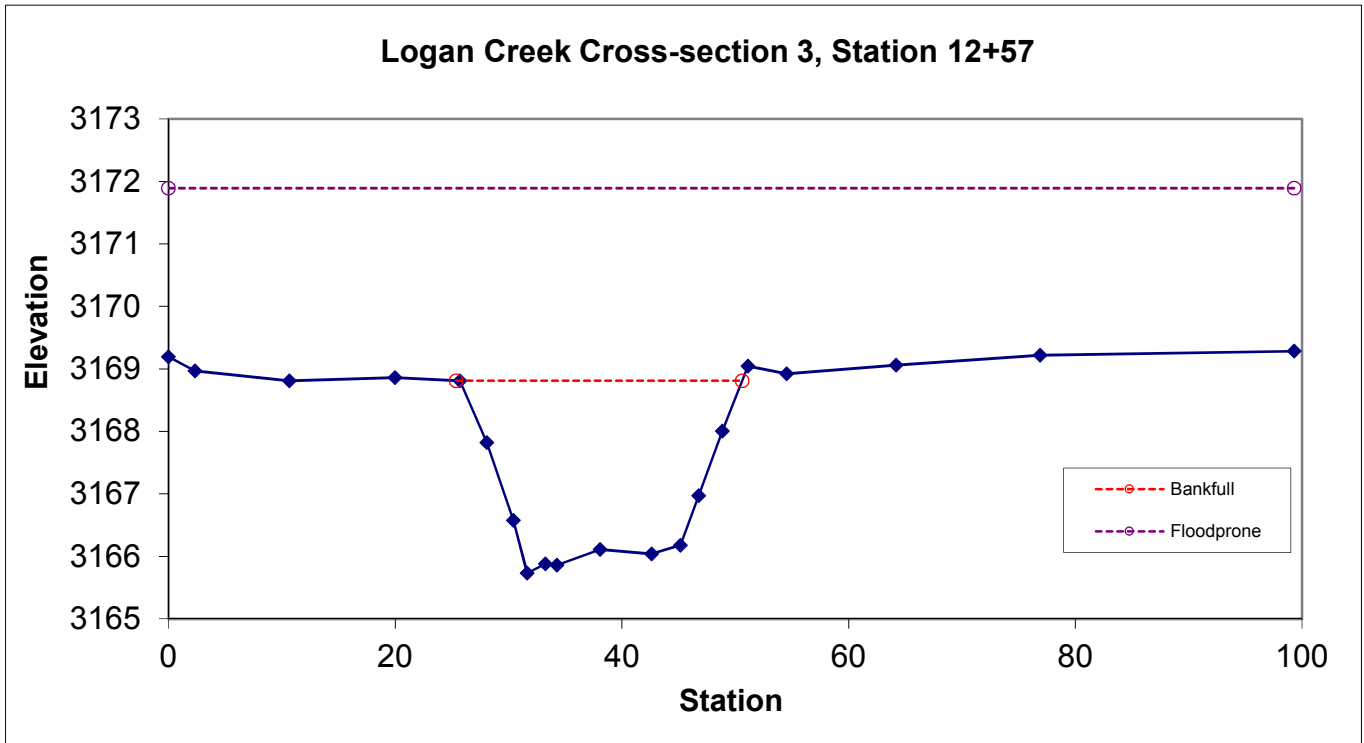
Permanent Cross-section 3
 (As-Built Data - collected May, 2015)

Feature	Stream Type	BKF Area	BKF Width	BKF Depth	Max BKF Depth	W/D	BH Ratio	ER	BKF Elev	TOB Elev
Riffle	C	53.2	25.23	2.11	3.08	11.97	1	3.9	3168.81	3168.86

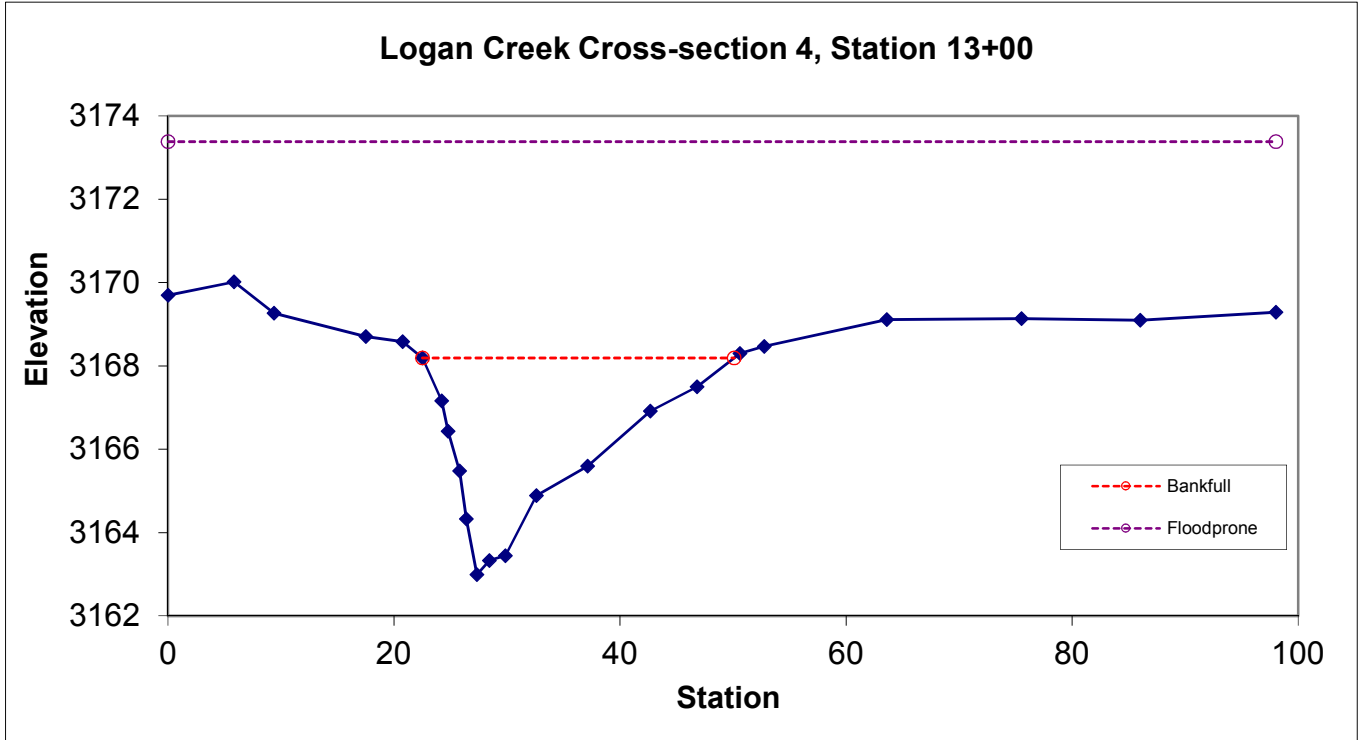
Permanent Cross-section 4
 (As-Built Data - collected May, 2015)

Feature	Stream Type	BKF Area	BKF Width	BKF Depth	Max BKF Depth	W/D	BH Ratio	ER	BKF Elev	TOB Elev
Pool		62.8	27.59	2.28	5.2	12.11	1	3.6	3168.19	3168.29

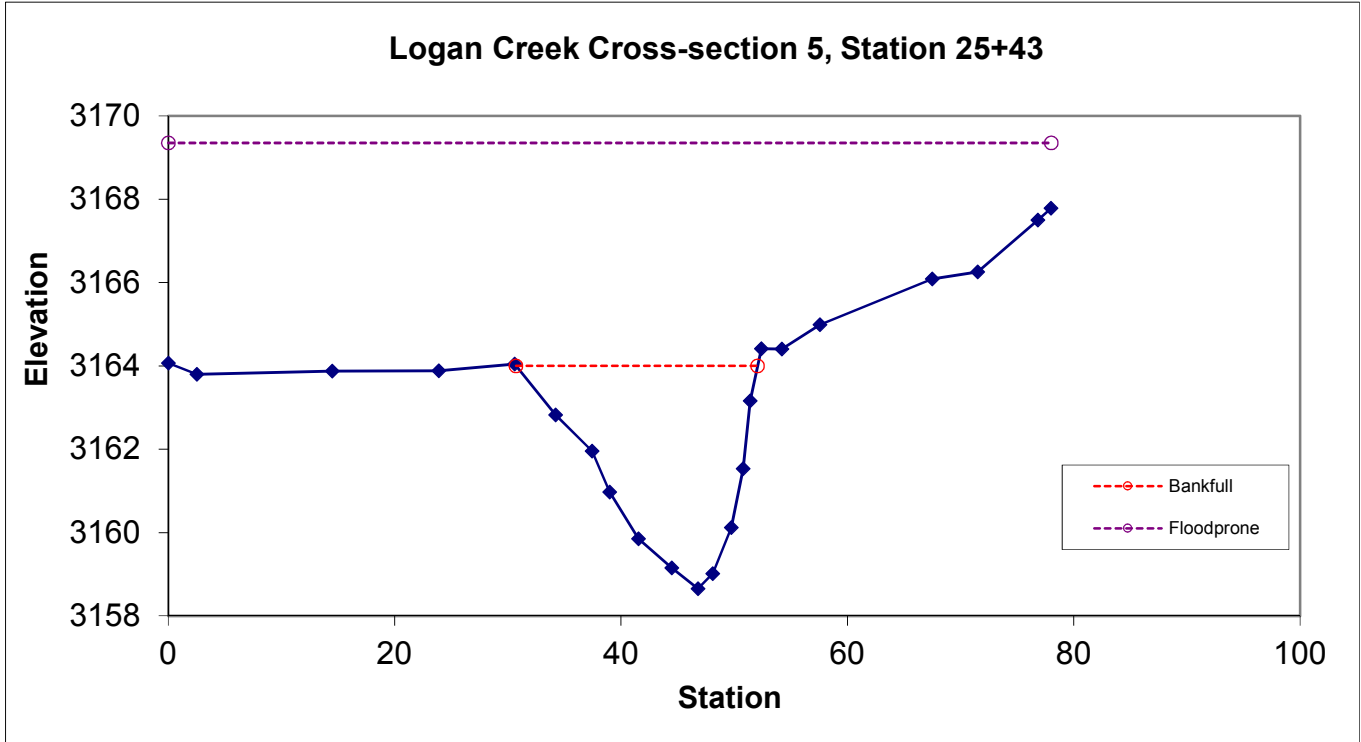
Permanent Cross-section 5
 (As-Built Data - collected May, 2015)

Feature	Stream Type	BKF Area	BKF Width	BKF Depth	Max BKF Depth	W/D	BH Ratio	ER	BKF Elev	TOB Elev
Pool		63.9	21.34	3	5.35	7.12	1	4.4	3164	3164.04

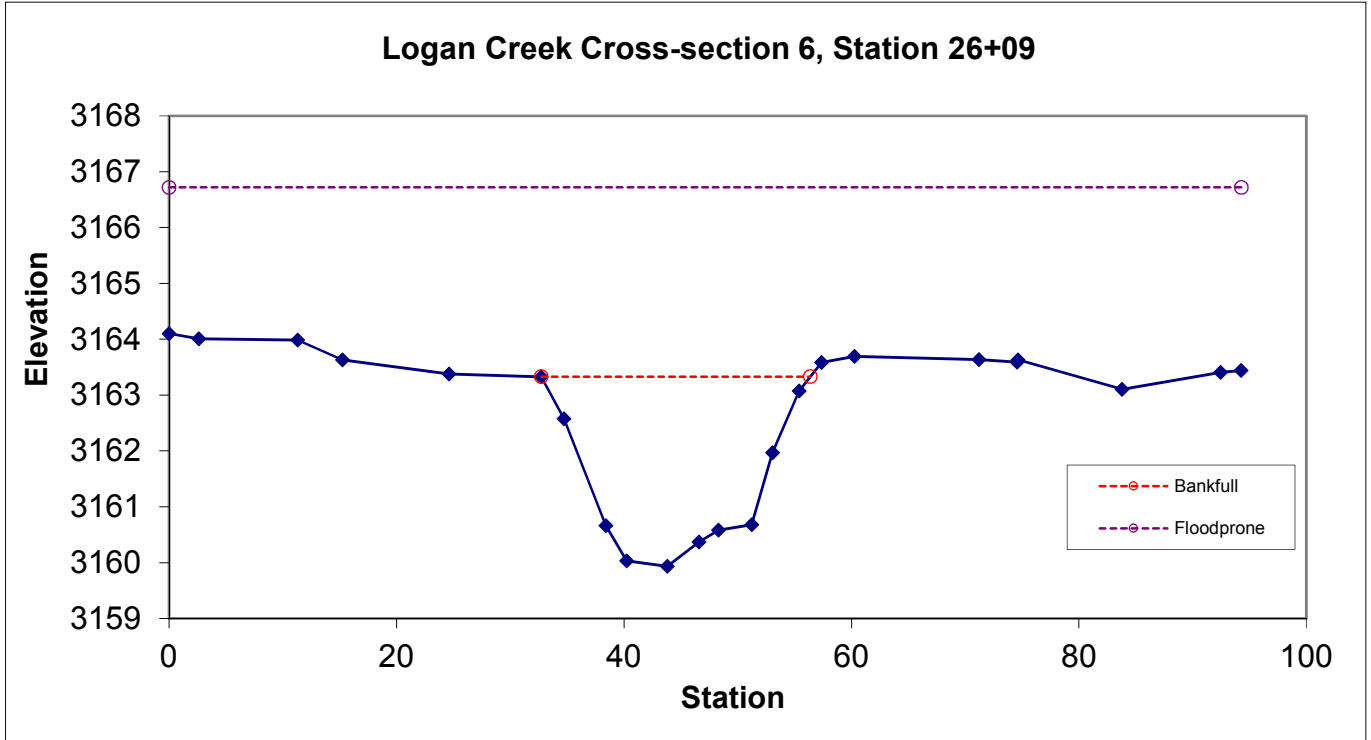
Permanent Cross-section 6
 (As-Built Data - collected May, 2015)

Feature	Stream Type	BKF Area	BKF Width	BKF Depth	Max BKF Depth	W/D	BH Ratio	ER	BKF Elev	TOB Elev
Riffle	E	51.7	23.64	2.19	3.39	10.81	1	4	3163.33	3163.38

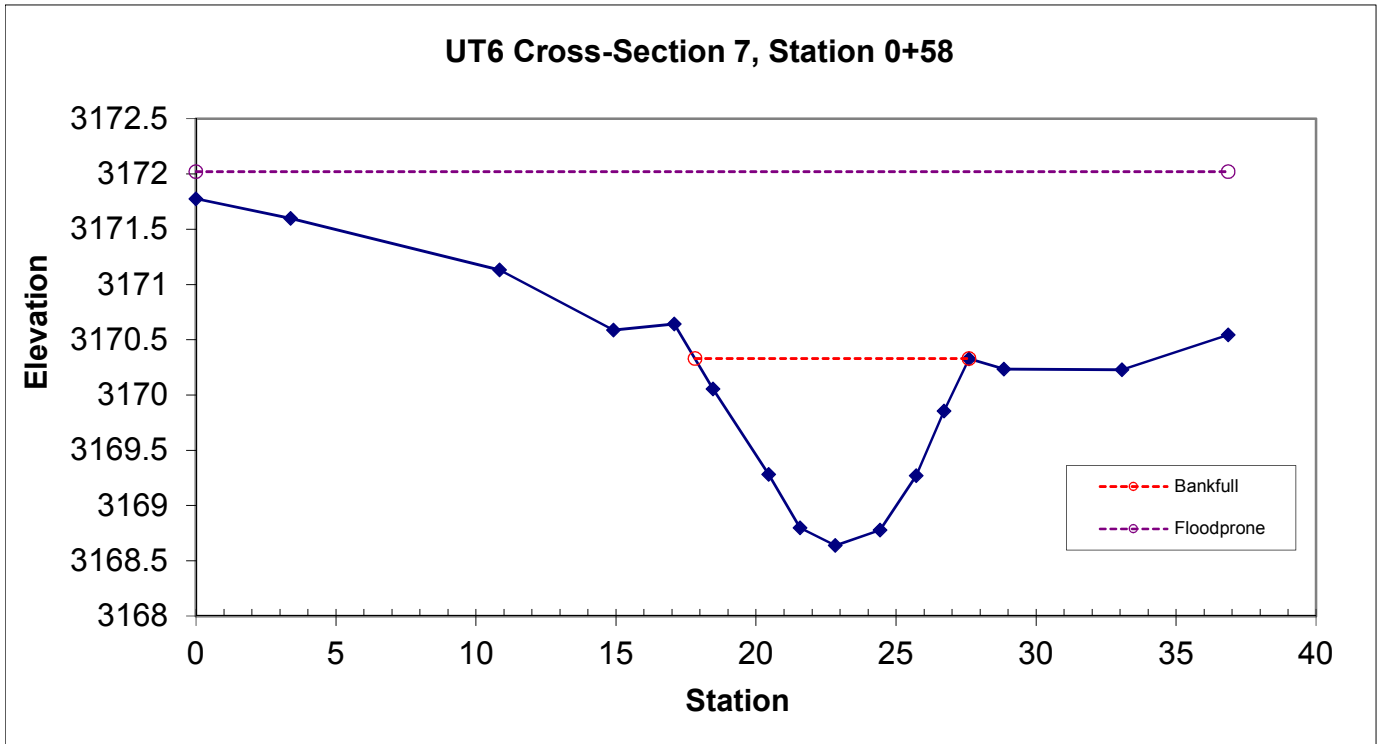
Permanent Cross-section 7
 (As-Built Data - collected May, 2015)

Feature	Stream Type	BKF Area	BKF Width	BKF Depth	Max BKF Depth	W/D	BH Ratio	ER	BKF Elev	TOB Elev
Pool		10.1	9.78	1.03	1.69	9.47	1	3.8	3170.33	3170.33

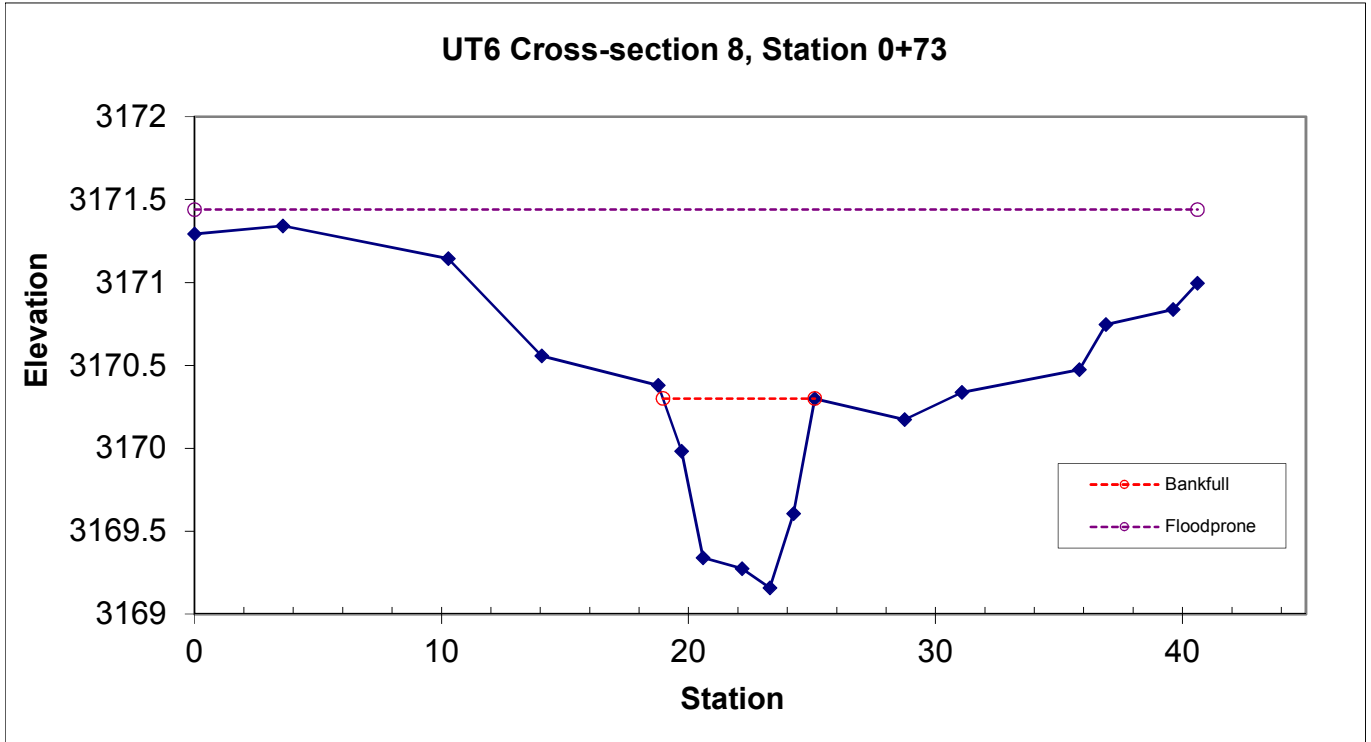
Permanent Cross-section 8
 (As-Built Data - collected May, 2015)

Feature	Stream Type	BKF Area	BKF Width	BKF Depth	Max BKF Depth	W/D	BH Ratio	ER	BKF Elev	TOB Elev
Riffle	E	4.6	6.14	0.76	1.14	8.12	1	6.6	3170.3	3170.3

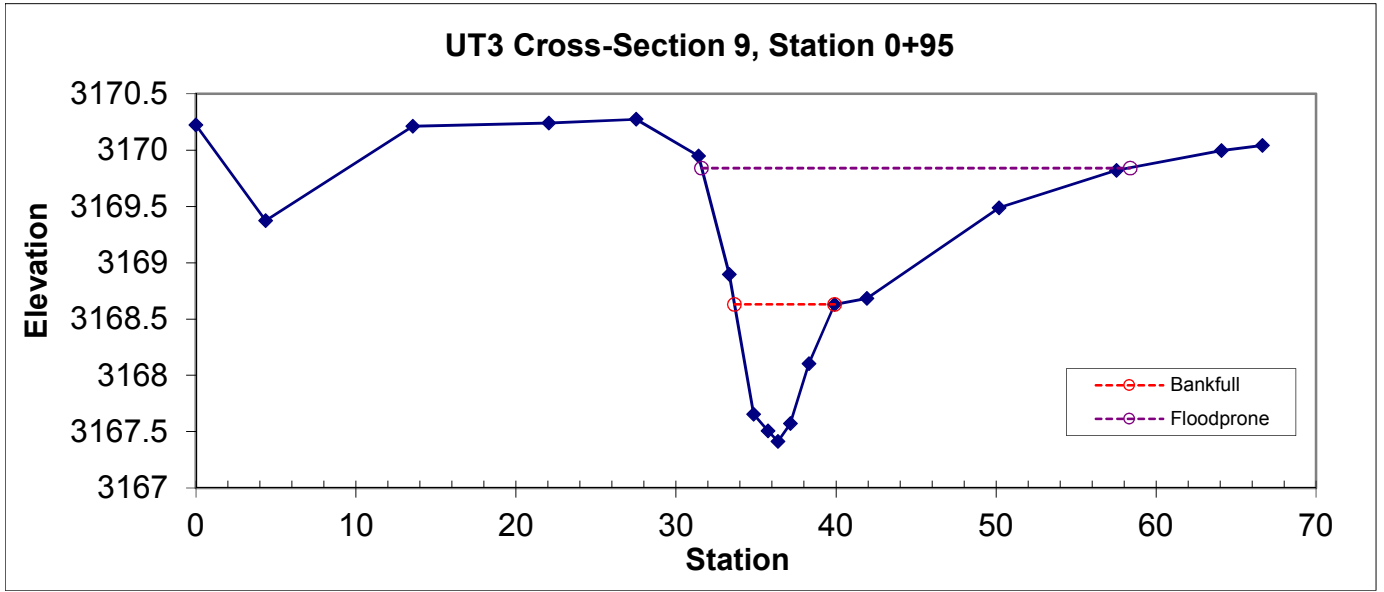
Permanent Cross-section 9
 (As-Built Data - collected May, 2015)

Feature	Stream Type	BKF Area	BKF Width	BKF Depth	Max BKF Depth	W/D	BH Ratio	ER	BKF Elev	TOB Elev
Riffle	E	4.5	6.25	0.72	1.22	8.73	1	4.3	3168.63	3168.63

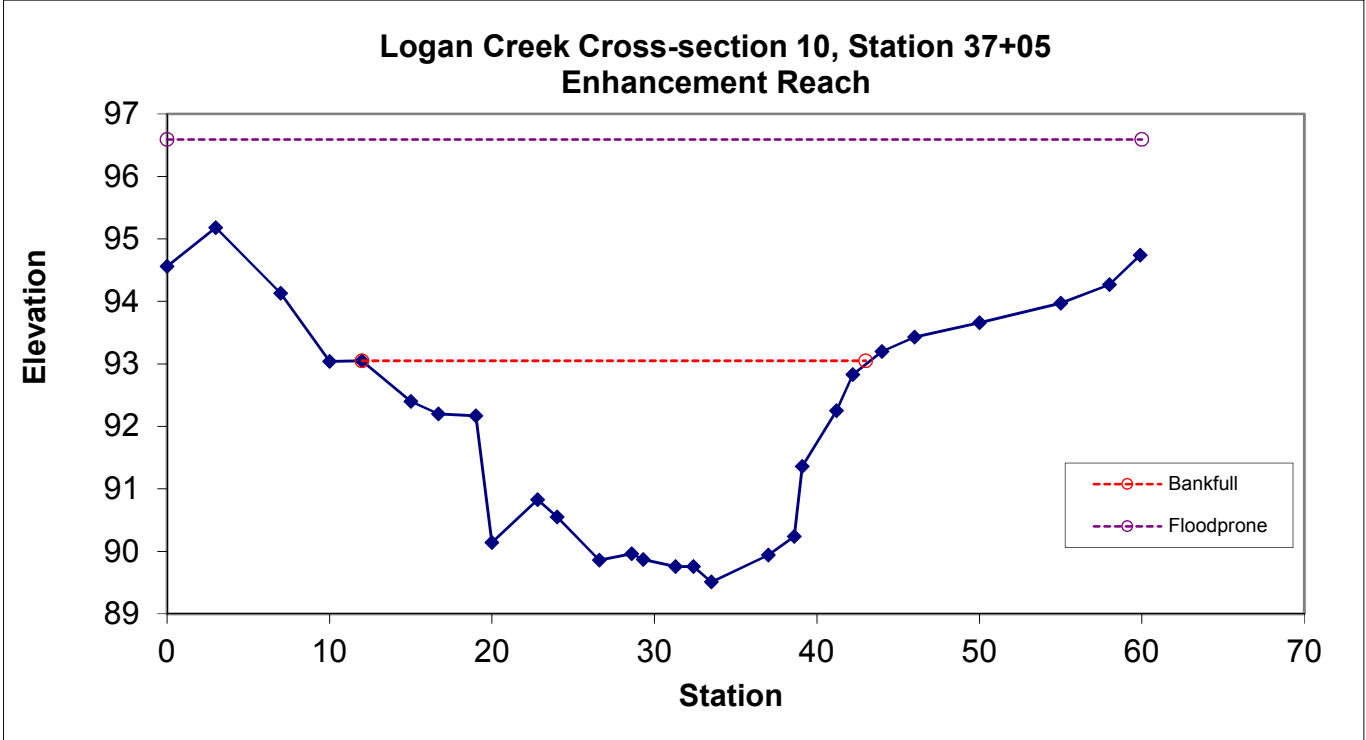
Permanent Cross-section 10
 (As-Built Data - collected October, 2015)

Feature	Stream Type	BKF Area	BKF Width	BKF Depth	Max BKF Depth	W/D	BH Ratio	ER	BKF Elev	TOB Elev
Pool		66.6	31	2.1	3.5	14.4	1.0	4.2	93.05	93.2

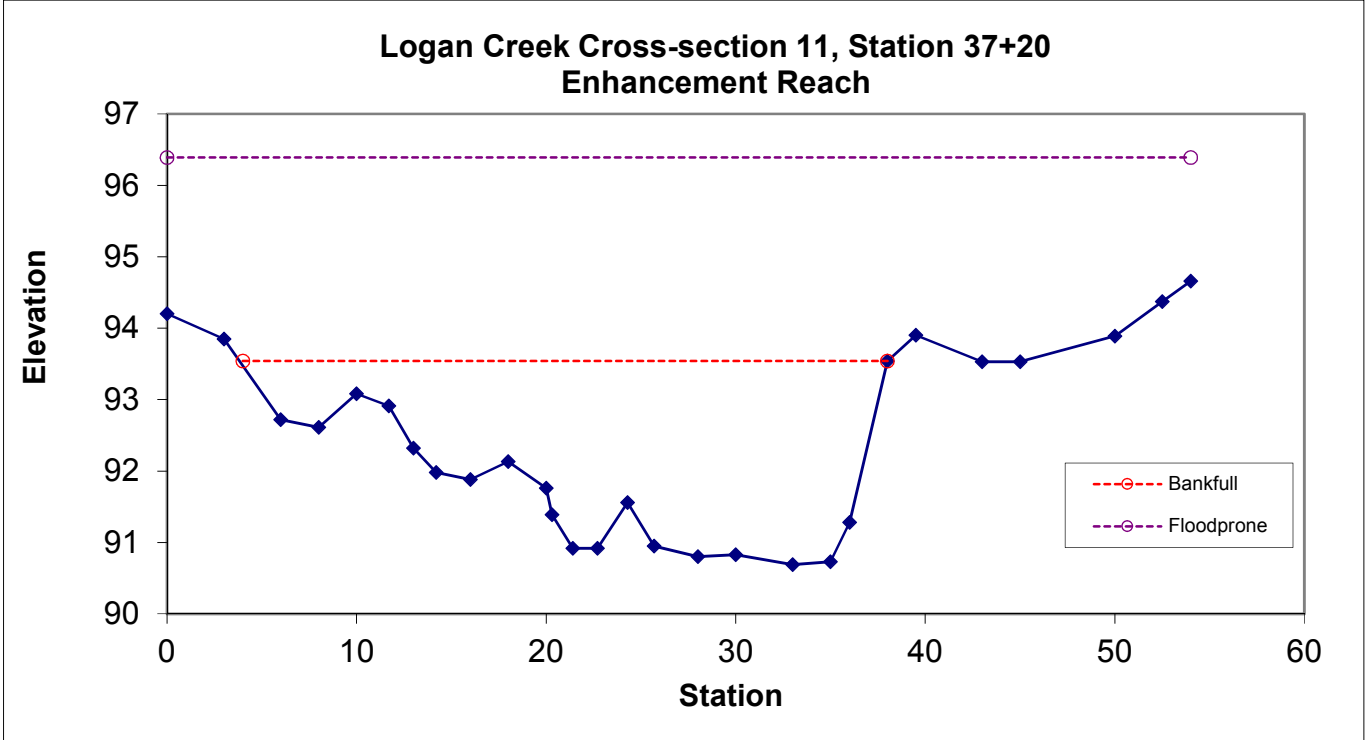
Permanent Cross-section 11
 (As-Built Data - collected October, 2015)

Feature	Stream Type	BKF Area	BKF Width	BKF Depth	Max BKF Depth	W/D	BH Ratio	ER	BKF Elev	TOB Elev
Riffle		60.73	29.2	2.1	2.9	14	1.1	4.5	93.54	93.85

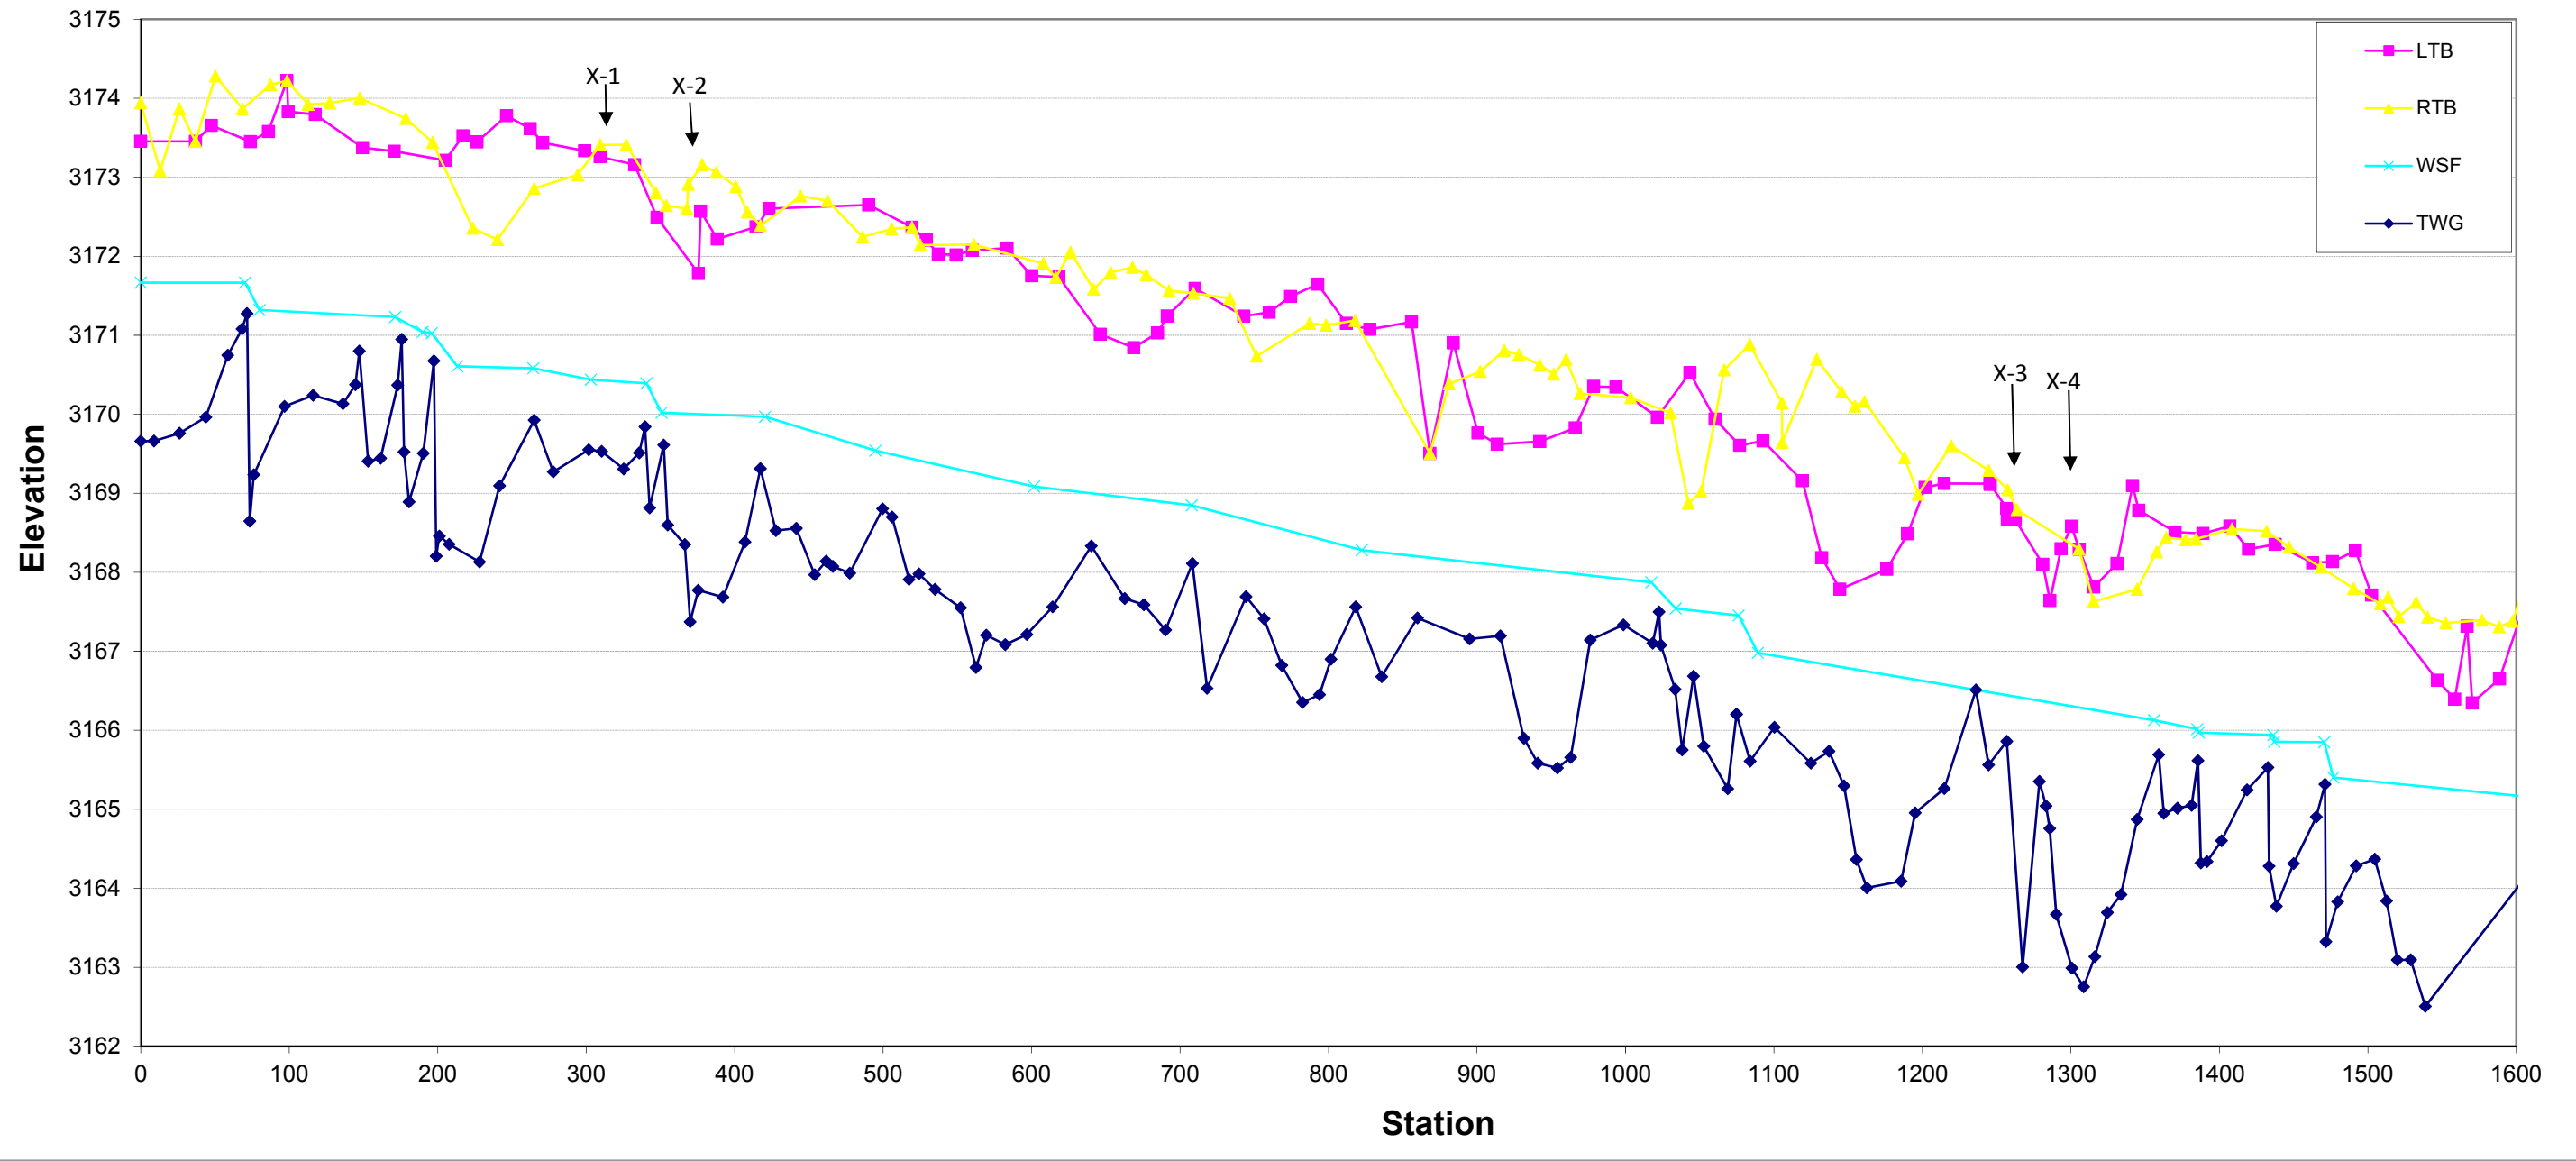
As-built Profile of Logan Creek, Station 0+00 to 16+00 Data collected May, 2015

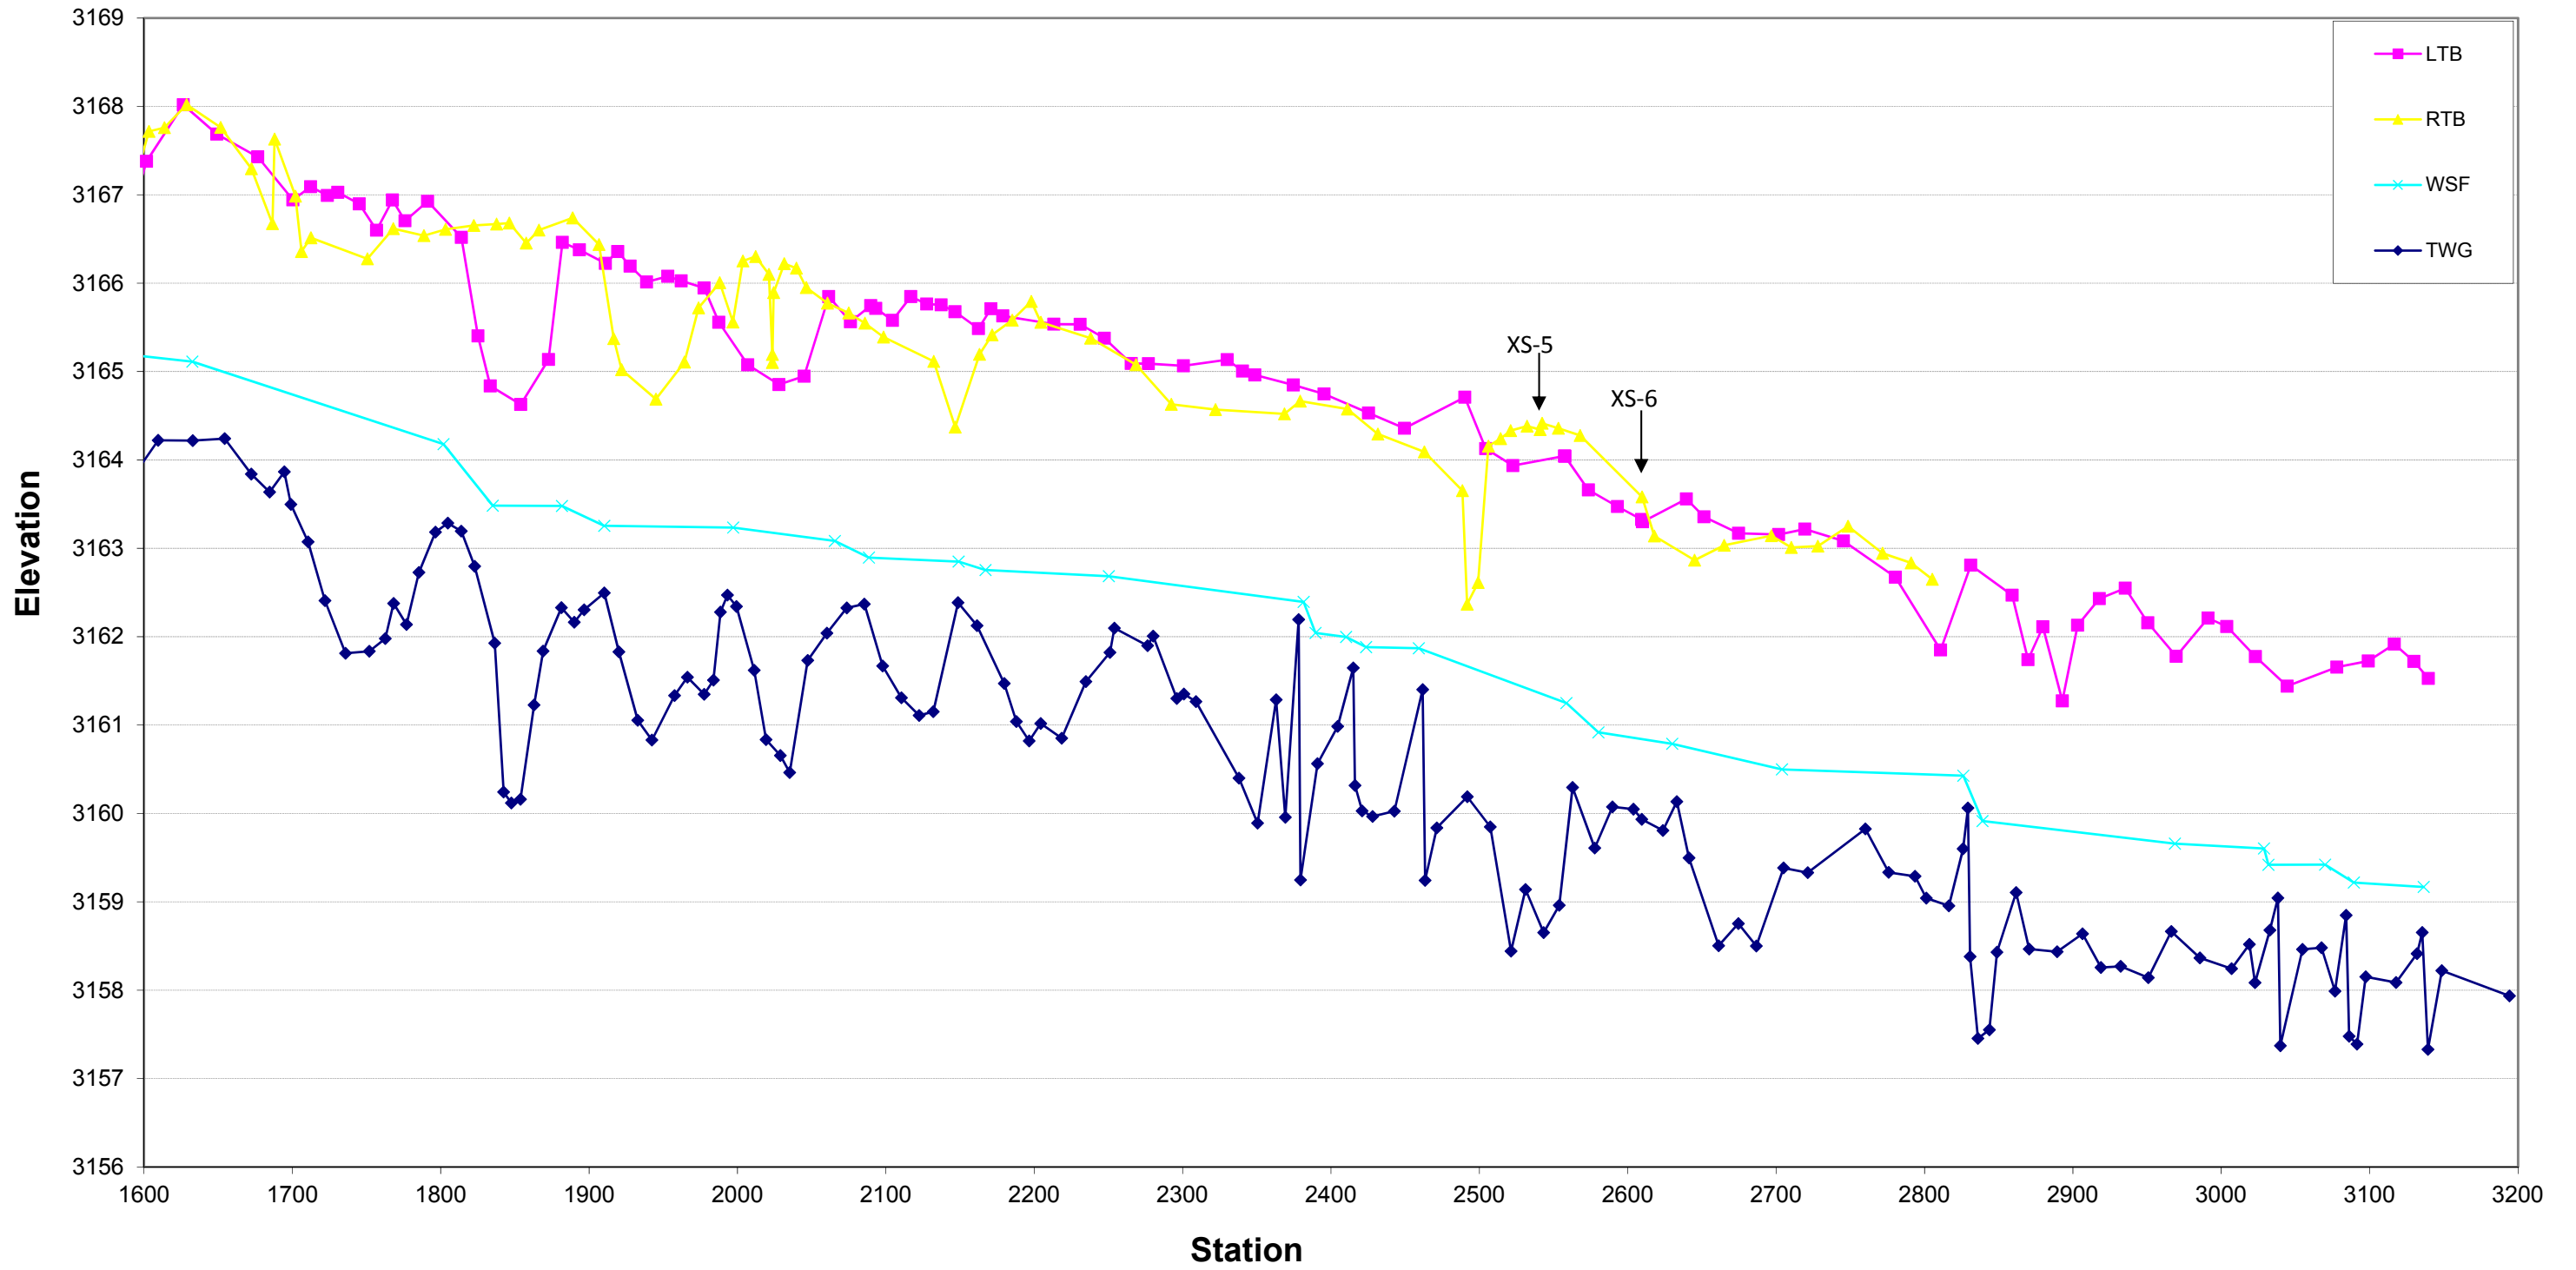
As-built Profile of Logan Creek, Station 16+00 to 32+00 Data collected May, 2015
