As-Built Baseline Monitoring Report

Logan Creek Stream Restoration Project

Jackson County, North Carolina

DMS Project ID No. 92515, Contract No. D06046

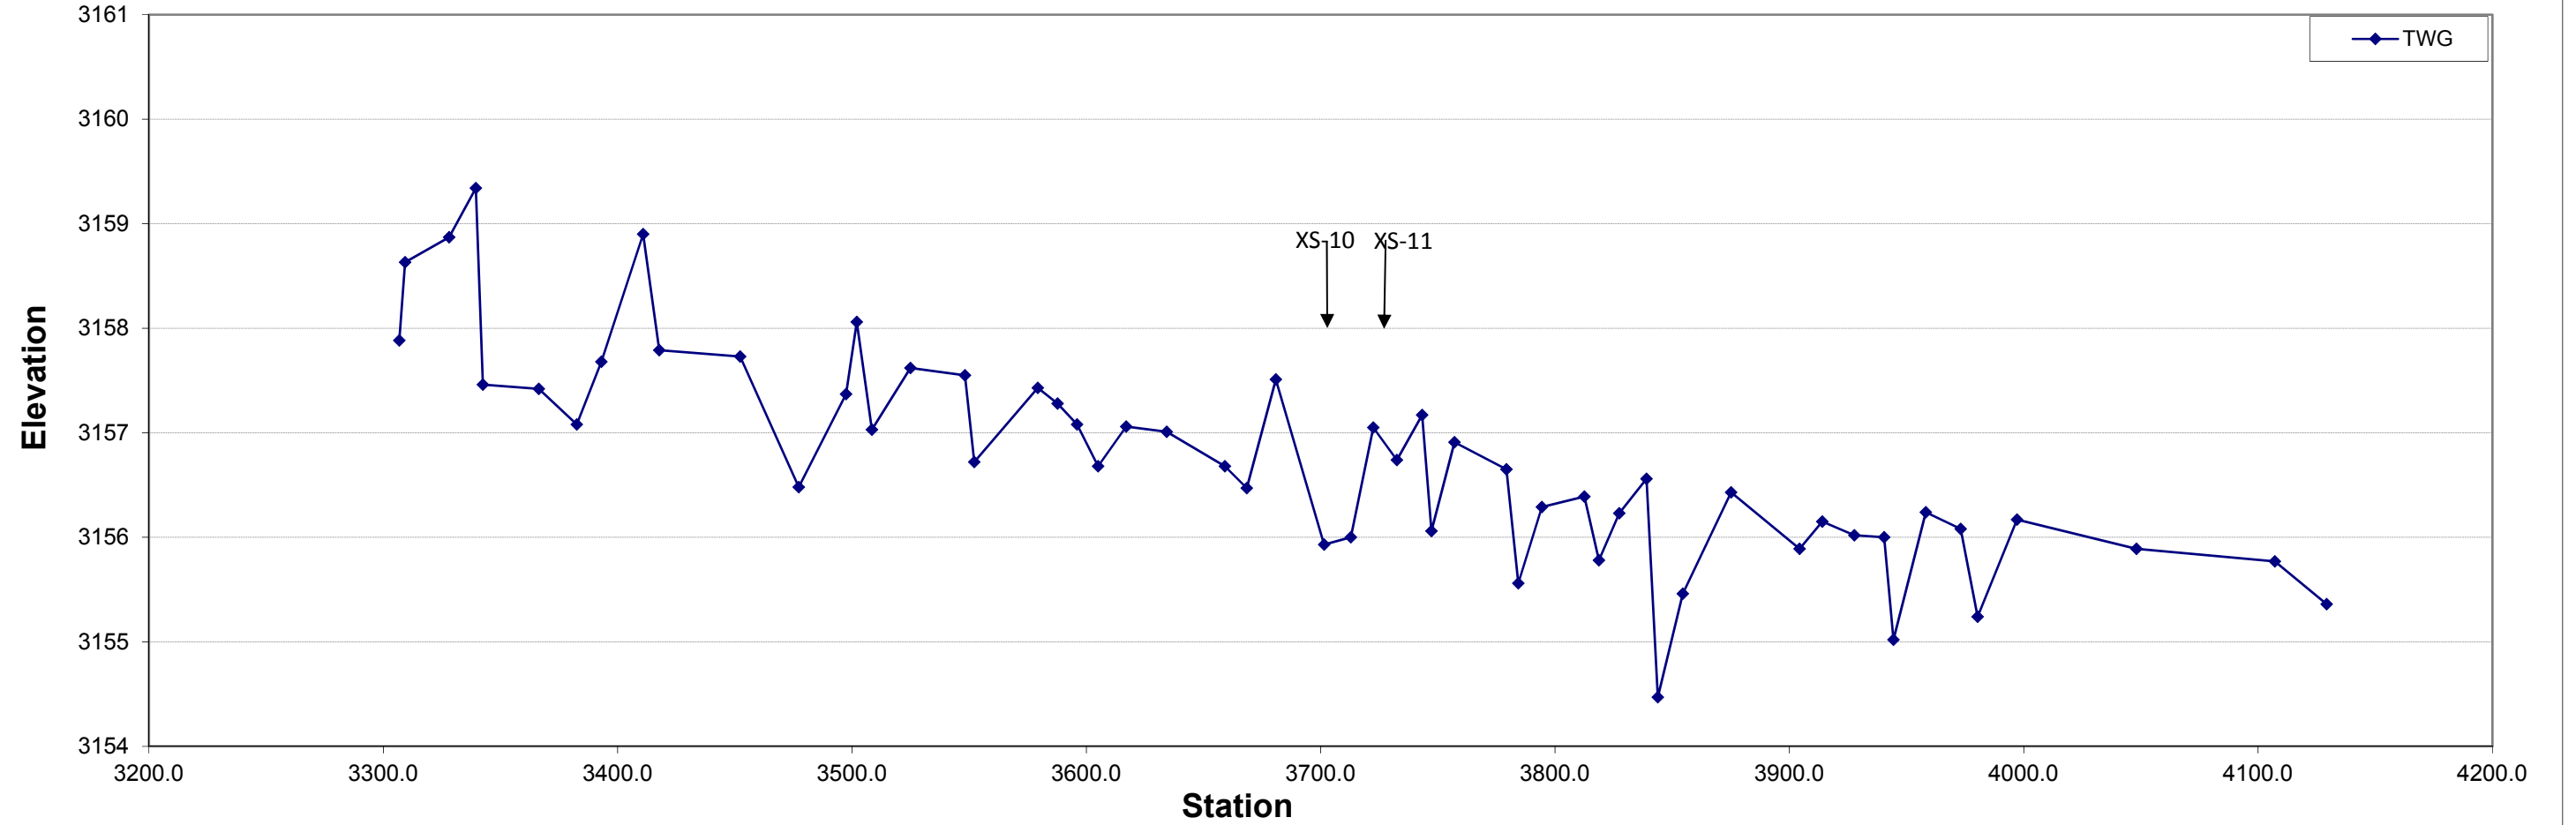
**As-built Thalweg Profile of Logan Creek Enhancement Reach,
Station 32+00 to 42+00, Data collected May, 2015**

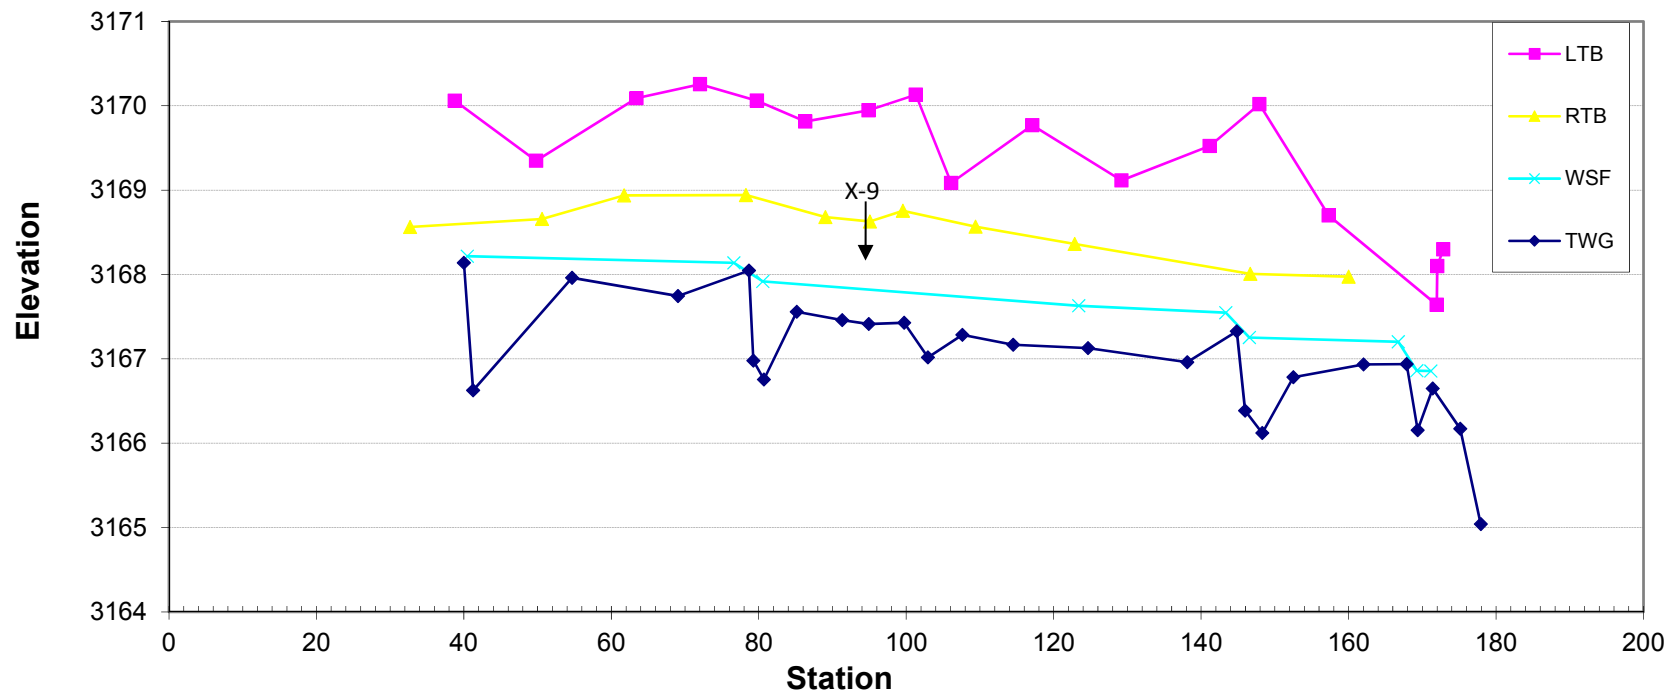
As-built Profile of UT3, Station 0+00 to 1+80
Data collected May, 2015

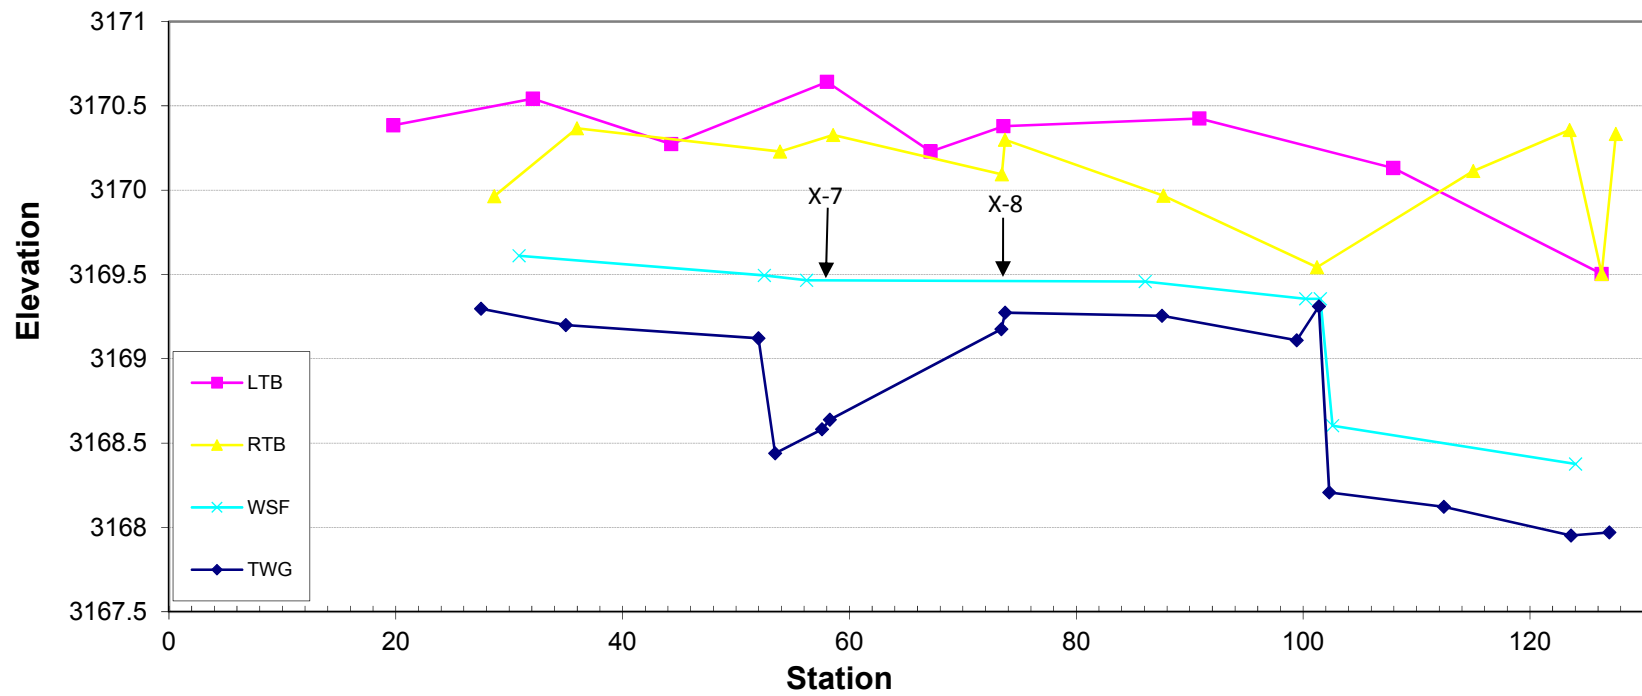
As-built Profile of UT6, Station 0+00 to 1+30
Data collected May, 2015

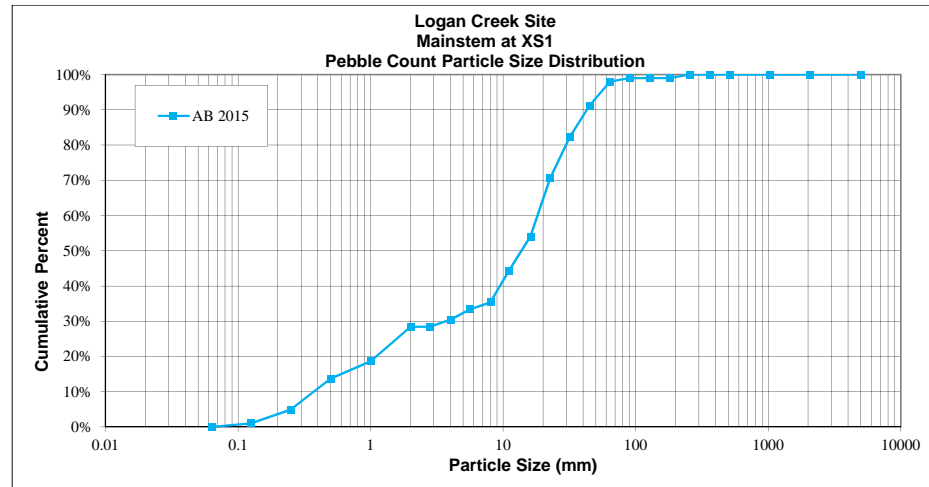
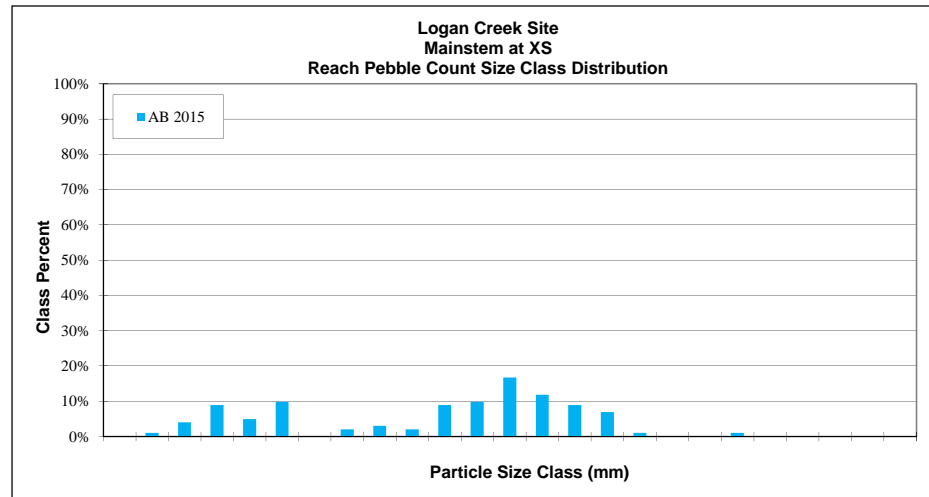
Cross-Section Pebble Count (MS); Monitoring AB
 Logan Creek Mitigation Project, DMS #92515

SITE OR PROJECT:	Logan Cr
REACH/LOCATION:	Riffle at XS1
FEATURE:	Riffle

Summary Data			
Channel materials			
D16 =	0.7	D84 =	34.1
D35 =	7.6	D95 =	54.8
D50 =	13.8	D100 =	180 - 256

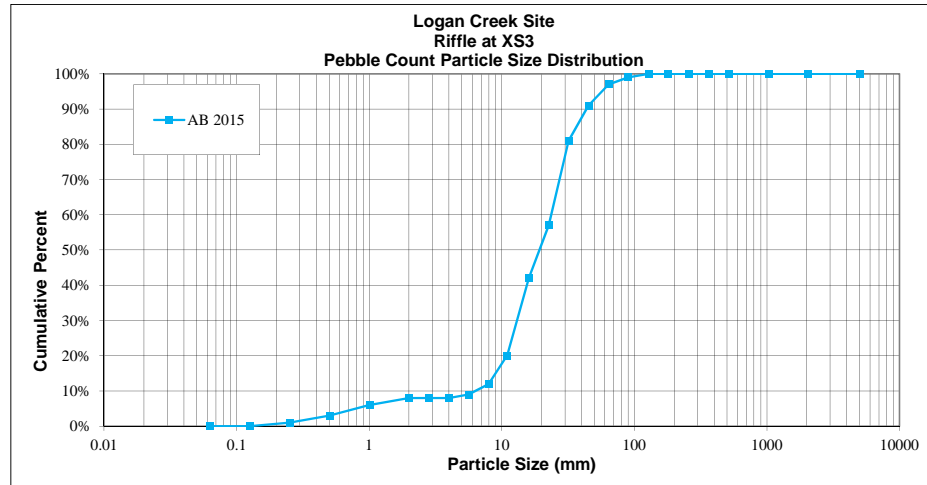
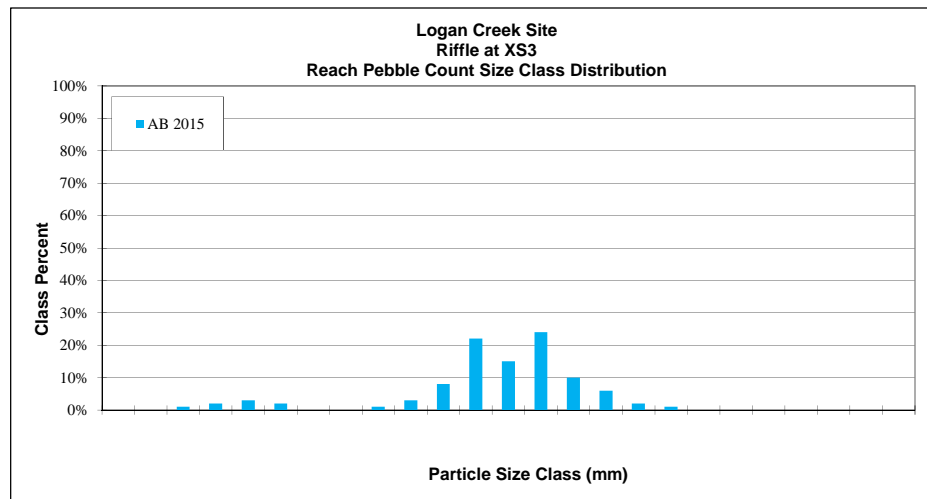
Cross-Section Pebble Count (MS); Monitoring AB
 Logan Creek Mitigation Project, DMS # 92515

SITE OR PROJECT:	Logan Cr
REACH/LOCATION:	Riffle at XS3
FEATURE:	Riffle

Summary Data			
Channel materials			
D16 =	9.4	D84 =	35.4
D35 =	14.2	D95 =	56.9
D50 =	19.2	D100 =	90 - 128

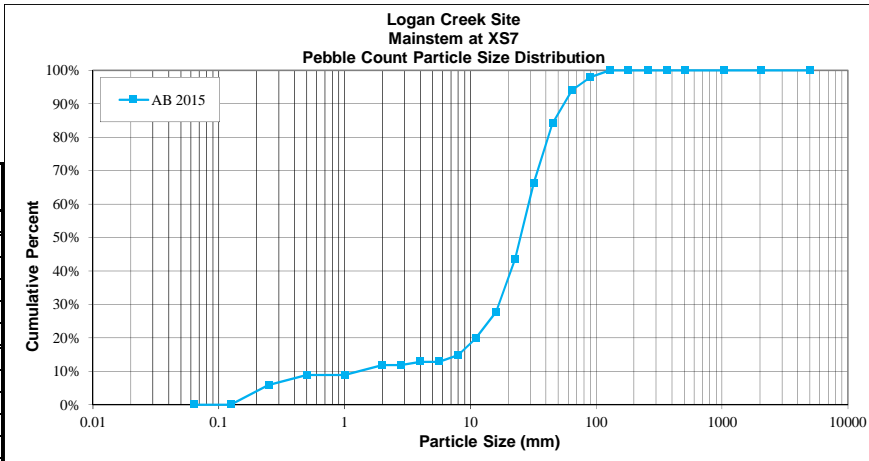
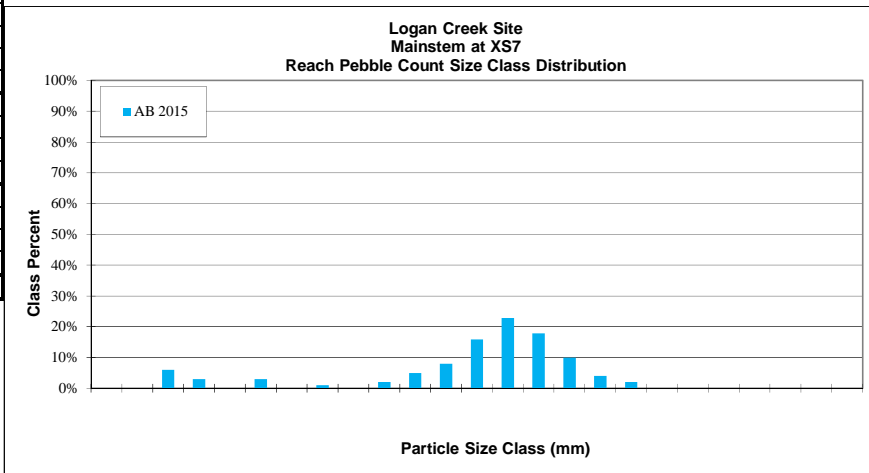
Cross-Section Pebble Count; Monitoring AB
 Logan Creek Mitigation Project, DMS # 92515

SITE OR PROJECT:	Logan Creek
REACH/LOCATION:	XS7
FEATURE:	Riffle

Summary Data			
Channel materials			
D16 =	8.6	D84 =	44.9
D35 =	18.8	D95 =	69.4
D50 =	24.9	D100 =	90 - 128

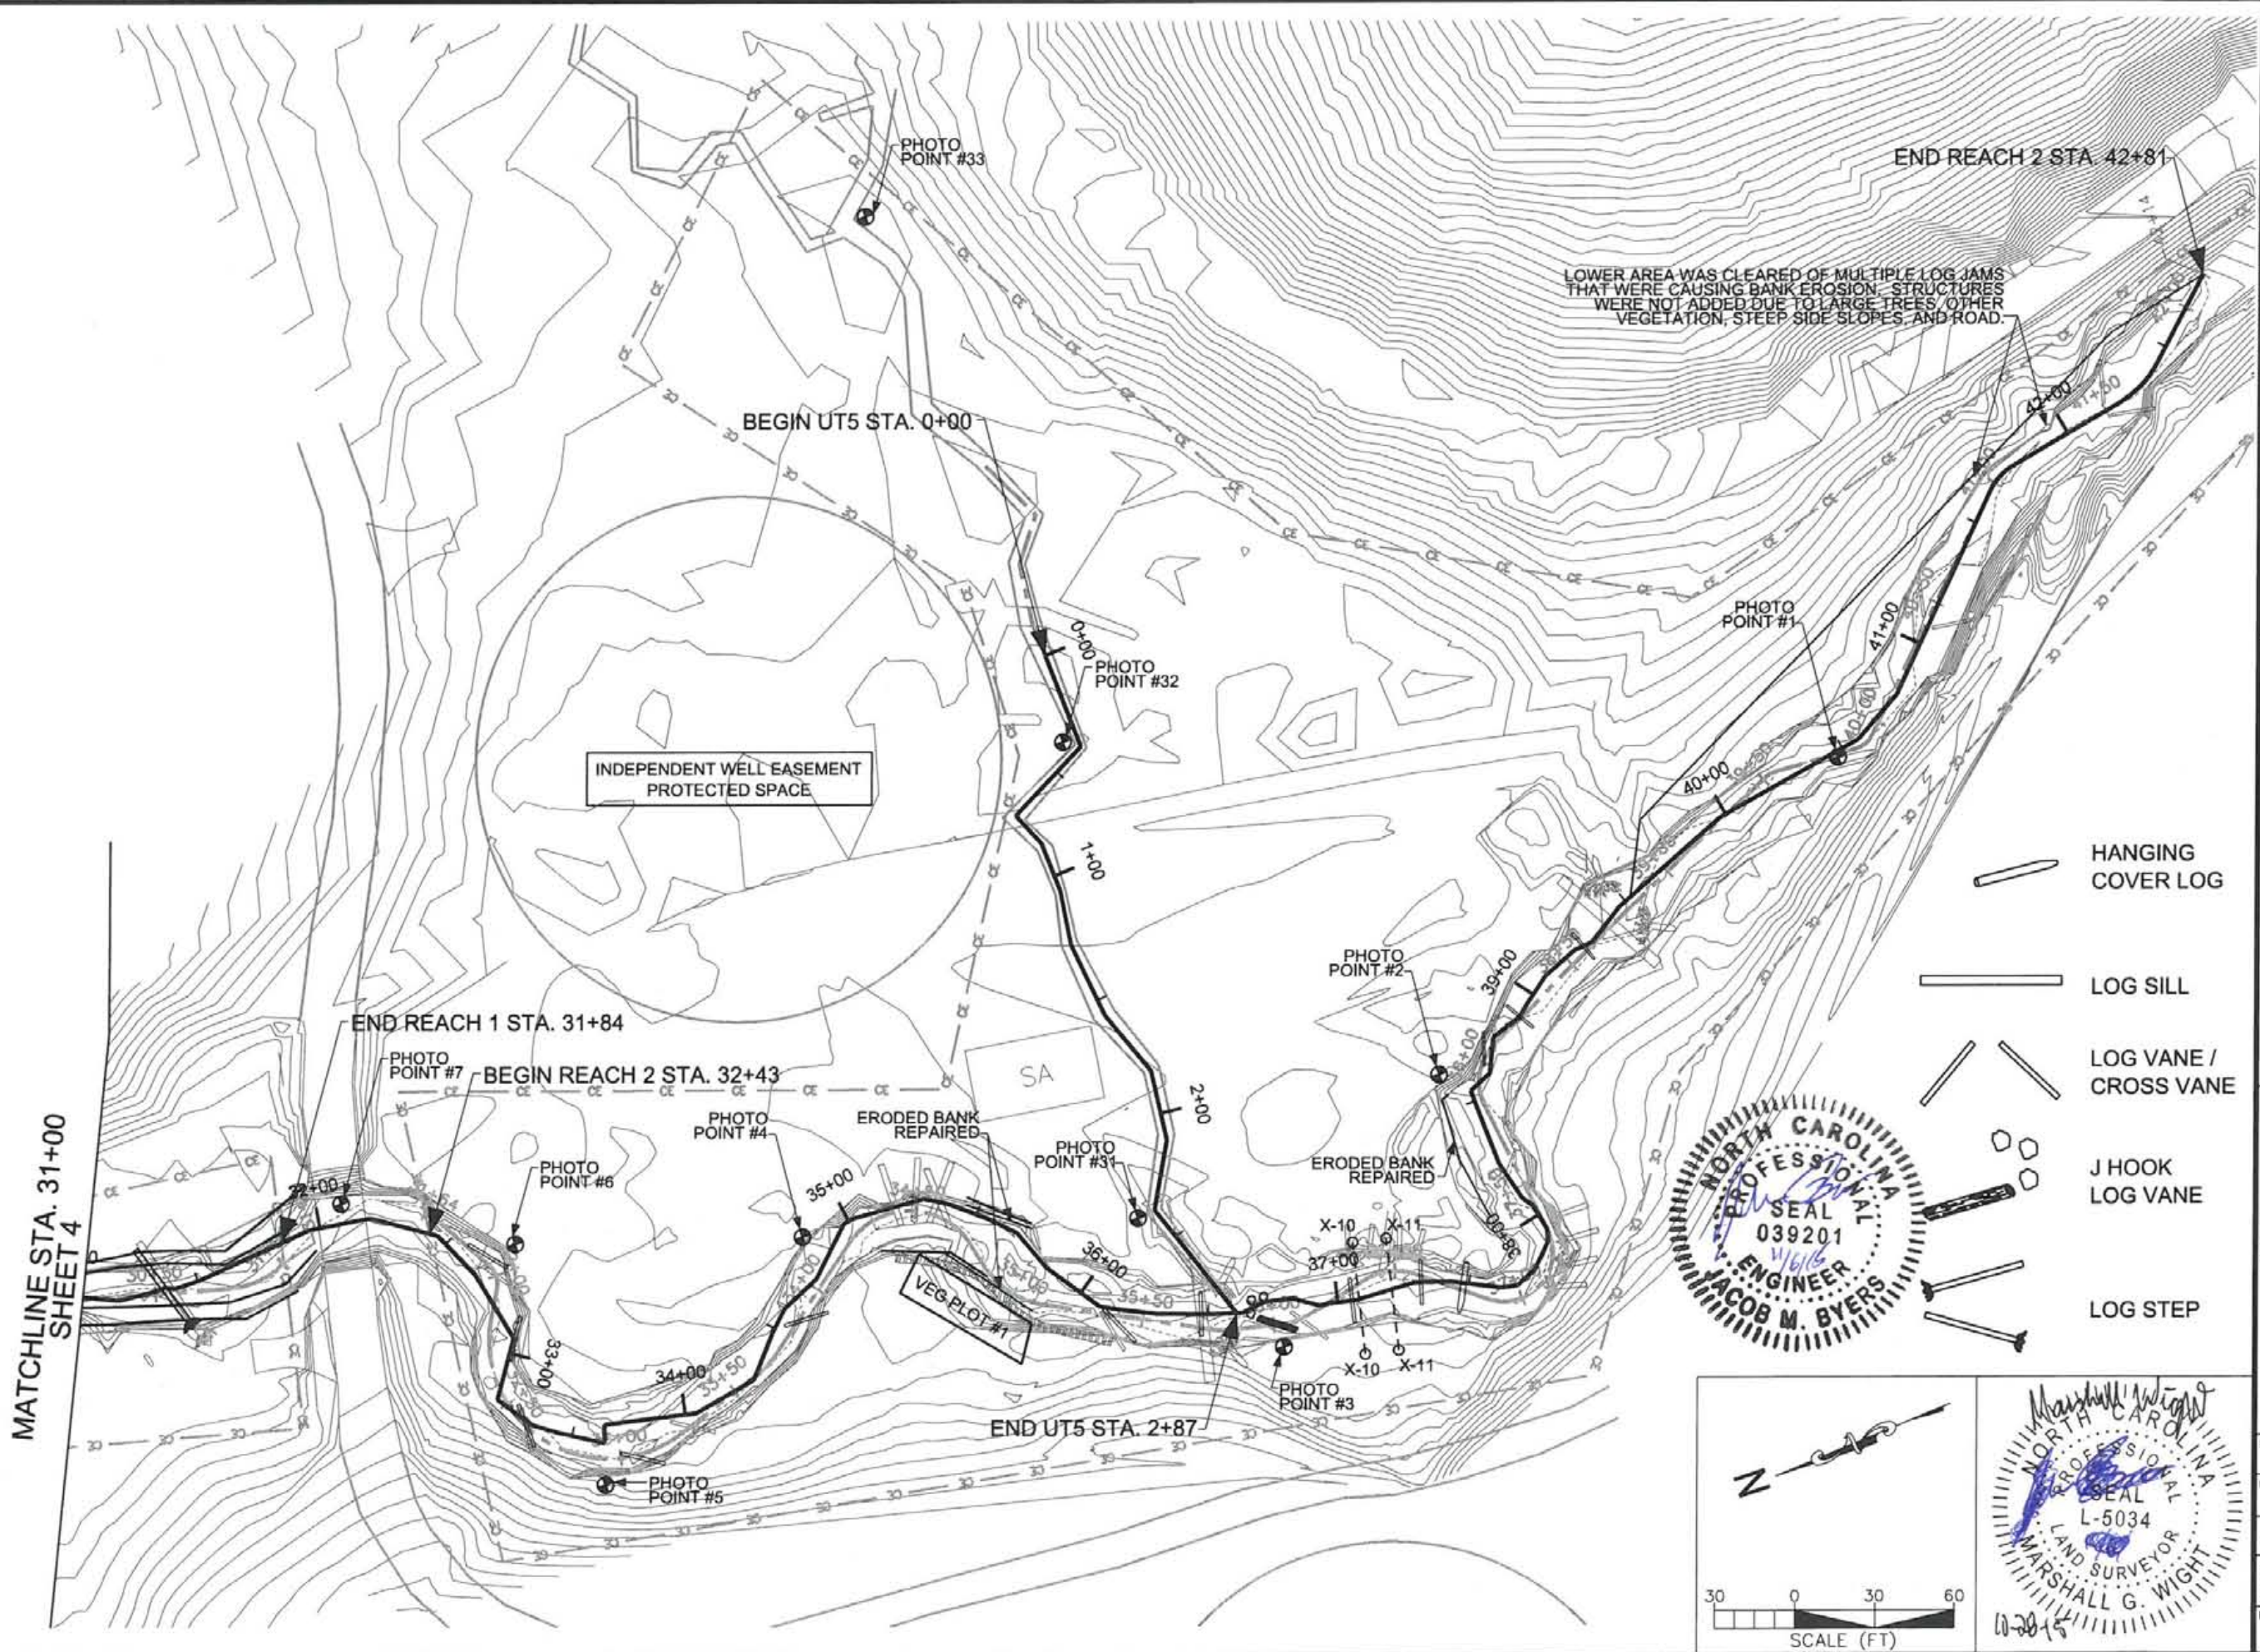
LOWER AREA WAS CLEARED OF MULTIPLE LOG JAMS THAT WERE CAUSING BANK EROSION. STRUCTURES WERE NOT ADDED DUE TO LARGE TREES, OTHER VEGETATION, STEEP SIDE SLOPES, AND ROAD.

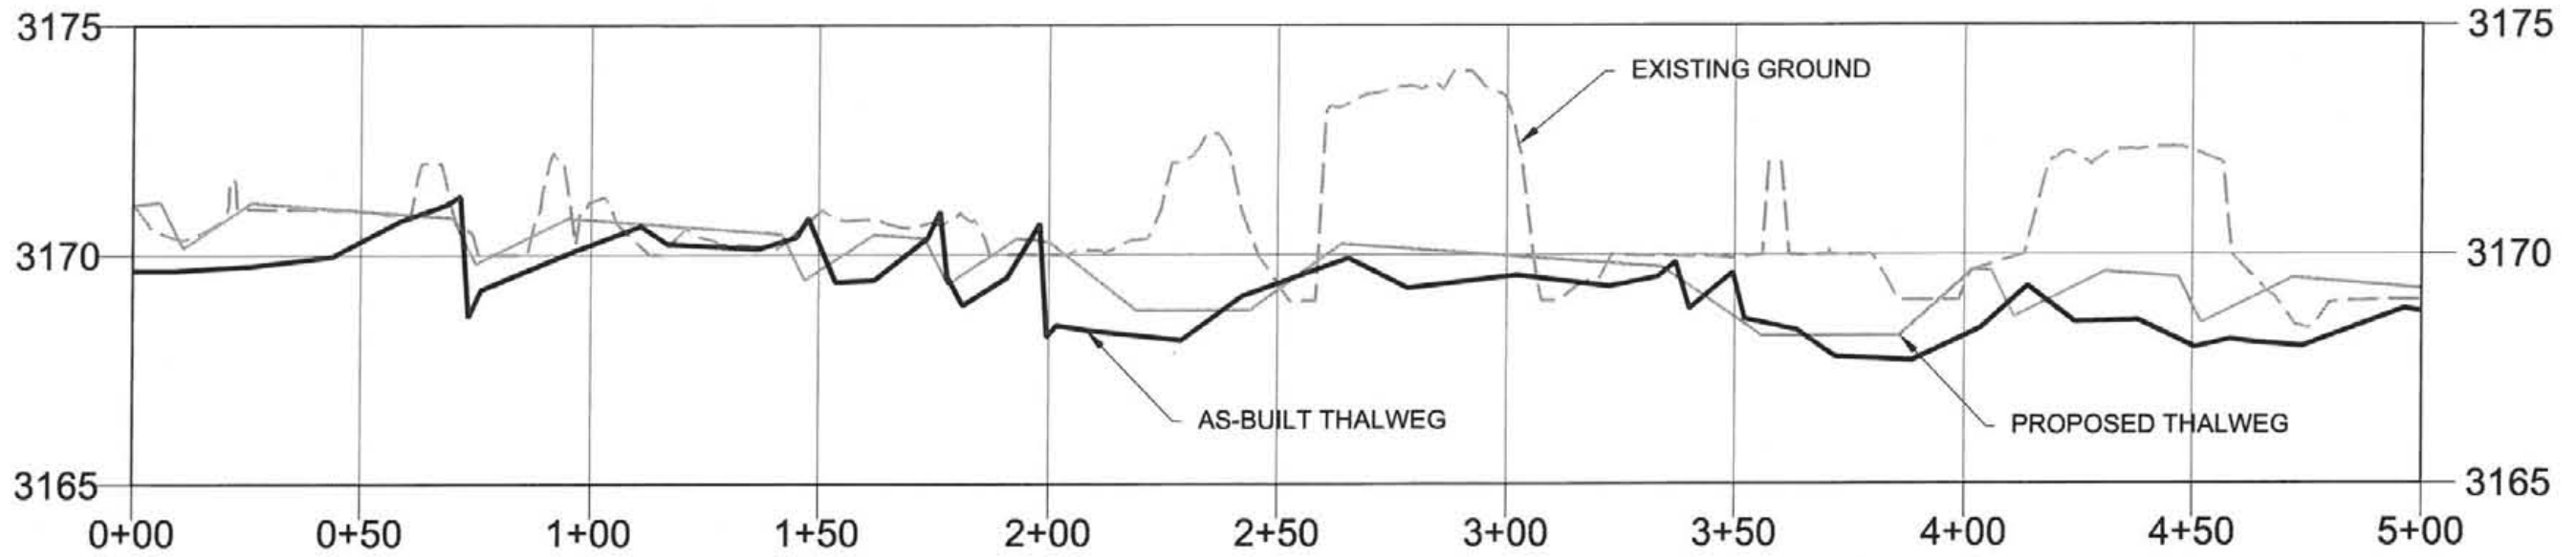
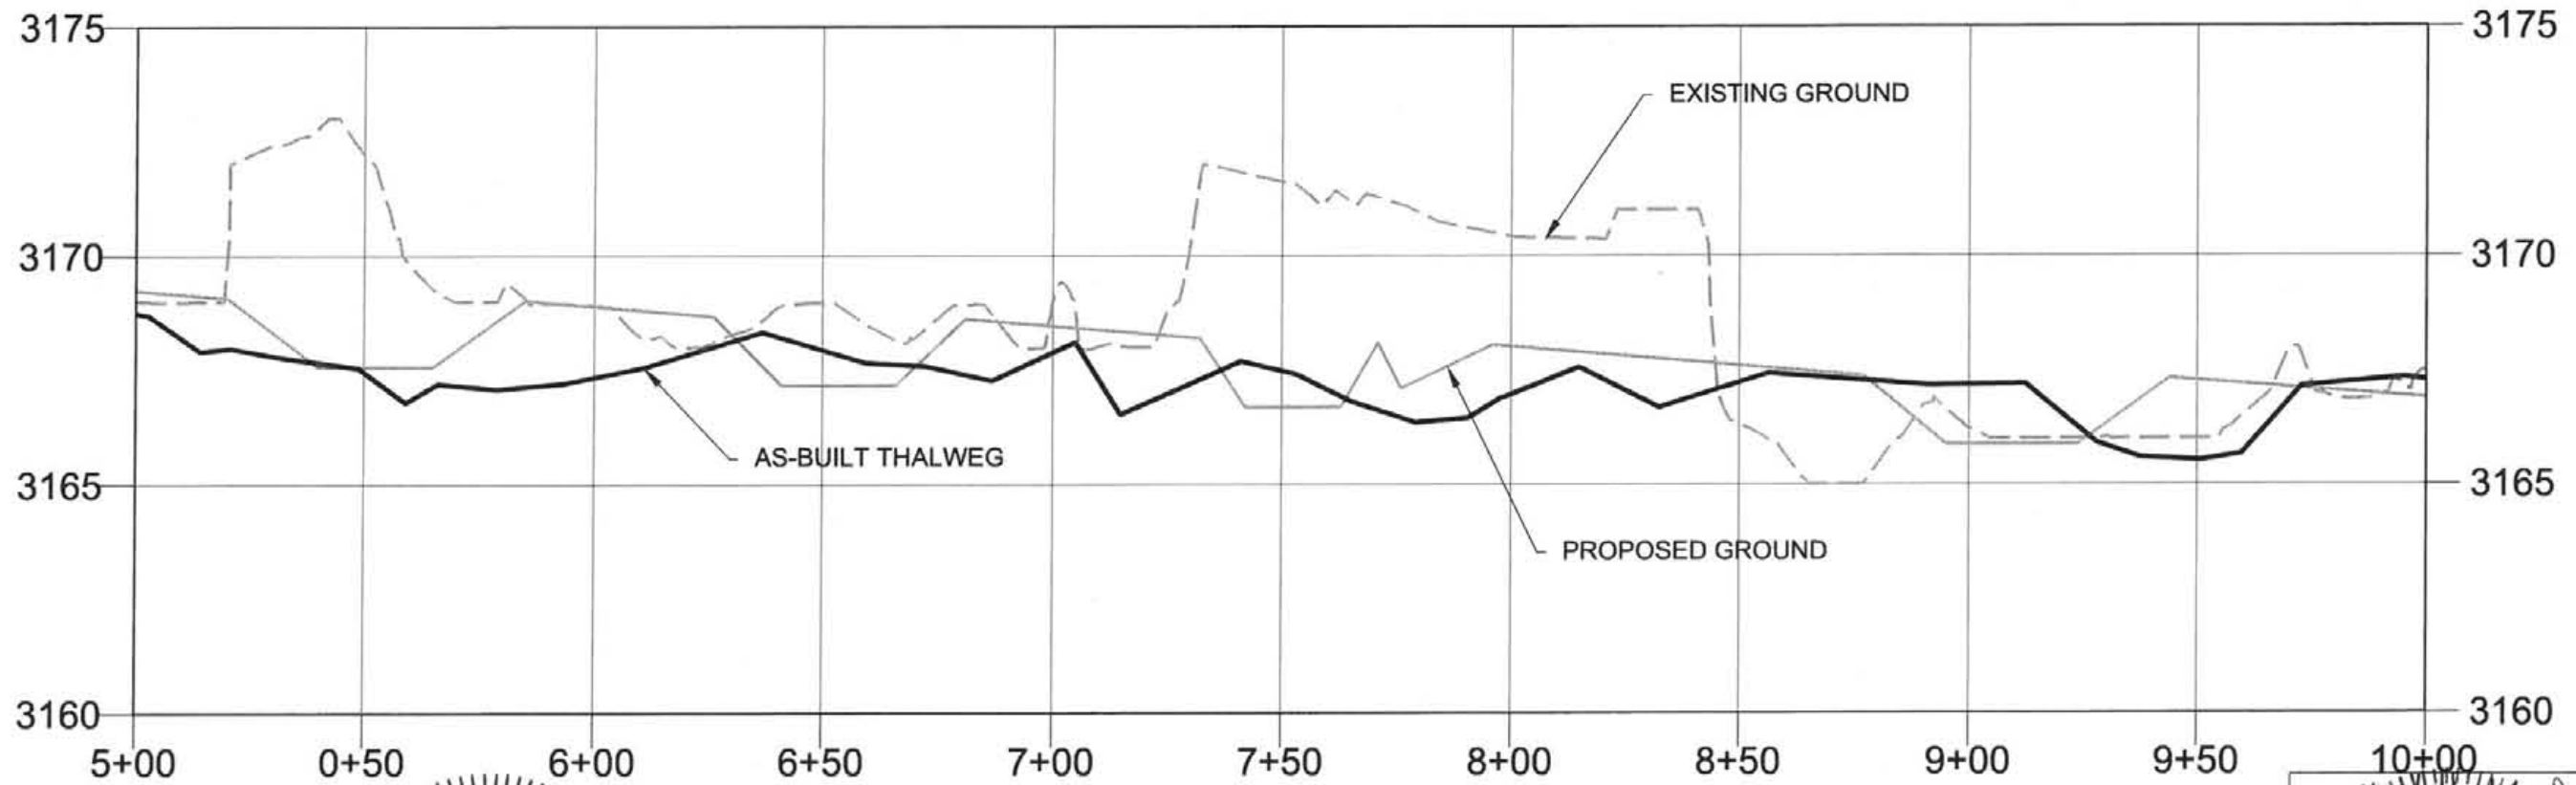
LOGAN CREEK PROFILE
 0+00 - 10+00

- PROPOSED THALWEG
- AS-BUILT THALWEG
- - - EXISTING GROUND

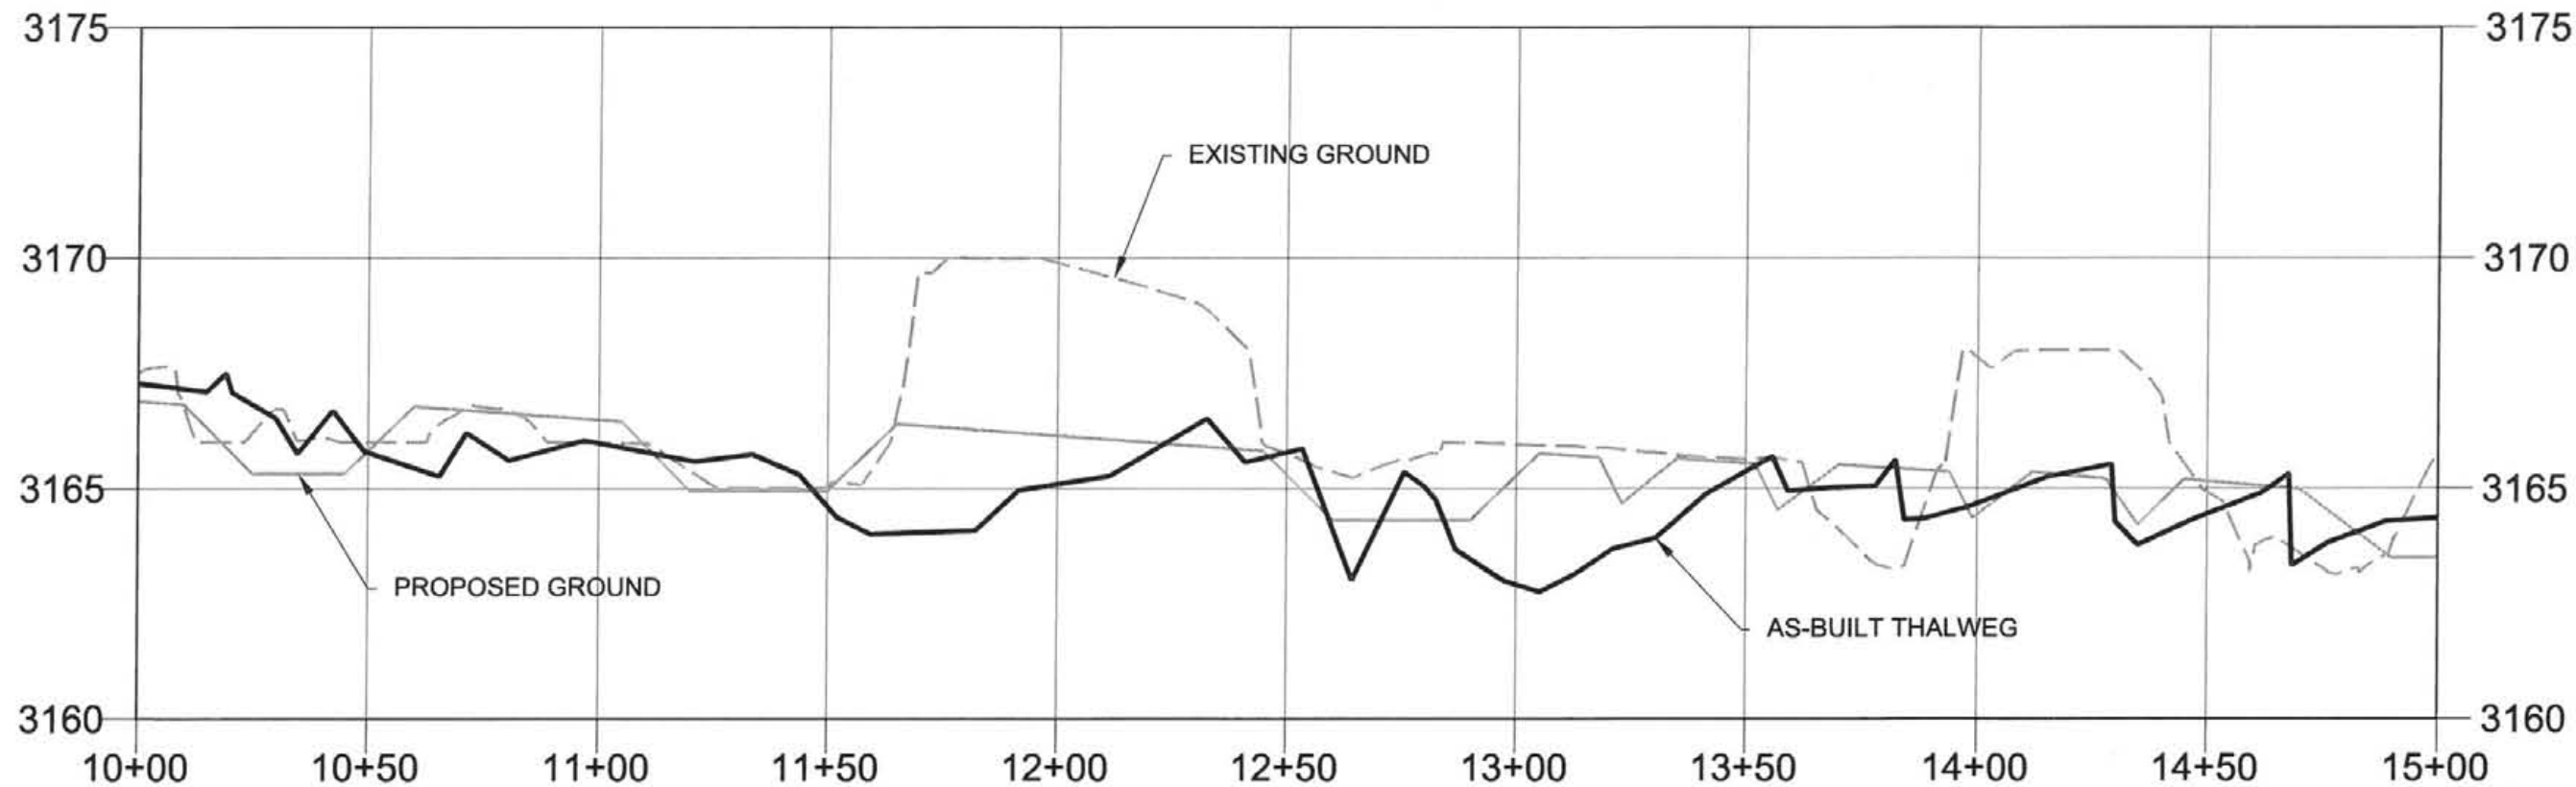
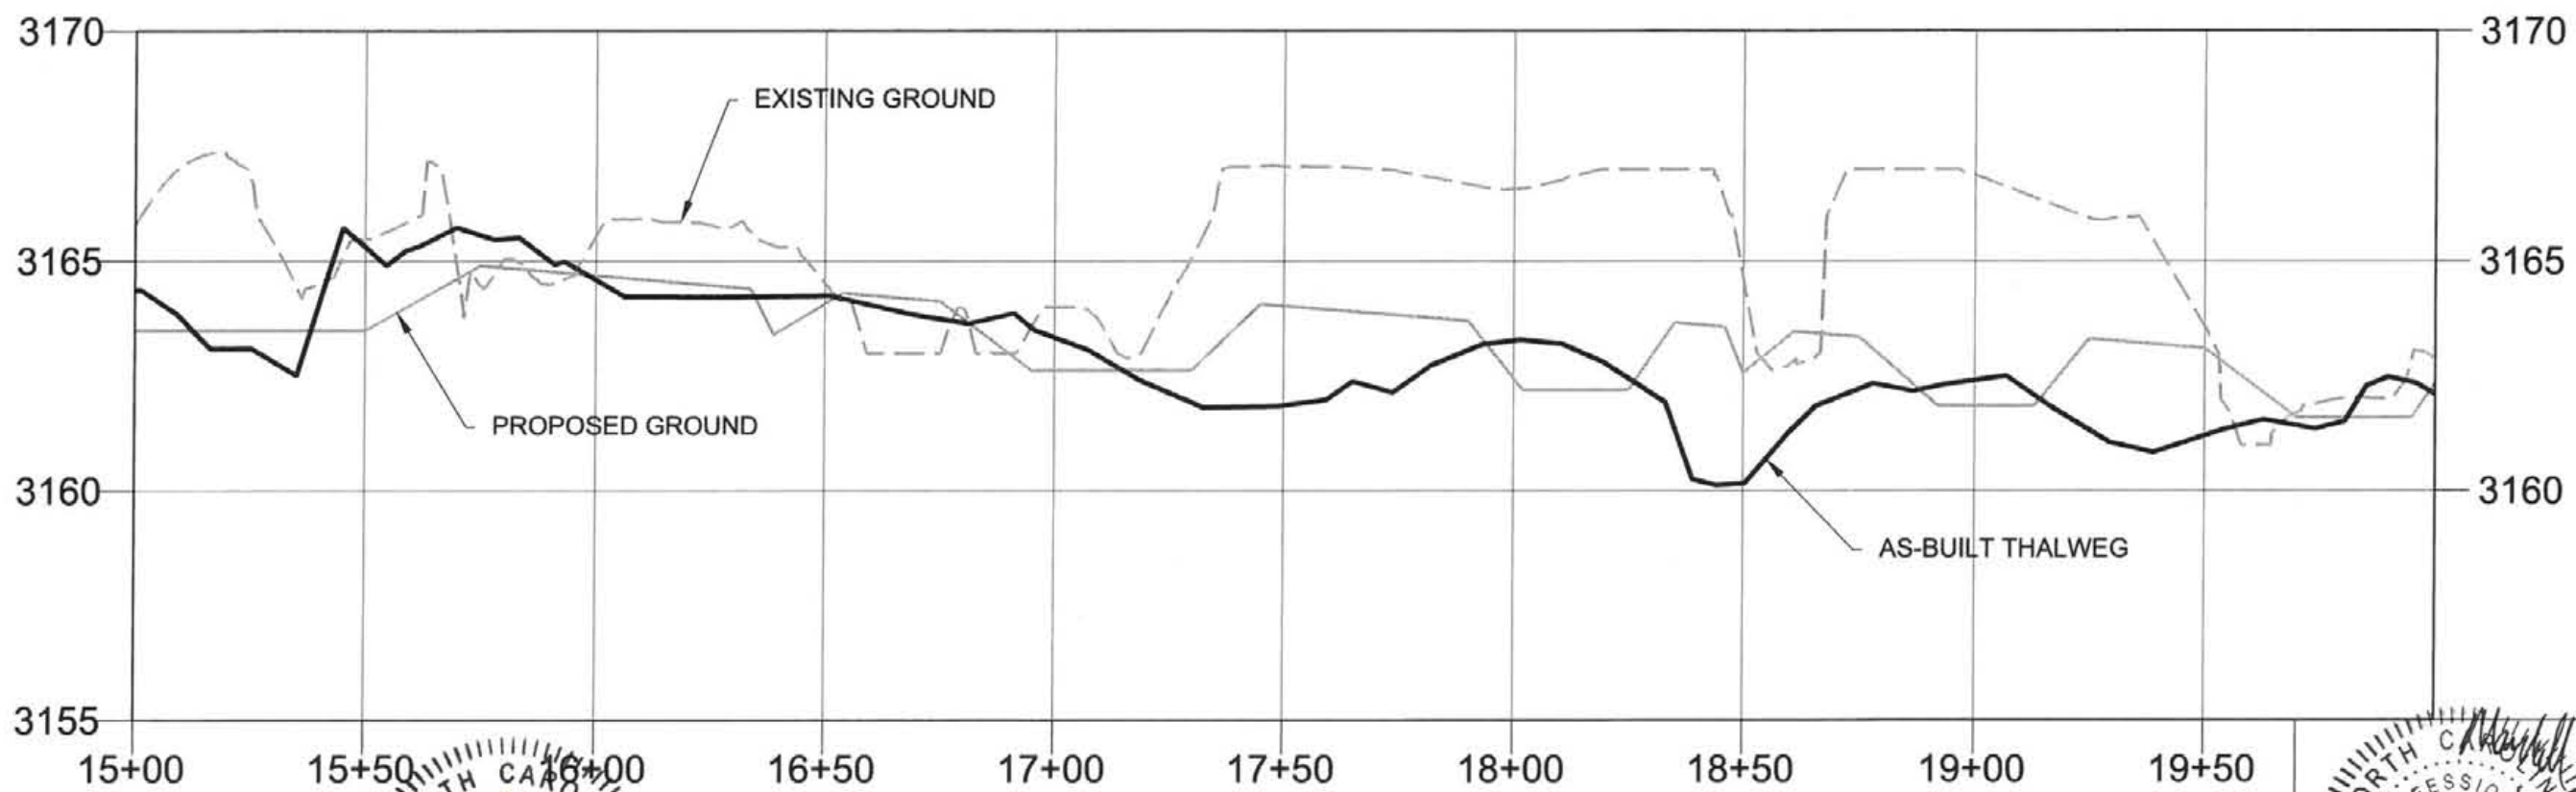
LOGAN CREEK PROFILE
10+00 - 20+00

- LEGEND OF PROFILES**
- PROPOSED THALWEG
 - AS-BUILT THALWEG
 - - - - - EXISTING GROUND

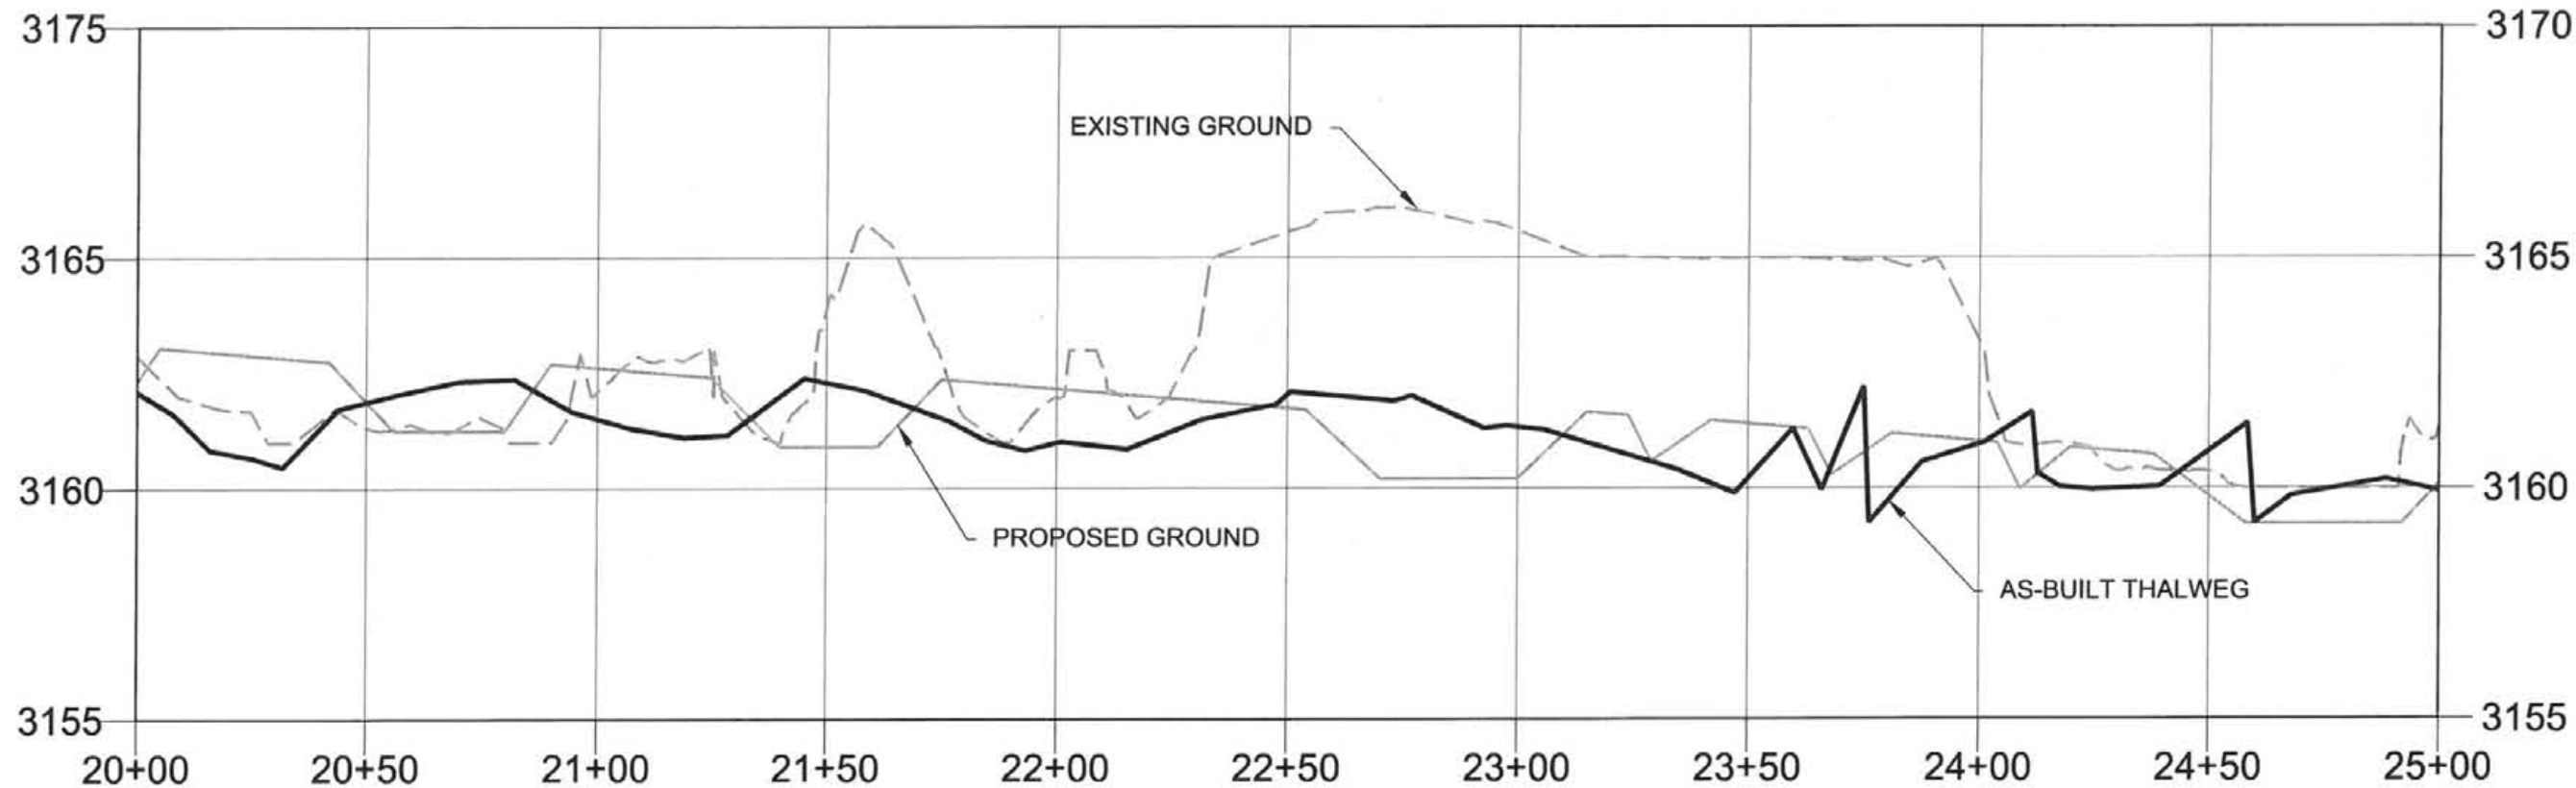
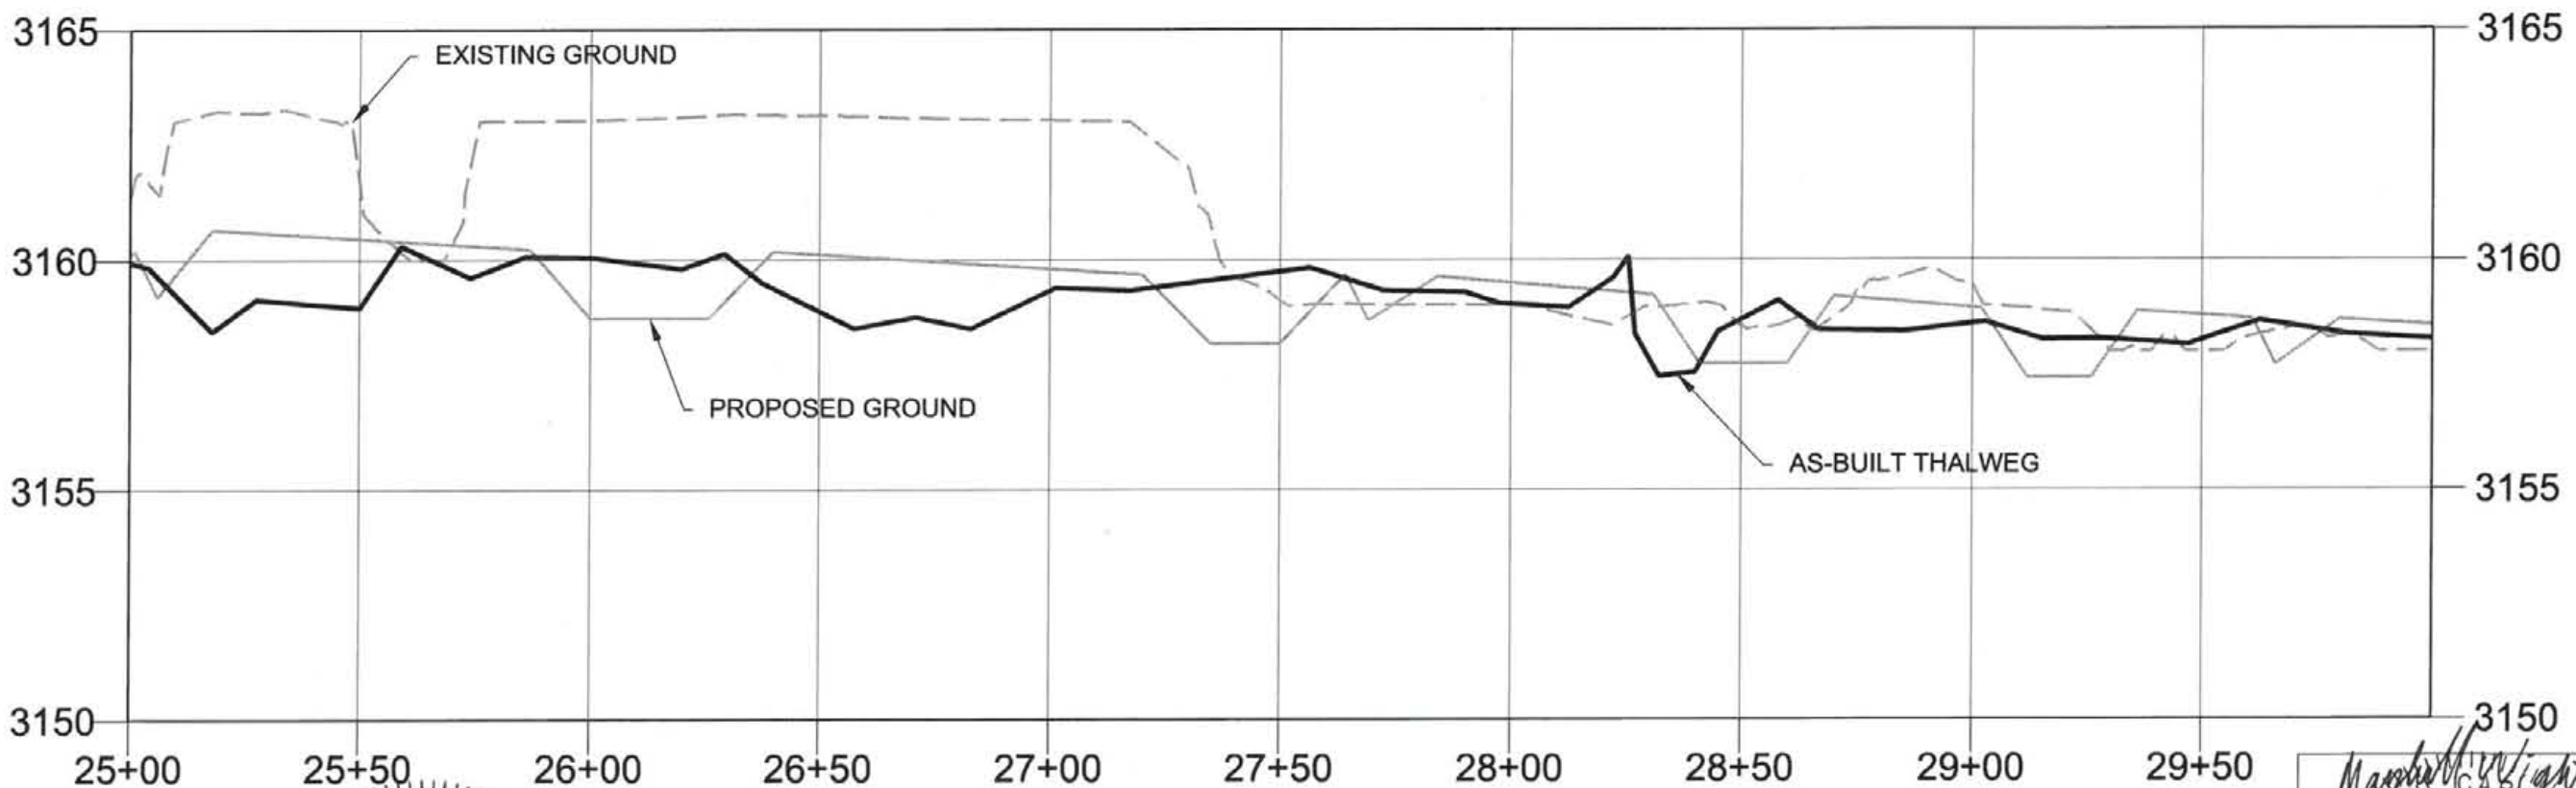
LOGAN CREEK PROFILE
20+00 - 30+00

- PROPOSED THALWEG
- AS-BUILT THALWEG
- EXISTING GROUND
