As-Built Baseline Monitoring Report

Logan Creek Stream Restoration Project

Jackson County, North Carolina

DMS Project ID No. 92515, Contract No. D06046

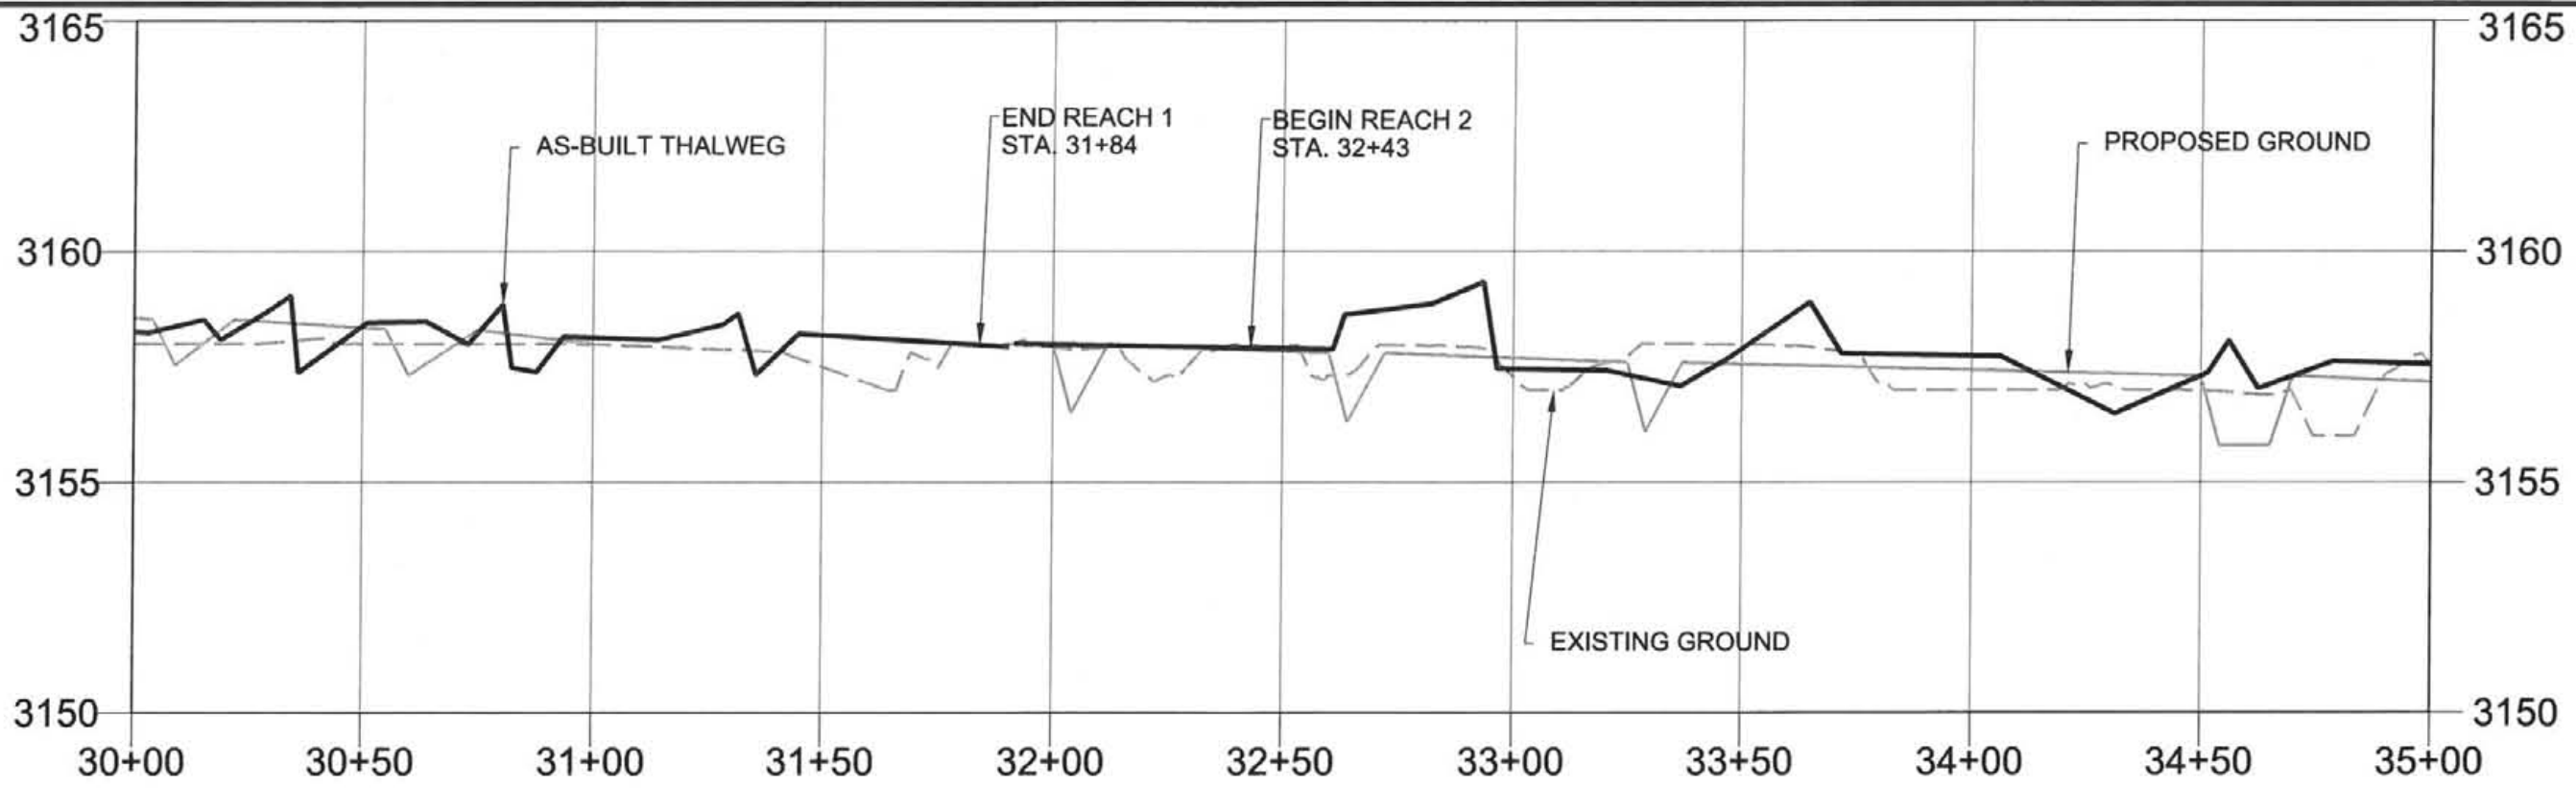
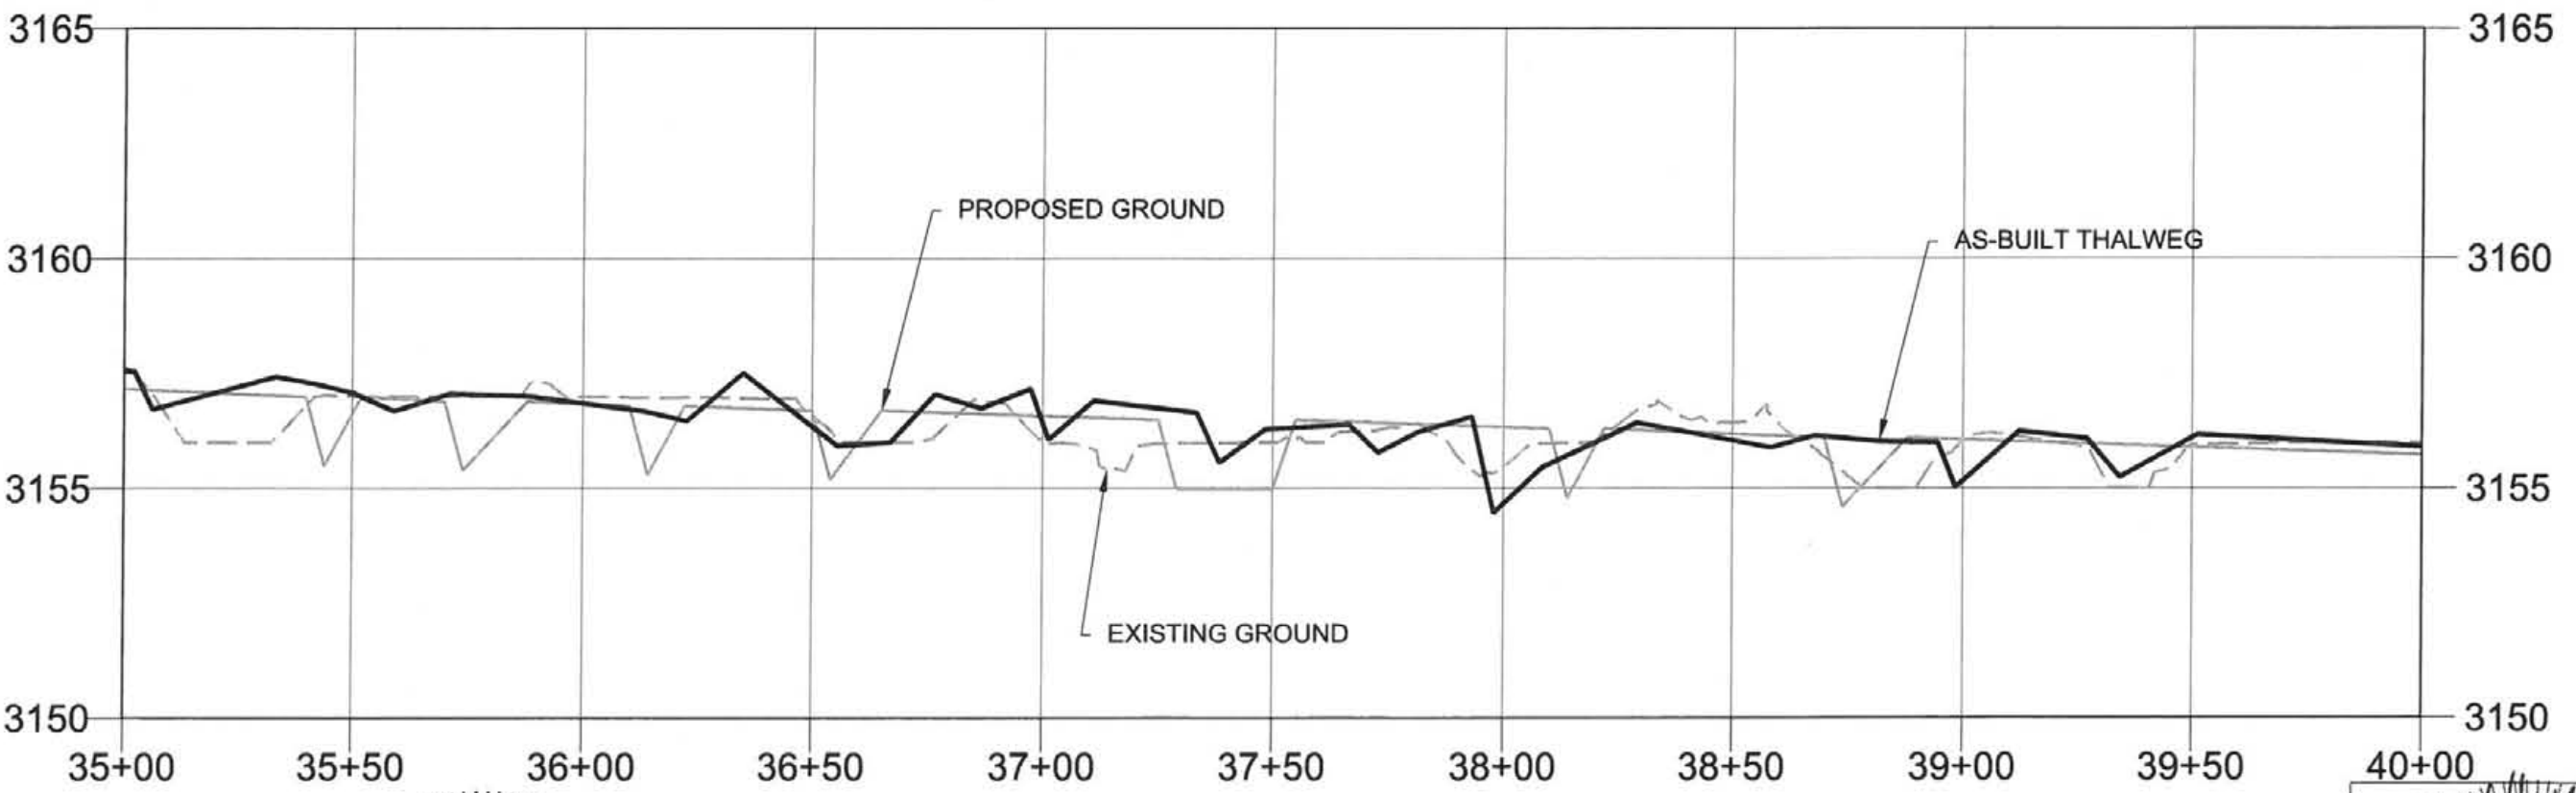
LOGAN CREEK PROFILE
30+00 - 40+00

- LEGEND OF PROFILES**
- PROPOSED THALWEG
 - AS-BUILT THALWEG
 - - - - EXISTING GROUND

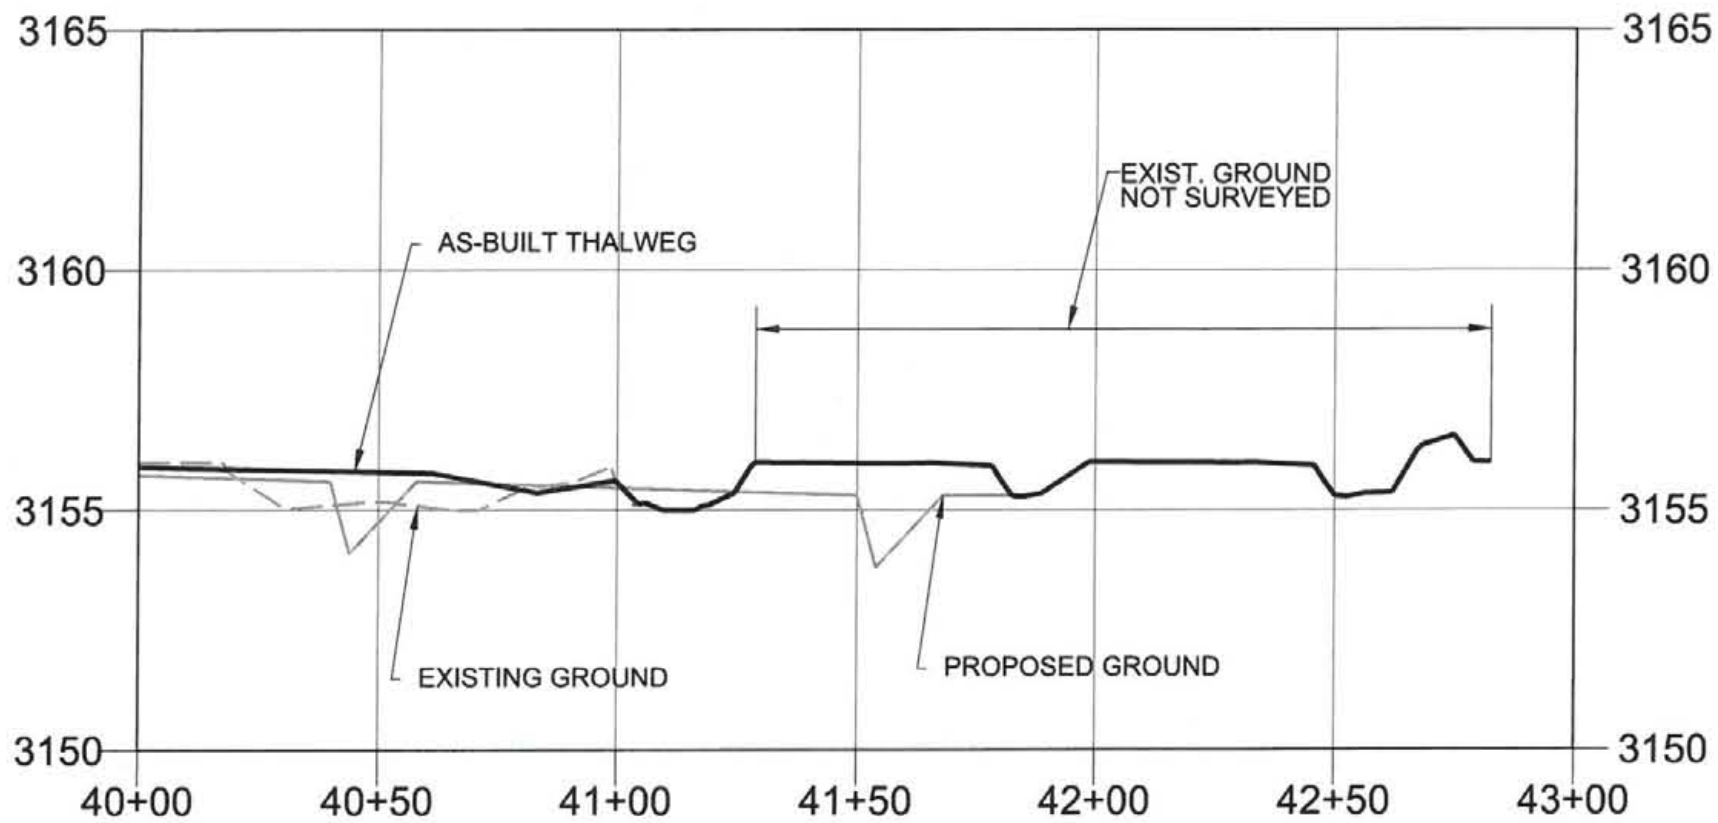
LOGAN CREEK PROFILE
40+00 - 42+81

- PROPOSED THALWEG
- AS-BUILT THALWEG
- EXISTING GROUND
- EXISTING GROUND NOT SURVEYED

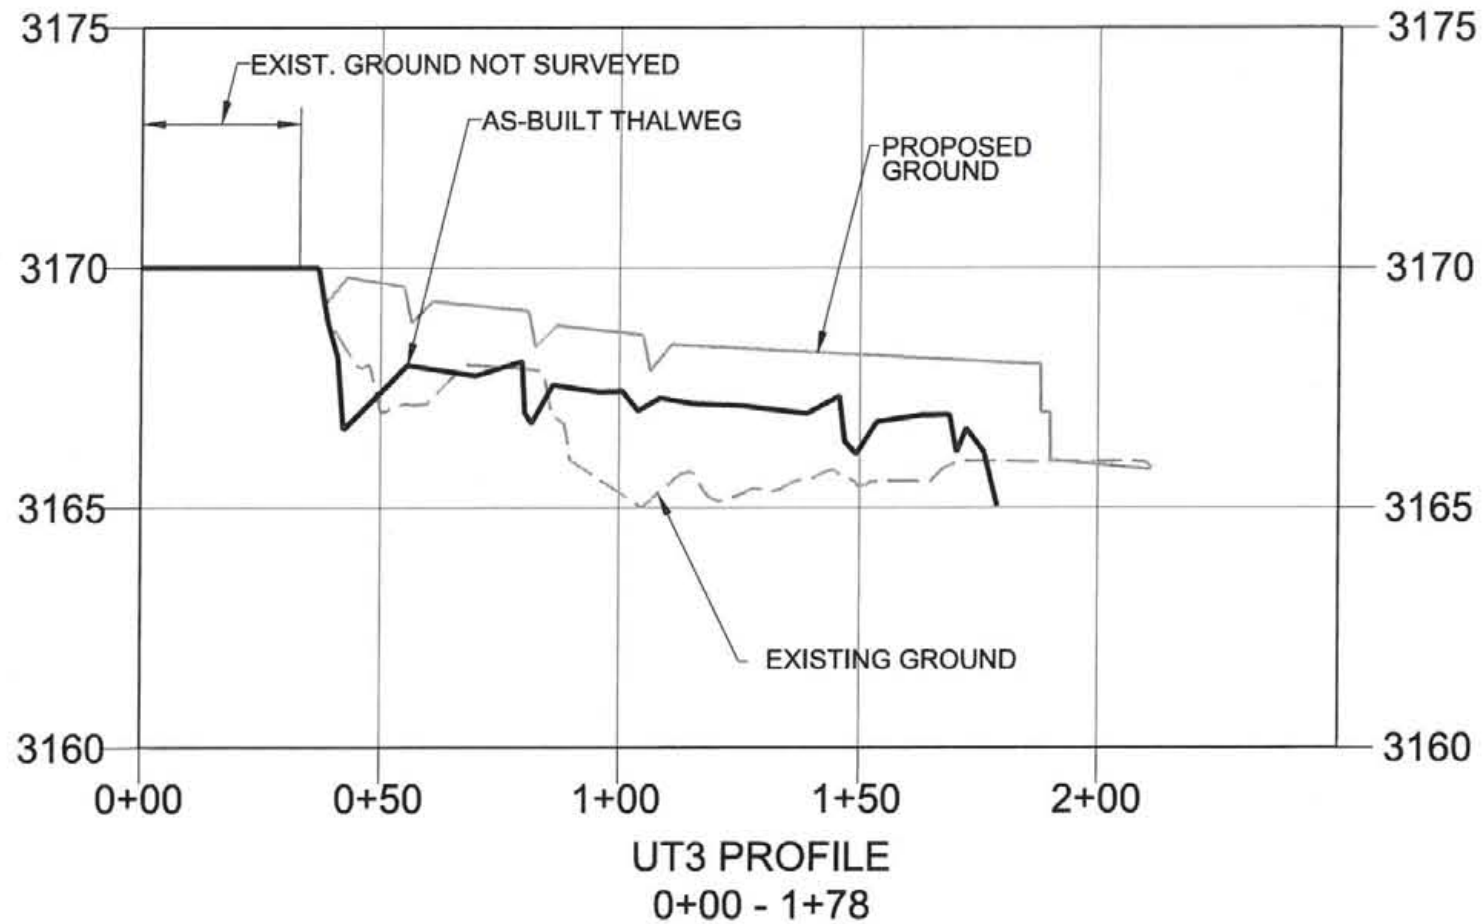
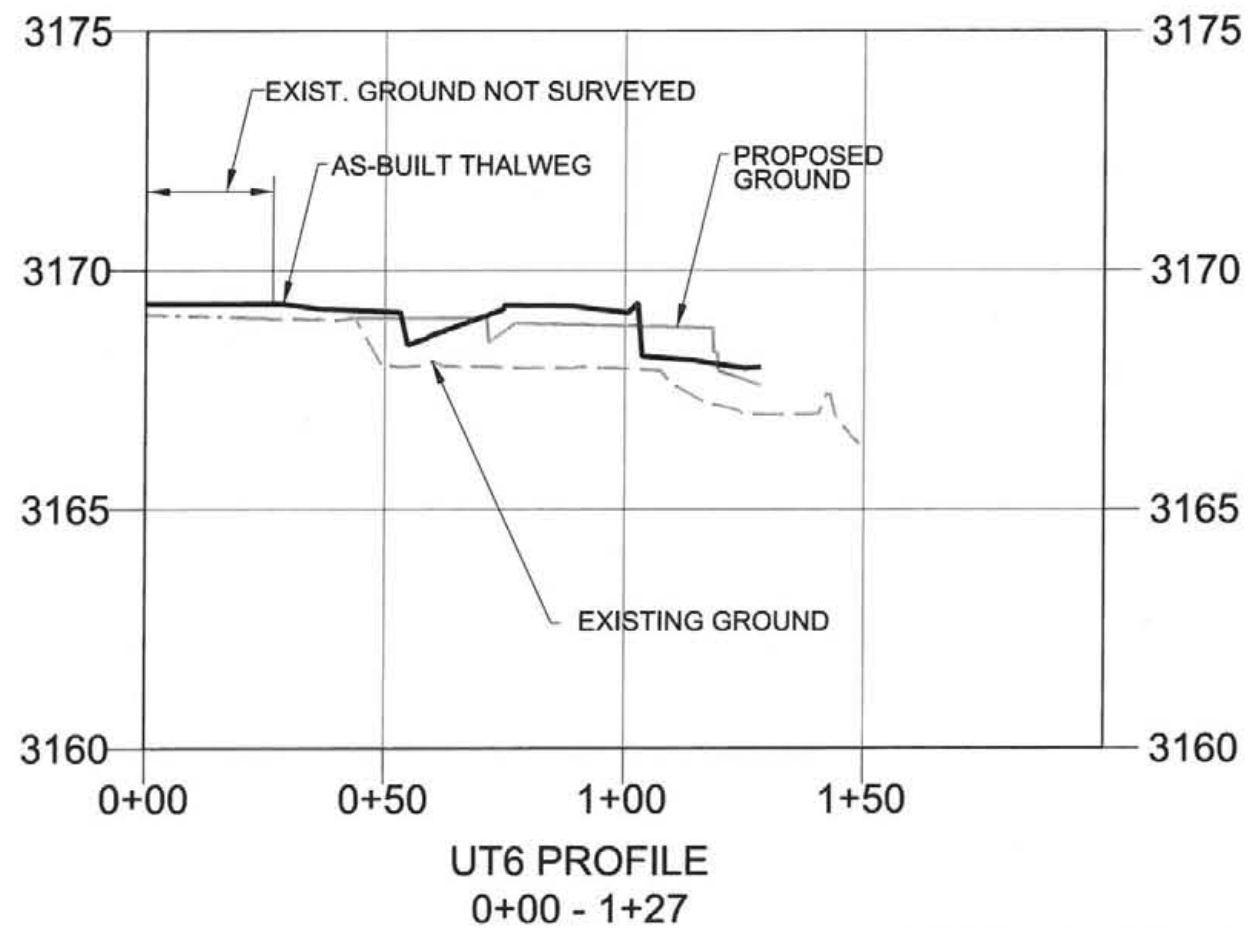
- PROPOSED THALWEG
- AS-BUILT THALWEG
- - - EXISTING GROUND
- - - EXISTING GROUND NOT SURVEYED

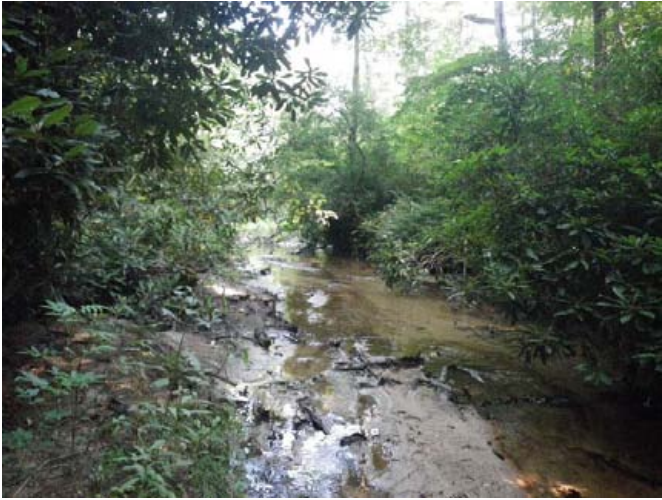
Photo 1. Logan Creek Photo Point 1 – Station 40+45 (August 2015) upstream view from right bank.

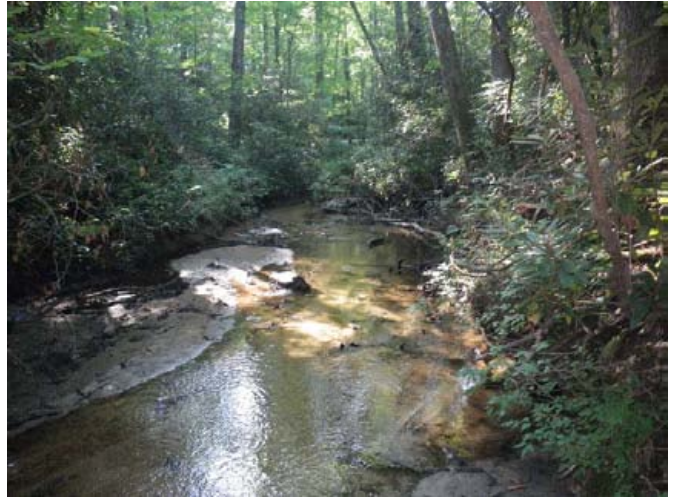
Photo 2. Logan Creek Photo Point 1 – Station 40+45 (August 2015) downstream view from right bank.

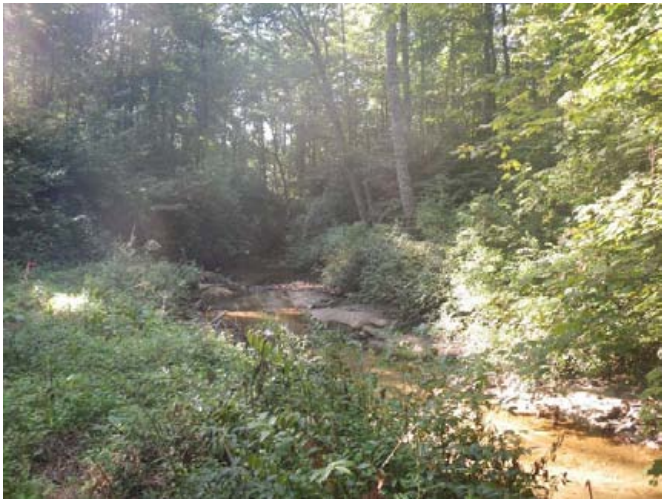
Photo 3. Logan Creek Photo Point 2 – Station 38+60 (August 2015) downstream view from left bank.

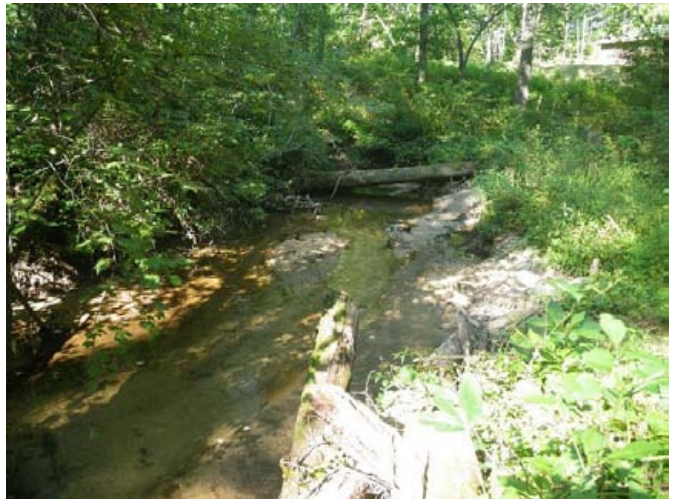
Photo 4. Logan Creek Photo Point 2 – Station 38+60 (August 2015) upstream view from left bank.

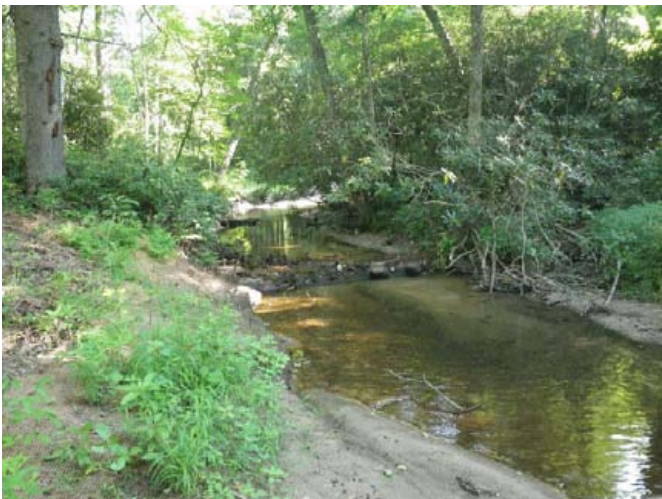
Photo 5. Logan Creek Photo Point 3 – Station 36+75 (August 2015) upstream view from right bank.

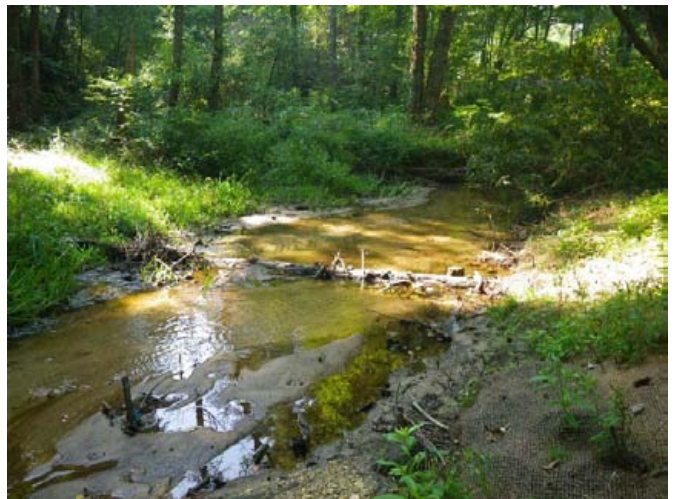
Photo 6. Logan Creek Photo Point 3 – Station 36+75 (August 2015) downstream view from right bank.

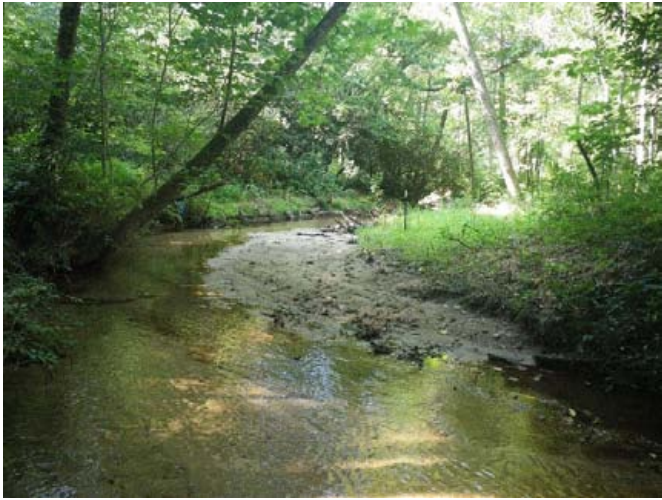
Photo 7. Logan Creek Photo Point 4 – Station 34+80 (August 2015) downstream from left bank.

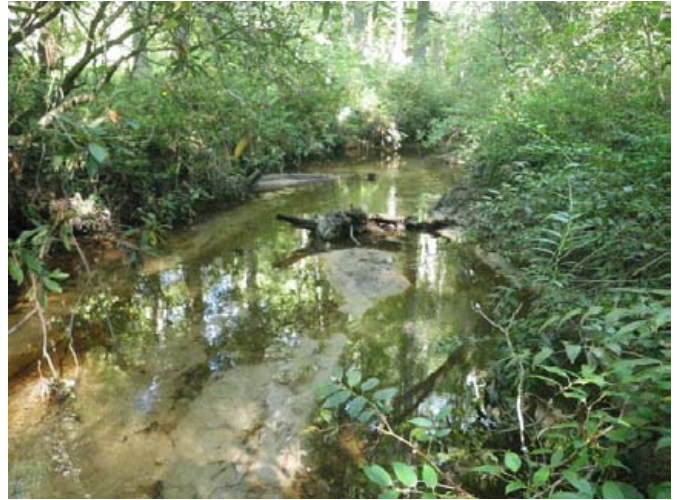
Photo 8. Logan Creek Photo Point 4 – Station 34+80 (August 2015) upstream from left bank.

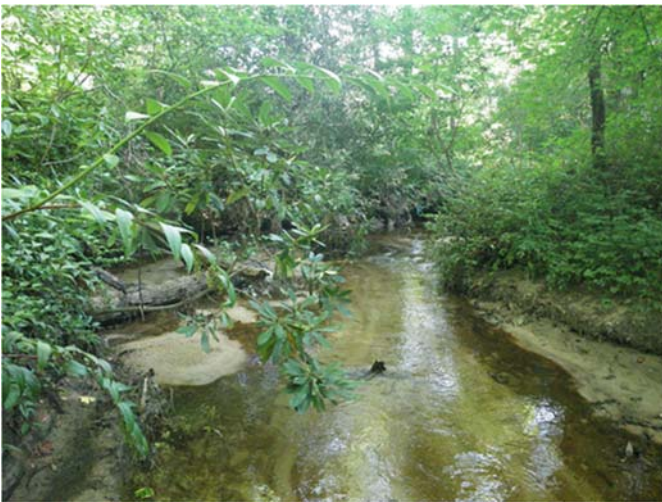
Photo 9. Logan Creek Photo Point 5 – Station 33+60 (August 2015) upstream from right bank.

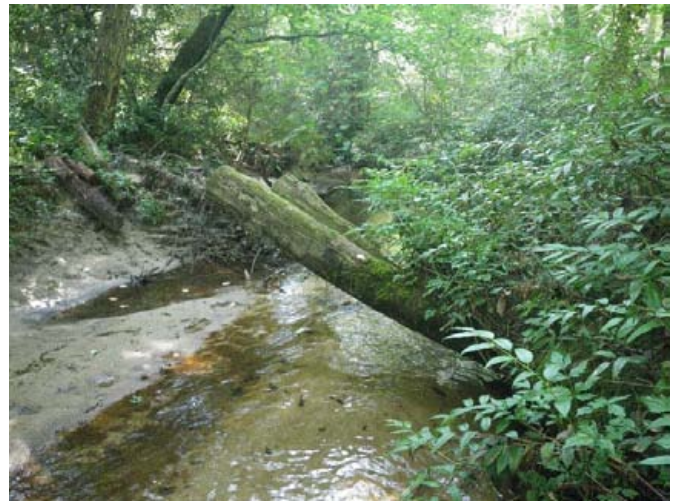
Photo Point 10, Logan Creek Photo Point 5 – Station 33+60 (August 2015) downstream from right bank.

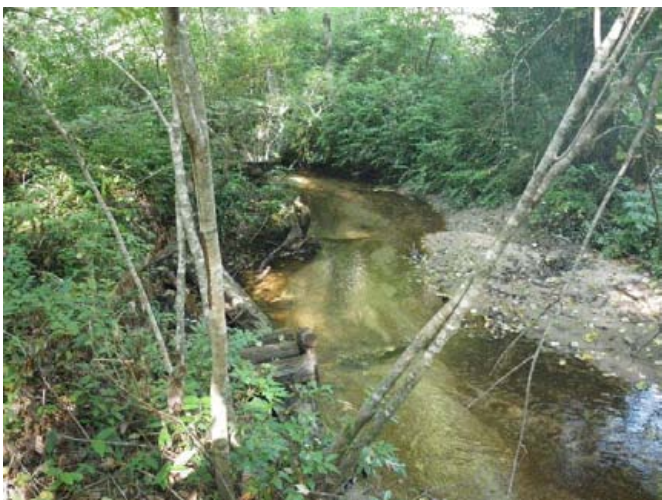
Photo 11. Logan Creek Photo Point 6 – Station 32+70 (August 2015) downstream view from left bank.

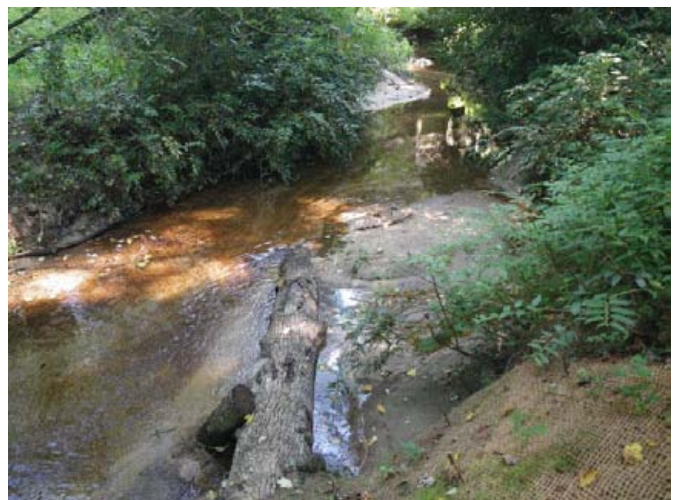
Photo 12. Logan Creek Photo Point 6 – Station 32+70 (August 2015) upstream view from left bank.

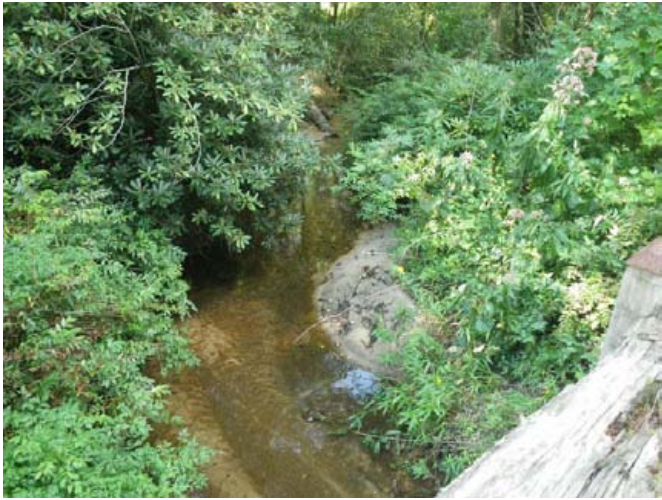
Photo 13. Logan Creek Photo Point 7 – Station 32+15 (August 2015) downstream view from bridge.

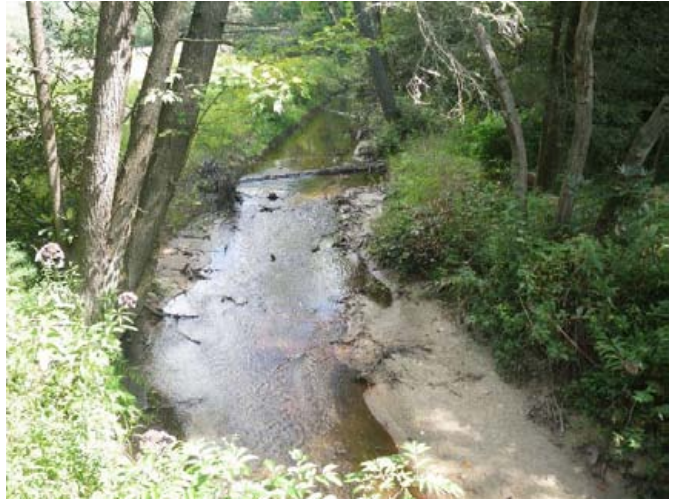
Photo 14. Logan Creek Photo Point 7 – Station 32+00 (August 2015) upstream view from bridge.

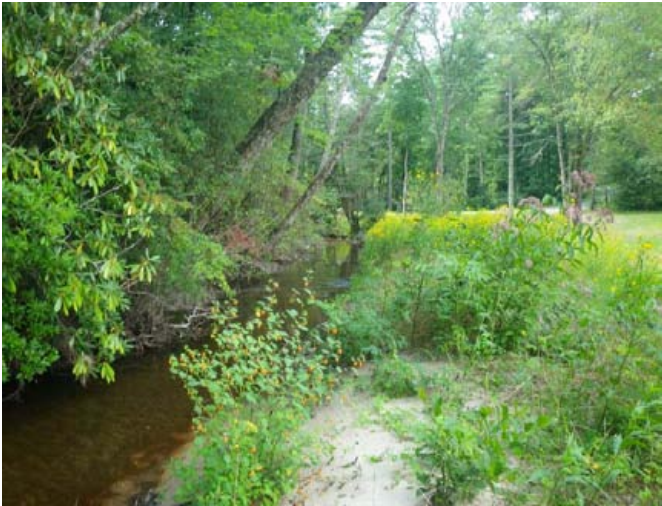
Photo 15. Logan Creek Photo Point 8a – Station 29+75 (August 2015) downstream view from right bank.

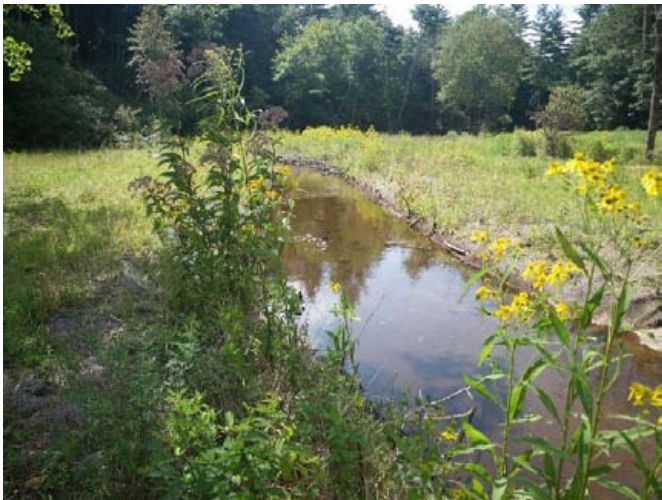
Photo 16. Logan Creek Photo Point 8b – Station 29+25 (August 2015) upstream view from right bank.

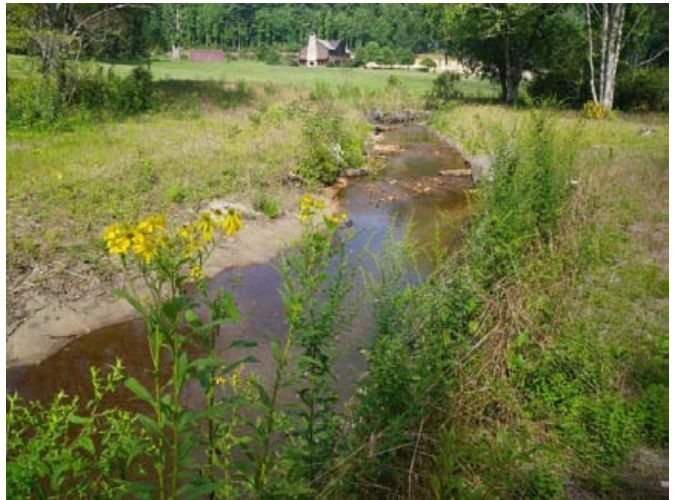
Photo 17. Logan Creek Photo Point 9 – Station 26+75 (August 2015) downstream view from left bank.

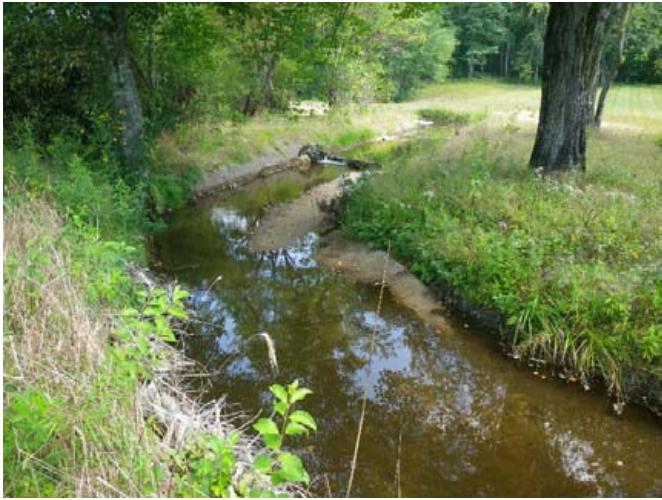
Photo 18. Logan Creek Photo Point 9 – Station 26+75 (August 2015) upstream view from left bank.

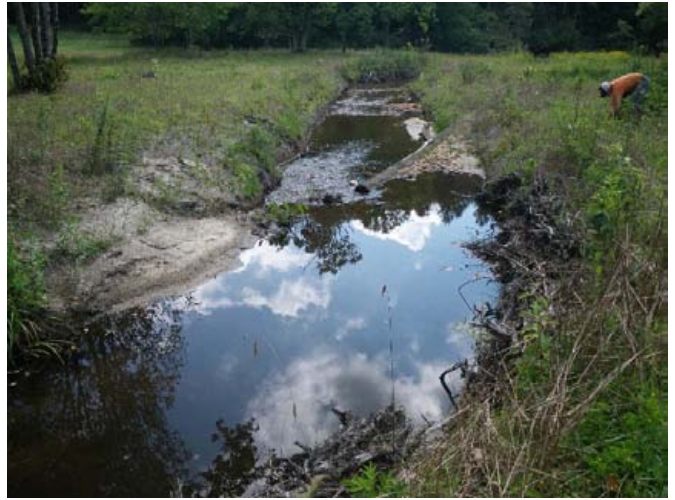
Photo 19. Logan Creek Photo Point 10 – Station 25+25 (August 2015) upstream view from right bank.

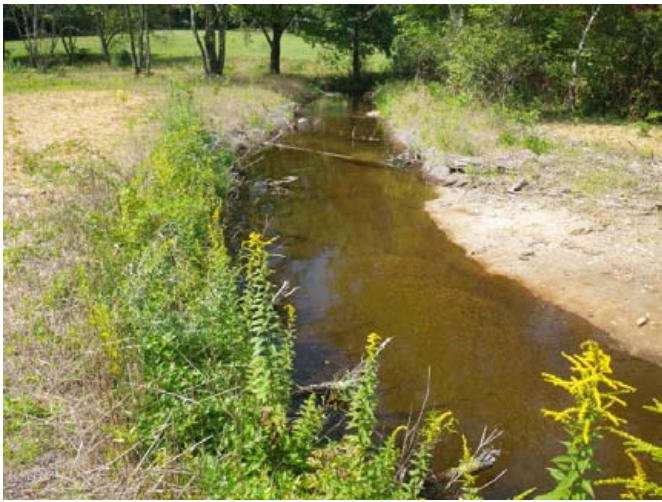
Photo 20. Logan Creek Photo Point 10 – Station 25+25 (August 2015) downstream view from right bank.

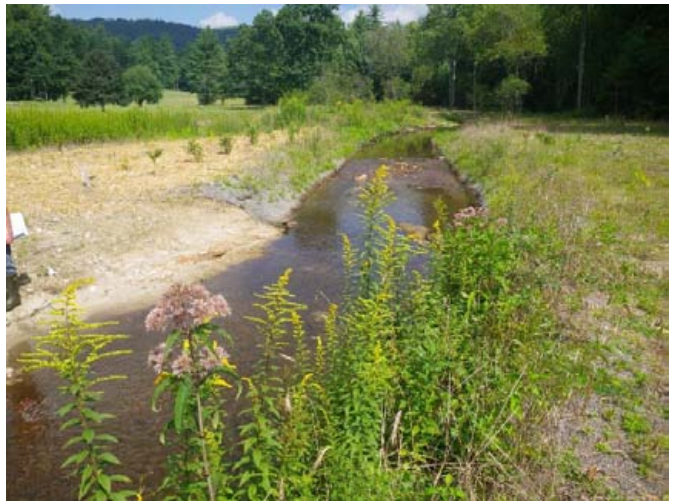
Photo 21. Logan Creek Photo Point 11 – Station 23+20 (August 2015) downstream view from left bank.

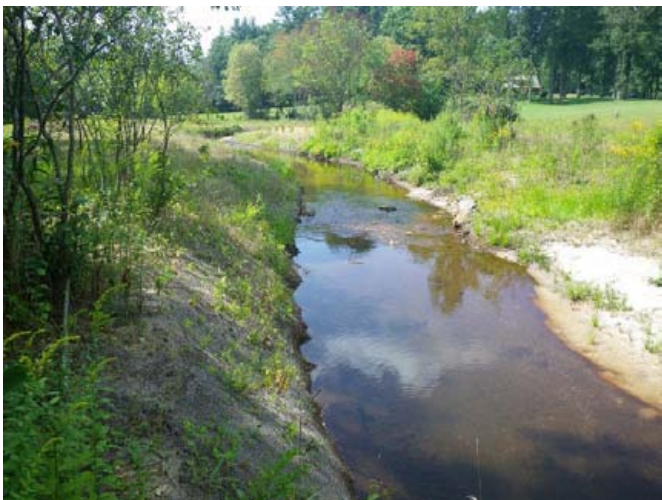
Photo 22. Logan Creek Photo Point 11 – Station 23+20 (August 2015) upstream view from left bank.

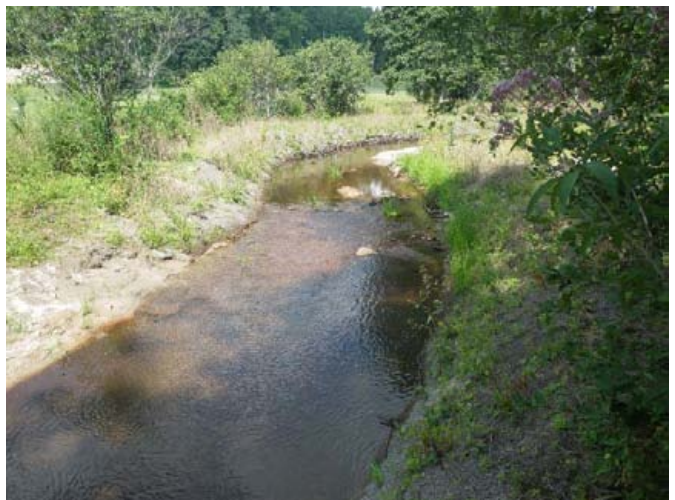
Photo 23. Logan Creek Photo Point 12 – Station 21+20 (August 2015) downstream view from left bank.

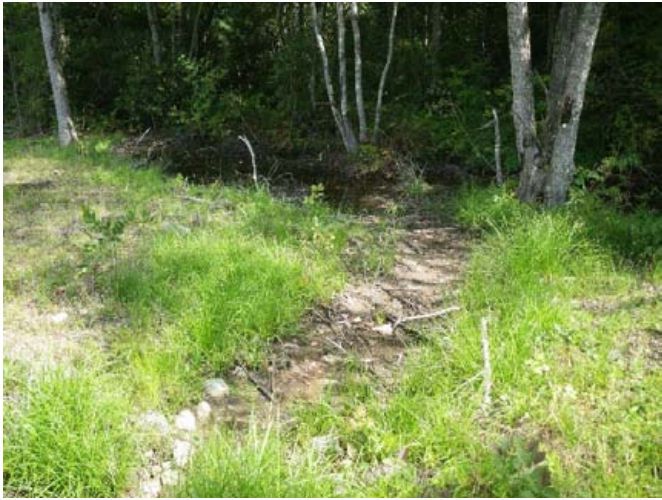
Photo 24. Logan Creek Photo Point 12 – Station 21+20 (August 2015) upstream view from left bank.

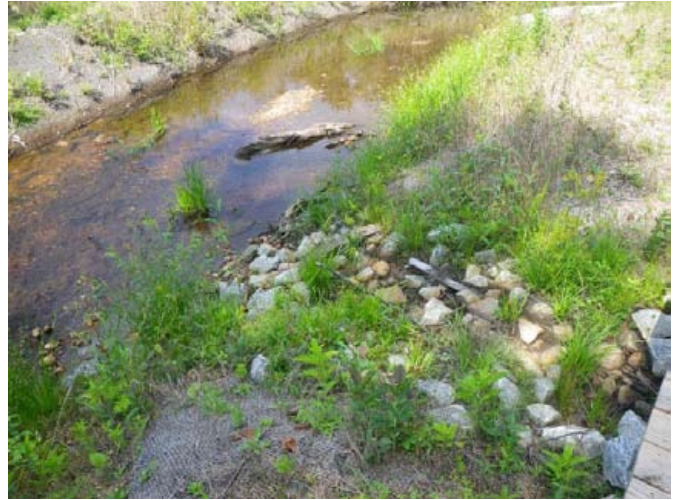
Photo 25. UT7 Photo Point 13 – (August 2015)
upstream view from left bank.

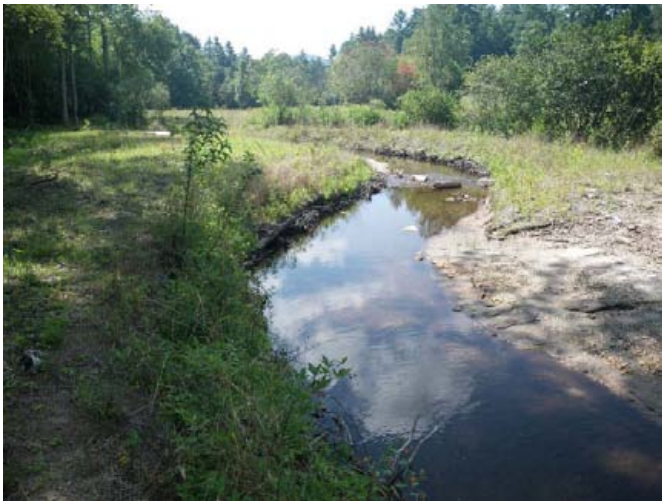
Photo 26. UT7 Photo Point 13 – (August 2015)
downstream view from left bank.

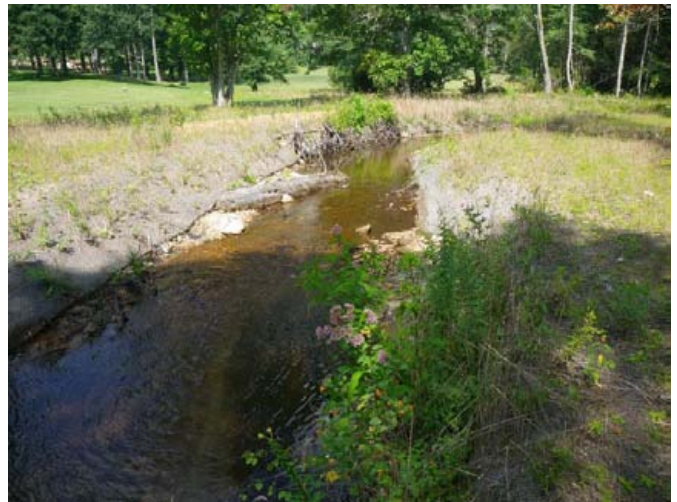
Photo 27. Logan Creek Photo Point 14 – Station 19+45
(August 2015) downstream view from left bank.

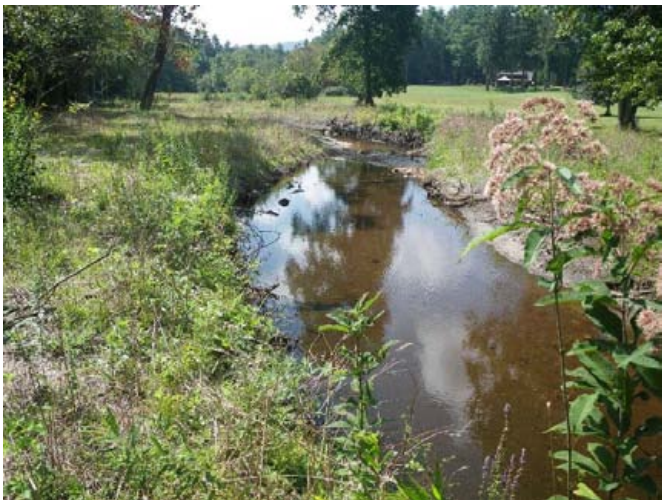
Photo 28. Logan Creek Photo Point 14 – Station 19+45
(August 2015) upstream view from left bank.

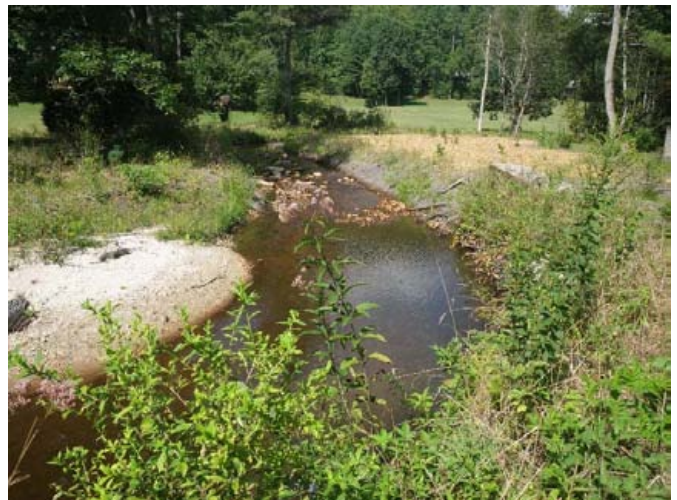
Photo 29. Logan Creek Photo Point 15 – Station 17+45
(August 2015) downstream view from left bank.

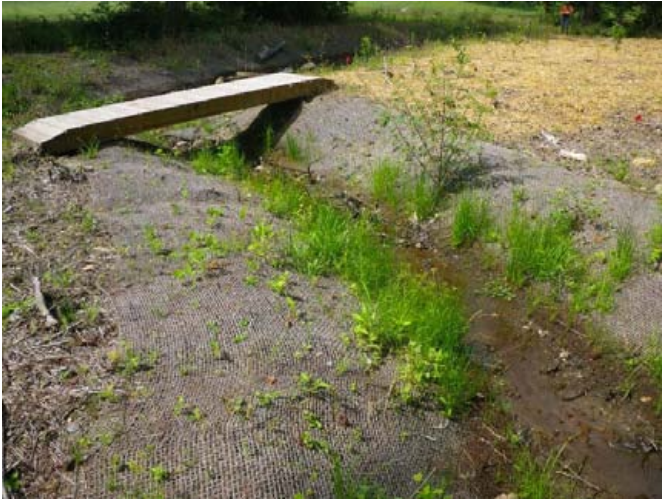
Photo 30. Logan Creek Photo Point 15 – Station 17+45
(August 2015) upstream view from left bank.

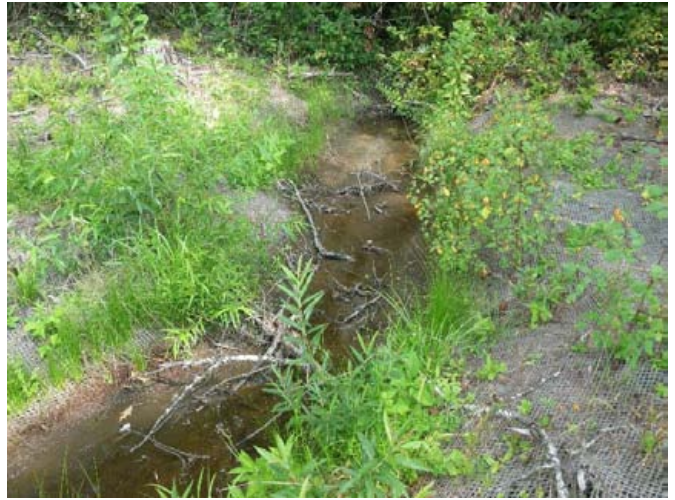
Photo 31. UT4 Photo Point 16 – Station 0+40 (August 2015) downstream view from left bank.

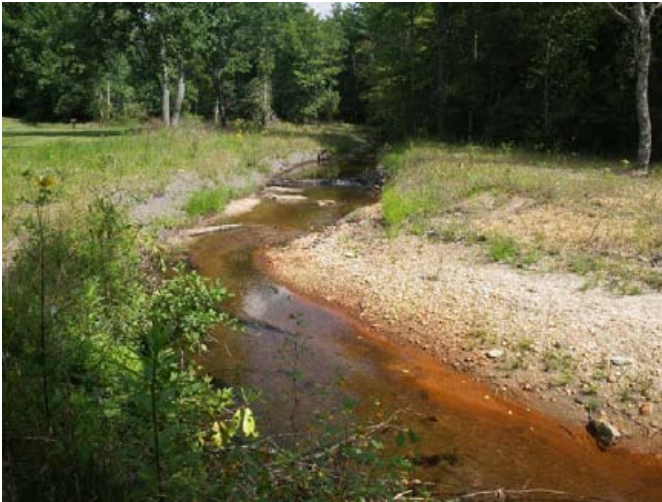
Photo 32. UT4 Photo Point 16 – Station 0+40 (August 2015) upstream view from left bank.

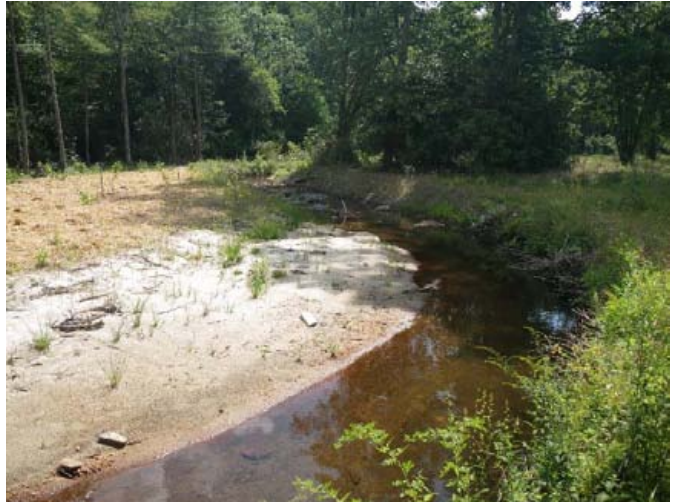
Photo 32. Logan Creek Photo Point 17 – Station 15+50 (August 2015) upstream view from right bank.

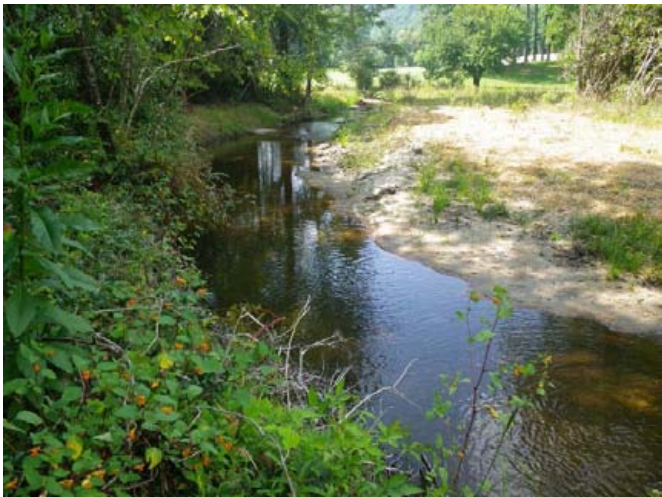
Photo 33. Logan Creek Photo Point 17 – Station 15+50 (August 2015) downstream view from right bank.

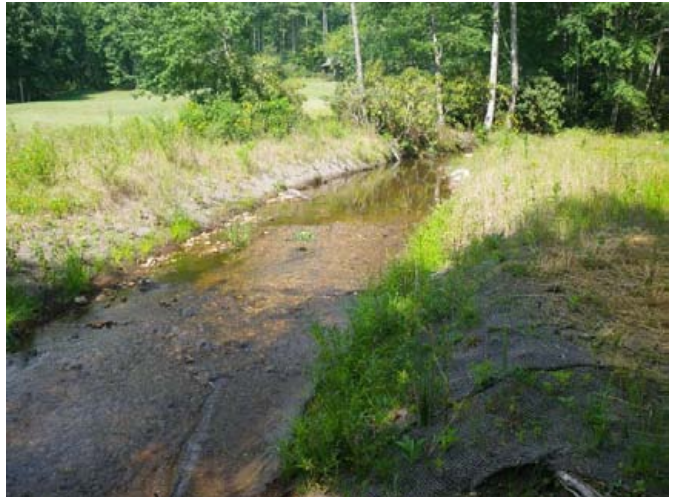
Photo 34. Logan Creek Photo Point 18 – Station 12+90 (August 2015) downstream view from left bank.

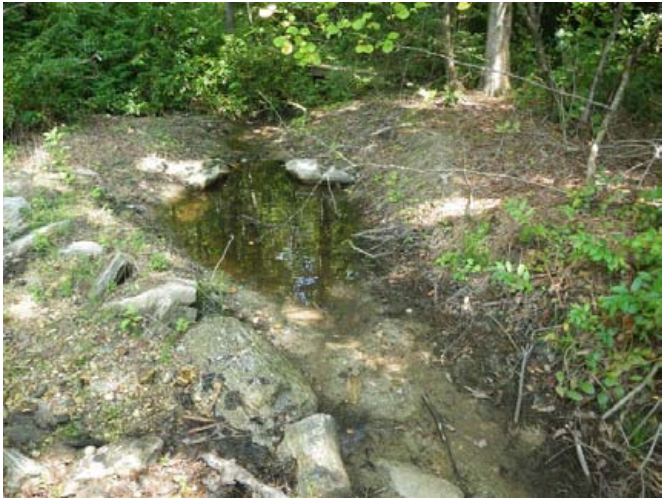
Photo 35. Logan Creek Photo Point 18 – Station 12+90 (August 2015) upstream view from left bank.

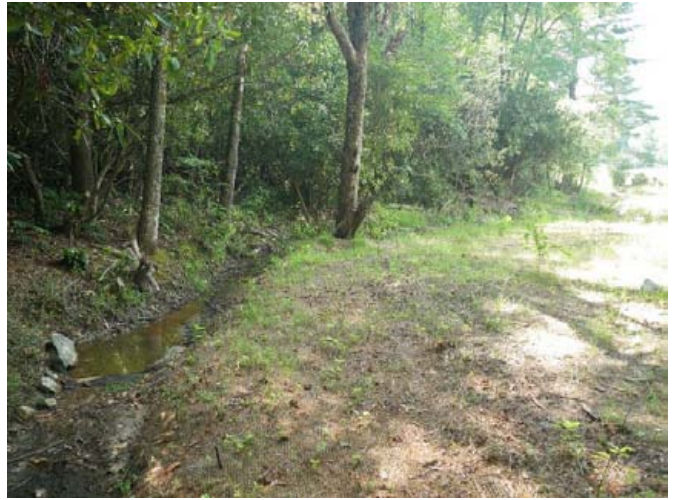
Photo 36. UT3 Photo Point 19 – Station 00+60 (August 2015) upstream from left bank.

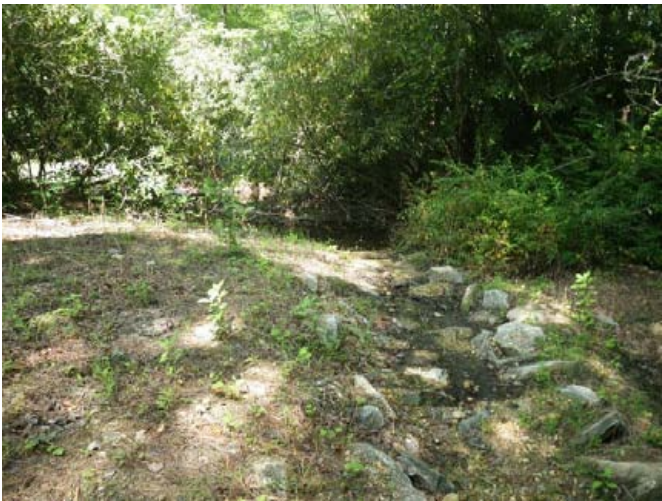
Photo 37. UT3 Photo Point 19 – Station 00+60 (August 2015) downstream from left bank.

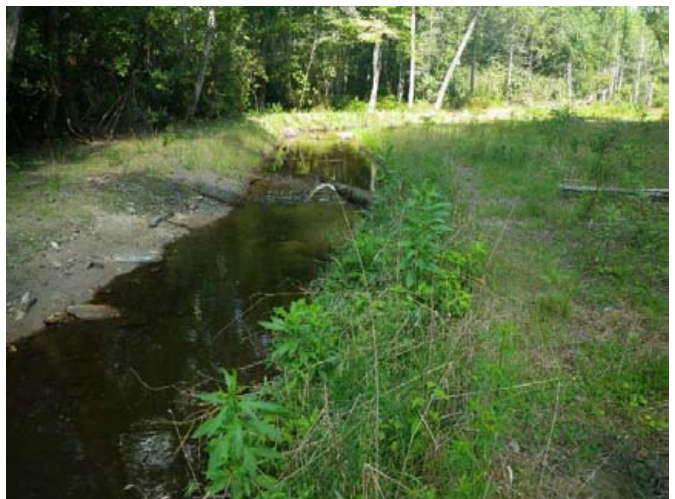
Photo 40. Logan Creek Photo Point 20 – Station 10+60 (August 2015) downstream view from left bank.

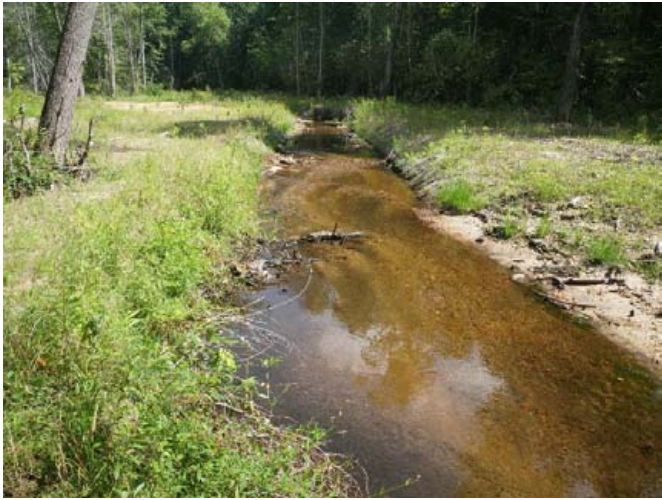
Photo 41. Logan Creek Photo Point 20 – Station 10+60 (August 2015) upstream view from left bank.

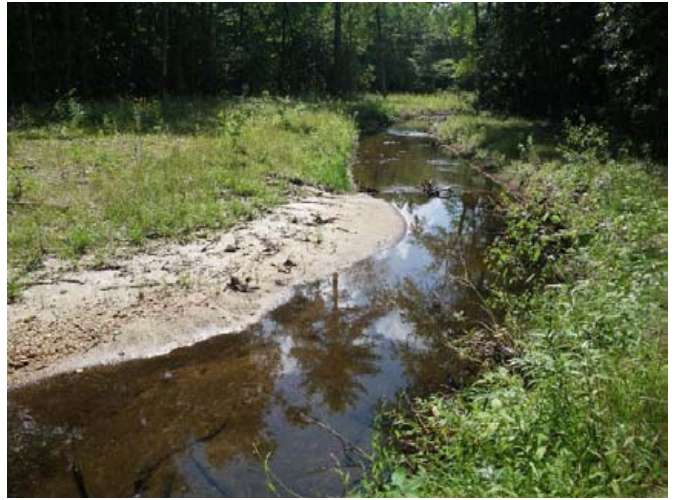
Photo 42. Logan Creek Photo Point 21 – Station 9+40 (August 2015) upstream view from right bank.

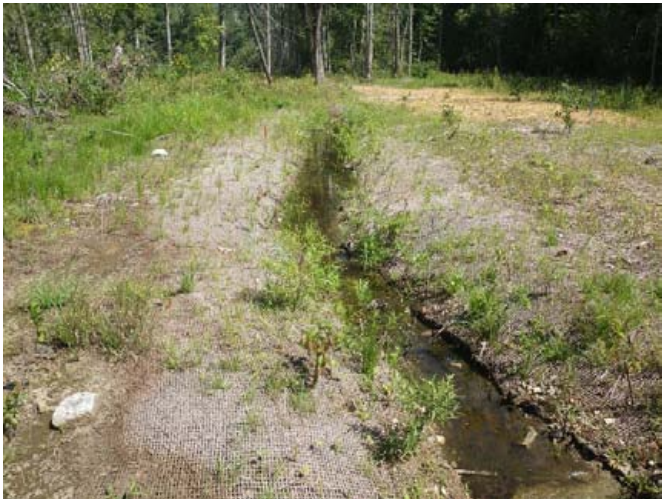
Photo 43. Logan Creek Photo Point 21 – Station 9+40 (August 2015) downstream view from right bank.
