As-Built Baseline Monitoring Report

Logan Creek Stream Restoration Project

Jackson County, North Carolina

DMS Project ID No. 92515, Contract No. D06046

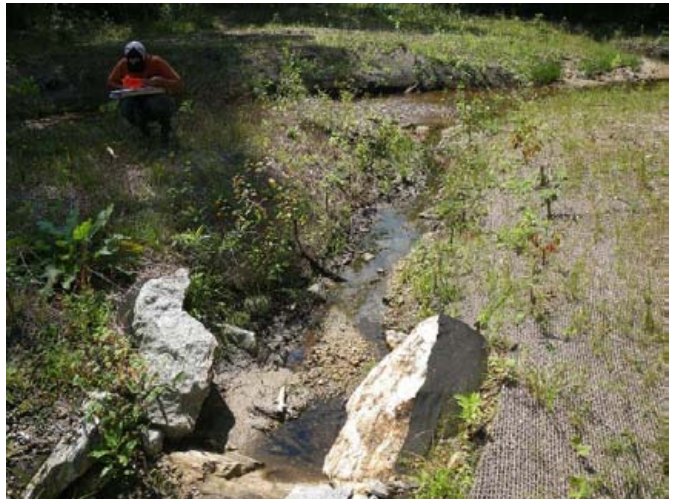
Photo 44. Logan Creek Photo Point 22 – Station 0+75 (August 2015) upstream view from right bank.

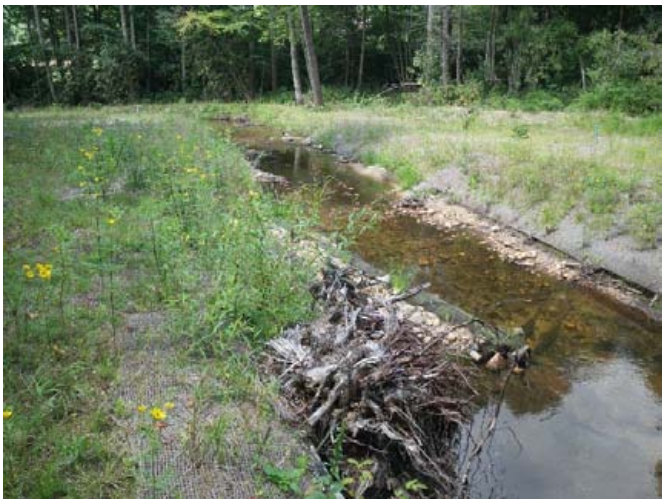
Photo 45. Logan Creek Photo Point 22 – Station 0+75 (August 2015) downstream view from right bank.

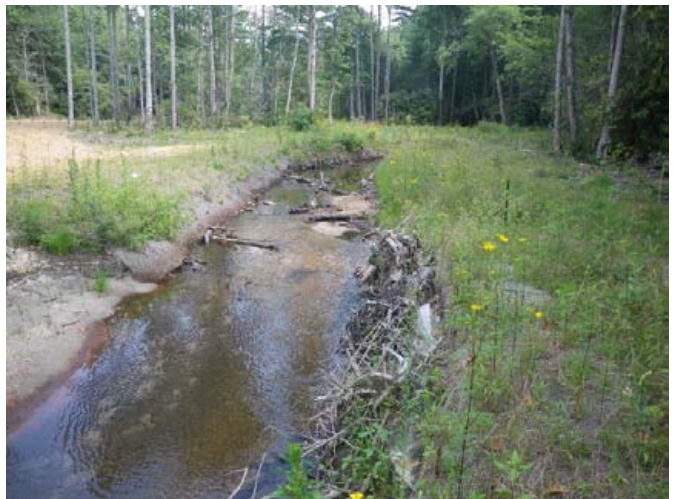
Photo 46. Logan Creek Photo Point 23 – Station 7+70 (August 2015) downstream view from left bank.

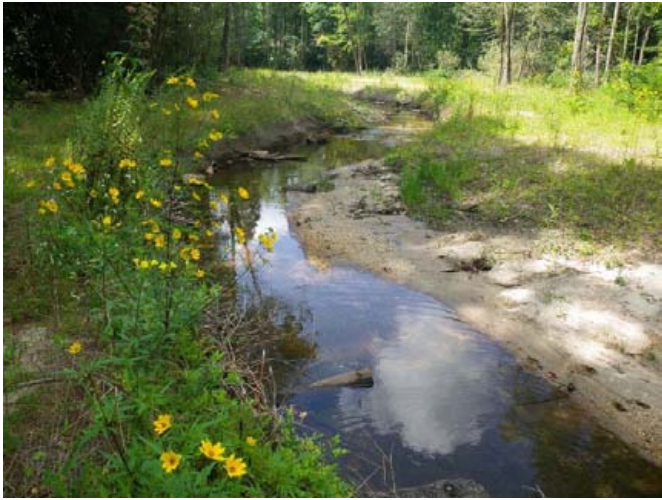
Photo 47. Logan Creek Photo Point 23 – Station 7+70 (August 2015) upstream view from left bank.

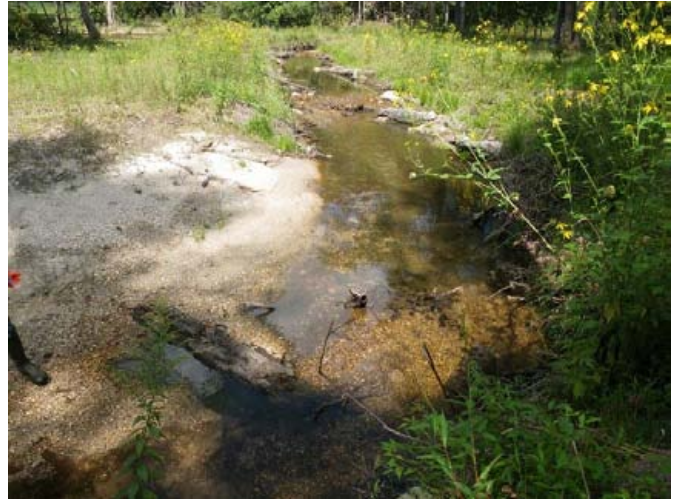
Photo 48. Logan Creek, Photo Point 24 – Station 5+70 (August 2015) downstream view from left bank.

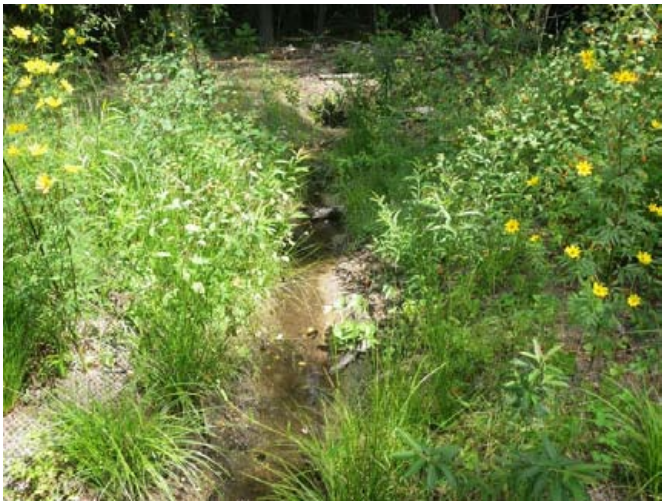
Photo 49. Logan Creek, Photo Point 24 – Station 5+70 (August 2015) upstream view from left bank.

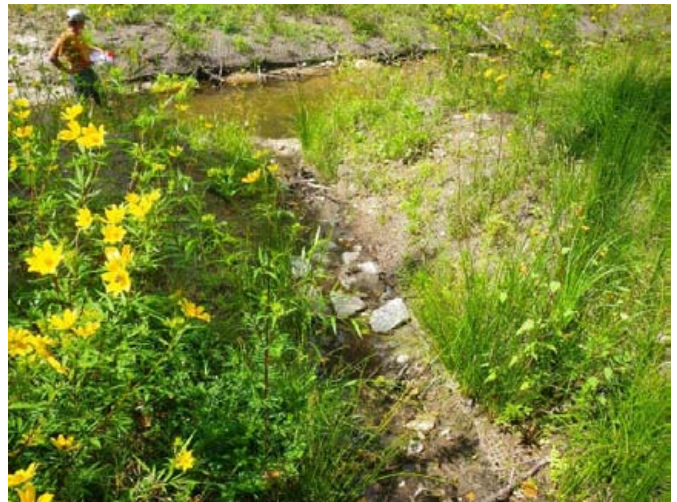
Photo 50. UT2, Photo Point 25 – Station 0+65 (August 2015) upstream view from left bank.

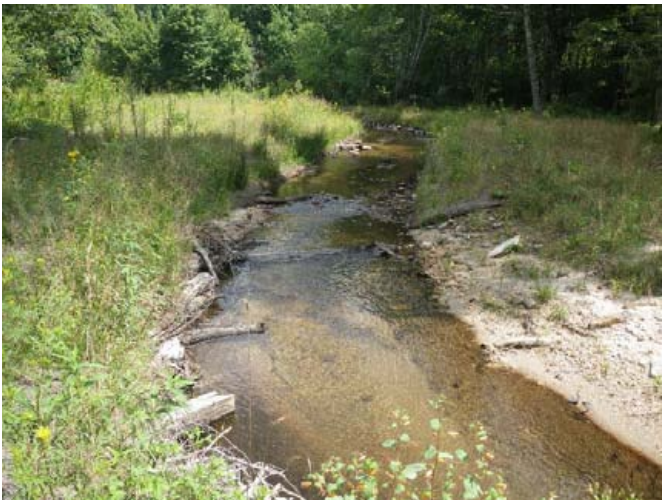
Photo 51. UT2, Photo Point 25 – Station 0+65 (August 2015) downstream view from left bank.

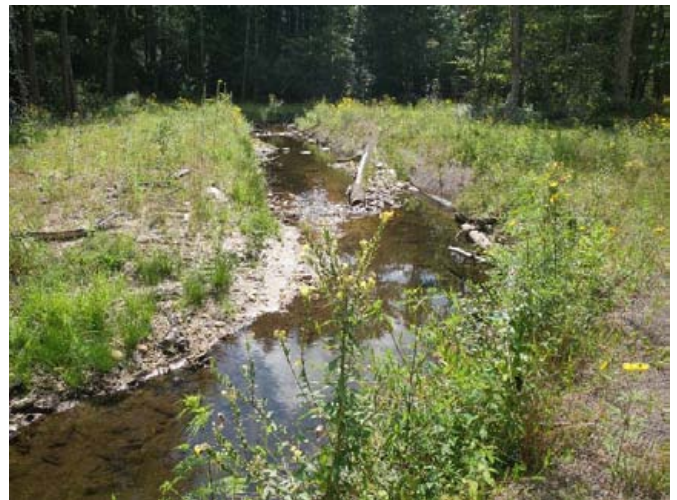
Photo 52. Logan Creek, Photo Point 26 – Station 3+80 (August 2015) upstream view from right bank.

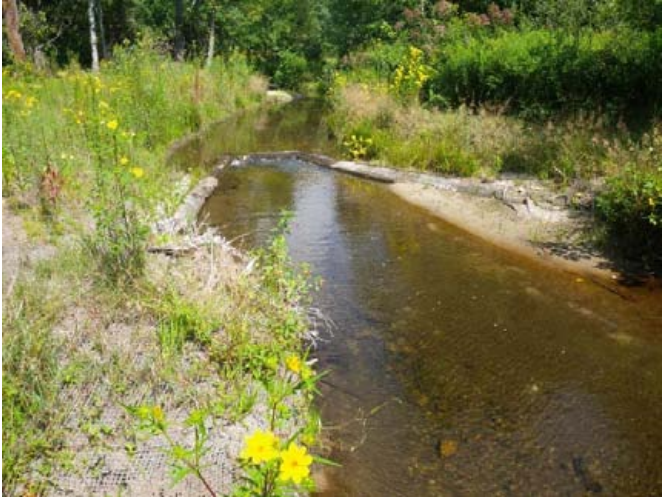
Photo 53. Logan Creek, Photo Point 26 – Station 3+80 (August 2015) downstream view from right bank.

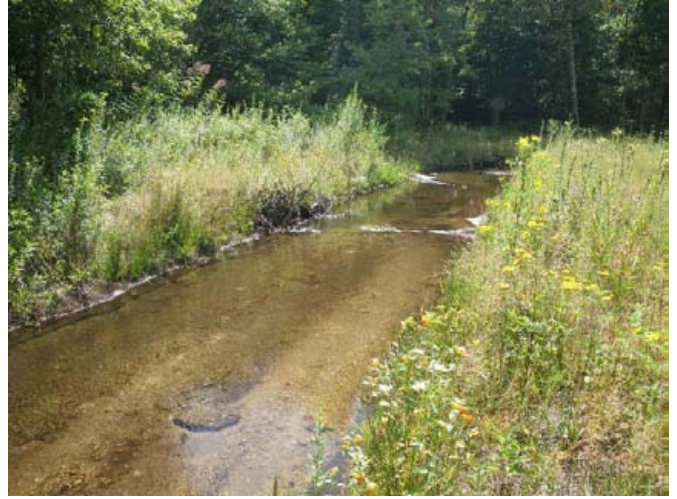
Photo 55. Logan Creek, Photo Point 27 – Station 1+12 (August 2015) downstream view from right bank.

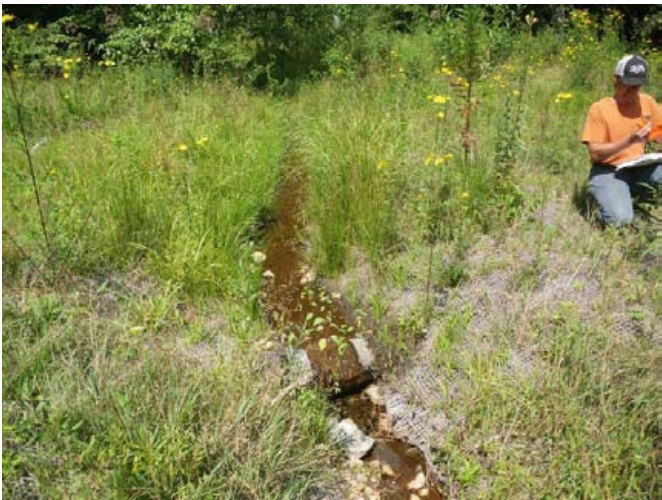
Photo 56. UT2, Photo Point 28 – Station 1+10 (August 2015) upstream view from right bank and confluence.

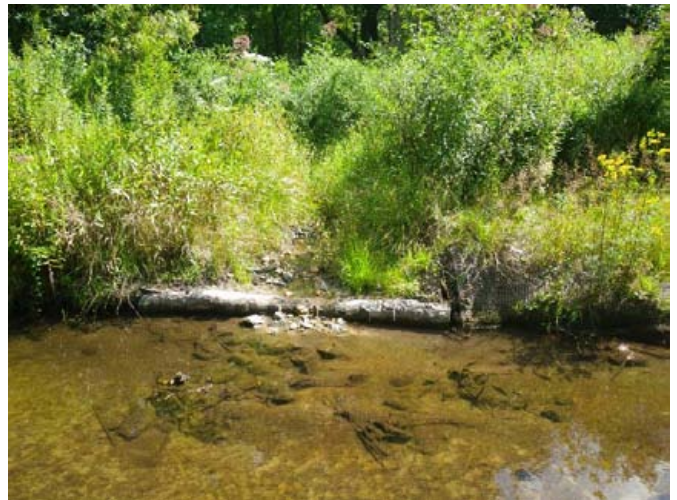
Photo 57. UT1, Photo Point 29 – Station 0+50 (August 2015) view upstream and confluence.

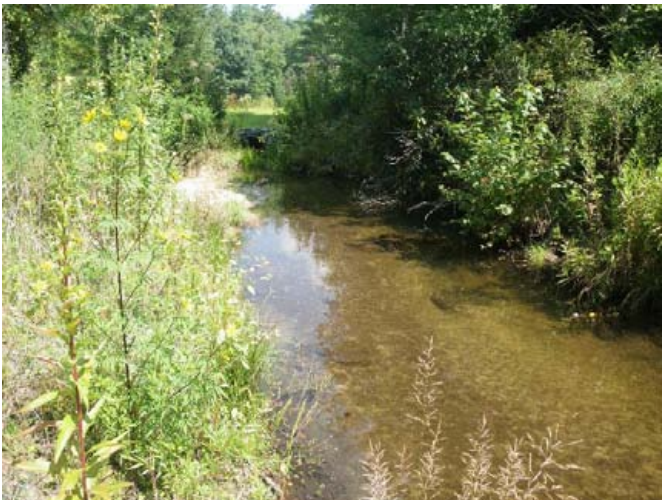
Photo 58. Logan Creek, Photo Point 30 – Station 0+50 (August 2015) upstream view from right bank.

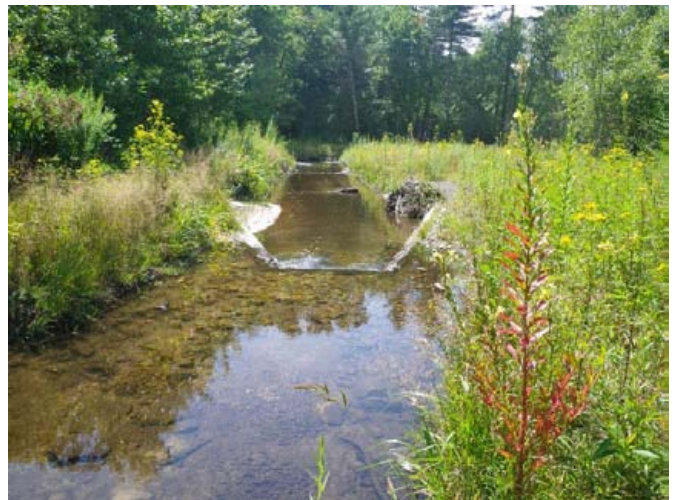
Photo 59. Logan Creek, Photo Point 30 – Station 0+50 (August 2015) downstream view from right bank.

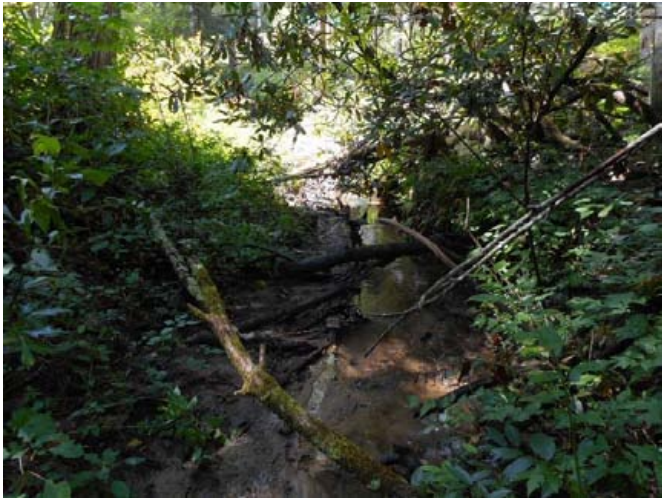
Photo 60. UT8 - Preservation, Photo Point 31 – Station 1+80 (August 2015) downstream view from mid-channel to confluence.

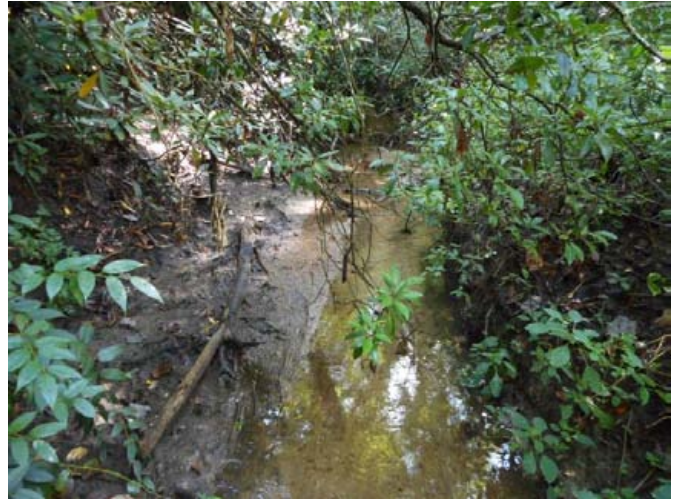
Photo 61. UT8 - Preservation, Photo Point 31 – Station 1+80 (August 2015) upstream view from mid-channel to confluence.

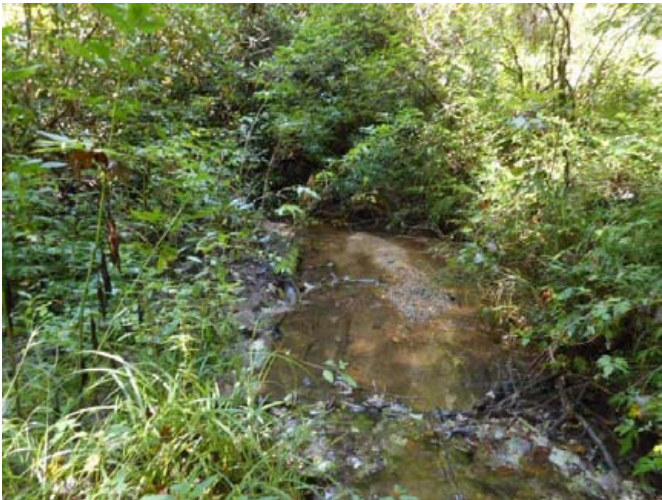
Photo 62. UT8 - Preservation, Photo Point 32 – (August 2015) downstream view from right bank.

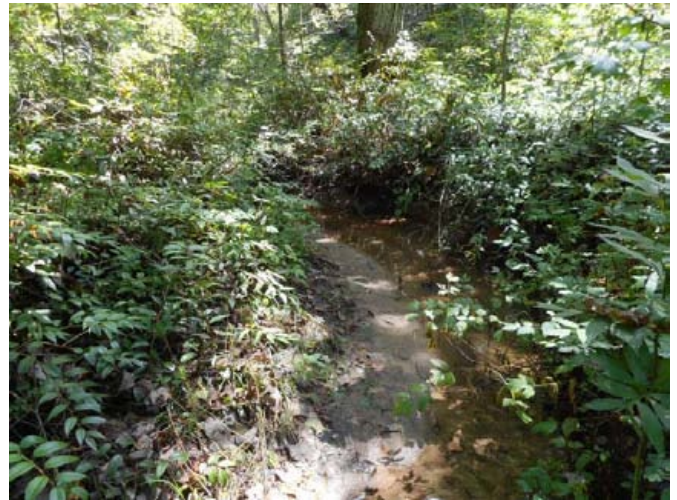
Photo 63. UT8 - Preservation, Photo Point 32 – (August 2015) upstream view from right bank.

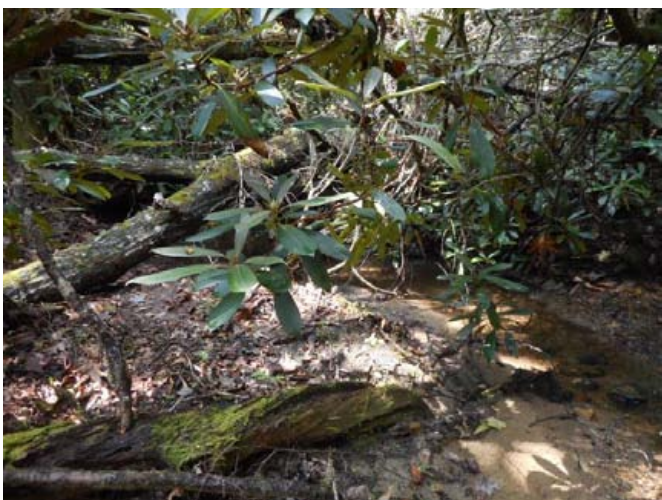
Photo 64. UT8 - Preservation, Photo Point 33 – (August 2015) downstream view from right bank.

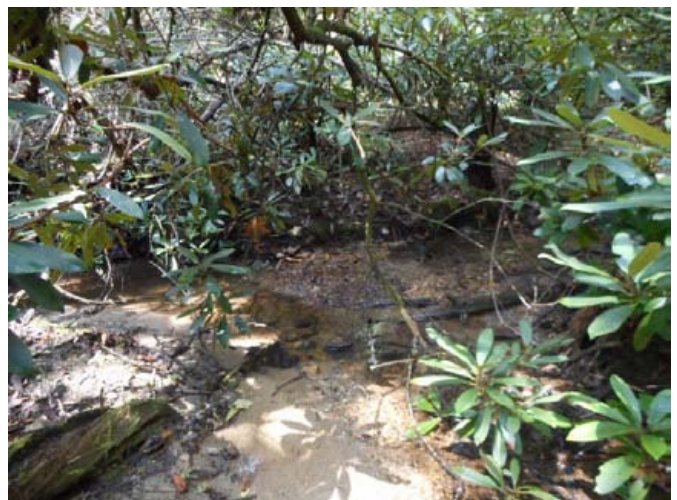
Photo 65. UT8 - Preservation, Photo Point 33 – (August 2015) downstream view from right bank.

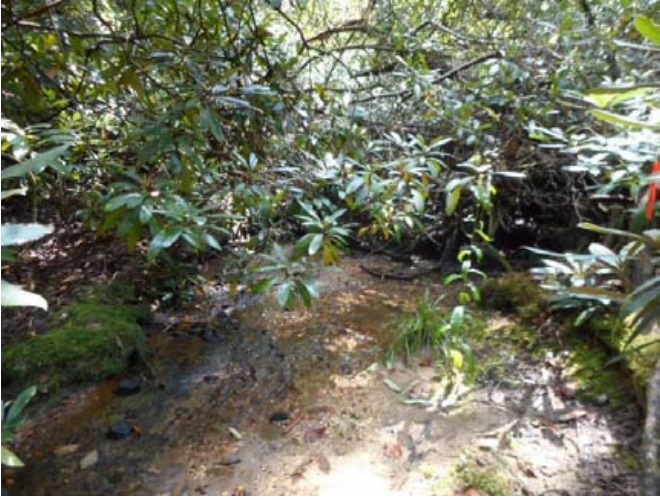
Photo 64. UT8 - Preservation, Photo Point 33 – (August 2015) upstream view from right bank.
