MONITORING YEAR 1 ANNUAL REPORT

LONE HICKORY MITIGATION SITE

Yadkin County, NC
DEQ Contract No. 6897
DMS Project No. 97135
DWR No. 20161044
USACE Action ID No. SAW-2017-00100
Yadkin River Basin
HUC 03040101

Data Collection Period: May 2019 – November 2019
Final Submission Date: January 14, 2020

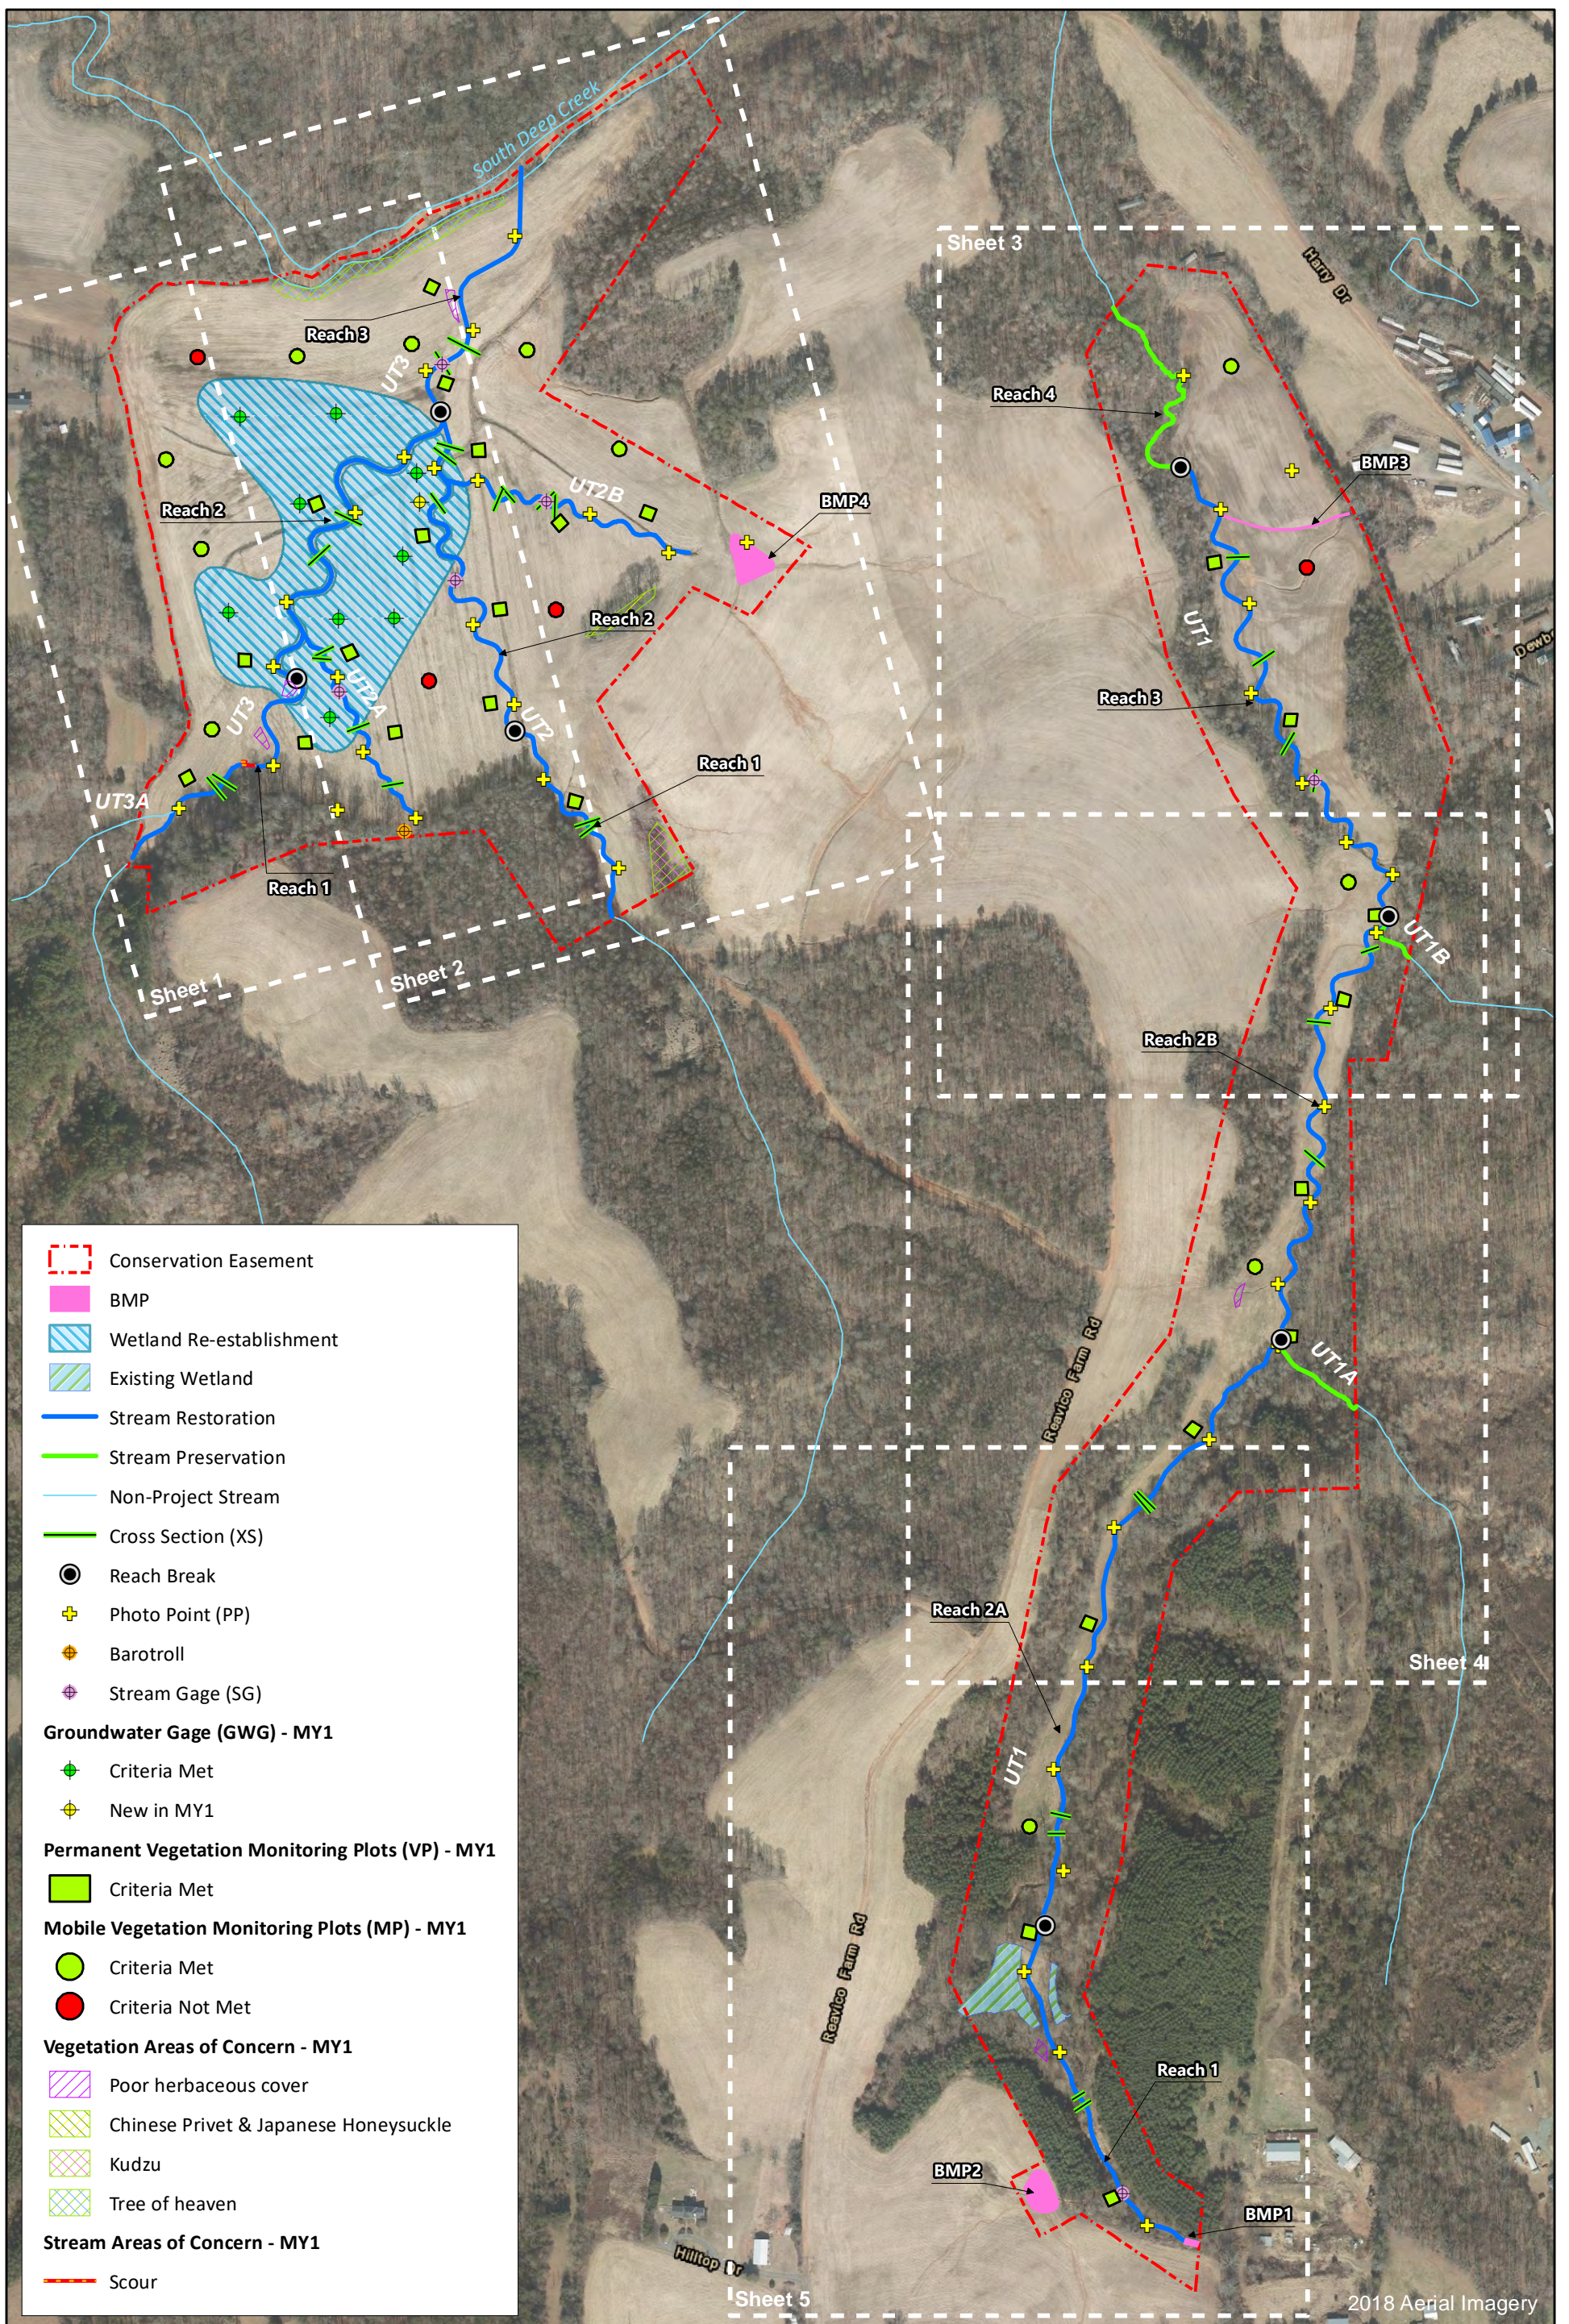
Figure 3.0 Integrated Current Condition Plan View Map (Key)
 Lone Hickory Mitigation Site
 DMS Project No. 97135
 Monitoring Year 1 - 2019

MY1 visual assessments indicate that some invasive plant populations are present within the conservation easement. These species include: kudzu (*Pueraria montana*), Chinese privet (*Ligustrum sinense*), Japanese honeysuckle (*Lonicera japonica*), tree of heaven (*Ailanthus altissima*), and Asian spiderwort (*Murdannia keisak*). In MY1, adaptive management occurred in September and October of 2019 by Wildlands staff. Primary focus areas for treatment included populations of kudzu re-sprouts within the Site near UT2, UT3, and UT3A that were previously treated prior to construction. In addition, aquatic invasive plant species including Asian spiderwort were treated within UT1. During the August 2019 IRT site visit, a grass noted to be similar to Johnson grass adjacent to UT1 was later identified by Wildlands to be barnyard grass (*Echinochloa sp.*). It is expected that this grass will be shaded out over time. Along UT3, small areas of the floodplain were re-seeded to promote stronger herbaceous cover. These vegetation areas of concern will continue to be monitored and addressed by Wildlands throughout the monitoring period. Current vegetation areas of concern are shown in Current Condition Plan View (CCPV) Figures 3.0-3.5 in Appendix 2.

MY1 visual assessments indicate that very few stream areas of concern exist on the Site, and project streams are functioning as designed. Along UT3 Reach 1, one isolated area of bank scour and bed degradation was observed along the riffle at station 304+20. After construction, storm flow caused scour along the outflow channel from BMP4. A repair was completed in September 2019 to stabilize the outflow channel from BMP4 above the start of UT2B. Wildlands will continue to monitor stream areas of concern for accelerated instability and will be addressed as needed throughout the monitoring period. Please refer to Appendix 2 for current CCPV Figures 3.0-3.5 and stream stability tables.

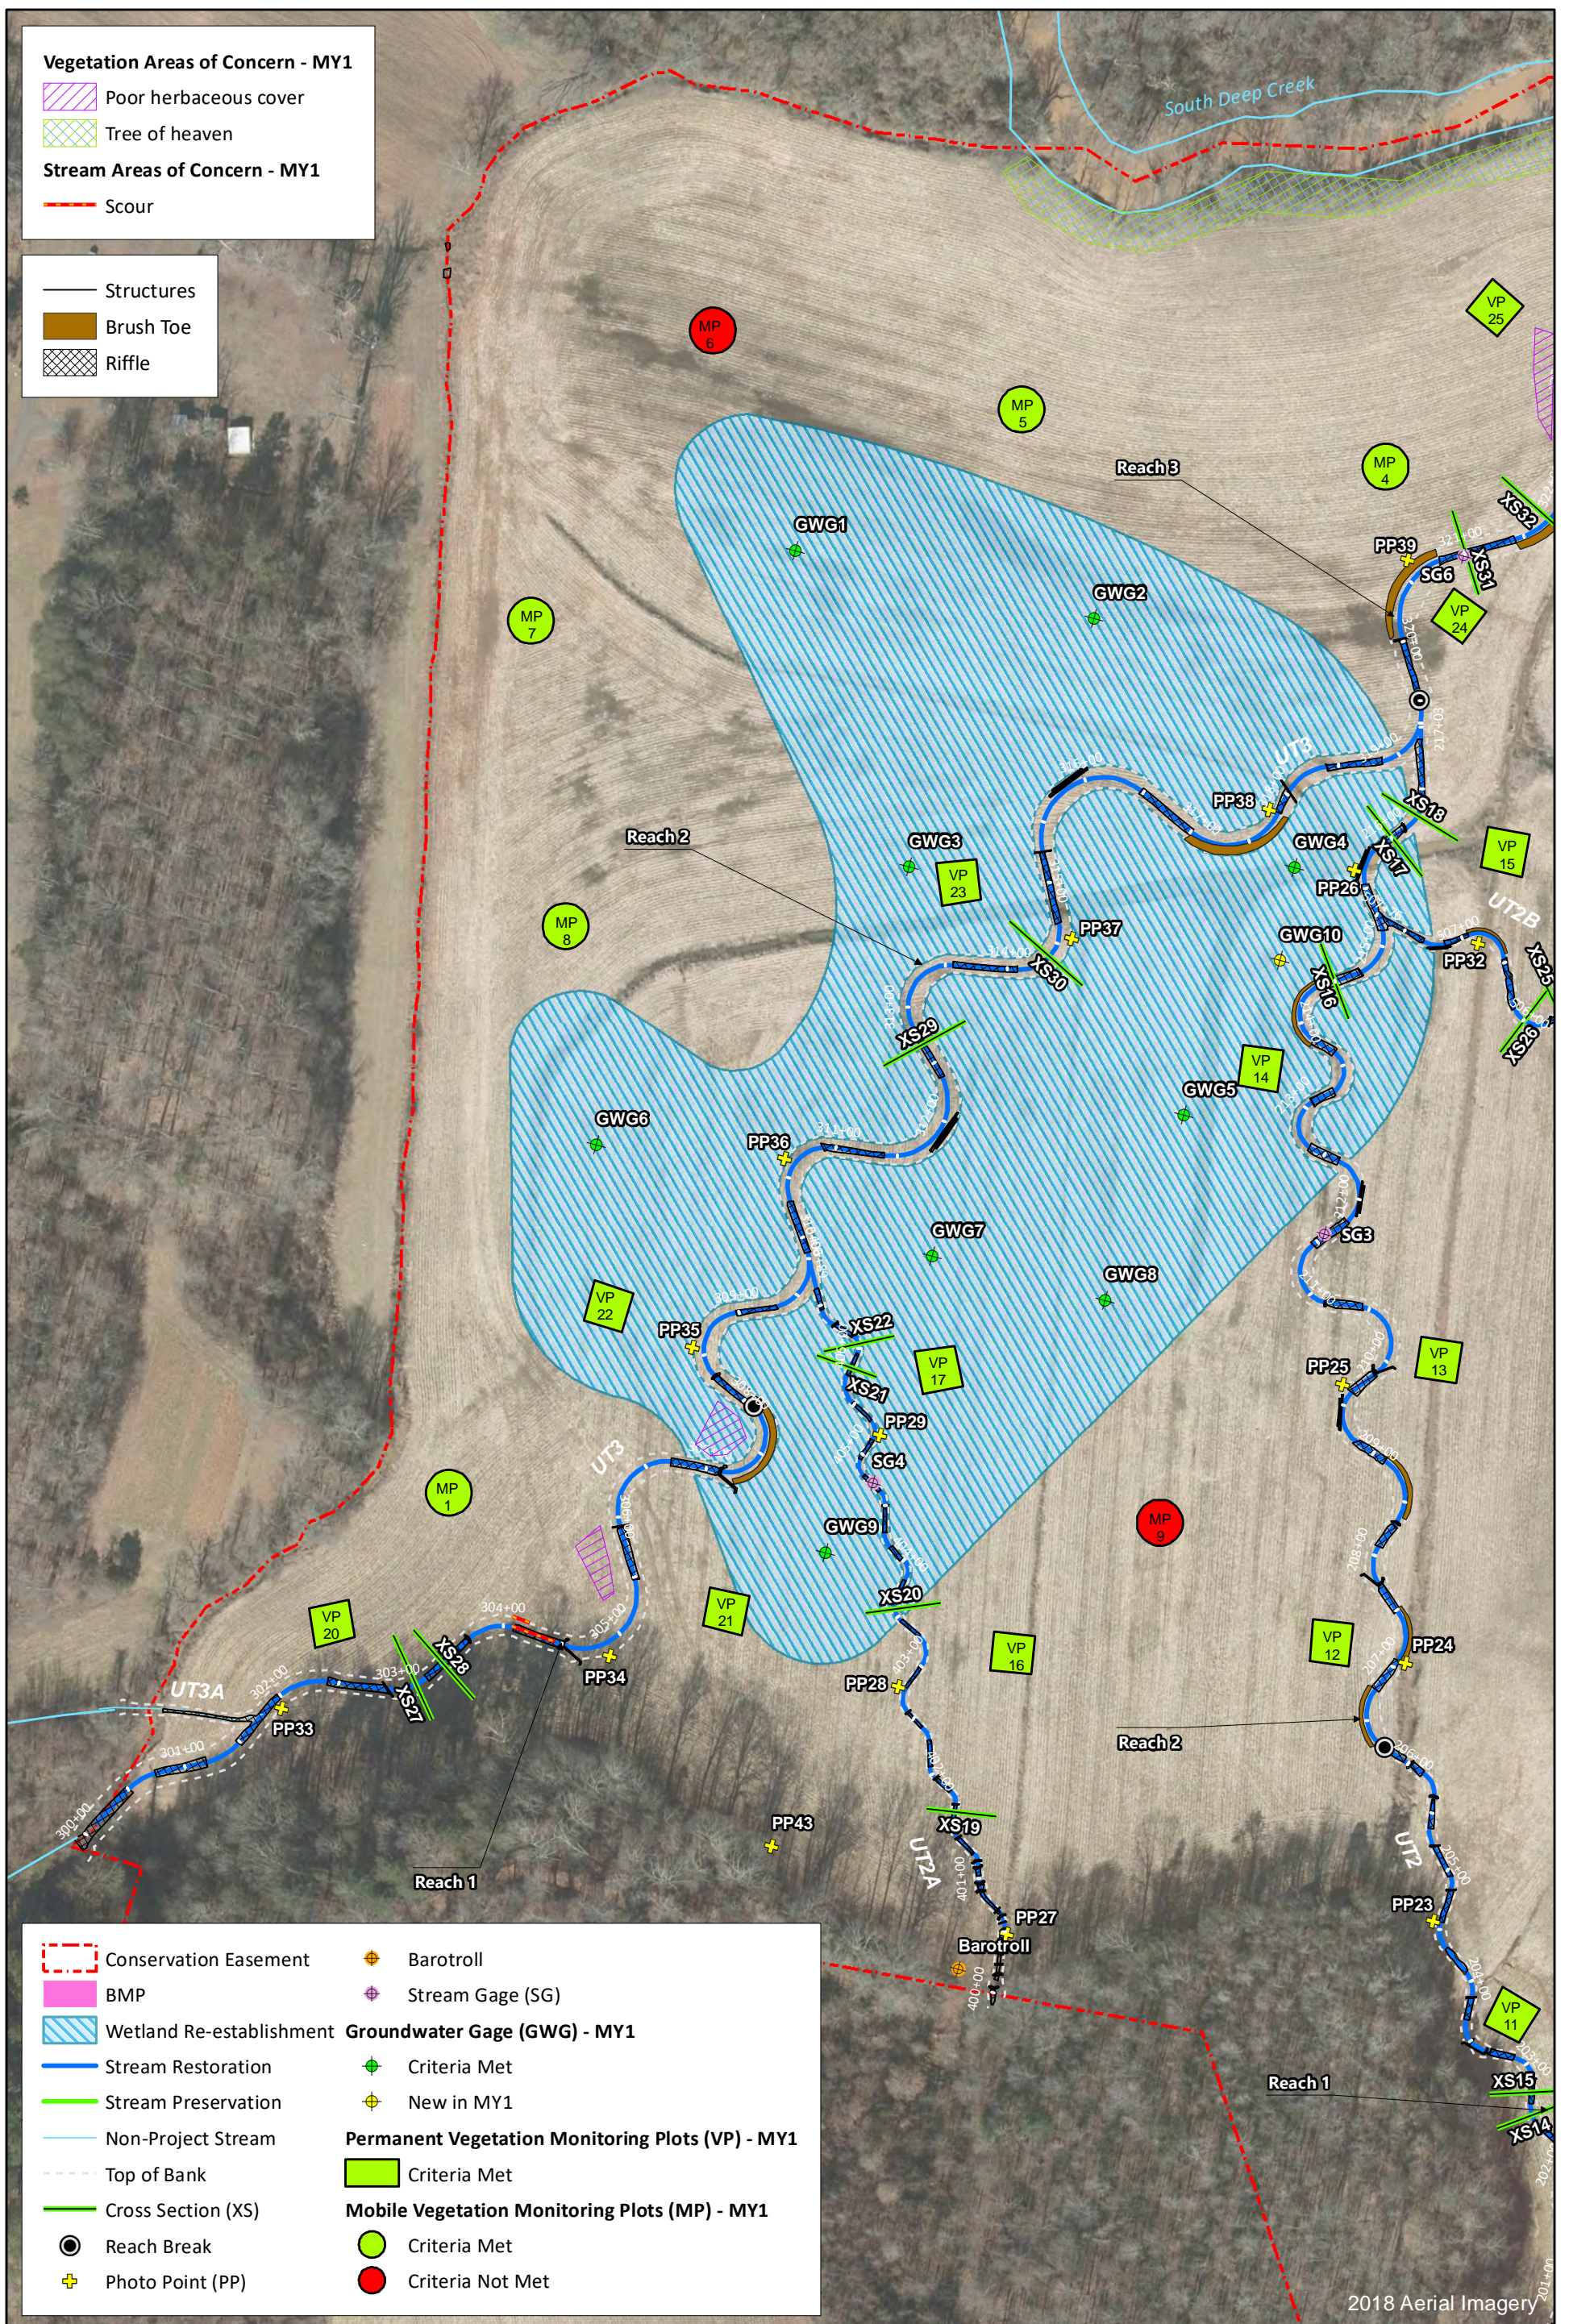
Figure 3.1 Integrated Current Condition Plan View Map (Sheet 1)
 Lone Hickory Mitigation Site
 DMS Project No. 97135
 Monitoring Year 1 - 2019

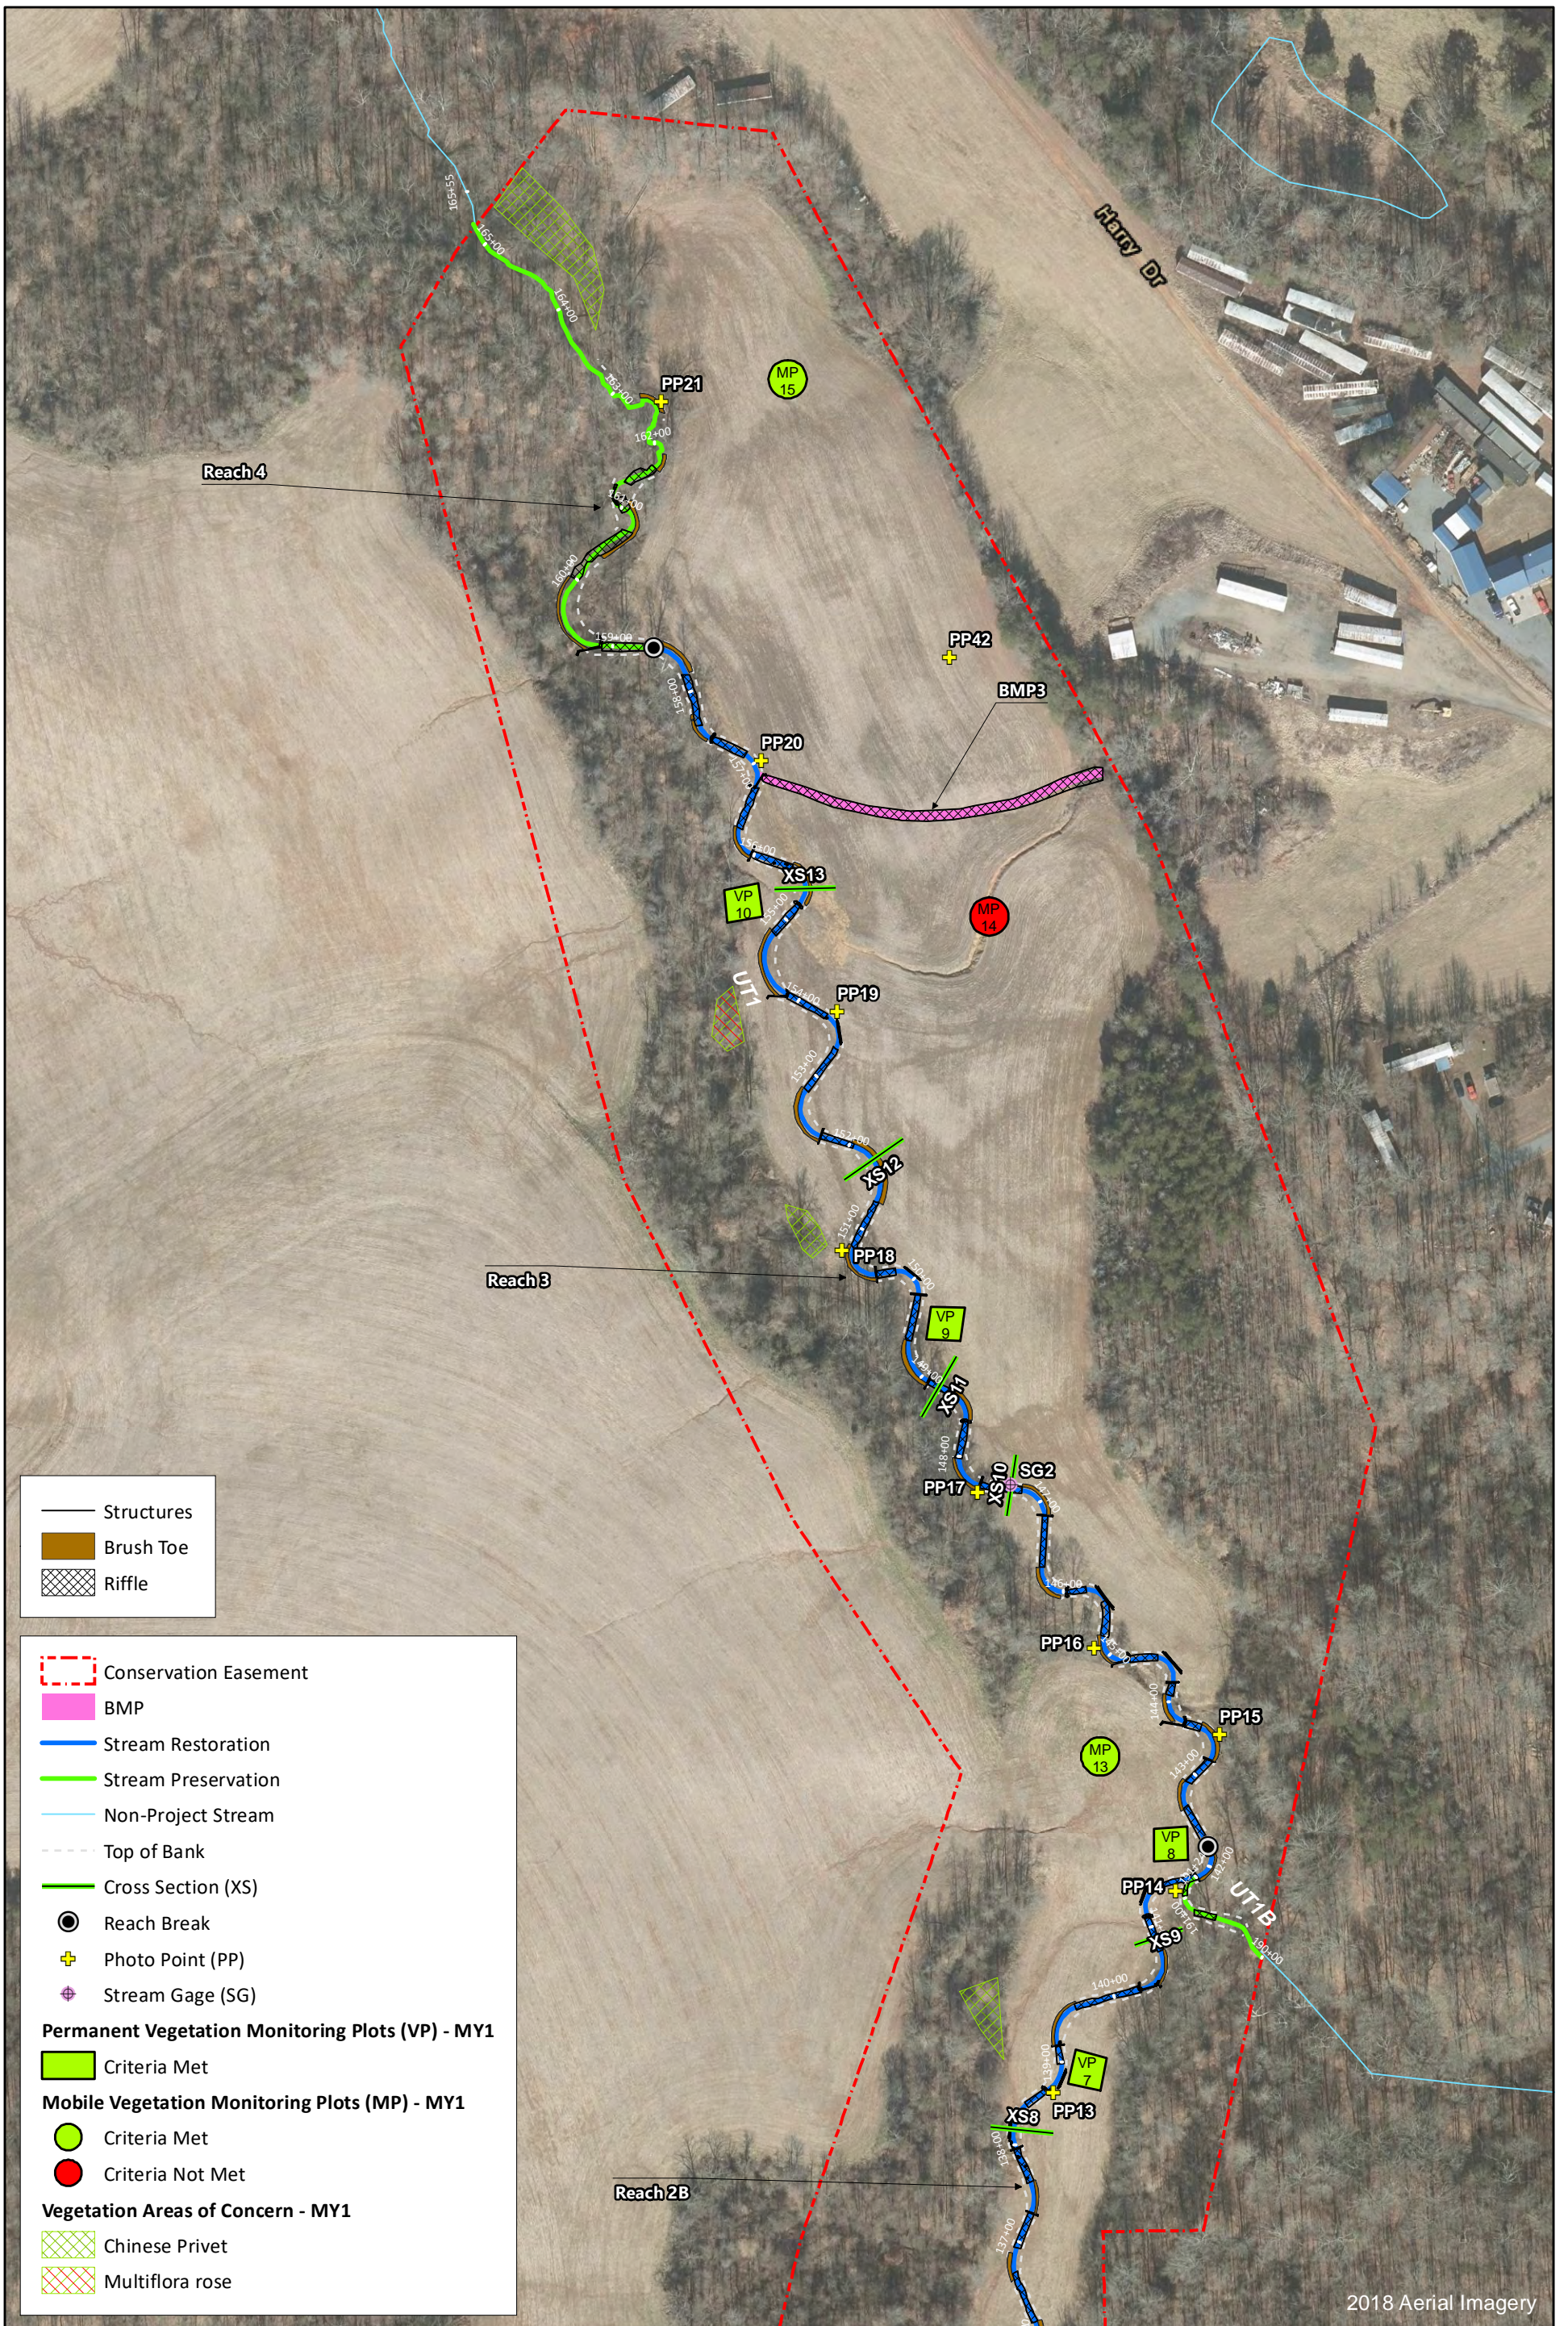
Figure 3.3 Integrated Current Condition Plan View Map (Sheet 3)
 Lone Hickory Mitigation Site
 DMS Project No. 97135
 Monitoring Year 1 - 2019

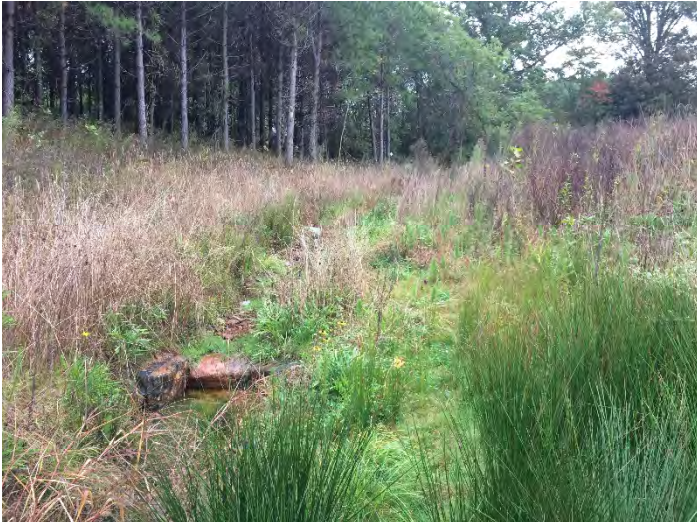
Photo Point 1 – UT1 Reach 1, view upstream (10/22/2019)

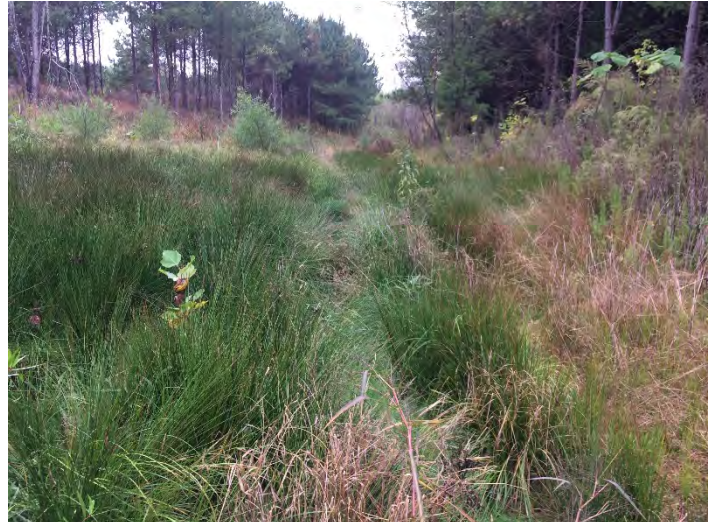
Photo Point 1 – UT1 Reach 1, view downstream (10/22/2019)

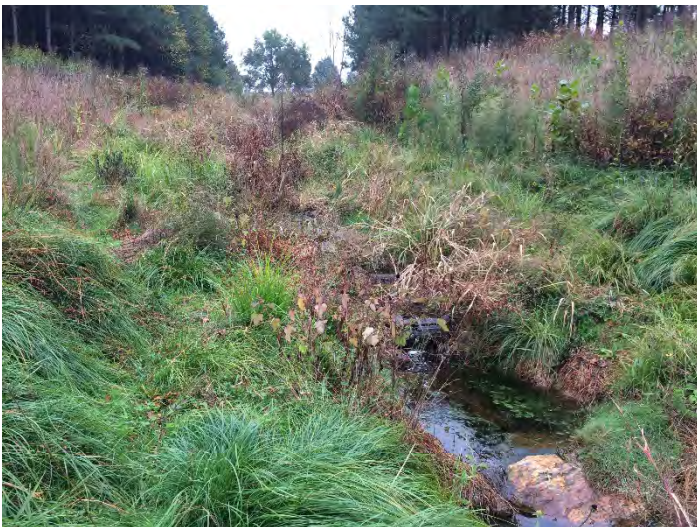
Photo Point 2 – UT1 Reach 1, view upstream (10/22/2019)

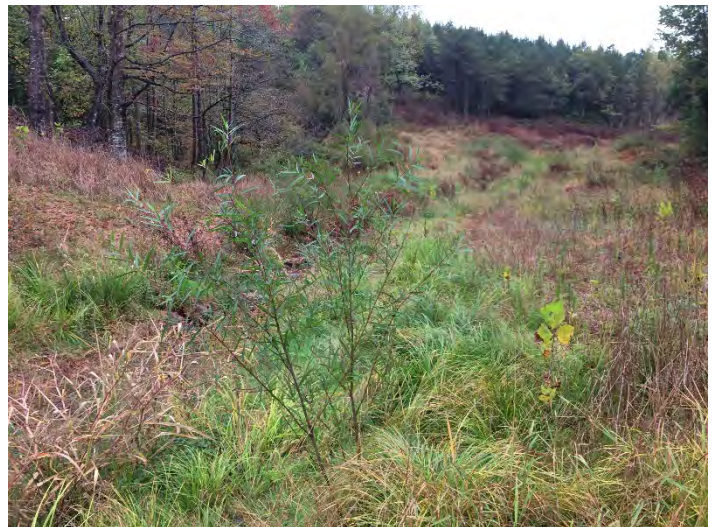
Photo Point 2 – UT1 Reach 1, view downstream (10/22/2019)

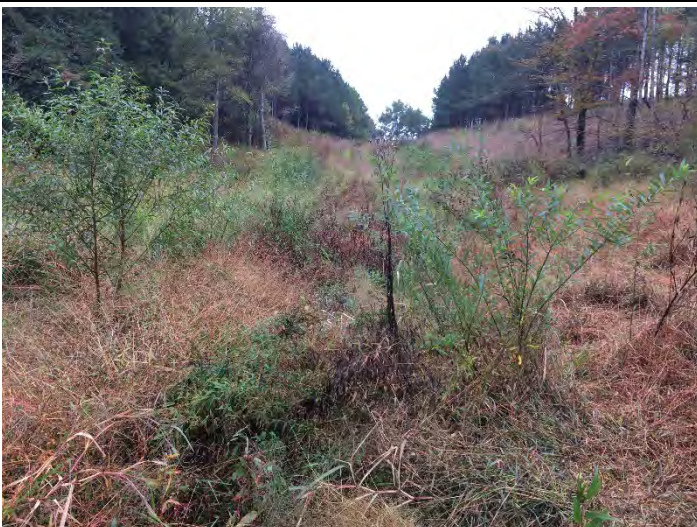
Photo Point 3 – UT1 Reach 1, view upstream (10/22/2019)

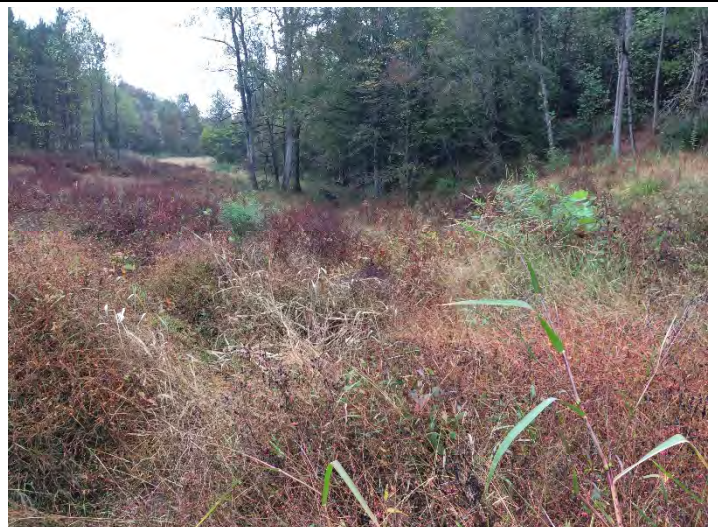
Photo Point 3 – UT1 Reach 1, view downstream (10/22/2019)

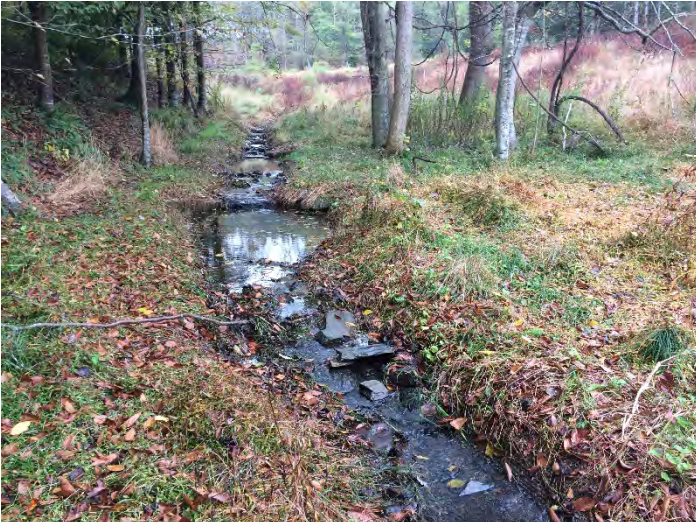
Photo Point 4 – UT1 Reach 2A, view upstream (10/22/2019)

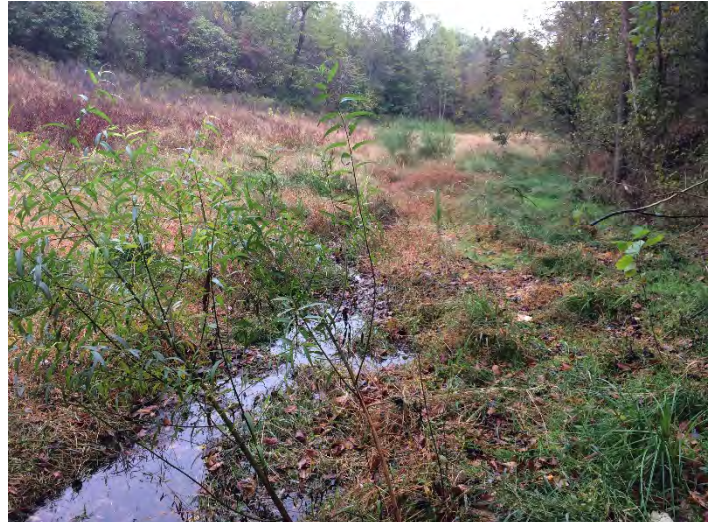
Photo Point 4 – UT1 Reach 2A, view downstream (10/22/2019)

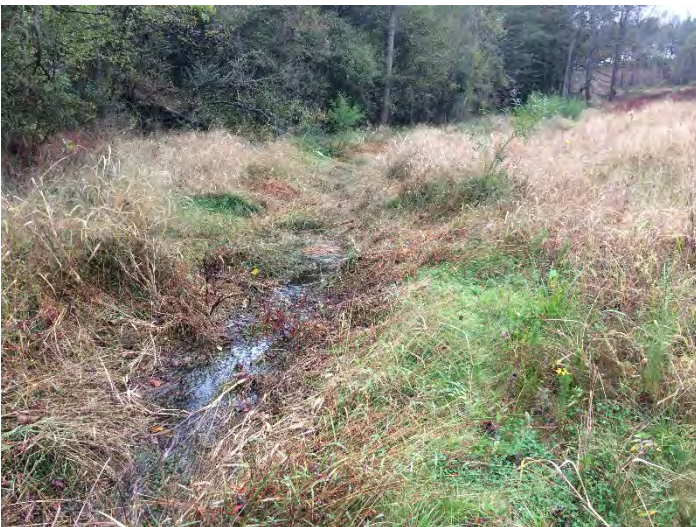
Photo Point 5 – UT1 Reach 2A, view upstream (10/22/2019)

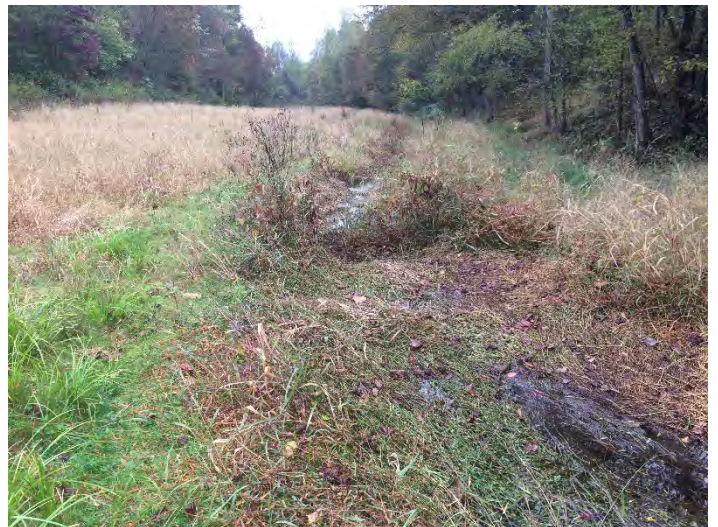
Photo Point 5 – UT1 Reach 2A, view downstream (10/22/2019)

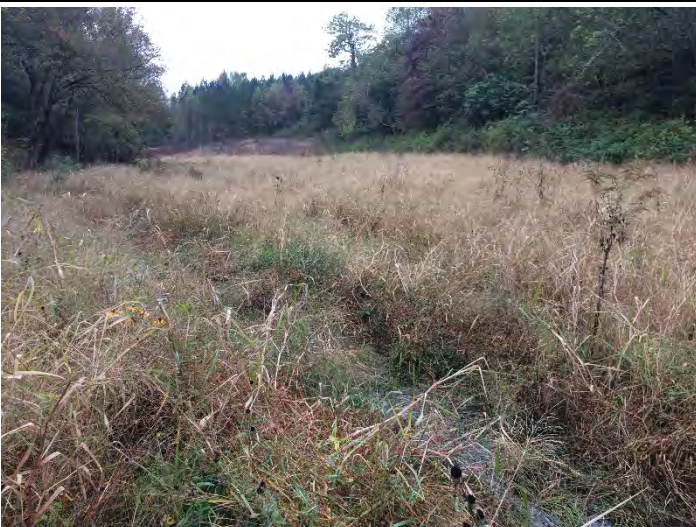
Photo Point 6 – UT1 Reach 2A, view upstream (10/22/2019)

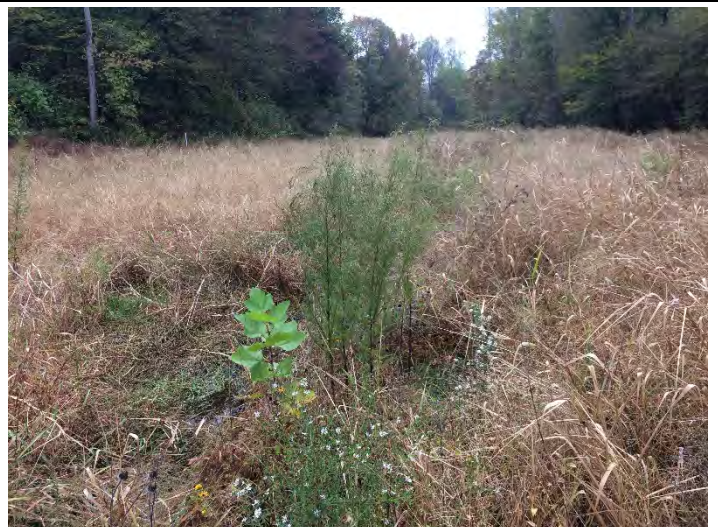
Photo Point 6 – UT1 Reach 2A, view downstream (10/22/2019)

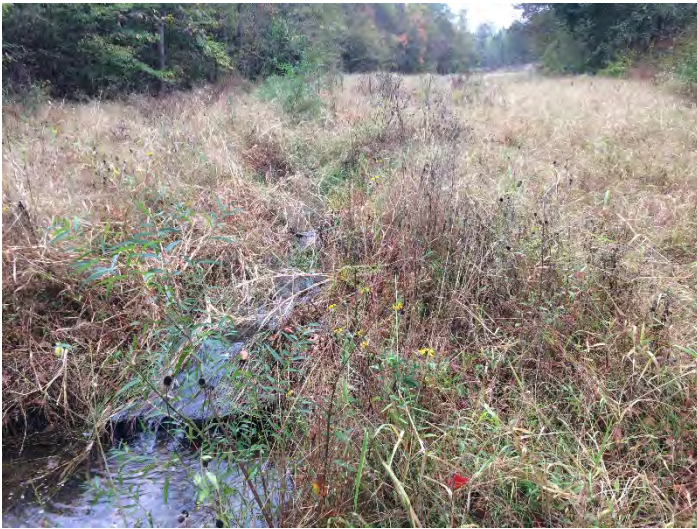
Photo Point 7 – UT1 Reach 2A, view upstream (10/22/2019)

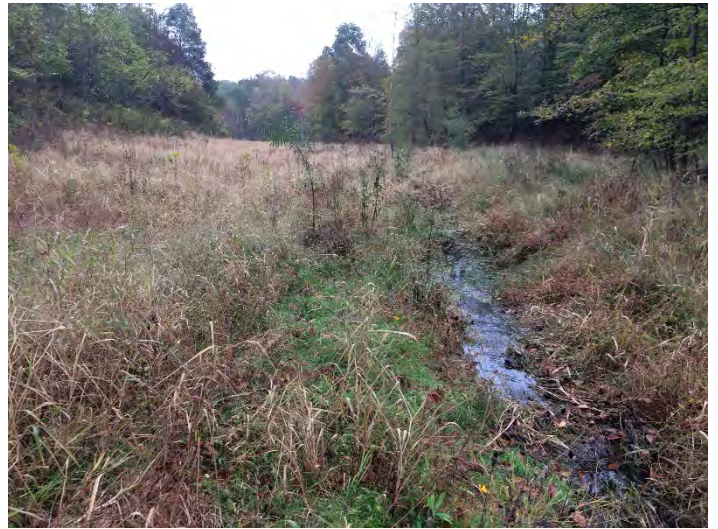
Photo Point 7 – UT1 Reach 2A, view downstream (10/22/2019)

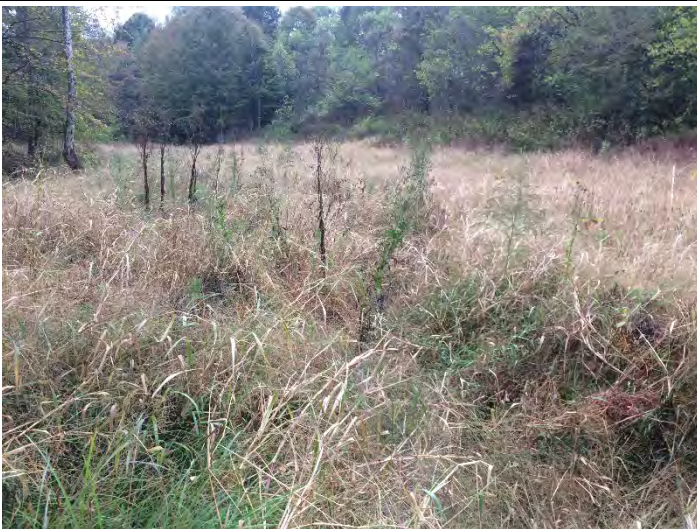
Photo Point 8 – UT1 Reach 2A, view upstream (10/22/2019)

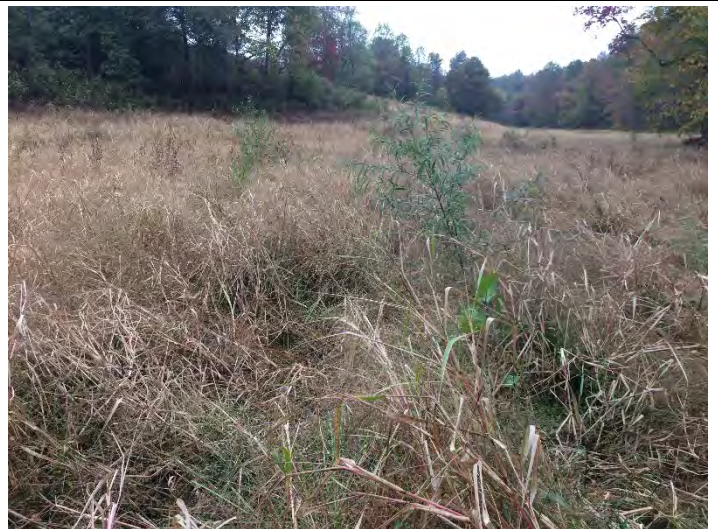
Photo Point 8 – UT1 Reach 2A, view downstream (10/22/2019)

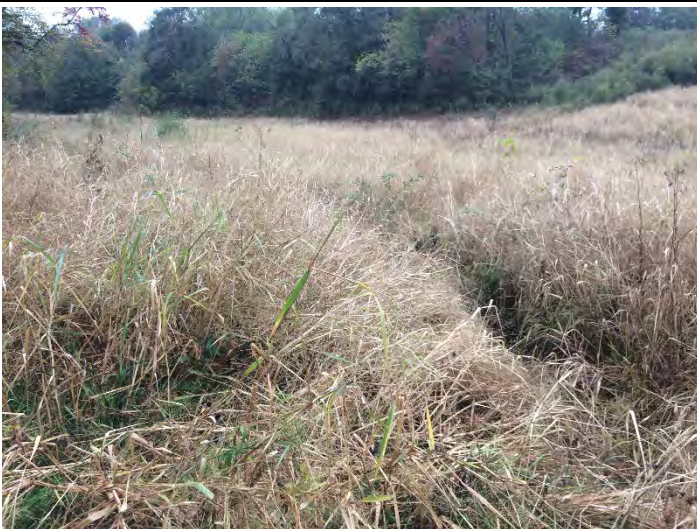
Photo Point 9 – UT1 Reach 2A, view upstream (10/22/2019)

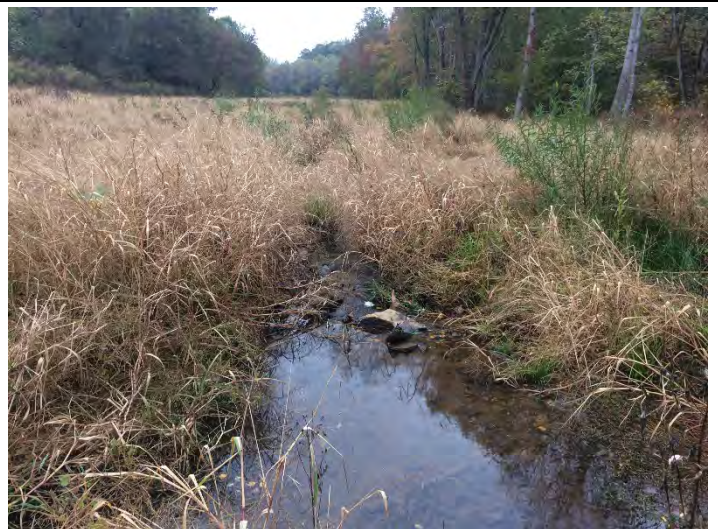
Photo Point 9 – UT1 Reach 2A, view downstream (10/22/2019)

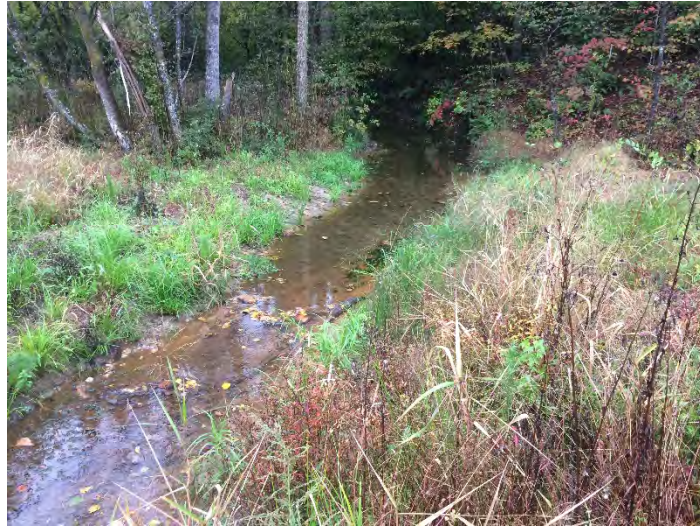
Photo Point 9 – UT1A, view upstream (10/22/2019)

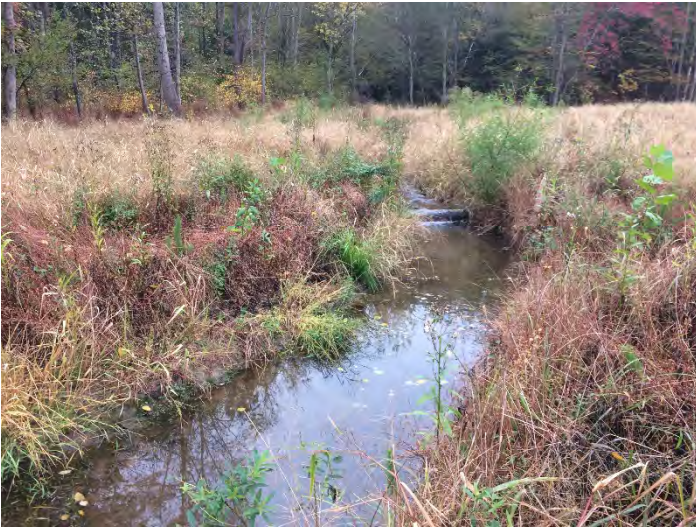
Photo Point 10 – UT1 Reach 2B, view upstream (10/22/2019)

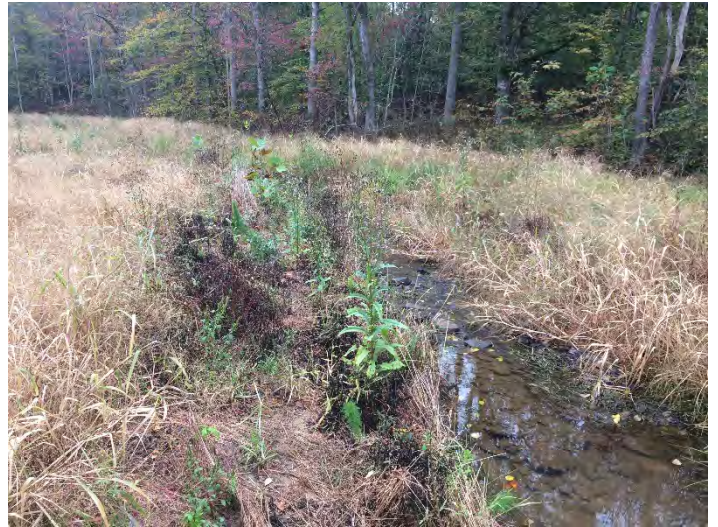
Photo Point 10 – UT1 Reach 2B, view downstream (10/22/2019)

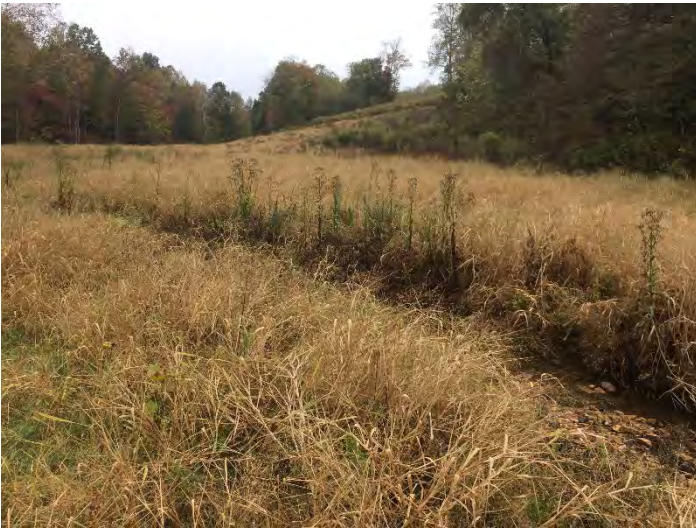
Photo Point 11 – UT1 Reach 2B, view upstream (10/22/2019)

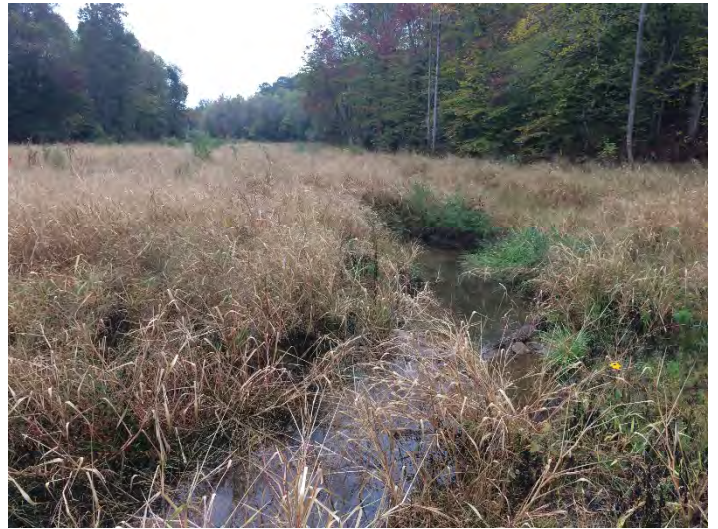
Photo Point 11 – UT1 Reach 2B, view downstream (10/22/2019)

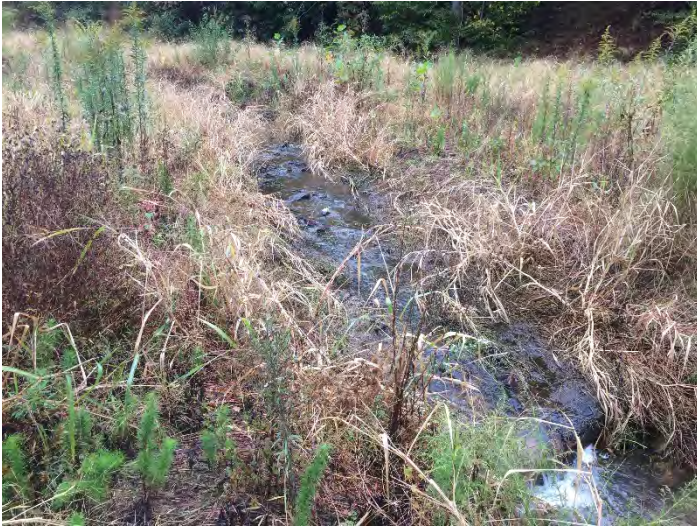
Photo Point 12 – UT1 Reach 2B, view upstream (10/22/2019)

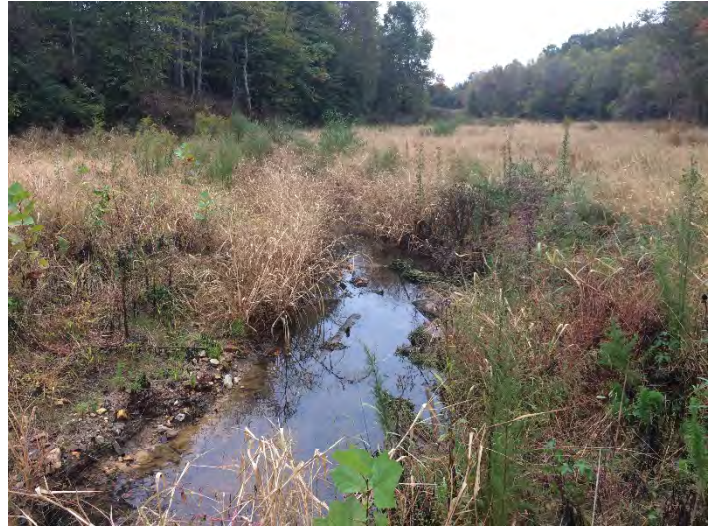
Photo Point 12 – UT1 Reach 2B, view downstream (10/22/2019)

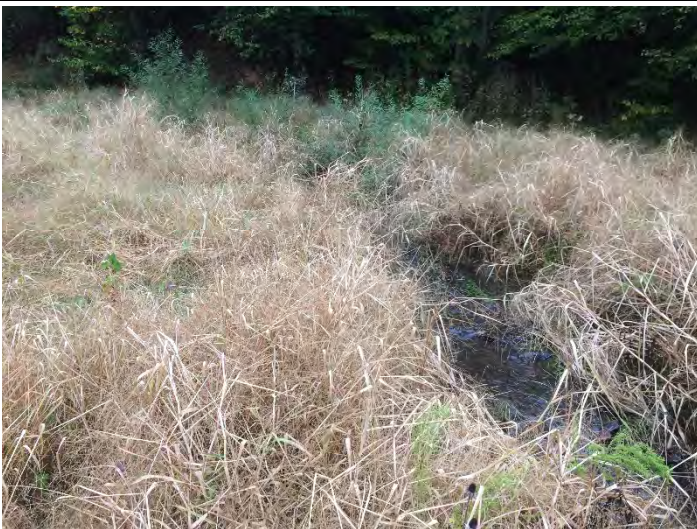
Photo Point 13 – UT1 Reach 2B, view upstream (10/22/2019)

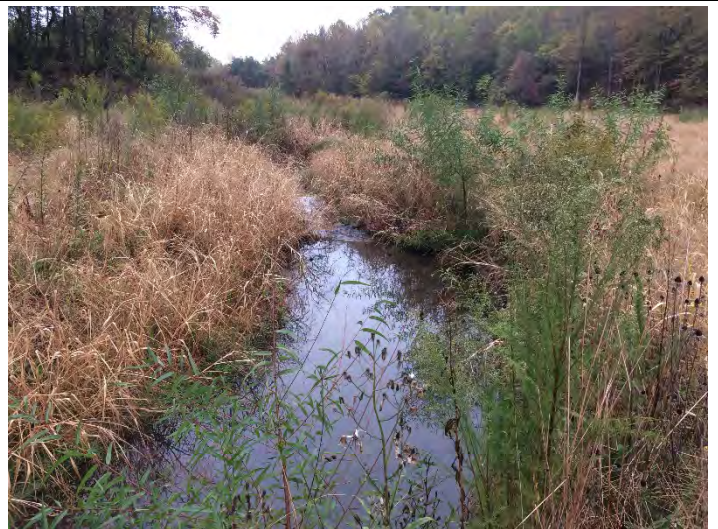
Photo Point 13 – UT1 Reach 2B, view downstream (10/22/2019)

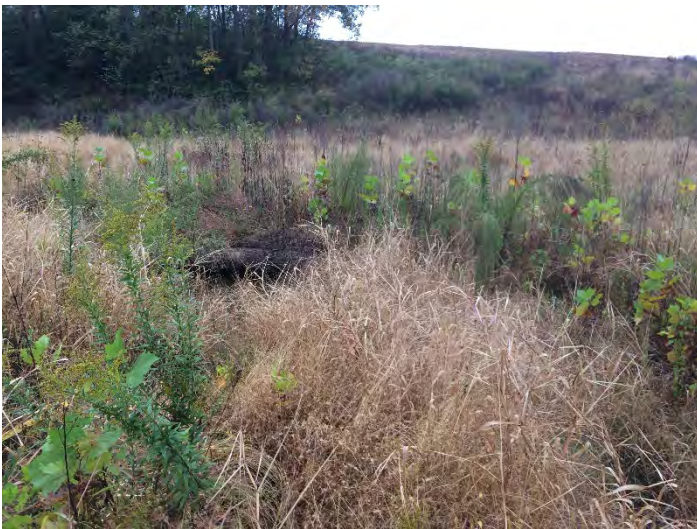
Photo Point 14 – UT1 Reach 2B, view upstream (10/22/2019)

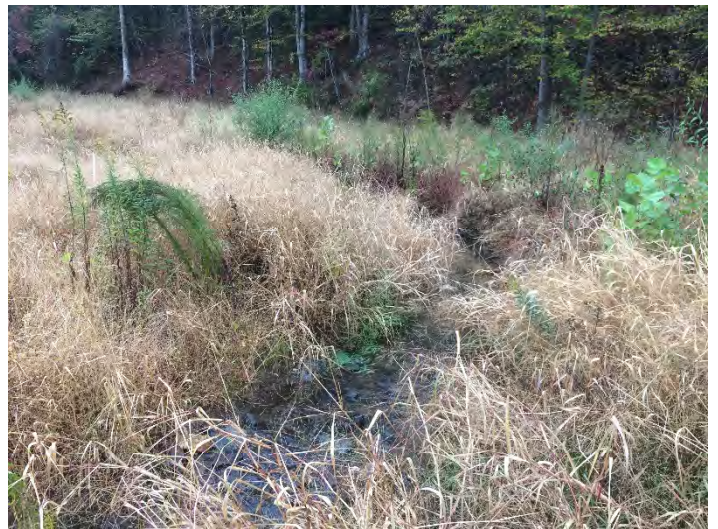
Photo Point 14 – UT1 Reach 2B, view downstream (10/22/2019)
