MONITORING YEAR 1 ANNUAL REPORT

LONE HICKORY MITIGATION SITE

Yadkin County, NC
DEQ Contract No. 6897
DMS Project No. 97135
DWR No. 20161044
USACE Action ID No. SAW-2017-00100
Yadkin River Basin
HUC 03040101

Data Collection Period: May 2019 – November 2019
Final Submission Date: January 14, 2020

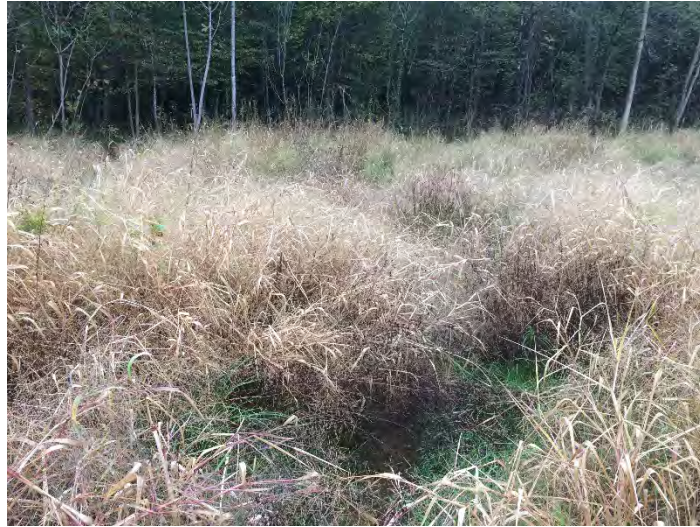
Photo Point 14 – UT1B, view upstream (10/22/2019)

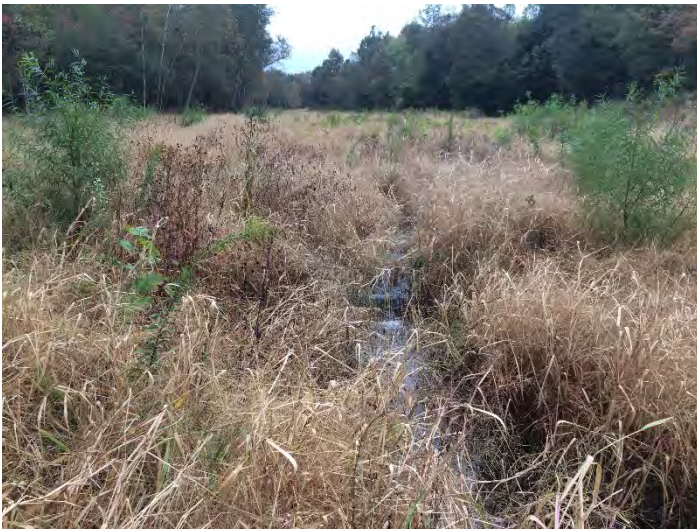
Photo Point 15 – UT1 Reach 3, view upstream (10/22/2019)

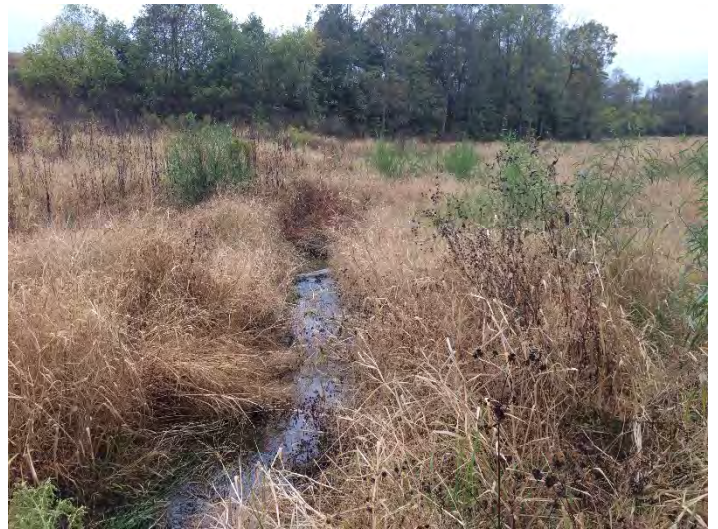
Photo Point 15 – UT1 Reach 3, view downstream (10/22/2019)

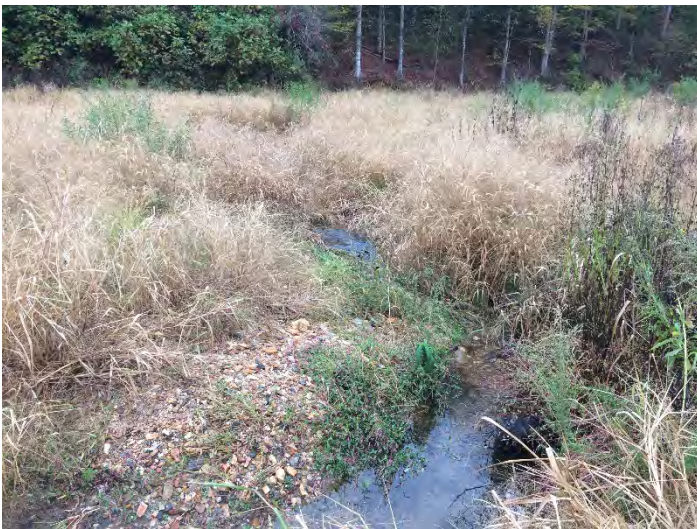
Photo Point 16 – UT1 Reach 3, view upstream (10/22/2019)

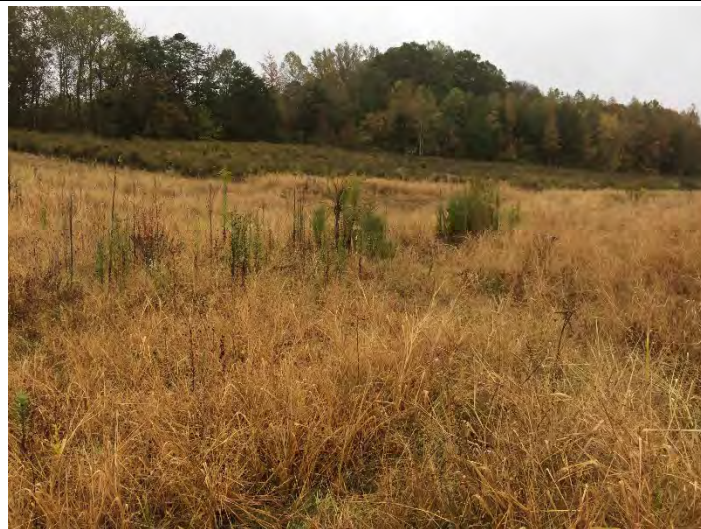
Photo Point 20 – UT1 Reach 3 BMP 3, view upstream (10/22/2019)

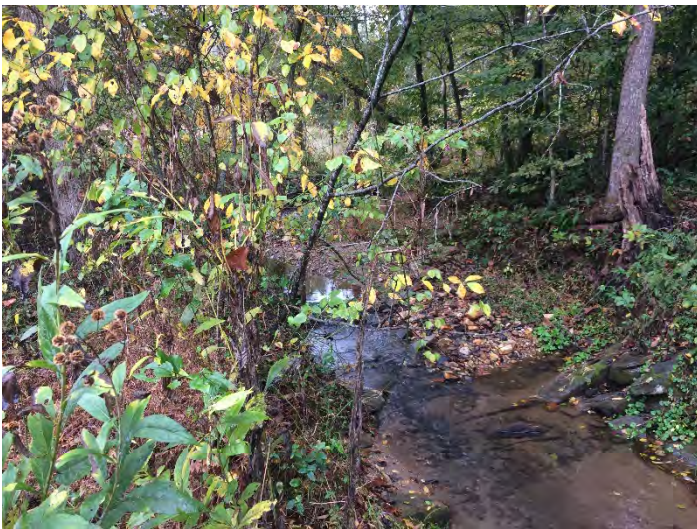
Photo Point 21 – UT1 Reach 4, view upstream (10/22/2019)

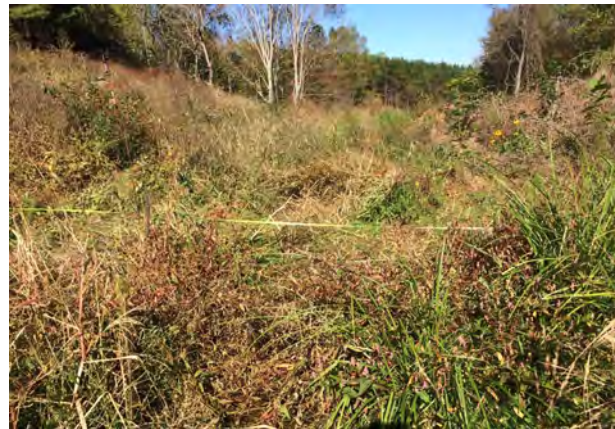
Cross-Section 1 - UT1 Reach 1

7.3	x-section area (ft.sq.)
8.5	width (ft)
0.9	mean depth (ft)
1.6	max depth (ft)
9.1	wetted perimeter (ft)
0.8	hydraulic radius (ft)
9.9	width-depth ratio

View Downstream

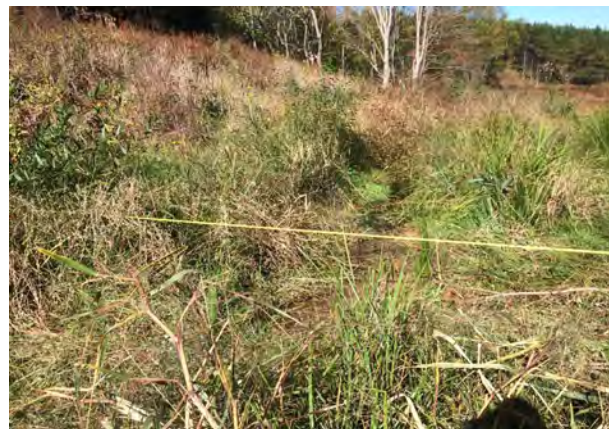
Cross-Section 2 - UT1 Reach 1

3.5	x-section area (ft.sq.)
7.0	width (ft)
0.5	mean depth (ft)
0.9	max depth (ft)
7.2	wetted perimeter (ft)
0.5	hydraulic radius (ft)
13.9	width-depth ratio
26.5	W flood prone area (ft)
3.8	entrenchment ratio
0.9	low bank height ratio

View Downstream

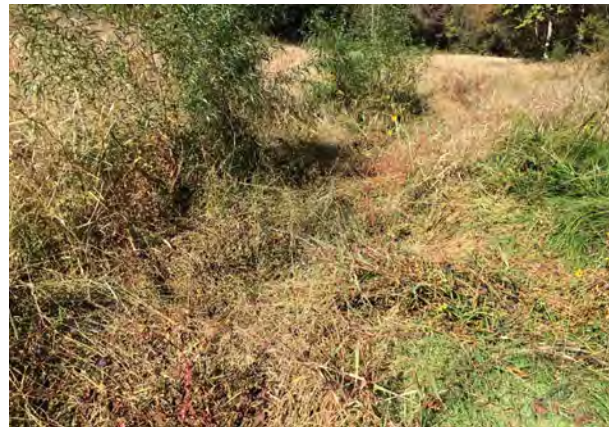
Cross-Section 3 - UT1 Reach 2A

12.1	x-section area (ft.sq.)
9.9	width (ft)
1.2	mean depth (ft)
2.5	max depth (ft)
11.4	wetted perimeter (ft)
1.1	hydraulic radius (ft)
8.0	width-depth ratio

View Downstream

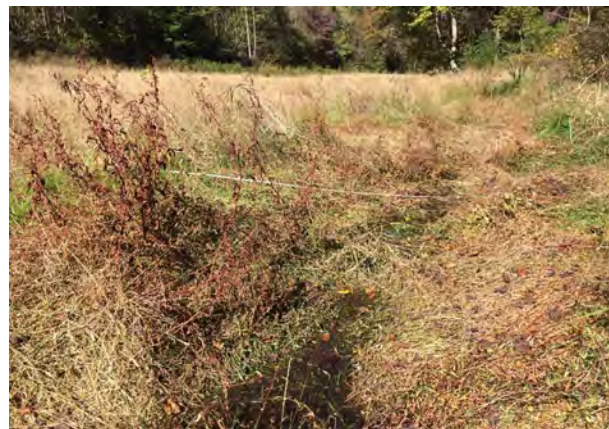
Cross-Section 4 - UT1 Reach 2A

5.1	x-section area (ft.sq.)
9.2	width (ft)
0.6	mean depth (ft)
1.1	max depth (ft)
9.5	wetted perimeter (ft)
0.5	hydraulic radius (ft)
16.4	width-depth ratio
45.6	W flood prone area (ft)
5.0	entrenchment ratio
1.1	low bank height ratio

View Downstream

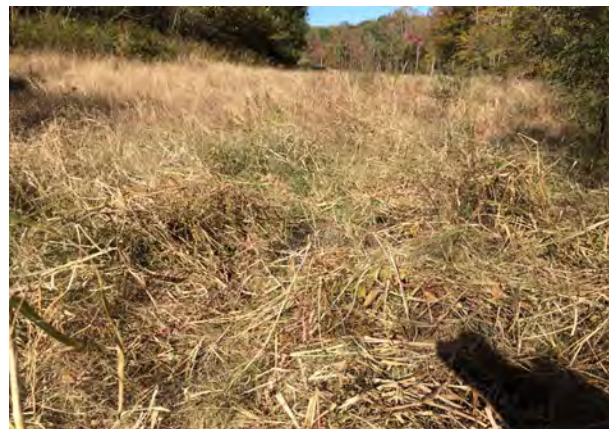
Cross-Section 5 - UT1 Reach 2A

5.3	x-section area (ft.sq.)
8.1	width (ft)
0.7	mean depth (ft)
1.2	max depth (ft)
8.6	wetted perimeter (ft)
0.6	hydraulic radius (ft)
12.4	width-depth ratio
65.4	W flood prone area (ft)
8.1	entrenchment ratio
1.1	low bank height ratio

View Downstream

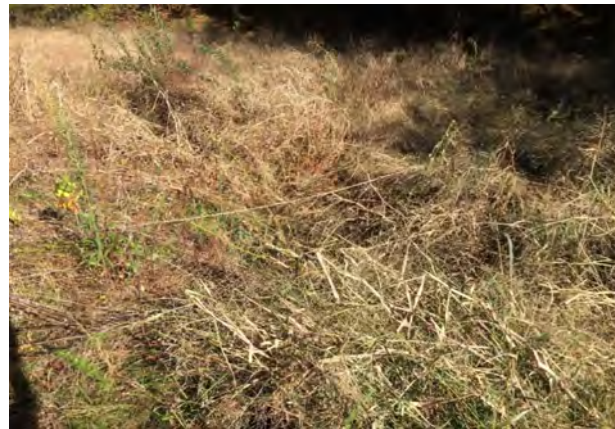
Cross-Section 6 - UT1 Reach 2A

13.6	x-section area (ft.sq.)
9.5	width (ft)
1.4	mean depth (ft)
2.5	max depth (ft)
11.1	wetted perimeter (ft)
1.2	hydraulic radius (ft)
6.6	width-depth ratio

View Downstream

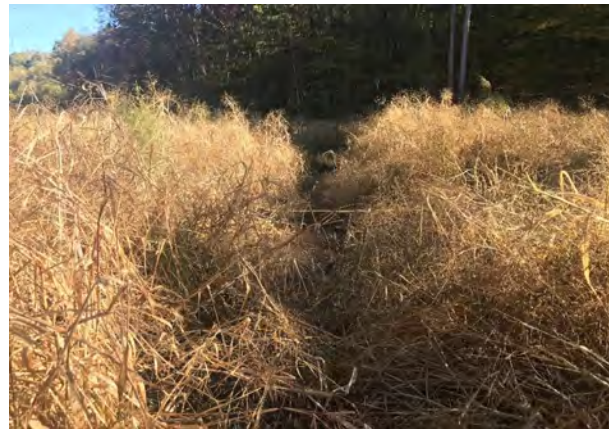
Cross-Section 7 - UT1 Reach 2B

7.5	x-section area (ft.sq.)
10.1	width (ft)
0.7	mean depth (ft)
1.3	max depth (ft)
10.6	wetted perimeter (ft)
0.7	hydraulic radius (ft)
13.7	width-depth ratio
68.0	W flood prone area (ft)
6.7	entrenchment ratio
1.0	low bank height ratio

View Downstream

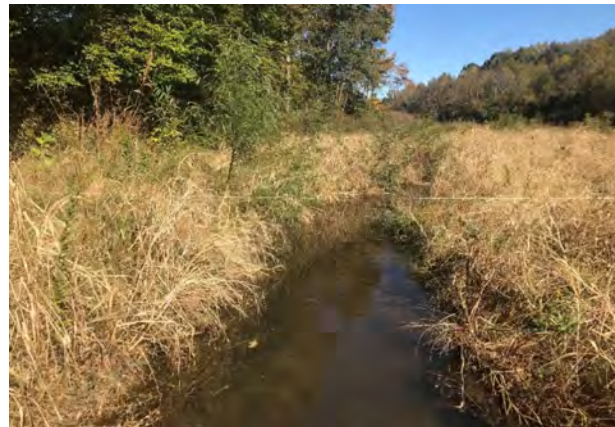
Cross-Section 8 - UT1 Reach 2B

12.8	x-section area (ft.sq.)
13.0	width (ft)
1.0	mean depth (ft)
2.1	max depth (ft)
14.6	wetted perimeter (ft)
0.9	hydraulic radius (ft)
13.2	width-depth ratio

View Downstream

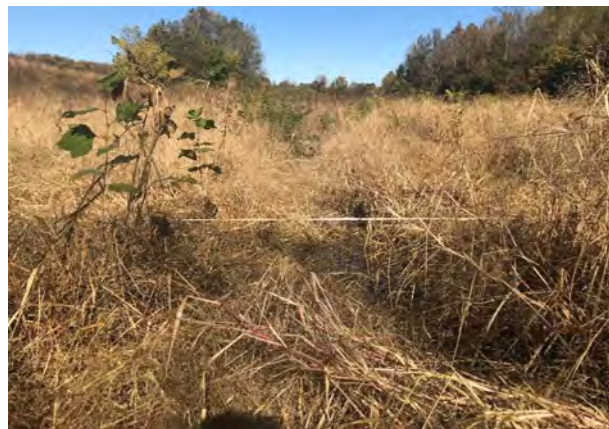
Cross-Section 9 - UT1 Reach 2B

8.9	x-section area (ft.sq.)
11.5	width (ft)
0.8	mean depth (ft)
1.4	max depth (ft)
12.1	wetted perimeter (ft)
0.7	hydraulic radius (ft)
15.0	width-depth ratio
49.1	W flood prone area (ft)
4.3	entrenchment ratio
1.0	low bank height ratio

View Downstream

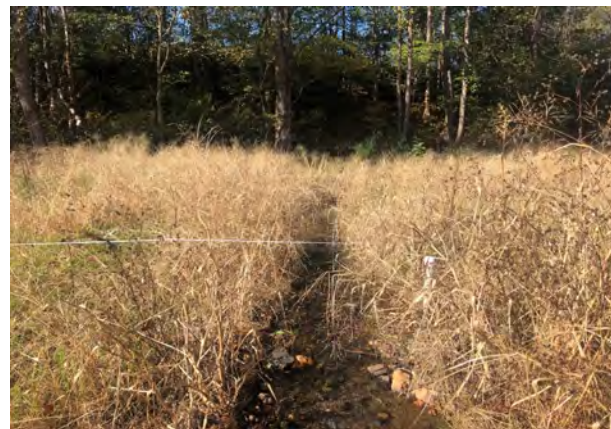
Cross-Section 10 - UT1 Reach 3

8.3	x-section area (ft.sq.)
10.8	width (ft)
0.8	mean depth (ft)
1.3	max depth (ft)
11.2	wetted perimeter (ft)
0.7	hydraulic radius (ft)
14.1	width-depth ratio
59.9	W flood prone area (ft)
5.5	entrenchment ratio
1.0	low bank height ratio

View Downstream

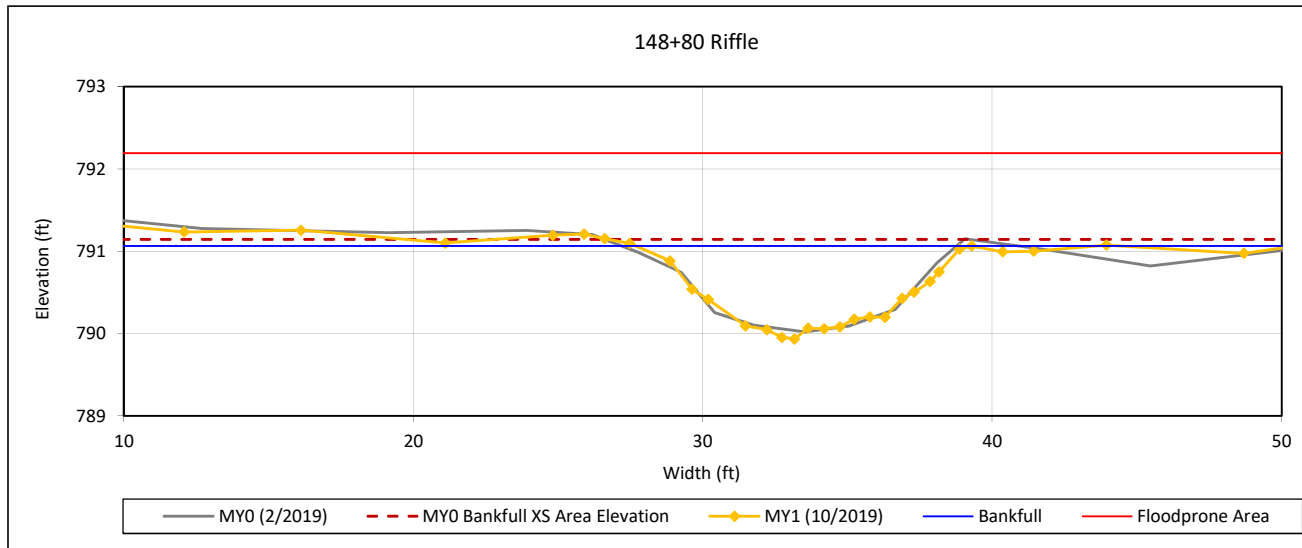
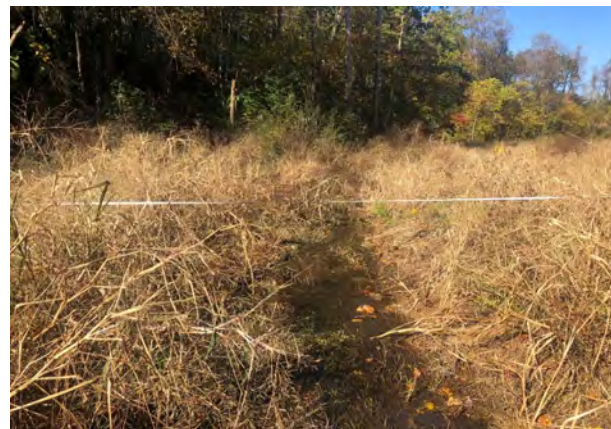
Cross-Section 11 - UT1 Reach 3

7.7	x-section area (ft.sq.)
11.6	width (ft)
0.7	mean depth (ft)
1.1	max depth (ft)
11.9	wetted perimeter (ft)
0.6	hydraulic radius (ft)
17.4	width-depth ratio
67.7	W flood prone area (ft)
5.8	entrenchment ratio
0.9	low bank height ratio

View Downstream

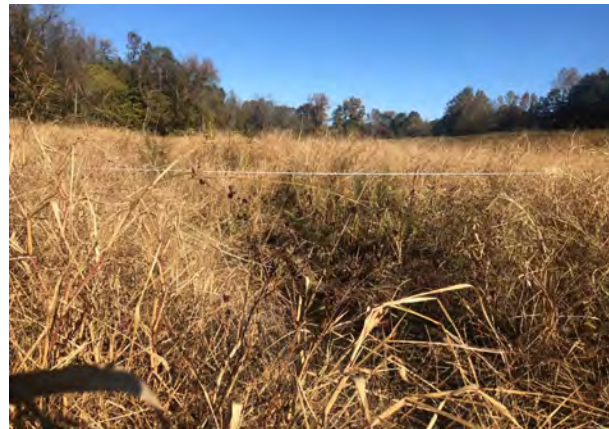
Cross-Section 12 - UT1 Reach 3

17.8	x-section area (ft.sq.)
16.2	width (ft)
1.1	mean depth (ft)
2.4	max depth (ft)
17.7	wetted perimeter (ft)
1.0	hydraulic radius (ft)
14.7	width-depth ratio

View Downstream

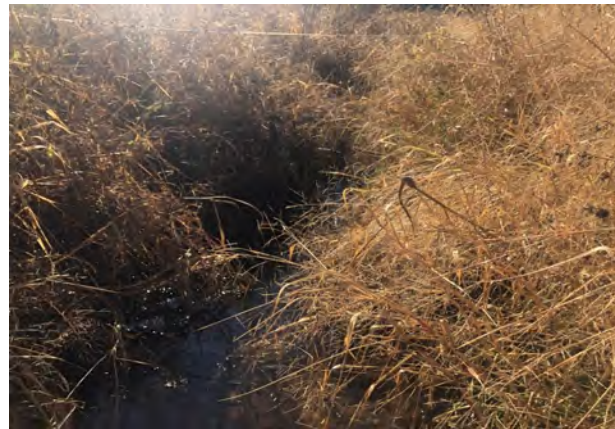
Cross-Section 13 - UT1 Reach 3

22.4	x-section area (ft.sq.)
16.3	width (ft)
1.4	mean depth (ft)
3.0	max depth (ft)
18.8	wetted perimeter (ft)
1.2	hydraulic radius (ft)
11.9	width-depth ratio

View Downstream

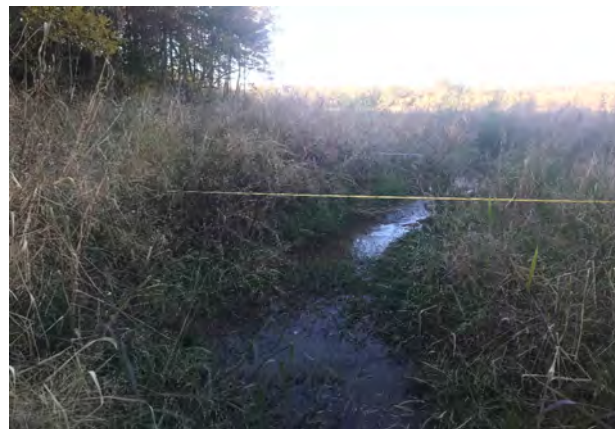
Cross-Section 14 - UT2 Reach 1

8.9	x-section area (ft.sq.)
10.4	width (ft)
0.9	mean depth (ft)
1.8	max depth (ft)
11.3	wetted perimeter (ft)
0.8	hydraulic radius (ft)
12.0	width-depth ratio

View Downstream

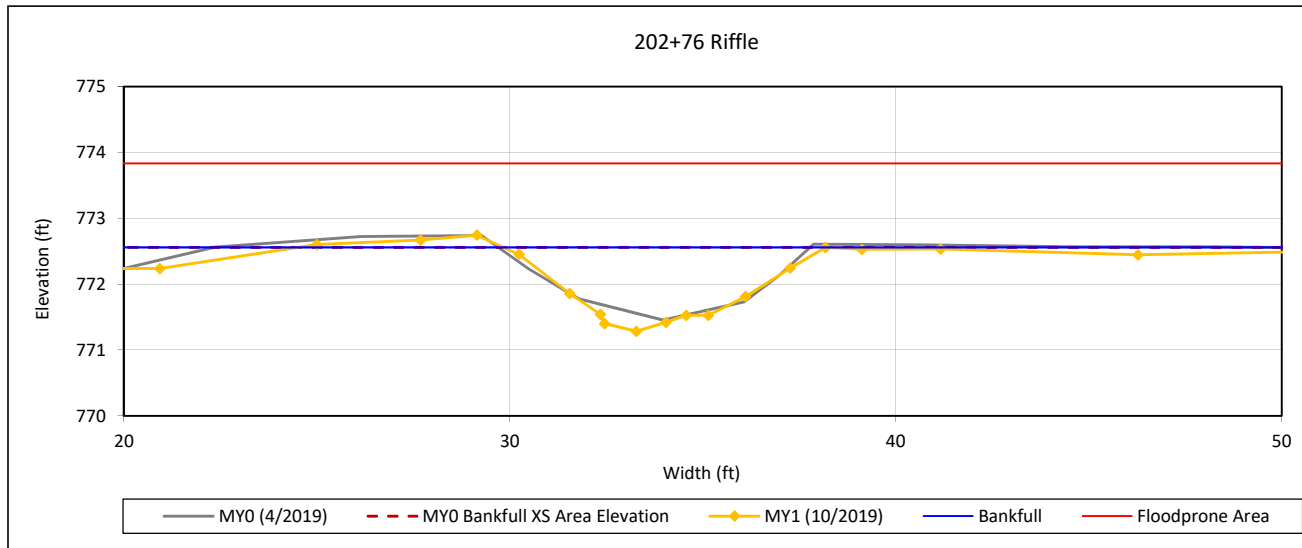
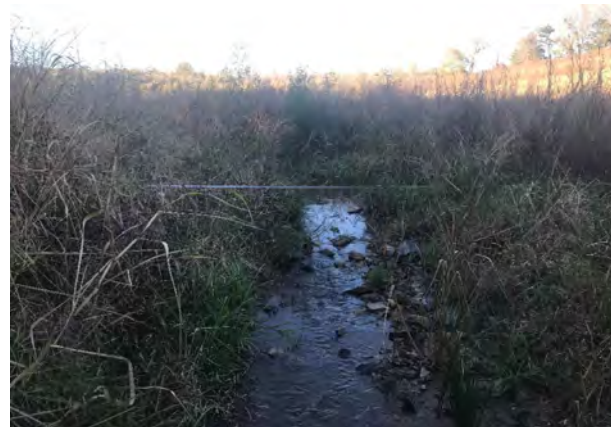
Cross-Section 15 - UT2 Reach 1

6.1	x-section area (ft.sq.)
8.3	width (ft)
0.7	mean depth (ft)
1.3	max depth (ft)
8.8	wetted perimeter (ft)
0.7	hydraulic radius (ft)
11.5	width-depth ratio
68.7	W flood prone area (ft)
8.2	entrenchment ratio
1.0	low bank height ratio

View Downstream

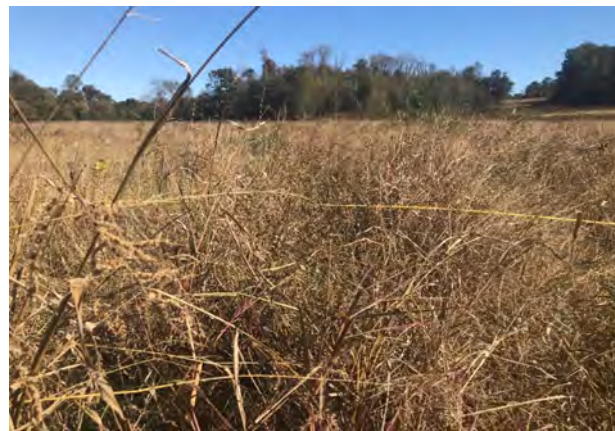
Cross-Section 16 - UT2 Reach 2

9.0	x-section area (ft.sq.)
12.2	width (ft)
0.7	mean depth (ft)
1.3	max depth (ft)
12.5	wetted perimeter (ft)
0.7	hydraulic radius (ft)
16.4	width-depth ratio
64.7	W flood prone area (ft)
5.3	entrenchment ratio
0.9	low bank height ratio

View Downstream

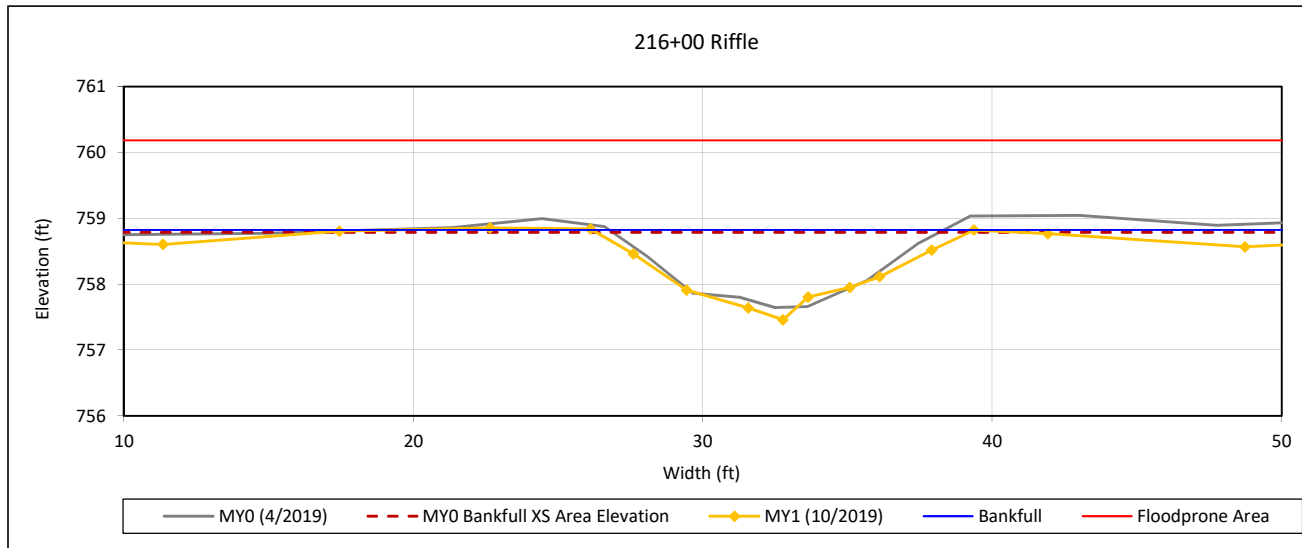
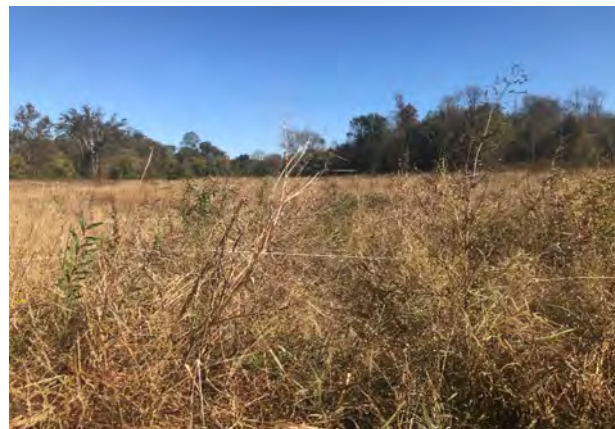
Cross-Section 17 - UT2 Reach 2

Bankfull Dimensions

9.5	x-section area (ft.sq.)
13.2	width (ft)
0.7	mean depth (ft)
1.4	max depth (ft)
13.5	wetted perimeter (ft)
0.7	hydraulic radius (ft)
18.2	width-depth ratio
72.2	W flood prone area (ft)
5.5	entrenchment ratio
1.0	low bank height ratio

View Downstream

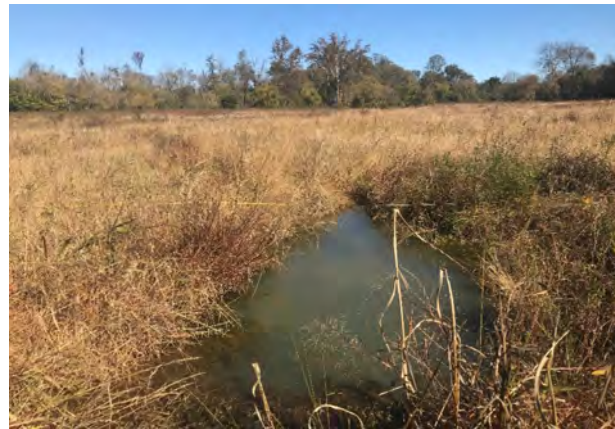
Cross-Section 18 - UT2 Reach 2

Bankfull Dimensions

24.0	x-section area (ft.sq.)
16.3	width (ft)
1.5	mean depth (ft)
2.6	max depth (ft)
17.4	wetted perimeter (ft)
1.4	hydraulic radius (ft)
11.1	width-depth ratio

View Downstream

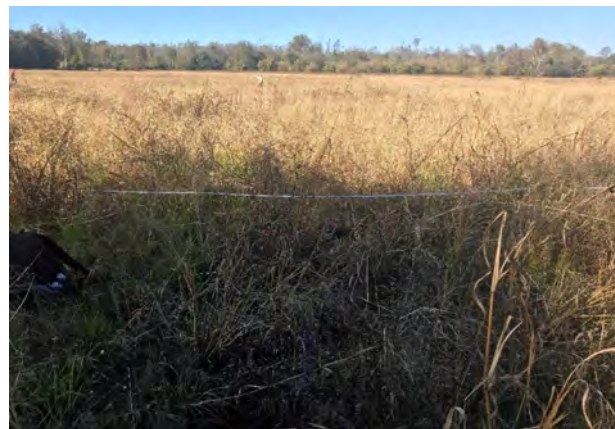
Cross-Section 19 - UT2A

Bankfull Dimensions

2.0	x-section area (ft.sq.)
5.5	width (ft)
0.4	mean depth (ft)
0.6	max depth (ft)
5.6	wetted perimeter (ft)
0.4	hydraulic radius (ft)
15.0	width-depth ratio
56.9	W flood prone area (ft)
10.4	entrenchment ratio
1.0	low bank height ratio

View Downstream

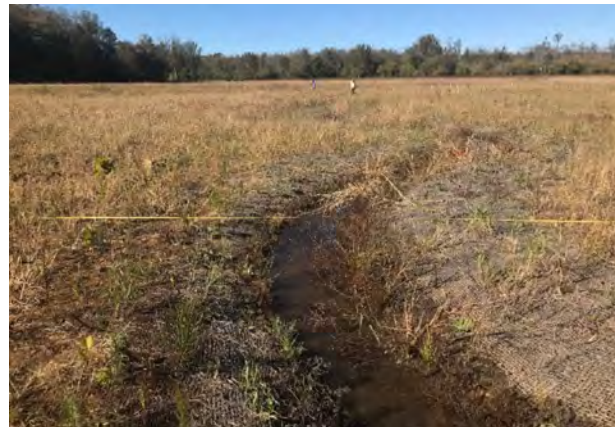
Cross-Section 20 - UT2A

Bankfull Dimensions

3.7	x-section area (ft.sq.)
6.6	width (ft)
0.6	mean depth (ft)
1.2	max depth (ft)
7.0	wetted perimeter (ft)
0.5	hydraulic radius (ft)
11.7	width-depth ratio

View Downstream

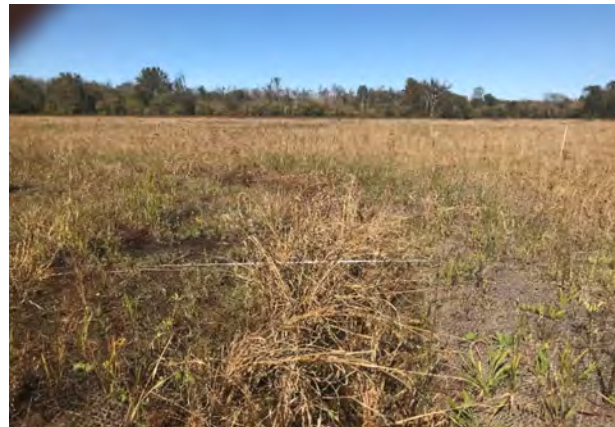
Cross-Section 21 - UT2A

Bankfull Dimensions

2.0	x-section area (ft.sq.)
5.8	width (ft)
0.3	mean depth (ft)
0.6	max depth (ft)
6.0	wetted perimeter (ft)
0.3	hydraulic radius (ft)
17.2	width-depth ratio
51.4	W flood prone area (ft)
8.8	entrenchment ratio
0.8	low bank height ratio

View Downstream

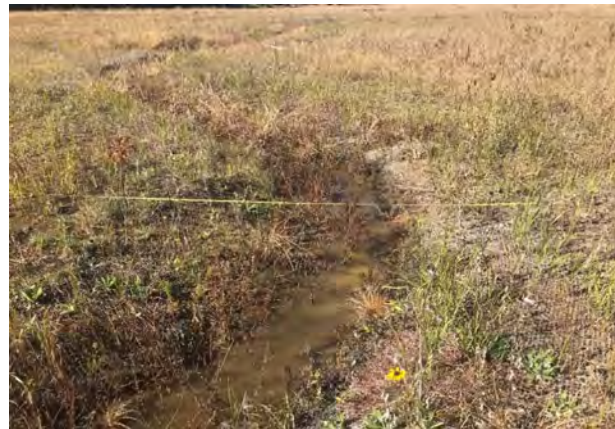
Cross-Section 22 - UT2A

Bankfull Dimensions

4.8	x-section area (ft.sq.)
9.3	width (ft)
0.5	mean depth (ft)
1.1	max depth (ft)
9.6	wetted perimeter (ft)
0.5	hydraulic radius (ft)
18.1	width-depth ratio

View Downstream

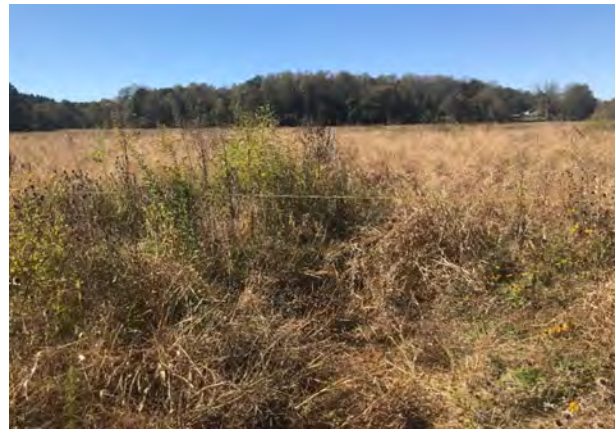
Cross-Section 23 - UT2B

Bankfull Dimensions

8.4	x-section area (ft.sq.)
10.1	width (ft)
0.8	mean depth (ft)
1.6	max depth (ft)
10.7	wetted perimeter (ft)
0.8	hydraulic radius (ft)
12.1	width-depth ratio

View Downstream

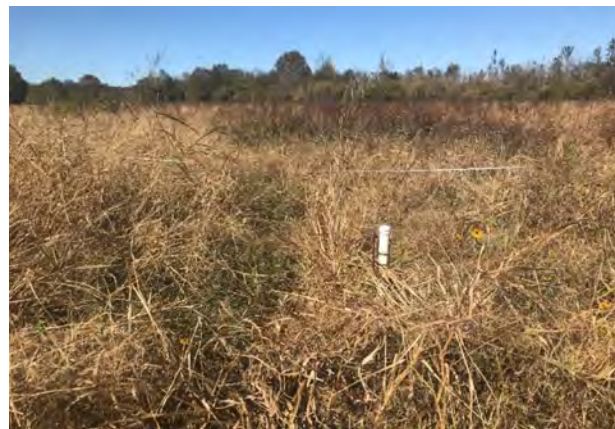
Cross-Section 24 - UT2B

Bankfull Dimensions

3.6	x-section area (ft.sq.)
7.9	width (ft)
0.5	mean depth (ft)
0.7	max depth (ft)
8.1	wetted perimeter (ft)
0.4	hydraulic radius (ft)
17.4	width-depth ratio
65.9	W flood prone area (ft)
8.3	entrenchment ratio
0.9	low bank height ratio

View Downstream

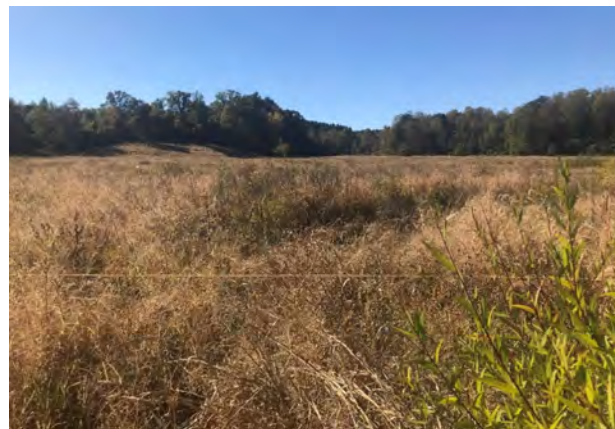
Cross-Section 25 - UT2B

Bankfull Dimensions

3.7	x-section area (ft.sq.)
6.9	width (ft)
0.5	mean depth (ft)
0.8	max depth (ft)
7.1	wetted perimeter (ft)
0.5	hydraulic radius (ft)
12.9	width-depth ratio
56.4	W flood prone area (ft)
8.2	entrenchment ratio
1.0	low bank height ratio

View Downstream

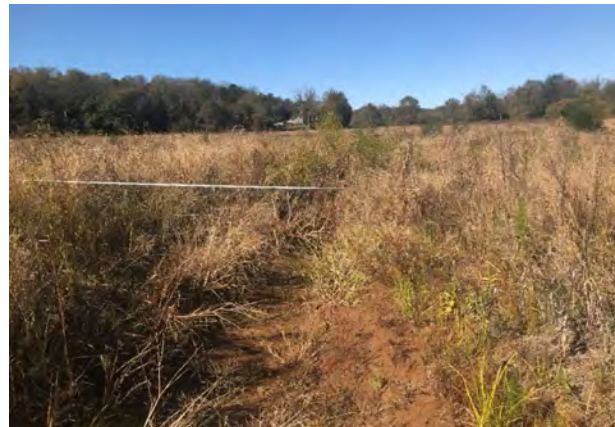
Cross-Section 26 - UT2B

Bankfull Dimensions

14.0	x-section area (ft.sq.)
12.0	width (ft)
1.2	mean depth (ft)
2.2	max depth (ft)
12.9	wetted perimeter (ft)
1.1	hydraulic radius (ft)
10.3	width-depth ratio

View Downstream

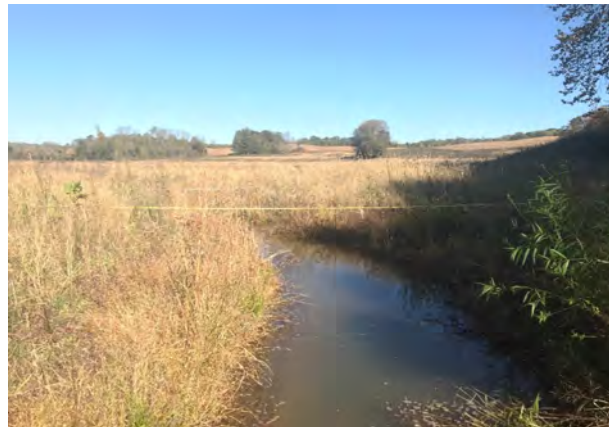
Cross-Section 27 - UT3 Reach 1

Bankfull Dimensions

23.0	x-section area (ft.sq.)
16.7	width (ft)
1.4	mean depth (ft)
2.7	max depth (ft)
17.8	wetted perimeter (ft)
1.3	hydraulic radius (ft)
12.1	width-depth ratio

View Downstream

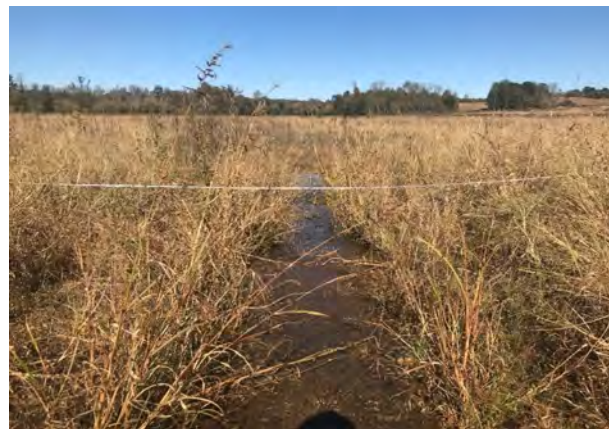
Cross-Section 28 - UT3 Reach 1

Bankfull Dimensions

12.3	x-section area (ft.sq.)
13.3	width (ft)
0.9	mean depth (ft)
1.5	max depth (ft)
13.8	wetted perimeter (ft)
0.9	hydraulic radius (ft)
14.3	width-depth ratio
72.9	W flood prone area (ft)
5.5	entrenchment ratio
1.0	low bank height ratio

View Downstream

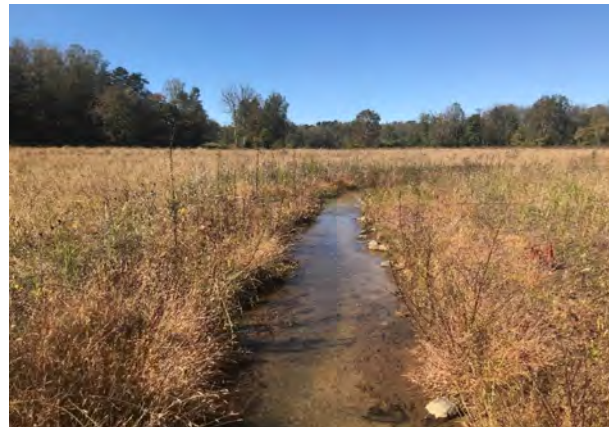
Cross-Section 29 - UT3 Reach 2

Bankfull Dimensions

16.7	x-section area (ft.sq.)
17.0	width (ft)
1.0	mean depth (ft)
1.8	max depth (ft)
17.5	wetted perimeter (ft)
1.0	hydraulic radius (ft)
17.2	width-depth ratio
75.6	W flood prone area (ft)
4.5	entrenchment ratio
1.0	low bank height ratio

View Downstream

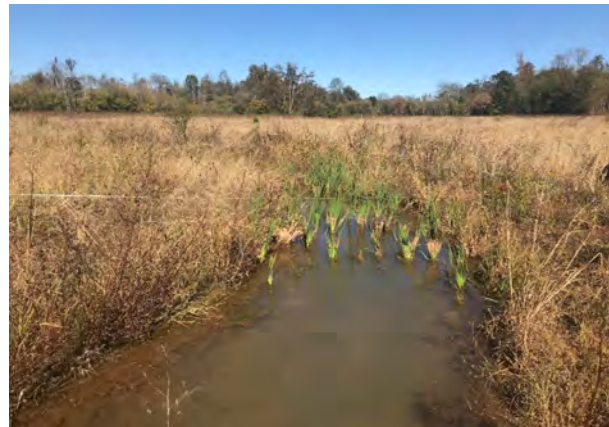
Cross-Section 30 - UT3 Reach 2

Bankfull Dimensions

26.6	x-section area (ft.sq.)
19.0	width (ft)
1.4	mean depth (ft)
2.9	max depth (ft)
20.0	wetted perimeter (ft)
1.3	hydraulic radius (ft)
13.6	width-depth ratio

View Downstream

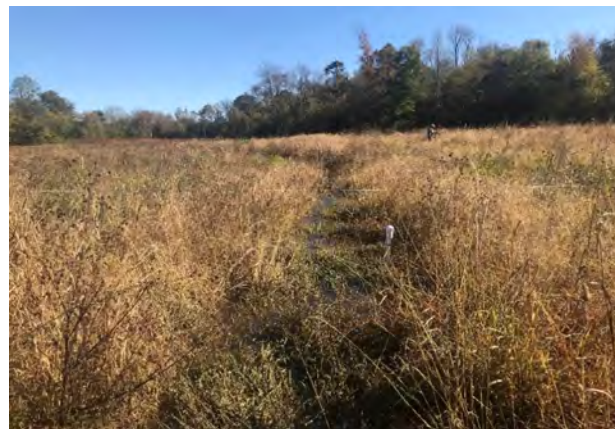
Cross-Section 31 - UT3 Reach 3

Bankfull Dimensions

17.8	x-section area (ft.sq.)
19.1	width (ft)
0.9	mean depth (ft)
1.9	max depth (ft)
19.7	wetted perimeter (ft)
0.9	hydraulic radius (ft)
20.5	width-depth ratio
70.8	W flood prone area (ft)
3.7	entrenchment ratio
1.0	low bank height ratio

View Downstream

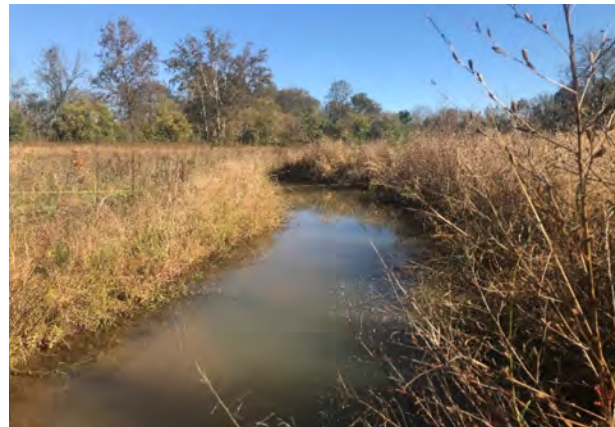
Cross-Section 32 - UT3 Reach 3

Bankfull Dimensions

46.1	x-section area (ft.sq.)
26.9	width (ft)
1.7	mean depth (ft)
3.7	max depth (ft)
28.5	wetted perimeter (ft)
1.6	hydraulic radius (ft)
15.8	width-depth ratio

View Downstream

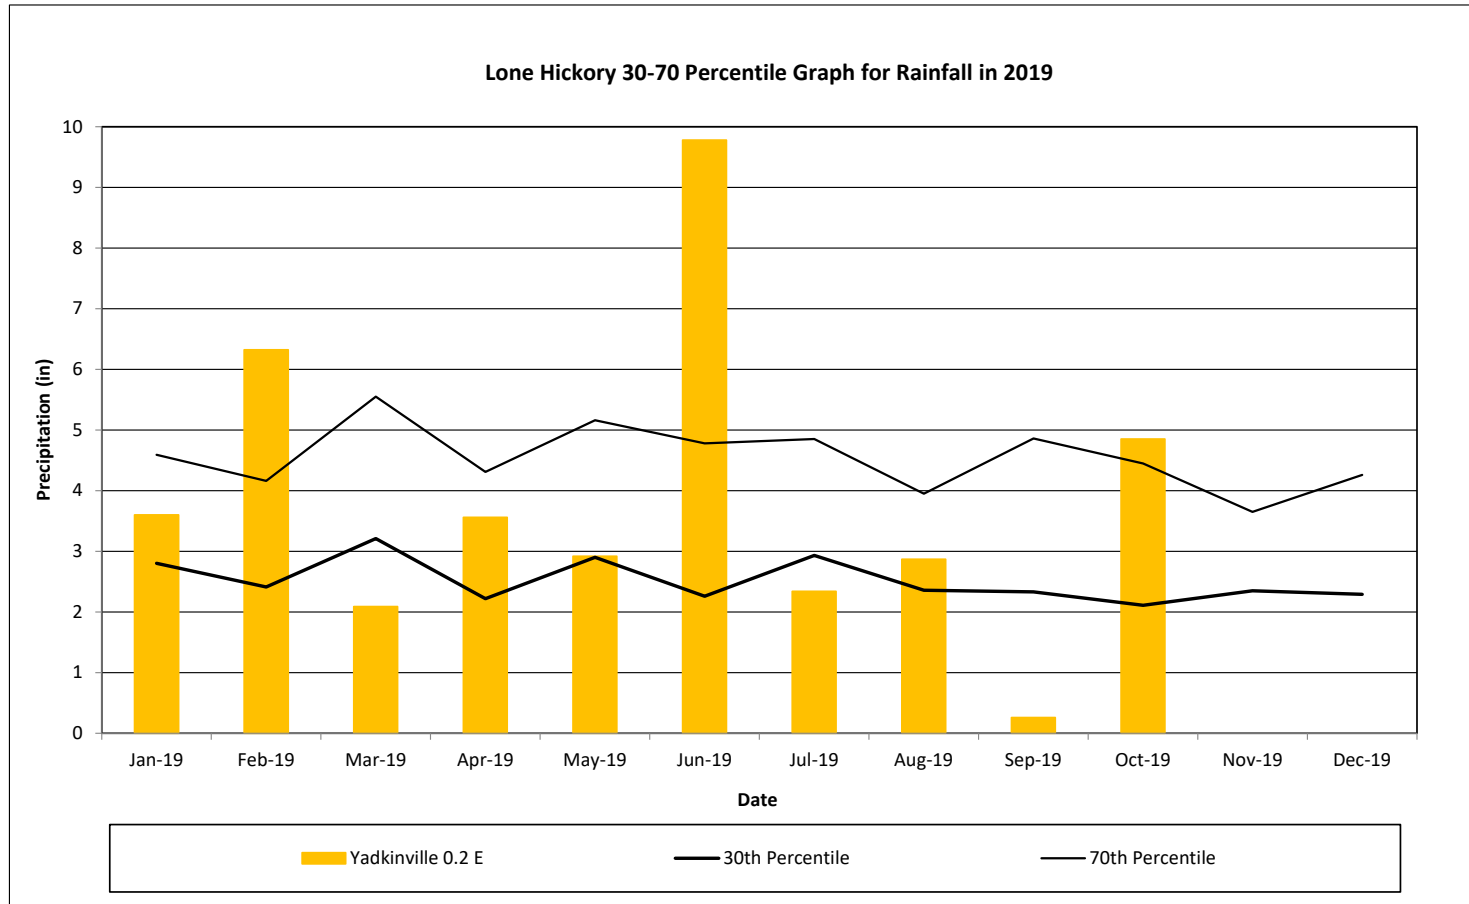
Monthly Rainfall Data

2019 rainfall collected by NC CRONOS Station, Yadkinville 0.2 E, NC

30th and 70th percentile rainfall data collected from WETS station Yadkinville 6E
