**LYLE CREEK MITIGATION SITE**  
*Catawba County, NC*  
*DENR Contract 003241*  
*NCEEP Project Number 94643*

**Monitoring Year 1 Annual Report**  
**FINAL**

# LYLE CREEK MITIGATION SITE Monitoring Year 1 Annual Report

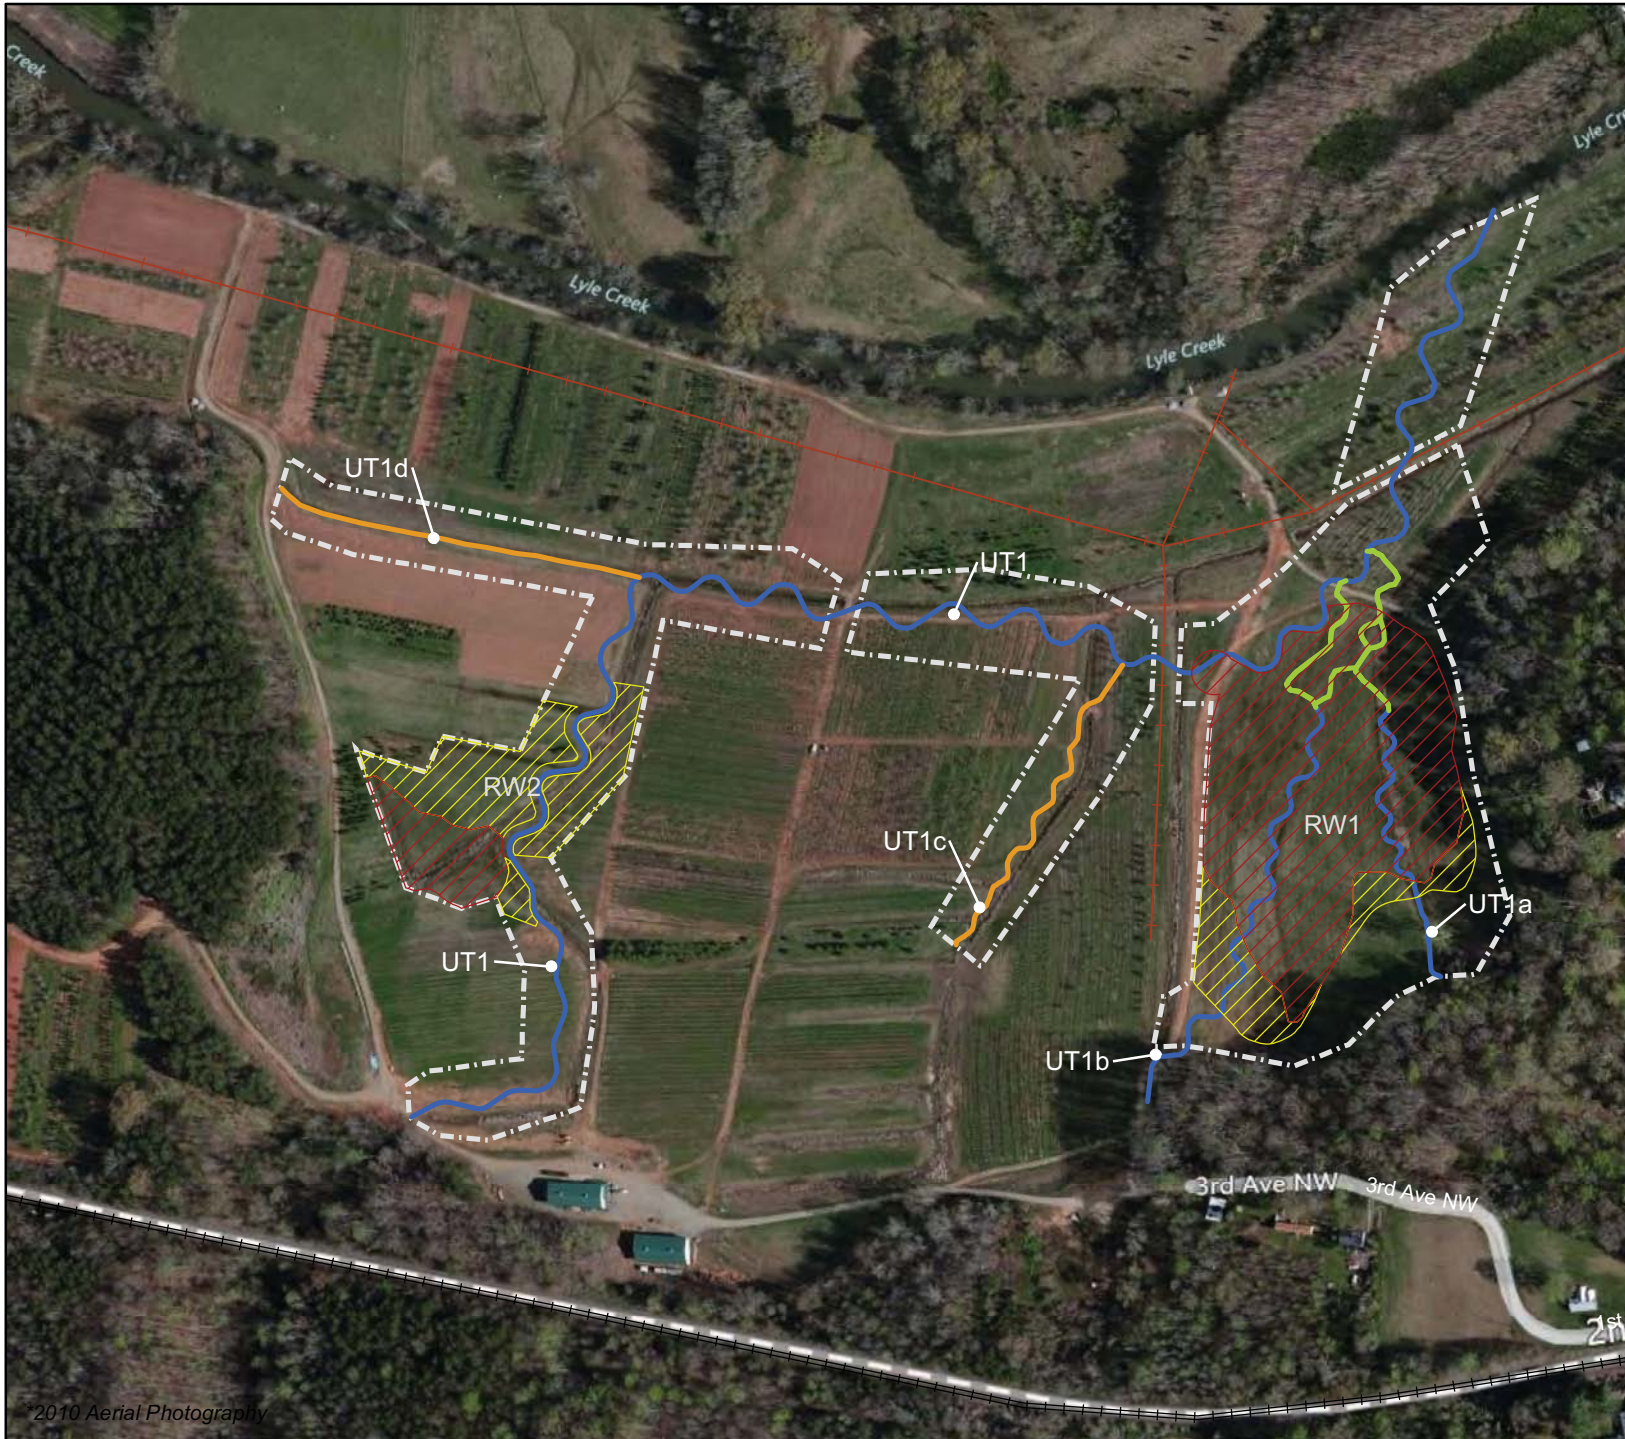
Figure 2 Project Component/  
Asset Map  
Lyle Creek Mitigation Site  
NCEEP Project Number 94643  
Monitoring Year 1 of 5  
Catawba County, NC

-   Stream Restoration
-   Stream Enhancement
-   Braided Reach (no credit)
-   Wetland Restoration
-   Wetland Creation
-   Conservation Easement
-   Railroad
-   Power Lines

The primary objectives of the project were to provide ecological and water quality enhancements to the Catawba River Basin while creating a functional riparian corridor at the site level, providing wetland habitat and ecological function, and restoring a Piedmont Bottomland Forest as described by Schafale and Weakley (1990). These objectives were achieved by restoring 5,411 linear feet (LF) of perennial and intermittent stream channel and 6.6 acres (ac) of wetland area, enhancing 1,384 LF of intermittent stream channel and creating 2.9 ac of wetland area. Approximately 179 LF of stream was excluded from the total project credit calculations from crossings (farm roads and power line easements). The Site's riparian areas were also planted to stabilize streambanks and wetland areas, improve habitat, and protect water quality. The ecological uplift can be summarized as starting from tree farming-impacted streams and wetlands and moving to stable channels and wetlands in a protected riparian corridor. Restoration of dimension, pattern, and profile was implemented for UT<sub>1</sub>, UT<sub>1a</sub>, and UT<sub>1b</sub>; enhancement of profile and dimension was implemented for UT<sub>1c</sub> and UT<sub>1d</sub>. Wetland restoration and creation included RW<sub>1</sub> and RW<sub>2</sub>. UT<sub>1a</sub> and UT<sub>1b</sub> discharge into an anastomosed wetland complex upstream of their confluence with UT<sub>1</sub> as depicted in Figure 2. This anastomosed wetland complex was not proposed for stream mitigation credit. Figure 2 and Table 1 present the implemented design for the Site.

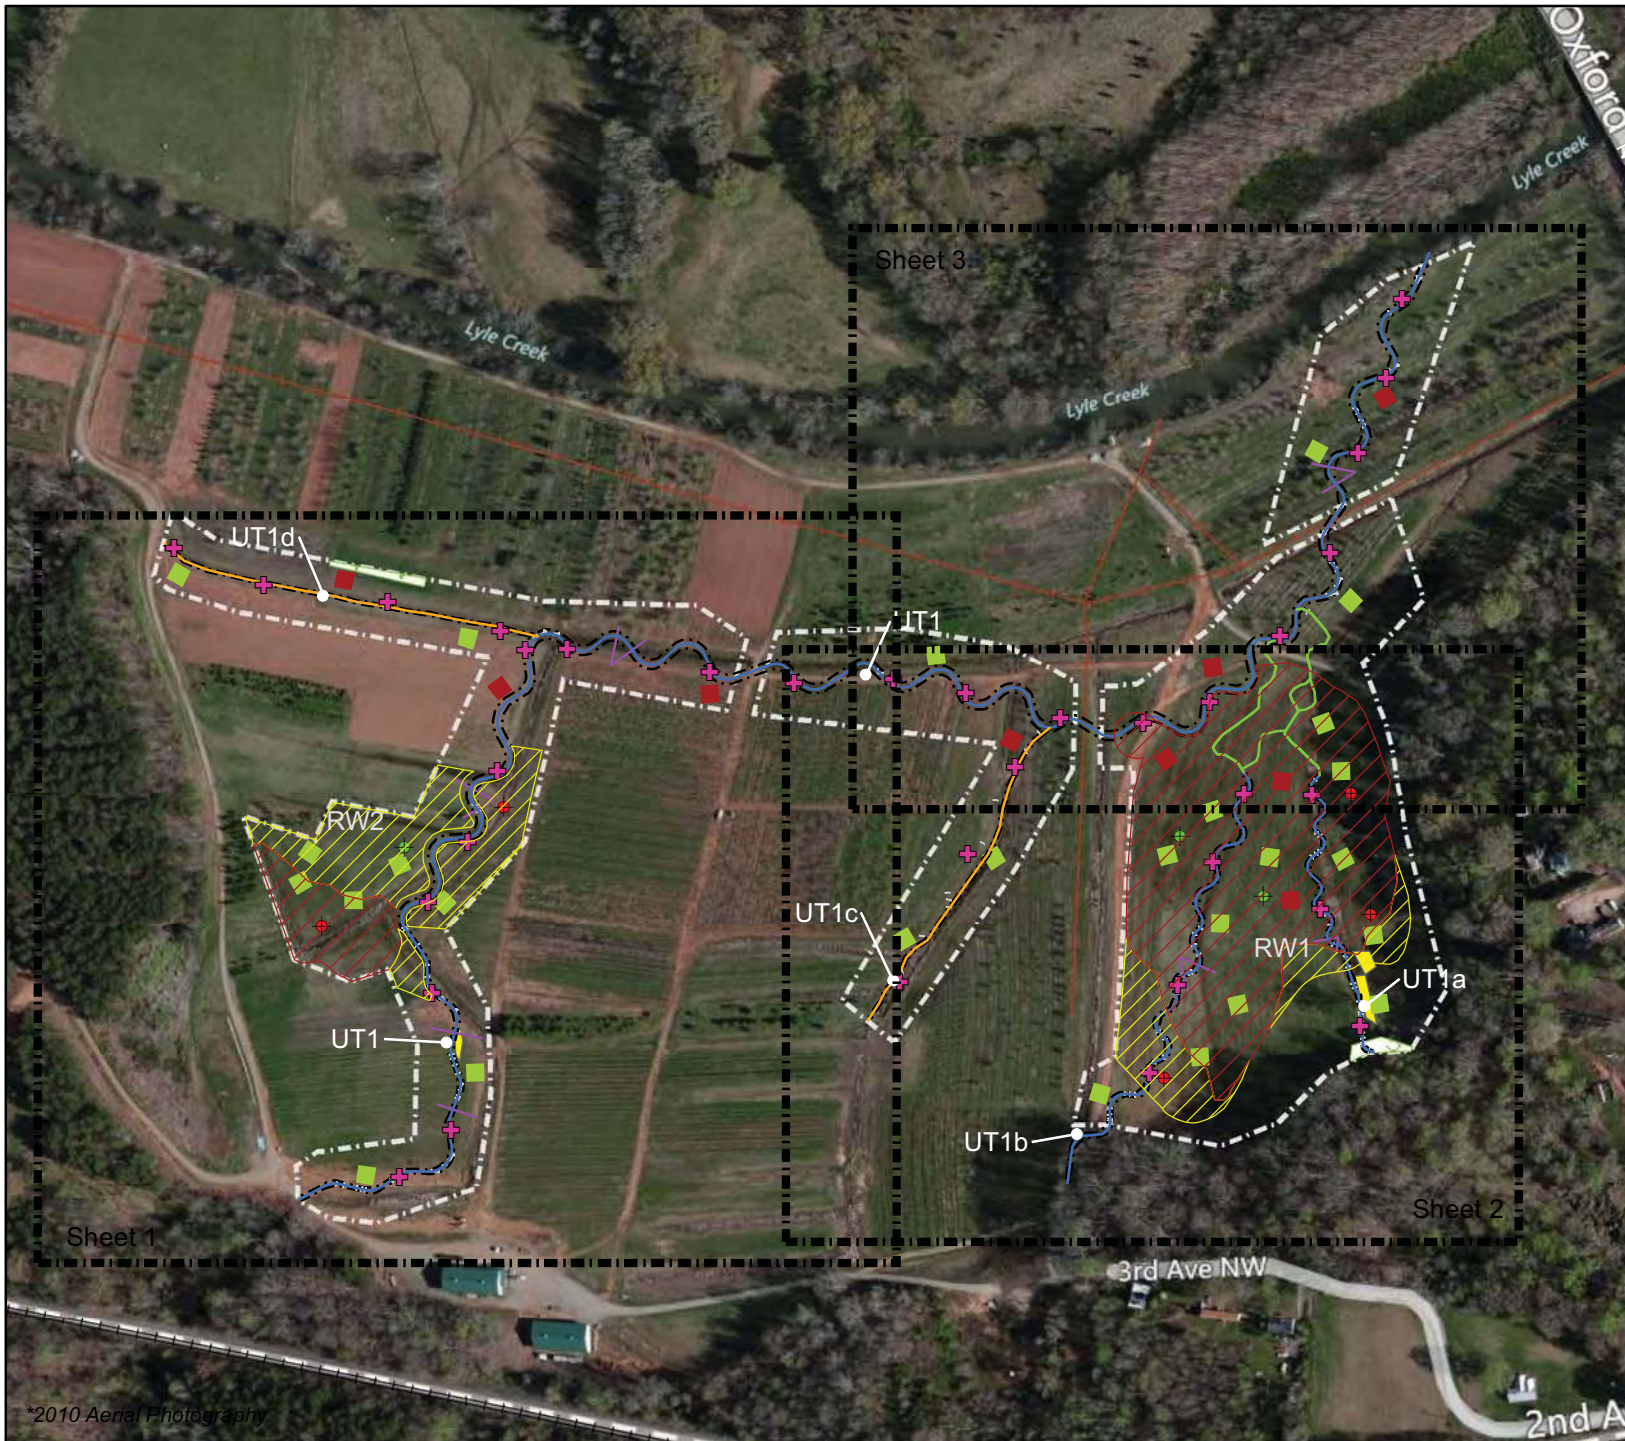
Figure 3 Integrated Current Condition Plan View (Key)  
 Lyle Creek Mitigation Site  
 NCEEP Project Number 94643  
 Monitoring Year 1 of 5  
 Catawba County, NC

- Conservation Easement
- Power Lines
- Railroad
- Wetland Restoration
- Wetland Creation
- Braided Reach (no credit)
- Stream Enhancement
- Stream Restoration
- Designed Bankfull
- Cross-Sections (XS)
- Structures
- Photo Points (PP)
- Groundwater Gage (GG)
  - Criteria Met
  - Criteria Not Met
- Vegetation Plot Condition - MY1
  - Criteria Met
  - Criteria Not Met
  - Bare Areas
  - Invasive Areas

Morphological surveys for the MY-1 were conducted in October 2012. All streams within the Site met the success criteria for MY-1. Please refer to Appendix 2 for the visual assessment table, current condition plan view (CCPV), and photographs and Appendix 4 for morphological data and plots.

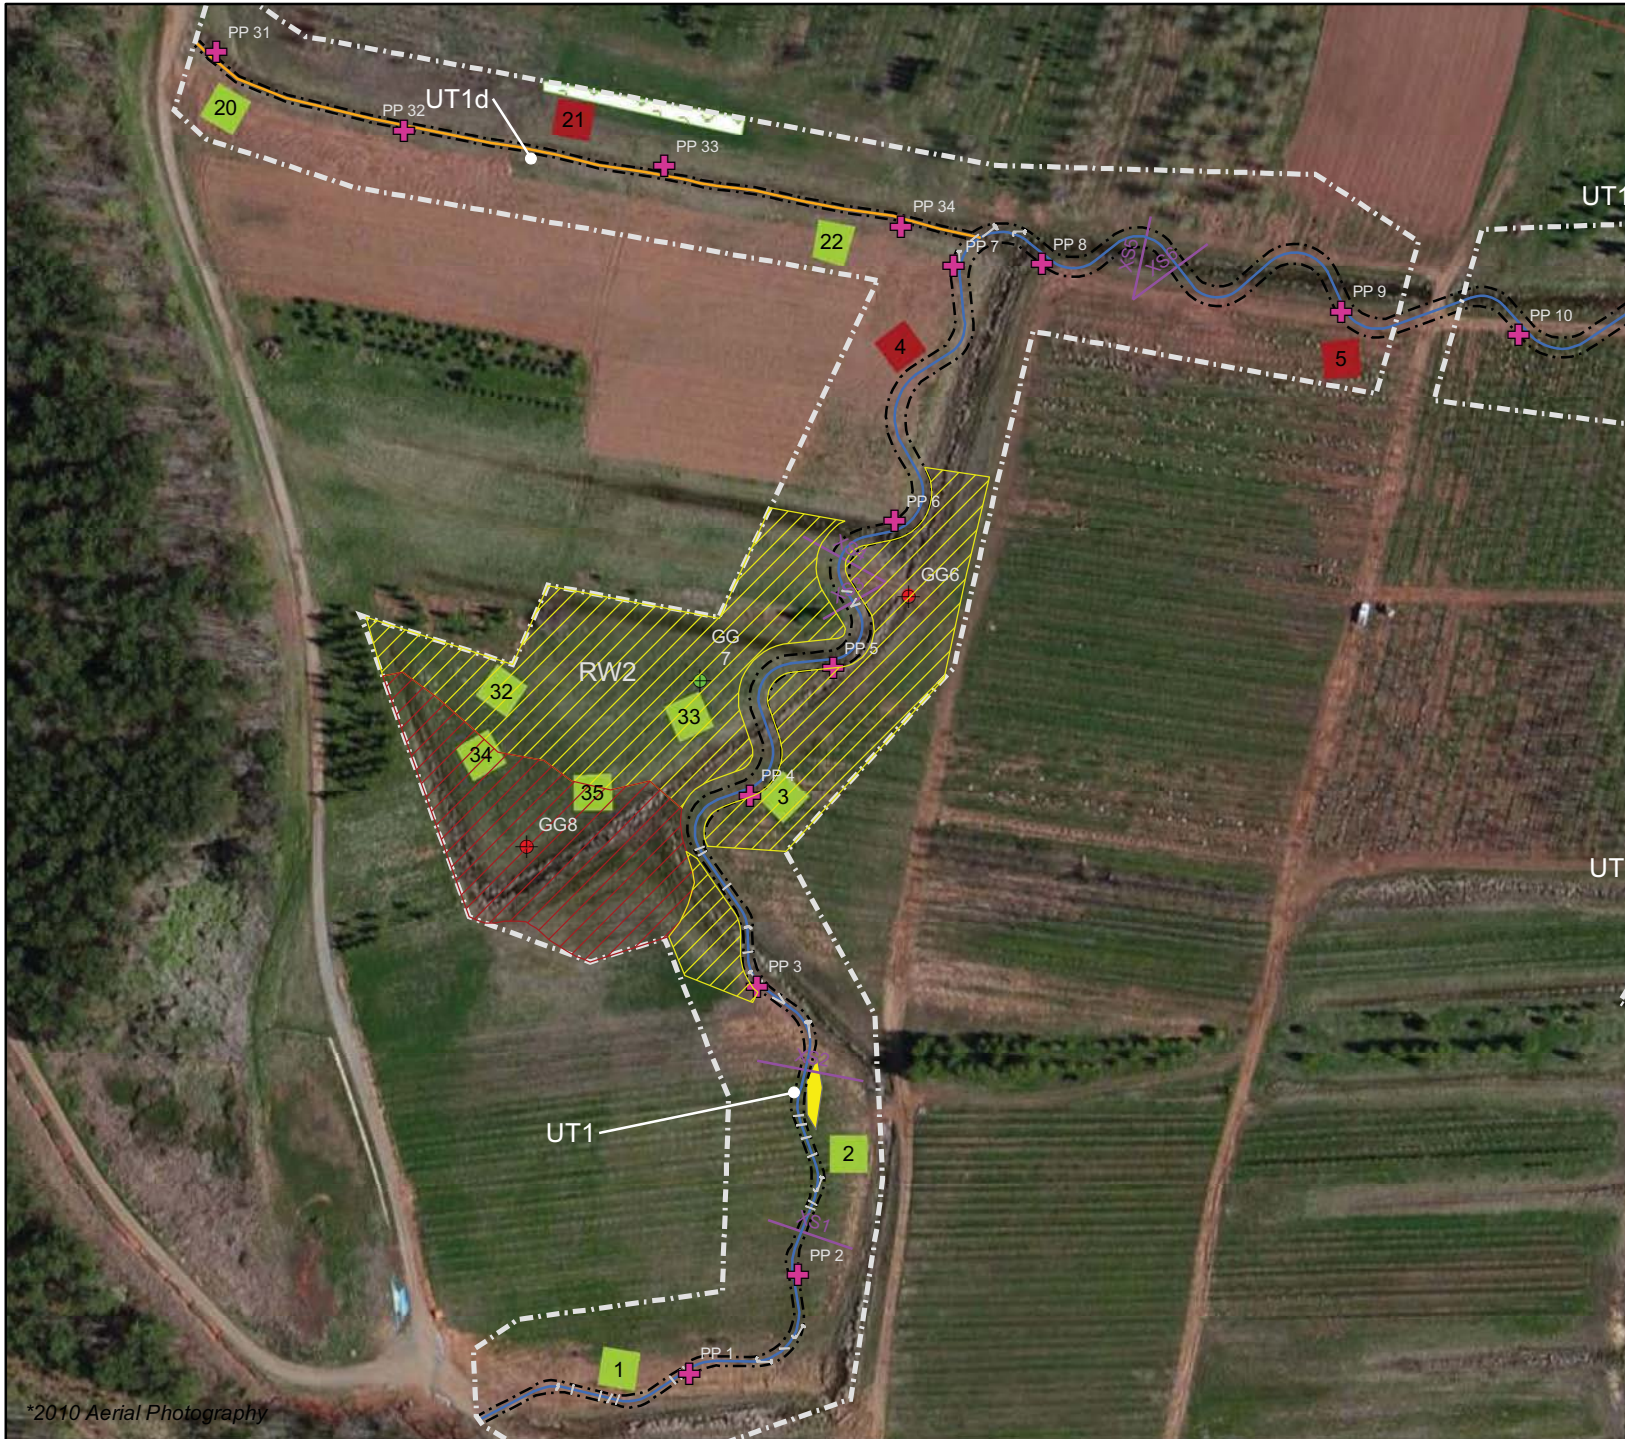
Figure 3.1 Integrated Current Condition Plan View  
 (Sheet 1 of 3)  
 Lyle Creek Mitigation Site  
 NCEEP Project Number 94643  
 Monitoring Year 1 of 5  
 Catawba County, NC

- Conservation Easement
- Power Lines
- Railroad
- Wetland Restoration
- Wetland Creation
- Braided Reach (no credit)
- Stream Enhancement
- Stream Restoration
- Designed Bankfull
- Cross-Sections (XS)
- Structures
- Photo Points (PP)
- Groundwater Gage (GG)
- Criteria Met
- Criteria Not Met
- Vegetation Plot Condition - MY1**
- Criteria Met
- Criteria Not Met
- Bare Areas
- Invasive Areas

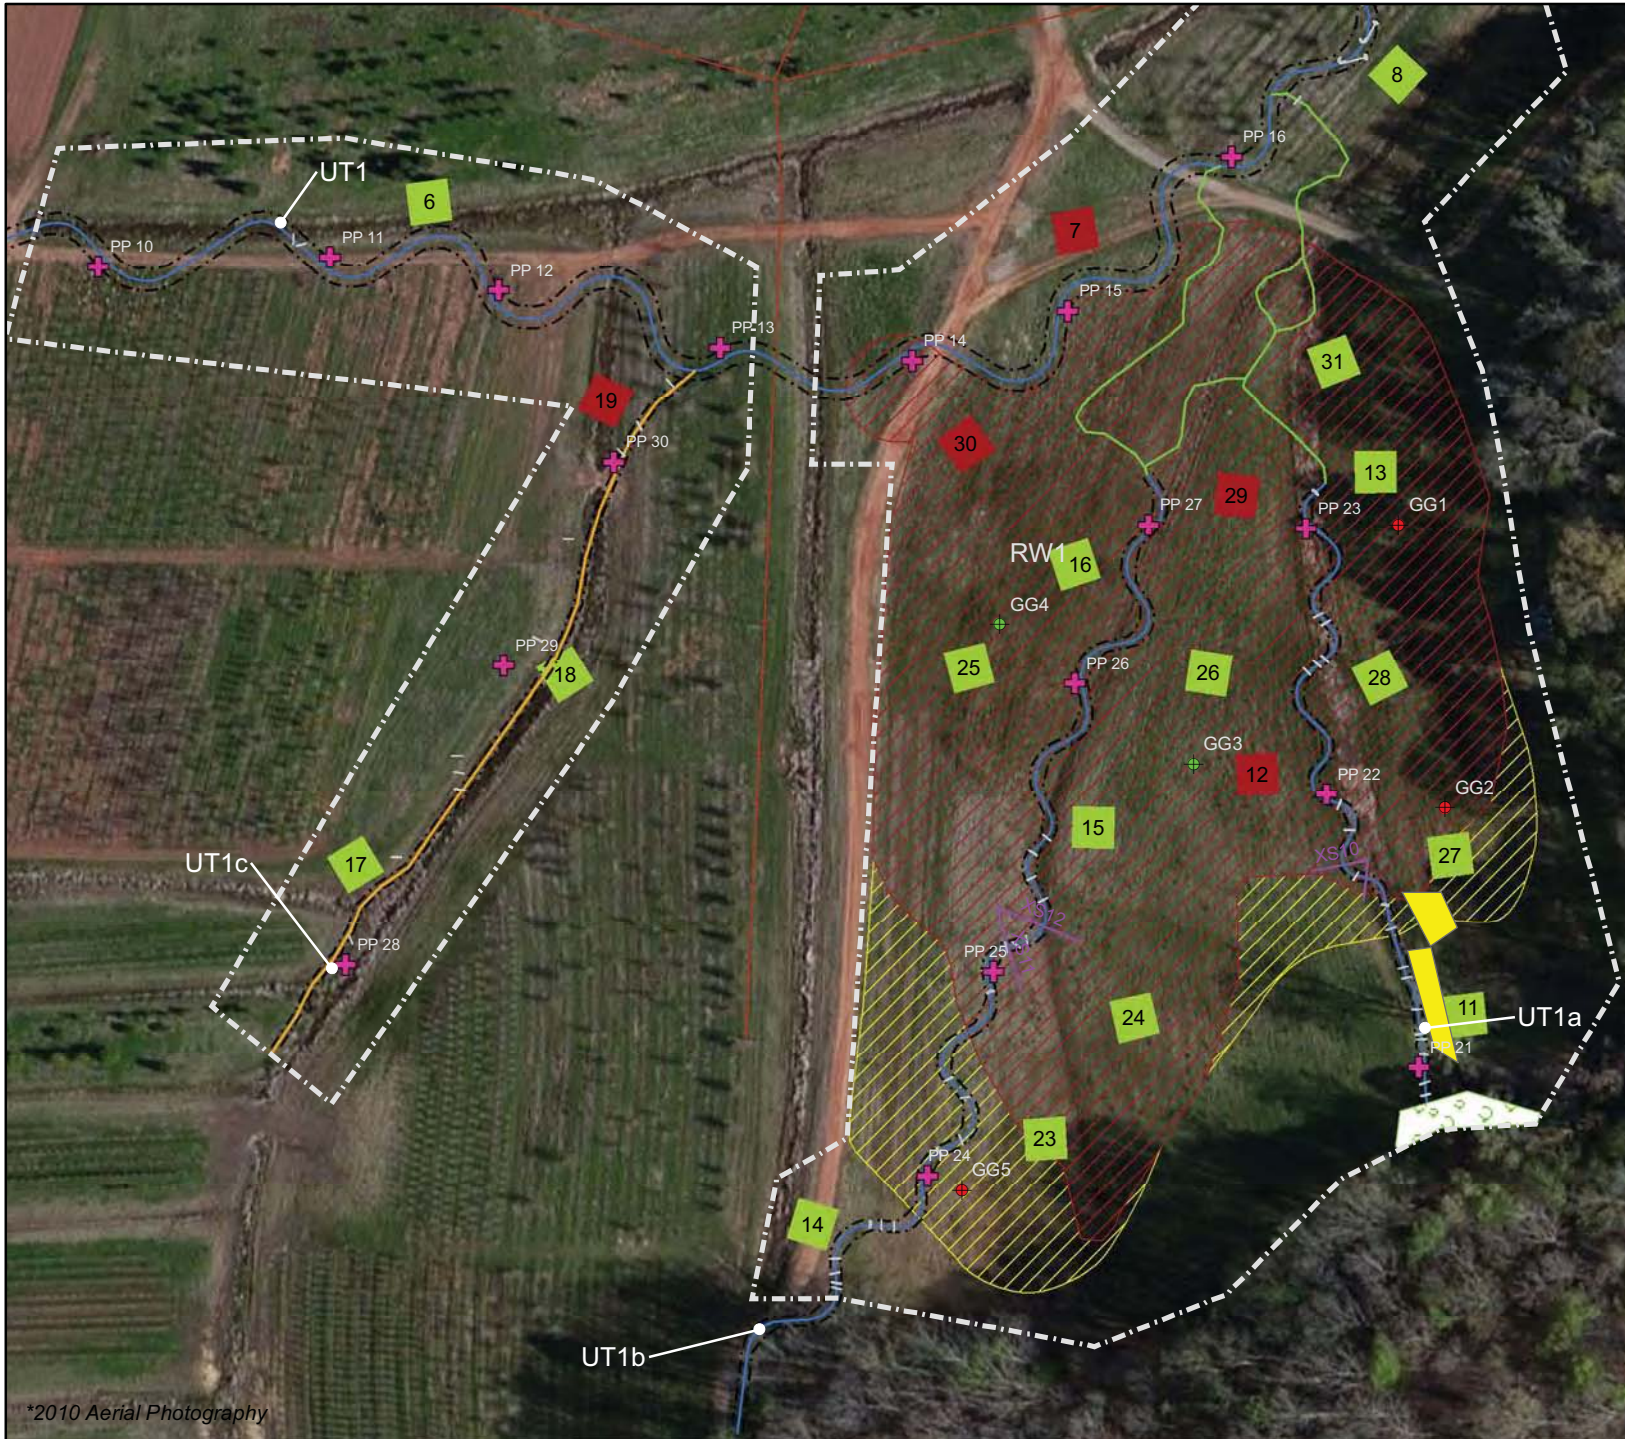
Figure 3.2 Integrated Current Condition Plan View  
 (Sheet 2 of 3)  
 Lyle Creek Mitigation Site  
 NCEEP Project Number 94643  
 Monitoring Year 1 of 5  
 Catawba County, NC

- Conservation Easement
- Power Lines
- Railroad
- Wetland Restoration
- Wetland Creation
- Braided Reach (no credit)
- Stream Enhancement
- Stream Restoration
- Designed Bankfull
- Cross-Sections (XS)
- Structures
- Photo Points (PP)
- Groundwater Gage (GG)
- Criteria Met
- Criteria Not Met
- Vegetation Plot Condition - MY1**
- Criteria Met
- Criteria Not Met
- Bare Areas
- Invasive Areas

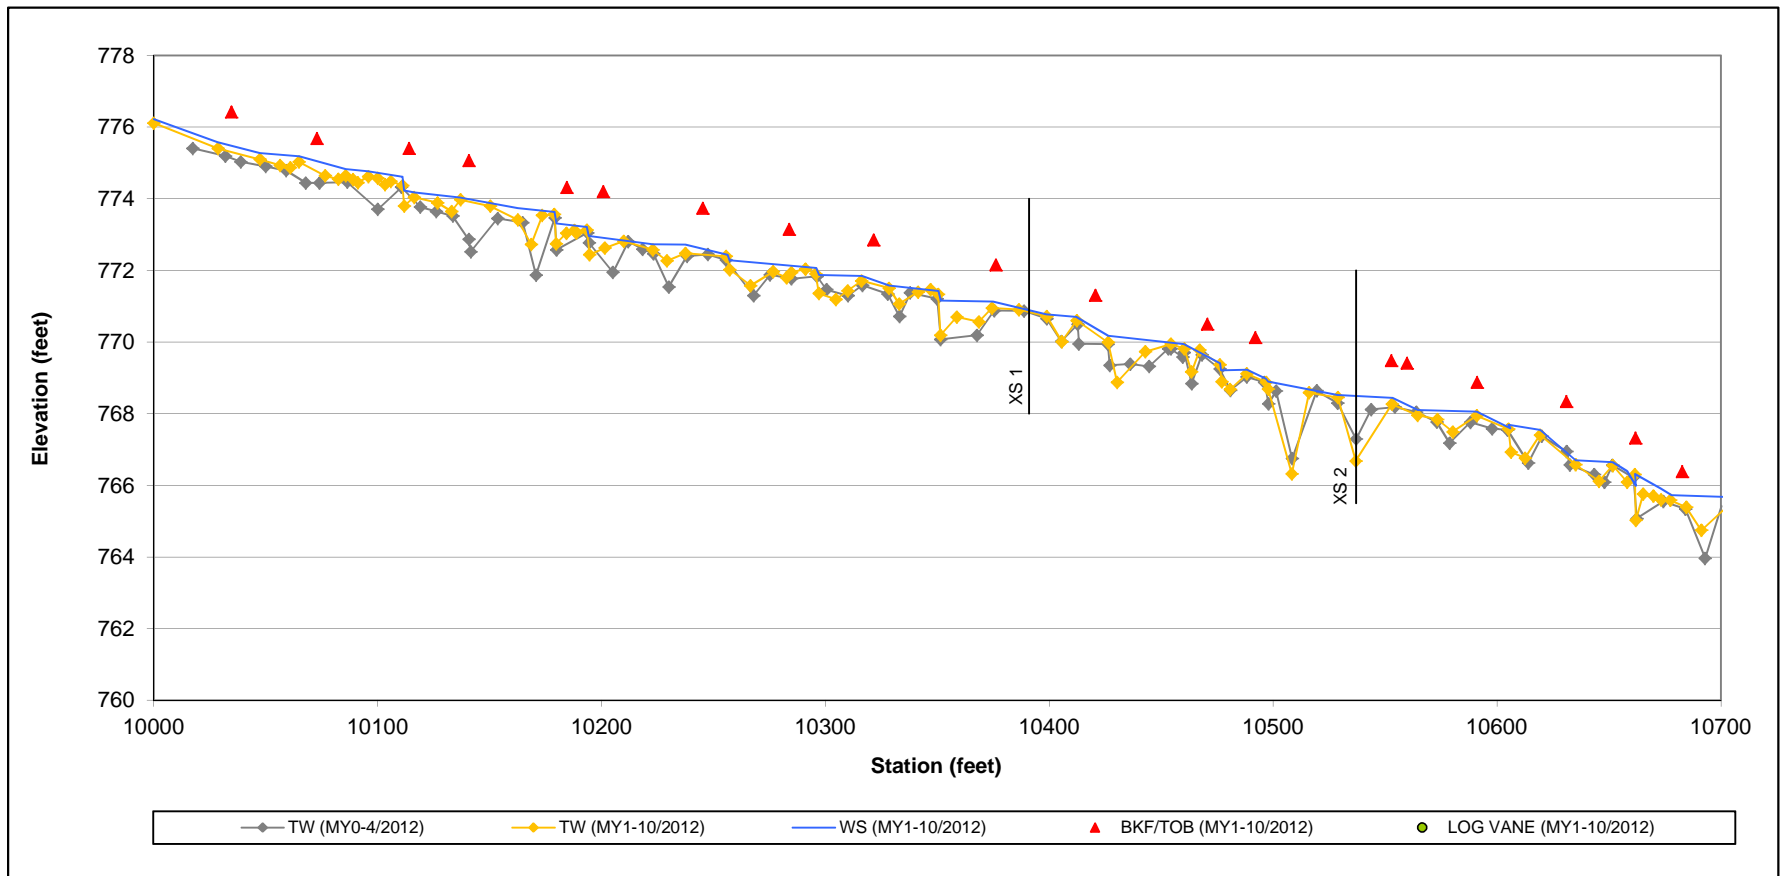
**Appendix 4. Morphological Summary Data and Plots**  
**Figure 4a. Longitudinal Profile Plots**  
**Lyle Creek Mitigation Site (EEP Project No. 94643)**  
**UT1 Reach 1 Upper**  
**Monitoring Year 1**

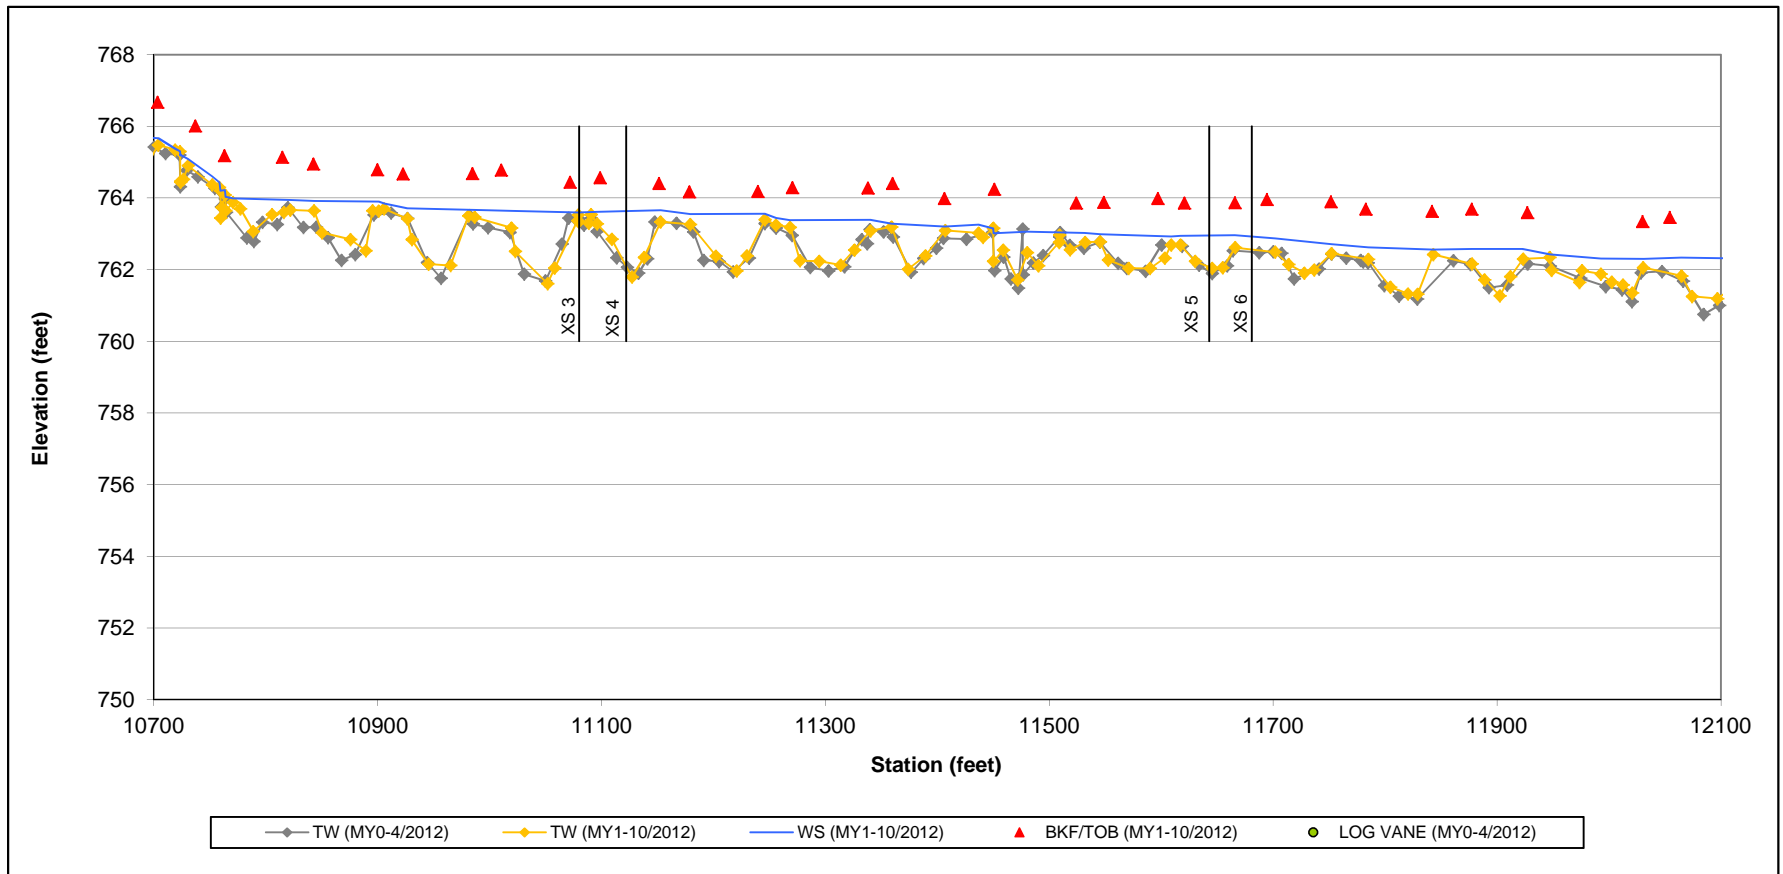
**Appendix 4. Morphological Summary Data and Plots**  
**Figure 4b. Longitudinal Profile Plots**  
**Lyle Creek Mitigation Site (EEP Project No. 94643)**  
**UT1 Reach 1 Lower**  
**Monitoring Year 1**

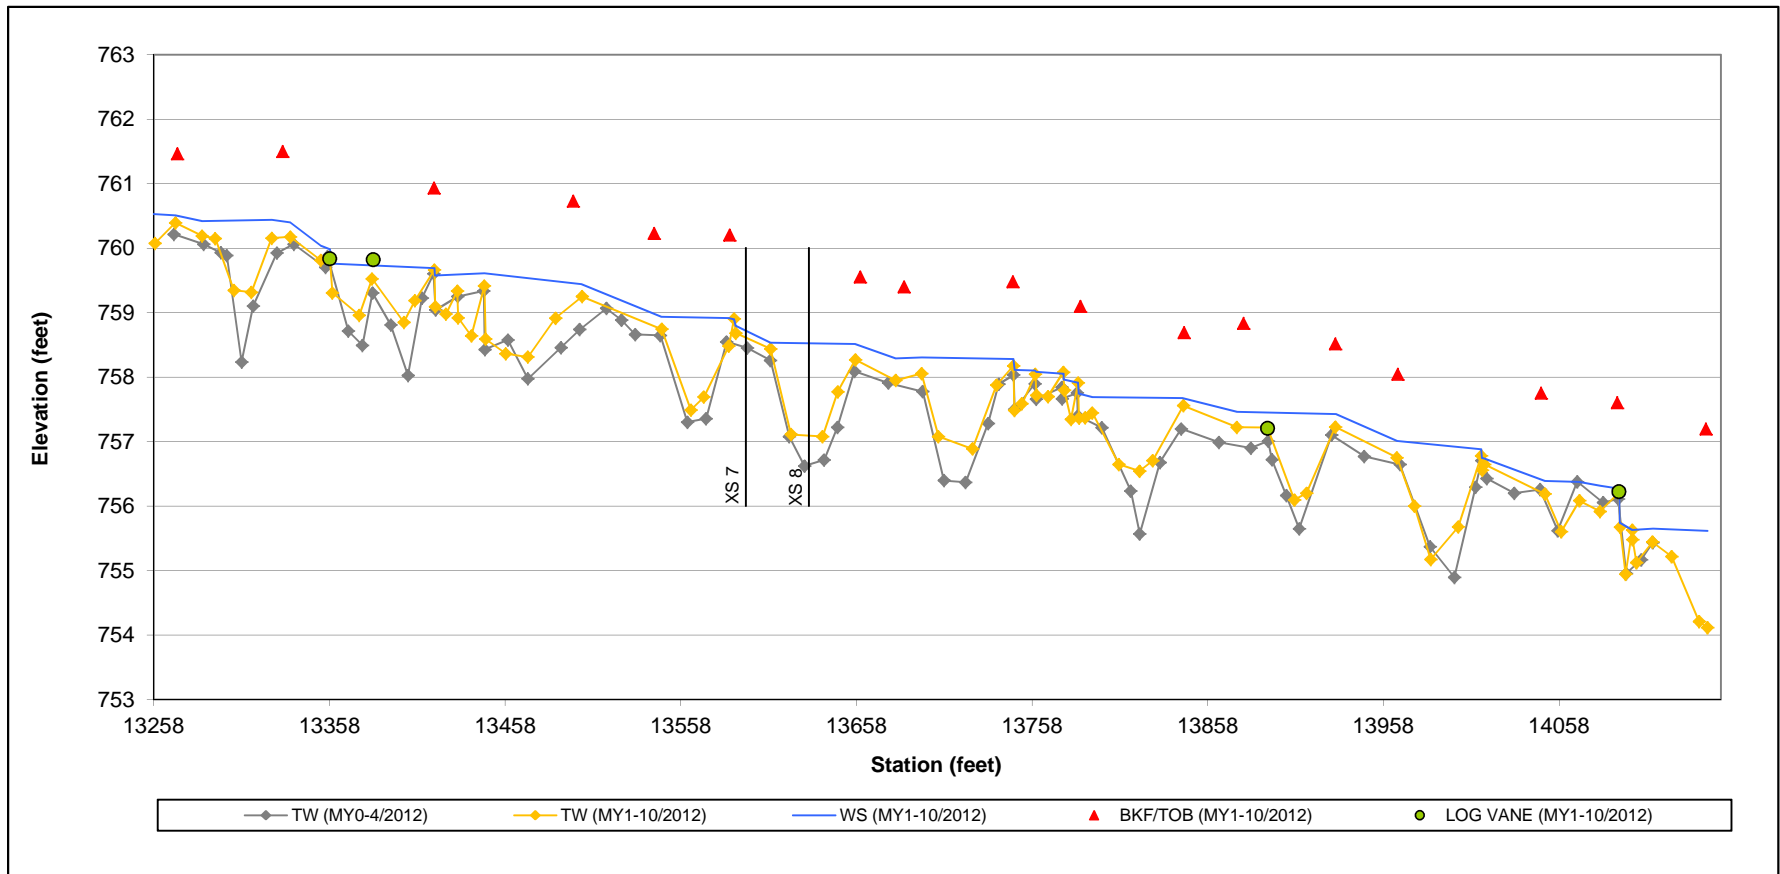
**Appendix 4. Morphological Summary Data and Plots**  
**Figure 4c. Longitudinal Profile Plots**  
**Lyle Creek Mitigation Site (EEP Project No. 94643)**  
**UT1 Reach 2**  
**Monitoring Year 1**

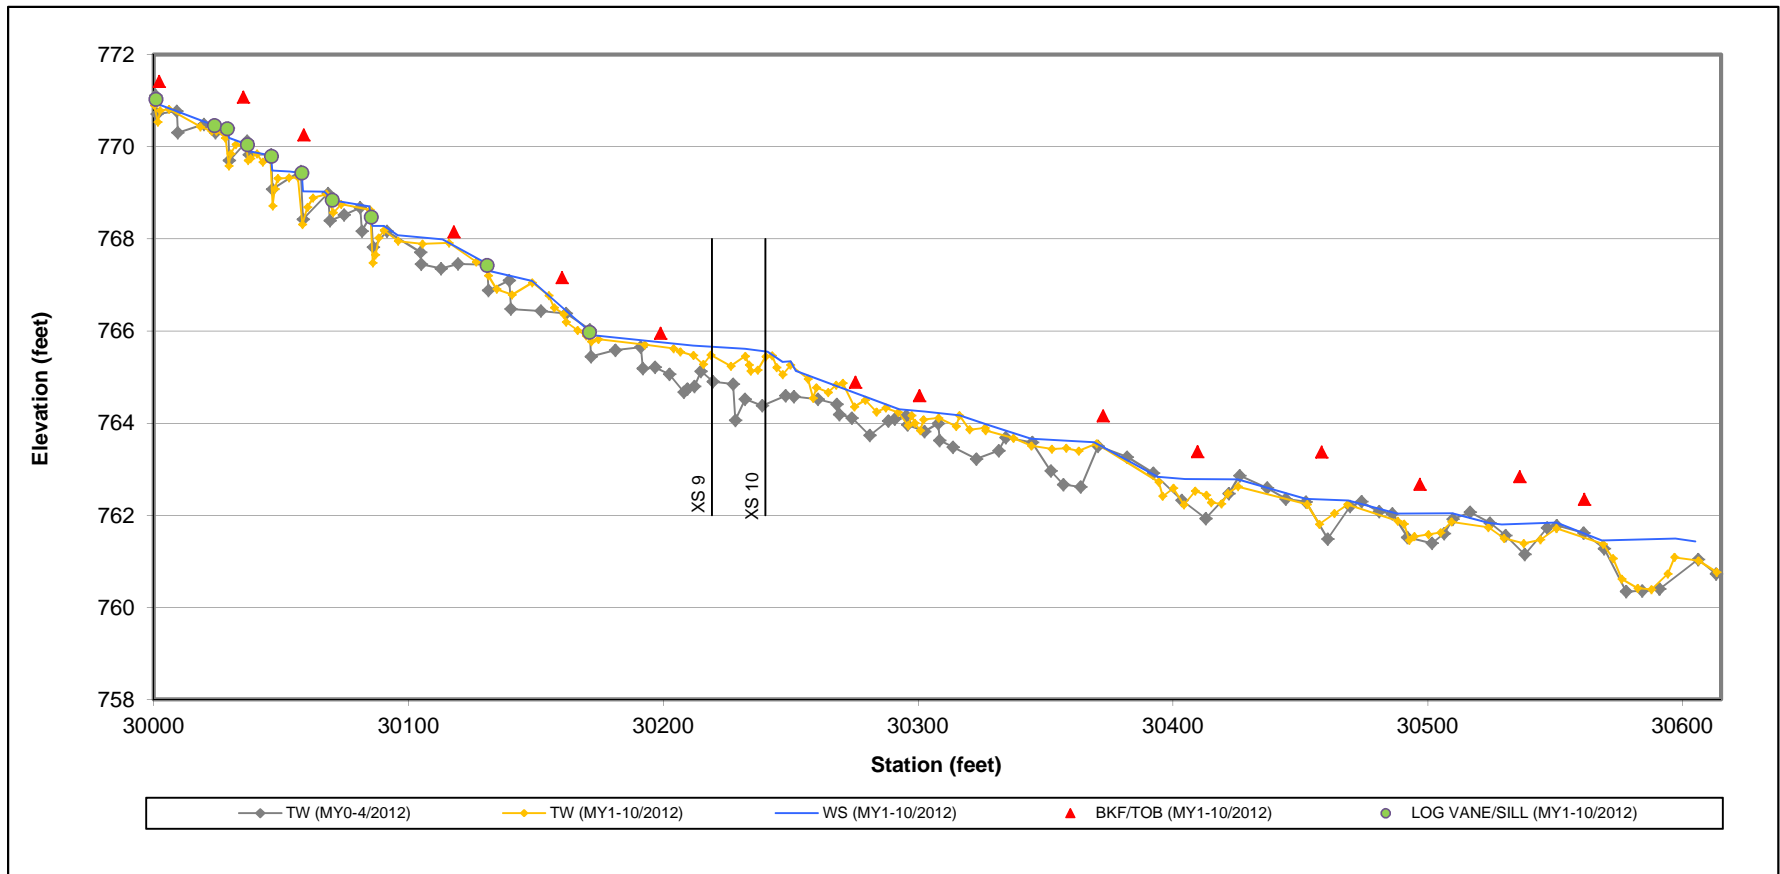
Appendix 4. Morphological Summary Data and Plots  
Figure 4d. Longitudinal Profile Plots  
Lyle Creek Mitigation Site (EEP Project No. 94643)  
UT1A  
Monitoring Year 1

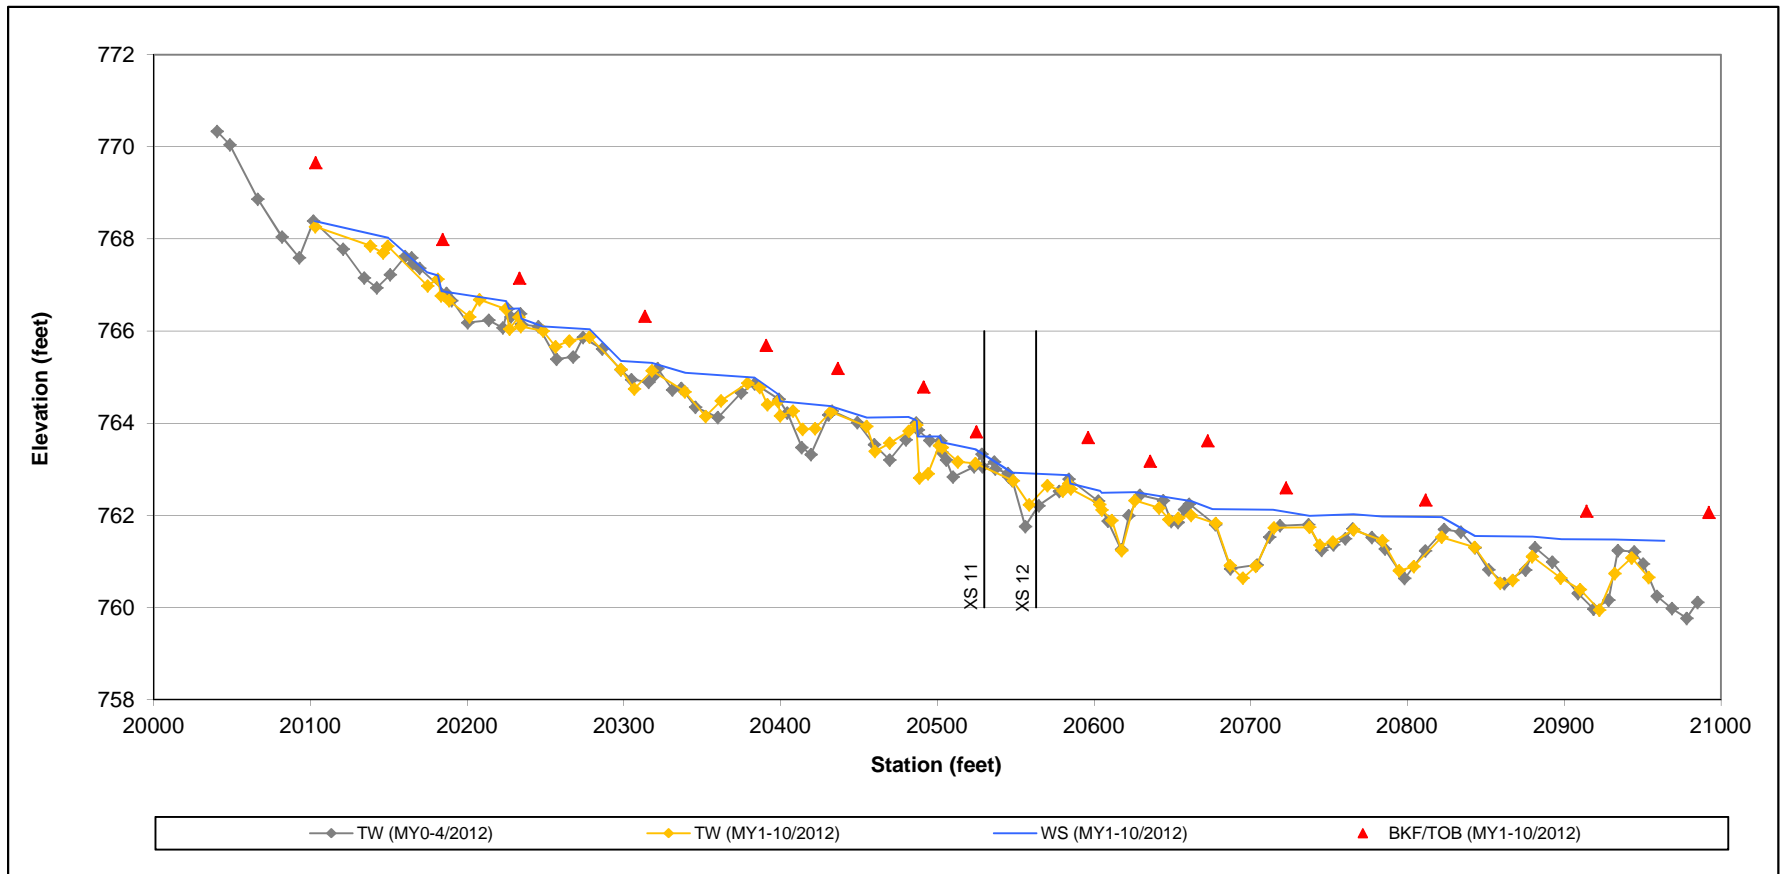
**Appendix 4. Morphological Summary Data and Plots**  
**Figure 4e. Longitudinal Profile Plots**  
**Lyle Creek Mitigation Site (EEP Project No. 94643)**  
**UT1B**  
**Monitoring Year 1**

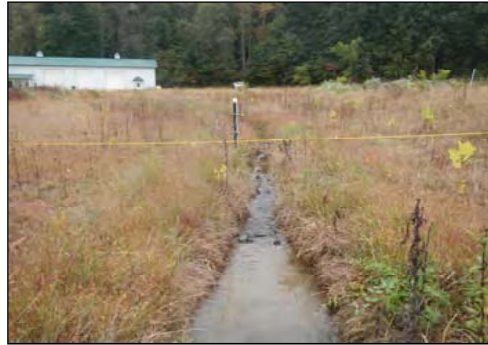
**Cross-Section 1: View Upstream (10/2012)**

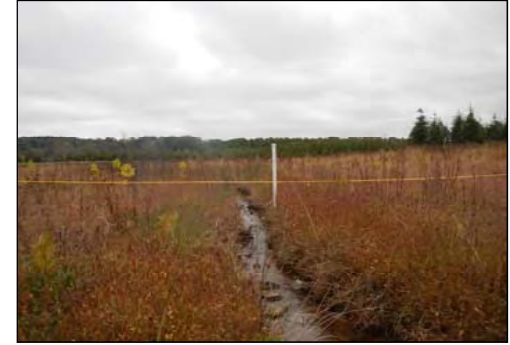
**Cross-Section 1: View Downstream (10/2012)**

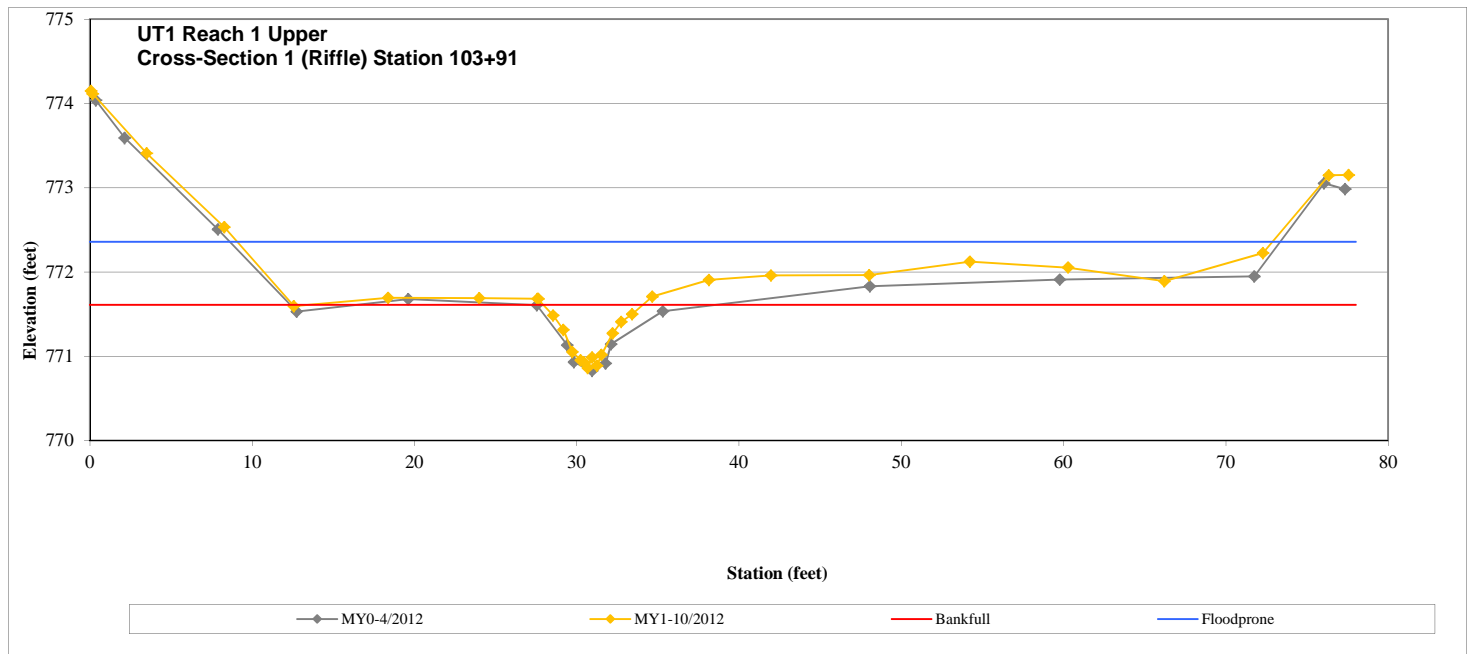
**Appendix 4. Morphological Summary Data and Plots**  
**Figure 5a. Cross-Section Plots**  
**Lyle Creek Mitigation Site (EEP Project No. 94643)**  
**UT1 Reach 1 Upper, Cross-Section 1 (Riffle)**  
**Monitoring Year 1**

<b>River Basin</b>	Catawba 03050101
<b>Watershed</b>	NCDWQ Subbasin 03-08-32
<b>XS ID</b>	1
<b>Drainage Area</b>	315 Acres
<b>Date</b>	10/2012
<b>Field Crew</b>	Wildlands Engineering

Summary Data	
<b>Bankfull Elevation (ft)</b>	771.6
<b>Bankfull Cross-Sectional Area (ft<sup>2</sup>)</b>	2.2
<b>Bankfull Width (ft)</b>	6.1
<b>Flood Prone Area Elevation (ft)</b>	772.4
<b>Flood Prone Width (ft)</b>	63.8
<b>Max Depth at Bankfull (ft)</b>	0.8
<b>Mean Depth at Bankfull (ft)</b>	0.4
<b>W/D Ratio</b>	17.2
<b>Entrenchment Ratio</b>	2.2+
<b>Bank Height Ratio</b>	1.0
<b>Stream Type</b>	C

Station	Elevation	Station	Elevation
0.07	774.15	48.03	771.97
0.18	774.12	54.24	772.12
3.50	773.41	60.28	772.05
8.30	772.53	66.22	771.89
12.57	771.60	72.28	772.23
18.38	771.69	76.34	773.15
24.00	771.69	77.58	773.15
27.64	771.68		
27.59	771.68		
28.55	771.49		
29.19	771.31		
29.74	771.05		
30.24	770.95		
30.44	770.93		
30.68	770.86		
30.95	770.99		
31.26	770.89		
31.52	771.02		
32.21	771.27		
32.76	771.41		
33.42	771.50		
34.67	771.71		
38.15	771.91		
41.98	771.96

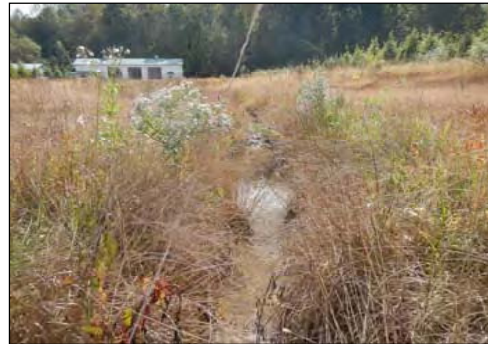
**Cross-Section 2: View Upstream (10/2012)**

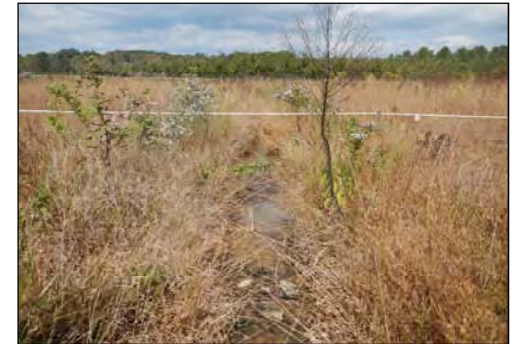
**Cross-Section 2: View Downstream (10/2012)**

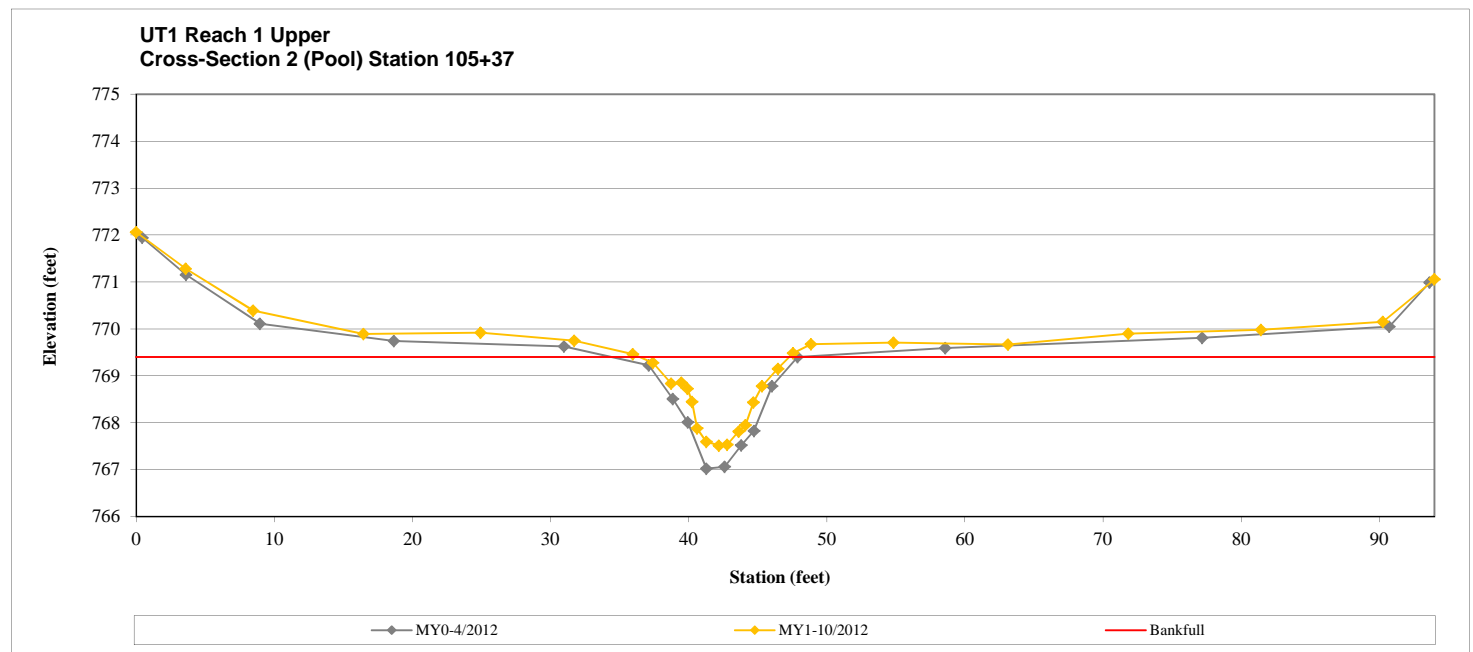
Summary Data	
<b>Bankfull Elevation (ft)</b>	769.4
<b>Bankfull Cross-Sectional Area (ft<sup>2</sup>)</b>	9.8
<b>Bankfull Width (ft)</b>	10.8
<b>Flood Prone Area Elevation (ft)</b>	N/A
<b>Flood Prone Width (ft)</b>	N/A
<b>Max Depth at Bankfull (ft)</b>	1.9
<b>Mean Depth at Bankfull (ft)</b>	0.9
<b>W/D Ratio</b>	12.0
<b>Entrenchment Ratio</b>	N/A
<b>Bank Height Ratio</b>	1.0
<b>Stream Type</b>	N/A

**Appendix 4. Morphological Summary Data and Plots**  
**Figure 5c. Cross-Section Plots**  
**Lyle Creek Mitigation Site (EEP Project No. 94643)**  
**UT1 Reach 1 Lower, Cross-Section 3 (Riffle)**  
**Monitoring Year 1**

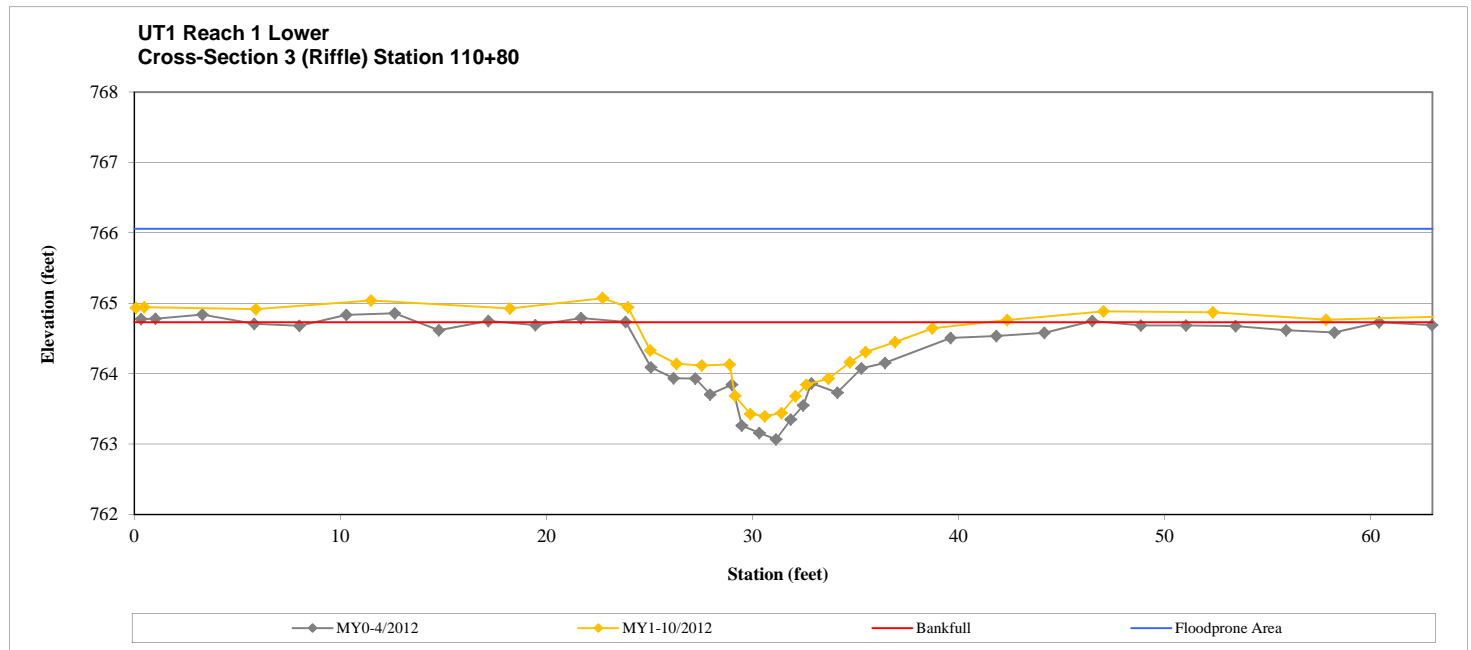
Summary Data	
<b>Bankfull Elevation (ft)</b>	764.7
<b>Bankfull Cross-Sectional Area (ft2)</b>	9.7
<b>Bankfull Width (ft)</b>	17.1
<b>Flood Prone Area Elevation (ft)</b>	766.1
<b>Flood Prone Width (ft)</b>	63.4
<b>Max Depth at Bankfull (ft)</b>	1.3
<b>Mean Depth at Bankfull (ft)</b>	0.6
<b>W/D Ratio</b>	30.1
<b>Entrenchment Ratio</b>	2.2+
<b>Bank Height Ratio</b>	1.0
<b>Stream Type</b>	C

**Appendix 4. Morphological Summary Data and Plots**

**Figure 5d. Cross-Section Plots**

**UT1 Reach 1 Lower, Cross-Section 4 (Pool)**
