**LYLE CREEK MITIGATION SITE**  
*Catawba County, NC*  
*DENR Contract 003241*  
*NCEEP Project Number 94643*

**Monitoring Year 1 Annual Report**  
**FINAL**

# LYLE CREEK MITIGATION SITE Monitoring Year 1 Annual Report

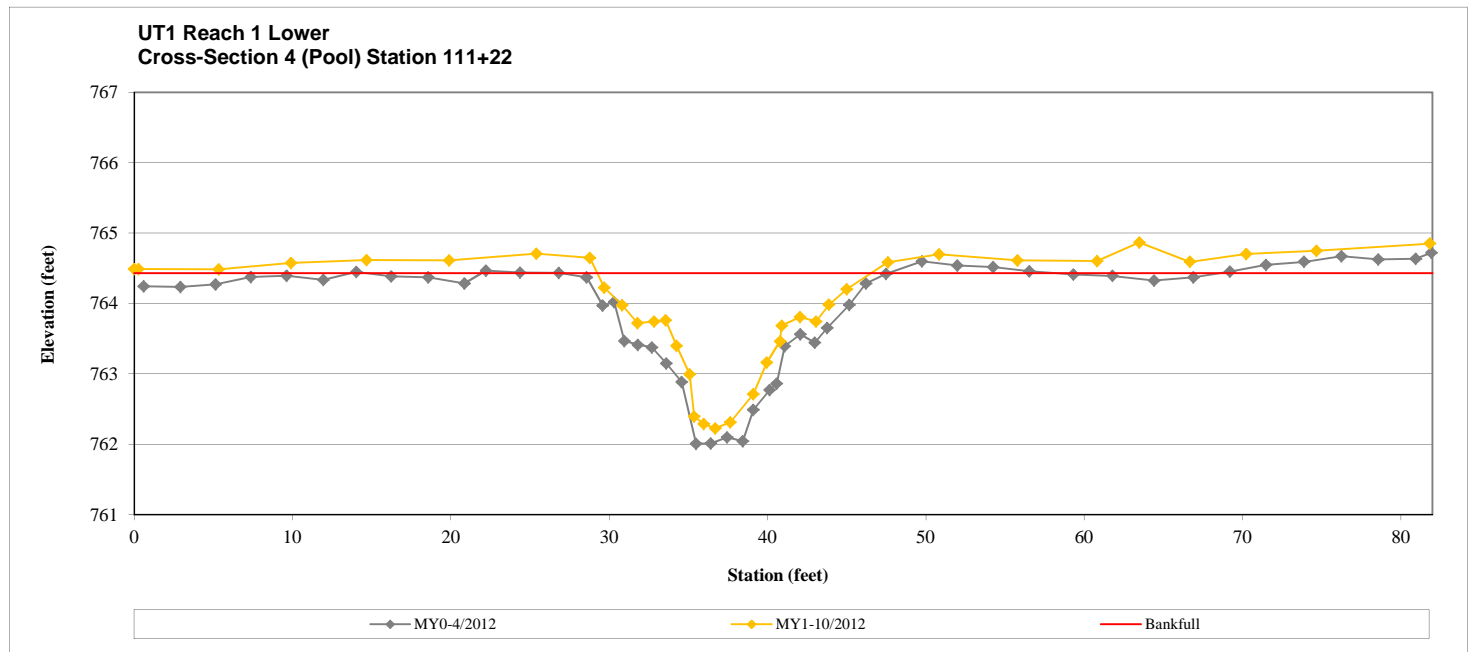
Summary Data	
<b>Bankfull Elevation (ft)</b>	764.4
<b>Bankfull Cross-Sectional Area (ft<sup>2</sup>)</b>	16.8
<b>Bankfull Width (ft)</b>	17.3
<b>Flood Prone Area Elevation (ft)</b>	N/A
<b>Flood Prone Width (ft)</b>	N/A
<b>Max Depth at Bankfull (ft)</b>	2.2
<b>Mean Depth at Bankfull (ft)</b>	1.0
<b>W/D Ratio</b>	17.9
<b>Entrenchment Ratio</b>	N/A
<b>Bank Height Ratio</b>	1.0
<b>Stream Type</b>	N/A

### Figure 5e. Cross-Section Plots

UT1 Reach 1 Lower, Cross-Section 5 (Pool)

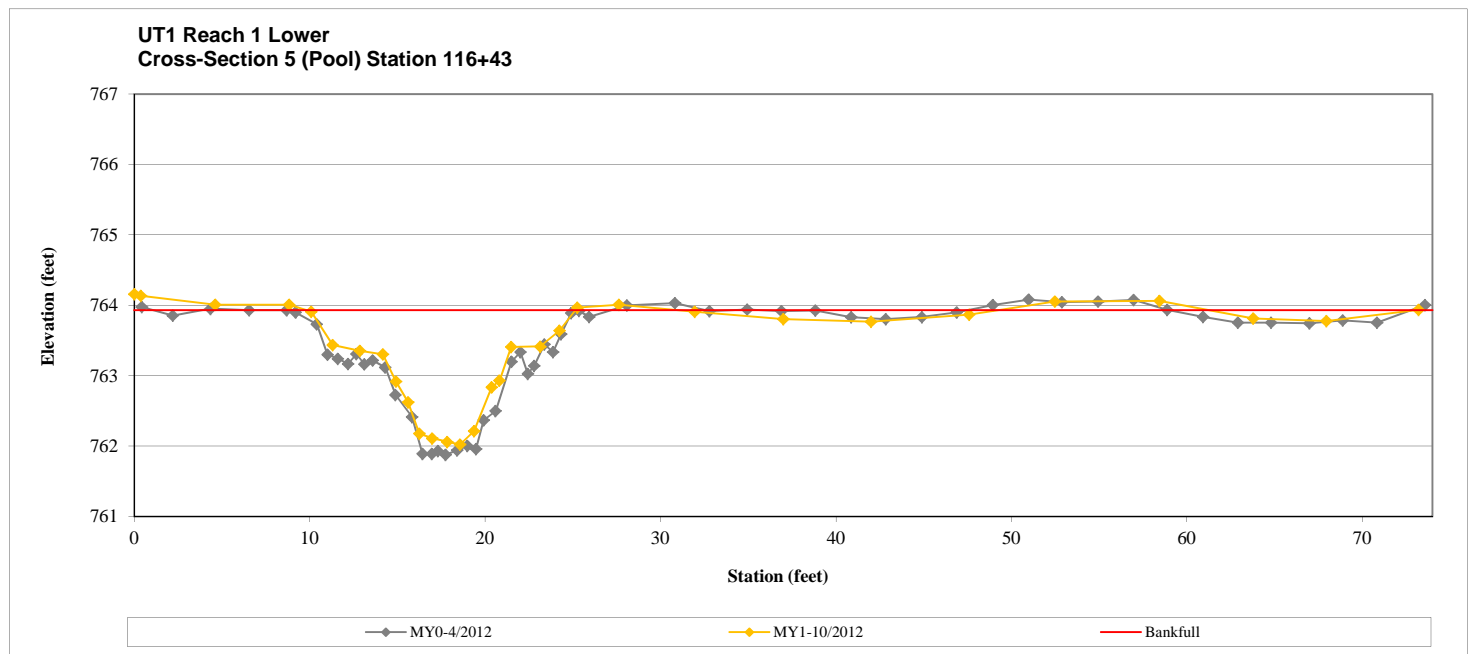
Summary Data	
Bankfull Elevation (ft)	763.9
Bankfull Cross-Sectional Area (ft <sup>2</sup> )	13.4
Bankfull Width (ft)	16.9
Flood Prone Area Elevation (ft)	N/A
Flood Prone Width (ft)	N/A
Max Depth at Bankfull (ft)	1.9
Mean Depth at Bankfull (ft)	0.9
W/D Ratio	16.6
Entrenchment Ratio	N/A
Bank Height Ratio	1.0
Stream Type	N/A

**Figure 5f. Cross-Section Plots**

**UT1 Reach 1 Lower, Cross-Section 6 (Riffle)**

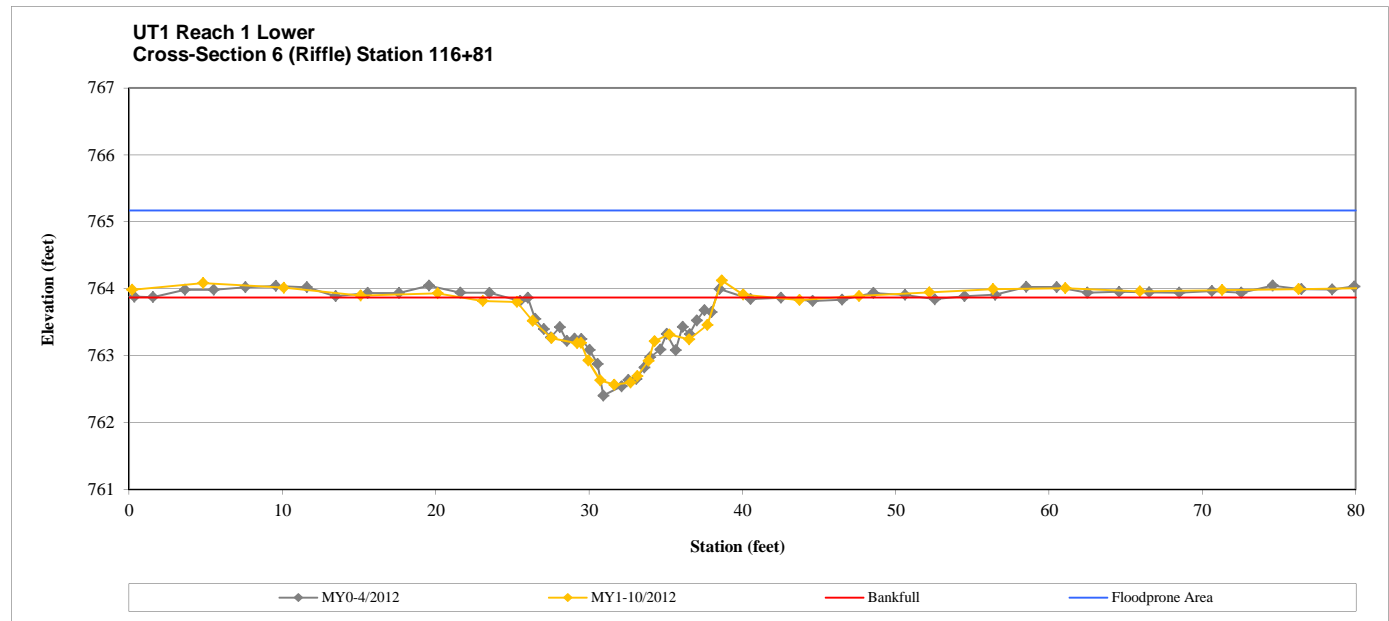
Summary Data	
<b>Bankfull Elevation (ft)</b>	763.9
<b>Bankfull Cross-Sectional Area (ft<sup>2</sup>)</b>	9.5
<b>Bankfull Width (ft)</b>	13.3
<b>Flood Prone Area Elevation (ft)</b>	765.2
<b>Flood Prone Width (ft)</b>	80.3
<b>Max Depth at Bankfull (ft)</b>	1.3
<b>Mean Depth at Bankfull (ft)</b>	0.7
<b>W/D Ratio</b>	18.5
<b>Entrenchment Ratio</b>	2.2+
<b>Bank Height Ratio</b>	1.0
<b>Stream Type</b>	C

**Appendix 4. Morphological Summary Data and Plots**  
**Figure 5g. Cross-Section Plots**  
**Lyle Creek Mitigation Site (EEP Project No. 94643)**  
**UT1 Reach 2, Cross-Section 7 (Riffle)**  
**Monitoring Year 1**

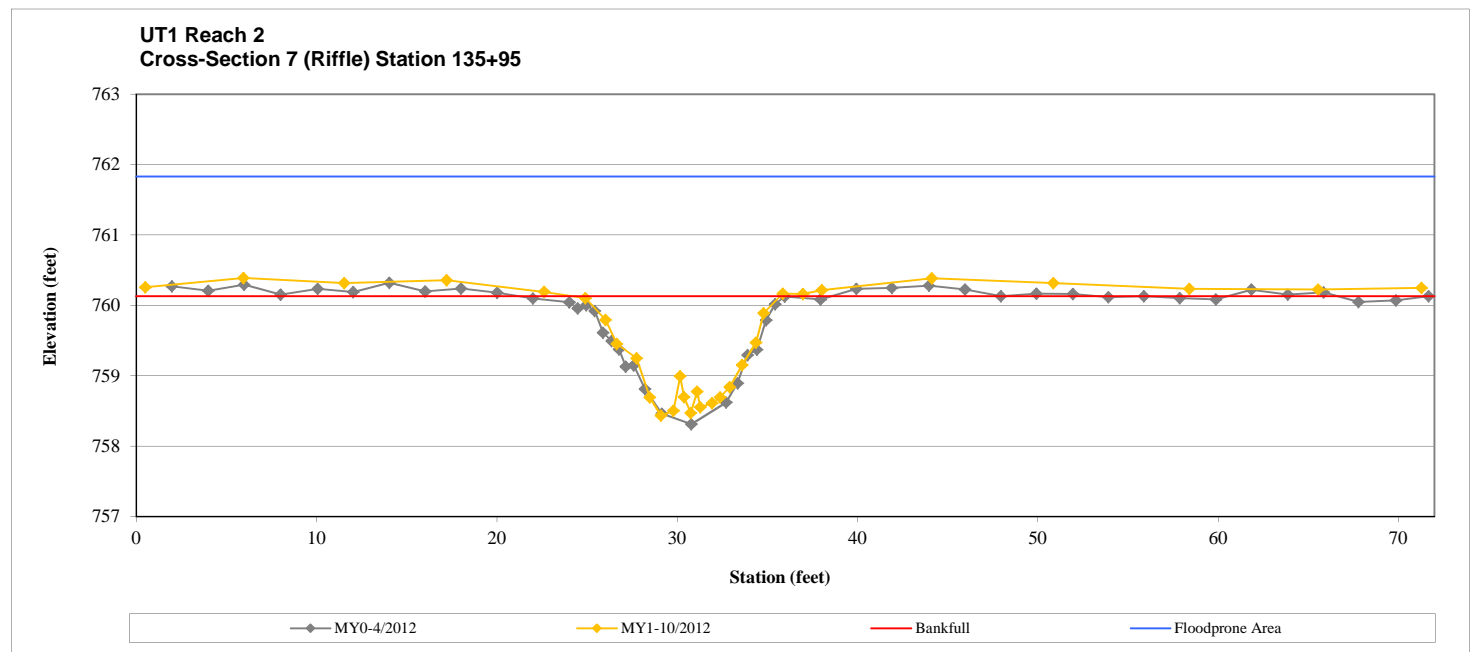
Summary Data	
<b>Bankfull Elevation (ft)</b>	760.1
<b>Bankfull Cross-Sectional Area (ft<sup>2</sup>)</b>	10.6
<b>Bankfull Width (ft)</b>	11.5
<b>Flood Prone Area Elevation (ft)</b>	761.8
<b>Flood Prone Width (ft)</b>	70.8
<b>Max Depth at Bankfull (ft)</b>	1.7
<b>Mean Depth at Bankfull (ft)</b>	0.9
<b>W/D Ratio</b>	12.5
<b>Entrenchment Ratio</b>	2.2+
<b>Bank Height Ratio</b>	1.0
<b>Stream Type</b>	C

**Appendix 4. Morphological Summary Data and Plots**  
**Figure 5h. Cross-Section Plots**  
**Lyle Creek Mitigation Site (EEP Project No. 94643)**  
**UT1 Reach 2, Cross-Section 8 (Pool)**  
**Monitoring Year 1**

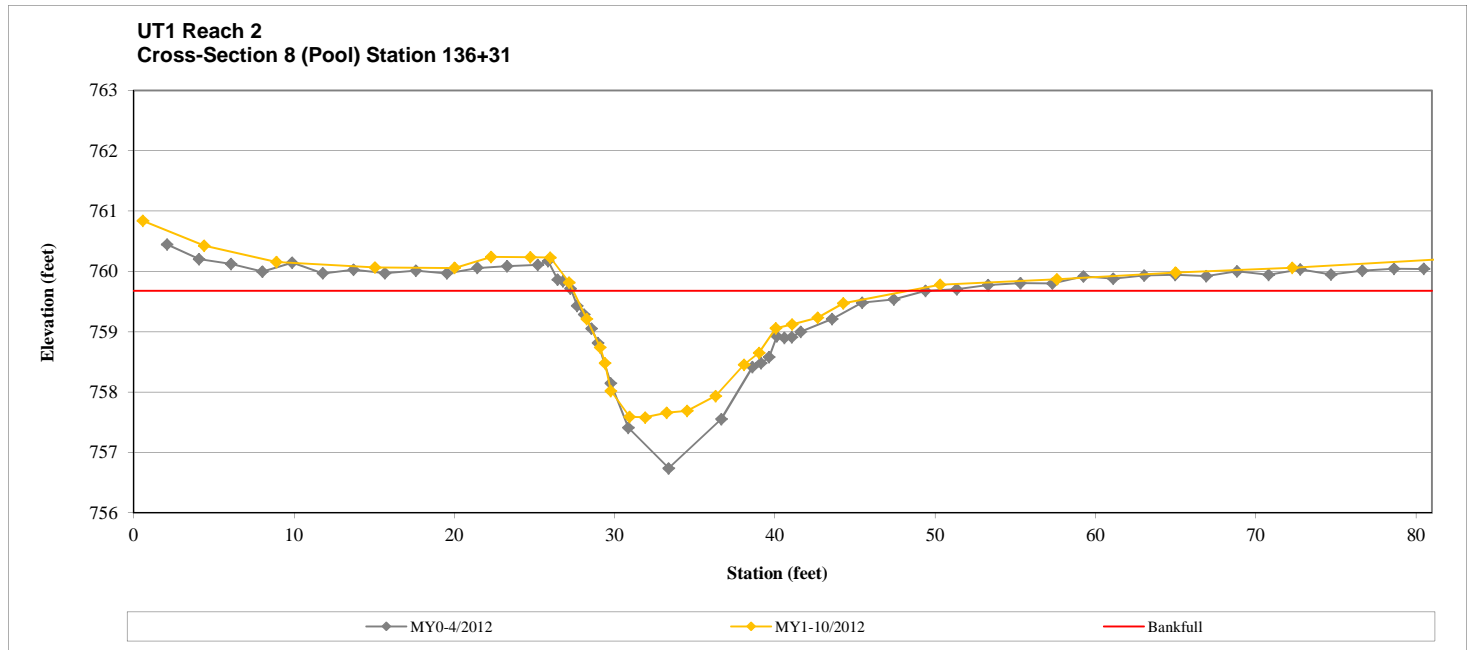
Summary Data	
<b>Bankfull Elevation (ft)</b>	759.7
<b>Bankfull Cross-Sectional Area (ft<sup>2</sup>)</b>	21.4
<b>Bankfull Width (ft)</b>	21.0
<b>Flood Prone Area Elevation (ft)</b>	N/A
<b>Flood Prone Width (ft)</b>	N/A
<b>Max Depth at Bankfull (ft)</b>	2.1
<b>Mean Depth at Bankfull (ft)</b>	1.0
<b>W/D Ratio</b>	20.5
<b>Entrenchment Ratio</b>	N/A
<b>Bank Height Ratio</b>	1.0
<b>Stream Type</b>	N/A

**Figure 5i. Cross-Section Plots**

**UT1A, Cross-Section 9 (Riffle)**

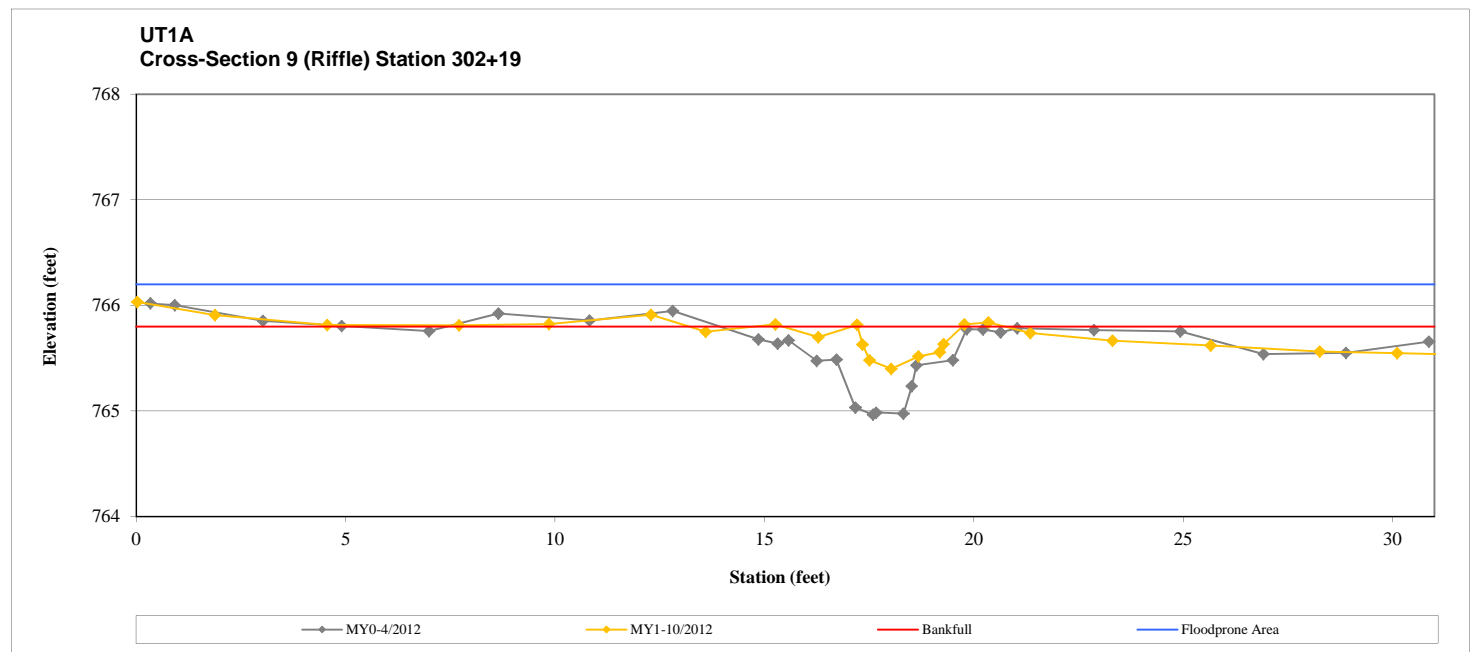
Summary Data	
<b>Bankfull Elevation (ft)</b>	765.8
<b>Bankfull Cross-Sectional Area (ft<sup>2</sup>)</b>	0.7
<b>Bankfull Width (ft)</b>	2.5
<b>Flood Prone Area Elevation (ft)</b>	766.2
<b>Flood Prone Width (ft)</b>	31.4
<b>Max Depth at Bankfull (ft)</b>	0.4
<b>Mean Depth at Bankfull (ft)</b>	0.3
<b>W/D Ratio</b>	9.4
<b>Entrenchment Ratio</b>	2.2+
<b>Bank Height Ratio</b>	1.0
<b>Stream Type</b>	E

**Appendix 4. Morphological Summary Data and Plots**  
**Figure 5j. Cross-Section Plots**  
**Lyle Creek Mitigation Site (EEP Project No. 94643)**  
**UT1A, Cross-Section 10 (Pool)**  
**Monitoring Year 1**

All streams within the Site are stable and functioning as designed. Aggradation observed on UT1A will be monitored for indications of long term instability but over time the channel is expected to transport the additional sediment. The average stem density for the entire Site is on track to meeting the overall success criteria; however, a portion of the individual vegetation plots did not meet the MY-3 success criteria as seen in the CCPV. A vegetation maintenance plan has been proposed and will be implemented in late winter 2012. There has been one (1) bankfull event recorded along each restored project reach since construction commenced; therefore, the MY-5 stream hydrology attainment requirement has been partially met for the Site at this time. Currently 3 of 8 groundwater gages are meeting the success criteria for wetland hydrology. This is likely due to below normal precipitation. It is anticipated that success criteria will be met using a growing season interval defined by the onsite soil temperature loggers during years of typical rainfall.

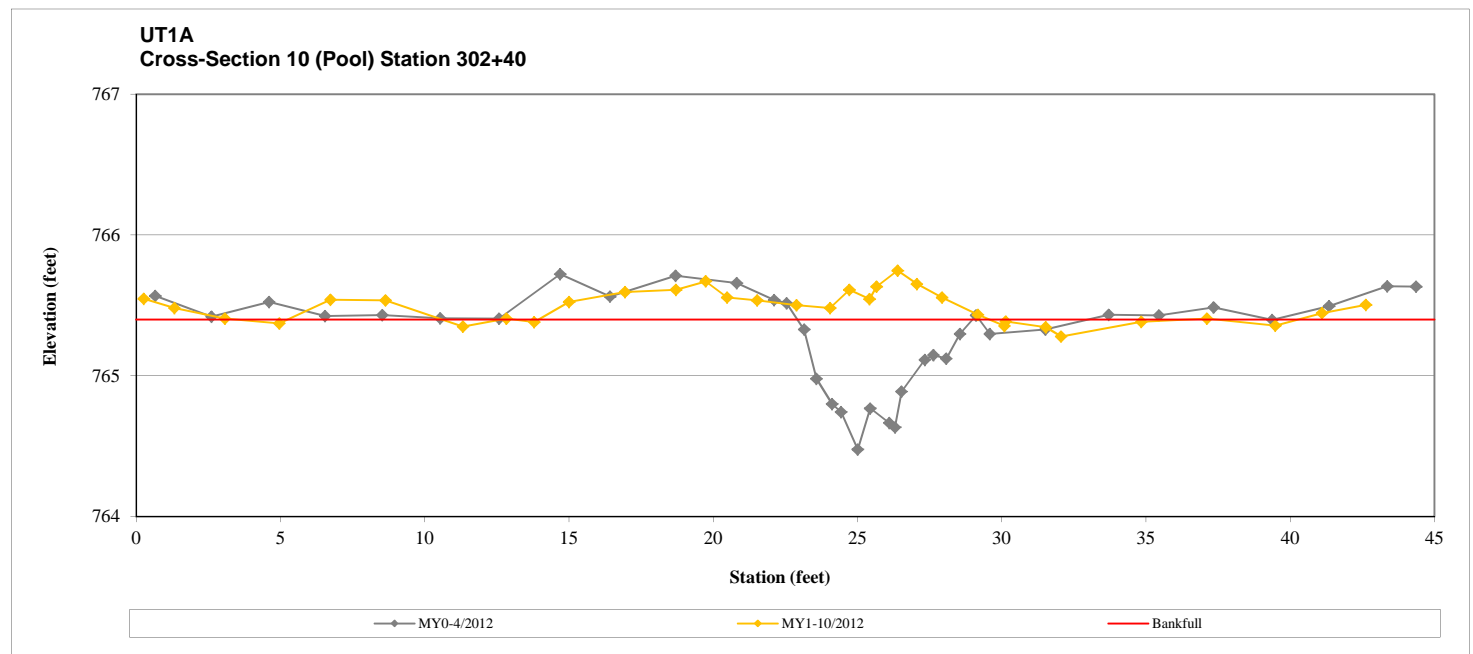
Summary Data	
<b>Bankfull Elevation (ft)</b>	765.4
<b>Bankfull Cross-Sectional Area (ft<sup>2</sup>)</b>	0.0
<b>Bankfull Width (ft)</b>	0.0
<b>Flood Prone Area Elevation (ft)</b>	N/A
<b>Flood Prone Width (ft)</b>	N/A
<b>Max Depth at Bankfull (ft)</b>	0.1
<b>Mean Depth at Bankfull (ft)</b>	0.0
<b>W/D Ratio</b>	0.0
<b>Entrenchment Ratio</b>	N/A
<b>Bank Height Ratio</b>	0.0
<b>Stream Type</b>	N/A

**Appendix 4. Morphological Summary Data and Plots**  
**Figure 5k. Cross-Section Plots**  
**Lyle Creek Mitigation Site (EEP Project No. 94643)**  
**UT1B, Cross-Section 11 (Riffle)**  
**Monitoring Year 1**

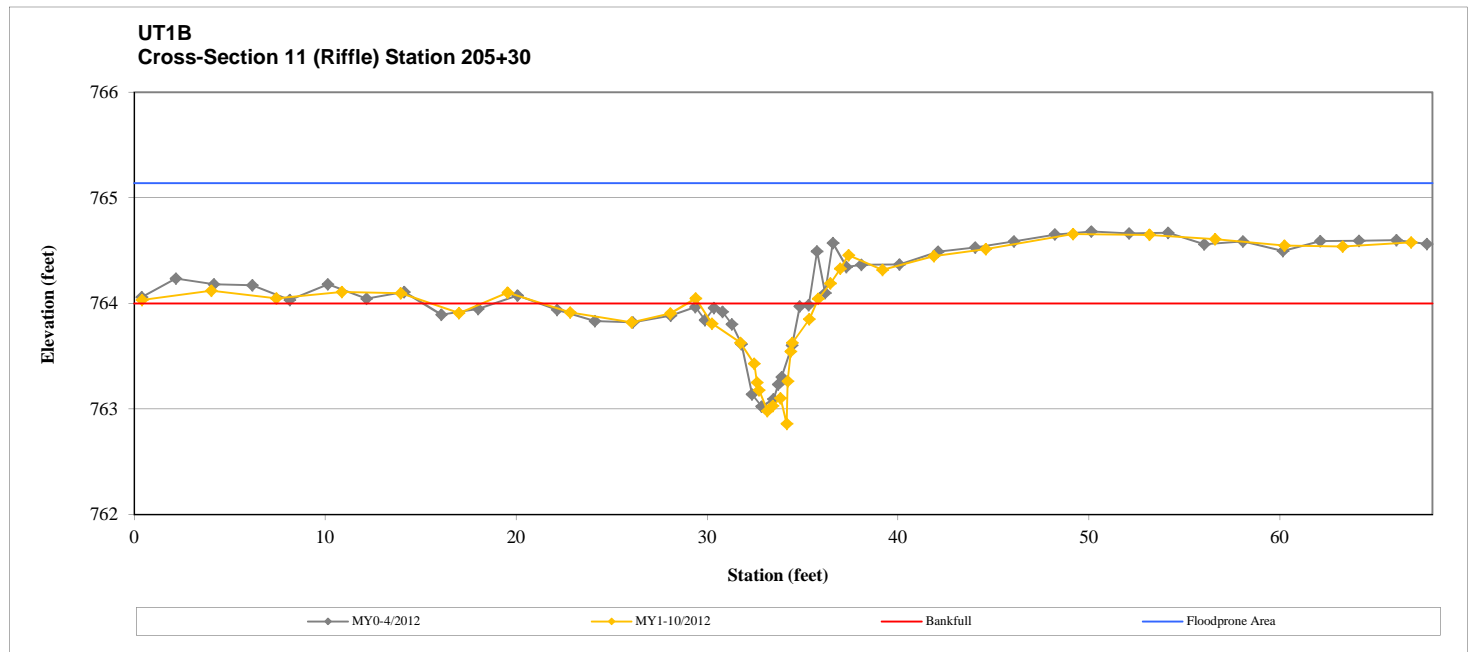
Summary Data	
<b>Bankfull Elevation (ft)</b>	764.0
<b>Bankfull Cross-Sectional Area (ft<sup>2</sup>)</b>	2.8
<b>Bankfull Width (ft)</b>	6.1
<b>Flood Prone Area Elevation (ft)</b>	765.1
<b>Flood Prone Width (ft)</b>	66.5
<b>Max Depth at Bankfull (ft)</b>	1.1
<b>Mean Depth at Bankfull (ft)</b>	0.5
<b>W/D Ratio</b>	13.3
<b>Entrenchment Ratio</b>	2.2+
<b>Bank Height Ratio</b>	1.0
<b>Stream Type</b>	C

**Figure 5I. Cross-Section Plots**

**UT1B, Cross-Section 12 (Pool)**

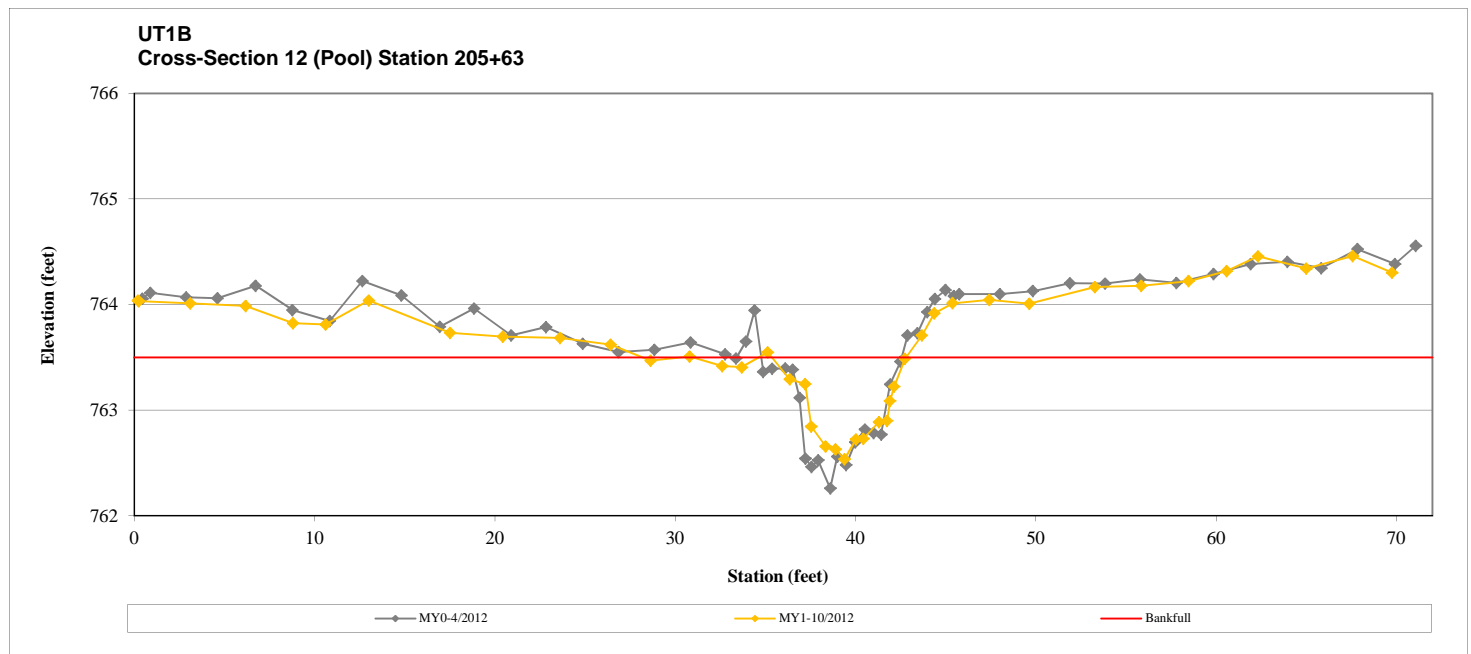
Summary Data	
<b>Bankfull Elevation (ft)</b>	763.5
<b>Bankfull Cross-Sectional Area (ft<sup>2</sup>)</b>	4.0
<b>Bankfull Width (ft)</b>	7.4
<b>Flood Prone Area Elevation (ft)</b>	N/A
<b>Flood Prone Width (ft)</b>	N/A
<b>Max Depth at Bankfull (ft)</b>	1.0
<b>Mean Depth at Bankfull (ft)</b>	0.5
<b>W/D Ratio</b>	13.9
<b>Entrenchment Ratio</b>	N/A
<b>Bank Height Ratio</b>	1.0
<b>Stream Type</b>	N/A

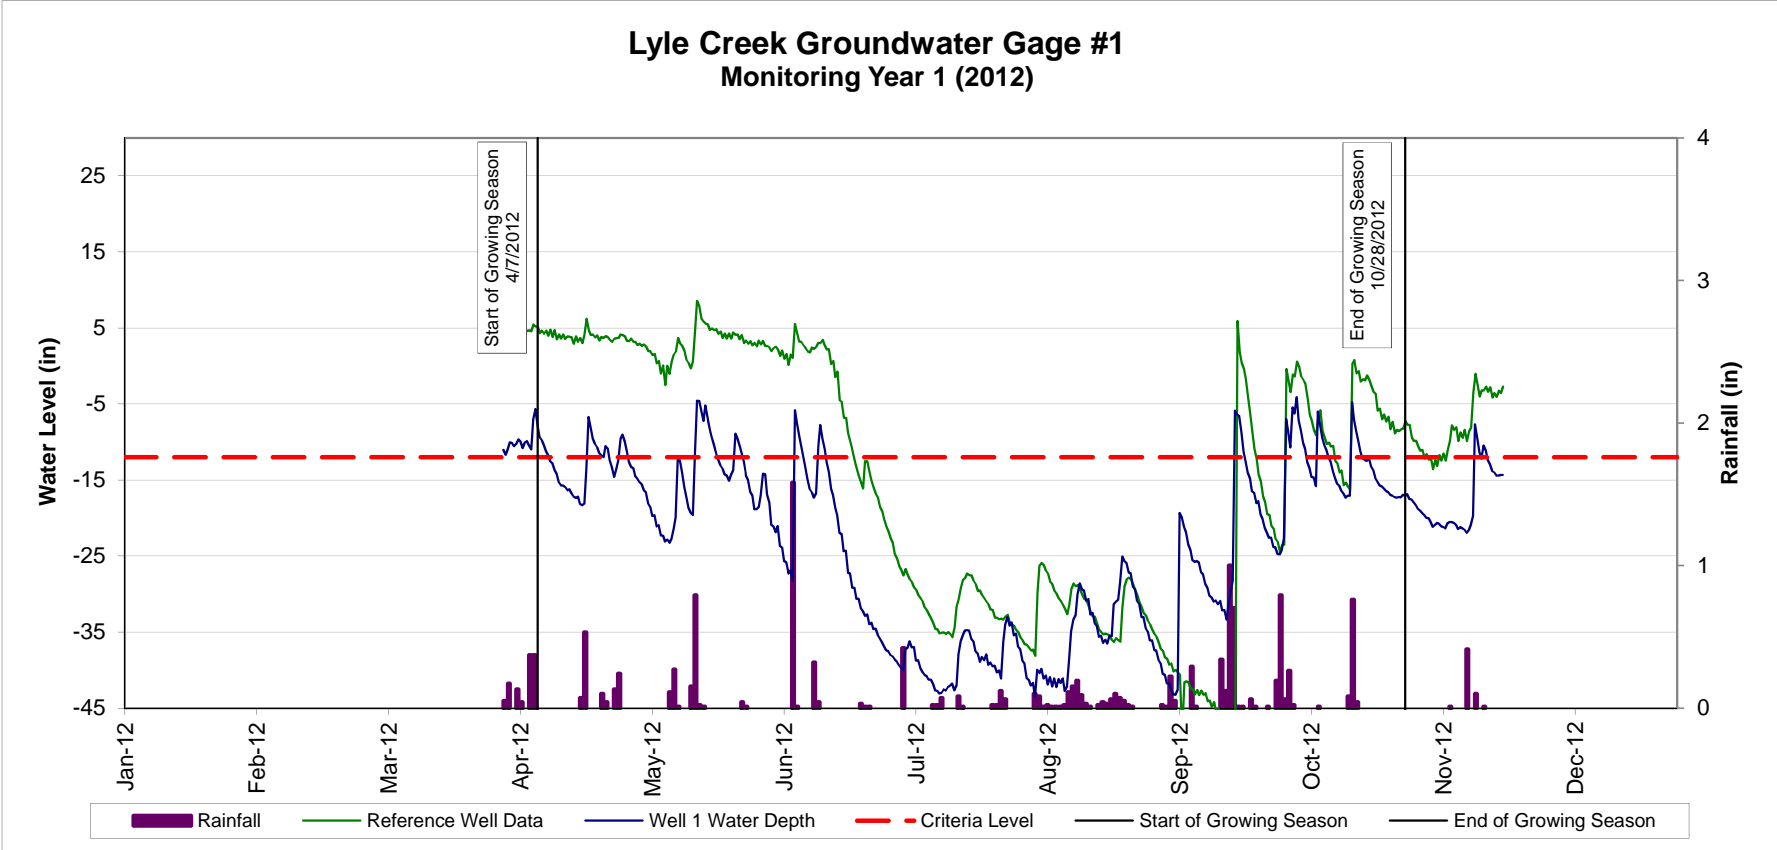
**Appendix 5. Hydrology Summary Data and Plots**  
**Figure 6a. Groundwater Gage Plots**  
**Lyle Creek Mitigation Site (EEP Project No. 94643)**  
**Wetland RW1**  
**Monitoring Year 1**

Summary of Groundwater Gage Results for Years 1 through 7							
Gage	Success Criteria Achieved/Max Consecutive Days During Growing Season (Percentage)						
	Year 1 (2012)	Year 2 (2013)	Year 3 (2014)	Year 4 (2015)	Year 5 (2016)	Year 6 (2017)	Year 7 (2018)
1	No/5 Days (2.5 %)						
2	No/0 Days (0 %)						
3	Yes/29 Days (14 %)						
4	Yes/27 Days (13 %)						
5	No/11 Days (5 %)						
6	No/5 Days (2.5 %)						
7	Yes/22 Days (11 %)						
8	No/12 Days (6 %)

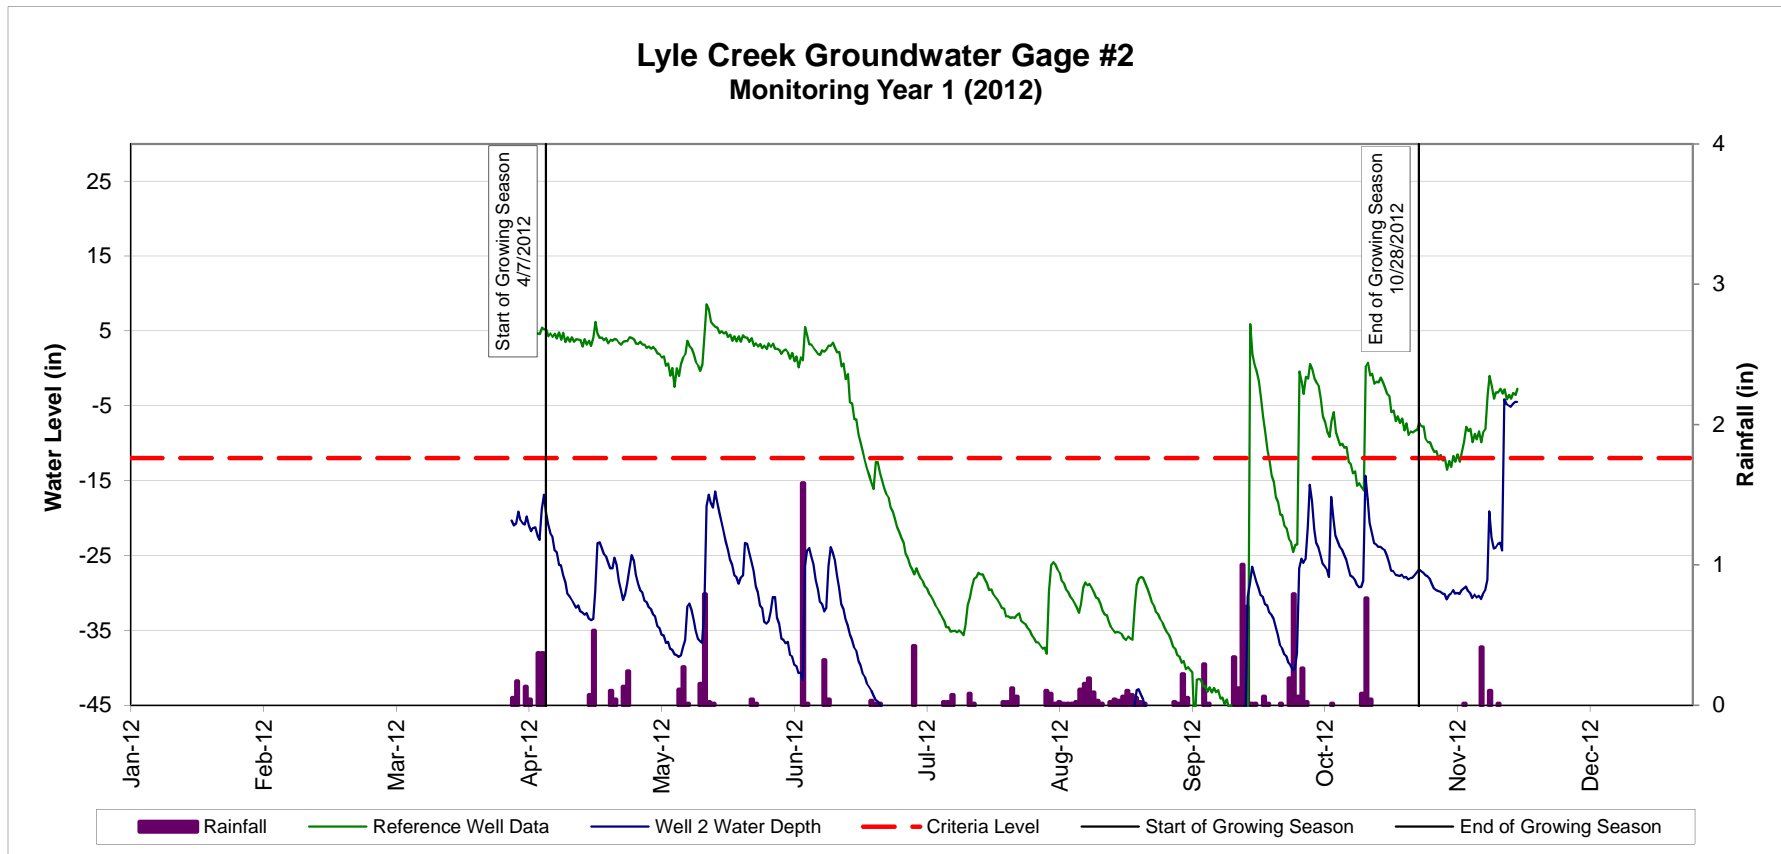
**Appendix 5. Hydrology Summary Data and Plots**  
**Figure 6b. Groundwater Gage Plots**  
**Lyle Creek Mitigation Site (EEP Project No. 94643)**  
**Wetland RW1**  
**Monitoring Year 1**

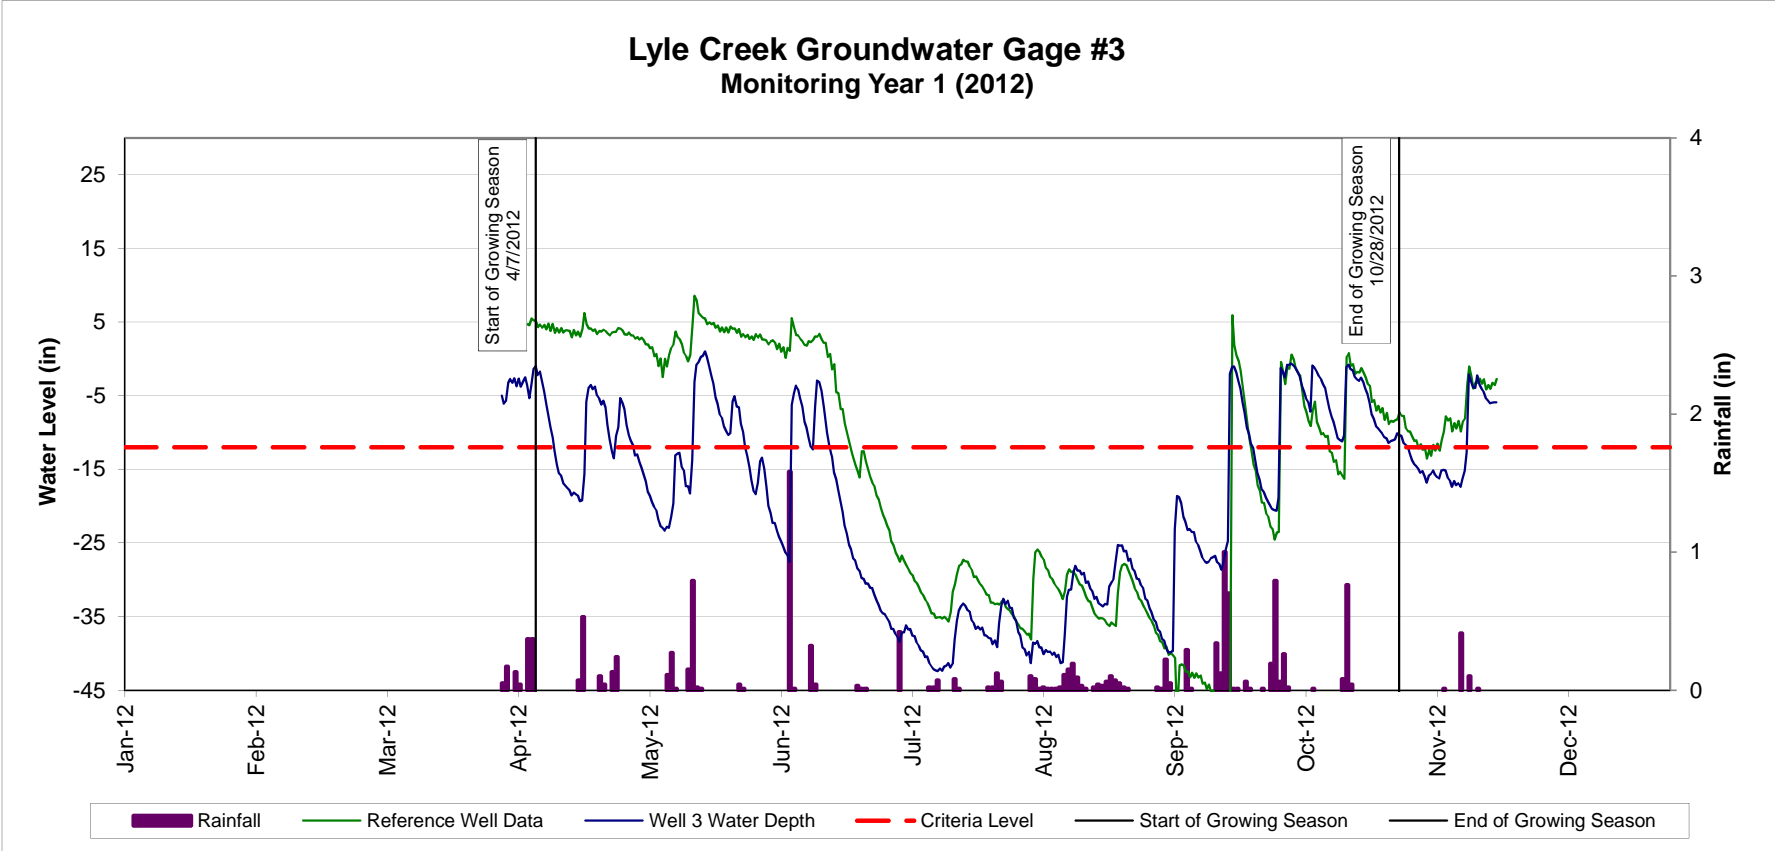
**Appendix 5. Hydrology Summary Data and Plots**  
**Figure 6c. Groundwater Gage Plots**  
**Lyle Creek Mitigation Site (EEP Project No. 94643)**  
**Wetland RW1**  
**Monitoring Year 1**

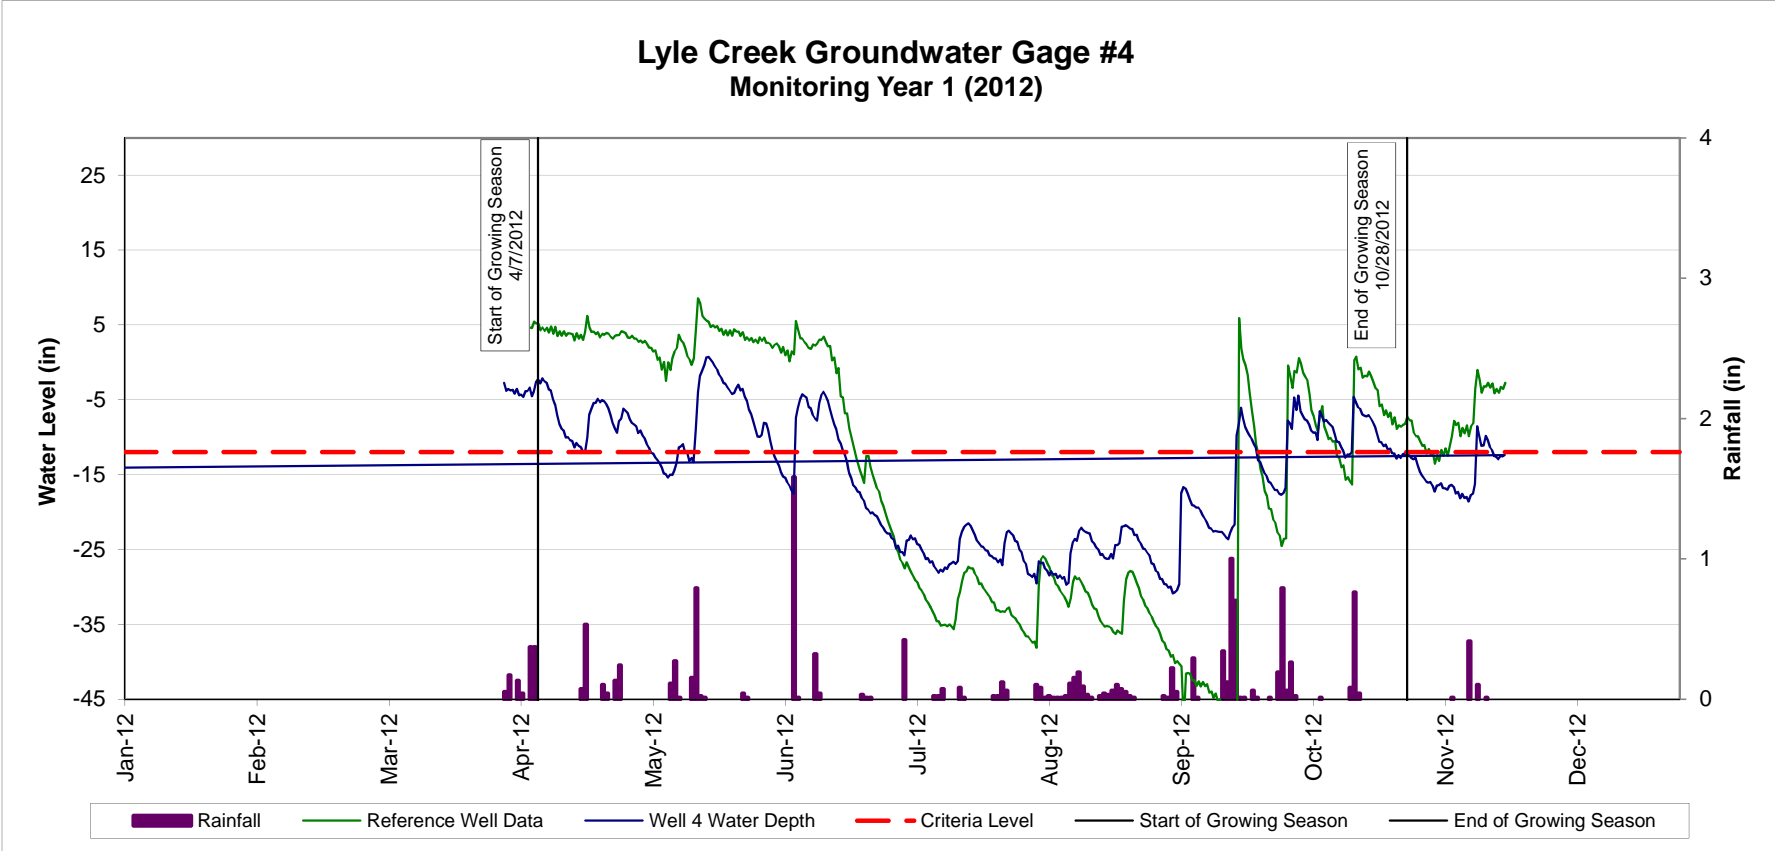
**Appendix 5. Hydrology Summary Data and Plots**  
**Figure 6d. Groundwater Gage Plots**  
**Lyle Creek Mitigation Site (EEP Project No. 94643)**  
**Wetland RW1**  
**Monitoring Year 1**

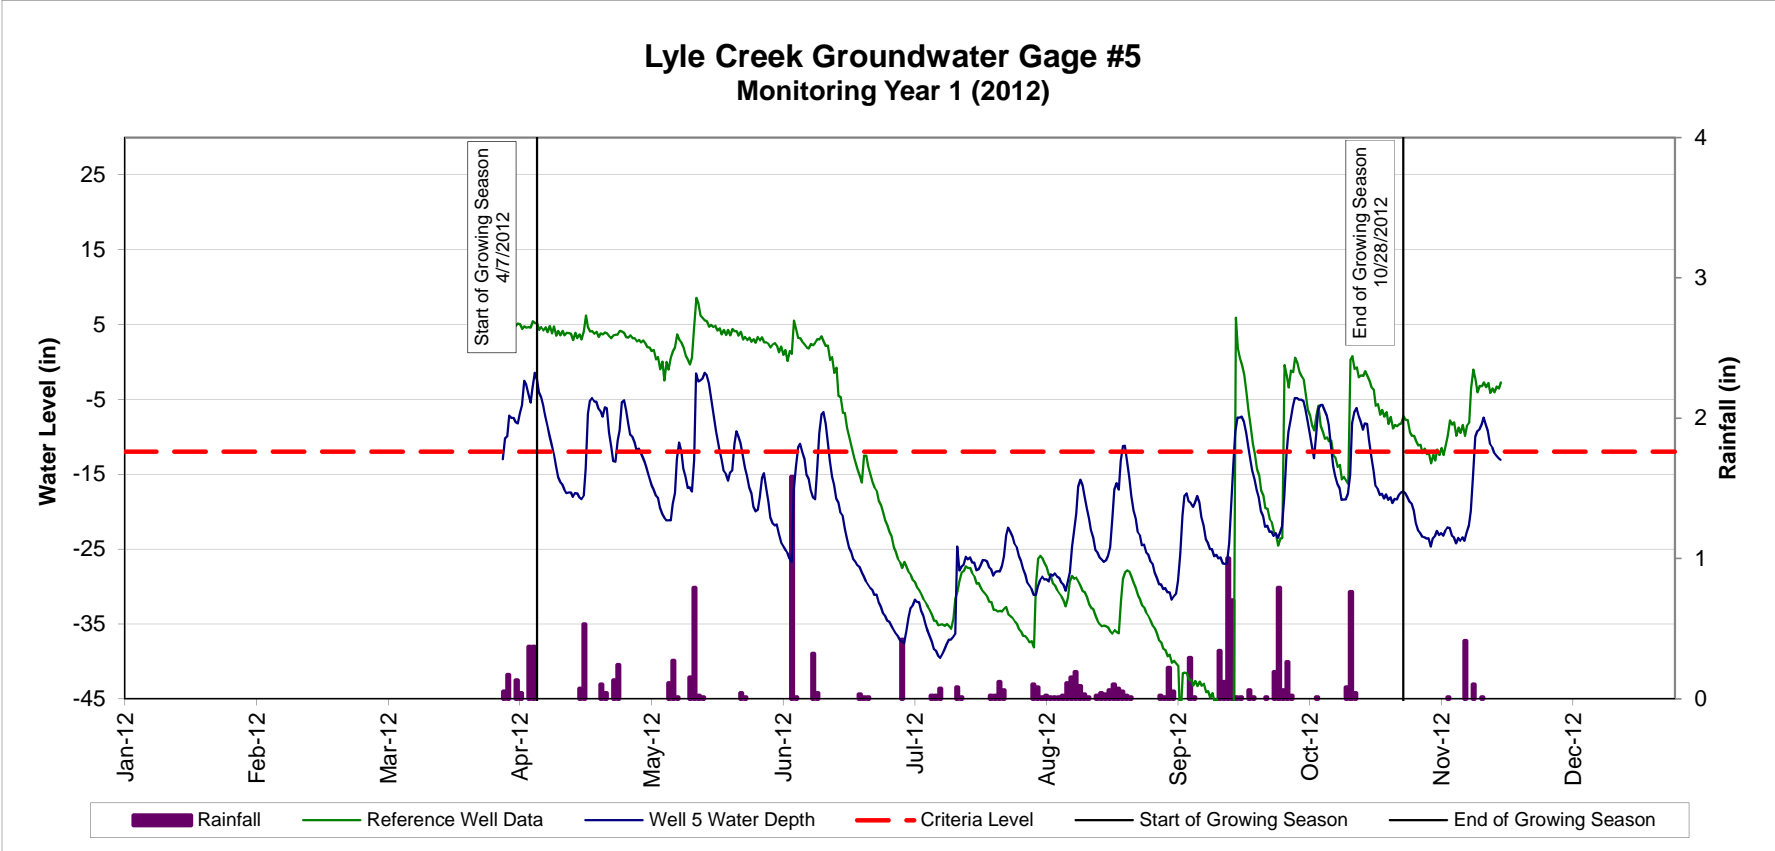
**Appendix 5. Hydrology Summary Data and Plots**  
**Figure 6e. Groundwater Gage Plots**  
**Lyle Creek Mitigation Site (EEP Project No. 94643)**  
**Wetland RW1**  
**Monitoring Year 1**

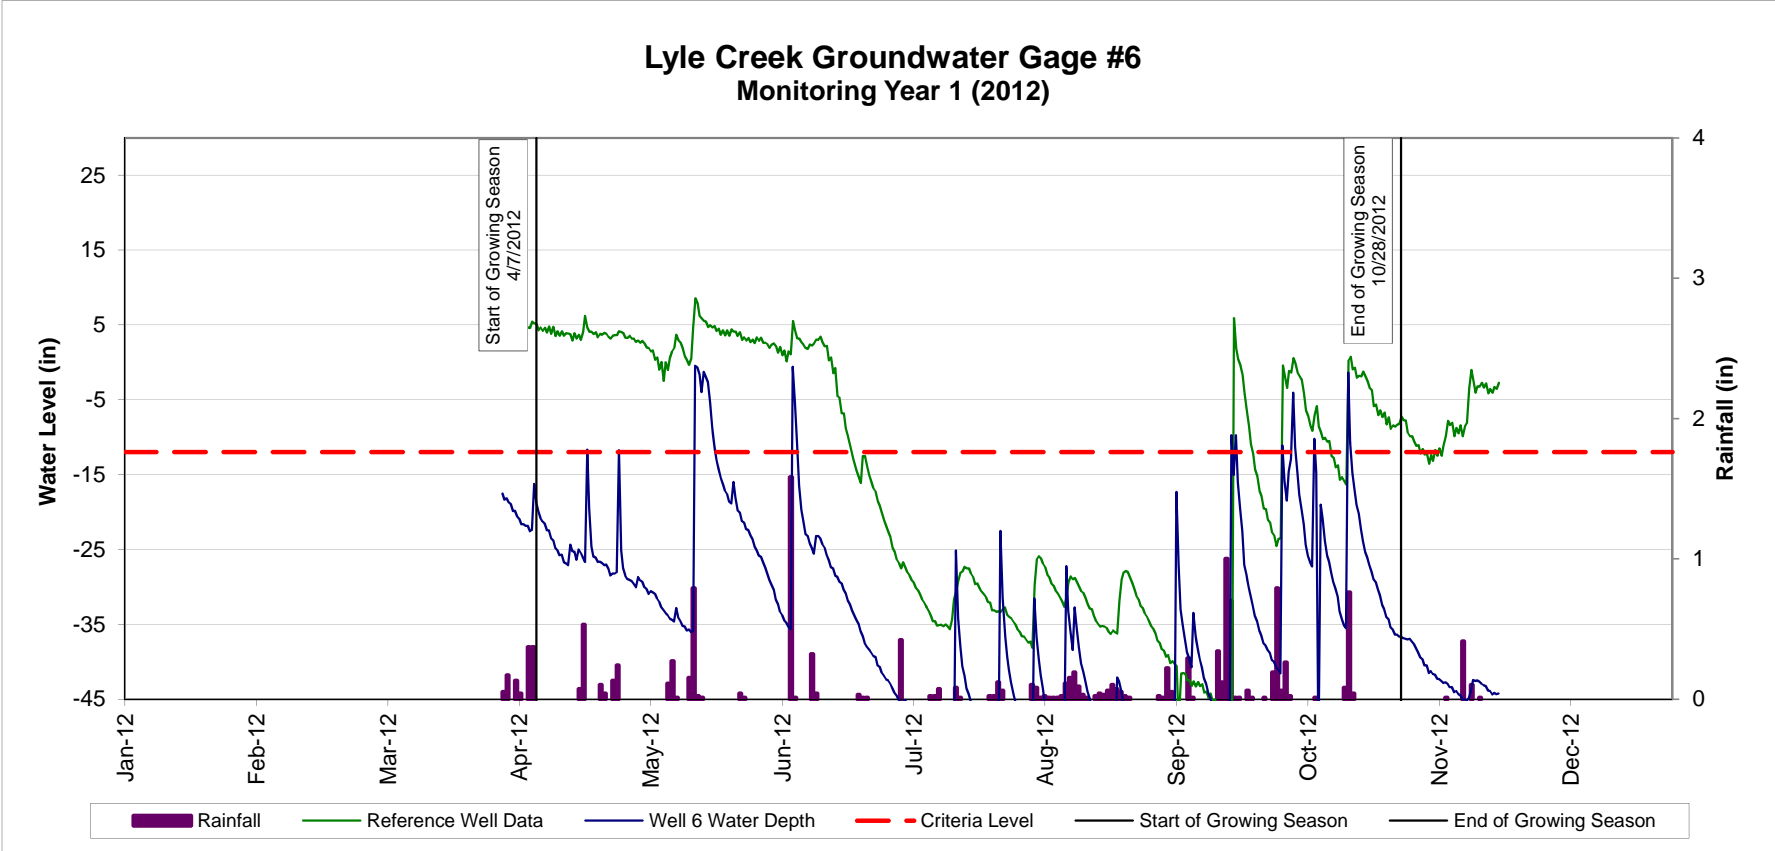
**Appendix 5. Hydrology Summary Data and Plots**  
**Figure 6f. Groundwater Gage Plots**  
**Lyle Creek Mitigation Site (EEP Project No. 94643)**  
**Wetland RW2**  
**Monitoring Year 1**

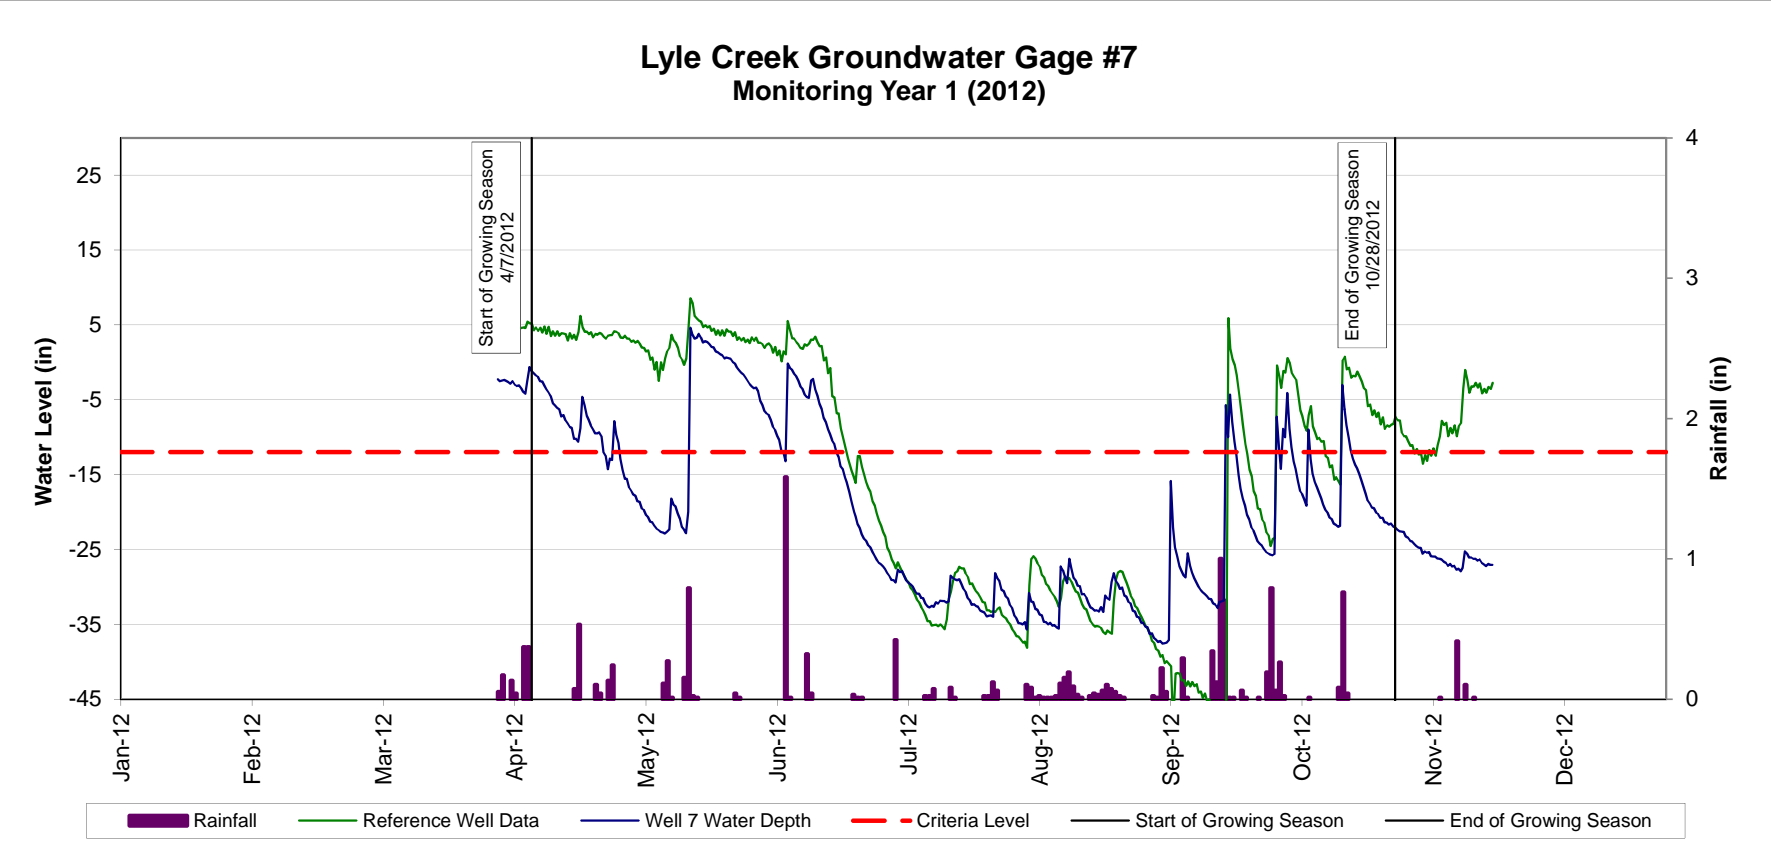
**Appendix 5. Hydrology Summary Data and Plots**  
**Figure 6g. Groundwater Gage Plots**  
**Lyle Creek Mitigation Site (EEP Project No. 94643)**  
**Wetland RW2**  
**Monitoring Year 1**

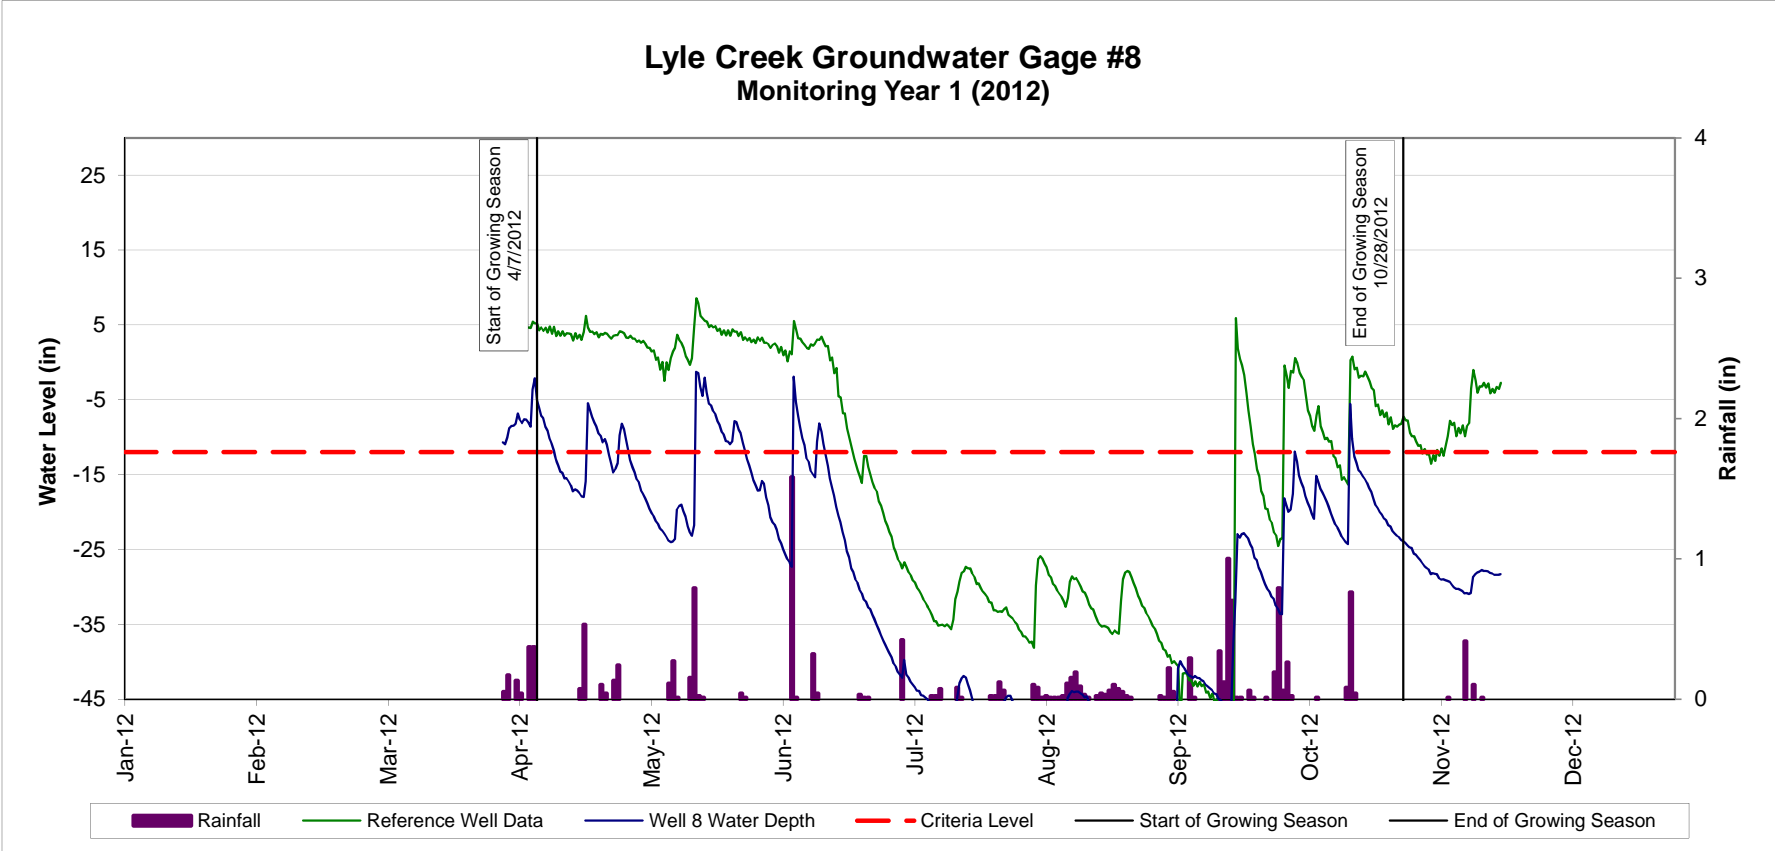
**Appendix 5. Hydrology Summary Data and Plots**  
**Figure 6h. Groundwater Gage Plots**  
**Lyle Creek Mitigation Site (EEP Project No. 94643)**  
**Wetland RW2**  
**Monitoring Year 1**
