**LYLE CREEK MITIGATION SITE**  
*Catawba County, NC*  
*DENR Contract 003241*  
*NCEEP Project Number 94643*

**Monitoring Year 1 Annual Report**  
**FINAL**

# LYLE CREEK MITIGATION SITE Monitoring Year 1 Annual Report

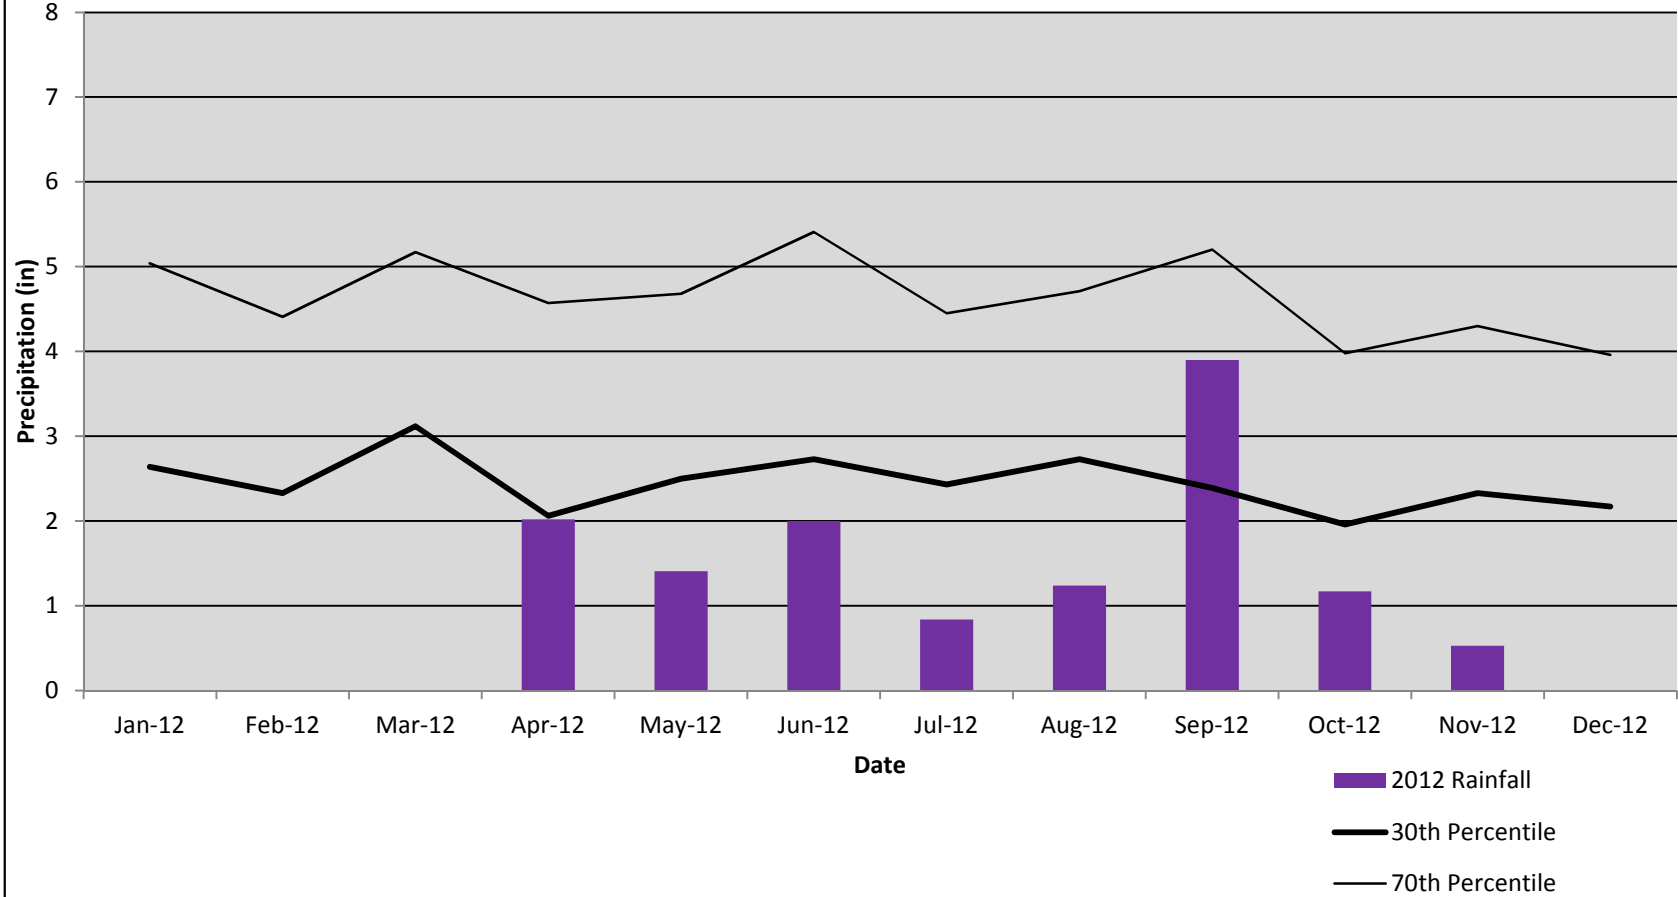
Figure 7. Lyle Creek 30-70 Percentile Graph for Rainfal in 2012 Catawba, NC

<sup>1</sup> 2012 rainfall collected by onsite rainfall gage.

<sup>2</sup> 30th and 70th percentile rainfall data collected from weather station Catawba 3 NNW, NC1579 (USDA, 2002)
