BASELINE MONITORING DOCUMENT AND AS-BUILT BASELINE REPORT

MANEY FARM MITIGATION PROJECT

Chatham County, NC
NCDEQ Contract No. 005793
DMS ID No. 96314

Wildlands Engineering, Inc.
312 West Millbrook Road, Suite 225
Raleigh, NC 27609

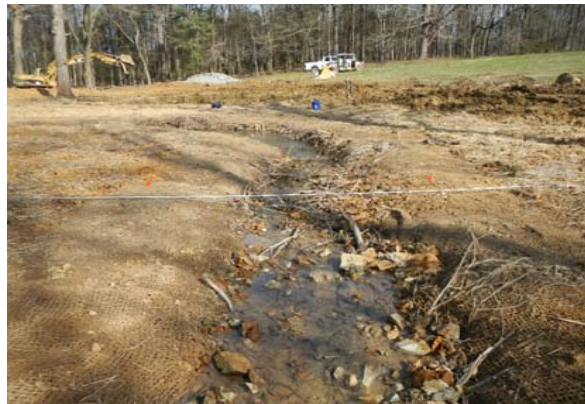
Cross Section 1, UTSF Reach 1

5.3	x-section area (ft.sq.)
8.8	width (ft)
0.6	mean depth (ft)
1.0	max depth (ft)
9.1	wetted parameter (ft)
0.6	hydraulic radius (ft)
14.6	width-depth ratio
85.0	W flood prone area (ft)
9.7	entrenchment ratio
1.0	low bank height ratio

View Downstream

The MYO dimension numbers fall within standard ranges as compared to the design parameters. Variations are primarily associated with a wider constructed bankfull width as reflected in the cross sections. It is expected that over time as vegetation is established, the channels may narrow more toward dimensions characteristic of an E channel. This narrowing over time would not be seen as an indicator of instability in and of itself. Summary data and cross section plots of each project reach can be found in Appendix 2.

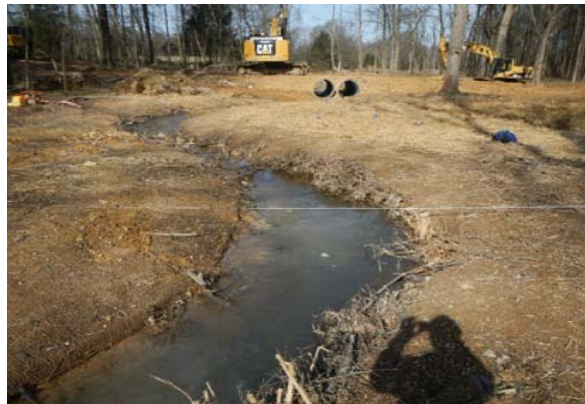
Cross Section 2, UTSF Reach 1

13.6	x-section area (ft.sq.)
11.1	width (ft)
1.2	mean depth (ft)
2.6	max depth (ft)
12.5	wetted parameter (ft)
1.1	hydraulic radius (ft)
9.1	width-depth ratio
---	W flood prone area (ft)
---	entrenchment ratio
1.0	low bank height ratio

View Downstream

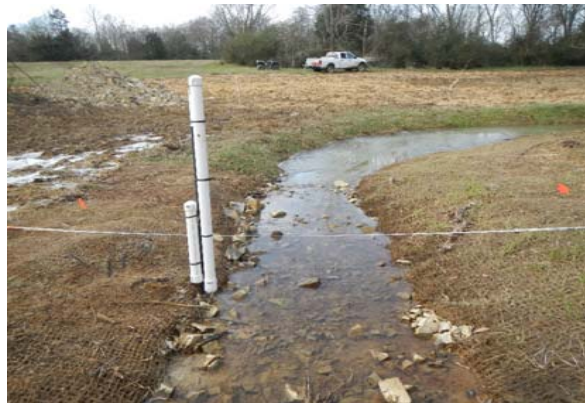
Cross Section 3, UTSF Reach 1

6.8	x-section area (ft.sq.)
9.3	width (ft)
0.7	mean depth (ft)
1.2	max depth (ft)
9.7	wetted parameter (ft)
0.7	hydraulic radius (ft)
12.8	width-depth ratio
85.0	W flood prone area (ft)
9.1	entrenchment ratio
1.0	low bank height ratio

View Downstream

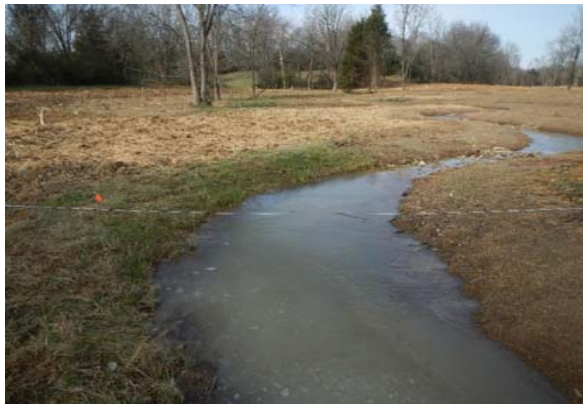
Cross Section 4, UTSF Reach 1

17.5	x-section area (ft.sq.)
14.8	width (ft)
1.2	mean depth (ft)
2.4	max depth (ft)
15.8	wetted parameter (ft)
1.1	hydraulic radius (ft)
12.6	width-depth ratio
---	W flood prone area (ft)
---	entrenchment ratio
1.0	low bank height ratio

View Downstream

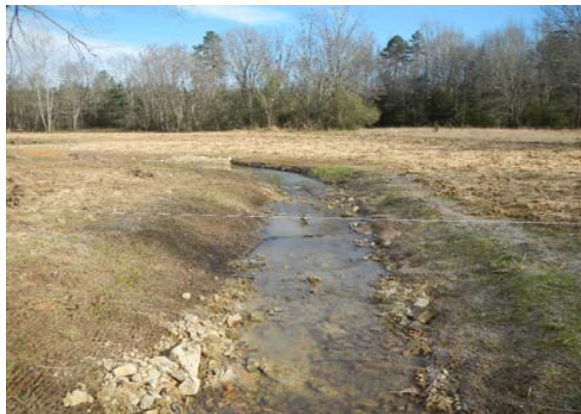
Cross Section 5, UTSF Reach 2

11.0	x-section area (ft.sq.)
12.7	width (ft)
0.9	mean depth (ft)
1.4	max depth (ft)
13.1	wetted parameter (ft)
0.8	hydraulic radius (ft)
14.5	width-depth ratio
150.0	W flood prone area (ft)
11.8	entrenchment ratio
1.0	low bank height ratio

View Downstream

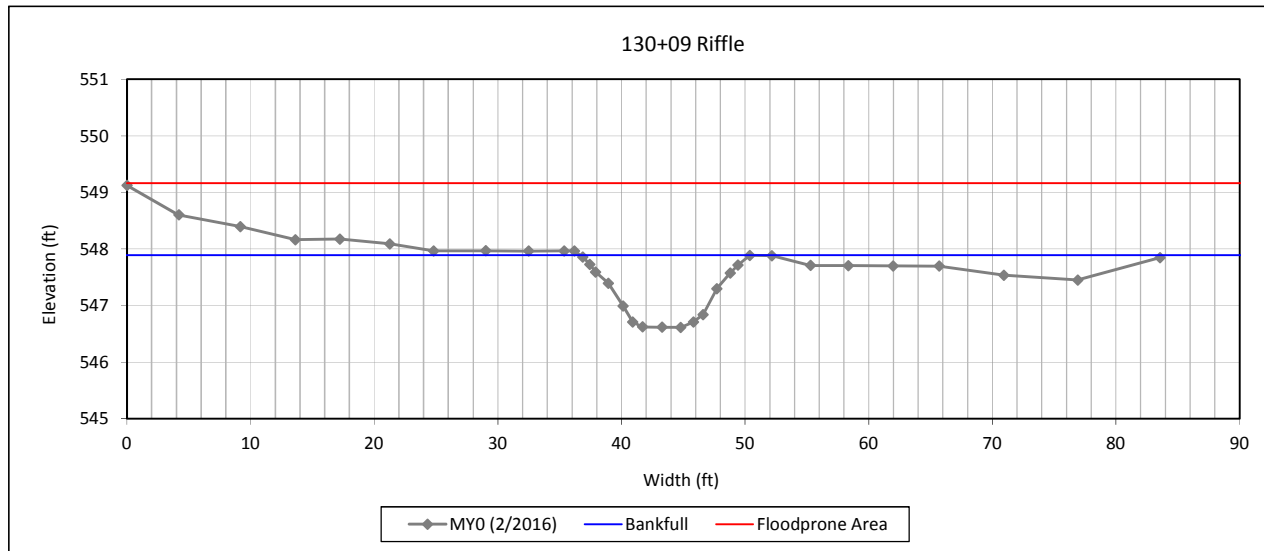
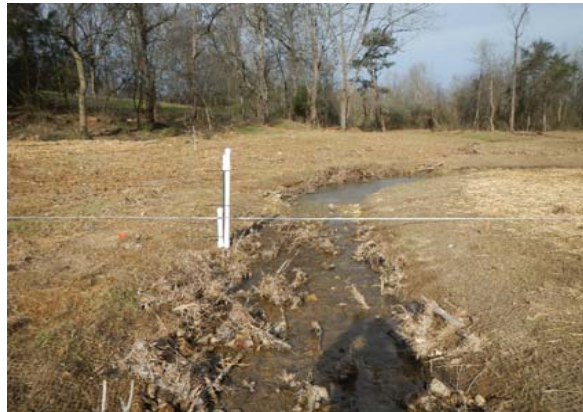
Cross Section 6, UTSF Reach 2

10.9	x-section area (ft.sq.)
13.7	width (ft)
0.8	mean depth (ft)
1.3	max depth (ft)
14.1	wetted parameter (ft)
0.8	hydraulic radius (ft)
17.3	width-depth ratio
150.0	W flood prone area (ft)
10.9	entrenchment ratio
1.0	low bank height ratio

View Downstream

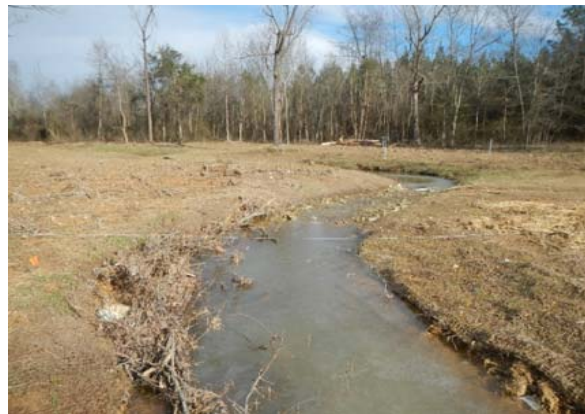
Cross Section 7, UTSF Reach 2

14.7	x-section area (ft.sq.)
12.3	width (ft)
1.2	mean depth (ft)
2.1	max depth (ft)
13.4	wetted parameter (ft)
1.1	hydraulic radius (ft)
10.3	width-depth ratio
---	W flood prone area (ft)
---	entrenchment ratio
1.0	low bank height ratio

View Downstream

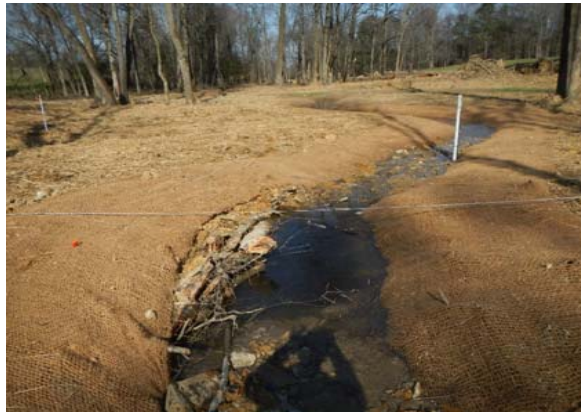
Cross Section 8, UT1C

7.7	x-section area (ft.sq.)
7.6	width (ft)
1.0	mean depth (ft)
2.0	max depth (ft)
8.9	wetted parameter (ft)
0.9	hydraulic radius (ft)
7.6	width-depth ratio
---	W flood prone area (ft)
---	entrenchment ratio
1.0	low bank height ratio

View Downstream

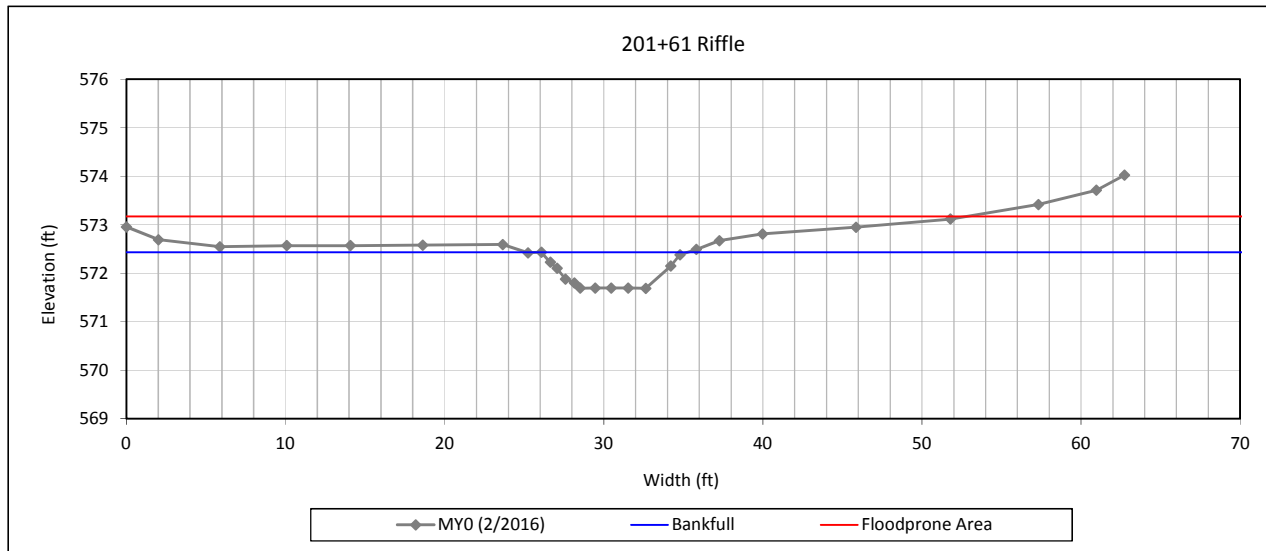
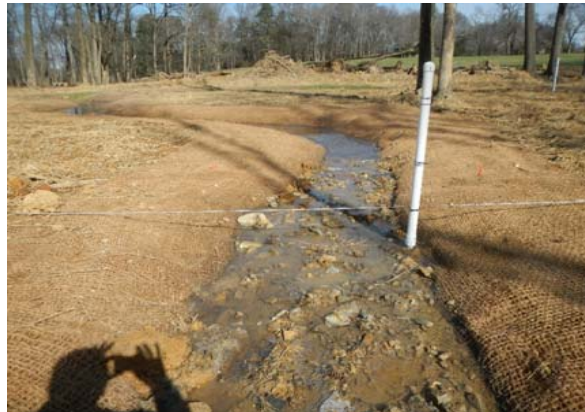
Cross Section 9, UT1C

4.9	x-section area (ft.sq.)
9.8	width (ft)
0.5	mean depth (ft)
0.7	max depth (ft)
10.0	wetted parameter (ft)
0.5	hydraulic radius (ft)
19.4	width-depth ratio
60.0	W flood prone area (ft)
6.1	entrenchment ratio
1.0	low bank height ratio

View Downstream

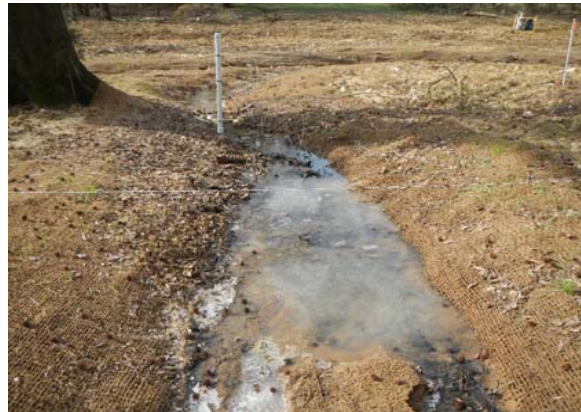
Cross Section 10, UT2B

8.6	x-section area (ft.sq.)
10.7	width (ft)
0.8	mean depth (ft)
1.5	max depth (ft)
11.1	wetted parameter (ft)
0.8	hydraulic radius (ft)
13.3	width-depth ratio
---	W flood prone area (ft)
---	entrenchment ratio
1.0	low bank height ratio

View Downstream

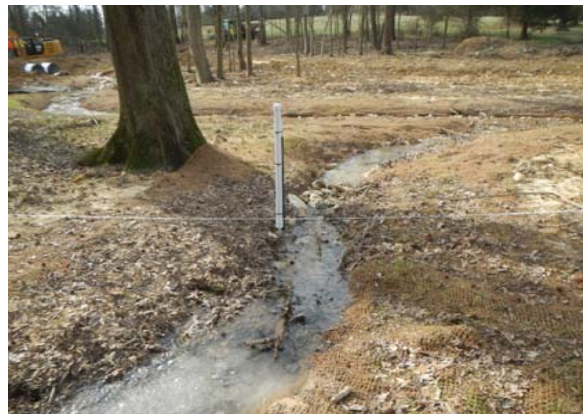
Cross Section 11, UT2B

2.3	x-section area (ft.sq.)
5.5	width (ft)
0.4	mean depth (ft)
0.7	max depth (ft)
5.8	wetted parameter (ft)
0.4	hydraulic radius (ft)
13.2	width-depth ratio
60.0	W flood prone area (ft)
10.8	entrenchment ratio
1.0	low bank height ratio

View Downstream

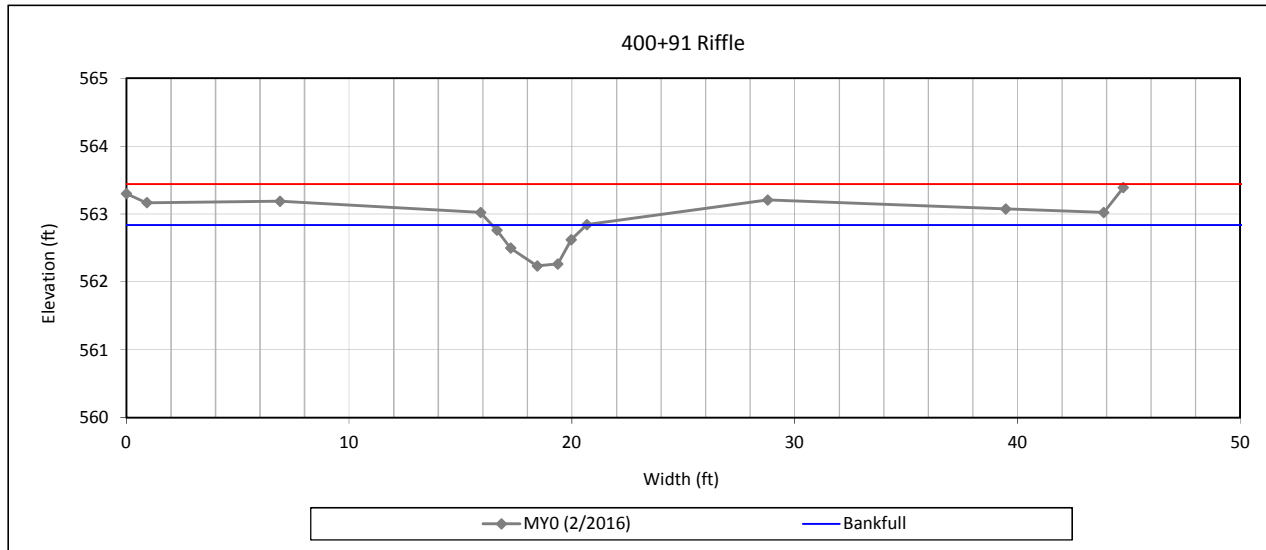
Cross Section 13, UT3B

Bankfull Dimensions

1.6	x-section area (ft.sq.)
4.2	width (ft)
0.4	mean depth (ft)
0.6	max depth (ft)
4.5	wetted parameter (ft)
0.3	hydraulic radius (ft)
11.6	width-depth ratio
60.0	W flood prone area (ft)
14.1	entrenchment ratio
1.0	low bank height ratio

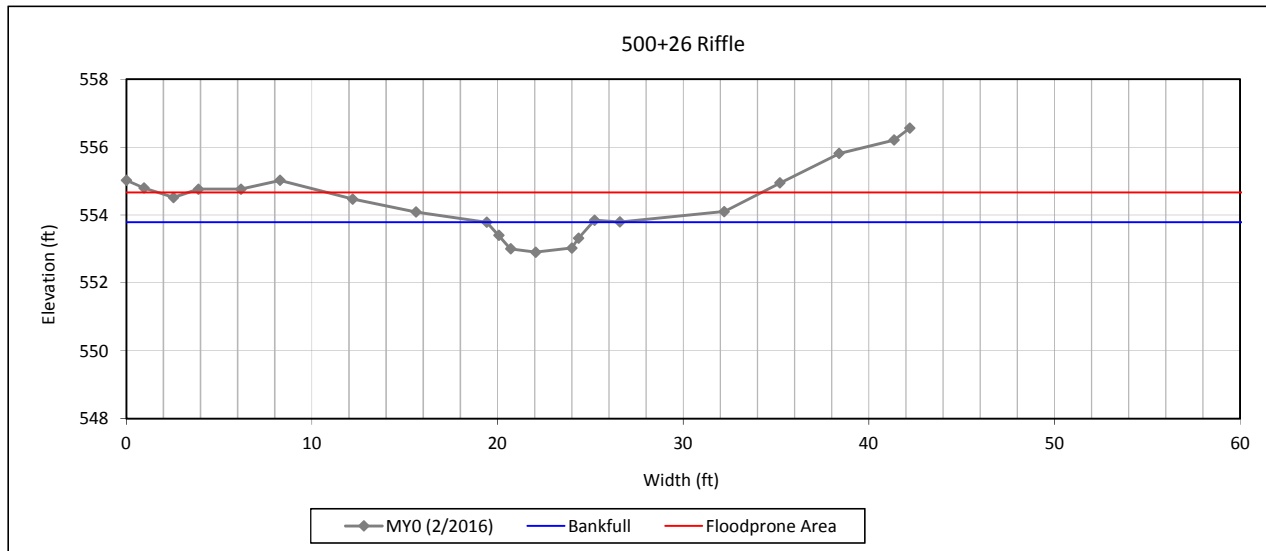
Cross Section 14, UT4B

Bankfull Dimensions

3.6	x-section area (ft.sq.)
5.7	width (ft)
0.6	mean depth (ft)
0.9	max depth (ft)
6.2	wetted parameter (ft)
0.6	hydraulic radius (ft)
9.1	width-depth ratio
25.0	W flood prone area (ft)
4.3	entrenchment ratio
1.0	low bank height ratio

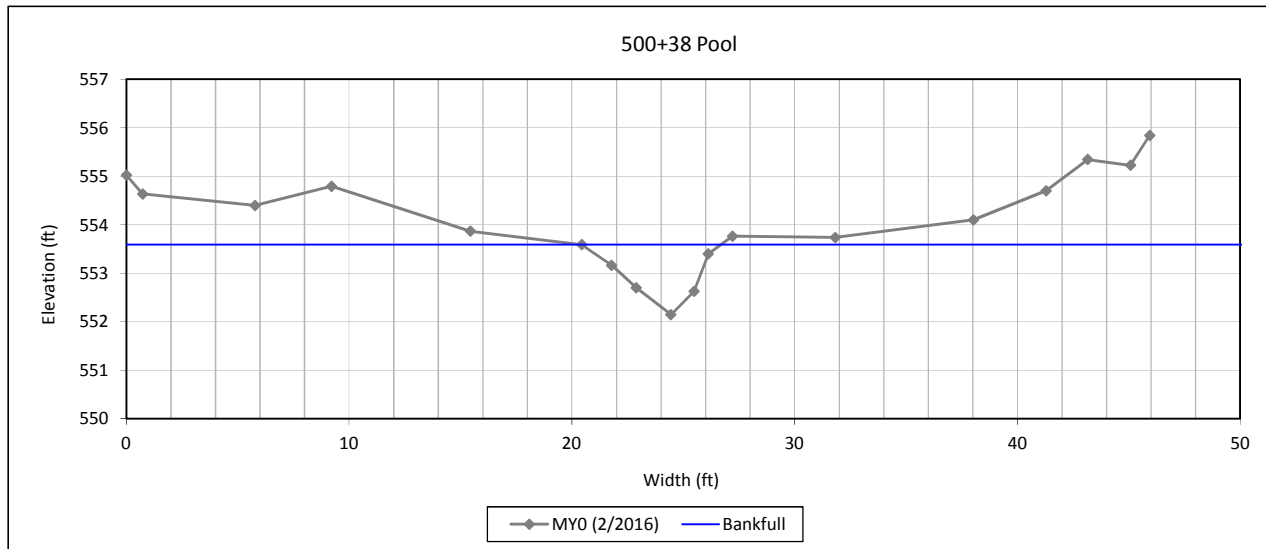
Cross Section 15, UT4B

Bankfull Dimensions

4.5	x-section area (ft.sq.)
6.3	width (ft)
0.7	mean depth (ft)
1.4	max depth (ft)
7.0	wetted parameter (ft)
0.6	hydraulic radius (ft)
8.7	width-depth ratio
---	W flood prone area (ft)
---	entrenchment ratio
1.0	low bank height ratio
