MONITORING YEAR 6 ANNUAL REPORT

MANEY FARM MITIGATION PROJECT

Chatham County, NC

DMS Project Number 96314

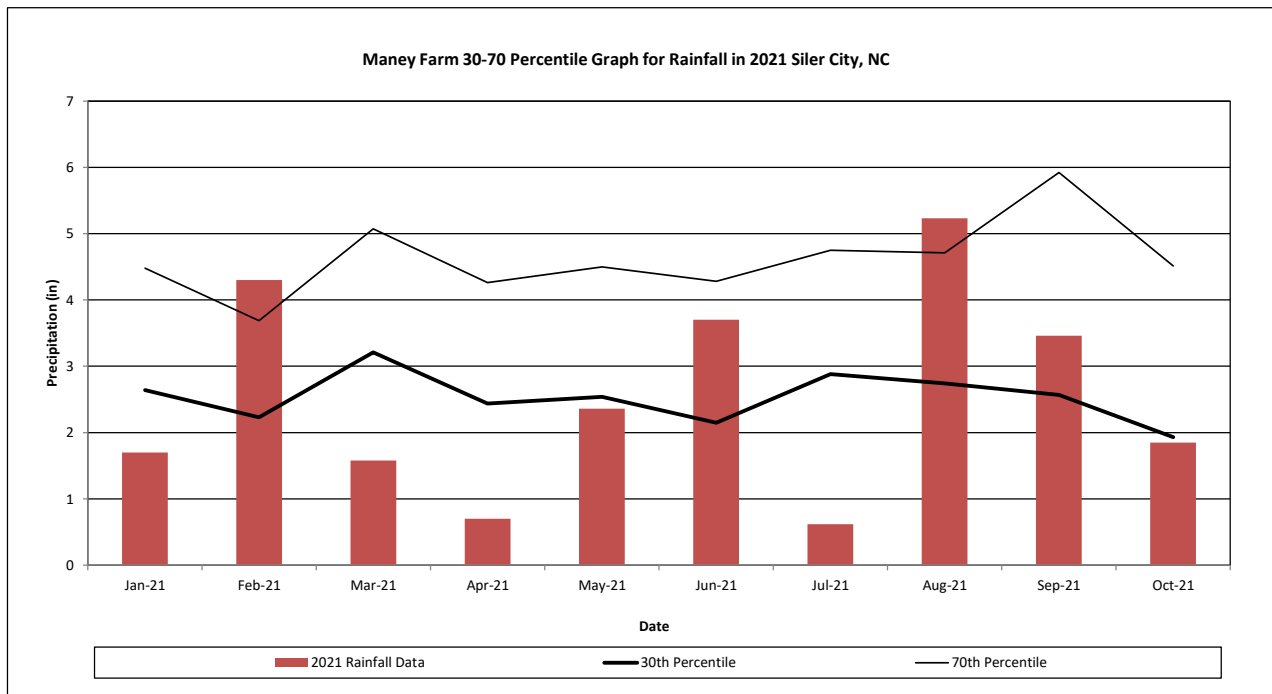
Monthly Rainfall Data

¹ 2021 monthly rainfall from USDA Station SILER CITY (317924)

² 30th and 70th percentile rainfall data collected from weather station Siler City 2 S, NC7924 (USDA, 2021).

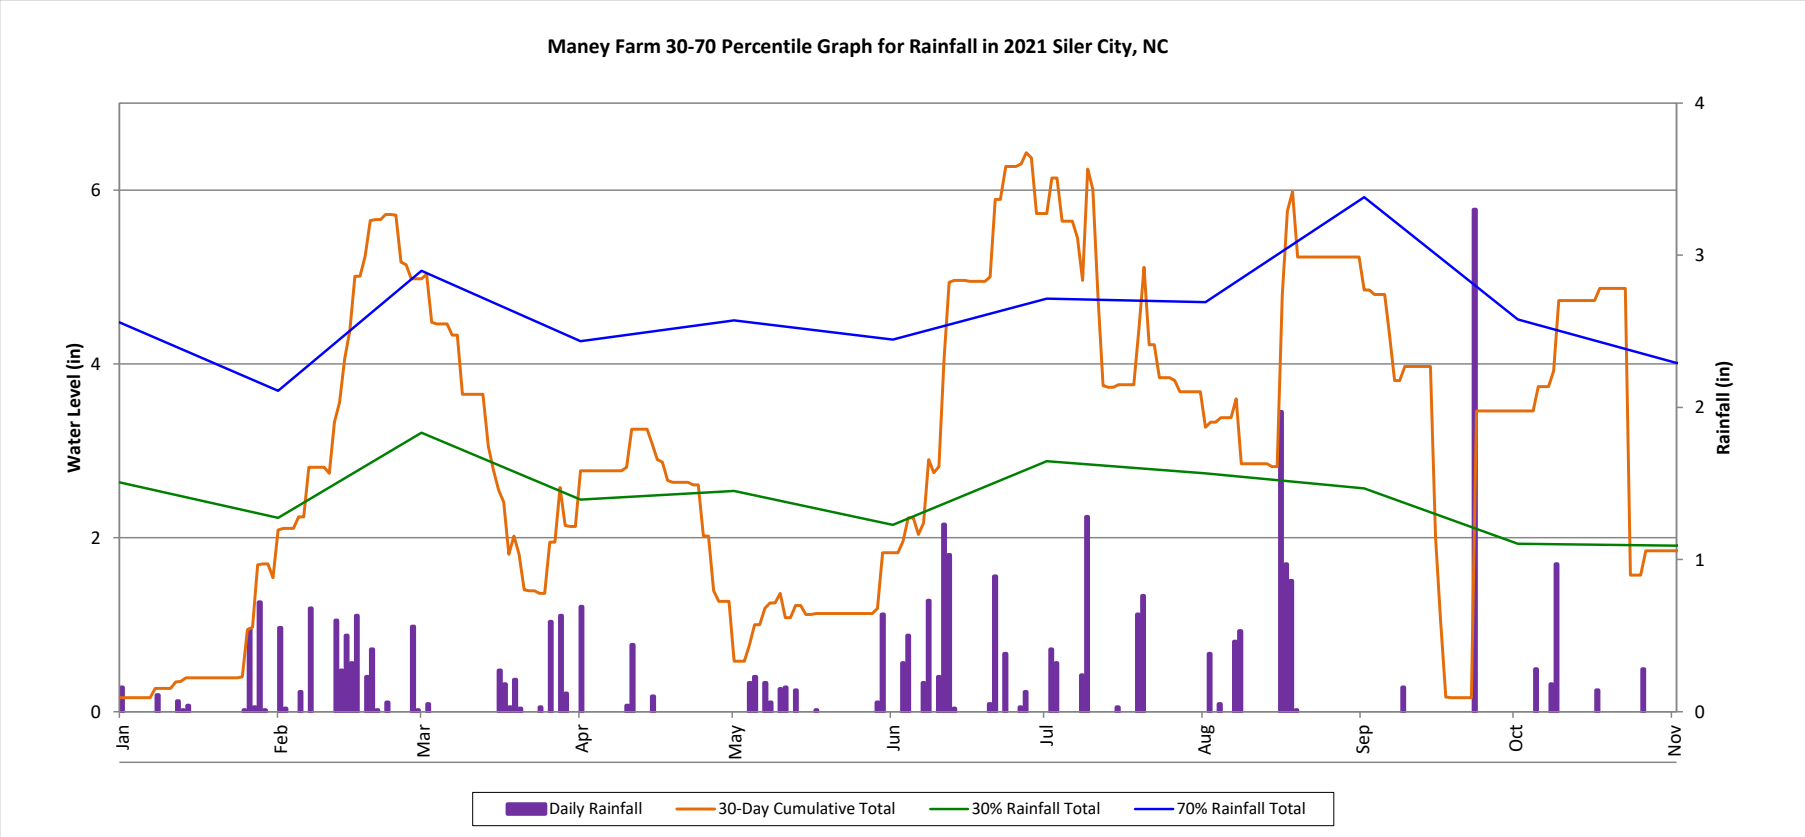
30-Day Cumulative Total Rainfall Data

¹ 2021 monthly rainfall from USDA Station SILER CITY (317924)

² 30th and 70th percentile rainfall data collected from weather station Siler City 2 S, NC7924 (USDA, 2021).
