# MONITORING YEAR 1 ANNUAL REPORT

## MARTIN DAIRY MITIGATION SITE

DMS Project Number 97087

Data Collection Period: March - October 2018

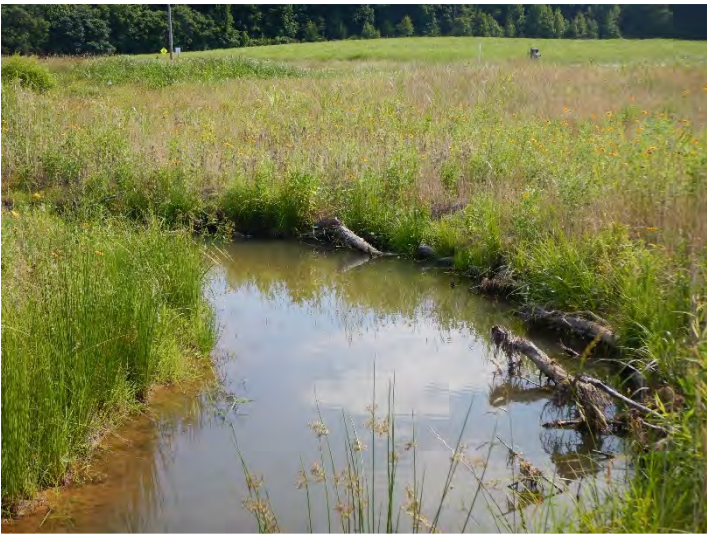
**PHOTO POINT 1 – looking upstream (6/6/2018)**

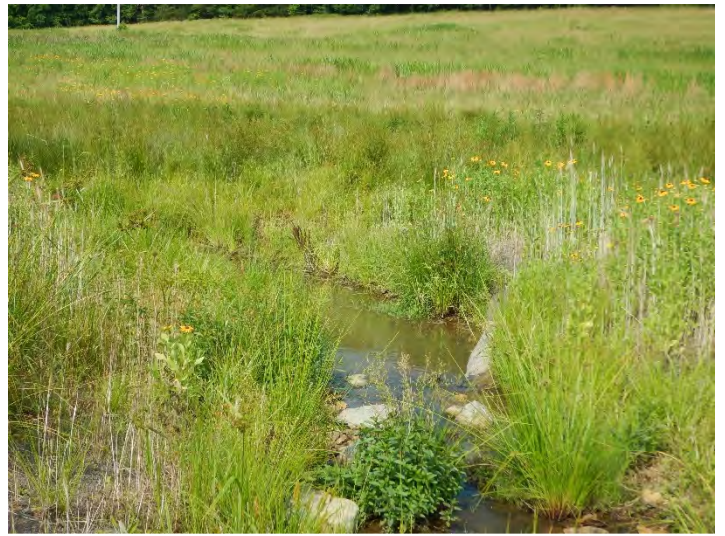
**PHOTO POINT 1 – looking downstream (6/6/2018)**

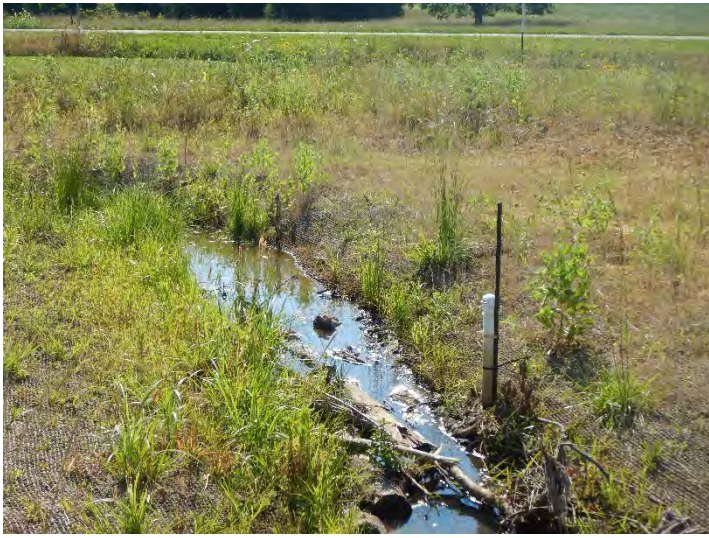
**PHOTO POINT 9 – looking upstream (6/6/2018)**

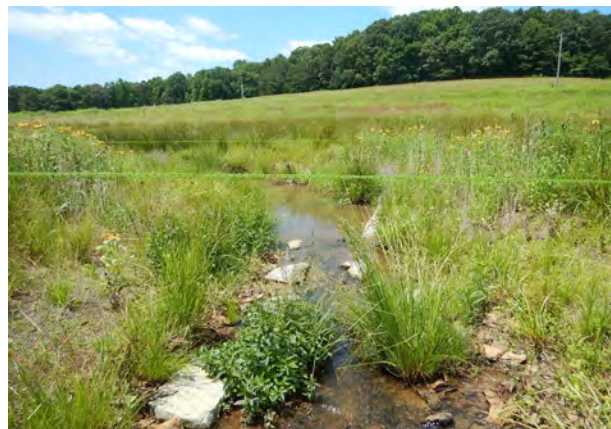
View Downstream

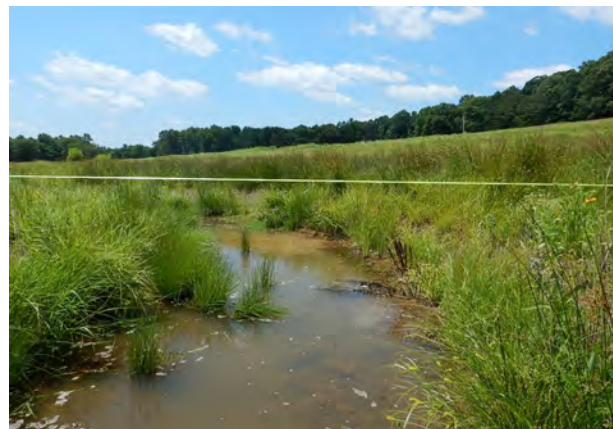
View Downstream

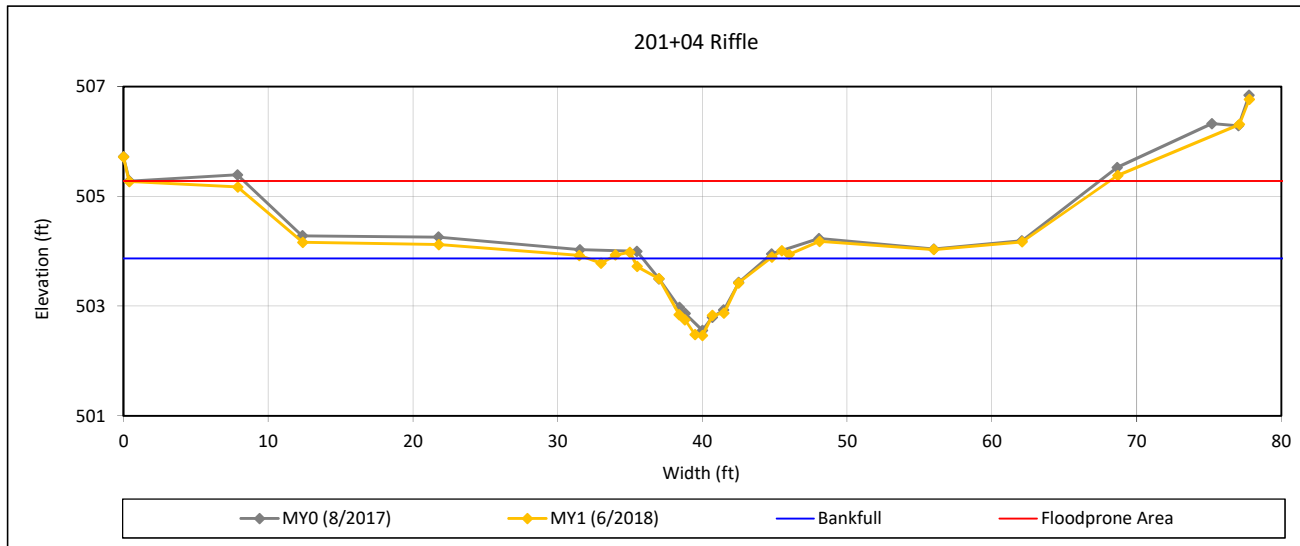
#### Cross-Section 5 UT1

#### Bankfull Dimensions

6.3	x-section area (ft.sq.)
9.5	width (ft)
0.7	mean depth (ft)
1.4	max depth (ft)
10.0	wetted perimeter (ft)
0.6	hydraulic radius (ft)
14.3	width-depth ratio
65.0	W flood prone area (ft)
6.8	entrenchment ratio
1.1	low bank height ratio

Survey Date: 6/2018

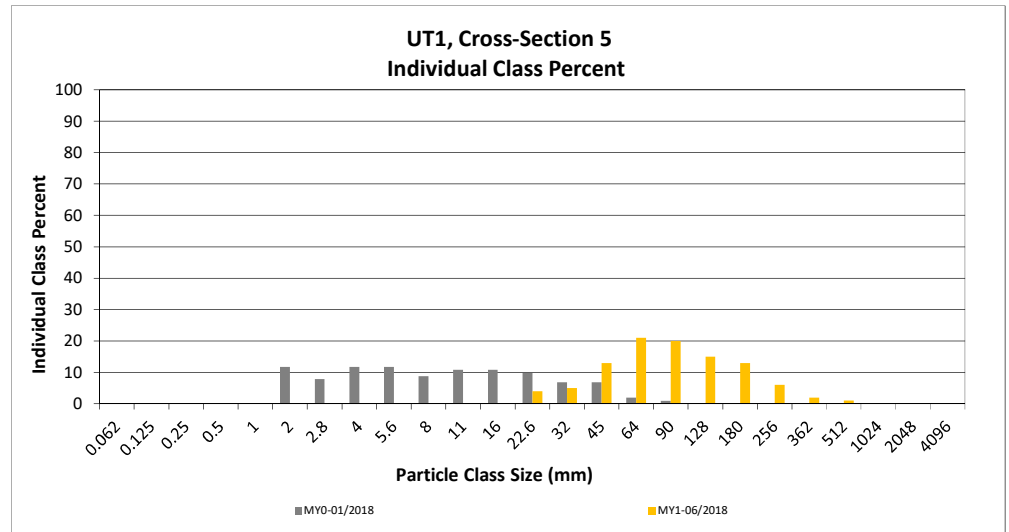
Particle Class		Diameter (mm)		Riffle 100-Count	Summary	
		min	max		Class Percentage	Percent Cumulative
<i>SILT/CLAY</i>	Silt/Clay	0.000	0.062			0
<i>SAND</i>	Very fine	0.062	0.125			0
	Fine	0.125	0.250			0
	Medium	0.25	0.50			0
	Coarse	0.5	1.0			0
	Very Coarse	1.0	2.0			0
<i>GRAVEL</i>	Very Fine	2.0	2.8			0
	Very Fine	2.8	4.0			0
	Fine	4.0	5.6			0
	Fine	5.6	8.0			0
	Medium	8.0	11.0			0
	Medium	11.0	16.0			0
	Coarse	16.0	22.6	4	4	4
	Coarse	22.6	32	5	5	9
	Very Coarse	32	45	13	13	22
	Very Coarse	45	64	21	21	43
<i>COBBLE</i>	Small	64	90	20	20	63
	Small	90	128	15	15	78
	Large	128	180	13	13	91
	Large	180	256	6	6	97
<i>BOULDER</i>	Small	256	362	2	2	99
	Small	362	512	1	1	100
	Medium	512	1024			100
	Large/Very Large	1024	2048			100
<i>BEDROCK</i>	Bedrock	2048	>2048			100
<b>Total</b>				<b>100</b>	<b>100</b>	<b>100</b>

Cross-Section 5 Channel materials (mm)	
D <sub>16</sub> =	38.45
D <sub>35</sub> =	55.96
D <sub>50</sub> =	72.1
D <sub>84</sub> =	149.8
D <sub>95</sub> =	227.6
D <sub>100</sub> =	512.0

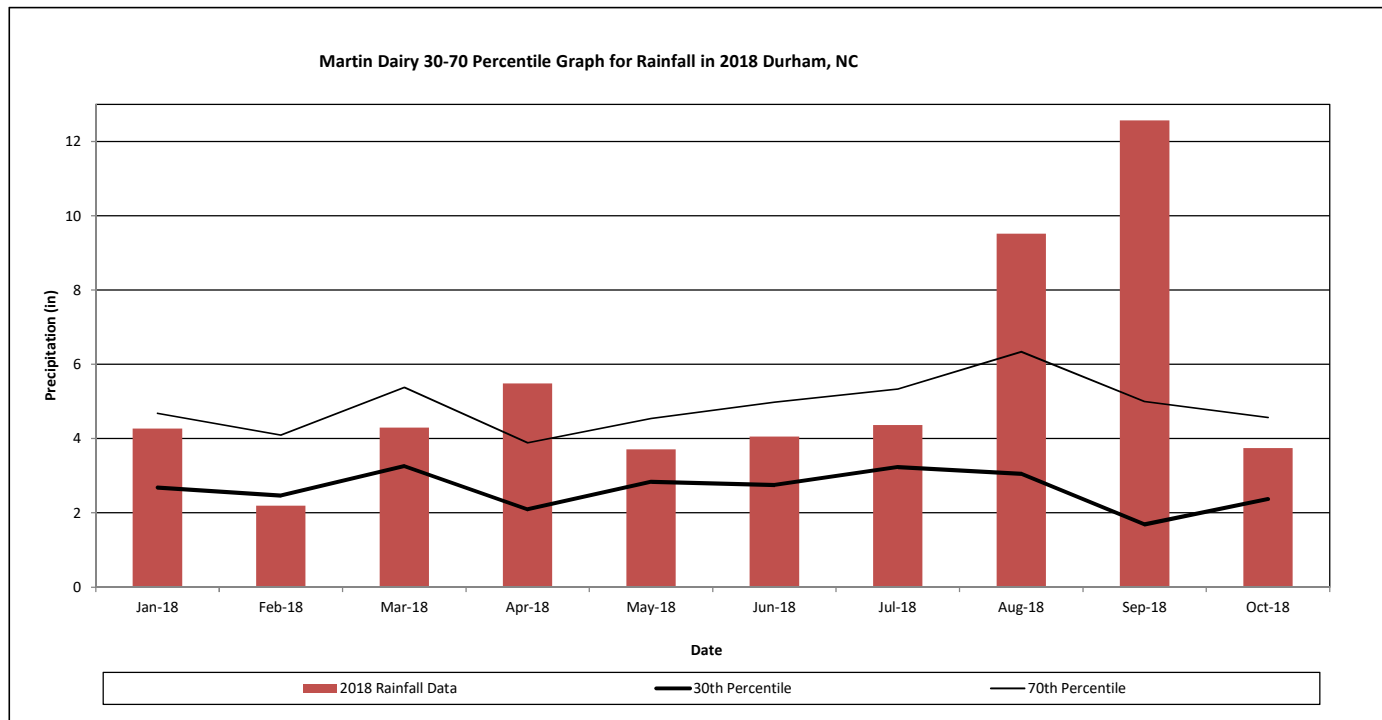
**Monthly Rainfall Data**

Martin Dairy Mitigation Site  
 DMS Project No. 97087  
**Monitoring Year 1 - 2018**

<sup>1</sup> 2018 monthly rainfall from USDA Station Durham 11 W

<sup>2</sup> 30th and 70th percentile rainfall data collected from weather station Chapel Hill 2 W, NC (USDA, 2018).
