FINAL
YEAR 1 (2014) ANNUAL MONITORING REPORT
MARTIN'S CREEK II MITIGATION PROJECT

Cherokee County, North Carolina
EEP Project No. 92633 (Contract No. 005717)
USACE Action ID No. SAW – 2009-00209/DWR Project No. 10-0952
SCO No. 08-07251-01

Data Collection – March-October 2014

Hiwassee River Basin
Cataloging Unit 06020002170010

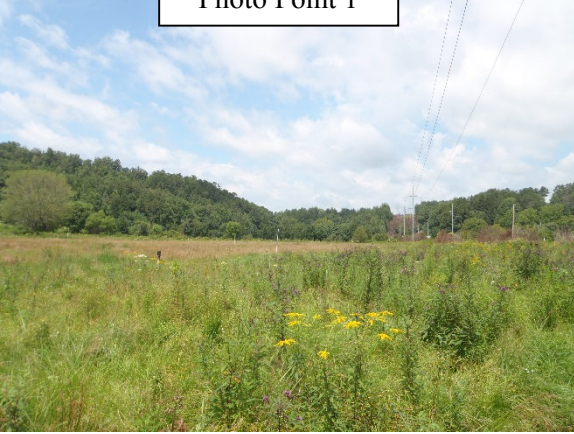
Photo Point 1

**Martin's Creek II
Year 1 Fixed Station Photographs
Taken August 2014**

Photographs will be used to evaluate channel aggradation or degradation, bank erosion, success of riparian vegetation, and effectiveness of erosion control measures subjectively. Lateral photos should not indicate excessive erosion or continuing degradation of the banks. A series of photos over time should indicate successive maturation of riparian vegetation.

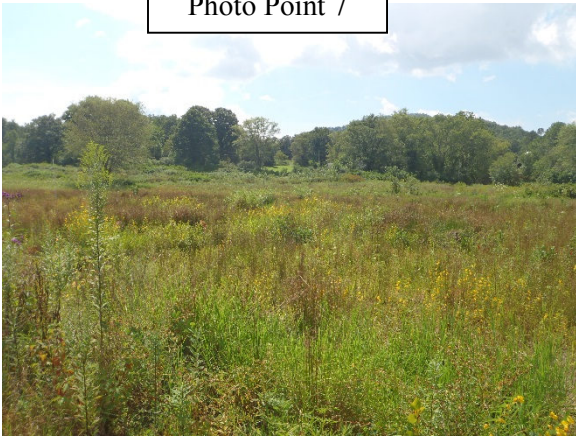
Photo Point 7

**Martin's Creek II
Year 1 Fixed Station Photographs (continued)
Taken August 2014**

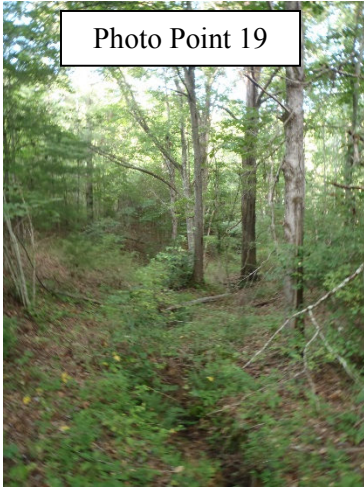
Photo Point 19

**Martin's Creek II
Year 1 Fixed Station Photographs (continued)
Taken August 2014**

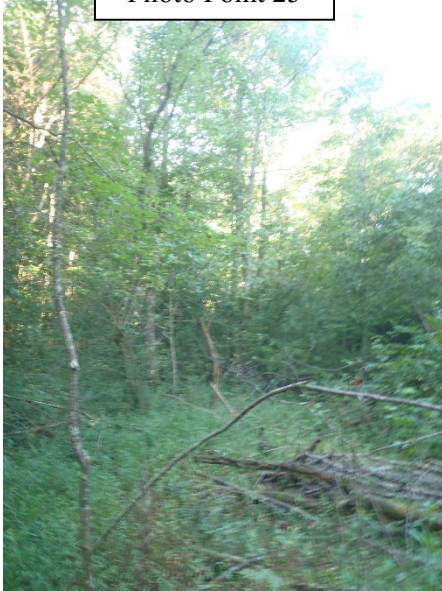
Photo Point 25

**Martin's Creek II
Year 1 Fixed Station Photographs (continued)
Taken August 2014**

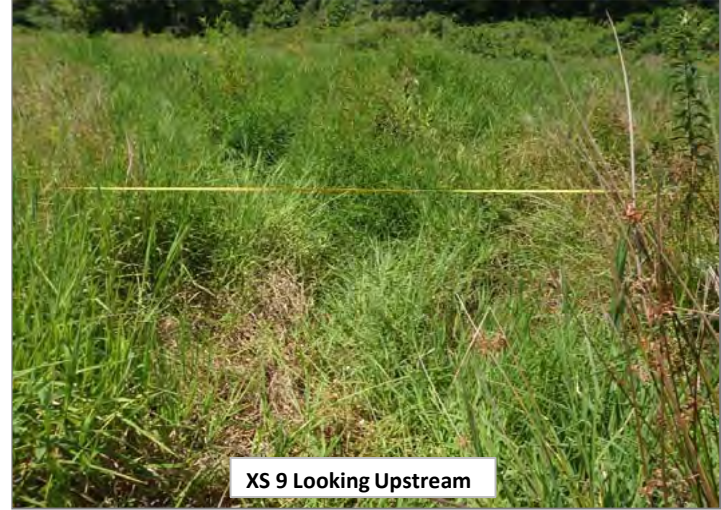
Site	Martins Creek II
Project Number:	92633
XS ID	XS - 9, Pool
Reach	UT 1- 3, Reach 2
Date:	9/10/2014
Field Crew:	Perkinson, Jernigan

Stream Type	E
-------------	---

SUMMARY DATA	
Bankfull Elevation:	101.1
Bankfull Cross-Sectional Area:	8.0
Bankfull Width:	10.6
Flood Prone Area Elevation:	NA
Flood Prone Width:	NA
Max Depth at Bankfull:	1.8
Mean Depth at Bankfull:	0.8
W / D Ratio:	NA
Entrenchment Ratio:	NA
Bank Height Ratio:	1.0

Station	Elevation
0.00	101.64
1.51	101.62
2.66	101.66
3.64	101.45
4.29	100.23
5.69	99.30
7.01	99.92
8.34	99.87
9.22	100.45
10.44	100.72
11.57	100.78
12.94	101.10
14.58	101.13

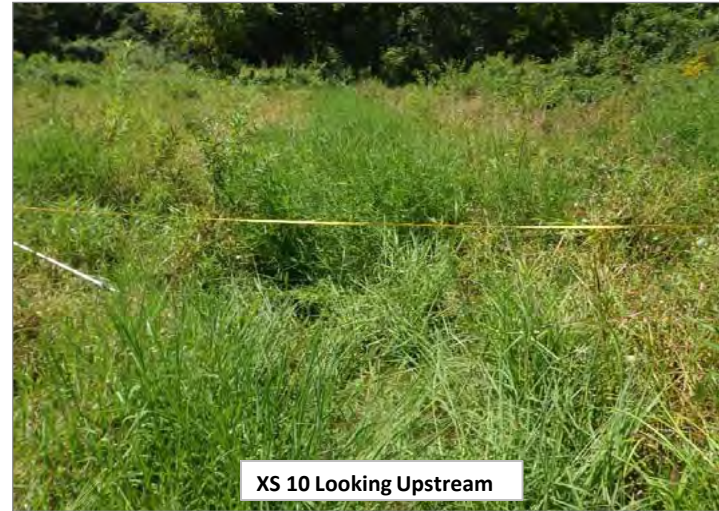
Site	Martins Creek II
Project Number:	92633
XS ID	XS - 10, Pool
Reach	UT 1-3, Reach 2
Date:	9/10/2014
Field Crew:	Perkinson, Jernigan

Stream Type	E
--------------------	---

Station	Elevation
0.30	105.75
1.46	105.78
1.93	105.78
3.08	105.46
3.91	105.27
4.66	105.31
5.18	104.59
5.77	104.38
6.37	103.89
6.98	104.50
7.93	104.75
8.83	105.25
9.97	105.34
10.99	105.63
12.19	105.63
13.00	105.68

SUMMARY DATA	
Bankfull Elevation:	105.3
Bankfull Cross-Sectional Area:	2.7
Bankfull Width:	4.1
Flood Prone Area Elevation:	NA
Flood Prone Width:	NA
Max Depth at Bankfull:	1.4
Mean Depth at Bankfull:	0.7
W / D Ratio:	NA
Entrenchment Ratio:	NA
Bank Height Ratio:	1.0

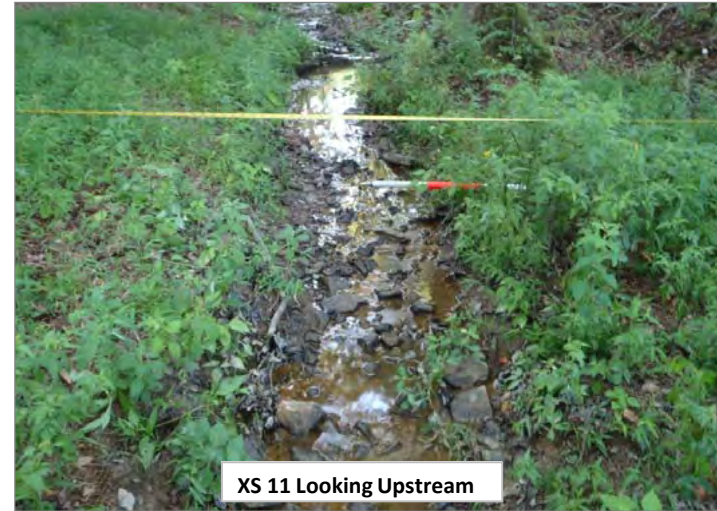
Site	Martins Creek II
Project Number:	92633
XS ID	XS - 11, Riffle
Reach	UT 1-3, Reach 1
Date:	9/10/2014
Field Crew:	Perkinson, Jernigan

Station	Elevation
0.00	113.81
2.28	113.89
3.74	113.81
4.56	113.47
4.95	113.19
5.63	113.41
6.15	113.08
7.20	113.22
7.85	113.25
8.68	113.61
10.48	113.95
12.30	114.29
13.86	114.49

SUMMARY DATA	
Bankfull Elevation:	113.8
Bankfull Cross-Sectional Area:	2.5
Bankfull Width:	6.0
Flood Prone Area Elevation:	114.5
Flood Prone Width:	25.0
Max Depth at Bankfull:	0.7
Mean Depth at Bankfull:	0.4
W / D Ratio:	14.4
Entrenchment Ratio:	4.2
Bank Height Ratio:	1.0

Stream Type	E
--------------------	---

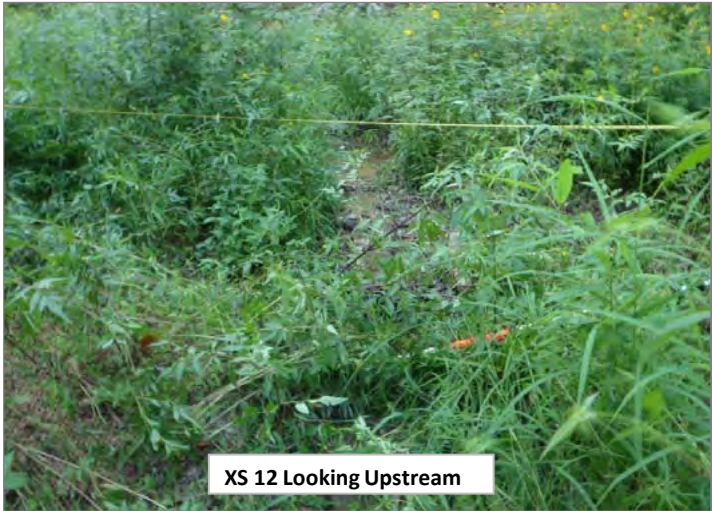
XS 12 Looking Upstream

Site	Martins Creek II
Project Number:	92633
XS ID	XS - 12, Riffle
Reach	UT 1-3, Reach 1
Date:	9/10/2014
Field Crew:	Perkinson, Jernigan

Station	Elevation
0.00	125.07
1.34	125.06
2.38	124.84
3.15	124.89
4.33	124.62
4.90	124.32
5.57	124.33
6.34	124.26
9.09	125.14
10.23	125.55
11.33	125.66
12.23	125.70

SUMMARY DATA	
Bankfull Elevation:	124.9
Bankfull Cross-Sectional Area:	1.7
Bankfull Width:	5.4
Flood Prone Area Elevation:	125.5
Flood Prone Width:	14.0
Max Depth at Bankfull:	0.6
Mean Depth at Bankfull:	0.3
W / D Ratio:	17.2
Entrenchment Ratio:	2.6
Bank Height Ratio:	1.0

Stream Type	E
--------------------	---

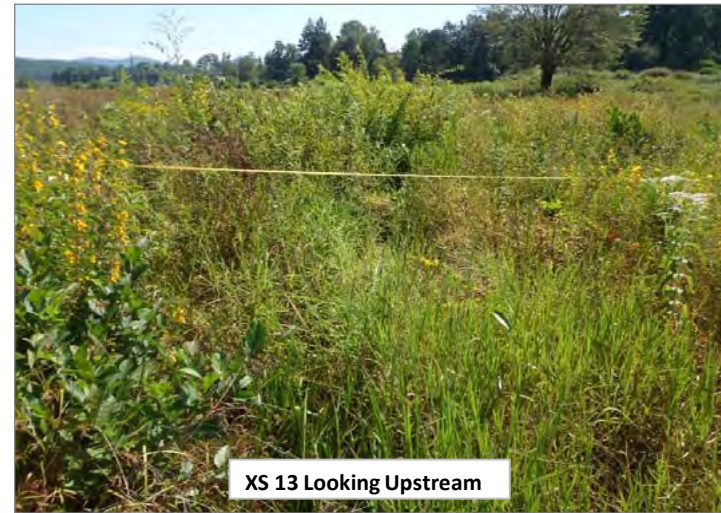
Site	Martins Creek II
Project Number:	92633
XS ID	XS - 13, Riffle
Reach	UT 1, Reach 4
Date:	9/10/2014
Field Crew:	Perkinson, Jernigan

Stream Type	E
--------------------	---

Station	Elevation
0.00	99.75
1.35	99.70
2.99	99.13
3.77	98.80
4.67	98.74
5.70	98.62
6.26	98.17
7.03	98.15
7.76	98.32
8.48	98.53
9.35	98.99
10.80	99.49
12.23	99.58
13.50	99.62

SUMMARY DATA	
Bankfull Elevation:	99.1
Bankfull Cross-Sectional Area:	3.3
Bankfull Width:	6.6
Flood Prone Area Elevation:	100.0
Flood Prone Width:	25.0
Max Depth at Bankfull:	0.9
Mean Depth at Bankfull:	0.5
W / D Ratio:	13.2
Entrenchment Ratio:	3.8
Bank Height Ratio:	1.0

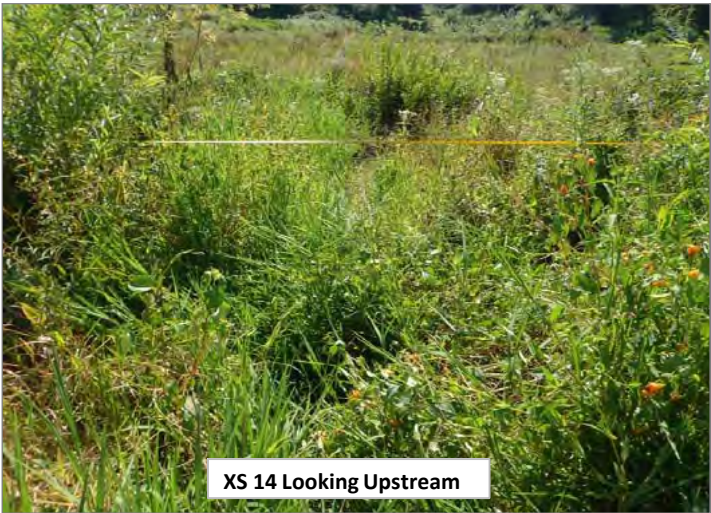
Site	Martins Creek II
Project Number:	92633
XS ID	XS - 14, Riffle
Reach	UT 1, Reach 4
Date:	9/10/2014
Field Crew:	Perkinson, Jernigan

Stream Type	E
--------------------	---

SUMMARY DATA	
Bankfull Elevation:	100.4
Bankfull Cross-Sectional Area:	2.9
Bankfull Width:	6.3
Flood Prone Area Elevation:	101.2
Flood Prone Width:	25.0
Max Depth at Bankfull:	0.8
Mean Depth at Bankfull:	0.5
W / D Ratio:	13.7
Entrenchment Ratio:	4.0
Bank Height Ratio:	1.0

Station	Elevation
0.00	101.13
1.66	101.09
2.80	100.59
3.94	100.21
4.80	99.88
5.41	99.66
6.48	99.78
7.63	99.95
8.83	99.99
9.55	100.41
10.39	100.71
12.08	100.66

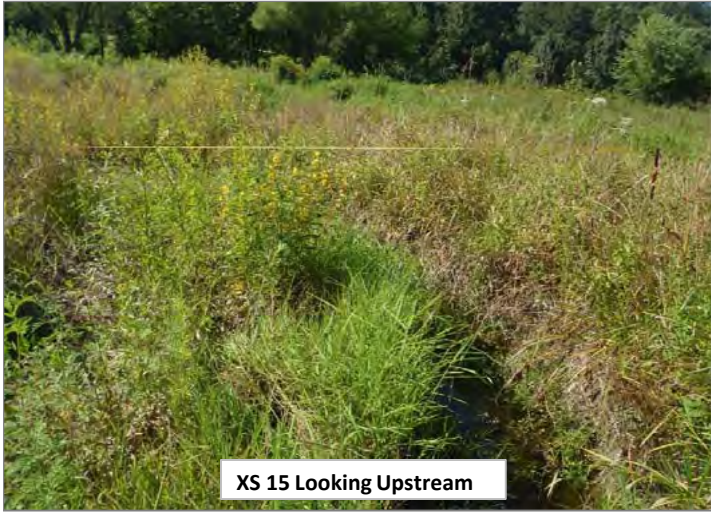
Site	Martins Creek II
Project Number:	92633
XS ID	XS - 15, Pool
Reach	UT 1, Reach 4
Date:	9/10/2014
Field Crew:	Perkinson, Jernigan

Station	Elevation
0.00	101.13
1.67	101.20
2.94	101.09
4.10	100.59
4.67	100.07
5.70	99.19
6.35	99.04
7.16	99.55
8.15	100.17
9.45	100.39
11.31	100.48
13.66	100.67
15.91	101.03
16.60	101.09

SUMMARY DATA	
Bankfull Elevation:	101.1
Bankfull Cross-Sectional Area:	10.2
Bankfull Width:	13.6
Flood Prone Area Elevation:	NA
Flood Prone Width:	NA
Max Depth at Bankfull:	2.1
Mean Depth at Bankfull:	0.8
W / D Ratio:	NA
Entrenchment Ratio:	NA
Bank Height Ratio:	1.0

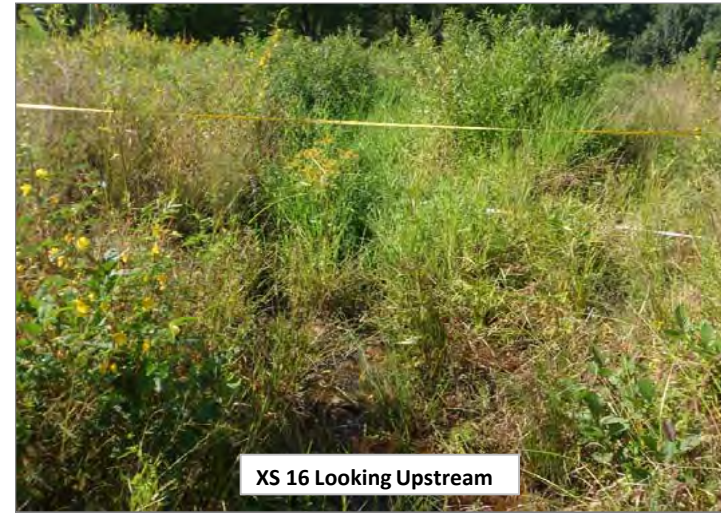
Martins Creek II - NCEEP Project Number 92633
 Stream Reach UT 1 Reach 4
 XS - 16, Station 09+53, Riffle

Site	Martins Creek II
Project Number:	92633
XS ID	XS - 16, Riffle
Reach	UT 1, Reach 4
Date:	9/10/2014
Field Crew:	Perkinson, Jernigan

Station	Elevation
0.00	102.04
1.67	101.93
2.81	101.52
3.37	101.22
3.80	100.82
4.77	100.96
5.74	101.01
6.38	100.77
7.26	100.89
7.83	100.95
8.77	101.42
10.65	102.09
12.20	101.99

SUMMARY DATA	
Bankfull Elevation:	101.9
Bankfull Cross-Sectional Area:	6.1
Bankfull Width:	8.6
Flood Prone Area Elevation:	103.1
Flood Prone Width:	25.0
Max Depth at Bankfull:	1.2
Mean Depth at Bankfull:	0.7
W / D Ratio:	12.1
Entrenchment Ratio:	2.9
Bank Height Ratio:	1.0

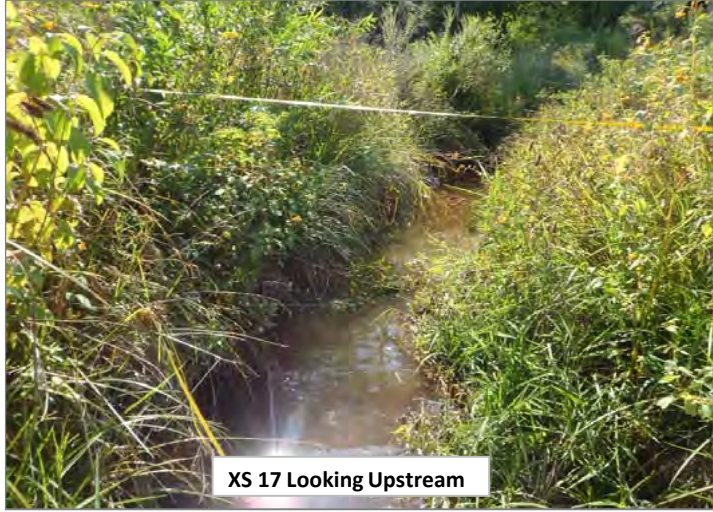
Site	Martins Creek II
Project Number:	92633
XS ID	XS - 17, Pool
Reach	UT 1, Reach 4
Date:	9/10/2014
Field Crew:	Perkinson, Jernigan

Station	Elevation
-0.30	106.04
1.81	105.93
2.90	105.56
4.00	105.64
4.69	104.97
5.84	104.64
6.84	103.97
8.13	103.74
9.42	103.46
9.79	103.68
10.62	103.82
11.48	103.03
12.32	106.42
13.99	106.57
15.42	106.45

SUMMARY DATA	
Bankfull Elevation:	105.8
Bankfull Cross-Sectional Area:	13.9
Bankfull Width:	9.9
Flood Prone Area Elevation:	NA
Flood Prone Width:	NA
Max Depth at Bankfull:	2.7
Mean Depth at Bankfull:	1.4
W / D Ratio:	NA
Entrenchment Ratio:	NA
Bank Height Ratio:	1.0

Stream Type	E
--------------------	---

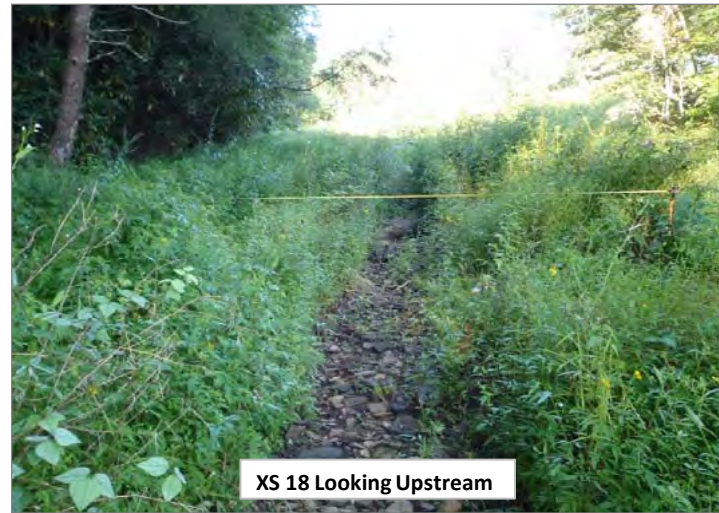
XS 18 Looking Upstream

Site	Martins Creek II
Project Number:	92633
XS ID	XS - 18, Riffle
Reach	MC UT 1, Reach 2
Date:	9/10/2014
Field Crew:	Perkinson, Jernigan

Stream Type	E
--------------------	---

Station	Elevation
0.00	75.58
2.30	75.50
3.21	75.36
4.07	74.86
5.07	74.73
6.07	74.57
6.93	74.29
8.04	74.33
8.73	74.27
9.97	74.80
11.12	75.35
12.47	75.55
13.58	75.52

SUMMARY DATA	
Bankfull Elevation:	75.4
Bankfull Cross-Sectional Area:	5.5
Bankfull Width:	7.9
Flood Prone Area Elevation:	76.5
Flood Prone Width:	25.0
Max Depth at Bankfull:	1.1
Mean Depth at Bankfull:	0.7
W / D Ratio:	11.3
Entrenchment Ratio:	3.2
Bank Height Ratio:	1.0

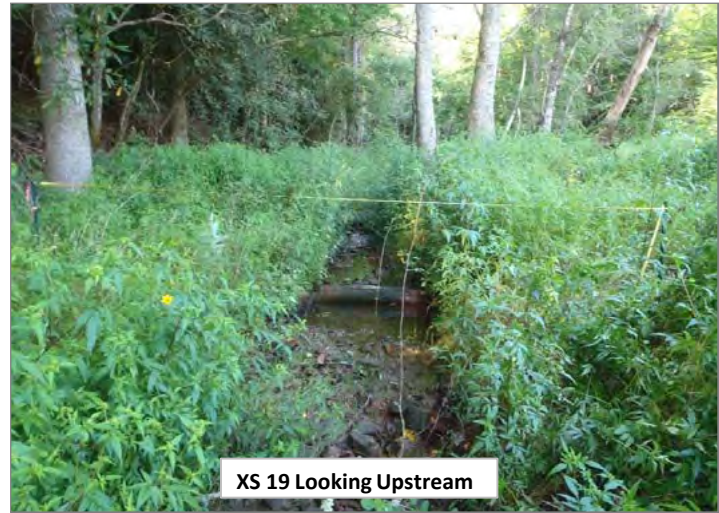
Site	Martins Creek II
Project Number:	92633
XS ID	XS - 19, Riffle
Reach	MC UT 1, Reach 2
Date:	9/10/2014
Field Crew:	Perkinson, Jernigan

SUMMARY DATA	
Bankfull Elevation:	102.5
Bankfull Cross-Sectional Area:	5.0
Bankfull Width:	8.0
Flood Prone Area Elevation:	103.5
Flood Prone Width:	25.0
Max Depth at Bankfull:	1.0
Mean Depth at Bankfull:	0.6
W / D Ratio:	12.8
Entrenchment Ratio:	3.1
Bank Height Ratio:	1.0

Station	Elevation
0.00	102.53
1.44	102.53
2.85	102.56
3.82	102.10
5.21	101.61
6.61	101.77
7.79	101.87
8.81	101.52
9.51	101.89
10.11	102.04
11.05	102.62
12.05	103.28
13.76	103.23

Stream Type E

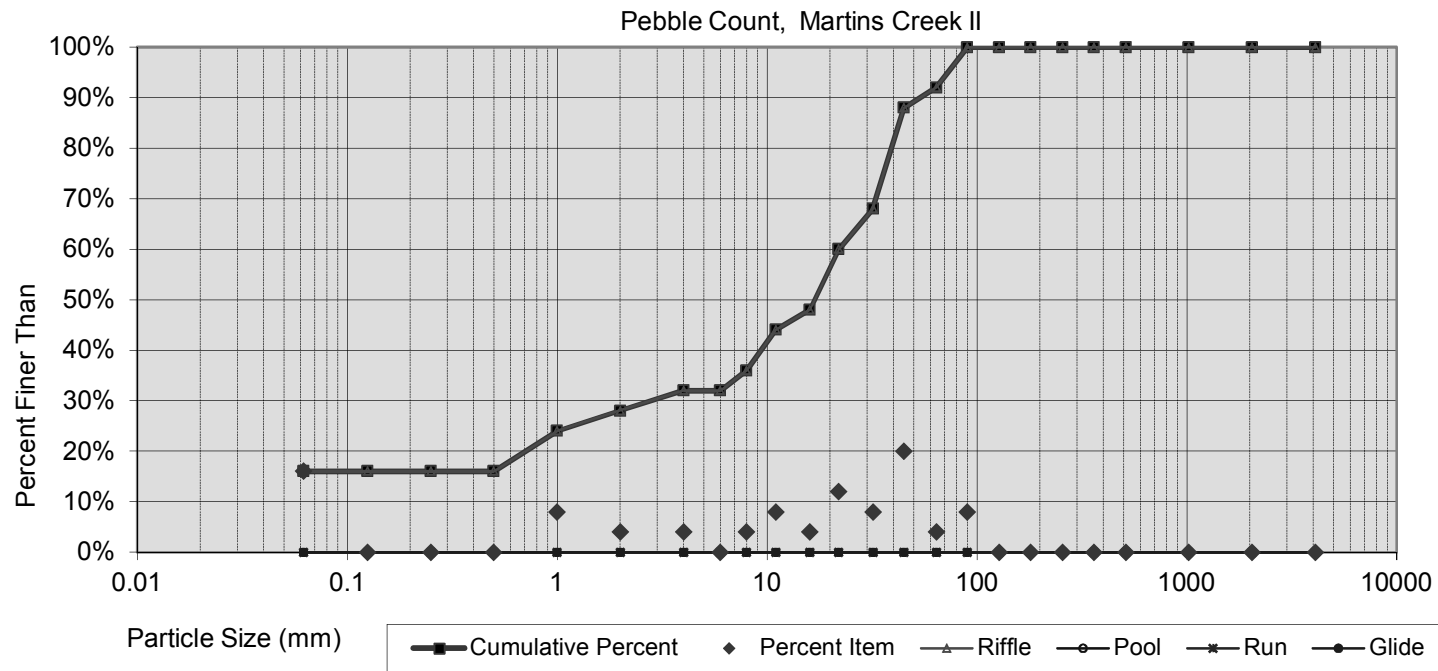
Note: Cross Section 2

Size percent less than (mm)					Percent by substrate type					
D16	D35	D50	D84	D95	silt/clay	sand	gravel	cobble	boulder	bedrock
0.500	7.44	16.9	42	73	16%	12%	64%	8%	0%	0%

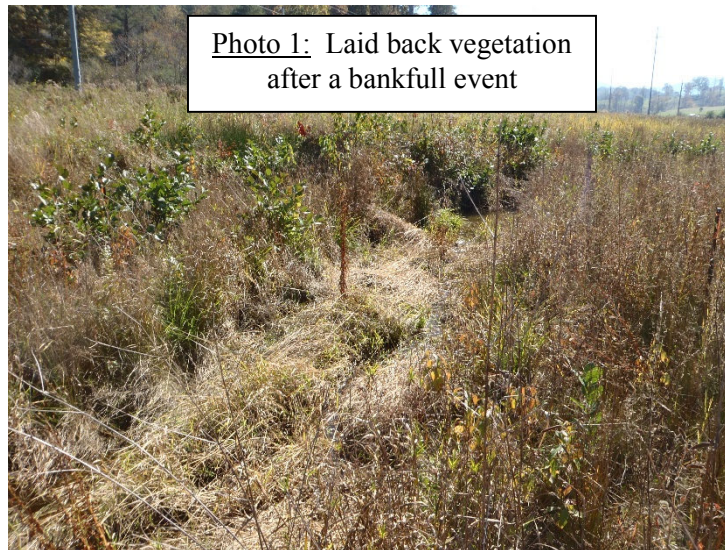
Date of Data Collection	Date of Occurrence	Method	Photo (if available)
August 25, 2014	April 7, 2014	Crest gauge data indicates a bankfull event after approximately 2.4 inches of rain documented in one day at an onsite rain gauge.	---
August 25, 2014	July 1, 2014	Crest gauge data indicates a bankfull event after approximately 2.02 inches of rain was documented over two days at an onsite rain gauge.	---
August 25, 2014	August 24, 2014	Crest gauge data indicates a bankfull event after approximately 1.39 inches of rain documented over two days at an onsite rain gauge.	---
October 27, 2014	September 3, 2014	Crest gauge data indicates a bankfull event after approximately 1.67 inches of rain documented in one day at an onsite rain gauge.	---
October 27, 2014	October 14, 2014	Crest gauge data and laid back vegetation indicate a bankfull event after approximately 2.5 inches of rain documented in one day at an onsite rain gauge.	1
