**Baseline Monitoring Report
McCain Stream Restoration Site - Project # 443
Randolph County**

**Data Collection: May 2009
Submitted: February 2010**

**Landmark Center II, Suite 220
4601 Six Forks Road
Raleigh, NC 27609
Phone: (919) 278-2514
Fax: (919) 783-9266
KCI Project #:12053743E**

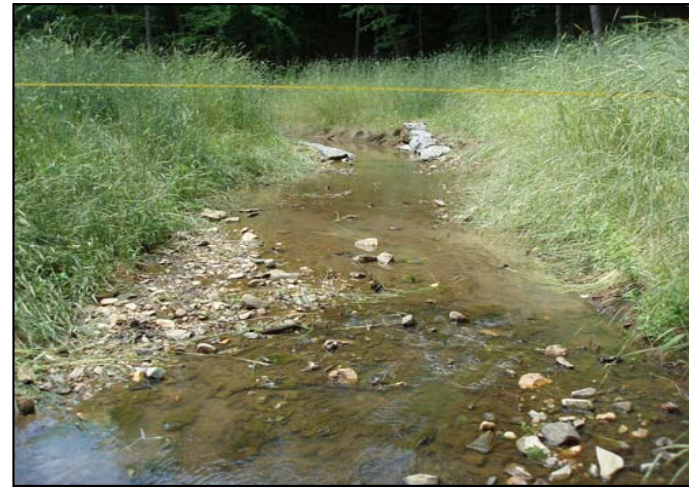
River Basin:	Yadkin
Watershed:	McCain, As-Built
XS ID	XS - 1, Riffle, Reach 1
Drainage Area (sq mi):	0.88
Date:	5/27/2009
Field Crew:	B. Roberts, C. Carter

Station	Elevation
0.0	548.39
6.5	547.76
14.0	546.79
21.1	546.16
25.5	545.21
30.6	544.82
34.1	543.31
36.2	543.19
38.7	543.11
40.5	543.01
42.8	543.01
45.2	542.91
45.7	543.12
47.1	543.83
48.4	544.42
54.2	545.10
56.5	545.81
59.7	546.45
64.5	547.03
69.0	547.76
72.6	548.15

SUMMARY DATA	
Bankfull Elevation:	544.4
Bankfull Cross-Sectional Area:	18.6
Bankfull Width:	16.9
Flood Prone Area Elevation:	545.9
Flood Prone Width:	34.9
Max Depth at Bankfull:	1.5
Mean Depth at Bankfull:	1.1
W / D Ratio:	15.4
Entrenchment Ratio:	2.1
Bank Height Ratio:	1.0

Stream Type B4c

Six permanent monitoring cross-sections have been established on the site. One riffle cross-section has been established in Reach 1 and the rest are spread throughout Reach 2. Permanent monuments of rebar in concrete have been established at each end of these cross-sections. These cross-sections will be surveyed each year, with measurements occurring at bankfull, top of bank, edge of water, and other significant breaks in slope.

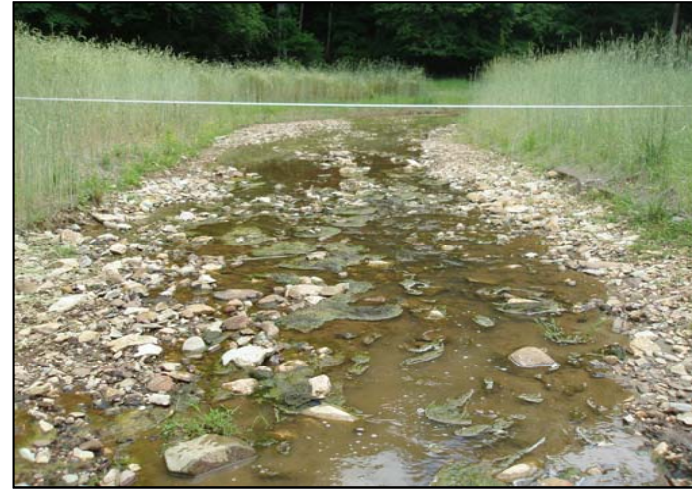
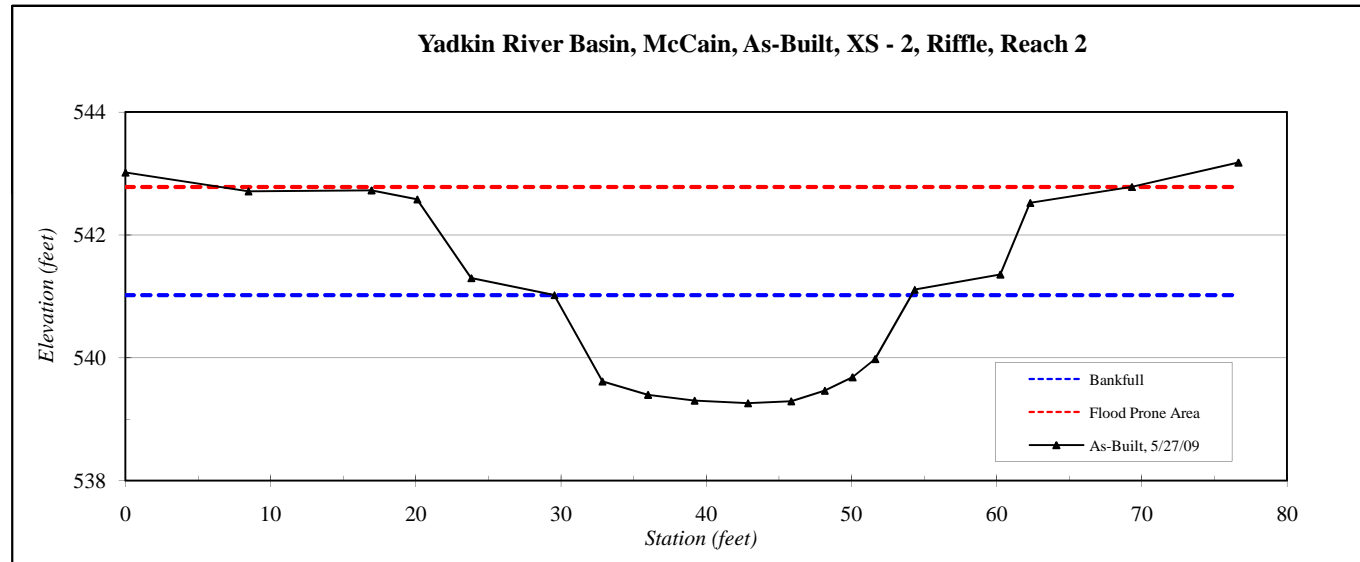
River Basin:	Yadkin
Watershed:	McCain, As-Built
XS ID	XS - 2, Riffle, Reach 2
Drainage Area (sq mi):	0.88
Date:	5/27/2009
Field Crew:	B. Roberts, C. Carter

Station	Elevation
0.0	543.01
8.5	542.71
16.9	542.73
20.1	542.57
23.8	541.30
29.5	541.02
32.9	539.61
36.0	539.40
39.2	539.30
42.9	539.26
45.9	539.29
48.2	539.47
50.1	539.68
51.6	539.98
54.4	541.11
60.3	541.36
62.3	542.52
69.3	542.78
76.7	543.18

SUMMARY DATA	
Bankfull Elevation:	541.0
Bankfull Cross-Sectional Area:	33.7
Bankfull Width:	24.6
Flood Prone Area Elevation:	542.8
Flood Prone Width:	62.7
Max Depth at Bankfull:	1.8
Mean Depth at Bankfull:	1.4
W / D Ratio:	18.0
Entrenchment Ratio:	2.5
Bank Height Ratio:	1.0

Stream Type C4

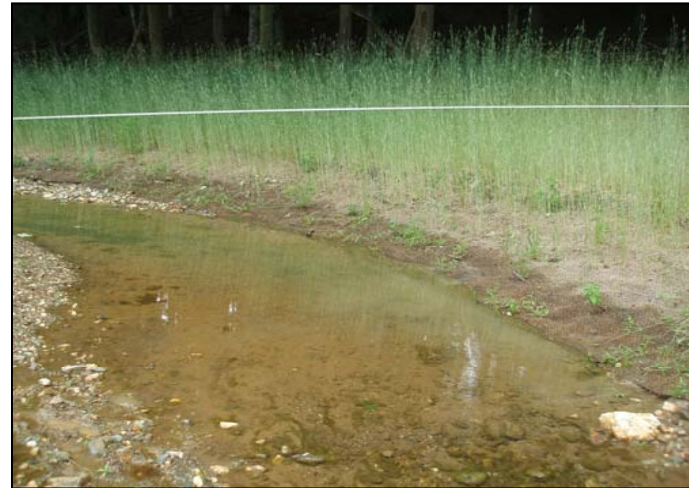
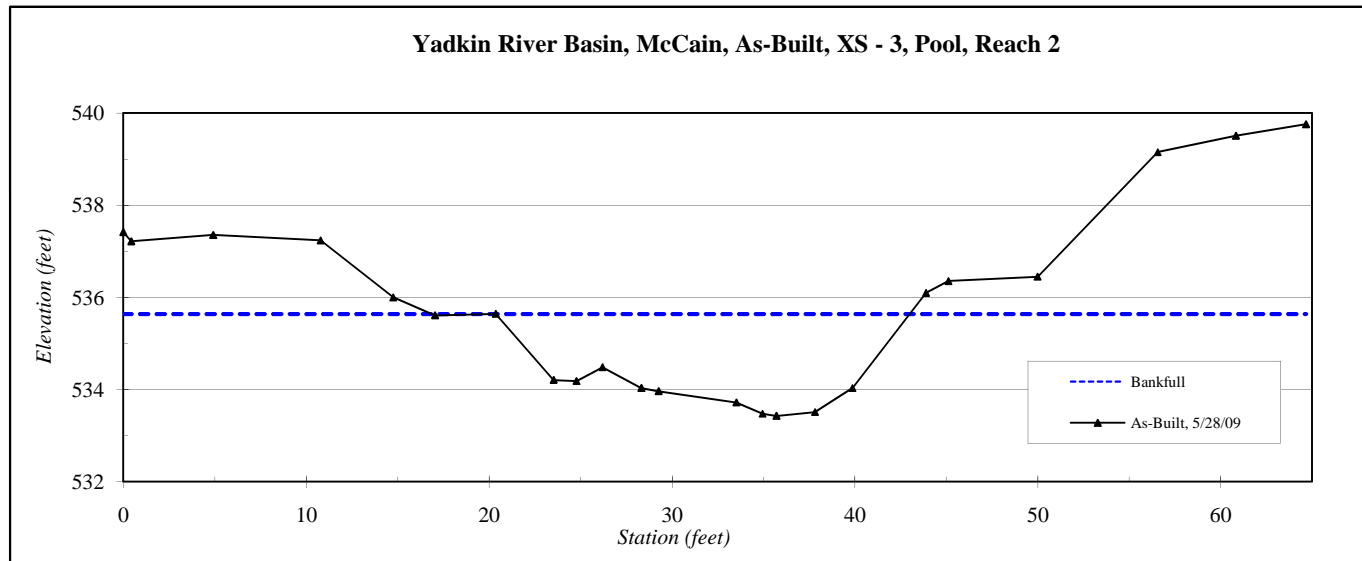
River Basin:	Yadkin
Watershed:	McCain, As-Built
XS ID	XS - 3, Pool, Reach 2
Drainage Area (sq mi):	0.88
Date:	5/28/2009
Field Crew:	B. Roberts, C. Carter

Stream Type C4

Station	Elevation
0.0	537.42
0.4	537.22
4.9	537.35
10.8	537.23
14.8	536.00
17.0	535.61
20.4	535.64
23.5	534.21
24.8	534.18
26.2	534.48
28.3	534.03
29.3	533.96
33.5	533.72
35.0	533.47
35.7	533.43
37.8	533.51
39.9	534.03
43.9	536.10
45.1	536.35
50.0	536.45
56.6	539.15
60.8	539.51
64.7	539.76

SUMMARY DATA	
Bankfull Elevation:	535.6
Bankfull Cross-Sectional Area:	33.6
Bankfull Width:	22.6
Flood Prone Area Elevation:	-
Flood Prone Width:	-
Max Depth at Bankfull:	2.2
Mean Depth at Bankfull:	1.5
W / D Ratio:	-
Entrenchment Ratio:	-
Bank Height Ratio:	-

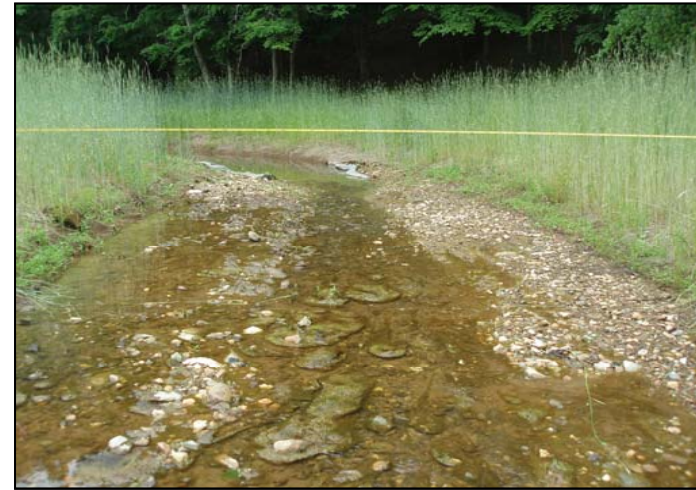
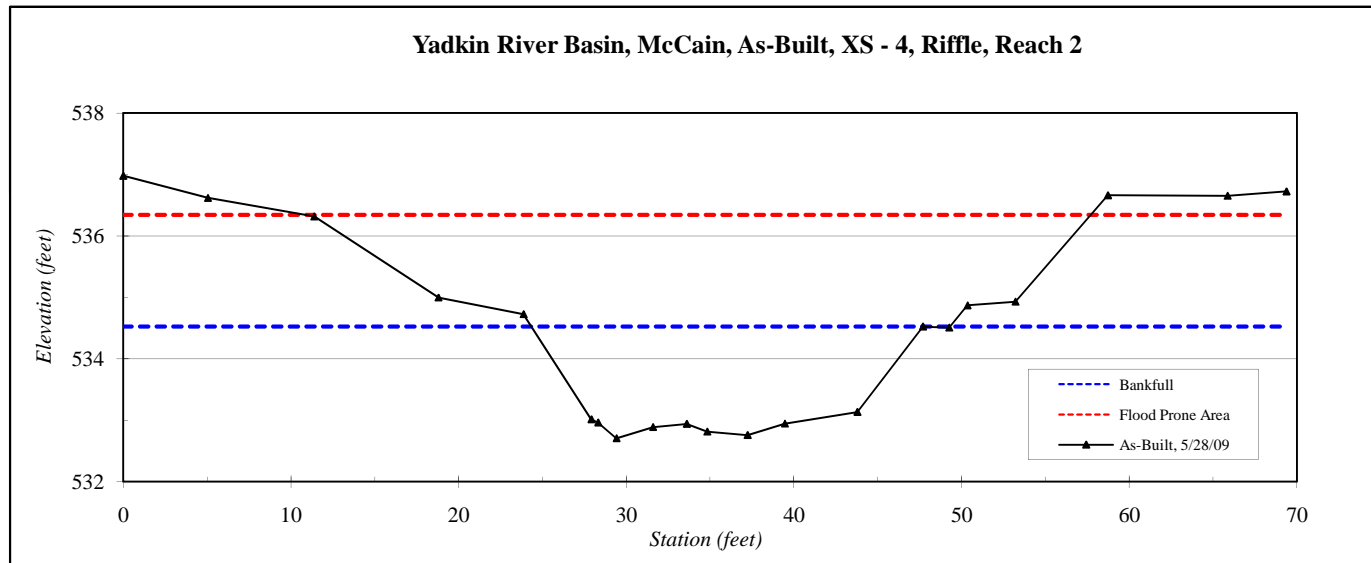
River Basin:	Yadkin
Watershed:	McCain, As-Built
XS ID	XS - 4, Riffle, Reach 2
Drainage Area (sq mi):	0.88
Date:	5/28/2009
Field Crew:	B. Roberts, C. Carter

Station	Elevation
0.0	536.98
5.0	536.62
11.4	536.32
18.8	535.00
23.9	534.73
27.9	533.01
28.3	532.96
29.4	532.71
31.6	532.89
33.6	532.94
34.8	532.81
37.2	532.76
39.5	532.94
43.8	533.13
47.7	534.52
49.3	534.51
50.4	534.87
53.2	534.93
58.7	536.66
65.9	536.65
69.4	536.72

SUMMARY DATA	
Bankfull Elevation:	534.5
Bankfull Cross-Sectional Area:	31.2
Bankfull Width:	23.3
Flood Prone Area Elevation:	536.3
Flood Prone Width:	46.9
Max Depth at Bankfull:	1.8
Mean Depth at Bankfull:	1.3
W / D Ratio:	17.4
Entrenchment Ratio:	2.0
Bank Height Ratio:	1.0

Stream Type C4

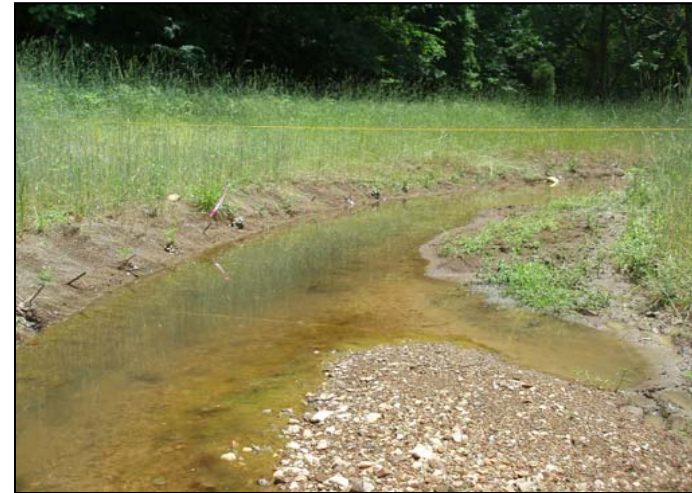
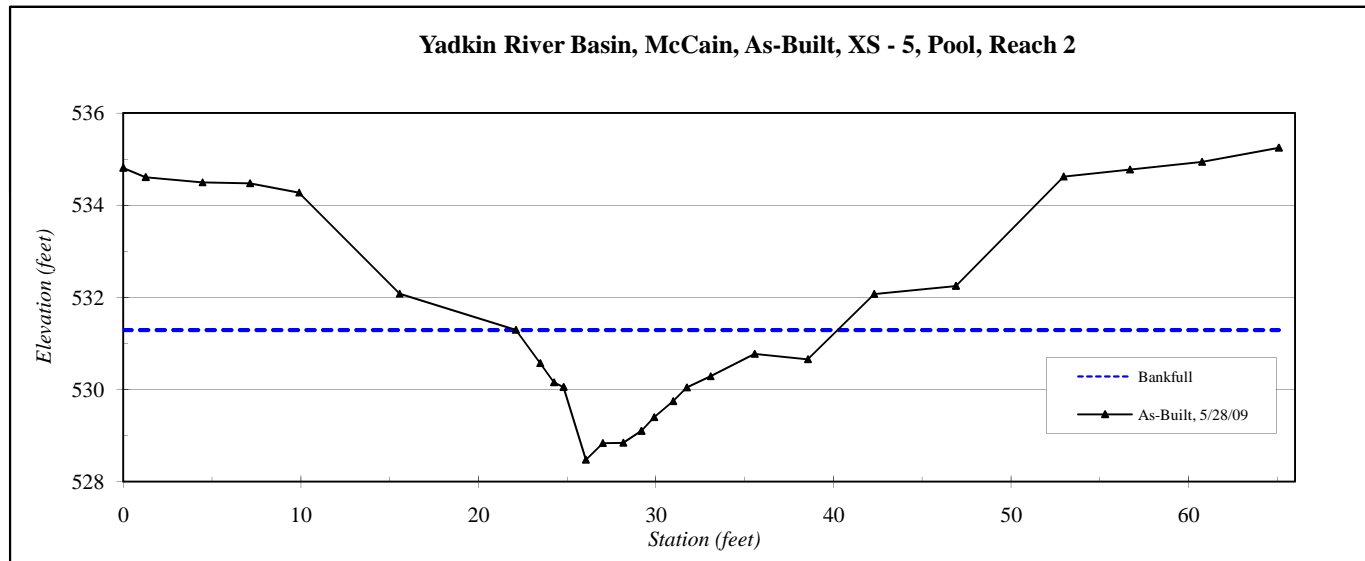
River Basin:	Yadkin
Watershed:	McCain, As-Built
XS ID	XS - 5, Pool, Reach 2
Drainage Area (sq mi):	0.88
Date:	5/28/2009
Field Crew:	B. Roberts, C. Carter

Station	Elevation
0.0	534.81
1.3	534.61
4.5	534.49
7.1	534.47
9.9	534.27
15.6	532.08
22.1	531.29
23.5	530.57
24.3	530.15
24.8	530.05
26.1	528.48
27.0	528.84
28.2	528.85
29.2	529.10
29.9	529.40
31.0	529.75
31.7	530.04
33.1	530.28
35.6	530.77
38.6	530.66
42.3	532.07
46.9	532.25
53.0	534.62
56.7	534.8
60.8	534.9
65.1	535.2

SUMMARY DATA	
Bankfull Elevation:	531.3
Bankfull Cross-Sectional Area:	22.2
Bankfull Width:	18.1
Flood Prone Area Elevation:	-
Flood Prone Width:	-
Max Depth at Bankfull:	2.8
Mean Depth at Bankfull:	1.2
W / D Ratio:	-
Entrenchment Ratio:	-
Bank Height Ratio:	-

Stream Type C4

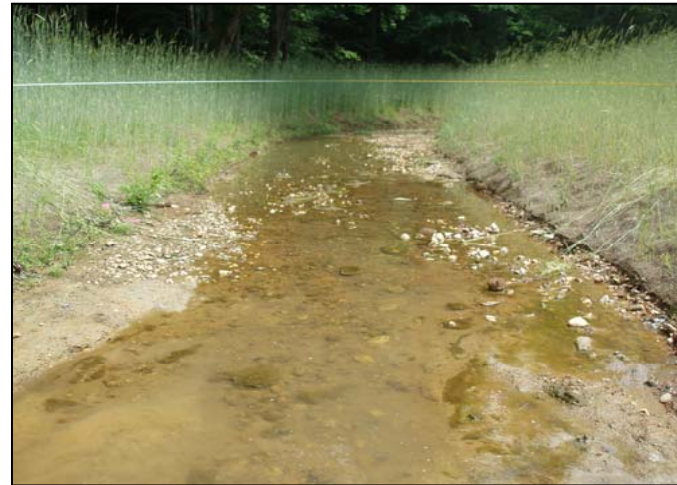
River Basin:	Yadkin
Watershed:	McCain, As-Built
XS ID	XS - 6, Riffle, Reach 2
Drainage Area (sq mi):	0.88
Date:	5/28/2009
Field Crew:	B. Roberts, C. Carter

Station	Elevation
0.0	534.05
1.2	533.88
6.3	533.79
12.0	532.04
18.4	531.79
27.2	531.57
31.9	529.62
35.4	529.32
37.2	529.17
39.2	529.13
41.3	529.29
43.1	529.25
43.7	529.27
44.3	529.66
48.6	531.25
53.7	531.47
57.9	533.34
60.0	533.68
65.8	533.81
67.8	534.22

SUMMARY DATA	
Bankfull Elevation:	531.3
Bankfull Cross-Sectional Area:	30.8
Bankfull Width:	20.6
Flood Prone Area Elevation:	533.4
Flood Prone Width:	50.5
Max Depth at Bankfull:	2.1
Mean Depth at Bankfull:	1.5
W / D Ratio:	13.8
Entrenchment Ratio:	2.5
Bank Height Ratio:	1.0

Stream Type C4

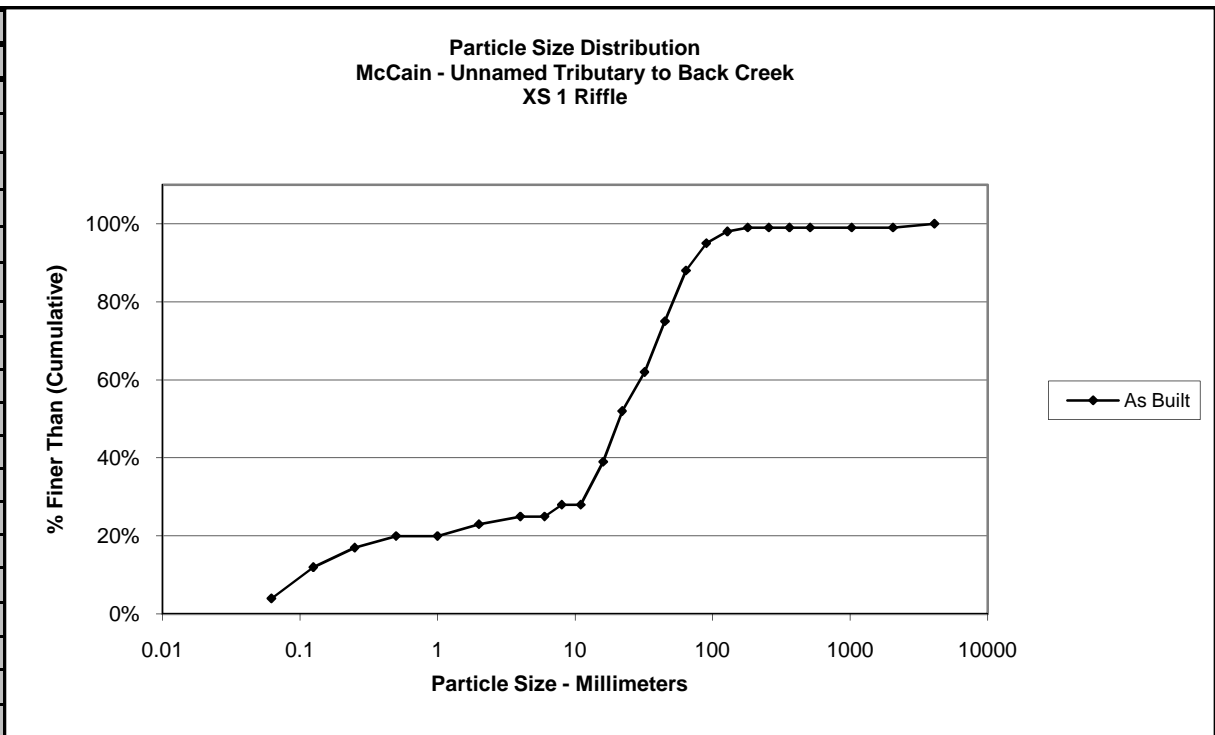
Cross-Section 1 Riffle - As-Built			
Particle	Millimeter		Count
Silt/Clay	< 0.062	S/C	4
Very Fine	.062 - .125	S	8
Fine	.125 - .25	A	5
Medium	.25 - .50	N	3
Coarse	.50 - 1	D	
Very Coarse	1 - 2	S	3
Very Fine	2 - 4		2
Fine	4 - 5.7	G	
Fine	5.7 - 8	R	3
Medium	8 - 11.3	A	
Medium	11.3 - 16	V	11
Coarse	16 - 22.6	E	13
Coarse	22.6 - 32	L	10
Very Coarse	32 - 45	S	13
Very Coarse	45 - 64		13
Small	64 - 90	C	7
Small	90 - 128	O	3
Large	128 - 180	B	1
Large	180 - 256	L	
Small	256 - 362	B	
Small	362 - 512	L	
Medium	512 - 1024	D	
Lrg- Very Lrg	1024 - 2048	R	
Bedrock	>2048	BDRK	1
		Total	100
Note:

Size (mm)	
D16	0.21
D35	14
D50	21
D65	34
D84	56
D95	86

Size Distribution	
mean	3.4
dispersion	51.3
skewness	-0.51

Type	
silt/clay	4%
sand	19%
gravel	65%
cobble	11%
boulder	0%
bedrock	1%
hardpan	0%
wood/det	0%
artificial	0%

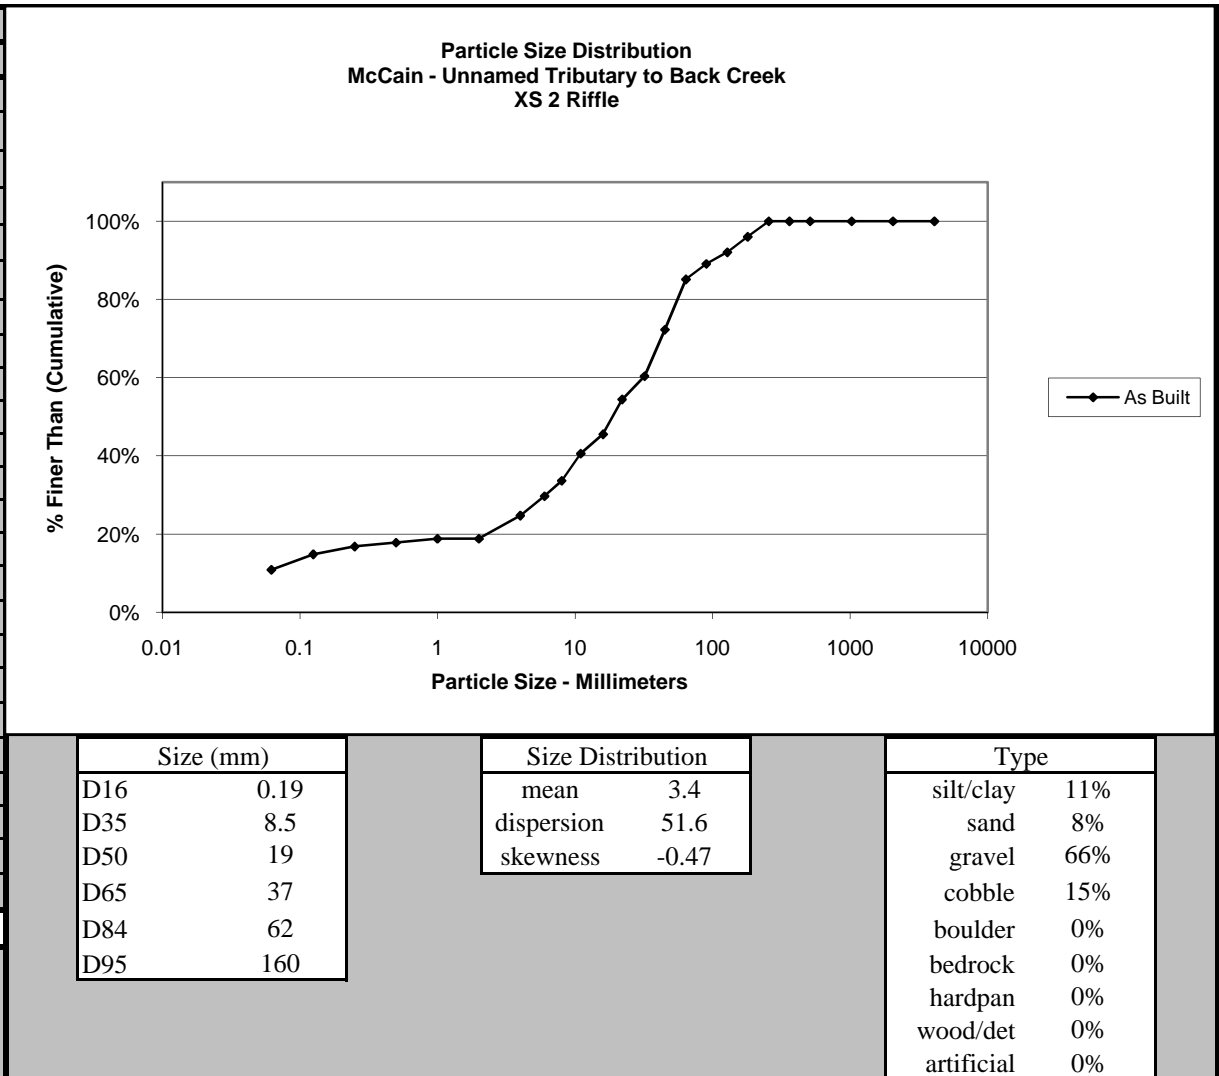
Cross-Section 2 Riffle - As-Built			
Particle	Millimeter		Count
Silt/Clay	< 0.062	S/C	11
Very Fine	.062 - .125	S	4
Fine	.125 - .25	A	2
Medium	.25 - .50	N	1
Coarse	.50 - 1	D	1
Very Coarse	1 - 2	S	
Very Fine	2 - 4		6
Fine	4 - 5.7	G	5
Fine	5.7 - 8	R	4
Medium	8 - 11.3	A	7
Medium	11.3 - 16	V	5
Coarse	16 - 22.6	E	9
Coarse	22.6 - 32	L	6
Very Coarse	32 - 45	S	12
Very Coarse	45 - 64		13
Small	64 - 90	C	4
Small	90 - 128	O	3
Large	128 - 180	B	4
Large	180 - 256	L	4
Small	256 - 362	B	
Small	362 - 512	L	
Medium	512 - 1024	D	
Lrg- Very Lrg	1024 - 2048	R	
Bedrock	>2048	BDRK	
		Total	101
Note:

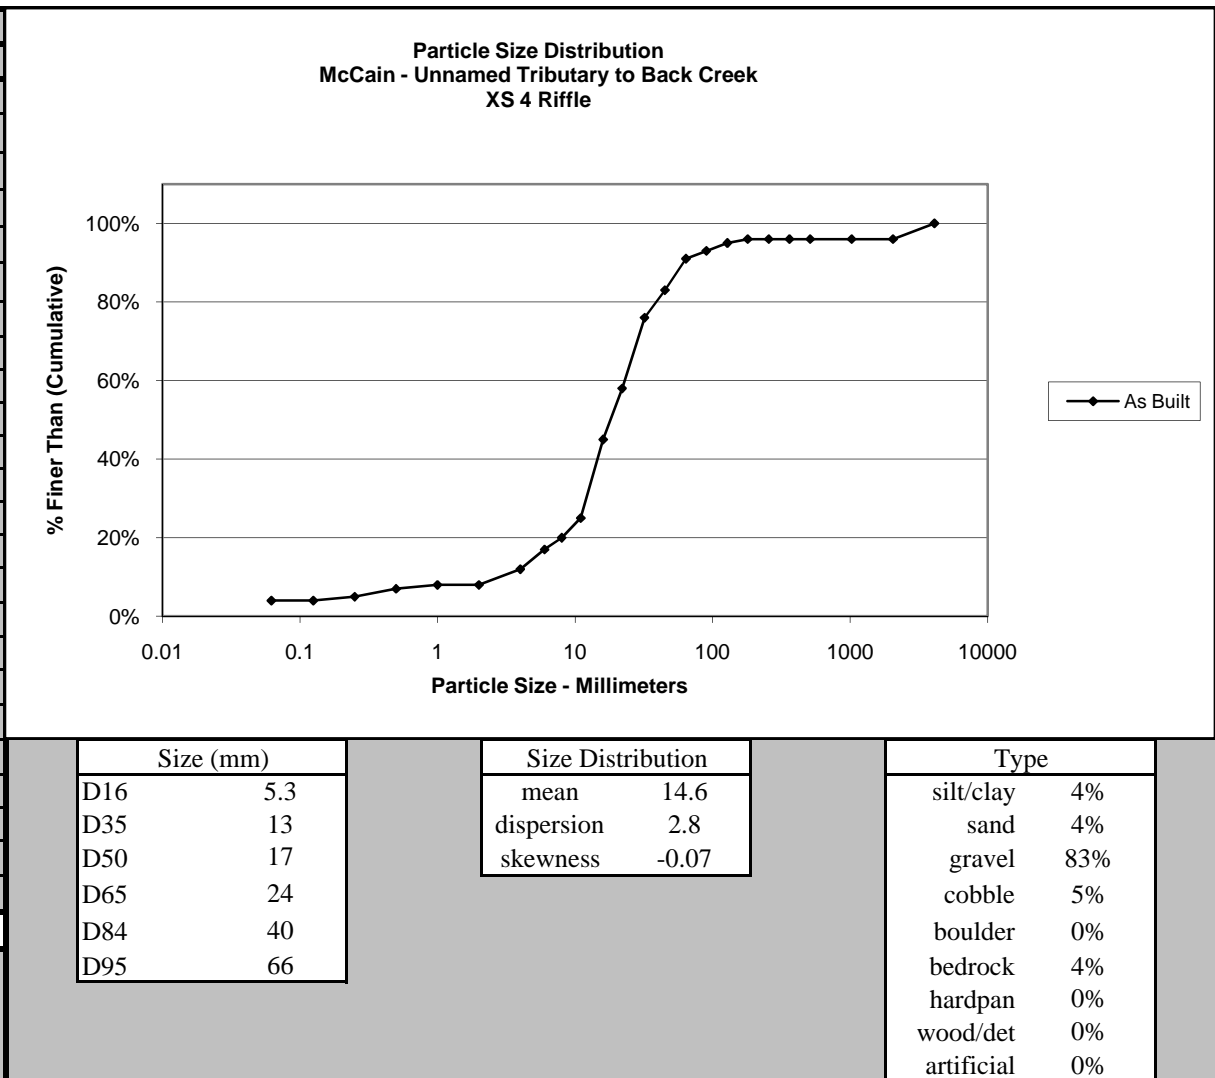
Cross-Section 4 Riffle - As-Built			
Particle	Millimeter		Count
Silt/Clay	< 0.062	S/C	4
Very Fine	.062 - .125	S	
Fine	.125 - .25	A	1
Medium	.25 - .50	N	2
Coarse	.50 - 1	D	1
Very Coarse	1 - 2	S	
Very Fine	2 - 4		4
Fine	4 - 5.7	G	5
Fine	5.7 - 8	R	3
Medium	8 - 11.3	A	5
Medium	11.3 - 16	V	20
Coarse	16 - 22.6	E	13
Coarse	22.6 - 32	L	18
Very Coarse	32 - 45	S	7
Very Coarse	45 - 64		8
Small	64 - 90	C	2
Small	90 - 128	O	2
Large	128 - 180	B	1
Large	180 - 256	L	
Small	256 - 362	B	
Small	362 - 512	L	
Medium	512 - 1024	D	
Lrg- Very Lrg	1024 - 2048	R	
Bedrock	>2048	BDRK	4
		Total	100
Note:

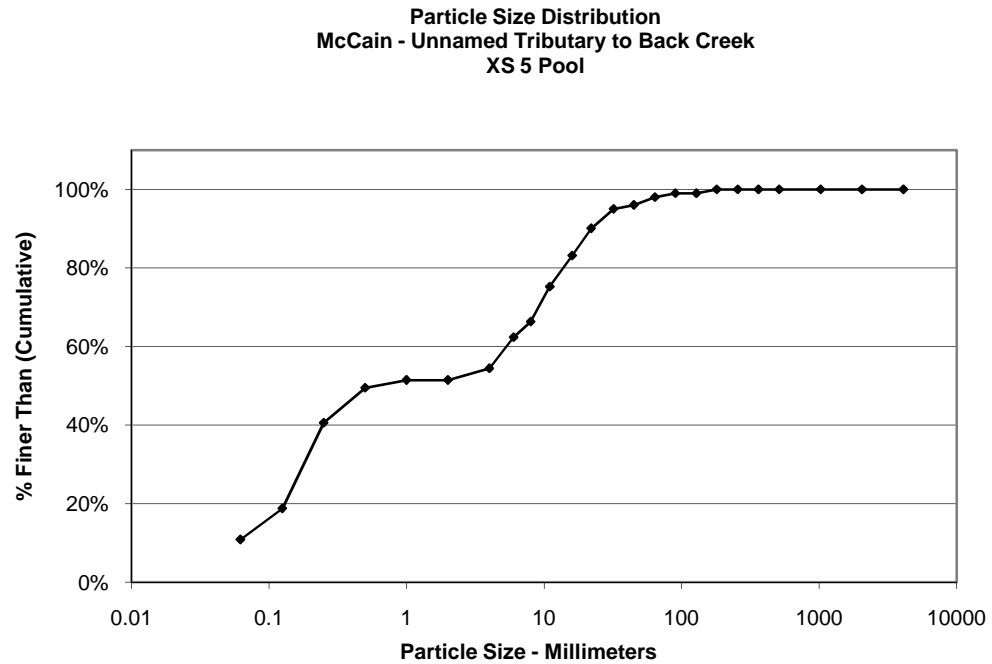
Cross-Section 5 Pool - As-Built			
Particle	Millimeter		Count
Silt/Clay	< 0.062	S/C	11
Very Fine	.062 - .125	S	8
Fine	.125 - .25	A	22
Medium	.25 - .50	N	9
Coarse	.50 - 1	D	2
Very Coarse	1 - 2	S	
Very Fine	2 - 4		3
Fine	4 - 5.7	G	8
Fine	5.7 - 8	R	4
Medium	8 - 11.3	A	9
Medium	11.3 - 16	V	8
Coarse	16 - 22.6	E	7
Coarse	22.6 - 32	L	5
Very Coarse	32 - 45	S	1
Very Coarse	45 - 64		2
Small	64 - 90	C	1
Small	90 - 128	O	
Large	128 - 180	B	1
Large	180 - 256	L	
Small	256 - 362	B	
Small	362 - 512	L	
Medium	512 - 1024	D	
Lrg- Very Lrg	1024 - 2048	R	
Bedrock	>2048	BDRK	
		Total	101
Note:

Size (mm)	
D16	0.097
D35	0.21
D50	0.59
D65	7.3
D84	17
D95	32

Size Distribution	
mean	1.3
dispersion	17.4
skewness	0.23

Type	
silt/clay	11%
sand	41%
gravel	47%
cobble	2%
boulder	0%
bedrock	0%
hardpan	0%
wood/det	0%
artificial	0%

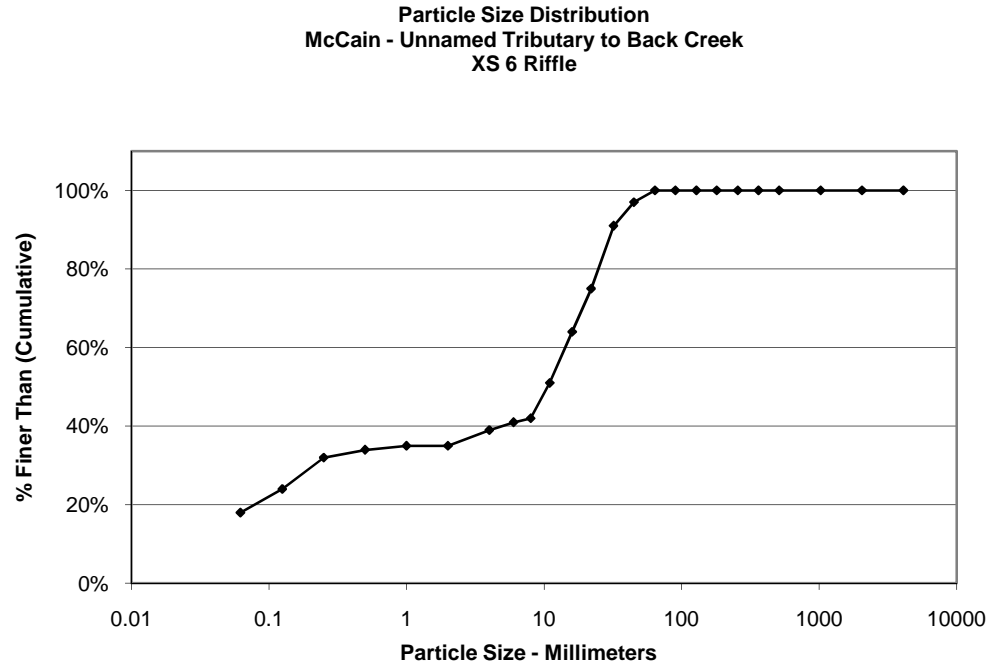
Cross-Section 6 Riffle - As-Built			
Particle	Millimeter		Count
Silt/Clay	< 0.062	S/C	18
Very Fine	.062 - .125	S	6
Fine	.125 - .25	A	8
Medium	.25 - .50	N	2
Coarse	.50 - 1	D	1
Very Coarse	1 - 2	S	
Very Fine	2 - 4		4
Fine	4 - 5.7	G	2
Fine	5.7 - 8	R	1
Medium	8 - 11.3	A	9
Medium	11.3 - 16	V	13
Coarse	16 - 22.6	E	11
Coarse	22.6 - 32	L	16
Very Coarse	32 - 45	S	6
Very Coarse	45 - 64		3
Small	64 - 90	C	
Small	90 - 128	O	
Large	128 - 180	B	
Large	180 - 256	L	
Small	256 - 362	B	
Small	362 - 512	L	
Medium	512 - 1024	D	
Lrg- Very Lrg	1024 - 2048	R	
Bedrock	>2048	BDRK	
		Total	100
Note:

Size (mm)	
D16	0.062
D35	2
D50	11
D65	16
D84	27
D95	40

Size Distribution	
mean	1.3
dispersion	89.9
skewness	-0.57

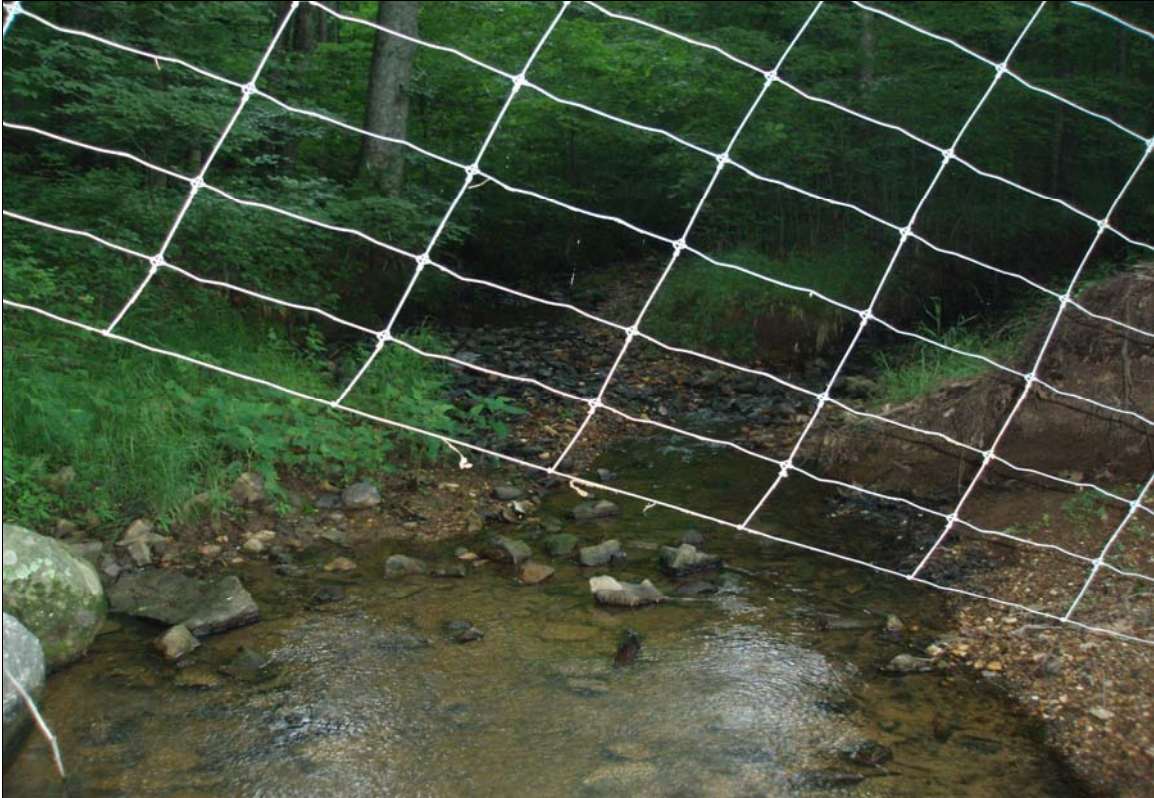
Photo Point 1u: View looking immediately upstream of the project. 5/29/08 – As-Built

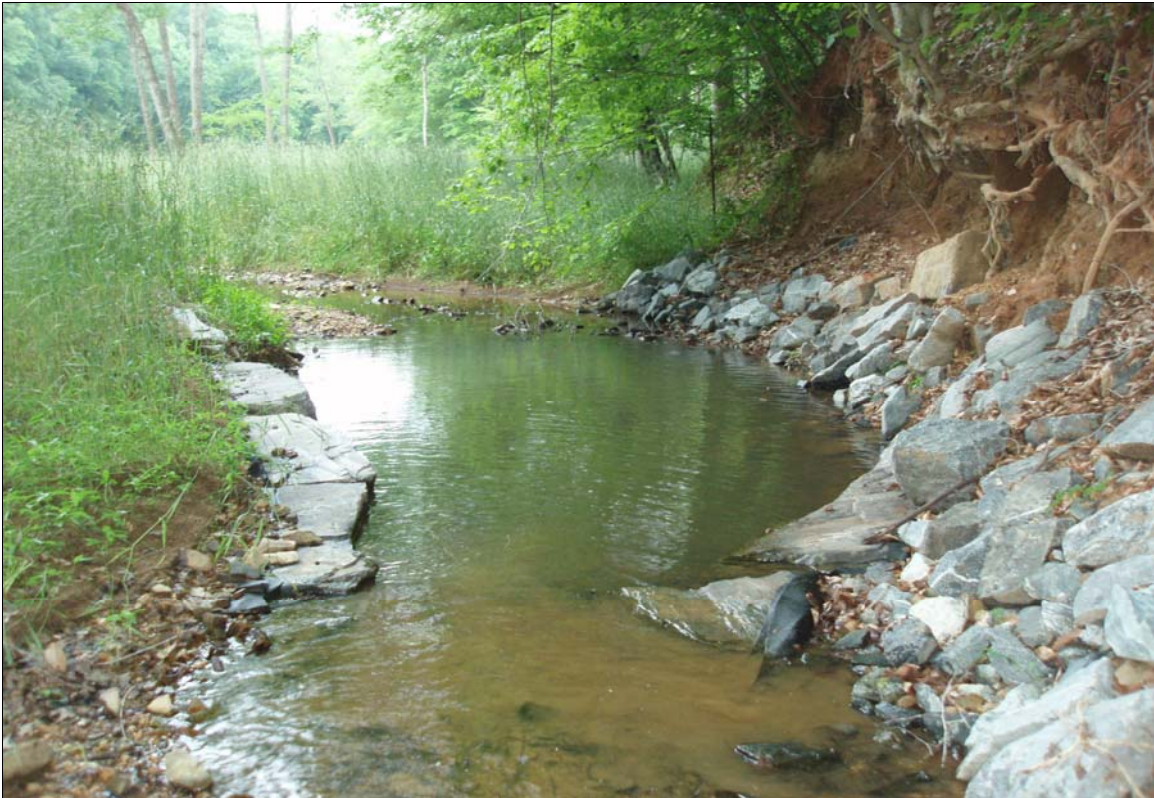
Photo Point 1d: View looking downstream near Station 10+00. 5/29/09 – As-Built

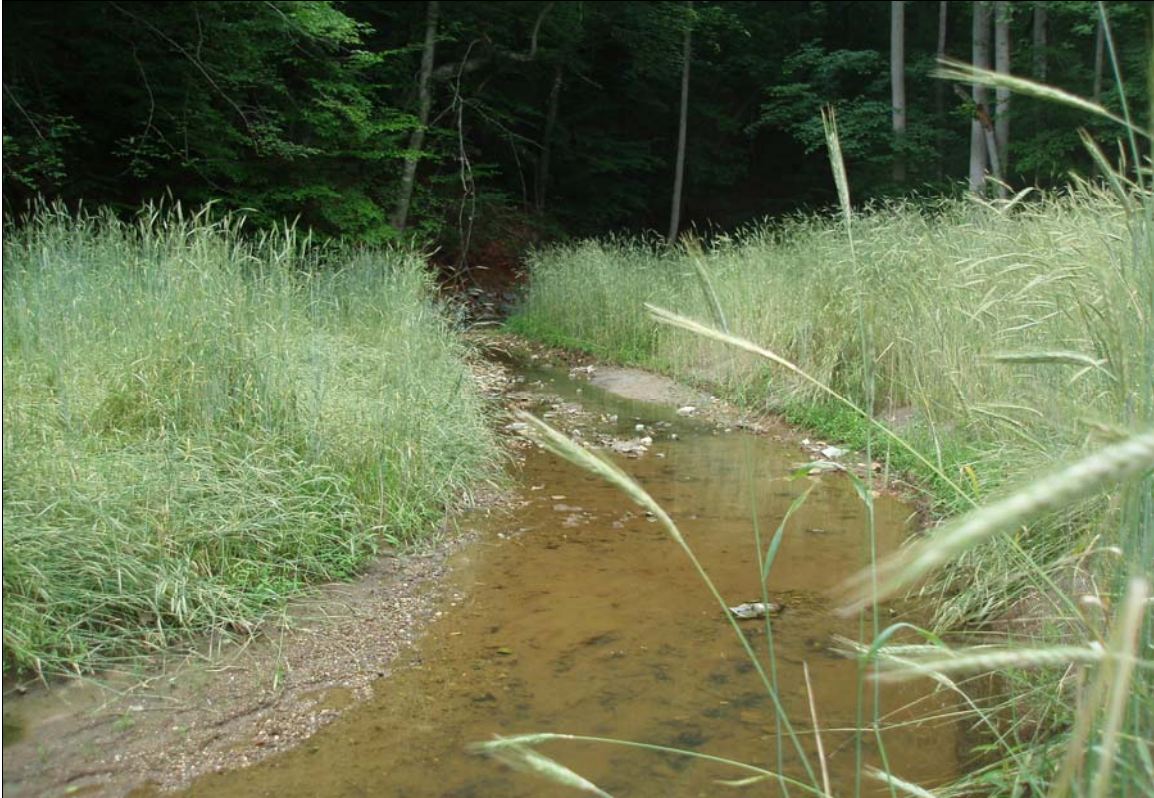
Photo Point 2u: View looking upstream taken near Station 11+50. 5/29/09 – As-Built

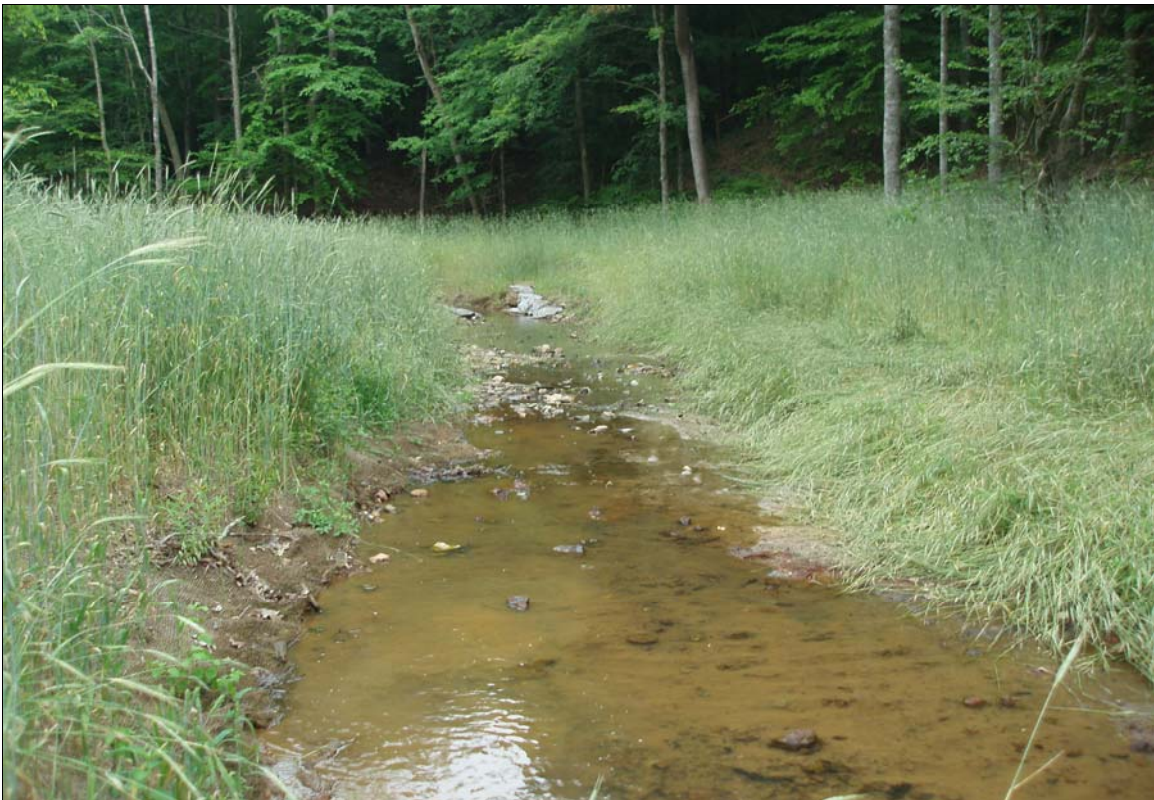
Photo Point 2d: View looking downstream taken near Station 11+50. 5/29/09 – As-Built

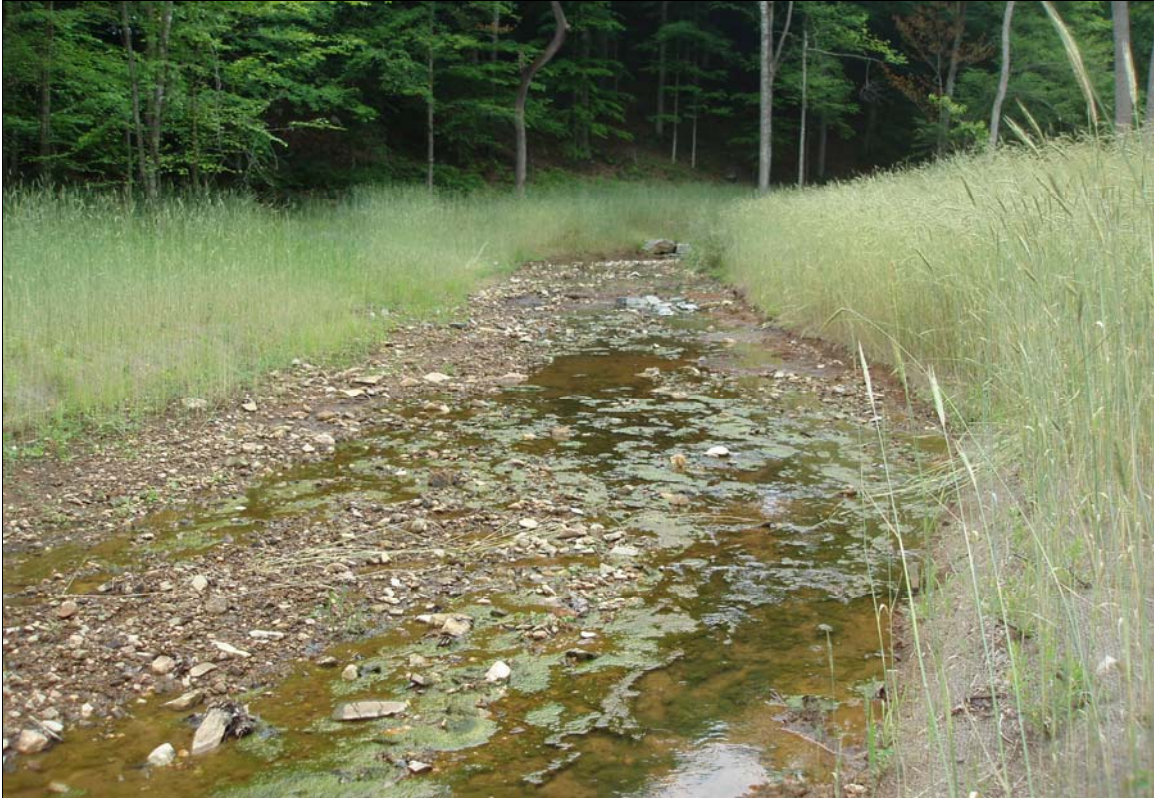
Photo Point 3u: View looking upstream near Station 14+30. 5/29/09 – As-Built

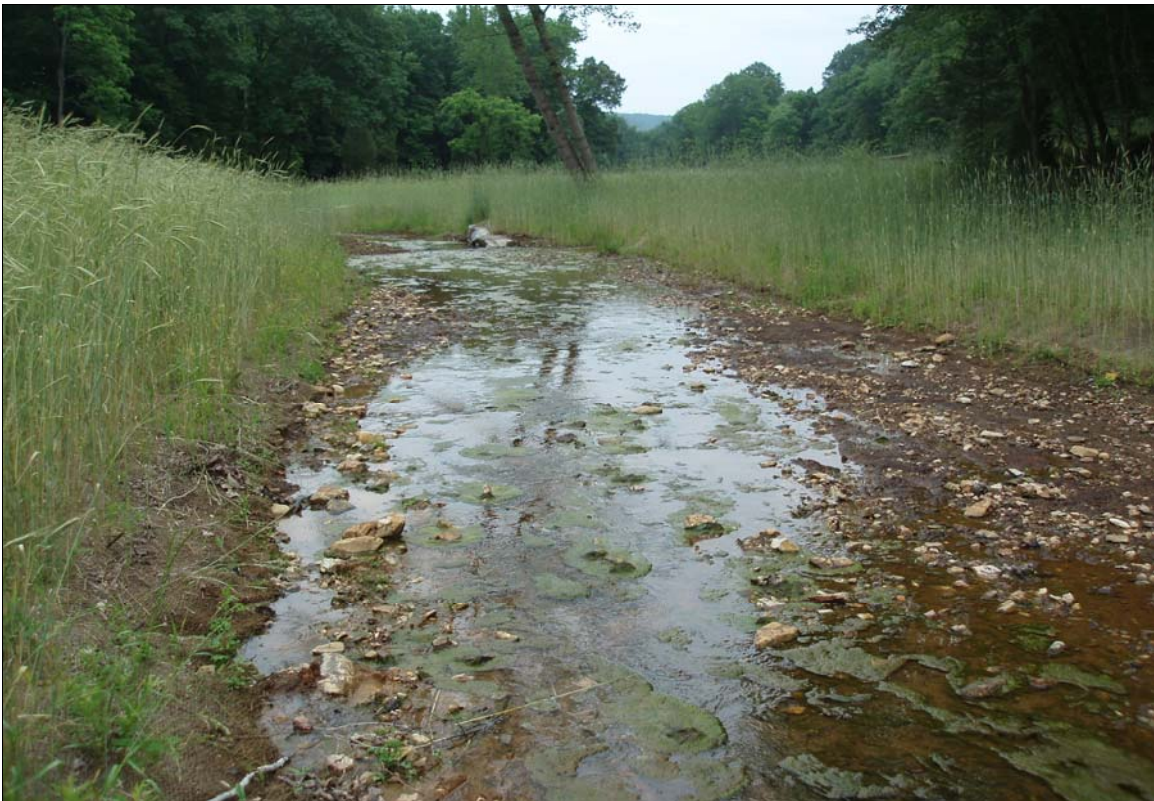
Photo Point 3d: View looking downstream near Station 14+30. 5/29/09 – As-Built

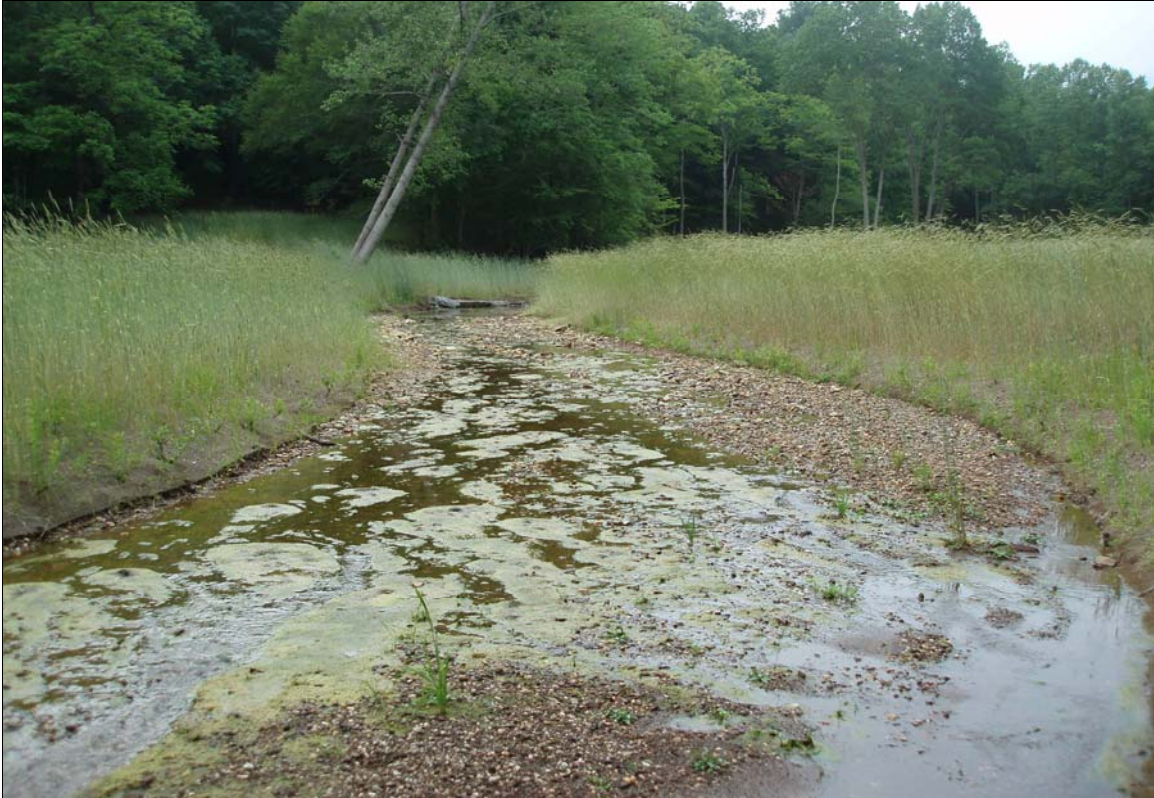
Photo Point 4u: View looking upstream near Station 17+35. 5/29/09 – As-Built

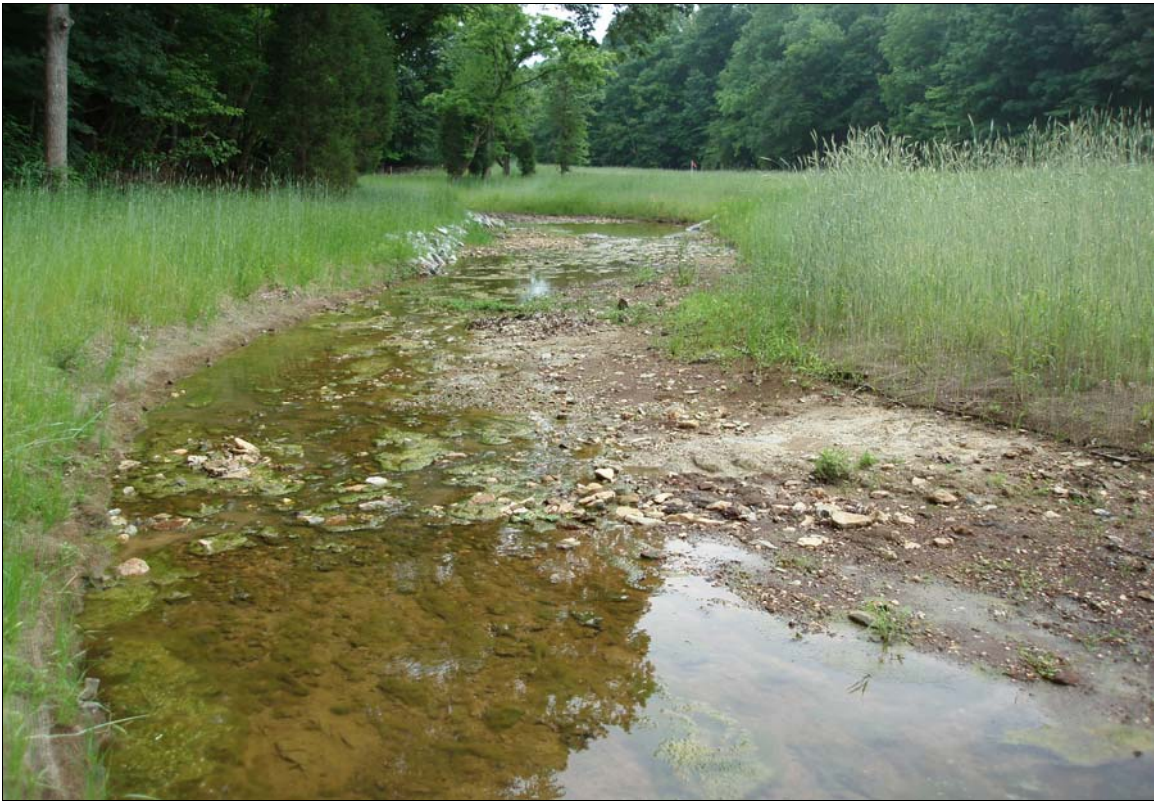
Photo Point 4d: View looking downstream near Station 17+35. 5/29/09 – As-Built

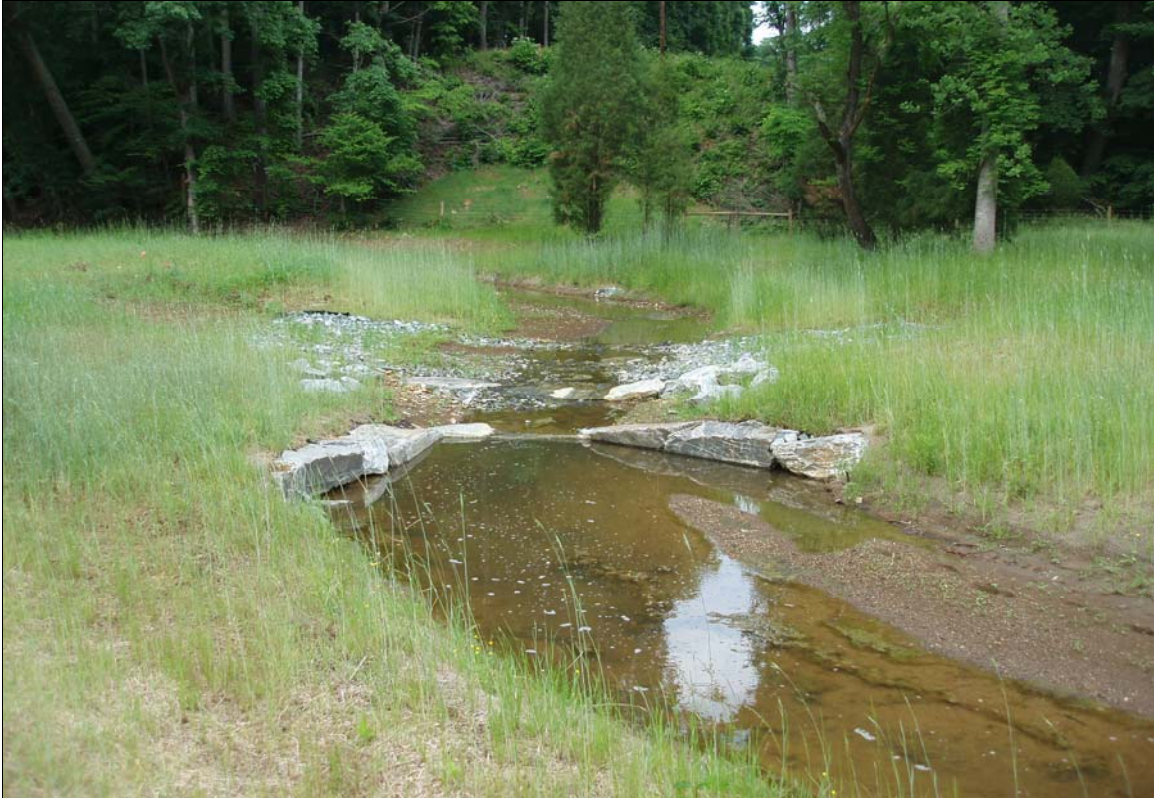
Photo Point 5u: View looking upstream near Station 21+00. 5/29/09 – As-Built

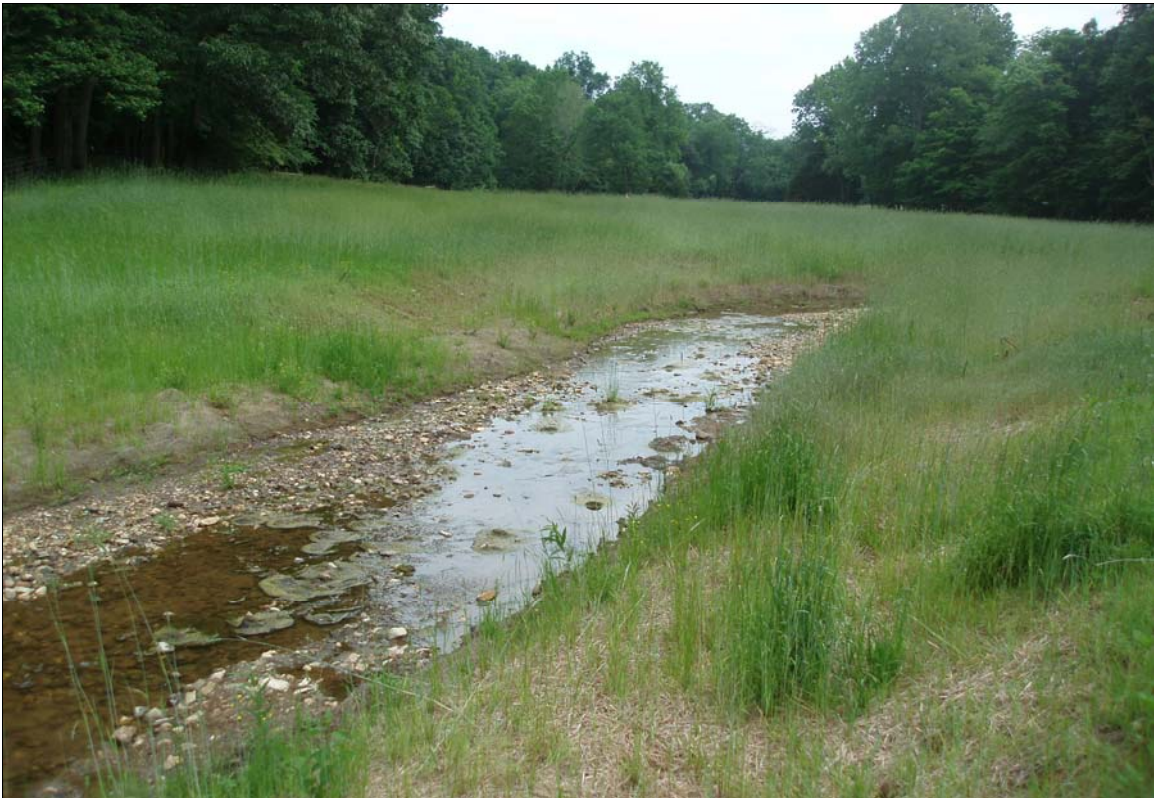
Photo Point 5d: View looking downstream near Station 21+00. 5/29/09 – As-Built

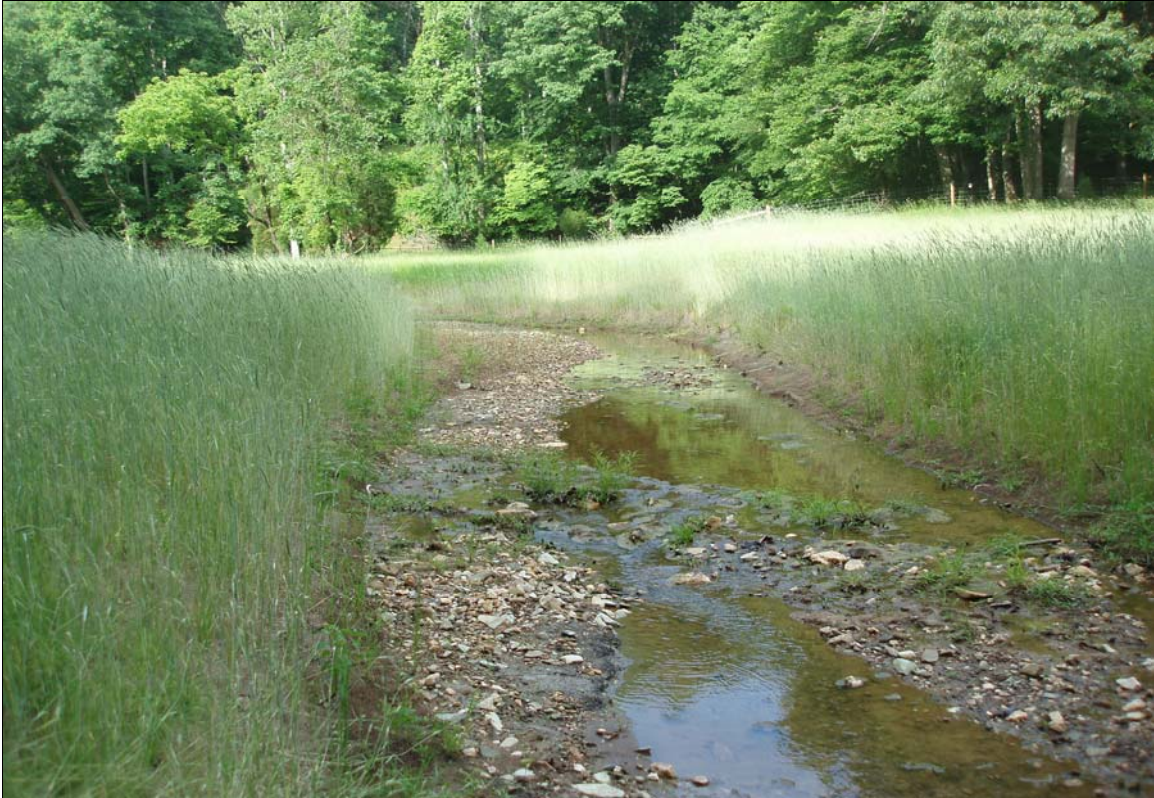
Photo Point 6u: View looking upstream near Station 23+00. 5/29/09 – As-Built
