**Baseline Monitoring Report
McCain Stream Restoration Site - Project # 443
Randolph County**

**Data Collection: May 2009
Submitted: February 2010**

**Landmark Center II, Suite 220
4601 Six Forks Road
Raleigh, NC 27609
Phone: (919) 278-2514
Fax: (919) 783-9266
KCI Project #:12053743E**

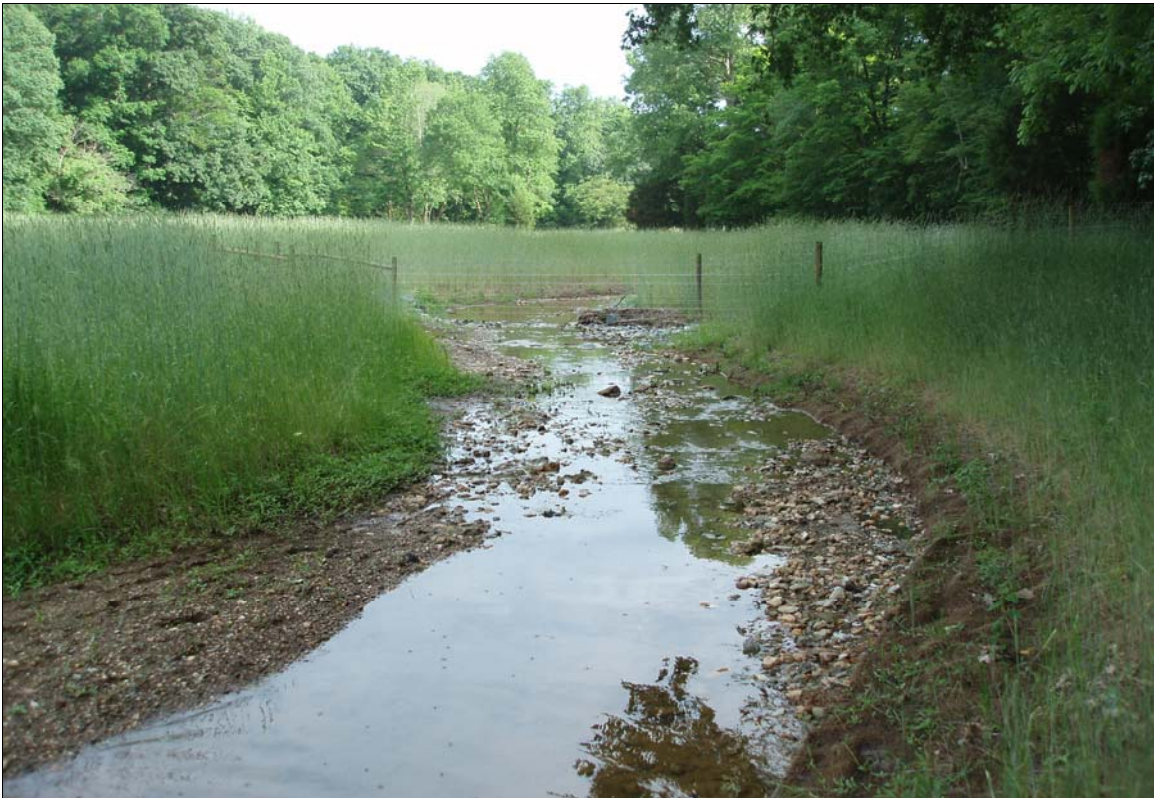
Photo Point 6d: View looking downstream near Station 23+00. 5/29/09 – As-Built

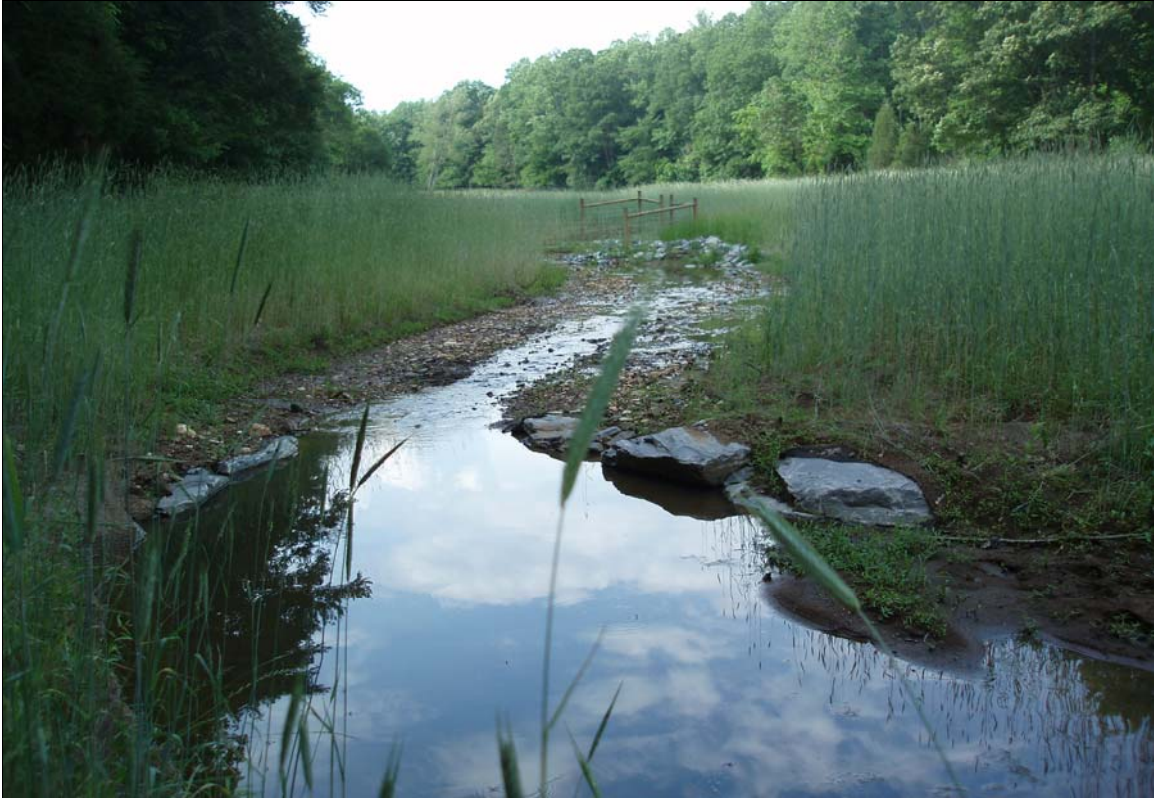
Photo Point 7u: View looking upstream near Station 25+25. 5/29/09 – As-Built

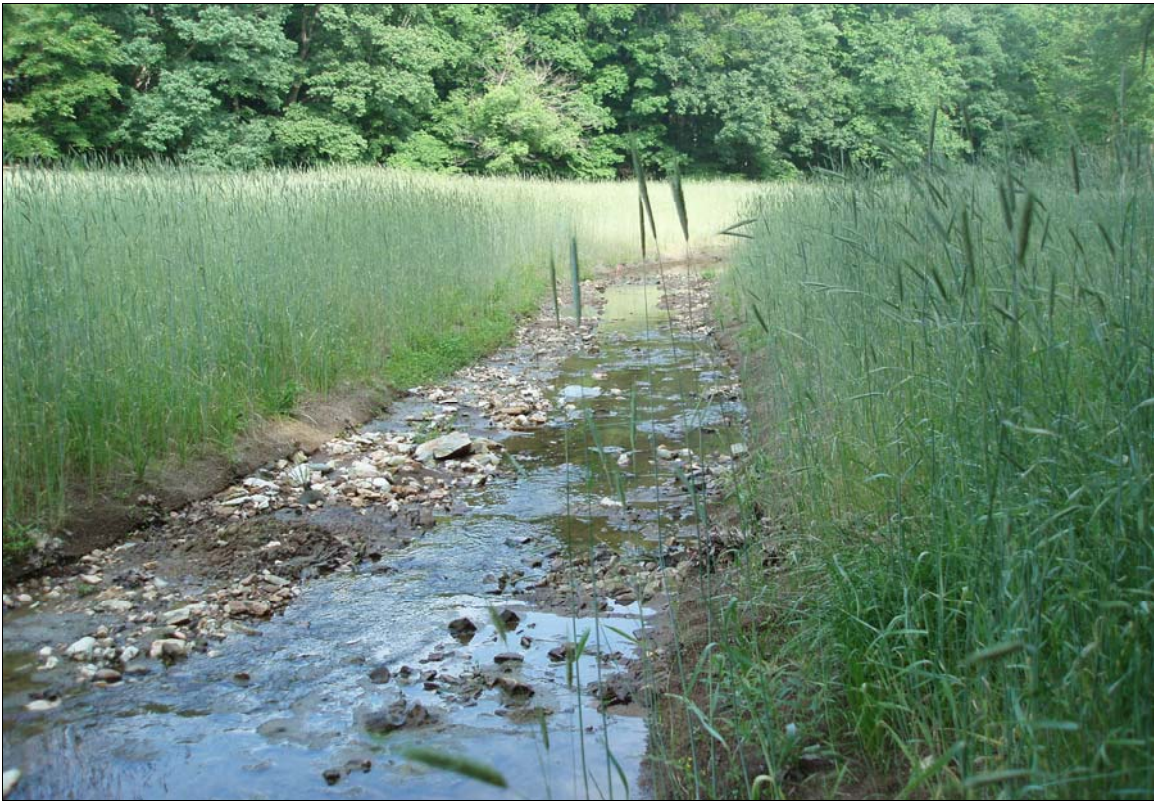
Photo Point 7d: View looking downstream near Station 25+25. 5/29/09 – As-Built

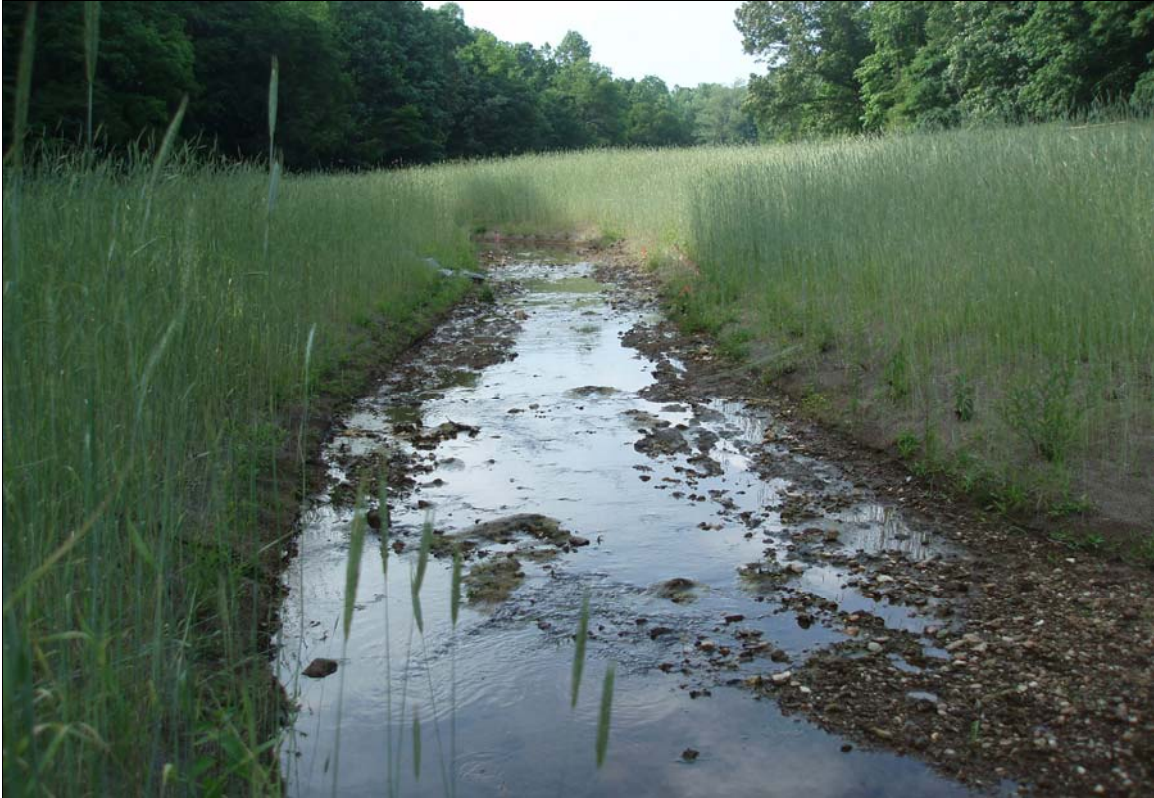
Photo Point 8u: View looking upstream near Station 27+75. 5/29/09 – As-Built

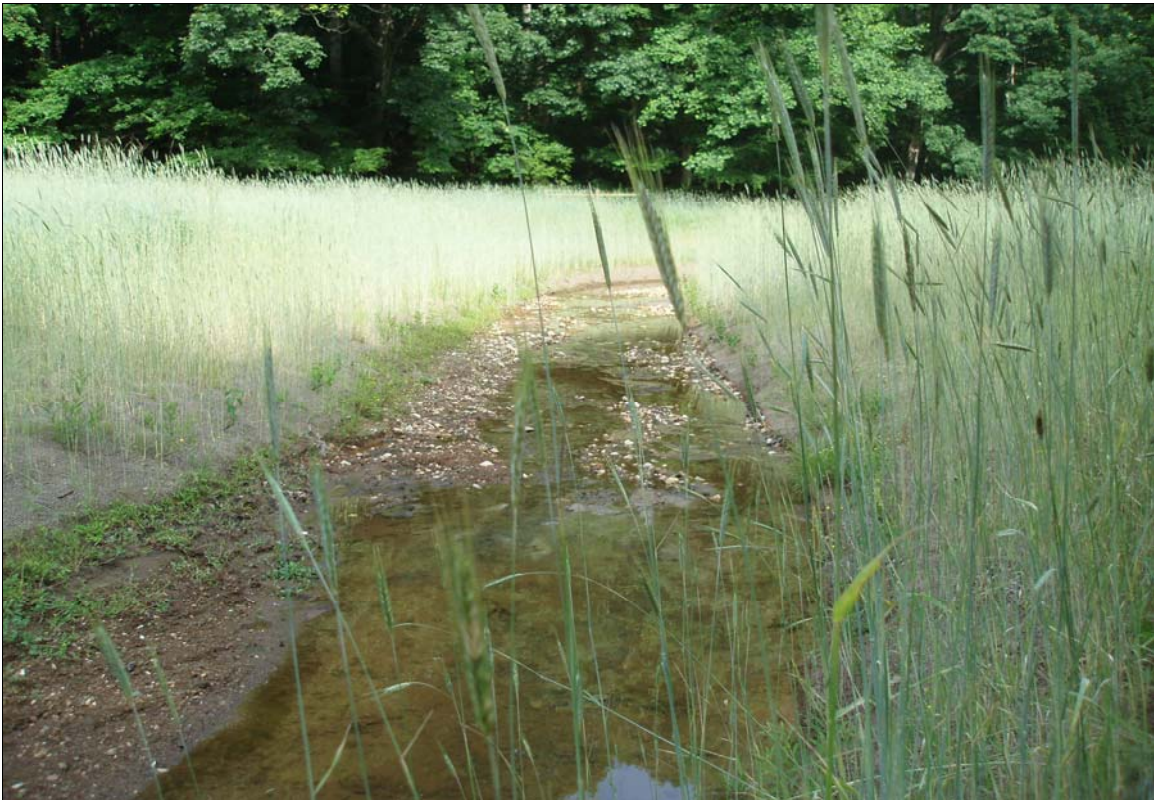
Photo Point 8d: View looking downstream near Station 27+75. 5/29/09 – As-Built

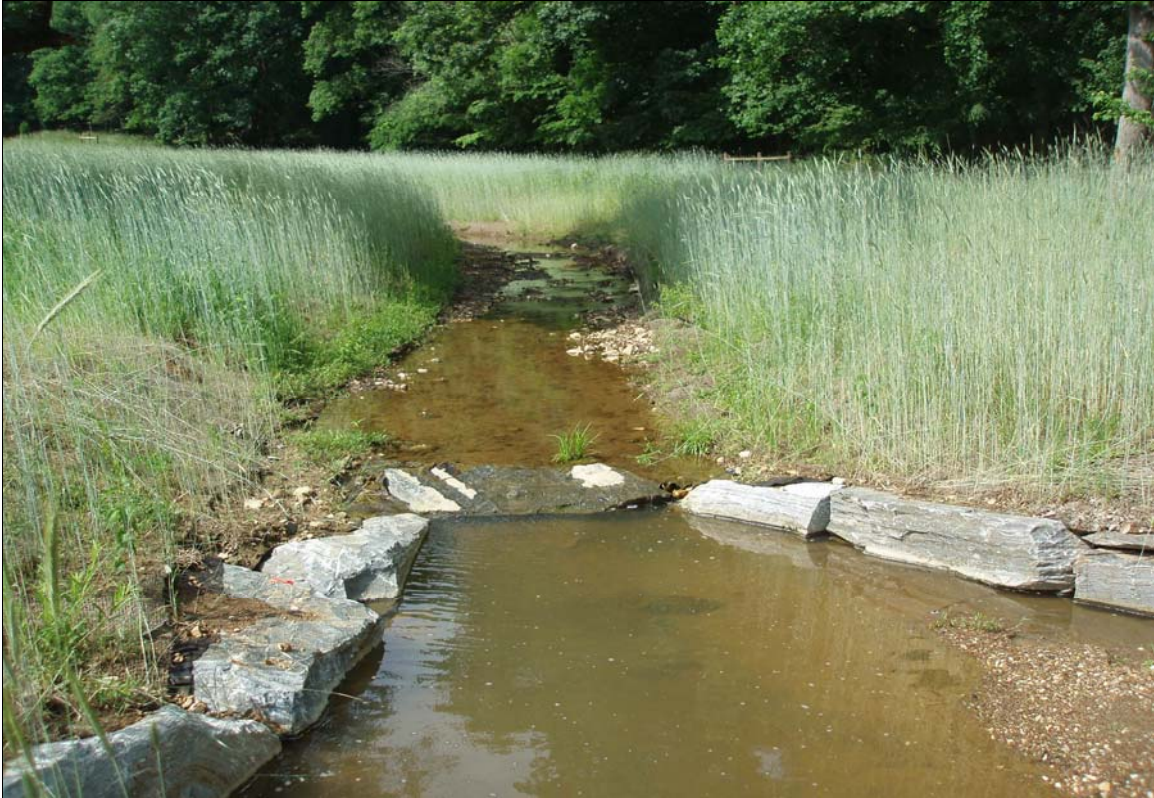
Photo Point 9u: View looking upstream near Station 30+30. 5/29/09 – As-Built

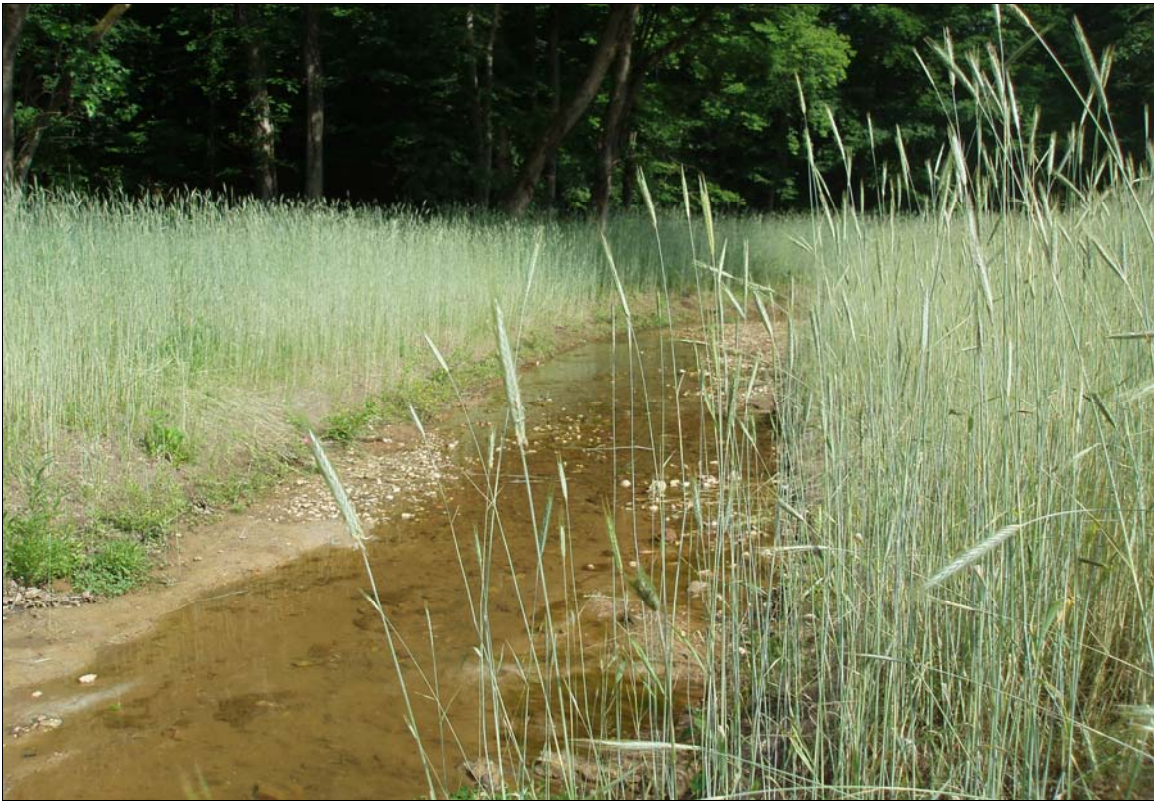
Photo Point 9d: View looking downstream near Station 30+30. 5/29/09 – As-Built

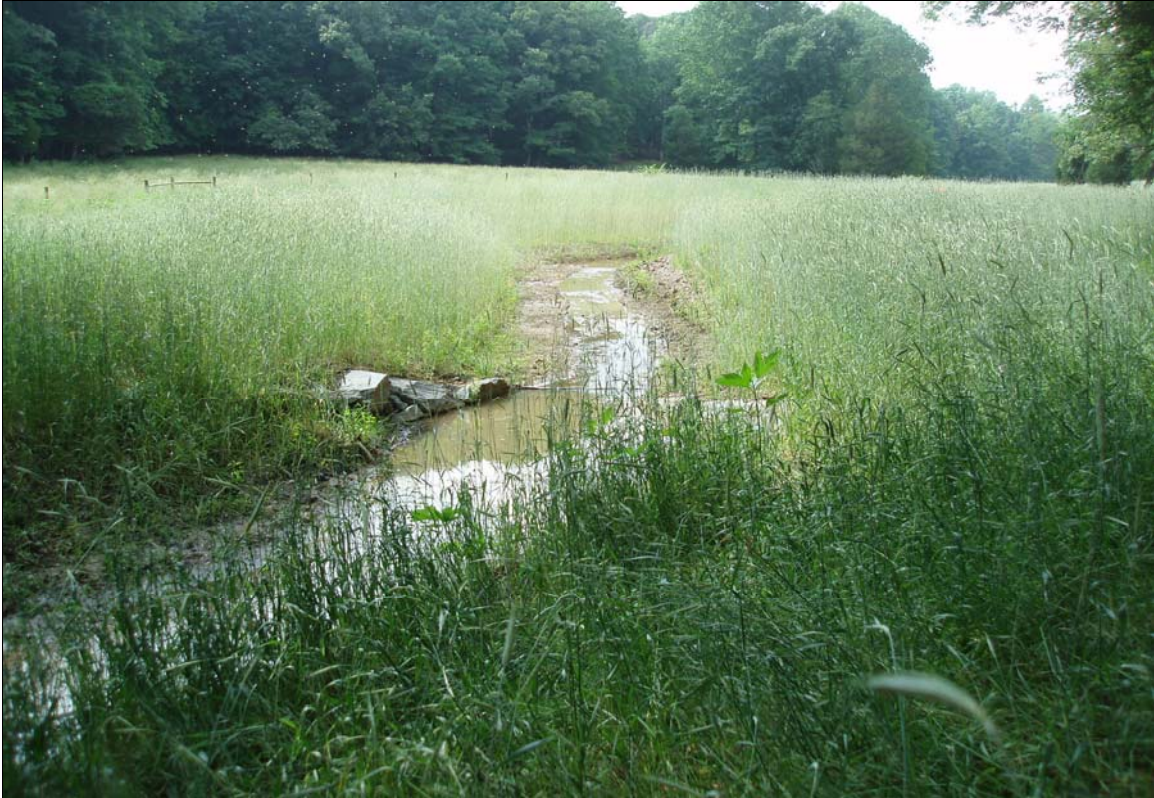
Photo Point 10u: View looking upstream near Station 34+25. 5/29/09 – As-Built

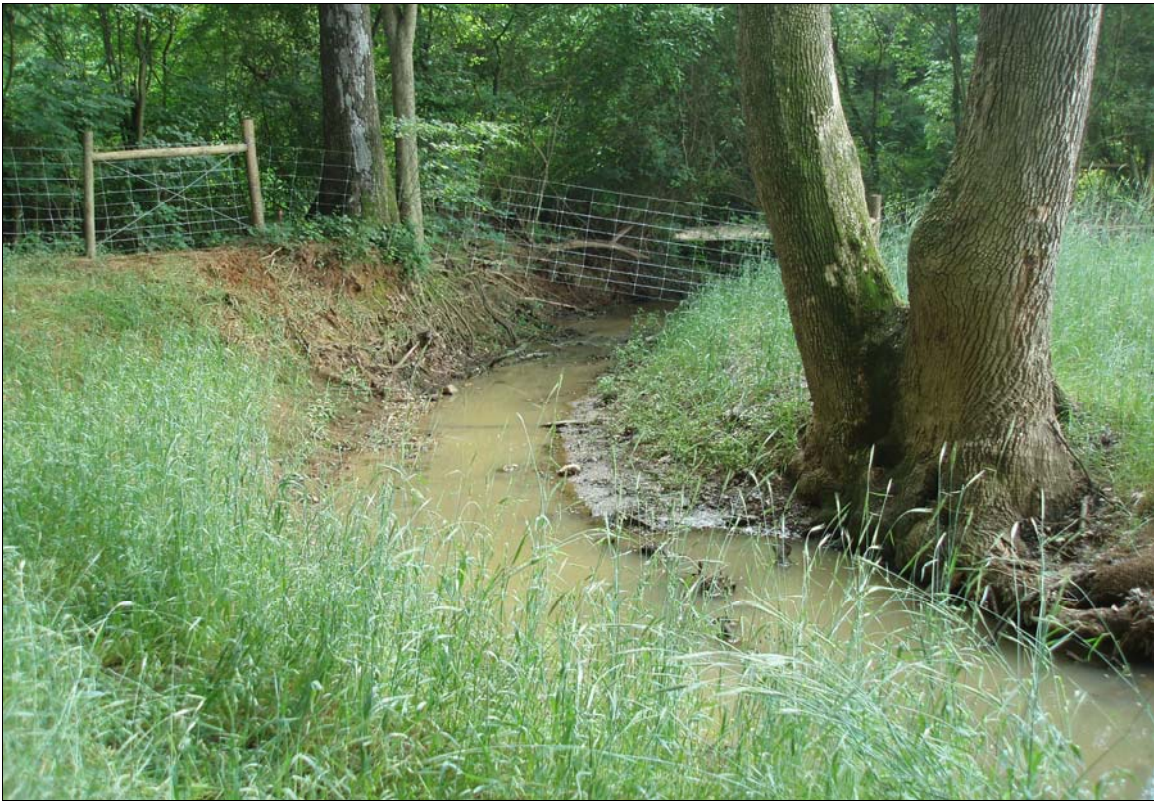
Photo Point 10d: View looking downstream towards the end of the project. 5/29/09 – As-Built
