Middle South Muddy
As-Built Baseline Monitoring Report

Middle South Muddy Stream Restoration Site
NCDMS Contract No. 6783
NCDMS Project No. 93875
McDowell County, North Carolina
Data Collected: May 18th, 2015 - May 4th, 2016
Date Submitted: July 11, 2016

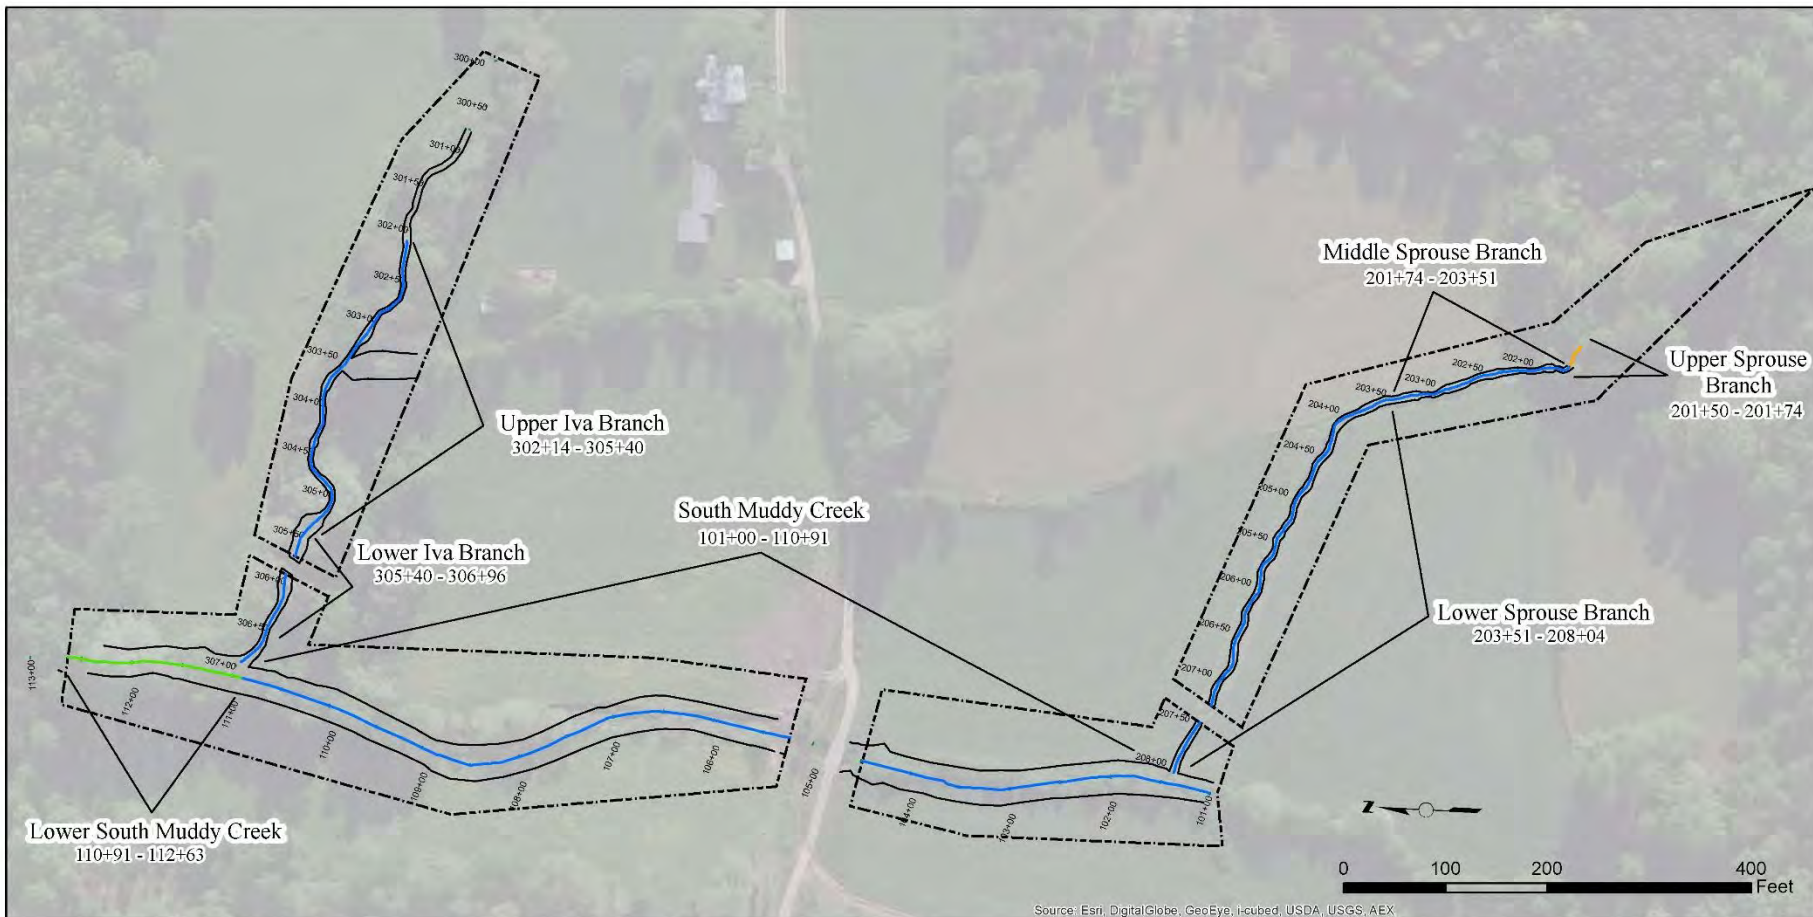
Prepared for DMS	Stream Asset Type Enhancement I Enhancement II Restoration Easement	Figure 2. Asset Map Middle South Muddy Stream Restoration Site Project No. 93875 McDowell County, North Carolina Sheet 1 of 2	Prepared by
--------------------------------	--	---	-----------------

Construction of the Site produced a total of 4,073 stream mitigation units, as outline in Table 1 and depicted in Figure 2. The Site is comprised of eight reaches totaling 11,981 length feet of Restoration or Restoration Equivalent; South Muddy Creek (916 feet), Lower South Muddy Creek (172 feet), Upper Sprouse Branch (24 feet), Middle and Lower Sprouse Branch (611 feet), Upper and Lower Iva Branch (462 feet), and Haney Tract (9,796 feet).

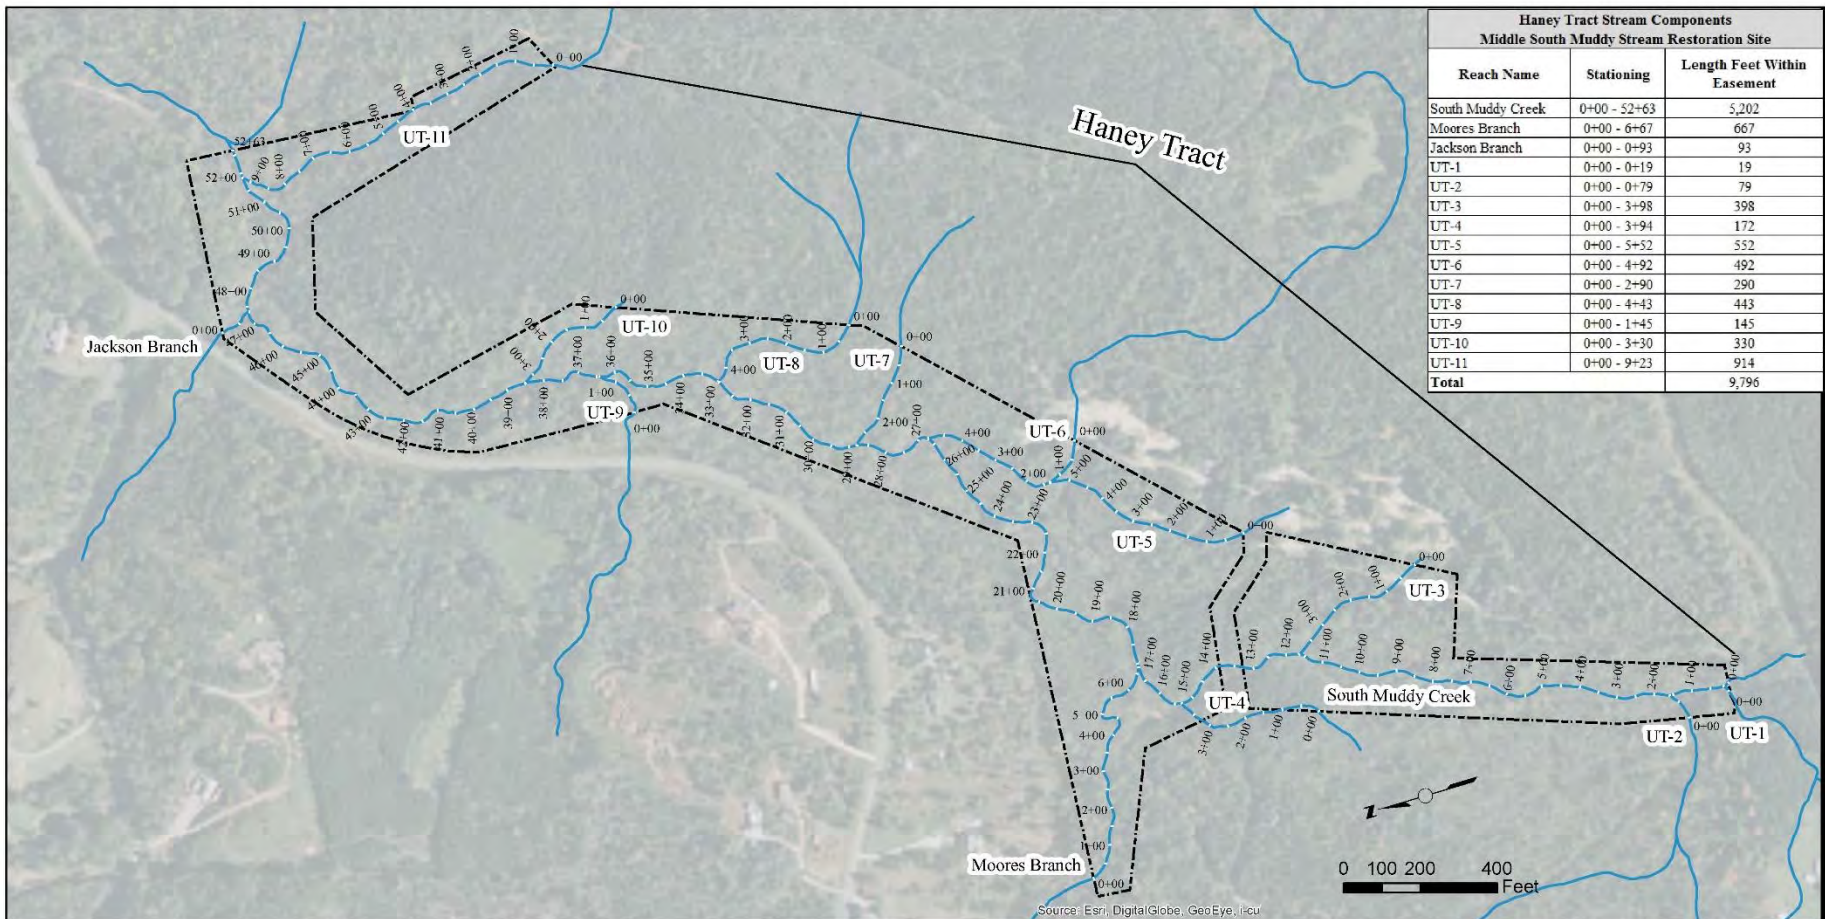
Haney Tract Stream Components Middle South Muddy Stream Restoration Site		
Reach Name	Stationing	Length Feet Within Easement
South Muddy Creek	0+00 - 52+63	5,202
Moores Branch	0+00 - 6+67	667
Jackson Branch	0+00 - 0+93	93
UT-1	0+00 - 0+19	19
UT-2	0+00 - 0+79	79
UT-3	0+00 - 3+98	398
UT-4	0+00 - 3+94	172
UT-5	0+00 - 5+52	552
UT-6	0+00 - 4+92	492
UT-7	0+00 - 2+90	290
UT-8	0+00 - 4+43	443
UT-9	0+00 - 1+45	145
UT-10	0+00 - 3+30	330
UT-11	0+00 - 9+23	914
Total		9,796

Prepared for DMS	Stream Asset Type Preservation Easement	Figure 2. Asset Map Middle South Muddy Stream Restoration Site Project No. 93875 McDowell County, North Carolina Sheet 2 of 2	Prepared by
----------------------------	--	---	-----------------

The Haney Tract was put under a permanent conservation easement to preserve approximately 5,836 linear feet of stream channel and approximately 35 acres of riparian buffer (Mitigation Plan, 2012). Due to historic commercial and recreational mining operations within the floodplain of South Muddy Creek, the riparian buffer has been degraded over time. Establishment of the conservation easement will protect stream and adjacent floodplain from future destructive mining activities. The network of dirt roads was also barricaded in strategic locations to prevent future vehicular access. The Haney Tract surveyed conservation easement plat reveals additional stream linear feet within the protected easement. Streams include South Muddy Creek, Moores Branch, Jackson Branch and eleven unamend tributaries. The total stream length within the conservation easement is 9,796 LF (Figure 2. Asset Map). The project preservation assets have been updated to reflect this additional stream length.

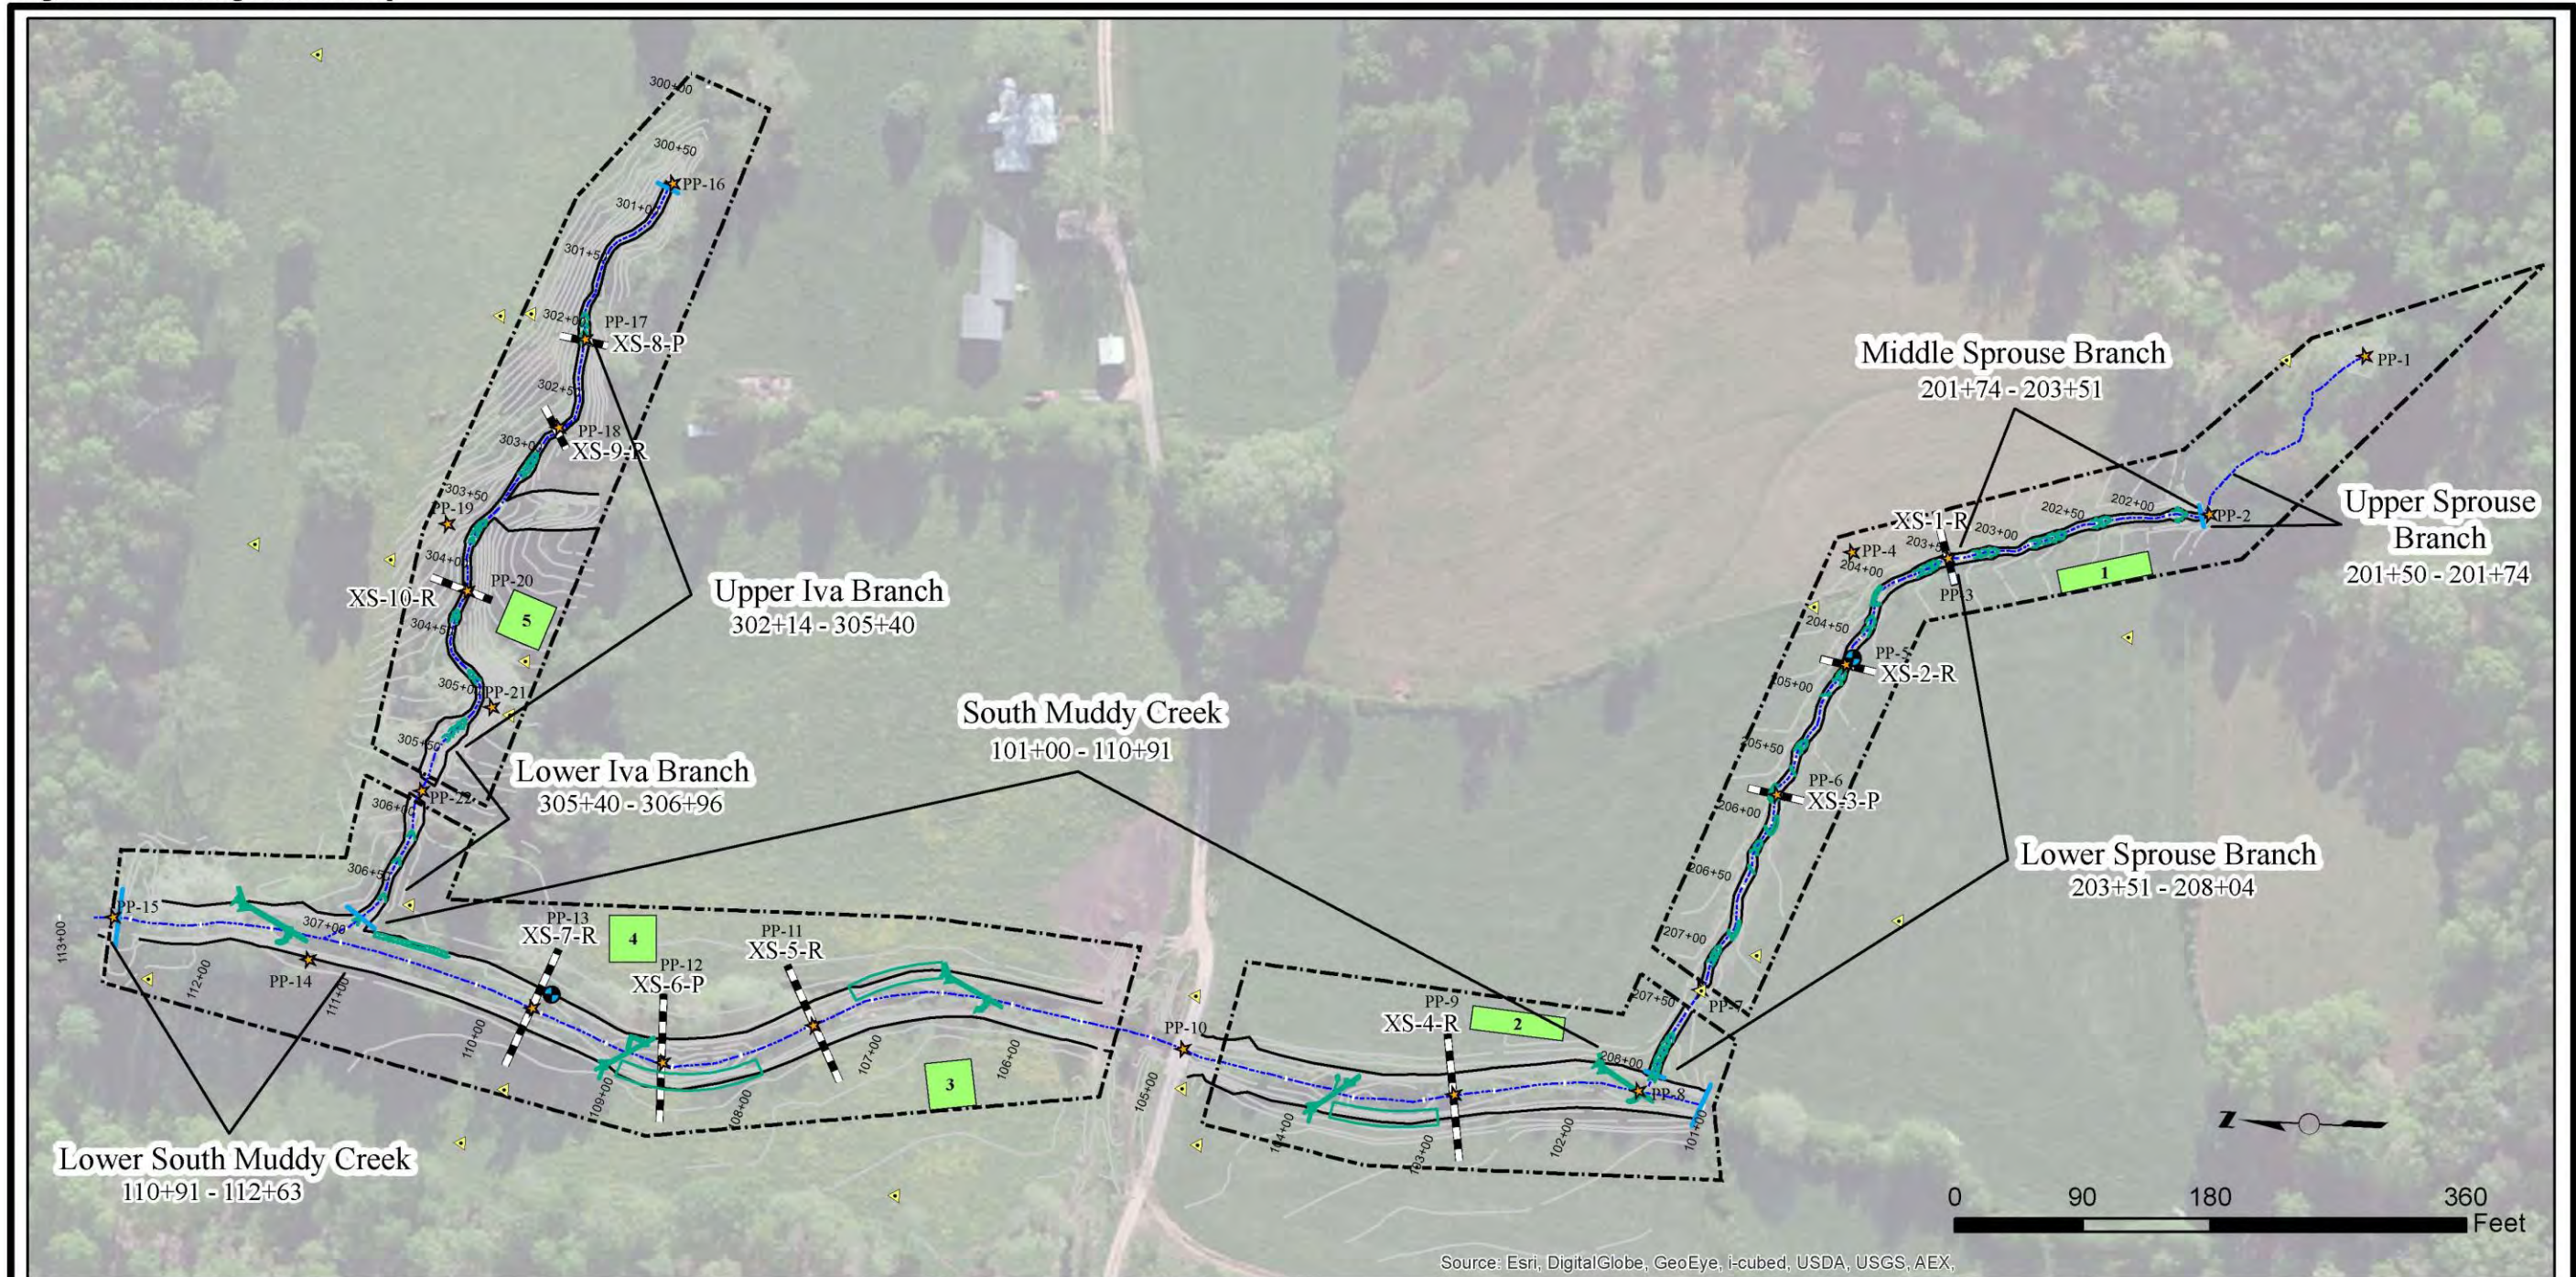
Figure 3. Monitoring Features Map

<p>Prepared for</p> <p>DMS</p>	<p>Middle South Muddy Stream Restoration Project Monitoring Year 0 McDowell County, NC NCDMS Contract No.: 00006783 NCDMS Project No.: 93875 May 2016 Sheet 1 of 2</p>

<table><tr> <td>★ Photo Point</td> <td>~ Thalweg</td> <td>⌋ Hook-Log Run</td> <td>⌋ Log Vane with Hook</td> </tr></table>

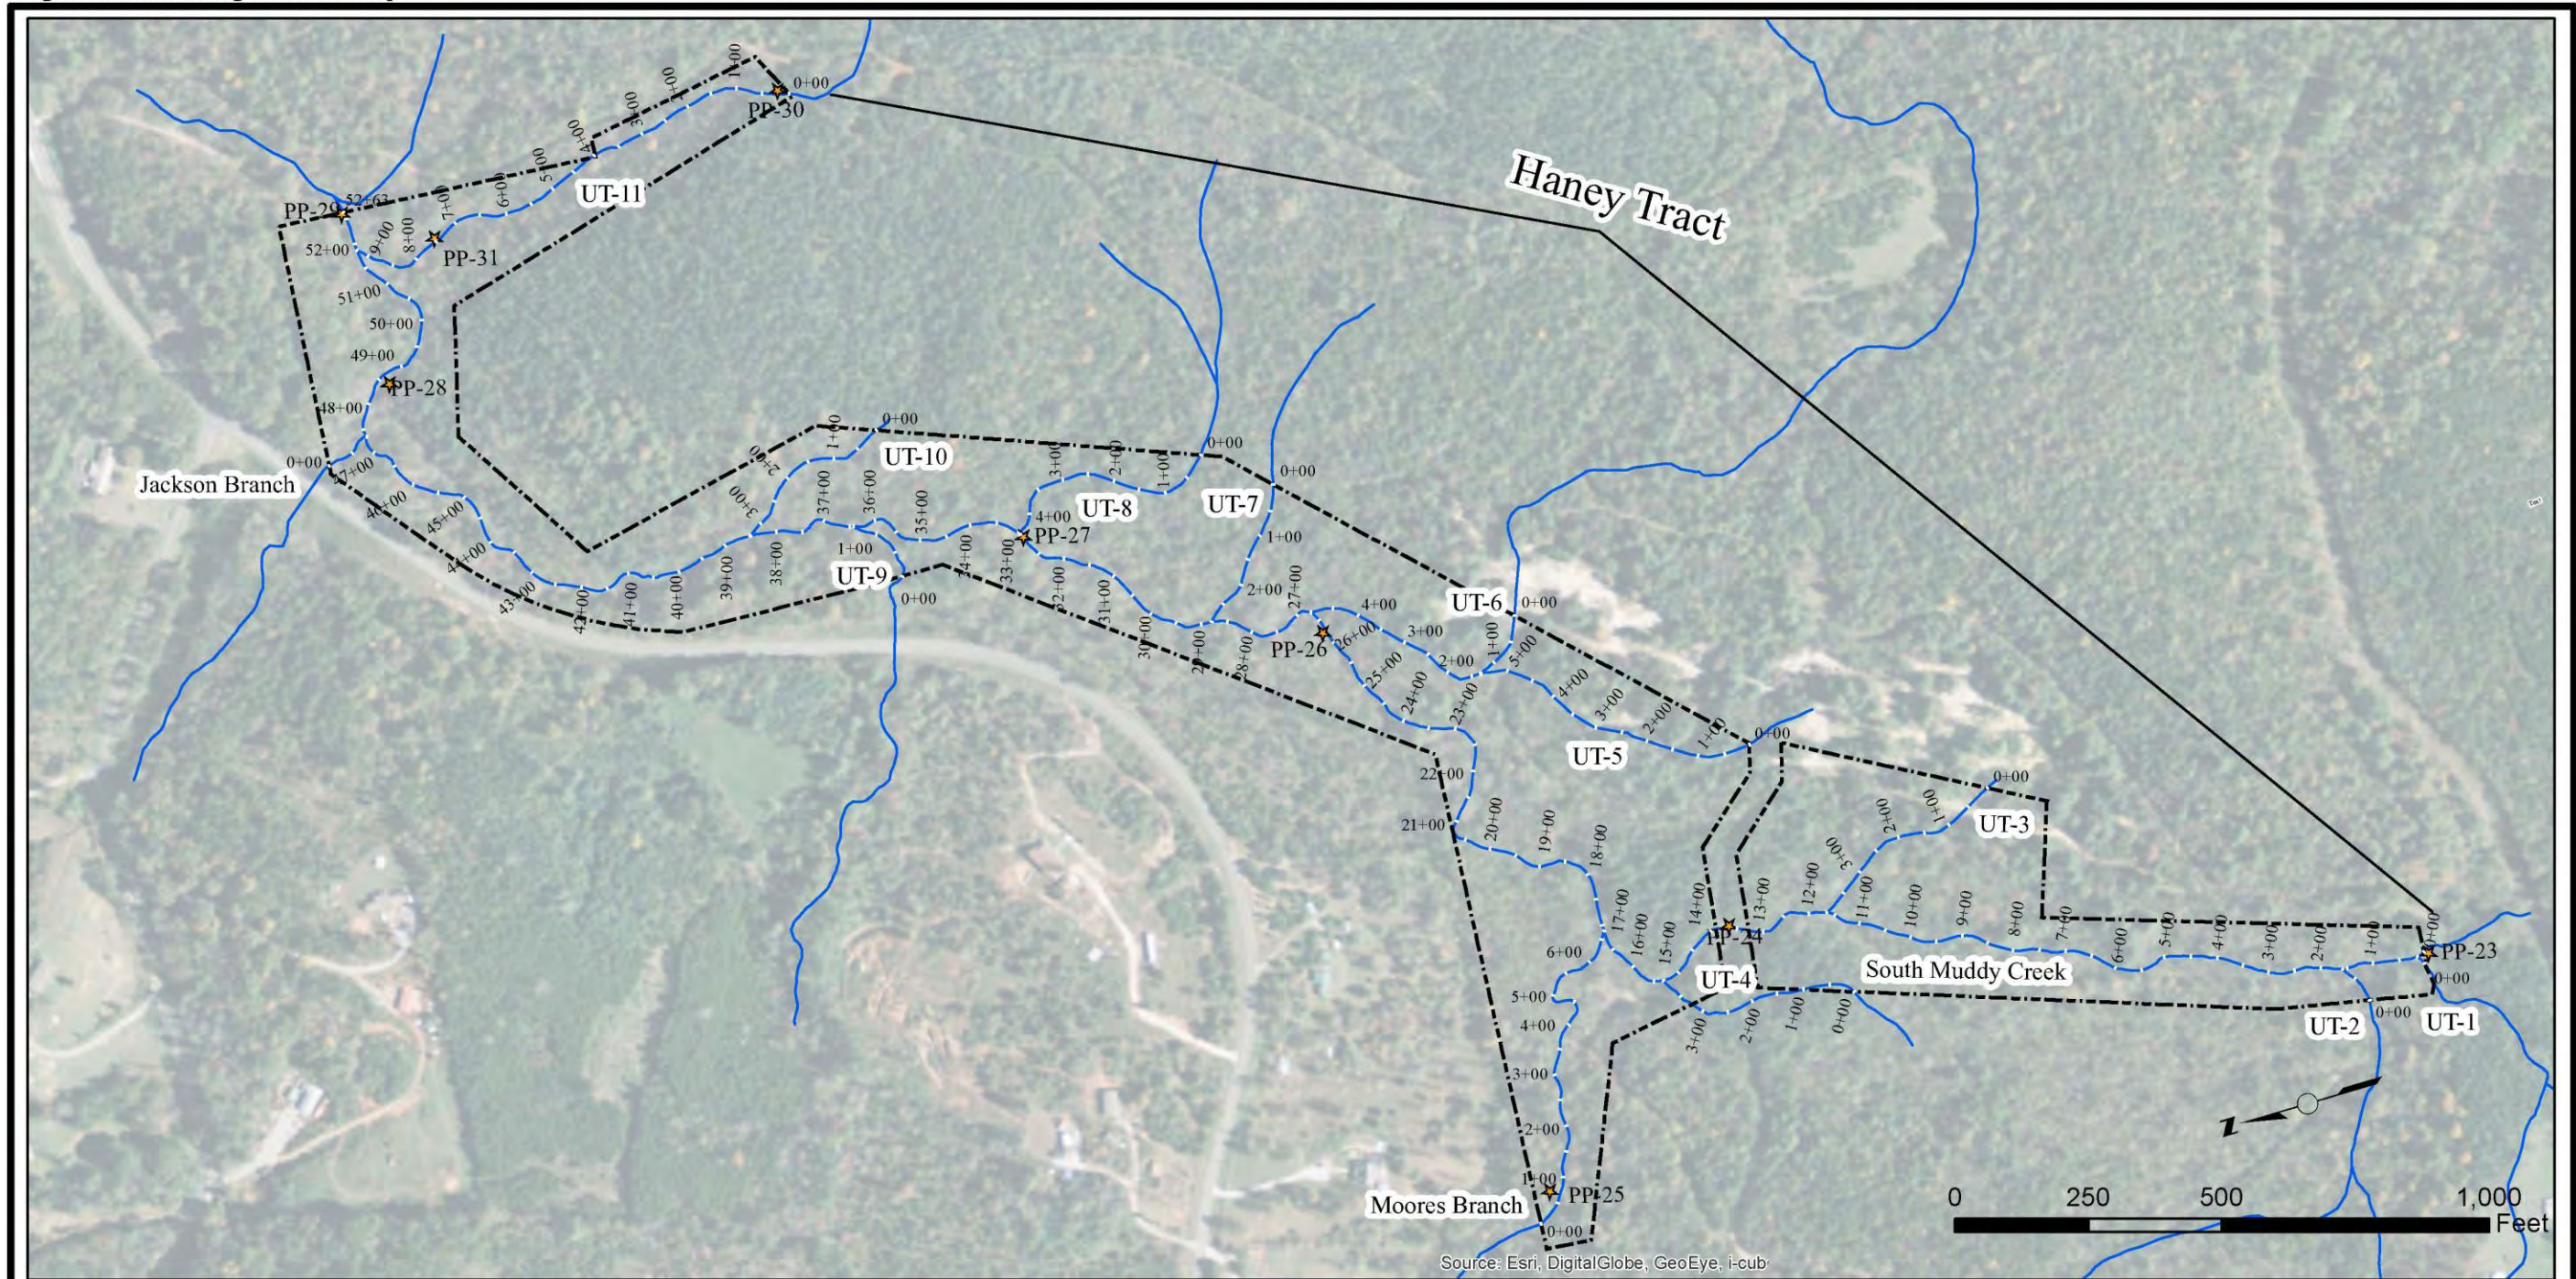
Figure 3. Monitoring Features Map

<p>Prepared for</p> <p>DMS</p>	<p>Middle South Muddy Stream Restoration Project Monitoring Year 0 McDowell County, NC NCDMS Contract No.: 00006783 NCDMS Project No.: 93875 May 2016 Sheet 2 of 2</p>	<ul style="list-style-type: none"> Photo Point Crest Gauge Control Point Structure Cross-Section Long Pro Start/End Preservation Streams Top of Bank Contour (1 ft) Vegetation Plots Easement 	<ul style="list-style-type: none"> Hook-Log Run Hook Run Boulder-Arch Boulder-Arch with Log Armored Riffle Log Vane with Hook Log Sill Log Sill no Baffle Brush Toe 	<p>Notes: 1) Baseline Data Provided by Turner Land Surveying</p>	<p>Prepared by</p>
---------------------------------------	--	---	---	--	--------------------

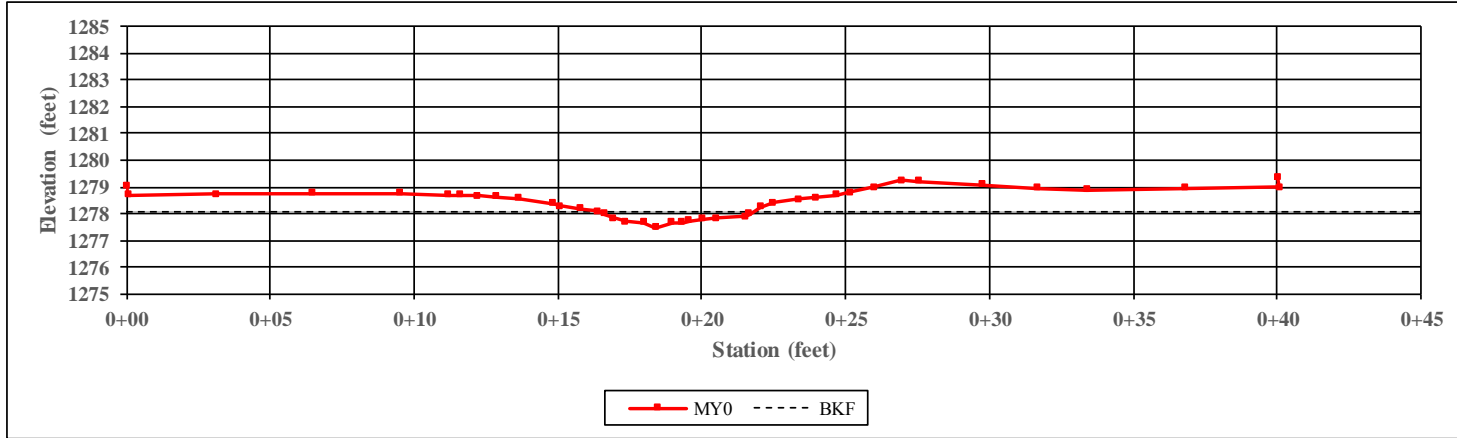
XS Number: 1
XS Type: Riffle

Station: 203+60

CHANNEL DIMENSIONS SUMMARY	MY0	MY1	MY2	MY3	MY4	MY5	MY6	MY7
Bankful Width (ft)	5.4	-	-	-	-	-	-	-
Floodprone Width (ft)	14.0	-	-	-	-	-	-	-
Bankfull Mean Depth (ft)	0.3	-	-	-	-	-	-	-
Bankfull Max Depth (ft)	0.6	-	-	-	-	-	-	-
Bankfull Cross-Sectional Area (ft ²)	1.8	-	-	-	-	-	-	-
Width/Depth Ratio	16.7	-	-	-	-	-	-	-
Entrenchment Ratio	2.6	-	-	-	-	-	-	-
Bank Height Ratio	1.0	-	-	-	-	-	-	-

Reach summary tables, cross-section summary tables, and cross-section plots related to stream morphology can be found in Appendix B. Generally the pattern, profile, and dimension were very similar to those values outlined in the design. The Lower Iva Branch as-built slope (0.032 ft/ft) was slightly higher than the design slope of 0.026 ft/ft; however the slope falls within the applicable slope ranges for B5 stream types (0.02-0.039 ft/ft).

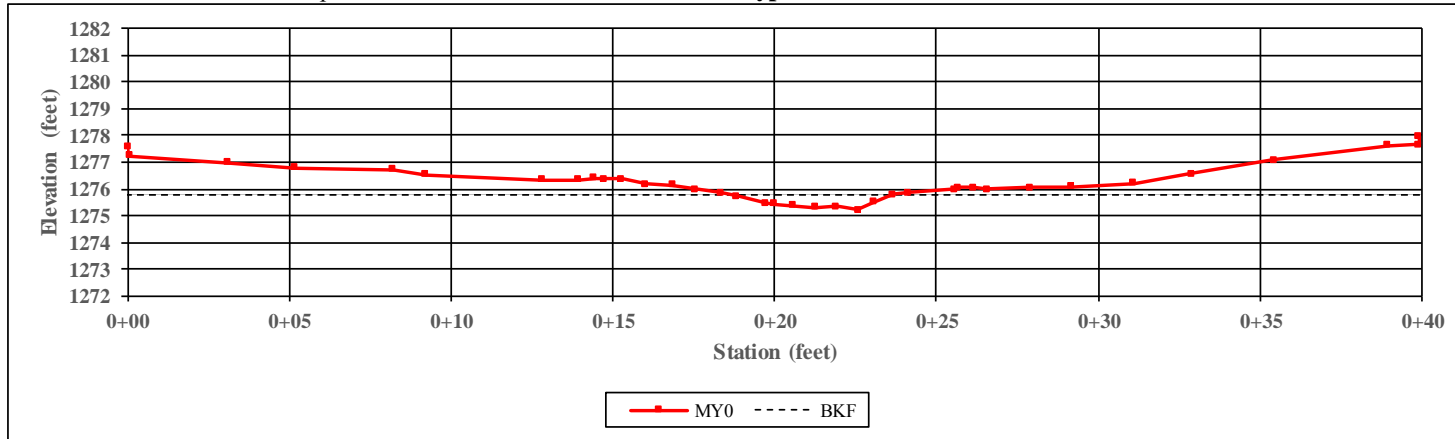
XS Number: 2
XS Type: Riffle

Project Name: Middle South Muddy
Reach Name: Lower Sprouse Branch

Station: 204+72

CHANNEL DIMENSIONS SUMMARY	MY0	MY1	MY2	MY3	MY4	MY5	MY6	MY7
Bankful Width (ft)	5.1	-	-	-	-	-	-	-
Floodprone Width (ft)	23.0	-	-	-	-	-	-	-
Bankfull Mean Depth (ft)	0.3	-	-	-	-	-	-	-
Bankfull Max Depth (ft)	0.6	-	-	-	-	-	-	-
Bankfull Cross-Sectional Area (ft ²)	1.7	-	-	-	-	-	-	-
Width/Depth Ratio	15.1	-	-	-	-	-	-	-
Entrenchment Ratio	4.5	-	-	-	-	-	-	-
Bank Height Ratio	1.0	-	-	-	-	-	-	-

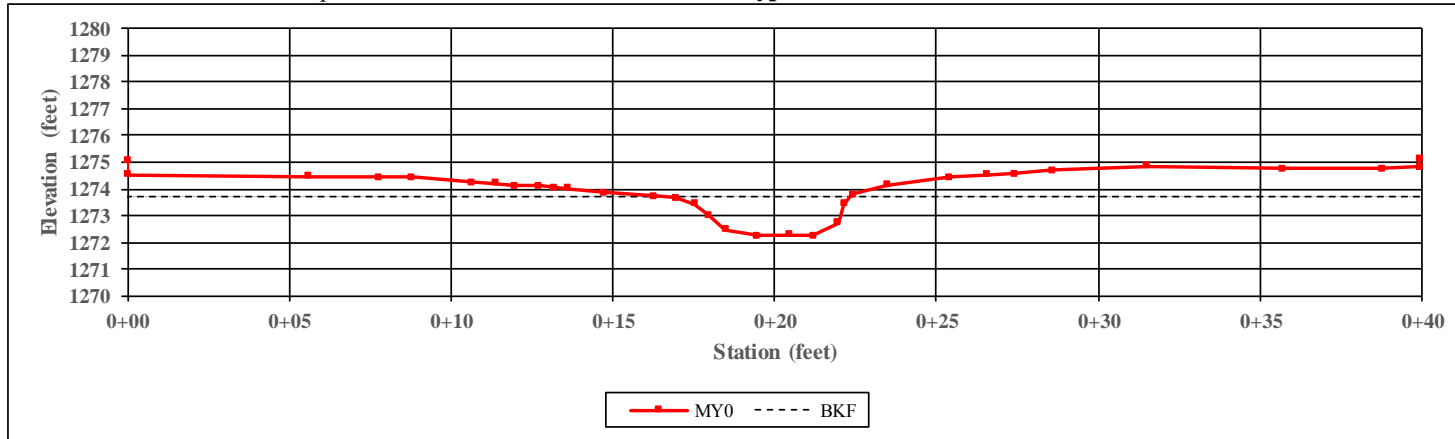
XS Number: 3
XS Type: Pool

Project Name: Middle South Muddy
Reach Name: Lower Sprouse Branch

Station: 205+79

CHANNEL DIMENSIONS SUMMARY	MY0	MY1	MY2	MY3	MY4	MY5	MY6	MY7
Bankful Width (ft)	6.1	-	-	-	-	-	-	-
Floodprone Width (ft)	32.0	-	-	-	-	-	-	-
Bankfull Mean Depth (ft)	1.0	-	-	-	-	-	-	-
Bankfull Max Depth (ft)	1.5	-	-	-	-	-	-	-
Bankfull Cross-Sectional Area (ft ²)	5.9	-	-	-	-	-	-	-
Width/Depth Ratio	6.3	-	-	-	-	-	-	-
Entrenchment Ratio	5.3	-	-	-	-	-	-	-
Bank Height Ratio	1.0	-	-	-	-	-	-	-

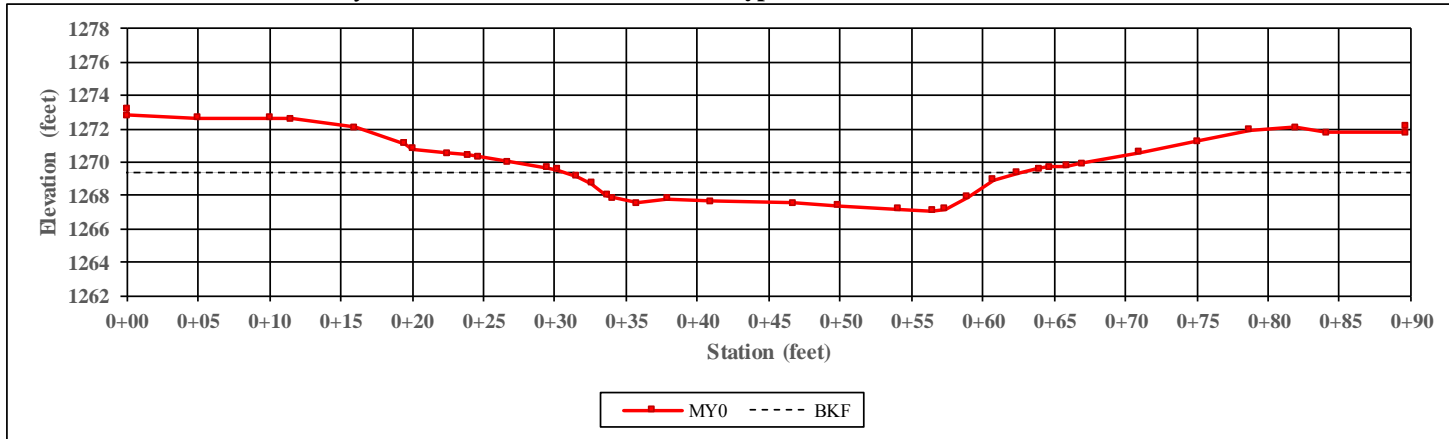
XS Number: 4
XS Type: Riffle

Project Name: Middle South Muddy
Reach Name: South Muddy Creek

Station: 102+79

CHANNEL DIMENSIONS SUMMARY		MY0	MY1	MY2	MY3	MY4	MY5	MY6	MY7
Bankful Width (ft)		31.6	-	-	-	-	-	-	-
Floodprone Width (ft)		65.0	-	-	-	-	-	-	-
Bankfull Mean Depth (ft)		1.6	-	-	-	-	-	-	-
Bankfull Max Depth (ft)		2.3	-	-	-	-	-	-	-
Bankfull Cross-Sectional Area (ft ²)		50.5	-	-	-	-	-	-	-
Width/Depth Ratio		19.8	-	-	-	-	-	-	-
Entrenchment Ratio		2.1	-	-	-	-	-	-	-
Bank Height Ratio		1.0	-	-	-	-	-	-	-

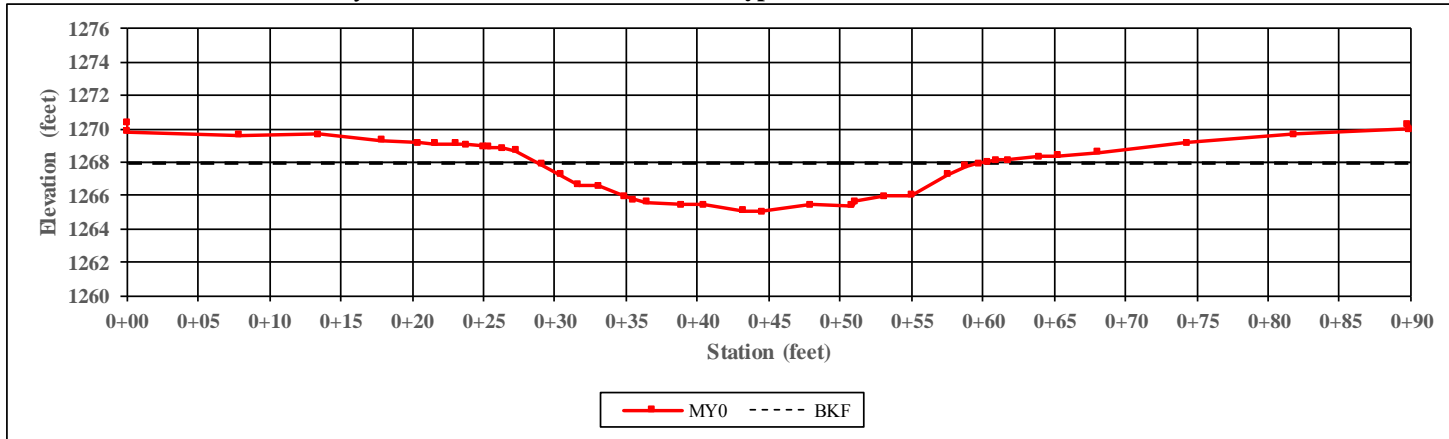
XS Number: 5
XS Type: Riffle

Project Name: Middle South Muddy
Reach Name: South Muddy Creek

Station: 107+45

CHANNEL DIMENSIONS SUMMARY	MY0	MY1	MY2	MY3	MY4	MY5	MY6	MY7
Bankful Width (ft)	30.7	-	-	-	-	-	-	-
Floodprone Width (ft)	101.0	-	-	-	-	-	-	-
Bankfull Mean Depth (ft)	1.9	-	-	-	-	-	-	-
Bankfull Max Depth (ft)	2.8	-	-	-	-	-	-	-
Bankfull Cross-Sectional Area (ft ²)	59.0	-	-	-	-	-	-	-
Width/Depth Ratio	15.9	-	-	-	-	-	-	-
Entrenchment Ratio	3.3	-	-	-	-	-	-	-
Bank Height Ratio	1.0	-	-	-	-	-	-	-

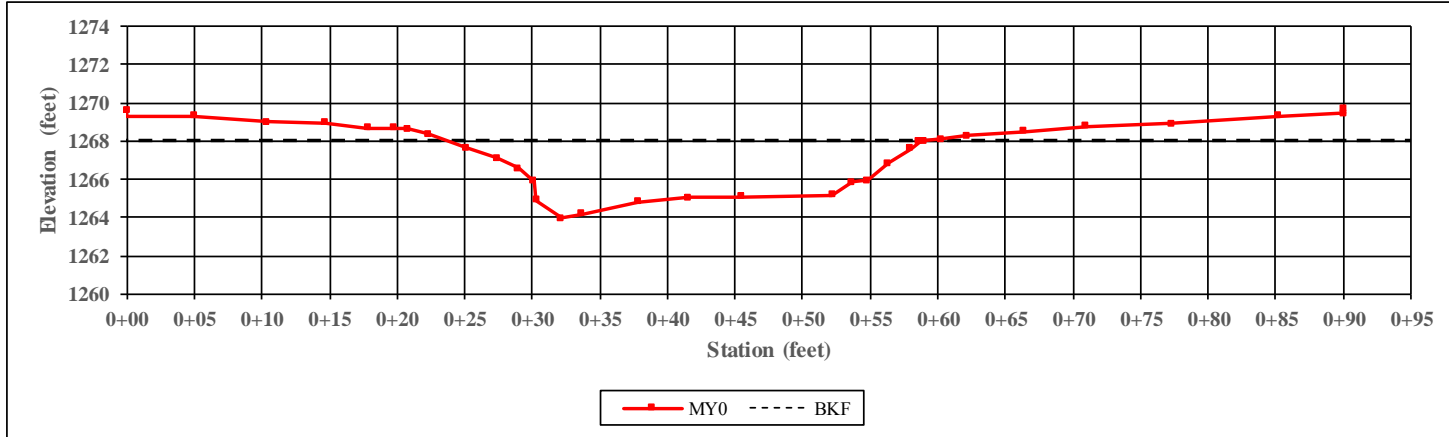
XS Number: 6
XS Type: Pool

Project Name: Middle South Muddy
Reach Name: South Muddy Creek

Station: 108+57

CHANNEL DIMENSIONS SUMMARY	MY0	MY1	MY2	MY3	MY4	MY5	MY6	MY7
Bankful Width (ft)	35.3	-	-	-	-	-	-	-
Floodprone Width (ft)	166.0	-	-	-	-	-	-	-
Bankfull Mean Depth (ft)	2.4	-	-	-	-	-	-	-
Bankfull Max Depth (ft)	4.0	-	-	-	-	-	-	-
Bankfull Cross-Sectional Area (ft ²)	85.7	-	-	-	-	-	-	-
Width/Depth Ratio	14.5	-	-	-	-	-	-	-
Entrenchment Ratio	4.7	-	-	-	-	-	-	-
Bank Height Ratio	1.0	-	-	-	-	-	-	-

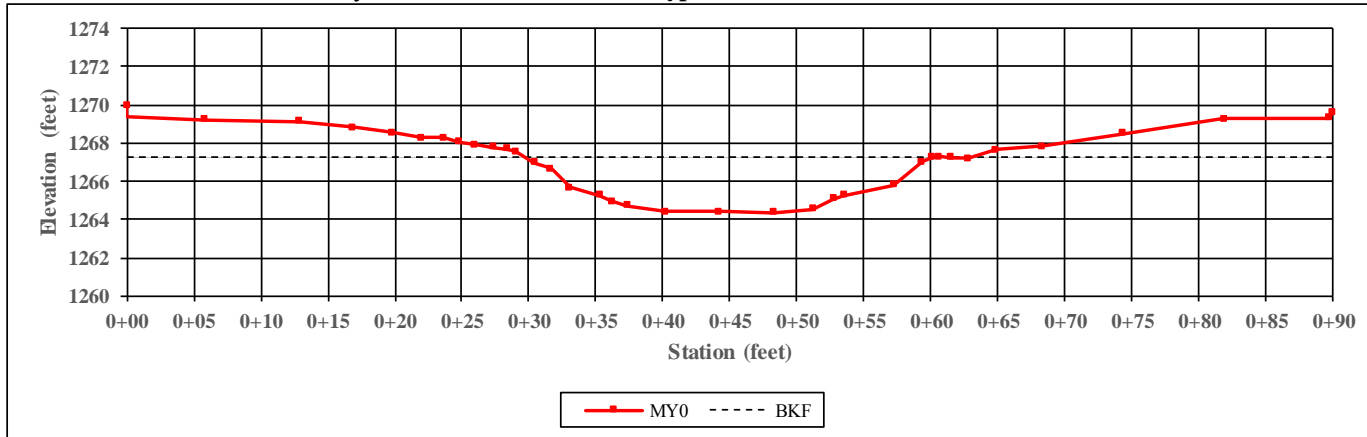
XS Number: 7
XS Type: Riffle

Project Name: Middle South Muddy
Reach Name: South Muddy Creek

Station: 109+57

CHANNEL DIMENSIONS SUMMARY	MY0	MY1	MY2	MY3	MY4	MY5	MY6	MY7
Bankful Width (ft)	31.0	-	-	-	-	-	-	-
Floodprone Width (ft)	88.0	-	-	-	-	-	-	-
Bankfull Mean Depth (ft)	2.1	-	-	-	-	-	-	-
Bankfull Max Depth (ft)	2.9	-	-	-	-	-	-	-
Bankfull Cross-Sectional Area (ft ²)	64.9	-	-	-	-	-	-	-
Width/Depth Ratio	14.8	-	-	-	-	-	-	-
Entrenchment Ratio	2.8	-	-	-	-	-	-	-
Bank Height Ratio	1.0	-	-	-	-	-	-	-

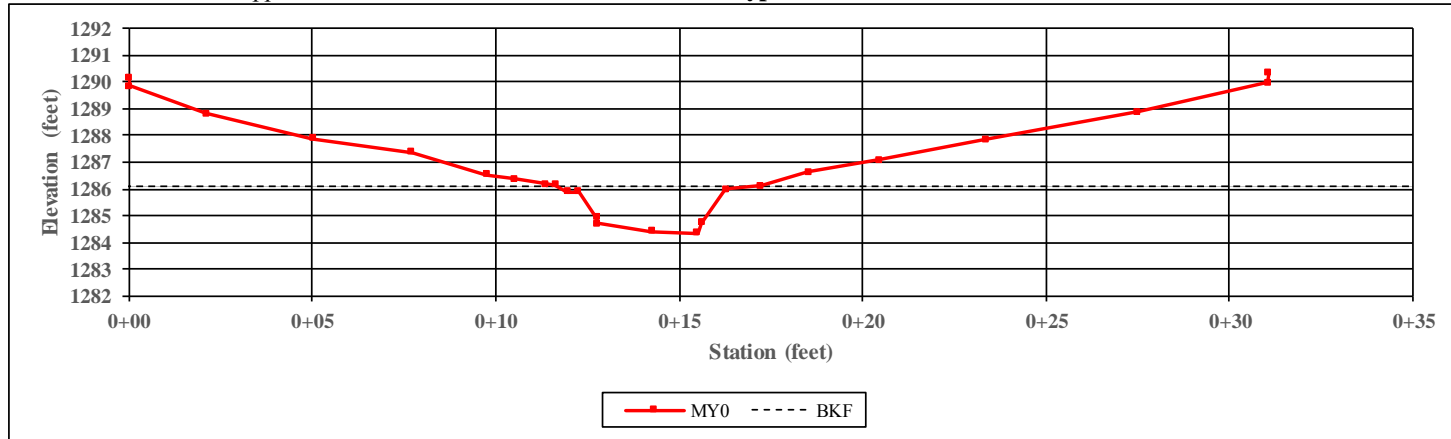
XS Number: 8
XS Type: Pool

Project Name: Middle South Muddy
Reach Name: Upper Iva Branch

Station: 302+13

CHANNEL DIMENSIONS SUMMARY	MY0	MY1	MY2	MY3	MY4	MY5	MY6	MY7
Bankful Width (ft)	5.5	-	-	-	-	-	-	-
Floodprone Width (ft)	17.0	-	-	-	-	-	-	-
Bankfull Mean Depth (ft)	1.0	-	-	-	-	-	-	-
Bankfull Max Depth (ft)	1.8	-	-	-	-	-	-	-
Bankfull Cross-Sectional Area (ft ²)	5.7	-	-	-	-	-	-	-
Width/Depth Ratio	5.4	-	-	-	-	-	-	-
Entrenchment Ratio	3.1	-	-	-	-	-	-	-
Bank Height Ratio	1.0	-	-	-	-	-	-	-

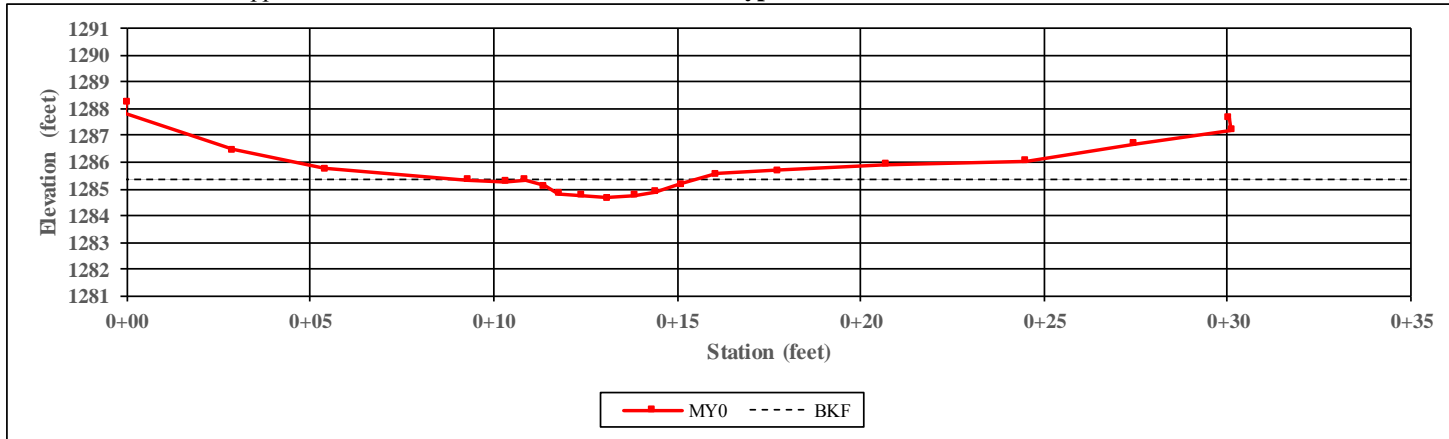
XS Number: 9
XS Type: Riffle

Project Name: Middle South Muddy
Reach Name: Upper Iva Branch

Station: 302+82

CHANNEL DIMENSIONS SUMMARY		MY0	MY1	MY2	MY3	MY4	MY5	MY6	MY7
Bankfull Width (ft)		4.6	-	-	-	-	-	-	-
Floodprone Width (ft)		14.0	-	-	-	-	-	-	-
Bankfull Mean Depth (ft)		0.4	-	-	-	-	-	-	-
Bankfull Max Depth (ft)		0.7	-	-	-	-	-	-	-
Bankfull Cross-Sectional Area (ft ²)		1.9	-	-	-	-	-	-	-
Width/Depth Ratio		11.0	-	-	-	-	-	-	-
Entrenchment Ratio		3.0	-	-	-	-	-	-	-
Bank Height Ratio		1.0	-	-	-	-	-	-	-

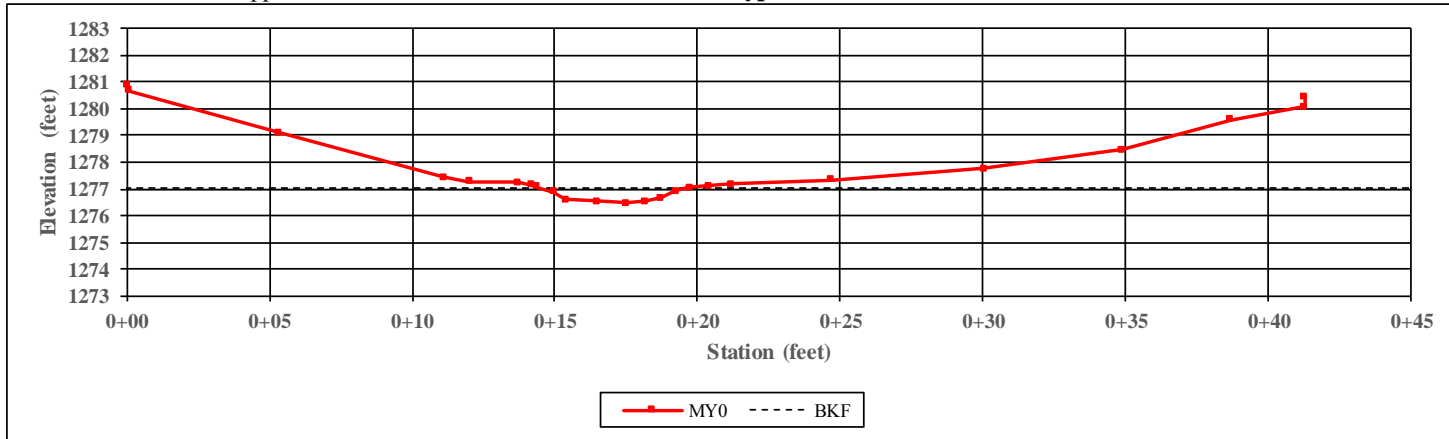
XS Number: 10
XS Type: Riffle

Project Name: Middle South Muddy
Reach Name: Upper Iva Branch

Station: 304+20

CHANNEL DIMENSIONS SUMMARY		MY0	MY1	MY2	MY3	MY4	MY5	MY6	MY7
Bankful Width (ft)		5.3	-	-	-	-	-	-	-
Floodprone Width (ft)		17.0	-	-	-	-	-	-	-
Bankfull Mean Depth (ft)		0.4	-	-	-	-	-	-	-
Bankfull Max Depth (ft)		0.6	-	-	-	-	-	-	-
Bankfull Cross-Sectional Area (ft ²)		2.1	-	-	-	-	-	-	-
Width/Depth Ratio		13.3	-	-	-	-	-	-	-
Entrenchment Ratio		3.2	-	-	-	-	-	-	-
Bank Height Ratio		1.0	-	-	-	-	-	-	-

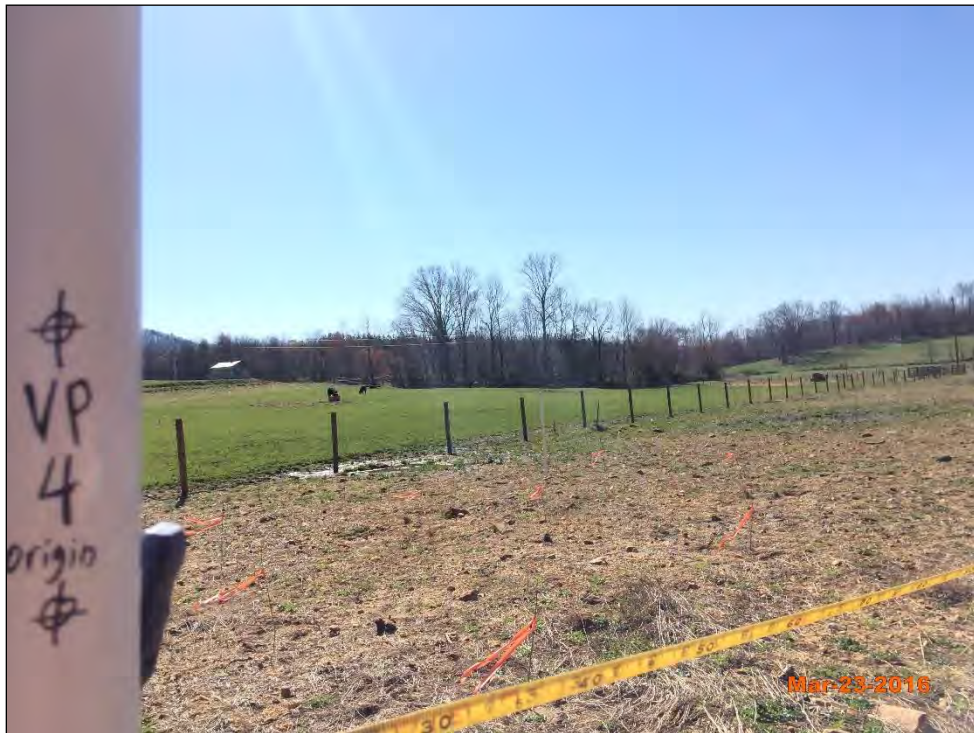
Vegetation Monitoring Plot 4

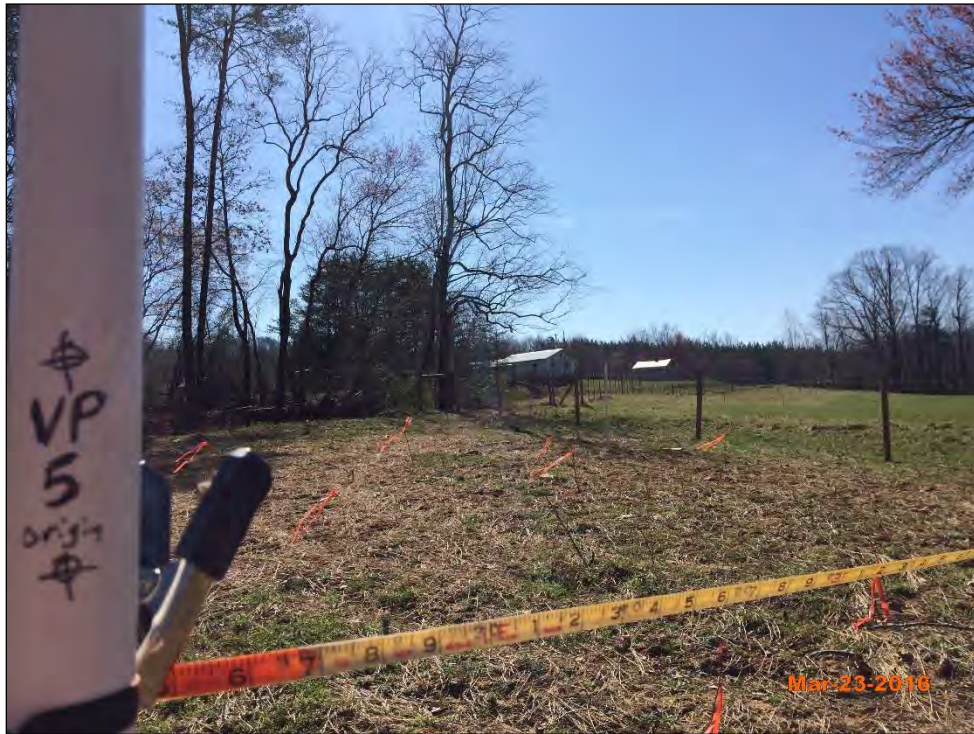
Vegetation Monitoring Plot 5

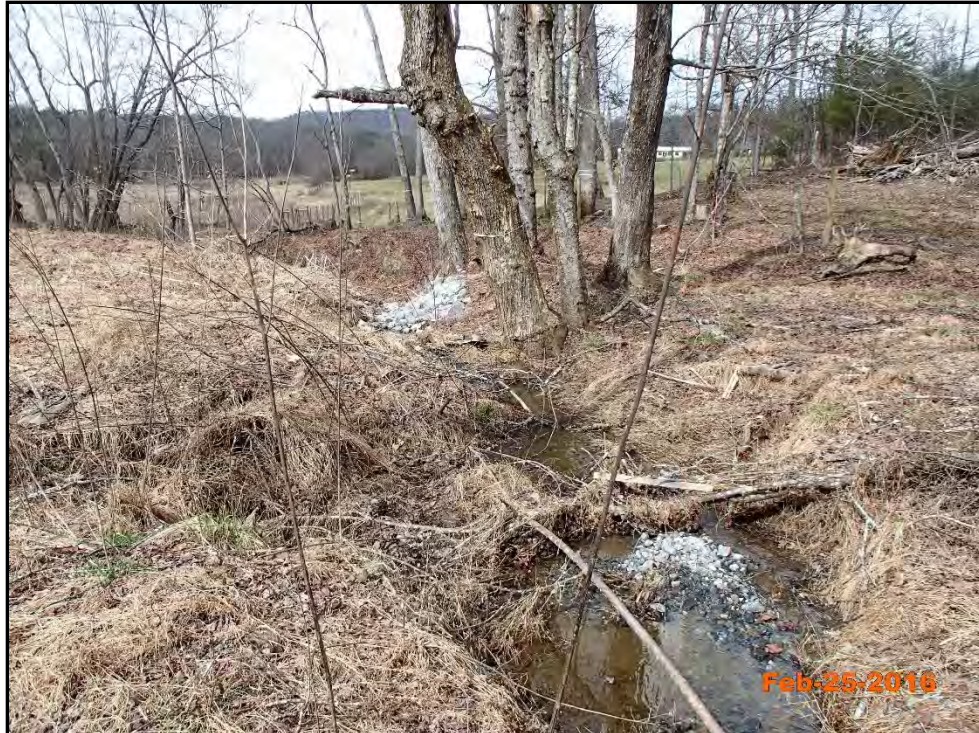
Upper Sprouse Branch – Permanent Photo Station 1
Looking Downstream

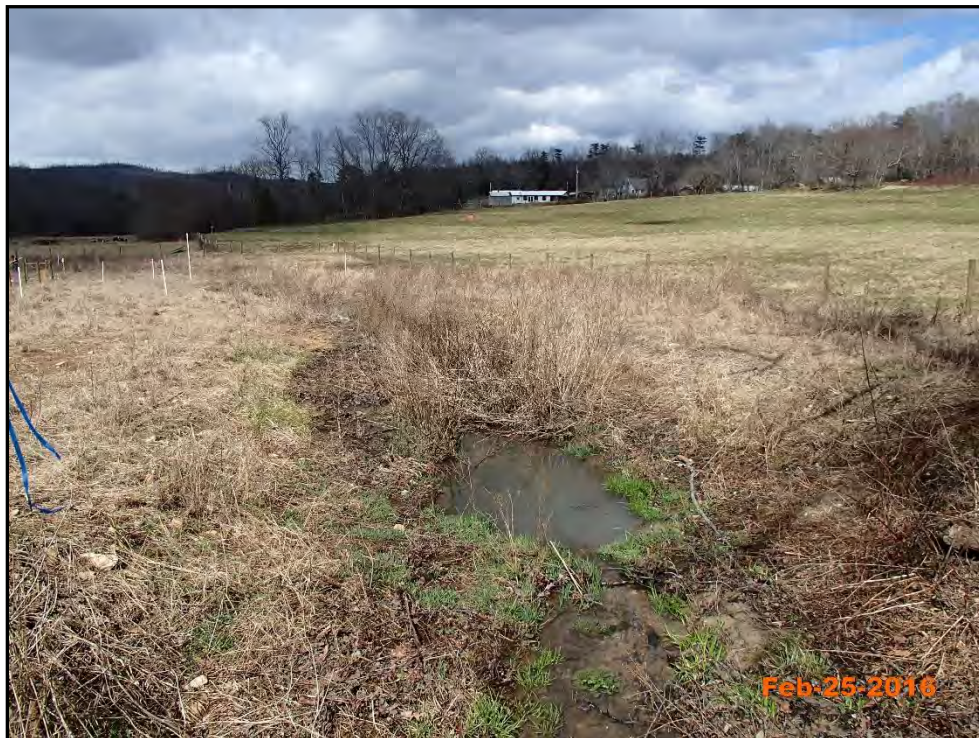
Upper Sprouse Branch – Permanent Photo Station 2
Looking Downstream

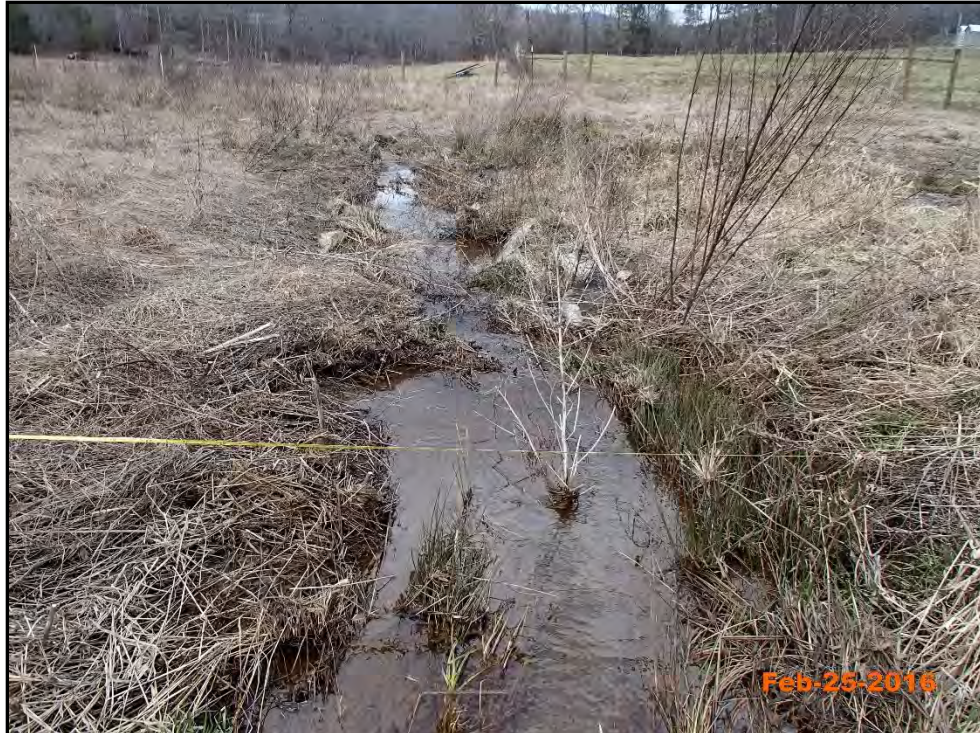
Lower Sprouse Branch – Permanent Photo Station 3
Looking Downstream at Cross-Section 1
