Middle South Muddy
As-Built Baseline Monitoring Report

Middle South Muddy Stream Restoration Site
NCDMS Contract No. 6783
NCDMS Project No. 93875
McDowell County, North Carolina
Data Collected: May 18th, 2015 - May 4th, 2016
Date Submitted: July 11, 2016

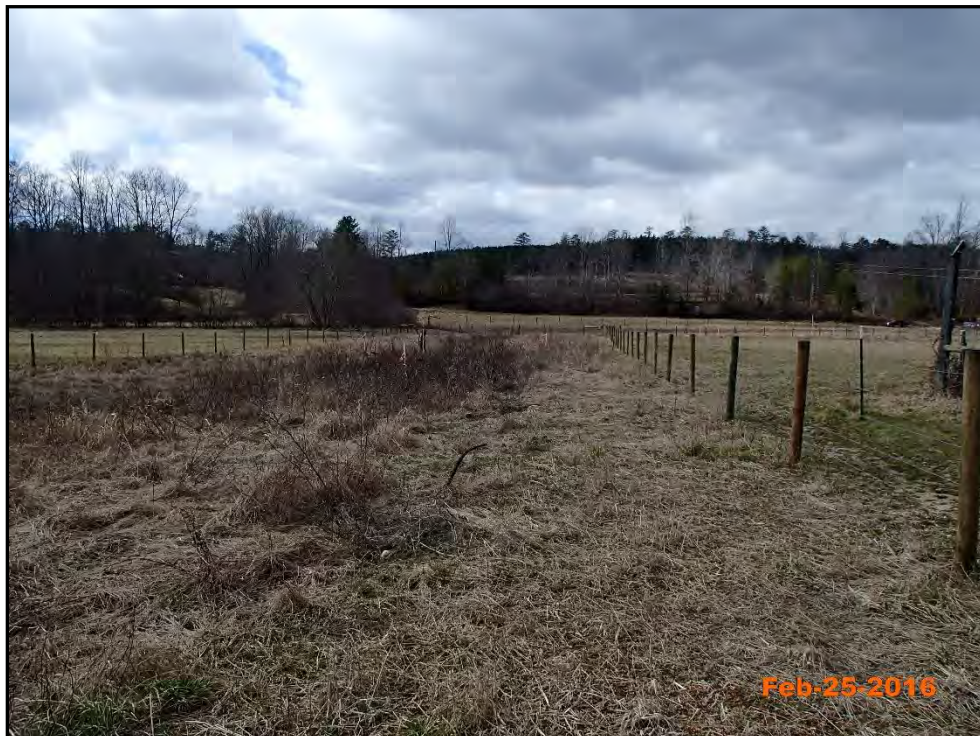
Lower Sprouse Branch – Permanent Photo Station 4
Looking Downstream, Northwest- 292 degrees

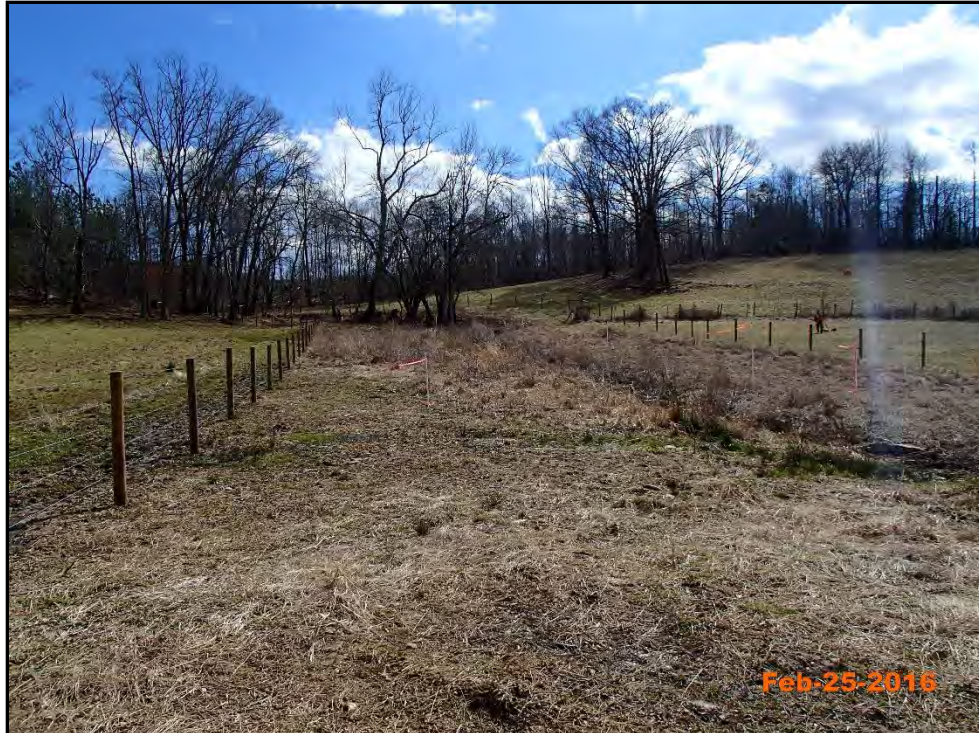
Lower Sprouse Branch – Permanent Photo Station 4
Looking Upstream; South 182 degrees

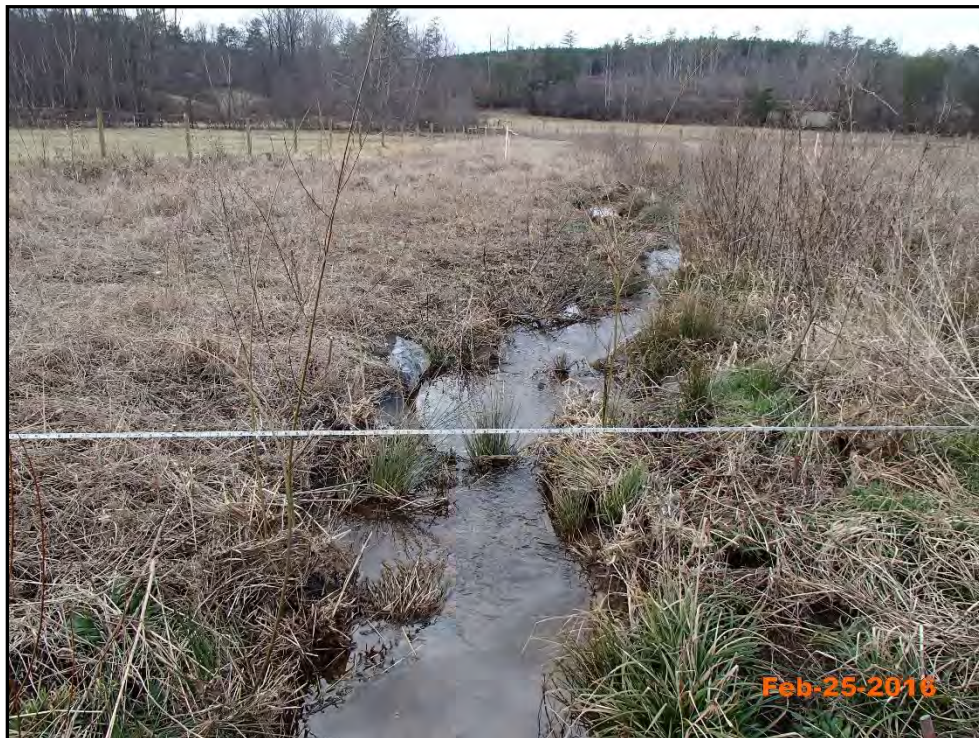
Lower Sprouse Branch – Permanent Photo Station 5
Looking Downstream at Cross-Section 2

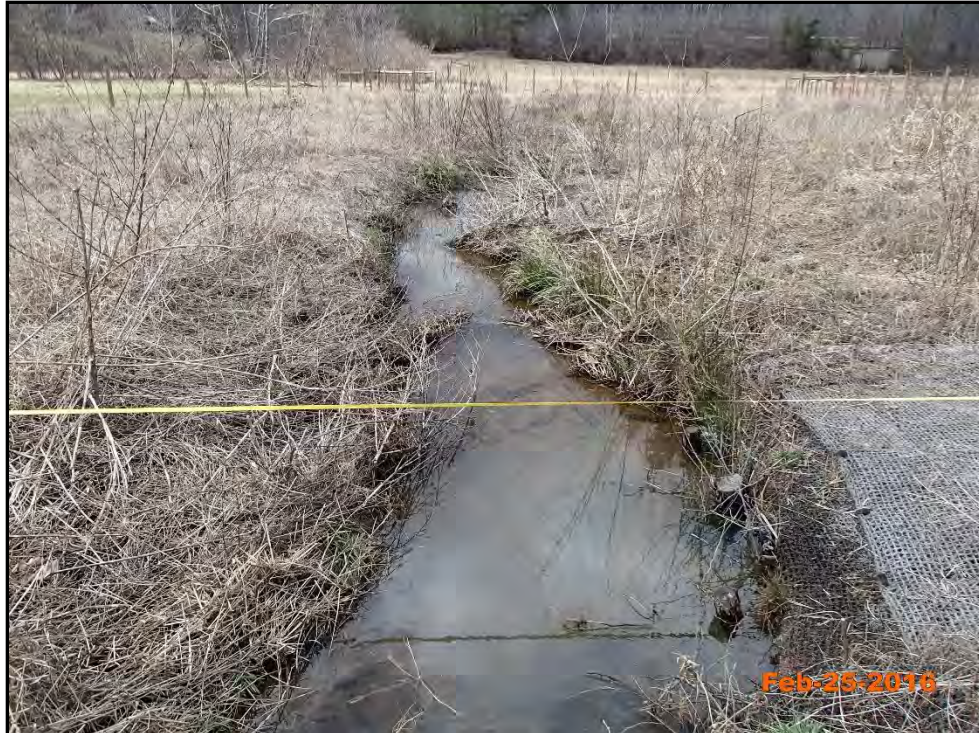
Lower Sprouse Branch – Permanent Photo Station 6
Looking Downstream at Cross-Section 3

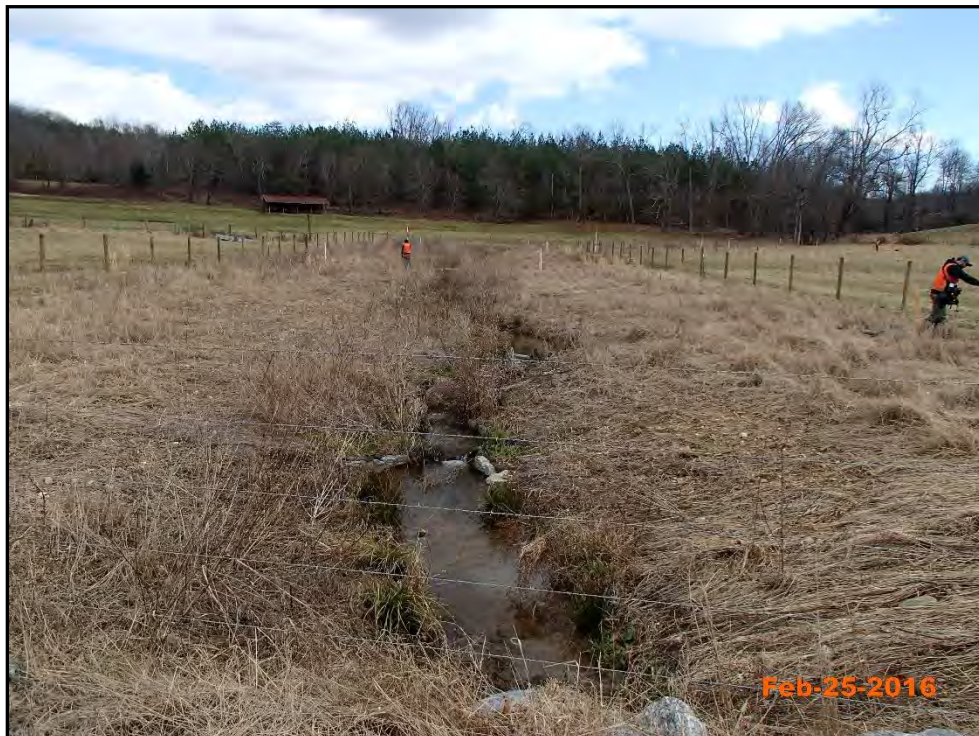
Lower Sprouse Branch – Permanent Photo Station 7
Looking Upstream from Crossing

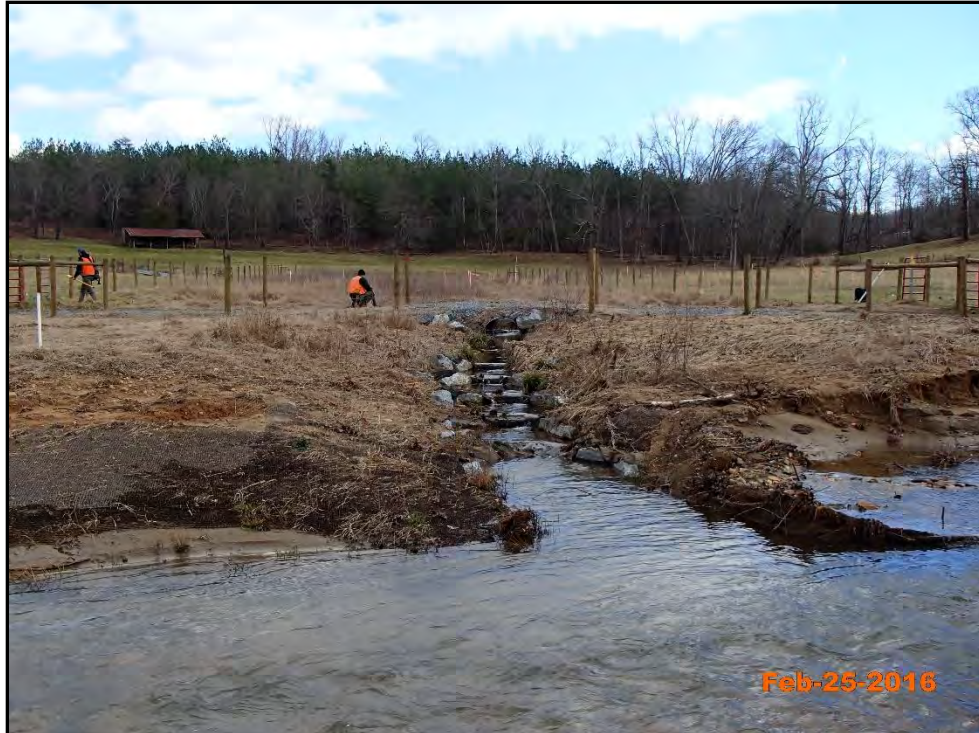
Lower Sprouse Branch – Permanent Photo Station 8
Station 101+50 - Looking Upstream at Confluence with South Muddy

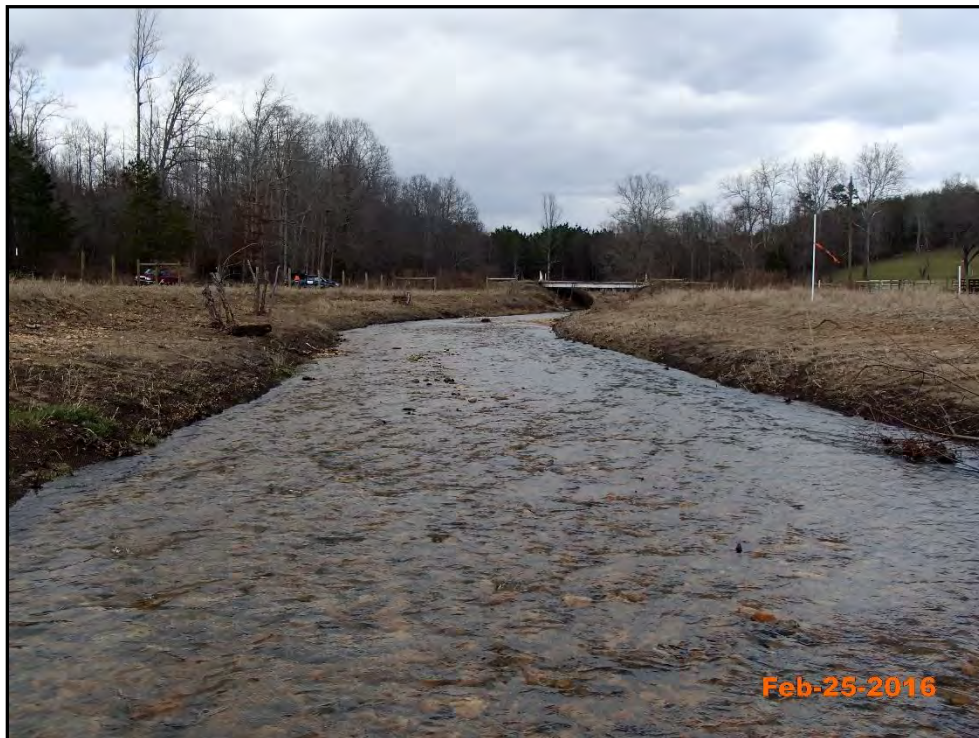
South Muddy Creek – Permanent Photo Station 8
Station 101+50 - Looking Downstream

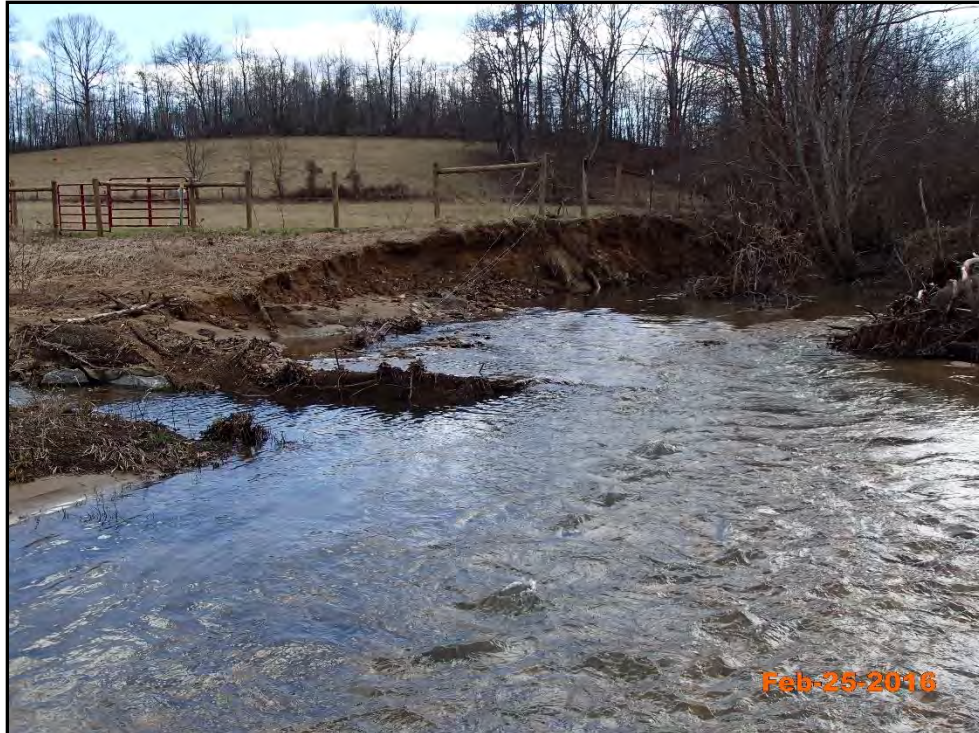
South Muddy Creek – Permanent Photo Station 8
Station 101+50 - Looking Upstream

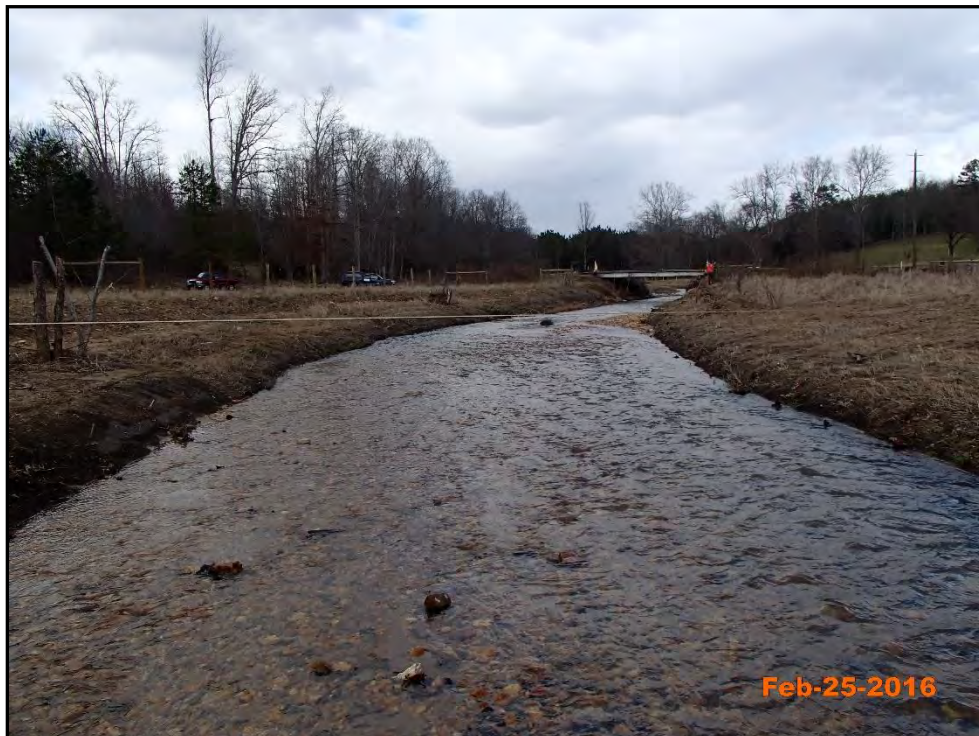
South Muddy Creek – Permanent Photo Station 9
Station 102+75 - Looking Downstream at Cross-Section 4

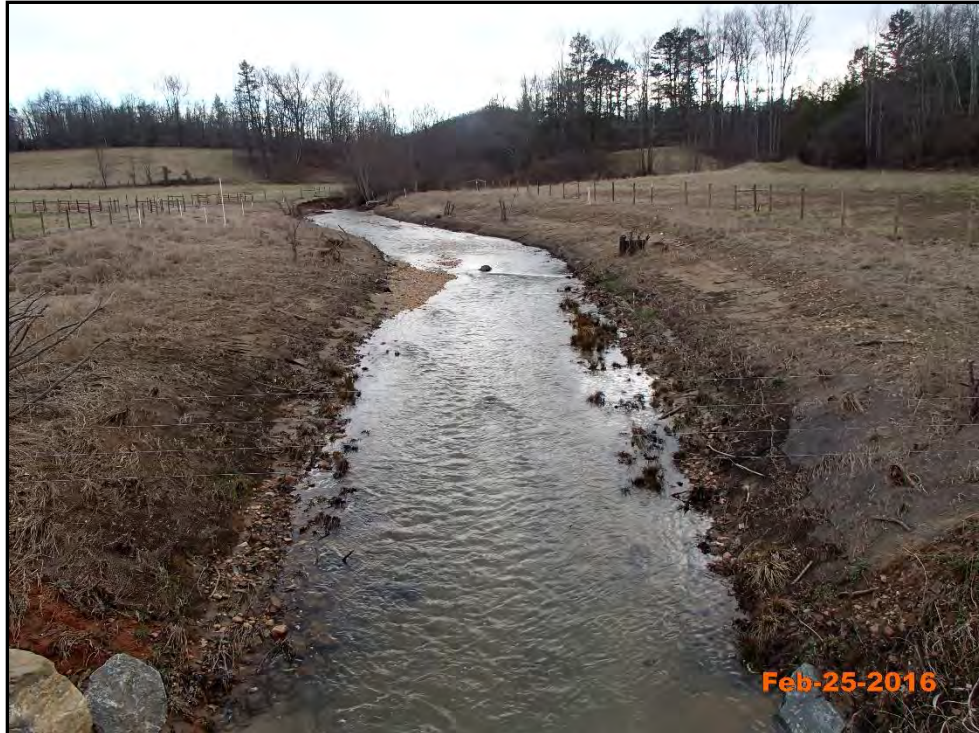
South Muddy Creek – Permanent Photo Station 10
Station 104+75 - Looking Upstream from Bridge

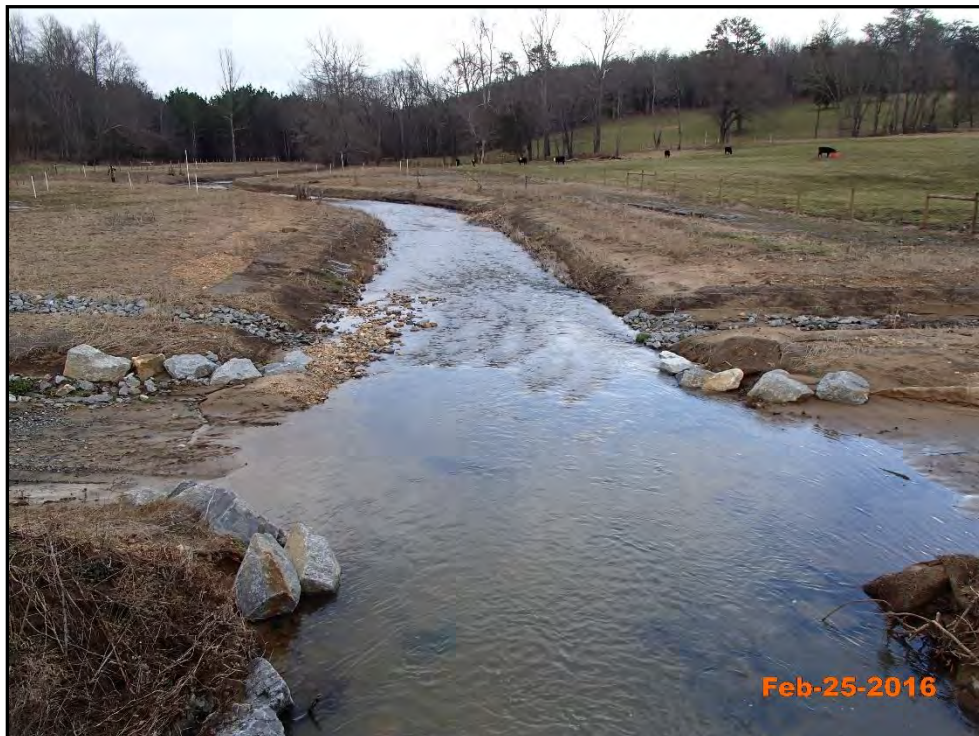
South Muddy Creek – Permanent Photo Station 10
Station 104+75 - Looking Downstream from Bridge

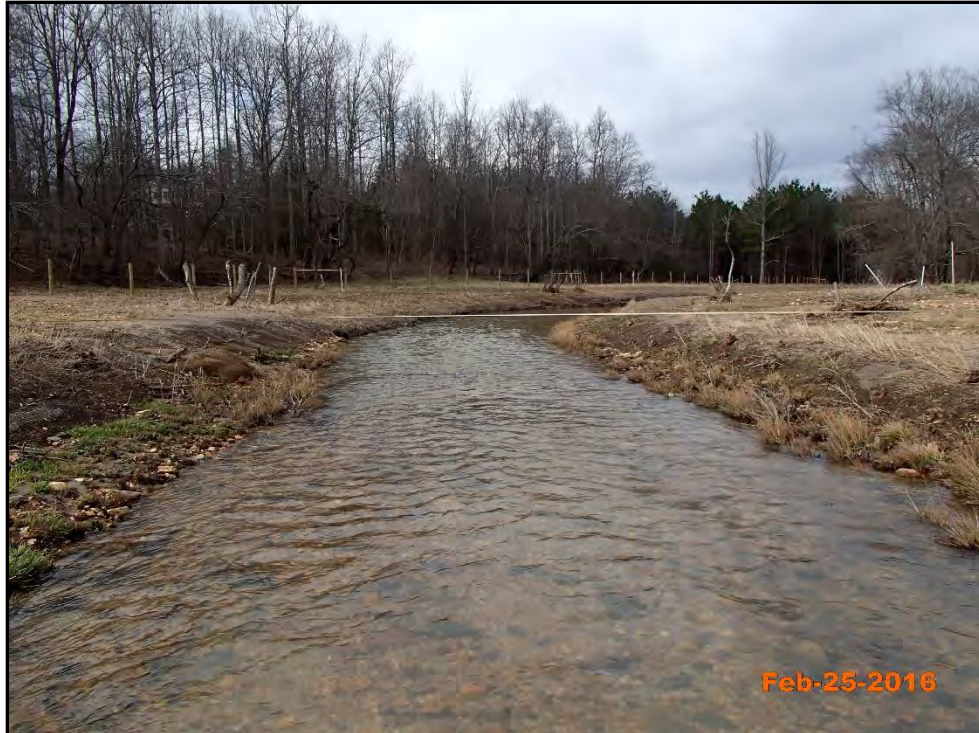
South Muddy Creek – Permanent Photo Station 11
Station 107+45 - Looking Downstream at Cross-Section 5

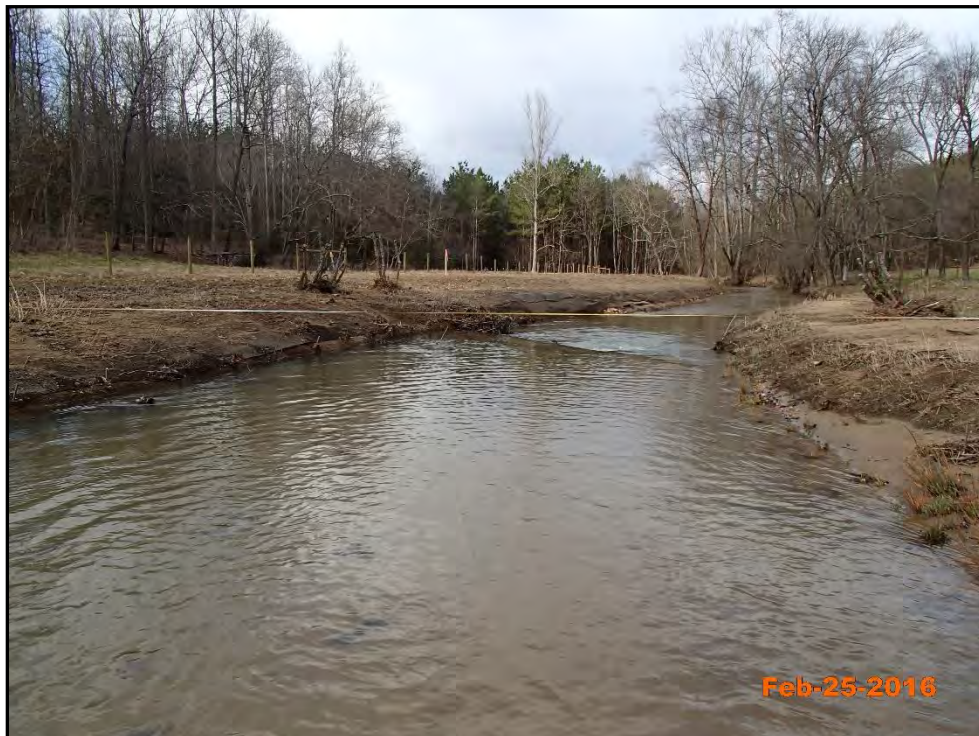
South Muddy Creek – Permanent Photo Station 12
Station 108+58- Looking Downstream at Cross-Section 6

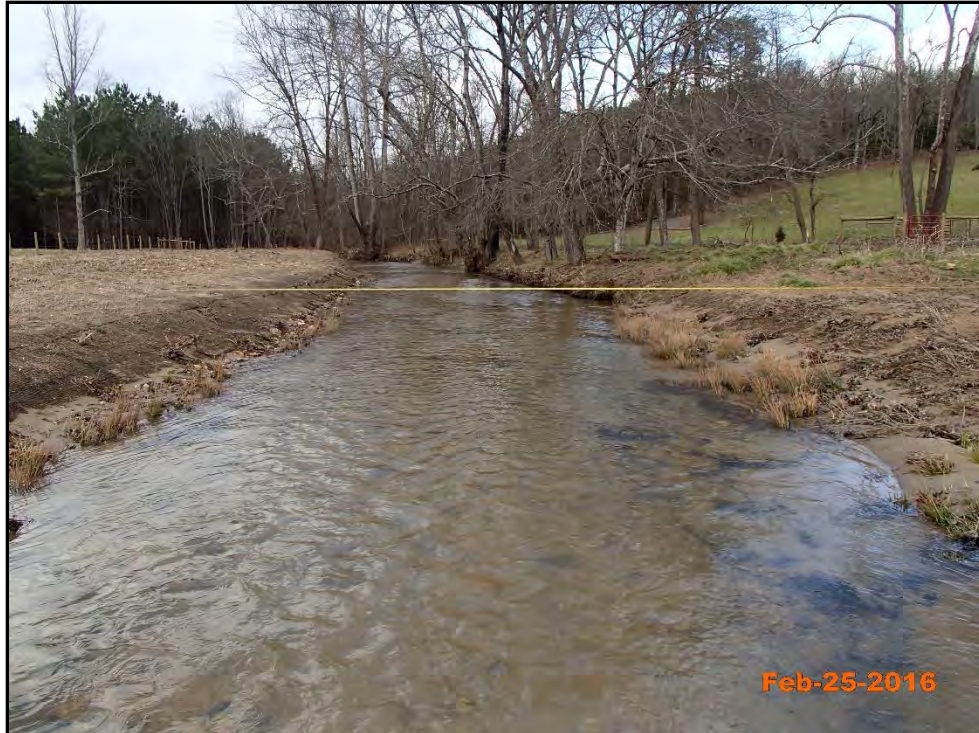
South Muddy Creek – Permanent Photo Station 13
Station 109+58 - Looking Downstream at Cross-Section 7

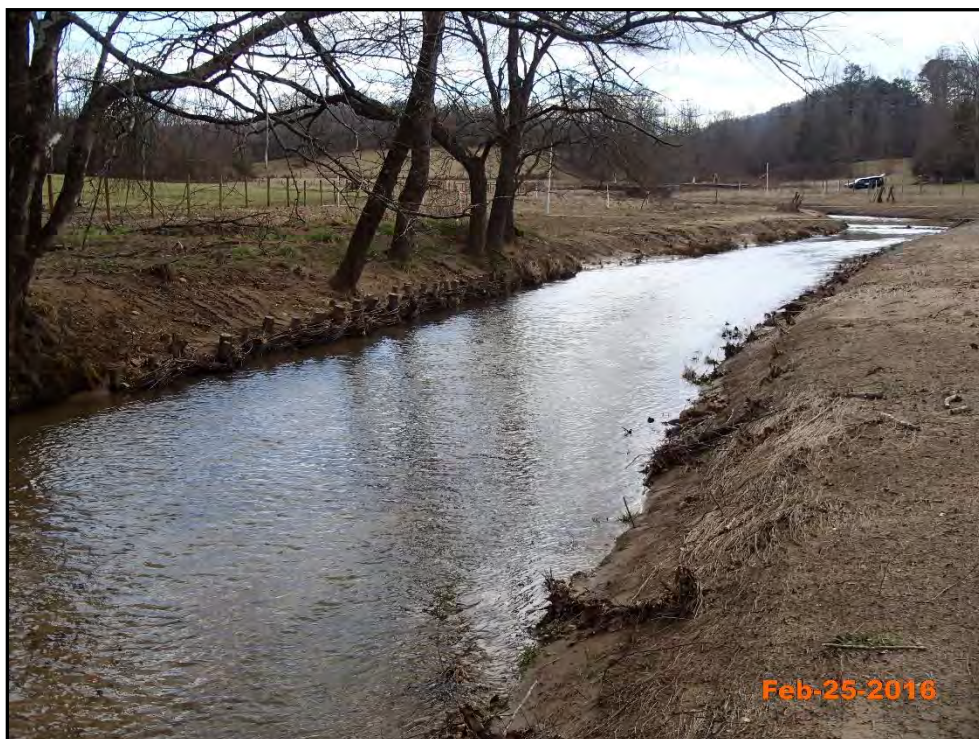
Lower South Muddy Creek – Permanent Photo Station 14
Station 111+20 - Looking Upstream

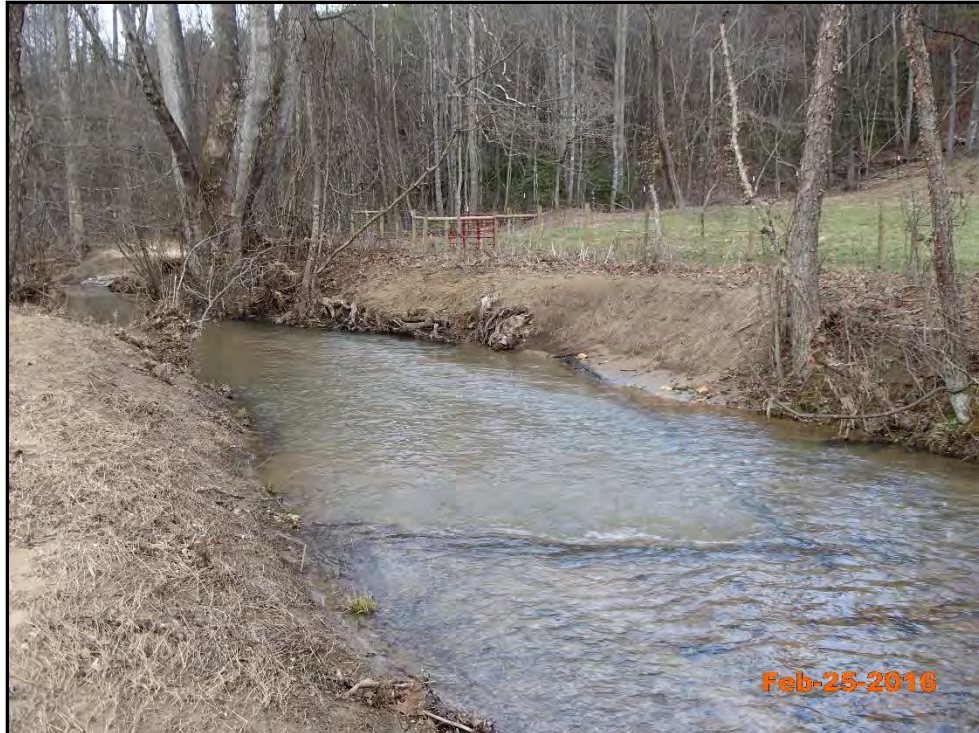
Lower South Muddy Creek – Permanent Photo Station 14
Station 111+20 - Looking Downstream

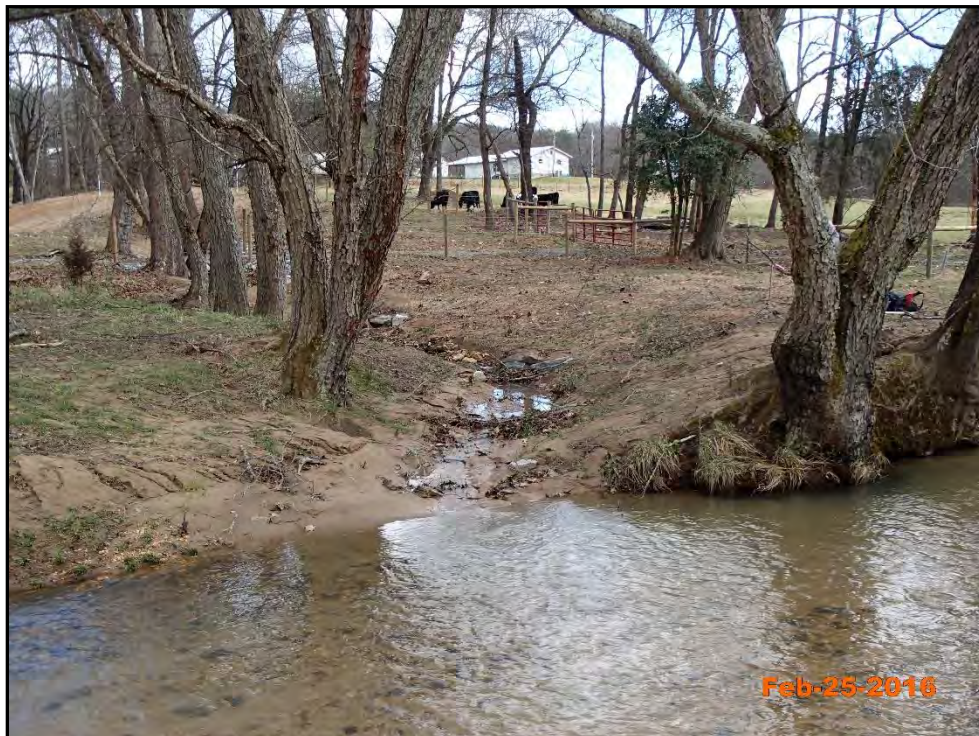
Lower Iva Branch – Permanent Photo Station 14
Station 111+20 - Looking Upstream from Confluence

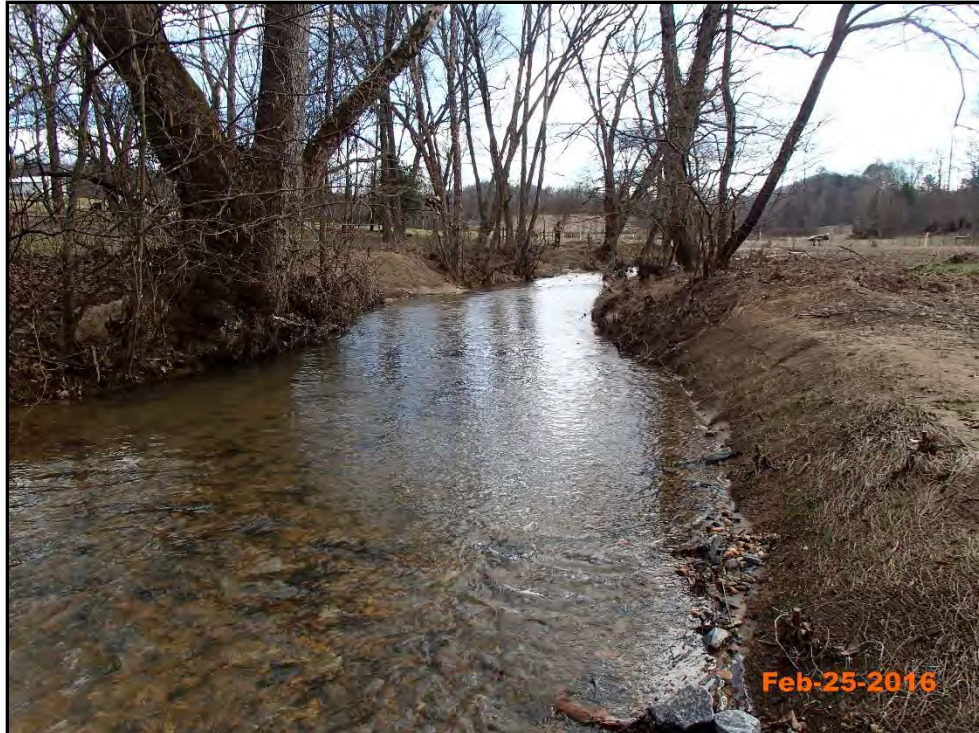
Lower South Muddy Creek – Permanent Photo Station 15
Station 112+62 - Looking Upstream

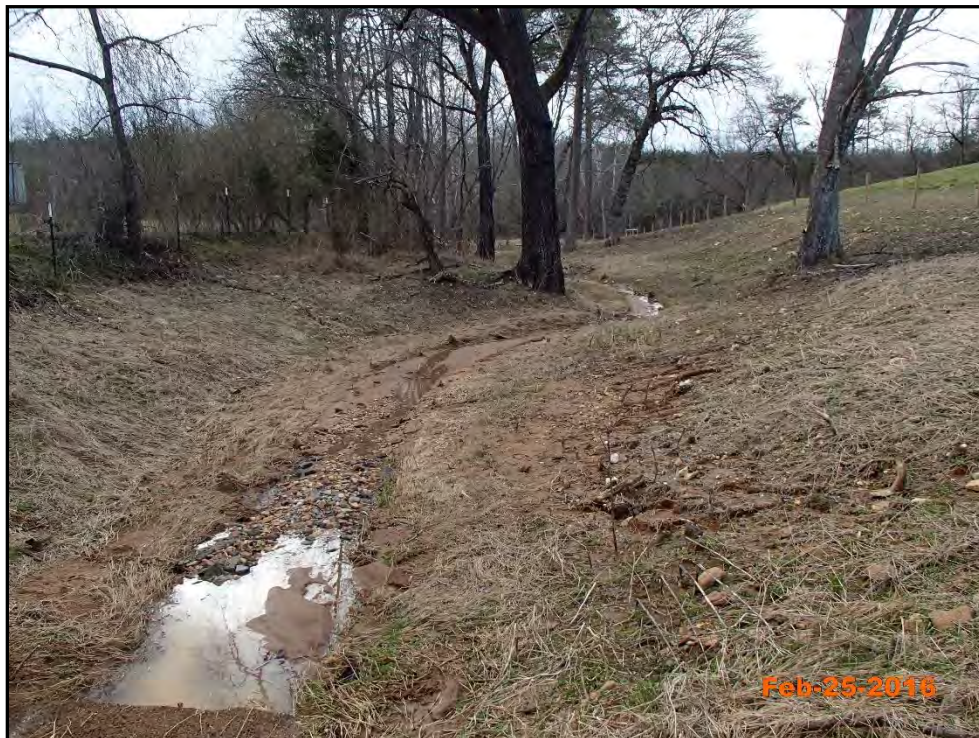
Upper Iva Branch – Permanent Photo Station 16
Station 300+50 - Looking Downstream

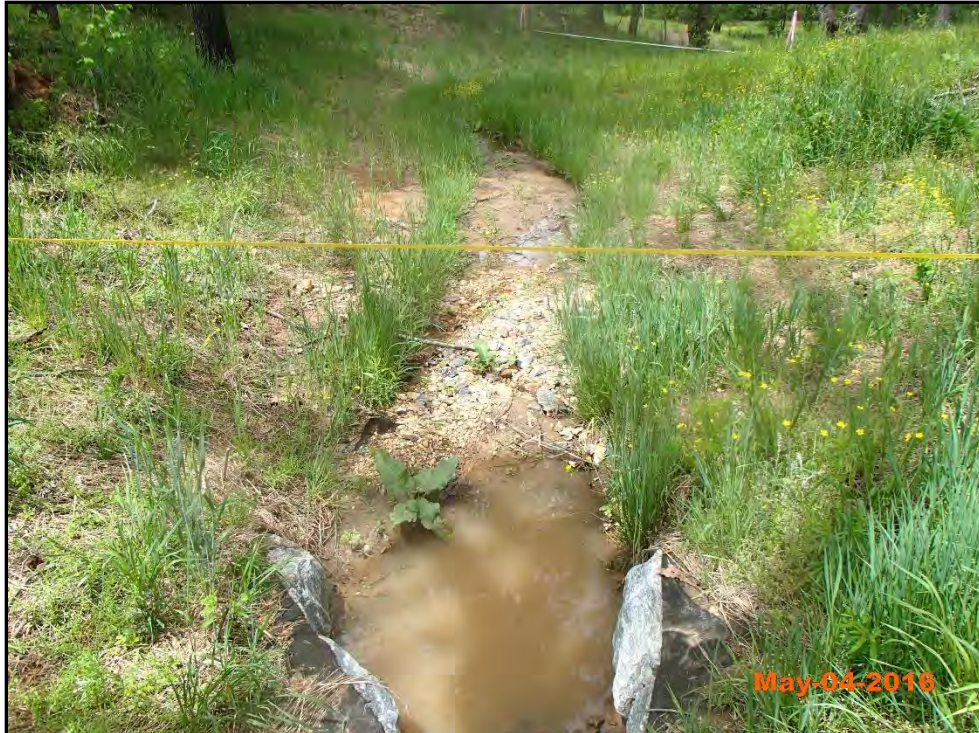
Upper Iva Branch – Permanent Photo Station 17
Station 300+50 - Looking Downstream at Cross-Section 8

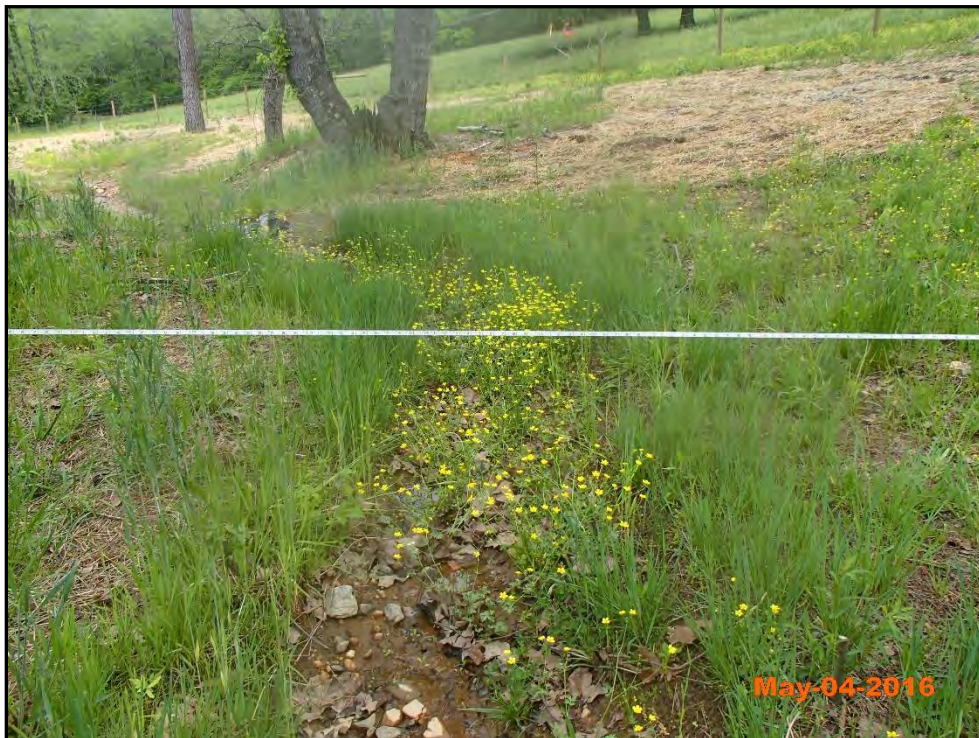
Upper Iva Branch – Permanent Photo Station 18
Station 300+50 - Looking Downstream at Cross-Section 9

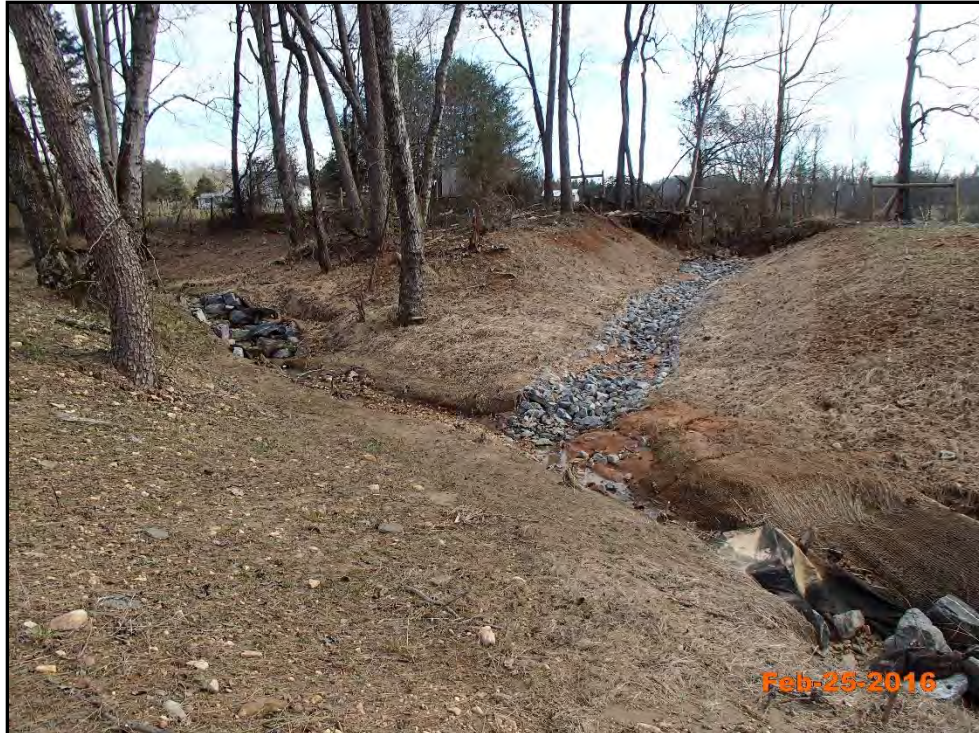
Upper Iva Branch – Permanent Photo Station 19
Station 303+75 - Looking Upstream

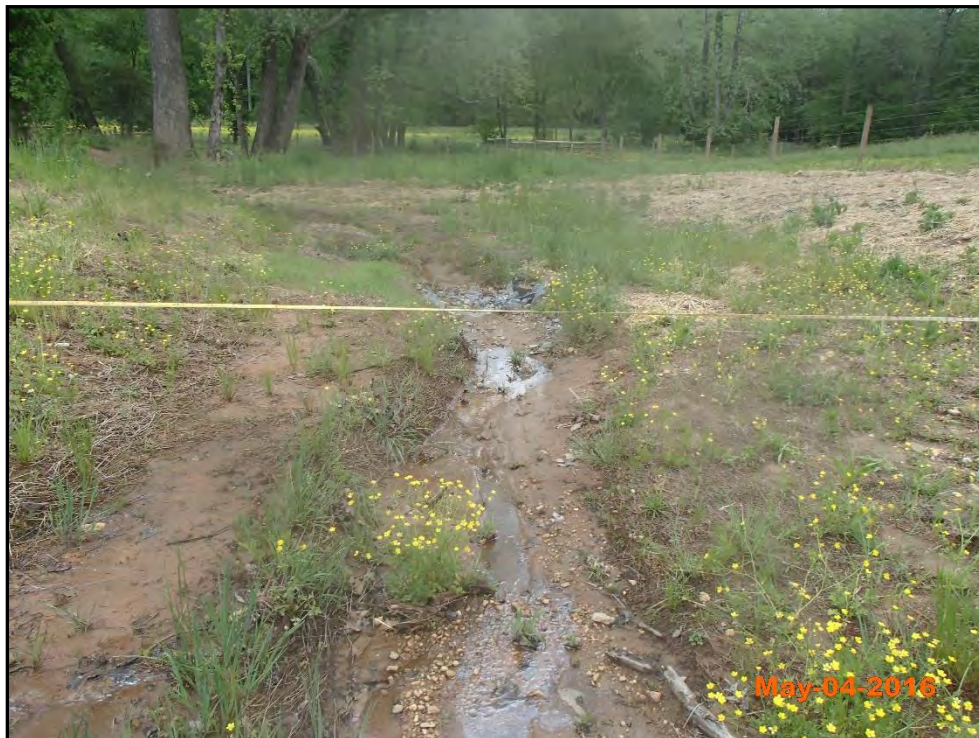
Upper Iva Branch – Permanent Photo Station 20
Station 300+50 - Looking Downstream at Cross-Section 10

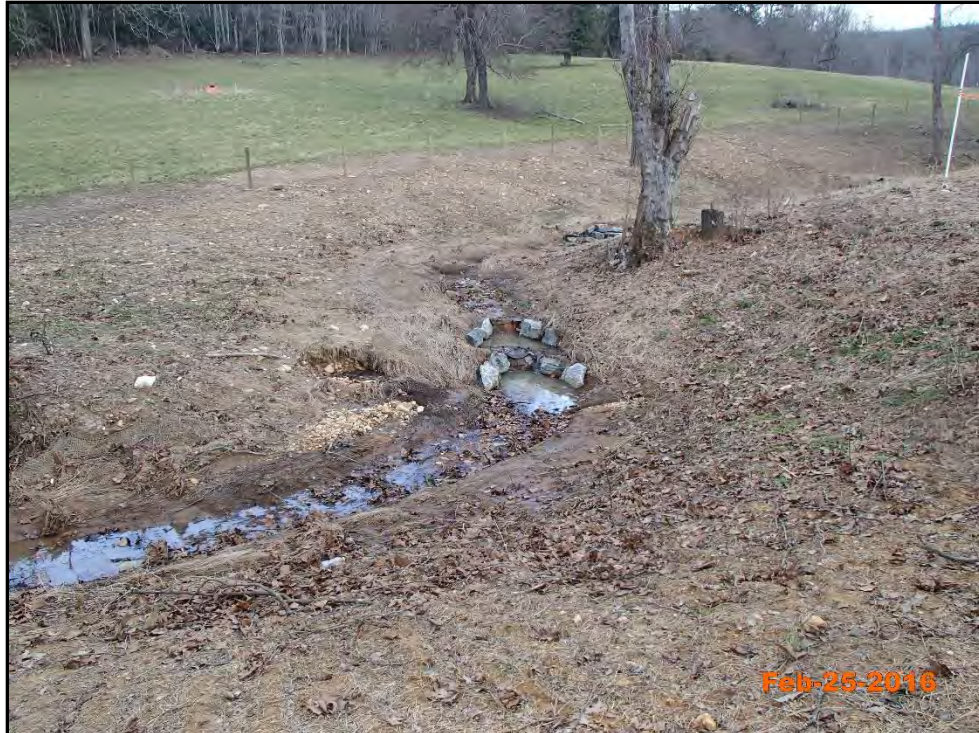
Upper Iva Branch – Permanent Photo Station 21
Station 305+10 - Looking Upstream

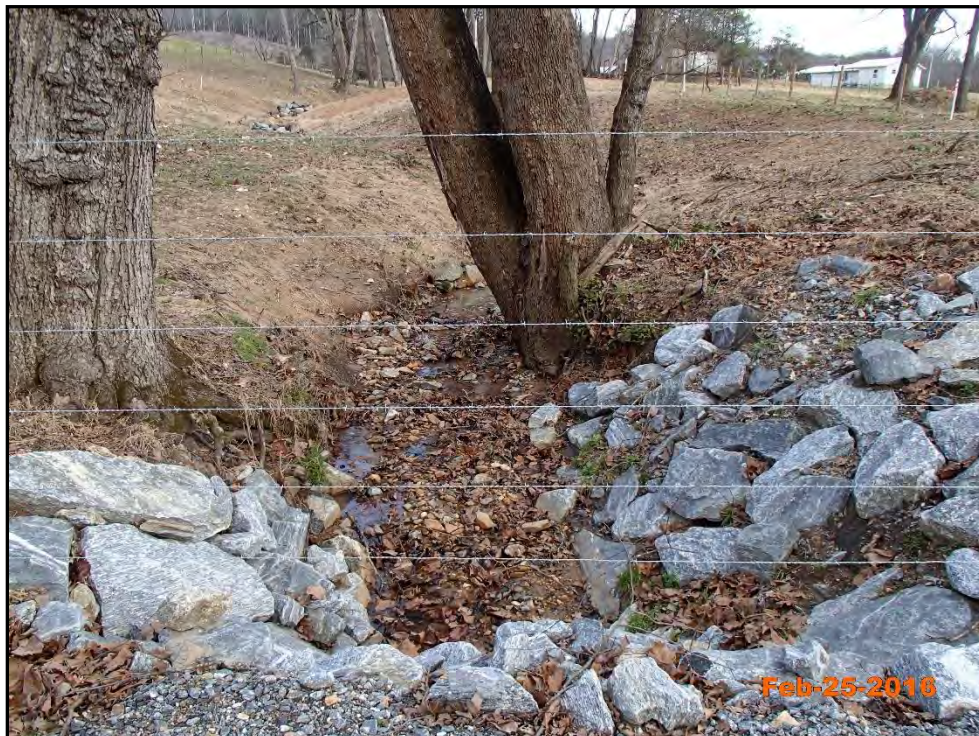
Lower Iva Branch – Permanent Photo Station 22
Station 305+85 - Looking Upstream from Crossing

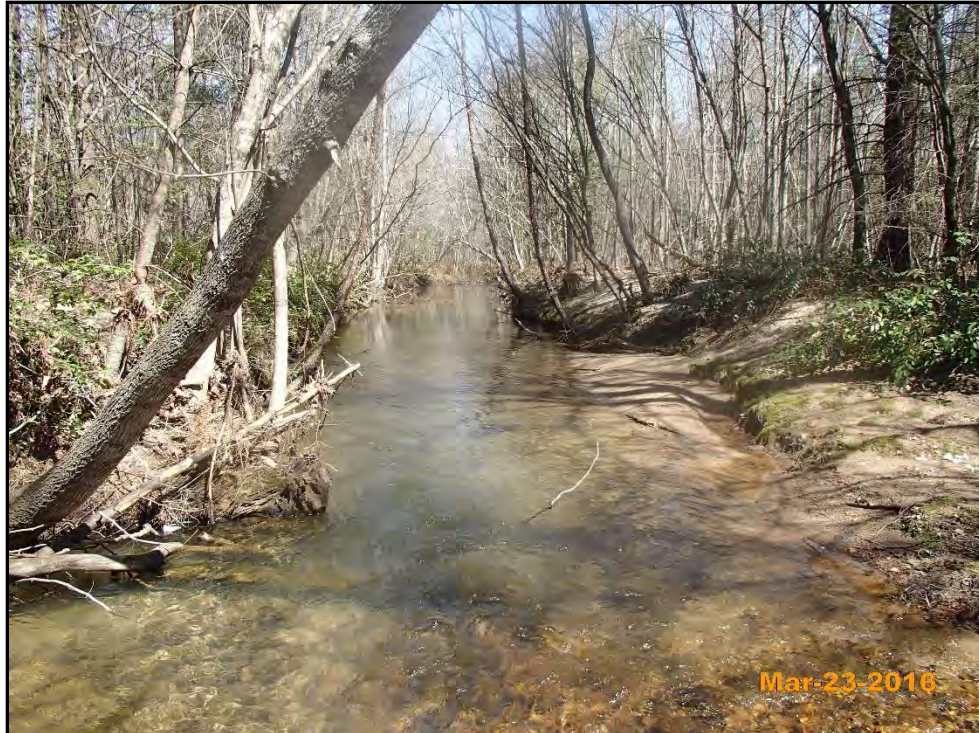
Haney Tract – Permanent Photo Station 23
Looking Upstream South Muddy Creek

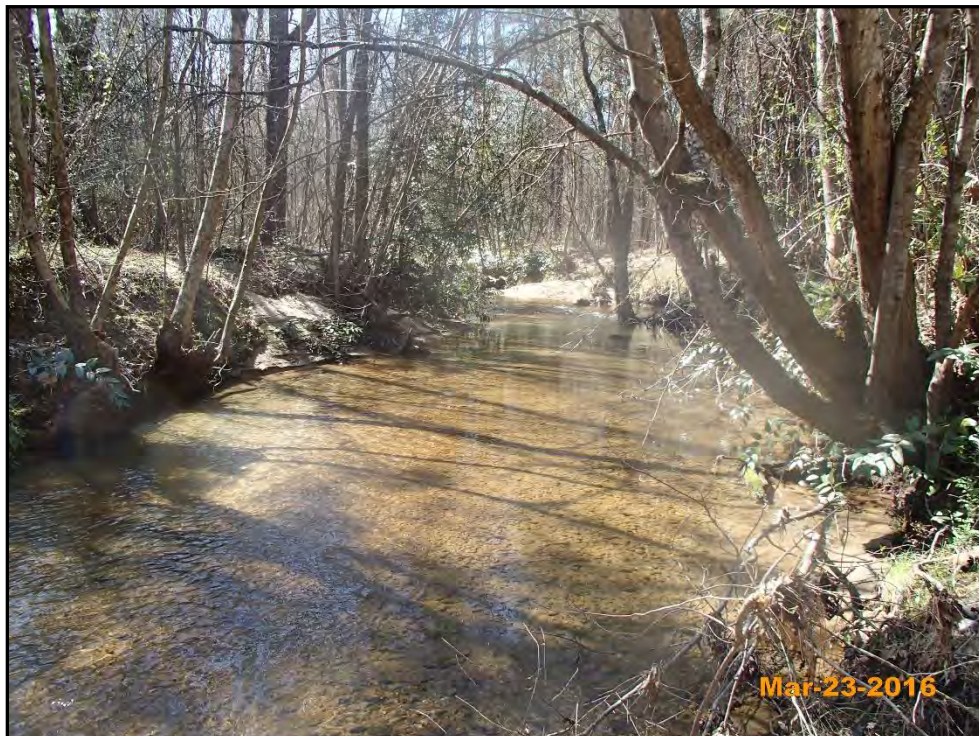
Haney Tract – Permanent Photo Station 24
Looking Upstream South Muddy Creek

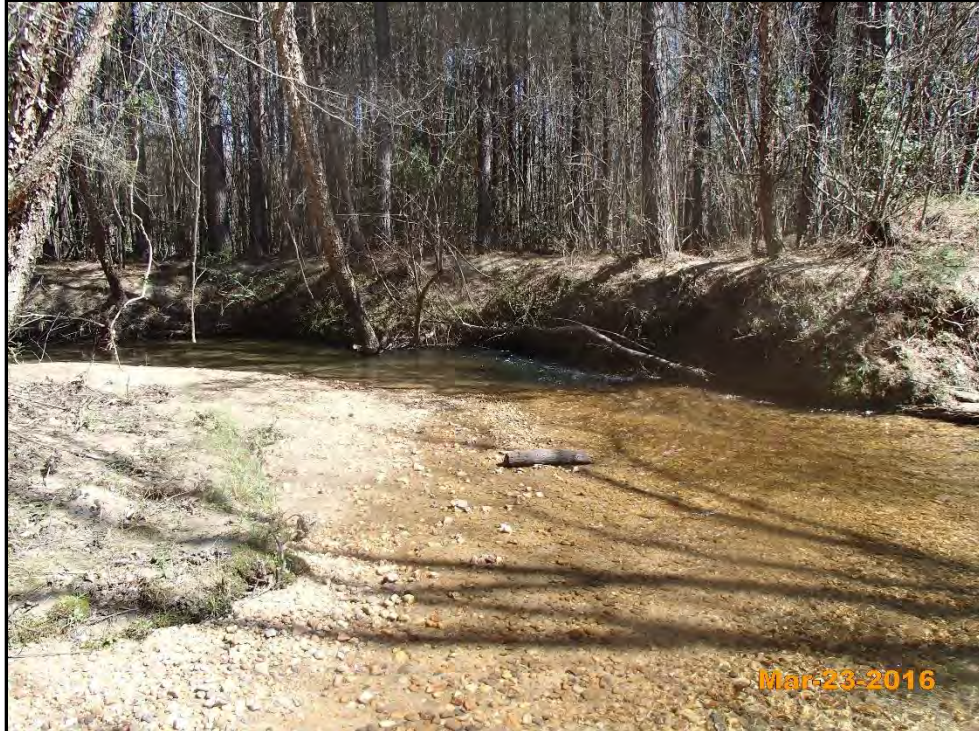
Haney Tract – Permanent Photo Station 24
Looking Downstream South Muddy Creek

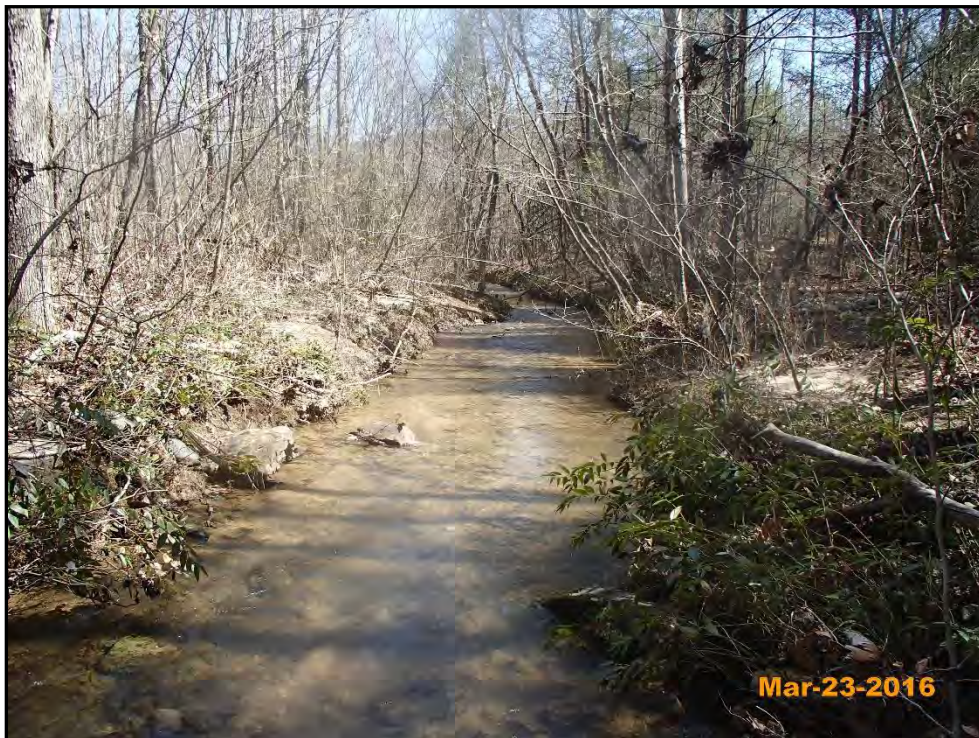
Haney Tract – Permanent Photo Station 25
Looking Downstream Tributary to South Muddy Creek

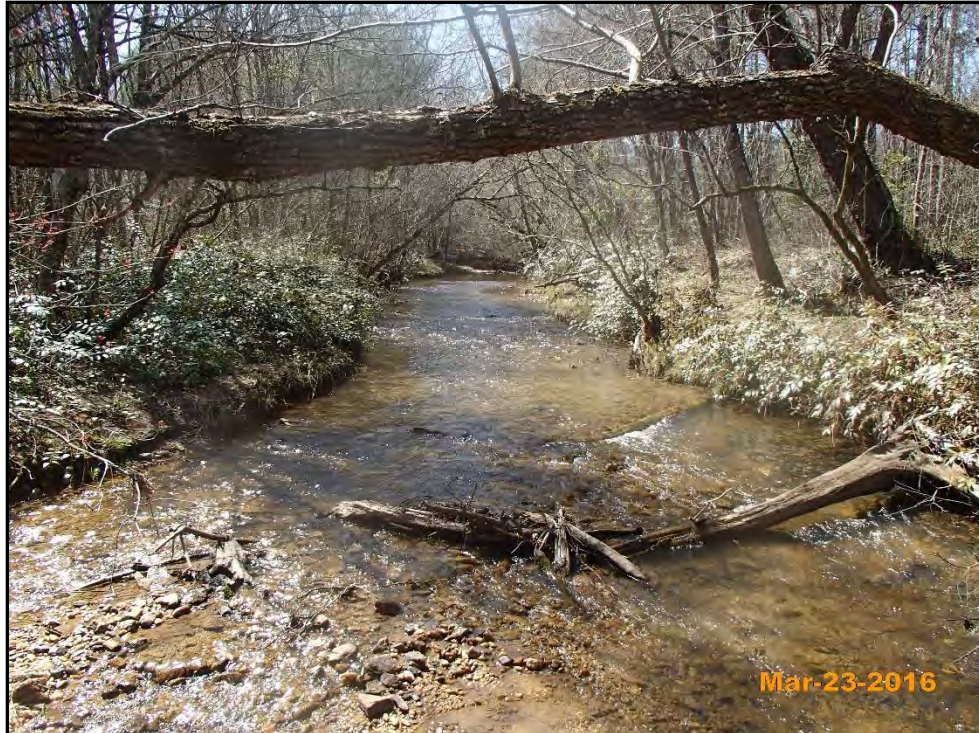
Haney Tract – Permanent Photo Station 26
Looking Upstream South Muddy Creek

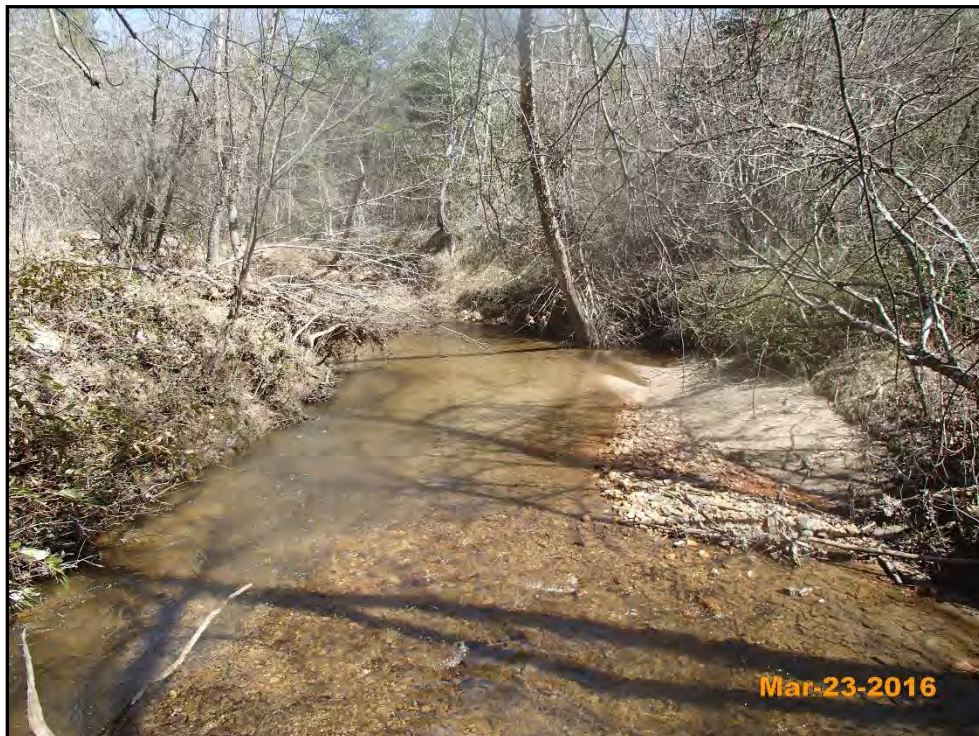
Haney Tract – Permanent Photo Station 26
Looking Downstream South Muddy Creek
