Middle South Muddy
As-Built Baseline Monitoring Report

Middle South Muddy Stream Restoration Site
NCDMS Contract No. 6783
NCDMS Project No. 93875
McDowell County, North Carolina
Data Collected: May 18th, 2015 - May 4th, 2016
Date Submitted: July 11, 2016

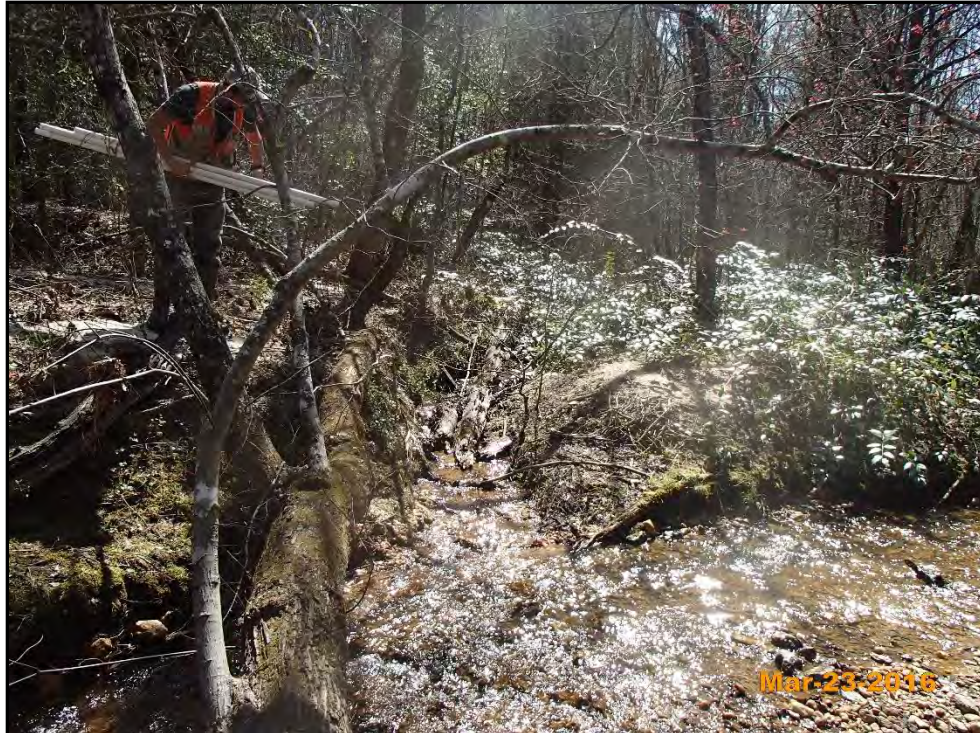
Haney Tract – Permanent Photo Station 26
Looking Upstream Tributary to South Muddy Creek

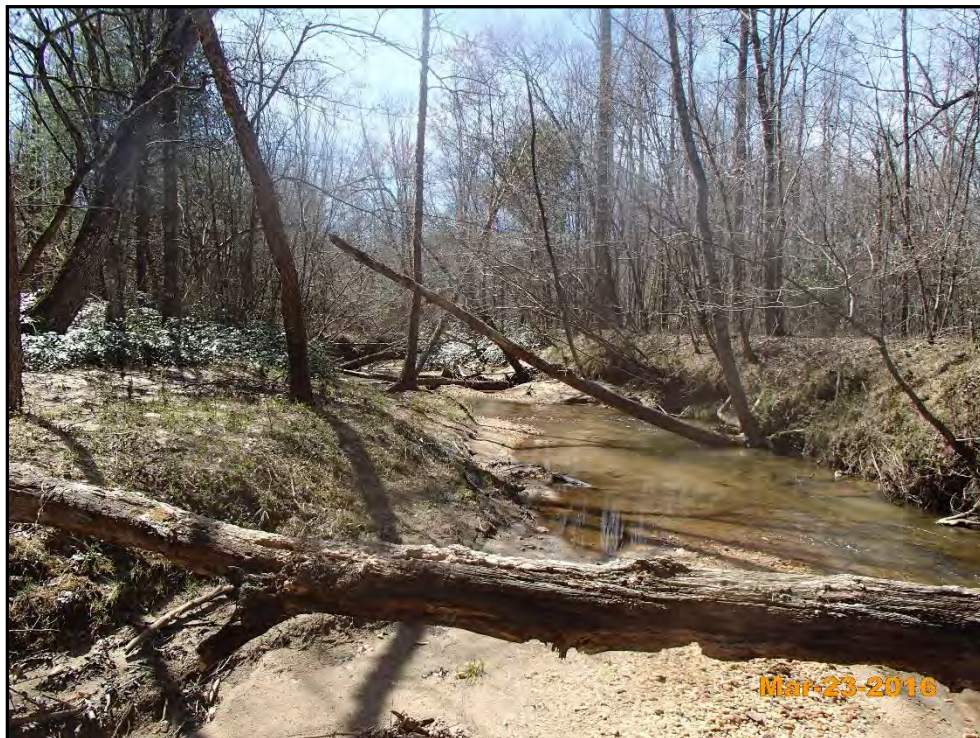
Haney Tract – Permanent Photo Station 27
Looking Upstream South Muddy Creek

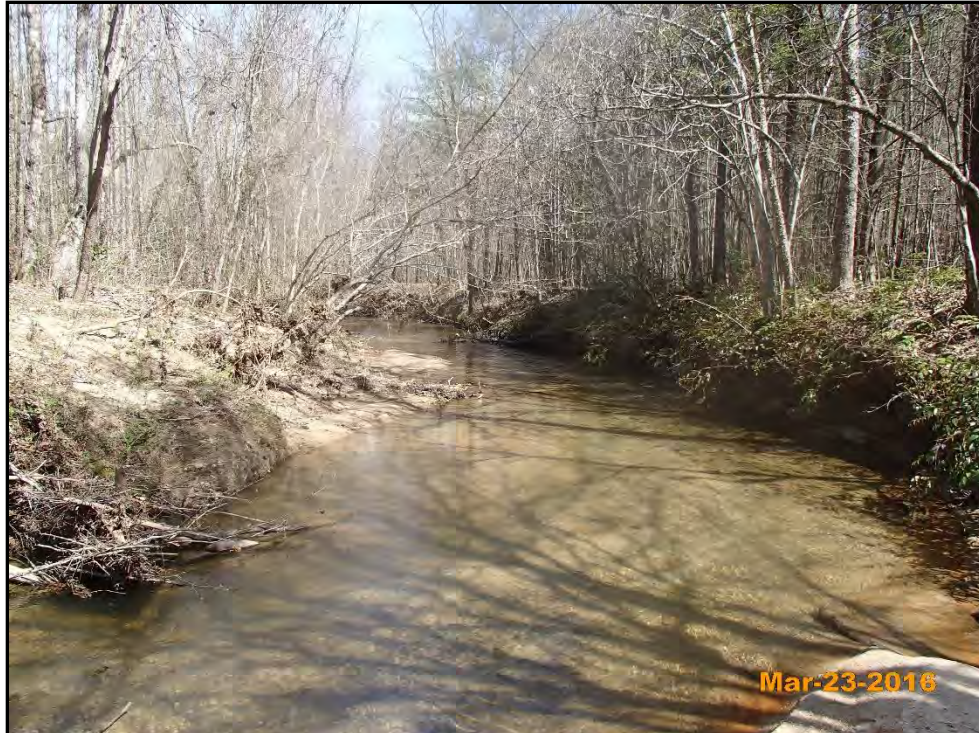
Haney Tract – Permanent Photo Station 27
Looking Downstream South Muddy Creek

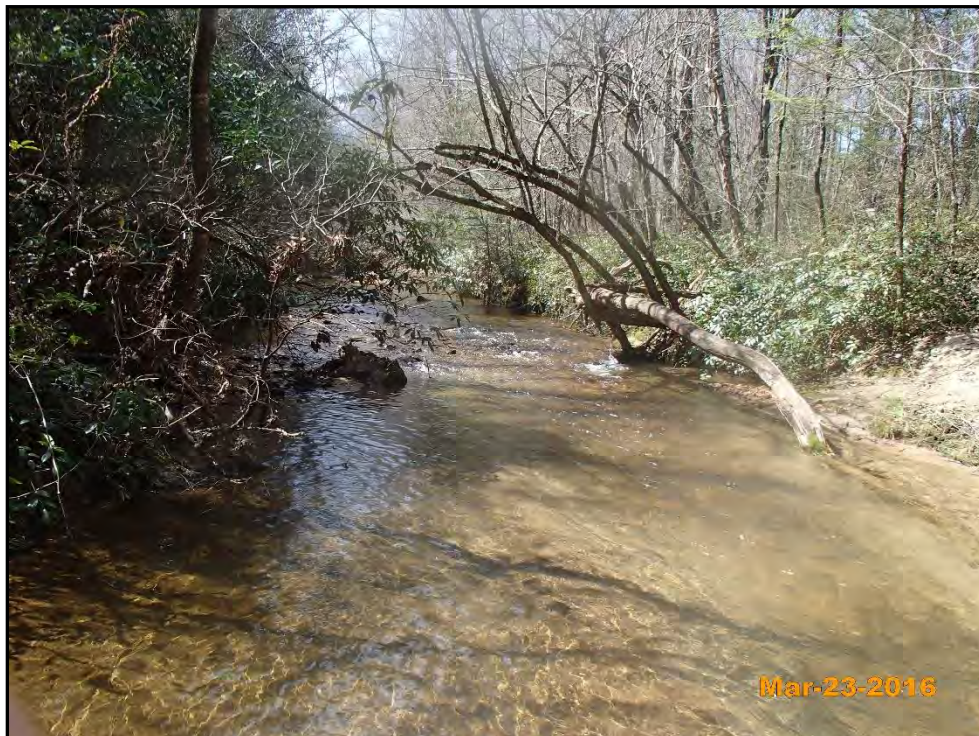
Haney Tract – Permanent Photo Station 28
Looking Upstream South Muddy Creek

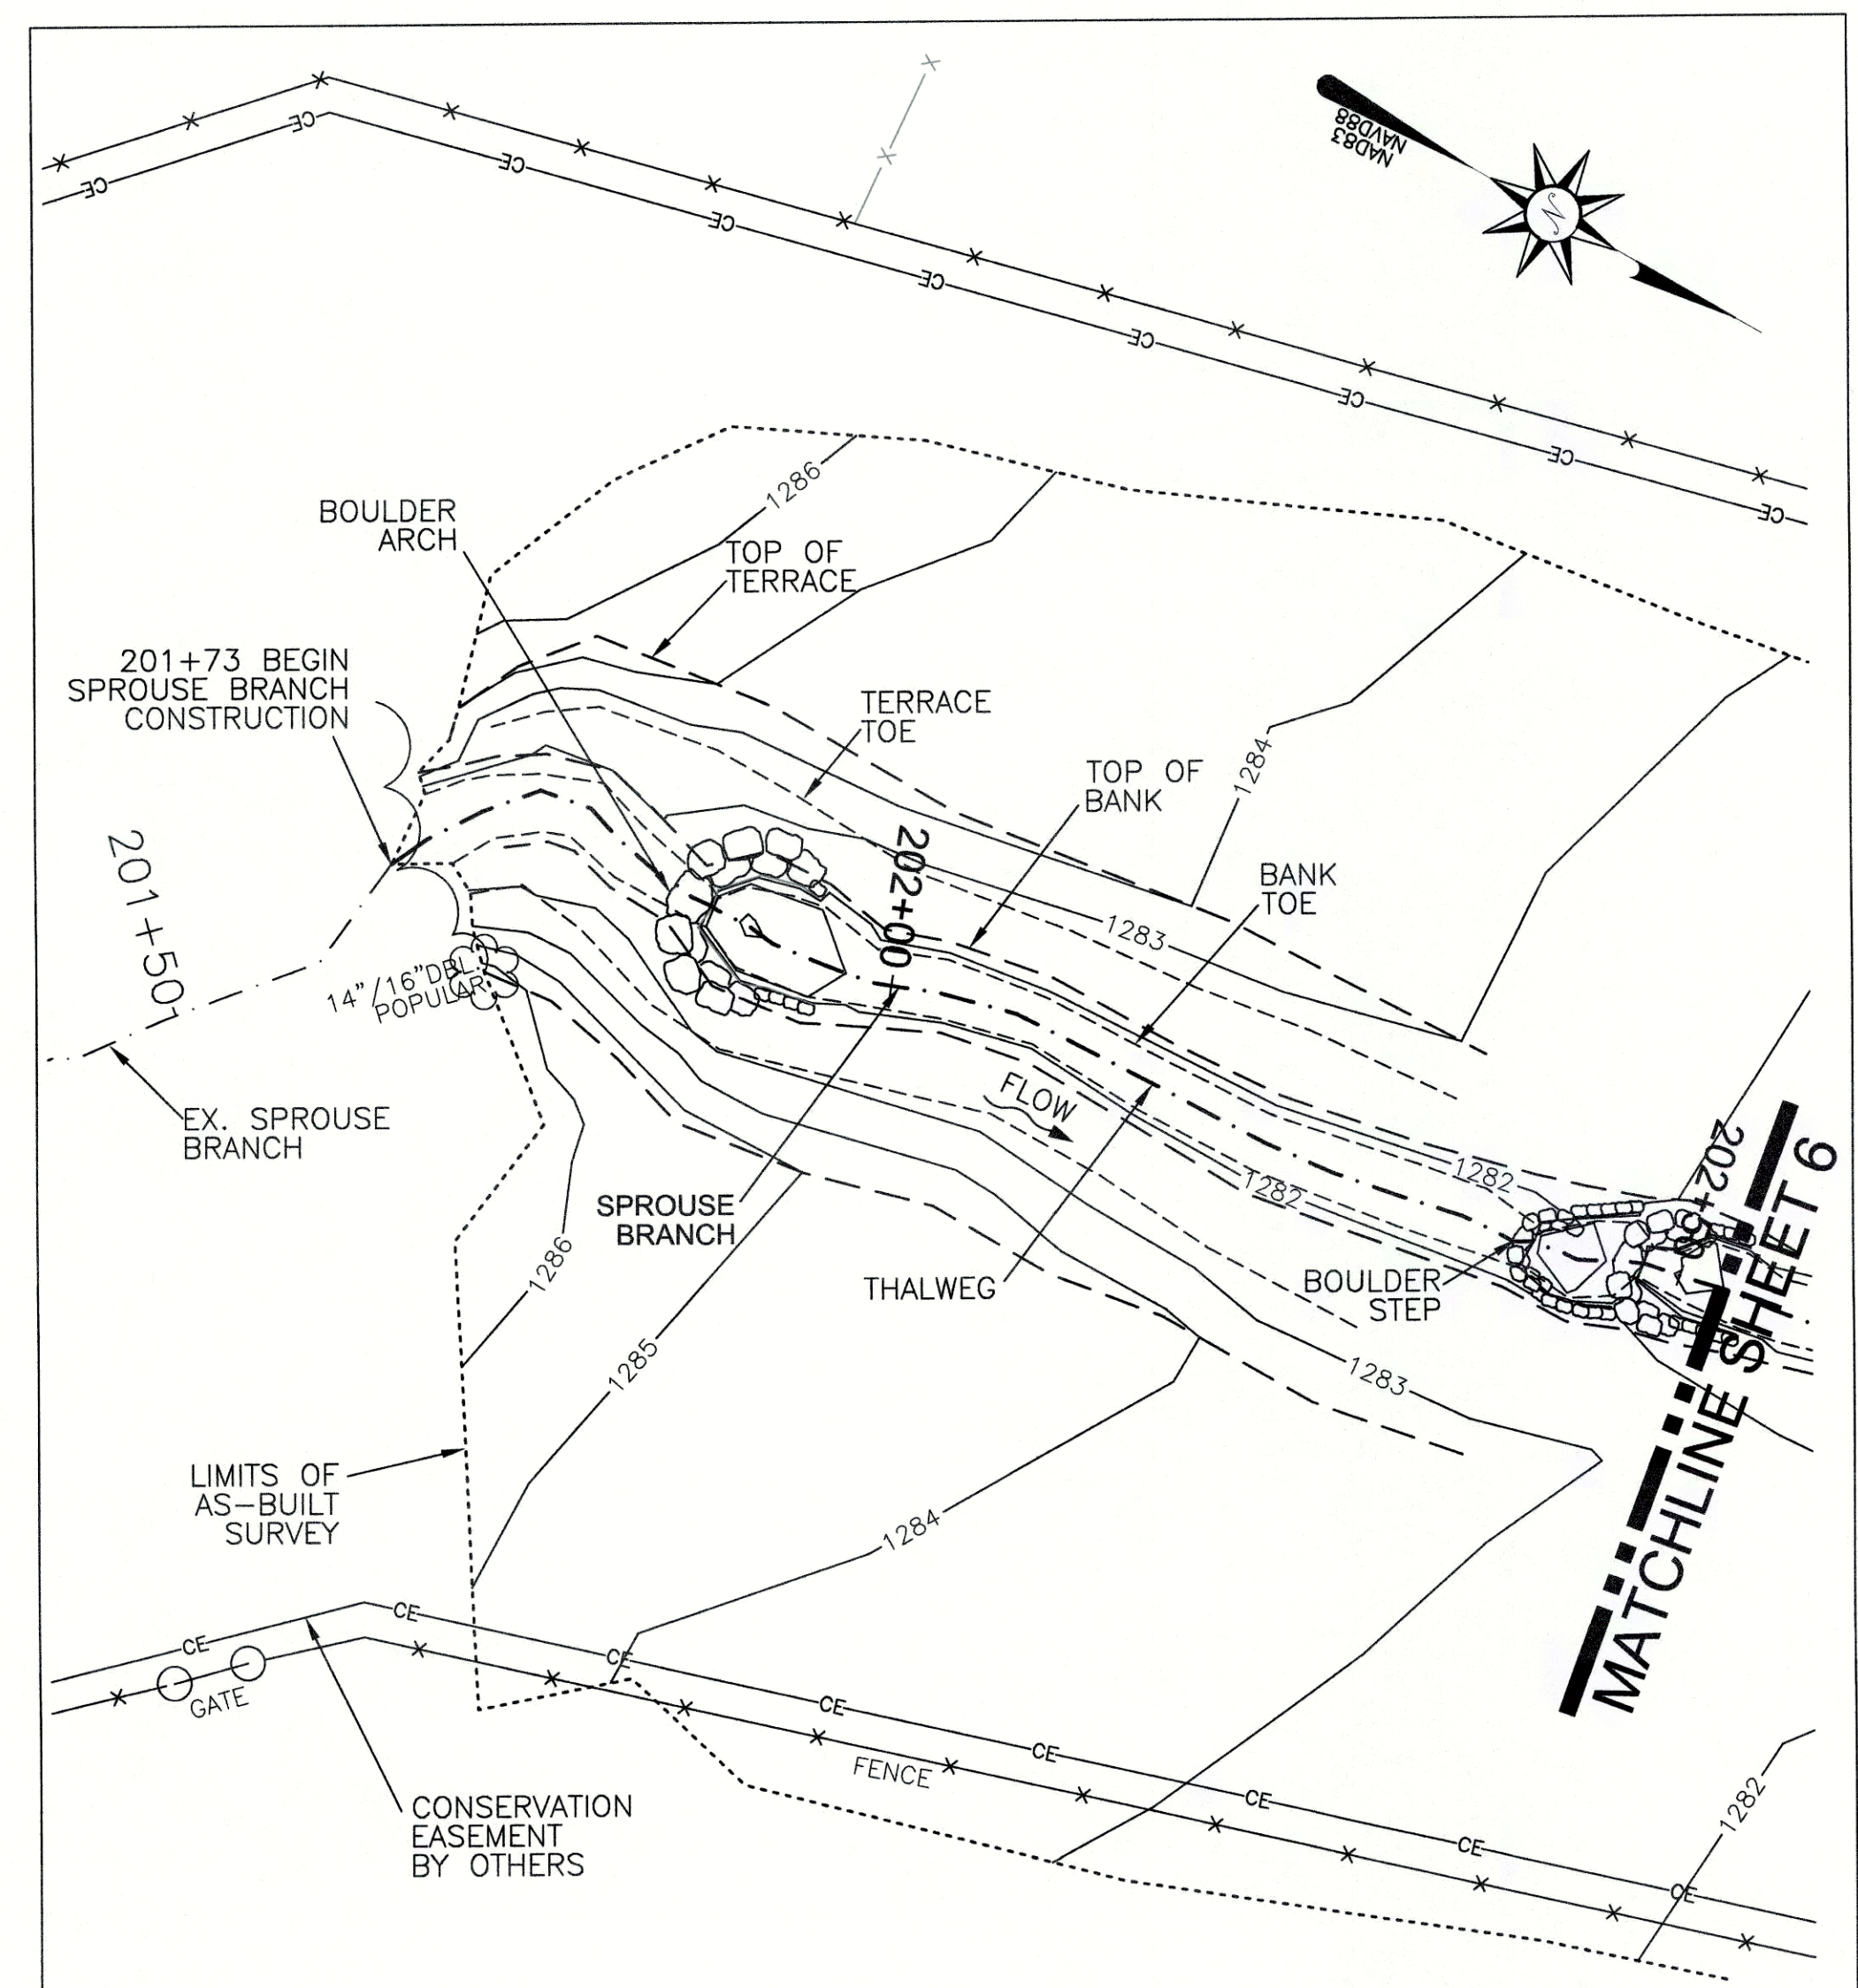
AS-BUILT LONGITUDINAL PROFILE
SPROUSE BRANCH
STA 201+60 TO 202+50

PROFILE SCALE
HORIZONTAL: 1"=10'(22x34)
1"=20'(11x17)
VERTICAL: 1"=2'(22x34)
1"=4'(11x17)

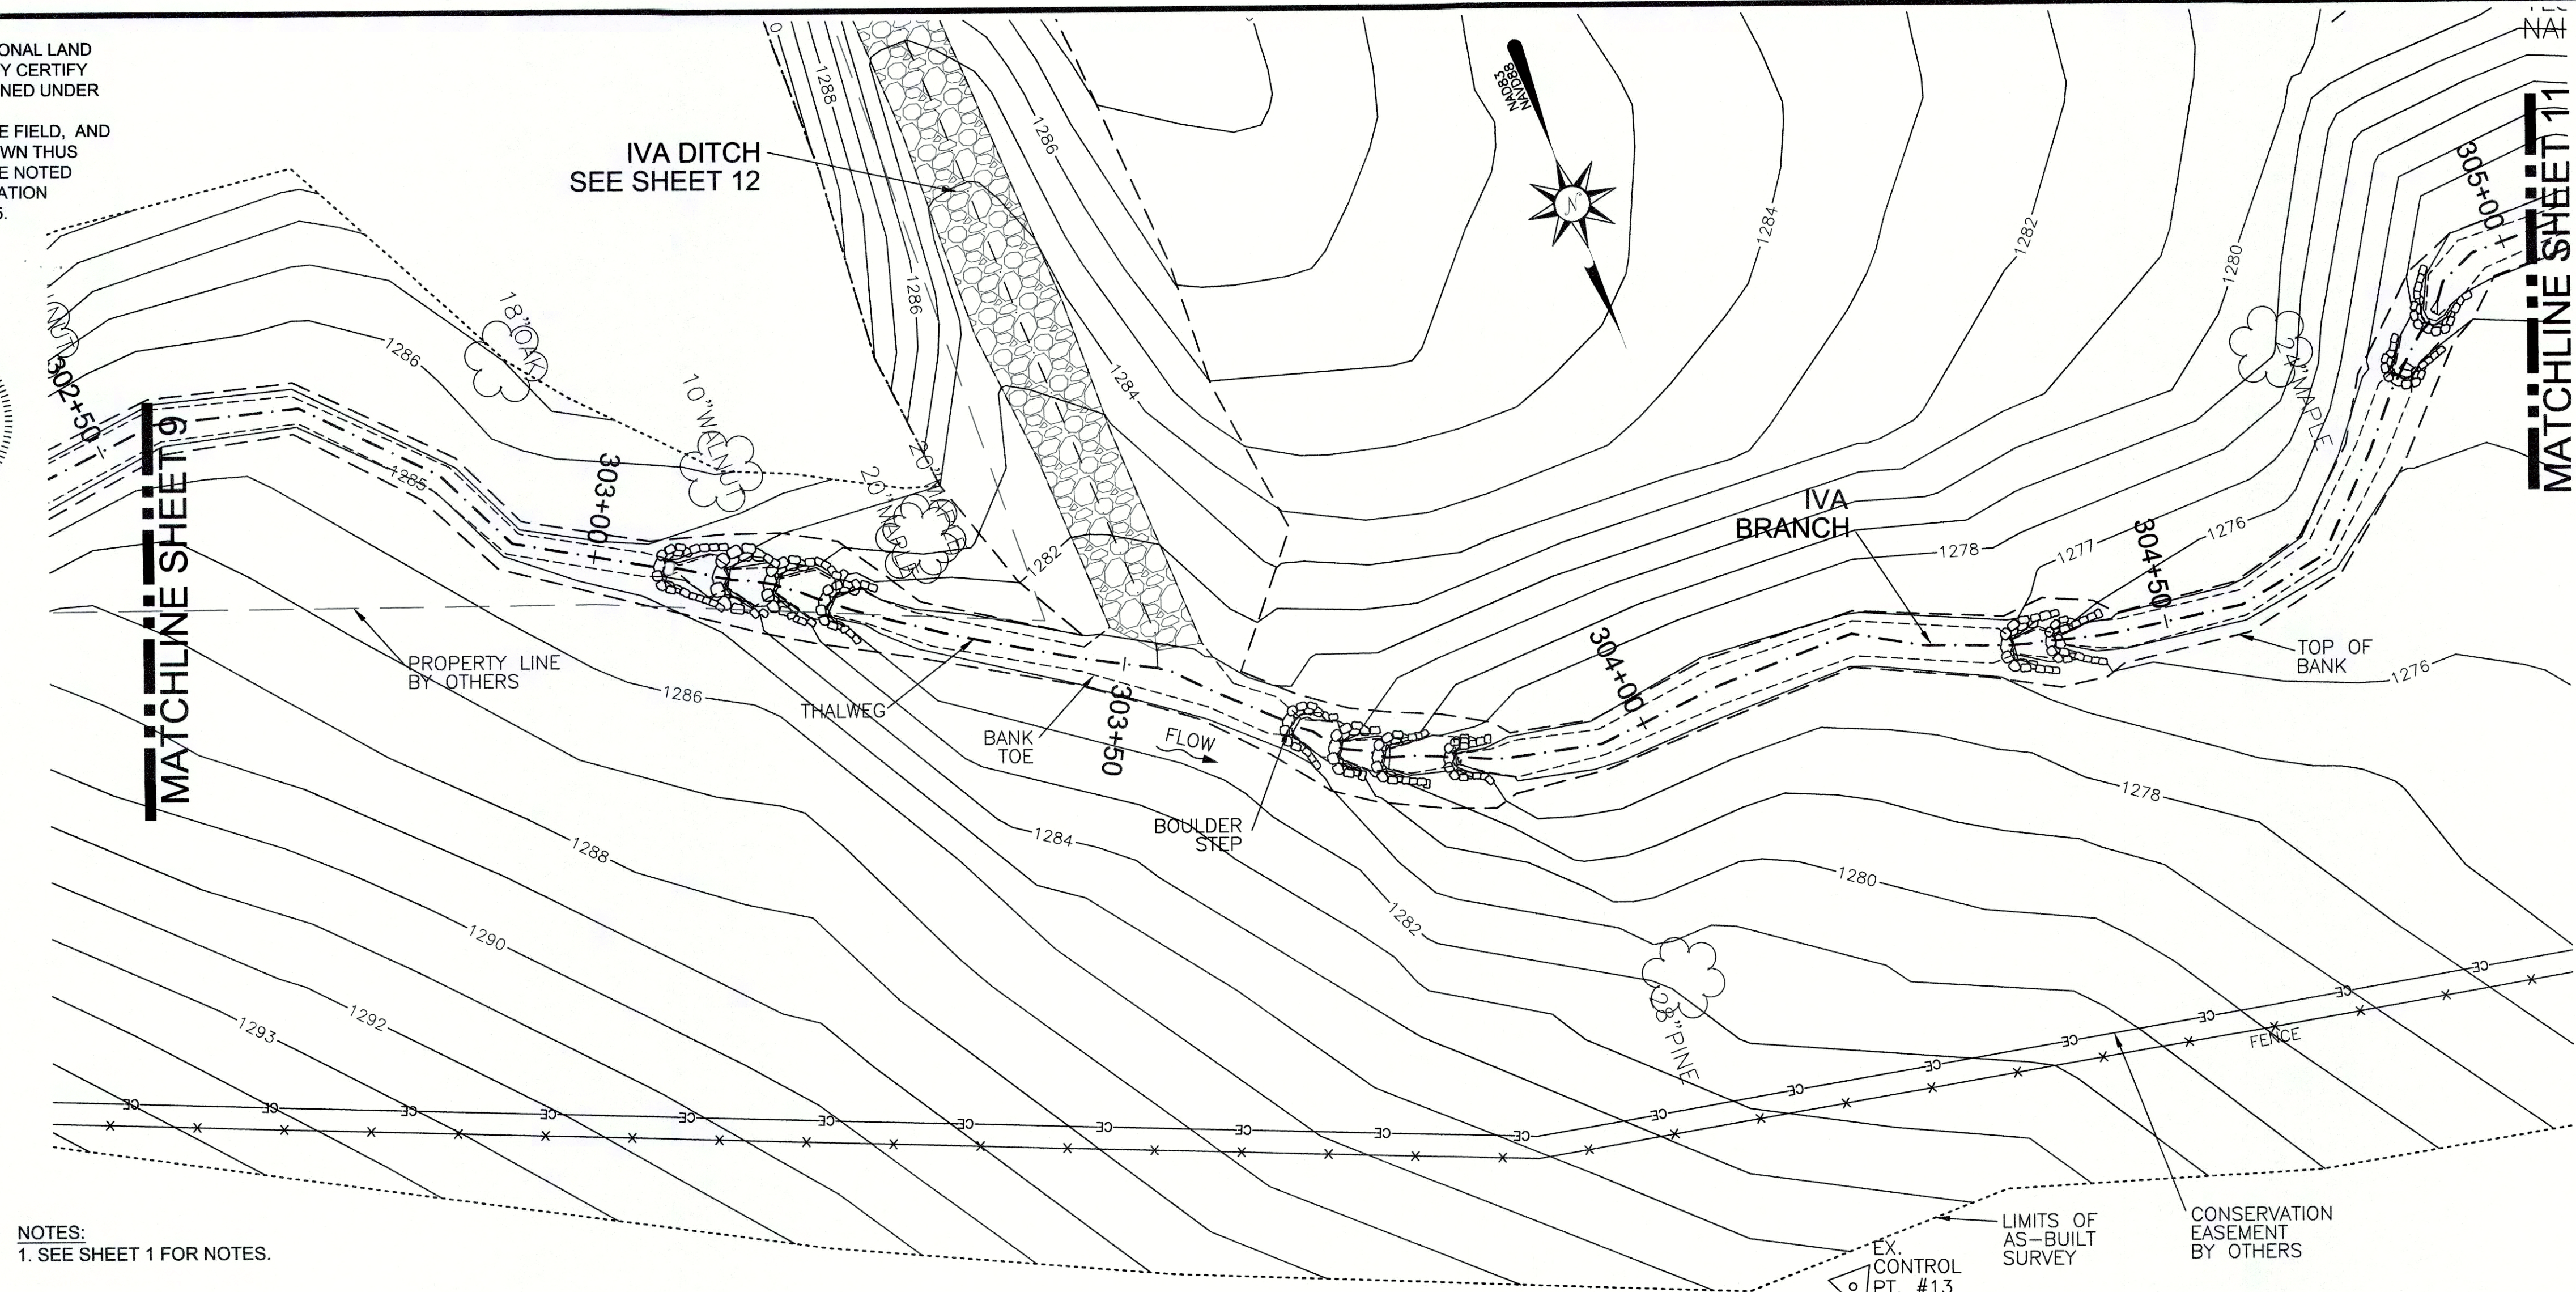
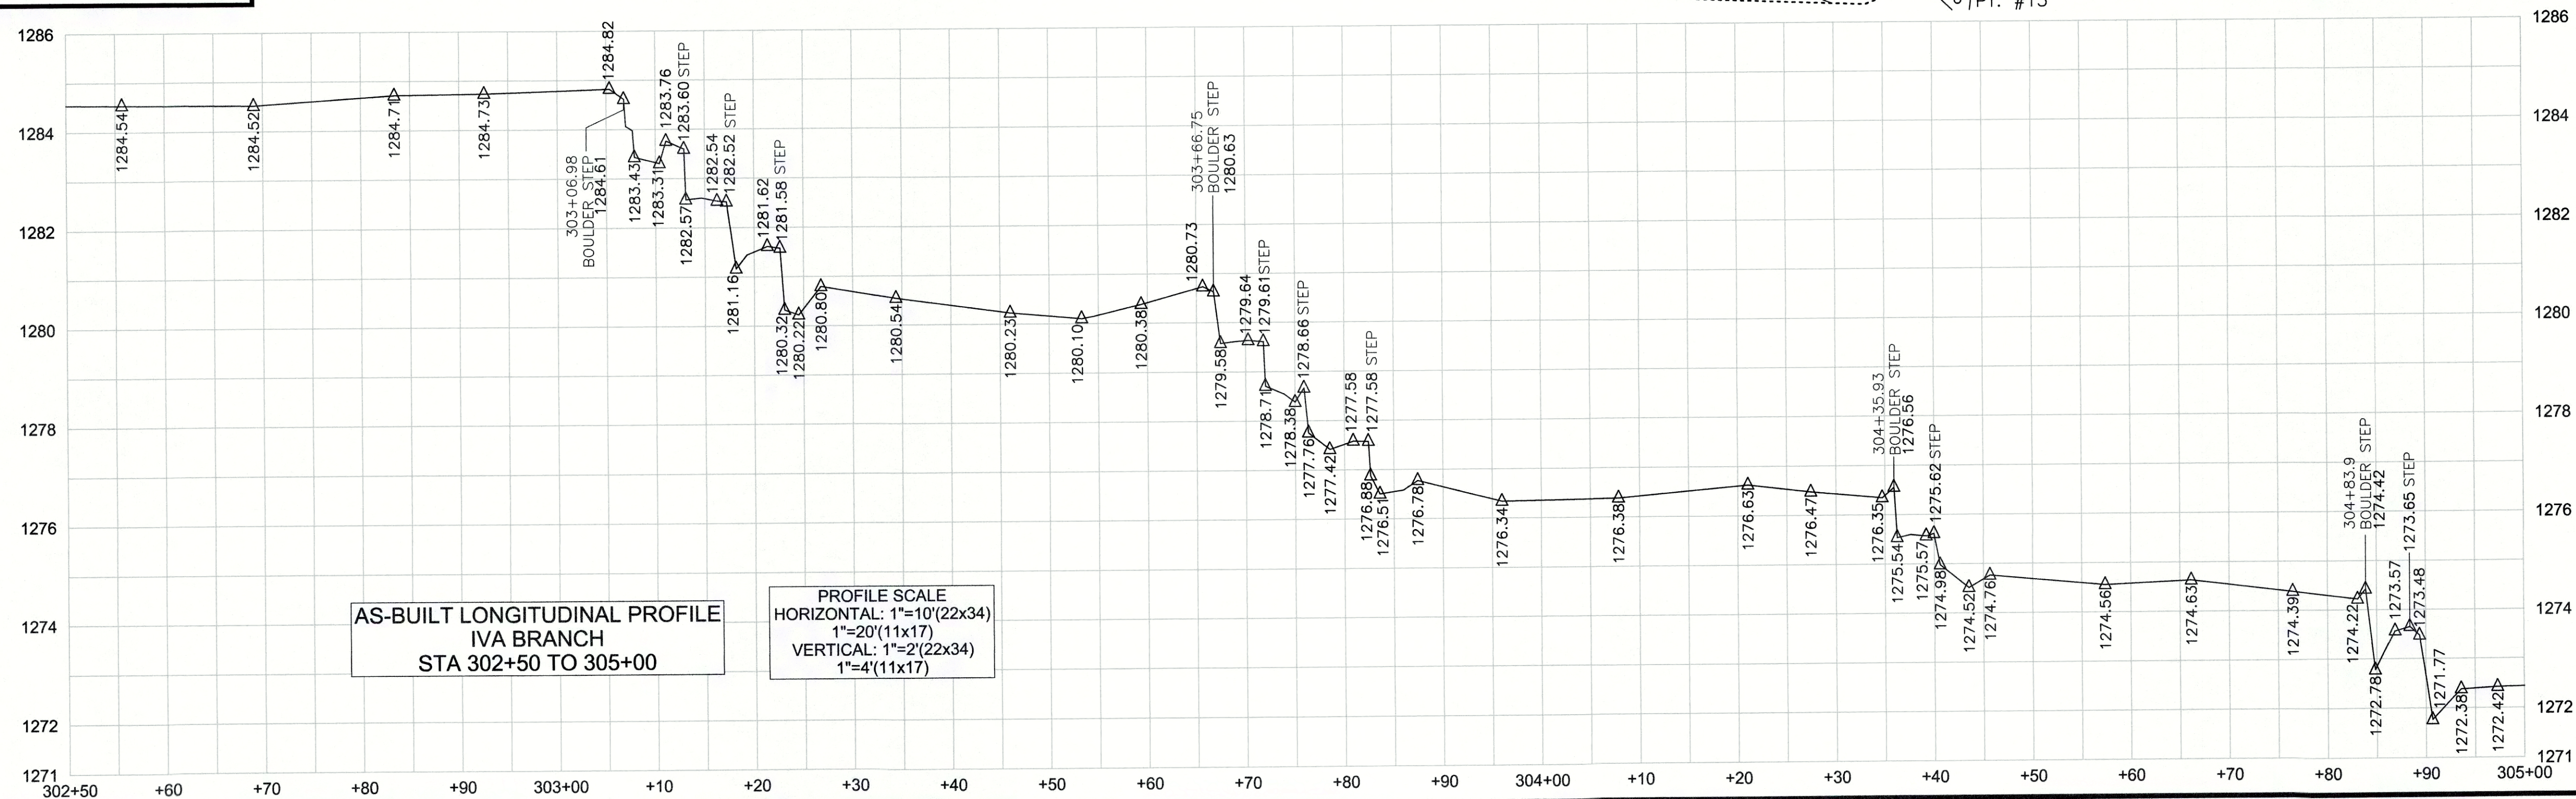
**AS-BUILT LONGITUDINAL PROFILE
IVA BRANCH
STA 302+50 TO 305+00**

PROFILE SCALE
HORIZONTAL: 1"=10'(22x34)
1"=20'(11x17)
VERTICAL: 1"=2'(22x34)
1"=4'(11x17)

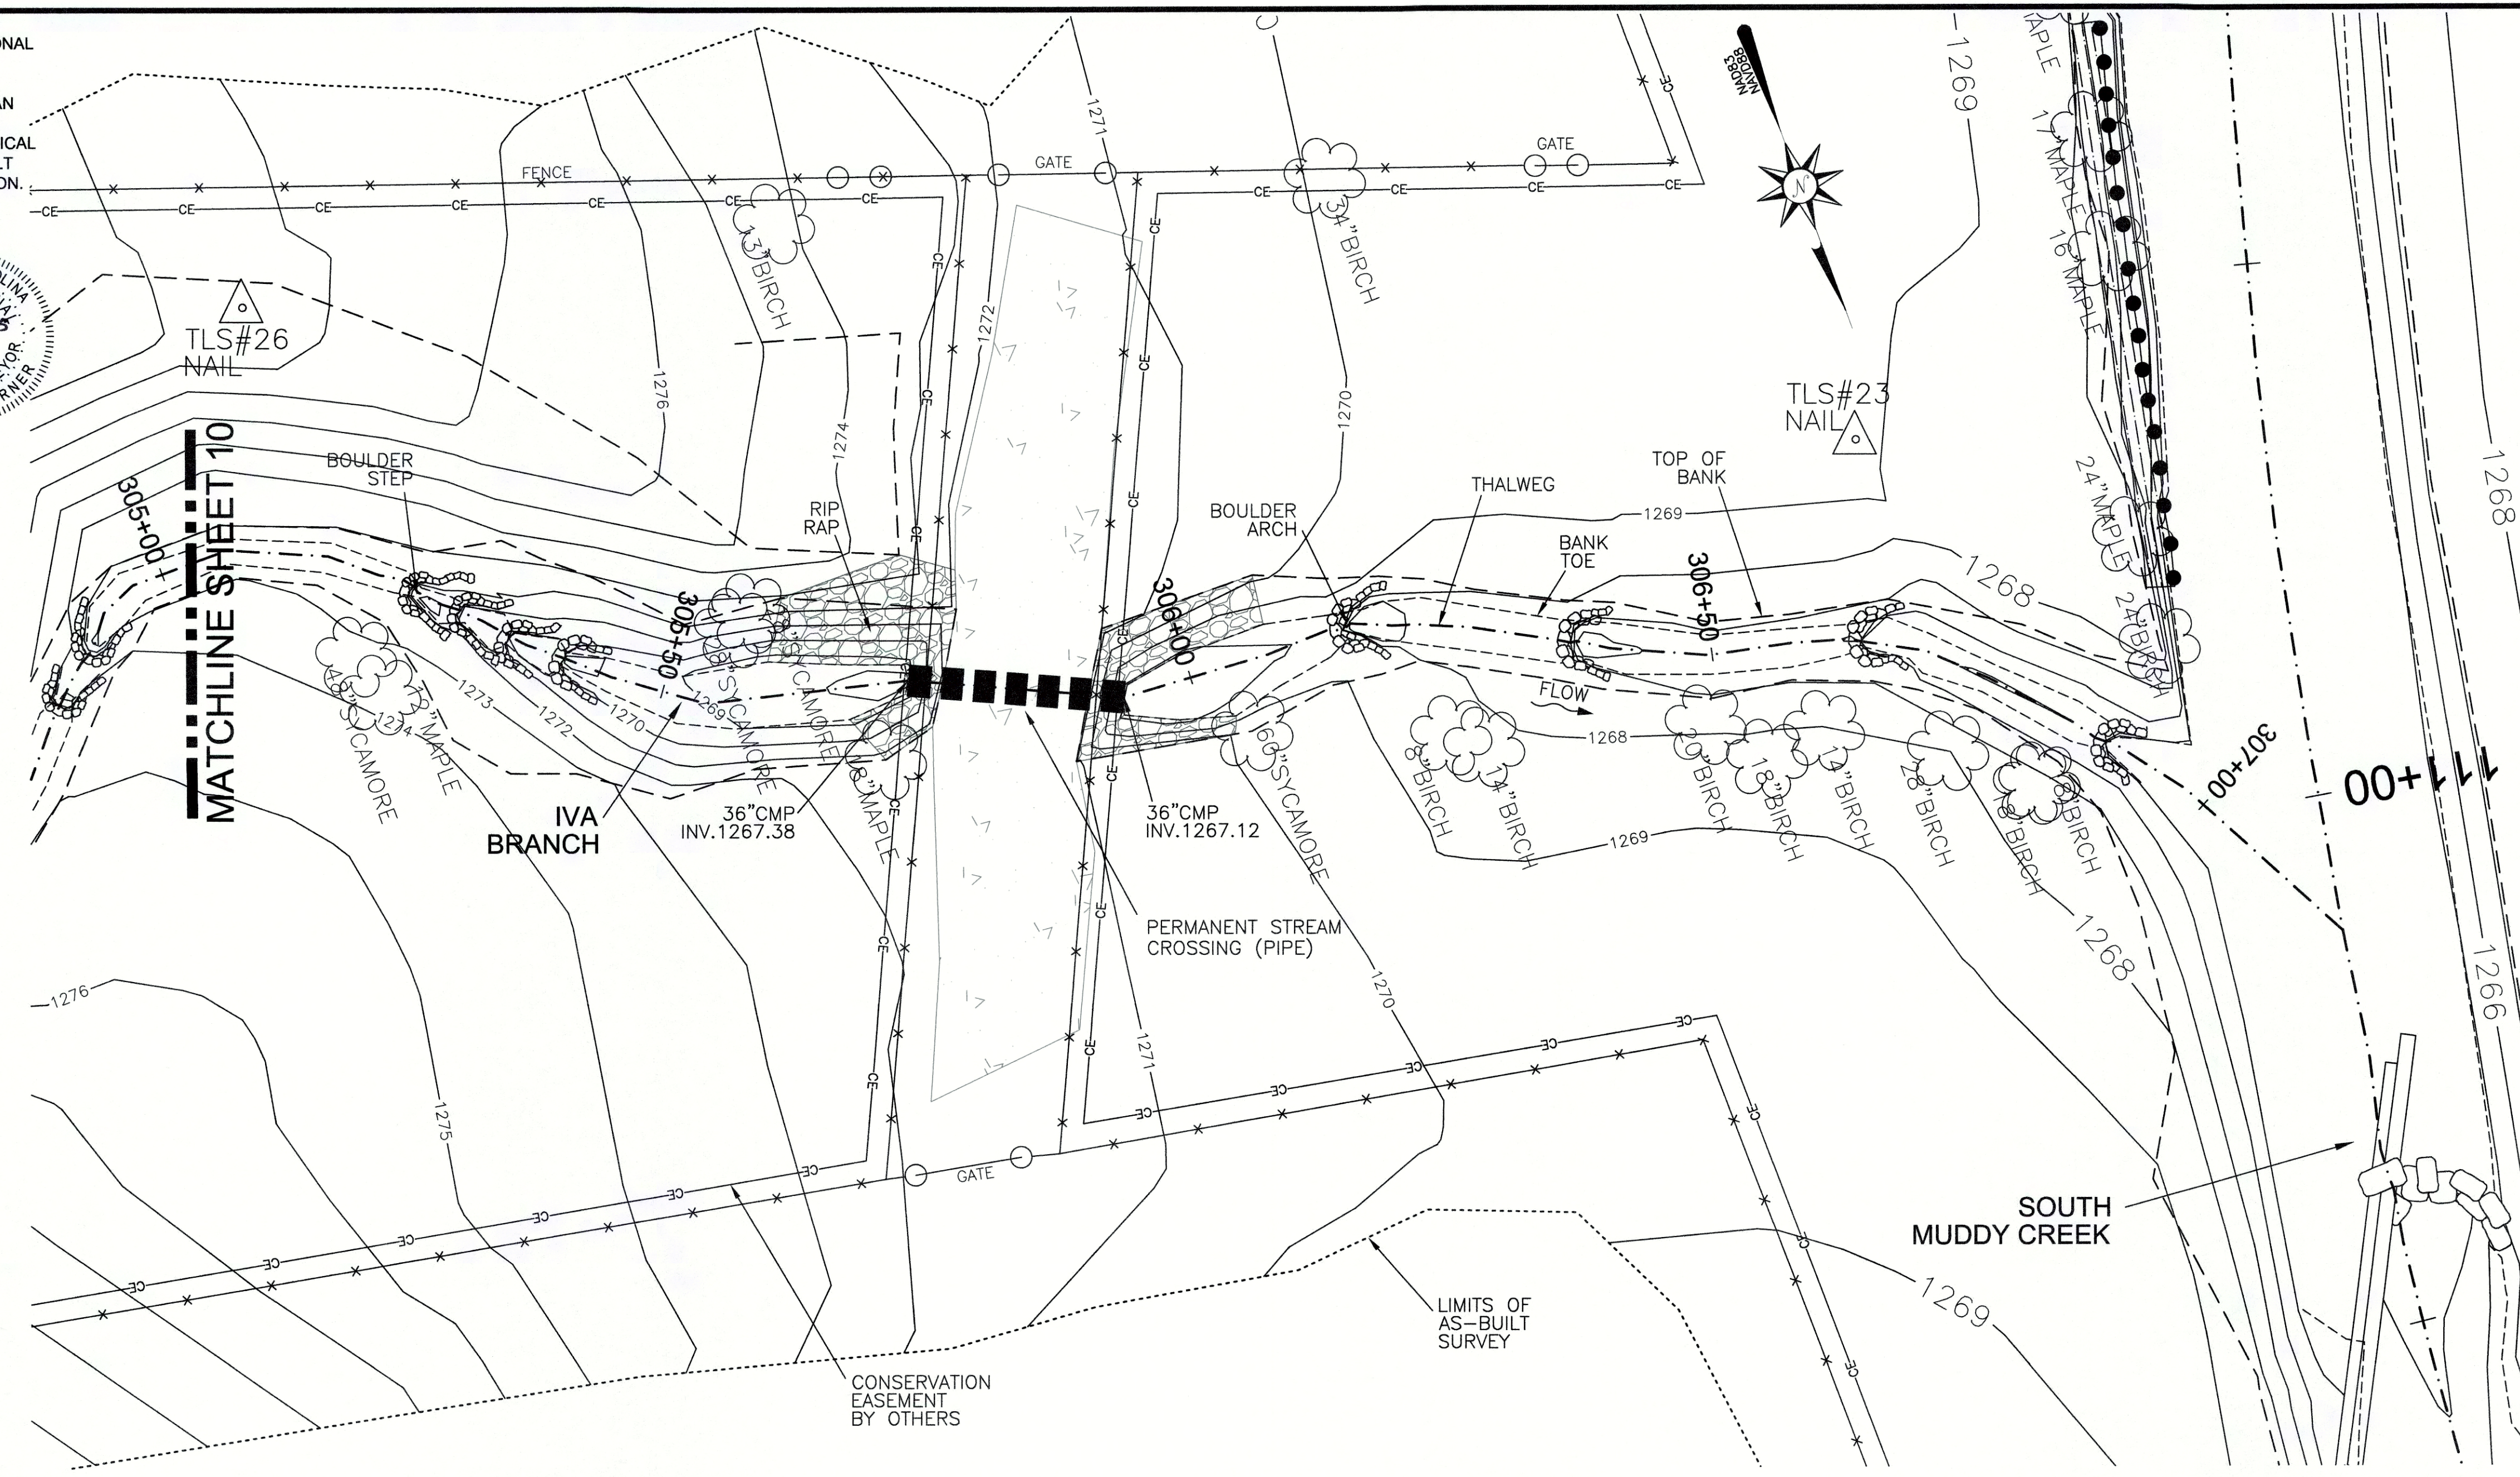
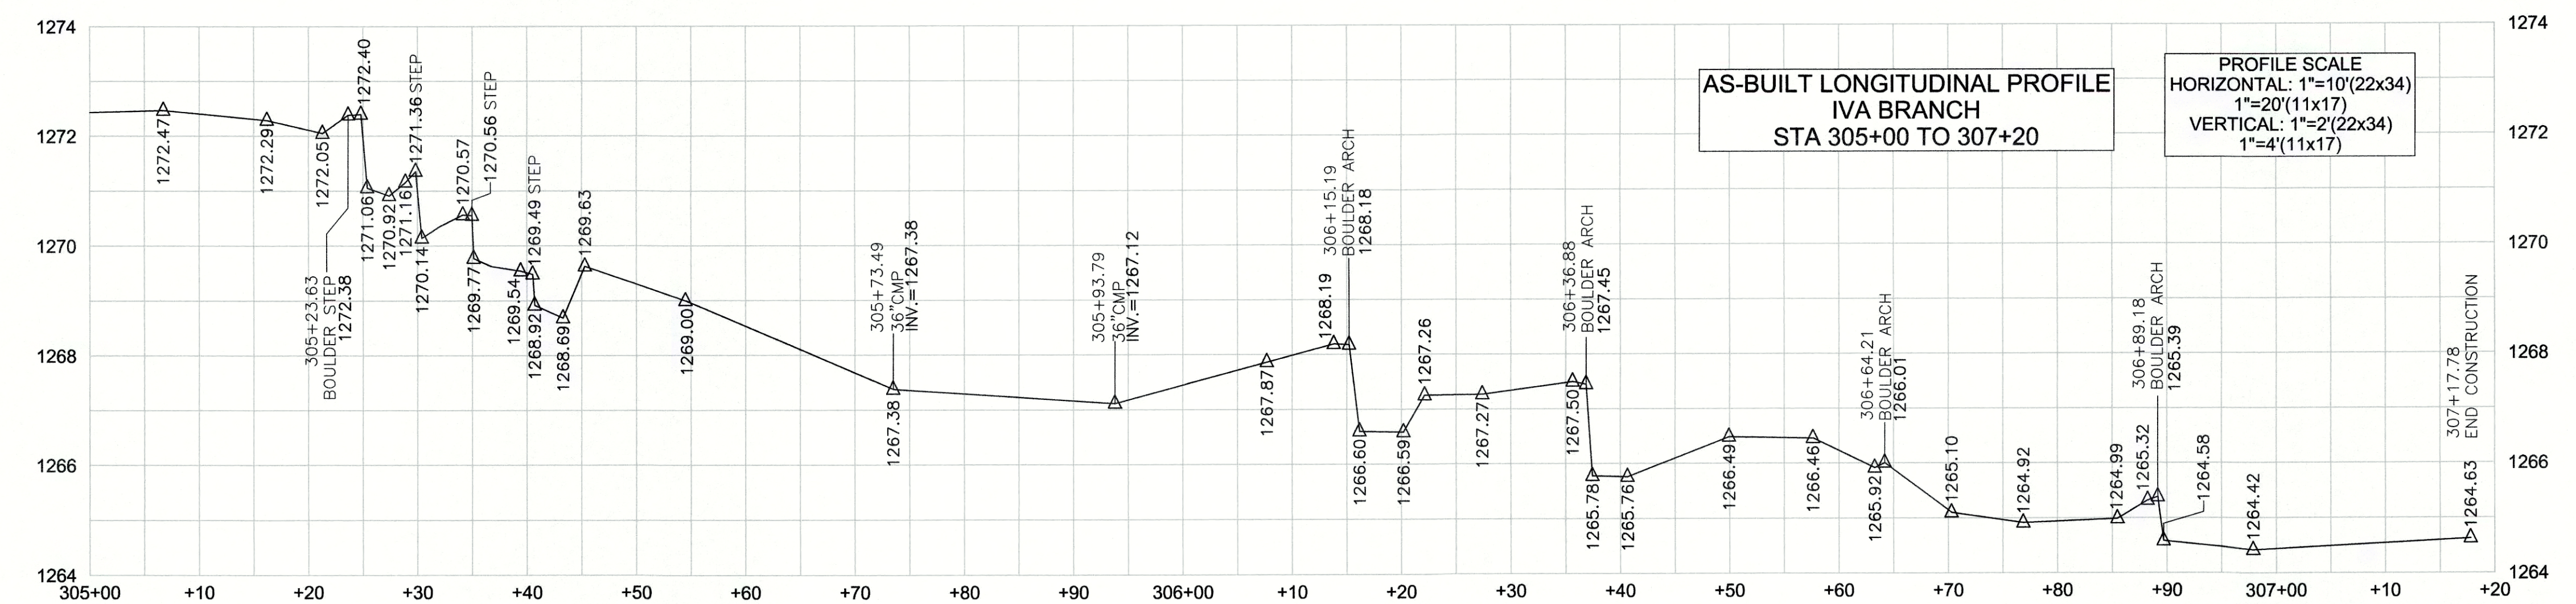
**AS-BUILT LONGITUDINAL PROFILE
IVA BRANCH
STA 305+00 TO 307+20**

PROFILE SCALE
HORIZONTAL: 1"=10'(22x34)
1"=20'(11x17)
VERTICAL: 1"=2'(22x34)
1"=4'(11x17)

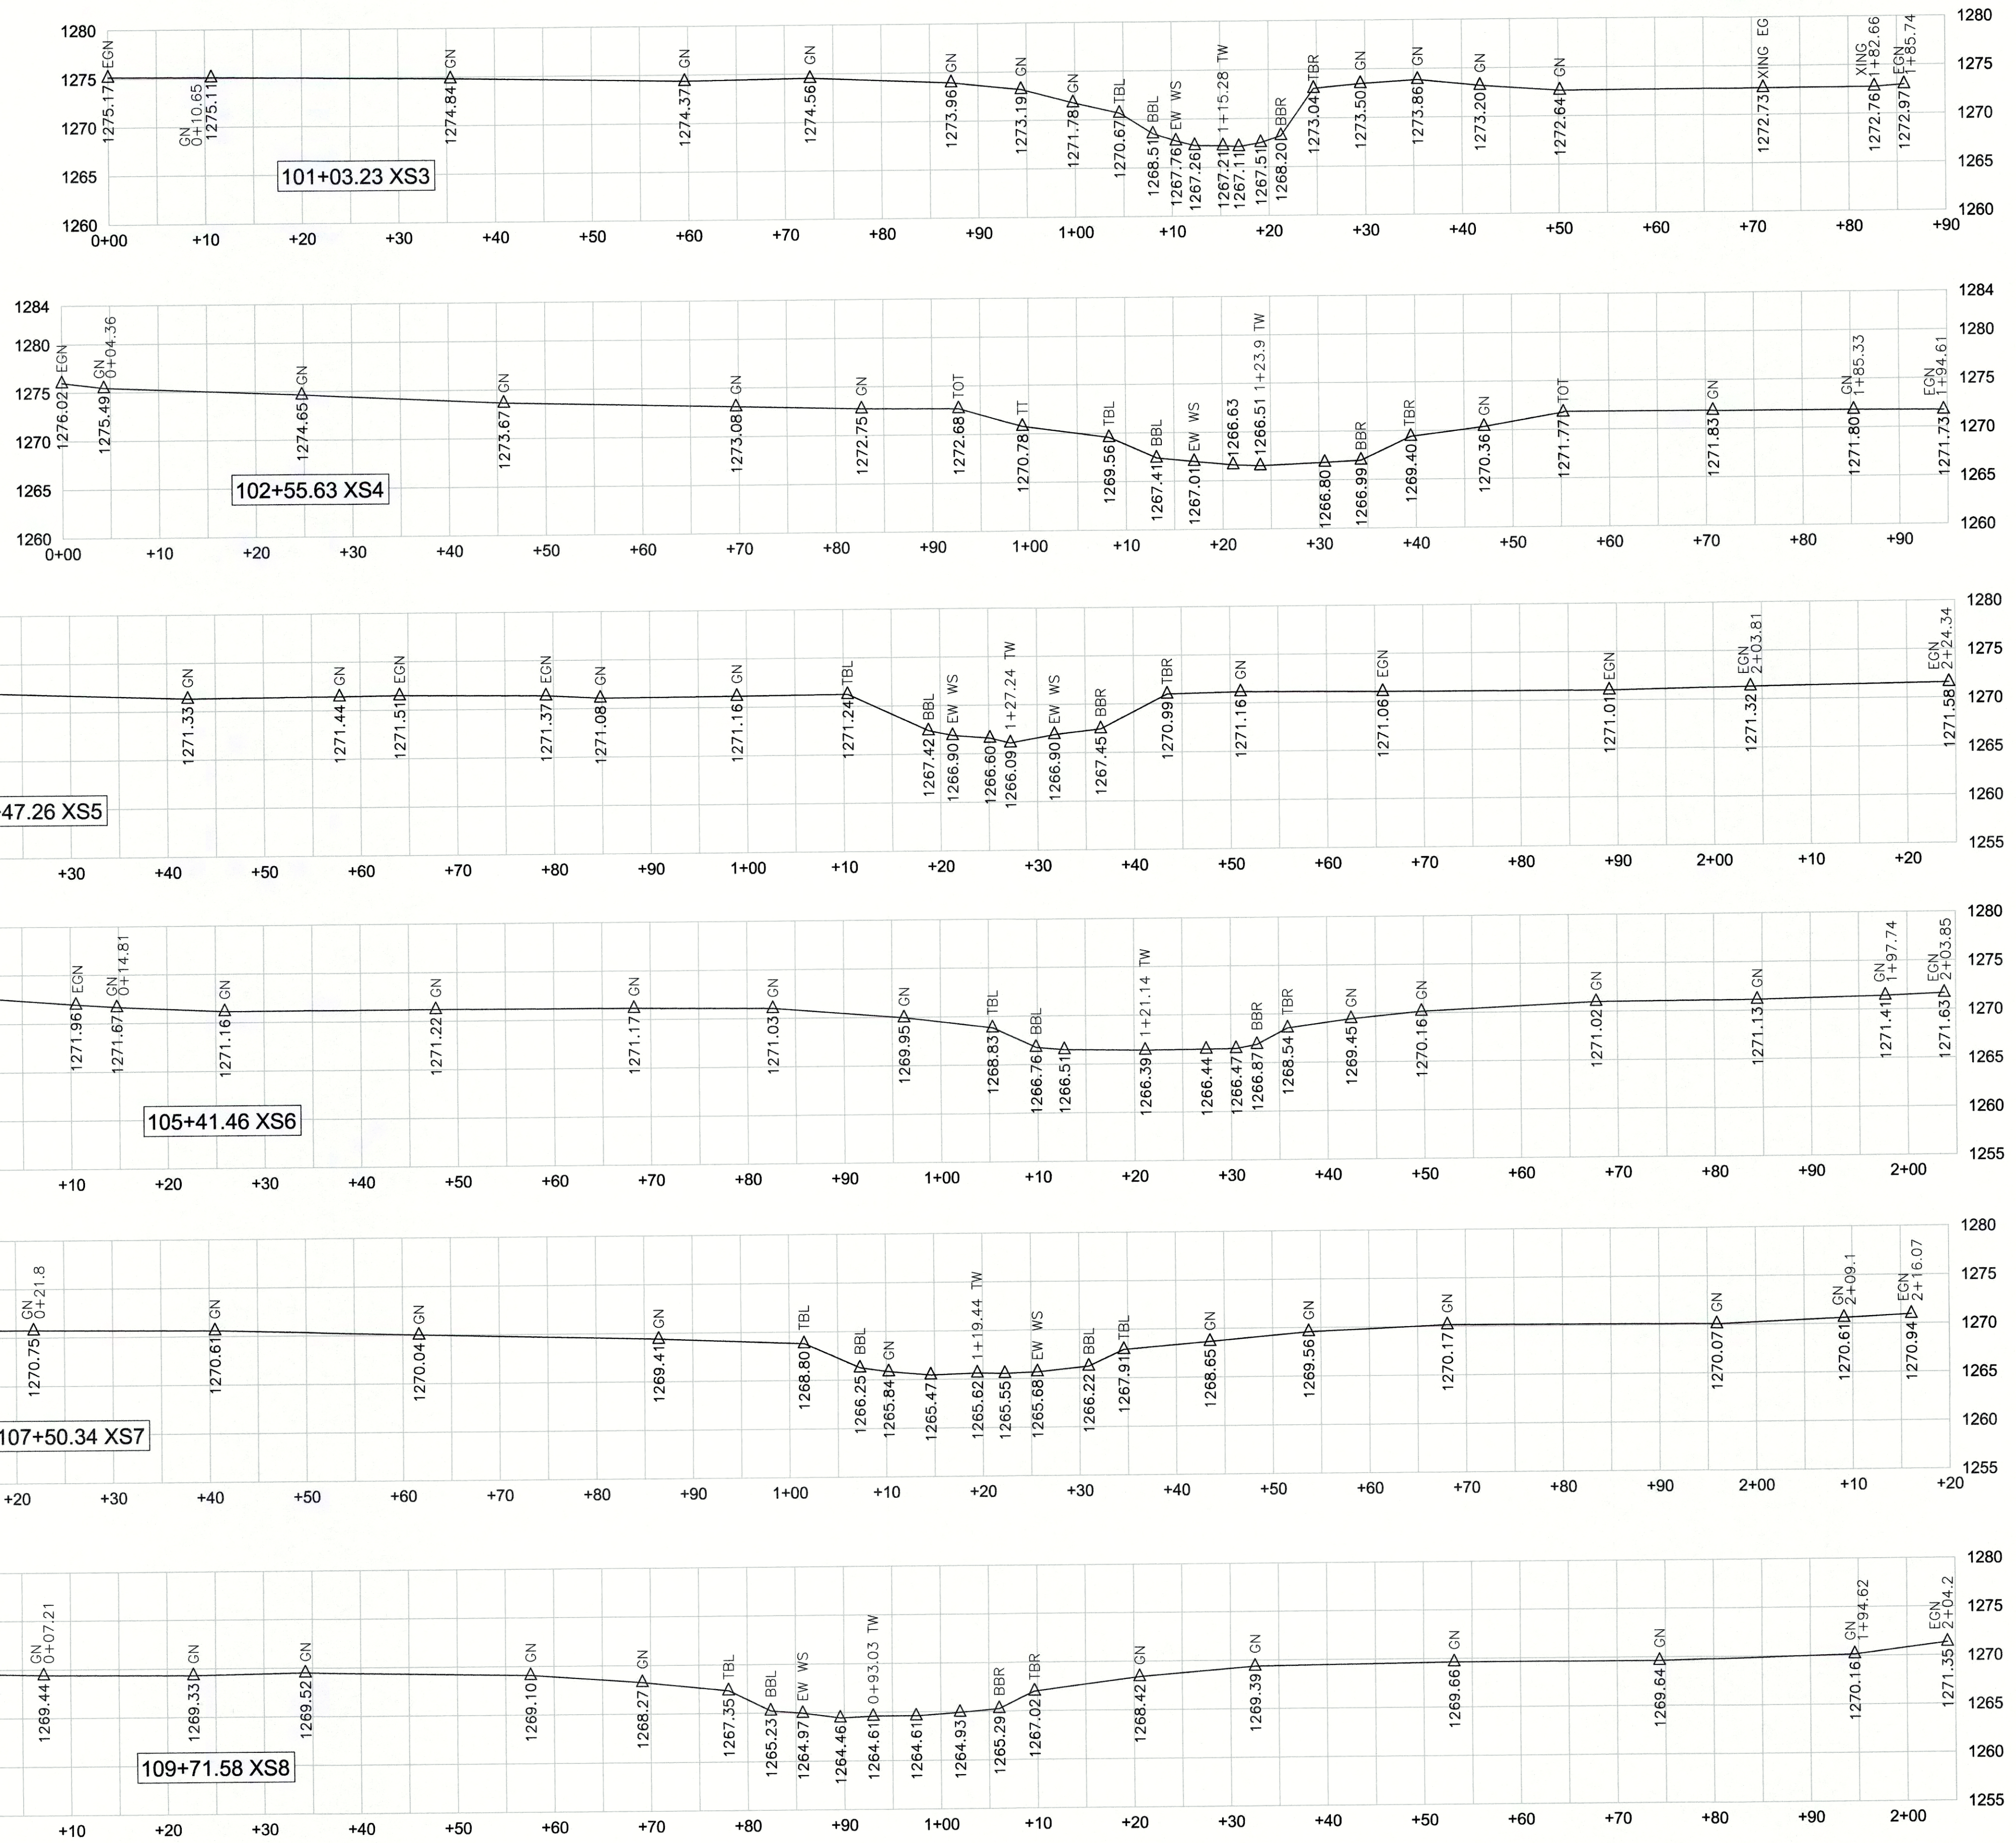
CROSS SECTIONS XS3-XS8

CROSS SECTION SCALE
HORIZONTAL: 1"=10'(22x34)
1"=20'(11x17)
VERTICAL: 1"=10'(22x34)
1"=20'(11x17)
