Annual Monitoring Report

Mill Dam Creek Restoration Site
Yadkin River Basin - 03040101
Monitoring Year 04
DEQ Contract 6898
DMS Project Number 97136
RFP#16-006706 (Date of Issue: October 21, 2015)

DWR #: 18-1349
USACE Action ID: 2016-01335
Yadkin County, North Carolina

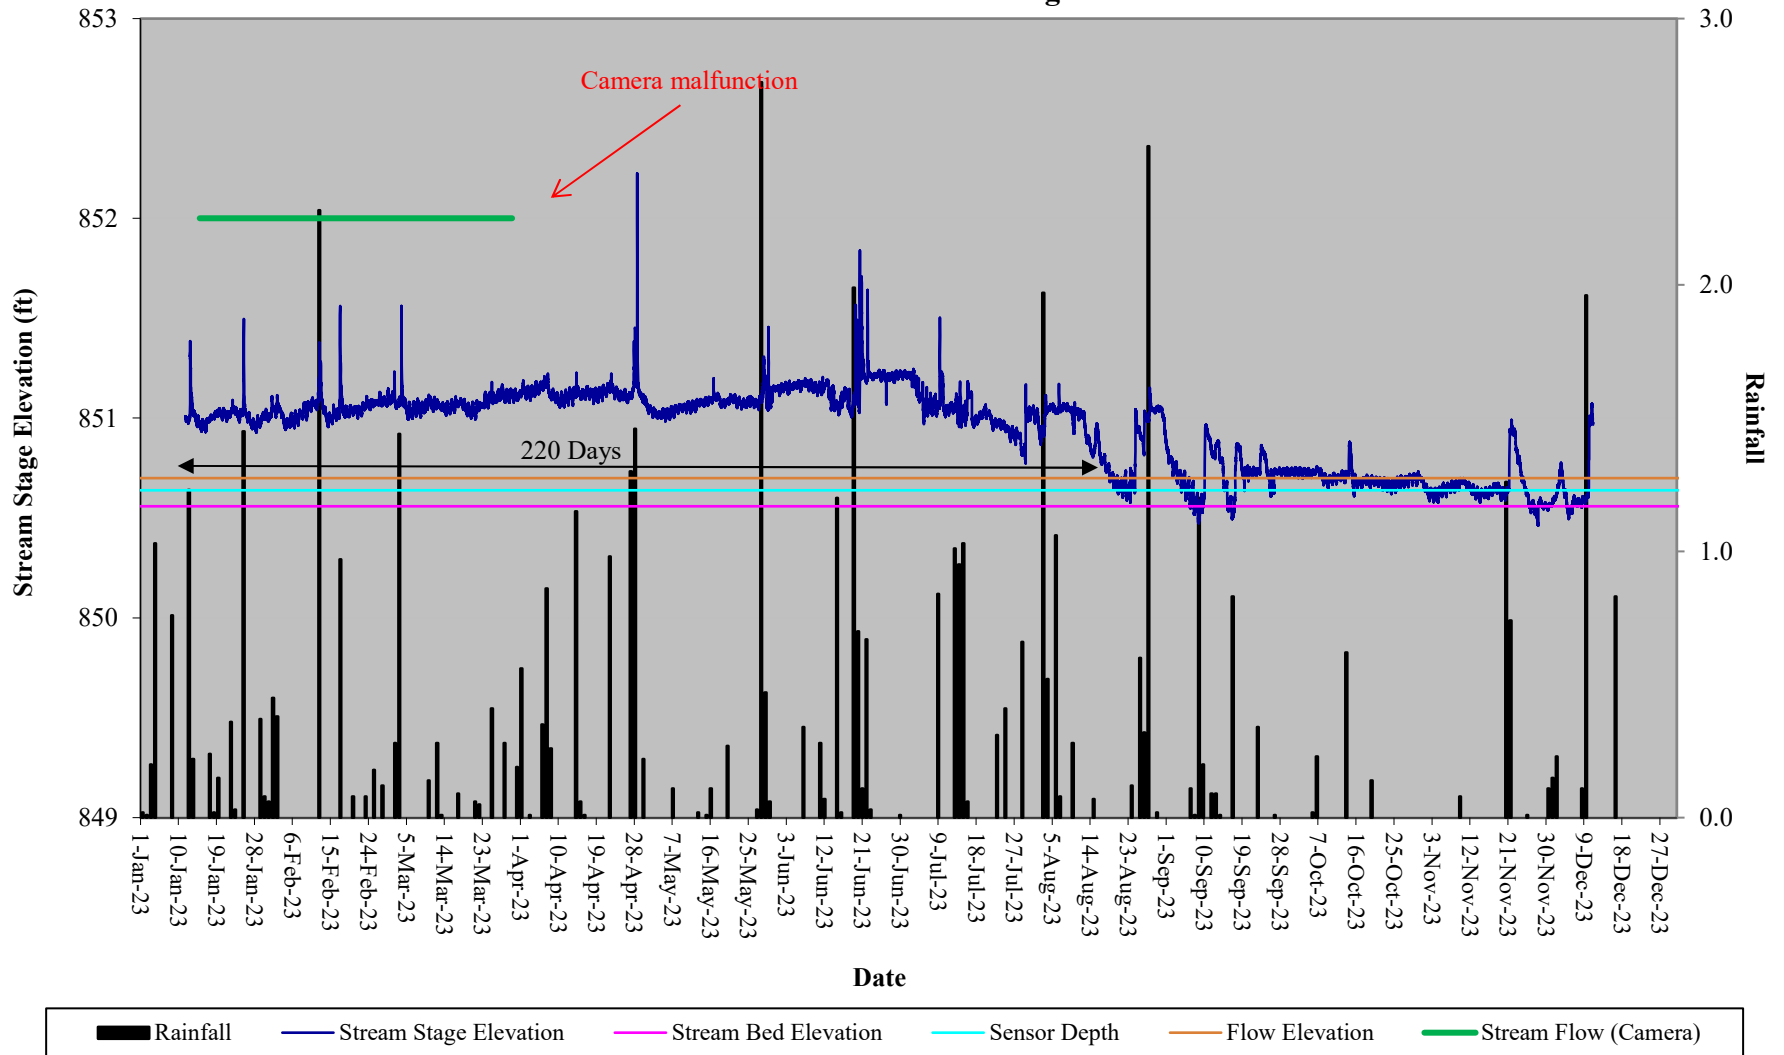
Mill Dam Creek Restoration Site Hydrograph T8A Stream Flow Gauge

- Table 2: Please include the live stake supplemental planting and invasive species treatment that occurred in MY4.
KCI Response: This change has been made.
- T8A stream flow gauge graph indicates that there was a camera malfunction. Has this camera been repaired or replaced?
KCI Response: This camera has been replaced with a functioning one.
- Please continue to include Appendix F from previous year report in all monitoring reports. The IRT communications are helpful for reviewing the site history.
KCI Response: Appendix F has been included in the report.

Table 12. Verification of Stream Flow Mill Dam Creek Restoration Site, DMS Project #97136				
	Gauge		Camera	
Reach	Dates Achieving	Maximum Consecutive Days	Dates Achieving	Maximum Consecutive Days
T1A	January 11 – March 30	79	January 12 – April 4	83
T5A	January 11 – December 11	335	January 12 – May 30	140
T8A	January 11 – August 18	220	January 12 – March 30	80

Table 13. Stream Flow Criteria Attainment Mill Dam Creek Restoration Site, DMS Project #97136							
	Greater than 30 Days of Flow/Max Consecutive Days						
Reach	MY-01 2020	MY-02 2021	MY-03 2022	MY-04 2023	MY-05 2024	MY-06 2025	MY-07 2026
T1A (Gauge)	Yes/68	Yes/121	Yes/34	Yes/79			
T1A (Camera)	Yes/44	Yes/55	Yes/104	Yes/83			
T5A (Gauge)	Yes/152	Yes/322	Yes/303	Yes/335			
T5A (Camera)	Yes/70	Yes/116	Yes/114	Yes/140			
T8A (Gauge)	Yes/152	Yes/167	Yes/217	Yes/220			
T8A (Camera)	Yes/84	Yes/180	Yes/92	Yes/80

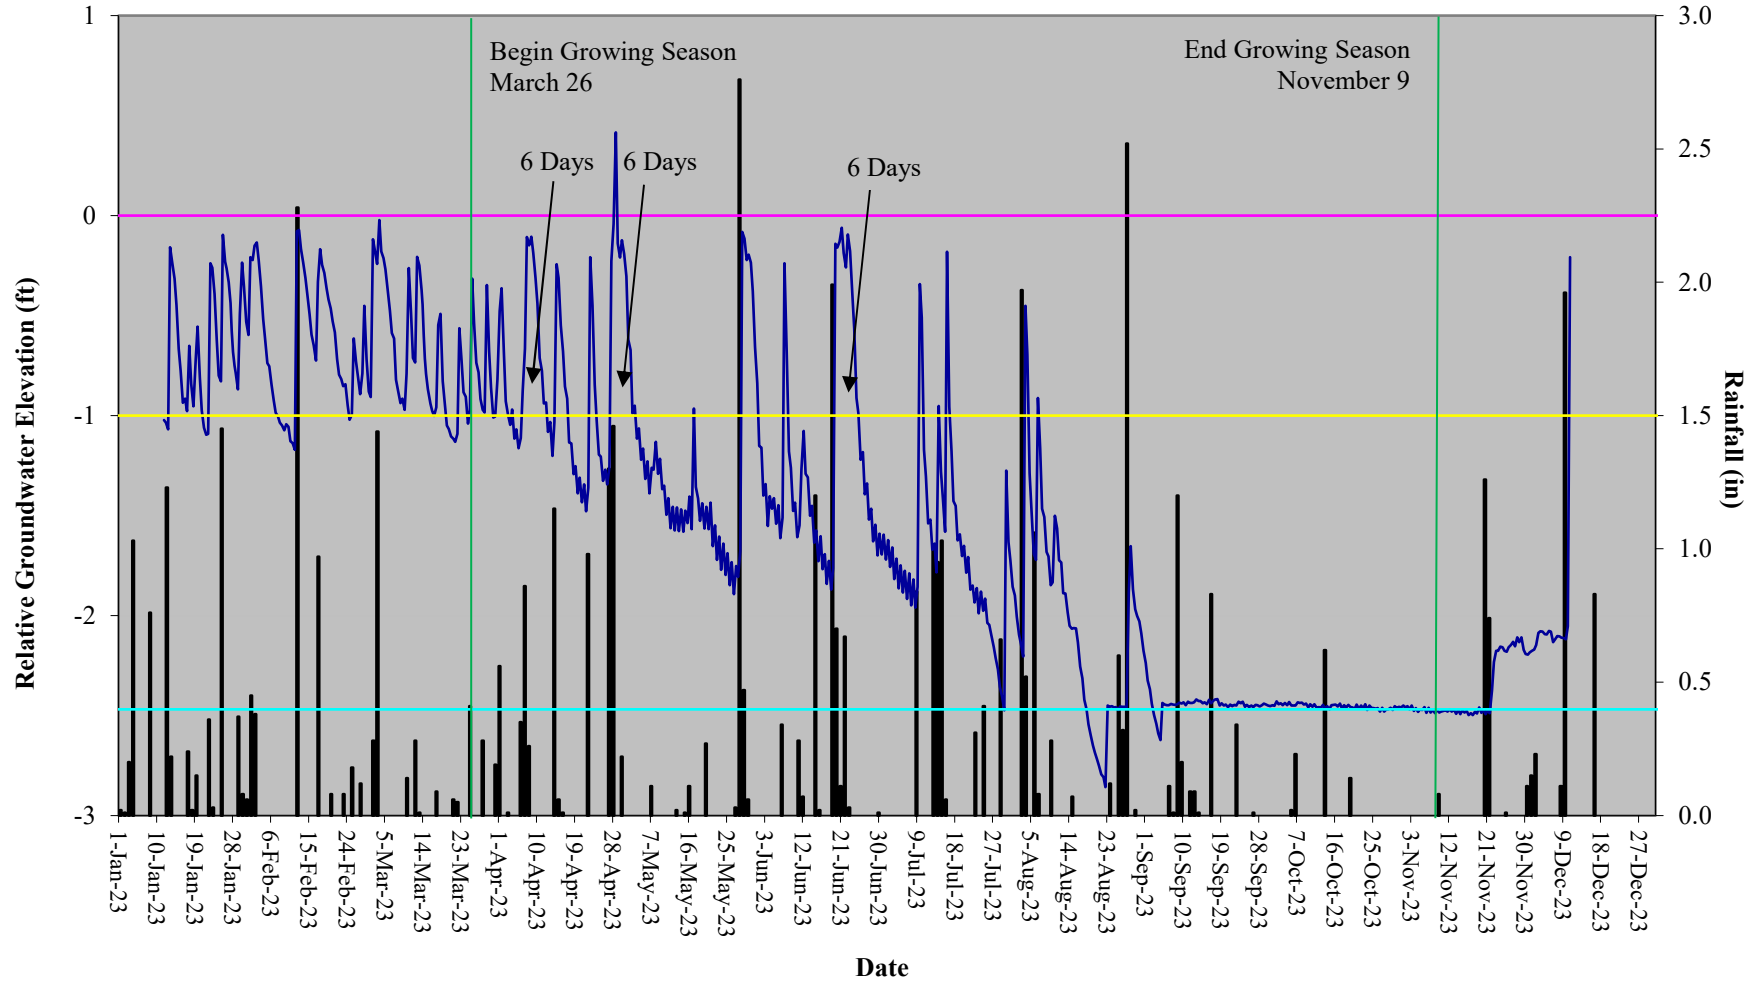
Mill Dam Creek Restoration Site Hydrograph Wetland Gauge 1, T7

Max Consecutive Days During Growing Season (Percentage)						
		MY-01 2020	MY-02 2021	MY-03 2022	MY-04 2023	MY-05 2024	MY-06 2025	MY-07 2026
Gauge #	Location	Normal Rainfall	Normal Rainfall	Below Average Rainfall	Normal Rainfall			
Gauge 1	T7	45 (19.7%)	57 (24.8%)	5 (2.2%)	6 (2.6%)			
Gauge 2	T8	Gauge malfunction	37 (15.6%)	9 (3.6%)	6 (2.6%)
