FINAL
ANNUAL MONITORING REPORT
YEAR 1 (2012)
MILL CREEK STREAM/WETLAND RESTORATION SITE
RANDOLPH COUNTY, NORTH CAROLINA
(EEP Project No. 253, Contract No. 004803)
Construction Completed March 2011

FINAL
ANNUAL MONITORING REPORT
YEAR 1 (2012)
MILL CREEK STREAM/WETLAND/BUFFER RESTORATION SITE
RANDOLPH COUNTY, NORTH CAROLINA
(EEP Project No. 253, Contract No. 004803)
Construction Completed March 2011

Prepared by:
Axiom Environmental, Inc.
218 Snow Avenue
Raleigh, North Carolina 27603

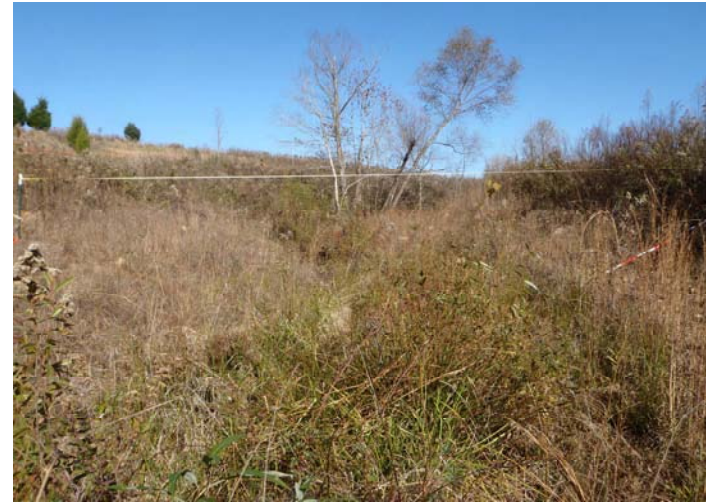
Station	Elevation
0.0	91.9
1.7	91.2
4.7	90.3
7.4	89.4
8.8	89.1
10.4	88.5
12.4	88.1
15.2	88.1
16.4	87.9
17.4	88.0
18.4	87.0
18.9	86.9
19.8	87.0
21.1	87.81
22.2	88.19
24.4	88.22
27.1	88.37
29.1	88.87
30.7	89.50
33.8	90.36
37.4	91.75

SUMMARY DATA	
Bankfull Elevation:	88.0
Bankfull Cross-Sectional Area:	2.7
Bankfull Width:	5.4
Flood Prone Area Elevation:	-
Flood Prone Width:	-
Max Depth at Bankfull:	1.1
Mean Depth at Bankfull:	0.5
W / D Ratio:	-
Entrenchment Ratio:	-
Bank Height Ratio:	1.0

Stream Type	B/C
--------------------	-----
