**FINAL**  
**ANNUAL MONITORING REPORT**  
**YEAR 2 (2013)**  
**MILL CREEK STREAM/WETLAND RESTORATION SITE**  
**RANDOLPH COUNTY, NORTH CAROLINA**  
**(EEP Project No. 253, Contract No. 004803)**  
**Construction Completed March 2011**

The Mill Creek Stream and Wetland Restoration Site (hereafter referred to as the “Site”) is situated within US Geological Survey (USGS) hydrologic unit 03040103 of the Yadkin River Basin and NC Division of Water Quality (NCDWQ) Priority Sub-basin 03-07-09. The Site is located in Randolph County, approximately 11 miles southwest of the City of Asheboro, North Carolina. The Site is encompassed within a 129.2-acre easement located in a 288-acre tract owned by Amy Grissom. Historically, the downstream portion of the Site (west of Lassiter Mill Rd – SR 1107) was used for agriculture and livestock production. Livestock were removed and part of the land become fallow while the remainder is used for hay production or has been recently planted and burned by the North Carolina Wildlife Resources Commission (NCWRC) as part of an ecosystem restoration initiative for the entire property. Prior livestock activity had compromised the riparian buffer along many of

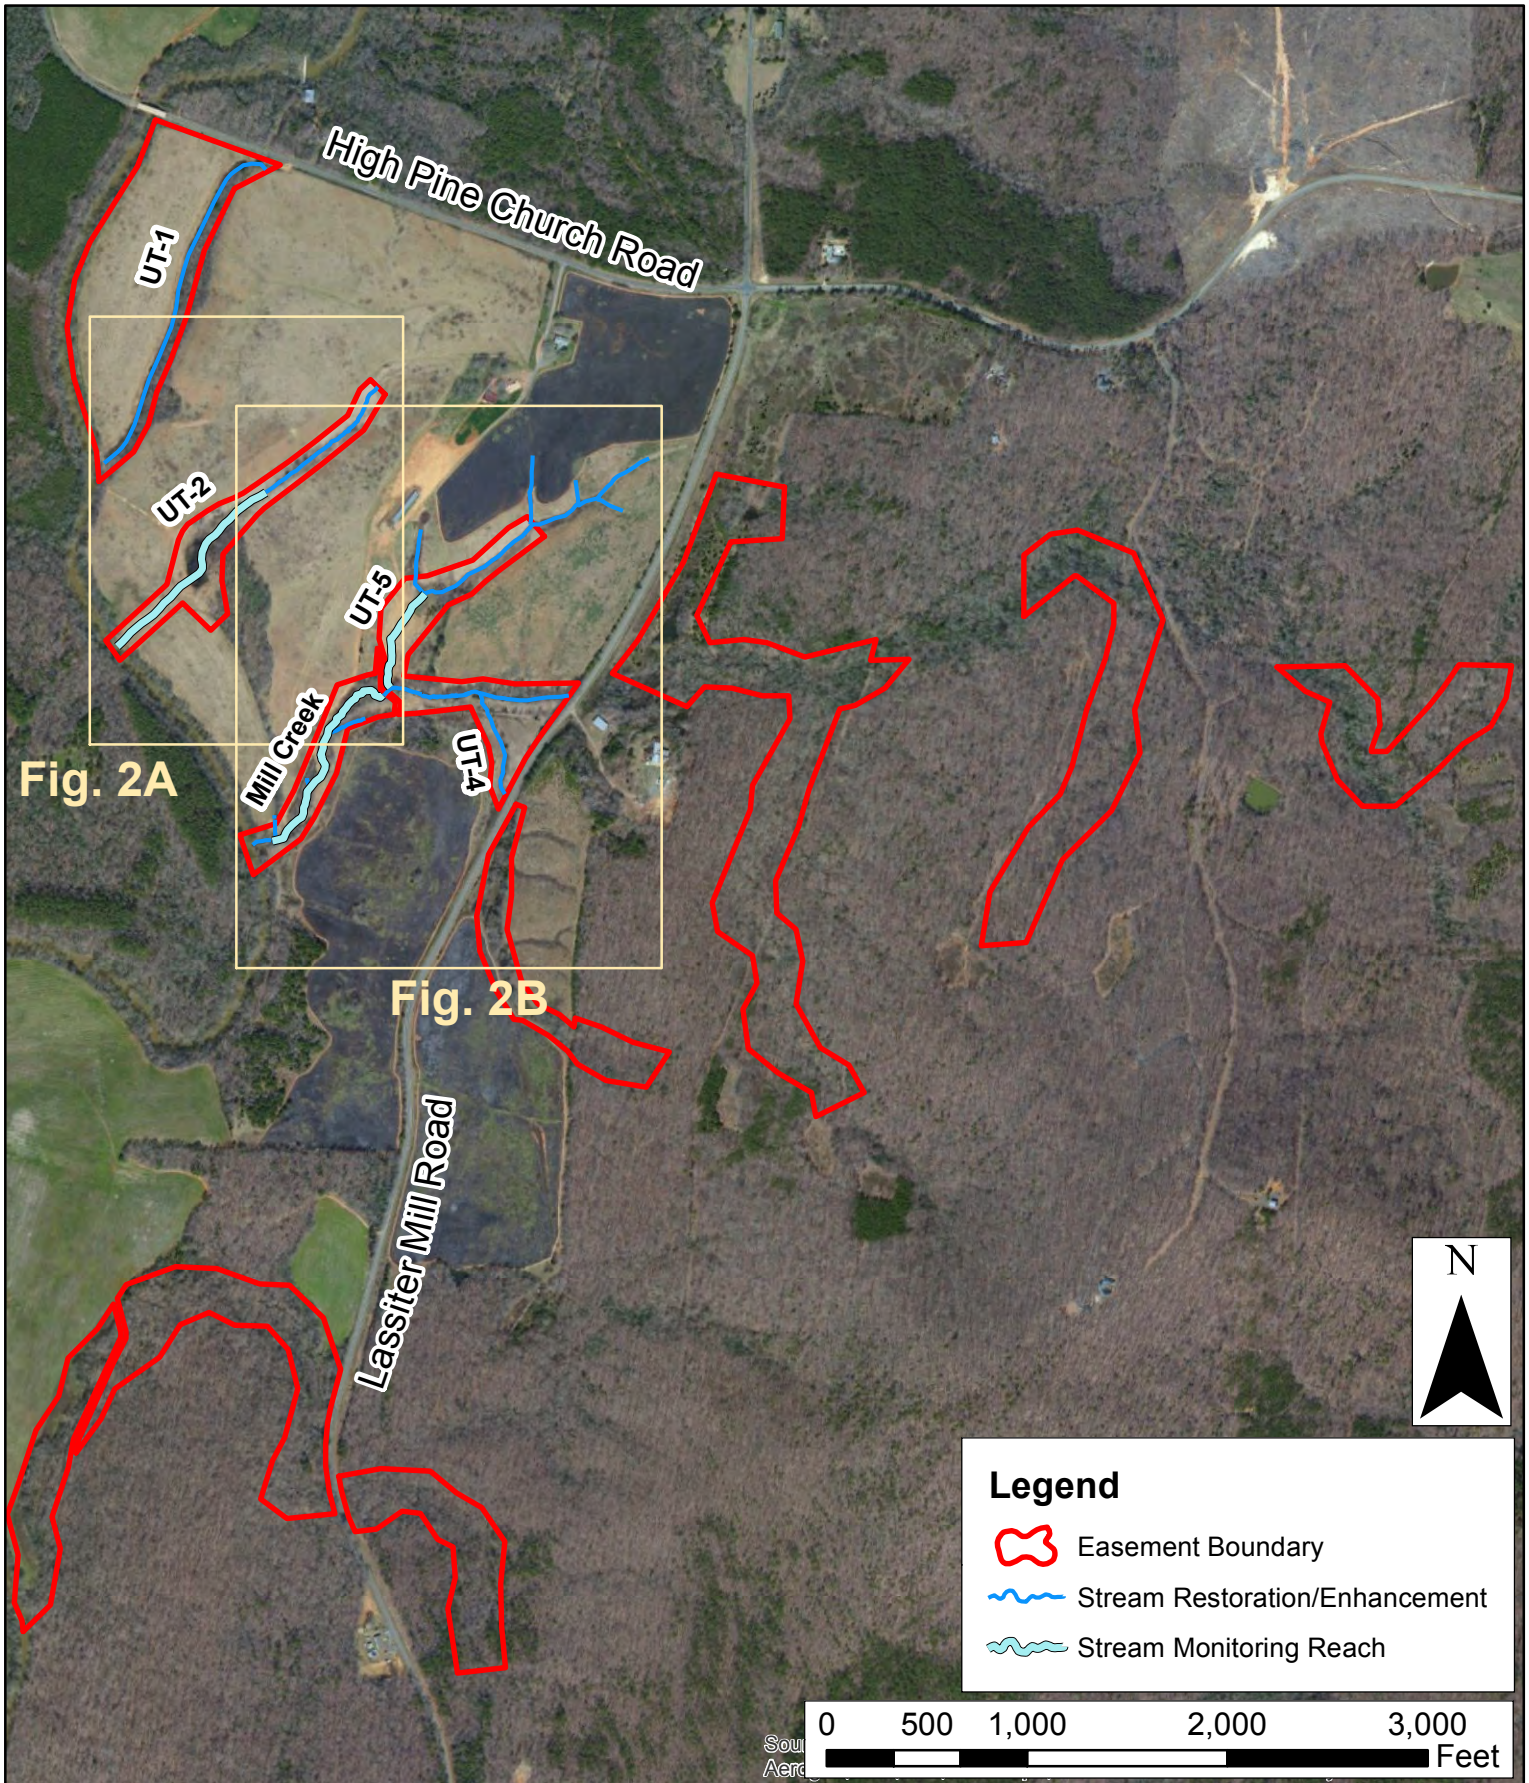
FIGURE  
2

Figures 2 and 2A-2B. Monitoring Plan View

Eight permanent cross-sections, six riffle and two pool, were established and will be used to evaluate stream dimension; locations are depicted on Figures 2A-2B (Appendix B). Cross-sections are permanently monumented with 5-foot metal t-posts at each end point. Cross-sections were surveyed to provide a detailed measurement of the stream and banks including points on the adjacent floodplain, top of bank, bankfull, breaks in slope, edge of water, and thalweg. Data were used to calculate width-depth ratios, entrenchment ratios, and bank height ratios for each cross-section. In addition, pebble counts were completed at cross-sections 3 and 6, and photographs will be taken at each permanent cross-section annually.

Three stream monitoring reaches were established and will be used to evaluate stream pattern and longitudinal profile; locations are depicted on Figures 2A-2B (Appendix B). Measurements of channel pattern will include belt-width, meander length, and radius of curvature (only in year one). Subsequently, data will be used to calculate meander-width ratios. Longitudinal profile measurements will include average water surface slopes, facet slopes, and pool-to-pool spacing. Thirteen permanent photo points were established throughout the restoration reach; locations are depicted on Figures 2A-2B (Appendix B). In addition, visual stream morphology stability assessments will be completed in each of the three monitoring reaches annually to assess the channel bed, banks, and in-stream structures.

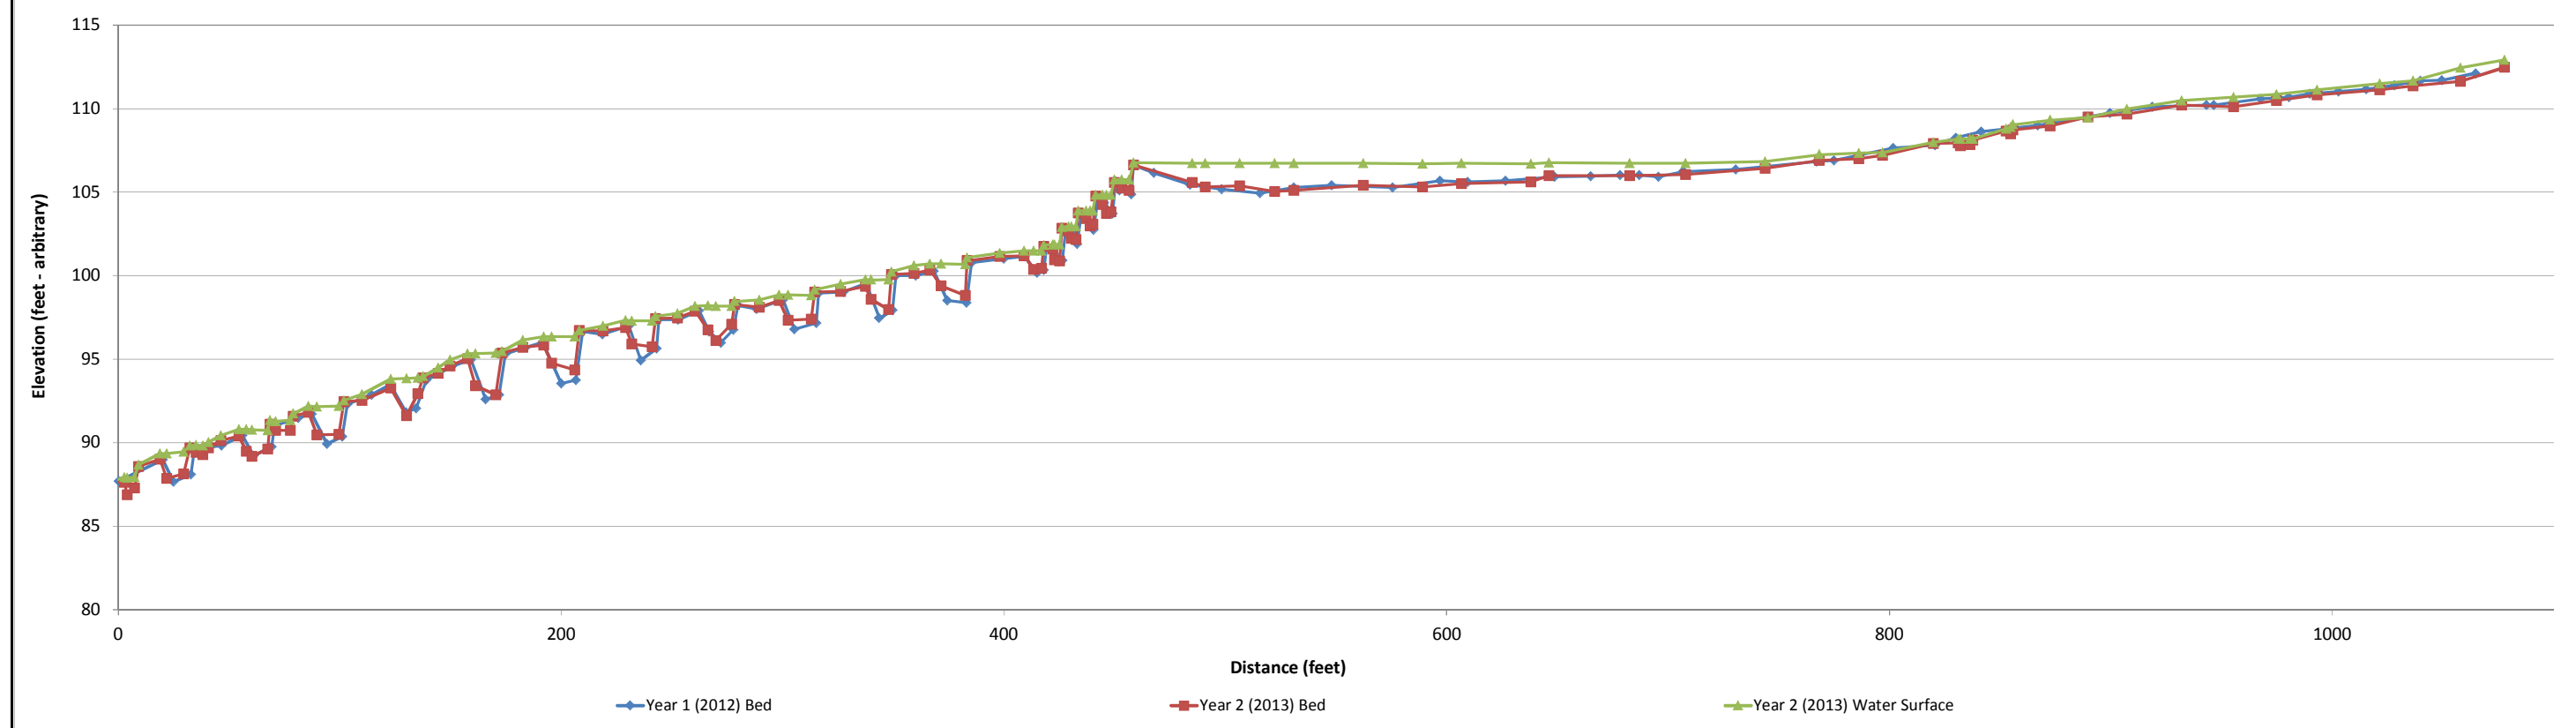
Mill Creek Year 2 (2013) Profile - UT 2 00+00 to 11+00

Project Name	Mill Creek - Profile
Reach	UT 2 Station 00+00 - 11+00
Feature	Profile
Date	6/11/13
Crew	Perkinson, Jernigan

2012	2013	2014	2015	2016
Avg. Water Surface Slope	**	0.0249			
Riffle Length	20	15			
Avg. Riffle Slope	**	0.0325			
Pool Length	15	11			
Pool to Pool Spacing	34	23

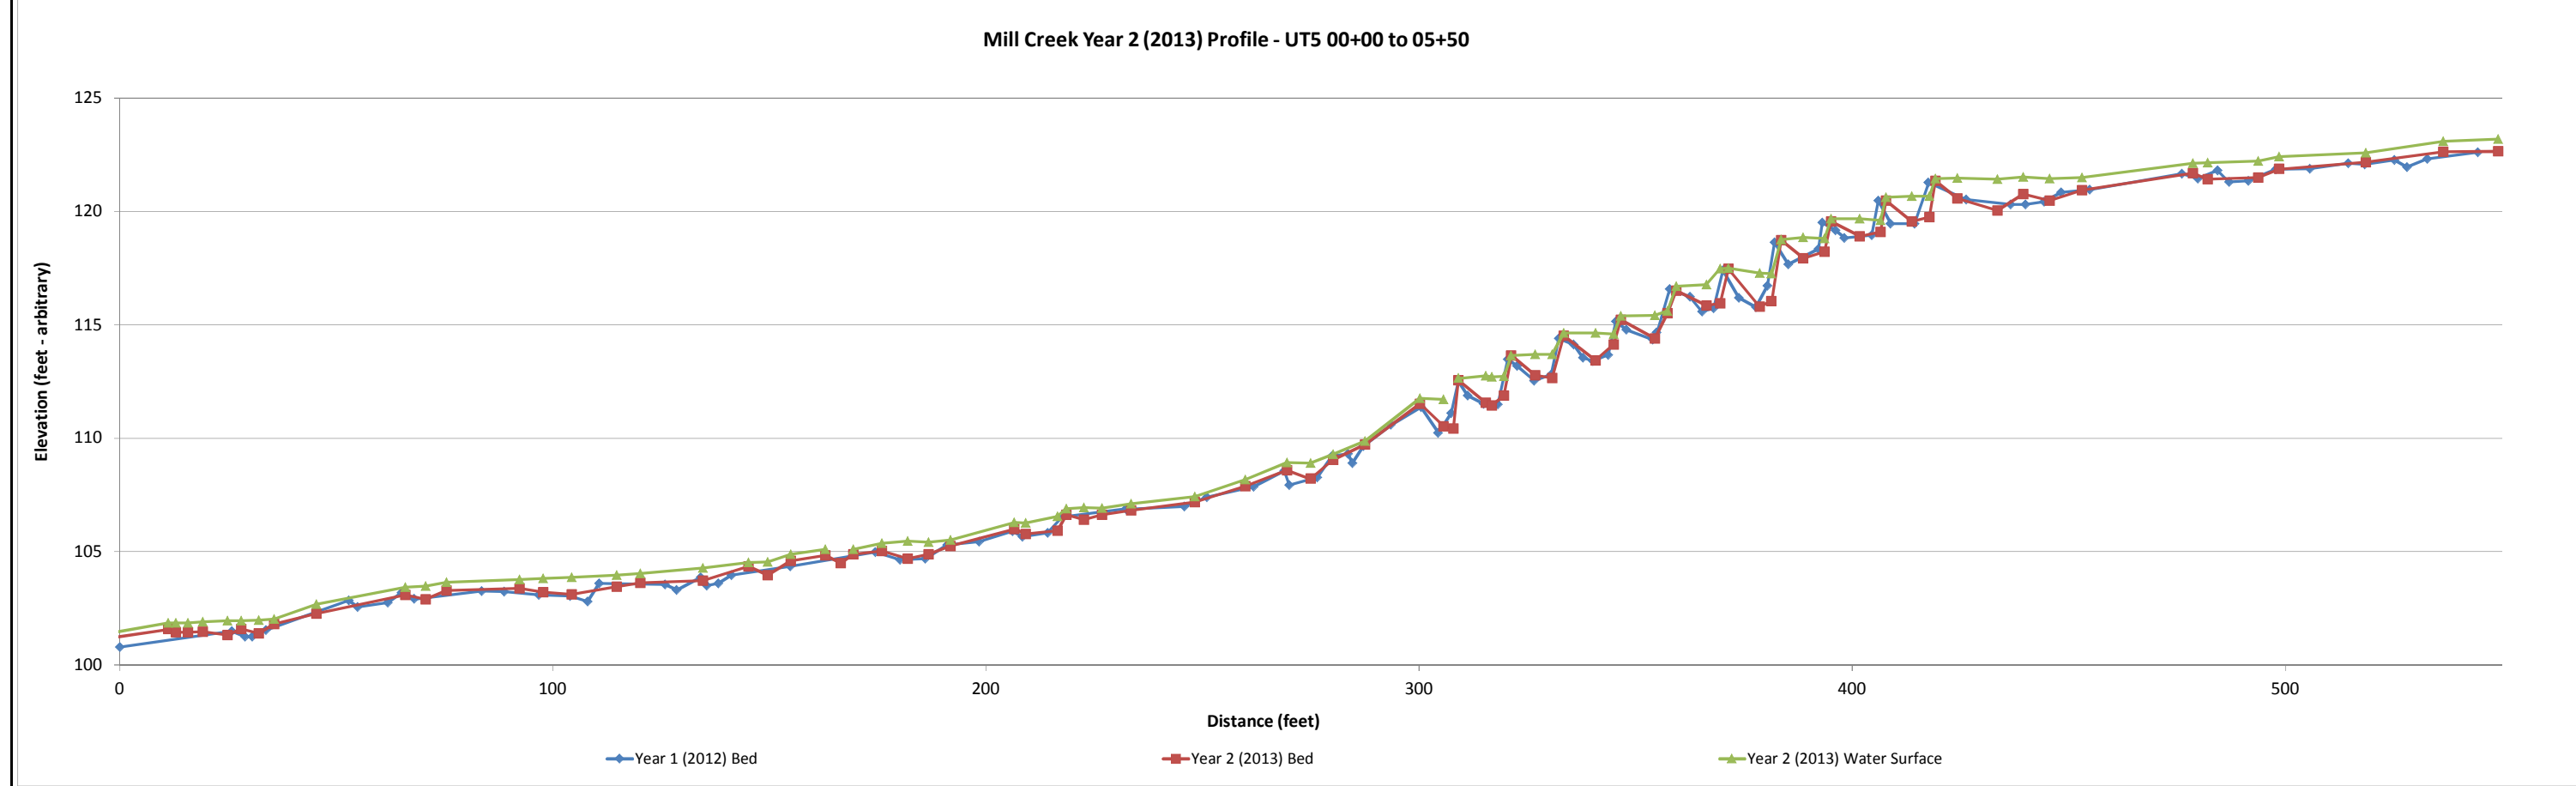
Project Name	Mill Creek - Profile
Reach	UT 5 Station 00+00 - 05+50
Feature	Profile
Date	6/11/13
Crew	Perkinson, Jernigan

Avg. Water Surface Slope	2012	2013	2014	2015	2016
Riffle Length	0.0201	0.0419			
Avg. Riffle Slope	30	23			
Pool Length	0.0235	0.0401			
Pool to Pool Spacing	21	13			
	44	21
