**Moccasin Creek Buffer & Wetland
Restoration, Enhancement &
Preservation
Wake and Franklin Counties
North Carolina**

Mitigation Report

May 26, 2006

Ward Consulting Engineers, P.C.
Project Manager: Becky Ward, P.E.
1512 Eglantyne Court
Raleigh, NC 27613
Ph: 919-870-0526
Fax: 919-870-5359

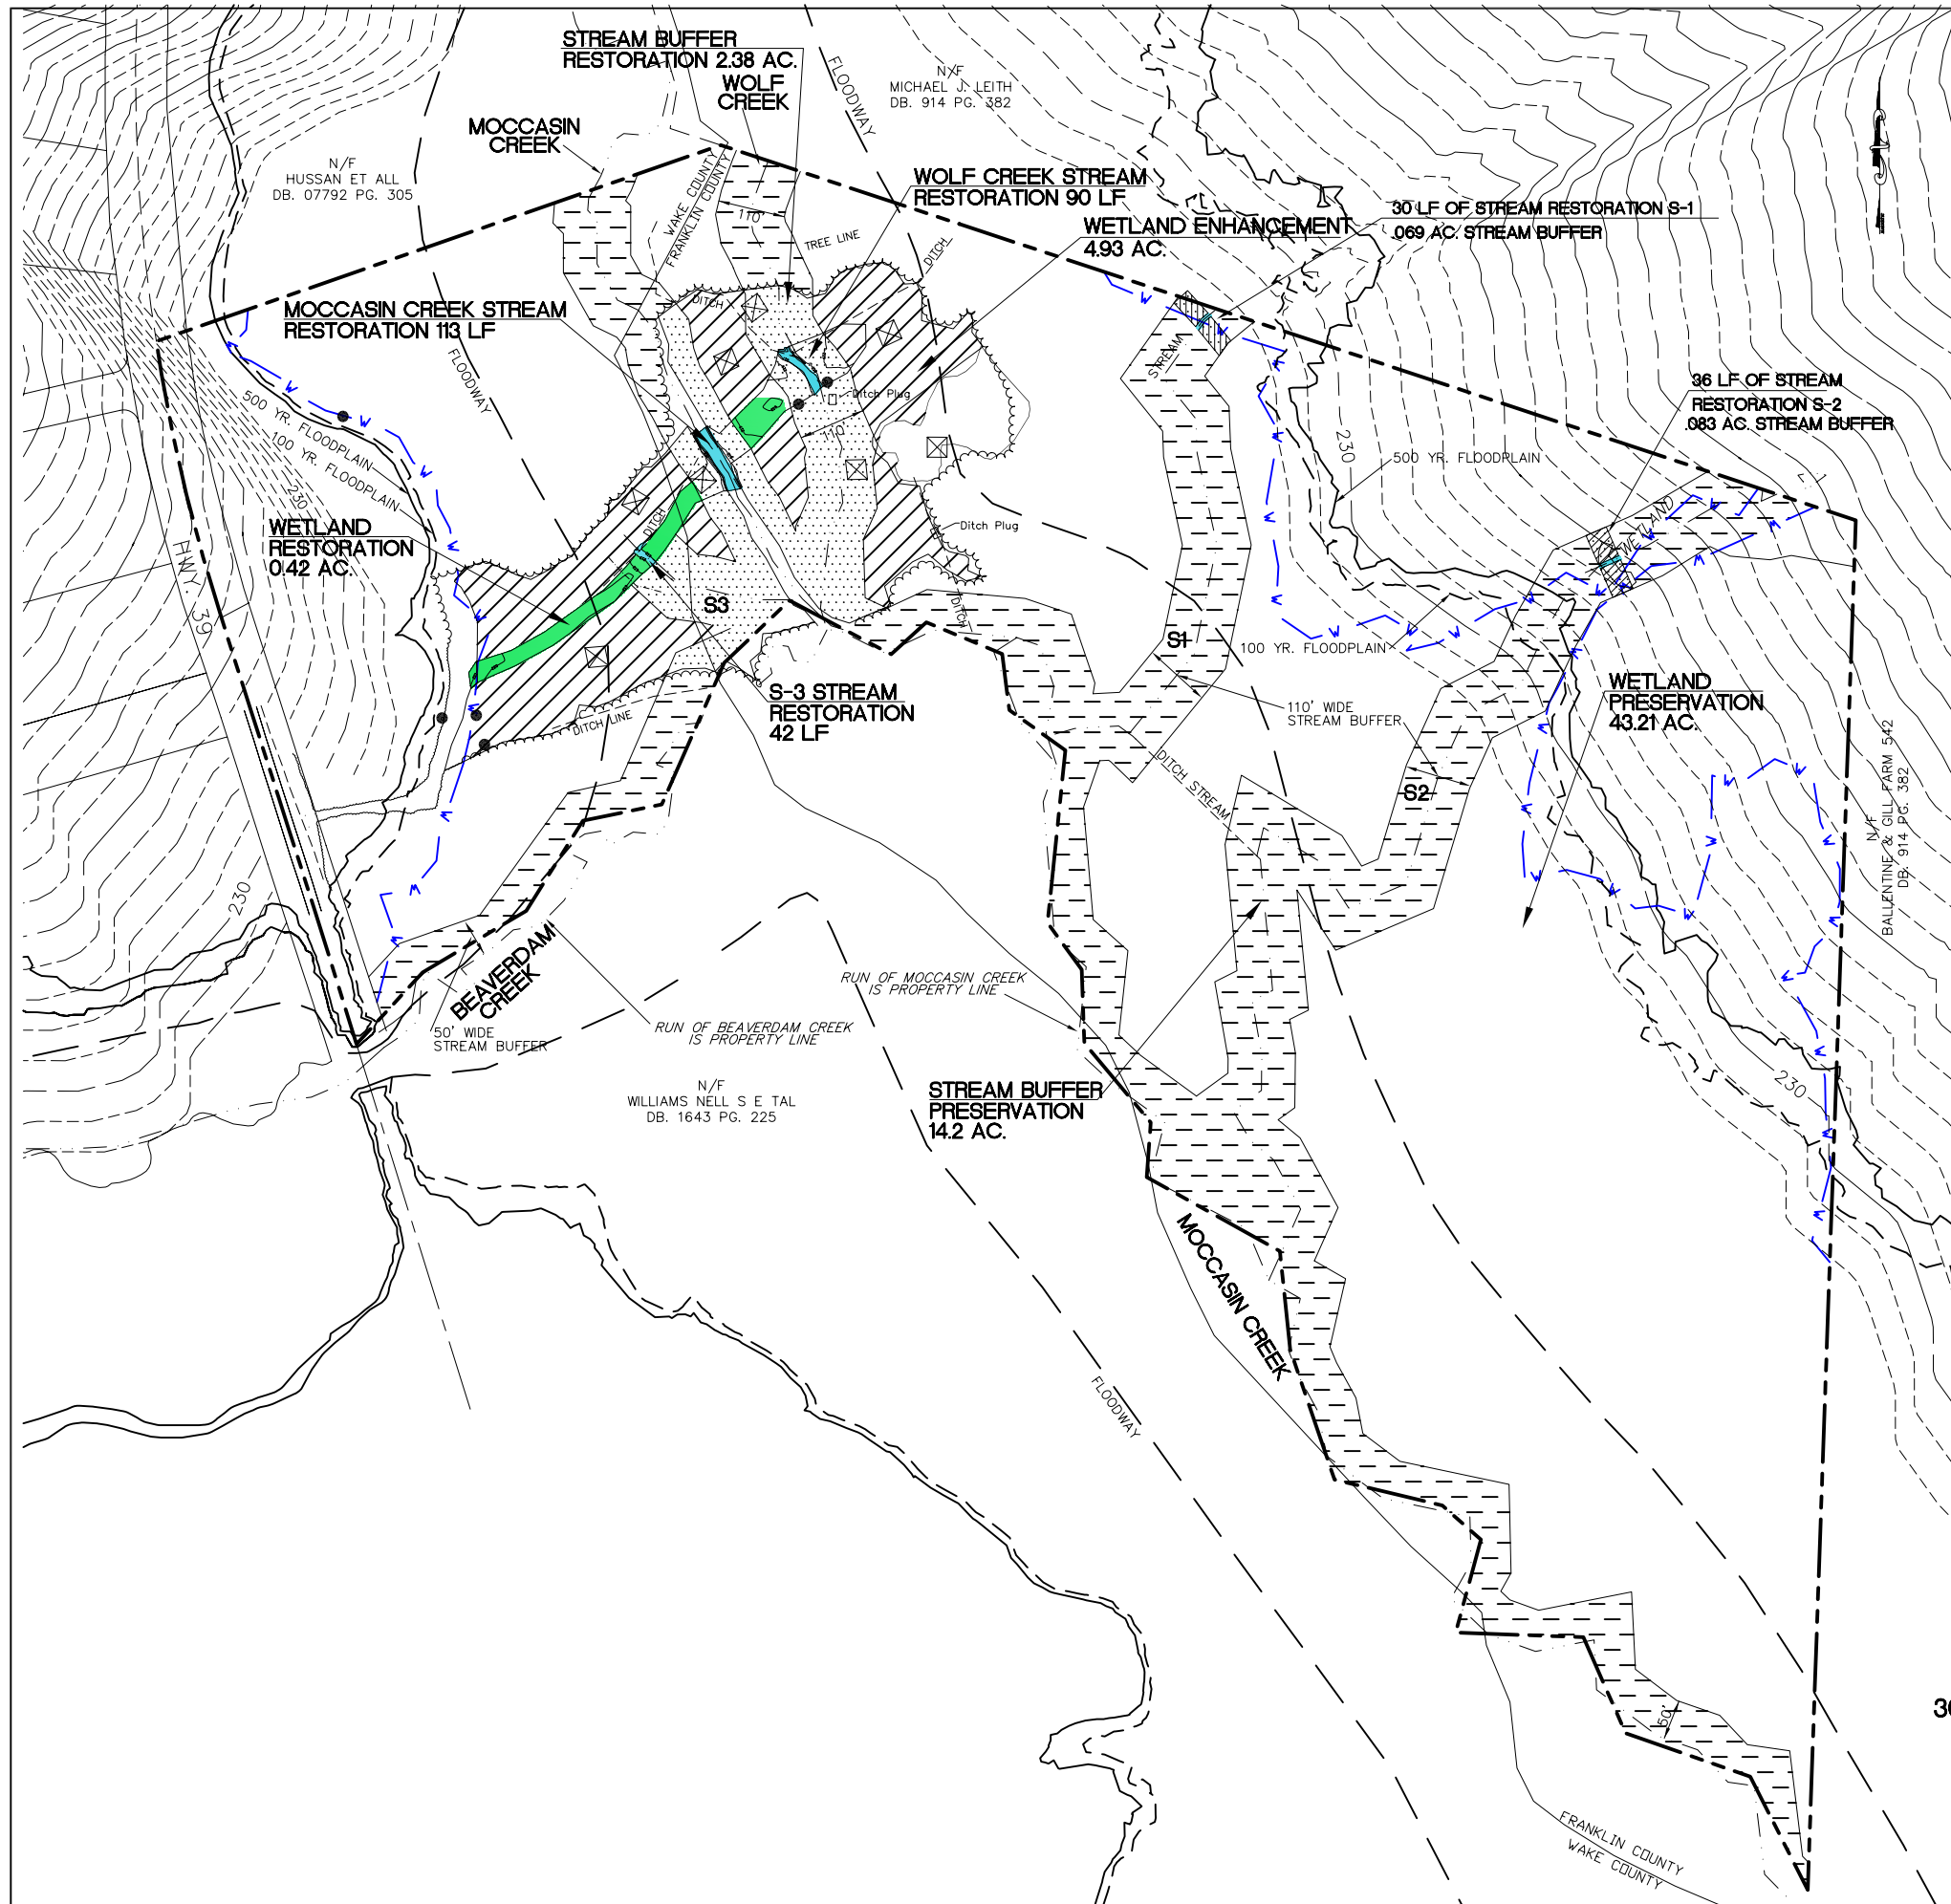
Figure 2: Mitigation Plan

Ecosystem type:
 Successional Bottomland
 Hardwood Forest. Moccasin Creek
 is a Riverine System Surrounded
 by a Palustrine Wetland System.

The mitigation goals and objectives of this project are to ensure that functioning wetlands, natural channel configurations in the five stream sections, and buffers along the streams have been established by the restoration efforts. Success will be determined once the vegetation success criteria have been met within the restoration and enhancement area. The Mitigation Plan, Figure 2, is located in the Figures section of this report.
