# FINAL MITIGATION PLAN

**Mockingbird Site  
Davie County, North Carolina**

**Yadkin River Basin  
HUC 03040101**

**DMS Project #: 100021  
Contract #: 7185  
USACE Action ID #: SAW-2017-01505  
DWR Project #: 20171040  
RFP #: 16-006993**

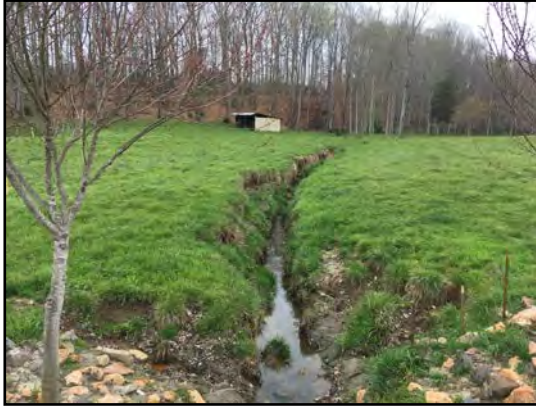
Reach JS1 looking upstream from driveway  
04/03/2018

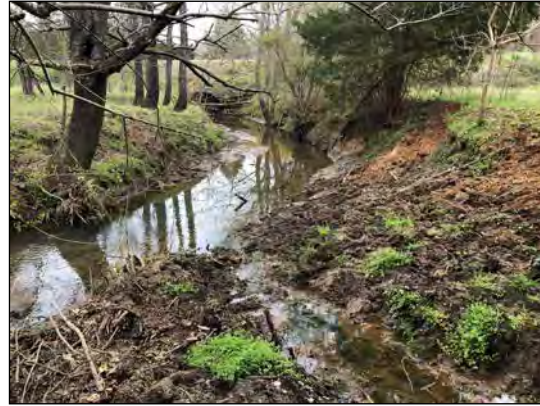
Looking downstream at confluence of HC1 and  
NM4, towards culvert under Spillman Rd.  
04/03/2018

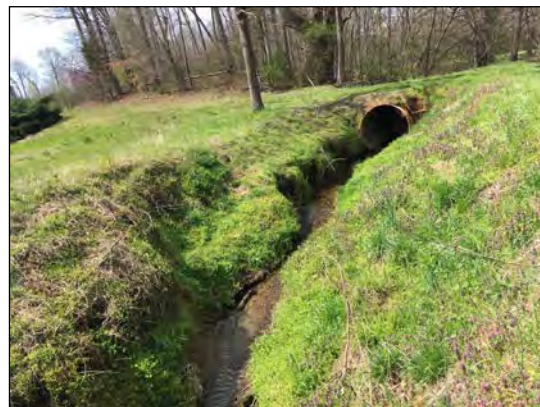
Culvert on Reach NM2  
04/03/2018

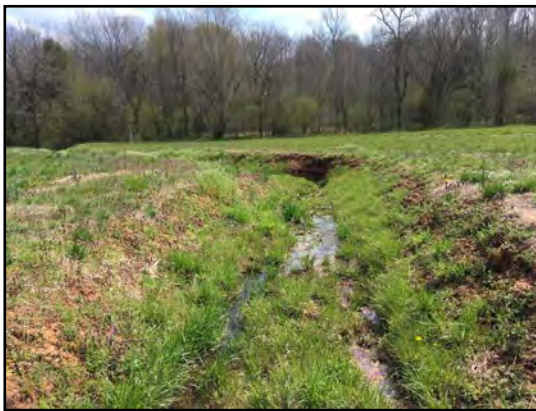
Looking downstream from culvert on NM3  
04/03/2018

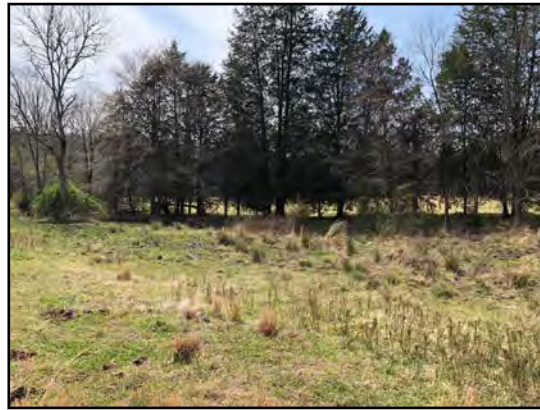
Reach TP3 origin/Wetland A  
04/03/2018

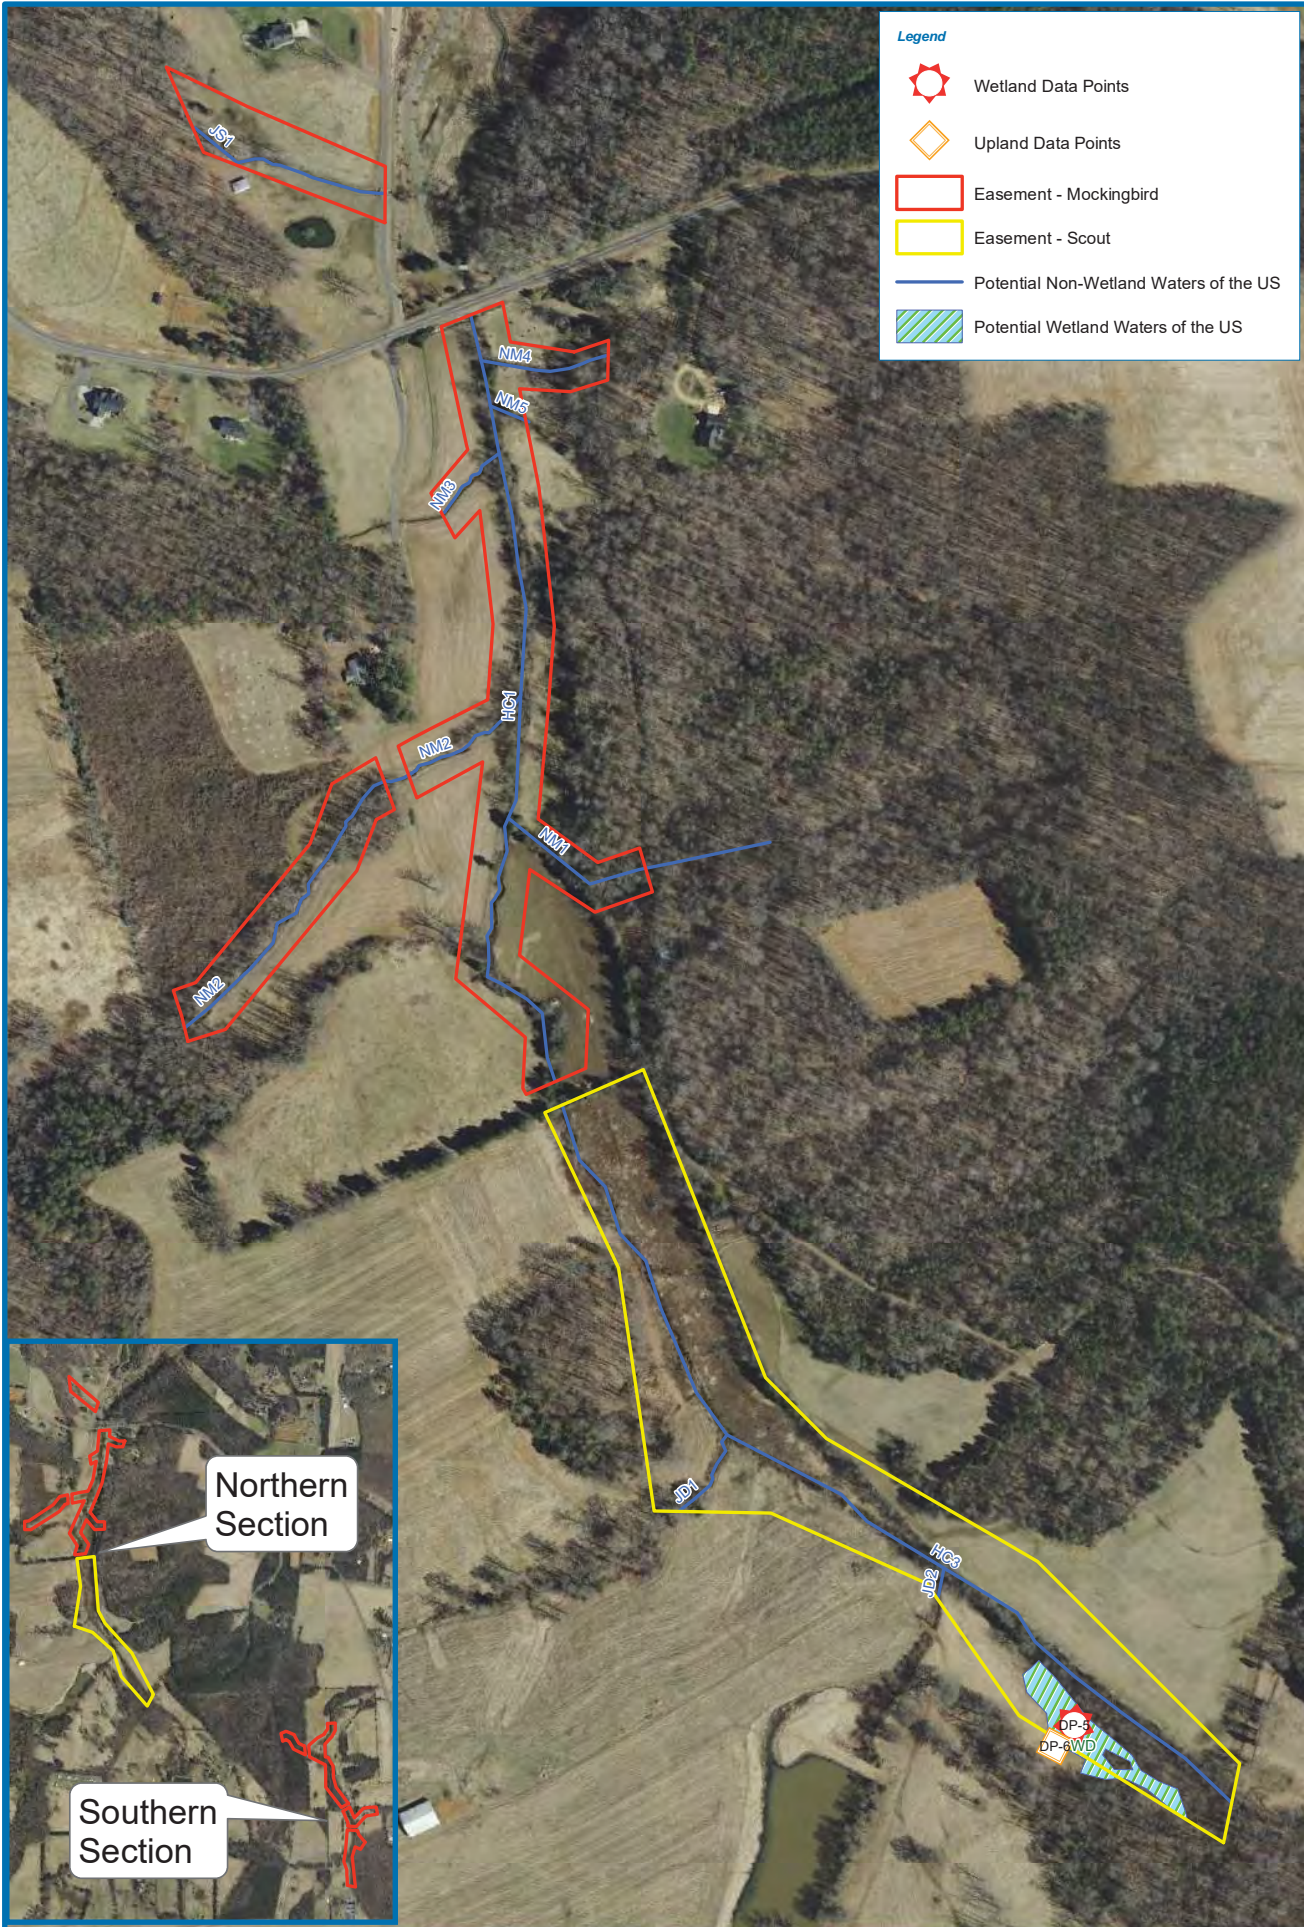
Potential Wetland or Non-Wetland Waters of the U.S. Map - Northern Section

Potential Wetland Waters of the US
