Morgan Creek Stream Restoration Site

Year 3 Final Monitoring Report

Project ID Number: 16-D06027

EEP Project # 92527

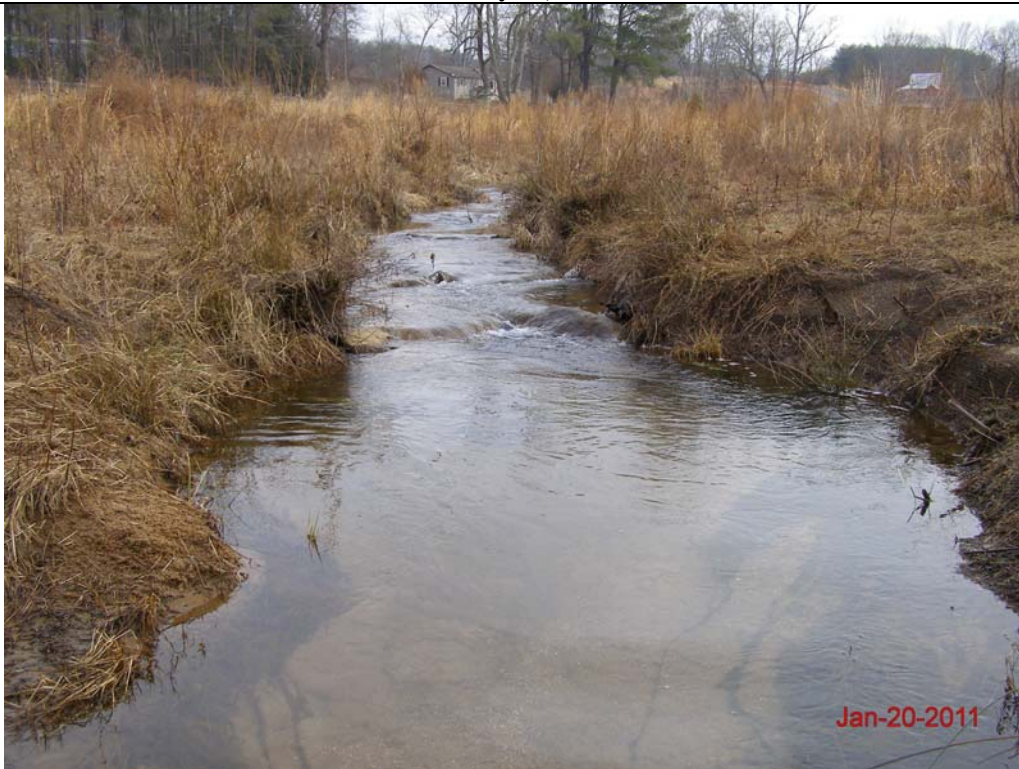
**Permanent Photo Point 29 – Morgan Creek
Looking Upstream
January 20, 2011**

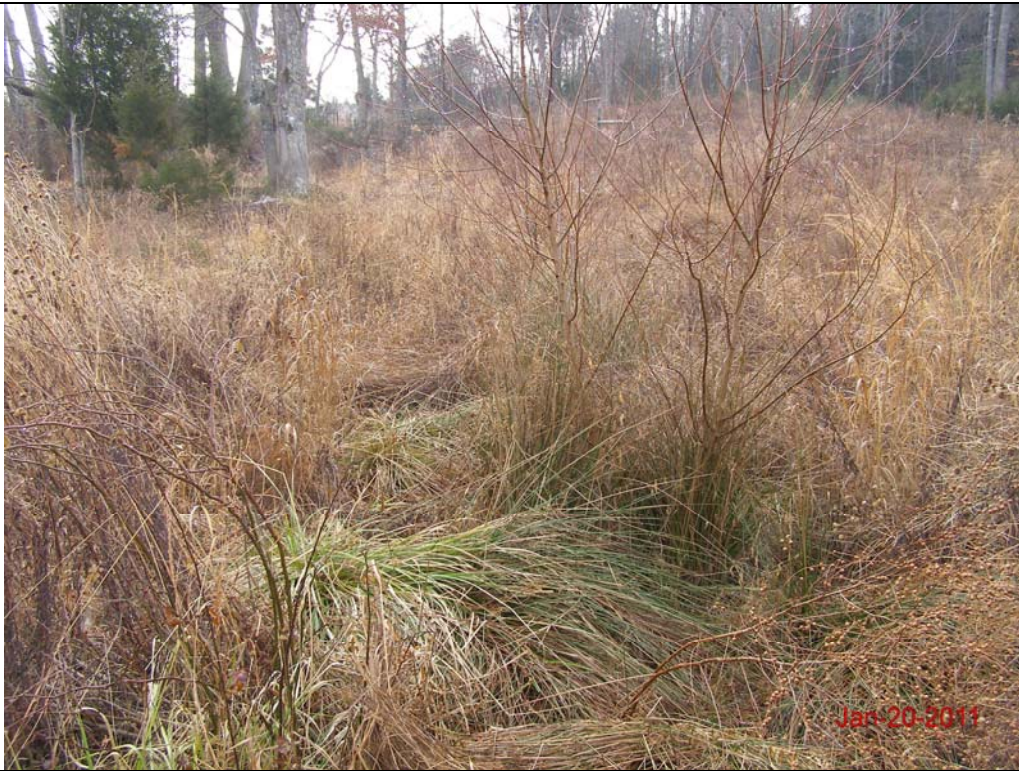
**Permanent Photo Point 30 – Morgan Creek
Looking Upstream
January 20, 2011**

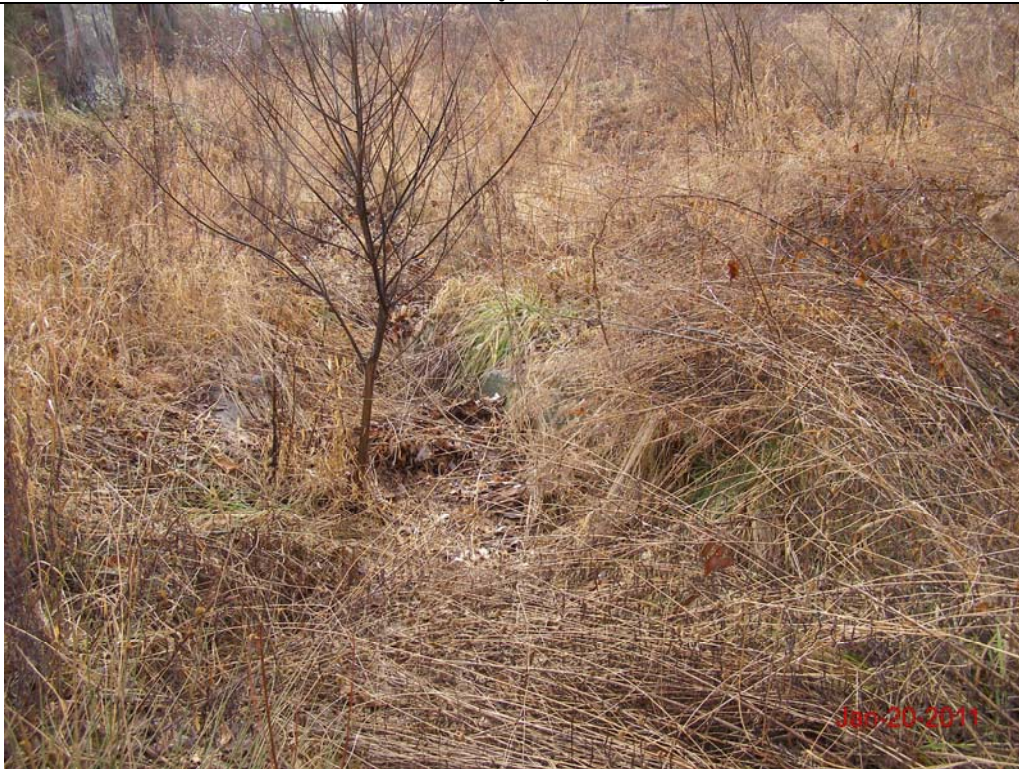
**Permanent Photo Point 30 – Unnamed Tributary 5
Looking Upstream
January 20, 2011**

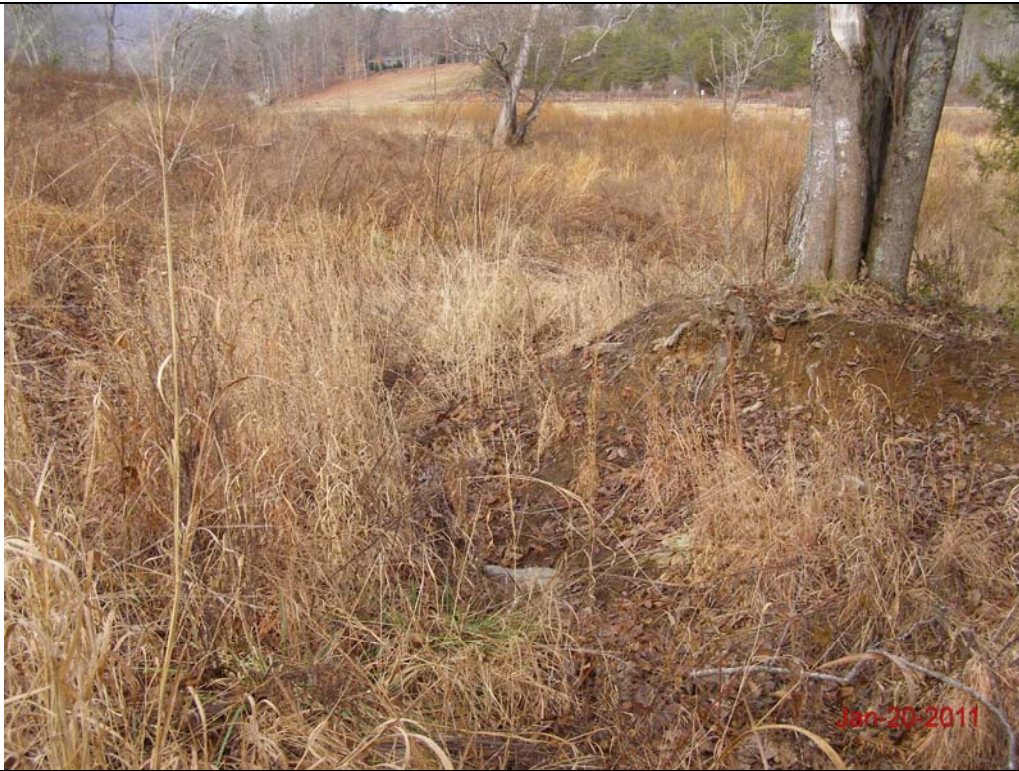
**Permanent Photo Point 31 – Unnamed Tributary 5
Looking Upstream
January 20, 2011**

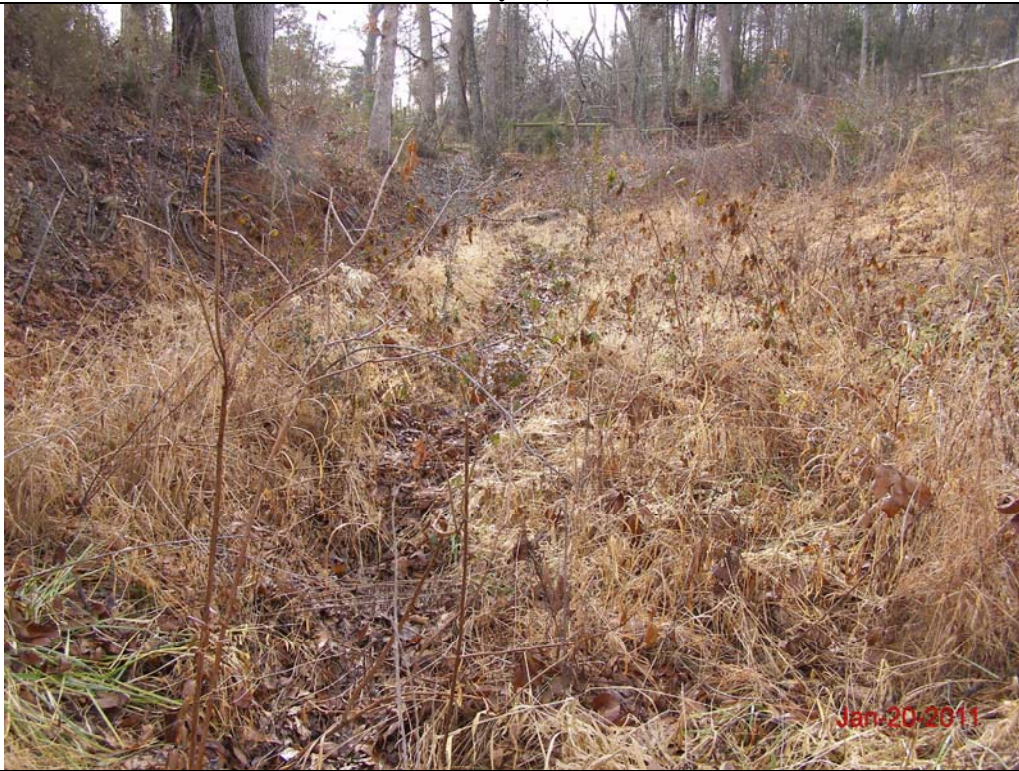
**Permanent Photo Point 32 – Unnamed Tributary 5
Looking Downstream
January 20, 2011**

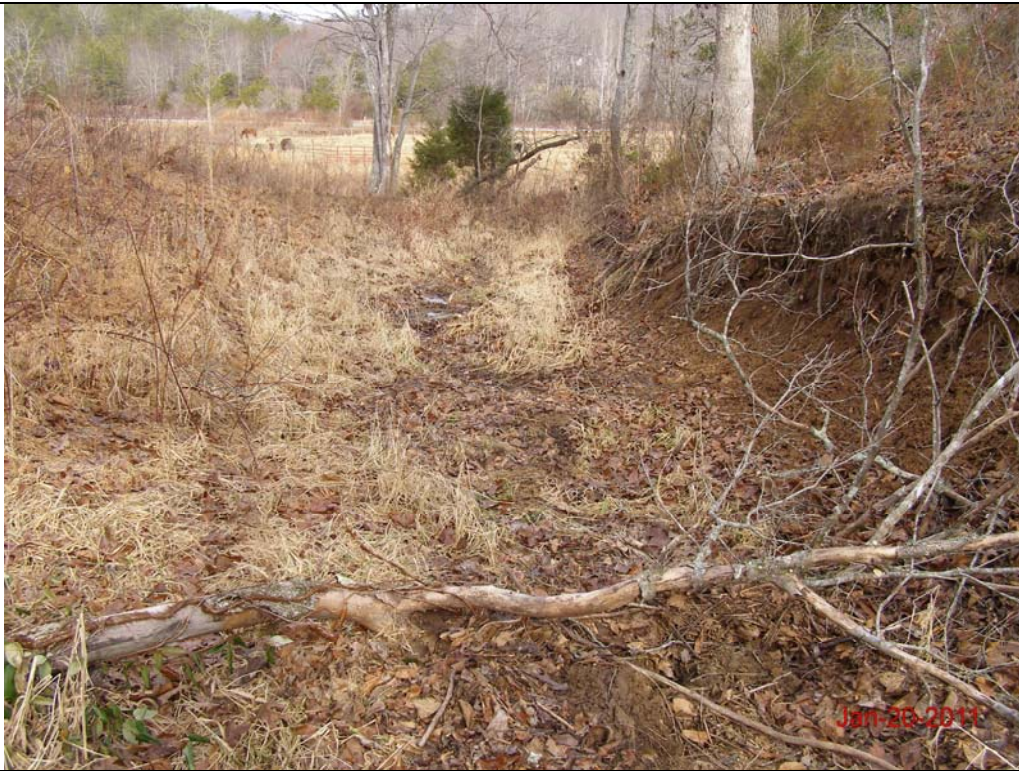
**Permanent Photo Point 32 – Unnamed Tributary 5
Looking Upstream
January 20, 2011**

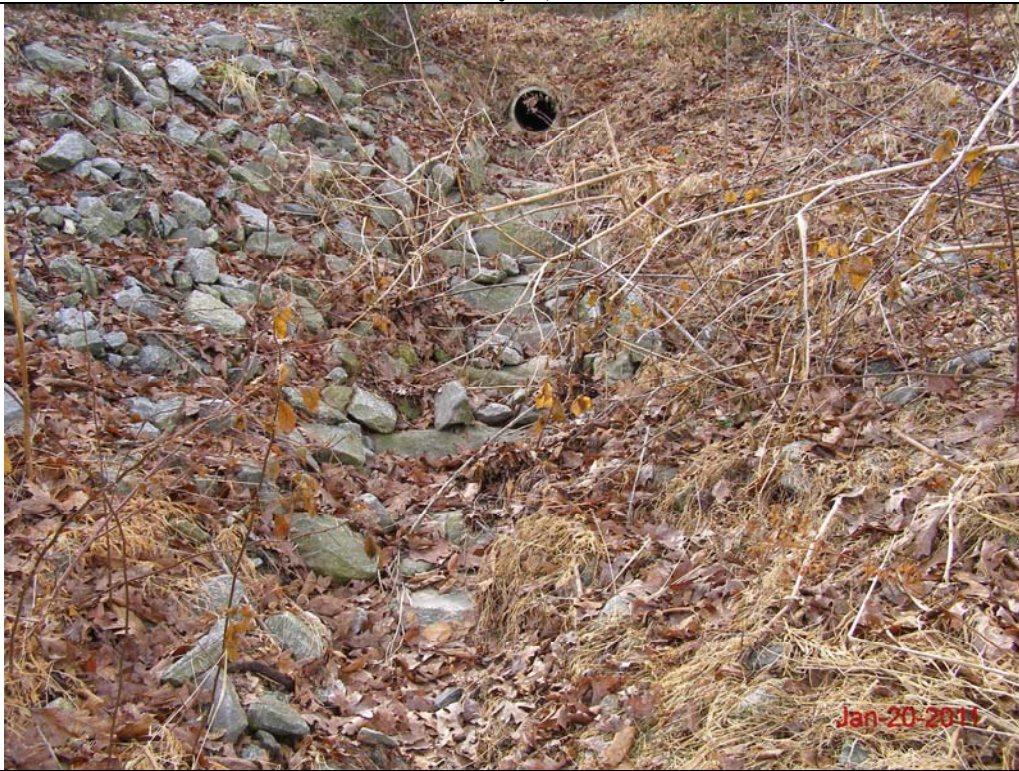
**Permanent Photo Point 33 – Unnamed Tributary 5
Looking Downstream
January 20, 2011**

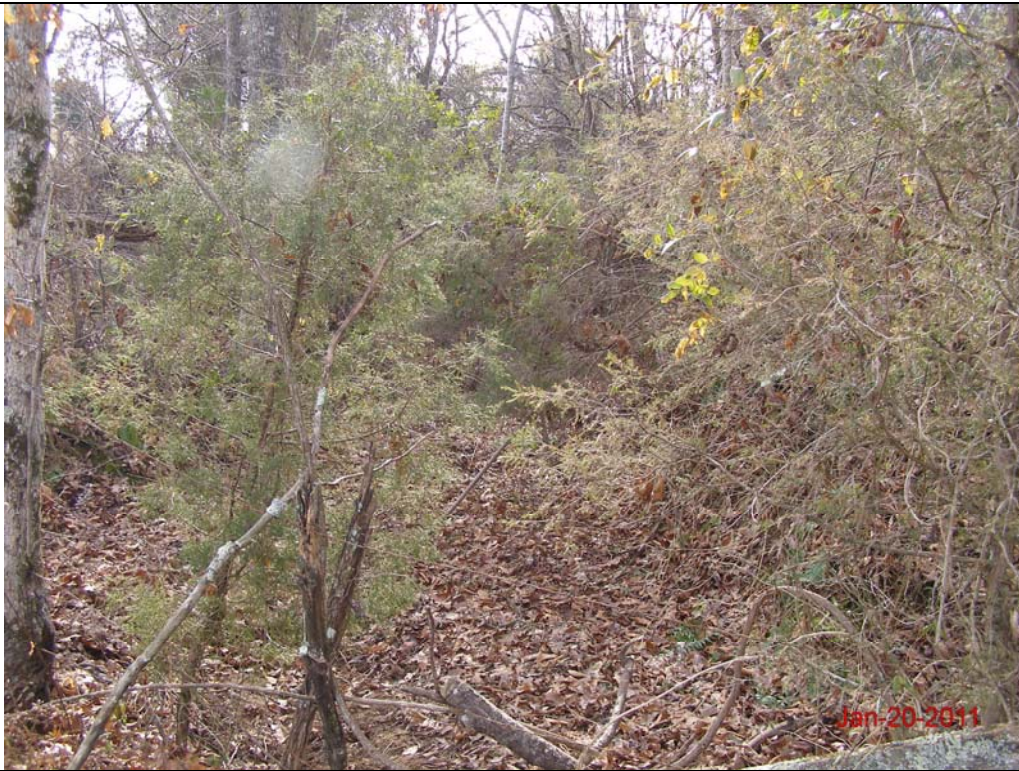
**Permanent Photo Point 33 – Unnamed Tributary 5
Looking Upstream
January 20, 2011**

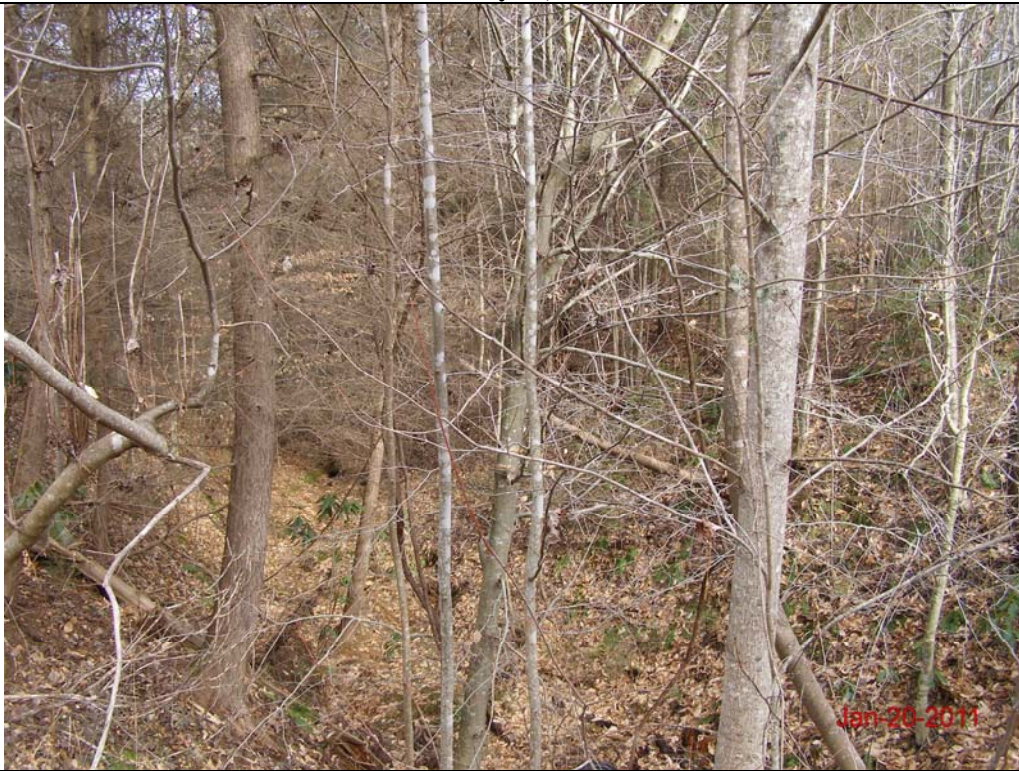
**Permanent Photo Point 34 – Unnamed Tributary 5
Looking Upstream
January 20, 2011**

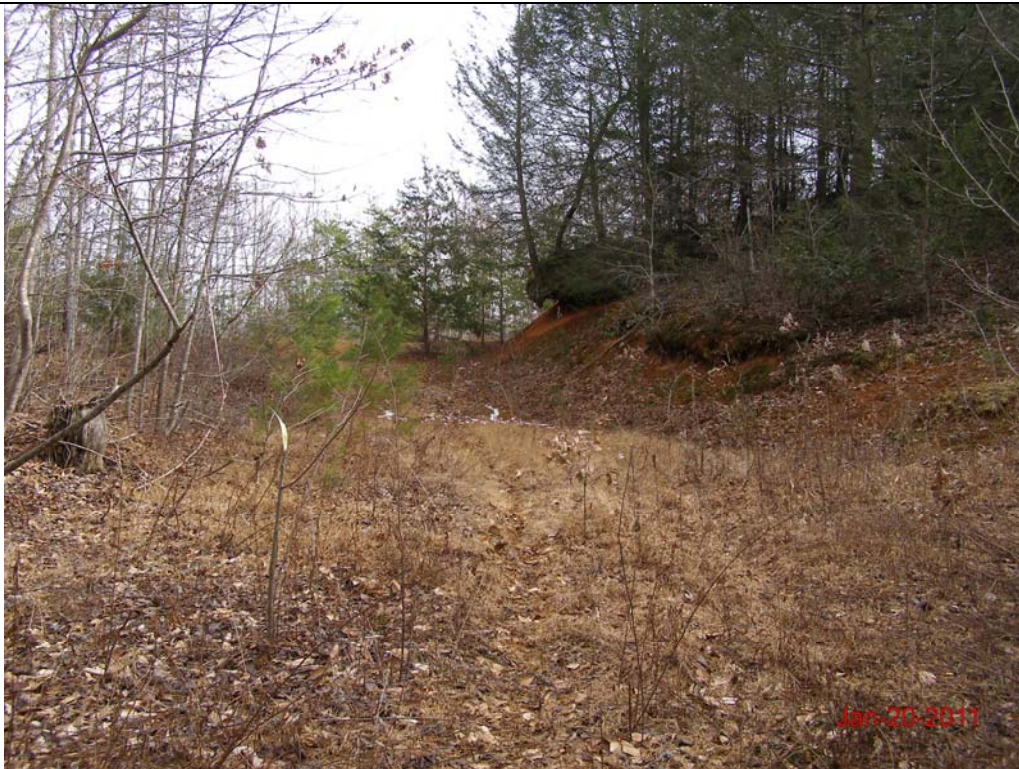
**Permanent Photo Point 35 – Unnamed Tributary 5
Looking Downstream
January 20, 2011**

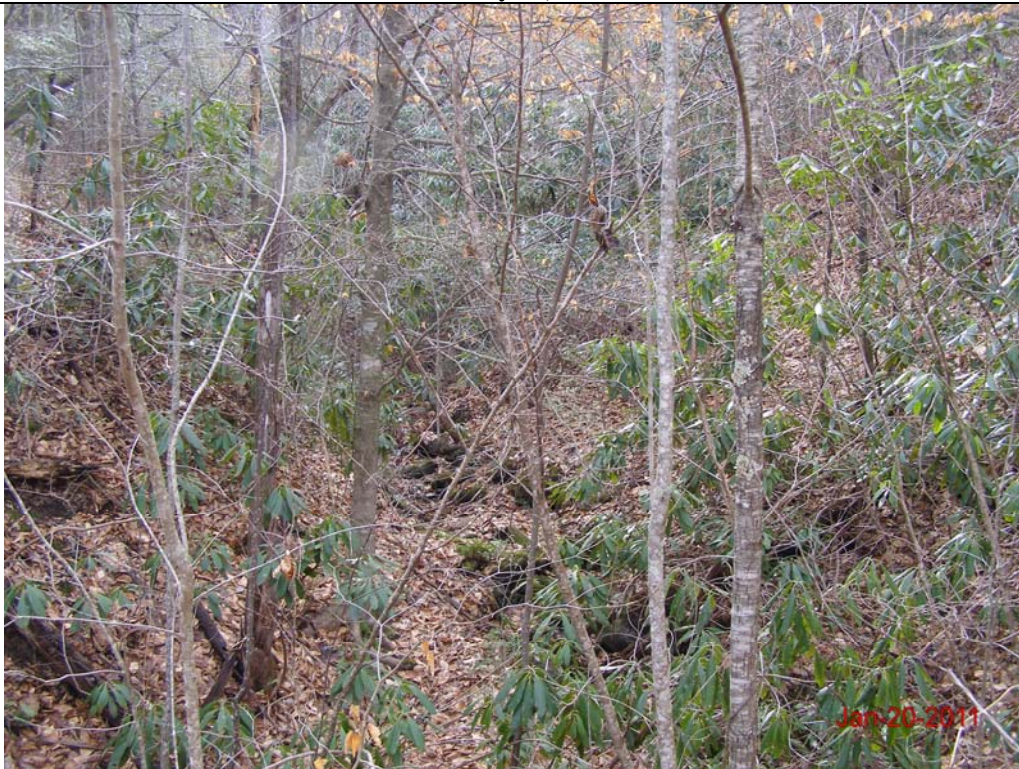
**Permanent Photo Point 35 – Unnamed Tributary 5
Looking 115 Degrees
January 20, 2011**

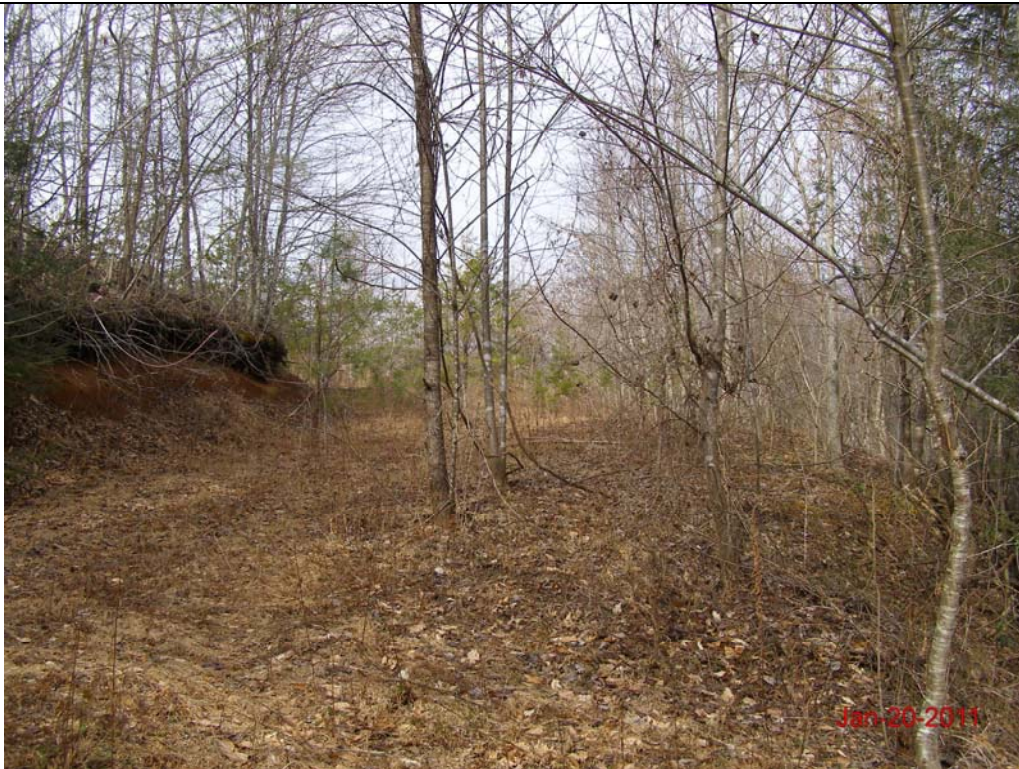
**Permanent Photo Point 35 – Unnamed Tributary 5
Looking Upstream
January 20, 2011**

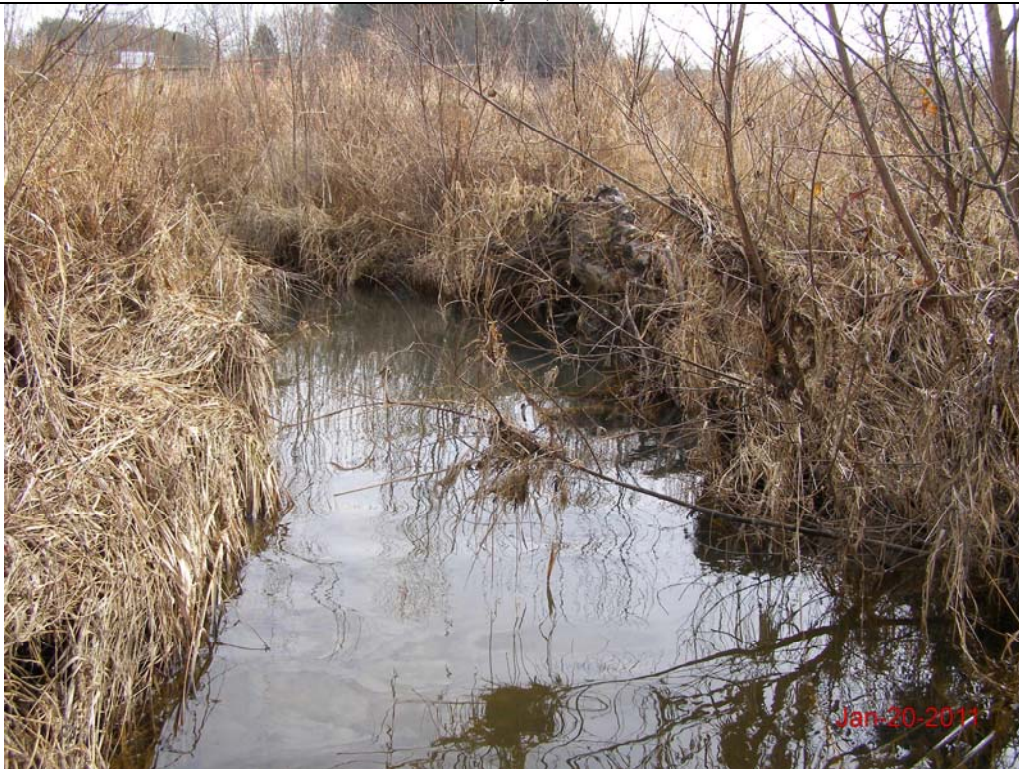
**Permanent Photo Point 35 – Unnamed Tributary 5
Looking 358 Degrees
January 20, 2011**

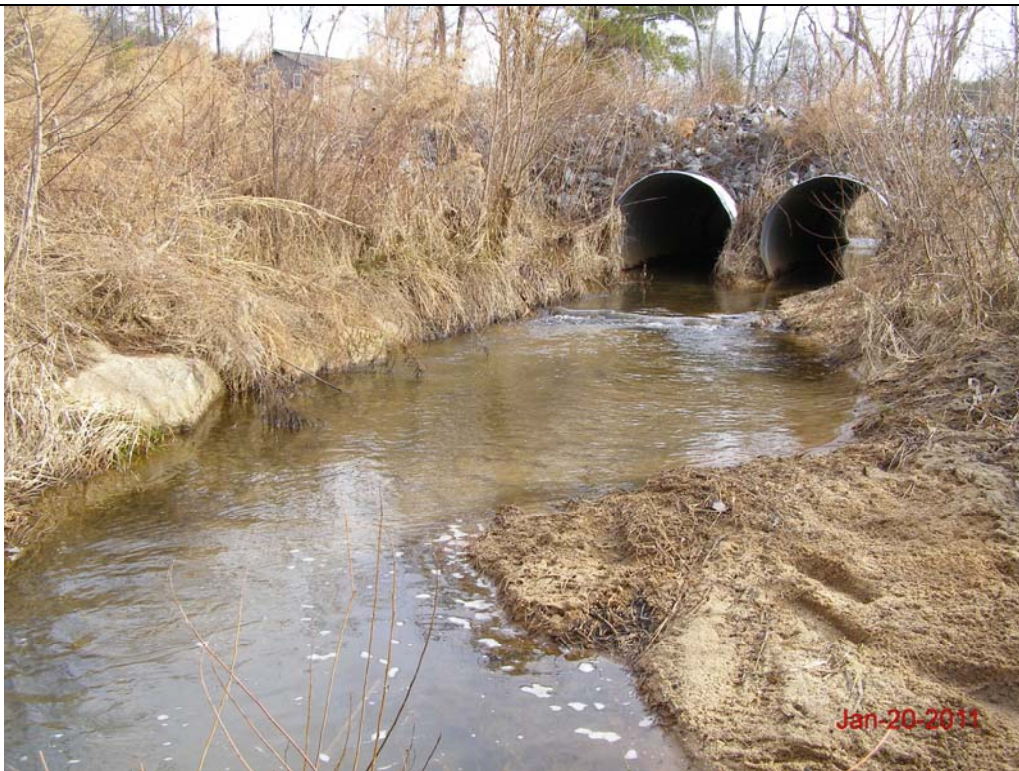
**Permanent Photo Point 36 – Morgan Creek
Looking Upstream
January 20, 2011**

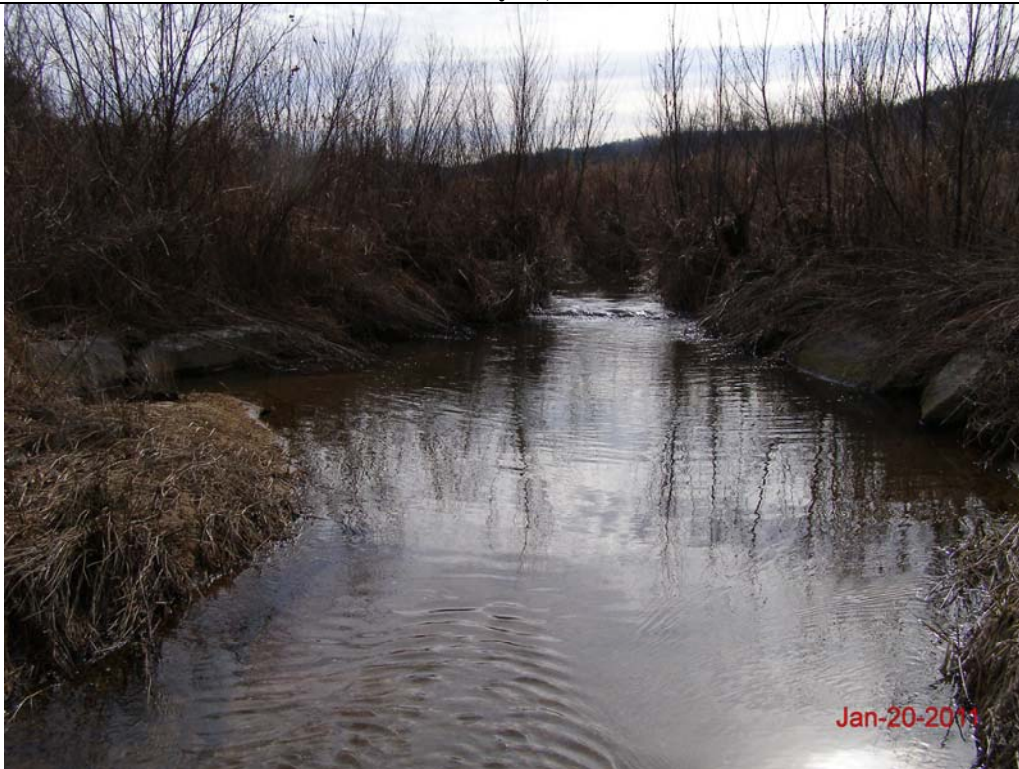
**Permanent Photo Point 37 – Morgan Creek
Looking Upstream
January 20, 2011**

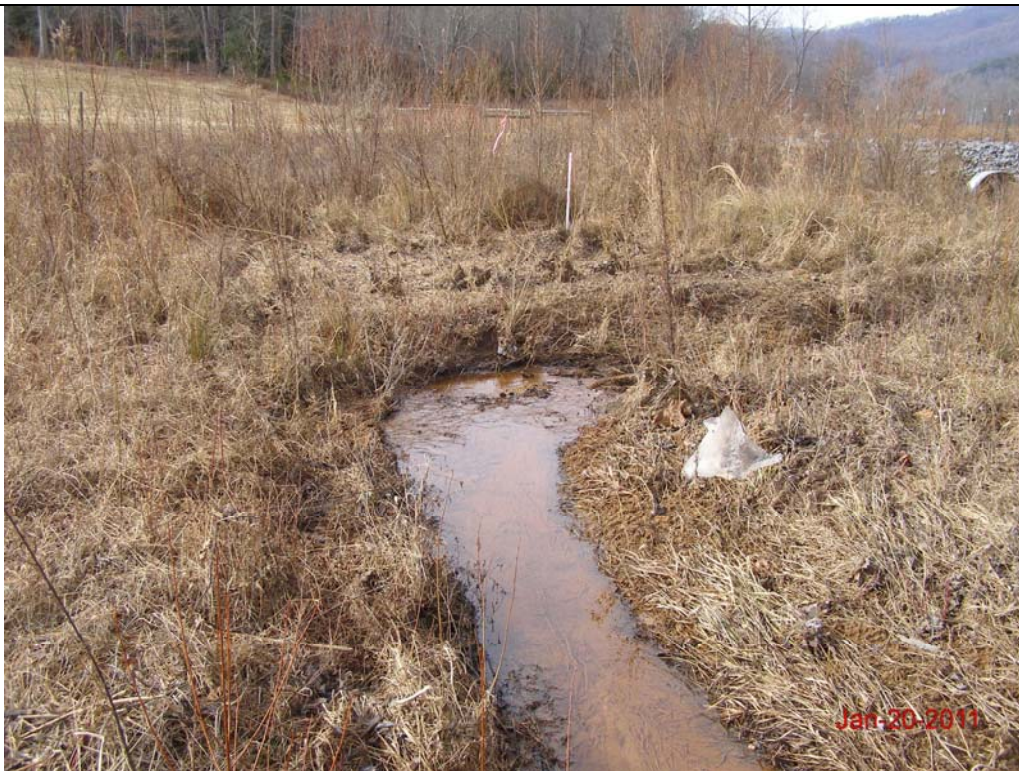
**Permanent Photo Point 38 – Morgan Creek
Looking Upstream
January 20, 2011**

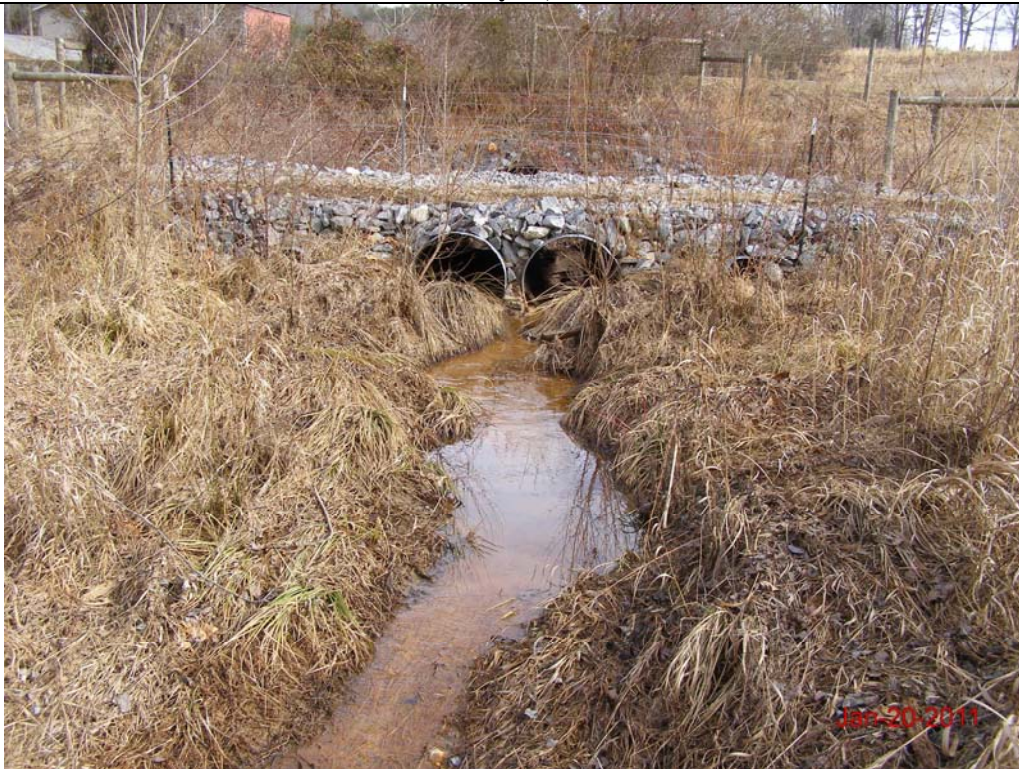
**Permanent Photo Point 39 – Unnamed Tributary 4
Looking Downstream
January 20, 2011**

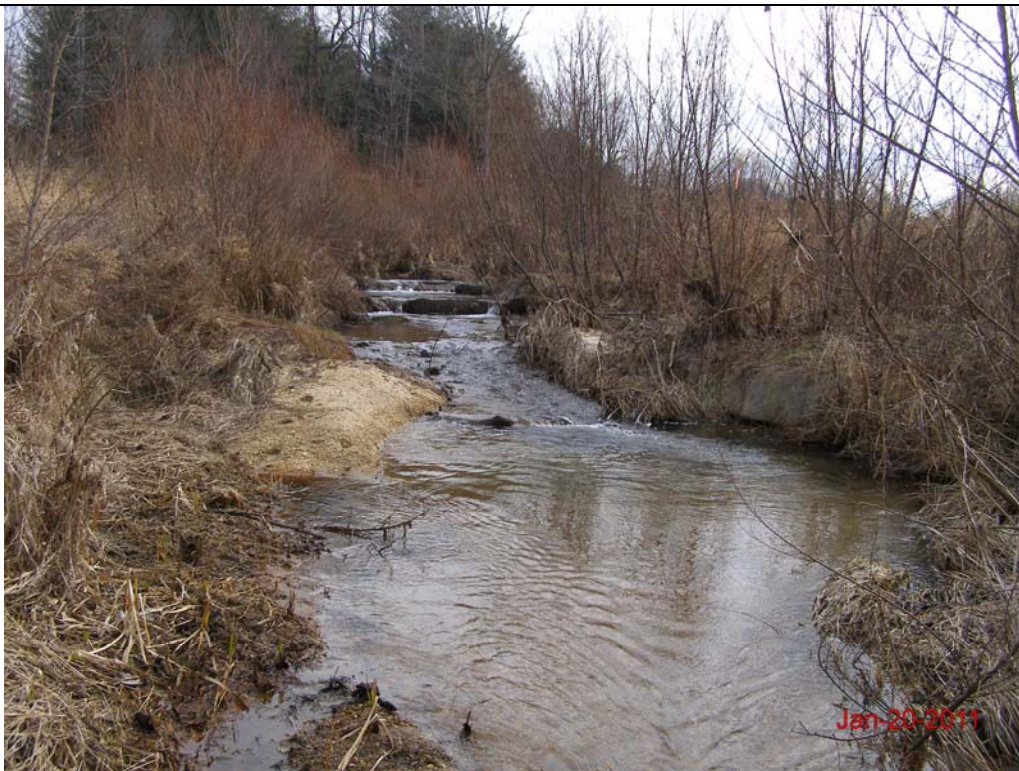
**Permanent Photo Point 39 – Unnamed Tributary 4
Looking Upstream
January 20, 2011**

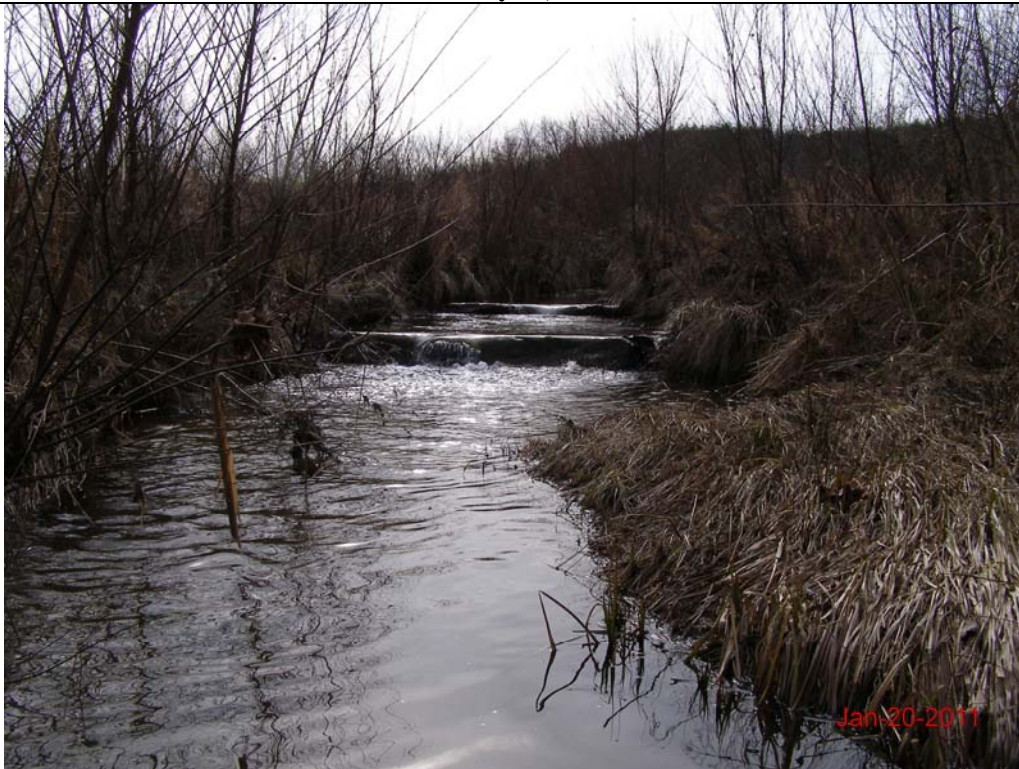
**Permanent Photo Point 40 – Morgan Creek
Looking Upstream
January 20, 2011**

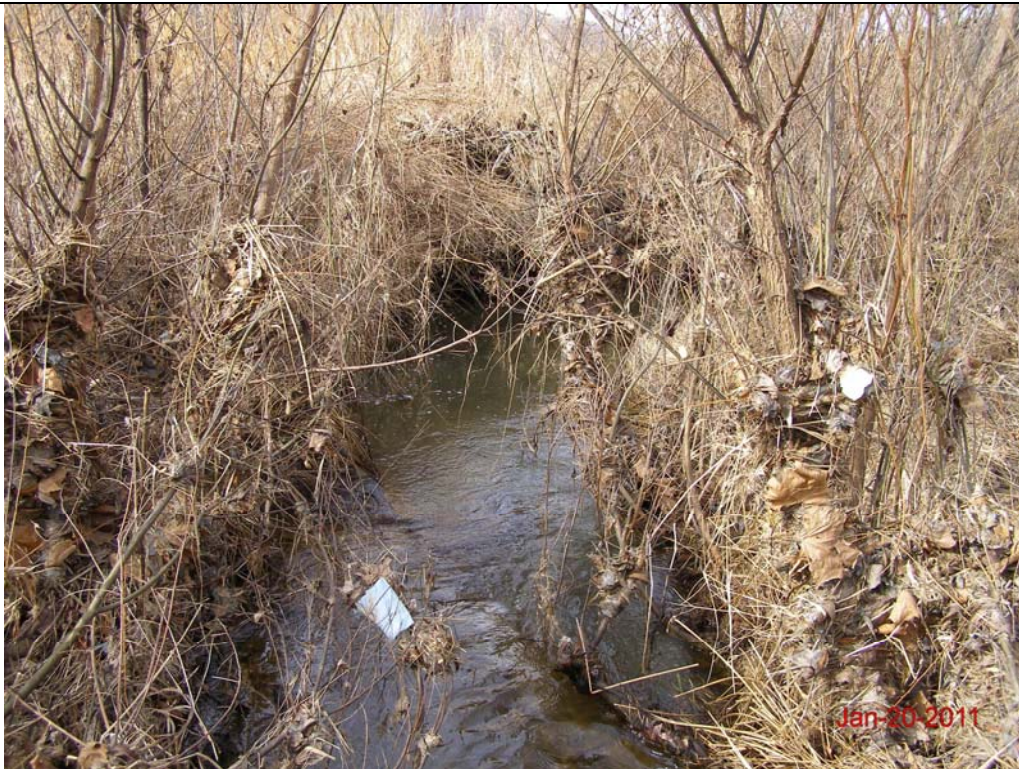
**Permanent Photo Point 41 – Morgan Creek
Looking Upstream
January 20, 2011**

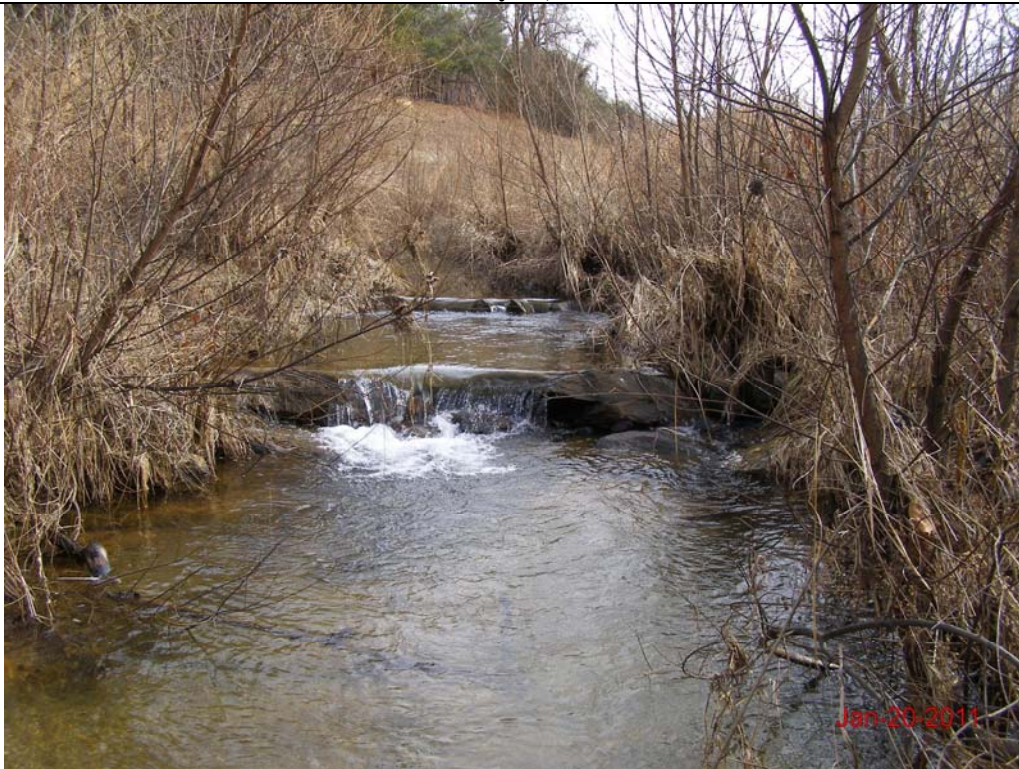
**Permanent Photo Point 42 – Morgan Creek
Looking Downstream
January 20, 2011**

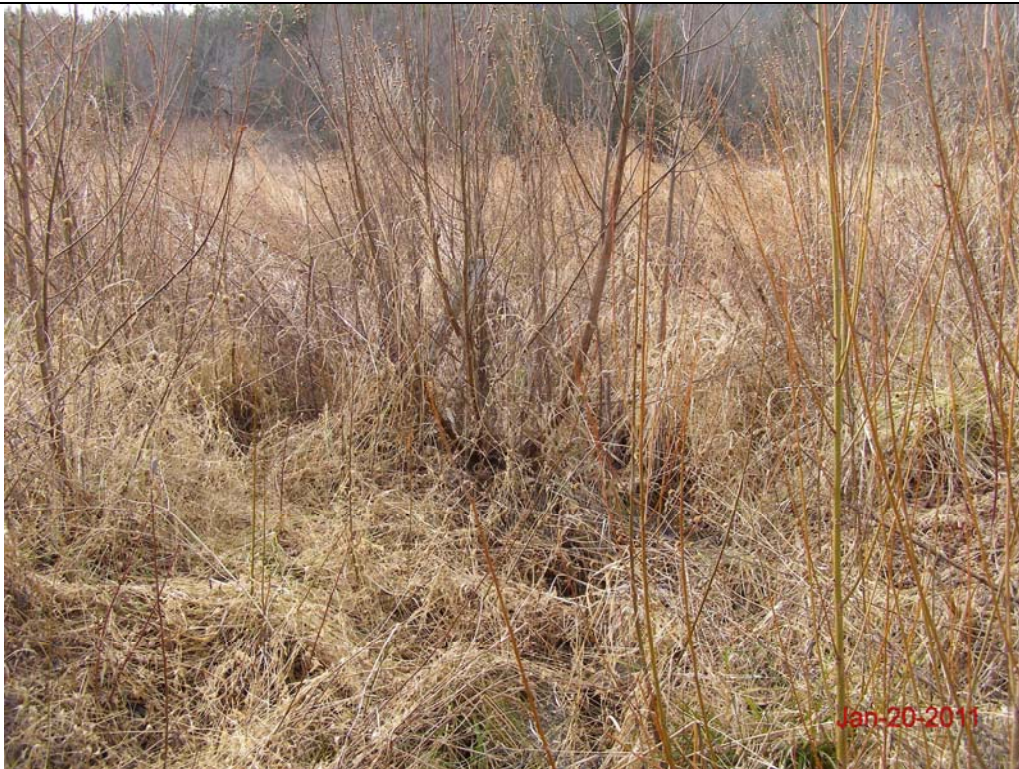
**Permanent Photo Point 42 – Morgan Creek
Looking Upstream
January 20, 2011**

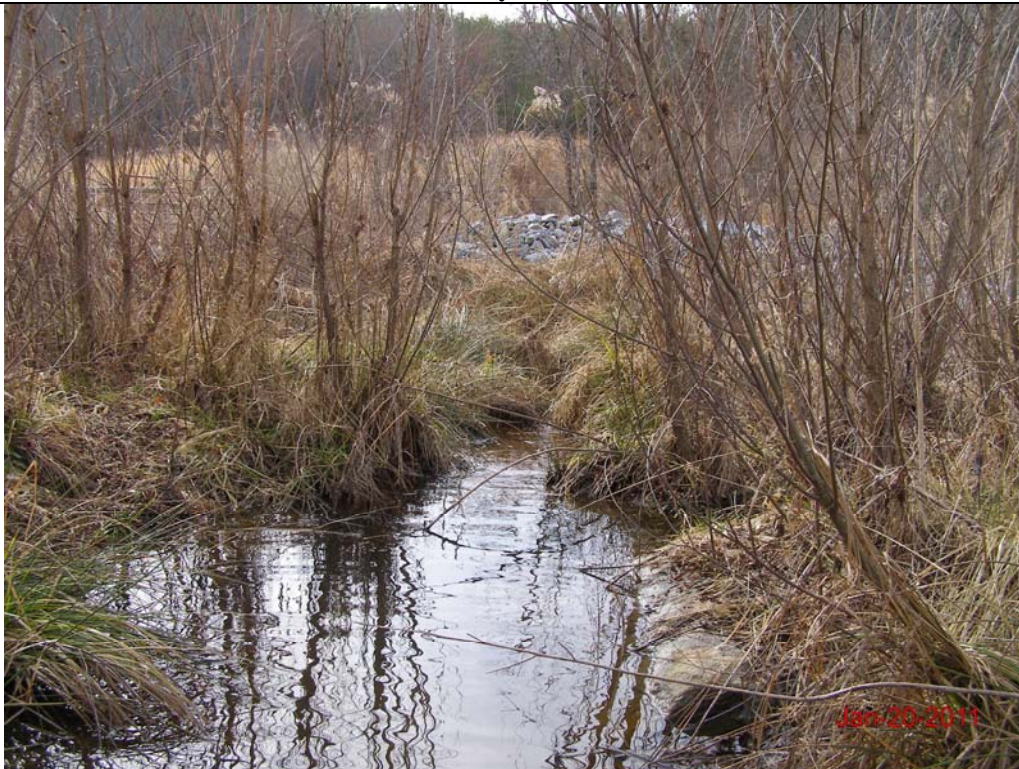
**Permanent Photo Point 43 – Unnamed Tributary 3
Looking Upstream
January 20, 2011**

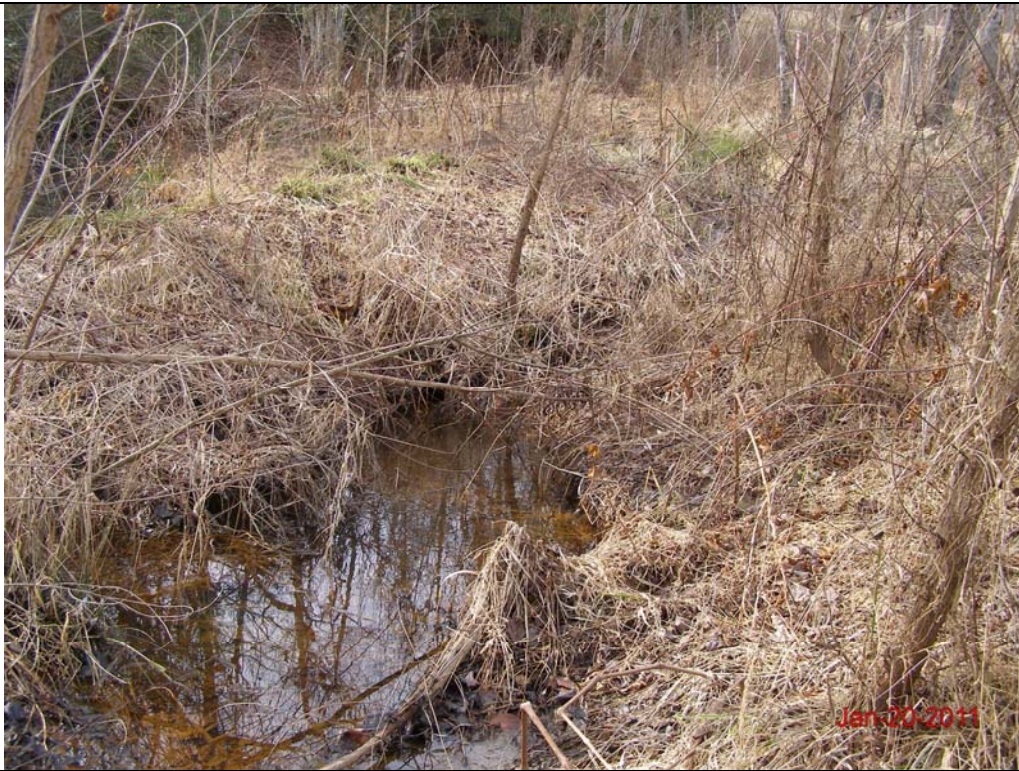
**Permanent Photo Point 44 – Unnamed Tributary 3
Looking Upstream
January 20, 2011**

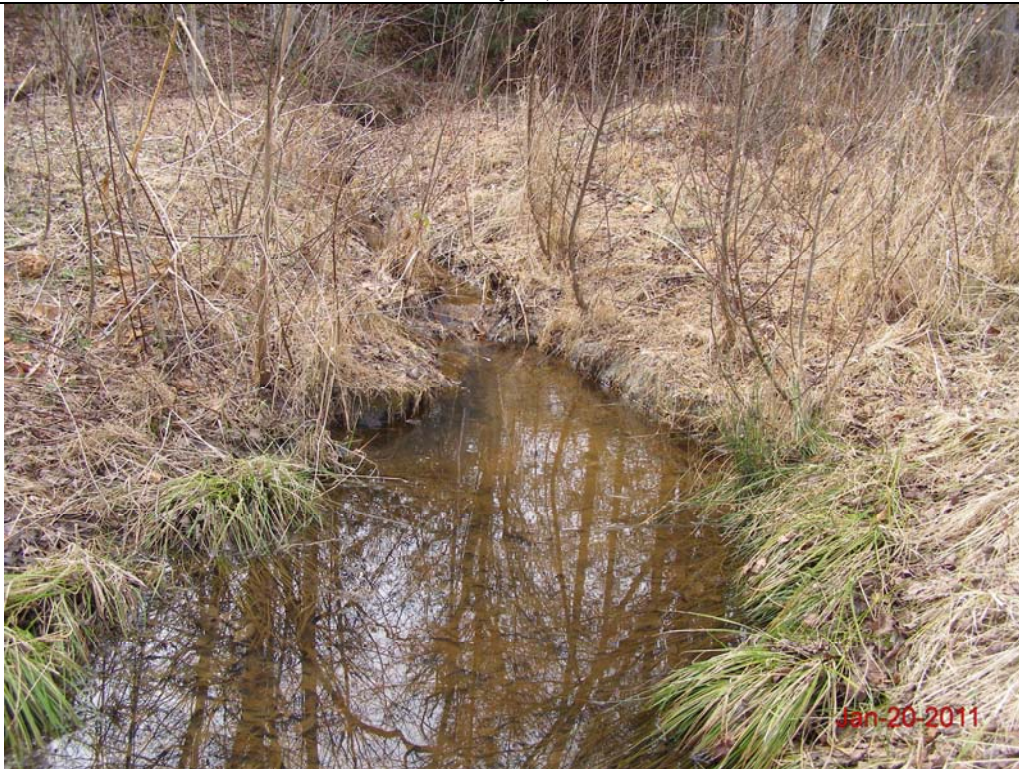
**Permanent Photo Point 45 – Unnamed Tributary 3
Looking Upstream
January 20, 2011**

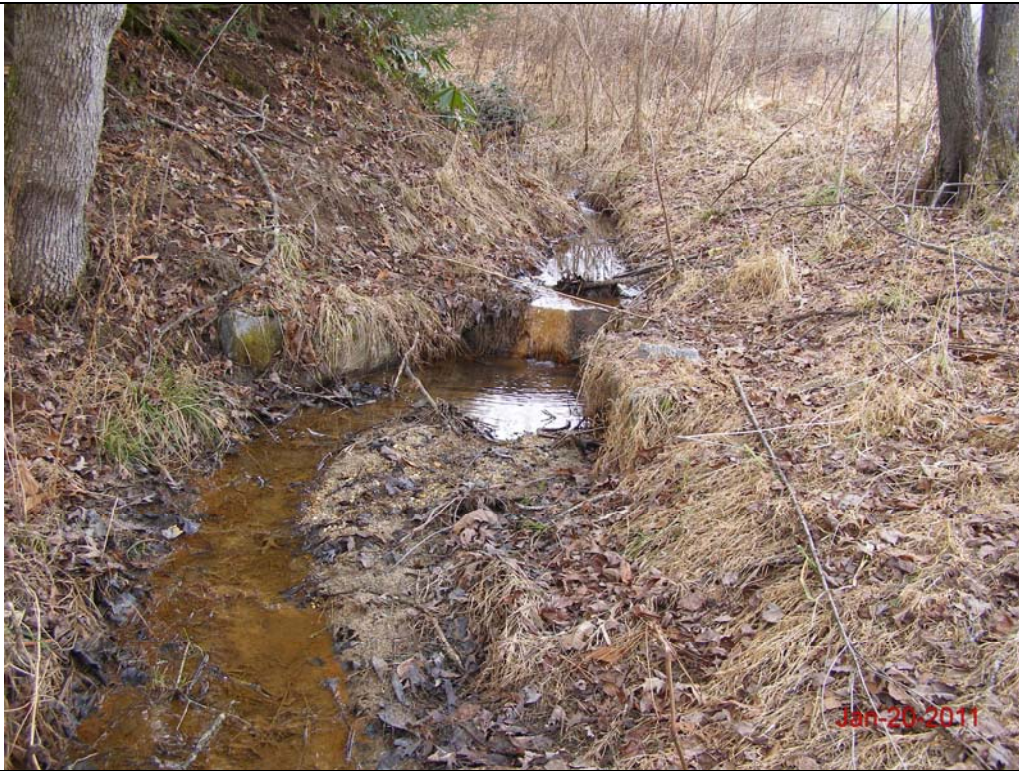
**Permanent Photo Point 46 – Unnamed Tributary 3
Looking Upstream
January 20, 2011**

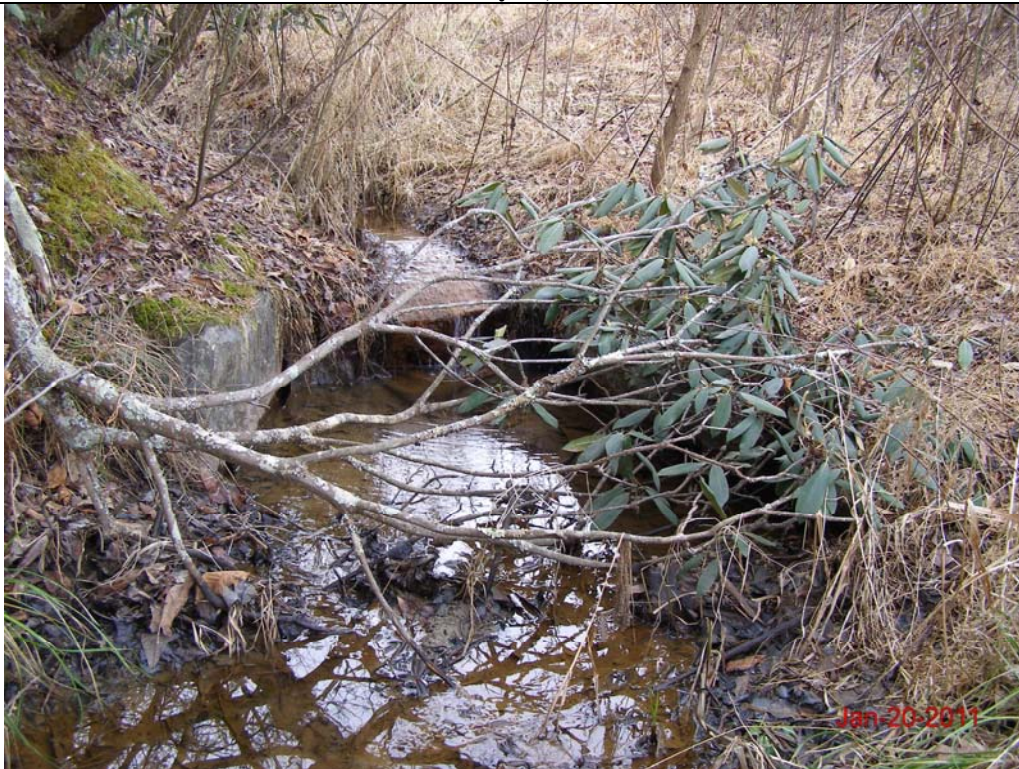
**Permanent Photo Point 47 – Unnamed Tributary 3
Looking Upstream
January 20, 2011**

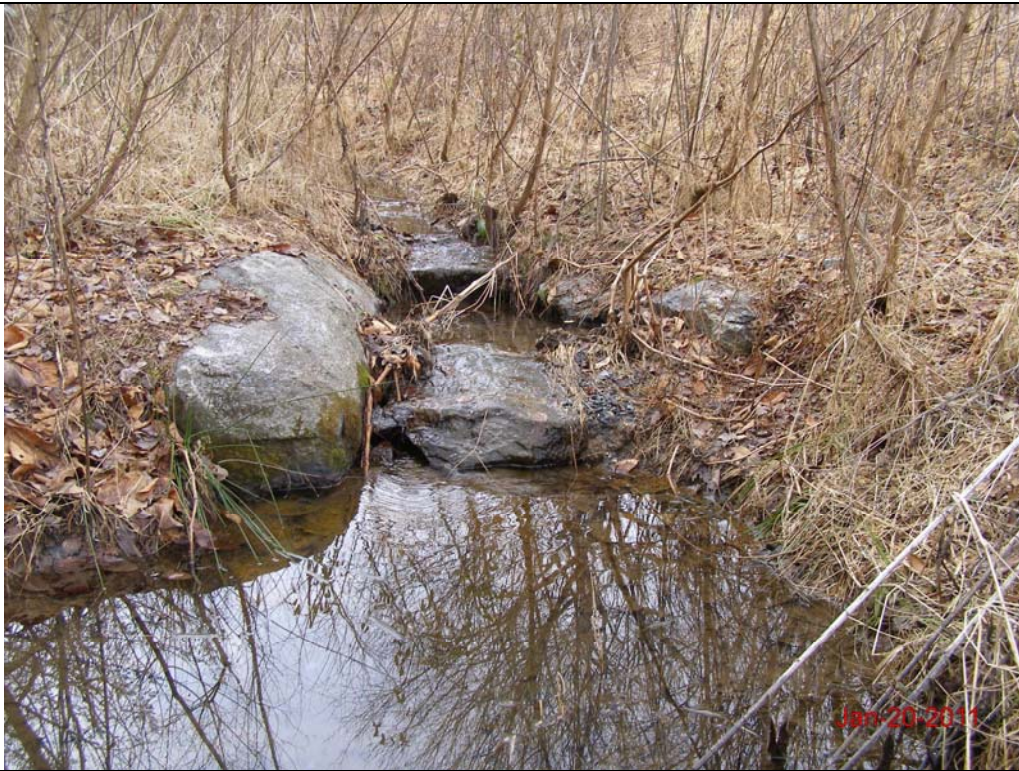
**Permanent Photo Point 48 – Unnamed Tributary 3
Looking Upstream
January 20, 2011**
