Morgan Creek Stream Restoration Site

Year 3 Final Monitoring Report

Project ID Number: 16-D06027

EEP Project # 92527

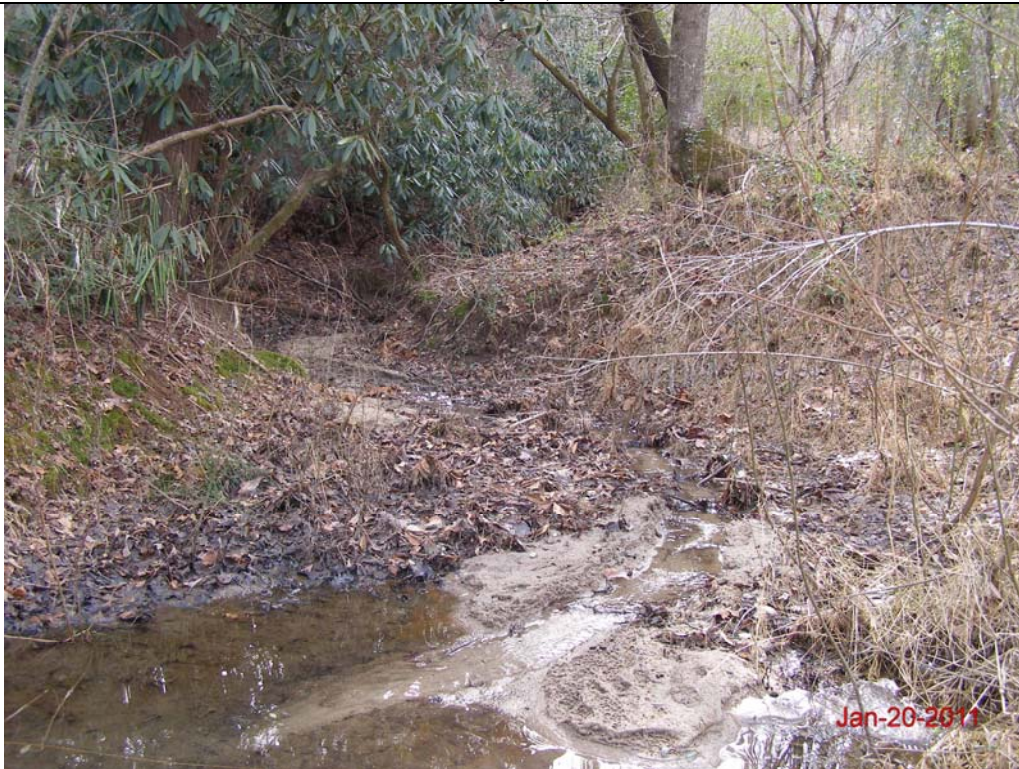
**Permanent Photo Point 49 – Unnamed Tributary 3
Looking Upstream
January 20, 2011**

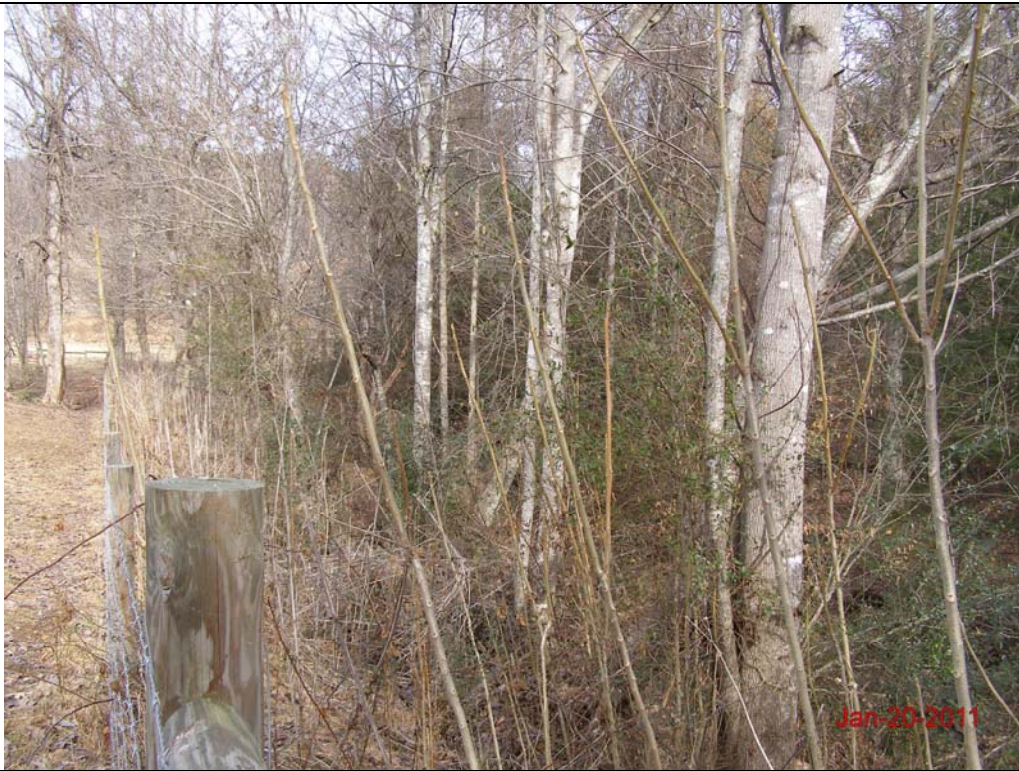
**Permanent Photo Point 50 – Unnamed Tributary 3
Looking Upstream
January 20, 2011**

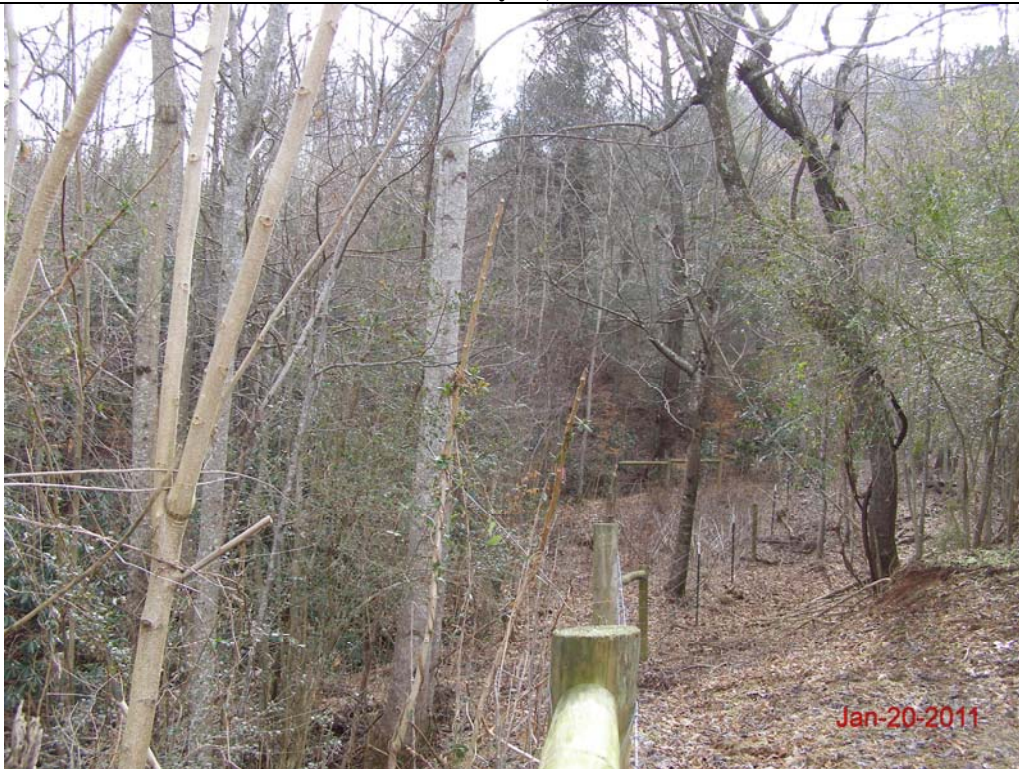
**Permanent Photo Point 51 – Unnamed Tributary 3
Looking Downstream
January 20, 2011**

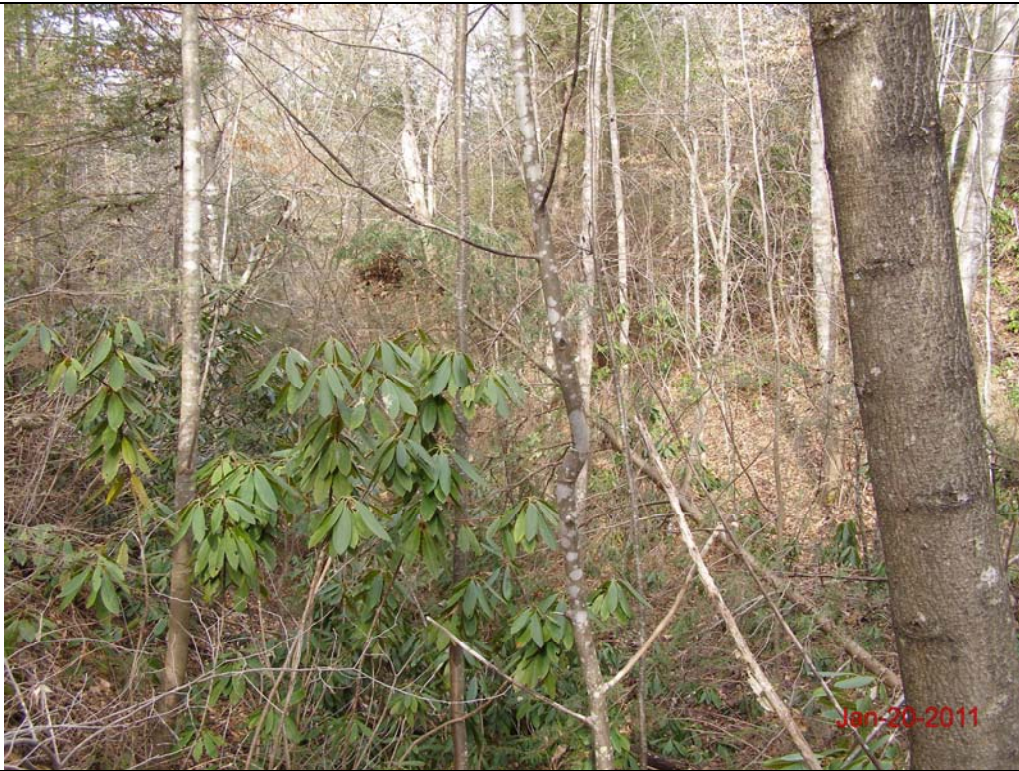
**Permanent Photo Point 51 – Unnamed Tributary 3
Looking Upstream
January 20, 2011**

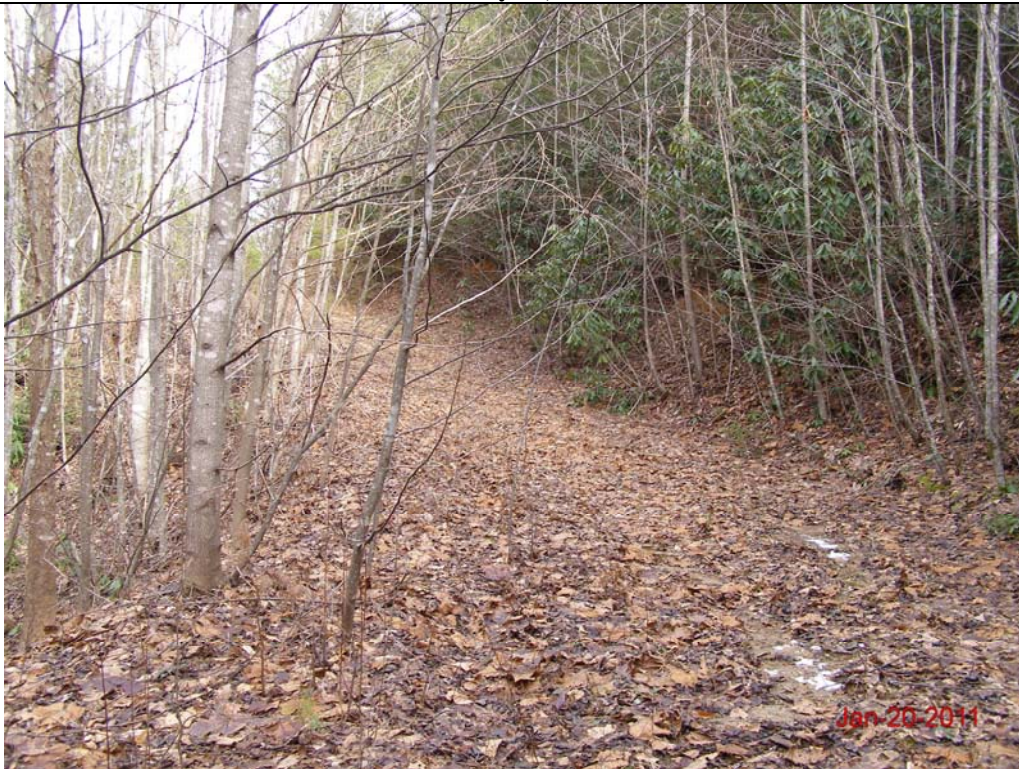
**Permanent Photo Point 52 – Unnamed Tributary 3
Looking Downstream
January 20, 2011**

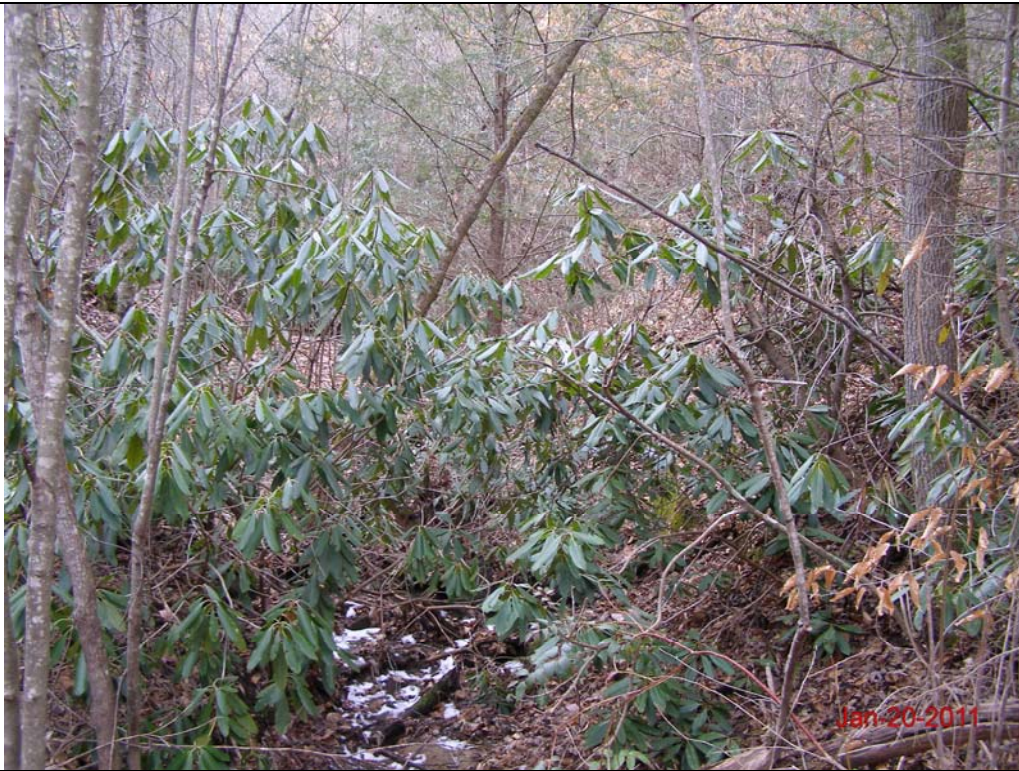
**Permanent Photo Point 52 – Unnamed Tributary 3
Looking 110 Degrees
January 20, 2011**

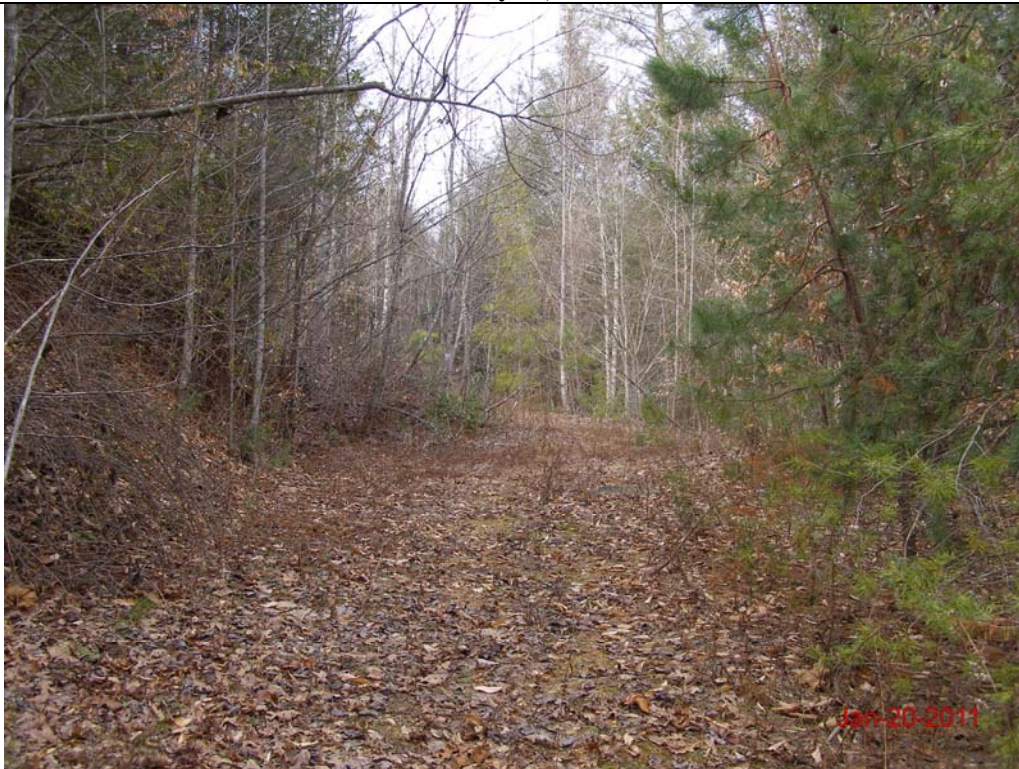
**Permanent Photo Point 52 – Unnamed Tributary 3
Looking Upstream
January 20, 2011**

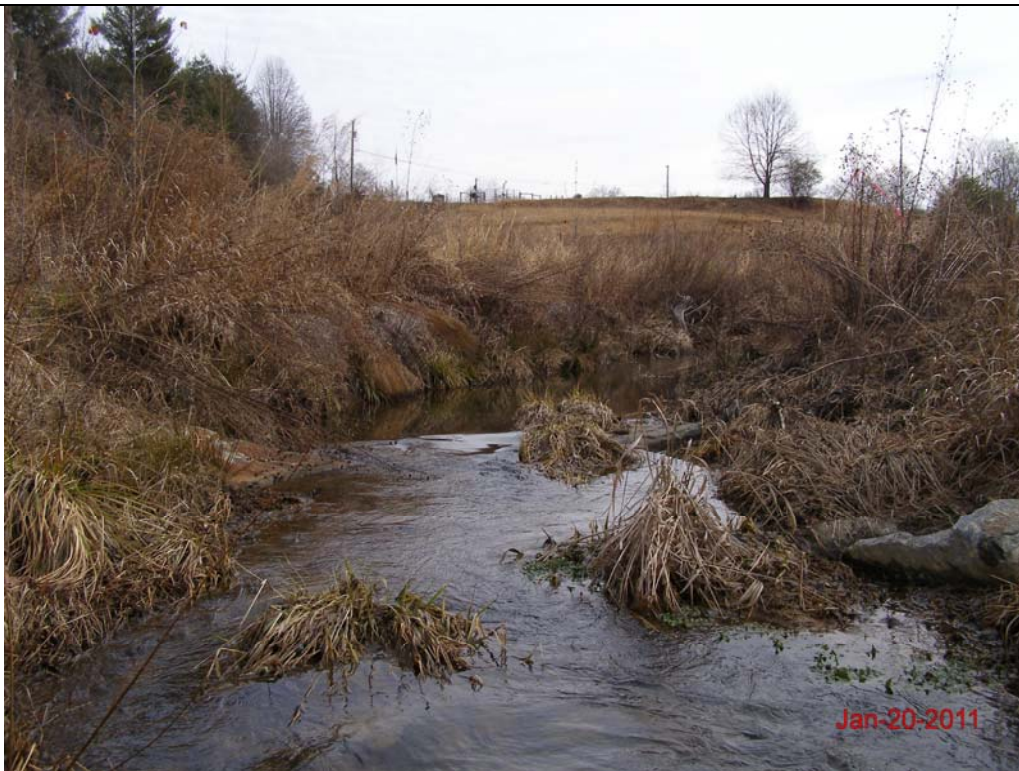
**Permanent Photo Point 52 – Unnamed Tributary 3
Looking 355 Degrees
January 20, 2011**

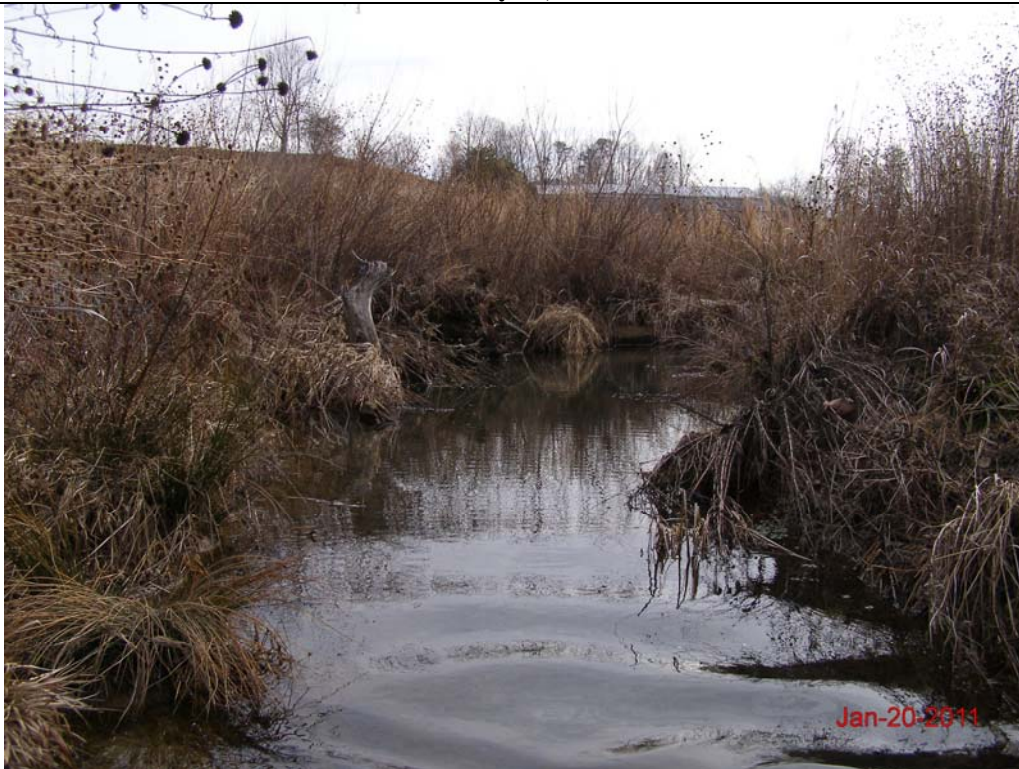
**Permanent Photo Point 53 – Morgan Creek
Looking Upstream
January 20, 2011**

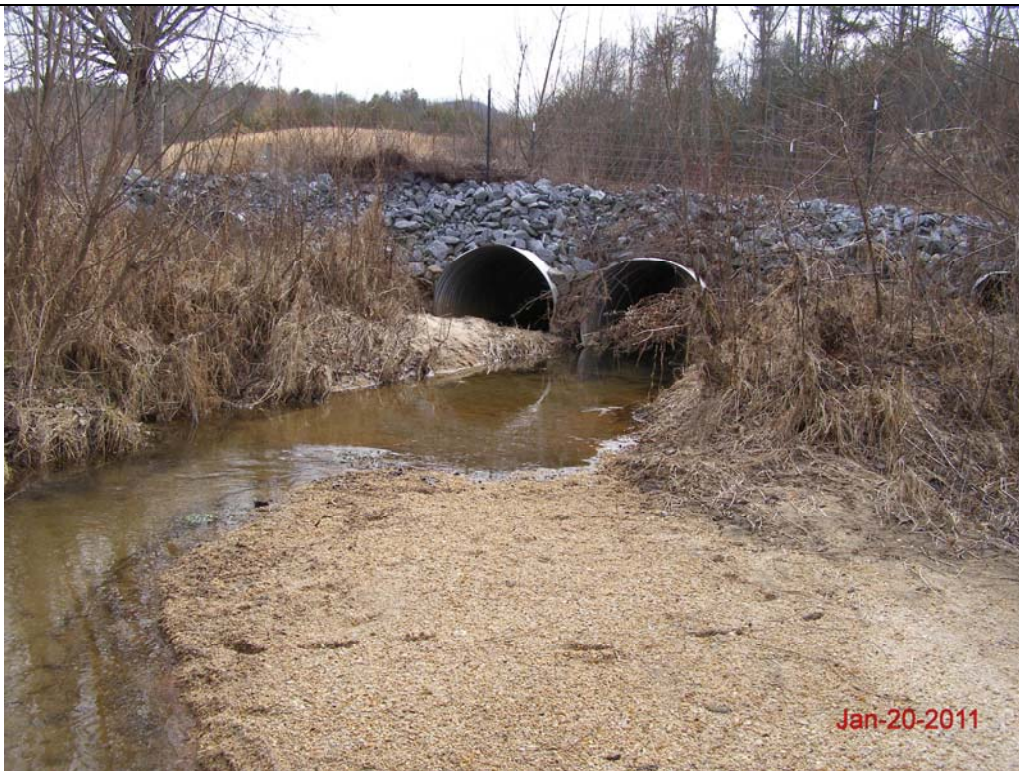
**Permanent Photo Point 54 – Morgan Creek
Looking Upstream
January 20, 2011**

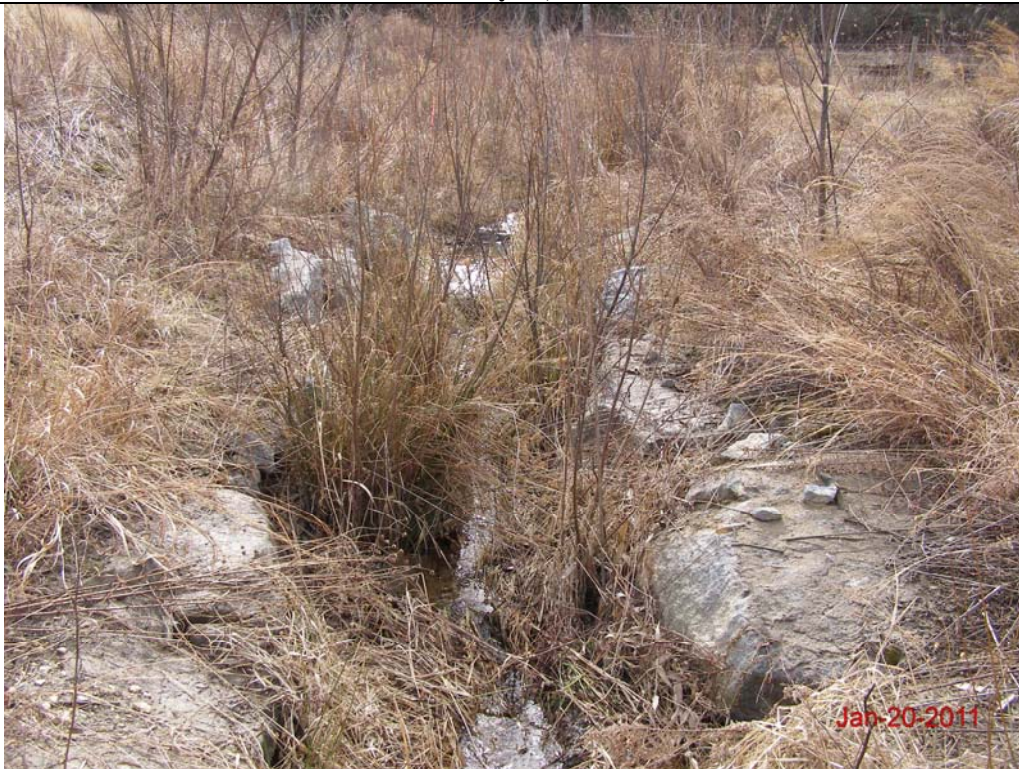
**Permanent Photo Point 55 – Morgan Creek
Looking Upstream
January 20, 2011**

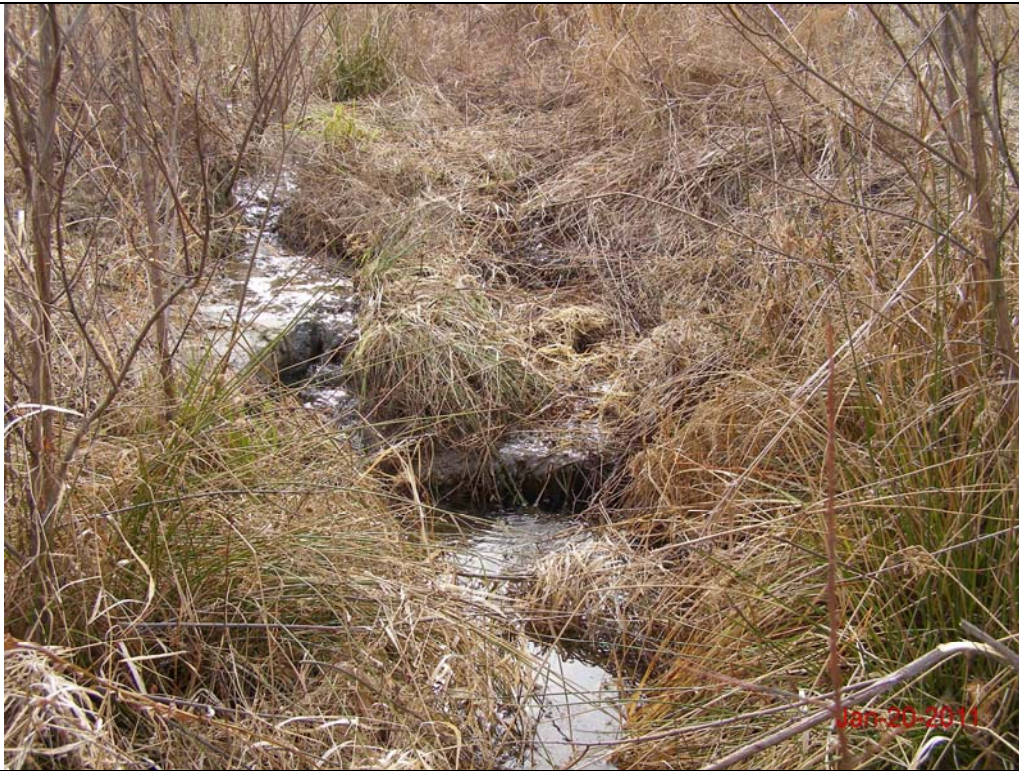
**Permanent Photo Point 56 – Unnamed Tributary 2
Looking Upstream
January 20, 2011**

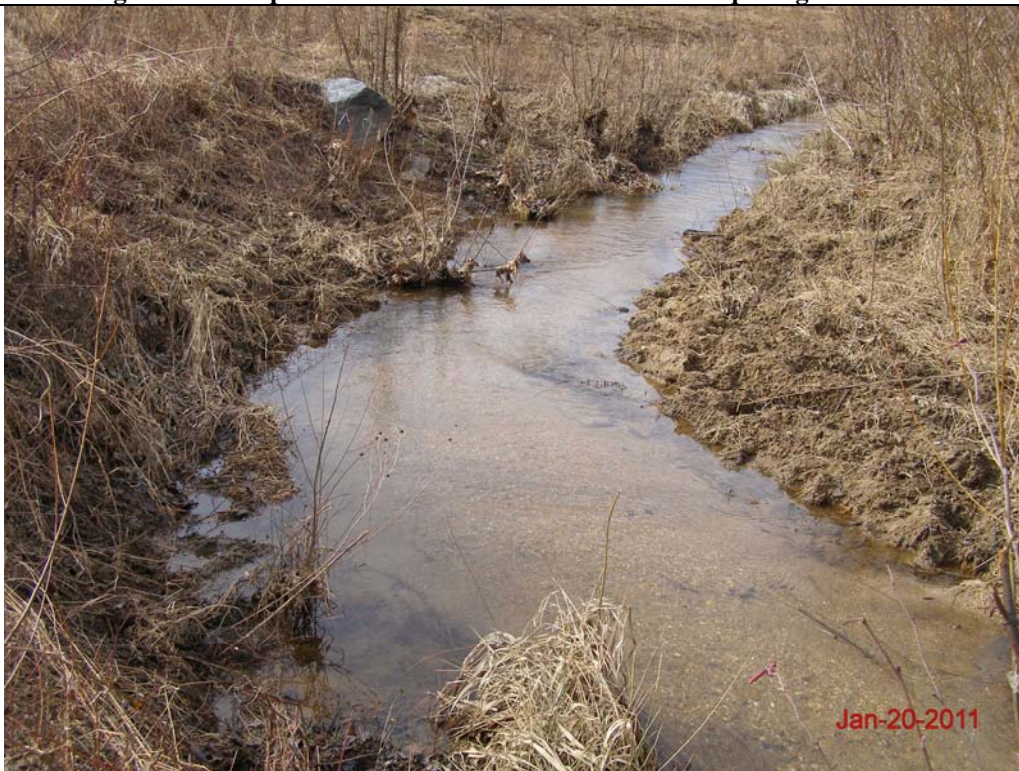
SPA 4 Morgan Creek Sta. 1002+25 – Reduced pool depth due to aggradation

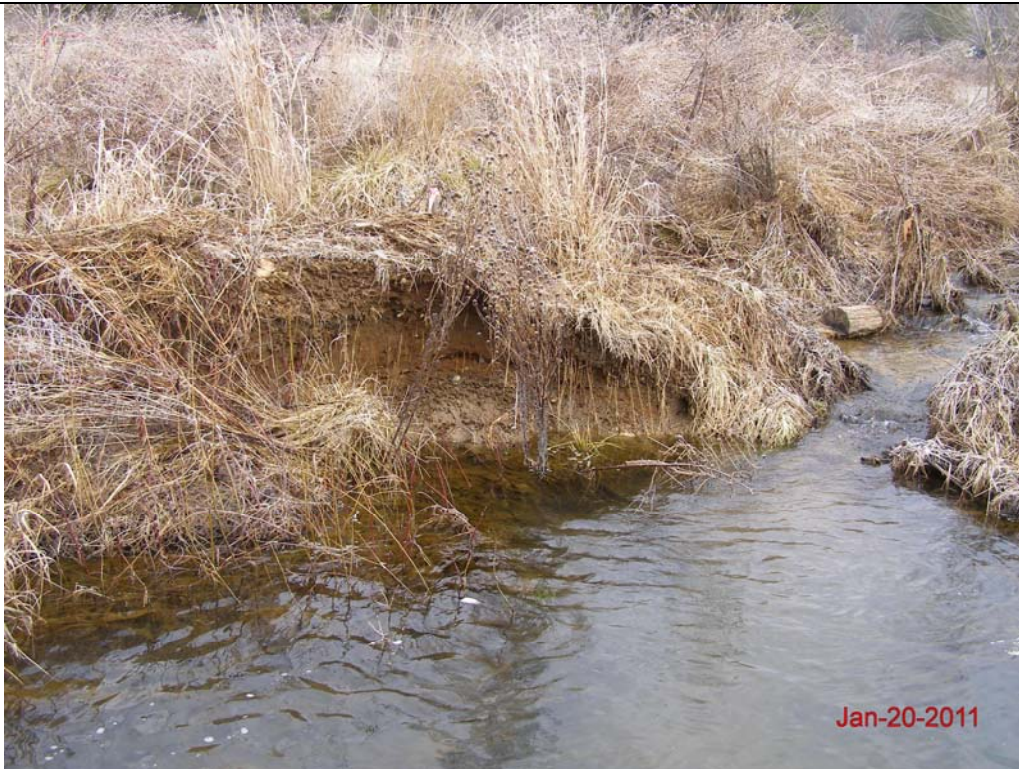
SPA 21 Morgan Creek Sta. 1029+40 – Bank erosion due to thalweg not centering

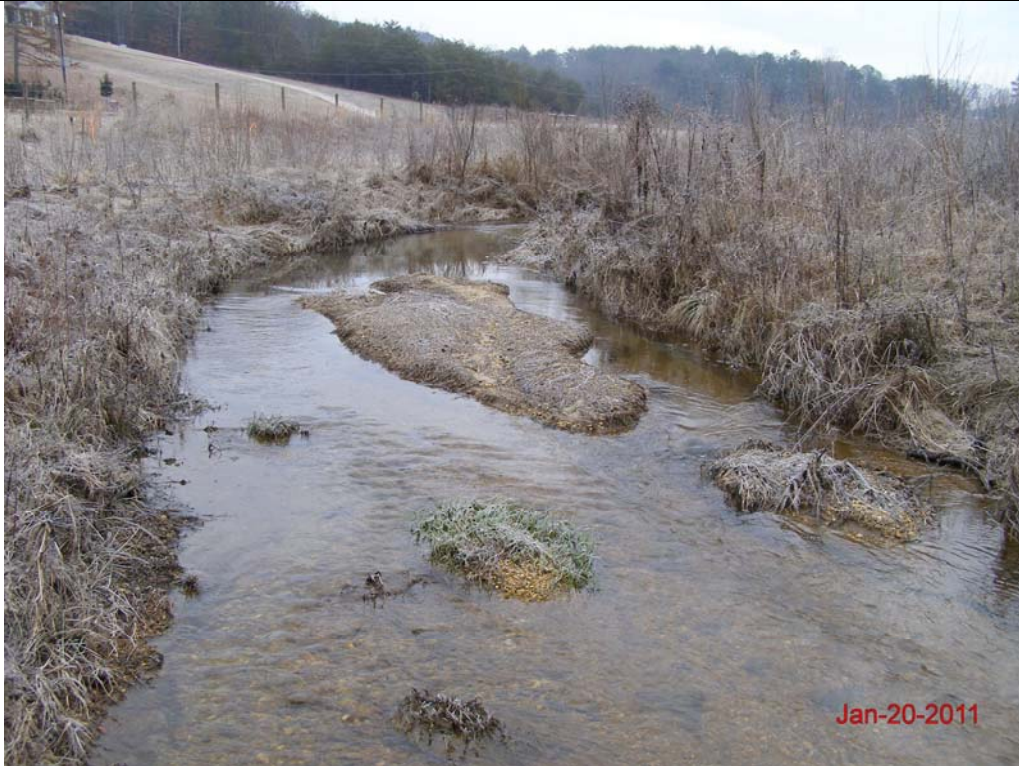
SPA 23 Morgan Creek Sta. 1038+50 – Riffle aggradation due to mid-channel bar formation

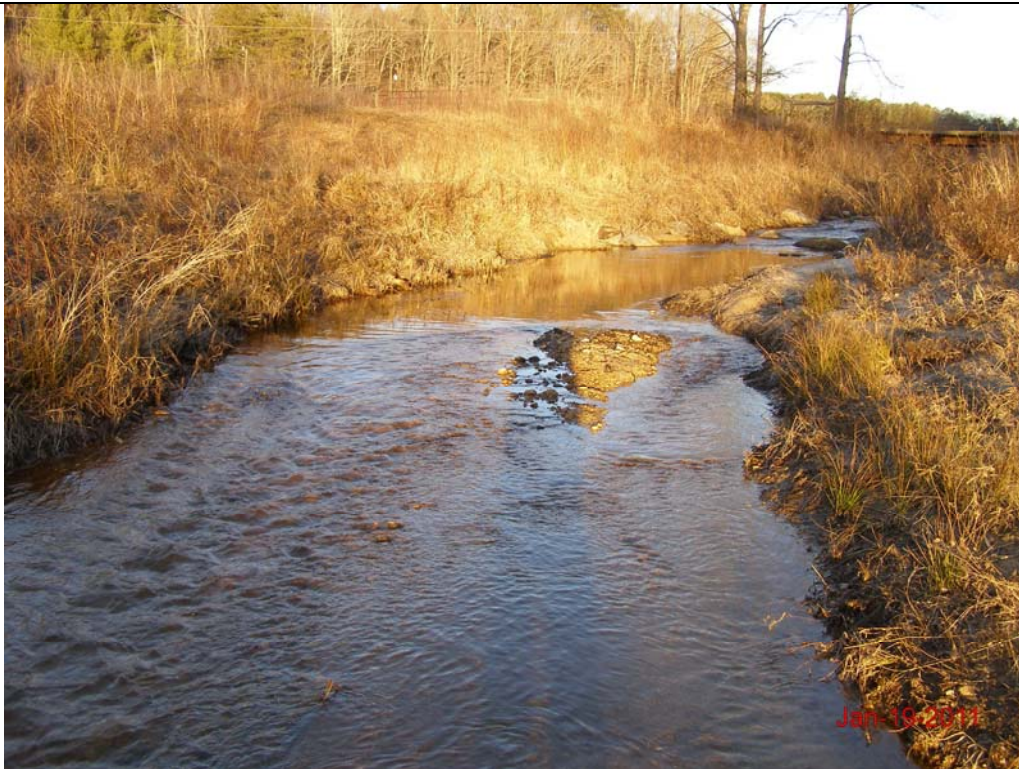
SPA 24 Morgan Creek Sta. 1047+00 – Reduced pool depth due to aggradation

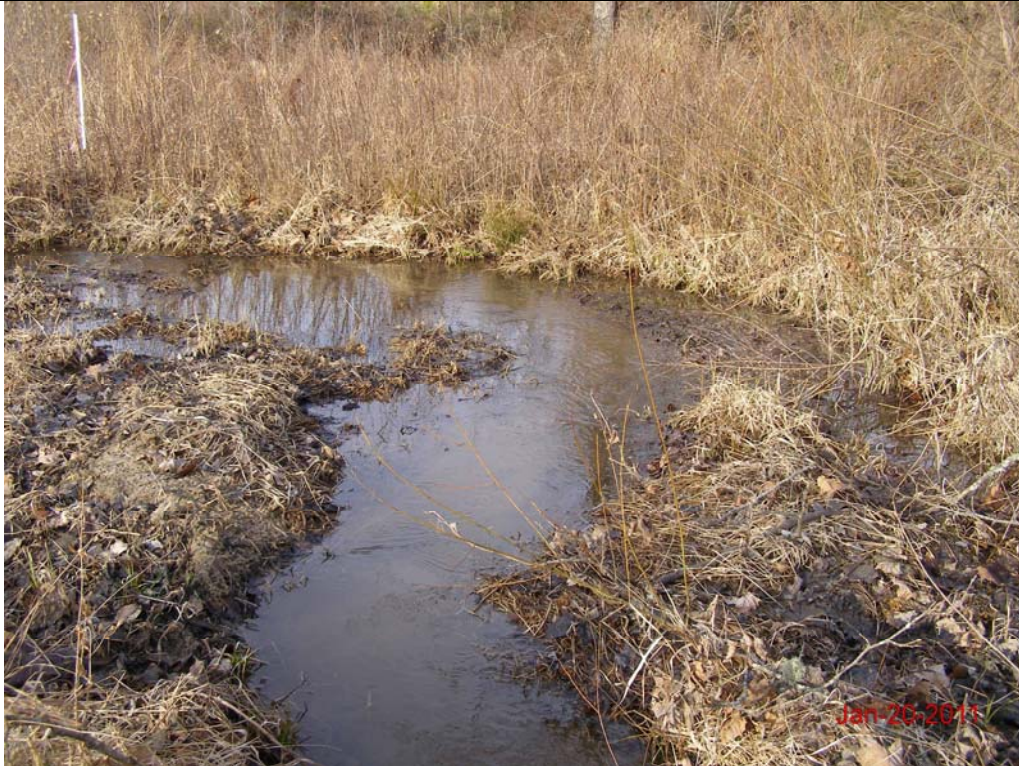
Unnamed Tributary 1 Representative Photos of Stream Areas Requiring Observation

SPA 2 UT1 Sta. 2001+75 – Reduced pool depth due to aggradation

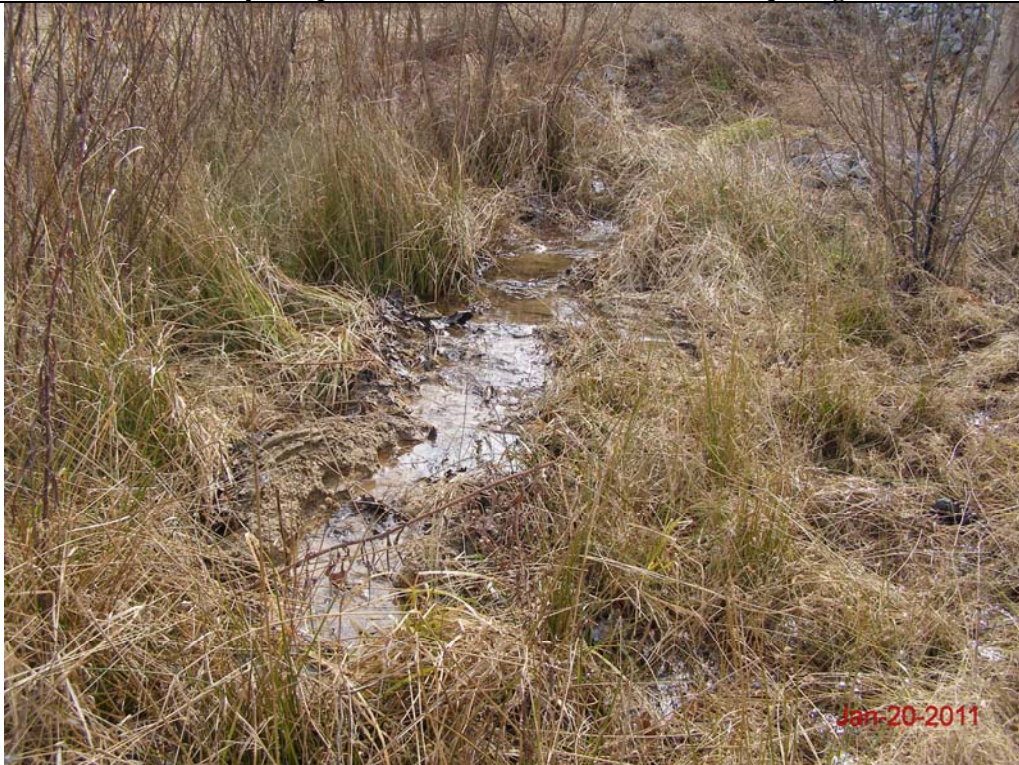
Unnamed Tributary 2 Representative Photo of Stream Areas Requiring Observation

SPA 5 UT2 Sta. 3000+50 – Reduced pool depth and riffle fining due to aggradation

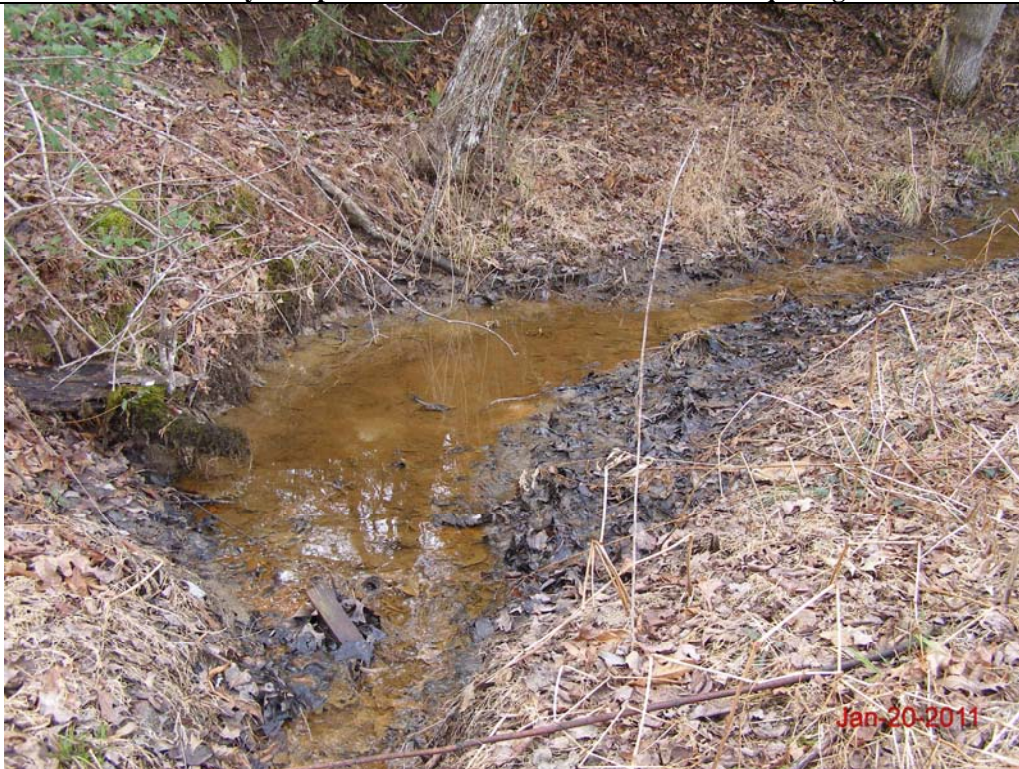
Unnamed Tributary 3 Representative Photo of Stream Areas Requiring Observation

SPA 13 UT3 Sta. 4001+90 – Reduced pool depth due to aggradation

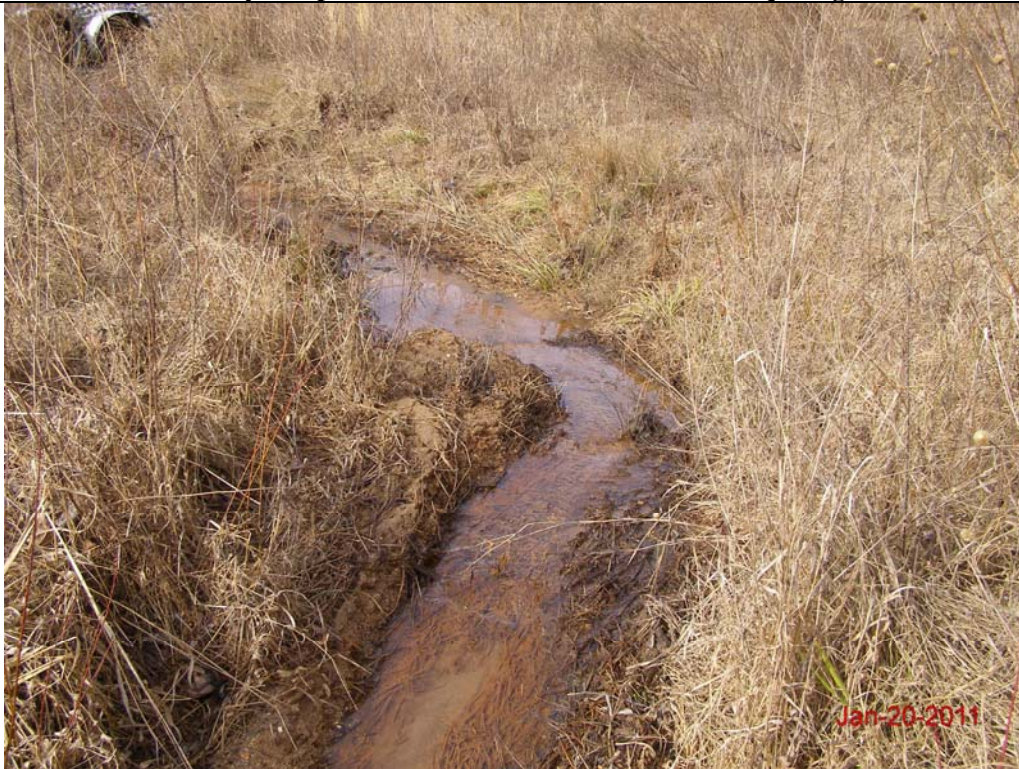
Unnamed Tributary 4 Representative Photo of Stream Areas Requiring Observation

SPA 16 UT4 Sta. 5001+50 – Reduced pool depth and riffle fining due to aggradation

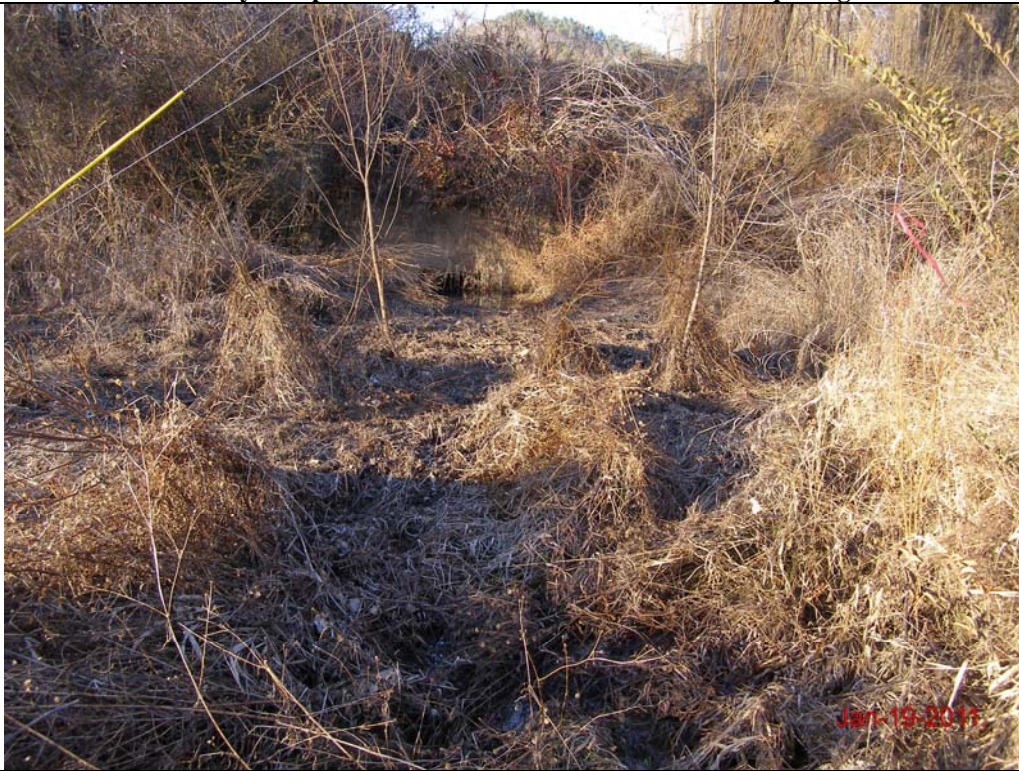
Unnamed Tributary 7 Representative Photos of Stream Areas Requiring Observation

SPA 25 UT7 Sta. 8000+40 – Reduced pool depth and riffle fining due to aggradation
