MITIGATION PLAN AND AS-BUILT BASELINE REPORT Morgan Creek Stream Restoration Site

Haywood County, North Carolina

EEP Contract #: D06035-A

MITIGATION PLAN AND AS-BUILT BASELINE REPORT

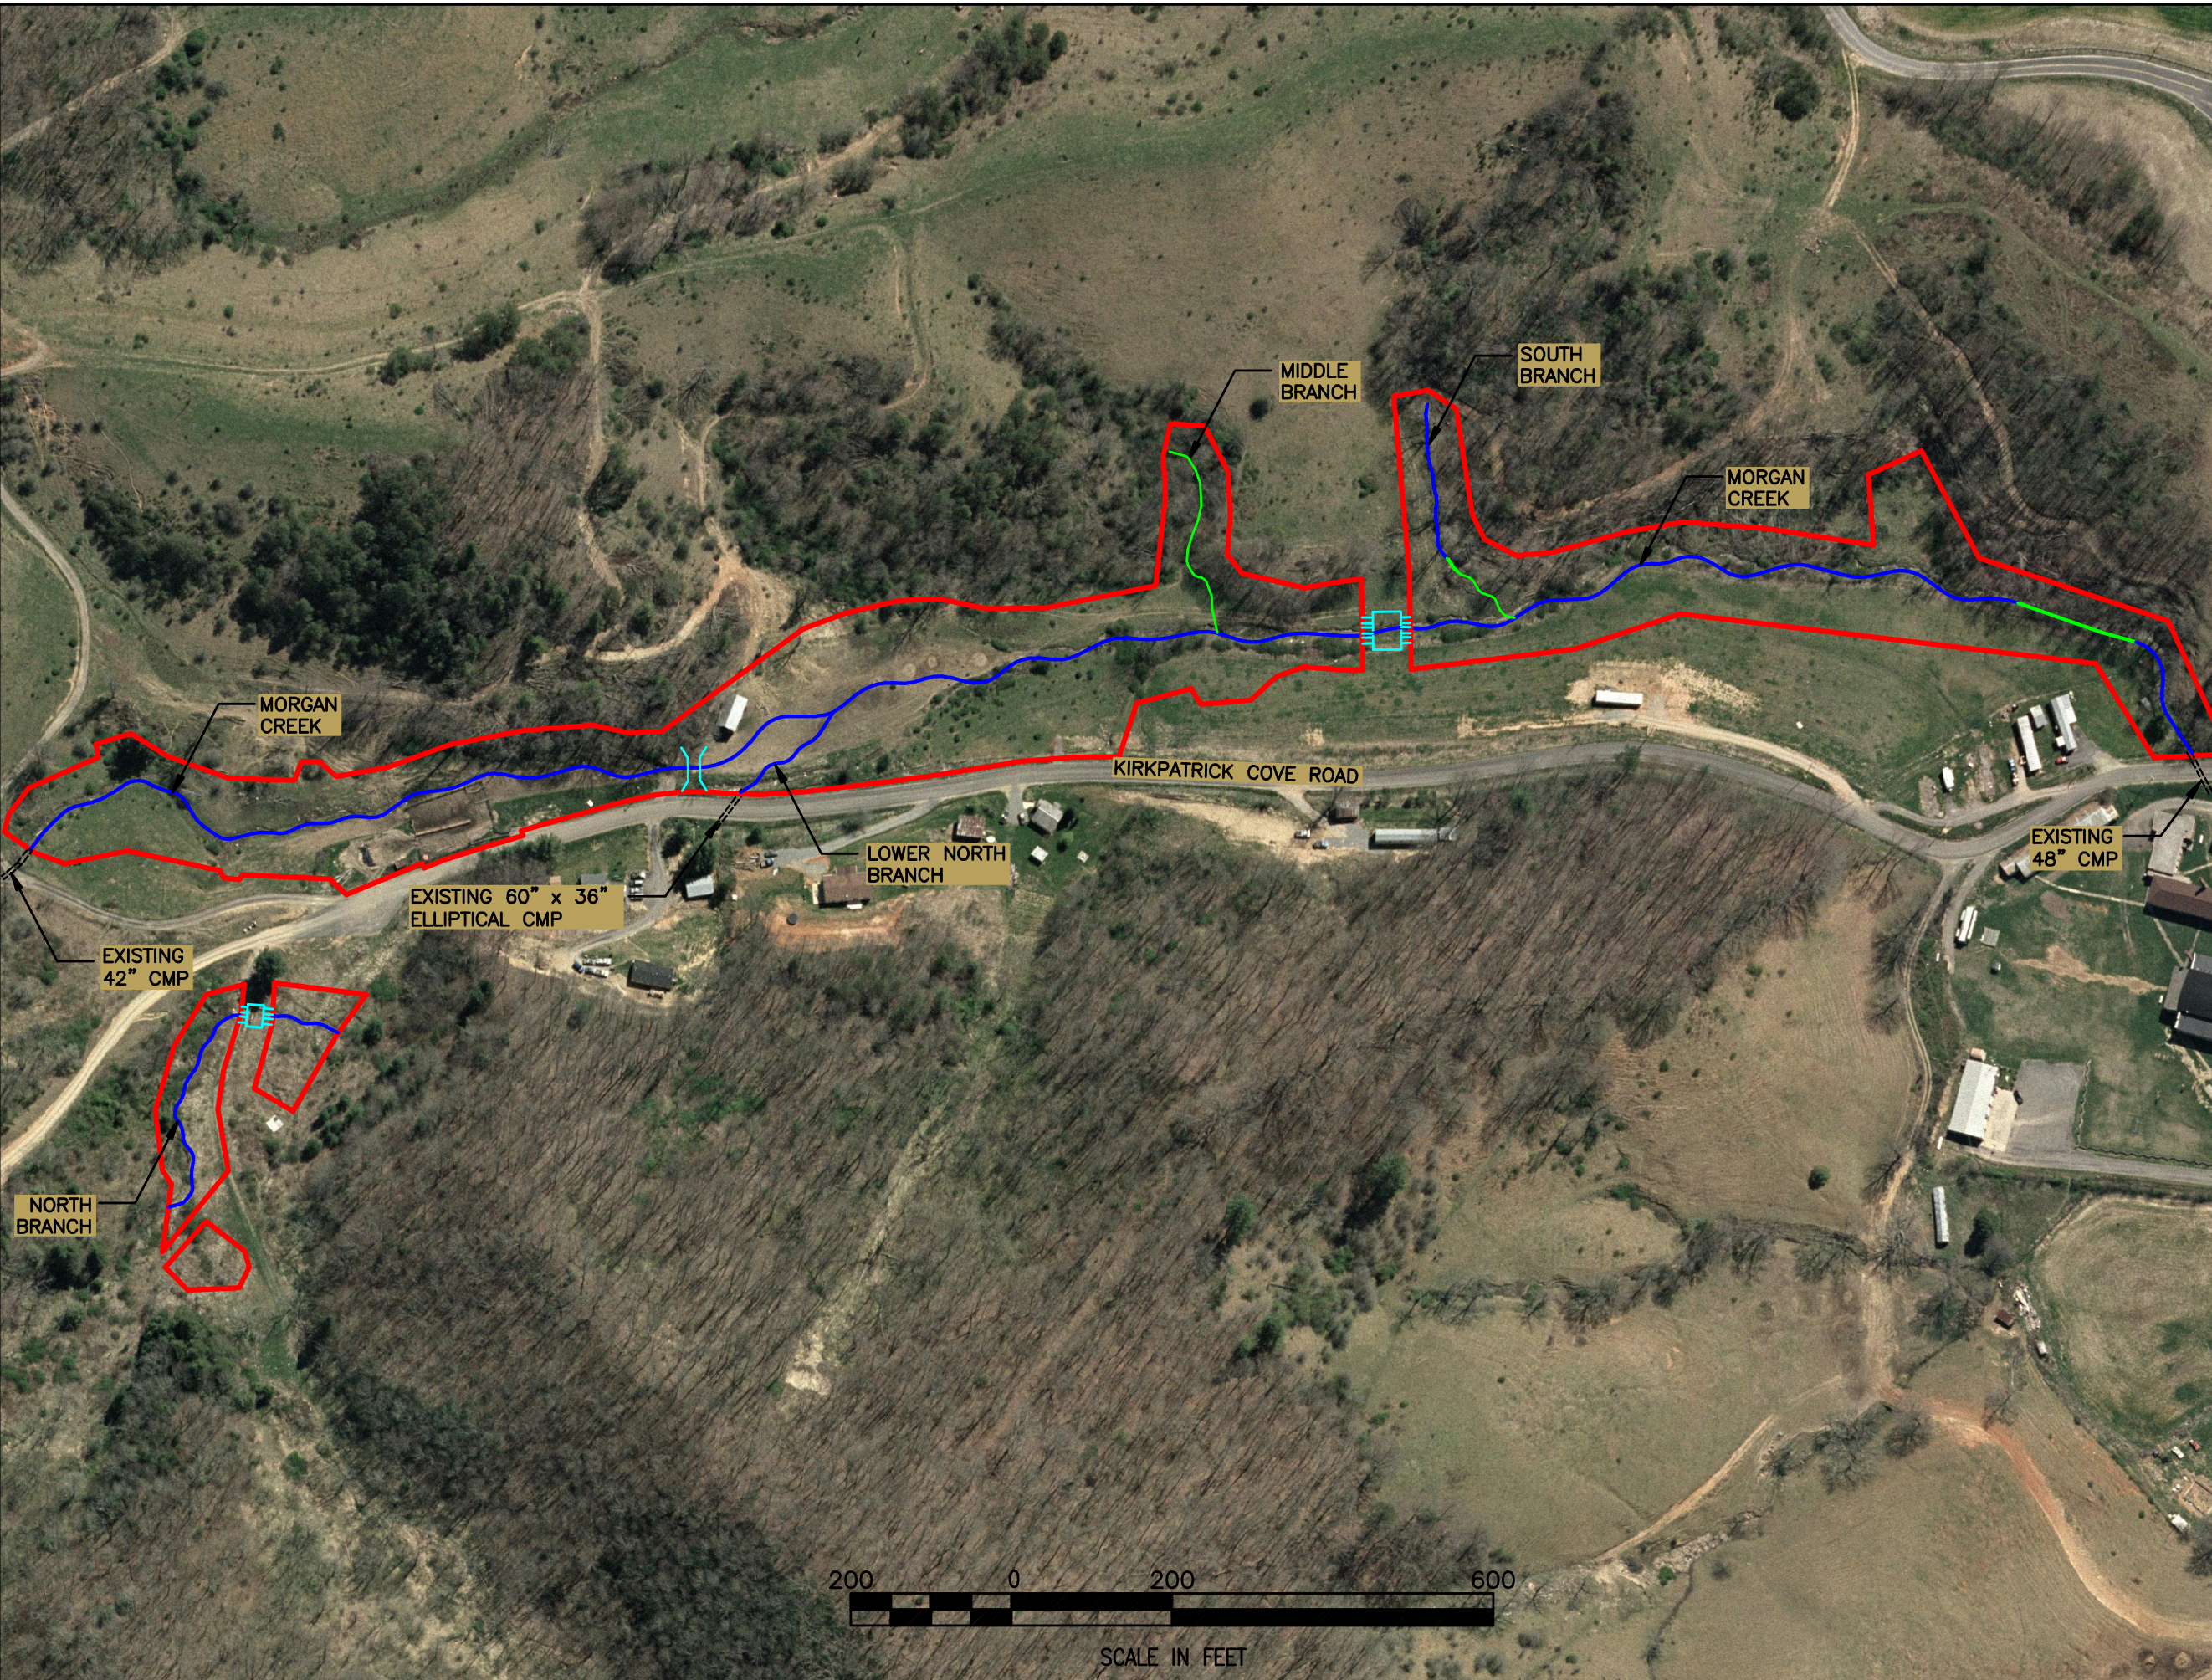
MORGAN CREEK RESTORATION SITE
HAYWOOD COUNTY, NORTH CAROLINA
FIGURE 2

SITE MAP

The project is illustrated in Figure 2 which depicts stream restoration and enhancement reaches for Morgan Creek and each of its tributaries. The project structure is tabulated in the corresponding Table 1 (See Appendix A).

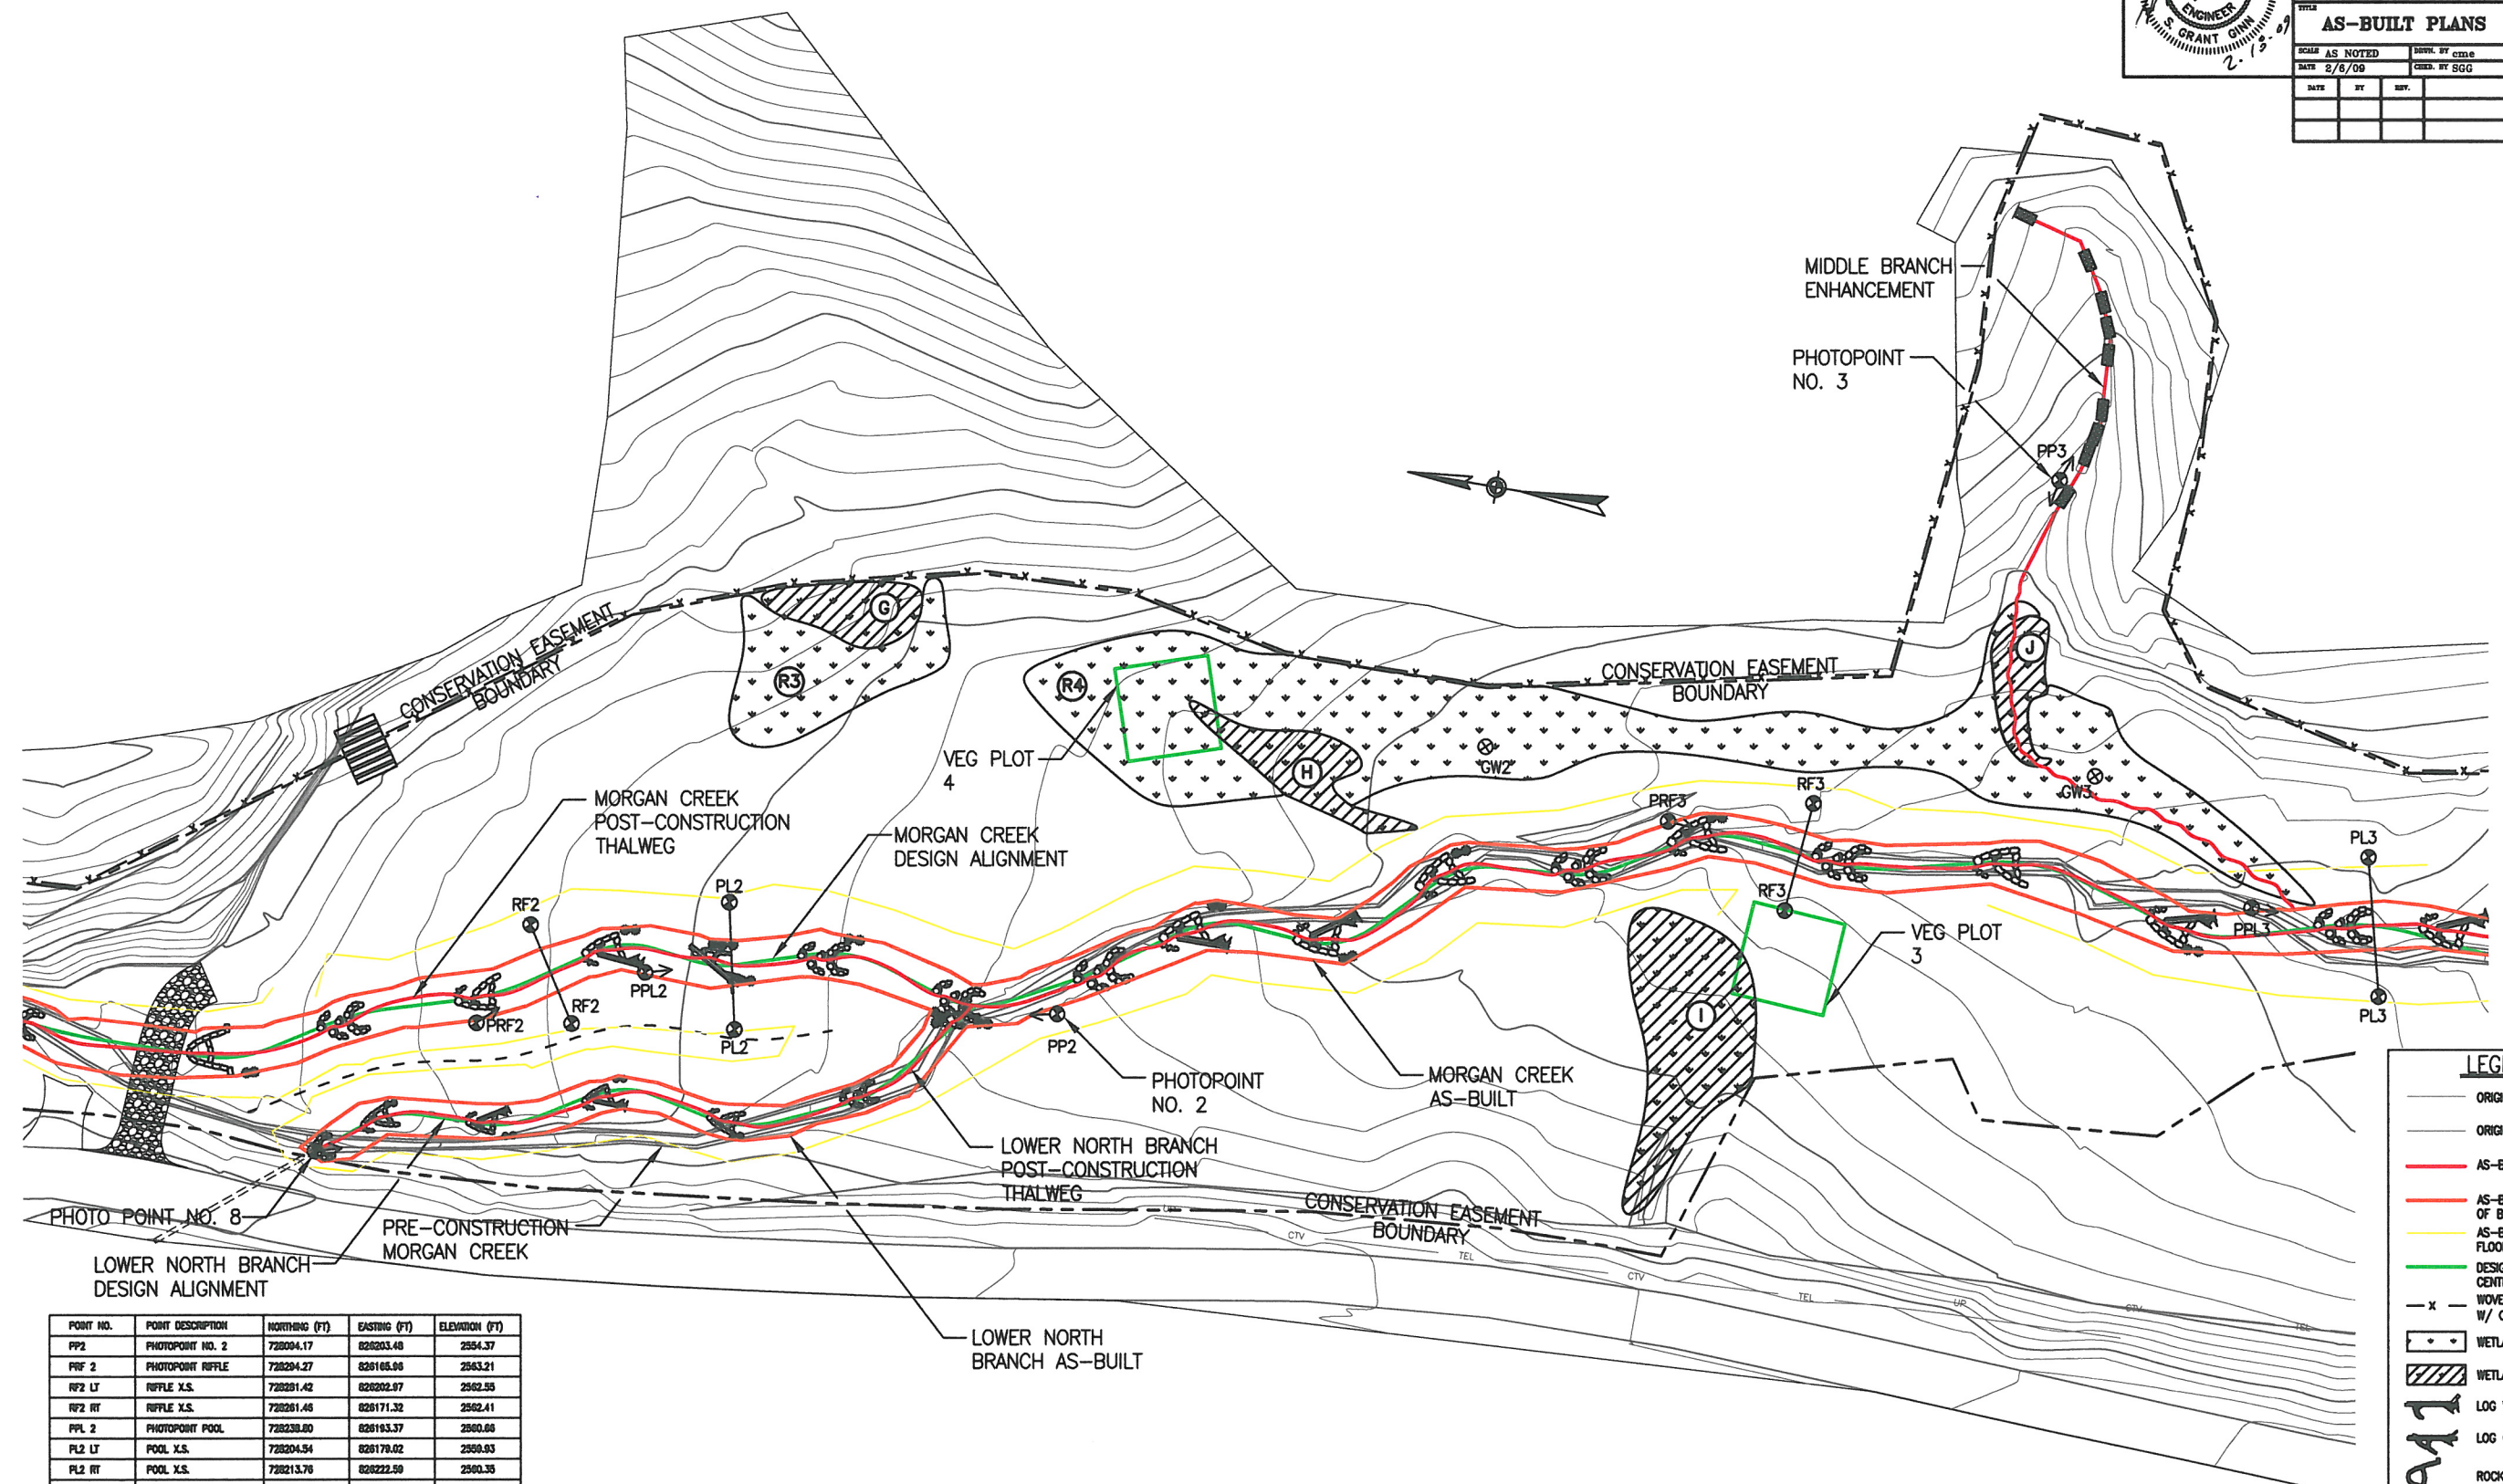
AS-BUILT PLANS

- ORIGINAL CHANNEL
- ORIGINAL CONTOUR
- AS-BUILT THALWEG
- AS-BUILT TOP OF BANK
- AS-BUILT FLOODPLAIN
- DESIGN CHANNEL CENTERLINE
- x - WOVEN WIRE FENCE W/ ONE STRAND B/W
- WETLAND RESTORATION
- ▨ WETLAND ENHANCEMENT
- LOG VANE
- LOG CROSS VANE
- ROCK CROSS VANE
- BOULDER RUN
- LOG VANE RUN
- DOUBLE HOOK RUN
- ⊗ IRON ROD
- ⊗ GAUGE

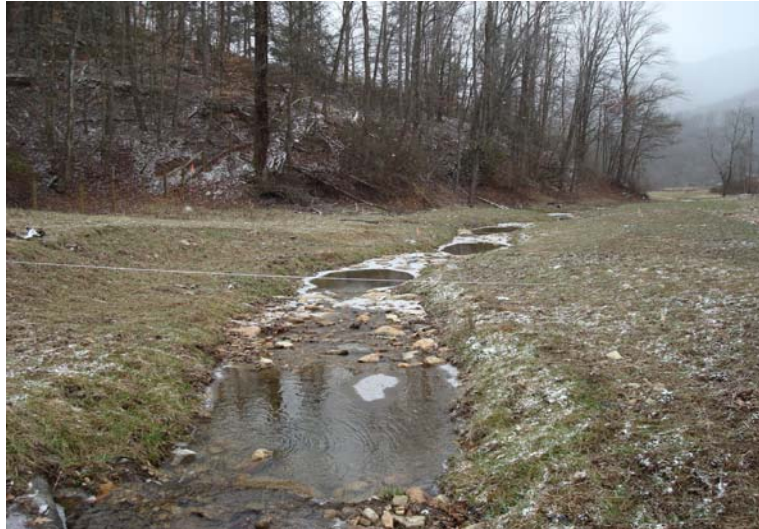
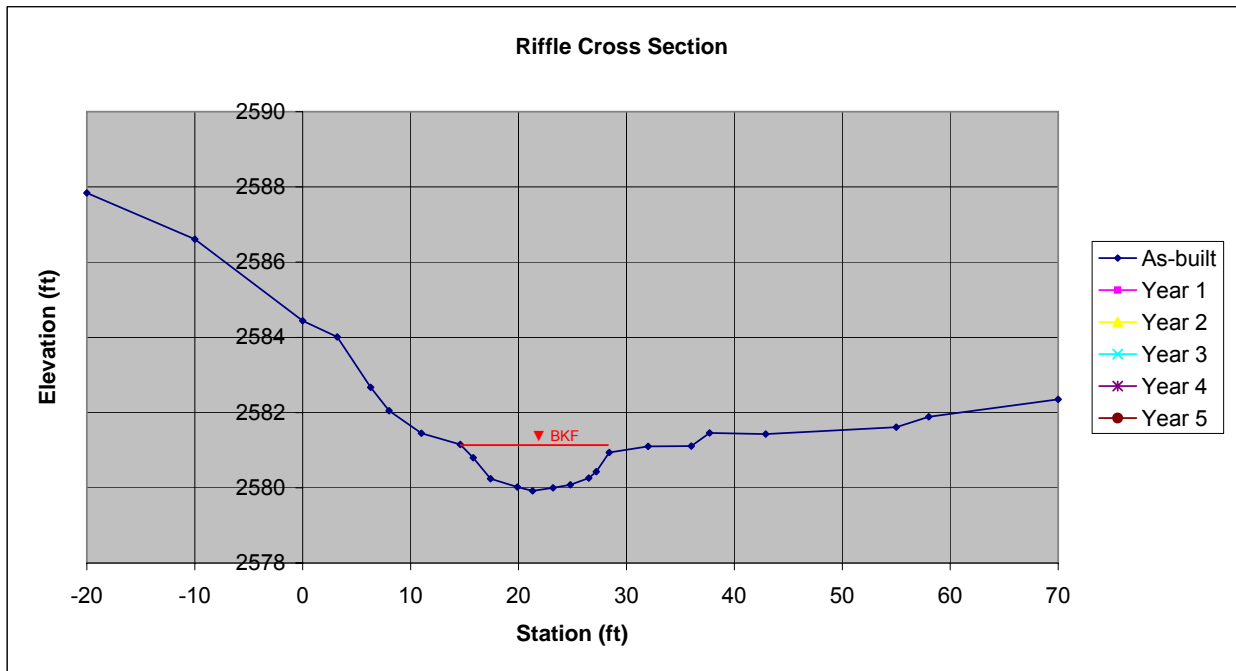
Haywood County, NC
 Riffle Cross Section RF1
 Reach 1 - Morgan Creek - Sta 15+21.4

Year 0

Facing Downstream

As-Built		Year 1		Year 2		Year 3		Year 4		Year 5	
Date	1/8/09	Date	0/0/0	Date	0/0/0	Date	0/0/0	Date	0/0/0	Date	0/0/0
Area	12.2	Area	0.0	Area	0.0	Area	0.0	Area	0.0	Area	0.0
Bkf W	13.8	Bkf W	10	Bkf W	10	Bkf W	10	Bkf W	10	Bkf W	10
Dmean	0.9	Dmean	0.0	Dmean	0.0	Dmean	0.0	Dmean	0.0	Dmean	0.0
Dmax	1.2	Dmax	0.0	Dmax	0.0	Dmax	0.0	Dmax	0.0	Dmax	0.0
W/d	15.6	W/d	0.0	W/d	0.0	W/d	0.0	W/d	0.0	W/d	0.0

Cross-section measurements should indicate little change from the as-built cross-sections. If changes do occur, they will be evaluated to determine whether the adjustments are associated with settling and increased stability or whether they indicate movement towards an unstable condition. The following thresholds will be considered indicators of concern:

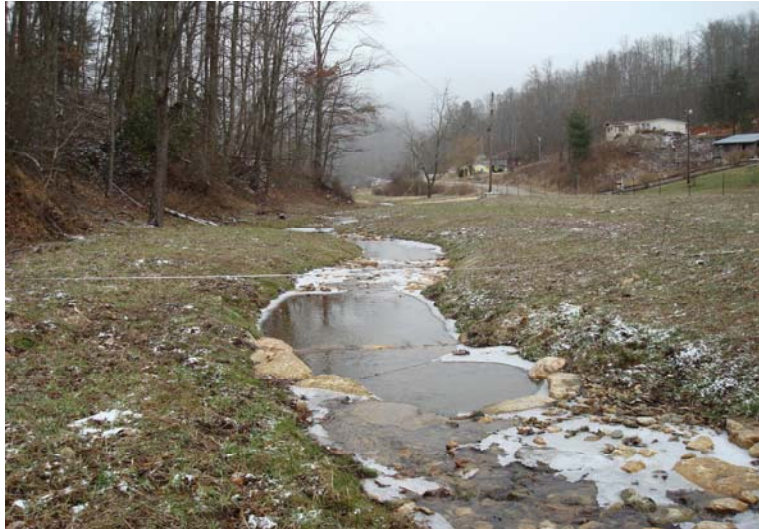
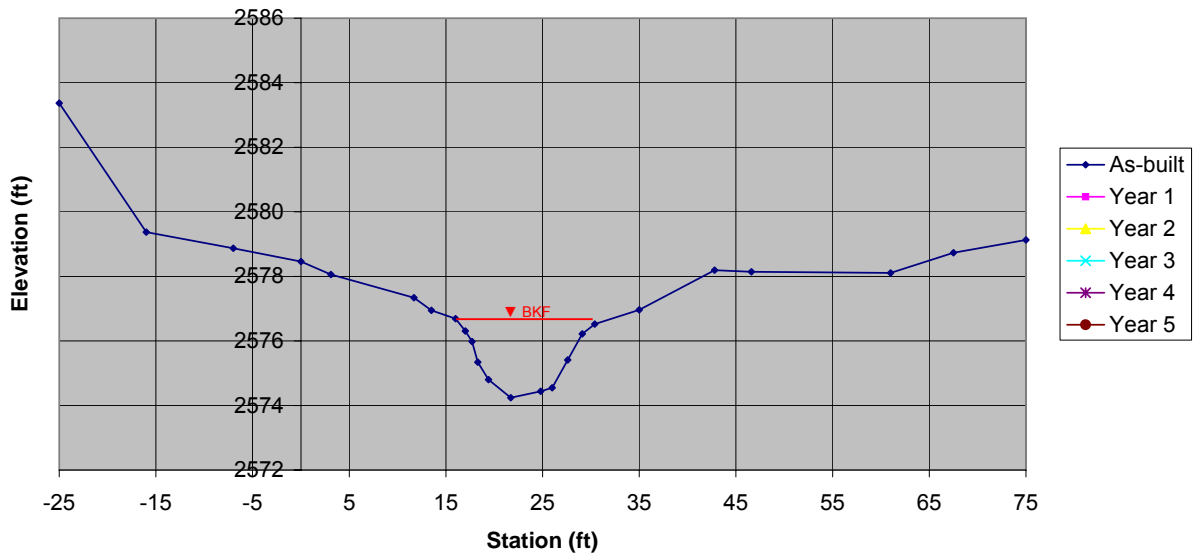
Pool Cross Section PL1

Reach 1 - Morgan Creek - Sta 16+28.6

Year 0

Facing Downstream

As-Built		Year 1		Year 2		Year 3		Year 4		Year 5	
Date	1/8/09	Date	0/0/0	Date	0/0/0	Date	0/0/0	Date	0/0/0	Date	0/0/0
Area	22.5	Area	0.0	Area	0.0	Area	0.0	Area	0.0	Area	0.0
Bkf W	14.4	Bkf W	10	Bkf W	10	Bkf W	10	Bkf W	10	Bkf W	10
Dmean	1.6	Dmean	0.0	Dmean	0.0	Dmean	0.0	Dmean	0.0	Dmean	0.0
Dmax	2.5	Dmax	0.0	Dmax	0.0	Dmax	0.0	Dmax	0.0	Dmax	0.0
W/d	9.2	W/d	0.0	W/d	0.0	W/d	0.0	W/d	0.0	W/d	0.0

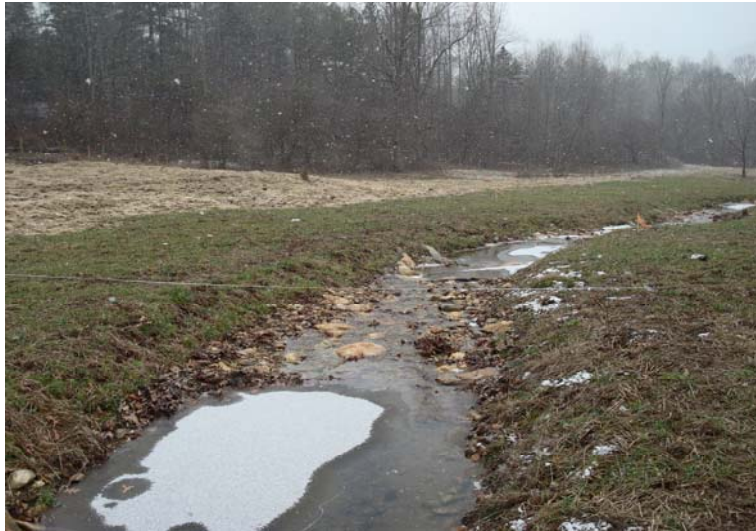
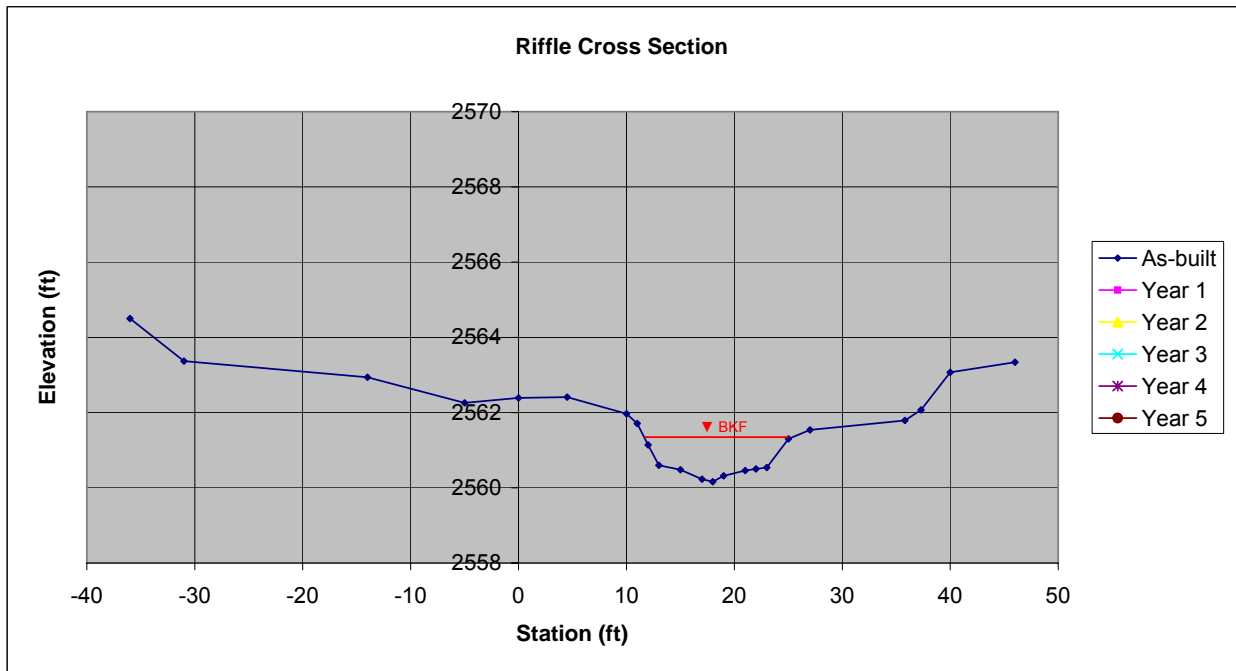
Haywood County, NC
 Riffle Cross Section RF2
 Reach 1 - Morgan Creek - Sta 20+74.6

Year 0

Facing Downstream

As-Built		Year 1		Year 2		Year 3		Year 4		Year 5	
Date	1/8/09	Date	0/0/0	Date	0/0/0	Date	0/0/0	Date	0/0/0	Date	0/0/0
Area	10.2	Area	0.0	Area	0.0	Area	0.0	Area	0.0	Area	0.0
Bkf W	13.5	Bkf W	10	Bkf W	10	Bkf W	10	Bkf W	10	Bkf W	10
Dmean	0.8	Dmean	0.0	Dmean	0.0	Dmean	0.0	Dmean	0.0	Dmean	0.0
Dmax	1.1	Dmax	0.0	Dmax	0.0	Dmax	0.0	Dmax	0.0	Dmax	0.0
W/d	17.9	W/d	0.0	W/d	0.0	W/d	0.0	W/d	0.0	W/d	0.0

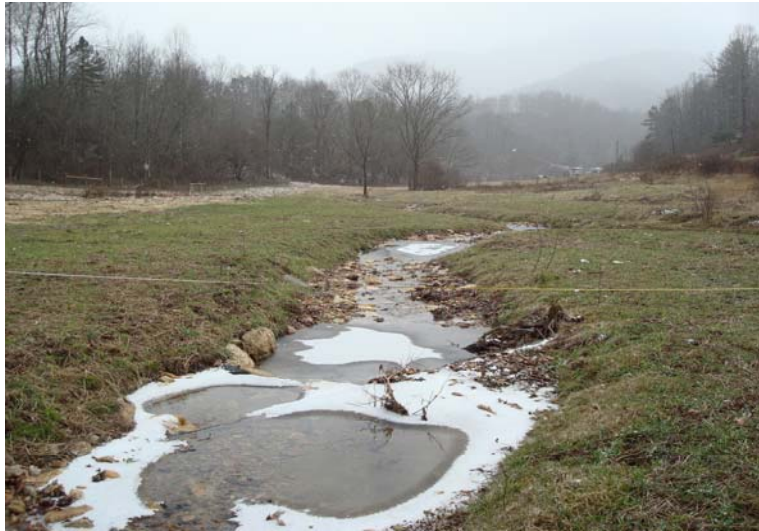
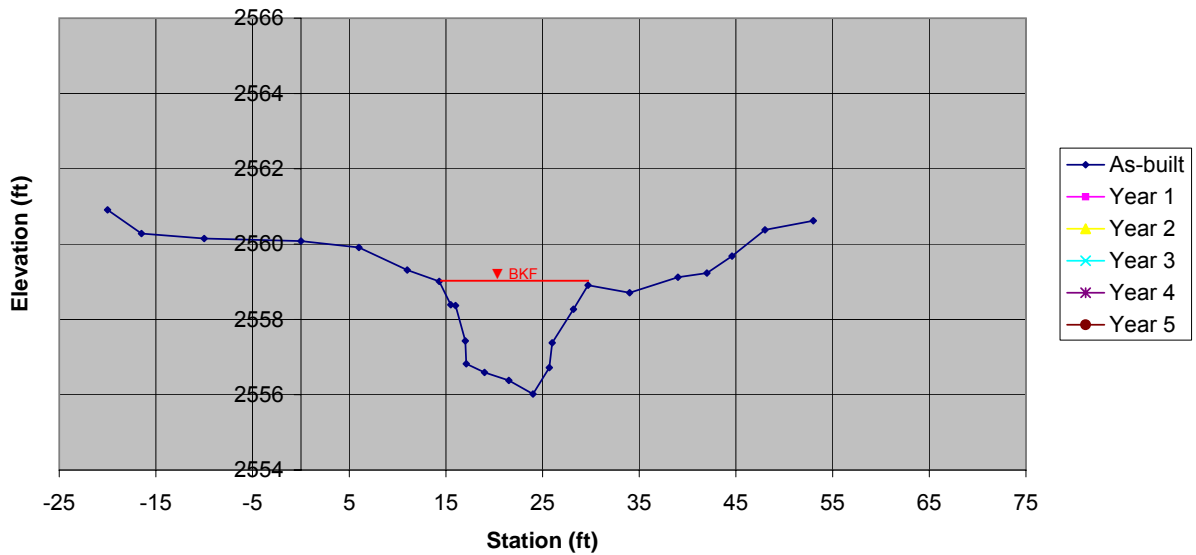
Pool Cross Section PL2

Reach 1 - Morgan Creek - Sta 21+44

Year 0

Facing Downstream

As-Built		Year 1		Year 2		Year 3		Year 4		Year 5	
Date	1/8/09	Date	0/0/0	Date	0/0/0	Date	0/0/0	Date	0/0/0	Date	0/0/0
Area	28.0	Area	0.0	Area	0.0	Area	0.0	Area	0.0	Area	0.0
Bkf W	15.4	Bkf W	10	Bkf W	10	Bkf W	10	Bkf W	10	Bkf W	10
Dmean	1.8	Dmean	0.0	Dmean	0.0	Dmean	0.0	Dmean	0.0	Dmean	0.0
Dmax	3.0	Dmax	0.0	Dmax	0.0	Dmax	0.0	Dmax	0.0	Dmax	0.0
W/d	8.5	W/d	0.0	W/d	0.0	W/d	0.0	W/d	0.0	W/d	0.0

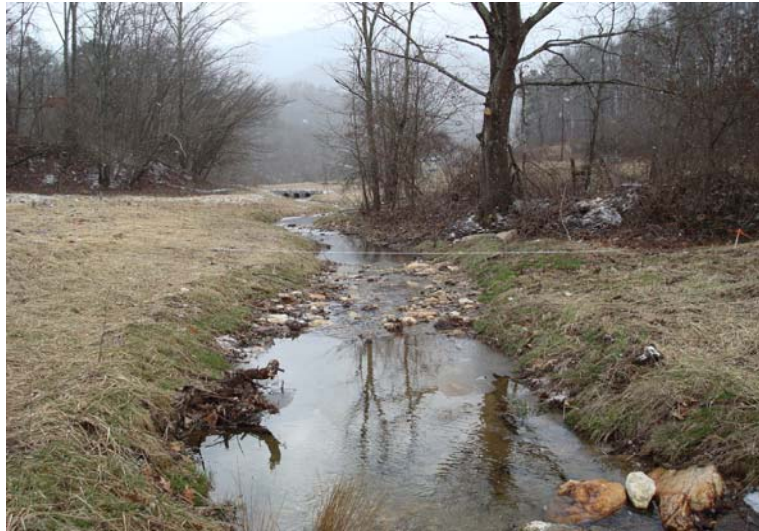
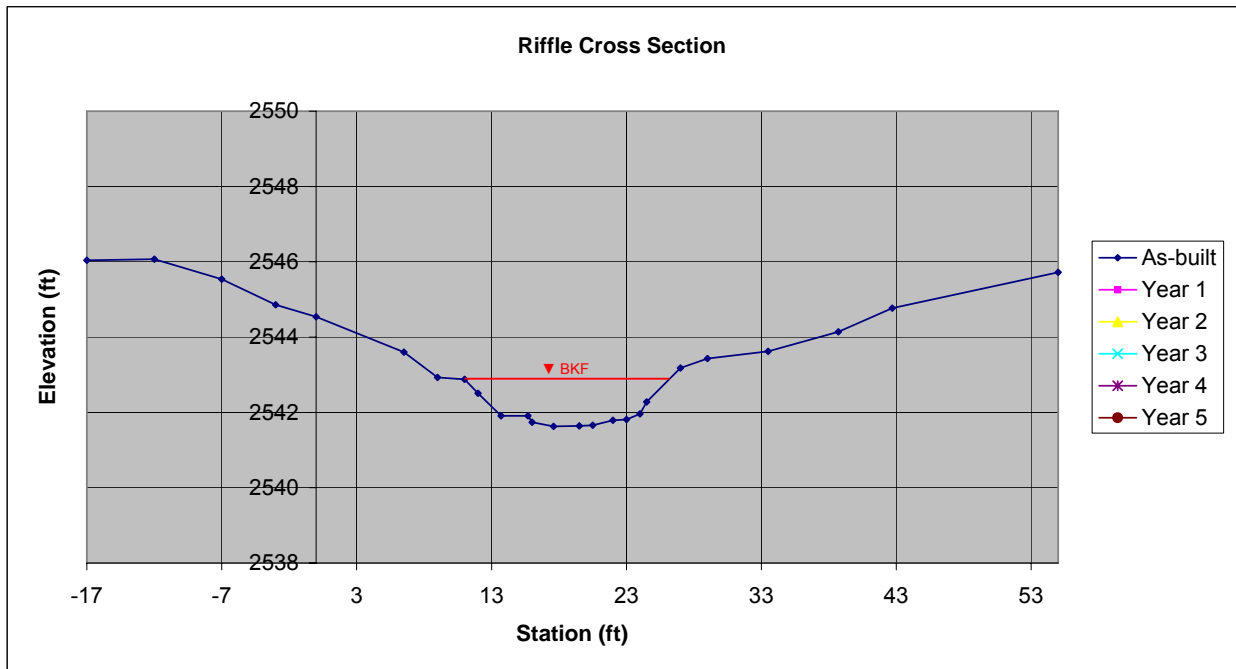
Haywood County, NC
 Riffle Cross Section RF3
 Reach 1 - Morgan Creek - Sta 25+60.4

Year 0

Facing Downstream

As-Built		Year 1		Year 2		Year 3		Year 4		Year 5	
Date	1/8/09	Date	0/0/0	Date	0/0/0	Date	0/0/0	Date	0/0/0	Date	0/0/0
Area	13.3	Area	0.0	Area	0.0	Area	0.0	Area	0.0	Area	0.0
Bkf W	15	Bkf W	10	Bkf W	10	Bkf W	10	Bkf W	10	Bkf W	10
Dmean	0.9	Dmean	0.0	Dmean	0.0	Dmean	0.0	Dmean	0.0	Dmean	0.0
Dmax	1.3	Dmax	0.0	Dmax	0.0	Dmax	0.0	Dmax	0.0	Dmax	0.0
W/d	16.9	W/d	0.0	W/d	0.0	W/d	0.0	W/d	0.0	W/d	0.0

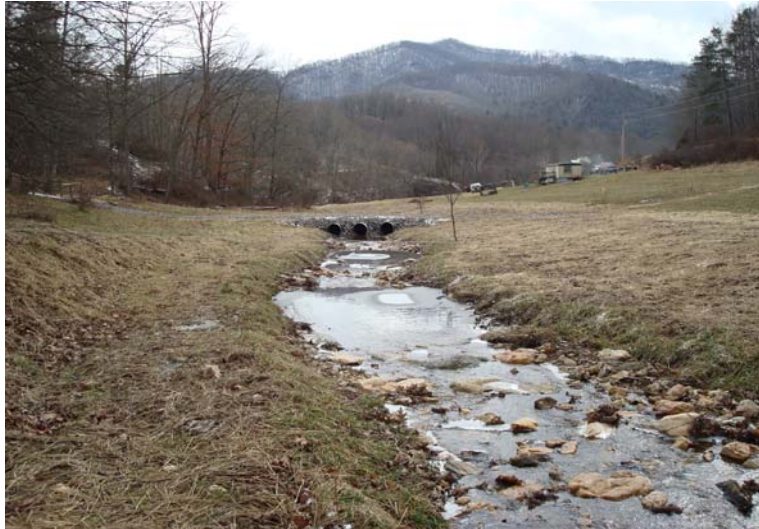
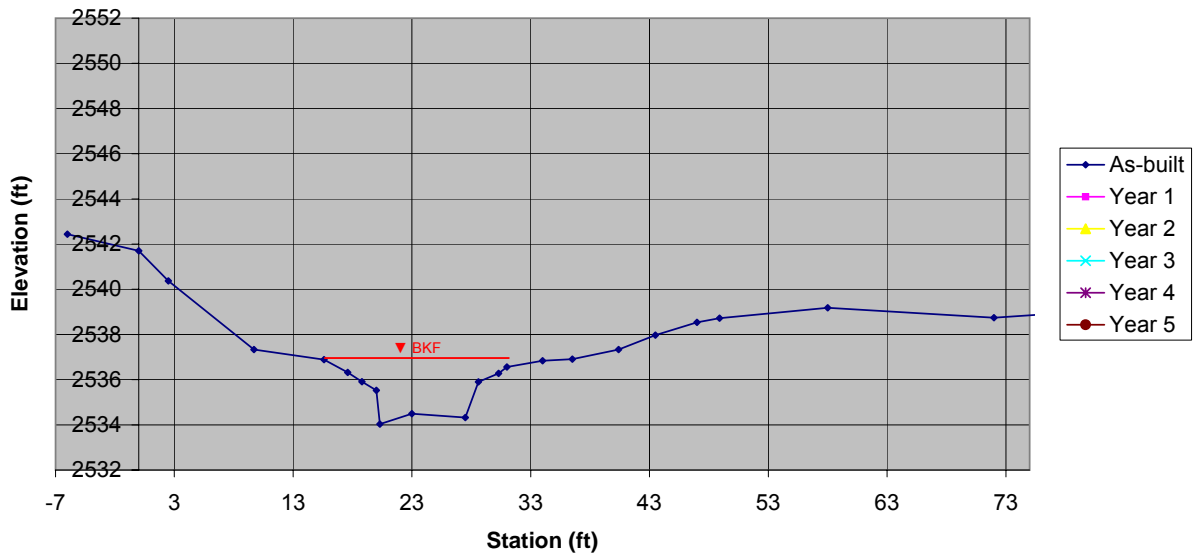
Haywood County, NC
Pool Cross Section PL3

Reach 1 - Morgan Creek - Sta 27+79.7

Year 0

Facing Downstream

As-Built		Year 1		Year 2		Year 3		Year 4		Year 5	
Date	1/8/09	Date	0/0/0	Date	0/0/0	Date	0/0/0	Date	0/0/0	Date	0/0/0
Area	25.5	Area	0.0	Area	0.0	Area	0.0	Area	0.0	Area	0.0
Bkf W	15.4	Bkf W	10	Bkf W	10	Bkf W	10	Bkf W	10	Bkf W	10
Dmean	1.7	Dmean	0.0	Dmean	0.0	Dmean	0.0	Dmean	0.0	Dmean	0.0
Dmax	2.9	Dmax	0.0	Dmax	0.0	Dmax	0.0	Dmax	0.0	Dmax	0.0
W/d	9.3	W/d	0.0	W/d	0.0	W/d	0.0	W/d	0.0	W/d	0.0

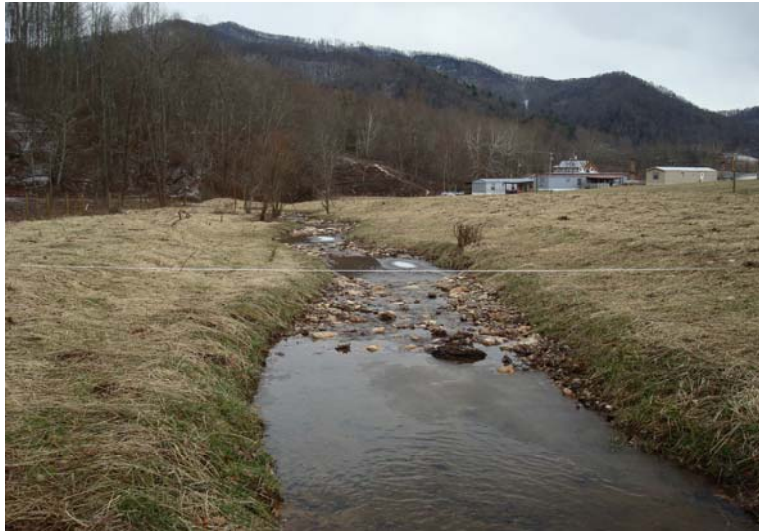
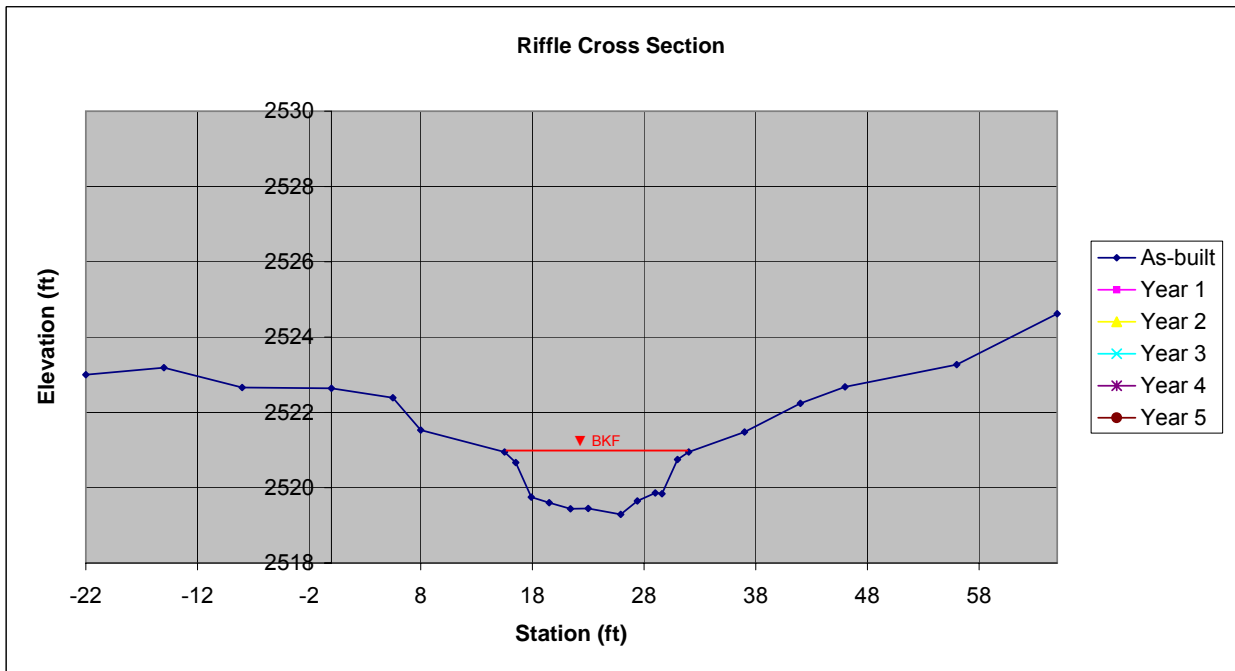
Haywood County, NC
 Riffle Cross Section RF4
 Reach 4 - Morgan Creek - Sta 33+24.4

Year 0

Facing Downstream

As-Built		Year 1		Year 2		Year 3		Year 4		Year 5	
Date	1/8/09	Date	0/0/0	Date	0/0/0	Date	0/0/0	Date	0/0/0	Date	0/0/0
Area	18.7	Area	0.0	Area	0.0	Area	0.0	Area	0.0	Area	0.0
Bkf W	16.5	Bkf W	10	Bkf W	10	Bkf W	10	Bkf W	10	Bkf W	10
Dmean	1.1	Dmean	0.0	Dmean	0.0	Dmean	0.0	Dmean	0.0	Dmean	0.0
Dmax	1.7	Dmax	0.0	Dmax	0.0	Dmax	0.0	Dmax	0.0	Dmax	0.0
W/d	14.5	W/d	0.0	W/d	0.0	W/d	0.0	W/d	0.0	W/d	0.0

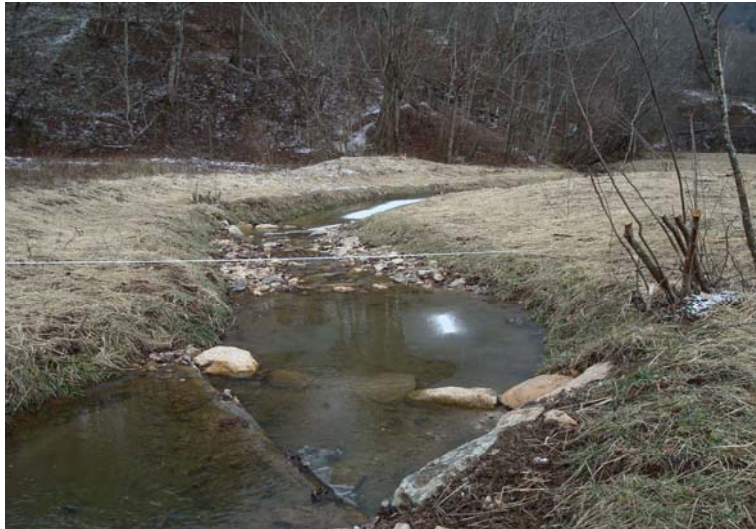
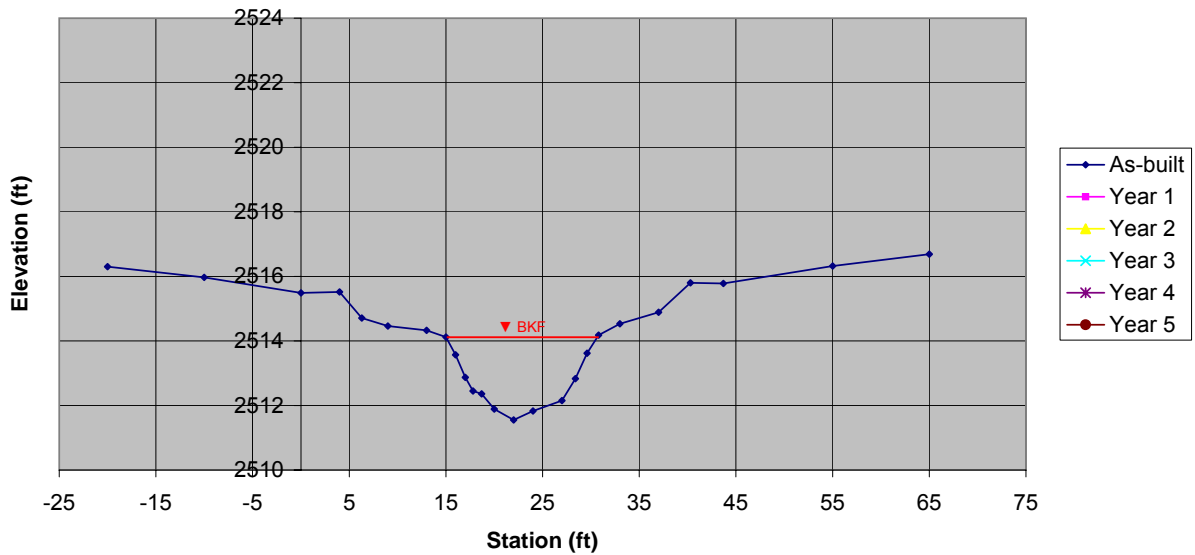
Haywood County, NC
Pool Cross Section PL4

Reach 1 - Morgan Creek - Sta 35+46

Year 0

Facing Downstream

As-Built	Year 1	Year 2	Year 3	Year 4	Year 5
Date 1/8/09	Date 0/0/0	Date 0/0/0	Date 0/0/0	Date 0/0/0	Date 0/0/0
Area 26.1	Area 0.0	Area 0.0	Area 0.0	Area 0.0	Area 0.0
Bkf W 15.8	Bkf W 10	Bkf W 10	Bkf W 10	Bkf W 10	Bkf W 10
Dmean 1.7	Dmean 0.0	Dmean 0.0	Dmean 0.0	Dmean 0.0	Dmean 0.0
Dmax 2.6	Dmax 0.0	Dmax 0.0	Dmax 0.0	Dmax 0.0	Dmax 0.0
W/d 9.5	W/d 0.0	W/d 0.0	W/d 0.0	W/d 0.0	W/d 0.0

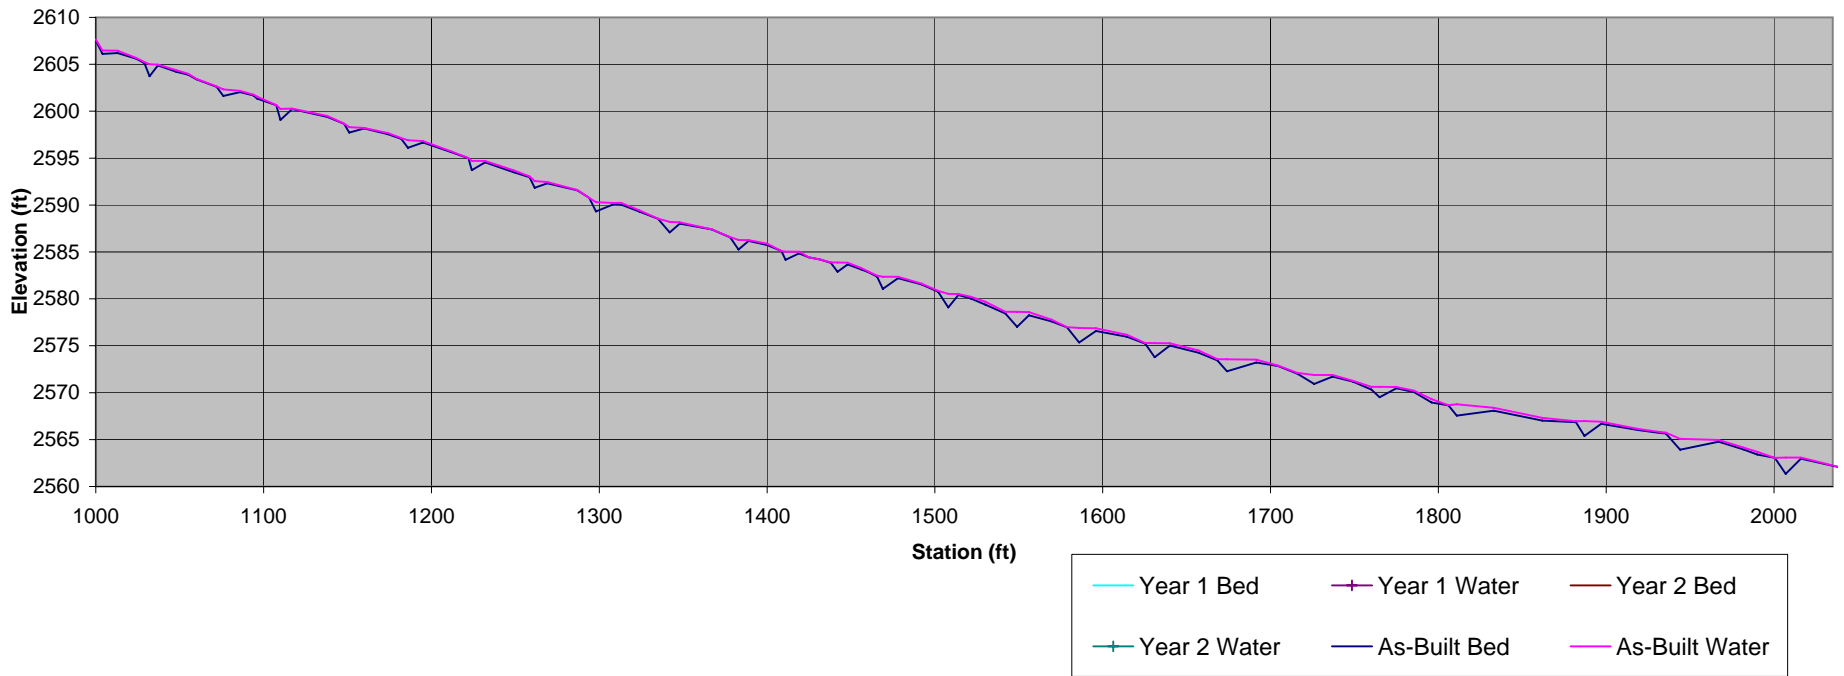
Morgan Creek Stream Restoration Site
Haywood County, NC
Profile Reach 1 - Morgan Creek

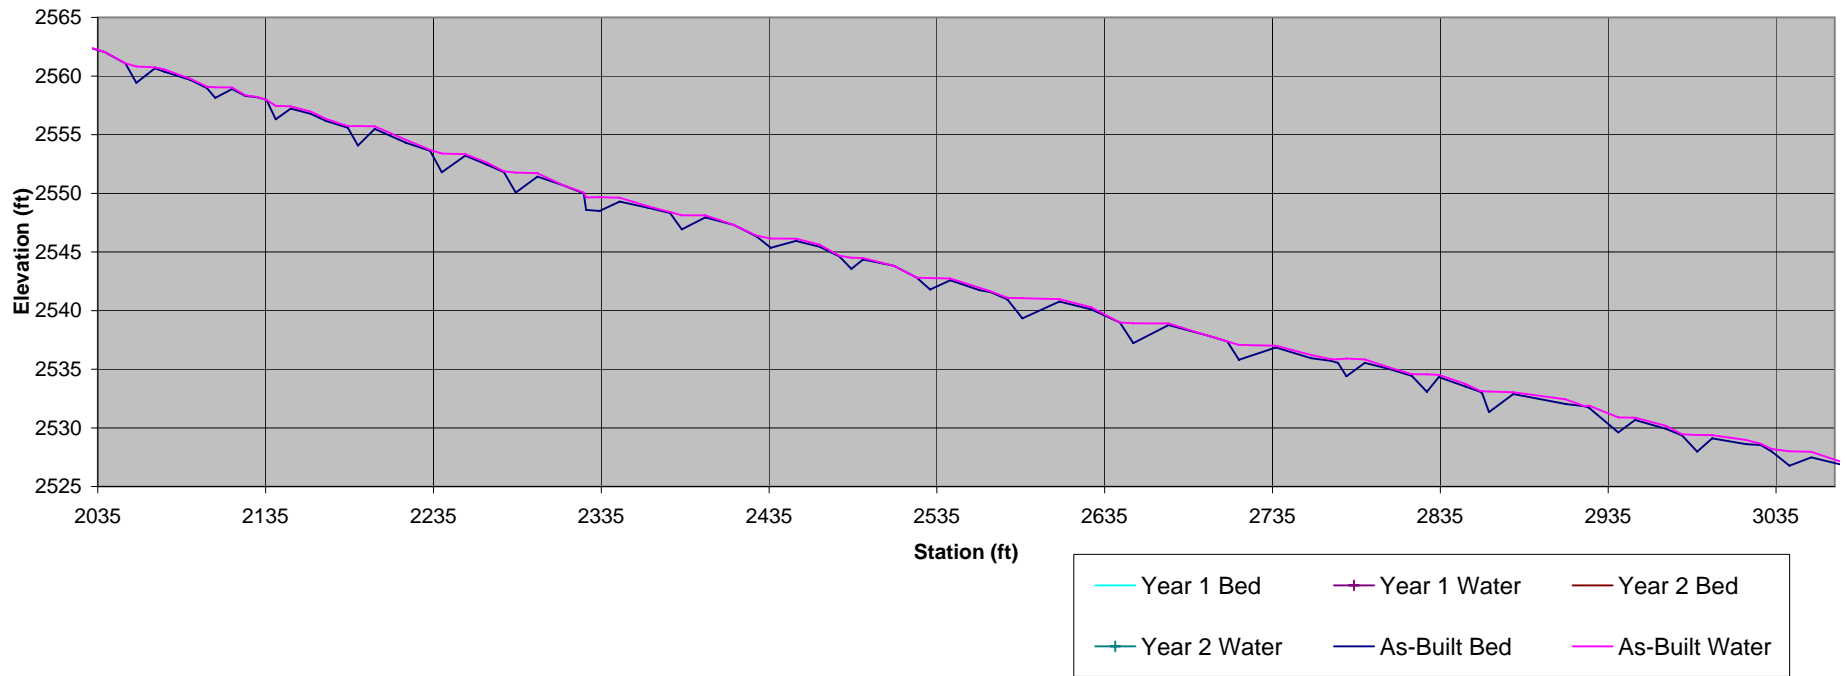
Morgan Creek Stream Restoration Site
Haywood County, NC
Profile Reach 1 - Morgan Creek

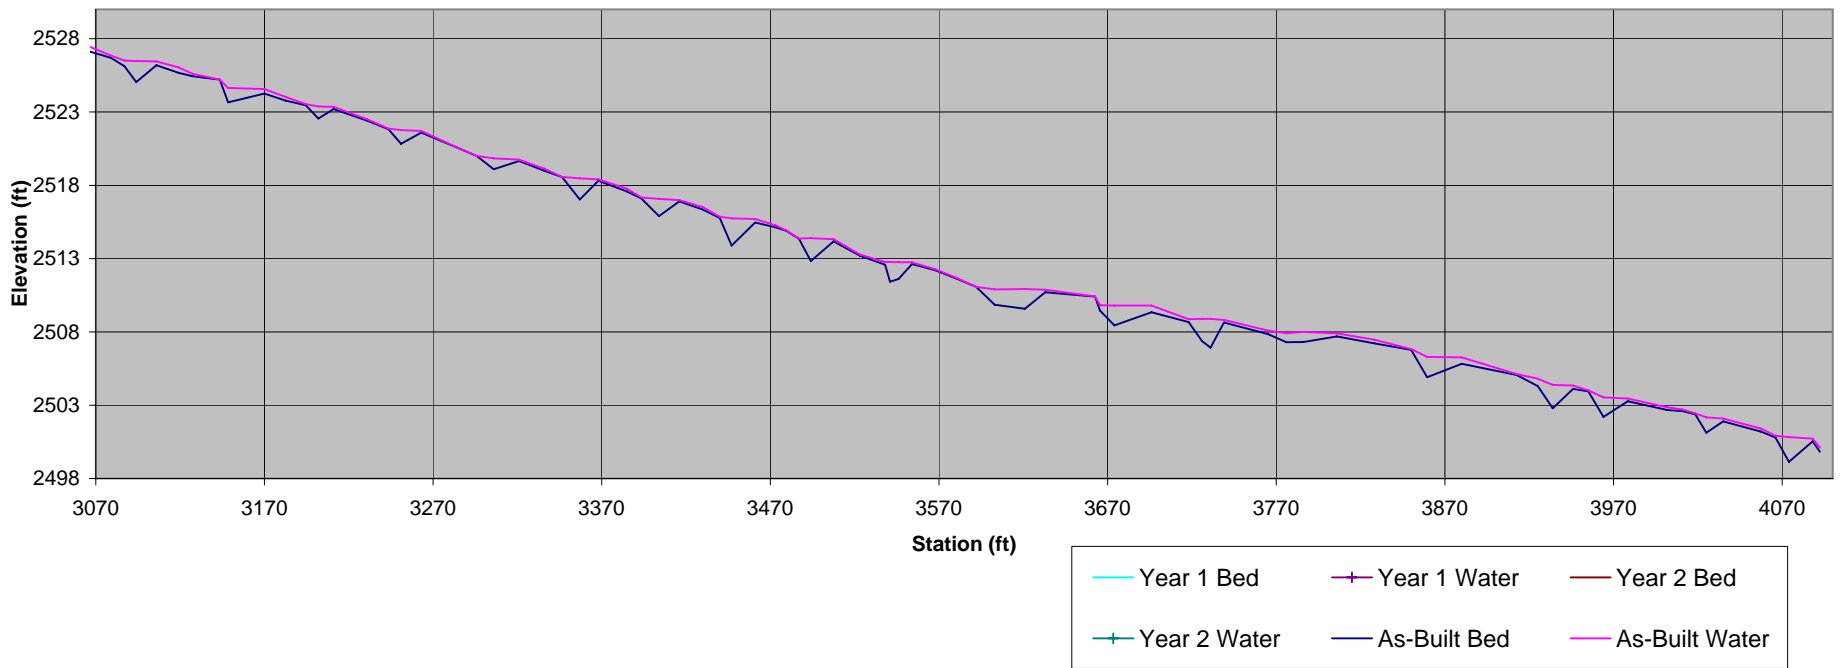
Morgan Creek Stream Restoration Site
Haywood County, NC
Profile Reach 1 - Morgan Creek

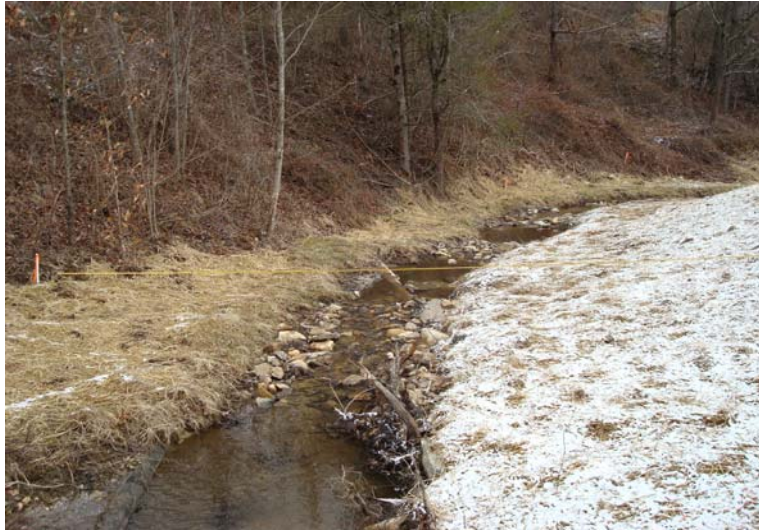
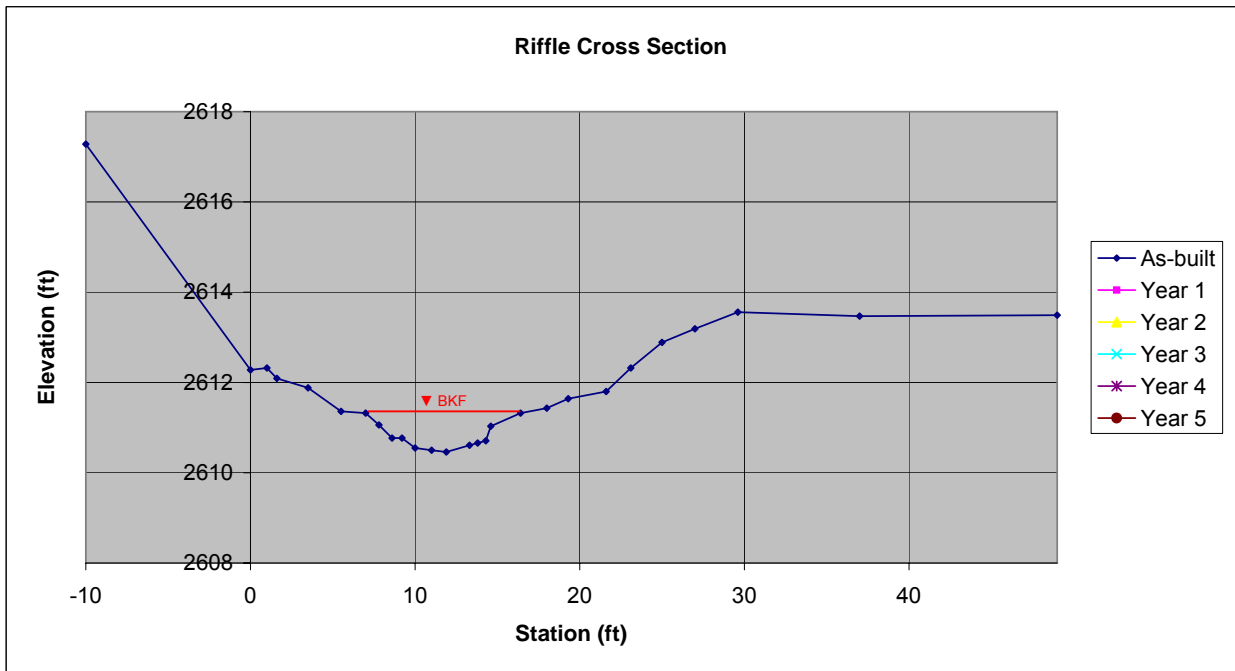
Haywood County, NC
 Riffle Cross Section RF5
 Reach 2 - North Branch - Sta 10+85.4

Year 0

Facing Downstream

As-Built		Year 1		Year 2		Year 3		Year 4		Year 5	
Date	1/8/09	Date	0/0/0	Date	0/0/0	Date	0/0/0	Date	0/0/0	Date	0/0/0
Area	5.0	Area	0.0	Area	0.0	Area	0.0	Area	0.0	Area	0.0
Bkf W	9.4	Bkf W	10	Bkf W	10	Bkf W	10	Bkf W	10	Bkf W	10
Dmean	0.5	Dmean	0.0	Dmean	0.0	Dmean	0.0	Dmean	0.0	Dmean	0.0
Dmax	0.9	Dmax	0.0	Dmax	0.0	Dmax	0.0	Dmax	0.0	Dmax	0.0
W/d	17.7	W/d	0.0	W/d	0.0	W/d	0.0	W/d	0.0	W/d	0.0
