MITIGATION PLAN AND AS-BUILT BASELINE REPORT Morgan Creek Stream Restoration Site

Haywood County, North Carolina

EEP Contract #: D06035-A

MITIGATION PLAN AND AS-BUILT BASELINE REPORT

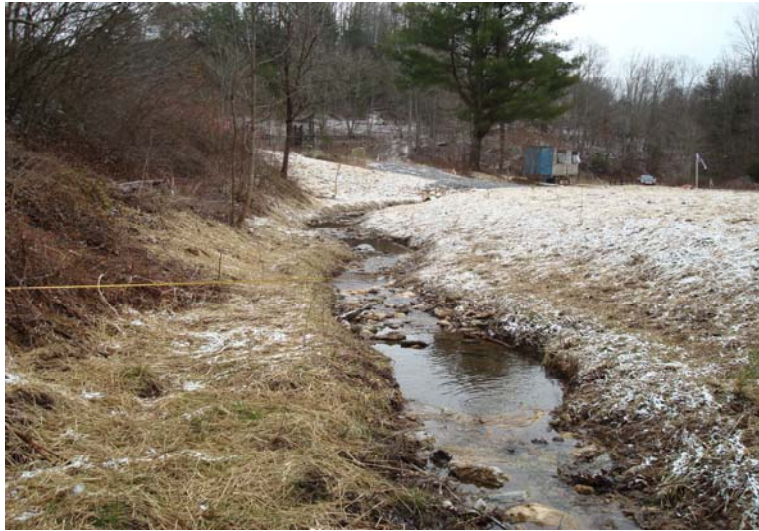
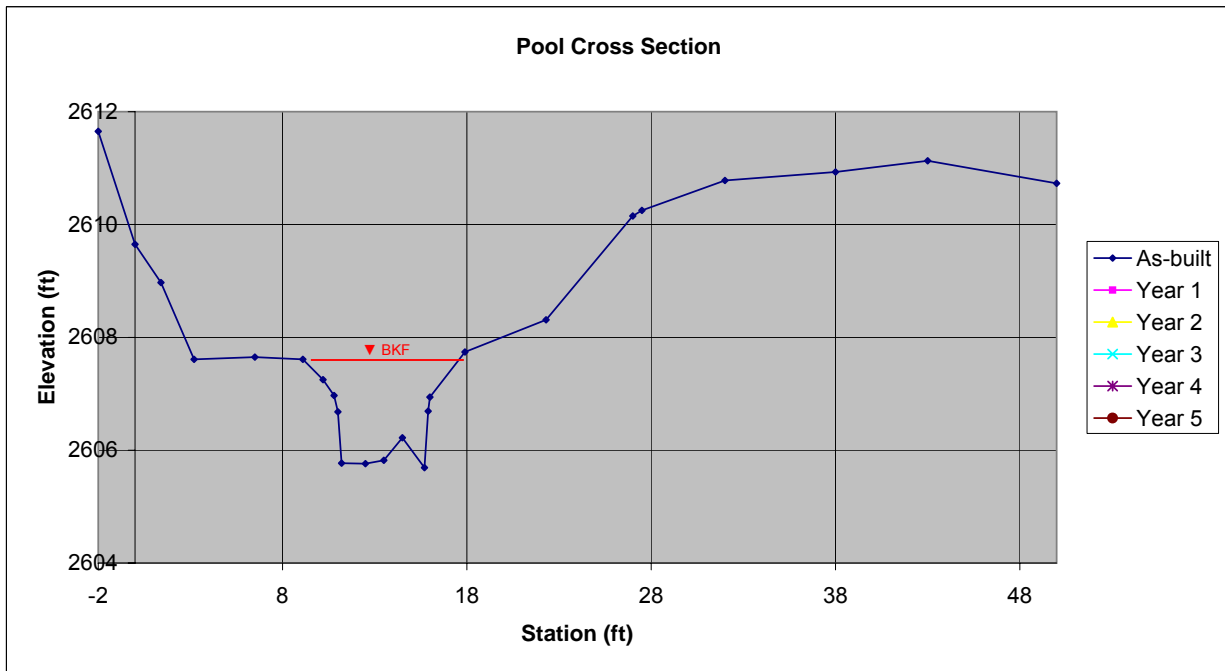
Haywood County, NC
 Pool Cross Section PL5
 Reach 2 -North Branch - Sta 11+54.5

Year 0

Facing Downstream

As-Built		Year 1		Year 2		Year 3		Year 4		Year 5	
Date	1/8/09	Date	0/0/0	Date	0/0/0	Date	0/0/0	Date	0/0/0	Date	0/0/0
Area	9.6	Area	0.0	Area	0.0	Area	0.0	Area	0.0	Area	0.0
Bkf W	8.8	Bkf W	10	Bkf W	10	Bkf W	10	Bkf W	10	Bkf W	10
Dmean	1.1	Dmean	0.0	Dmean	0.0	Dmean	0.0	Dmean	0.0	Dmean	0.0
Dmax	1.9	Dmax	0.0	Dmax	0.0	Dmax	0.0	Dmax	0.0	Dmax	0.0
W/d	8.1	W/d	0.0	W/d	0.0	W/d	0.0	W/d	0.0	W/d	0.0

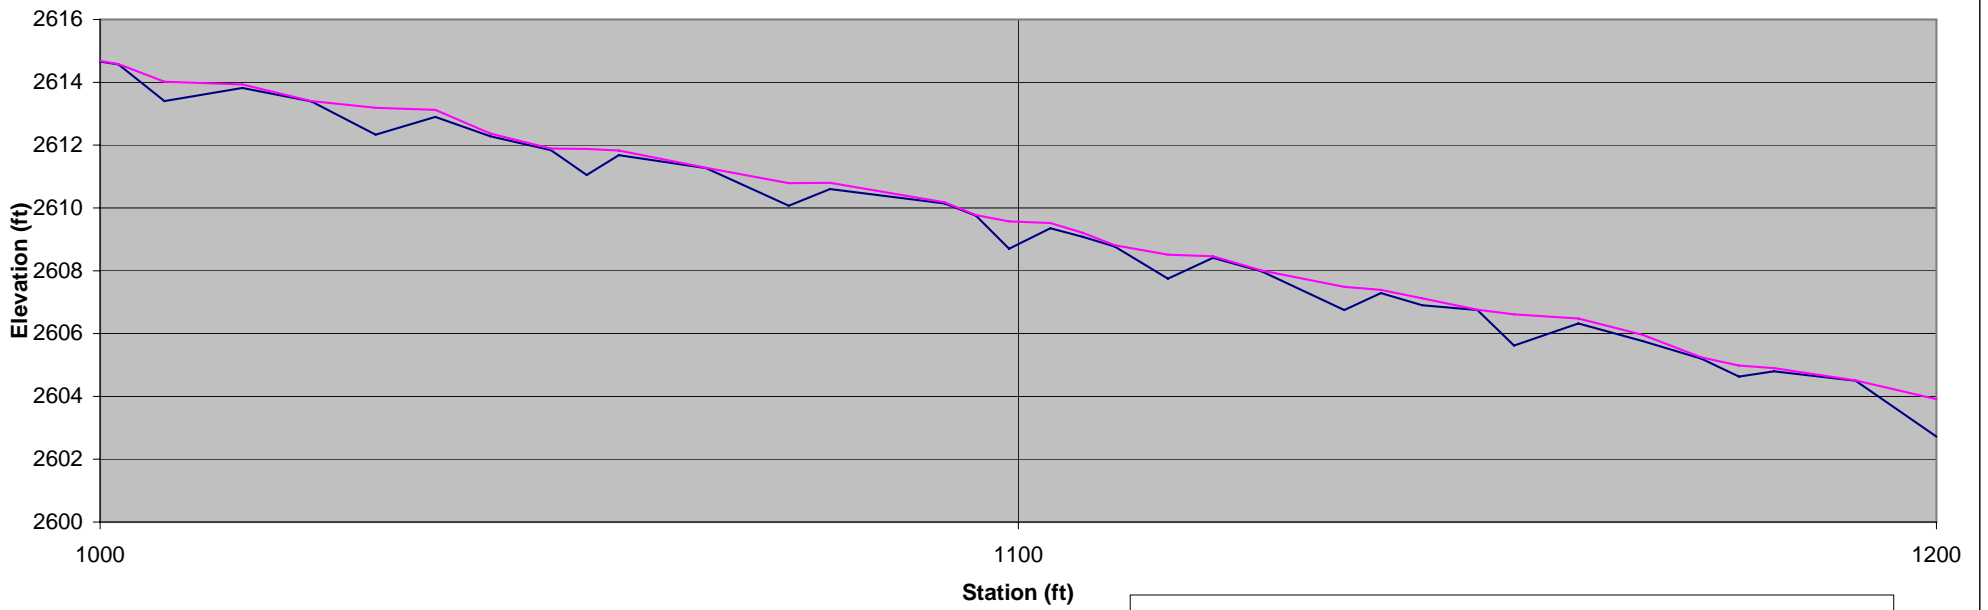
Profile Reach 2 - North Branch

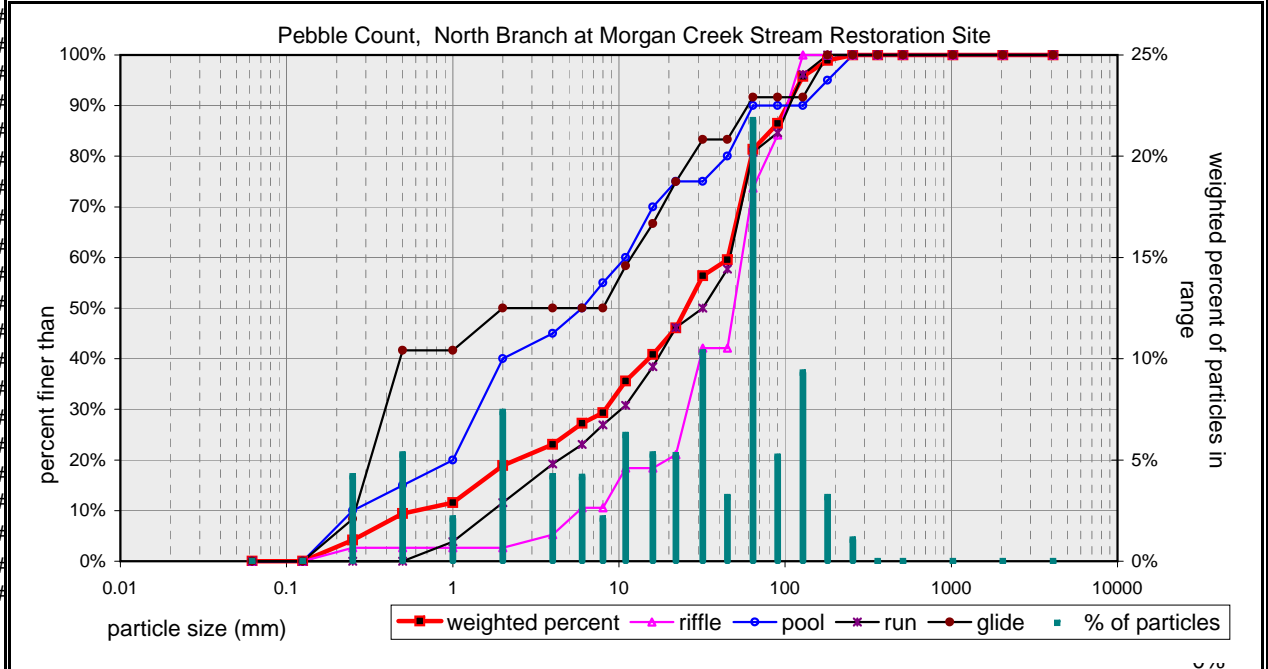
Material	Size Range (mm)	weighted	#	
silt/clay	0	0.062	0.0	#
very fine sand	0.062	0.13	0.0	#
fine sand	0.13	0.25	4.0	#
medium sand	0.25	0.5	5.0	#
coarse sand	0.5	1	2.0	#
very coarse sand	1	2	7.0	#
very fine gravel	2	4	4.0	#
fine gravel	4	6	4.0	#
fine gravel	6	8	2.0	#
medium gravel	8	11	5.9	#
medium gravel	11	16	5.0	#
coarse gravel	16	22	5.0	#
coarse gravel	22	32	9.8	#
very coarse gravel	32	45	3.0	#
very coarse gravel	45	64	20.7	#
small cobble	64	90	4.9	#
medium cobble	90	128	8.9	#
large cobble	128	180	3.0	#
very large cobble	180	256	1.0	#
small boulder	256	362	0.0	#
small boulder	362	512	0.0	#
medium boulder	512	1024	0.0	#
large boulder	1024	2048	0.0	#
very large boulder	2048	4096	0.0	#

North Branch at Morgan Creek Stream Restoration Site
 Haywood County, NC
 North Branch: Reach 2
 Note: **North Branch Beiginning at Sta 10+56** 0%

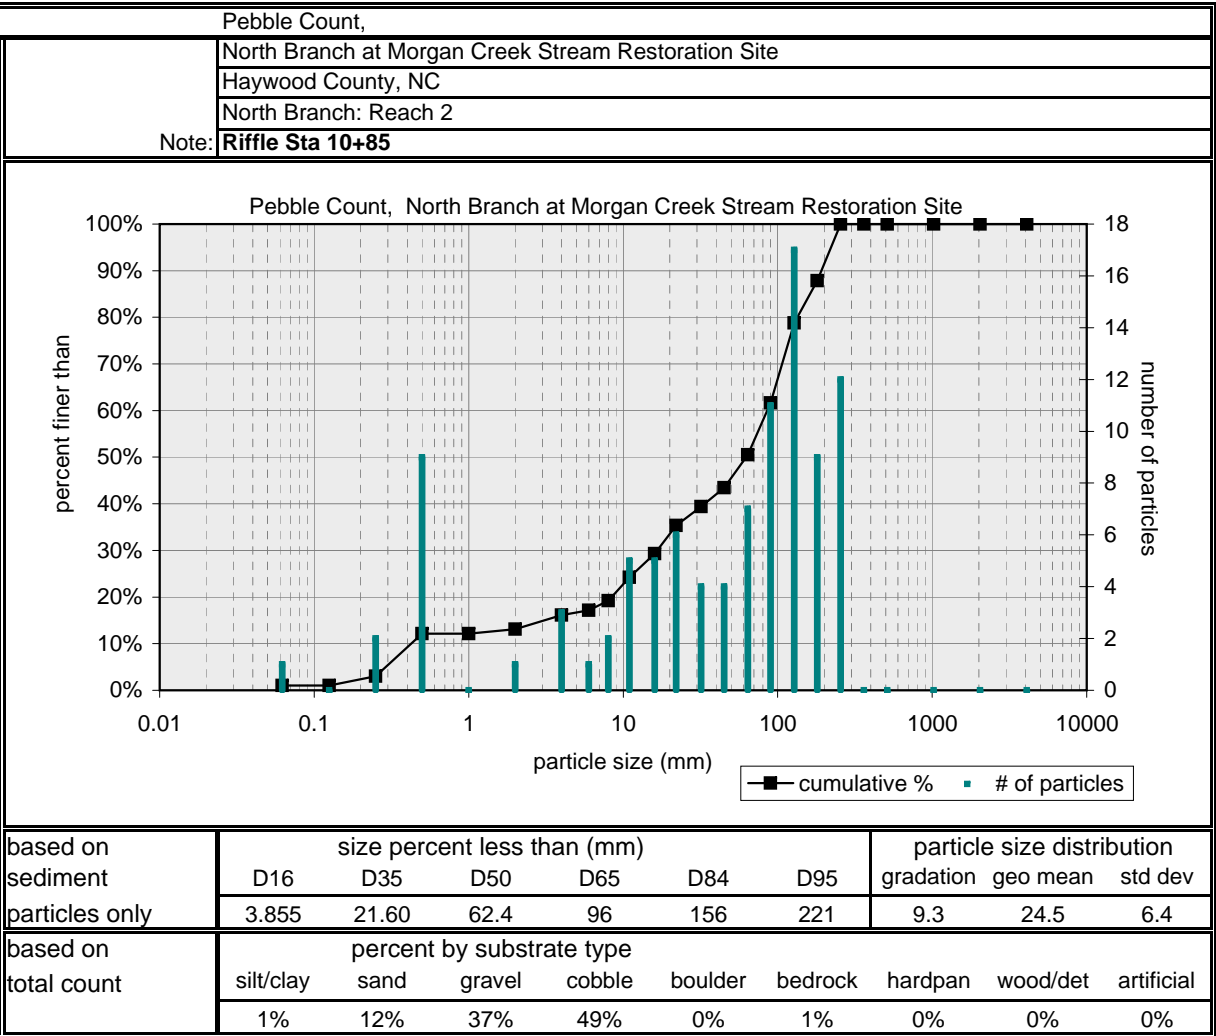
Pebble Count of Channel Reach			
Material	Size Range (mm)		Count
silt/clay	0	0.062	1
very fine sand	0.062	0.13	0
fine sand	0.13	0.25	2
medium sand	0.25	0.5	9
coarse sand	0.5	1	0
very coarse sand	1	2	1
very fine gravel	2	4	3
fine gravel	4	6	1
fine gravel	6	8	2
medium gravel	8	11	5
medium gravel	11	16	5
coarse gravel	16	22	6
coarse gravel	22	32	4
very coarse gravel	32	45	4
very coarse gravel	45	64	7
small cobble	64	90	11
medium cobble	90	128	17
large cobble	128	180	9
very large cobble	180	256	12
small boulder	256	362	0
small boulder	362	512	0
medium boulder	512	1024	0
large boulder	1024	2048	0
very large boulder	2048	4096	0
total particle count:			99
bedrock			1
clay hardpan			
detritus/wood			
artificial			
total count:			100

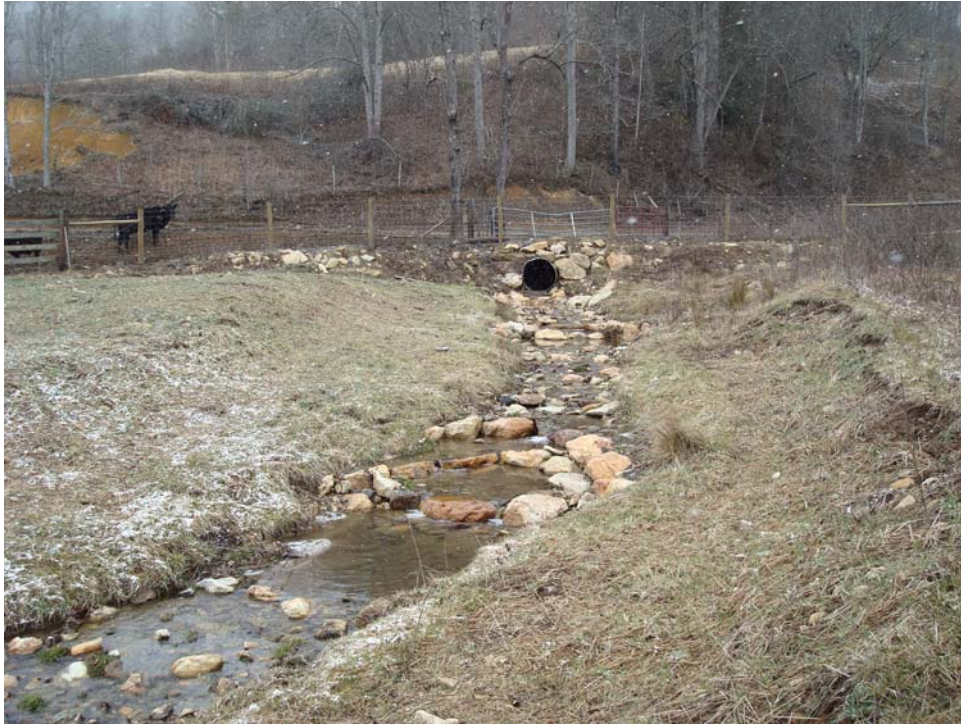
Photo No. 1

Morgan Creek facing upstream

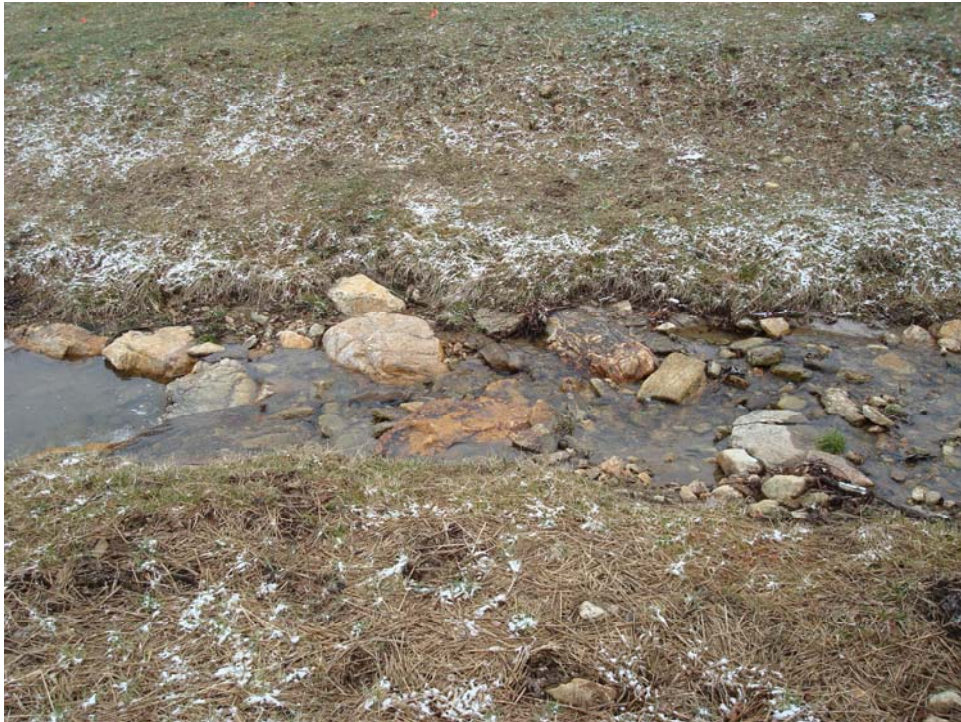
Photo No. 2

Morgan Creek perpendicular to stream

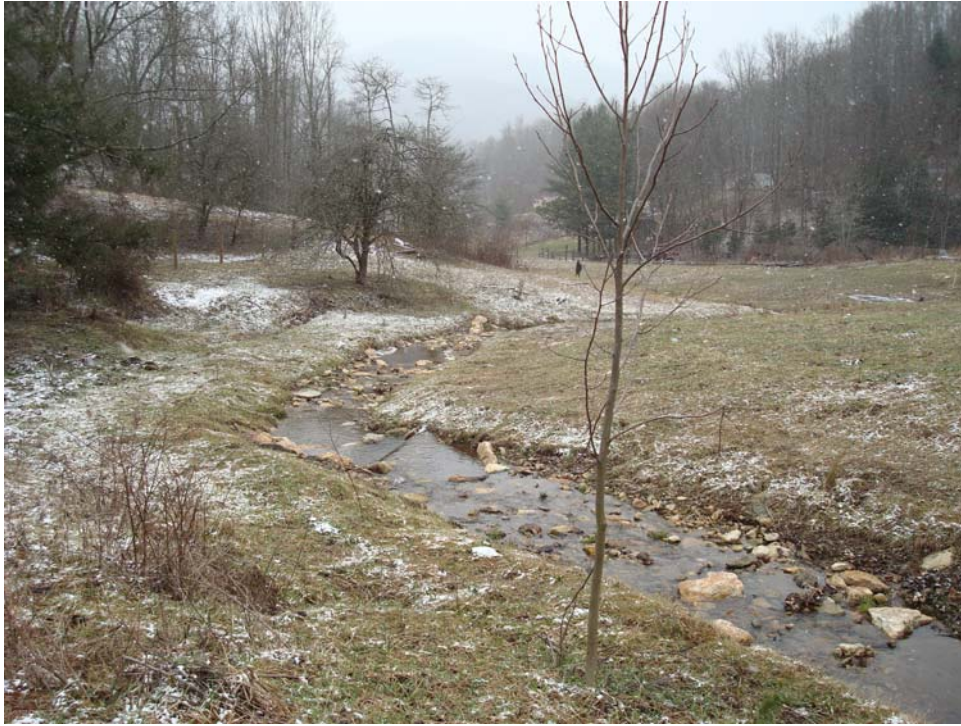
Photo No. 3

Morgan Creek facing downstream

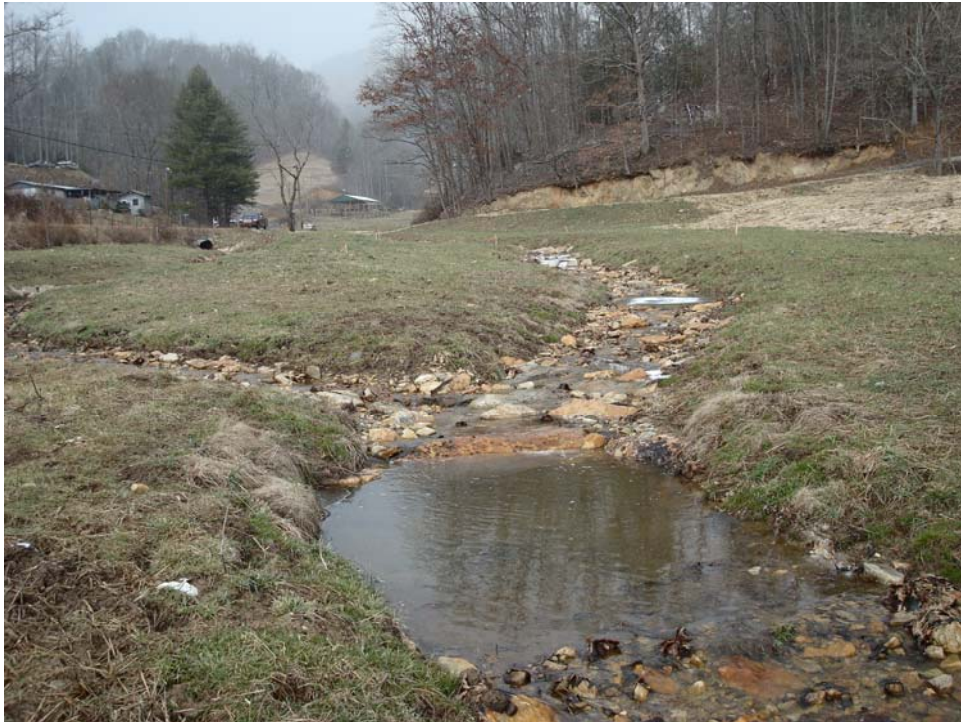
Photo No. 4

Morgan Cr. / Lower North Br. confluence facing upstream

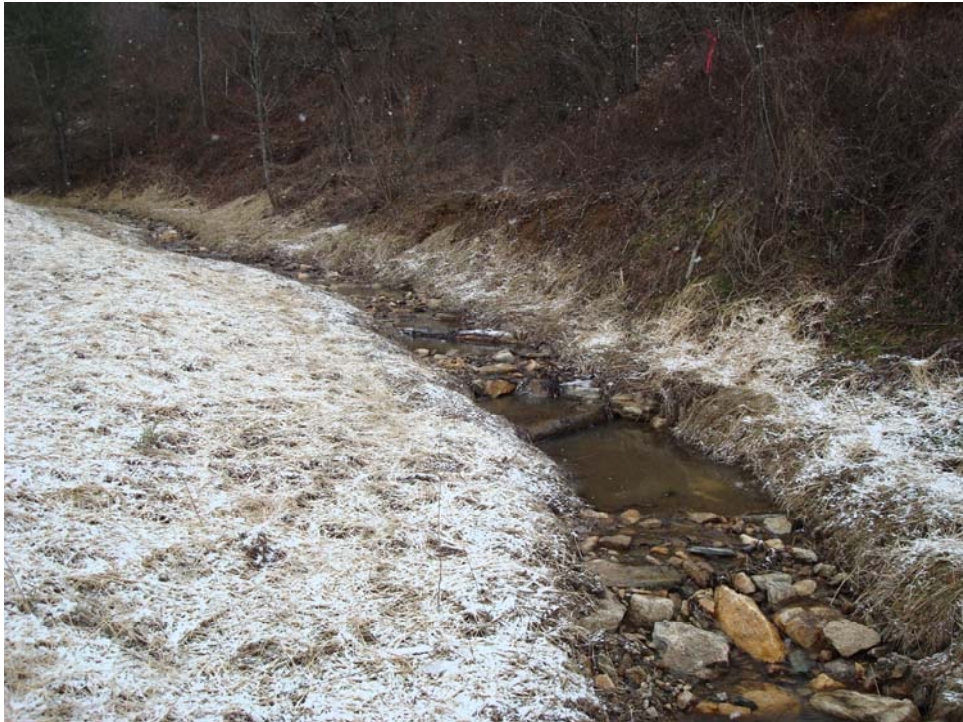
Photo No. 10

North Branch from piped crossing, facing upstream

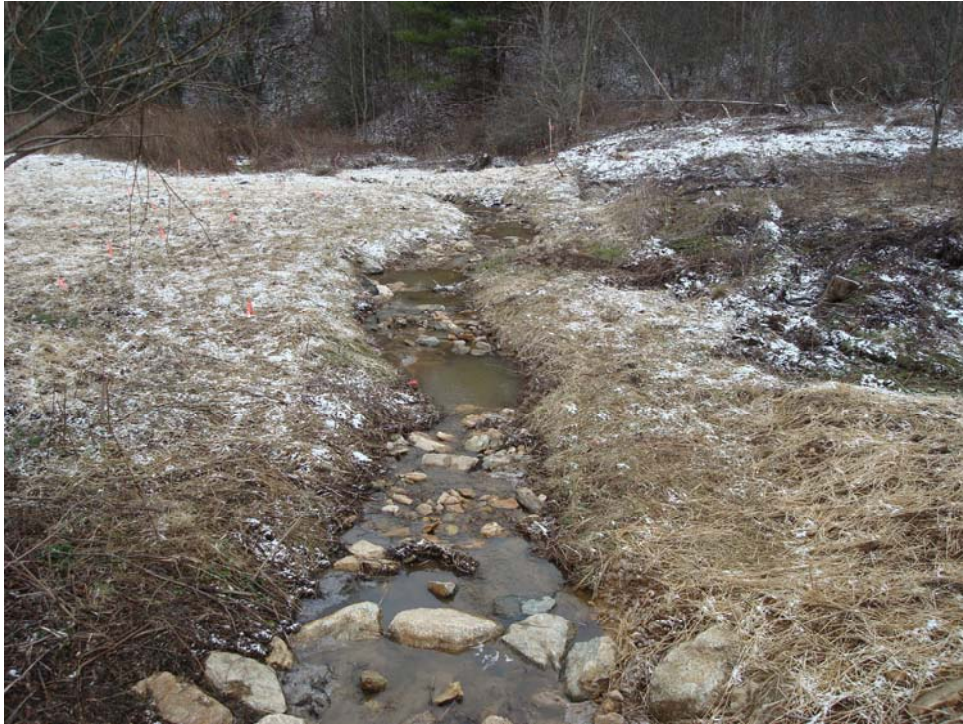
Photo No. 11

North Branch from piped crossing, facing downstream

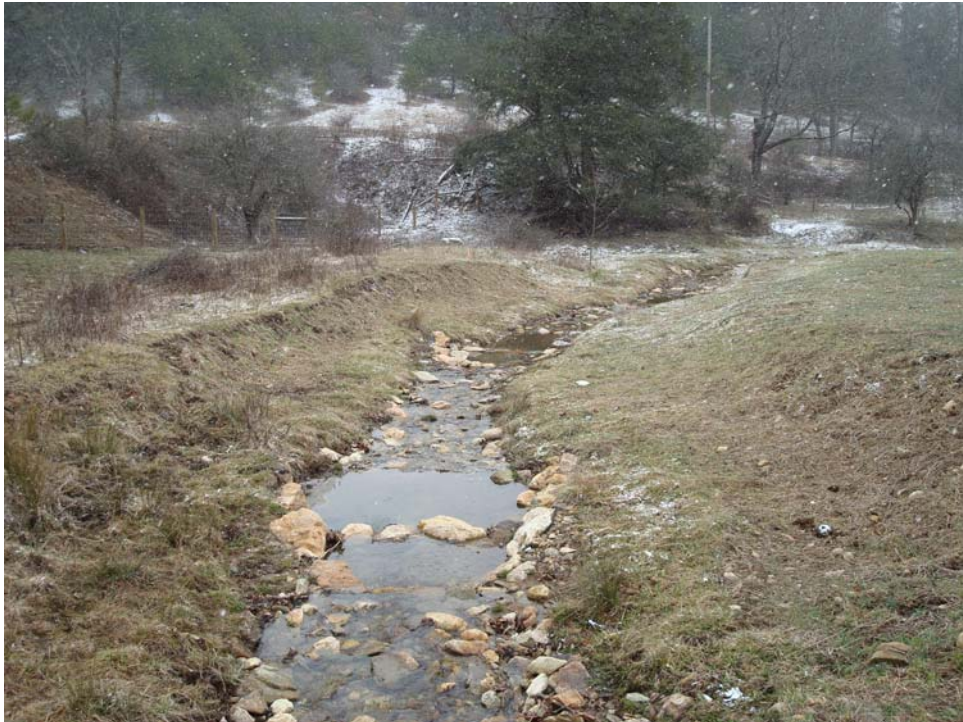
Photo No. 12

Morgan Creek from U/S pipe outfall, facing downstream

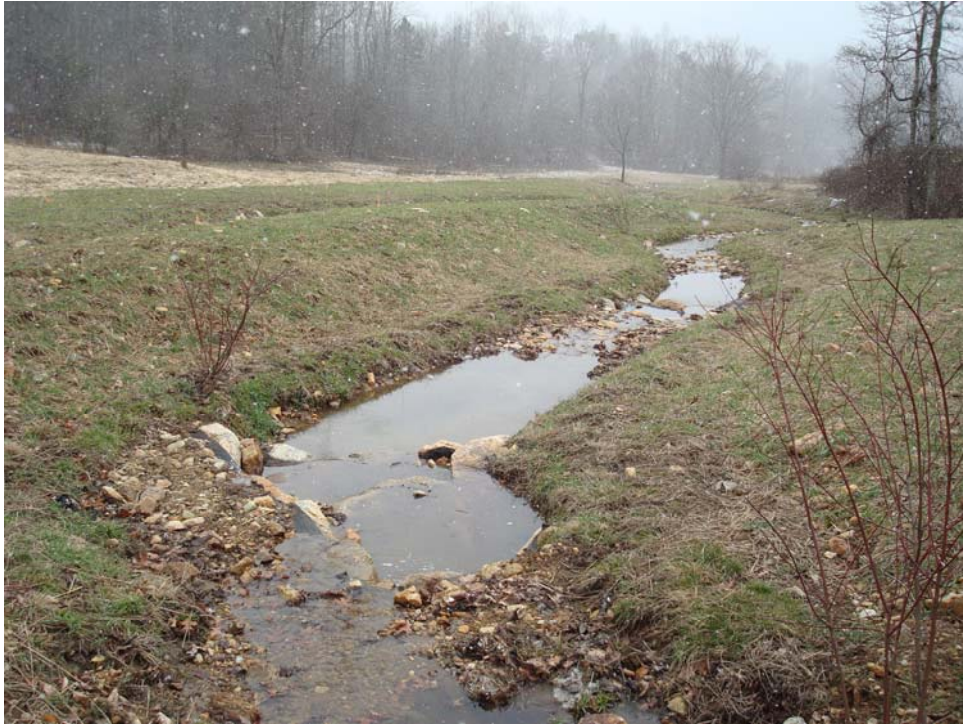
Lower North Branch from pipe outfall, facing downstream Photo No. 13

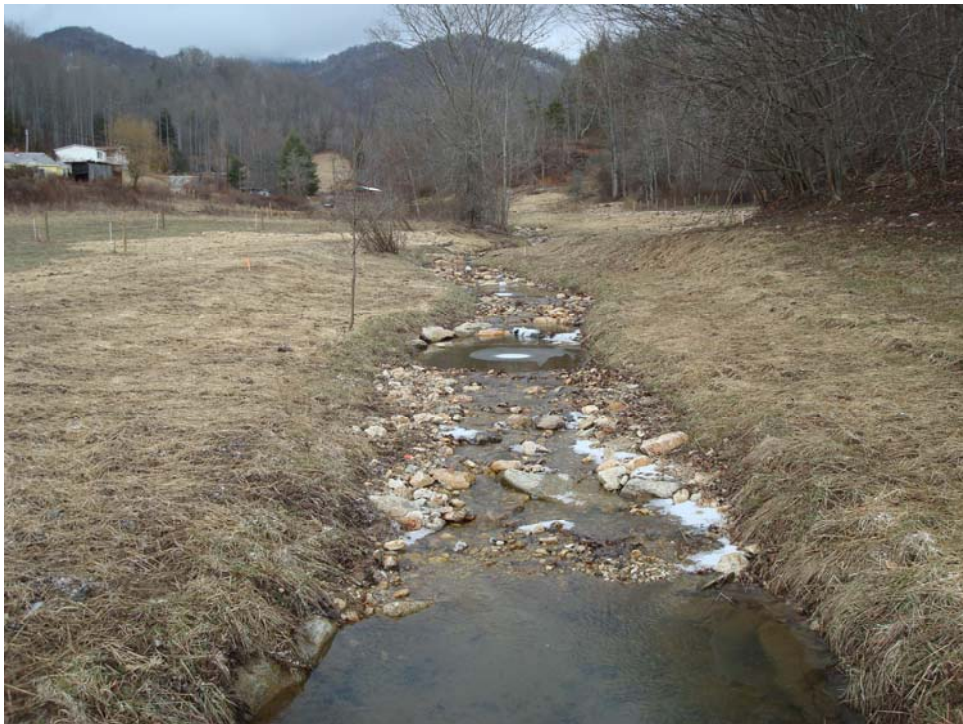
Piped crossing at easement break, facing upstream Photo No. 14

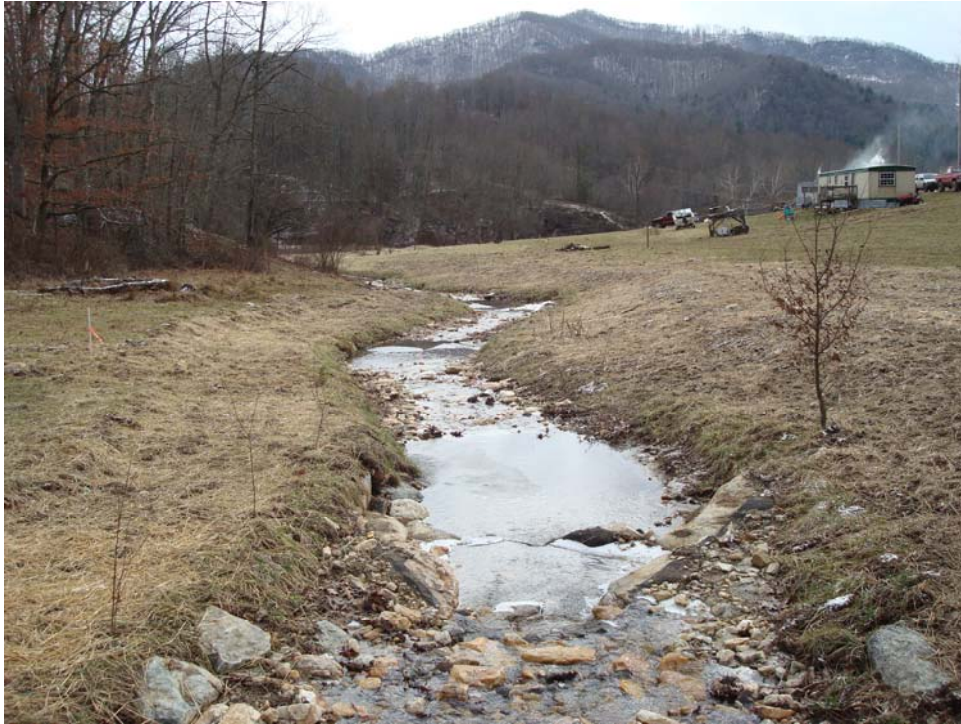
Photo No. 15

Piped crossing at easement break, facing downstream

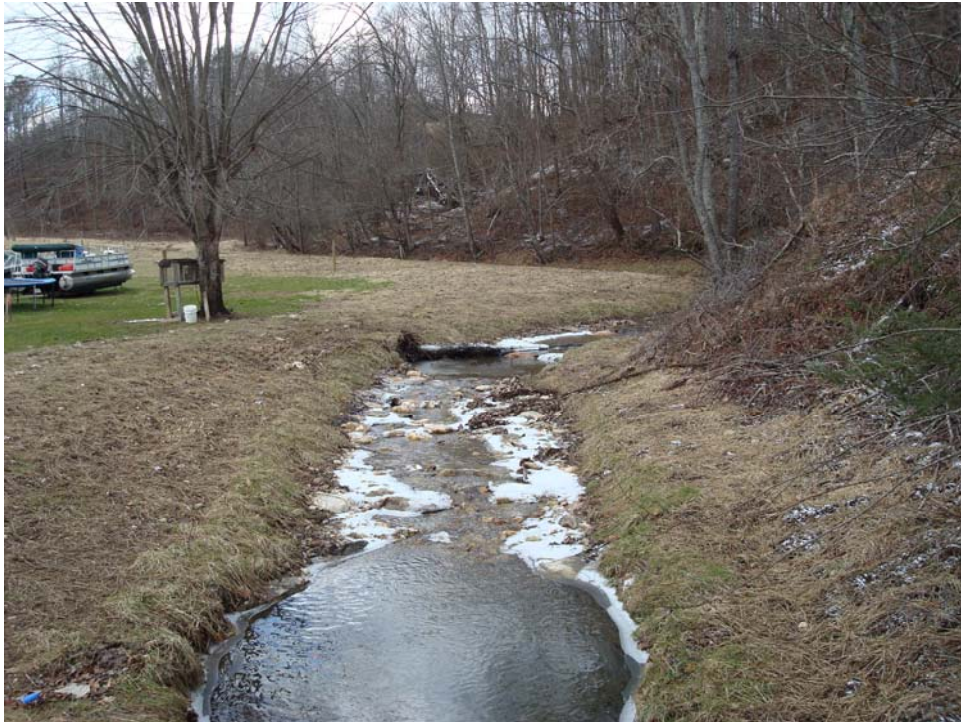
Photo No. 16

Morgan Creek from D/S pipe inlet, facing upstream
