# **MUDDY RUN STREAM RESTORATION PROJECT BASELINE MONITORING REPORT**

DUPLIN COUNTY, NORTH CAROLINA, PROJECT # 95018

**Muddy Run  
Duplin County, North Carolina  
EEP Project ID 95018**

**Cape Fear River Basin  
HUC 0030007060010**

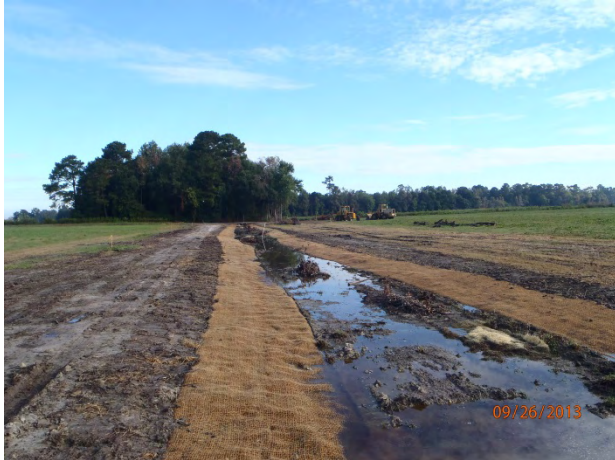
Reach 1A HWV – Looking Downstream - Sta. 2+80 Construction (09/26/2013)

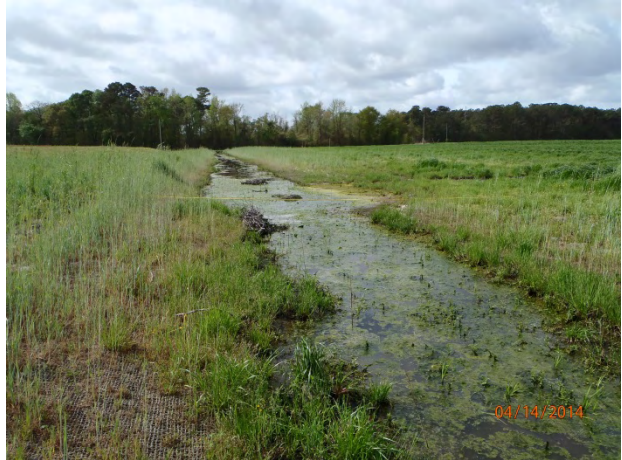
Reach 1A HWV – Looking Downstream - Sta. 2+80 Post-Construction (04/14/2014)

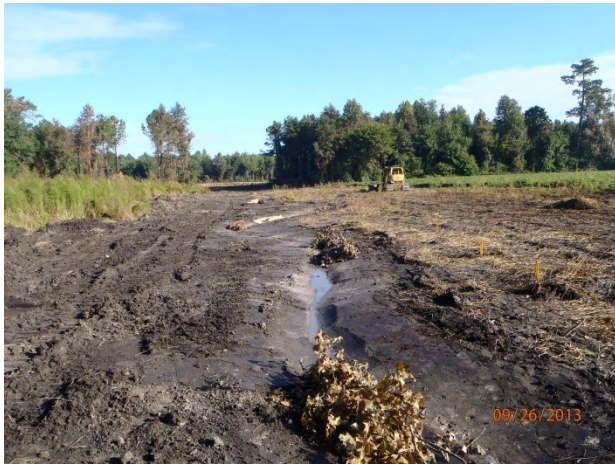
Reach 1A Looking Downstream Sta. 14+80 - Construction (09/26/2013)

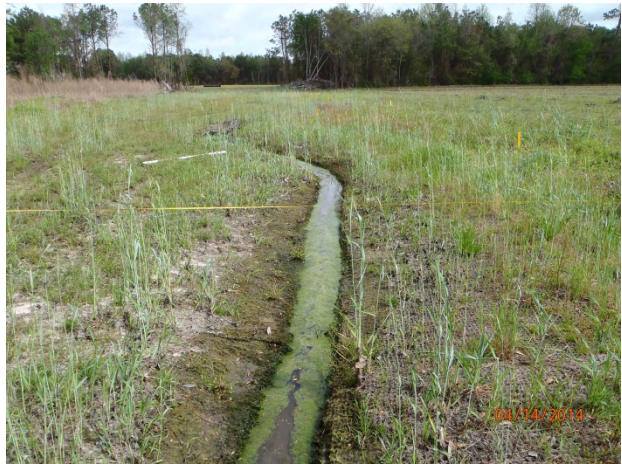
Reach 1A Looking Downstream Sta. 14+80 – Post-Construction (04/14/2014)

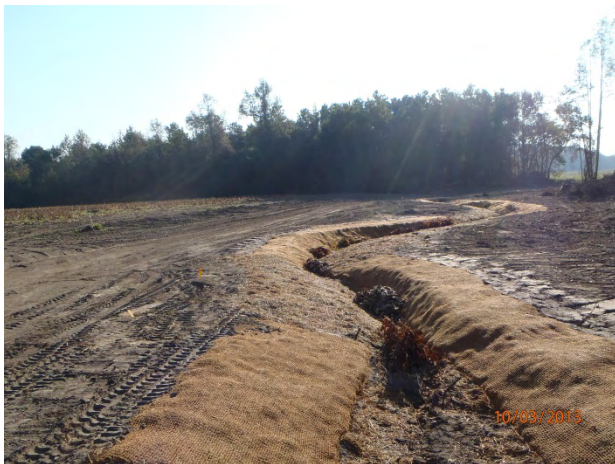
Reach 1A Looking Downstream Sta. 20+55 - Construction (10/03/2013)

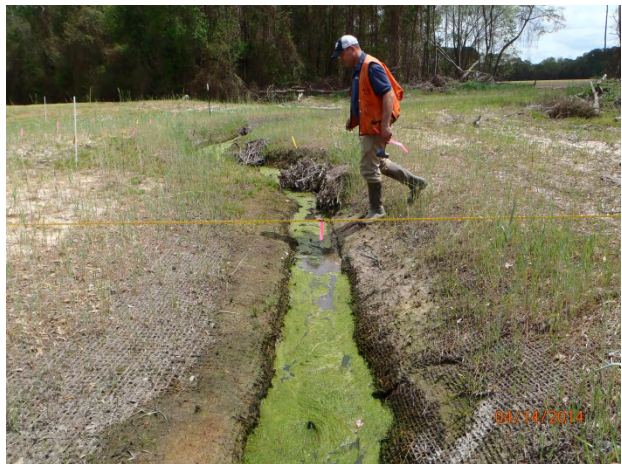
Reach 1A Looking Downstream Sta. 20+55 – Post-Construction (04/14/2014)

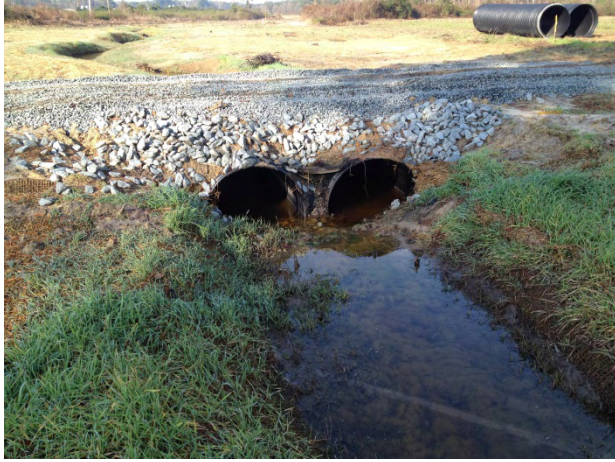
Reach 1A/1B Looking Downstream Sta. 22+00 - Crossing (12/03/2013)

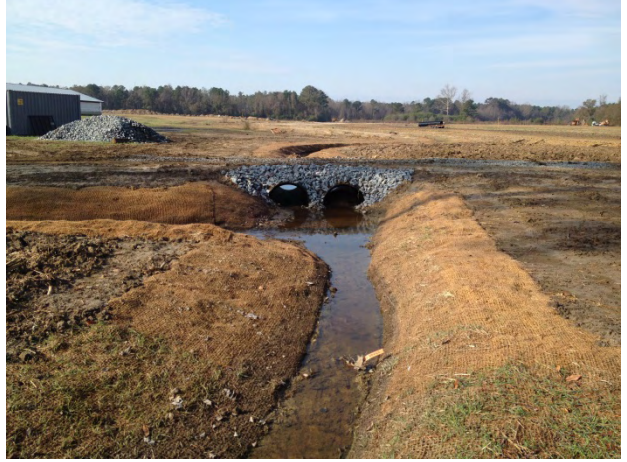
Reach 1B Looking Downstream Sta. 34+00 - Crossing (12/03/2013)

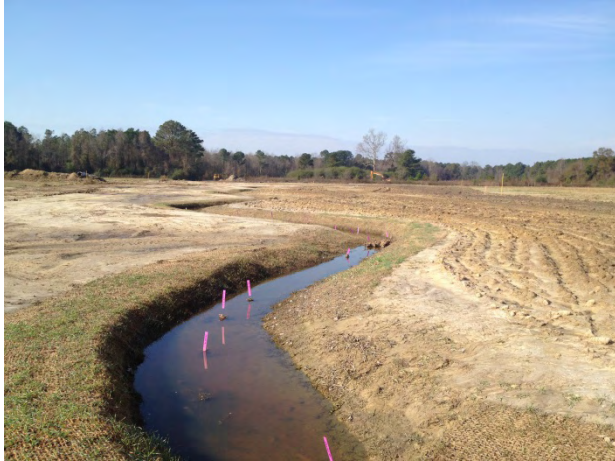
Reach 1C Looking Downstream Sta. 39+50 - Post - Construction (12/03/2013)

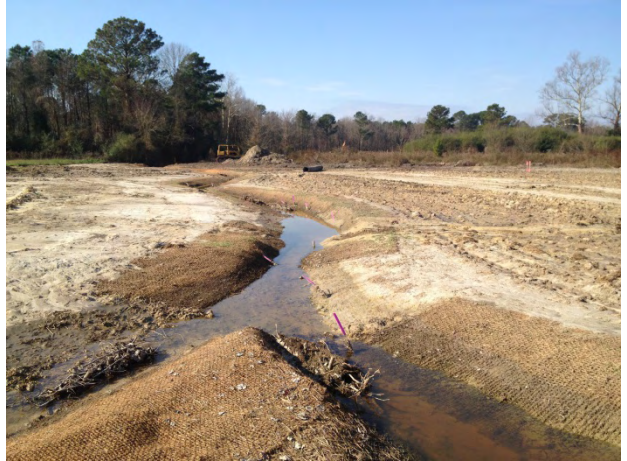
Reach 1C/2 Looking Downstream Sta. 45+50 - Confluence (12/03/2013)

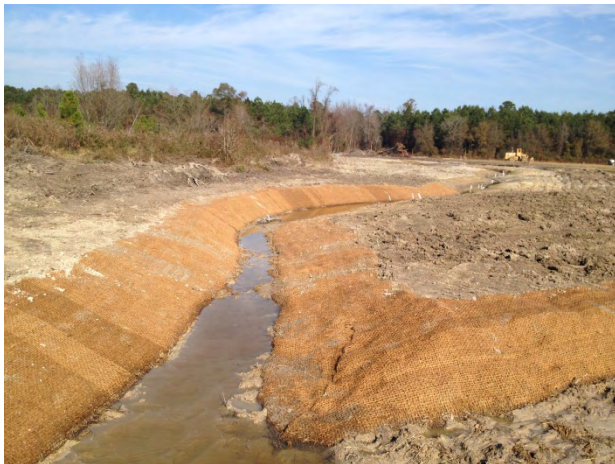
Reach 1C/3 Looking Upstream Sta. 47+80 - Confluence (12/03/2013)

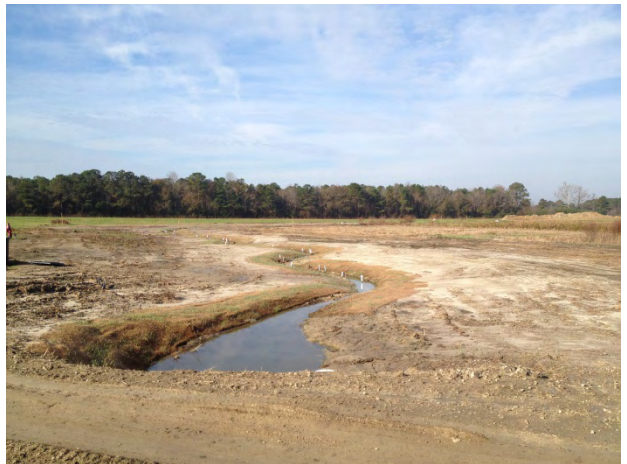
Reach 2 Looking Downstream Sta. 2+00 - Post - Construction (12/03/2013)

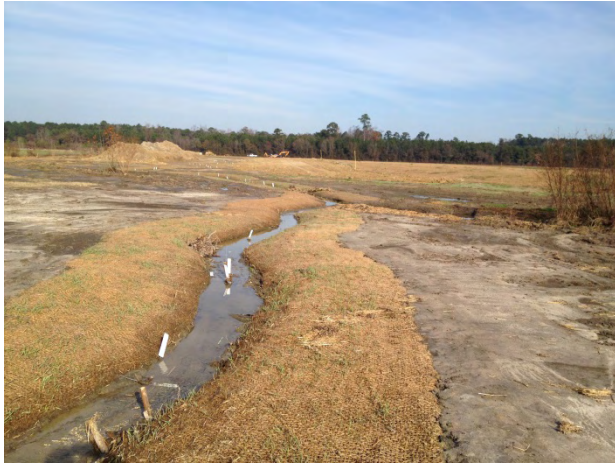
Reach 2 Looking Downstream Sta. 8+15 - Post-Construction (12/03/2013)

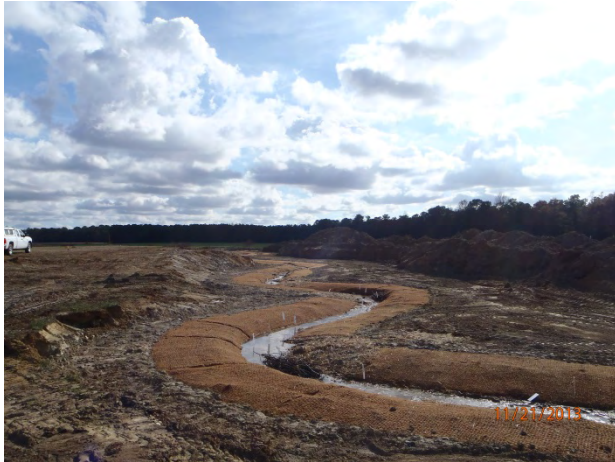
Reach 2 Looking Upstream Sta. 16+10 - Construction (11/21/2013)

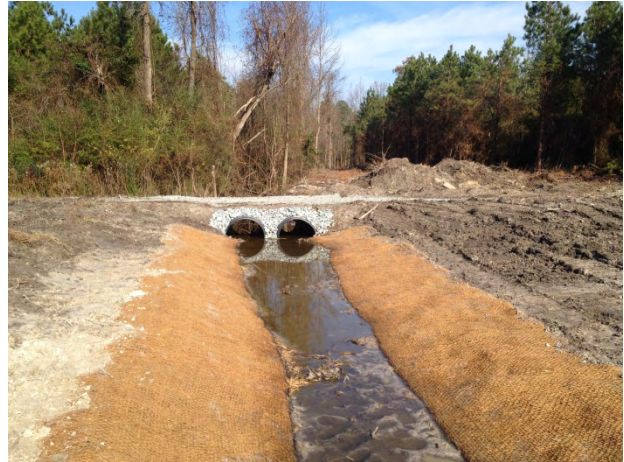
Reach 3 Looking Upstream Sta. 1+50 - Crossing (12/03/2013)

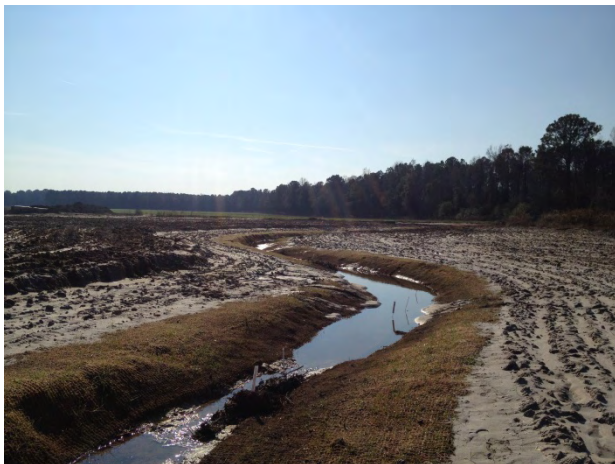
Reach 3 Looking Downstream Sta. 2+60 -Post-Construction (11/14/2013)

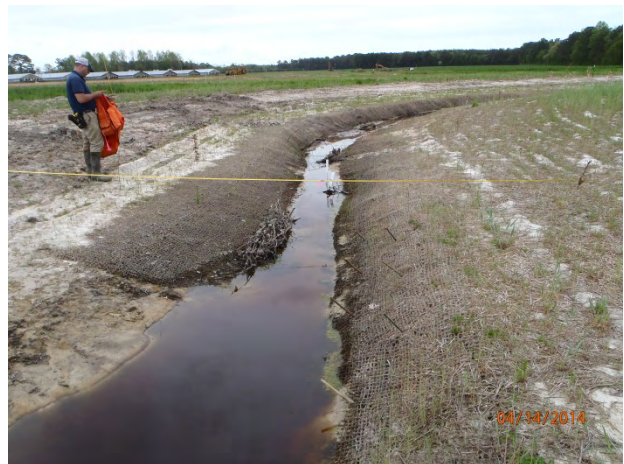
Reach 3 Looking Downstream Sta. 3+20 -Post-Construction (04/14/2014)

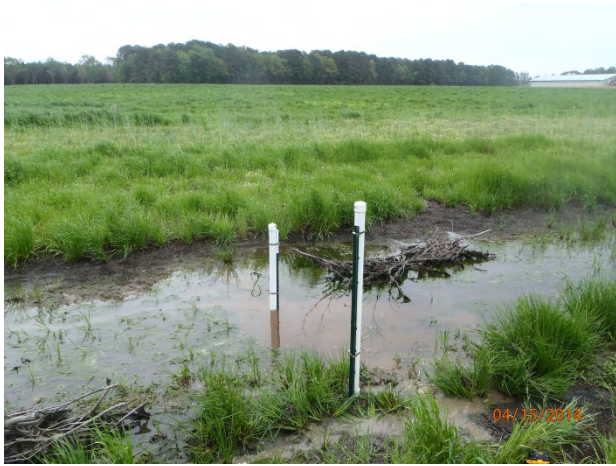
Crest Gauge 1 Reach 1A (04/15/2014)

Multiple bankfull events have been observed during construction and post construction activities on stream reaches 1 and 2. Four sets of manual and auto-logging crest gauges were installed on the site, one along Reach 1A, one along Reach 1C, one along Reach 2, and one along Reach 3. Crest gauge data will be reported in the Year 1 monitoring report.

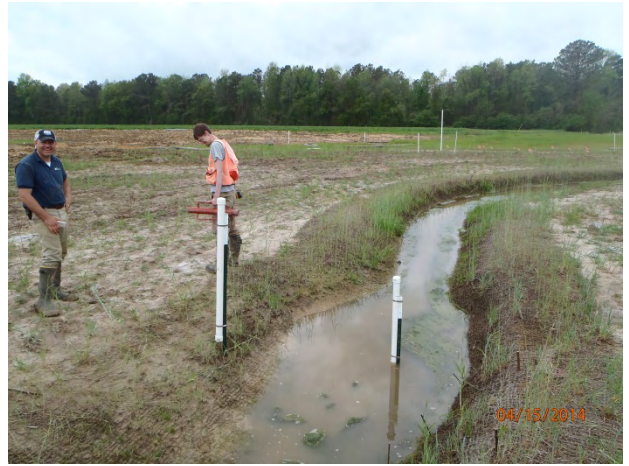
Crest Gauge 1C Reach 1C (04/15/2014)

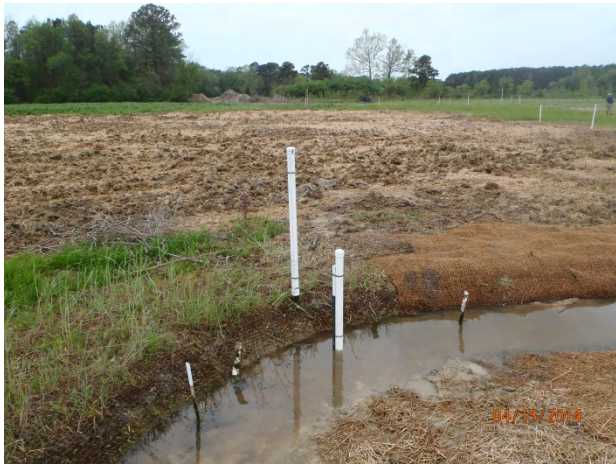
Crest Gauge 2 Reach 1C (04/15/2014)

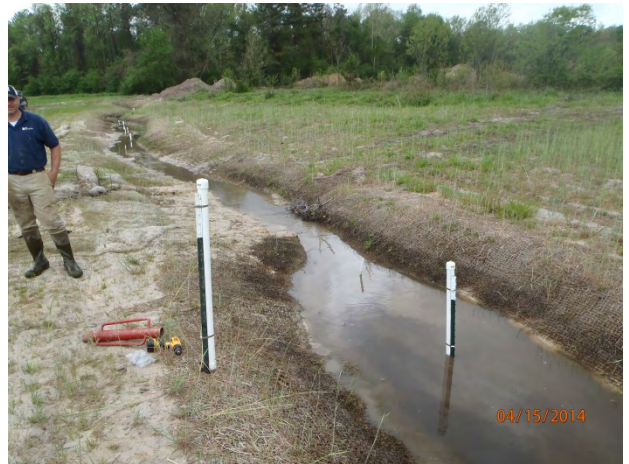
Crest Gauge 3 Reach 1C (04/15/2014)

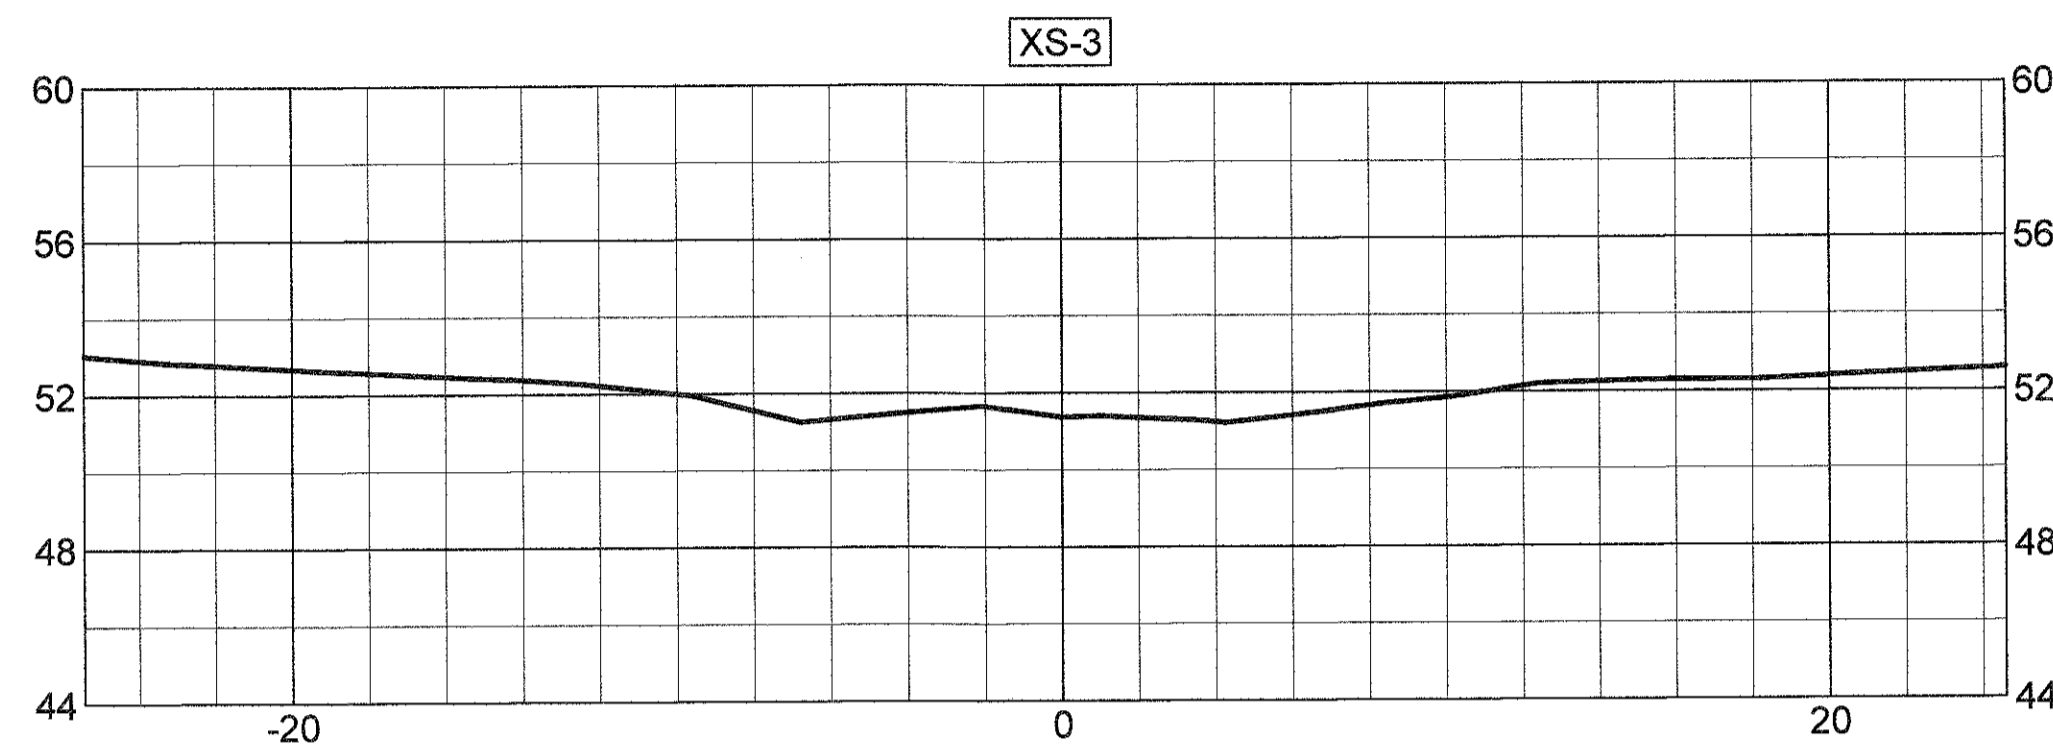
STREAM CROSS-SECTIONS (XS-1 - XS-10)

NOTE:  
THALWEG SURVEY FOR REACHES 1B, 1C, 2,  
& 3 WAS PERFORMED BY W.K. DICKSON  
AND CO., INC. ALL OTHER SURVEYING WAS  
PERFORMED BY MATRIX EAST, PLLC.

The baseline (MY-0) cross sectional dimensions closely matches the proposed design cross section parameters. All cross section plots and data tables can be found in Appendix B.
