**MUDDY RUN STREAM RESTORATION PROJECT**  
**MONITORING REPORT**  
**MONITORING YEAR 5**  
**FINAL**

DUPLIN COUNTY, NORTH CAROLINA  
PROJECT NO. 95018  
SAW-2011-02191  
DWR 2012-0817

**Cape Fear River Basin  
HUC 03030007060010**

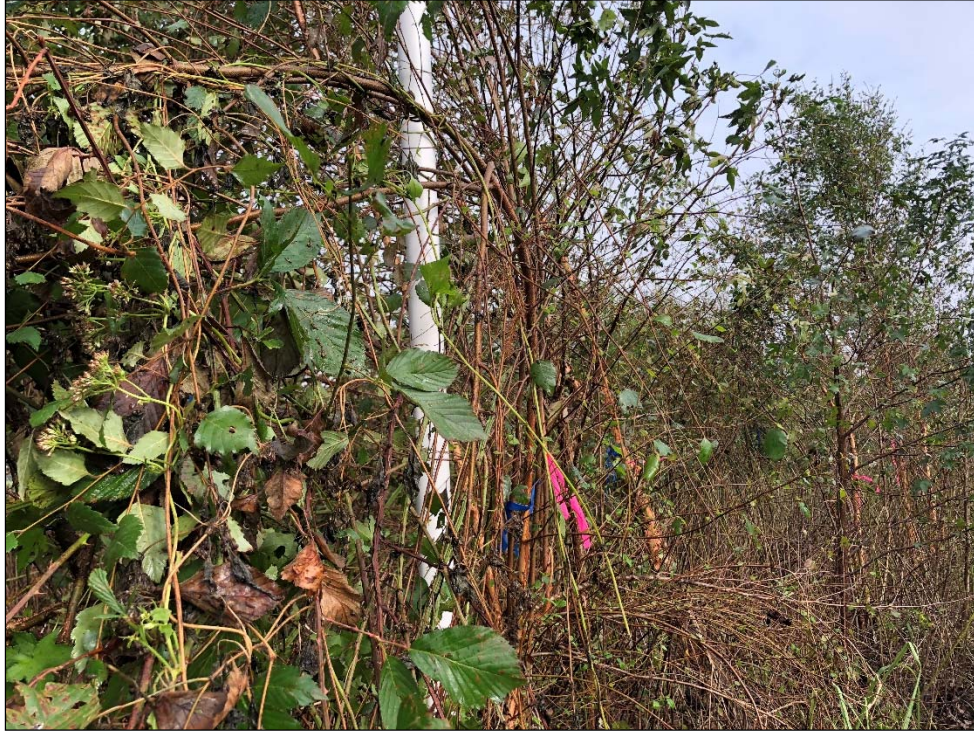
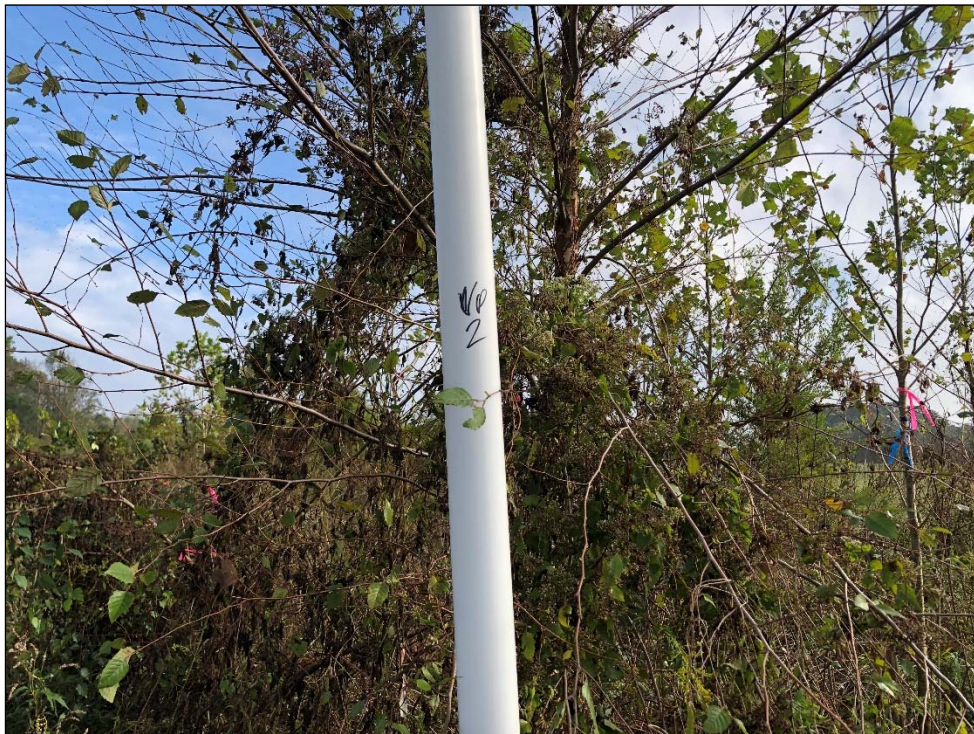
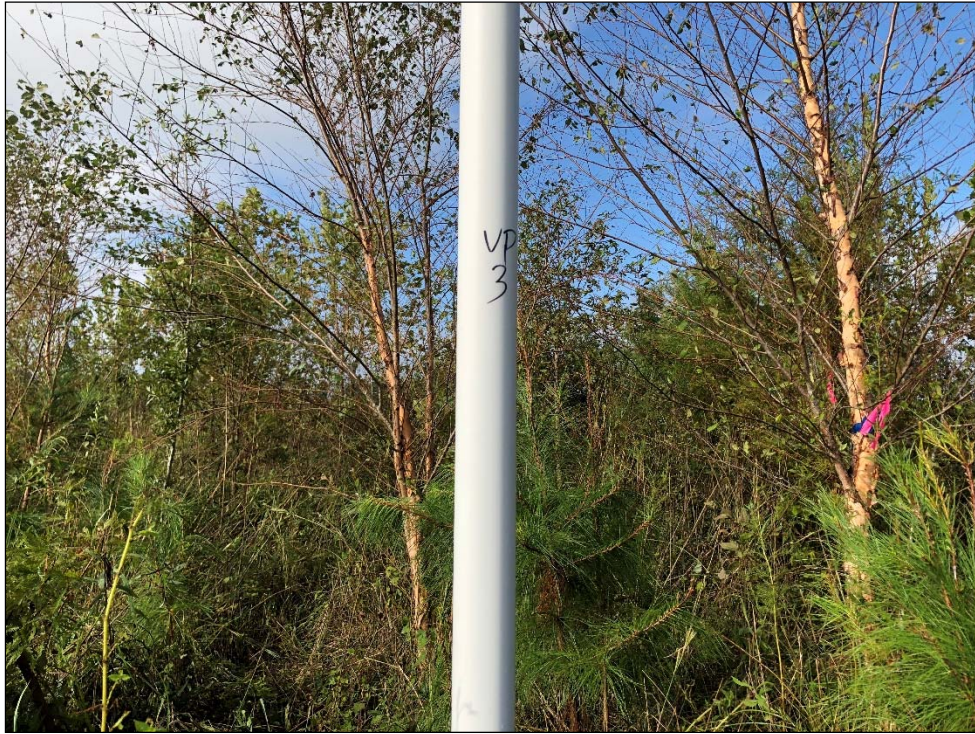
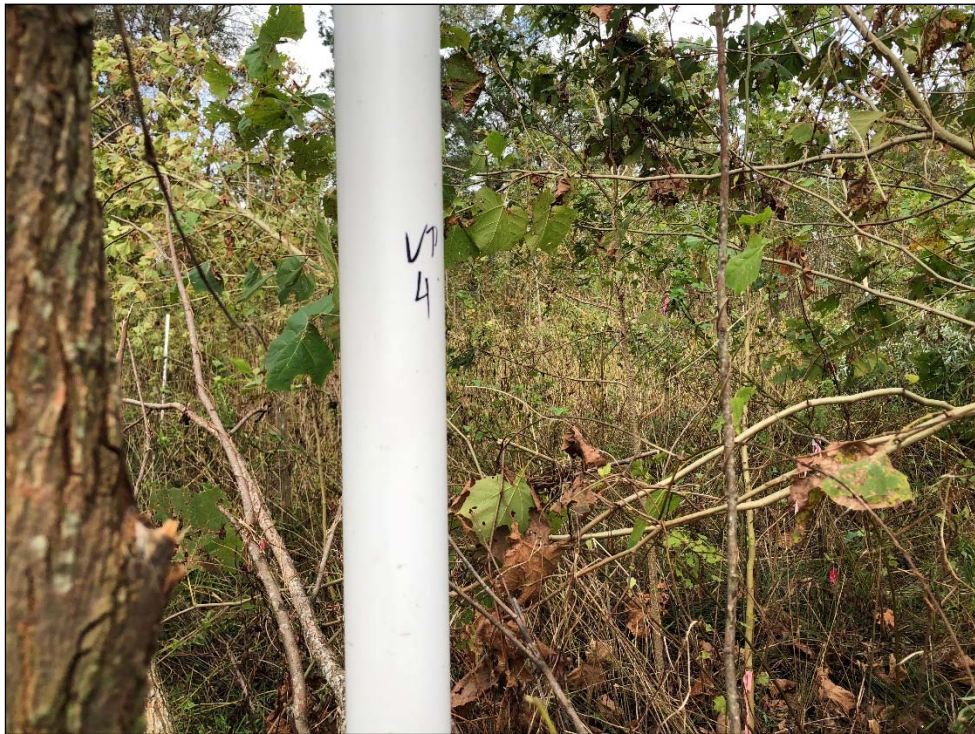
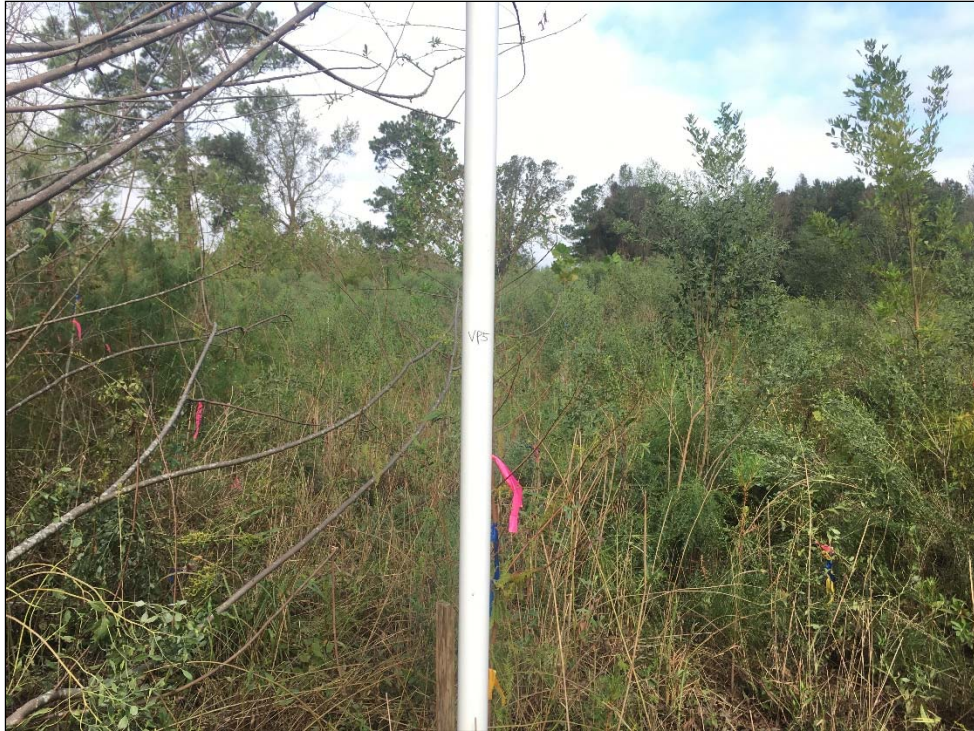
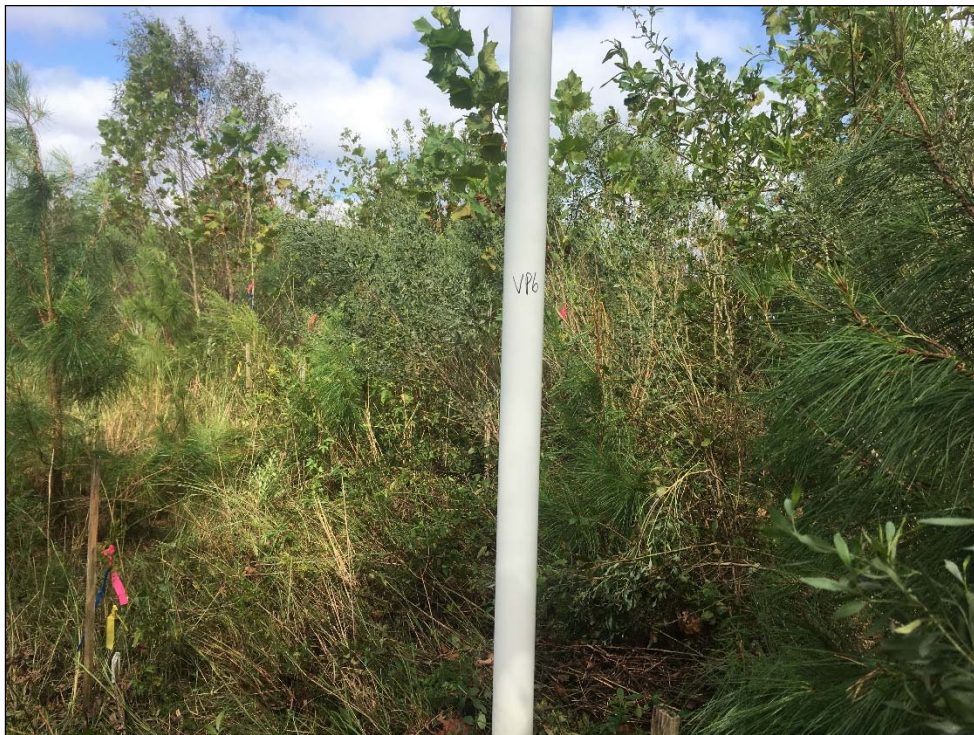
**Figure 4. MY5 – 2018 Vegetation Plot Photos**

Muddy Run - Vegetation Monitoring Plot 1  
September 25, 2018

Muddy Run - Vegetation Monitoring Plot 2  
September 25, 2018

Muddy Run - Vegetation Monitoring Plot 3  
September 25, 2018

Muddy Run - Vegetation Monitoring Plot 4  
September 25, 2018

Muddy Run - Vegetation Monitoring Plot 5  
September 25, 2018

Muddy Run - Vegetation Monitoring Plot 6  
September 25, 2018

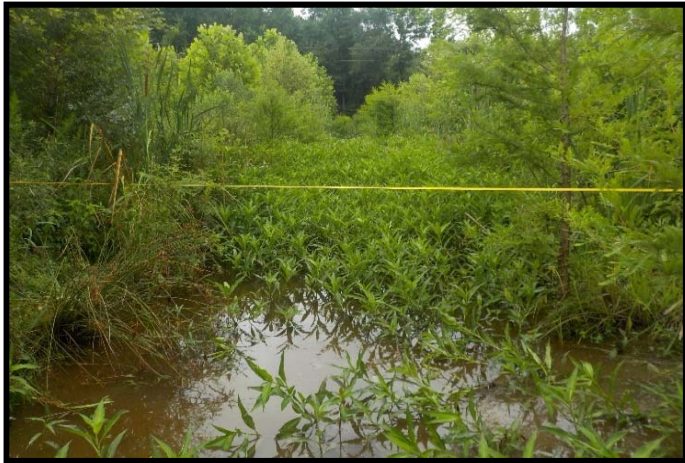
Upstream

Digital images were used to subjectively evaluate channel aggradation or degradation, bank erosion, success of riparian vegetation, and effectiveness of erosion control measures. Longitudinal images should not indicate the absence of developing bars within the channel or an excessive increase in channel depth. Lateral images should not indicate excessive erosion or continuing degradation of the banks over time. A series of images over time should indicate successional maturation of riparian vegetation.

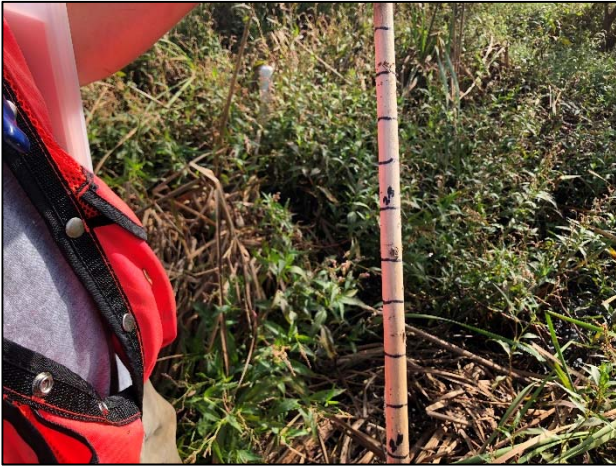
Crest Gauge 1 Reading: 2.82 feet

Figure 7. Crest Gauge Verification Photos

**Figure 7 – Crest Gauge Verification Photos**

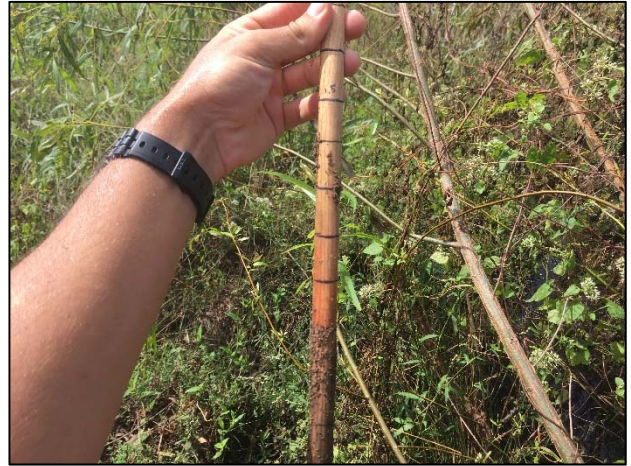
Crest Gauge 2 Reading: 1.4 feet

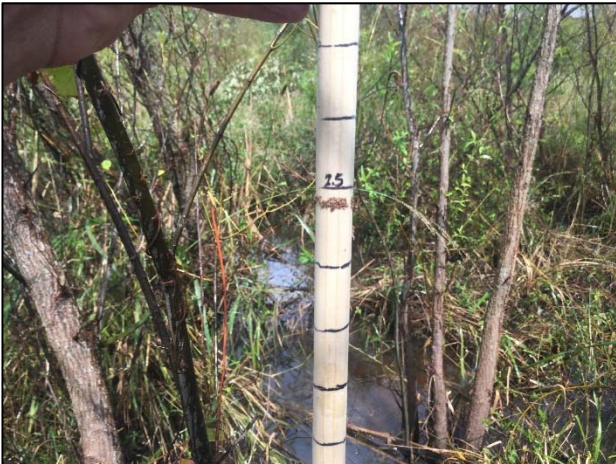
Crest Gauge 3 Reading: 2.48 feet

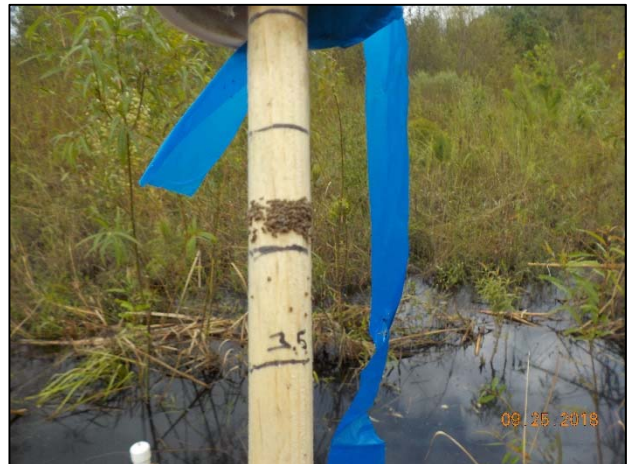
Crest Gauge 4 Reading: 3.65 feet
