Naked Creek Stream Final Mitigation Report

Wilkes County, North Carolina

Project ID No. 040619201

AS-BUILT DRAWINGS FOR *NAKED CREEK* STREAM RESTORATION PROJECT

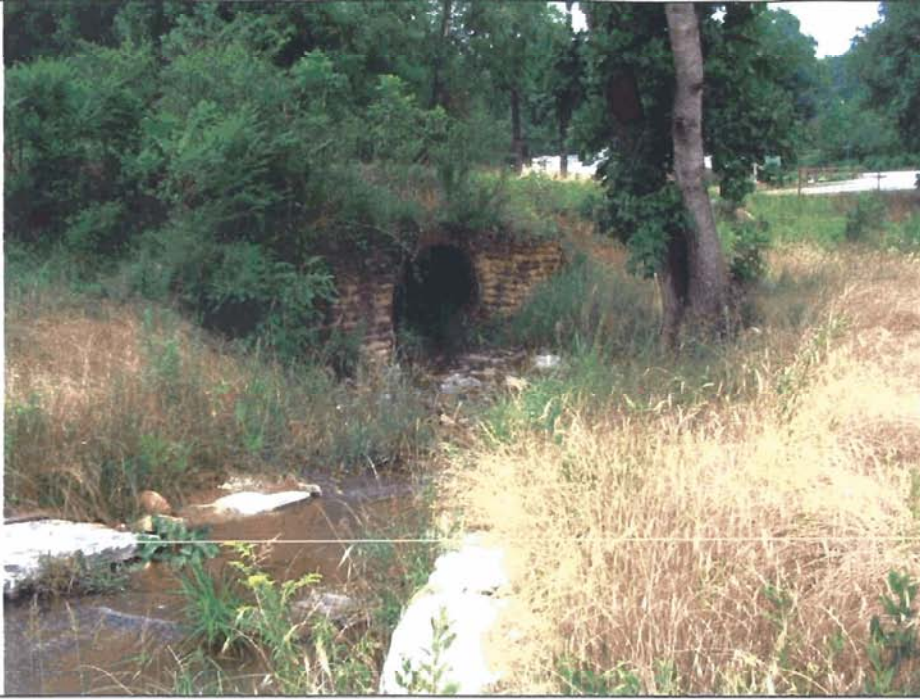
Photo 1: Looking upstream at culvert at top of project.

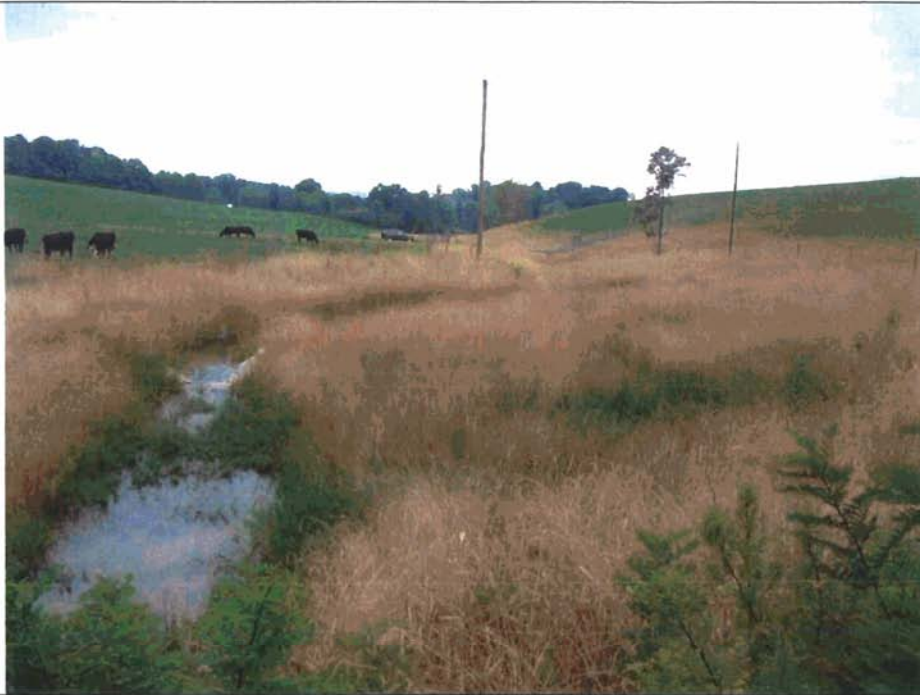
Photo 2: Looking downstream at channel and wet area near right bank.

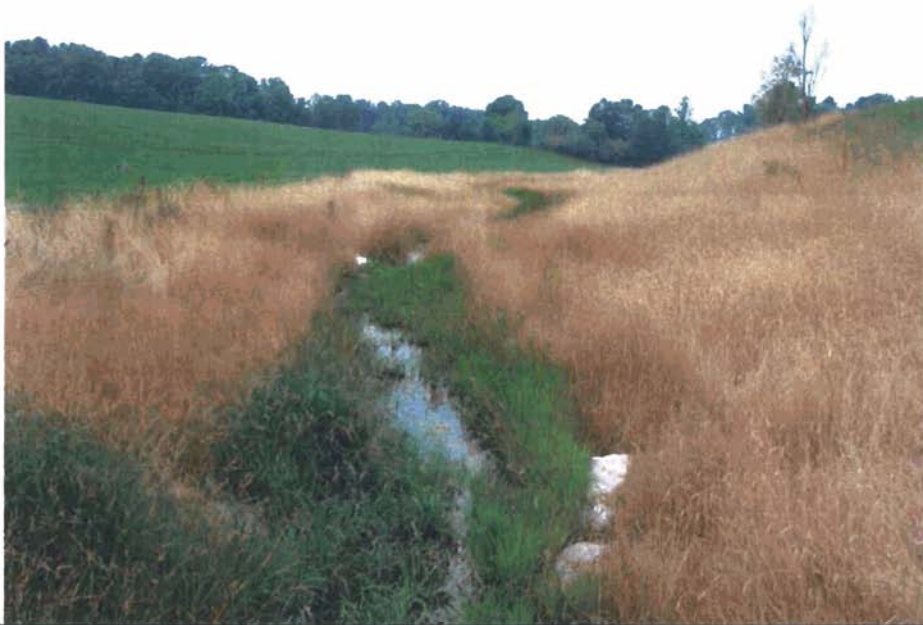
Photo 4: Looking downstream from upper crossing at channel.

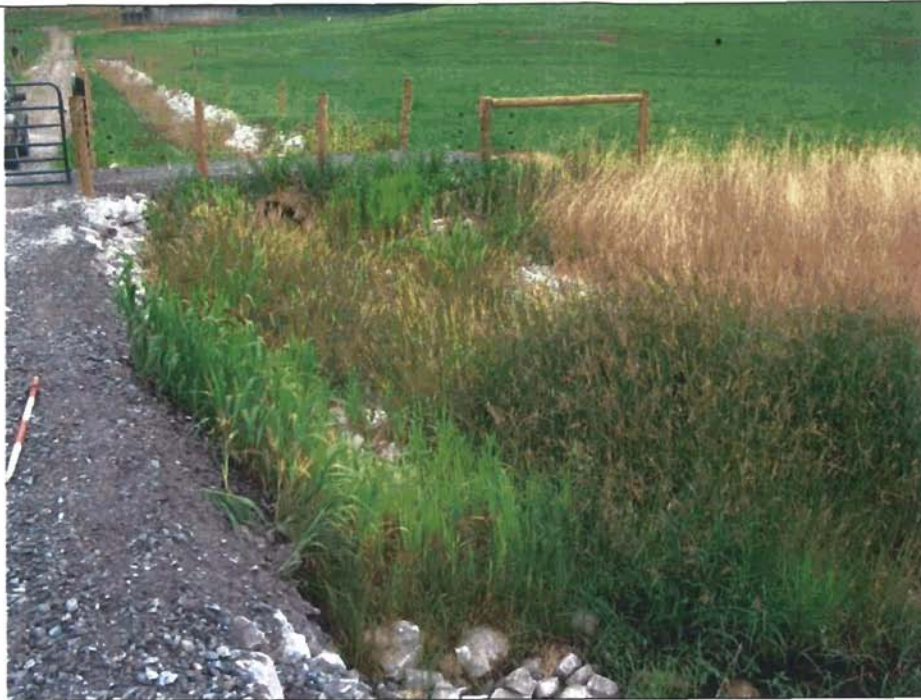
Photo 5: Looking at left bank at drainage swale entering channel from left side.

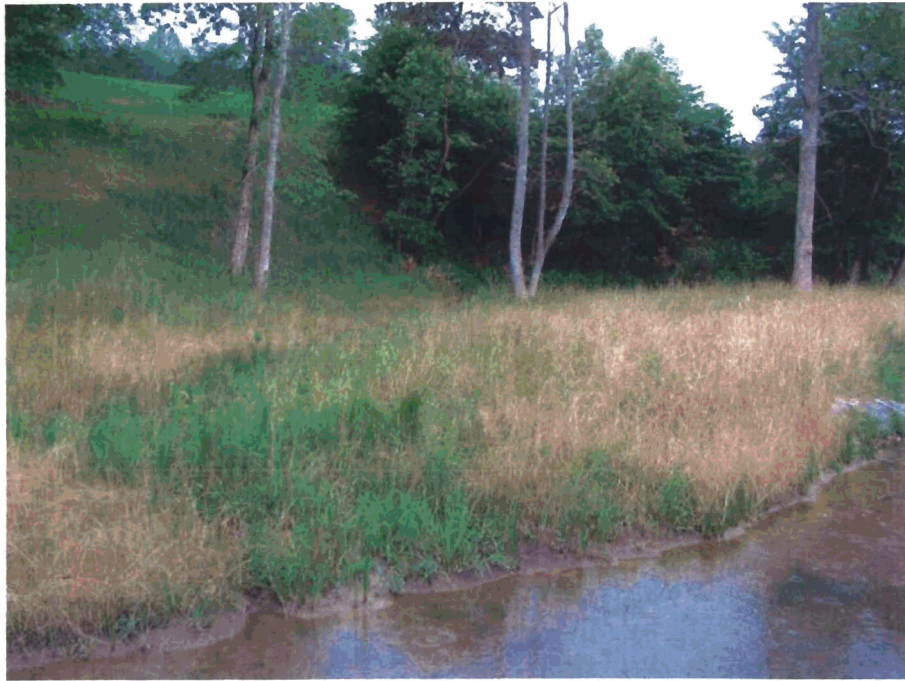
Photo 13: Looking from left bank toward right bank at wet area draining into right side of channel.

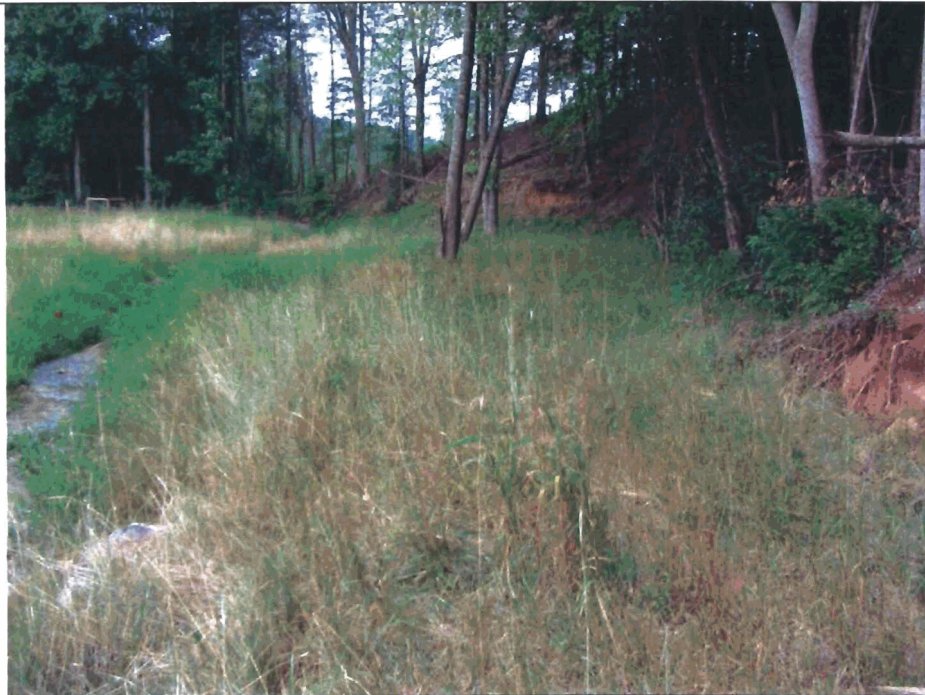
Photo 14: Looking downstream from right bank at channel and riparian area.

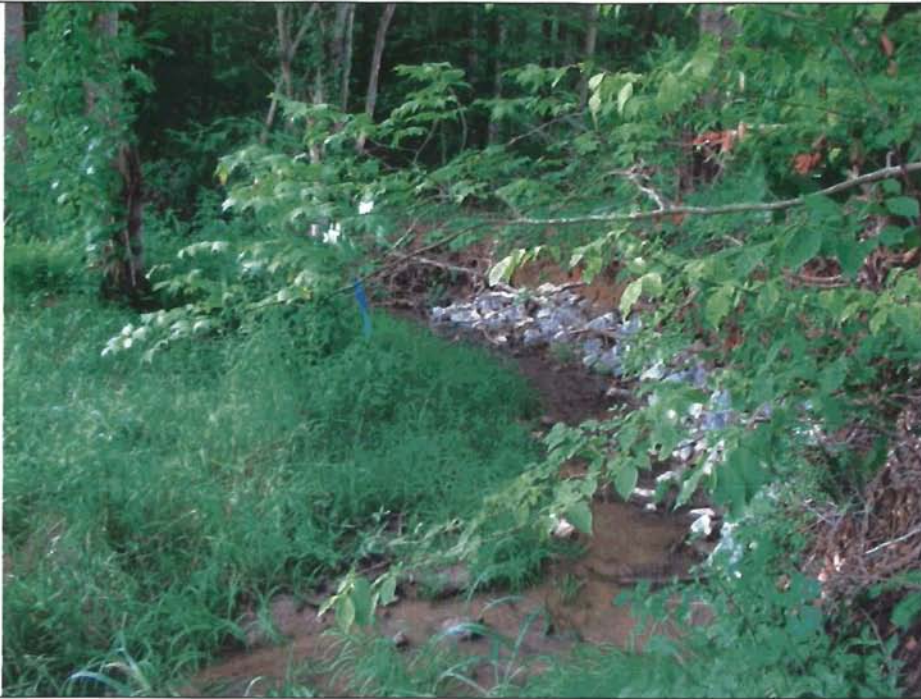
Photo 15: Looking downstream from right bank at rip-rap toe protection.

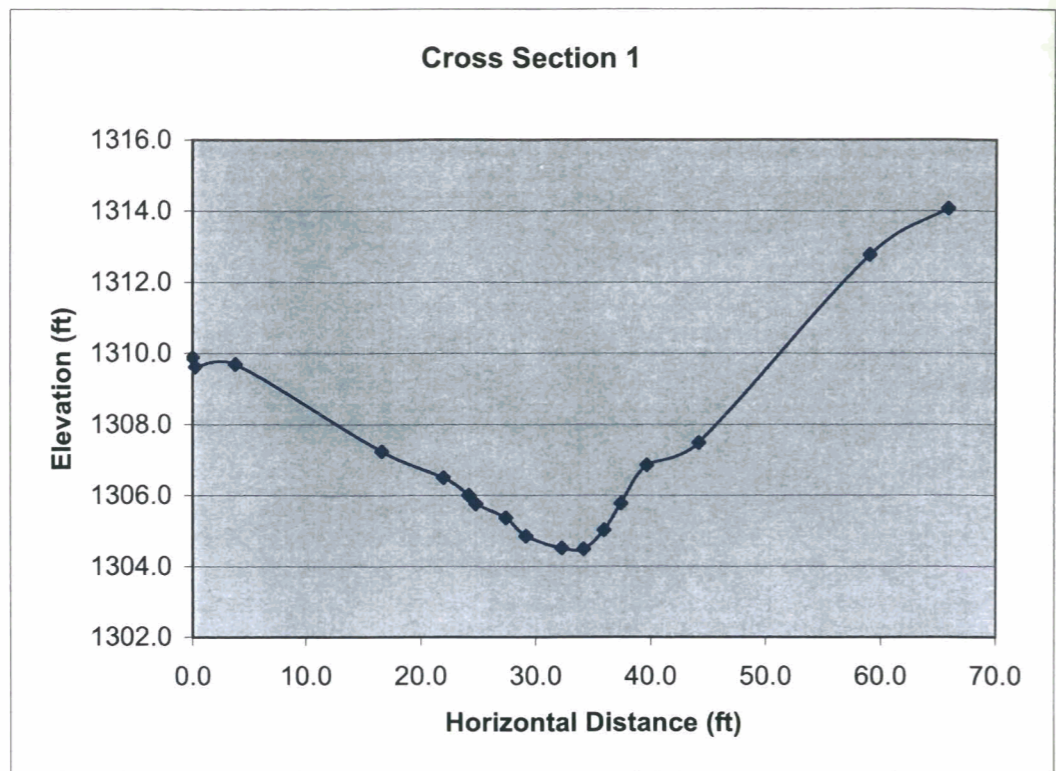
STA (ft)	Elev (ft)	Desc.
0.0	1309.9	
0.2	1309.6	
3.8	1309.7	
16.6	1307.2	
21.9	1306.5	
24.1	1306.0	
24.8	1305.7	LEW
27.4	1305.3	
29.1	1304.8	
32.3	1304.5	
34.2	1304.5	
35.9	1305.0	
37.4	1305.8	REW
39.7	1306.8	BKF
44.2	1307.5	
59.0	1312.8	
65.9	1314.1

W_{bkf} (ft)	D_{bkf} (ft)	A_{bkf} (SF)
20.3	1.3	27.3

The survey of channel dimension consists of 6 permanent cross sections placed at unique stream segments throughout the project extent. The cross sections represent 4 riffles and 2 pools. Annual photographs showing both banks and upstream and downstream views will be taken for each cross section.

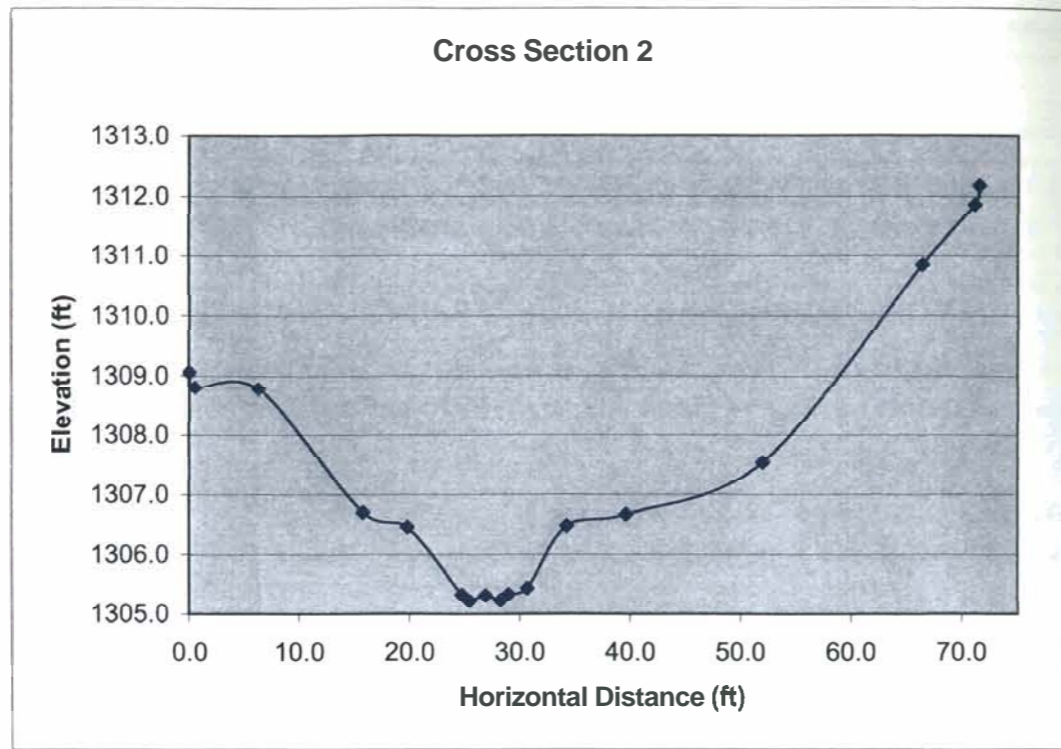
STA (ft)	Elev (ft)	Desc.
0.0	1309.0	
0.5	1308.8	
6.3	1308.8	
15.8	1306.7	
19.8	1306.4	
24.8	1305.3	LEW
25.5	1305.2	
26.9	1305.3	
28.3	1305.2	
29.0	1305.3	REW
30.7	1305.4	
34.3	1306.5	BKF
39.6	1306.7	
52.0	1307.5	
66.4	1310.8	
71.1	1311.8	
71.5	1312.2

W_{bkf} (ft)	D_{bkf} (ft)	A_{bkf} (SF)
14.8	0.8	11.7

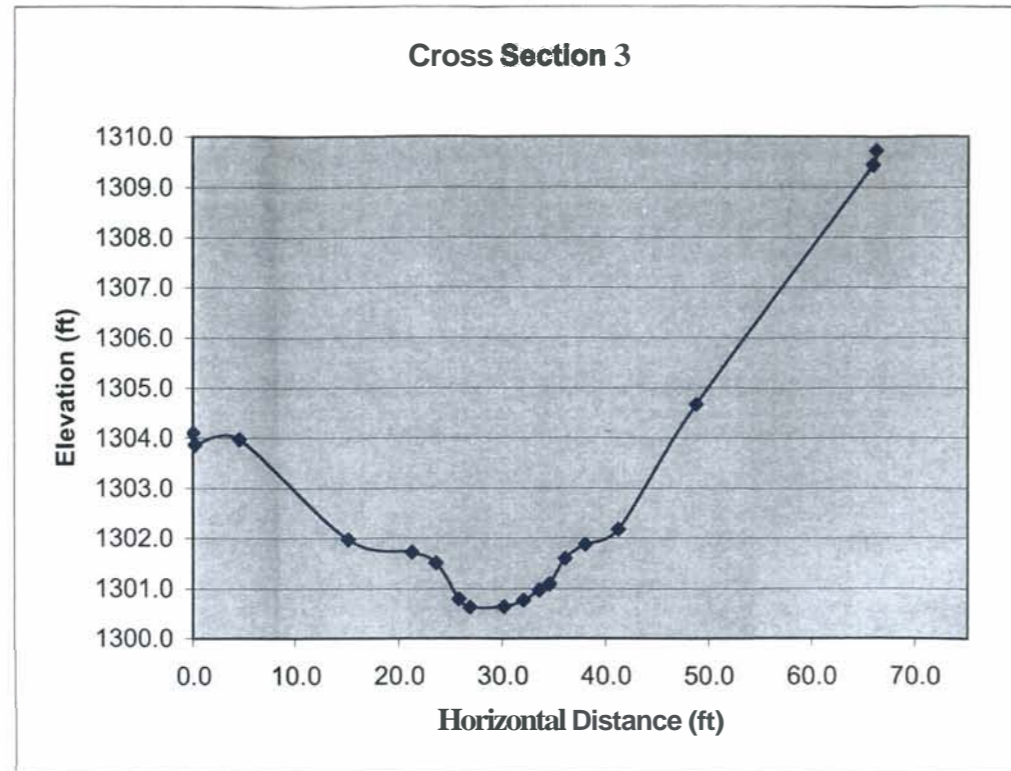
STA (ft)	Elev (ft)	Desc.
0.0	1304.1	
0.2	1303.9	
4.6	1304.0	
15.1	1302.0	
21.3	1301.7	
23.6	1301.5	
25.8	1300.8	LEW
26.9	1300.6	
30.1	1300.6	
32.0	1300.8	REW
33.5	1301.0	
34.5	1301.1	
36.0	1301.6	BKF
38.0	1301.9	
41.2	1302.2	
48.7	1304.7	
65.9	1309.4	
66.2	1309.7

W_{bkf} (ft)	D_{bkf} (ft)	A_{bkf} (SF)
13.4	0.7	8.8

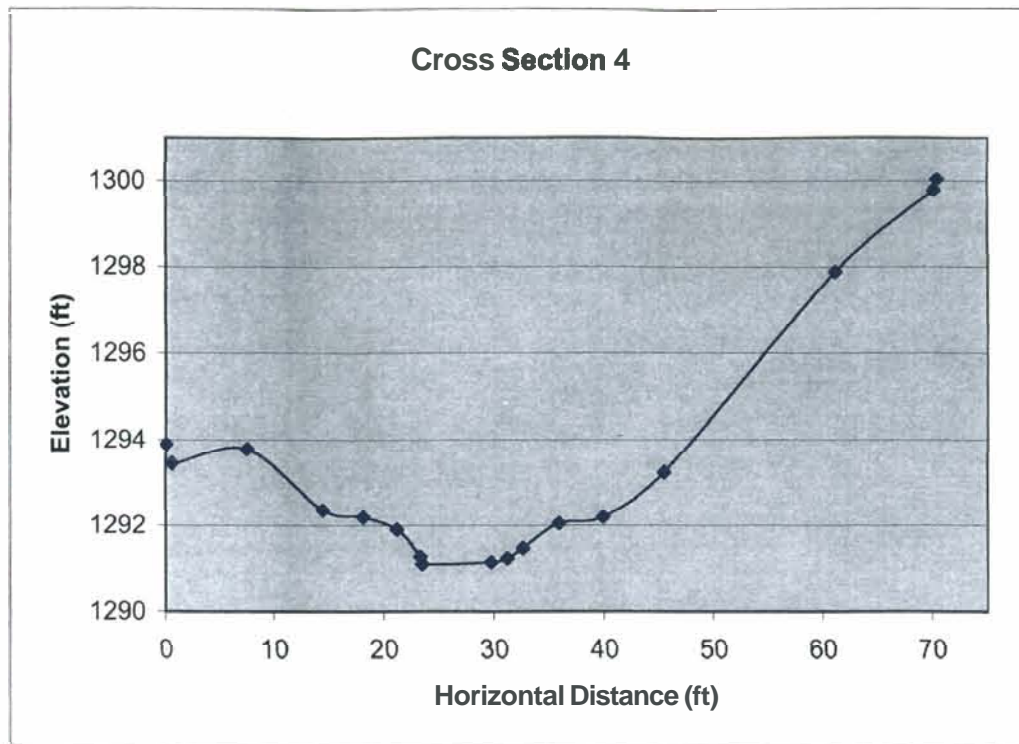
STA (ft)	Elev (ft)	Desc.
0	1293.879	
0.59	1293.437	
7.49	1293.767	
14.47	1292.345	
18.12	1292.176	
21.19	1291.885	
23.31	1291.257	LEW
23.49	1291.085	
29.76	1291.132	
31.21	1291.226	REW
32.63	1291.461	
35.9	1292.036	BKF
39.93	1292.185	
45.5	1293.225	
61.12	1297.868	
70.11	1299.77	
70.42	1300.029

W_{bkf} (ft)	D_{bkf} (ft)	A_{bkf} (SF)
16.5	0.6	10.3

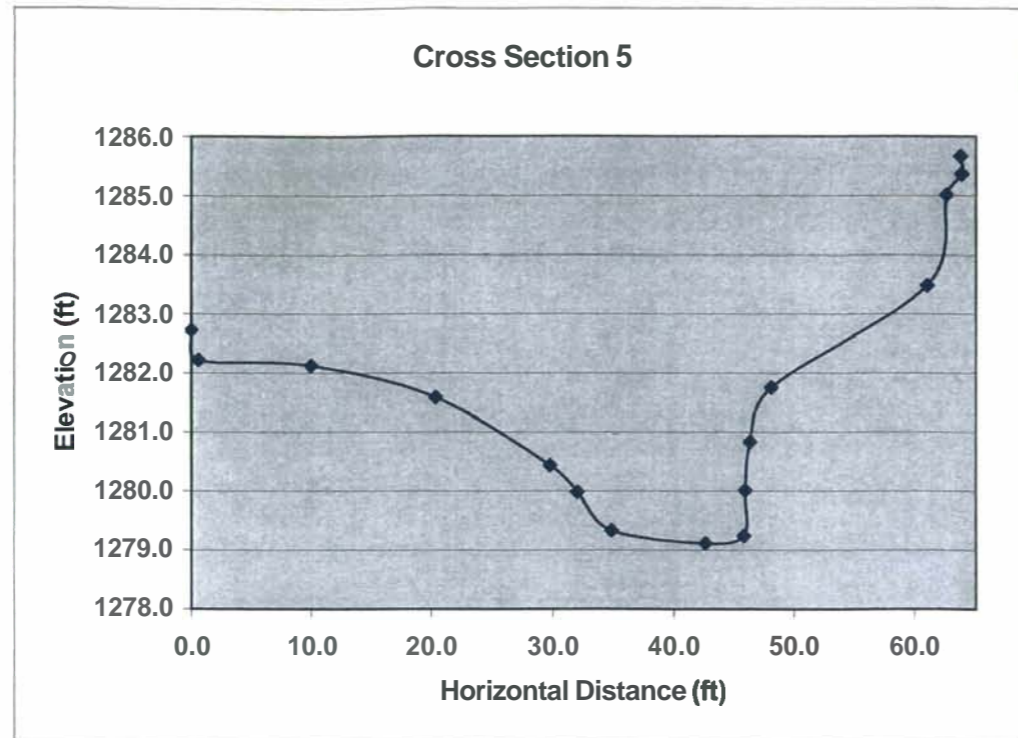
STA (ft)	Elev (ft)	Desc.
0.0	1282.7	
0.6	1282.2	
10.0	1282.1	
20.3	1281.6	
29.8	1280.4	
32.0	1280.0	LEW
34.9	1279.3	
42.6	1279.1	
45.8	1279.2	
45.9	1280.0	REW
46.3	1280.8	
48.1	1281.7	BKF
61.0	1283.5	
62.6	1285.0	
63.8	1285.4	
63.7	1285.7

W_{bkf} (ft)	D_{bkf} (ft)	A_{bkf} (SF)
31.1	1.5	46.4

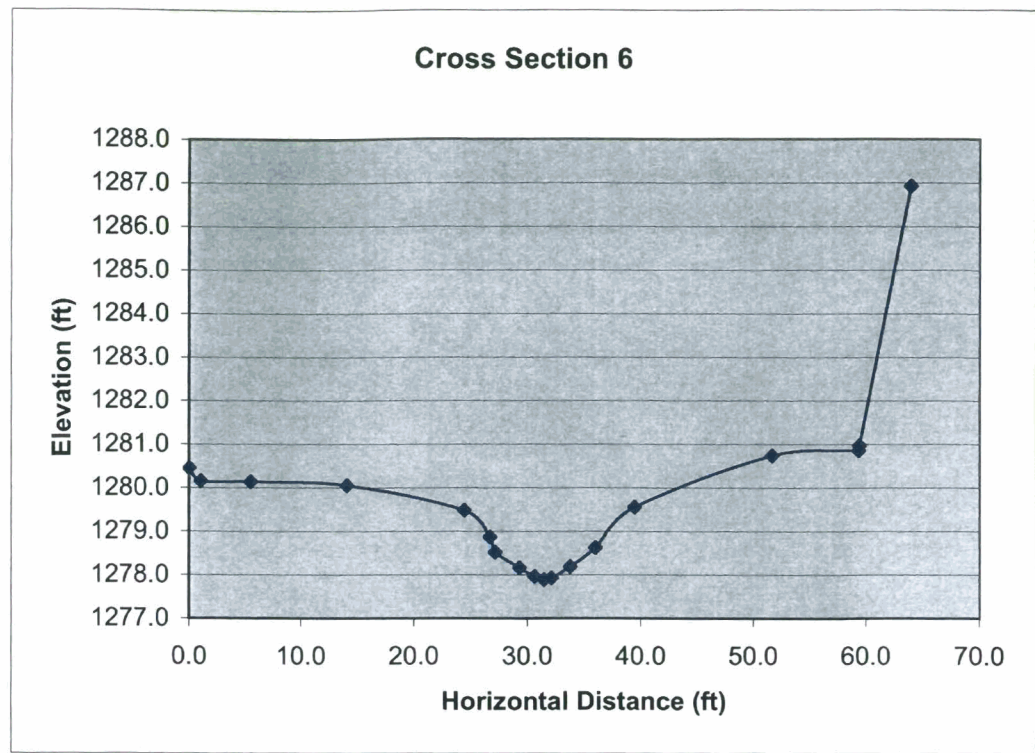
STA (ft)	Elev (ft)	Desc.
0.0	1280.4	
1.0	1280.1	
5.5	1280.1	
14.1	1280.0	
24.5	1279.5	
26.7	1278.9	
27.2	1278.5	
29.3	1278.1	LEW
30.6	1277.9	
31.5	1277.9	
32.1	1277.9	
33.8	1278.2	REW
36.0	1278.6	
39.5	1279.5	BKF
51.7	1280.7	
59.3	1280.9	
59.4	1281.0	
63.9	1286.9

W_{bkf} (ft)	D_{bkf} (ft)	A_{bkf} (SF)
16.3	0.9	14.9
