FINAL
AS-BUILT BASELINE
MONITORING REPORT

**NEIGHBORS BRANCH/WALTON CRAWLEY BRANCH
STREAM & WETLAND RESTORATION SITE**

NCDMS Project No. 92872
Contract No. D09023S
USACE Action ID No. SAW-2009-917 & NCDWR Project No. 10-0122
SCO No. 08-07308-01
McDowell County, North Carolina

Data Collection: April 2016
Submission: July 2016

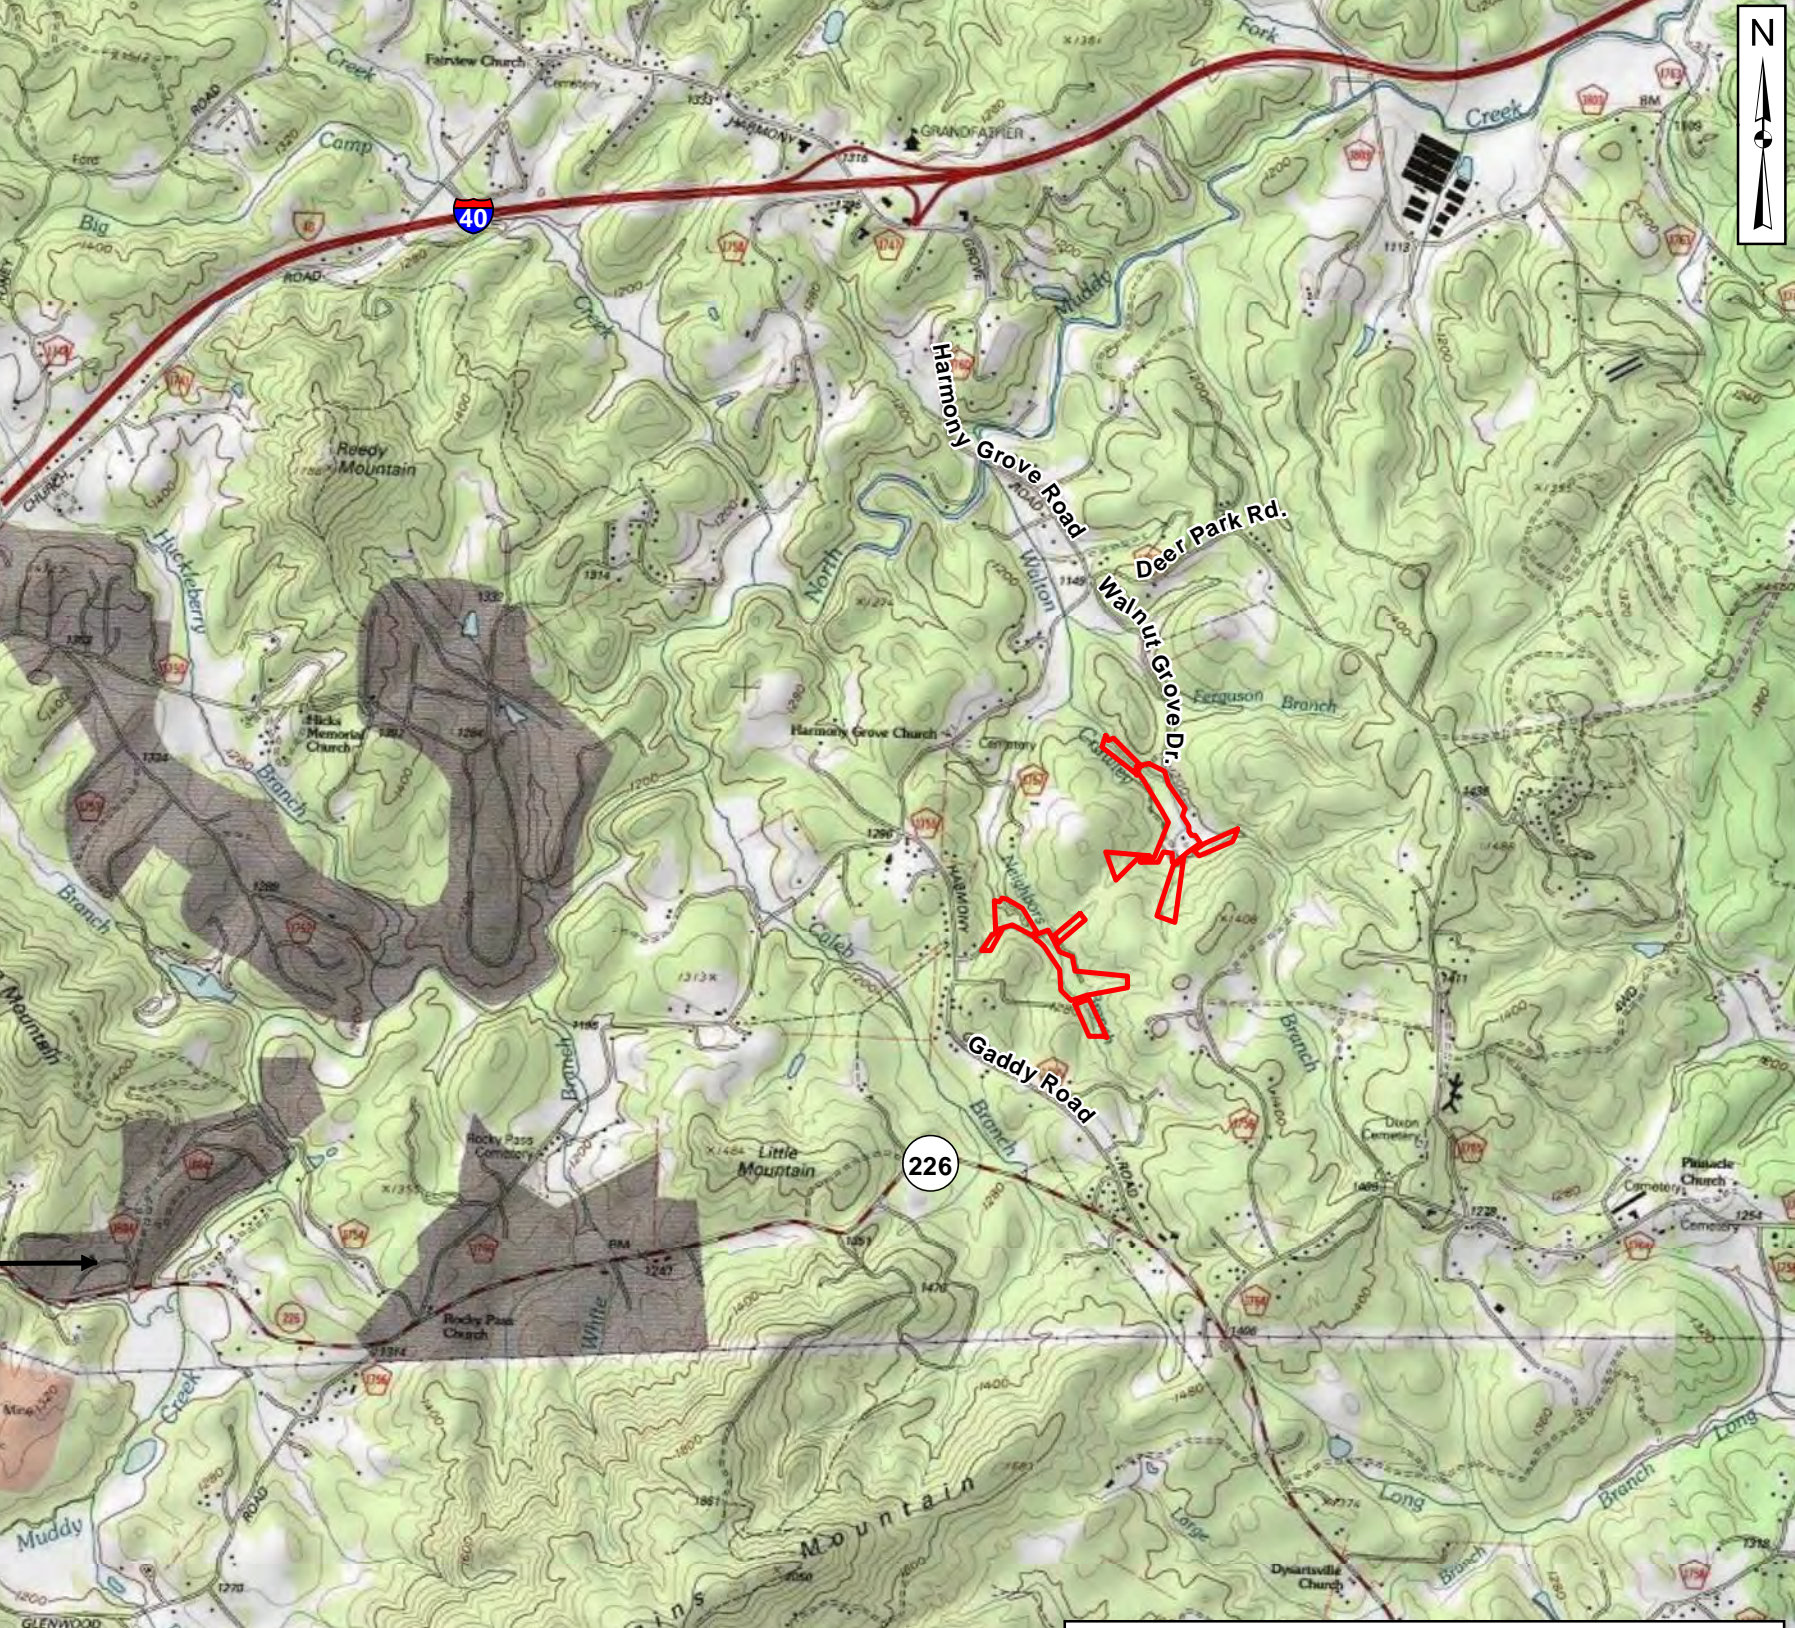
1

Figure 1. Site Location

The Site is located approximately six miles southeast of the town of Marion (Figure 1, Appendix B). The Site is situated due southwest of the intersection of Deer Park Road and Harmony Grove Road in McDowell County, North Carolina and is located within the United States Geological Survey (USGS) Hydrologic Unit

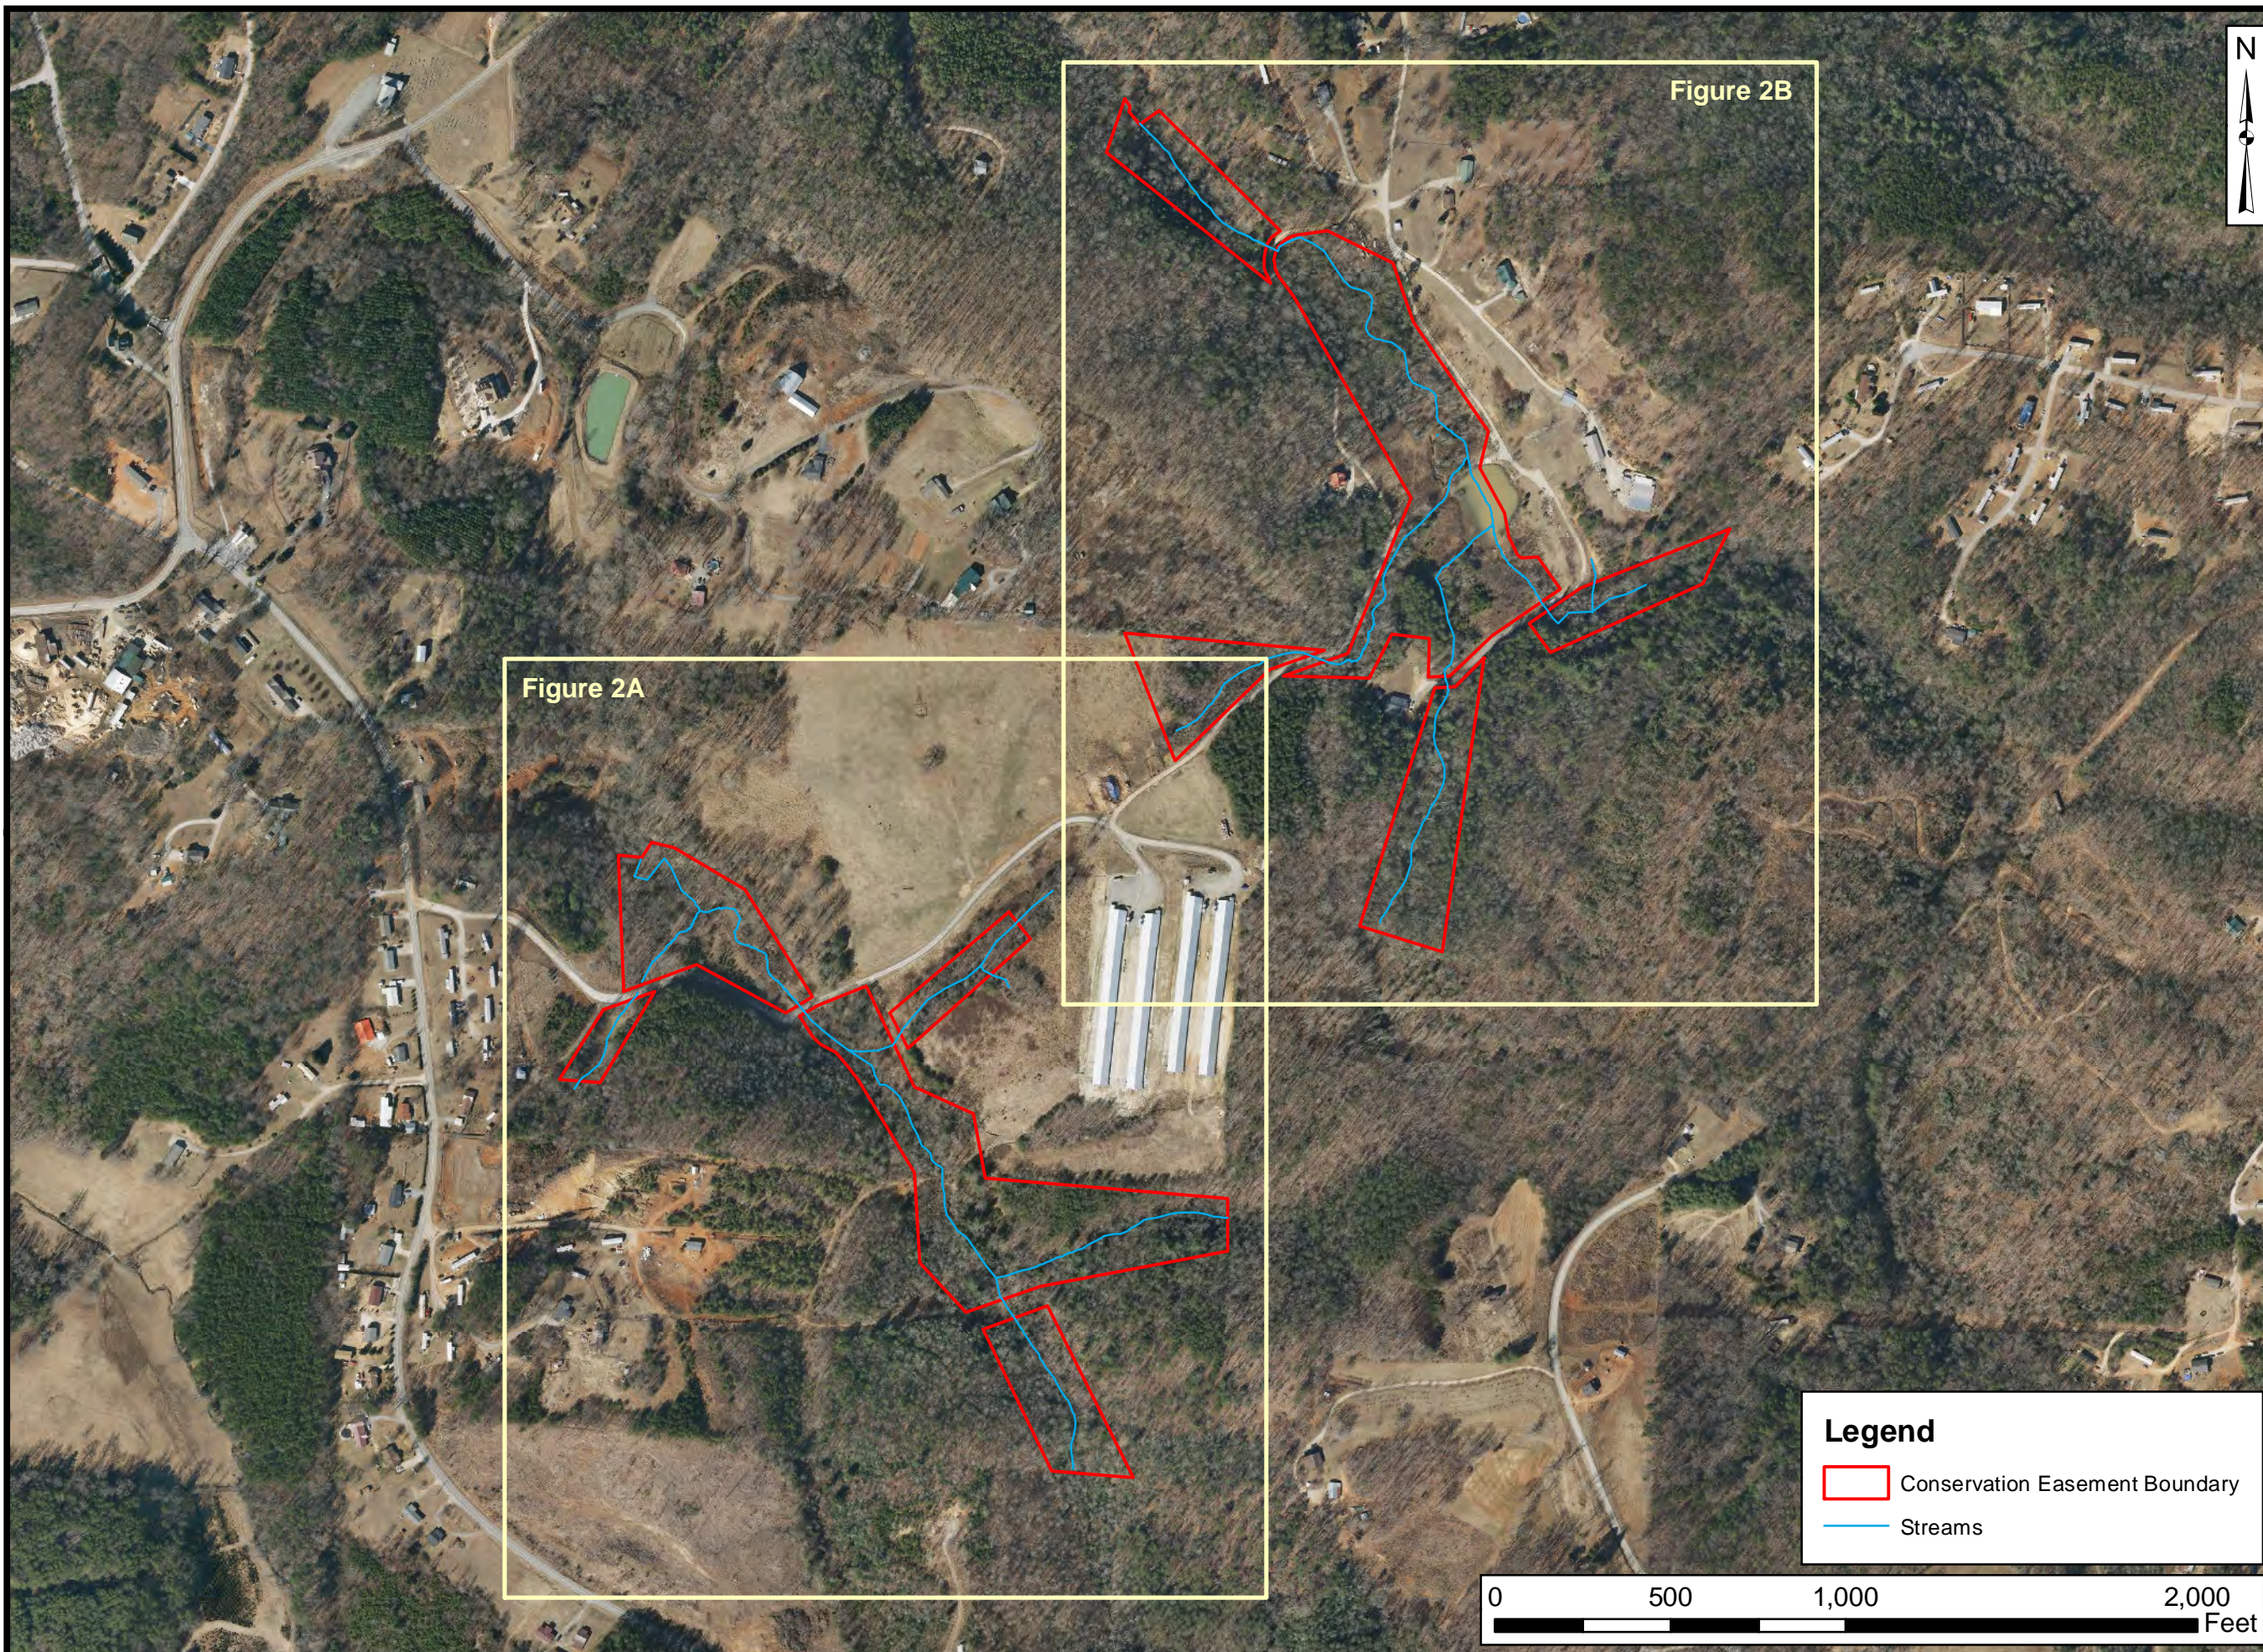
FIGURE
2

Title:
**Current Conditions
 Plan View**

Monitoring of restoration efforts will be performed for five years, or until success criteria are fulfilled. Monitoring is proposed for the stream channel, vegetation, and wetland hydrology. In general, the restoration success criteria, and required remediation actions, are based on the *Stream Mitigation Guidelines* (USACE et al. 2003). Monitoring features are described below and are depicted on Figure 2 (Appendix B).

Two groundwater monitoring gauges were installed to take measurements after hydrological modifications were performed at the Site. Hydrological sampling will occur quarterly throughout the growing season. Approximate locations of gauges are depicted on Figure 2 (Appendix B).

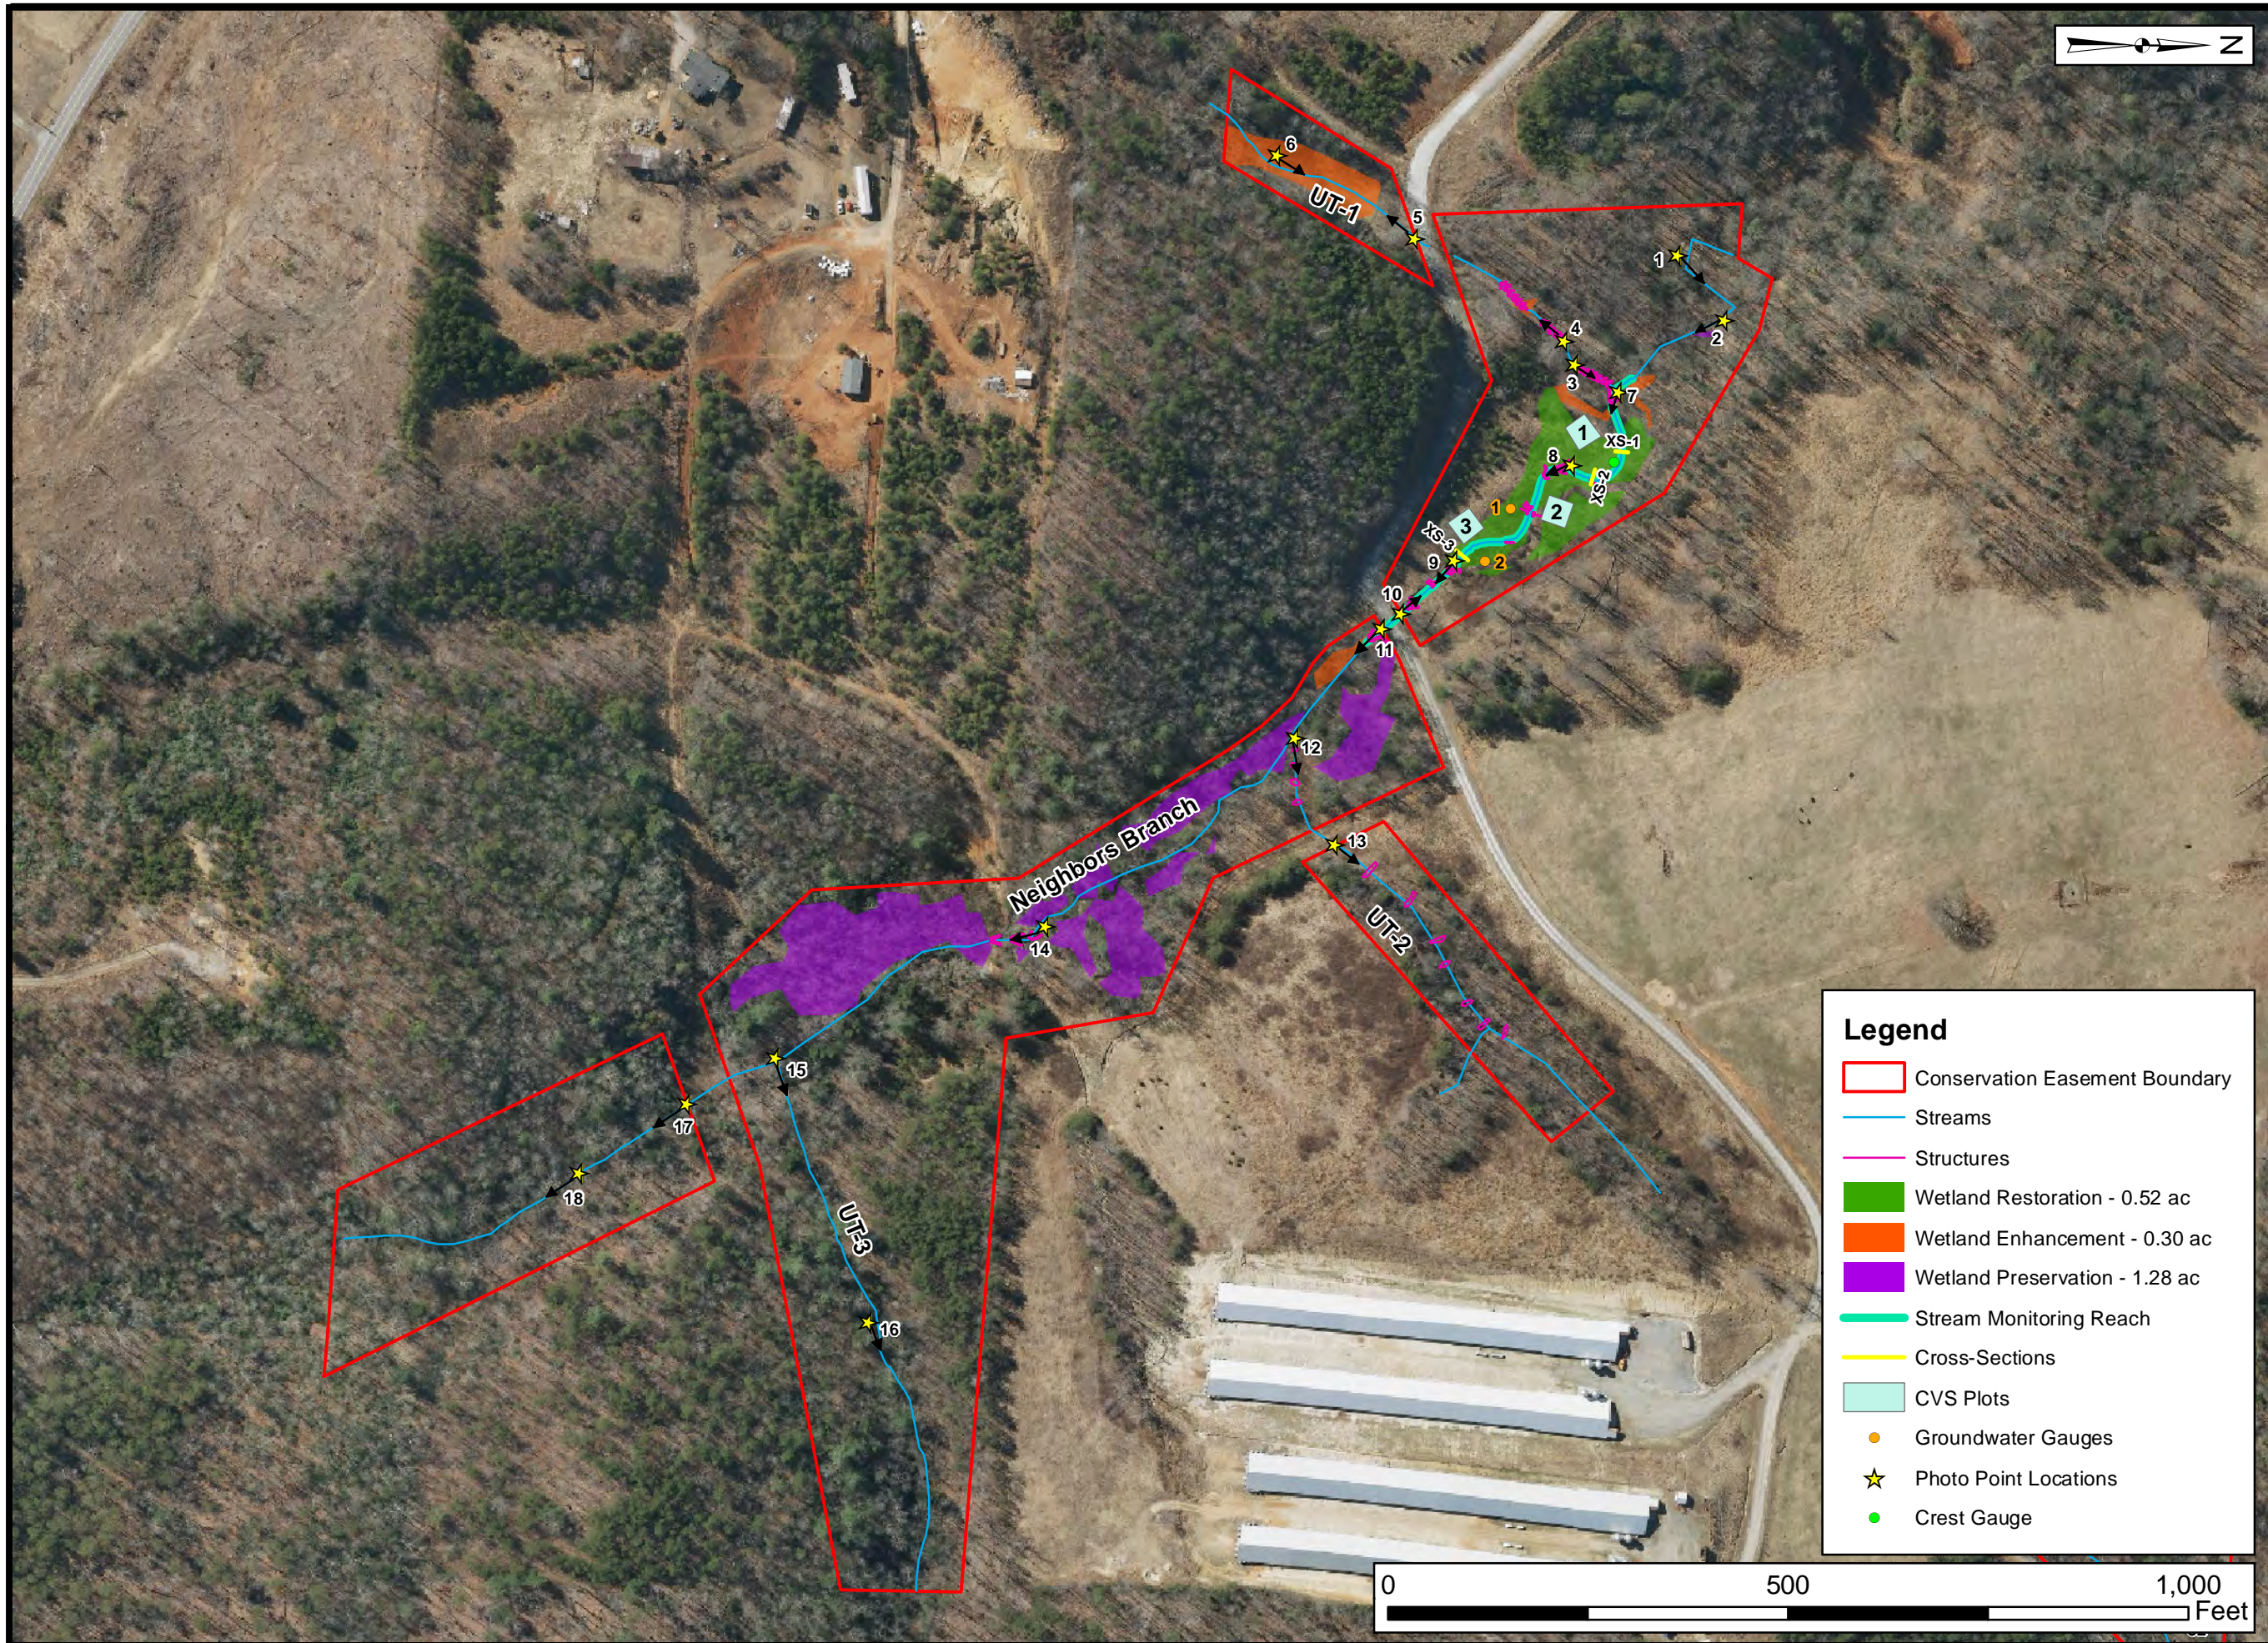
FIGURE
2A

Title:
**Current Conditions
 Plan View**

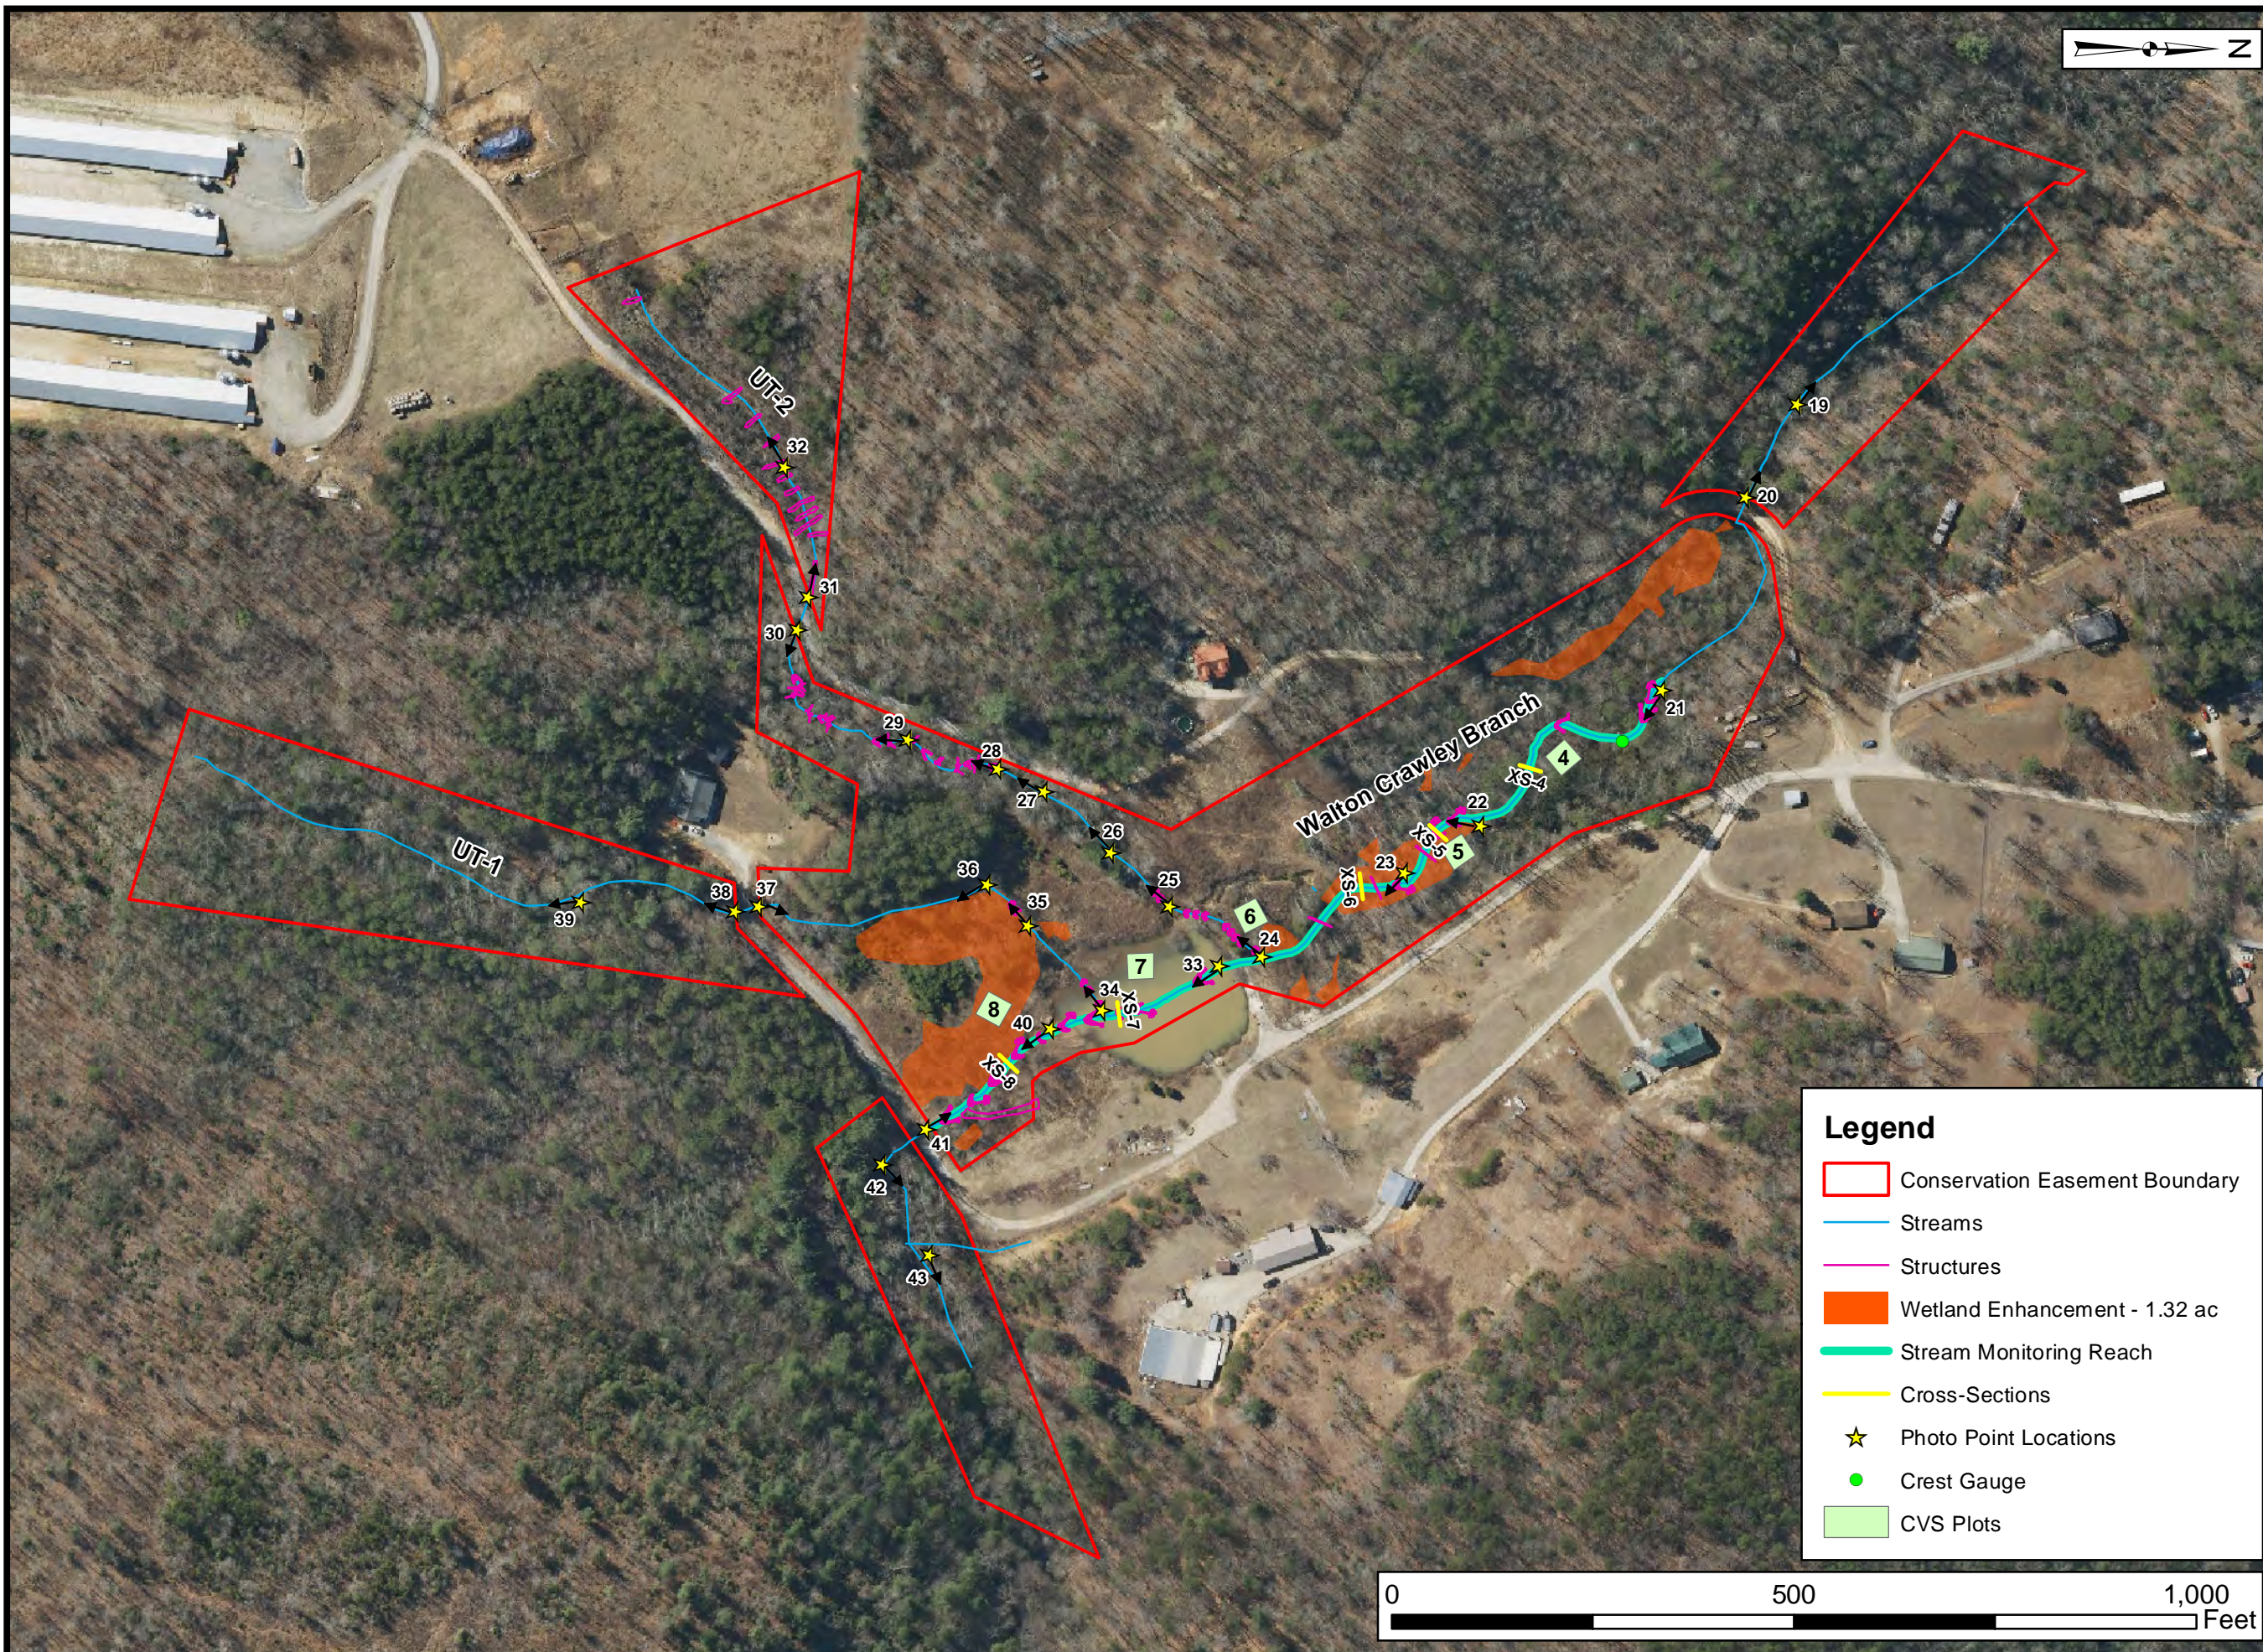
FIGURE
2B

Title:
**Current Conditions
 Plan View**

- Conservation Easement Boundary
- Streams
- Structures
- Wetland Enhancement - 1.32 ac
- Stream Monitoring Reach
- Cross-Sections
- ★ Photo Point Locations
- Crest Gauge
- CVS Plots

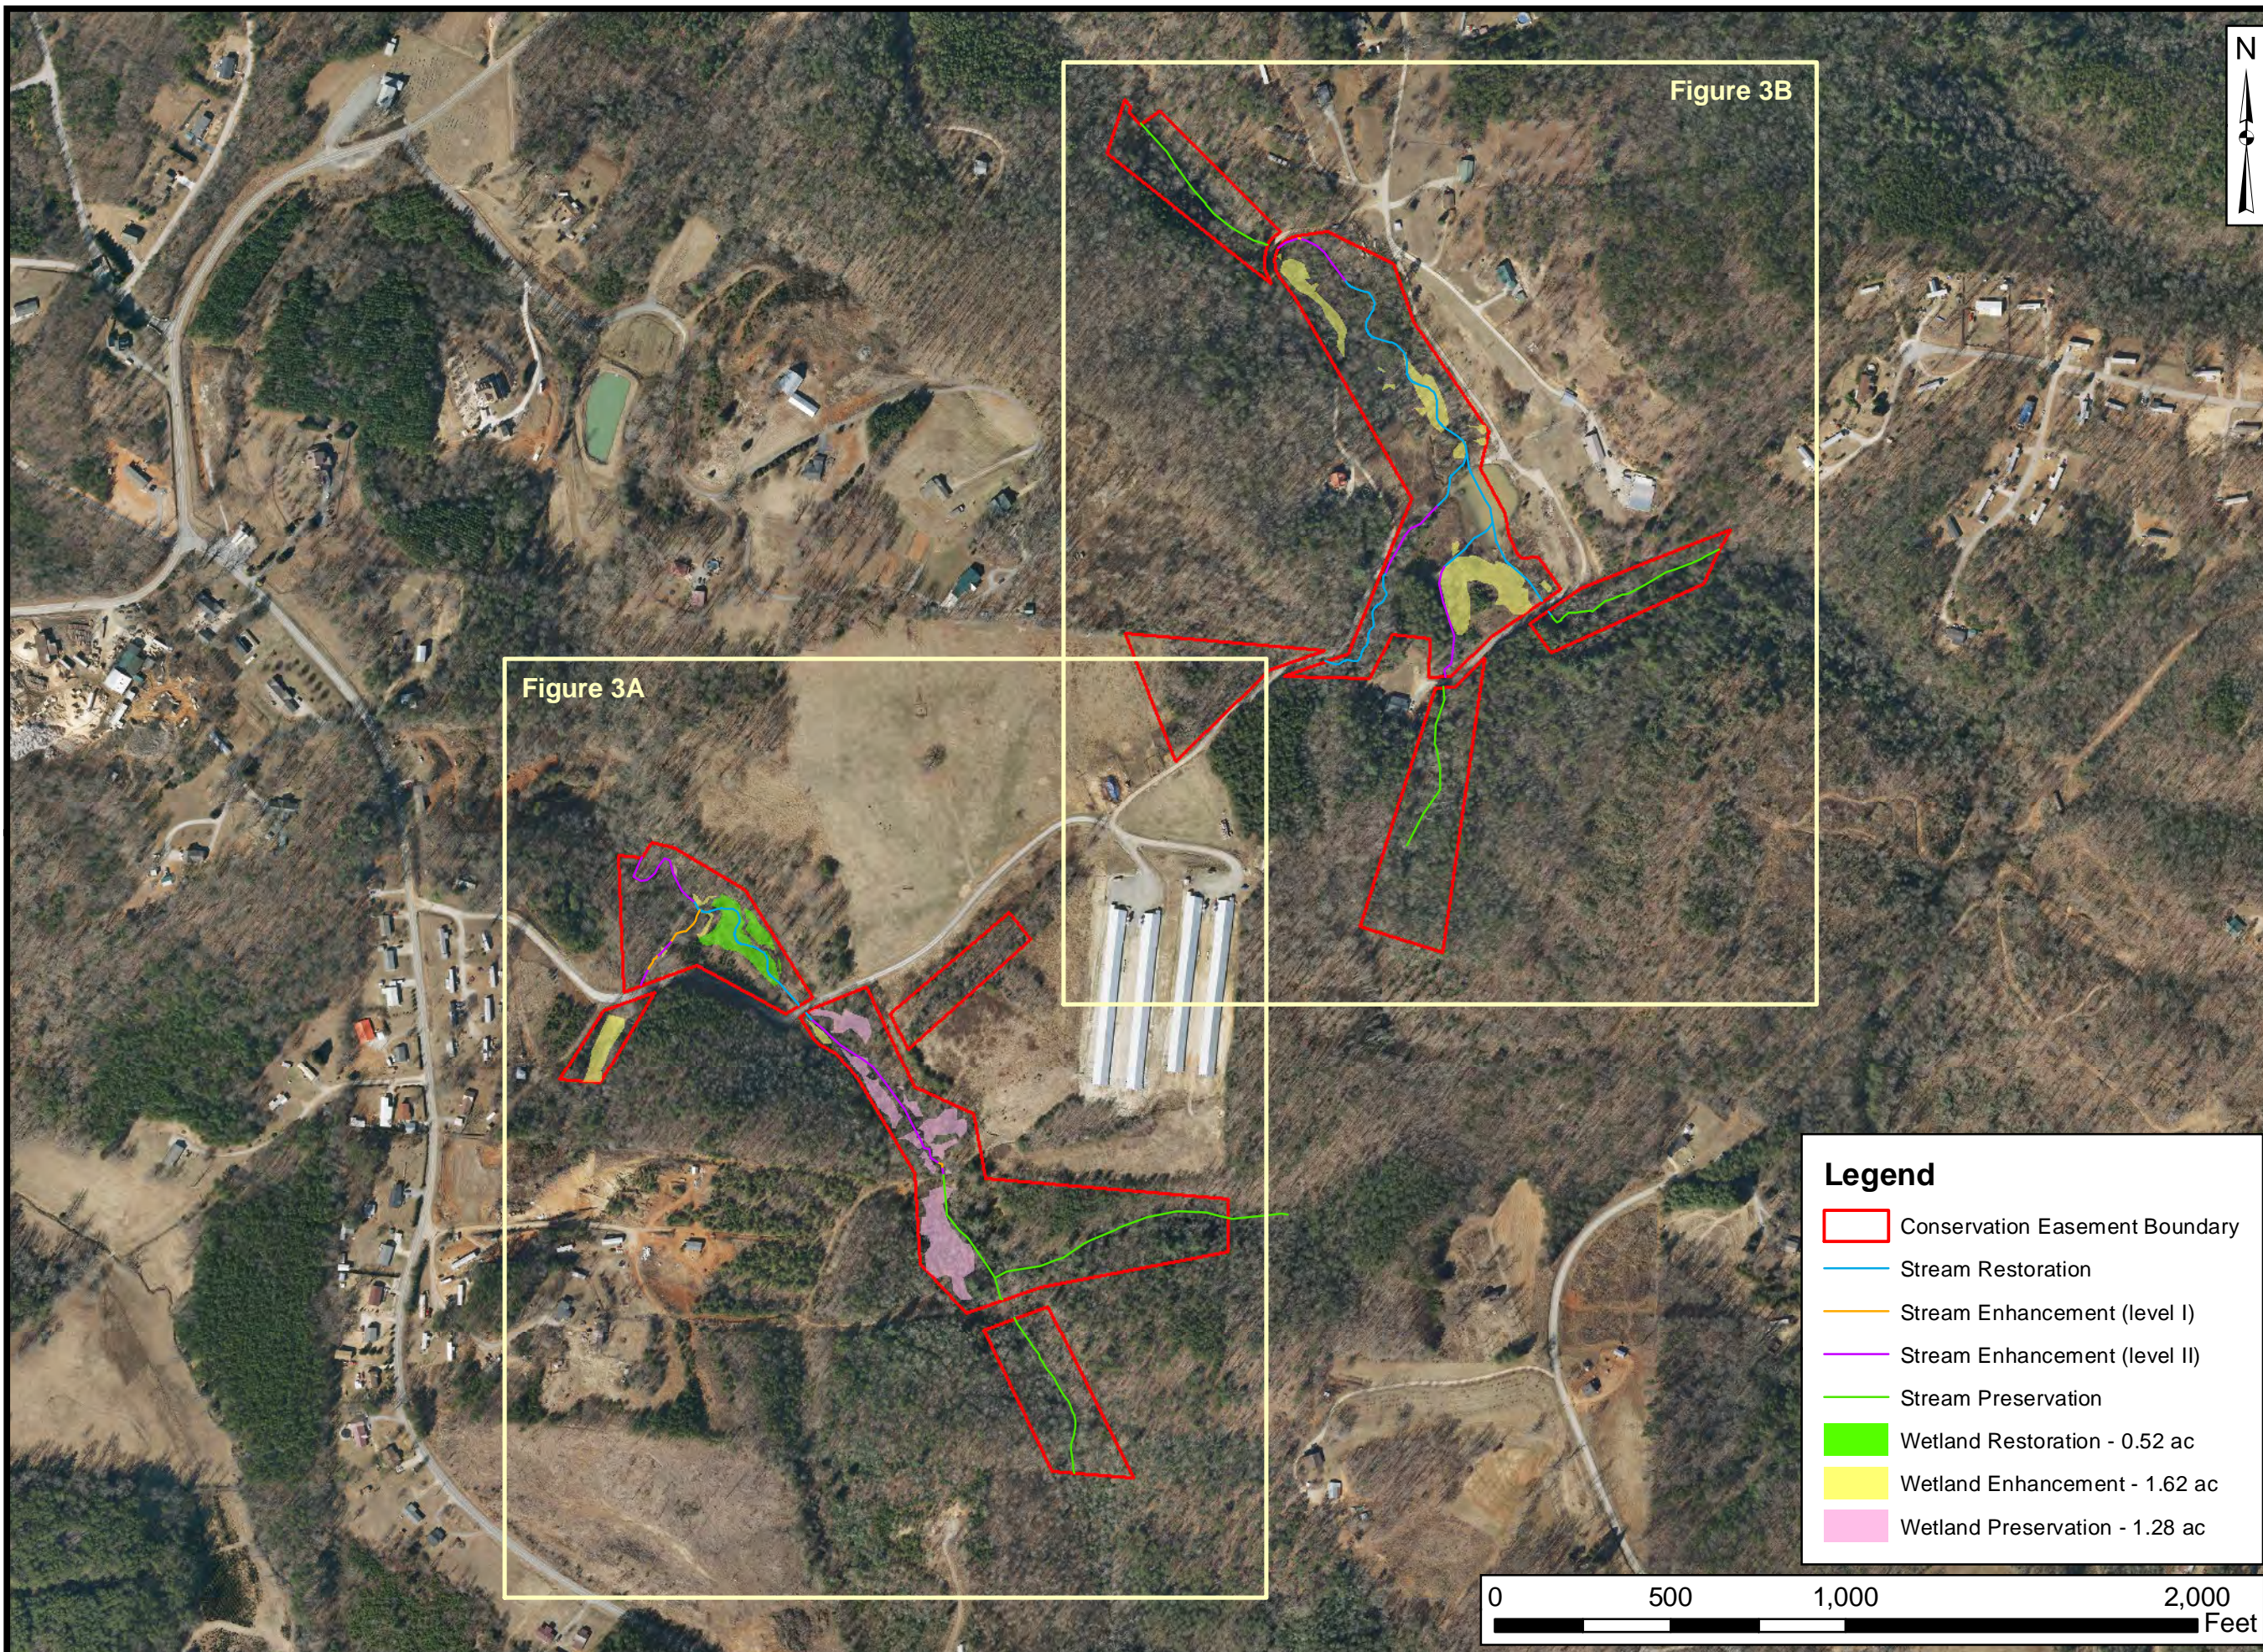
**FIGURE
 3**

Figures 3, 3A-3B. Project Assets

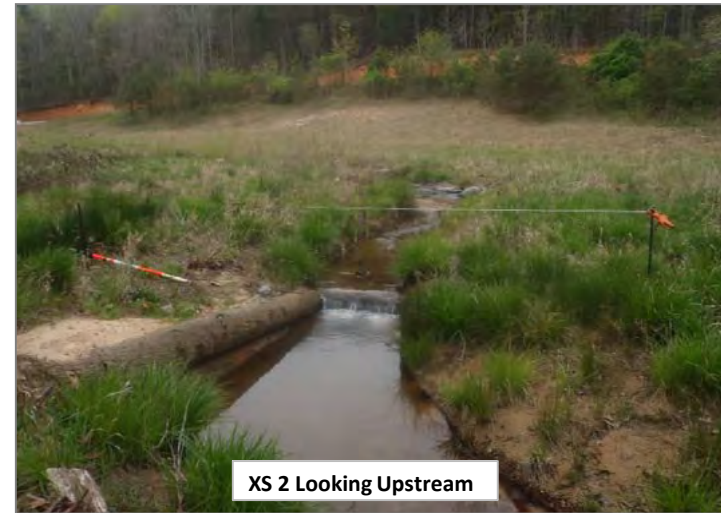
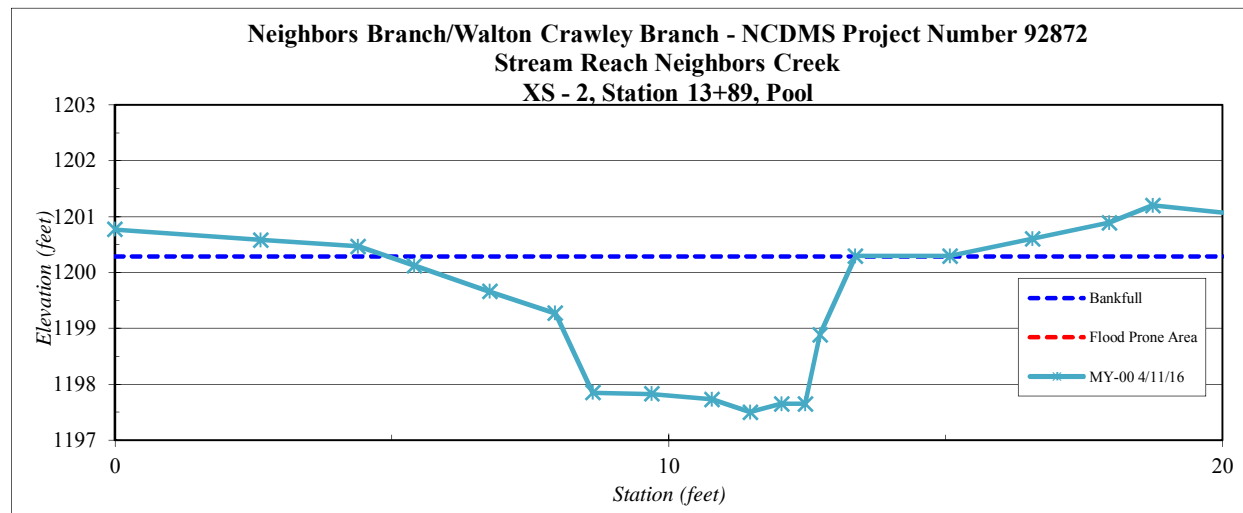
Station	Elevation
0.0	1200.8
2.6	1200.6
4.4	1200.5
5.4	1200.1
6.8	1199.7
8.0	1199.3
8.6	1197.9
9.7	1197.8
10.8	1197.7
11.5	1197.5
12.0	1197.6
12.5	1197.7
12.7	1198.9
13.4	1200.3
15.1	1200.3
16.6	1200.6
18.0	1200.9
18.7	1201.2
20.1	1201.1

SUMMARY DATA	
Bankfull Elevation:	1200.3
Bankfull Cross-Sectional Area:	13.6
Bankfull Width:	8.5
Flood Prone Area Elevation:	NA
Flood Prone Width:	NA
Max Depth at Bankfull:	2.8
Mean Depth at Bankfull:	1.6
W / D Ratio:	NA
Entrenchment Ratio:	NA
Bank Height Ratio:	1.0

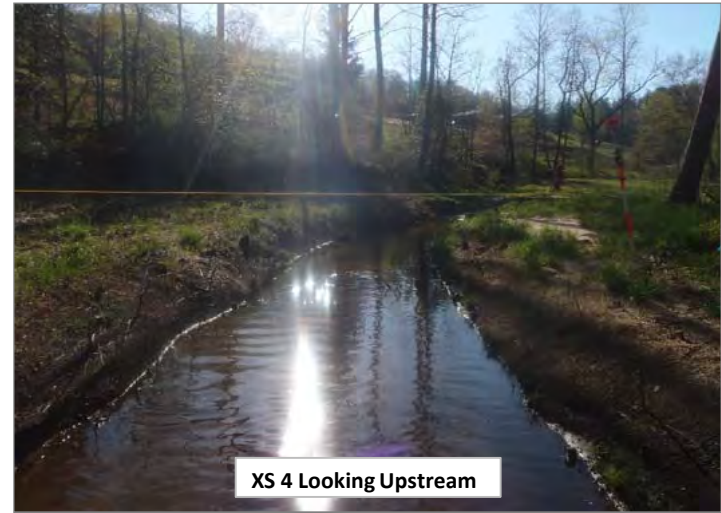
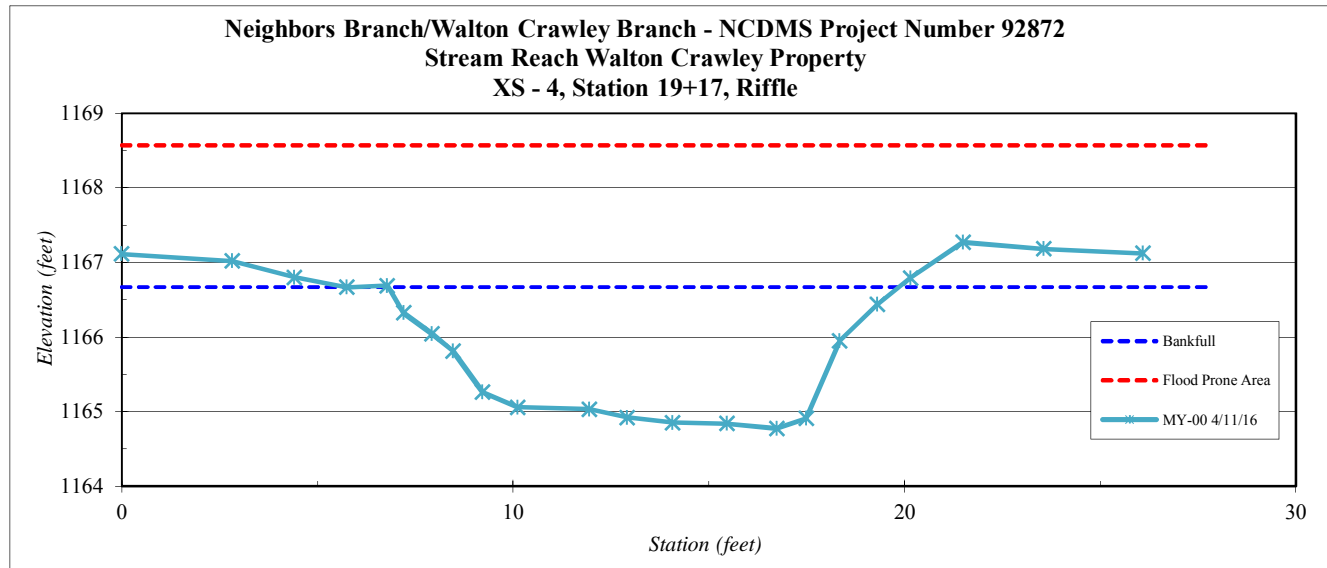
Site	Neighbors Br./Walton Crawley Br.
Project Number:	92872
XS ID	XS - 4, Riffle
Reach	Walton Crawley Branch
Date:	4/11/2016
Field Crew:	Perkinson, Jernigan

Station	Elevation
0.00	1167.11
2.83	1167.02
4.41	1166.80
5.75	1166.67
6.78	1166.69
7.20	1166.32
7.92	1166.05
8.46	1165.81
9.22	1165.26
10.11	1165.06
11.95	1165.03
12.91	1164.92
14.08	1164.85
15.46	1164.84
16.75	1164.77
17.5	1164.91
18.3	1165.95
19.3	1166.44
20.2	1166.79
21.5	1167.27
23.6	1167.18
26.1	1167.12
27.7	1167.12

SUMMARY DATA	
Bankfull Elevation:	1166.7
Bankfull Cross-Sectional Area:	17.6
Bankfull Width:	13.2
Flood Prone Area Elevation:	1168.6
Flood Prone Width:	100.0
Max Depth at Bankfull:	1.9
Mean Depth at Bankfull:	1.3
W / D Ratio:	9.9
Entrenchment Ratio:	7.6
Bank Height Ratio:	1.0

XS 4 Looking Upstream

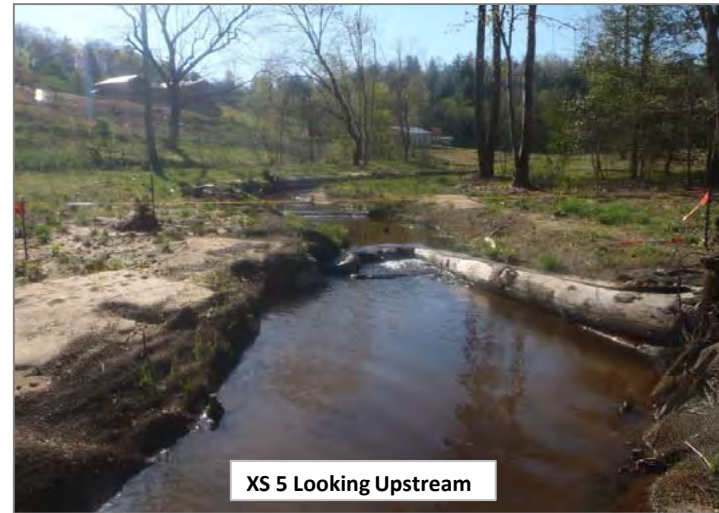
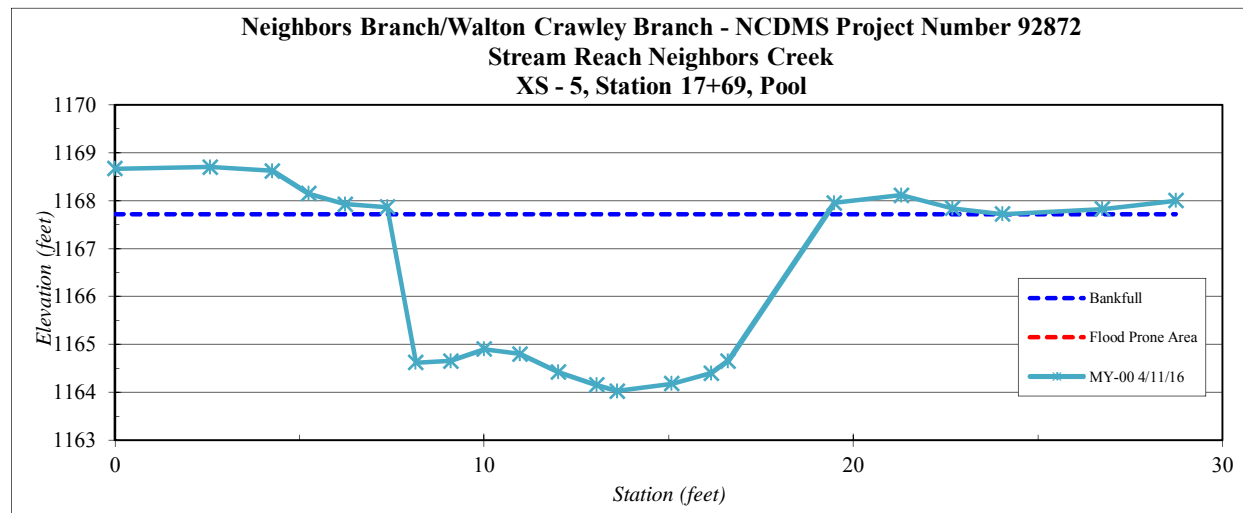
Site	Neighbors Br./Walton Crawley Br.
Project Number:	92872
XS ID	XS - 5, Pool
Reach	Walton Crawley Branch
Date:	4/11/2016
Field Crew:	Perkinson, Jernigan

Station	Elevation
0.0	1168.7
2.6	1168.7
4.3	1168.6
5.3	1168.1
6.2	1167.9
7.4	1167.9
8.1	1164.6
9.1	1164.7
10.0	1164.9
11.0	1164.8
12.0	1164.4
13.0	1164.1
13.6	1164.0
15.1	1164.2
16.2	1164.4
16.6	1164.7
19.5	1168.0
21.3	1168.1
22.7	1167.8
24.0	1167.7
26.7	1167.8
28.7	1168.0

SUMMARY DATA	
Bankfull Elevation:	1167.7
Bankfull Cross-Sectional Area:	32.9
Bankfull Width:	11.9
Flood Prone Area Elevation:	NA
Flood Prone Width:	NA
Max Depth at Bankfull:	3.7
Mean Depth at Bankfull:	2.8
W / D Ratio:	NA
Entrenchment Ratio:	NA
Bank Height Ratio:	1.0
