FINAL
AS-BUILT BASELINE
MONITORING REPORT

**NEIGHBORS BRANCH/WALTON CRAWLEY BRANCH
STREAM & WETLAND RESTORATION SITE**

NCDMS Project No. 92872
Contract No. D09023S
USACE Action ID No. SAW-2009-917 & NCDWR Project No. 10-0122
SCO No. 08-07308-01
McDowell County, North Carolina

Data Collection: April 2016
Submission: July 2016

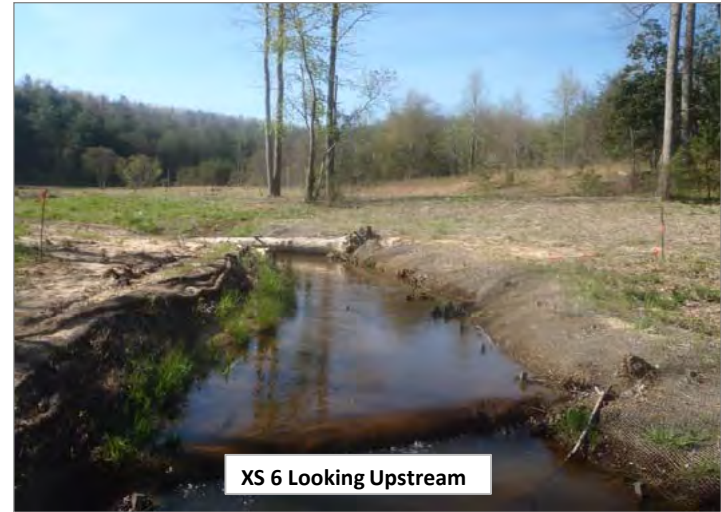
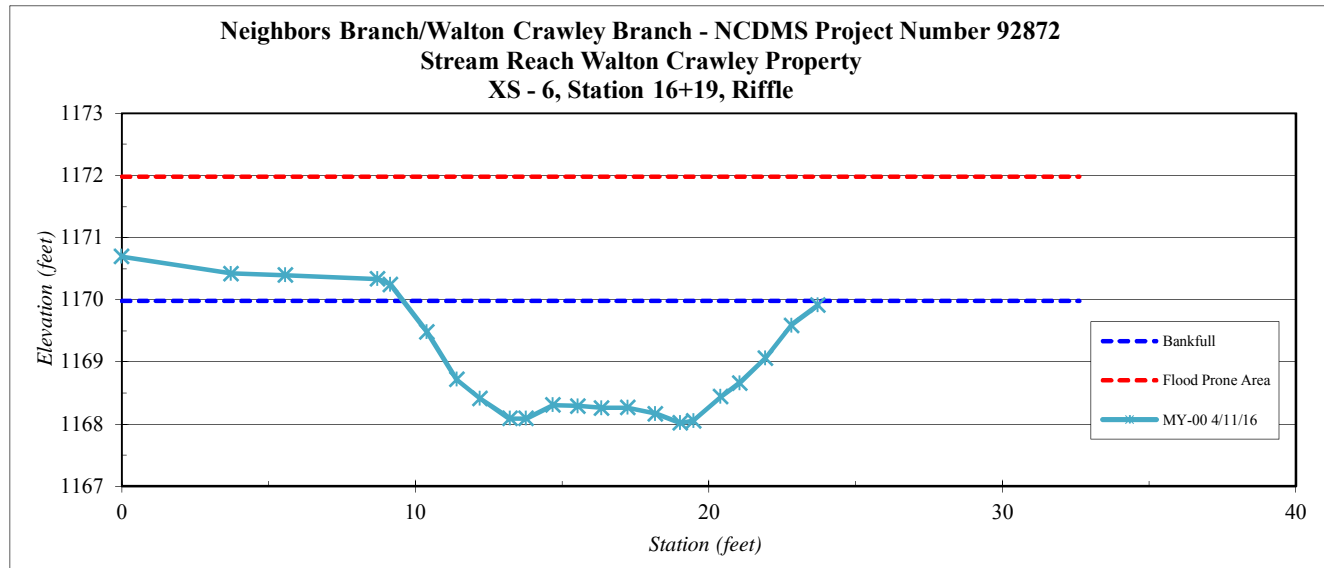
Site	Neighbors Br./Walton Crawley Br.
Project Number:	92872
XS ID	XS - 6, Riffle
Reach	Walton Crawley Branch
Date:	4/11/2016
Field Crew:	Perkinson, Jernigan

XS 6 Looking Upstream

SUMMARY DATA	
Bankfull Elevation:	1170.0
Bankfull Cross-Sectional Area:	19.4
Bankfull Width:	14.3
Flood Prone Area Elevation:	1172.0
Flood Prone Width:	100.0
Max Depth at Bankfull:	2.0
Mean Depth at Bankfull:	1.4
W / D Ratio:	10.5
Entrenchment Ratio:	7.0
Bank Height Ratio:	1.0

Station	Elevation
0.00	1170.69
3.72	1170.42
5.56	1170.40
8.72	1170.34
9.15	1170.25
10.40	1169.49
11.41	1168.72
12.19	1168.41
13.22	1168.09
13.78	1168.09
14.69	1168.31
15.54	1168.29
16.35	1168.26
17.23	1168.27
18.18	1168.17
19.0	1168.02
19.5	1168.06
20.4	1168.44
21.1	1168.66
21.9	1169.06
22.8	1169.59
23.7	1169.91
24.1	1170.12
26.1	1170.20
28.1	1170.10
30.3	1169.98
32.6	1170.15

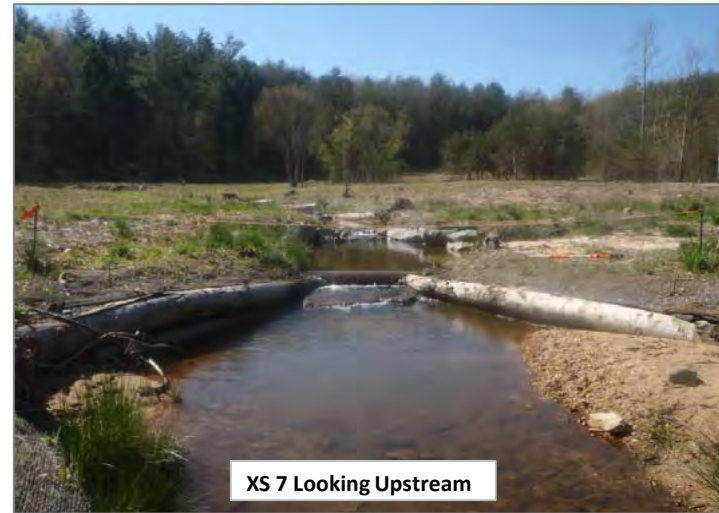
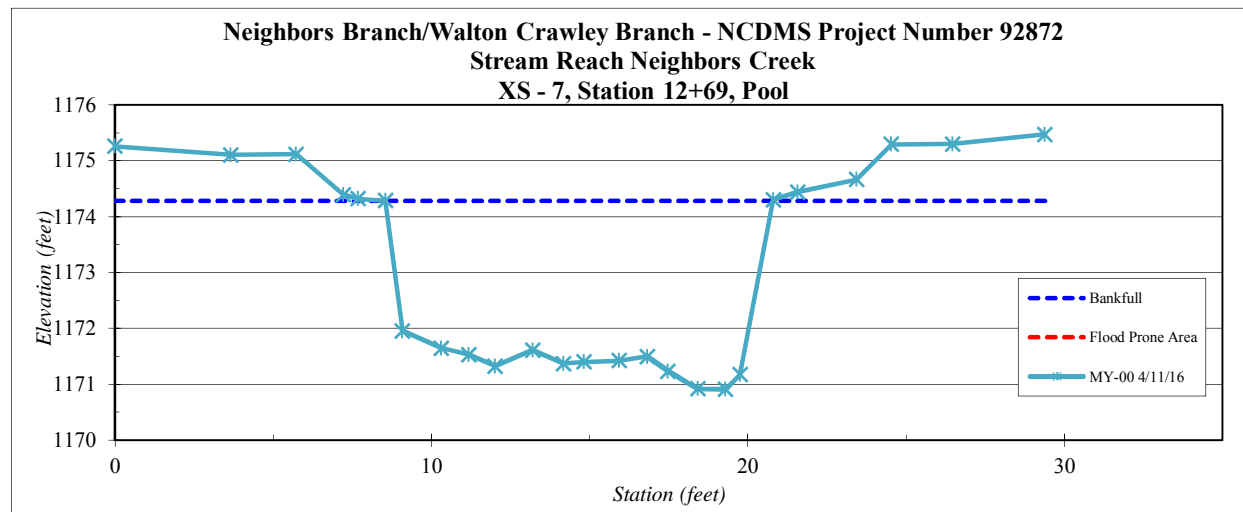
Site	Neighbors Br./Walton Crawley Br.
Project Number:	92872
XS ID	XS - 7, Pool
Reach	Walton Crawley Branch
Date:	4/11/2016
Field Crew:	Perkinson, Jernigan

Station	Elevation
0.0	1175.3
3.7	1175.1
5.7	1175.1
7.2	1174.4
7.7	1174.3
8.5	1174.3
9.1	1172.0
10.3	1171.6
11.2	1171.5
12.0	1171.3
13.2	1171.6
14.2	1171.4
14.8	1171.4
15.9	1171.4
16.8	1171.5
17.5	1171.2
18.4	1170.9
19.3	1170.9
19.8	1171.2
20.8	1174.3
21.6	1174.4
23.4	1174.7
24.5	1175.3
26.5	1175.3
29.4	1175.5

SUMMARY DATA	
Bankfull Elevation:	1174.3
Bankfull Cross-Sectional Area:	33.0
Bankfull Width:	12.2
Flood Prone Area Elevation:	NA
Flood Prone Width:	NA
Max Depth at Bankfull:	3.4
Mean Depth at Bankfull:	2.7
W / D Ratio:	NA
Entrenchment Ratio:	NA
Bank Height Ratio:	1.0

XS 7 Looking Upstream

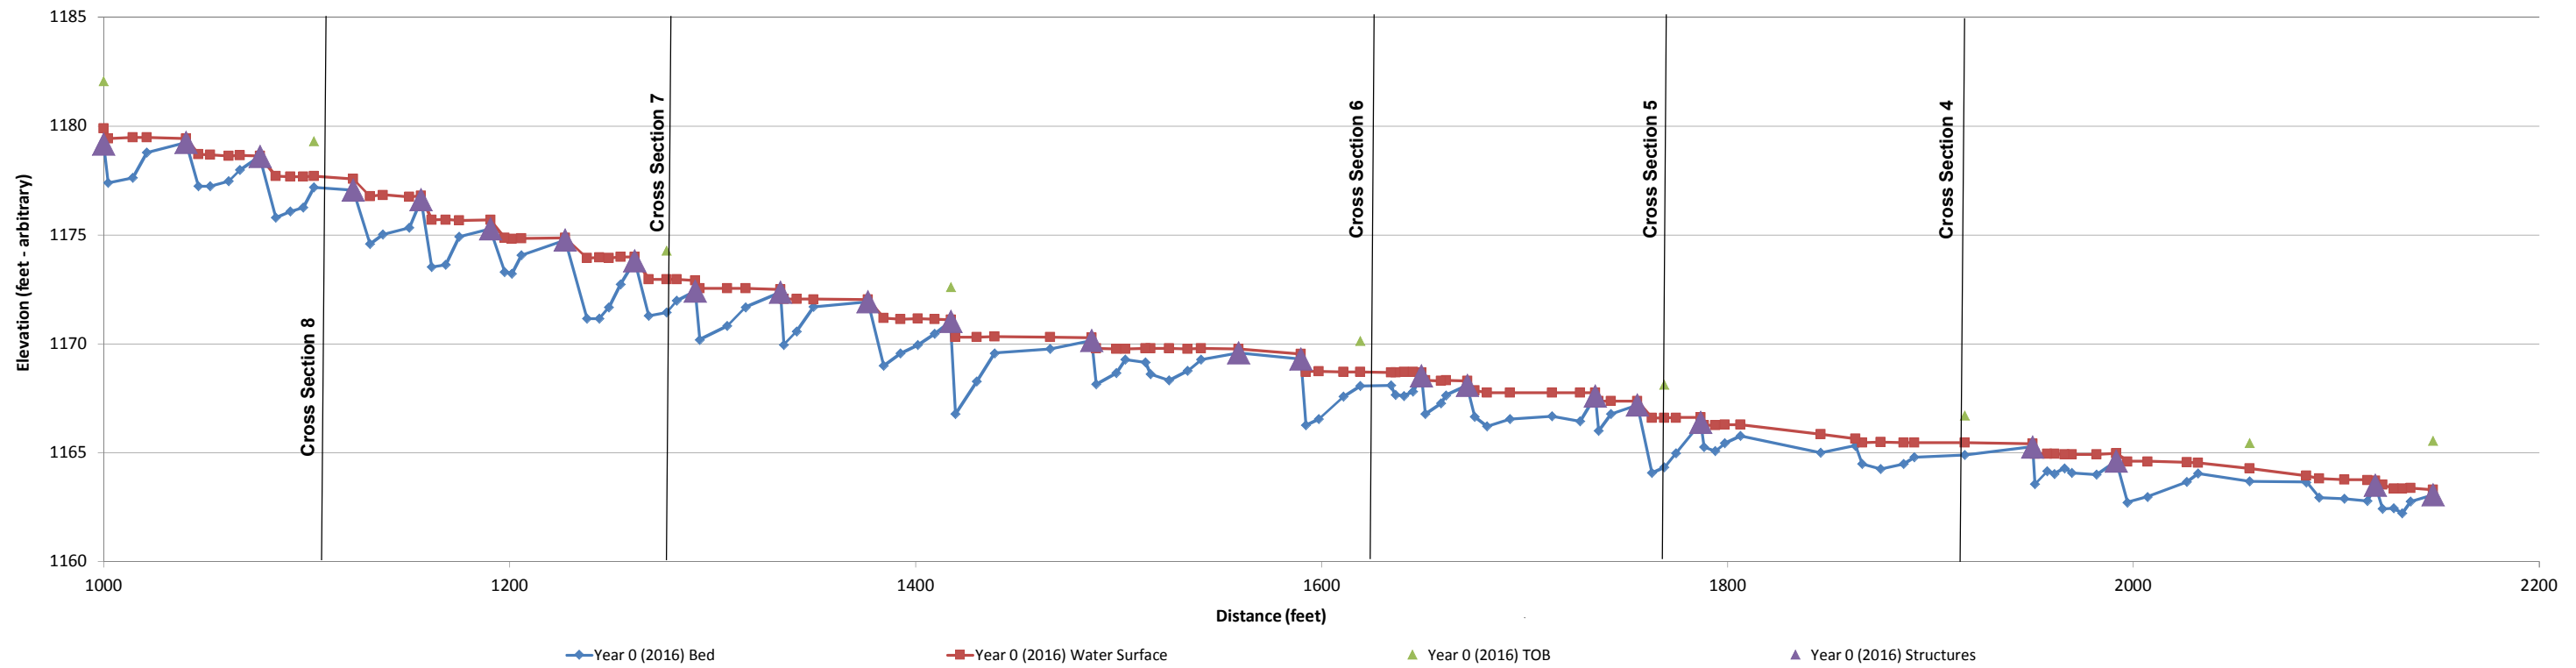
Walton Crawley Branch Year 0 (2014) Profile - Station 10+00 to 22+00

Project Name Neighbors Branch/Walton Crawley Branch - Profile
Reach Walton Crawley Branch, Station 10+00 - 22+00
Feature Profile
Date 4/11/16
Crew Perkinson, Jernigan

2016	2016	2017	2018	2019
Avg. Water Surface Slope	0.0145				
Riffle Length	24				
Avg. Riffle Slope	0.0032				
Pool Length	25				
Pool to Pool Spacing	43

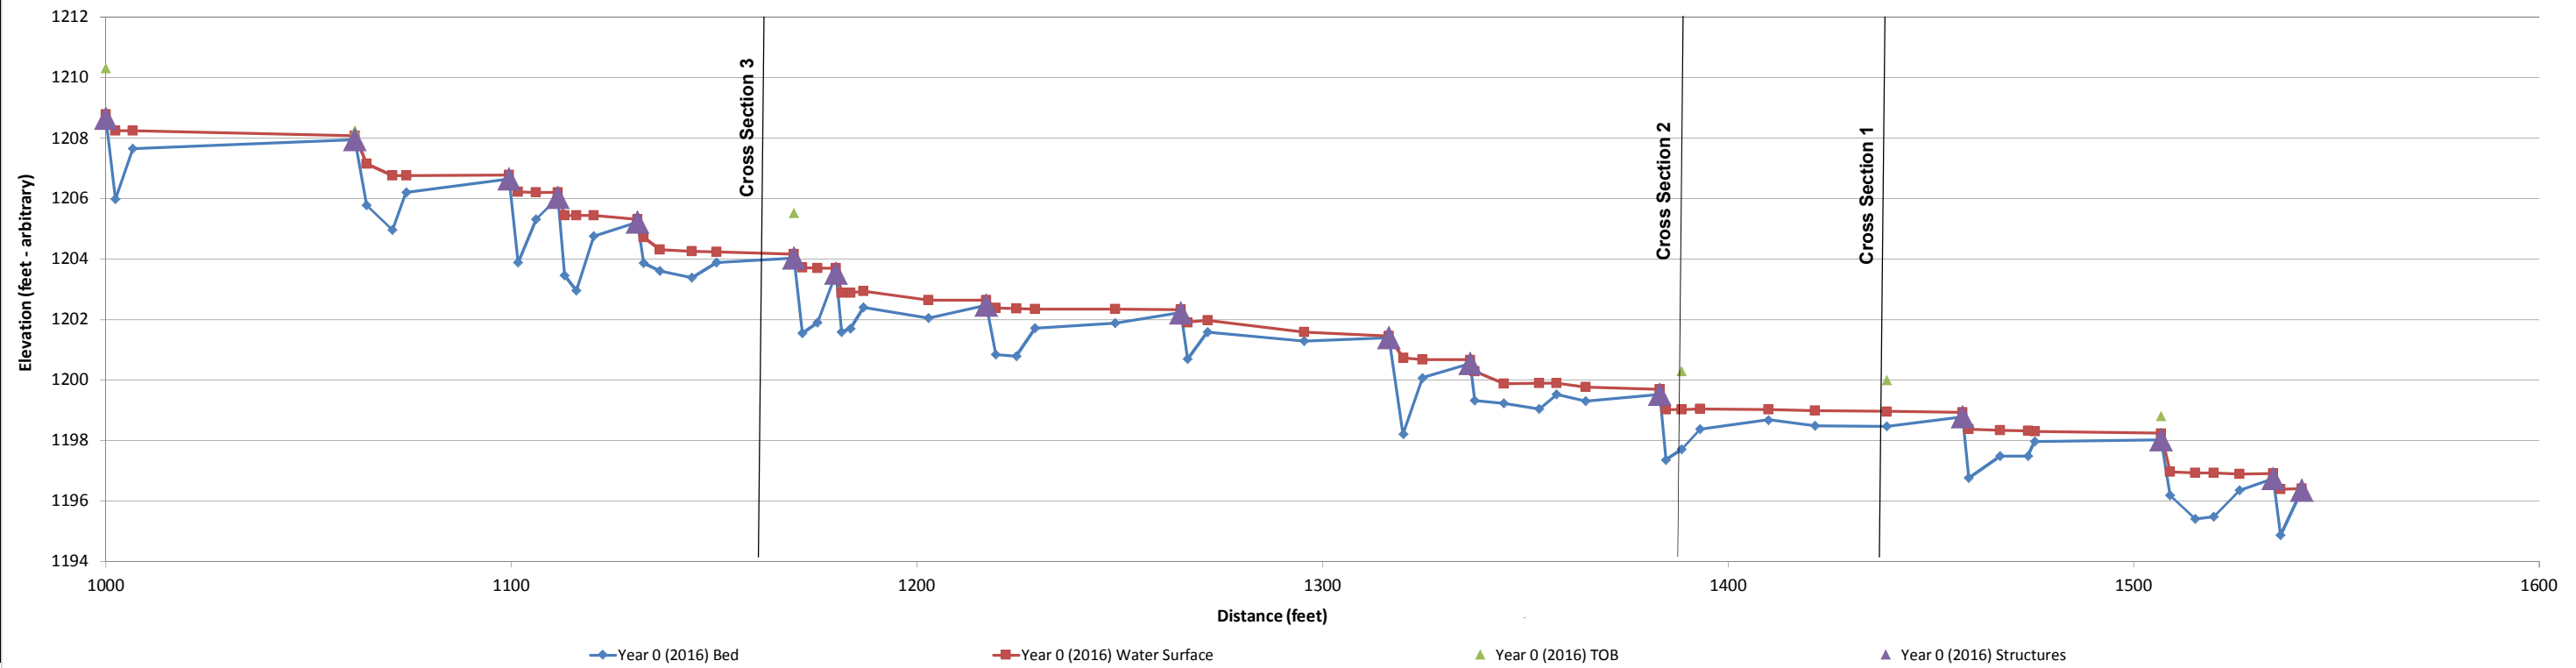
Neighbors Branch Year 0 (2016) Profile - Station 10+00 to 16+00

Project Name Neighbors Branch/Walton Crawley Branch - Profile
Reach Neighbors Branch, Station 10+00 - 16+00
Feature Profile
Date 4/11/16
Crew Perkinson, Jernigan

2016	2016	2017	2018	2019
Avg. Water Surface Slope	0.0222				
Riffle Length	28				
Avg. Riffle Slope	0.0043				
Pool Length	12				
Pool to Pool Spacing	36

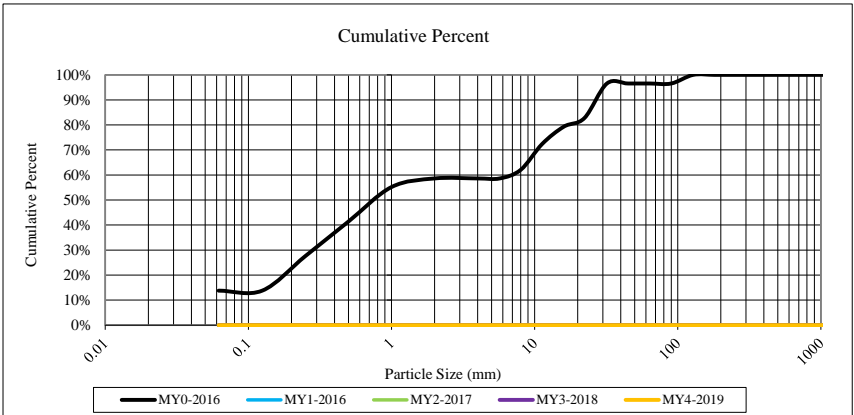
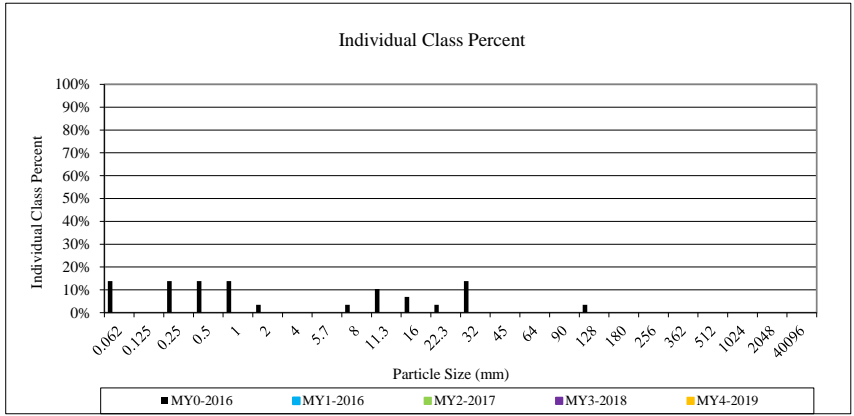
Project Name: Neighbors Branch/Walton Crawley Branch Stream and Wetland Restoration Site					
Cross-Section: 1					
Feature: Riffle					
		2016			
Description	Material	Size (mm)	Total #	Item %	Cum %
Silt/Clay	silt/clay	0.062	36	36%	36%
Sand	very fine sand	0.125	8	8%	44%
	fine sand	0.250	4	4%	48%
	medium sand	0.50	0	0%	48%
	coarse sand	1.00	8	8%	56%
	very coarse sand	2.0	4	4%	60%
Gravel	very fine gravel	4.0	8	8%	68%
	fine gravel	5.7	4	4%	72%
	fine gravel	8.0	12	12%	84%
	medium gravel	11.3	8	8%	92%
	medium gravel	16.0	0	0%	92%
	course gravel	22.3	4	4%	96%
	course gravel	32.0	0	0%	96%
	very coarse gravel	45	0	0%	96%
	very coarse gravel	64	4	4%	100%
Cobble	small cobble	90	0	0%	100%
	medium cobble	128	0	0%	100%
	large cobble	180	0	0%	100%
	very large cobble	256	0	0%	100%
Boulder	small boulder	362	0	0%	100%
	small boulder	512	0	0%	100%
	medium boulder	1024	0	0%	100%
	large boulder	2048	0	0%	100%
Bedrock	bedrock	40096	0	0%	100%

Summary Data	
D50	0.8
D84	23
D95	31

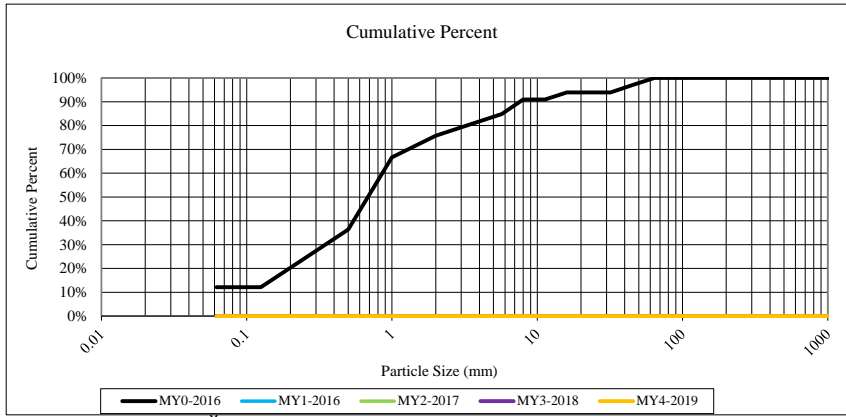
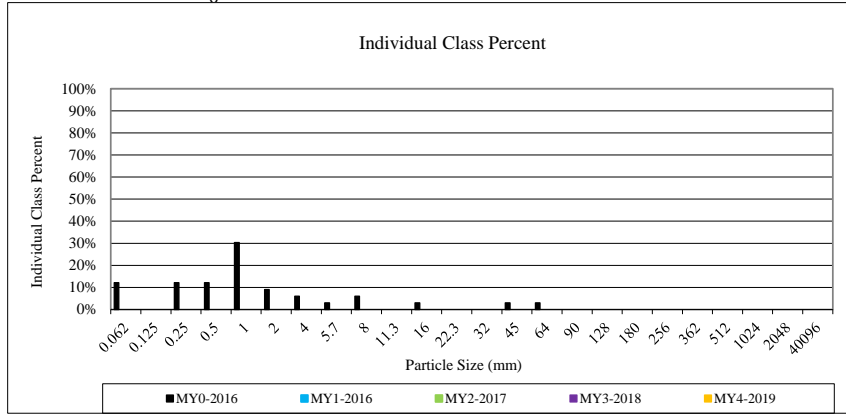
Project Name: Neighbors Branch/Walton Crawley Branch Stream and Wetland Restoration Site						
Cross-Section: 3						
Feature: Riffle						
			2016			
Description	Material	Size (mm)	Total #	Item %	Cum %	
Silt/Clay	silt/clay	0.062	28	33%	33%	
	very fine sand	0.125	8	10%	43%	
Sand	fine sand	0.250	4	5%	48%	
	medium sand	0.50	4	5%	52%	
	coarse sand	1.00	8	10%	62%	
	very coarse sand	2.0	4	5%	67%	
	very fine gravel	4.0	0	0%	67%	
Gravel	fine gravel	5.7	0	0%	67%	
	fine gravel	8.0	4	5%	71%	
	medium gravel	11.3	4	5%	76%	
	medium gravel	16.0	8	10%	86%	
	course gravel	22.3	4	5%	90%	
	course gravel	32.0	4	5%	95%	
	very coarse gravel	45	0	0%	95%	
	very coarse gravel	64	0	0%	95%	
	Cobble	small cobble	90	4	5%	100%
		medium cobble	128	0	0%	100%
large cobble		180	0	0%	100%	
very large cobble		256	0	0%	100%	
Boulder		small boulder	362	0	0%	100%
	small boulder	512	0	0%	100%	
	medium boulder	1024	0	0%	100%	
	large boulder	2048	0	0%	100%

Bedrock	bedrock	40096	0	0%	100%	
TOTAL % of whole count			84	100%	100%	
Summary Data						
D50	0.7					
D84	5					
D95	36

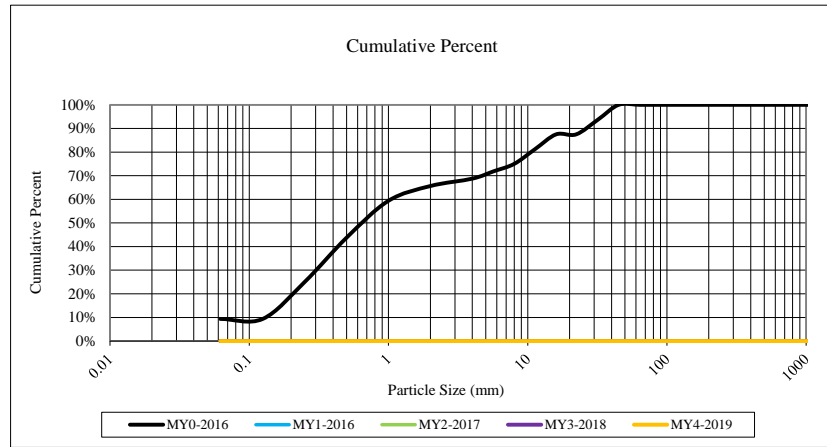
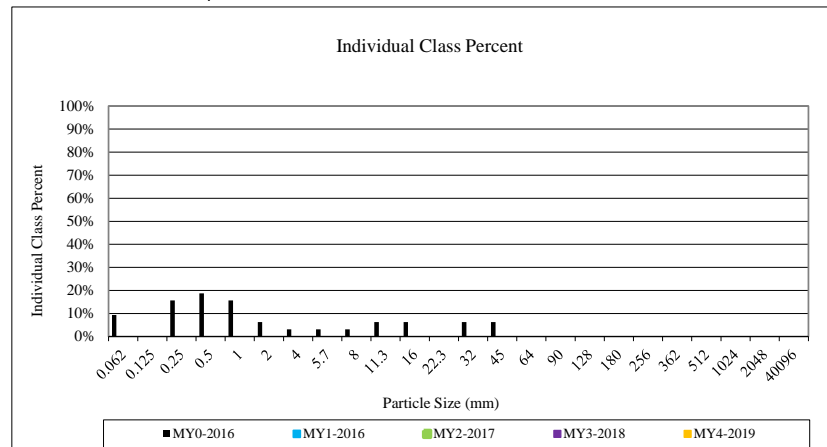
Project Name: Neighbors Branch/Walton Crawley Branch Stream and Wetland Restoration Site					
Cross-Section: 4					
Feature: Riffle					
			2016		
Description	Material	Size (mm)	Total #	Item %	Cum %
Silt/Clay	silt/clay	0.062	24	24%	24%
	very fine sand	0.125	8	8%	32%
Sand	fine sand	0.250	12	12%	44%
	medium sand	0.50	4	4%	48%
	coarse sand	1.00	8	8%	56%
	very coarse sand	2.0	4	4%	60%
	very fine gravel	4.0	8	8%	68%
Gravel	fine gravel	5.7	4	4%	72%
	fine gravel	8.0	8	8%	80%
	medium gravel	11.3	0	0%	80%
	medium gravel	16.0	4	4%	84%
	course gravel	22.3	12	12%	96%
	course gravel	32.0	0	0%	96%
	very coarse gravel	45	0	0%	96%
	very coarse gravel	64	4	4%	100%
	small cobble	90	0	0%	100%
Cobble	medium cobble	128	0	0%	100%
	large cobble	180	0	0%	100%
	very large cobble	256	0	0%	100%
	small boulder	362	0	0%	100%
Boulder	small boulder	512	0	0%	100%
	medium boulder	1024	0	0%	100%
	large boulder	2048	0	0%	100%
	bedrock	bedrock	40096	0	0%

Summary Data	
D50	0.7
D84	13
D95	34

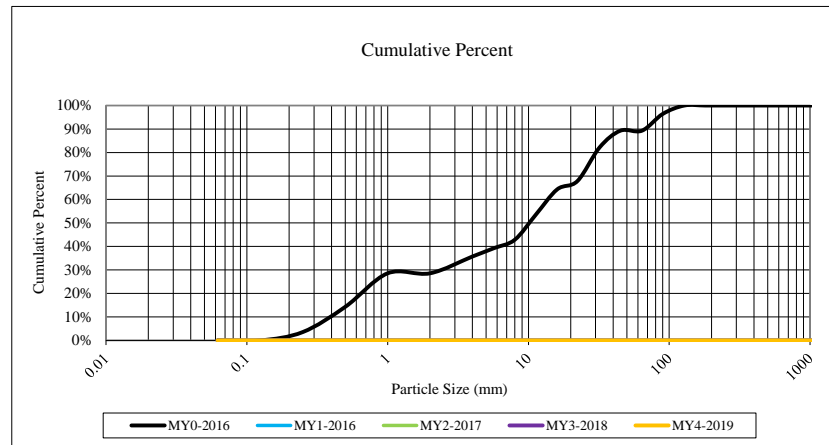
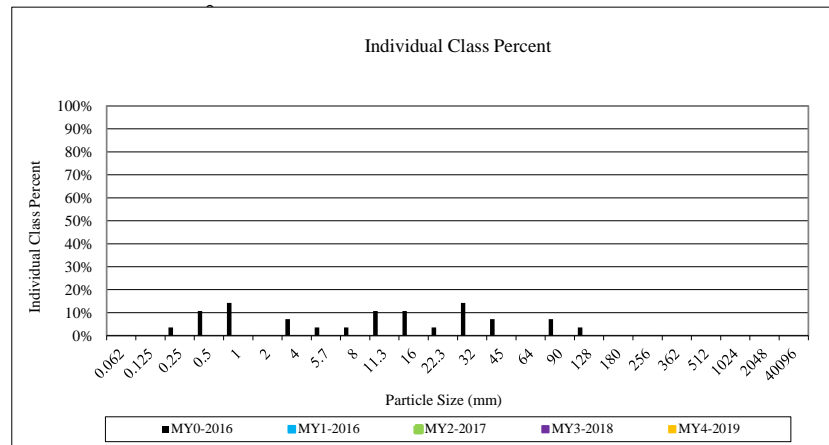
D50	9.9
D84	35
D95	84

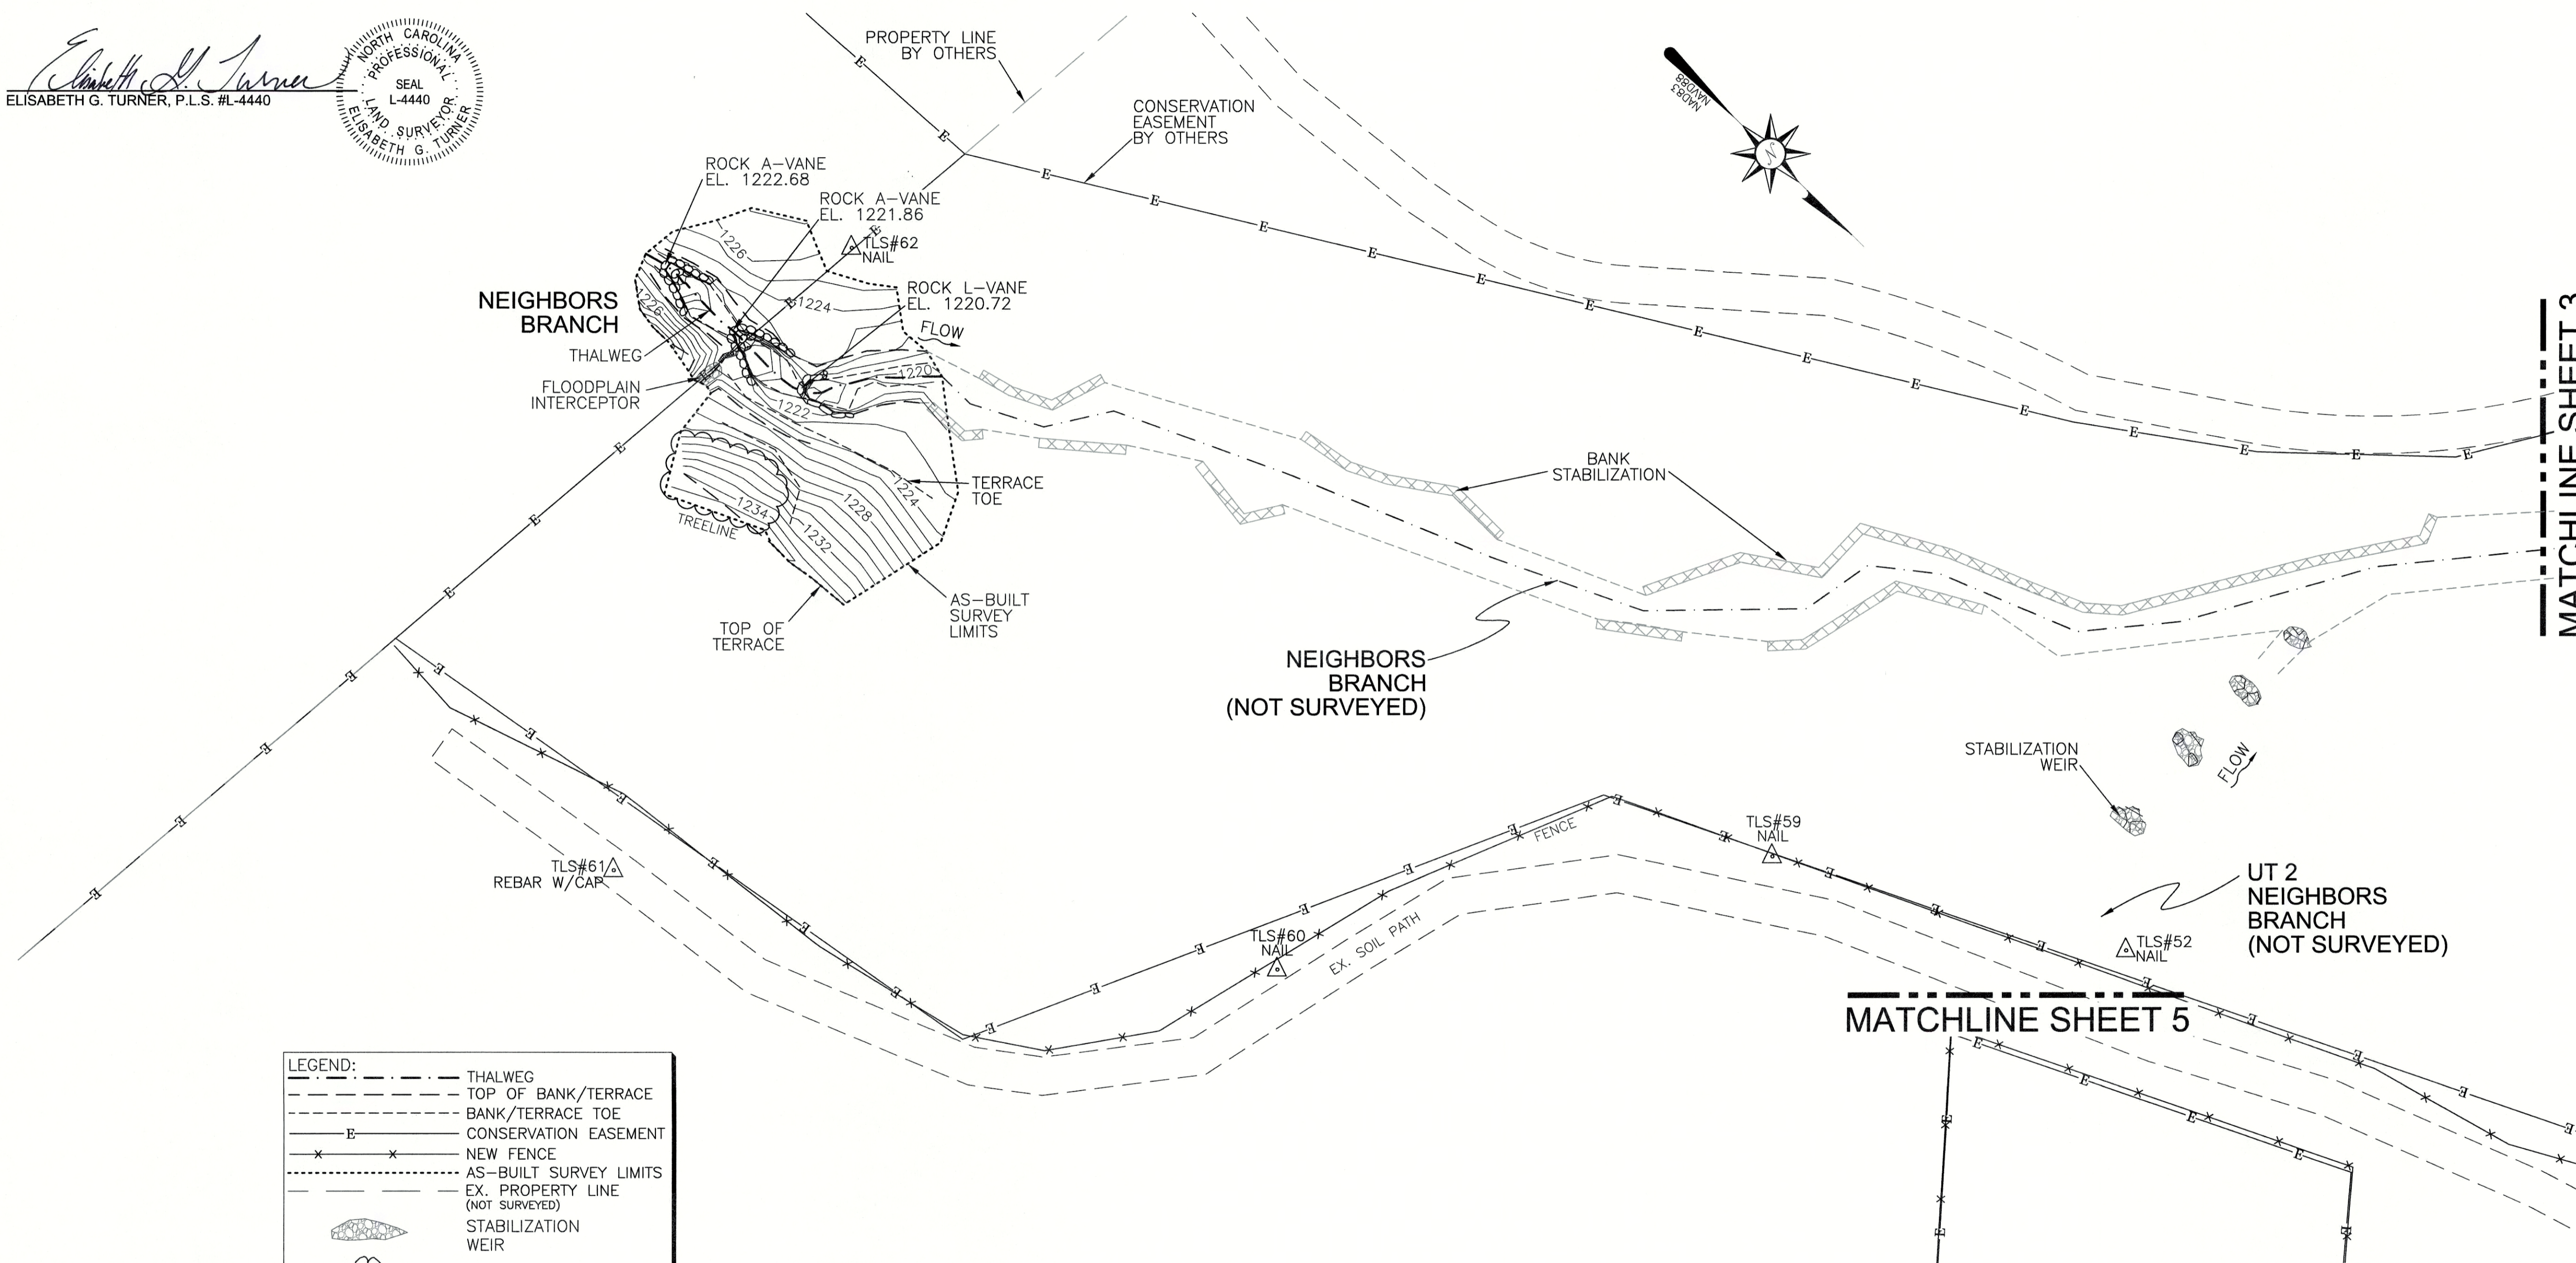
THALWEG
	TOP OF BANK/TERRACE
	BANK/TERRACE TOE
	CONSERVATION EASEMENT
	NEW FENCE
	AS-BUILT SURVEY LIMITS
	EX. PROPERTY LINE (NOT SURVEYED)
	STABILIZATION WEIR
	ROCK L-VANE
	ROCK A-VANE

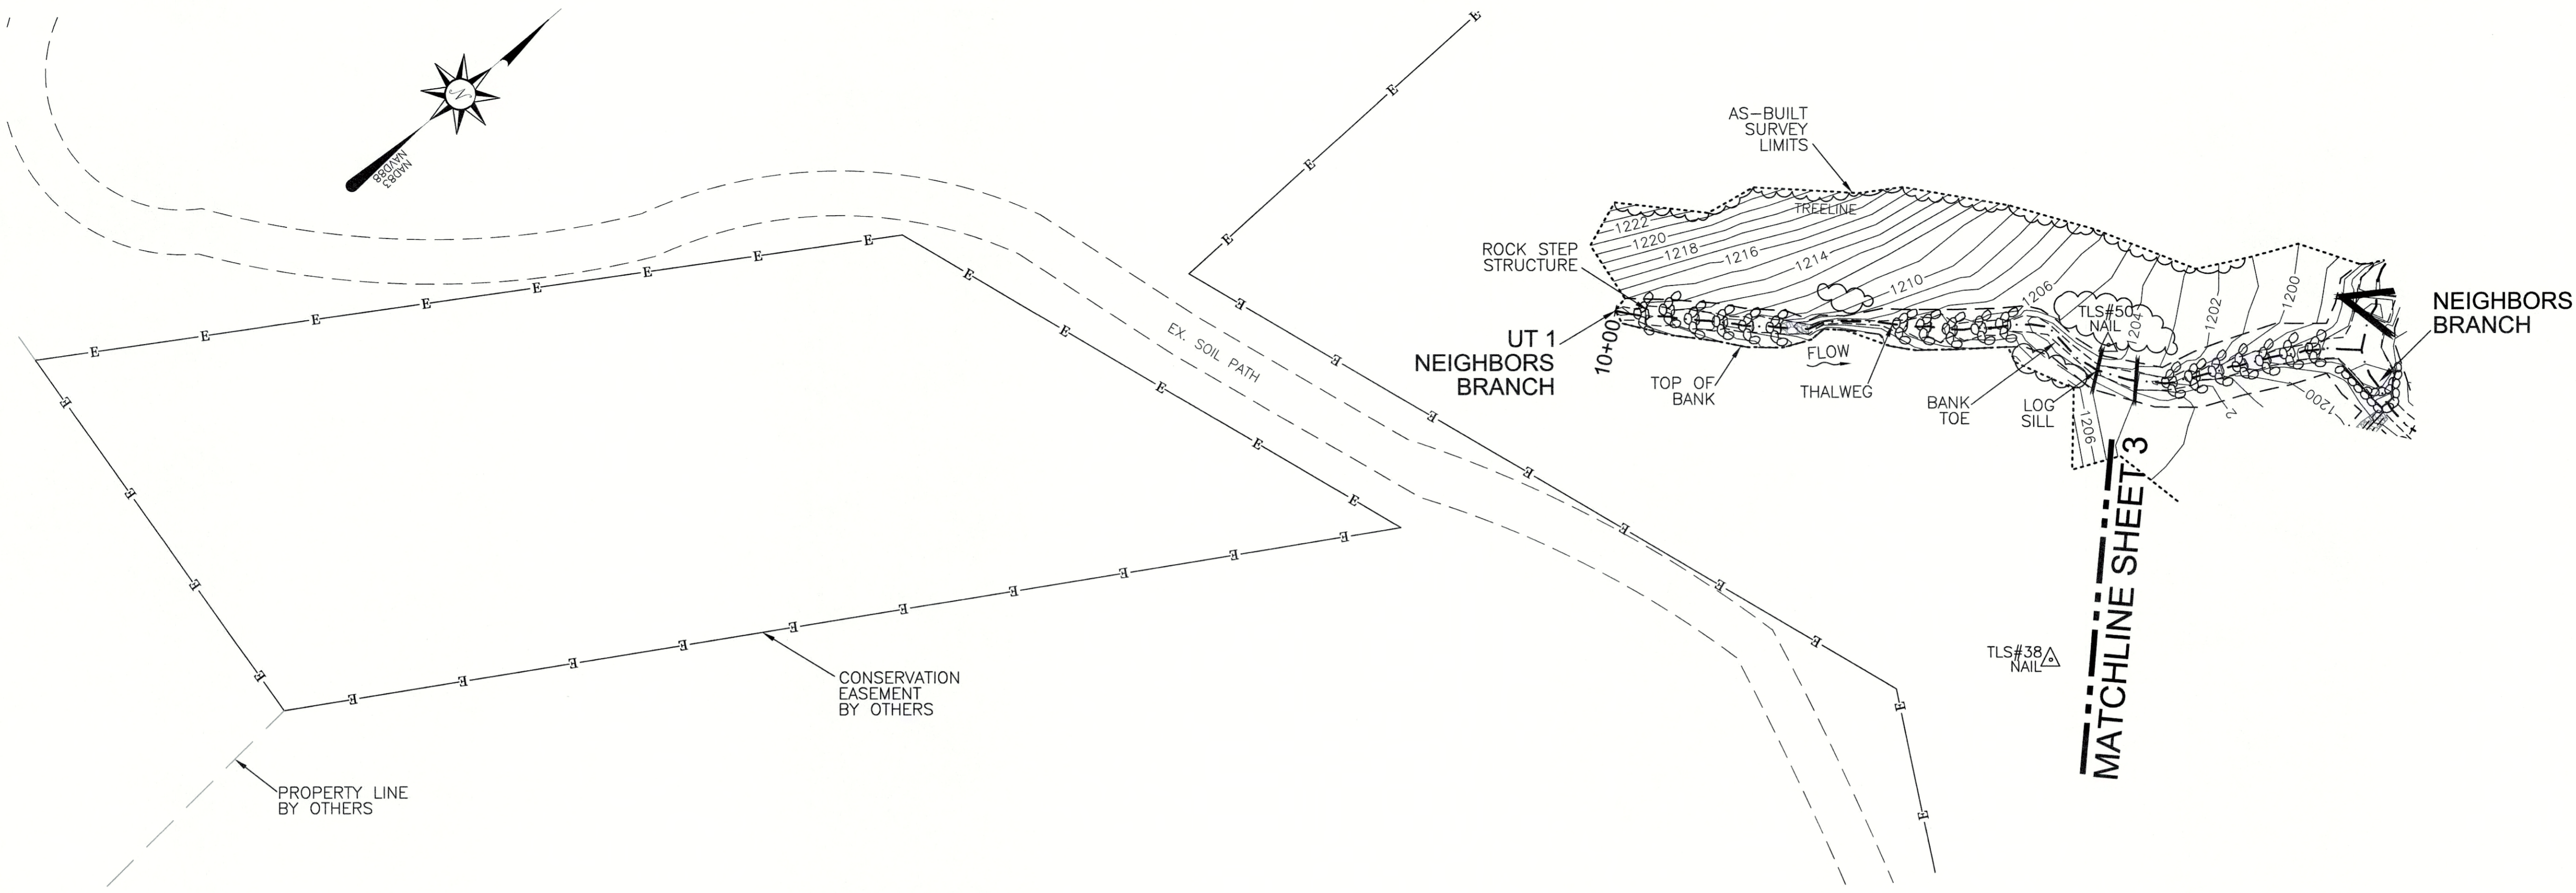
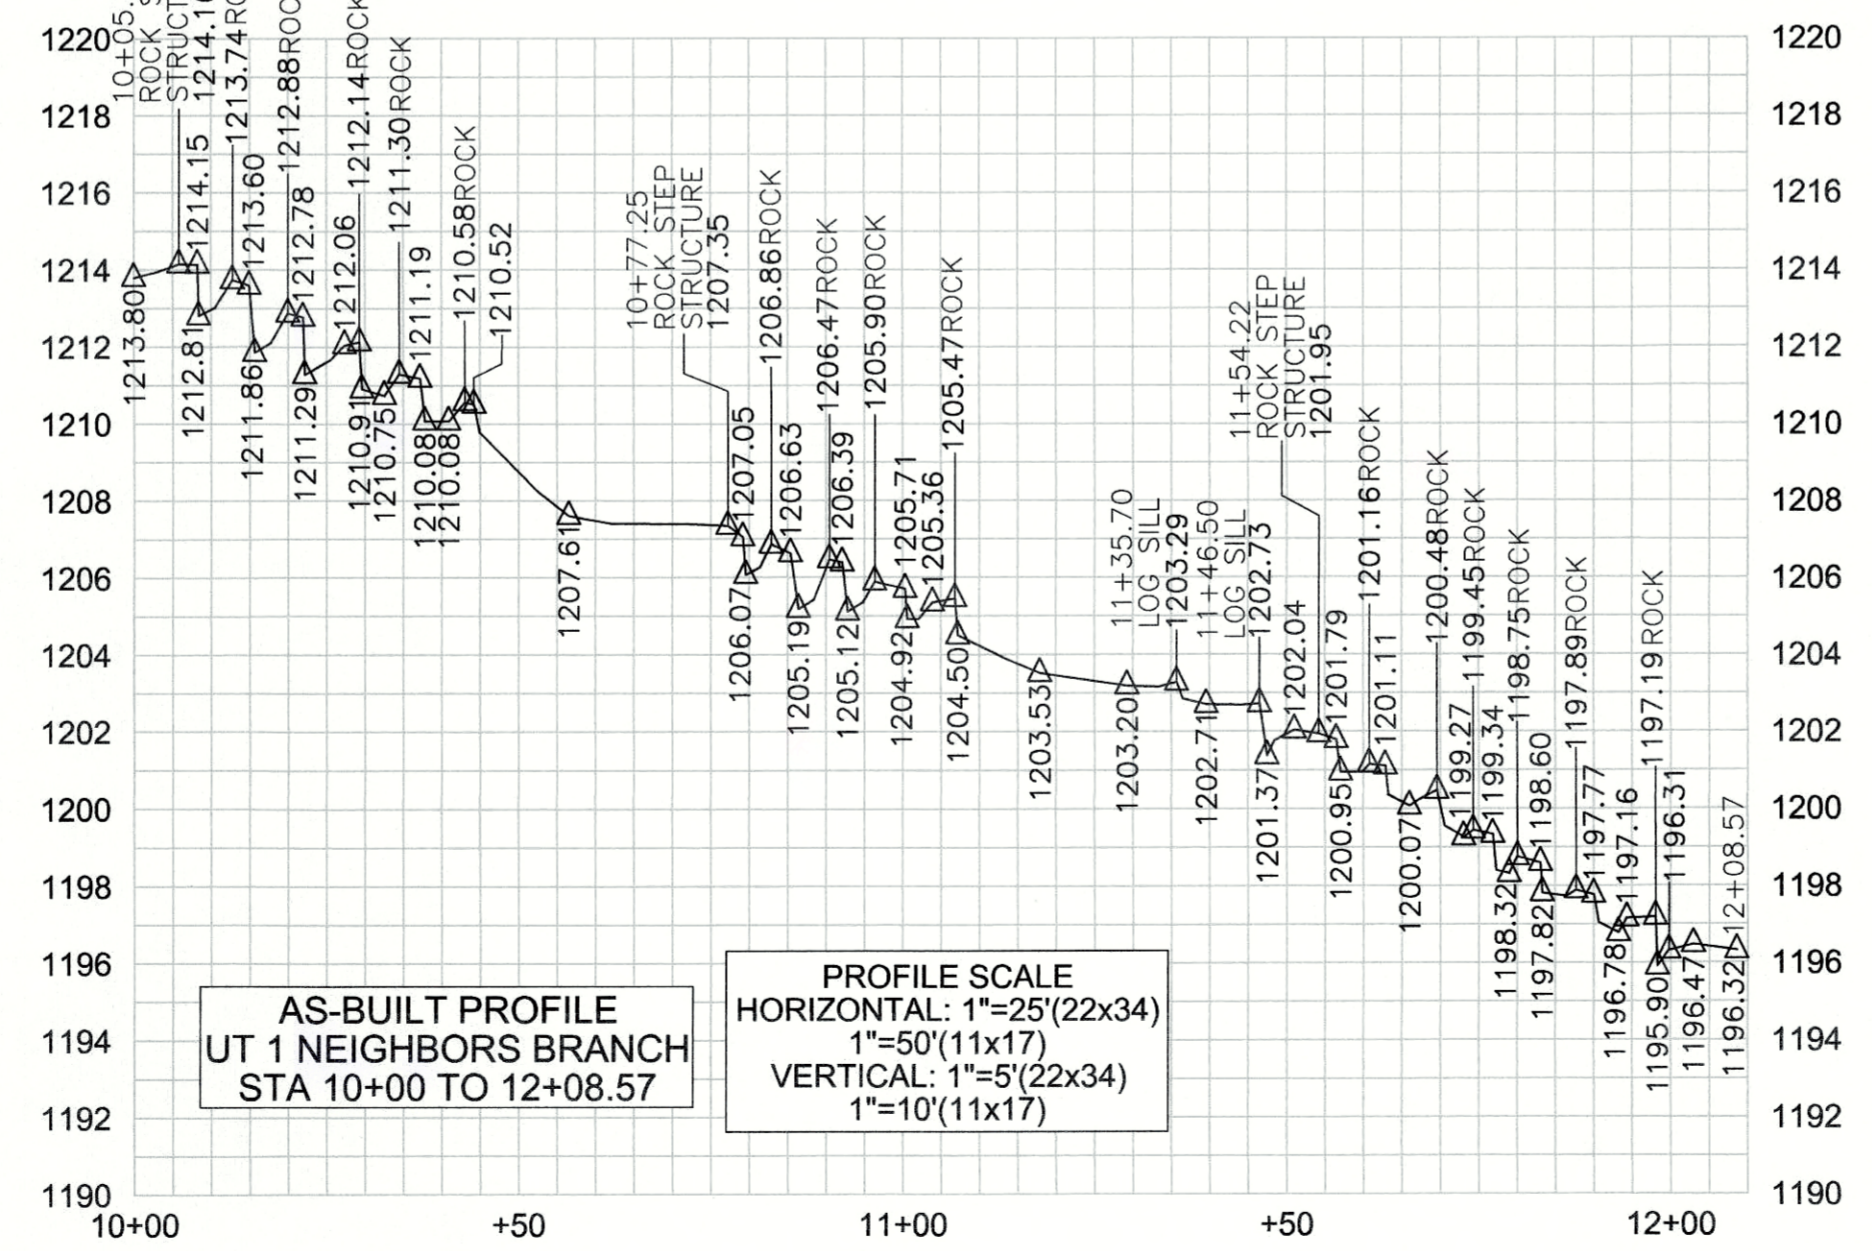
--- (dashed line)	THALWEG
--- (dashed line)	TOP OF BANK/TERRACE
--- (dashed line)	BANK/TERRACE TOE
--- (dashed line)	CONSERVATION EASEMENT
--- (dashed line)	AS-BUILT SURVEY LIMITS
--- (dashed line)	EX. PROPERTY LINE (NOT SURVEYED)
--- (dashed line)	LOG SILL
--- (dashed line)	ROCK STEP STRUCTURE

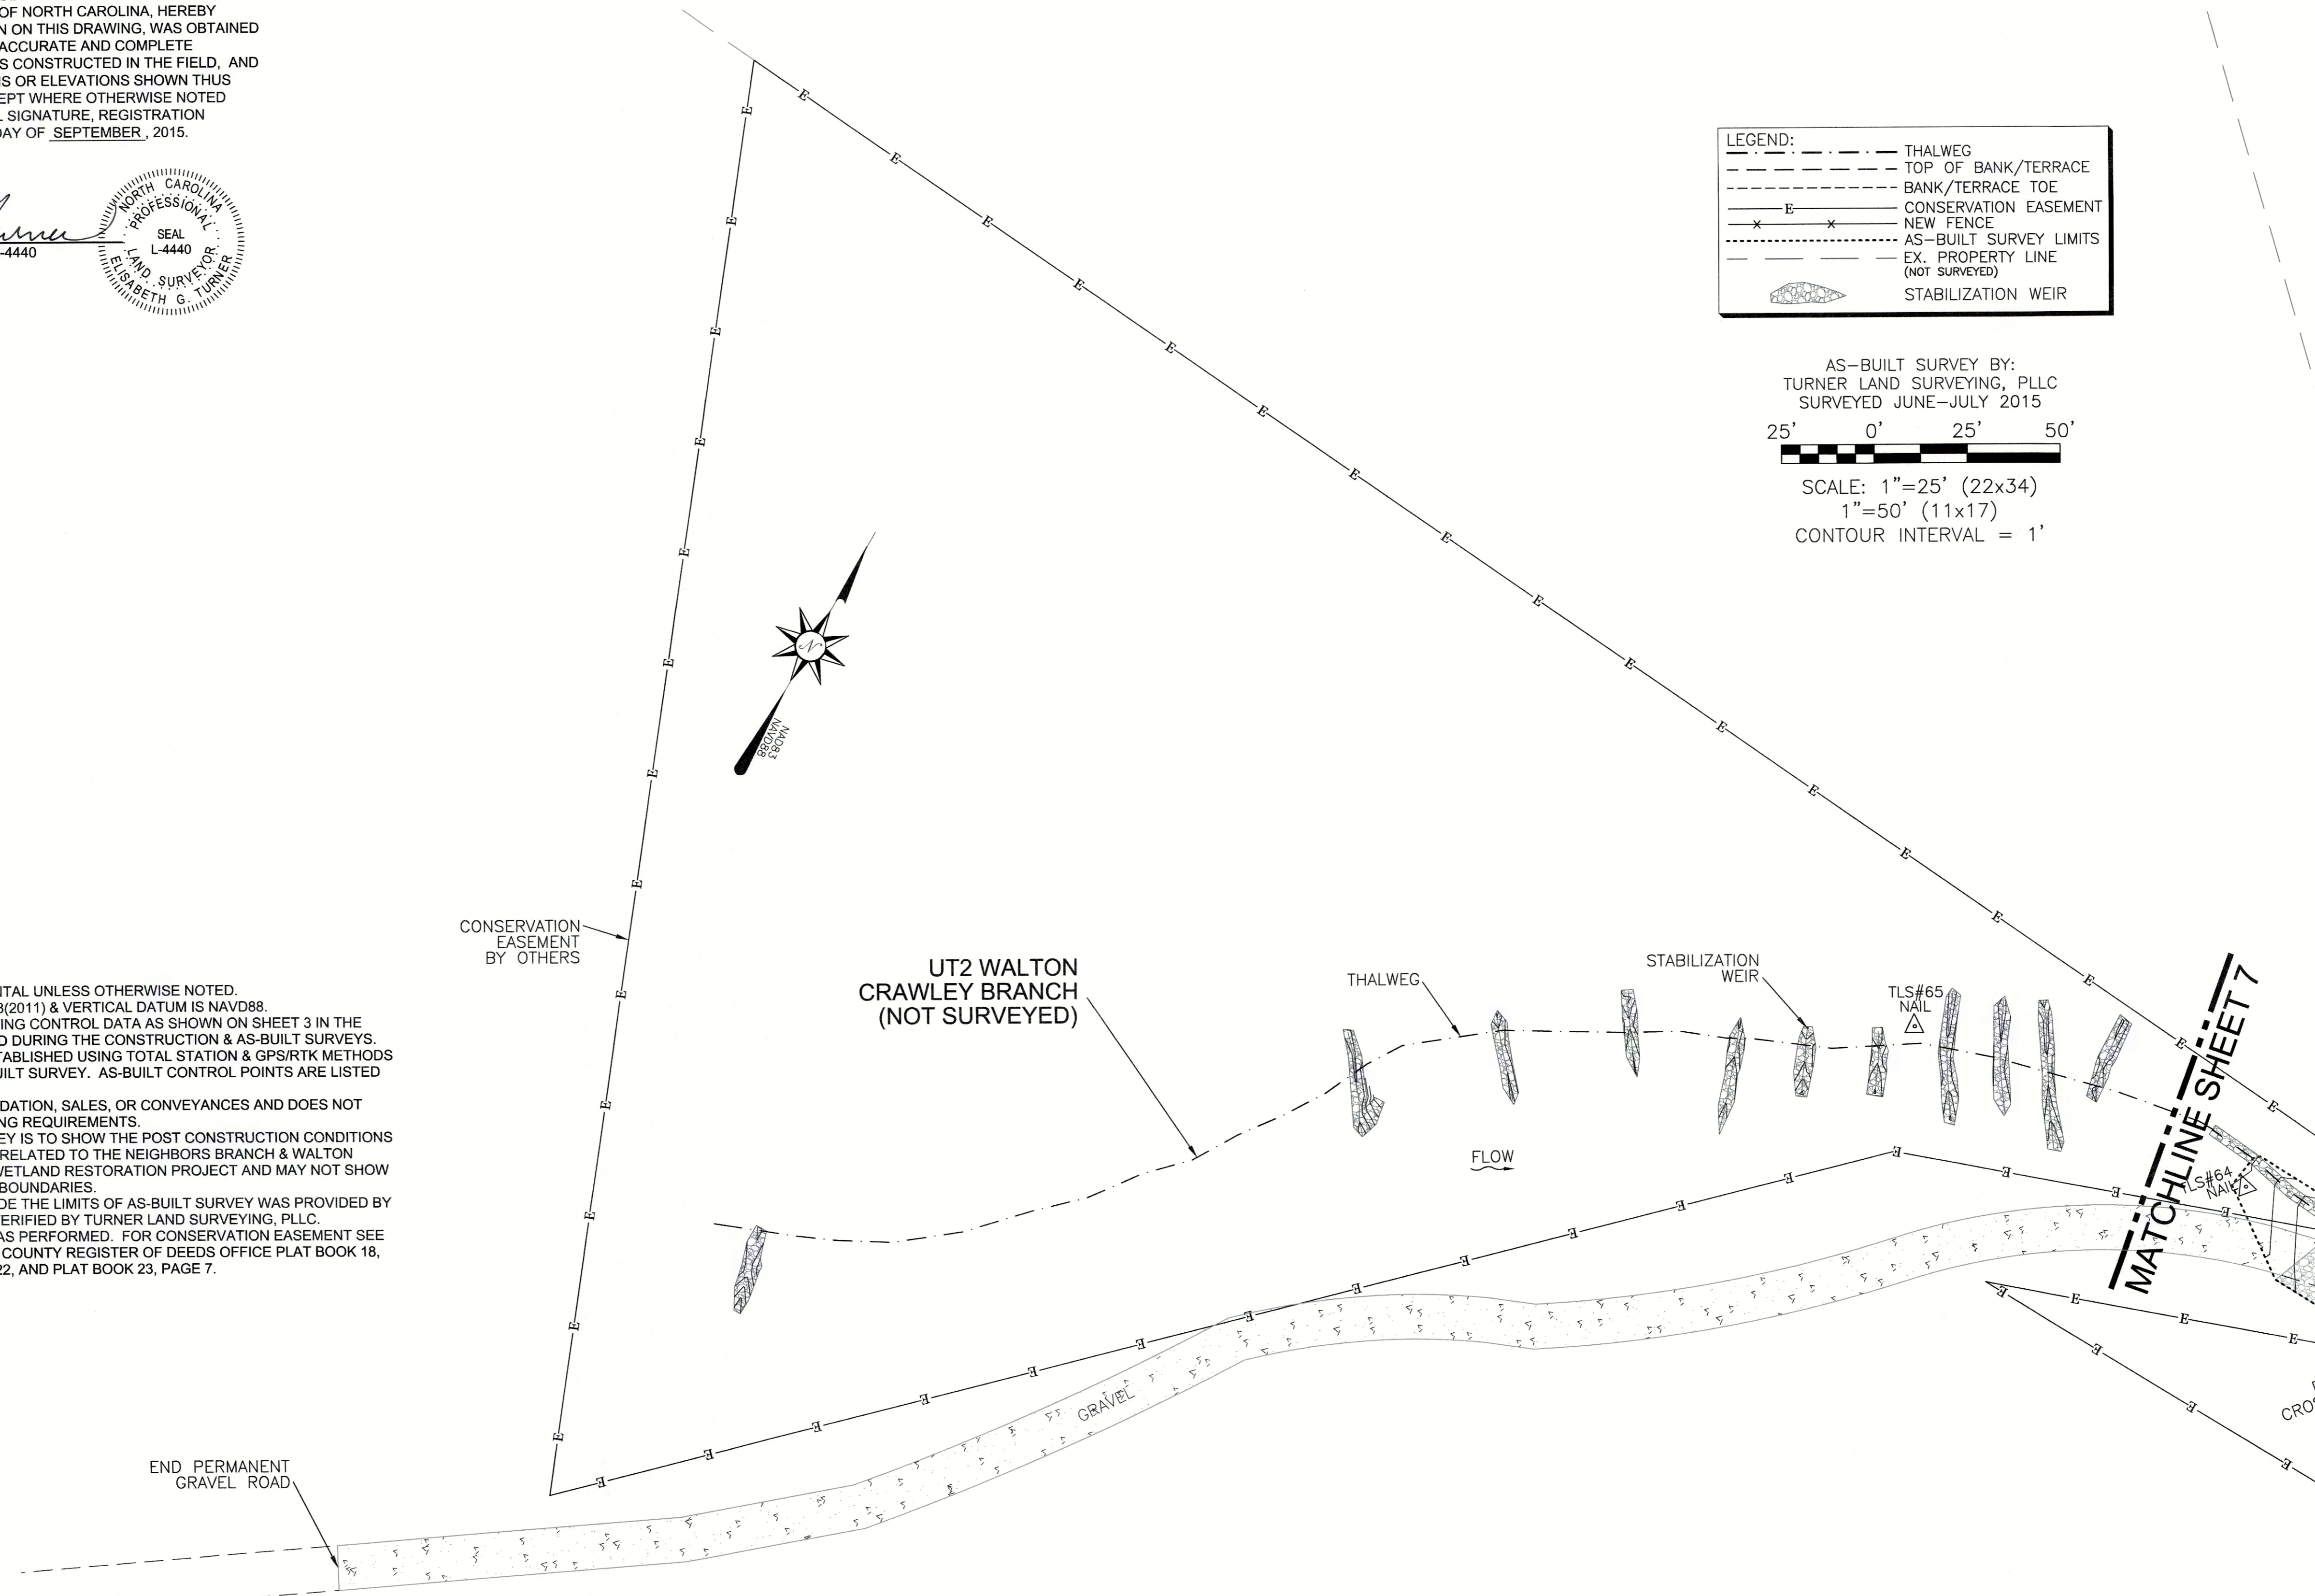
UT2 NEIGHBORS BRANCH (UPSTREAM)
 NEIGHBORS BRANCH & WALTON CRAWLEY
 STREAM RESTORATION PROJECT
 NCEEP PROJECT #92872
 McDowell County
 NORTH CAROLINA

LEGEND:	
	THALWEG
	TOP OF BANK/TERRACE
	BANK/TERRACE TOE
	CONSERVATION EASEMENT
	NEW FENCE
	AS-BUILT SURVEY LIMITS
	EX. PROPERTY LINE (NOT SURVEYED)
	STABILIZATION WEIR

- SHEET 1- TITLE, VICINITY MAP, & SHEET INDEX
- SHEET 2- NEIGHBORS BRANCH (UPSTREAM) & UT2 (DOWNSTREAM)
- SHEET 3- NEIGHBORS BRANCH (DOWNSTREAM)
- SHEET 4- UT1 NEIGHBORS BRANCH
- SHEET 5- UT2 NEIGHBORS BRANCH (UPSTREAM)
- SHEET 6- UT2 WALTON CRAWLEY BRANCH
- SHEET 7- UT2 UPSTREAM WALTON CRAWLEY BRANCH
- SHEET 8- WALTON CRAWLEY BRANCH
- SHEET 9- WALTON CRAWLEY BRANCH POND
- SHEET 10- UT1 WALTON CRAWLEY BRANCH
UT2 DOWNSTREAM WALTON CRAWLEY BRANCH
- SHEET 11- WALTON CRAWLEY BRANCH
- SHEET 12- WALTON CRAWLEY BRANCH
