FINAL
AS-BUILT BASELINE
MONITORING REPORT

**NEIGHBORS BRANCH/WALTON CRAWLEY BRANCH
STREAM & WETLAND RESTORATION SITE**

NCDMS Project No. 92872
Contract No. D09023S
USACE Action ID No. SAW-2009-917 & NCDWR Project No. 10-0122
SCO No. 08-07308-01
McDowell County, North Carolina

Data Collection: April 2016
Submission: July 2016

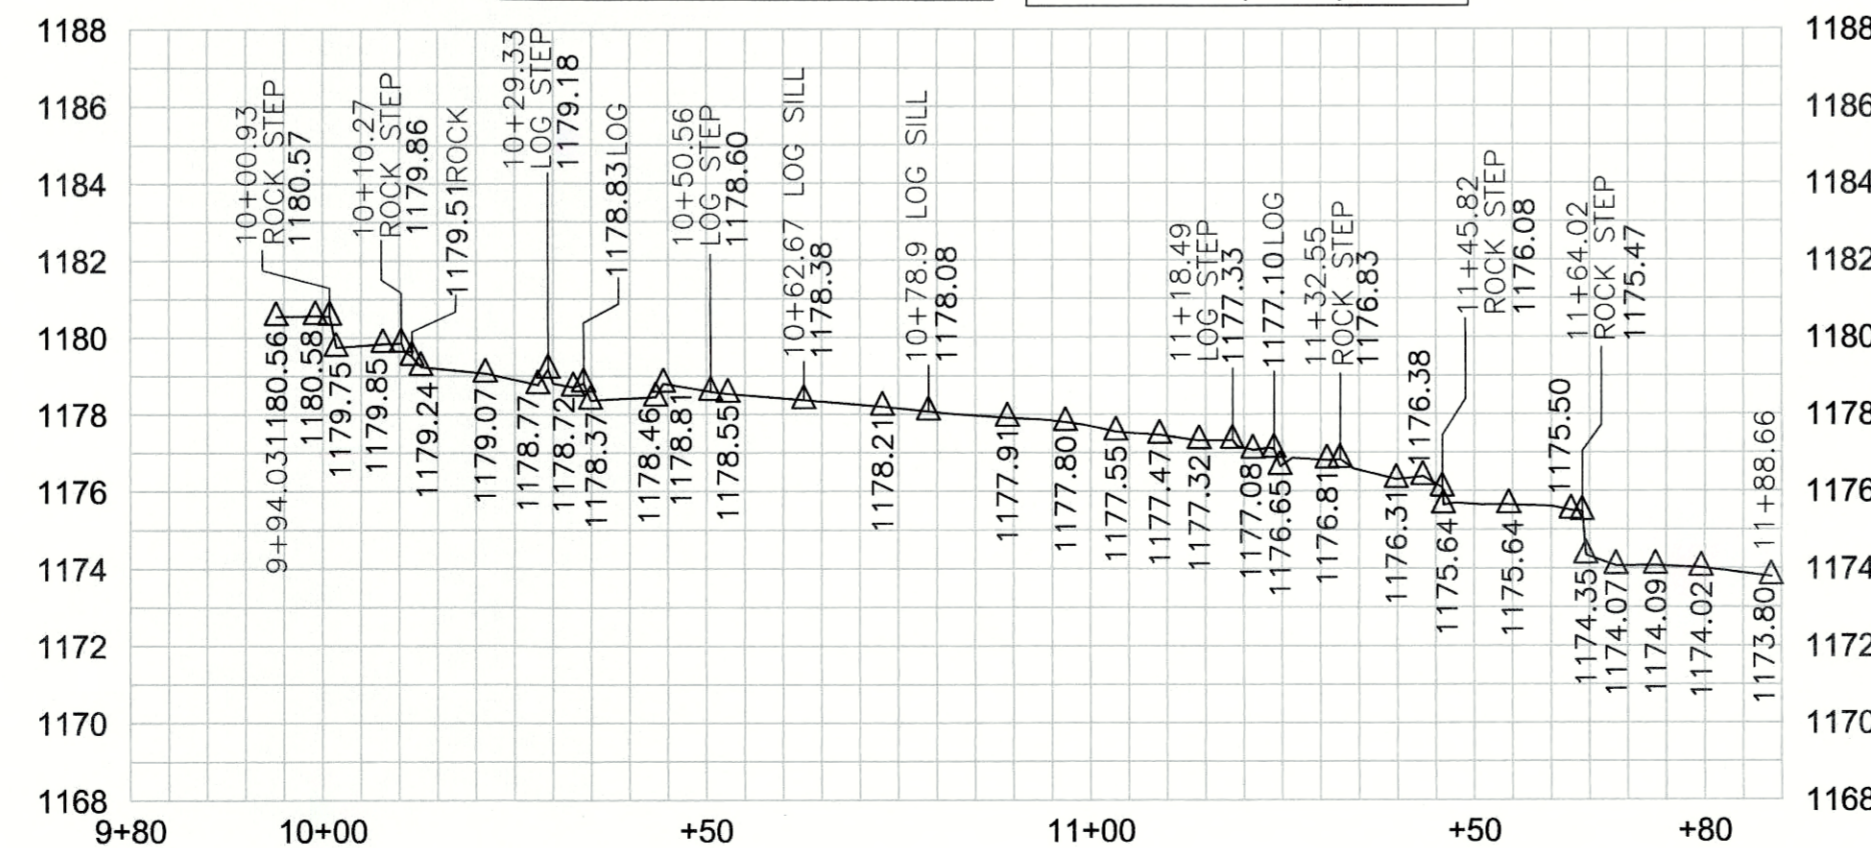
**AS-BUILT PROFILE
 UT1 WALTON
 CRAWLEY BRANCH
 STA 9+94.03 TO 11+88.66**

**PROFILE SCALE
 HORIZONTAL: 1"=25'(22x34)
 1"=50'(11x17)
 VERTICAL: 1"=5'(22x34)
 1"=10'(11x17)**

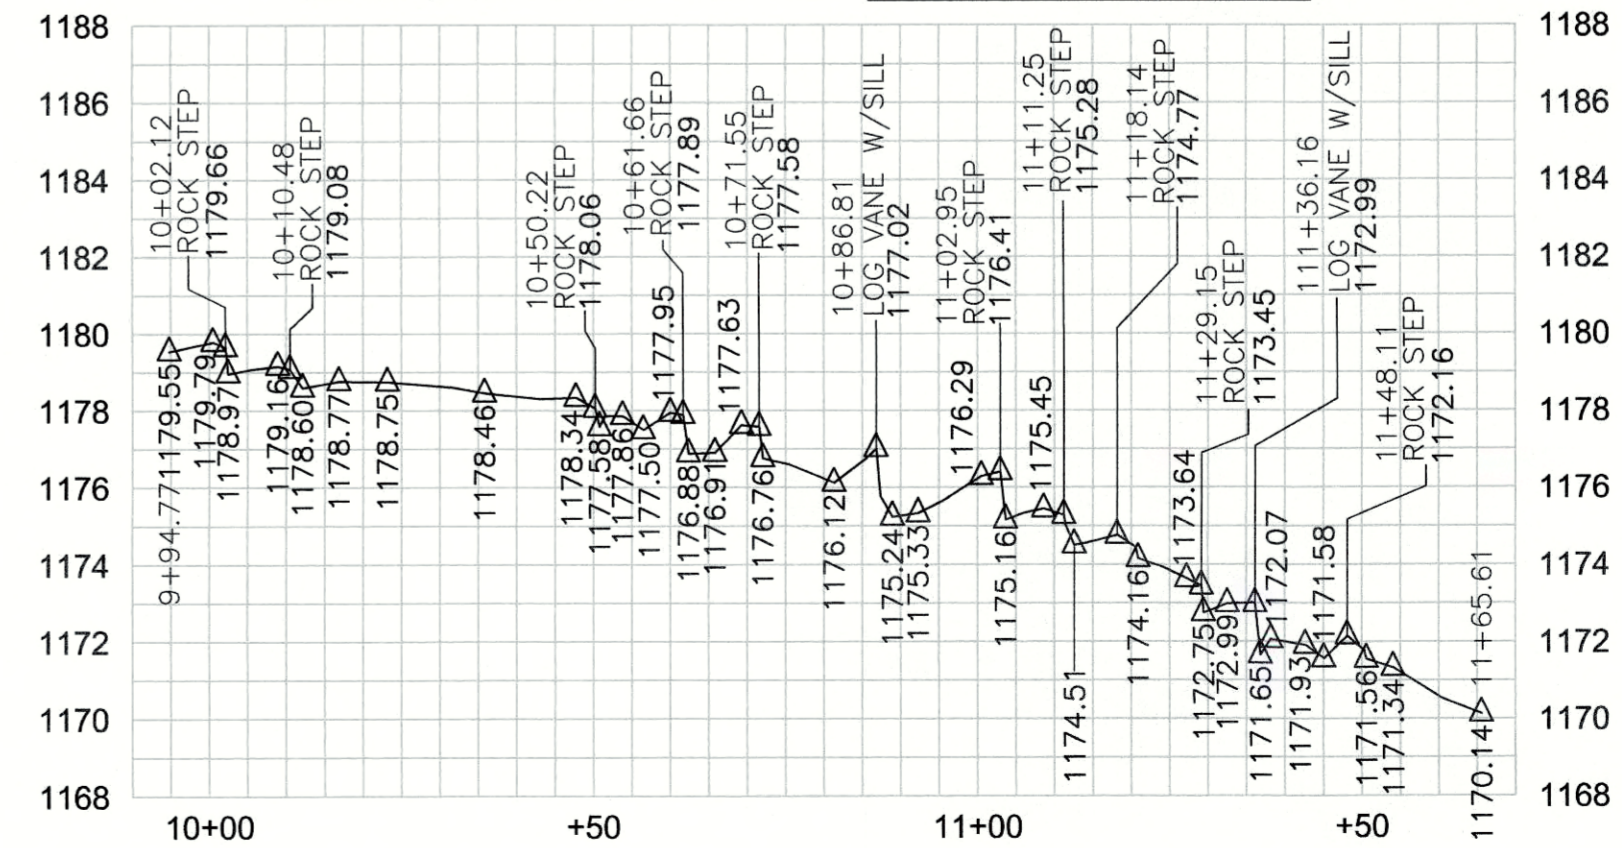
**AS-BUILT PROFILE
 UT2 DOWNSTREAM
 WALTON CRAWLEY BRANCH
 STA 9+94.77 TO 11+65.61**

**PROFILE SCALE
 HORIZONTAL: 1"=25'(22x34)
 1"=50'(11x17)
 VERTICAL: 1"=5'(22x34)
 1"=10'(11x17)**
