FINAL
YEAR 1 (2016) ANNUAL
MONITORING REPORT

**NEIGHBORS BRANCH/WALTON CRAWLEY BRANCH
STREAM & WETLAND RESTORATION SITE**

NCDMS Project No. 92872
Contract No. D09023S
USACE Action ID No. SAW-2009-917 & NCDWR Project No. 10-0122
SCO No. 08-07308-01
McDowell County, North Carolina

Data Collection: May-November 2016
Submission: January 2017

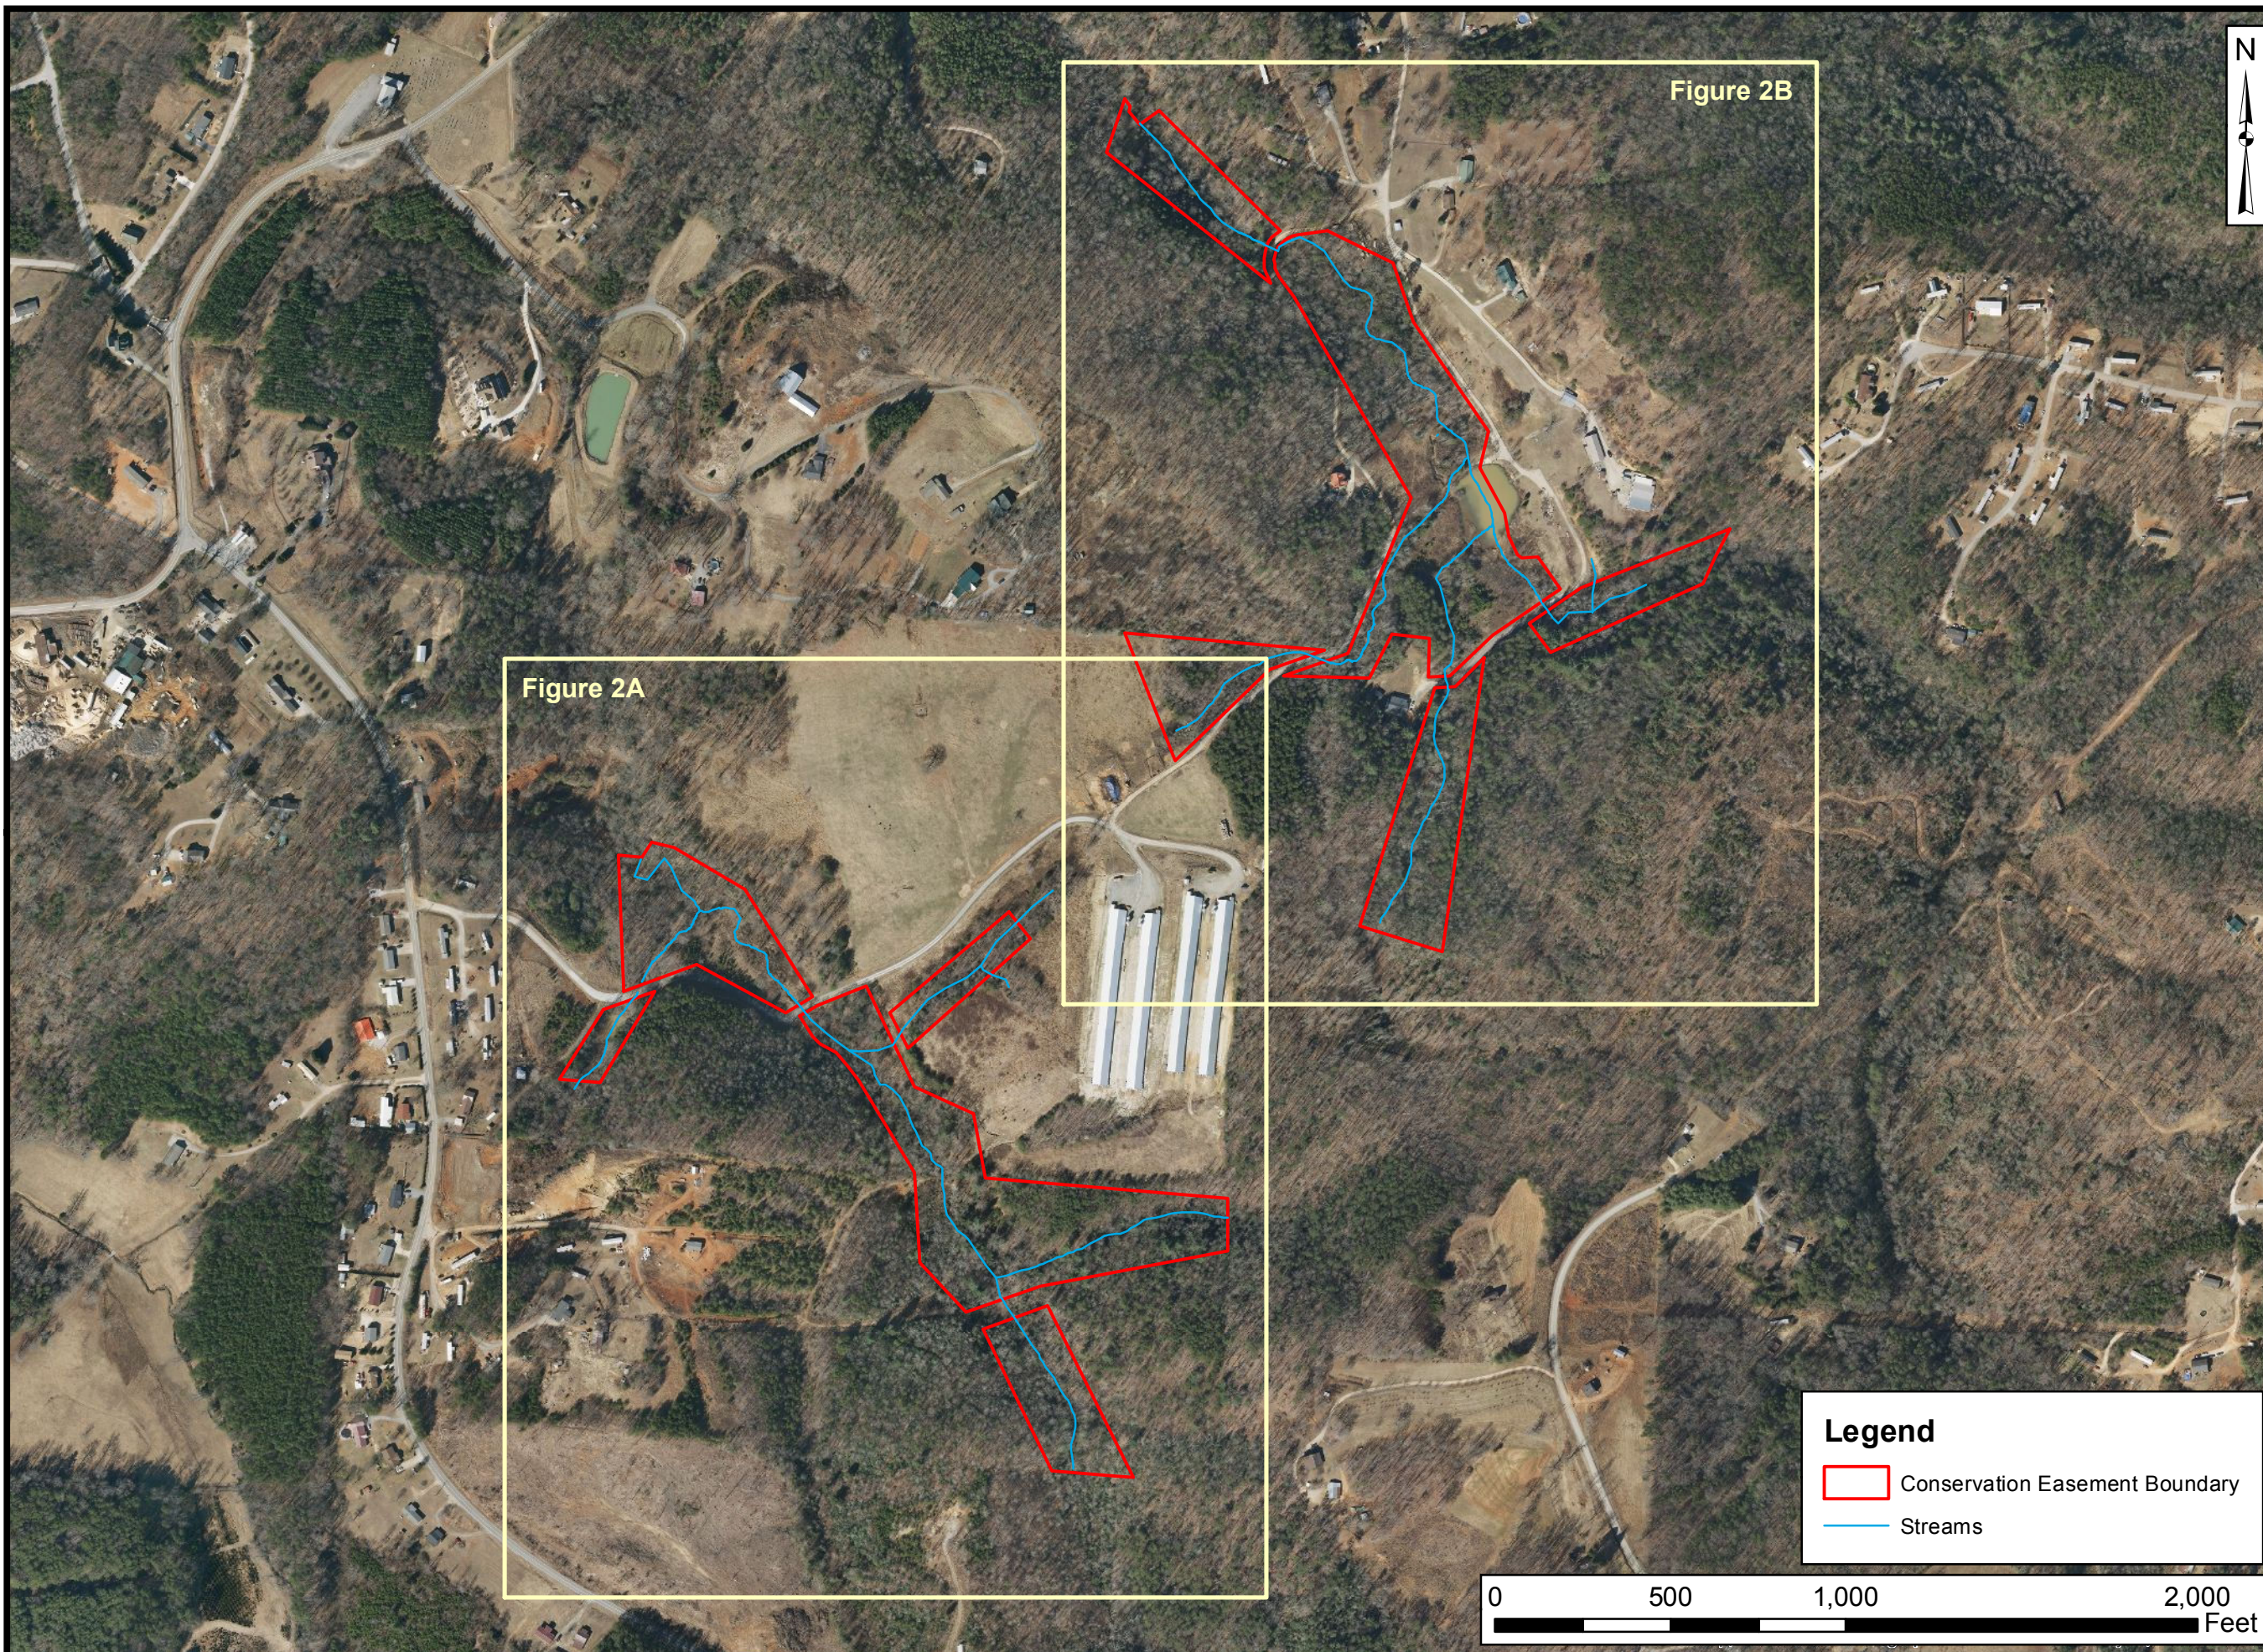
FIGURE
2

Title:
**Current Conditions
 Plan View**

Two groundwater monitoring gauges were installed to take measurements after hydrological modifications were performed at the Site. Hydrological sampling will occur quarterly throughout the growing season (March 26 to November 5). Approximate locations of gauges are depicted on Figure 2 (Appendix B) and hydrology data can be found in Appendix E.

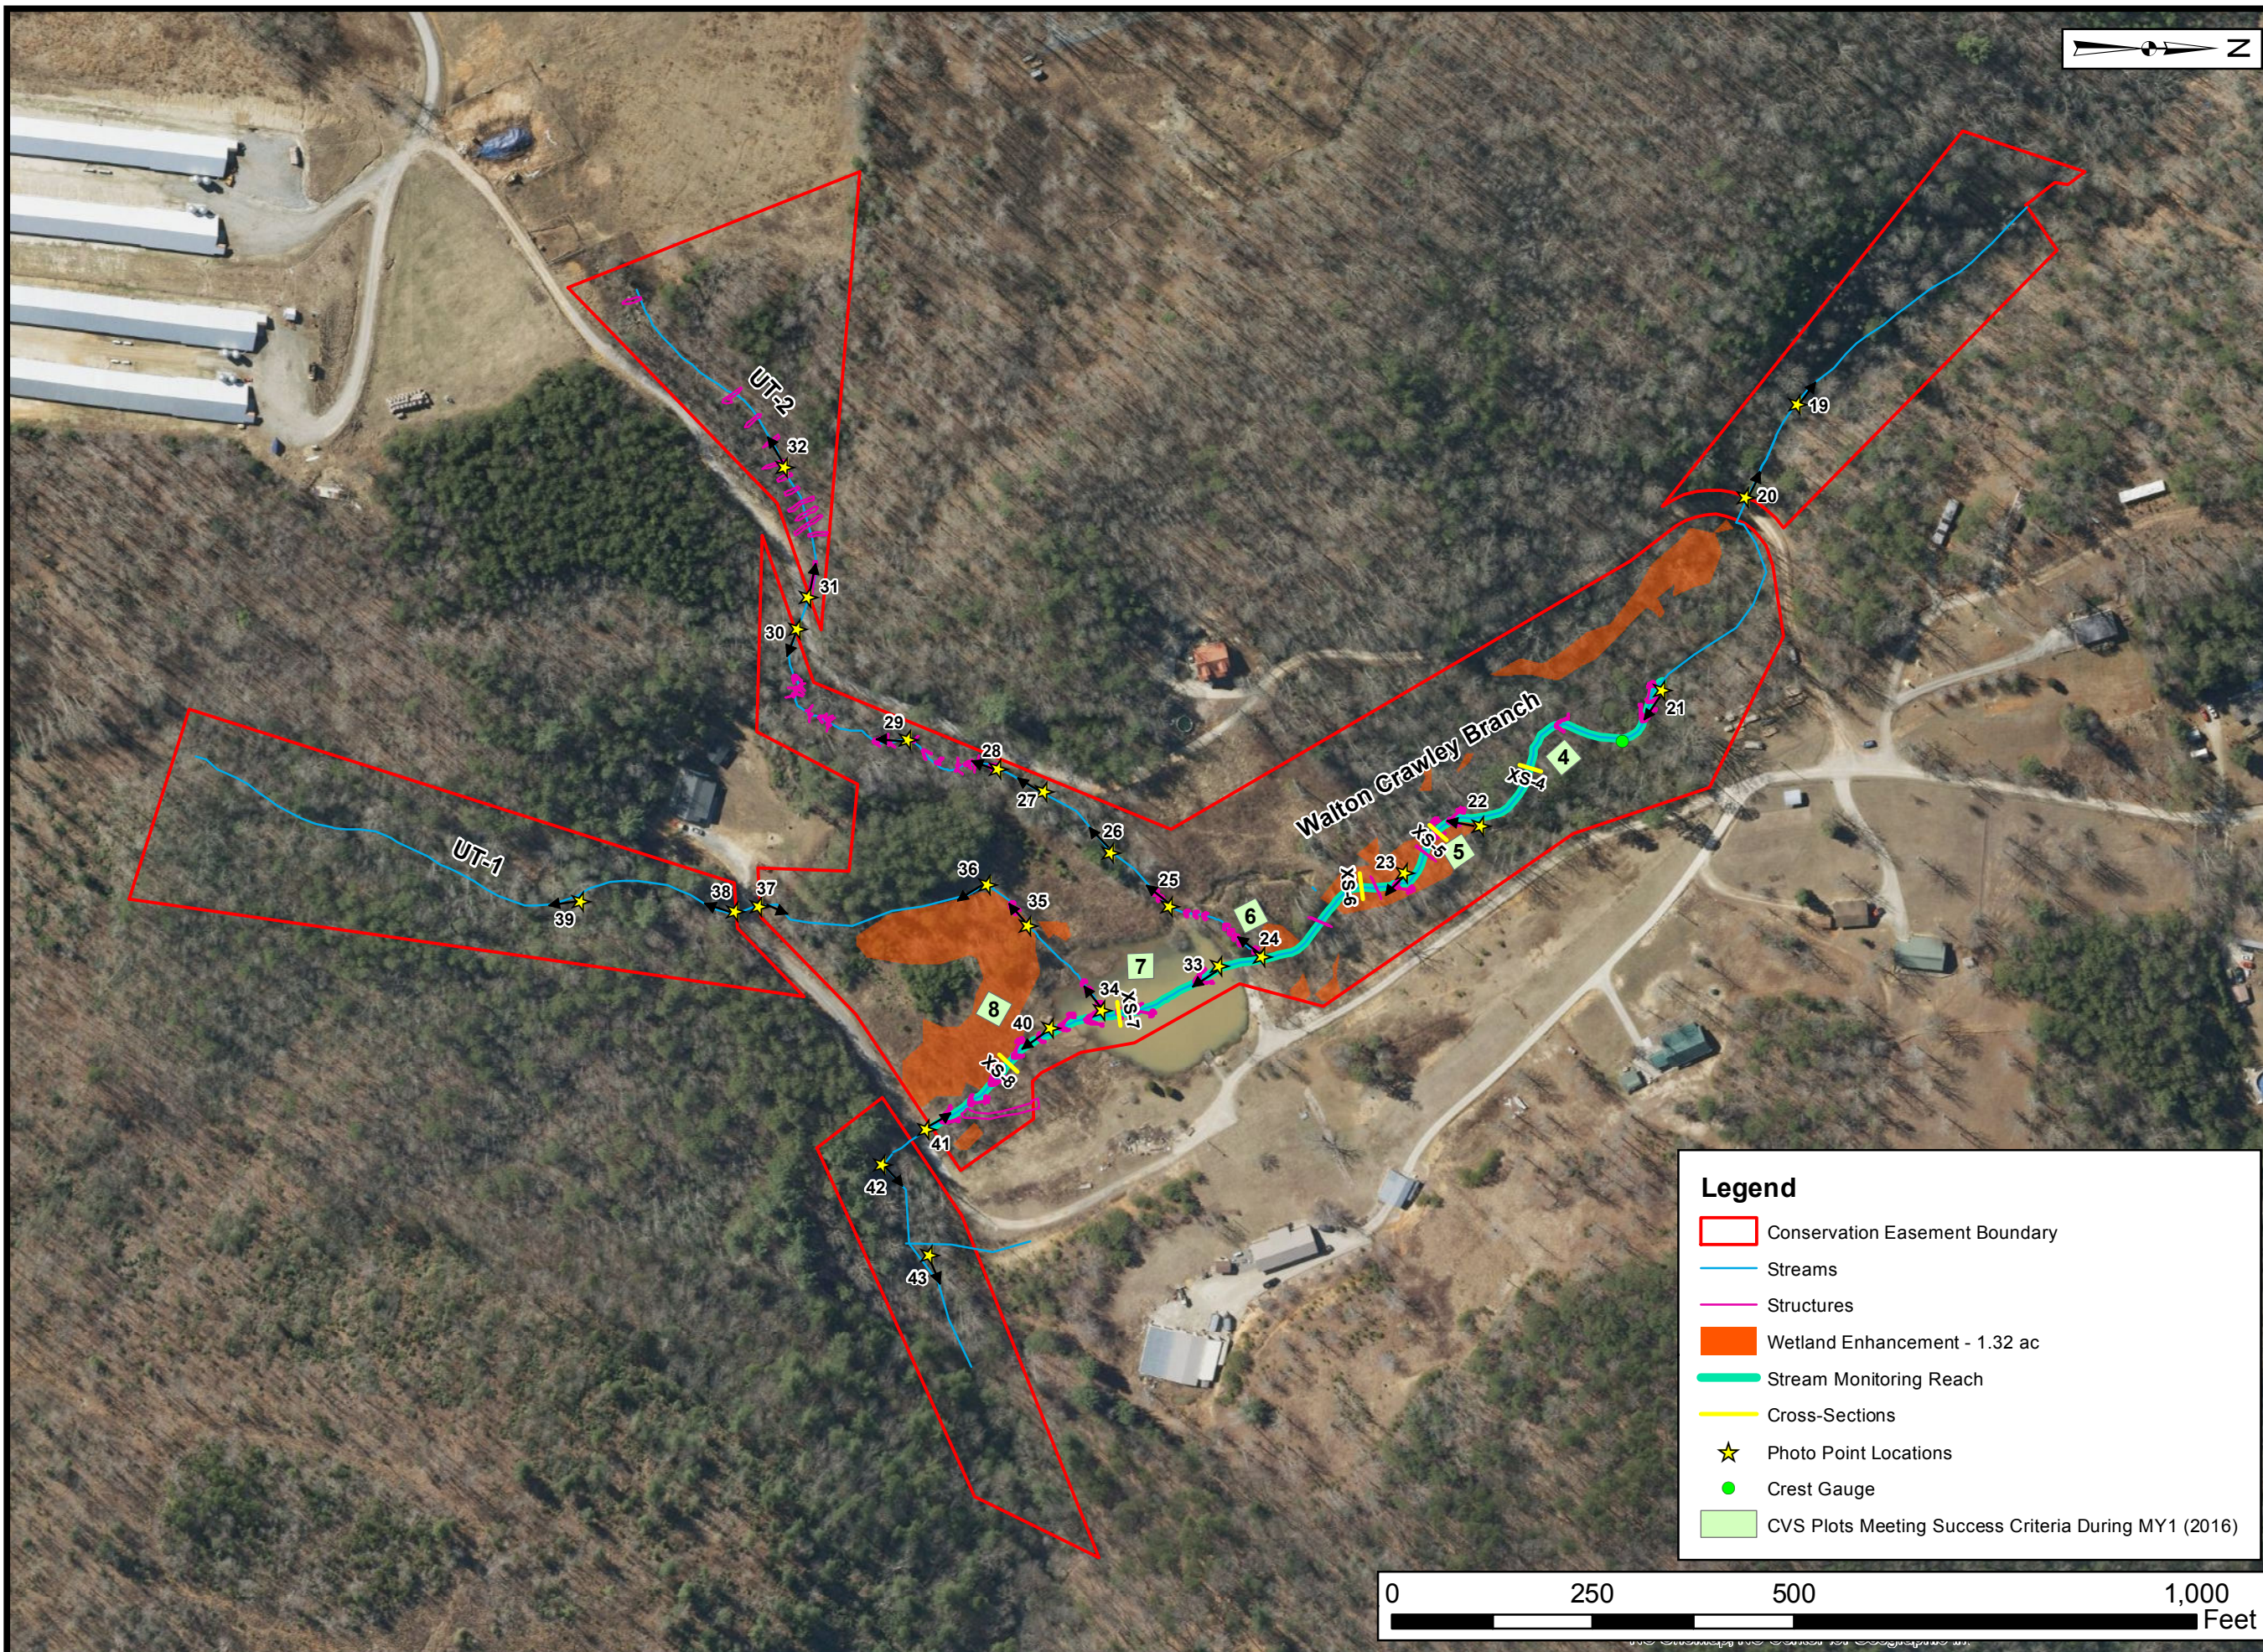
FIGURE
2B

Title:
**Current Conditions
 Plan View**

- Conservation Easement Boundary
- Streams
- Structures
- Wetland Enhancement - 1.32 ac
- Stream Monitoring Reach
- Cross-Sections
- ★ Photo Point Locations
- Crest Gauge
- CVS Plots Meeting Success Criteria During MY1 (2016)

Monitoring of restoration efforts will be performed for five years, or until success criteria are fulfilled. Monitoring is proposed for the stream channel, vegetation, and wetland hydrology. In general, the restoration success criteria, and required remediation actions, are based on the *Stream Mitigation Guidelines* (USACE et al. 2003). Monitoring features are described below and are depicted on Figures 2A-B (Appendix B).

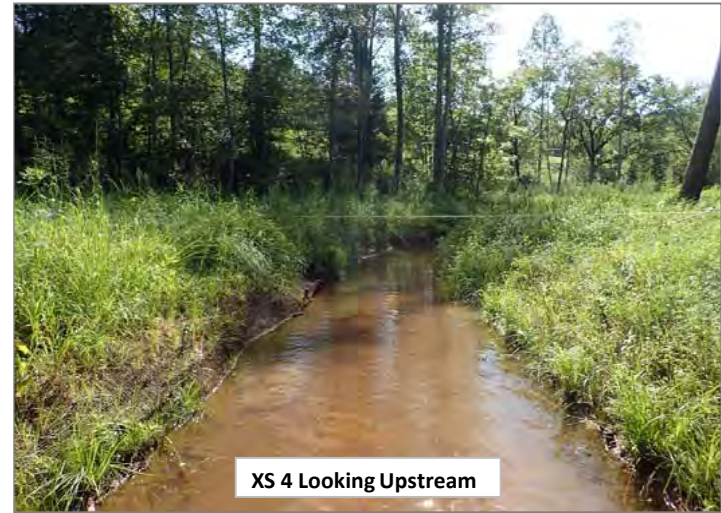
XS 4 Looking Upstream

| Stream Type | E |

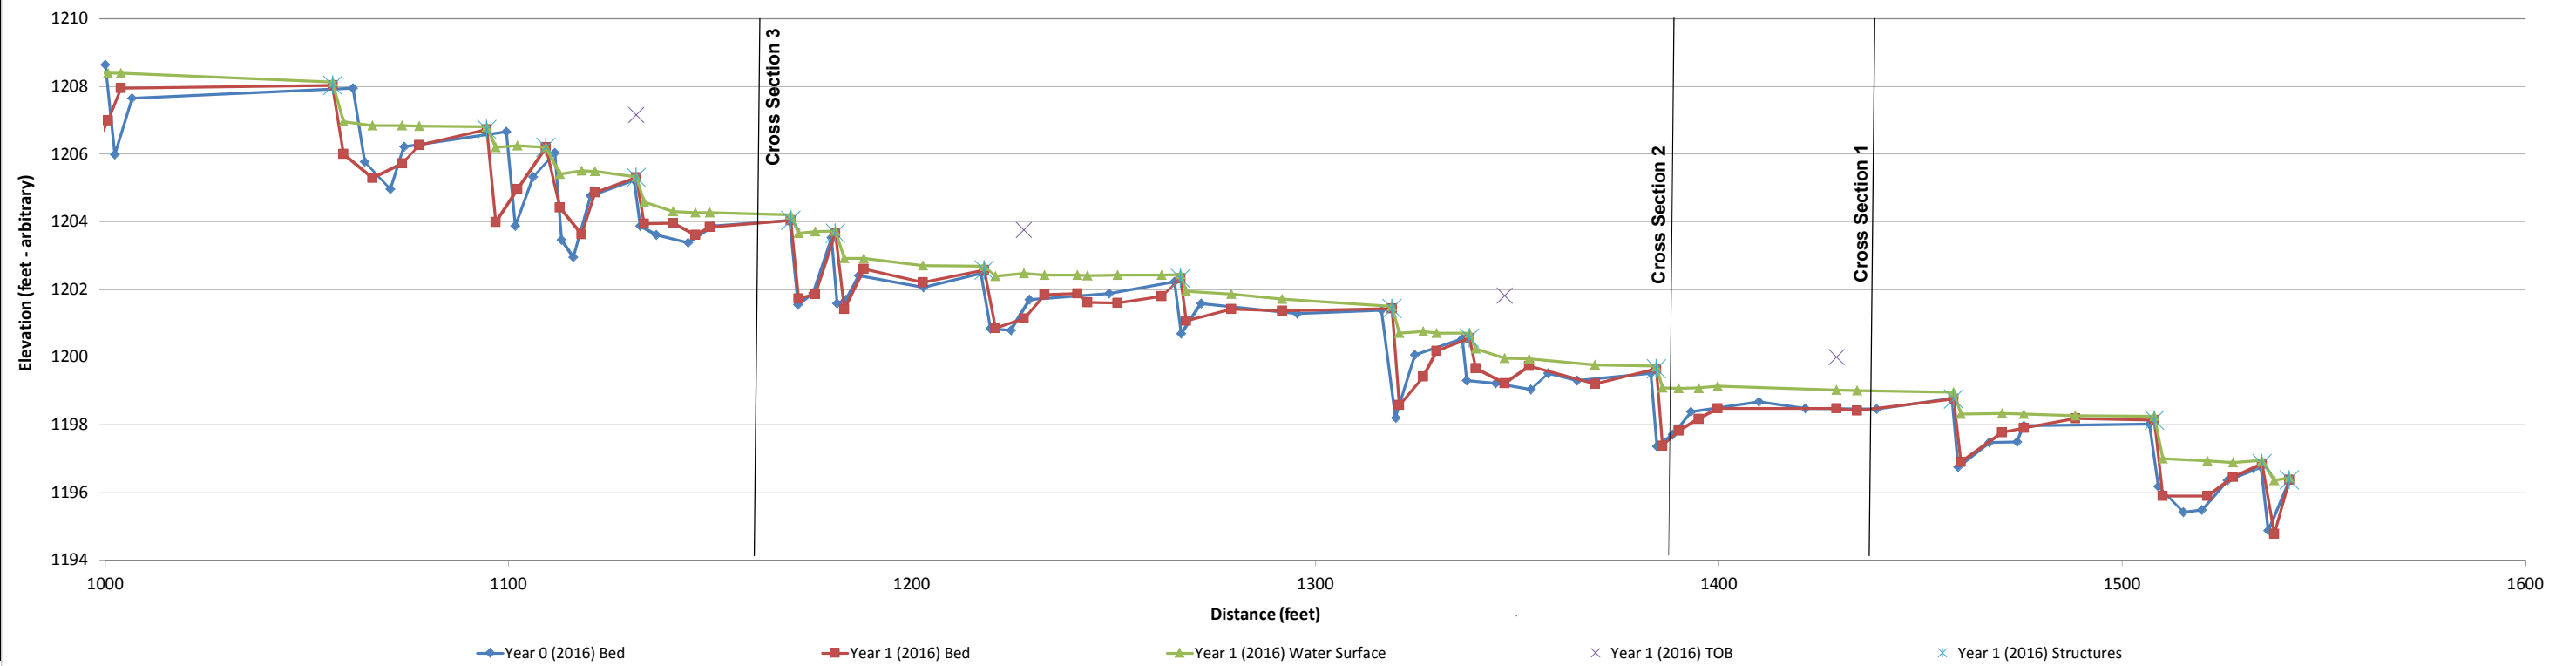
Neighbors Branch Year 1 (2016) Profile - Station 10+00 to 16+00

Project Name Neighbors Branch/Walton Crawley Branch - Profile
Reach Neighbors Branch, Station 10+00 - 16+00
Feature Profile
Date 8/23/16
Crew Perkinson, Jernigan

Stream Pattern and Profile: The profile should not demonstrate significant trends towards degradation or aggradation over a significant portion of a reach. Additionally, bed form variables should remain noticeably intact and consistent with original design parameters that were based off of reference conditions. Pattern features should show little adjustment over the standard 5-year monitoring period and will be monitored to ensure adjustment is minor prior to close out.

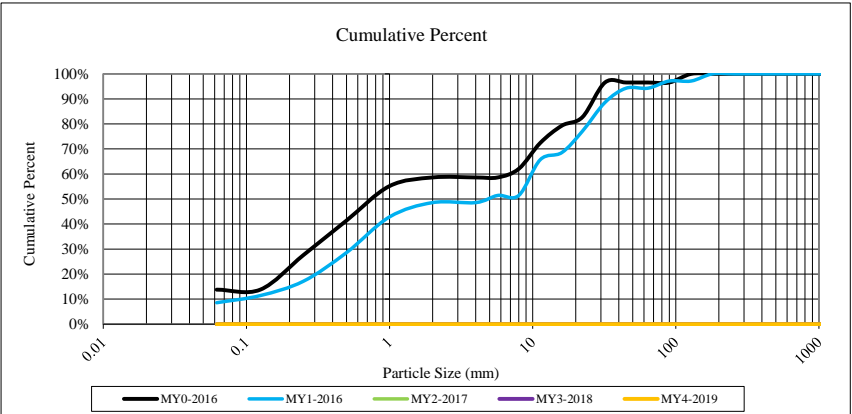
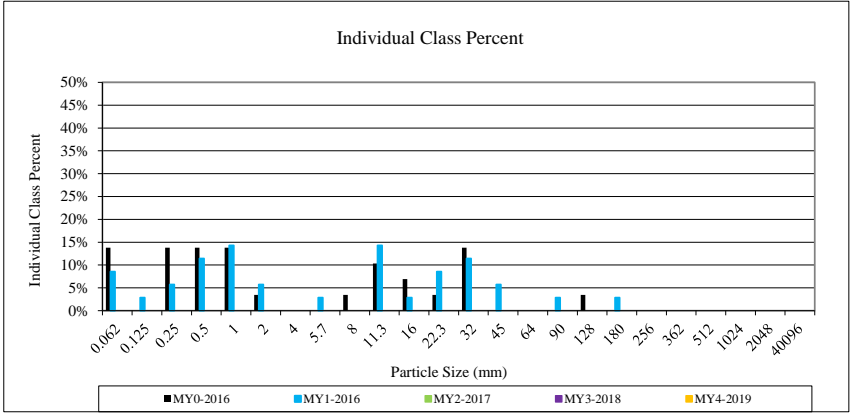
| Project Name: Neighbors Branch/Walton Crawley Branch Stream and Wetland Restoration Site | | | | | |
|--|---|---|---|---|---|
| Cross-Section: 1 | | | | | |

| Project Name: Neighbors Branch/Walton Crawley Branch Stream and Wetland Restoration Site | | | | | |
|--|---|---|---|---|---|
| D84 | 28 | | | | |
| D95 | 70 | | | | |

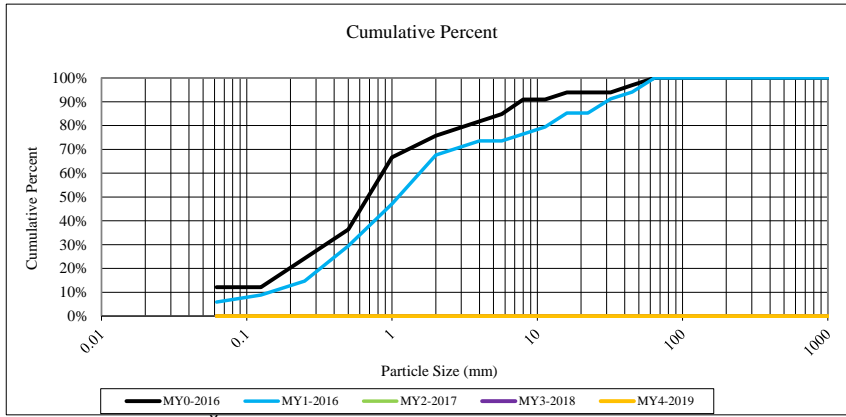
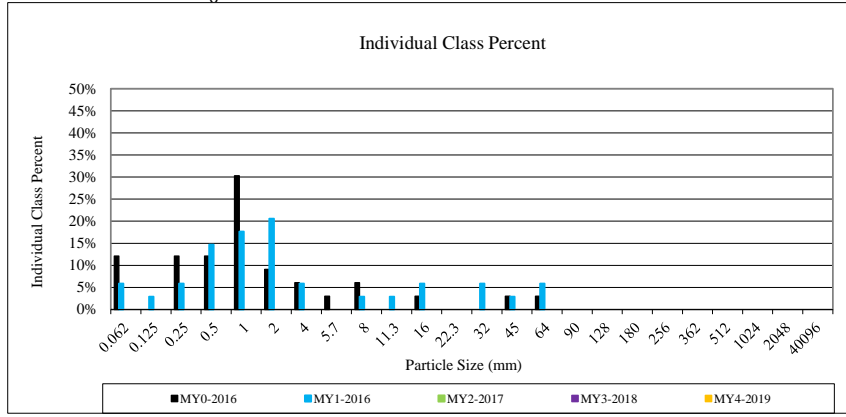
| Project Name: Neighbors Branch/Walton Crawley Branch Stream and Wetland Restoration Site | | | | | | |
|--|---|---|---|---|---|---|
| Cross-Section: 3 | | | | | | |

| Summary Data | |
|---|---|
| D84 | 15 |
| D95 | 47 |

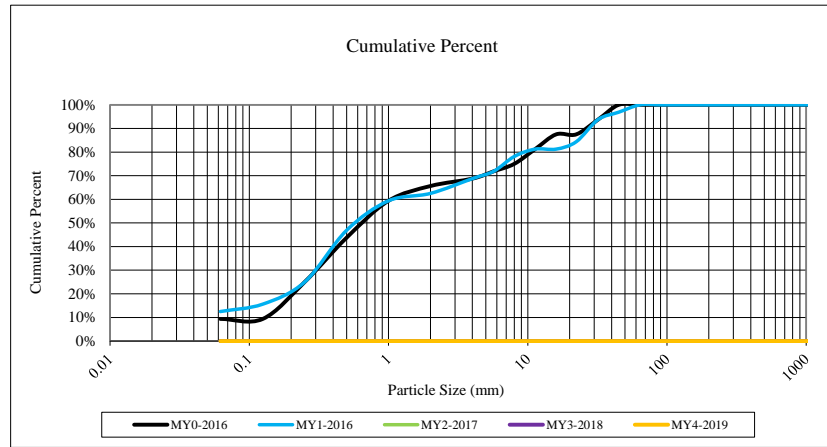
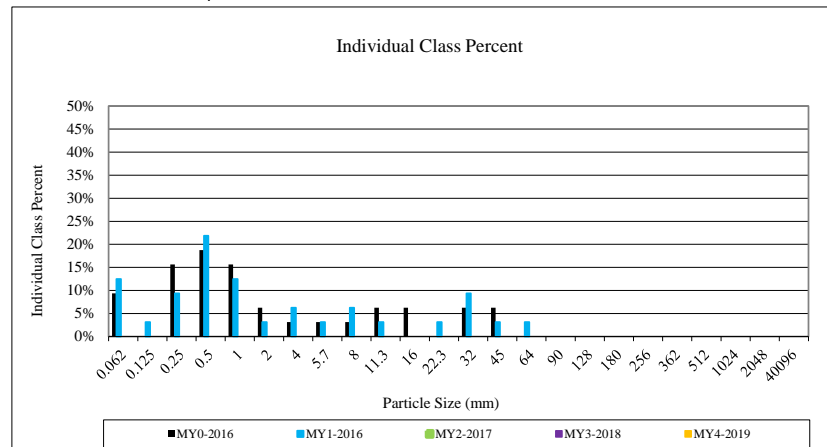
| Project Name: Neighbors Branch/Walton Crawley Branch Stream and Wetland Restoration Site | | | | | | |
|--|---|---|---|---|---|---|
| Cross-Section: 4 | | | | | | |

| Summary Data | |
|---|---|
| D84 | 21 |
| D95 | 37 |

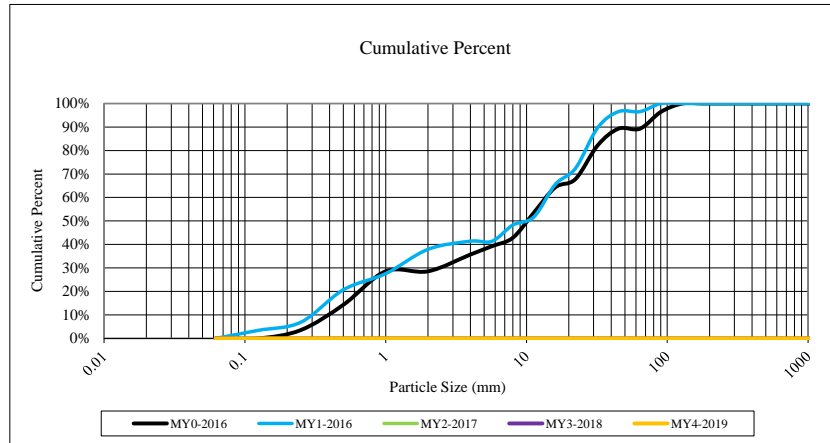
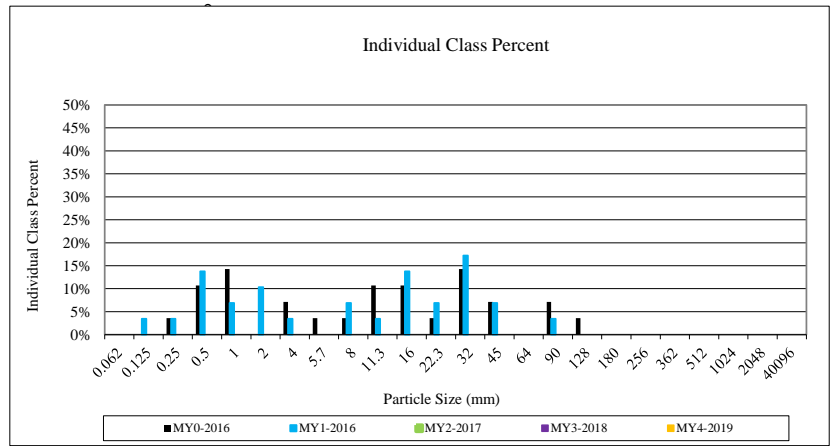
Cross-Section: 6

| D84 | 28 |
| D95 | 42 |

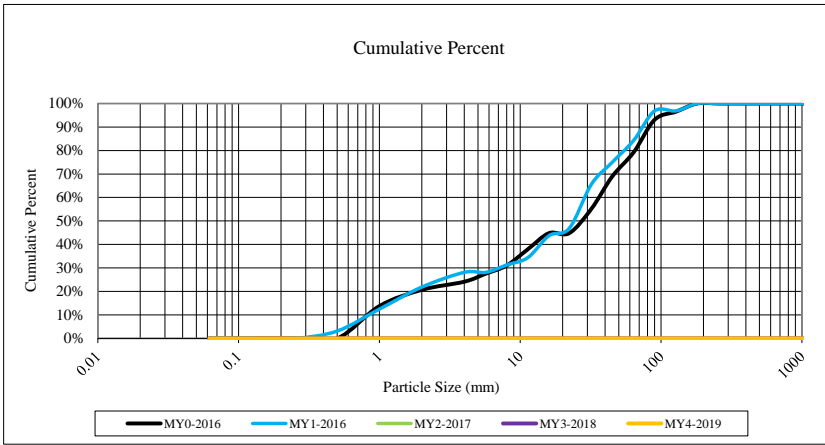
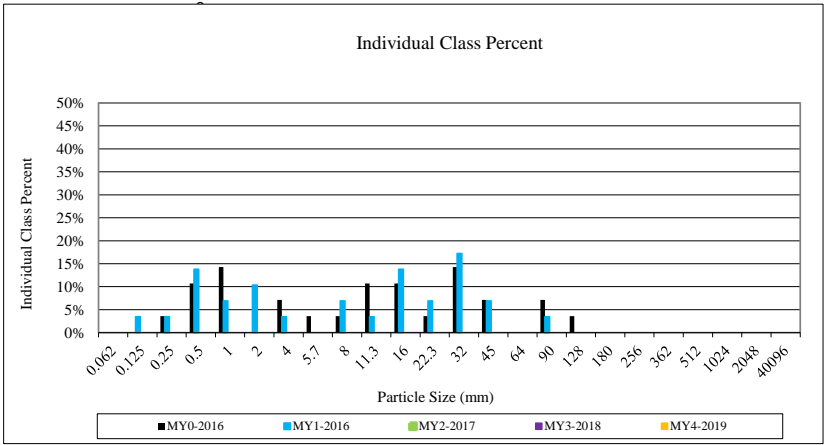
| Project Name: Neighbors Branch/Walton Crawley Branch Stream and Wetland Restoration Site | | | | | |
|--|---|---|---|---|---|
| Cross-Section: 8 | | | | | |

| Summary Data | |
|---|---|
| D84 | 63 |
| D95 | 86 |

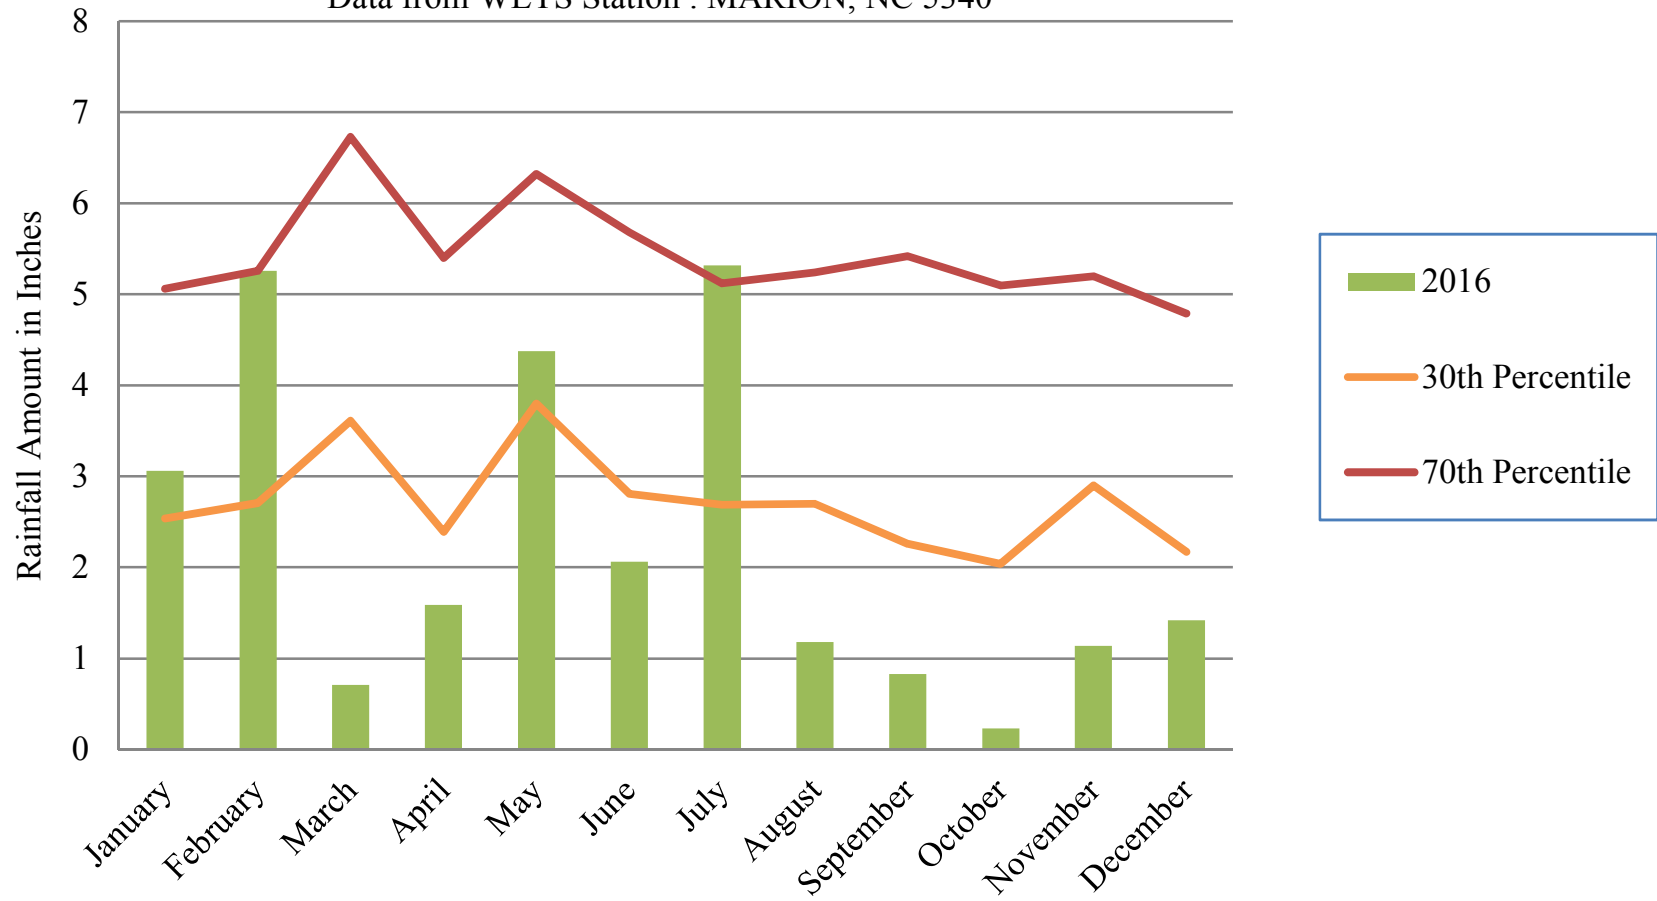
Figure E1: Neighbors Branch/Walton Crawley Branch 30-70 Percentile Graph for Rainfall

Data from WETS Station : MARION, NC 5340

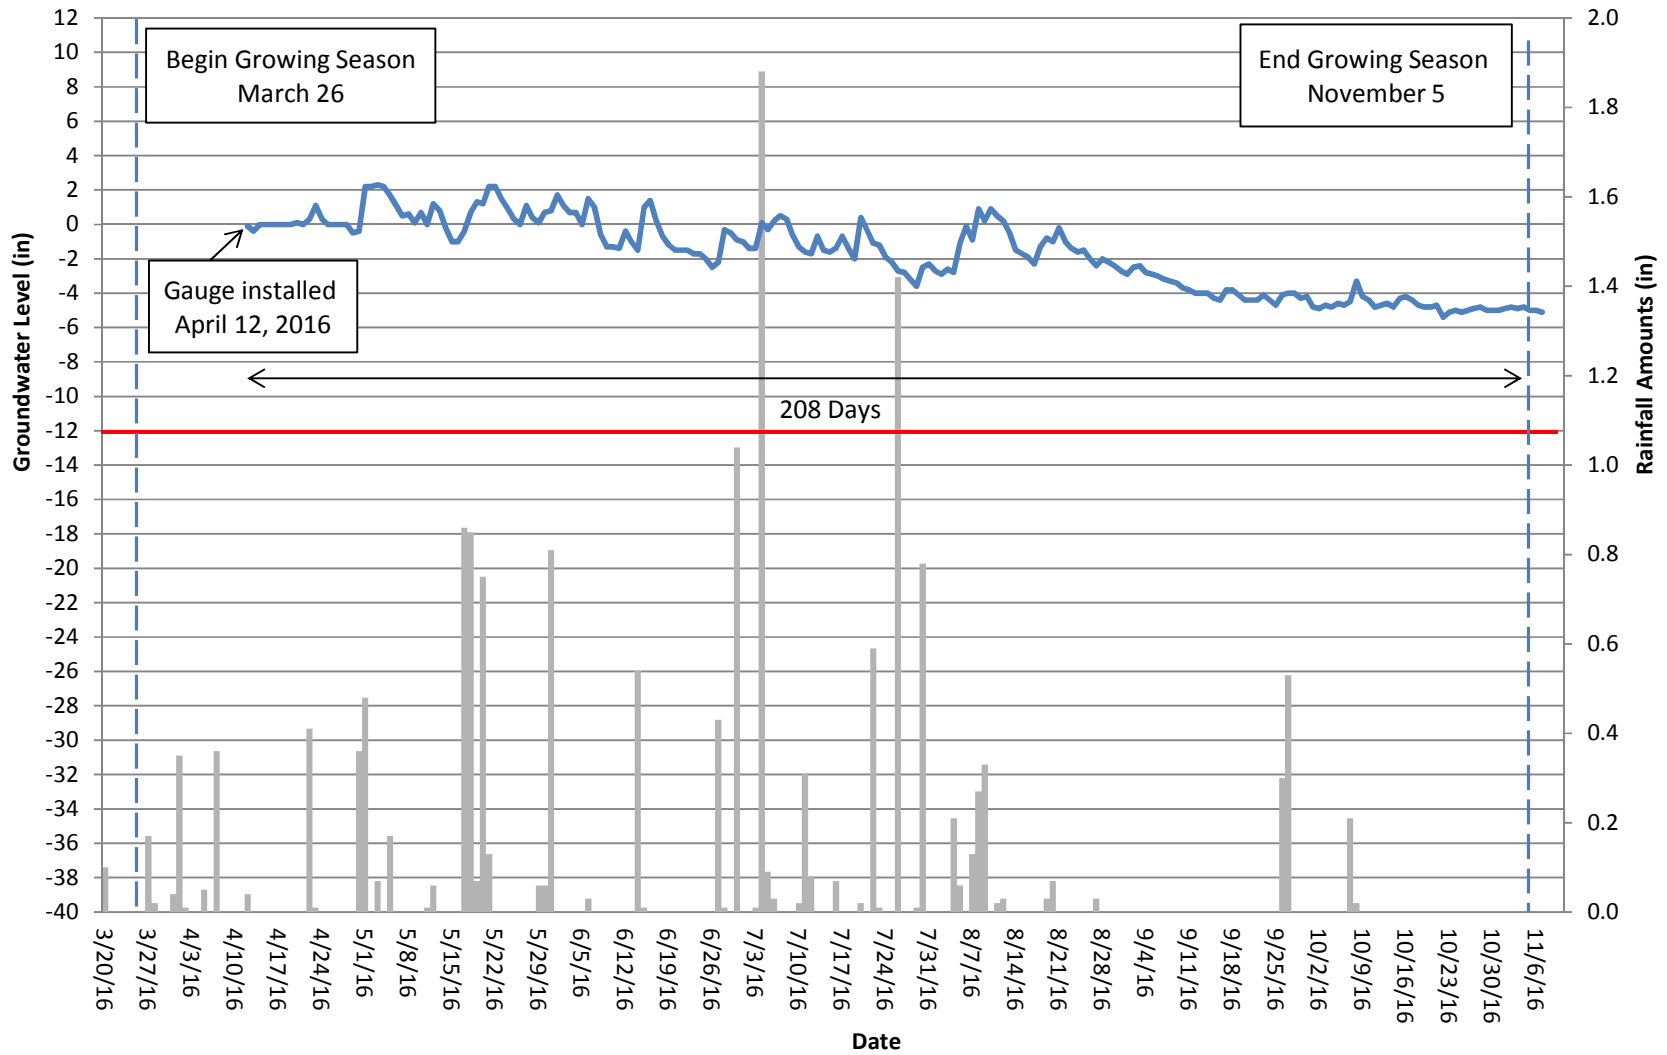
Neighbors Branch Groundwater Gauge 1 Year 1 (2016 Data)

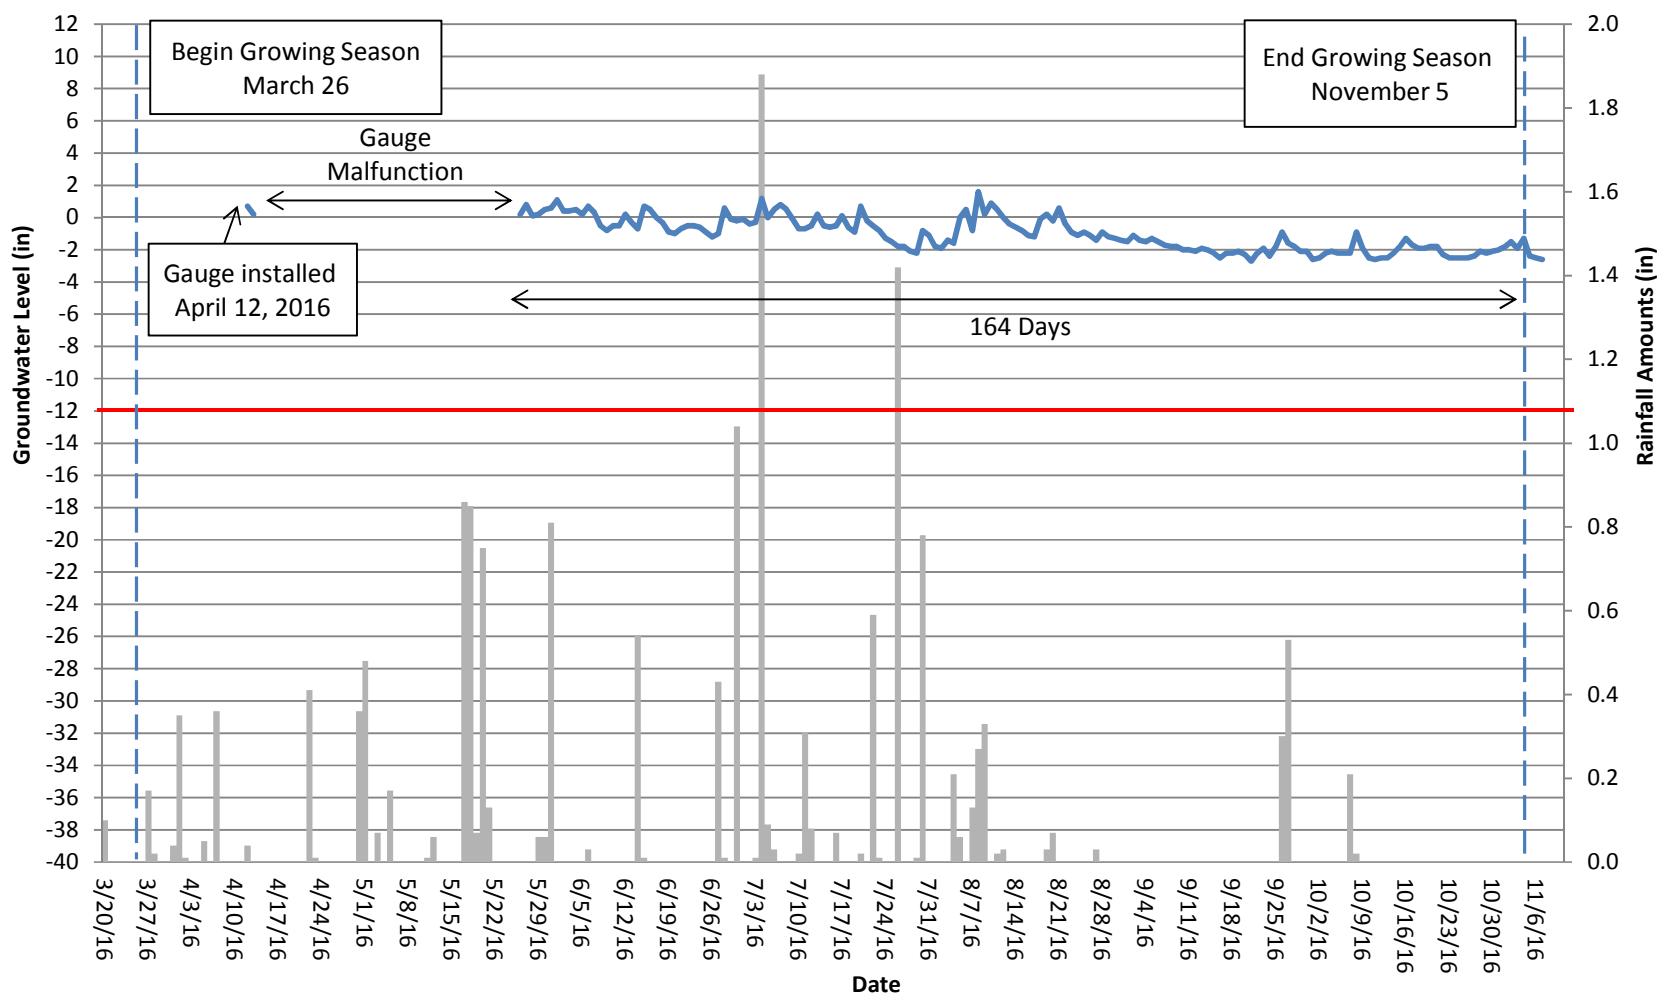
Tate Farm Groundwater Gauge 2 Year 5 (2016 Data)
