# **MYO FINAL MONITORING REPORT**

## **NESBIT SITE**

Union County, North Carolina  
Catawba River Basin  
Cataloging Unit 03050103

DMS Project No. 100121  
Full Delivery Contract No. 7868  
DMS RFP No. 16-007704 (issued 9/6/2018)  
USACE Action ID No. SAW-2019-00832  
DWR Project No. 2019-0862

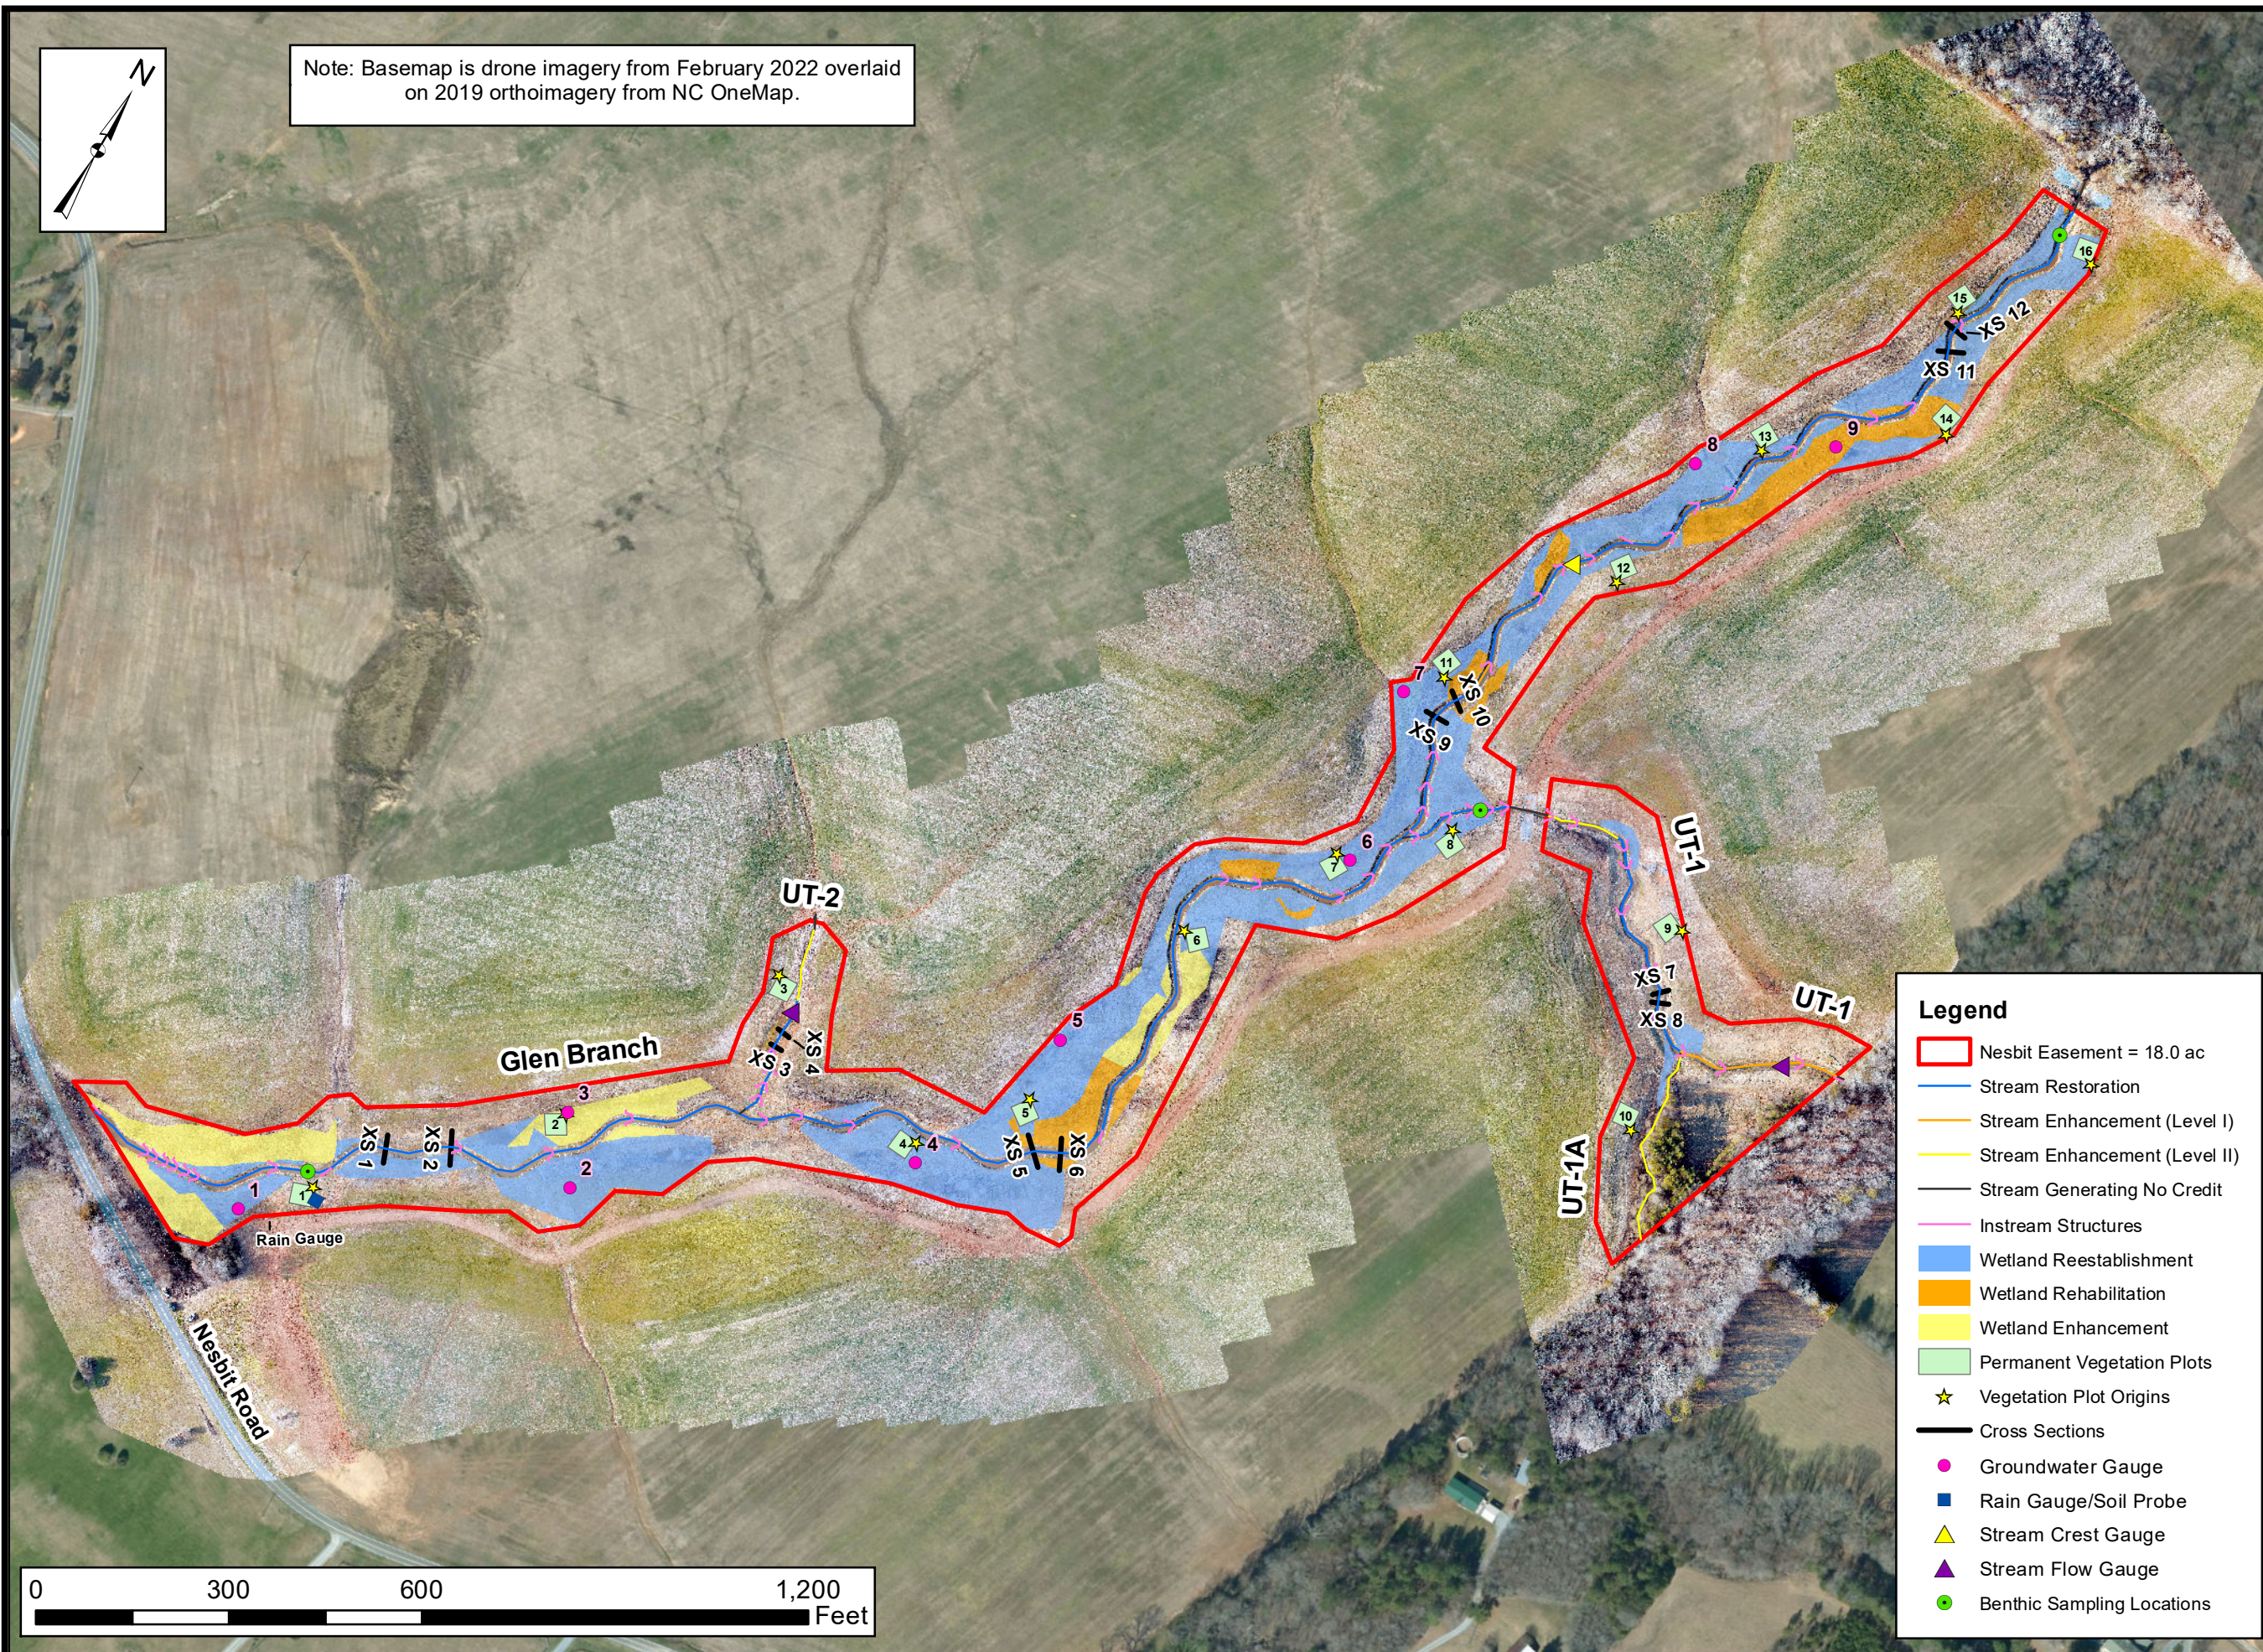
**1**

**CURRENT CONDITIONS PLAN VIEW**

Figure 1. Current Conditions Plan View  
Tables 4A-C. Stream Visual Stability Assessment  
Table 5. Visual Vegetation Assessment  
Vegetation Plot Photographs

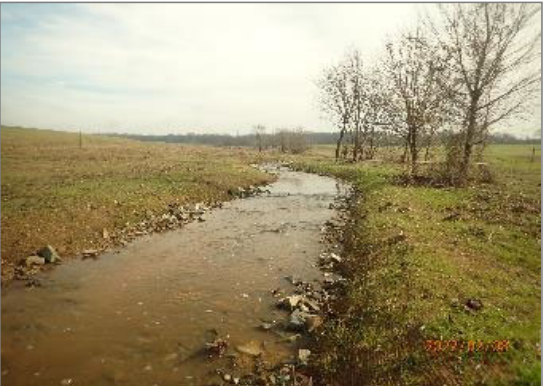
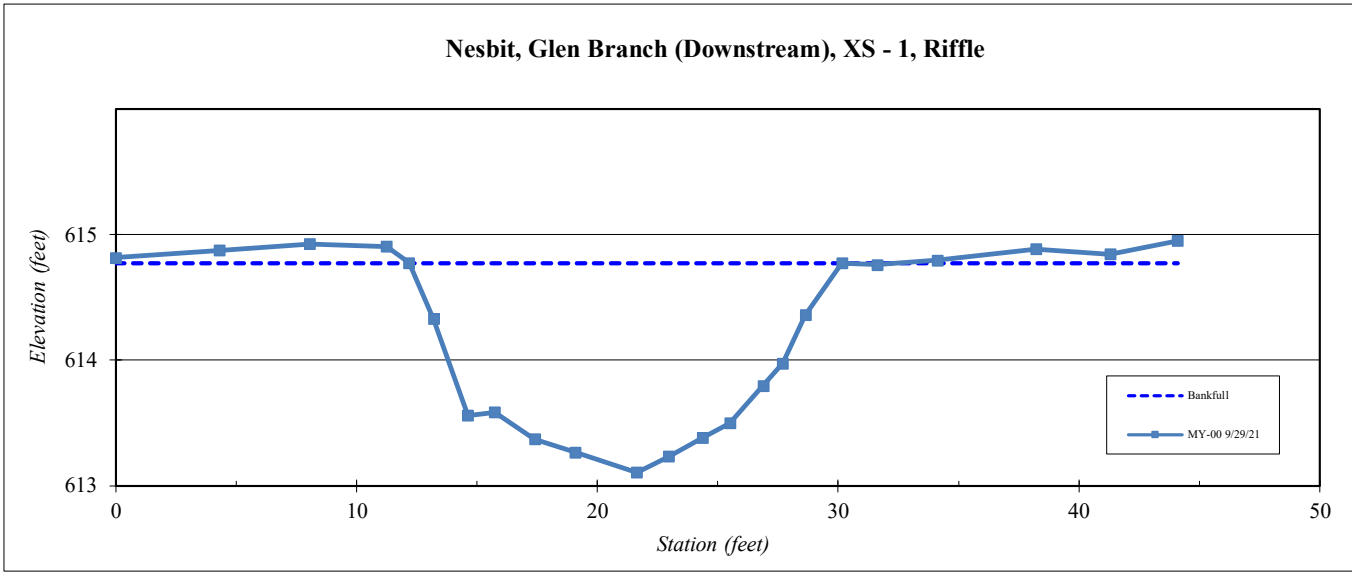
Site	Nesbit
Watershed:	Catawba River Basin, 03050103
XS ID	Glen Br (Downstream), XS - 1, Riffle
Feature	Riffle
Date:	2/8/2022
Field Crew:	Perkinson

Station	Elevation
0.0	614.8
4.3	614.9
8.1	615.0
11.2	614.9
12.2	614.8
13.2	614.3
14.6	613.4
15.7	613.4
17.4	613.2
19.1	613.1
21.6	612.9
23.0	613.0
24.4	613.2
25.5	613.3
26.9	613.7
27.7	613.9
28.6	614.3
30.2	614.8
31.6	614.8
34.1	614.8
38.2	614.91
41.3	614.9
44.1	615.0

SUMMARY DATA	
Bankfull Elevation:	614.79
Bank Height Ratio:	1.00
Thalweg Elevation:	612.90
LTOB Elevation:	614.79
LTOB Max Depth:	1.88
LTOB Cross Sectional Area:	22.9

Stream Type	E/C 5
-------------	-------

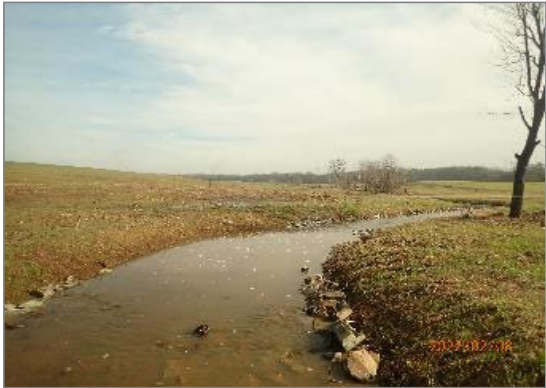
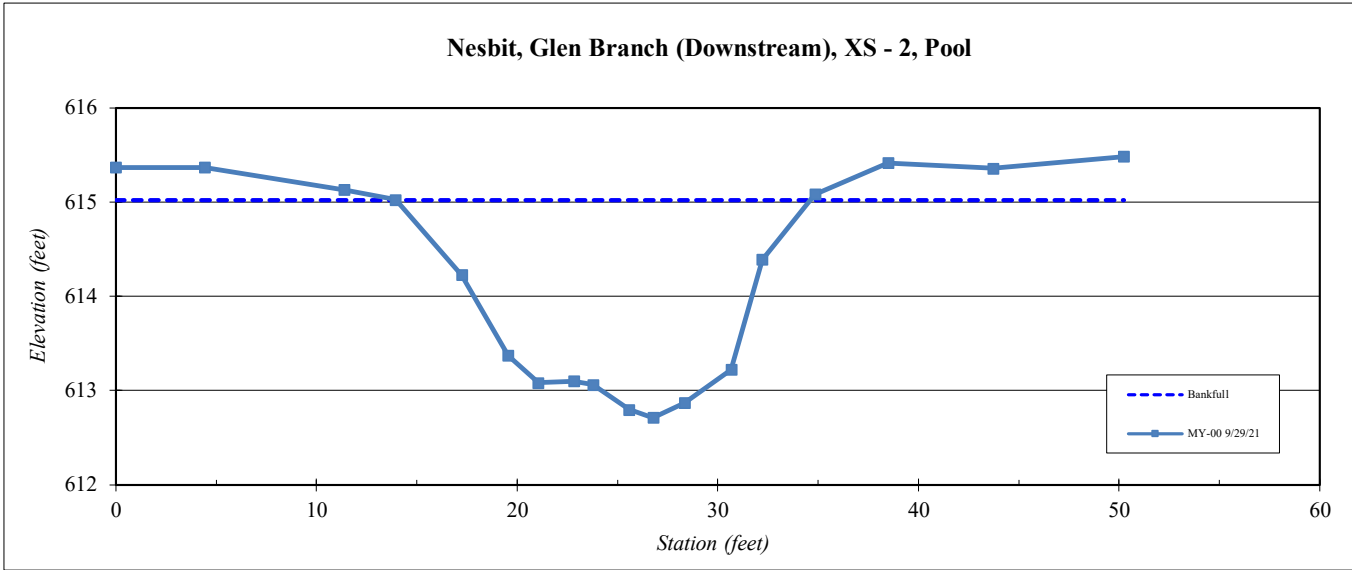
Site	Nesbit
Watershed:	Catawba River Basin, 03050103
XS ID	Glen Br (Downstream), XS - 2, Pool
Feature	Pool
Date:	2/8/2022
Field Crew:	Perkinson

Station	Elevation
0.0	615.5
4.4	615.5
11.4	615.2
13.9	615.1
17.2	614.2
19.6	613.2
21.1	612.9
22.8	612.9
23.8	612.9
25.6	612.6
26.8	612.5
28.3	612.6
30.7	613.0
32.2	614.4
34.8	615.1
38.5	615.5
43.7	615.4
50.2	615.6

SUMMARY DATA	
Bankfull Elevation:	615.07
Bank Height Ratio:	1.00
Thalweg Elevation:	612.46
LTOB Elevation:	615.07
LTOB Max Depth:	2.61
LTOB Cross Sectional Area:	33.2

Stream Type	E/C 5
-------------	-------

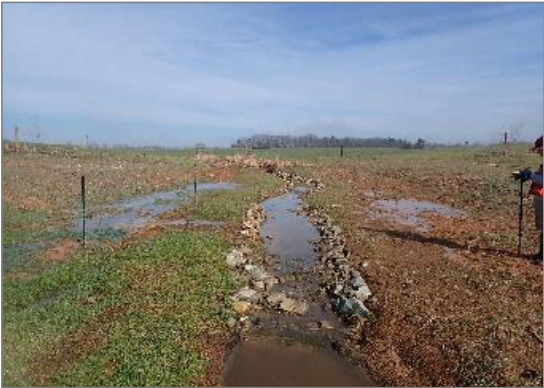
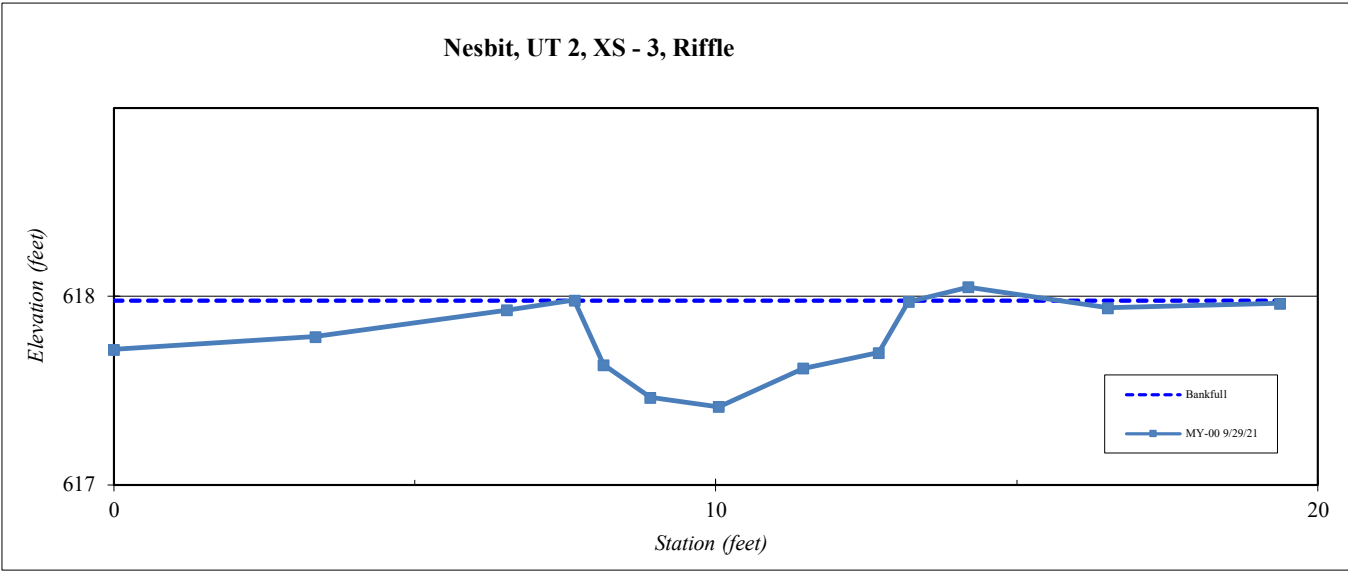
Site	Nesbit
Watershed:	Catawba River Basin, 03050103
XS ID	UT 2, XS - 3, Riffle
Feature	Riffle
Date:	2/8/2022
Field Crew:	Perkinson

Station	Elevation
0.0	618.1
3.3	618.2
6.5	618.4
7.6	618.4
8.1	618.0
8.9	617.8
10.0	617.8
11.5	618.0
12.7	618.1
13.2	618.4
14.2	618.5
16.5	618.4
19.4	618.4

SUMMARY DATA	
Bankfull Elevation:	618.41
Bank Height Ratio:	1.00
Thalweg Elevation:	617.78
LTOB Elevation:	618.41
LTOB Max Depth:	0.64
LTOB Cross Sectional Area:	2.4

Stream Type E/C 5

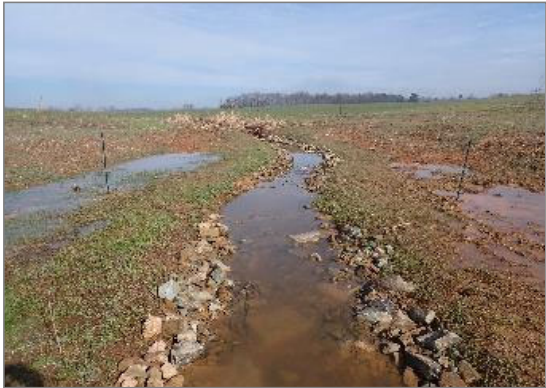
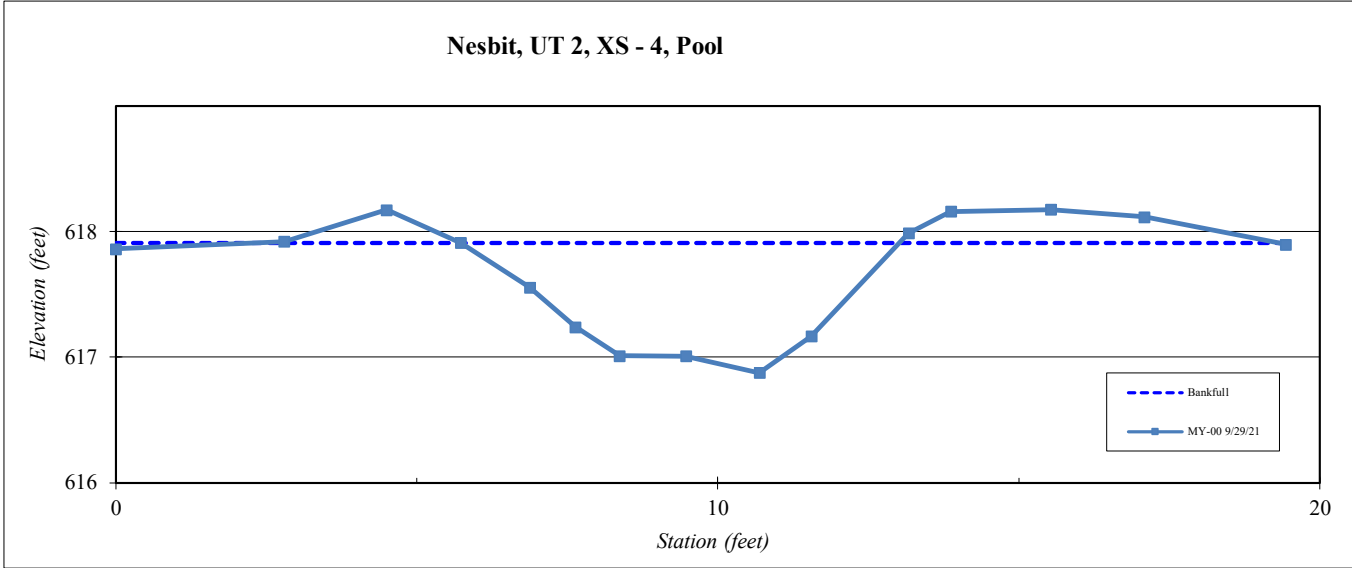
<b>Site</b>	Nesbit
<b>Watershed:</b>	Catawba River Basin, 03050103
<b>XS ID</b>	UT 2, XS - 4, Pool
<b>Feature</b>	Pool
<b>Date:</b>	2/8/2022
<b>Field Crew:</b>	Perkinson

Station	Elevation
0.0	618.3
2.8	618.3
4.5	618.6
5.7	618.3
6.9	617.9
7.6	617.6
8.4	617.3
9.5	617.3
10.7	617.2
11.6	617.5
13.2	618.4
13.9	618.6
15.5	618.6
17.1	618.6
19.4	618.3

SUMMARY DATA	
<b>Bankfull Elevation:</b>	618.33
<b>Bank Height Ratio:</b>	1.00
<b>Thalweg Elevation:</b>	617.17
<b>LTOB Elevation:</b>	618.33
<b>LTOB Max Depth:</b>	1.17
<b>LTOB Cross Sectional Area:</b>	5.3

<b>Stream Type</b>	E/C 5
--------------------	-------

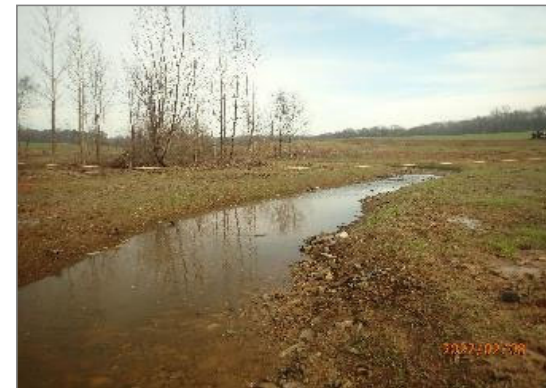
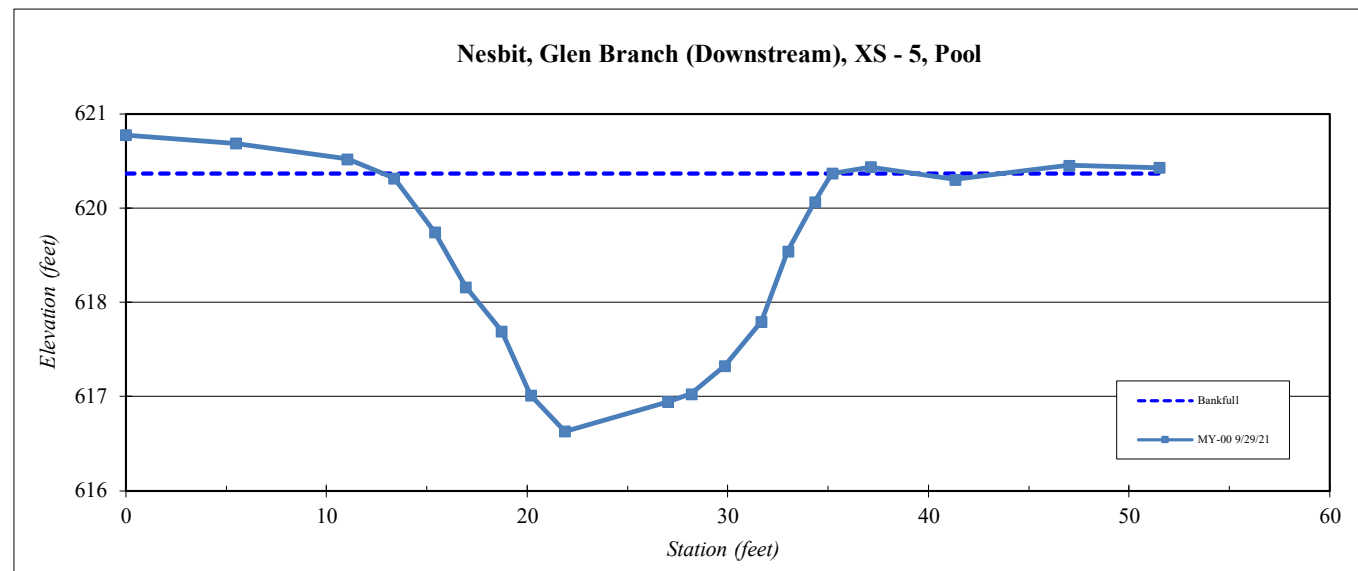
<b>Site</b>	Nesbit
<b>Watershed:</b>	Catawba River Basin, 03050103
<b>XS ID</b>	Glen Br (Downstream), XS - 5, Pool
<b>Feature</b>	Pool
<b>Date:</b>	2/8/2022
<b>Field Crew:</b>	Perkinson

Station	Elevation
0.0	620.4
5.5	620.3
11.0	620.2
13.4	619.9
15.4	619.3
16.9	618.6
18.7	618.1
20.2	617.3
21.9	616.9
27.0	617.2
28.2	617.3
29.9	617.7
31.7	618.2
33.0	619.1
34.3	619.6
35.2	620.0
37.1	620.1
41.3	619.9
47.0	620.1
51.5	620.1

SUMMARY DATA	
<b>Bankfull Elevation:</b>	619.98
<b>Bank Height Ratio:</b>	1.00
<b>Thalweg Elevation:</b>	616.89
<b>LTOB Elevation:</b>	619.98
<b>LTOB Max Depth:</b>	3.09
<b>LTOB Cross Sectional Area:</b>	42.3

<b>Stream Type</b>	E/C 5
--------------------	-------

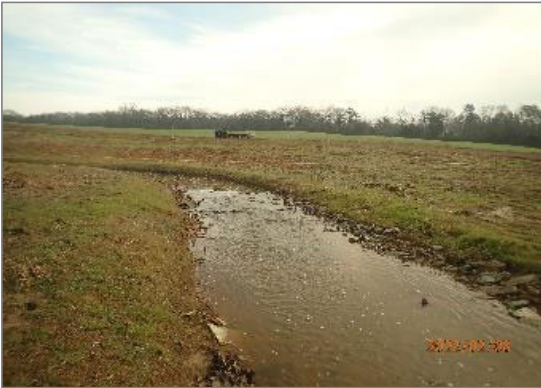
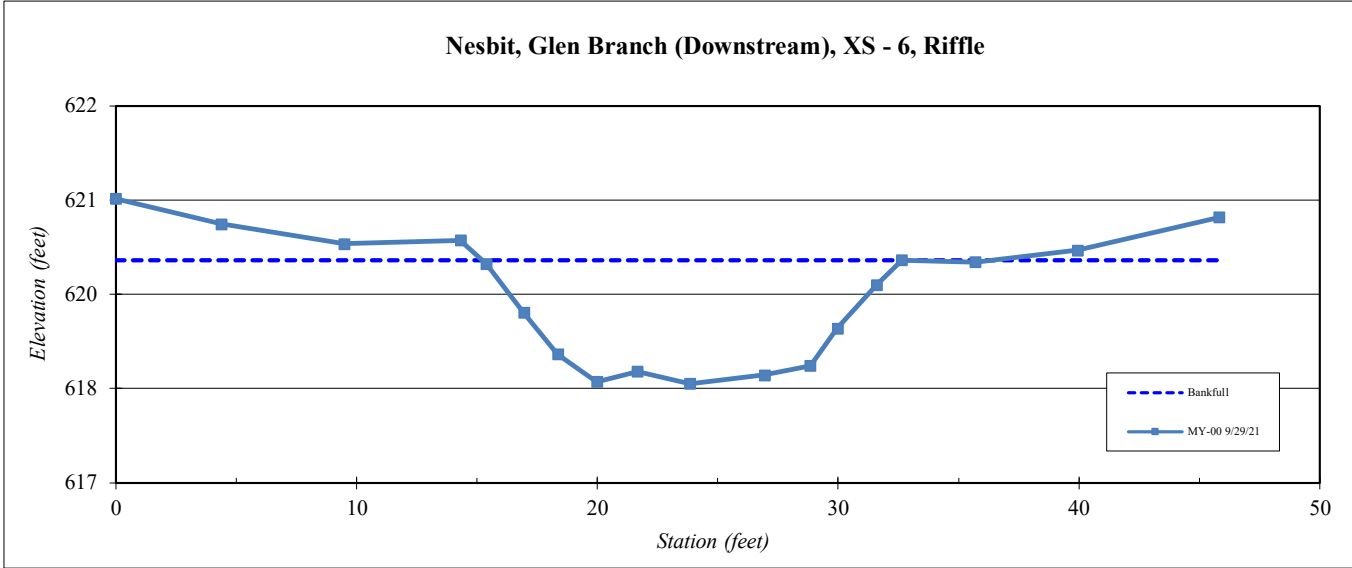
Site	Nesbit
Watershed:	Catawba River Basin, 03050103
XS ID	Glen Br (Downstream), XS - 6, Riffle
Feature	Riffle
Date:	2/8/2022
Field Crew:	Perkinson

Station	Elevation
0.0	620.7
4.4	620.4
9.5	620.2
14.3	620.2
15.4	619.9
17.0	619.3
18.4	618.8
20.0	618.5
21.7	618.6
23.8	618.5
26.9	618.6
28.8	618.7
30.0	619.2
31.6	619.7
32.6	620.0
35.7	620.0
40.0	620.1
45.8	620.5

SUMMARY DATA	
Bankfull Elevation:	619.97
Bank Height Ratio:	1.00
Thalweg Elevation:	618.49
LTOB Elevation:	619.97
LTOB Max Depth:	1.48
LTOB Cross Sectional Area:	18.5

Stream Type	E/C 5
-------------	-------

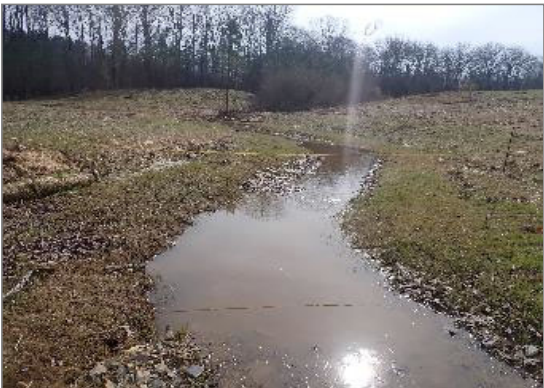
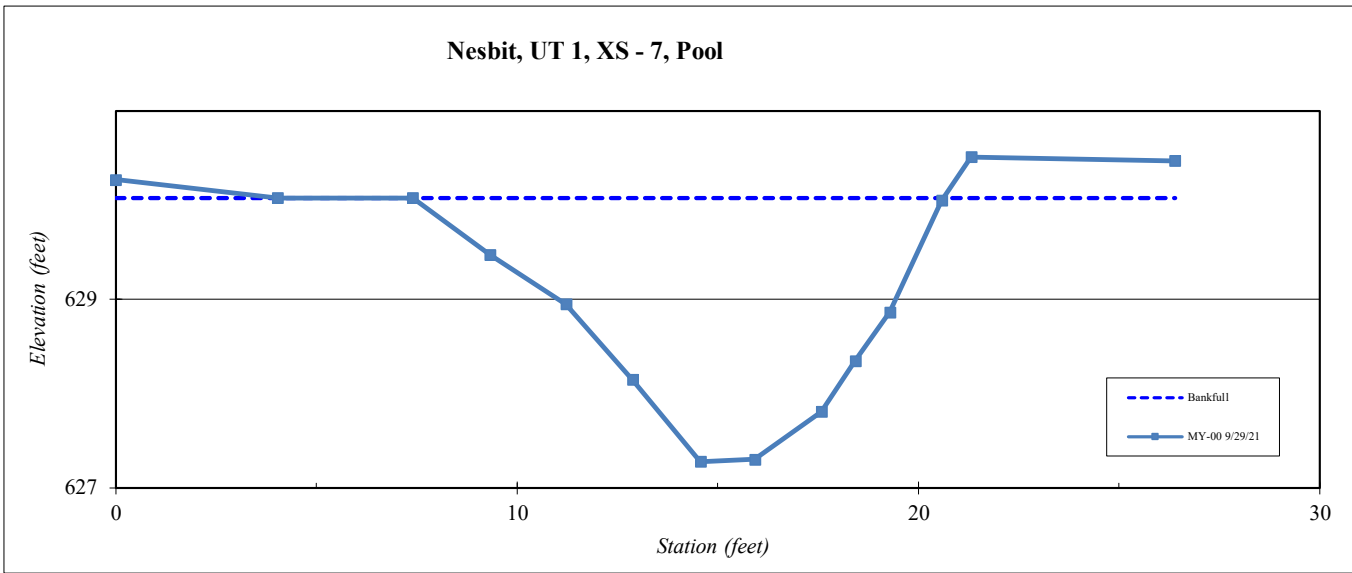
<b>Site</b>	Nesbit
<b>Watershed:</b>	Catawba River Basin, 03050103
<b>XS ID</b>	UT 1, XS - 7, Pool
<b>Feature</b>	Pool
<b>Date:</b>	2/8/2022
<b>Field Crew:</b>	Perkinson

Station	Elevation
0.0	629.3
4.0	629.2
7.4	629.2
9.3	628.9
11.2	628.6
12.9	628.1
14.6	627.6
15.9	627.7
17.6	627.9
18.4	628.2
19.3	628.5
20.6	629.2
21.3	629.5
26.4	629.4

SUMMARY DATA	
<b>Bankfull Elevation:</b>	629.22
<b>Bank Height Ratio:</b>	1.00
<b>Thalweg Elevation:</b>	627.64
<b>LTOB Elevation:</b>	629.22
<b>LTOB Max Depth:</b>	1.58
<b>LTOB Cross Sectional Area:</b>	11.6

**Stream Type** E/C 5

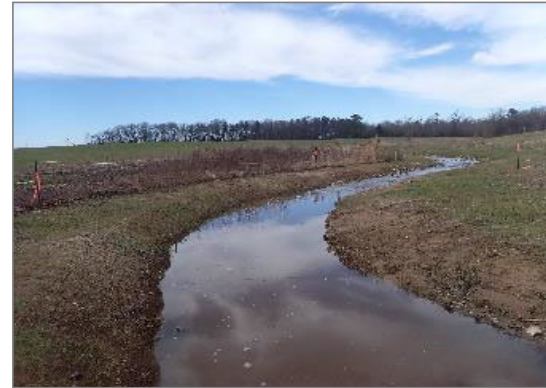
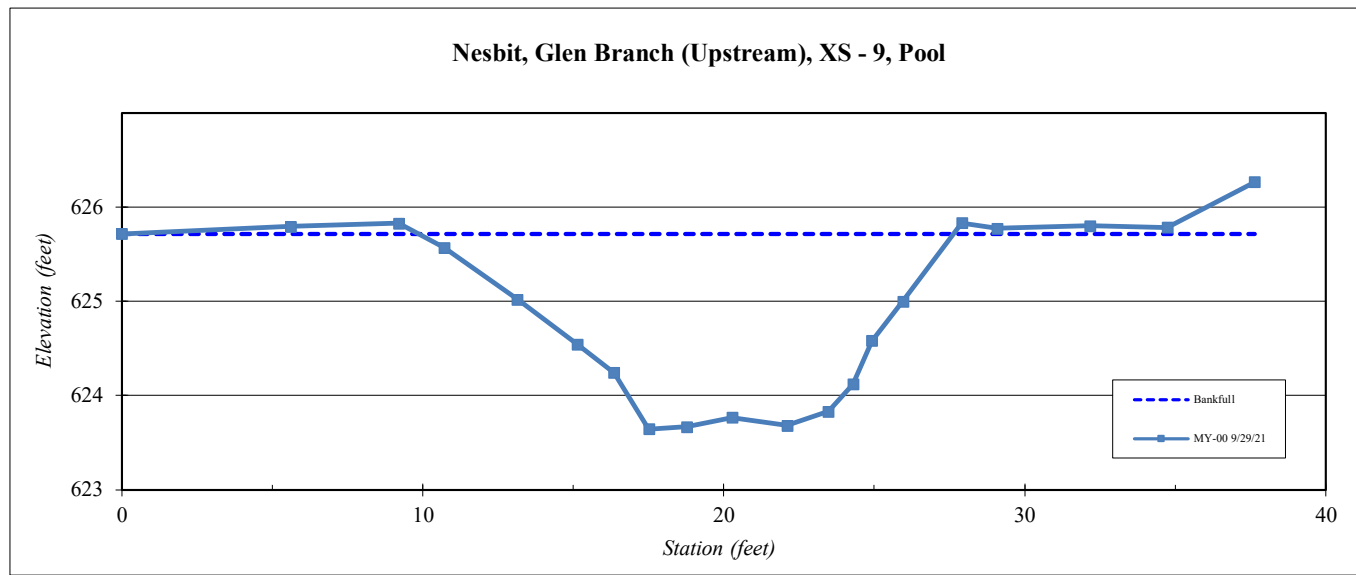
<b>Site</b>	Nesbit
<b>Watershed:</b>	Catawba River Basin, 03050103
<b>XS ID</b>	Glen Br (Upstream), XS - 9, Pool
<b>Feature</b>	Pool
<b>Date:</b>	2/8/2022
<b>Field Crew:</b>	Perkinson

Station	Elevation
0.0	626.0
5.6	626.1
9.2	626.2
10.7	625.9
13.1	625.2
15.1	624.7
16.3	624.4
17.5	623.7
18.8	623.7
20.3	623.8
22.1	623.7
23.5	623.9
24.3	624.2
24.9	624.7
26.0	625.2
27.9	626.2
29.1	626.1
32.2	626.1
34.7	626.1
37.6	626.7

SUMMARY DATA	
<b>Bankfull Elevation:</b>	626.03
<b>Bank Height Ratio:</b>	1.03
<b>Thalweg Elevation:</b>	623.71
<b>LTOB Elevation:</b>	626.09
<b>LTOB Max Depth:</b>	2.38
<b>LTOB Cross Sectional Area:</b>	26.0

<b>Stream Type</b>	E/C 5
--------------------	-------

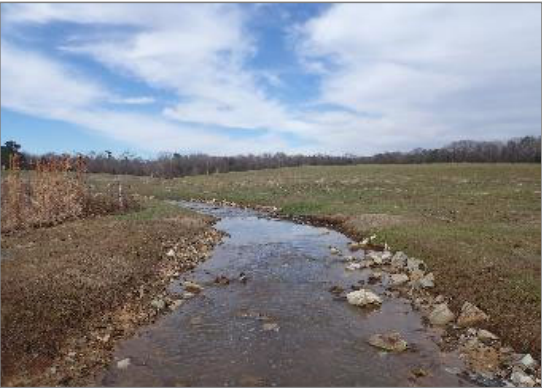
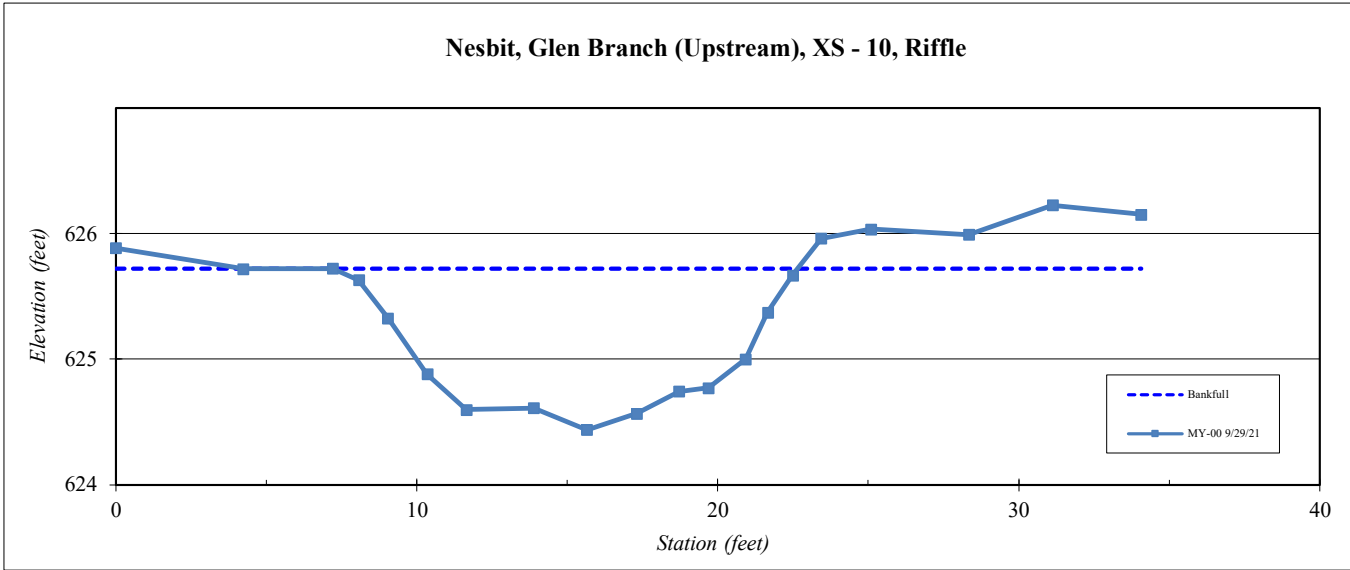
<b>Site</b>	Nesbit
<b>Watershed:</b>	Catawba River Basin, 03050103
<b>XS ID</b>	Glen Br (Upstream), XS - 10, Riffle
<b>Feature</b>	Riffle
<b>Date:</b>	2/8/2022
<b>Field Crew:</b>	Perkinson

Station	Elevation
0.0	626.2
4.2	626.0
7.2	626.0
8.1	625.9
9.0	625.6
10.3	625.1
11.6	624.8
13.9	624.8
15.6	624.6
17.3	624.7
18.7	624.9
19.7	625.0
20.9	625.2
21.7	625.6
22.5	626.0
23.4	626.3
25.1	626.4
28.3	626.3
31.1	626.6
34.1	626.5

SUMMARY DATA	
<b>Bankfull Elevation:</b>	626.04
<b>Bank Height Ratio:</b>	1.00
<b>Thalweg Elevation:</b>	624.59
<b>LTOB Elevation:</b>	626.04
<b>LTOB Max Depth:</b>	1.45
<b>LTOB Cross Sectional Area:</b>	14.7

<b>Stream Type</b>	E/C 5
--------------------	-------

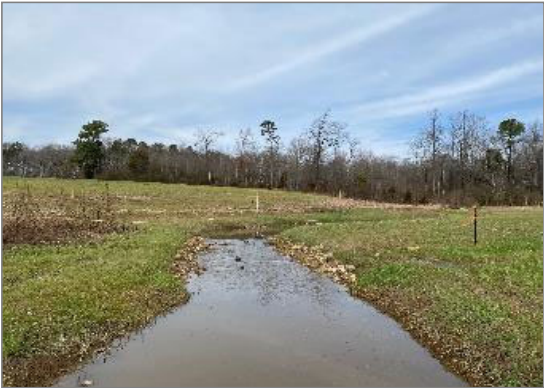
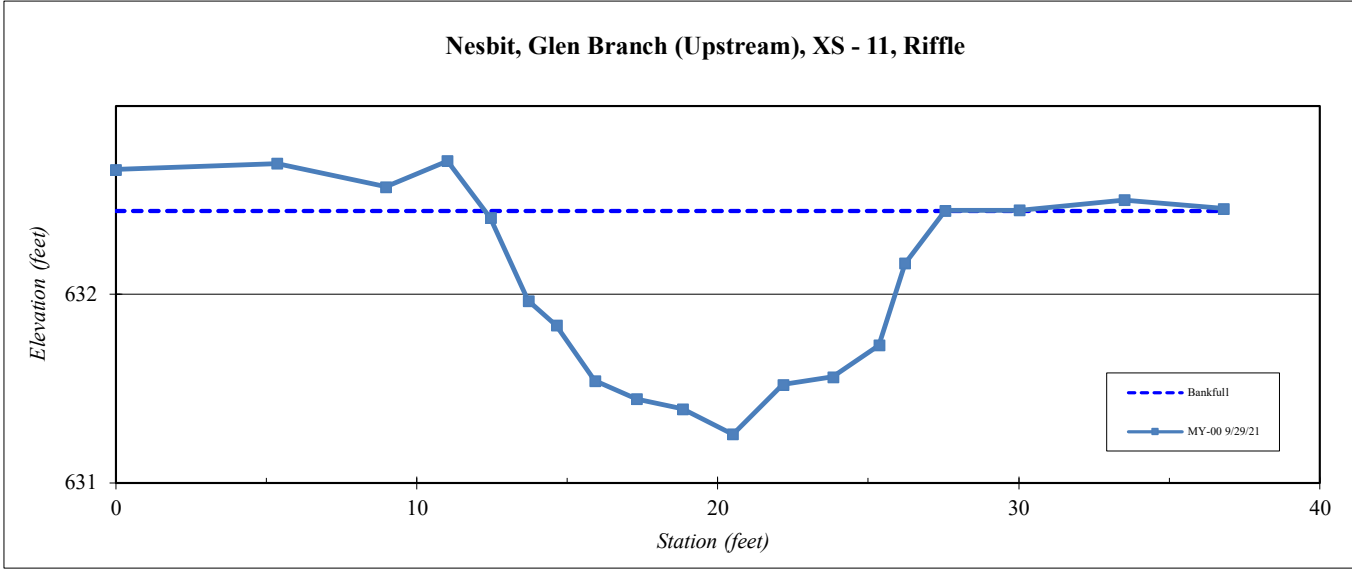
<b>Site</b>	Nesbit
<b>Watershed:</b>	Catawba River Basin, 03050103
<b>XS ID</b>	Glen Br (Upstream), XS - 11, Riffle
<b>Feature</b>	Riffle
<b>Date:</b>	2/8/2022
<b>Field Crew:</b>	Perkinson

Station	Elevation
0.0	632.8
5.4	632.8
9.0	632.6
11.0	632.8
12.5	632.5
13.7	632.0
14.6	631.8
15.9	631.5
17.3	631.4
18.8	631.3
20.5	631.2
22.2	631.5
23.8	631.5
25.4	631.7
26.2	632.2
27.6	632.5
30.0	632.5
33.5	632.6
36.8	632.5

SUMMARY DATA	
<b>Bankfull Elevation:</b>	632.51
<b>Bank Height Ratio:</b>	1.00
<b>Thalweg Elevation:</b>	631.16
<b>LTOB Elevation:</b>	632.51
<b>LTOB Max Depth:</b>	1.34
<b>LTOB Cross Sectional Area:</b>	13.2

<b>Stream Type</b>	E/C 5
--------------------	-------

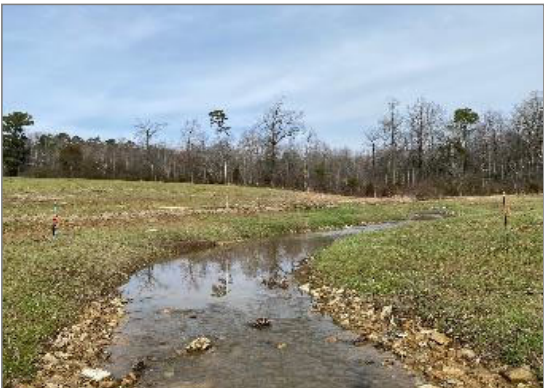
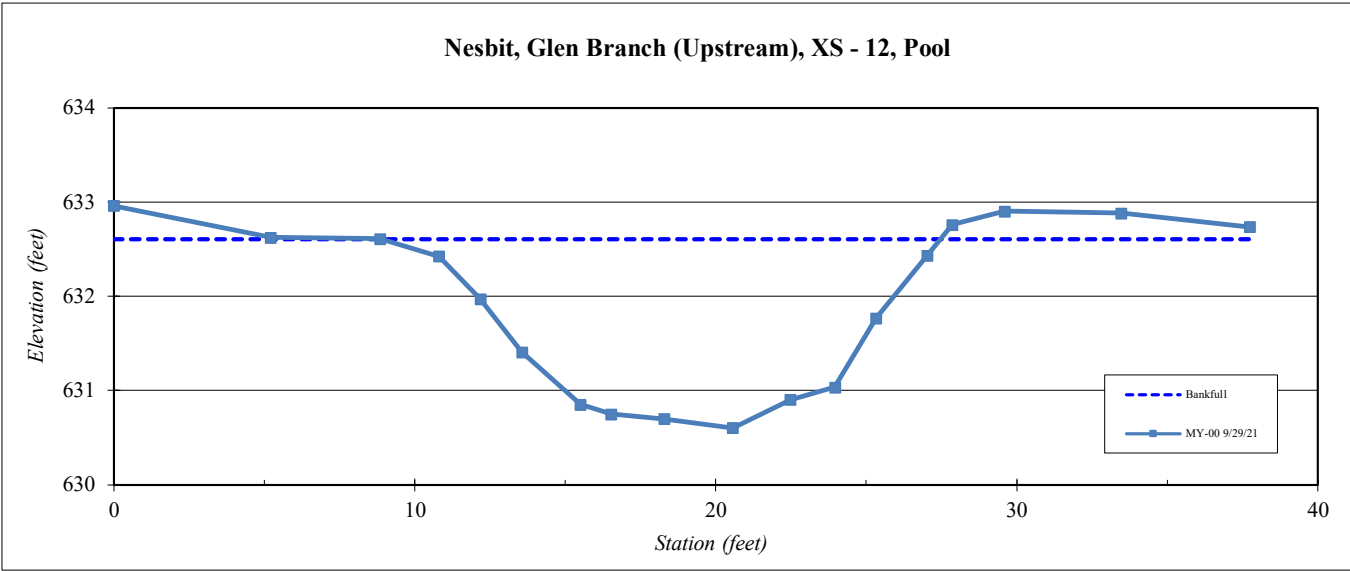
<b>Site</b>	Nesbit
<b>Watershed:</b>	Catawba River Basin, 03050103
<b>XS ID</b>	Glen Br (Upstream), XS - 12, Pool
<b>Feature</b>	Pool
<b>Date:</b>	2/8/2022
<b>Field Crew:</b>	Perkinson

SUMMARY DATA	
<b>Bankfull Elevation:</b>	632.69
<b>Bank Height Ratio:</b>	1.00
<b>Thalweg Elevation:</b>	630.43
<b>LTOB Elevation:</b>	632.69
<b>LTOB Max Depth:</b>	2.27
<b>LTOB Cross Sectional Area:</b>	26.1

Station	Elevation
0.0	633.1
5.2	632.7
8.8	632.7
10.8	632.5
12.2	632.0
13.6	631.3
15.5	630.7
16.5	630.6
18.3	630.5
20.6	630.4
22.5	630.8
24.0	630.9
25.3	631.7
27.0	632.5
27.9	632.9
29.6	633.0
33.5	633.0
37.7	632.8

**Stream Type** E/C 5

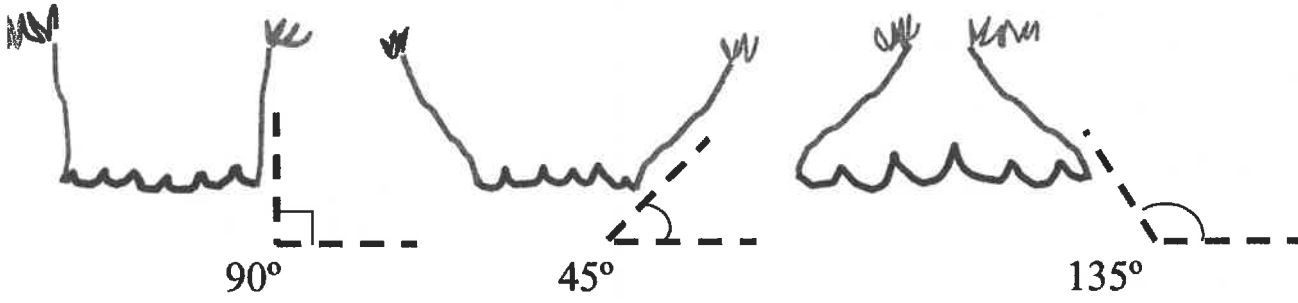
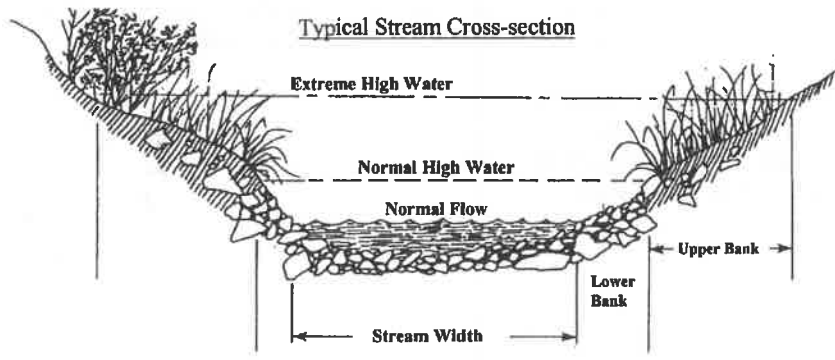
Diagram to determine bank angle:

This side is 45° bank angle.

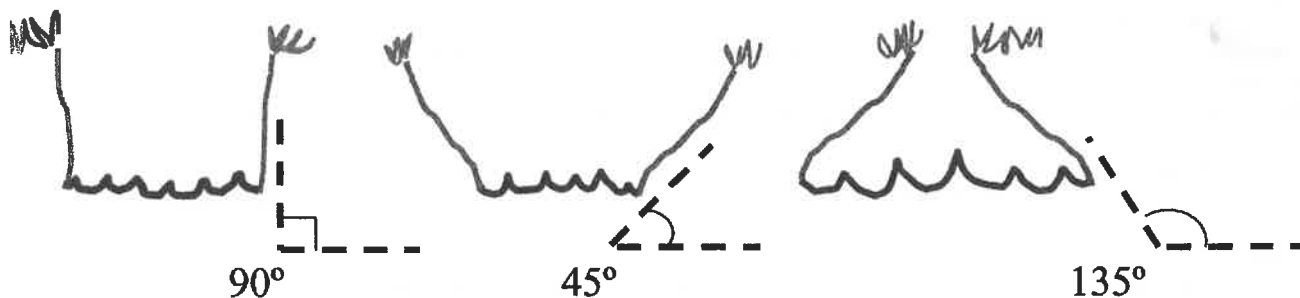
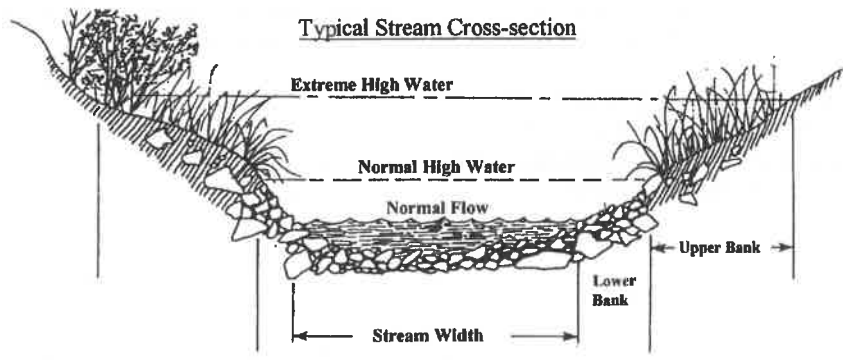
Diagram to determine bank angle:

This side is 45° bank angle.

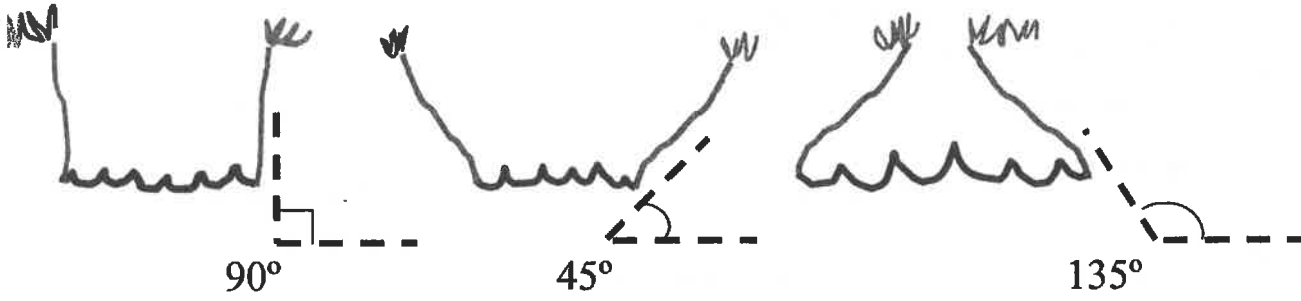
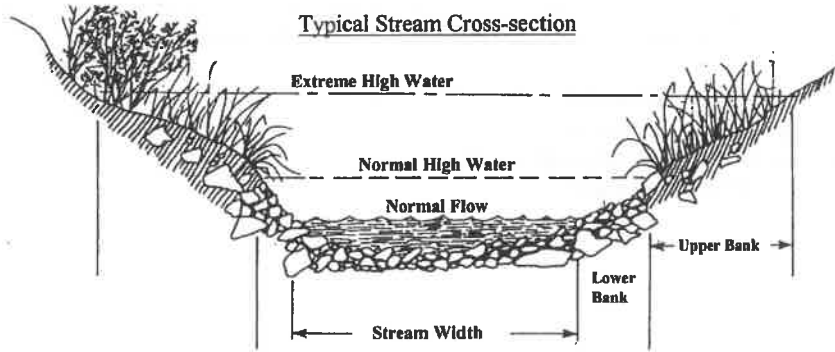
Diagram to determine bank angle:

This side is 45° bank angle.

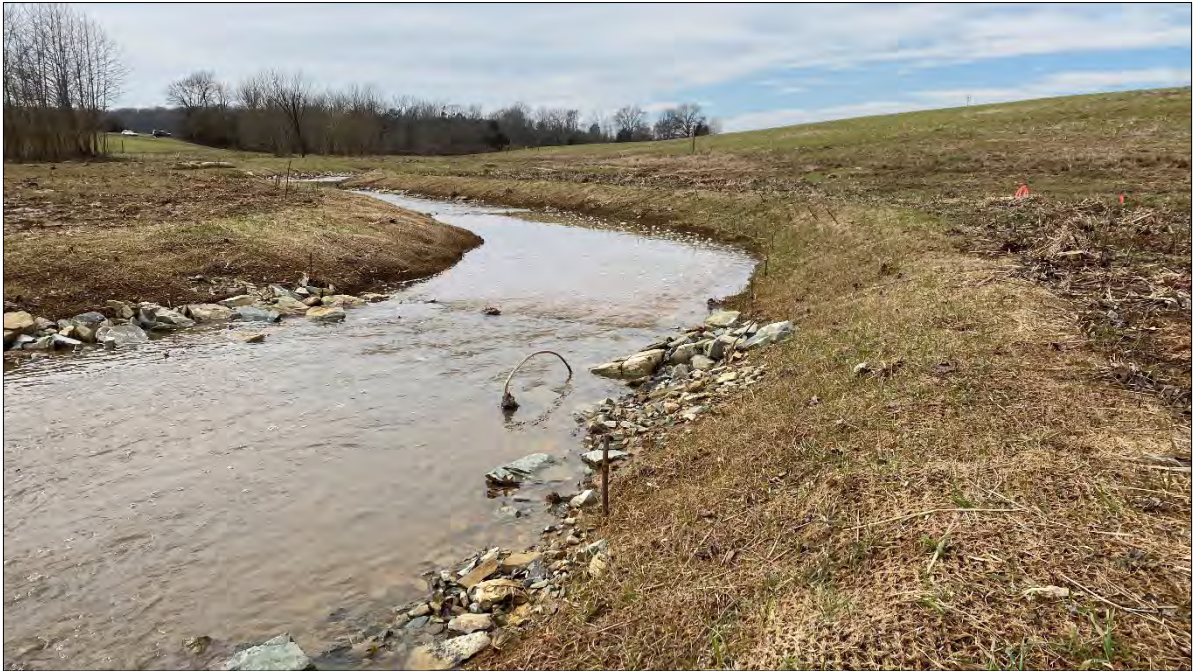
Live Stakes - 02/08/2022

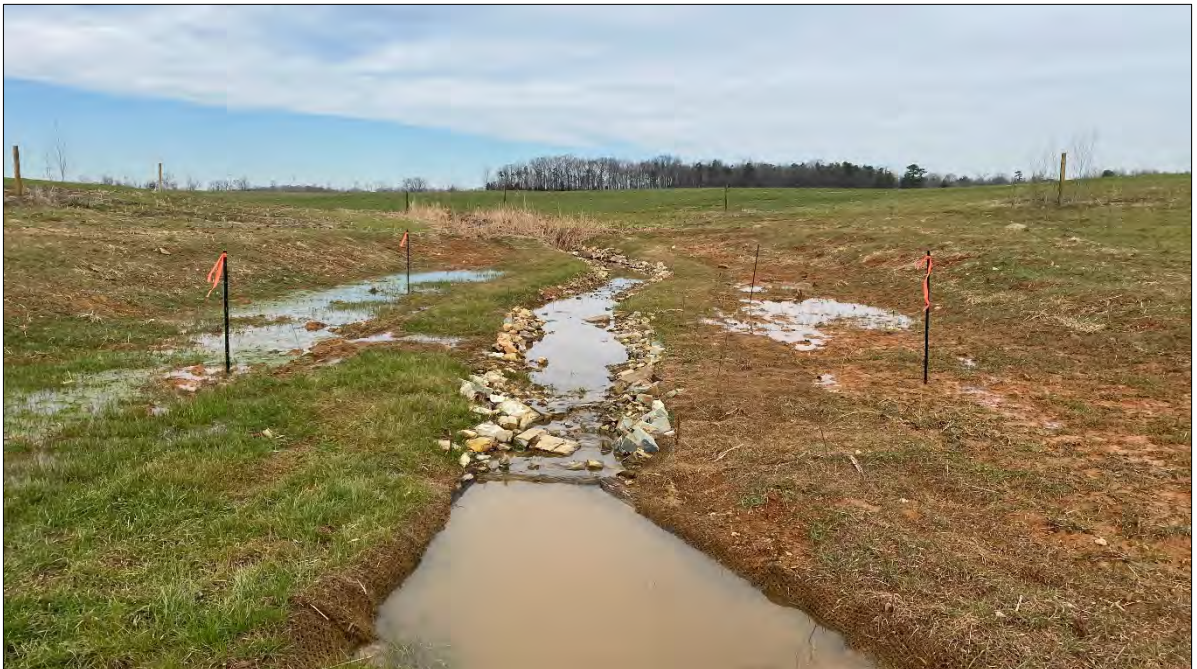
UT-2 Cross Sections - 02/08/2022

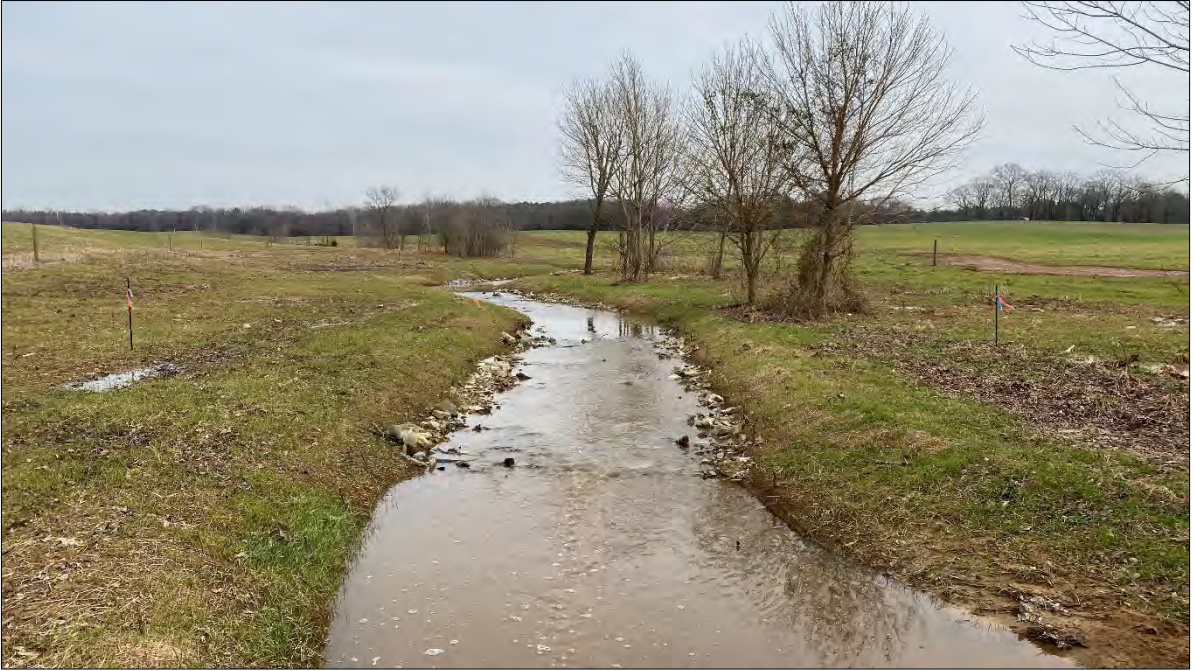
Glen Branch Cross Section - 02/08/2022

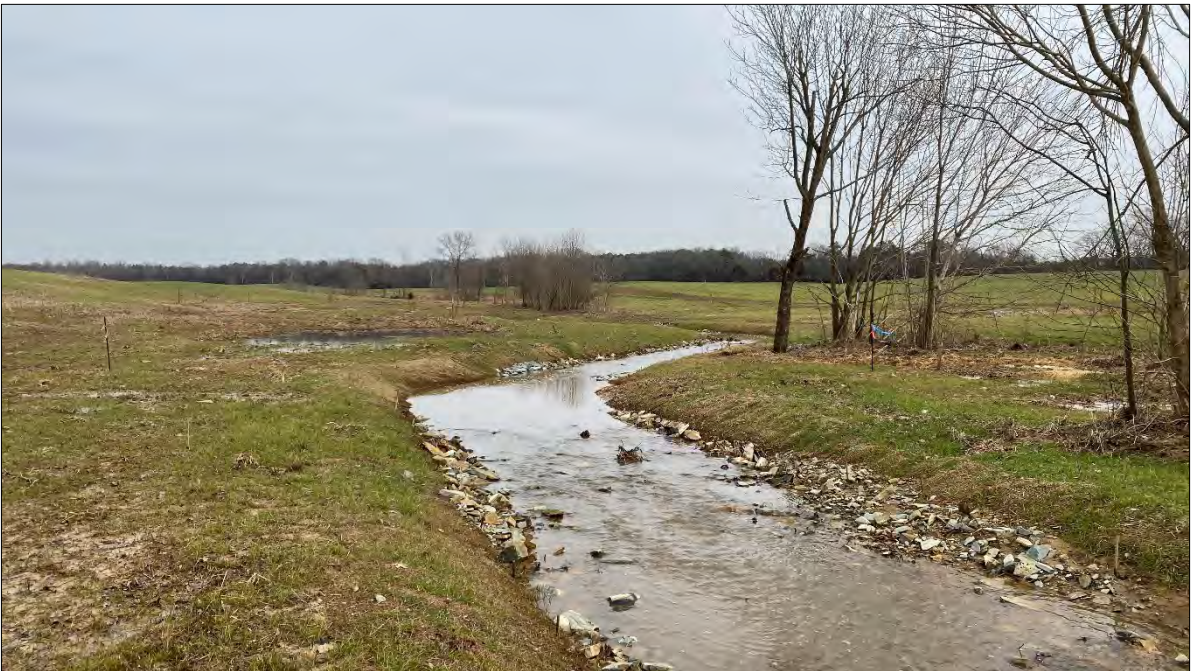
Glen Branch Cross Section - 02/08/2022

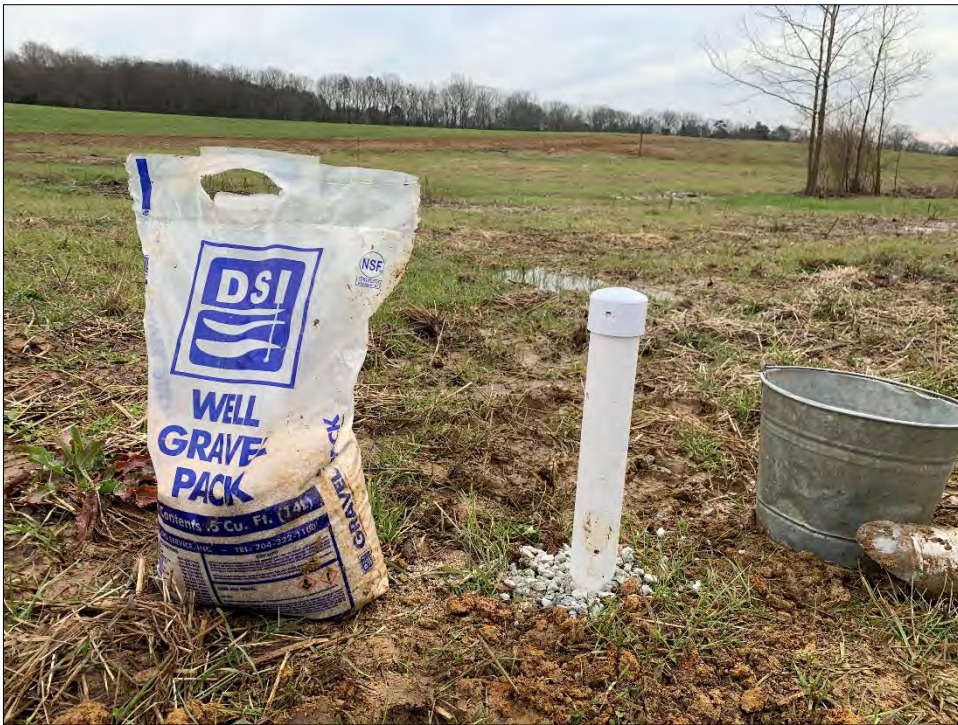
Ground Water Gauge Install - 02/02/2022

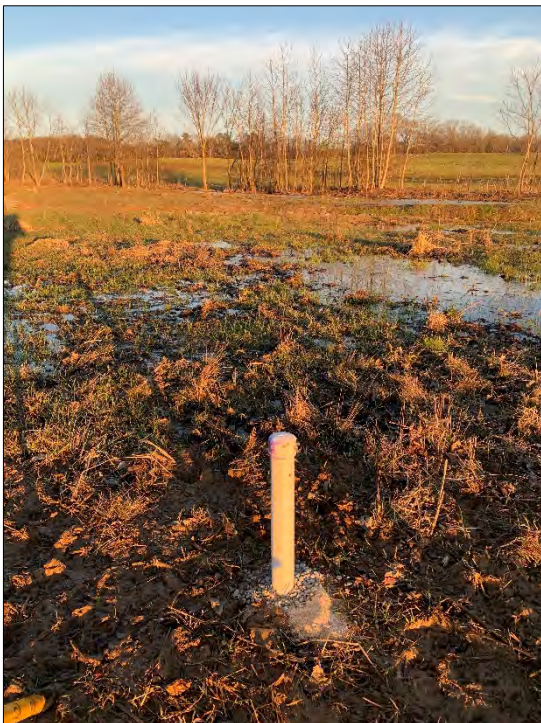
Ground Water Gauge Install - 02/02/2022
