# **MYO FINAL MONITORING REPORT**

## **NESBIT SITE**

Union County, North Carolina  
Catawba River Basin  
Cataloging Unit 03050103

DMS Project No. 100121  
Full Delivery Contract No. 7868  
DMS RFP No. 16-007704 (issued 9/6/2018)  
USACE Action ID No. SAW-2019-00832  
DWR Project No. 2019-0862

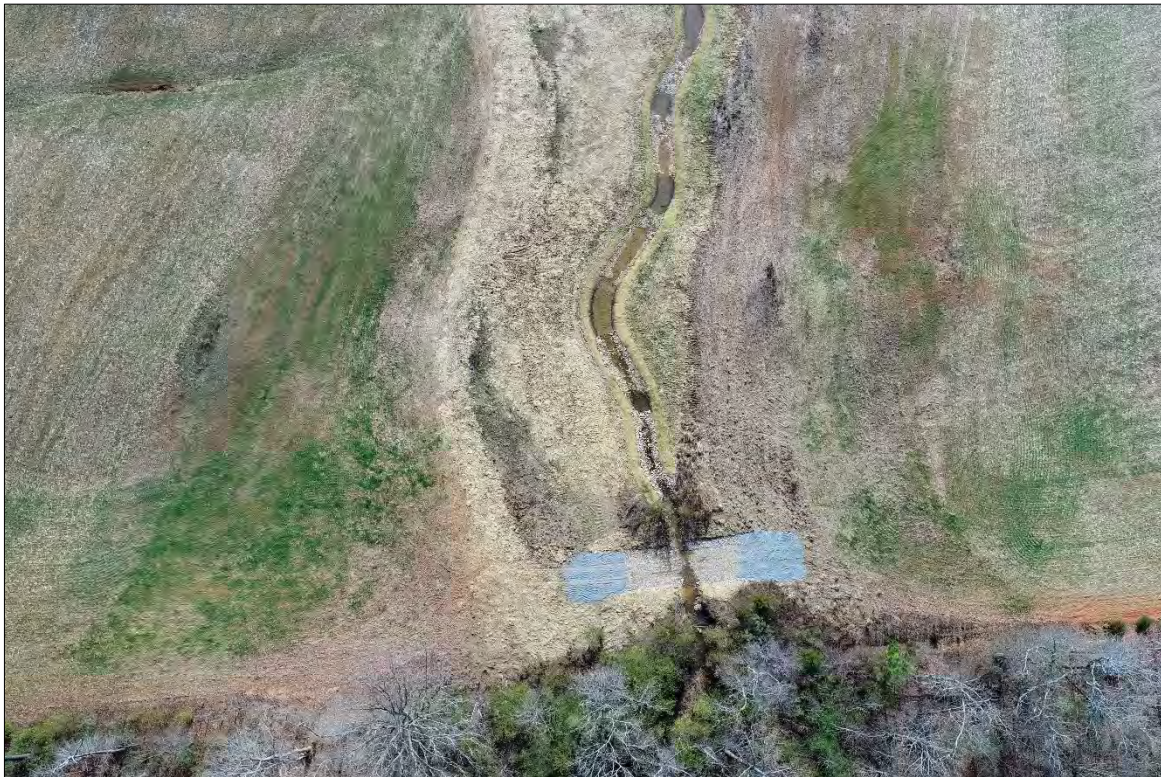
Glen Branch, upper extent, ford crossing - 01/15/2022

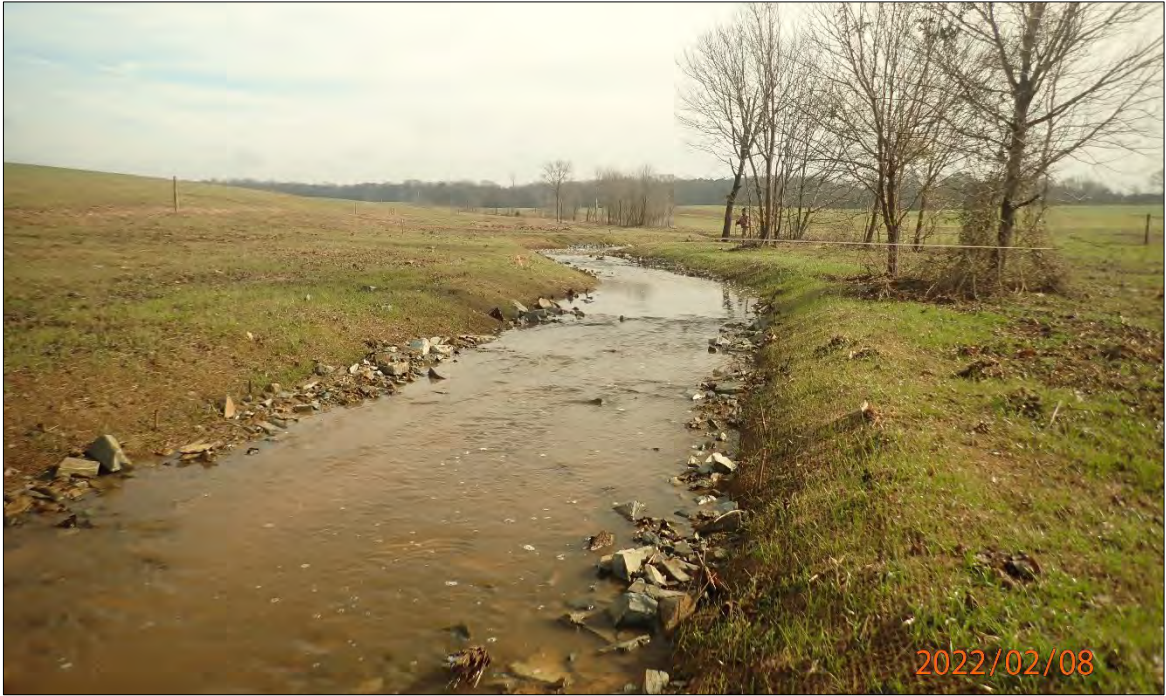
Cross sections 1, Glen Branch - 02/08/2022

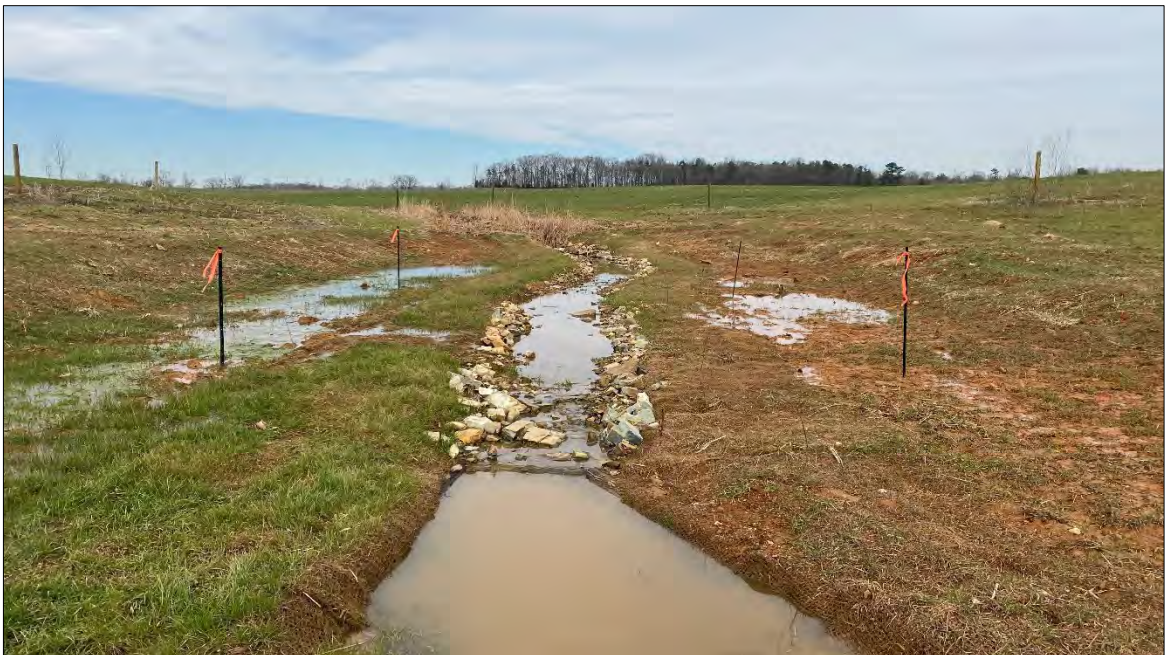
Cross sections 3 and 4, UT 2 - 02/08/2022

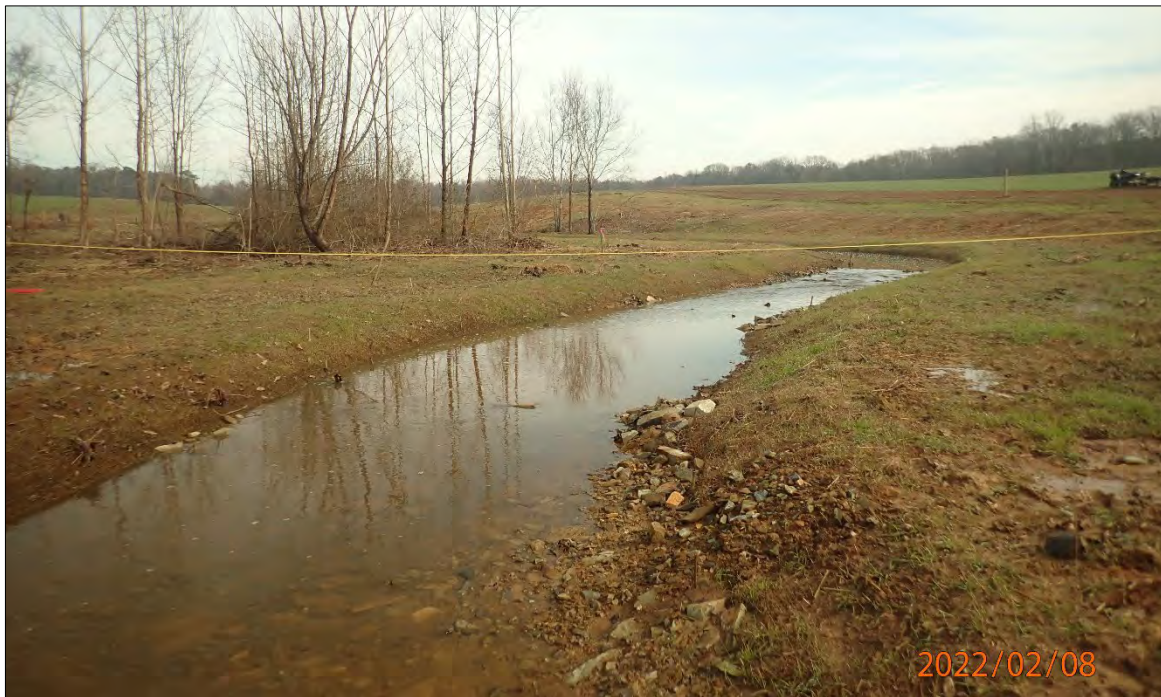
Cross sections 5, Glen Branch - 02/08/2022

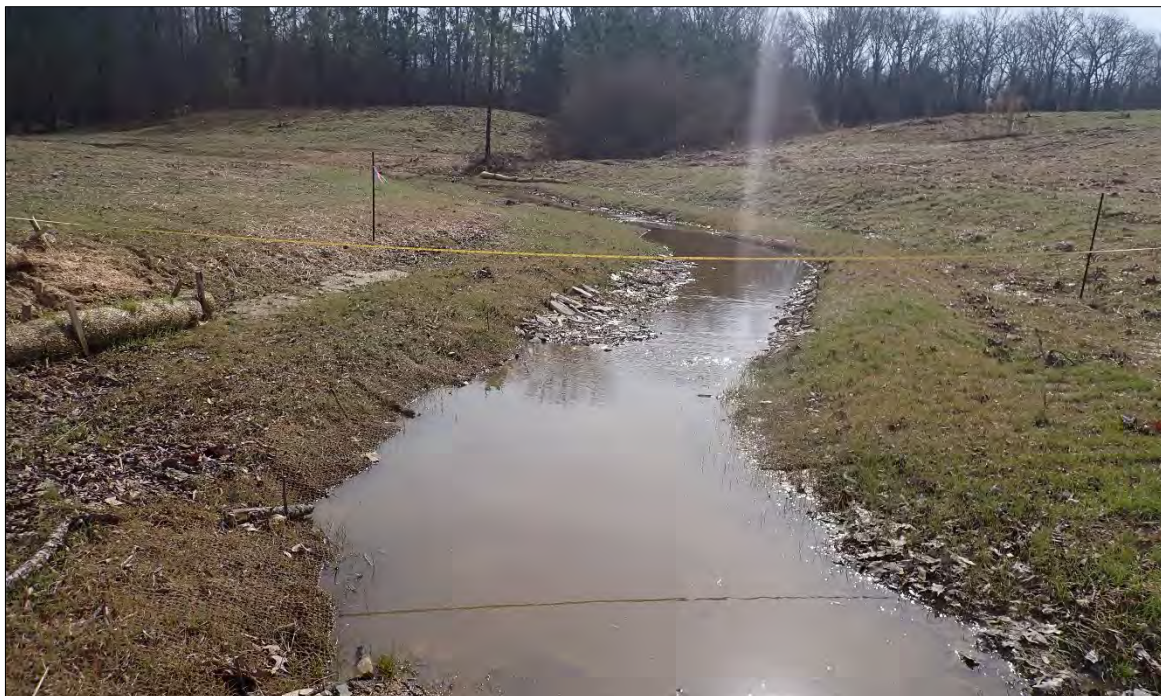
Cross sections 7 and 8, UT 1 - 02/08/2022

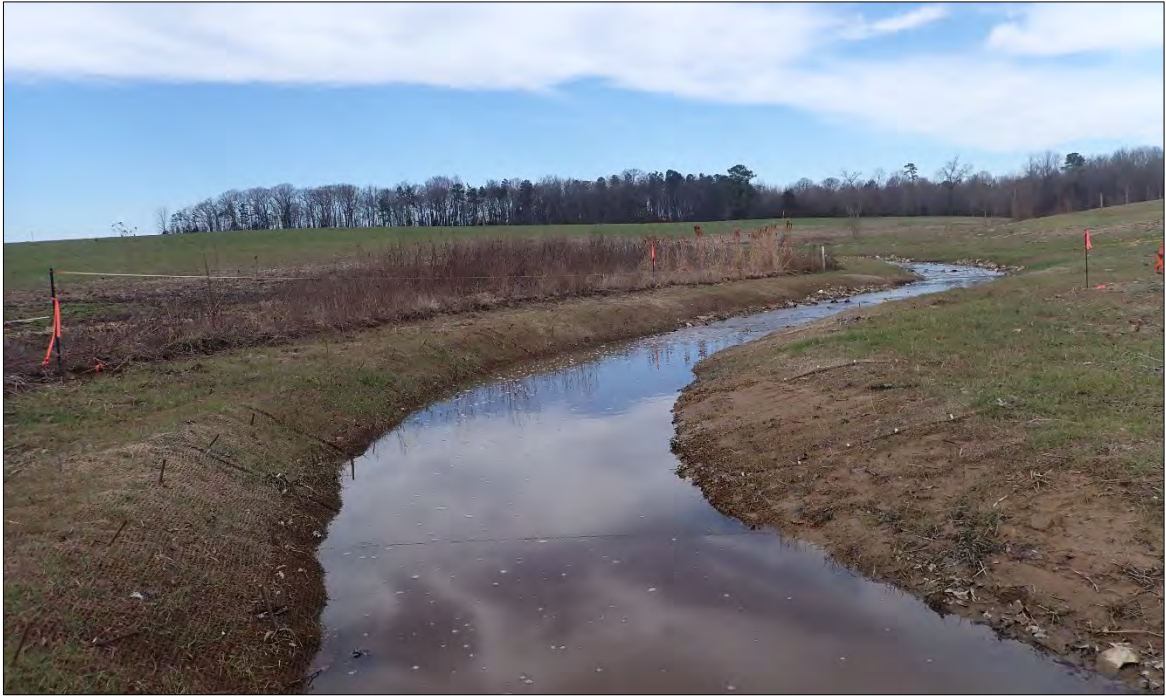
Cross sections 9, Glen Branch - 02/08/2022

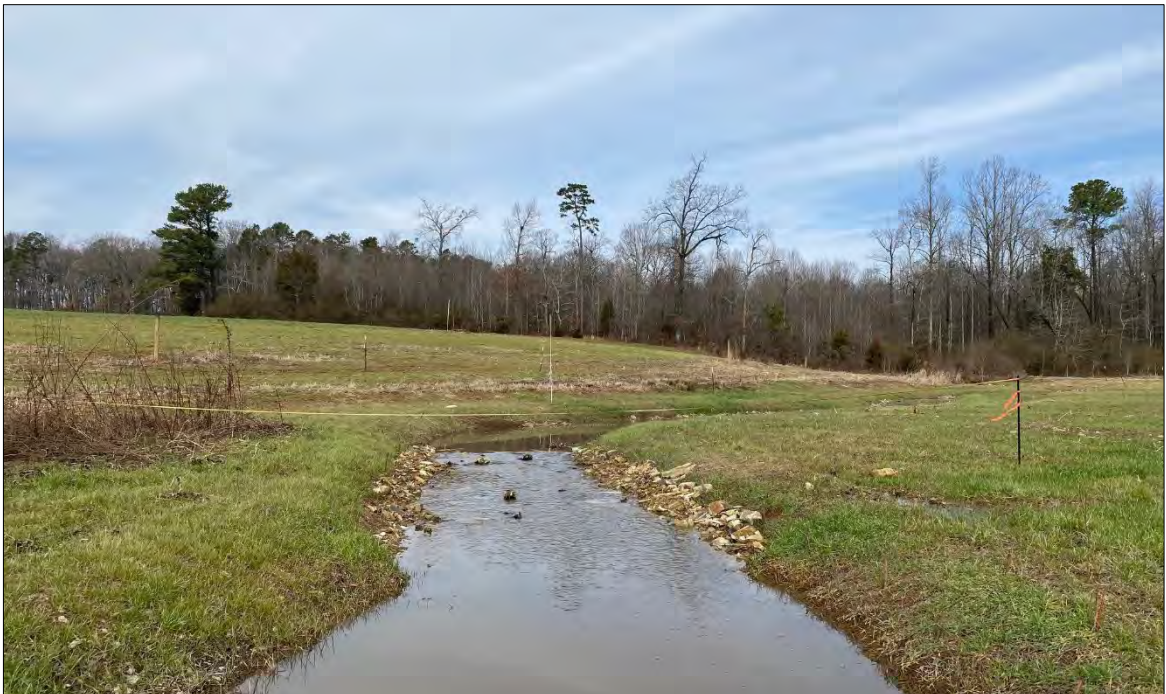
Cross sections 11, Glen Branch - 02/08/2022

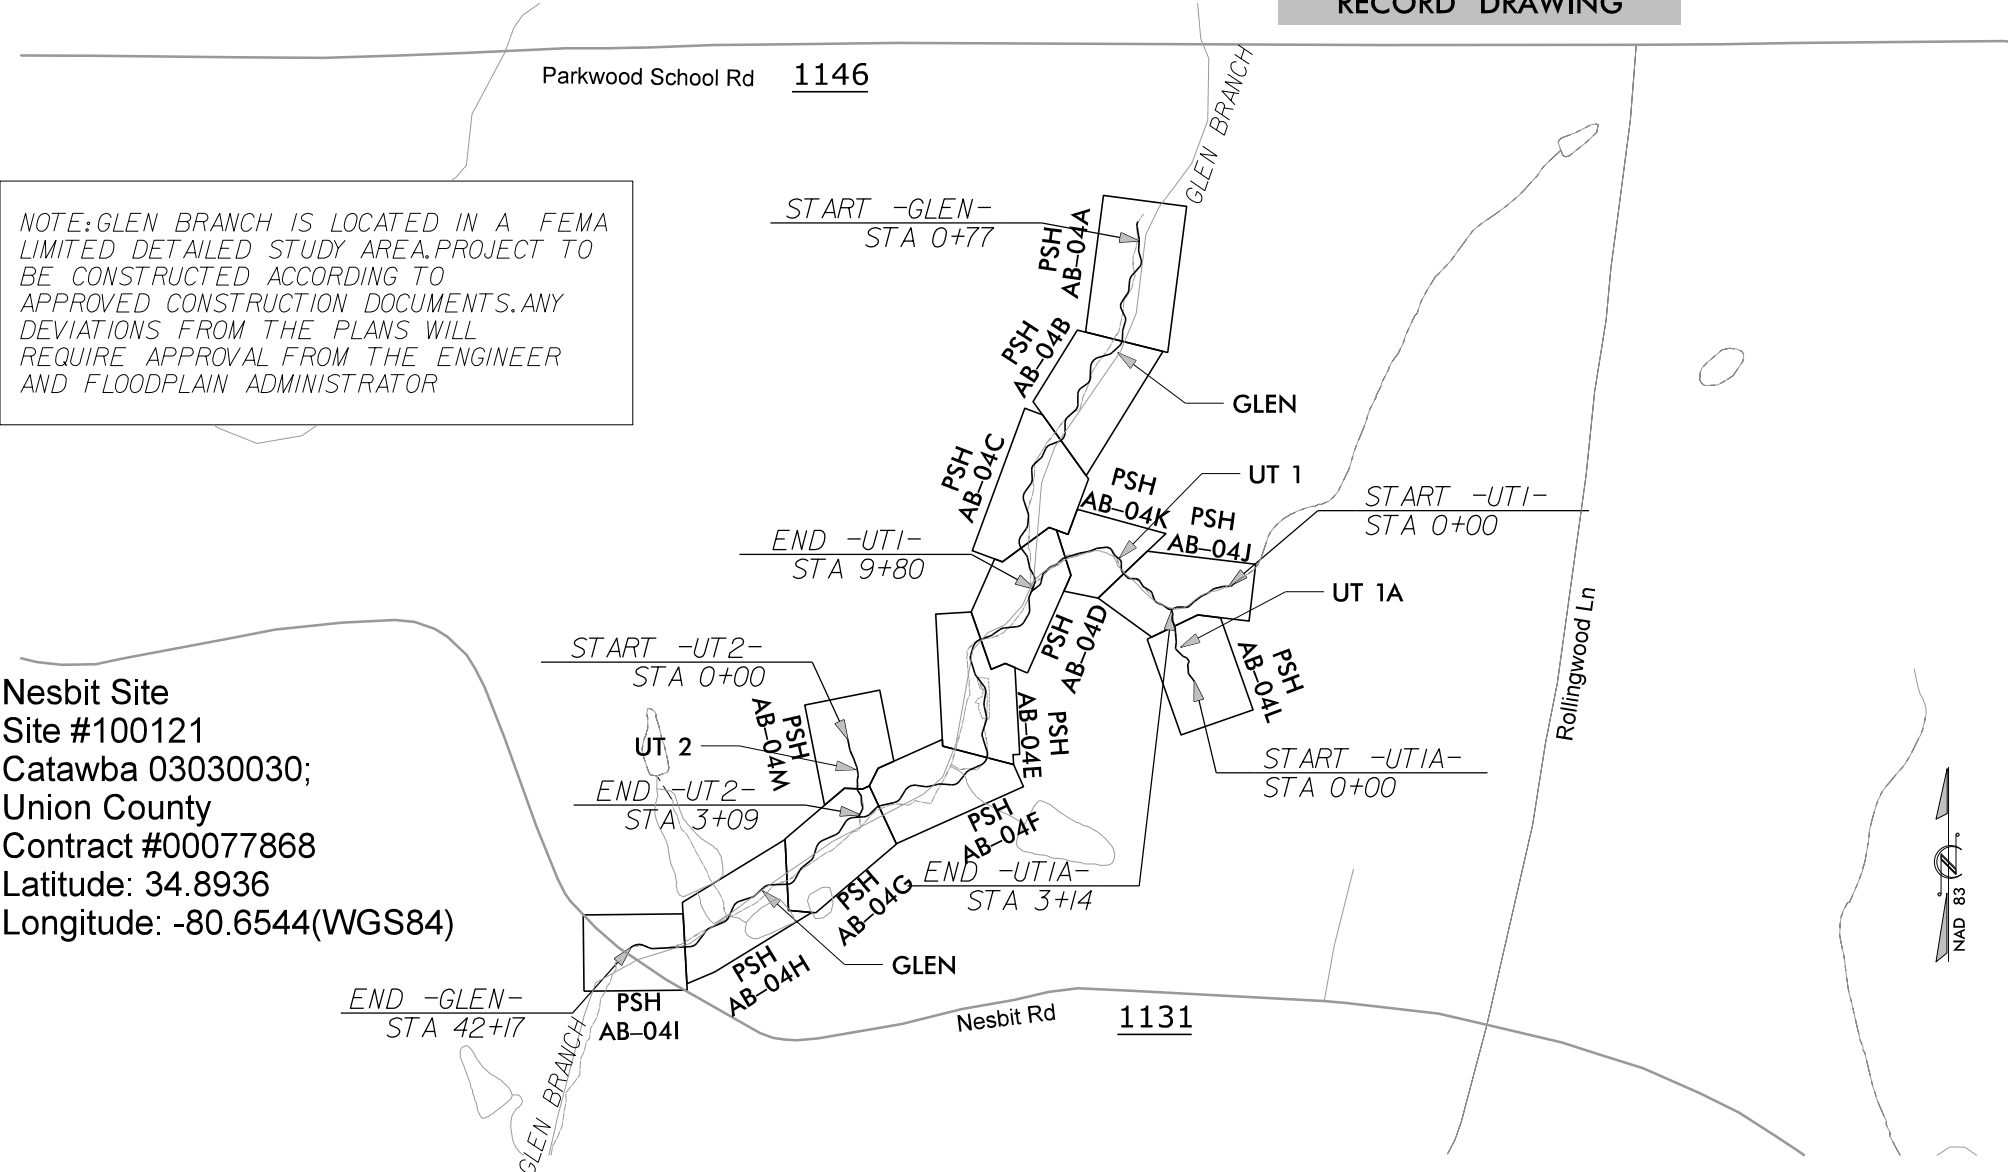
## RECORD DRAWING

**TYPE OF WORK: STREAM RESTORATION AND ENHANCEMENT (CLEARING, GRUBBING, GRADING, EROSION CONTROL AND PLANTING)**

NOTE: GLEN BRANCH IS LOCATED IN A FEMA LIMITED DETAILED STUDY AREA. PROJECT TO BE CONSTRUCTED ACCORDING TO APPROVED CONSTRUCTION DOCUMENTS. ANY DEVIATIONS FROM THE PLANS WILL REQUIRE APPROVAL FROM THE ENGINEER AND FLOODPLAIN ADMINISTRATOR

PROPOSED LENGTH OF -GLEN- = 4140	PROPOSED LENGTH OF -UT 1A- = 314		
PROPOSED LENGTH OF -UT 1- = 980	PROPOSED LENGTH OF -UT 2- = 309		
<b>TOTAL STREAM LENGTHS (LF) = 5743</b>			
RESTORATION LEVEL	STREAM (linear footage)	RIPARIAN WETLAND (acreage)	NONRIPARIAN WETLAND (acreage)
RESTORATION	4801	5.338 (Reestablishment)	0.000
ENHANCEMENT I	316	1.789 (Rehabilitation)	0.000
ENHANCEMENT II	541	0.000	0.000
PRESERVATION	0	0.000	0.000
TOTALS	5658	7.127	0.000
MITIGATION UNITS	5199.756 SMUs	6.531 RIPARIAN WMUs	NONRIPARIAN WMUs

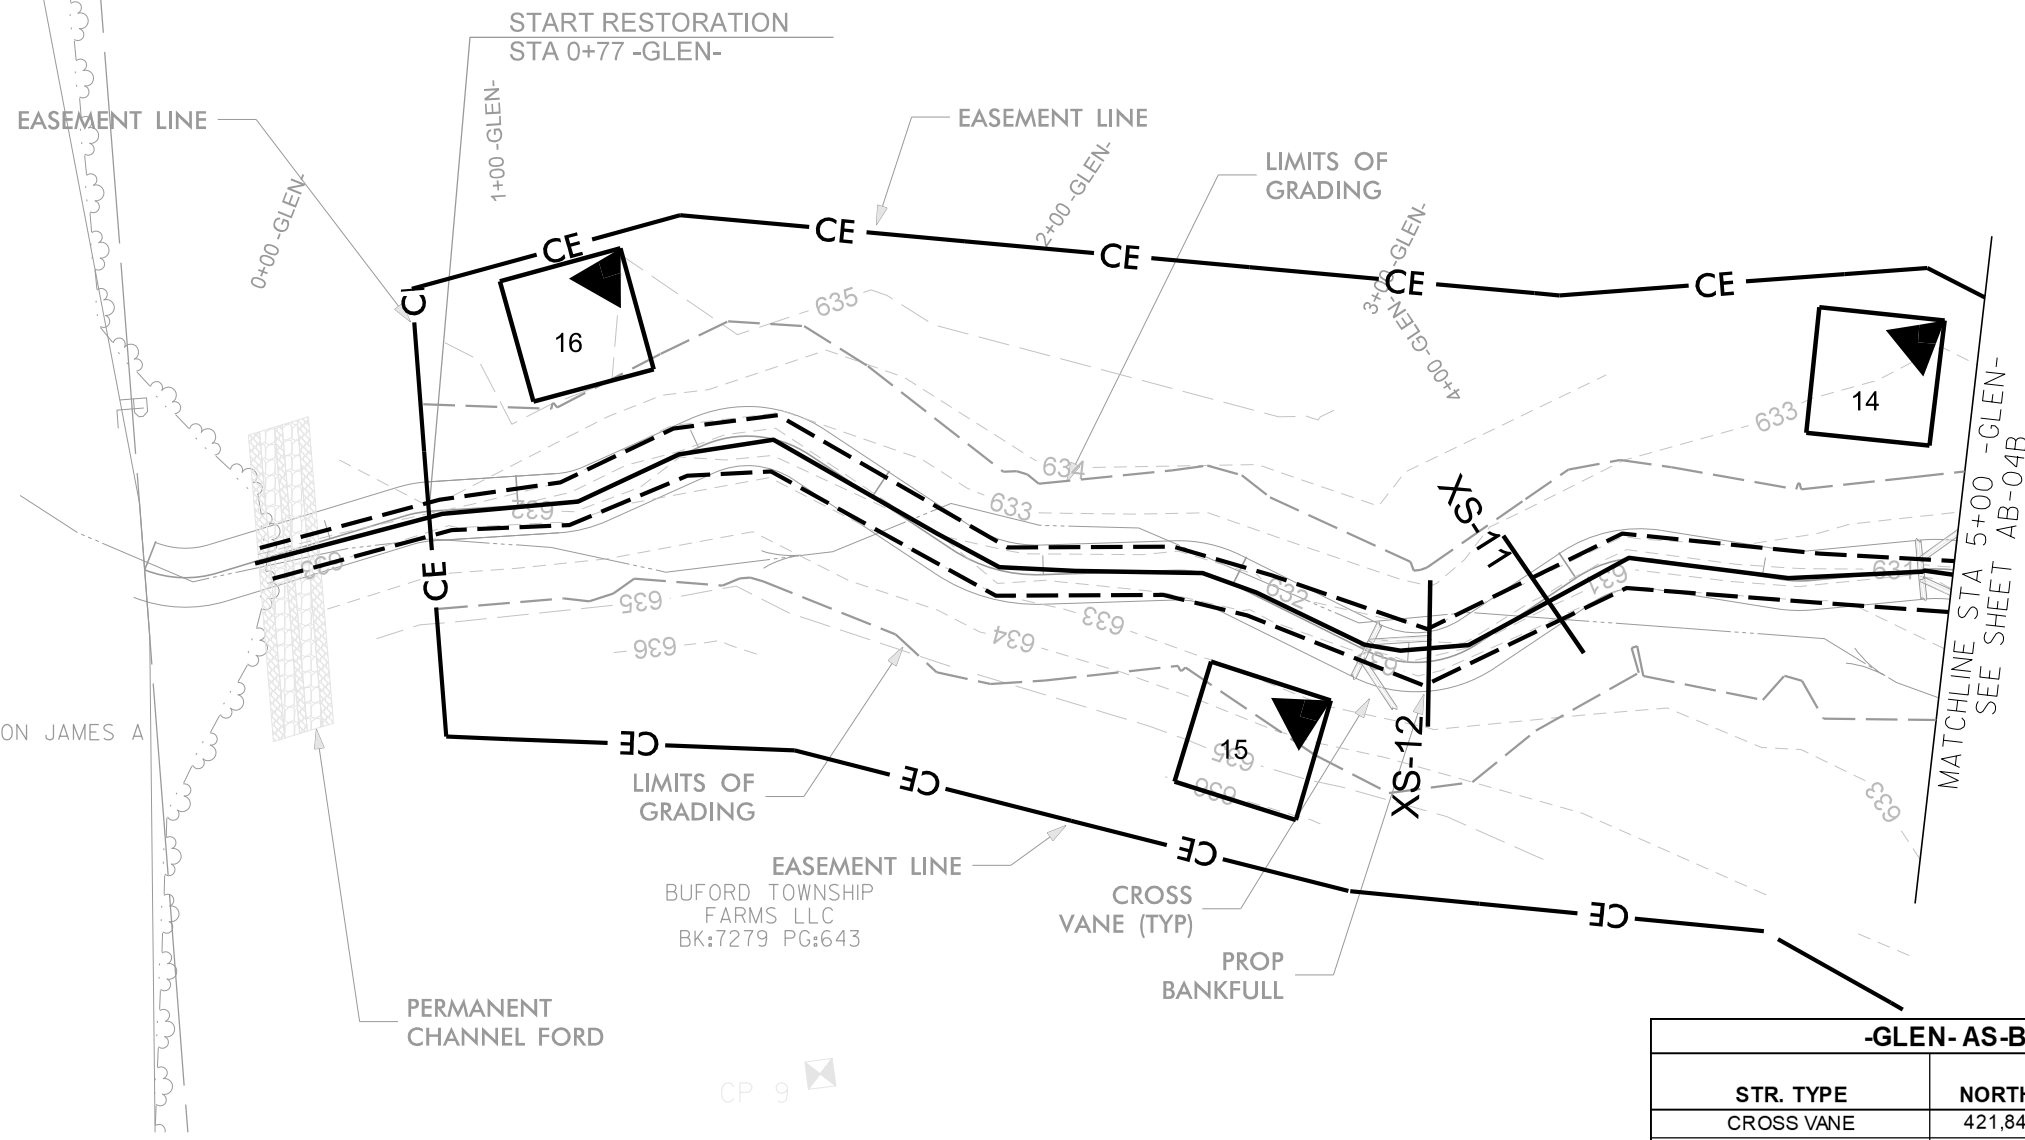
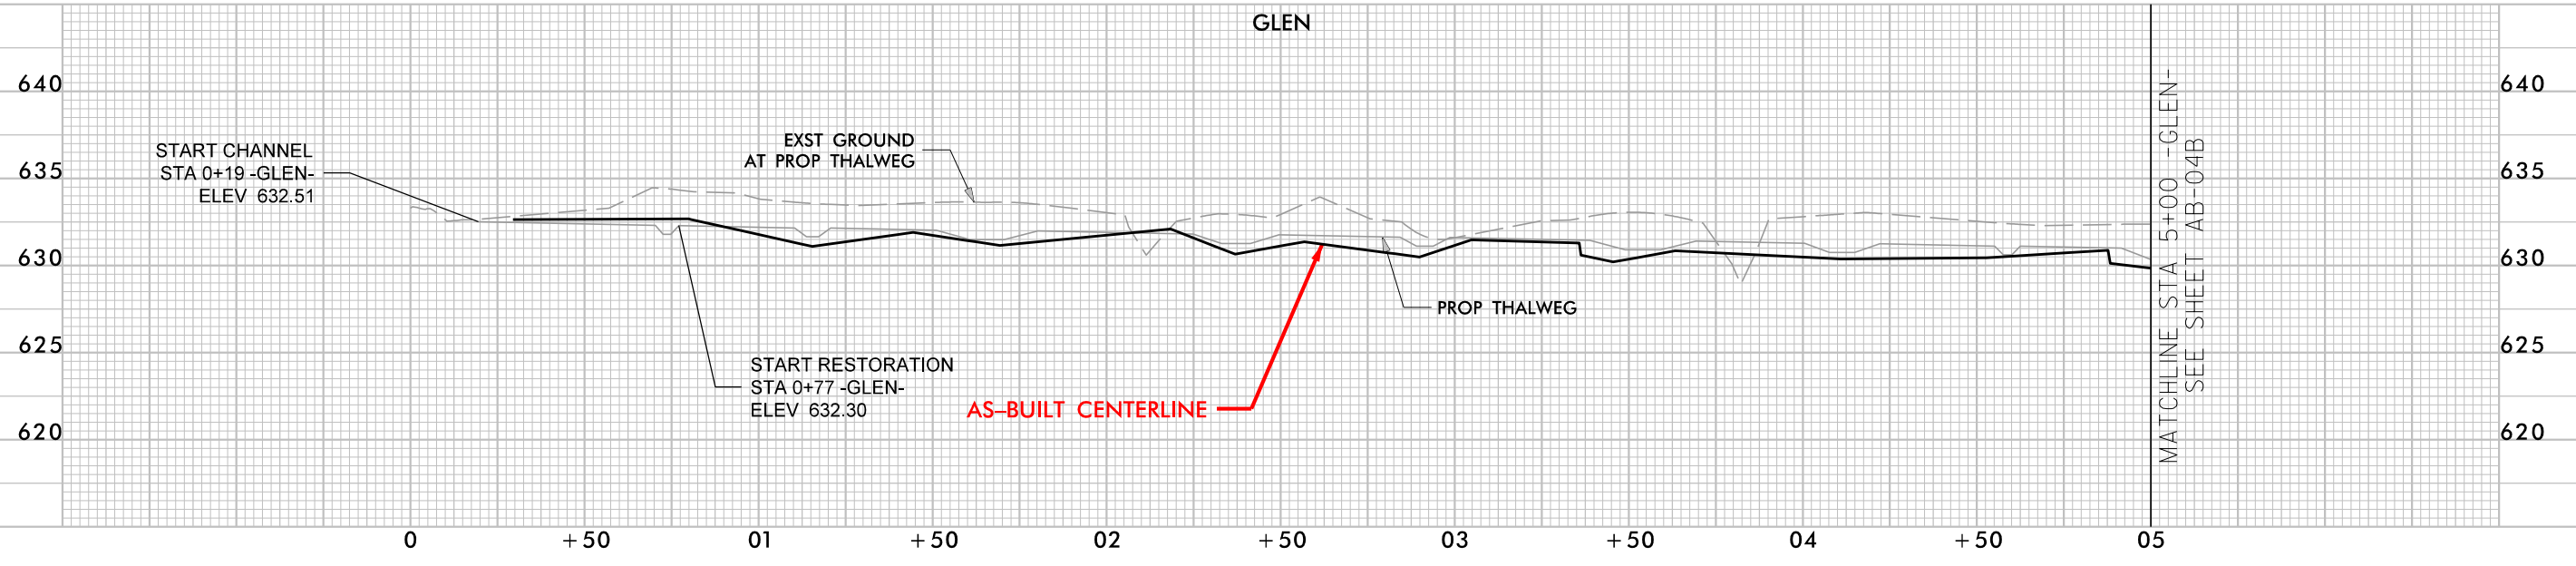
-GLEN- AS-BUILT STRUCTURE LOCATIONS				
STR. TYPE	NORTHING	EASTING	Prop Elevation	AB Survey Elevation
CROSS VANE	421,847.05	1,504,567.15	631.45	631.30
CROSS VANE	421,701.08	1,504,569.32	631.00	630.88

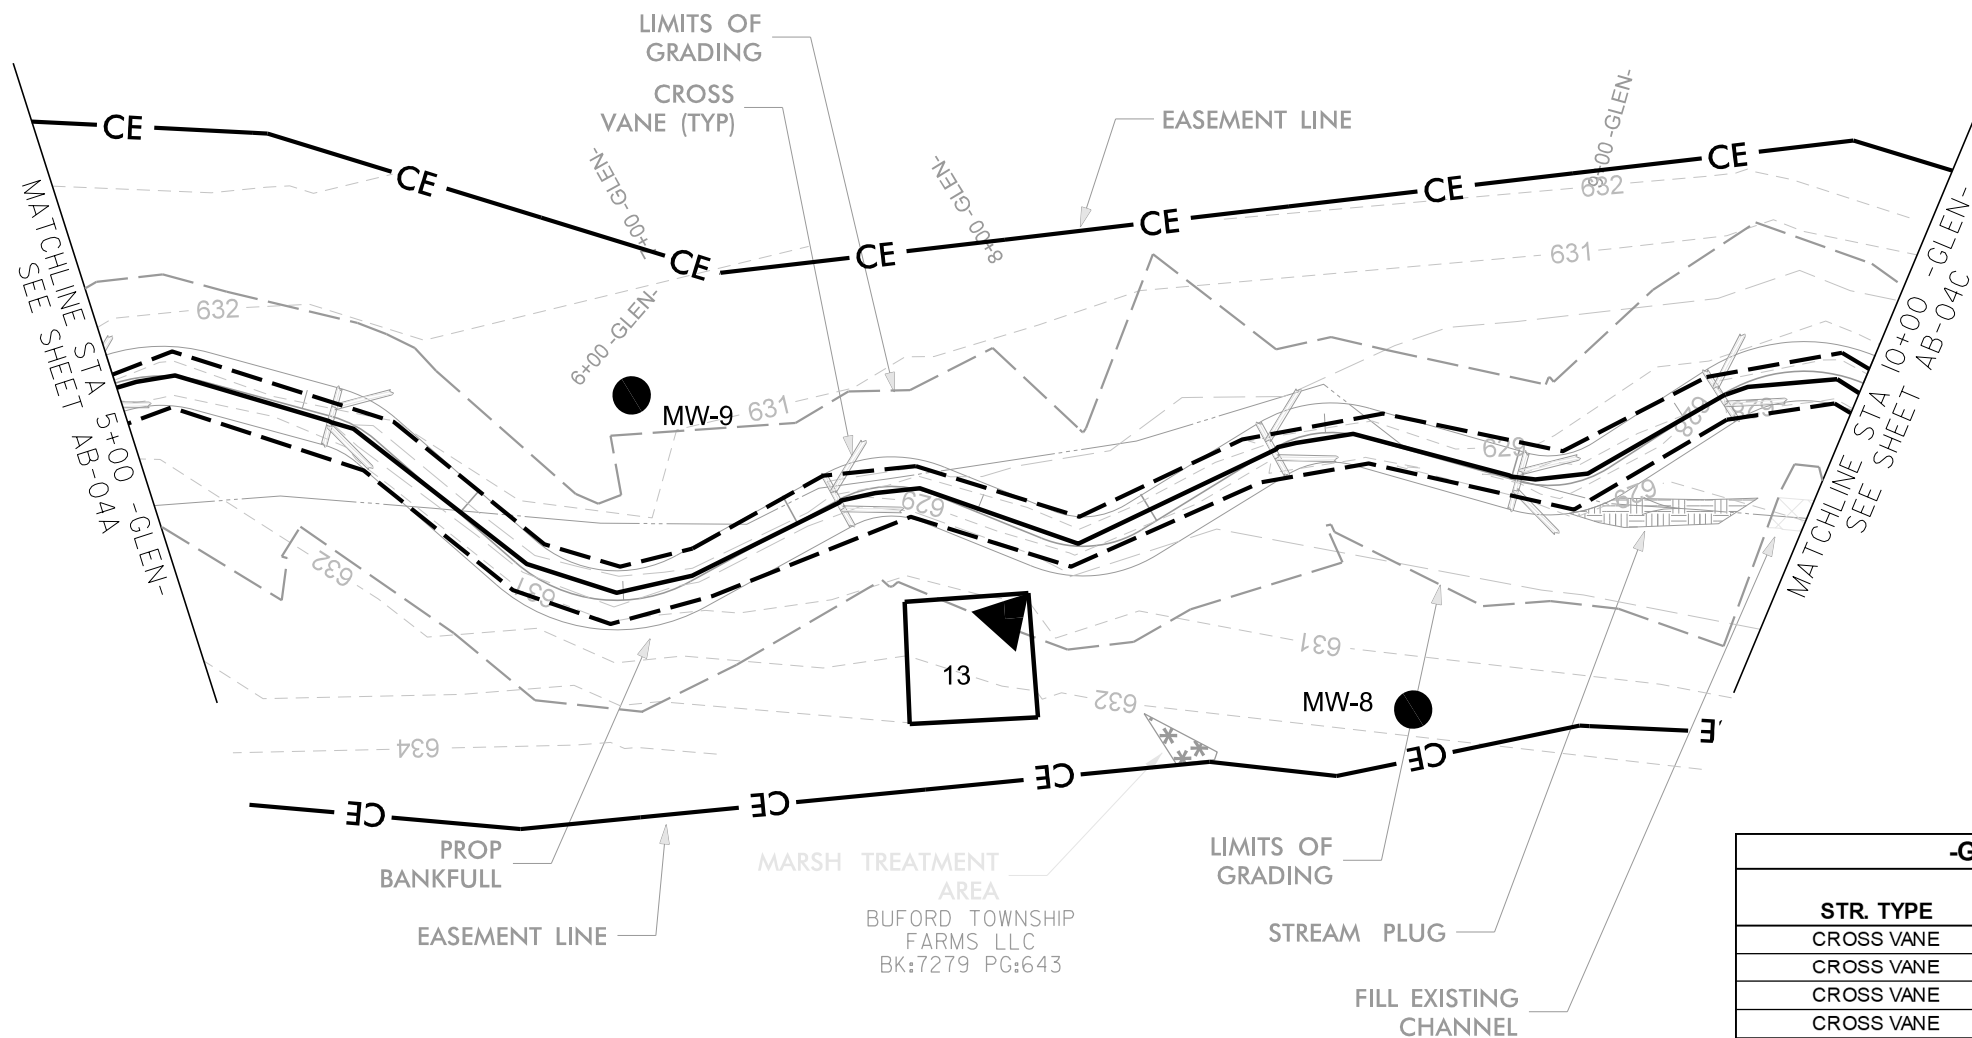
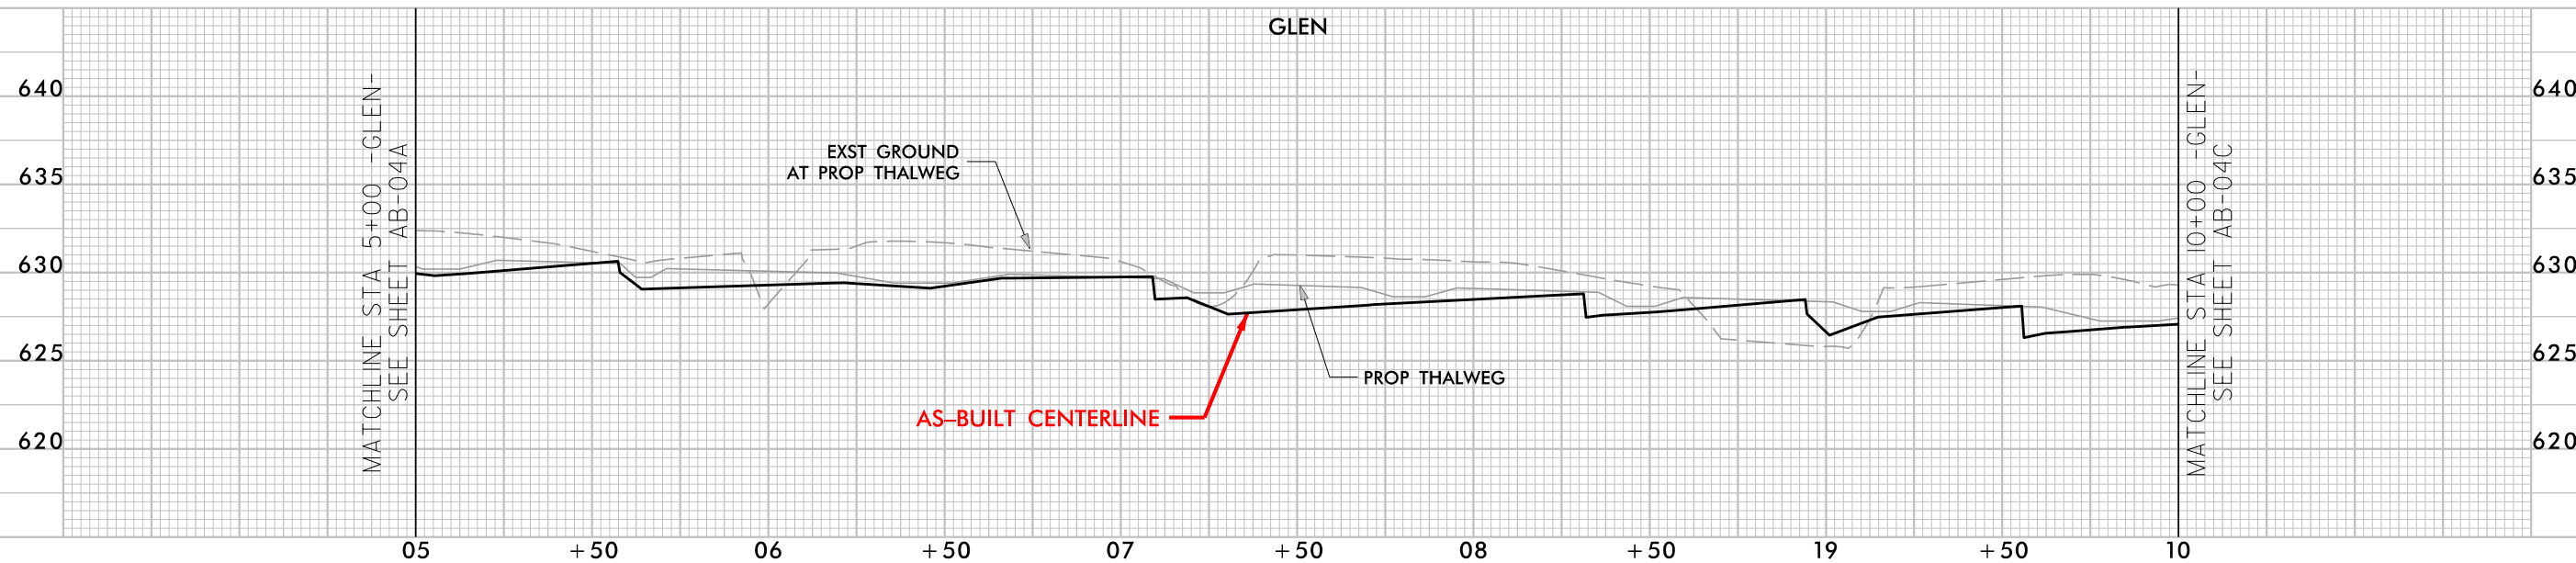
-GLEN- AS-BUILT STRUCTURE LOCATIONS				
STR. TYPE	NORTHING	EASTING	Prop Elevation	AB Survey Elevation
CROSS VANE	421,649.30	1,504,531.06	630.52	630.64
CROSS VANE	421,548.54	1,504,443.25	629.65	629.77
CROSS VANE	421,445.17	1,504,395.08	628.88	628.80
CROSS VANE	421,395.15	1,504,354.34	628.33	628.47
CROSS VANE	421,338.52	1,504,345.58	628.05	628.10

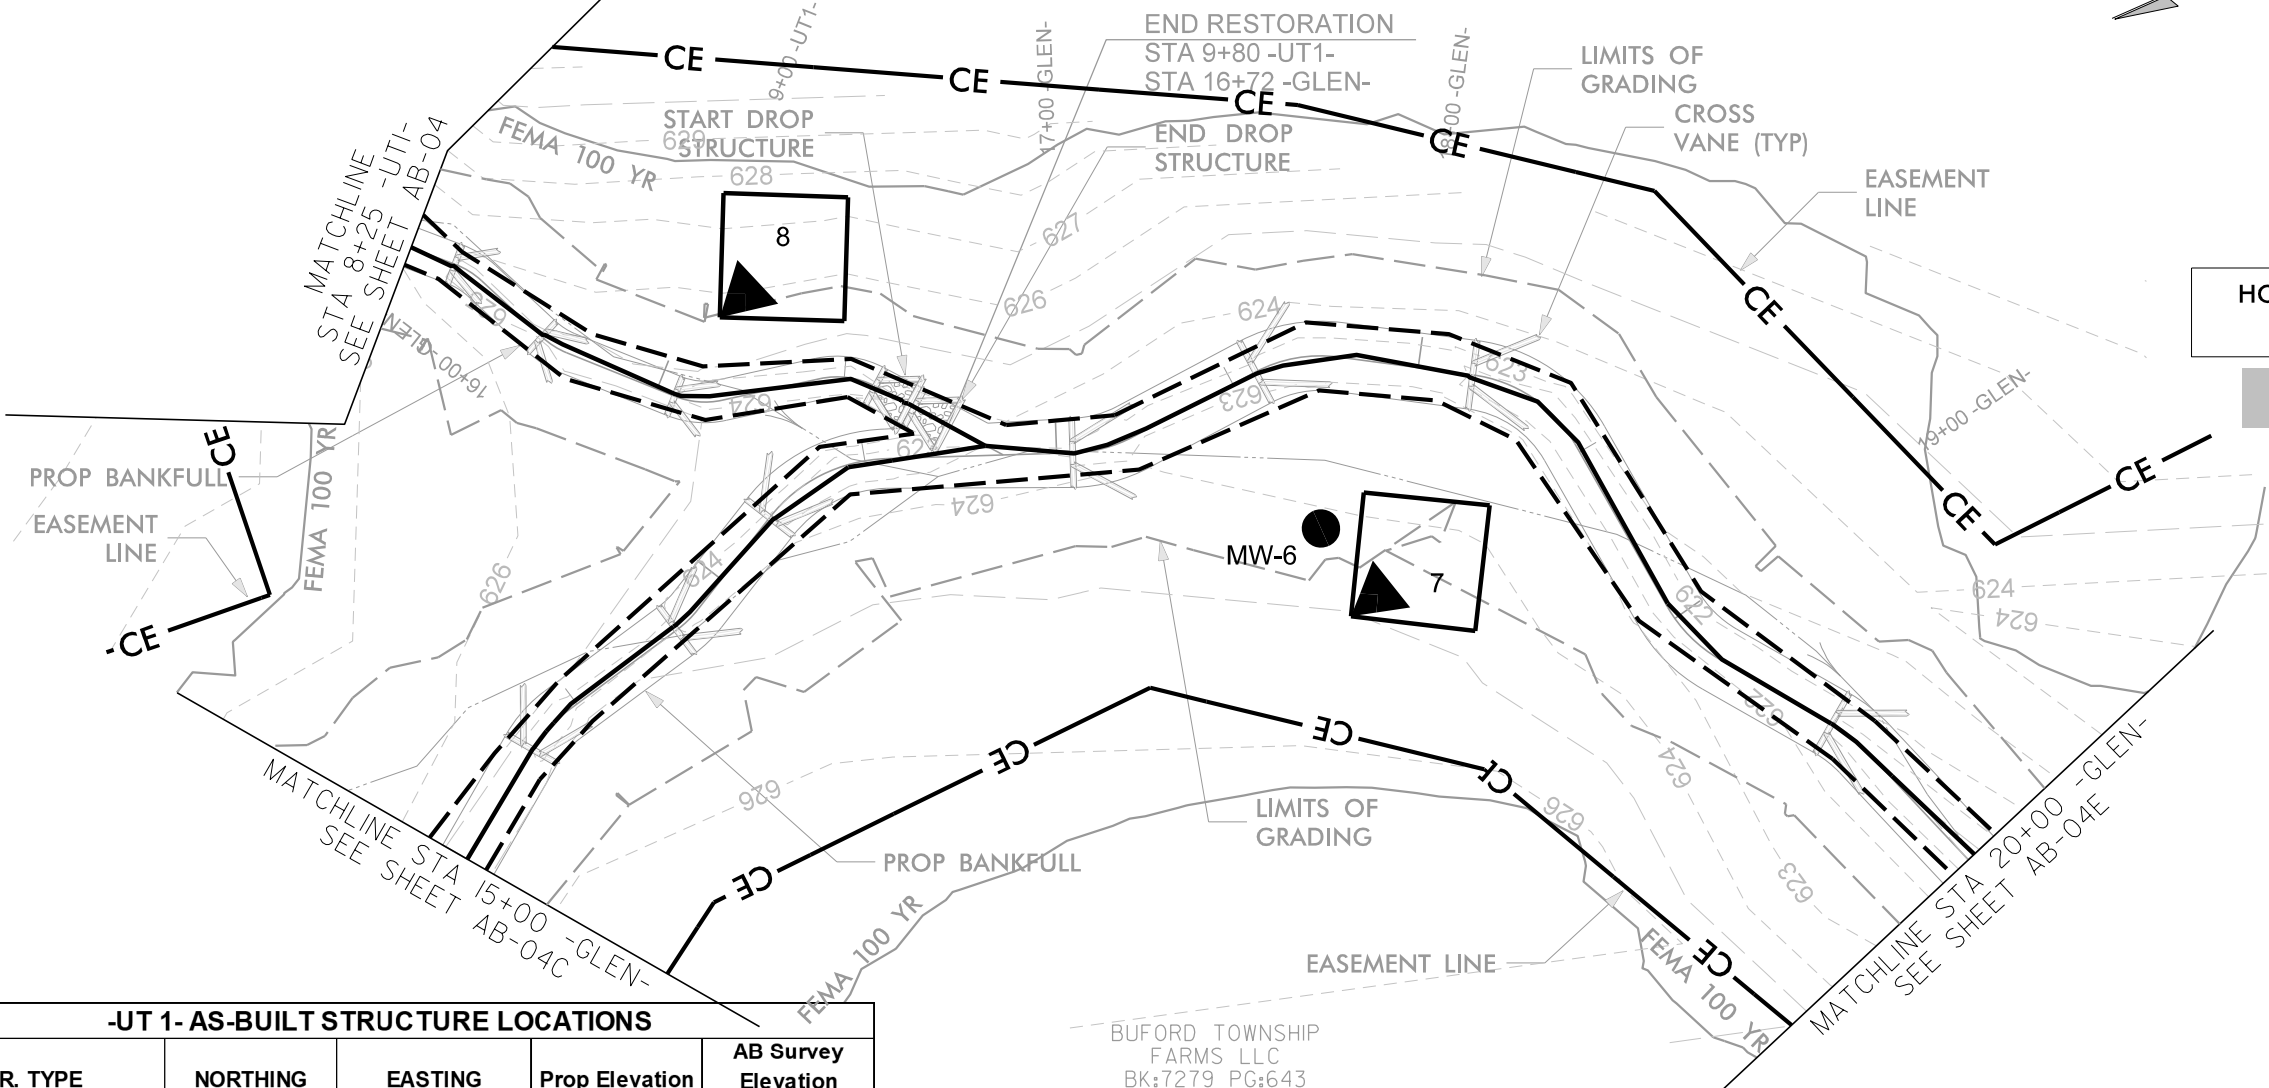
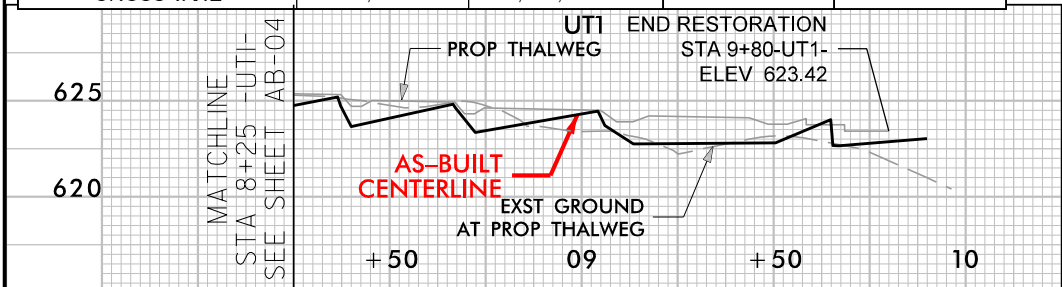
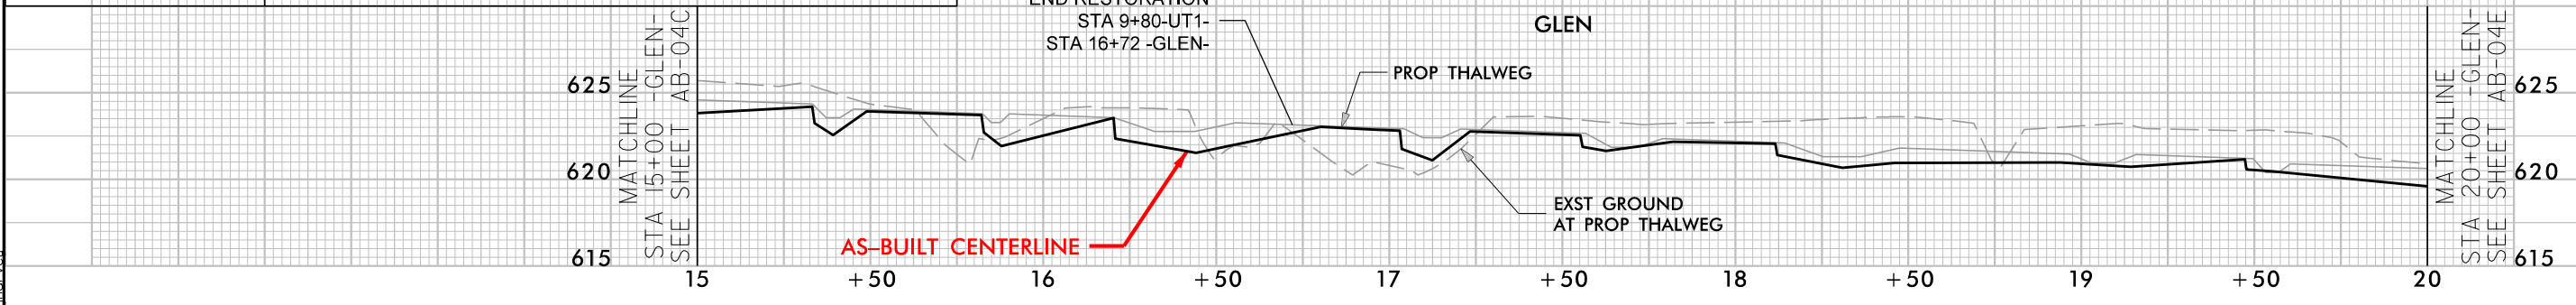
-UT 1- AS-BUILT STRUCTURE LOCATIONS				
STR. TYPE	NORTHING	EASTING	Prop Elevation	AB Survey Elevation
CROSS VANE	420,825.34	1,504,316.94	625.32	625.20
CROSS VANE	420,812.27	1,504,290.44	624.93	624.83
CROSS VANE	420,786.94	1,504,262.35	624.51	624.46

-GLEN- AS-BUILT STRUCTURE LOCATIONS				
STR. TYPE	NORTHING	EASTING	Prop Elevation	AB Survey Elevation
CROSS VANE	420,858.18	1,504,193.38	624.35	614.19
CROSS VANE	420,811.13	1,504,206.43	623.79	623.71
CROSS VANE	420,777.11	1,504,223.41	623.56	623.54
CROSS VANE	420,698.11	1,504,206.85	622.92	622.80
CROSS VANE	420,646.00	1,504,206.84	622.65	622.54
CROSS VANE	420,594.61	1,504,183.26	622.10	622.06
CROSS VANE	420,545.73	1,504,062.30	621.19	621.15
