# **MYO FINAL MONITORING REPORT**

## **NESBIT SITE**

Union County, North Carolina  
Catawba River Basin  
Cataloging Unit 03050103

DMS Project No. 100121  
Full Delivery Contract No. 7868  
DMS RFP No. 16-007704 (issued 9/6/2018)  
USACE Action ID No. SAW-2019-00832  
DWR Project No. 2019-0862

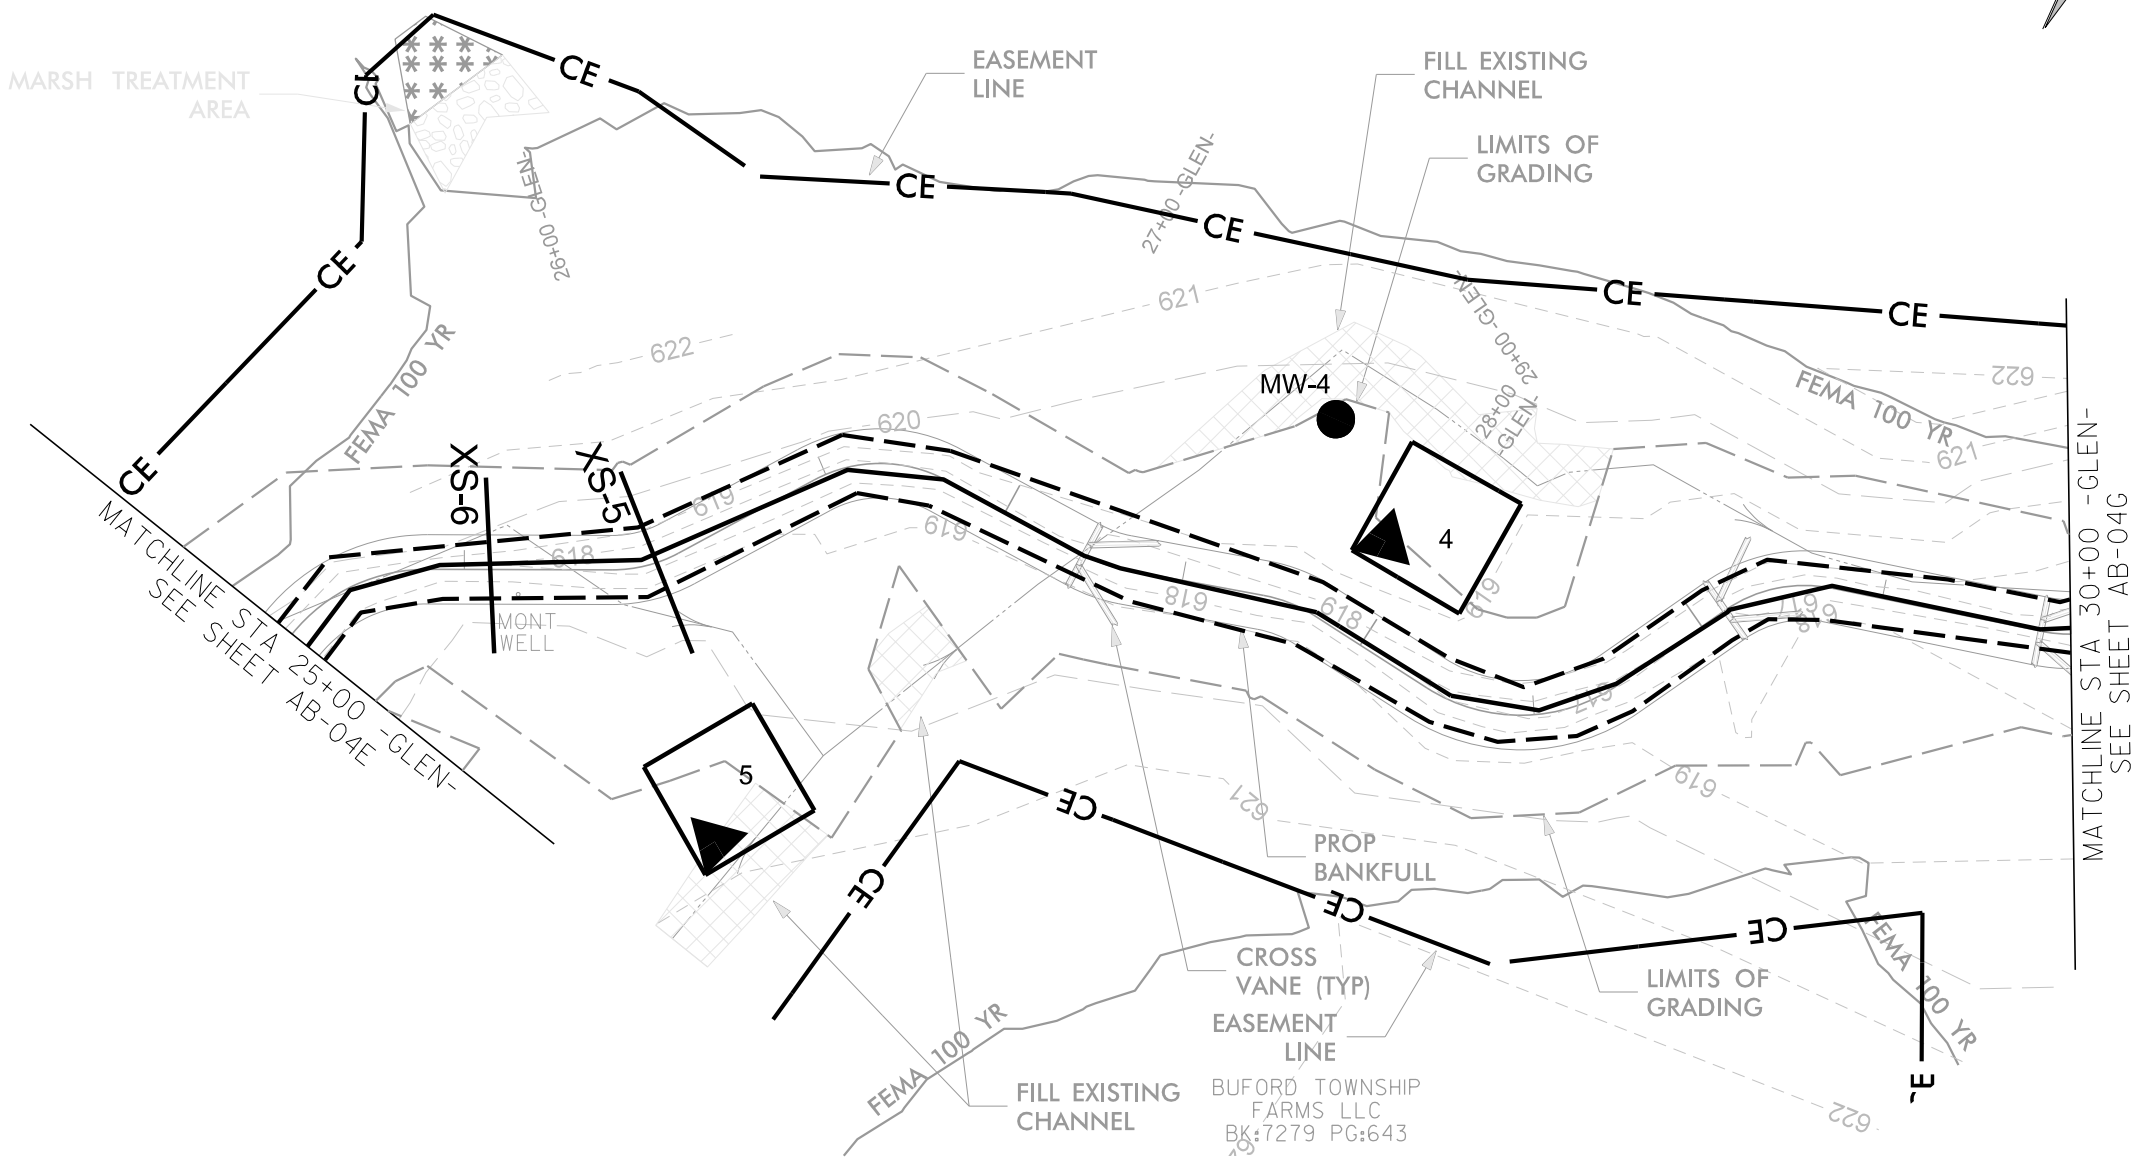
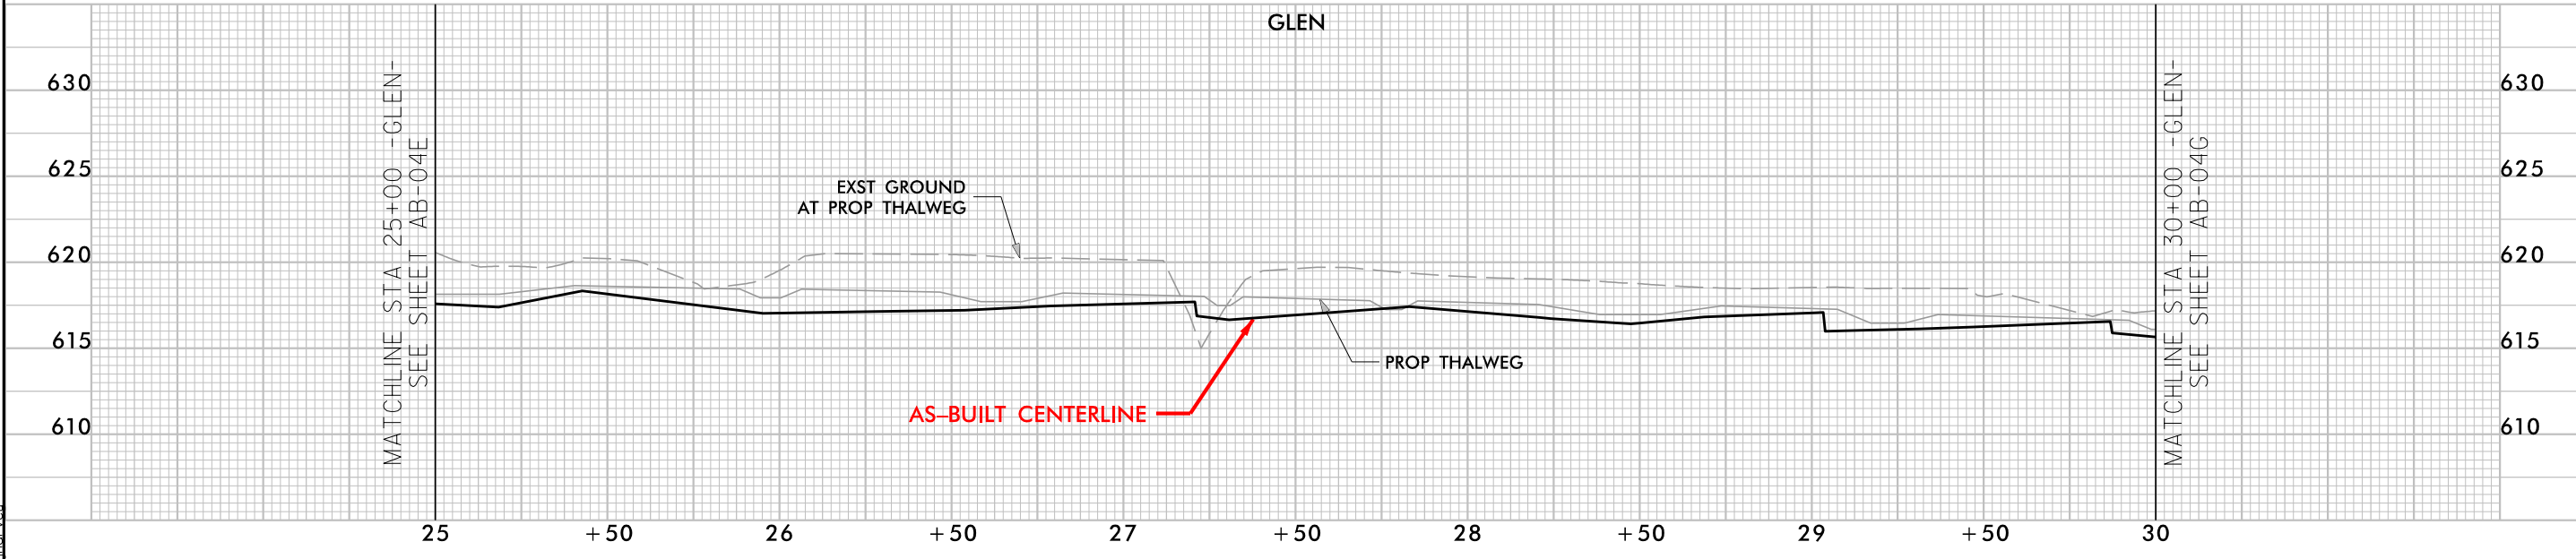
PROJECT # :
DRAWING NAME:
DATE: 2022
DRAWN BY: JRH
REVIEWED BY: JGD
REVISIONS:
SHEET NO. <b>AB-04F</b>

-GLEN- AS-BUILT STRUCTURE LOCATIONS				
STR. TYPE	NORTHING	EASTING	Prop Elevation	AB Survey Elevation
CROSS VANE	419,844.28	1,503,581.33	616.38	616.26
CROSS VANE	419,743.25	1,503,399.45	615.16	614.96
CROSS VANE	419,636.42	1,503,318.18	614.35	614.14

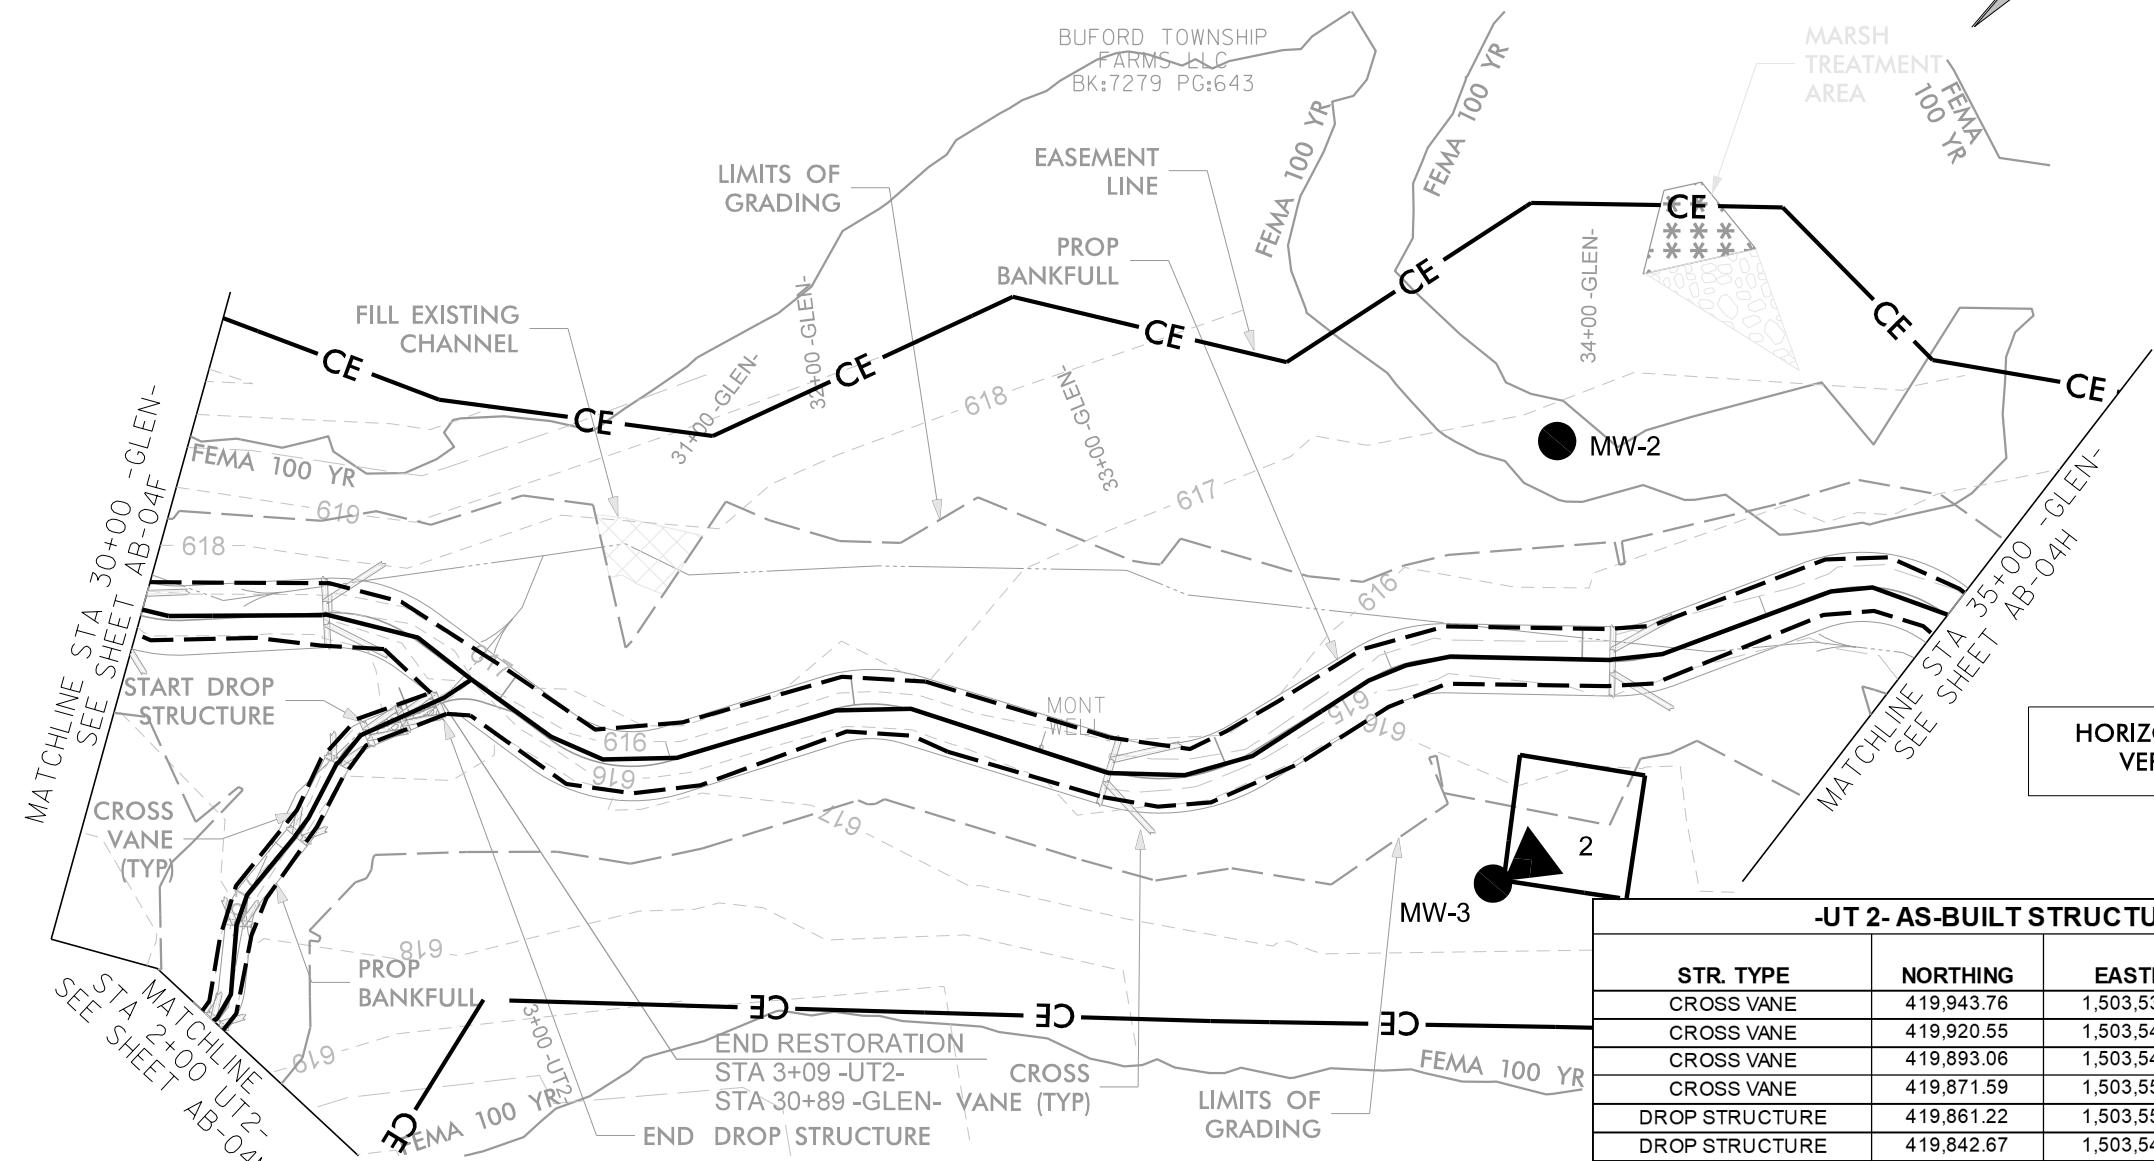
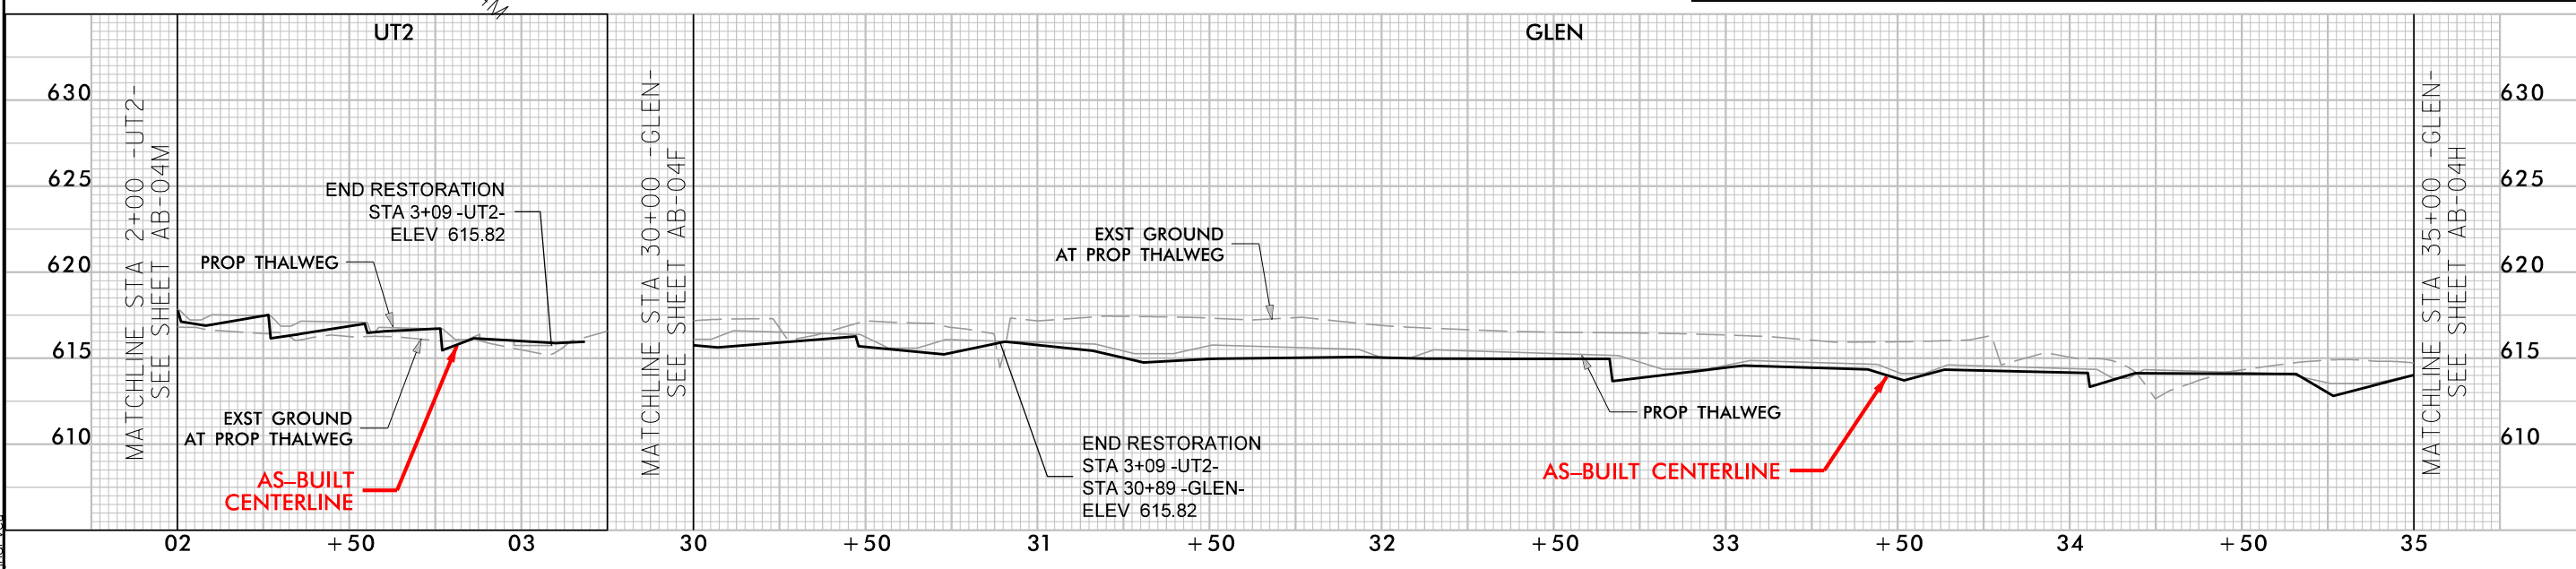
-UT 2- AS-BUILT STRUCTURE LOCATIONS				
STR. TYPE	NORTHING	EASTING	Prop Elevation	AB Survey Elevation
CROSS VANE	419,943.76	1,503,533.96	617.83	617.72
CROSS VANE	419,920.55	1,503,546.20	617.46	617.52
CROSS VANE	419,893.06	1,503,549.12	617.09	617.00
CROSS VANE	419,871.59	1,503,553.93	616.69	616.73
DROP STRUCTURE	419,861.22	1,503,552.69	616.39	
DROP STRUCTURE	419,842.67	1,503,543.17	615.82

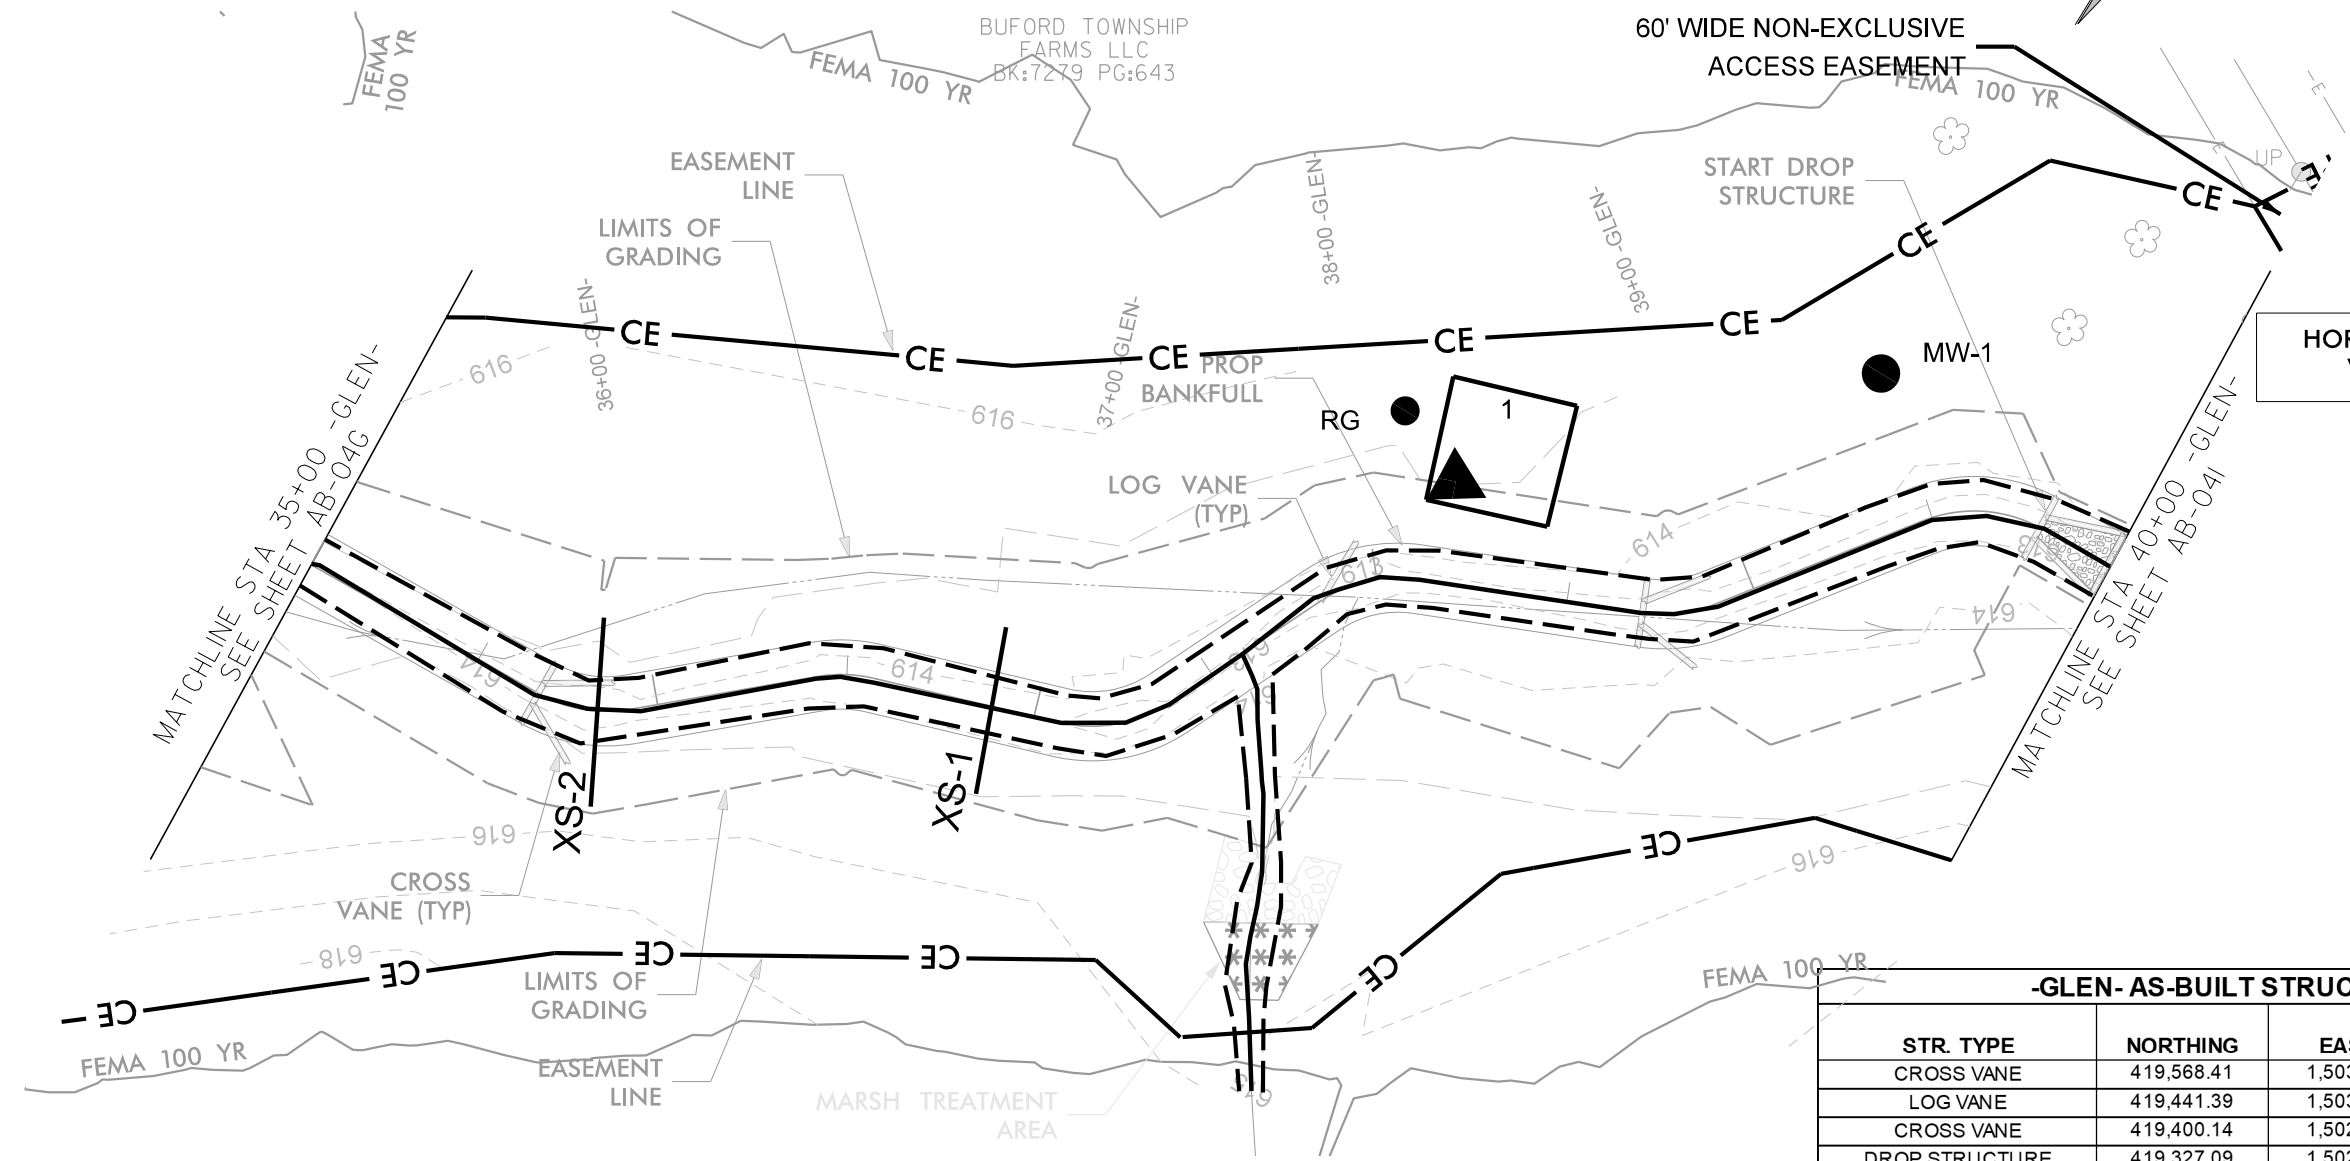
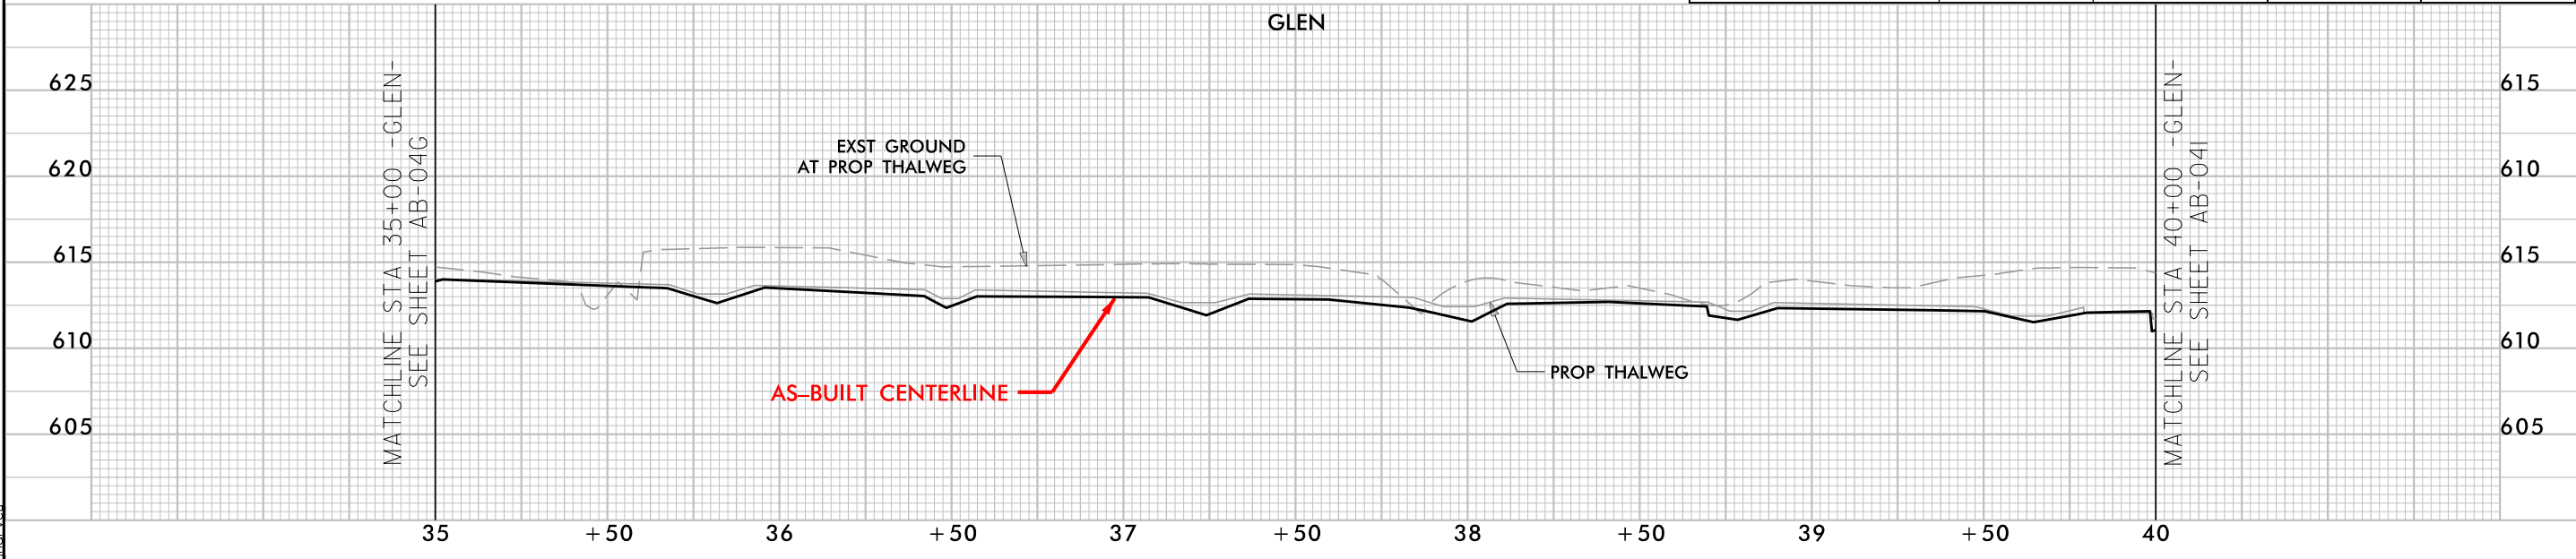
-GLEN- AS-BUILT STRUCTURE LOCATIONS				
STR. TYPE	NORTHING	EASTING	Prop Elevation	AB Survey Elevation
CROSS VANE	419,568.41	1,503,191.67	613.69	613.49
LOG VANE	419,441.39	1,503,030.54	612.96	612.36
CROSS VANE	419,400.14	1,502,957.46	612.68	612.43
DROP STRUCTURE	419,327.09	1,502,880.74	612.37	612.16

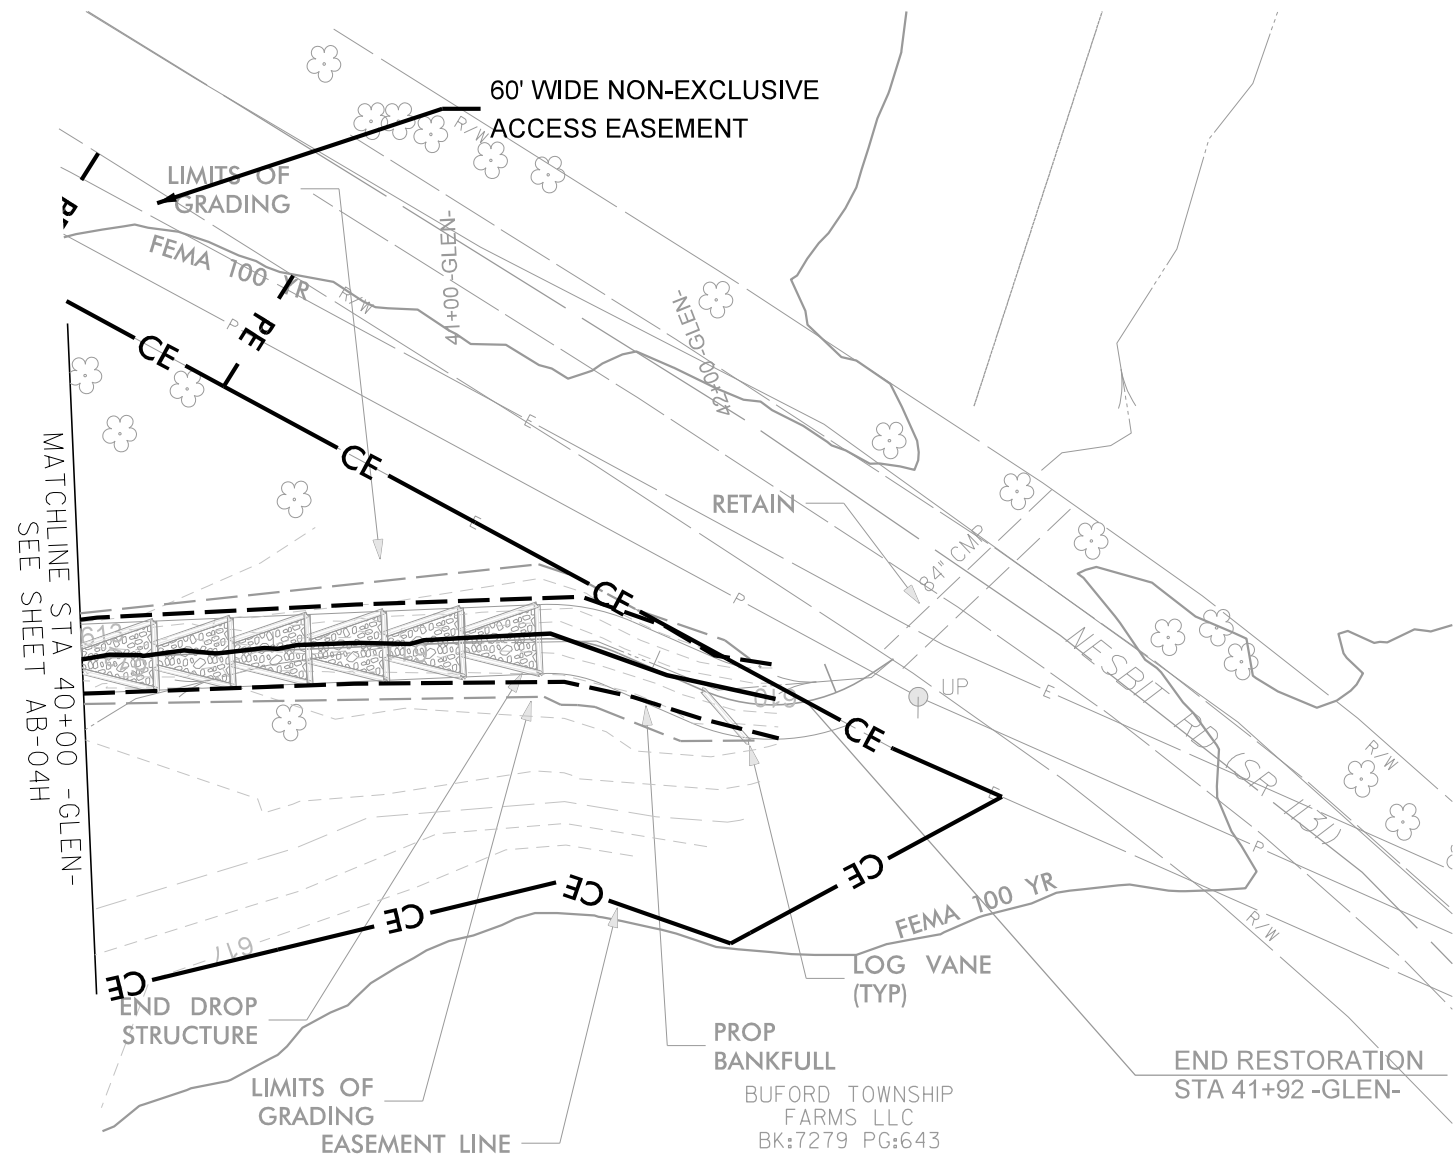
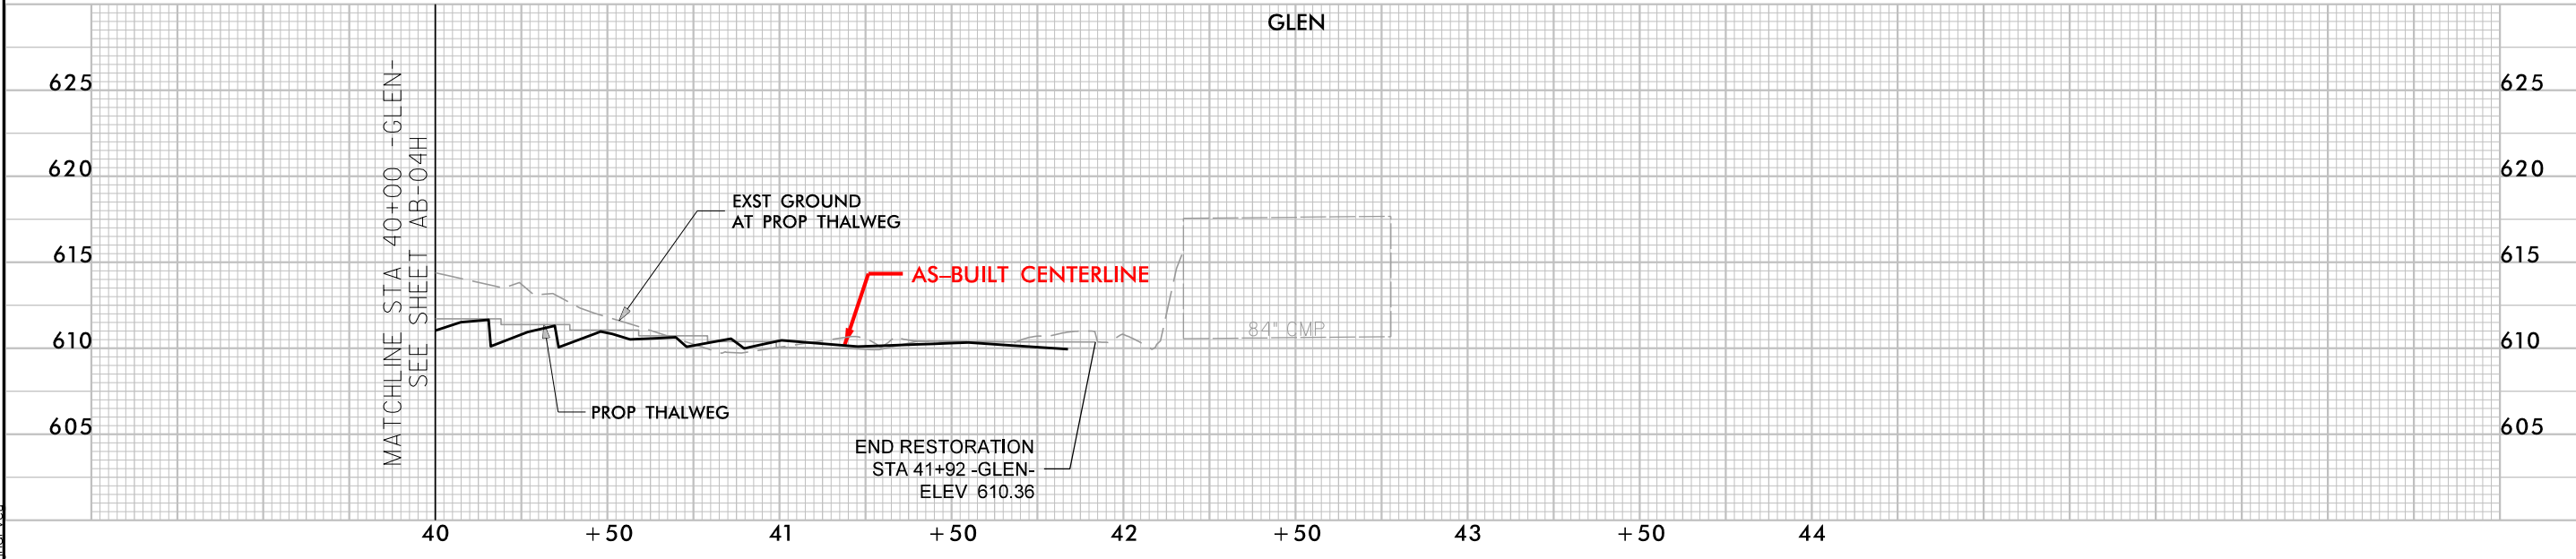
-GLEN- AS-BUILT STRUCTURE LOCATIONS				
STR. TYPE	NORTHING	EASTING	Prop Elevation	AB Survey Elevation
DROP STRUCTURE	419,319.49	1,502,740.15	609.99	610.56
LOG VANE	419,332.39	1,502,698.02	610.37

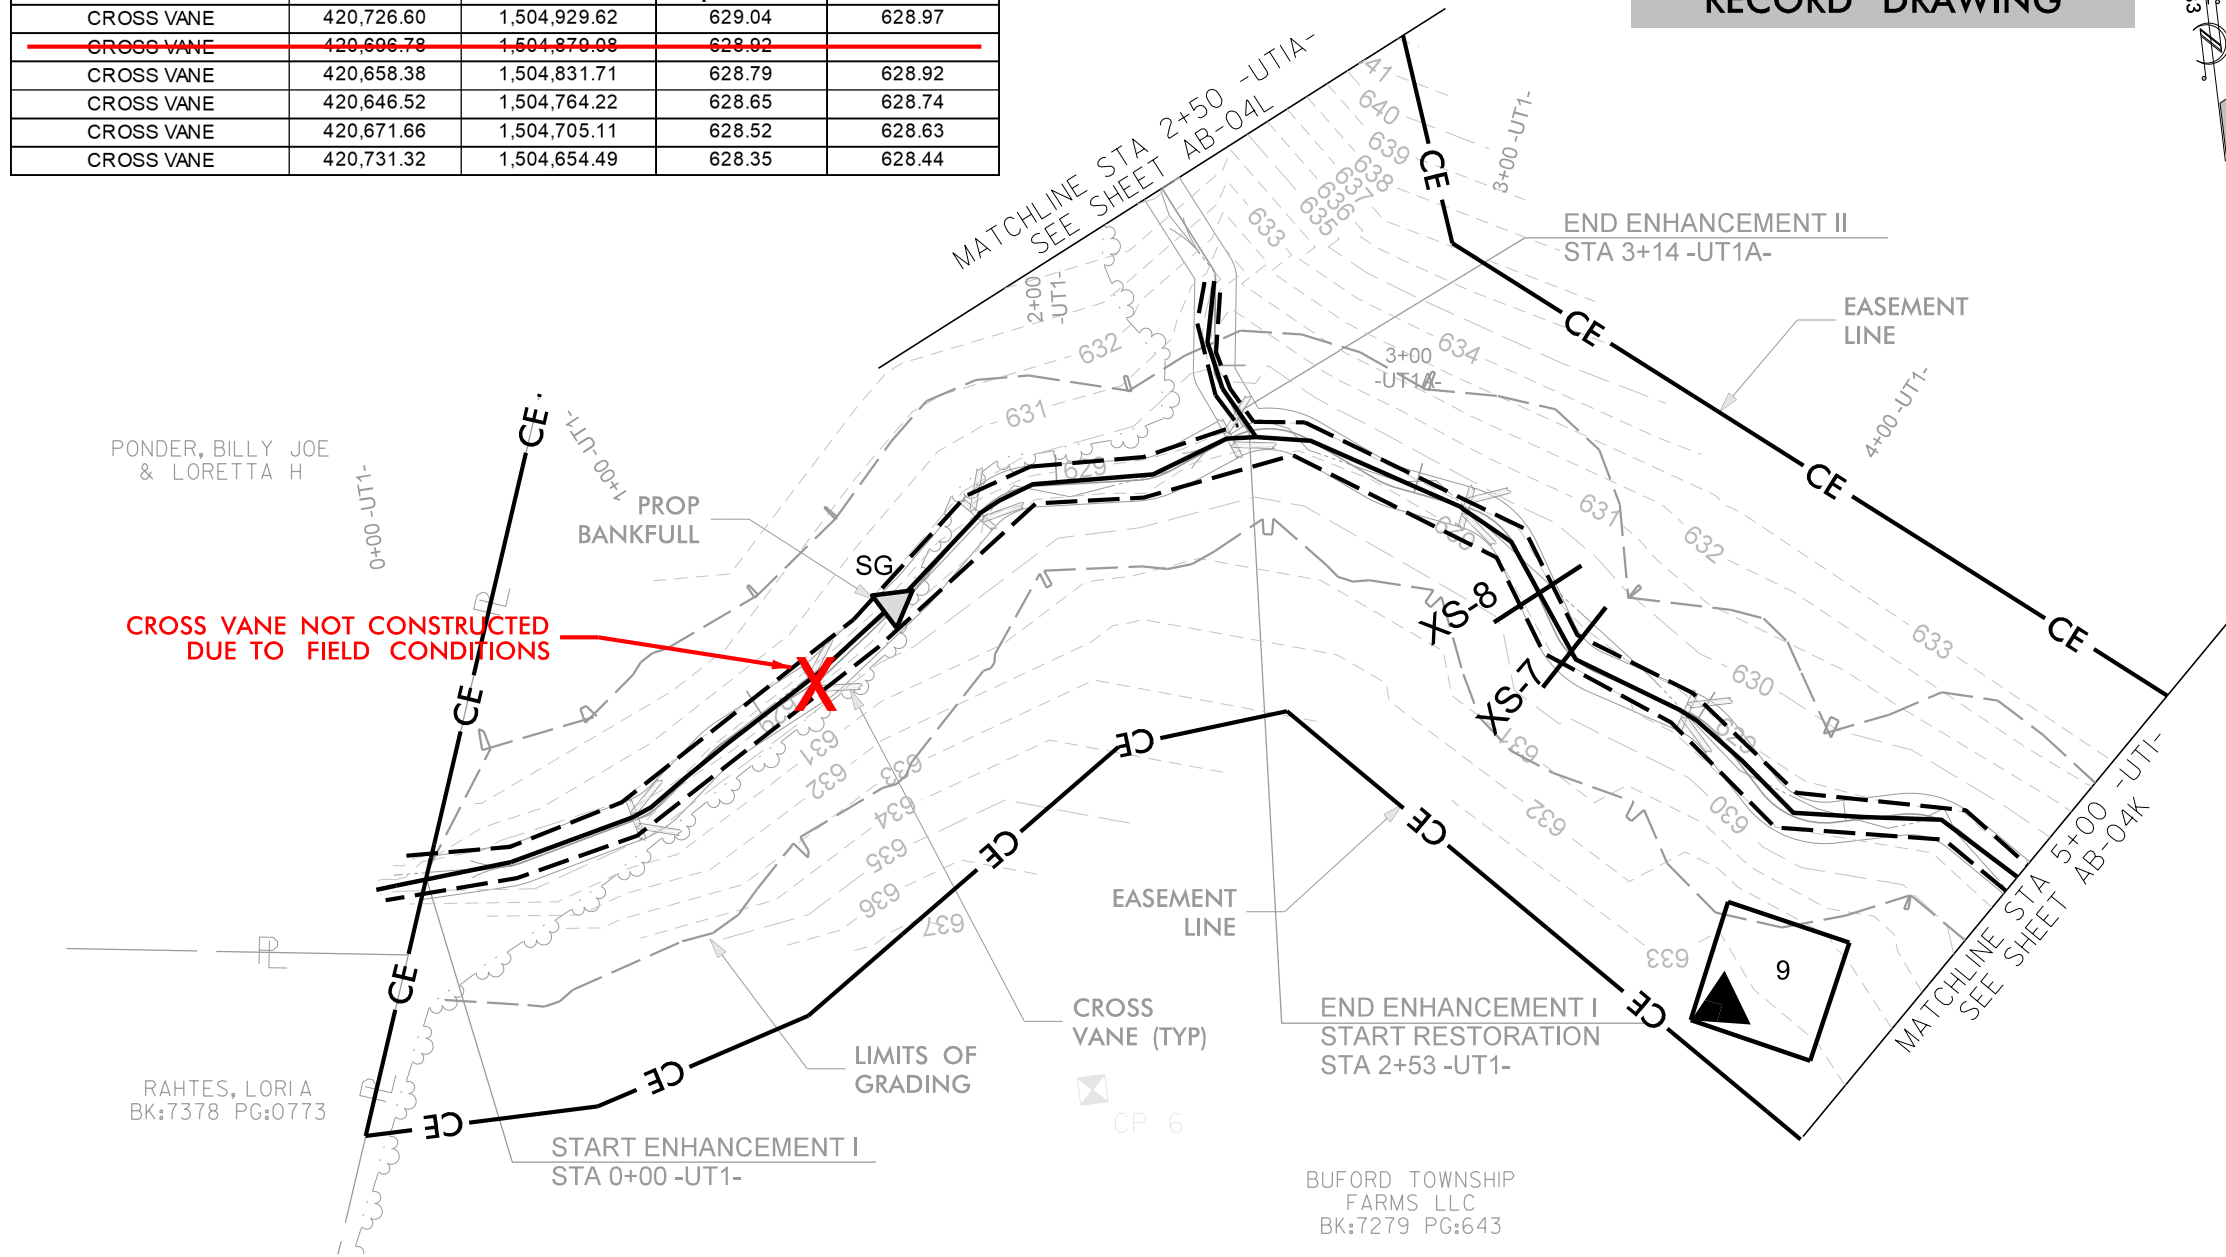
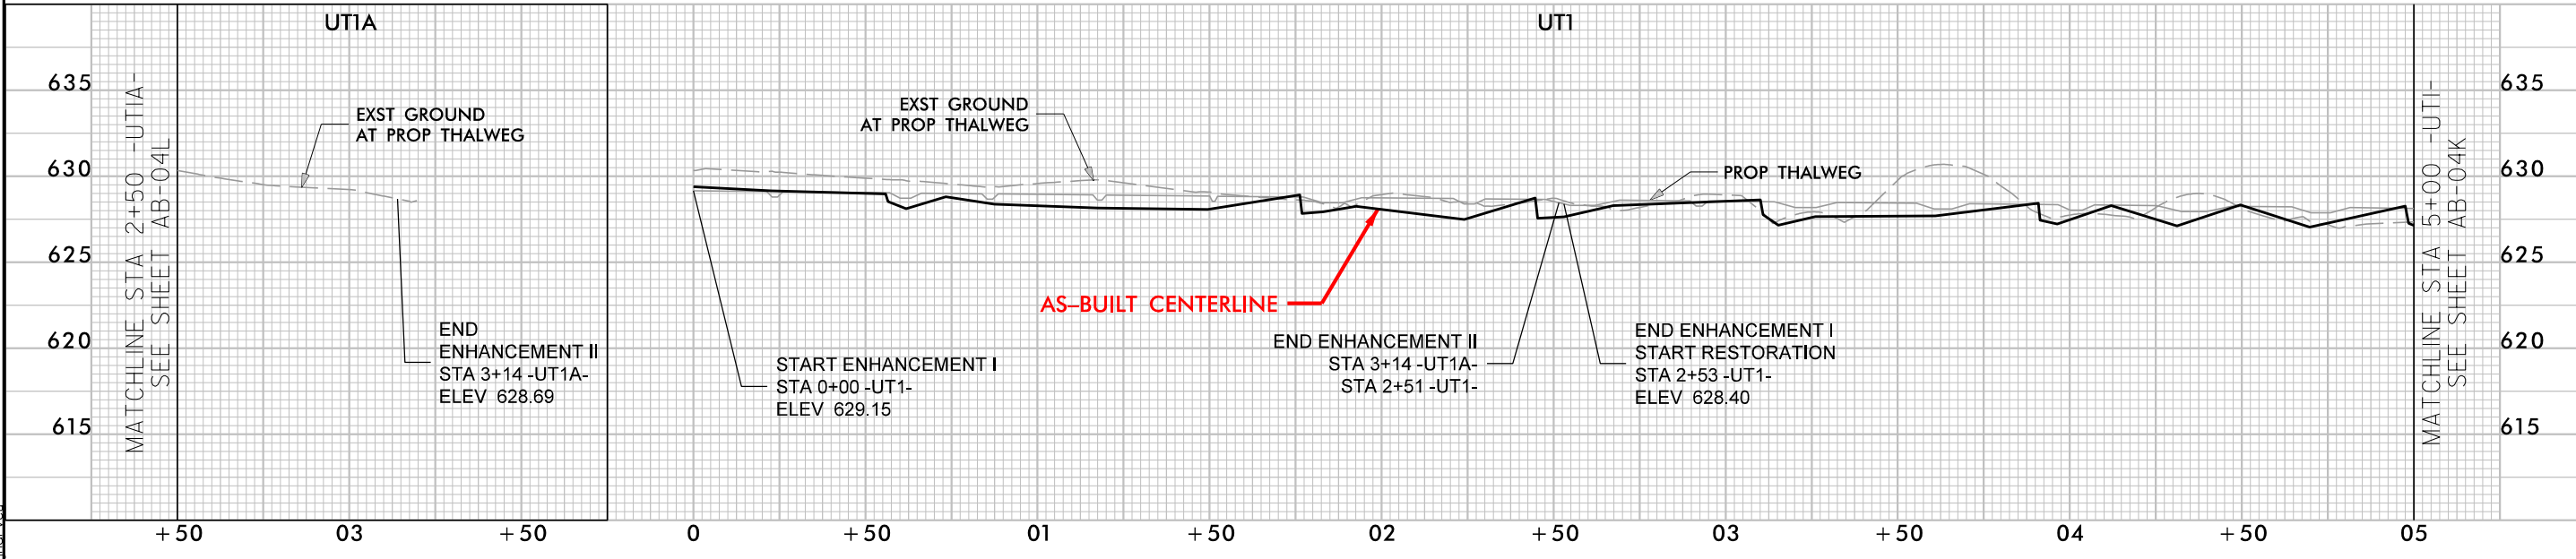
-UT 1- AS-BUILT STRUCTURE LOCATIONS				
STR. TYPE	NORTHING	EASTING	Prop Elevation	AB Survey Elevation
CROSS VANE	420,726.60	1,504,929.62	629.04	628.97
<del>CROSS VANE</del>	<del>420,606.78</del>	<del>1,504,870.08</del>	<del>628.02</del>	<del>628.92</del>
CROSS VANE	420,658.38	1,504,831.71	628.79	628.92
CROSS VANE	420,646.52	1,504,764.22	628.65	628.74
CROSS VANE	420,671.66	1,504,705.11	628.52	628.63
CROSS VANE	420,731.32	1,504,654.49	628.35	628.44
