**Newtown Stream and Wetland  
Restoration Project  
Union County, North Carolina  
EEP Project #94150  
Contract No. 002025**

**MY-02 Monitoring Report**

Data Collected: September/October 2012  
Submitted: January 2013

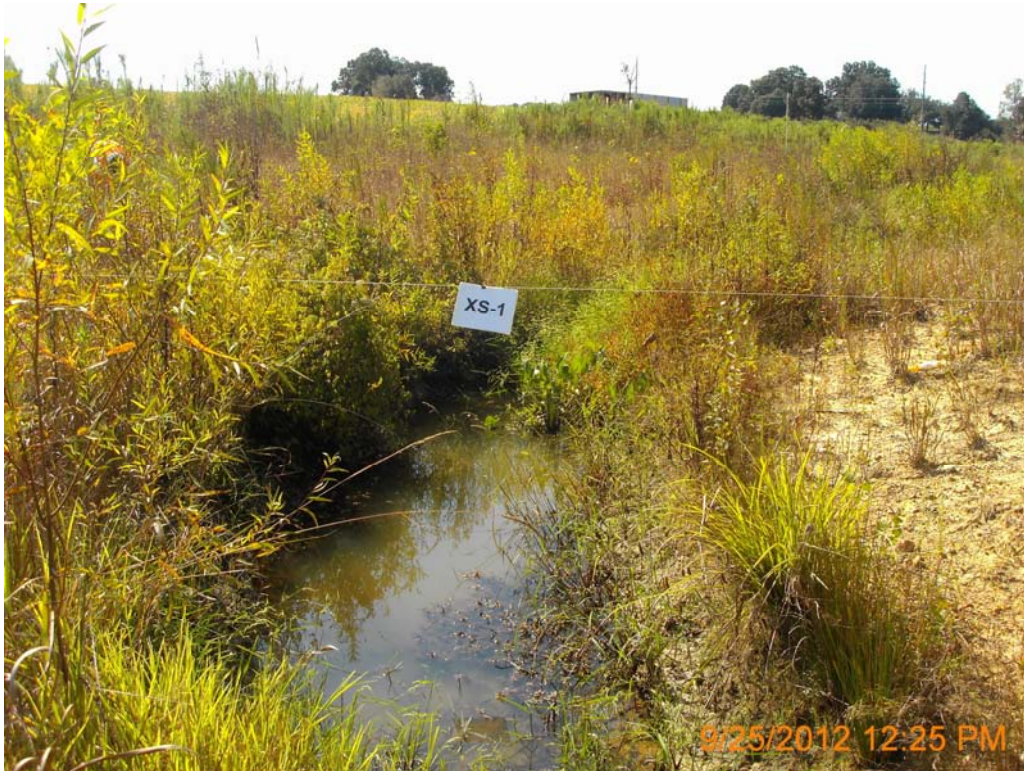
Photo 1. Looking downstream at Underwood Creek XS-1

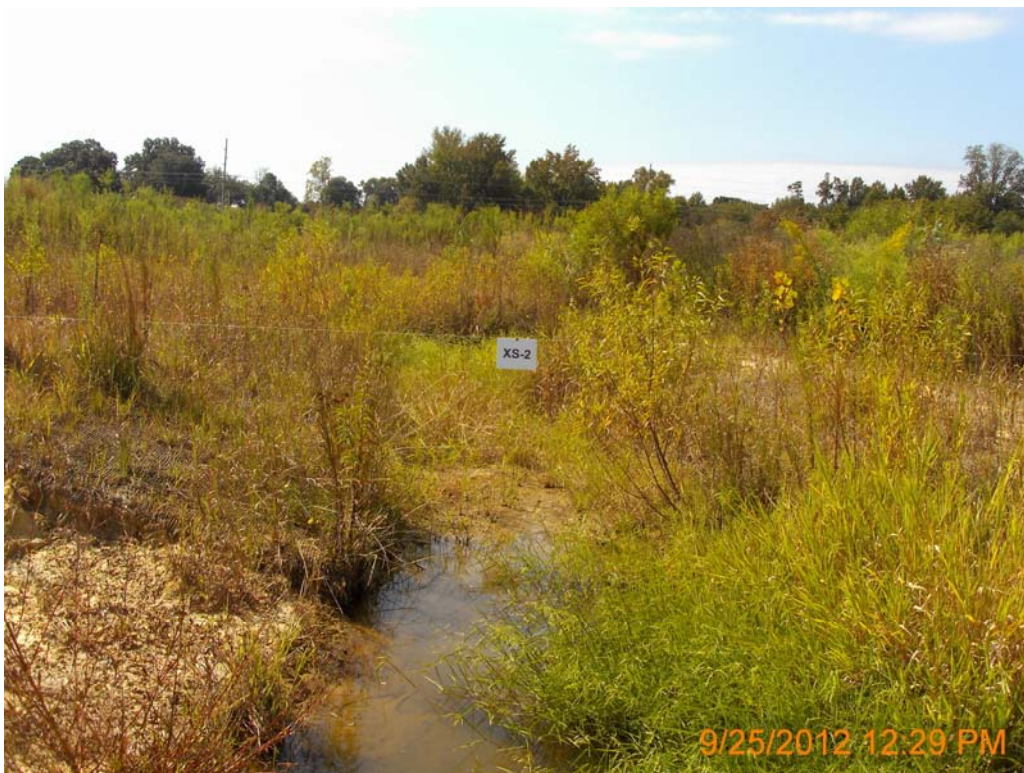
Photo 2. Looking downstream at Underwood Creek XS-2

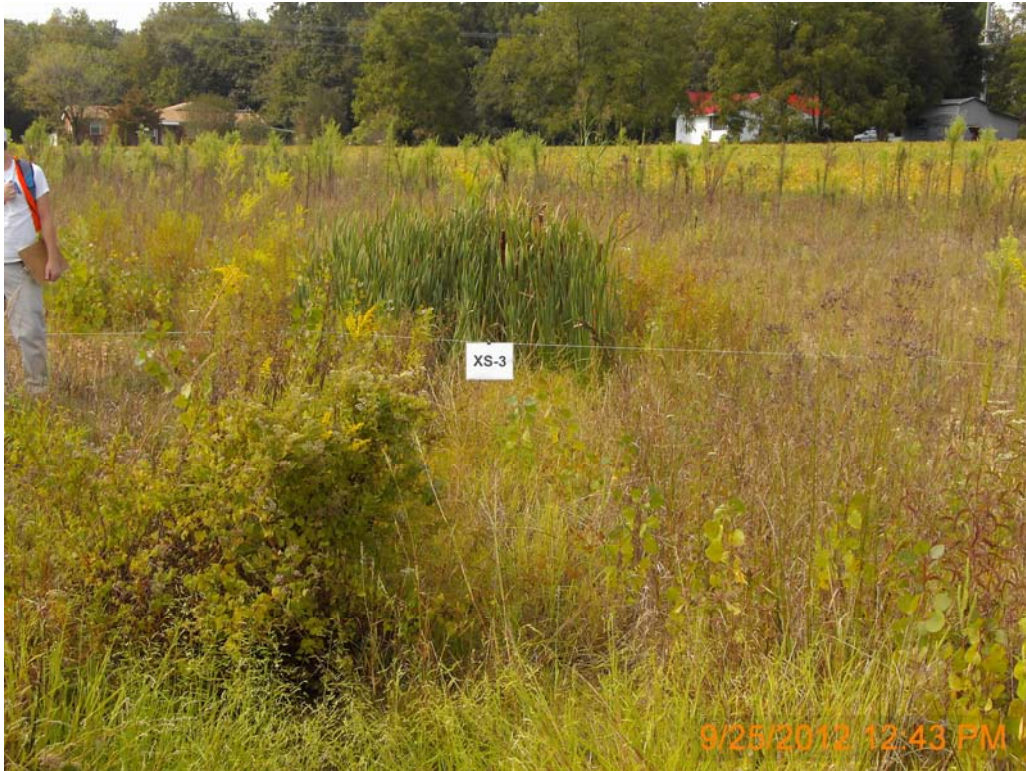
Photo 3. Looking downstream at Underwood Creek XS-3

comparison of the MY-02 cross sections to the MY-01 cross section data shows little change. Several of the riffles throughout the reach exhibit vegetation in the stream bed, leading to a fining of the substrate, as the smaller particles are being trapped. As a result, cross section 3 pebble count shows significant fining. The finer particles are expected to flush out of the riffles during larger flow events. In some of these riffles, a small low flow channel has formed. This was noted in MY-01, and is the cause of the apparent riffles downcutting. However, this is limited to a very limited part of the channel and is not significant enough to be noted as a problem on the CCPV. The low flow area (when present) is the primary cause of the longitudinal profile showing a decrease of riffle elevation and is not a representation of the entire riffle cross section. The longitudinal profile of the stream is stable.

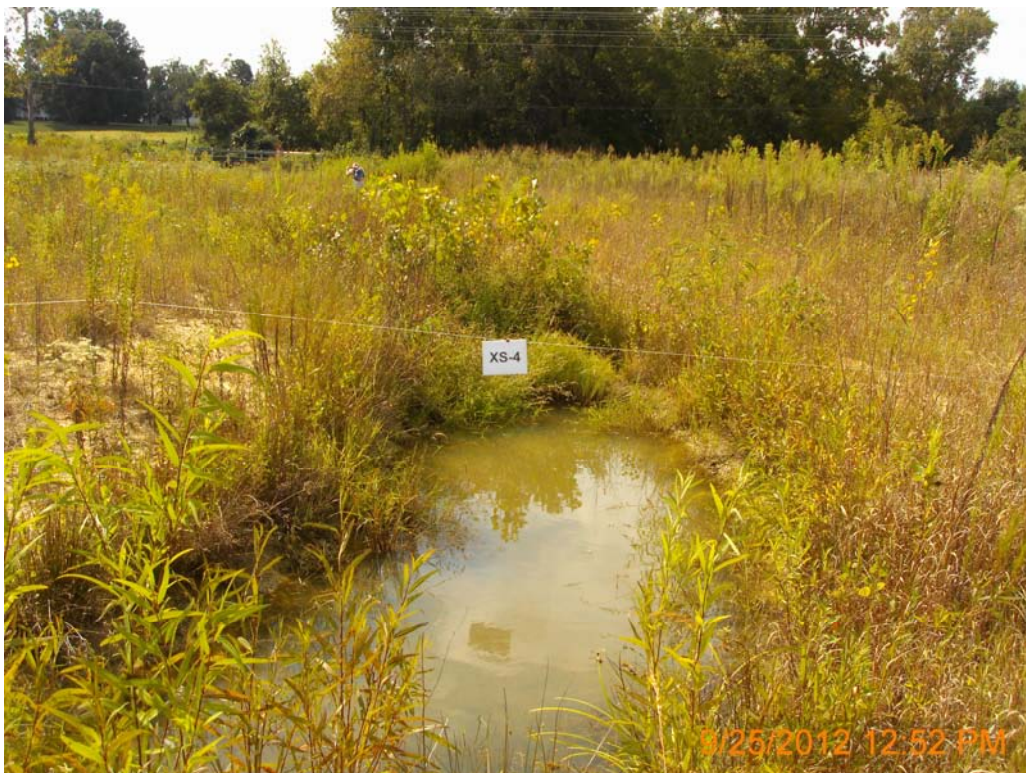
Photo 4. Looking downstream at Underwood Creek XS-4

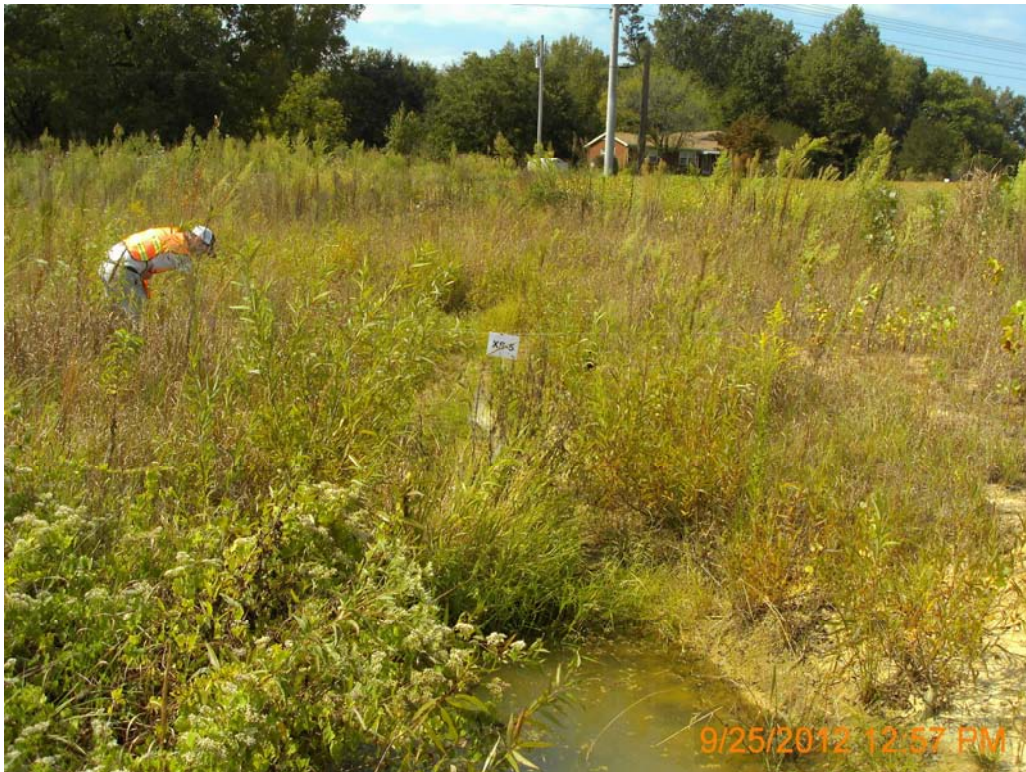
Photo 5. Looking downstream at Underwood Creek XS-5

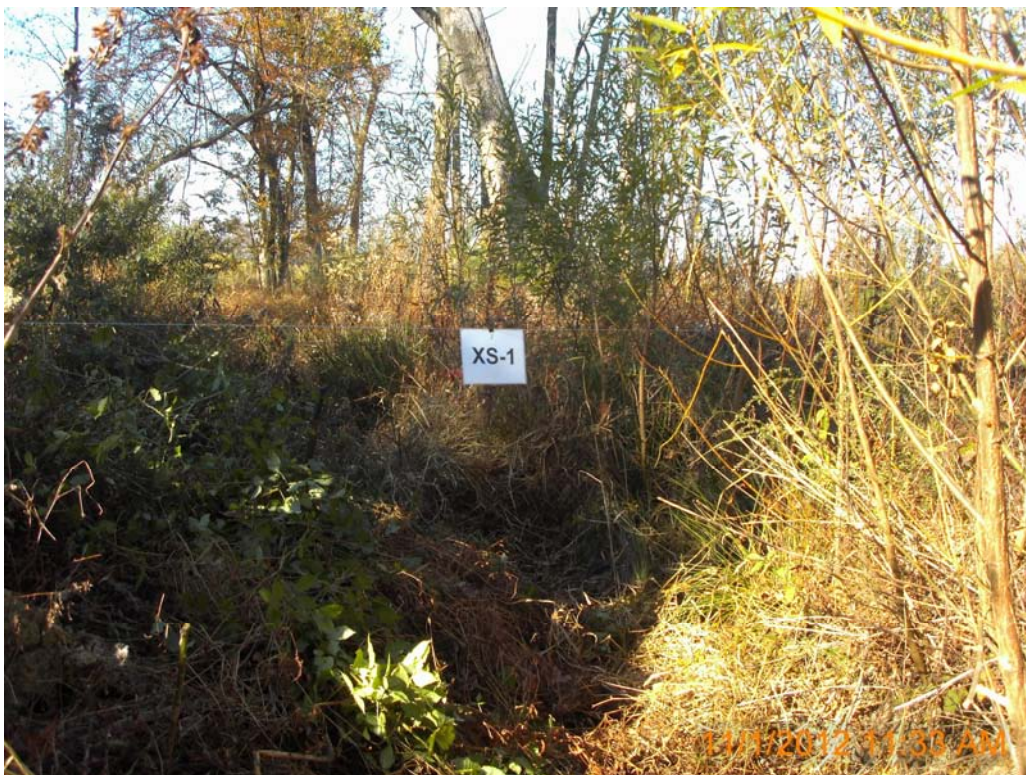
Photo 6. Looking downstream at UT to Underwood Creek XS-1

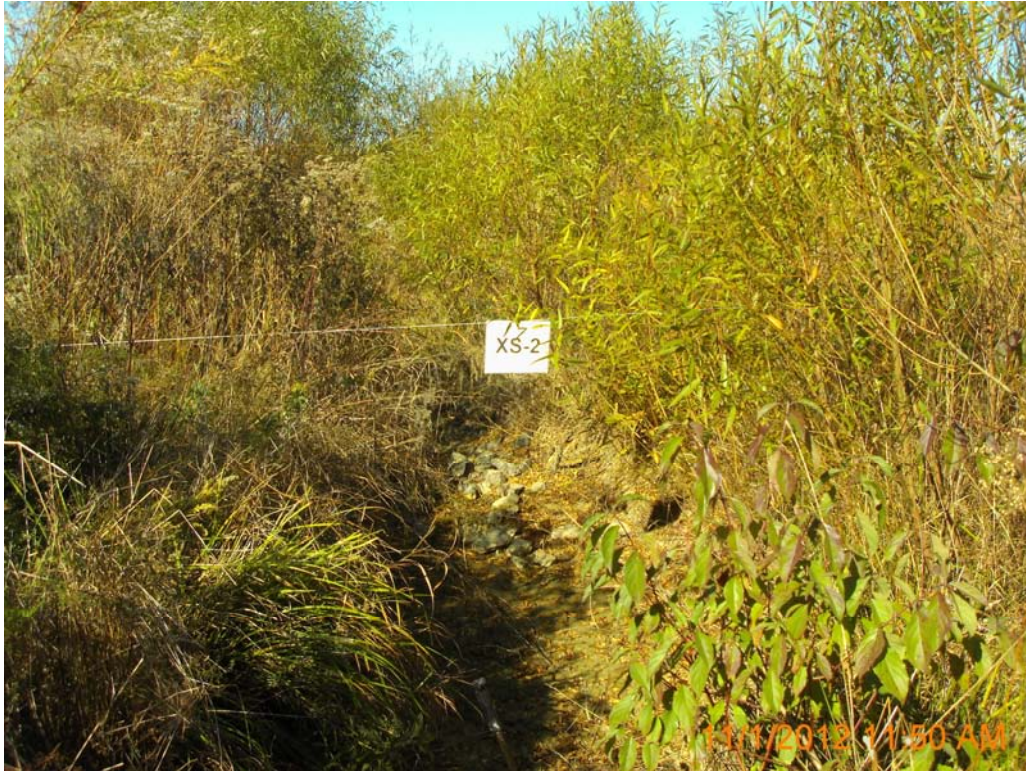
Photo 7. Looking downstream at UT to Underwood Creek XS-2

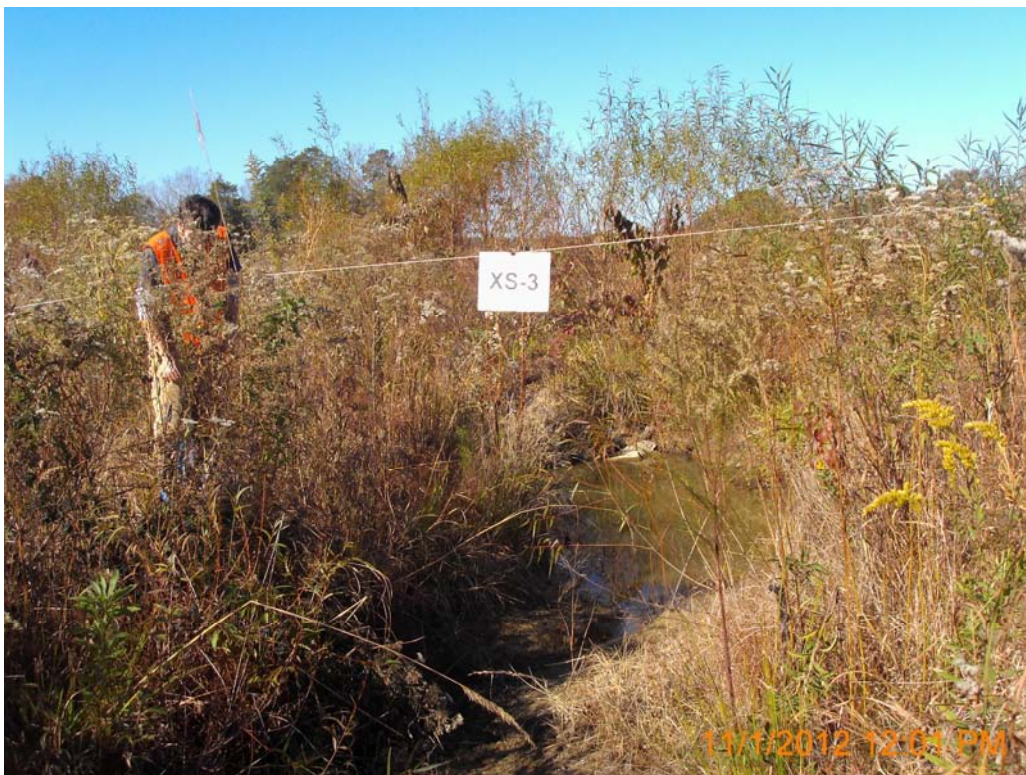
Photo 8. Looking downstream at UT to Underwood Creek XS-3

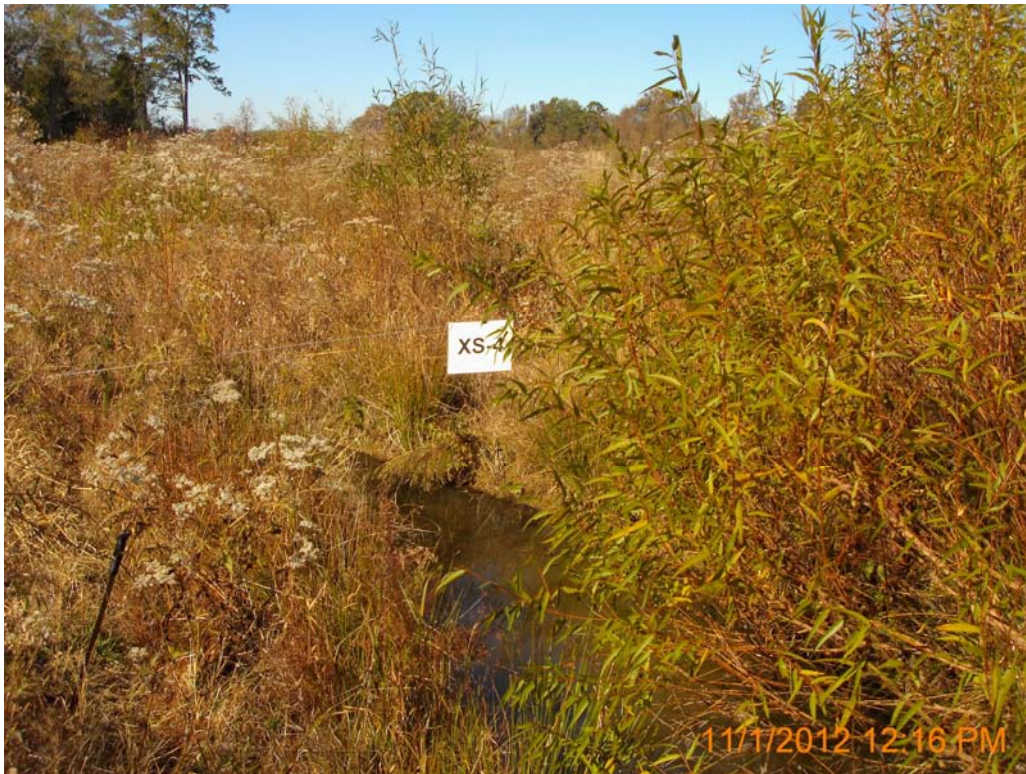
Photo 9. Looking downstream at UT to Underwood Creek XS-4

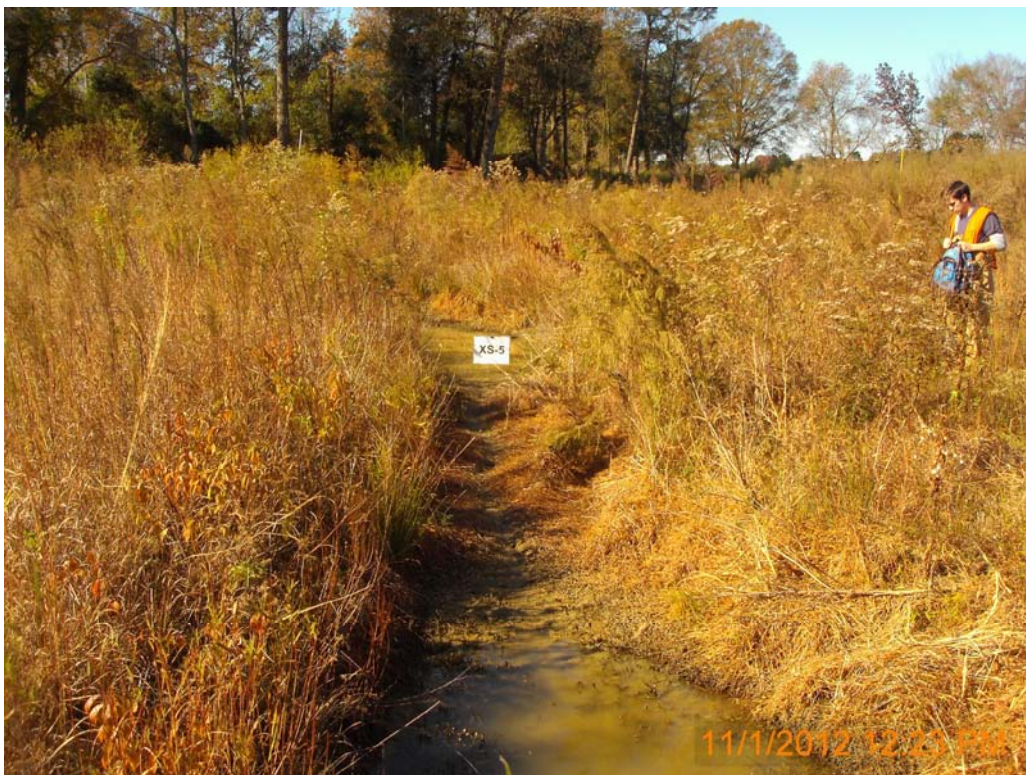
Photo 10. Looking downstream at UT to Underwood Creek XS-5

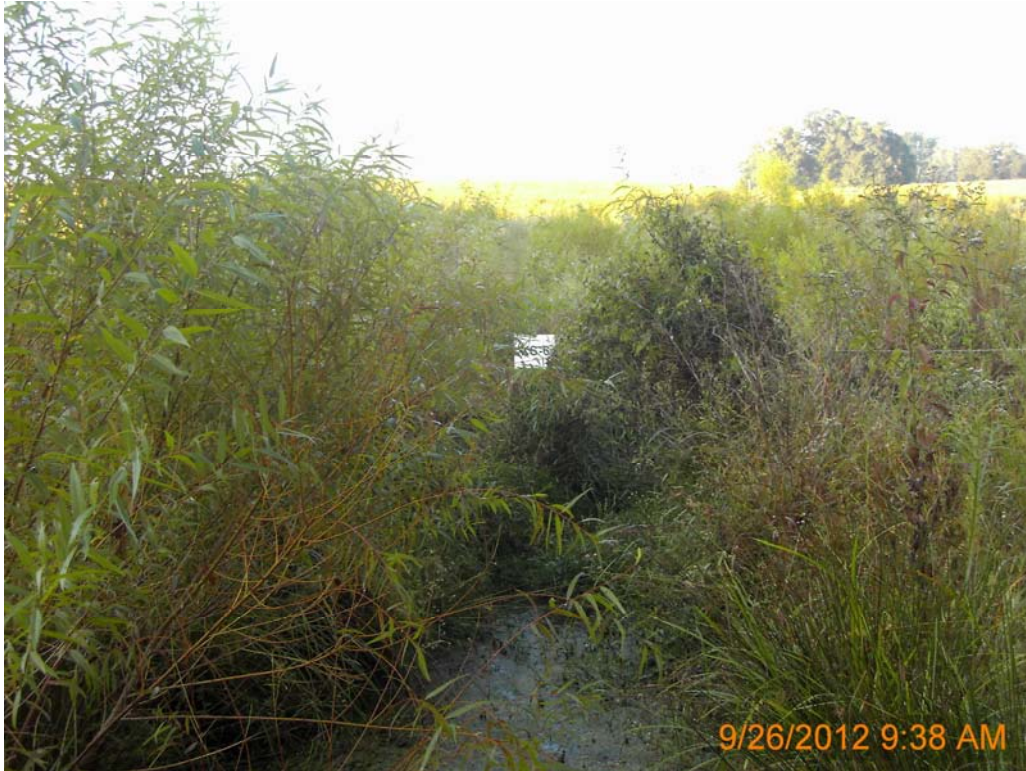
Photo 11. Looking downstream at UT to Underwood Creek XS-6

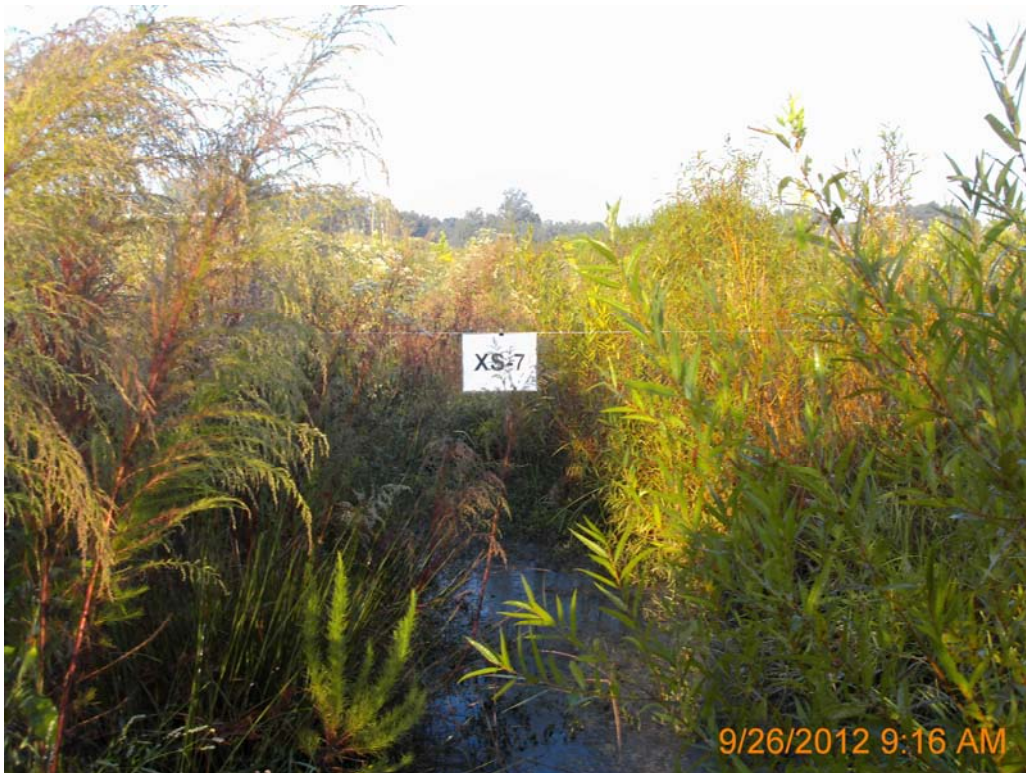
Photo 12. Looking downstream at UT to Underwood Creek XS-7

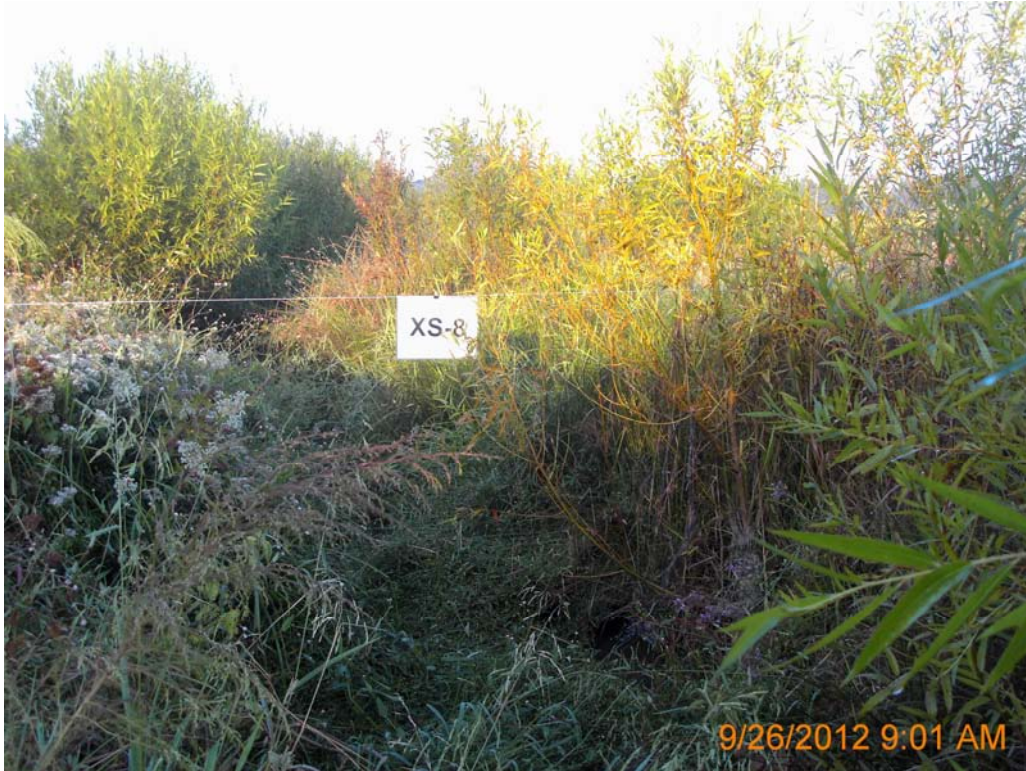
Photo 13. Looking downstream at UT to Underwood Creek XS-8

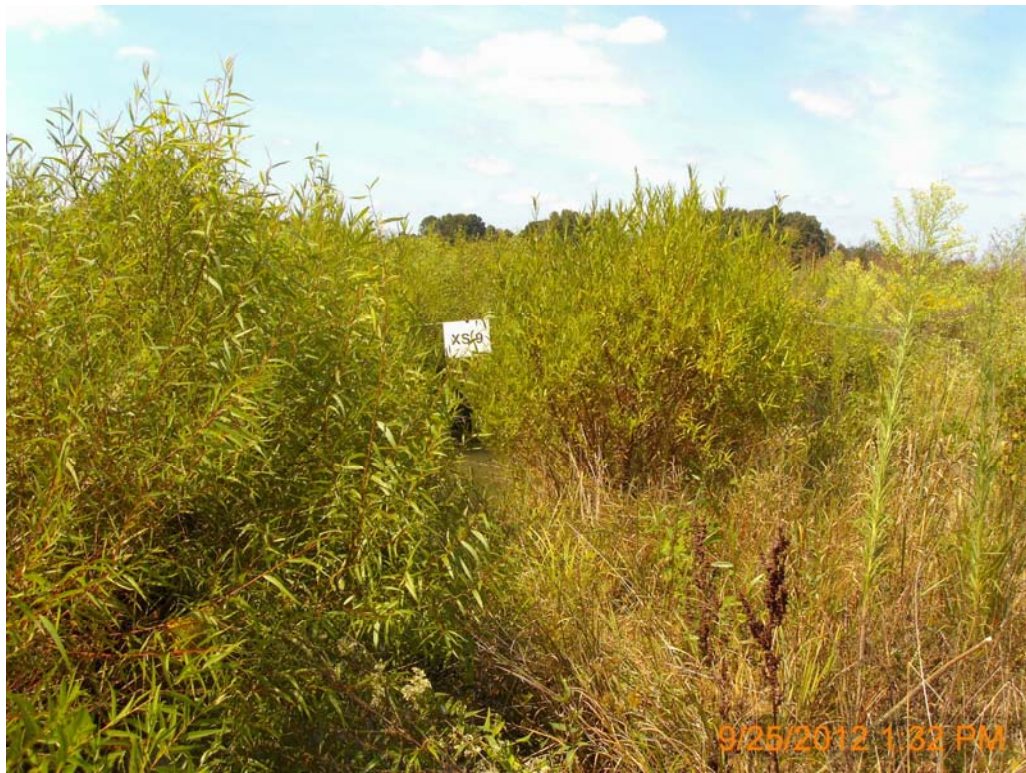
Photo 14. Looking downstream at UT to Underwood Creek XS-9

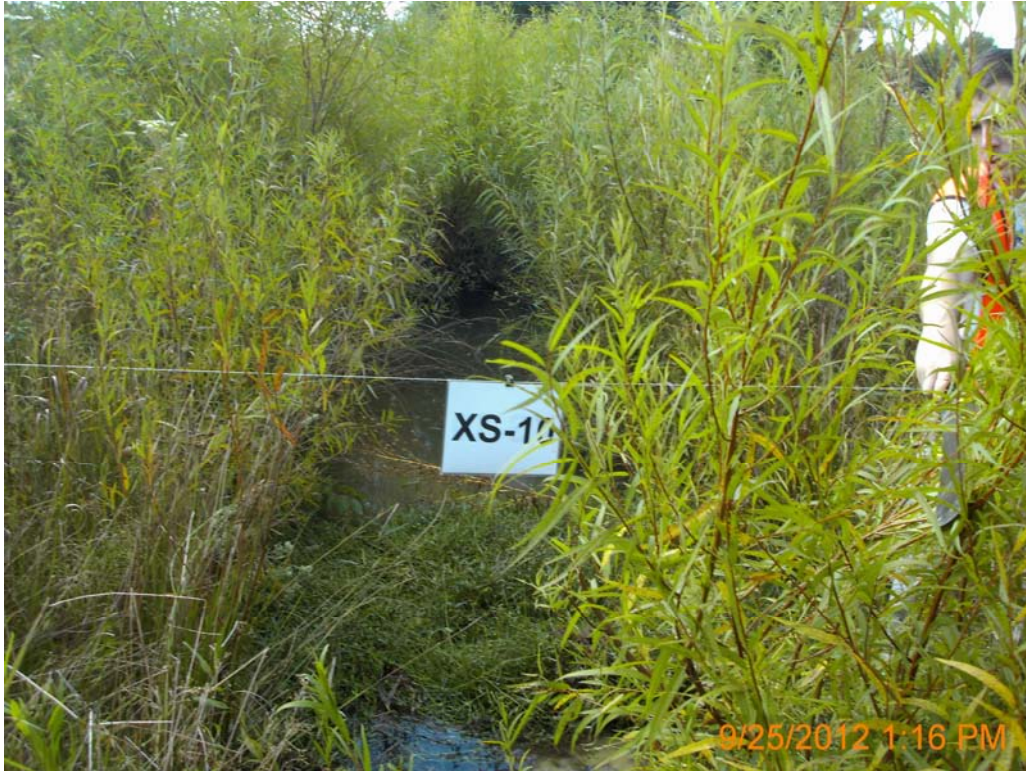
Photo 15. Looking downstream at UT to Underwood Creek XS-10

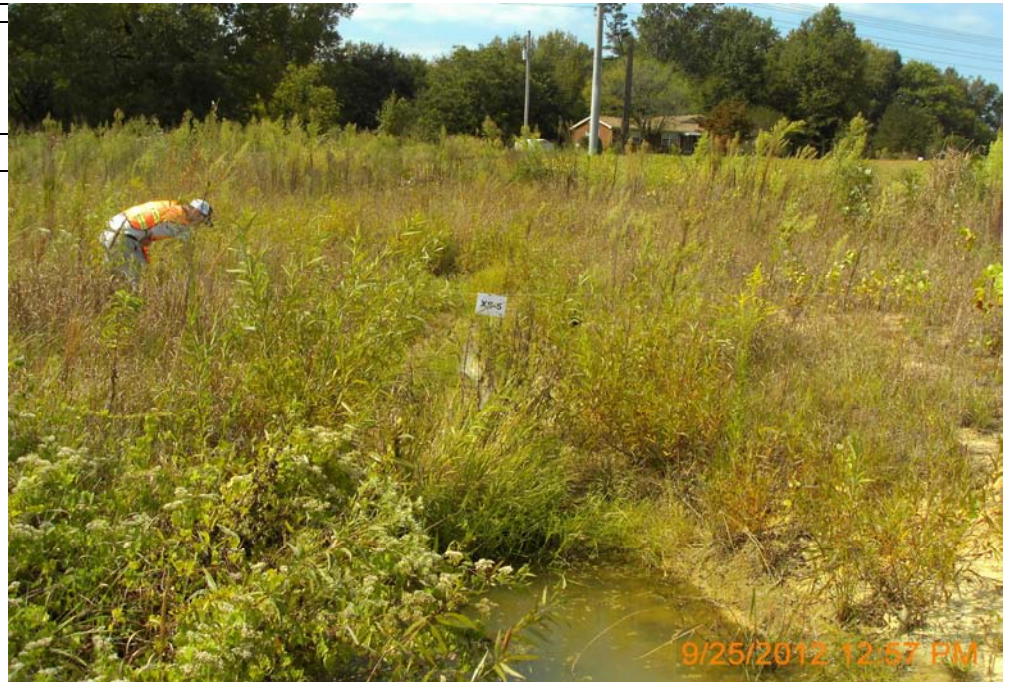
Project:	Underwood Creek	Summary (bankfull)					
Cross Section:	Cross Section 5 (CS-3 in MY-00)	MY0	MY1	MY2	MY3	MY4	MY5
Feature:	Riffle	A (BKF)	15.9	17.5	19.7		
Station:	17+13	W (BKF)	15.3	15.1	26.5		
Date:	9/25/12	Max d	1.7	2.1	2.1		
Crew:	SV, ZP	Mean d	1.0	1.2	0.7		
		W/D	14.7	13.1	35.6

Photo of XS-5, looking in the downstream direction

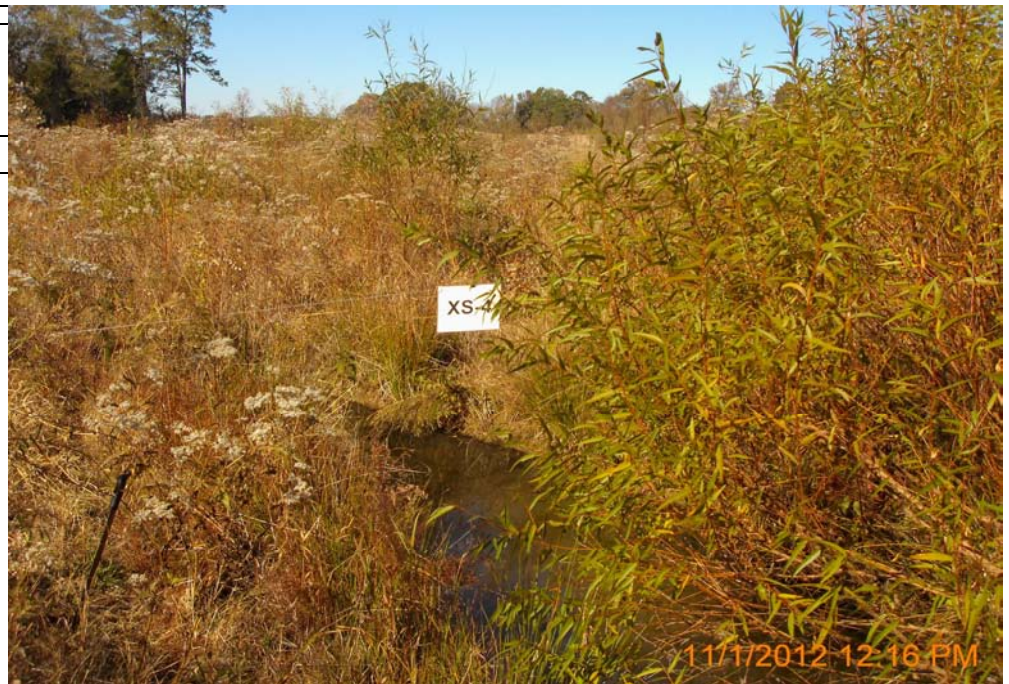
Project:	UT to Underwood Creek	Summary (bankfull)					
Cross Section:	Cross Section 4 (New for MY-01)	MY0	MY1	MY2	MY3	MY4	MY5
Feature:	Pool	A (BKF)	24.8	25.0			
Station:	16+30	W (BKF)	17.5	16.6			
Date:	9/25/12	Max d	2.8	2.8			
Crew:	SV, ZP	Mean d	1.4	1.5			
		W/D	#DIV/0!	12.4	11.1

Photo of XS-4, looking in the downstream direction

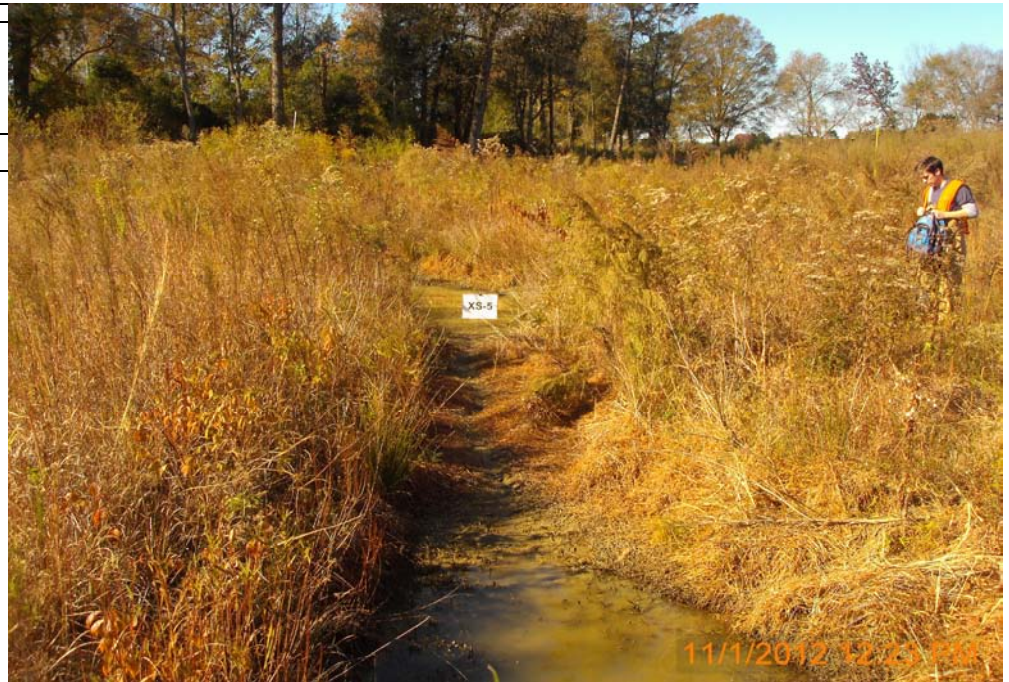
Project:	UT to Underwood Creek	Summary (bankfull)						
Cross Section:	Cross Section 5 (CS-3 in MY-00)	MY0	MY1	MY2	MY3	MY4	MY5	
Feature:	Riffle	A (BKF)	13.6	13.4	13.5			
Station:	20+04	W (BKF)	14.0	14.2	14.3			
Date:	9/25/12	Max d	1.6	1.5	1.7			
Crew:	SV, ZP	Mean d	1.0	0.9	0.9			
		W/D	14.4	15.2	15.1

Photo of XS-5, looking in the downstream direction

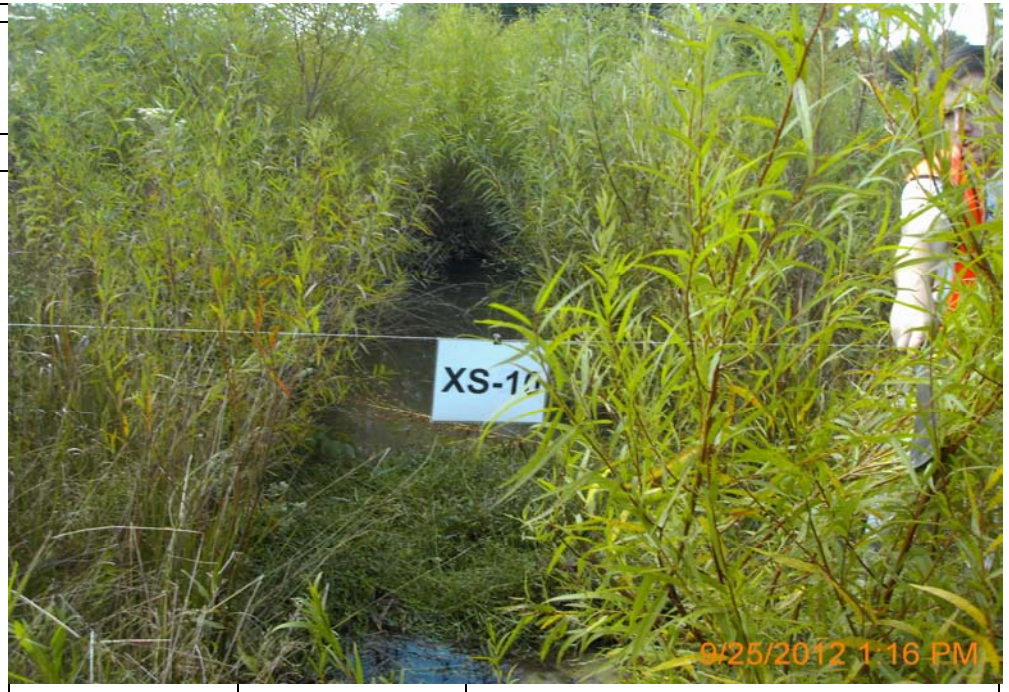
Project:	UT to Underwood Creek	Summary (bankfull)						
Cross Section:	Cross Section 10 (CS-7 in MY-00)	MY0	MY1	MY2	MY3	MY4	MY5	
Feature:	Riffle	A (BKF)	15.2	14.1	13.3			
Station:	39+90	W (BKF)	15.3	15.0	14.8			
Date:	9/25/12	Max d	1.6	1.6	1.5			
Crew:	SV, ZP	Mean d	1.0	0.9	0.9			
		W/D	15.3	15.9	16.5

Photo of XS-10, looking in the downstream direction

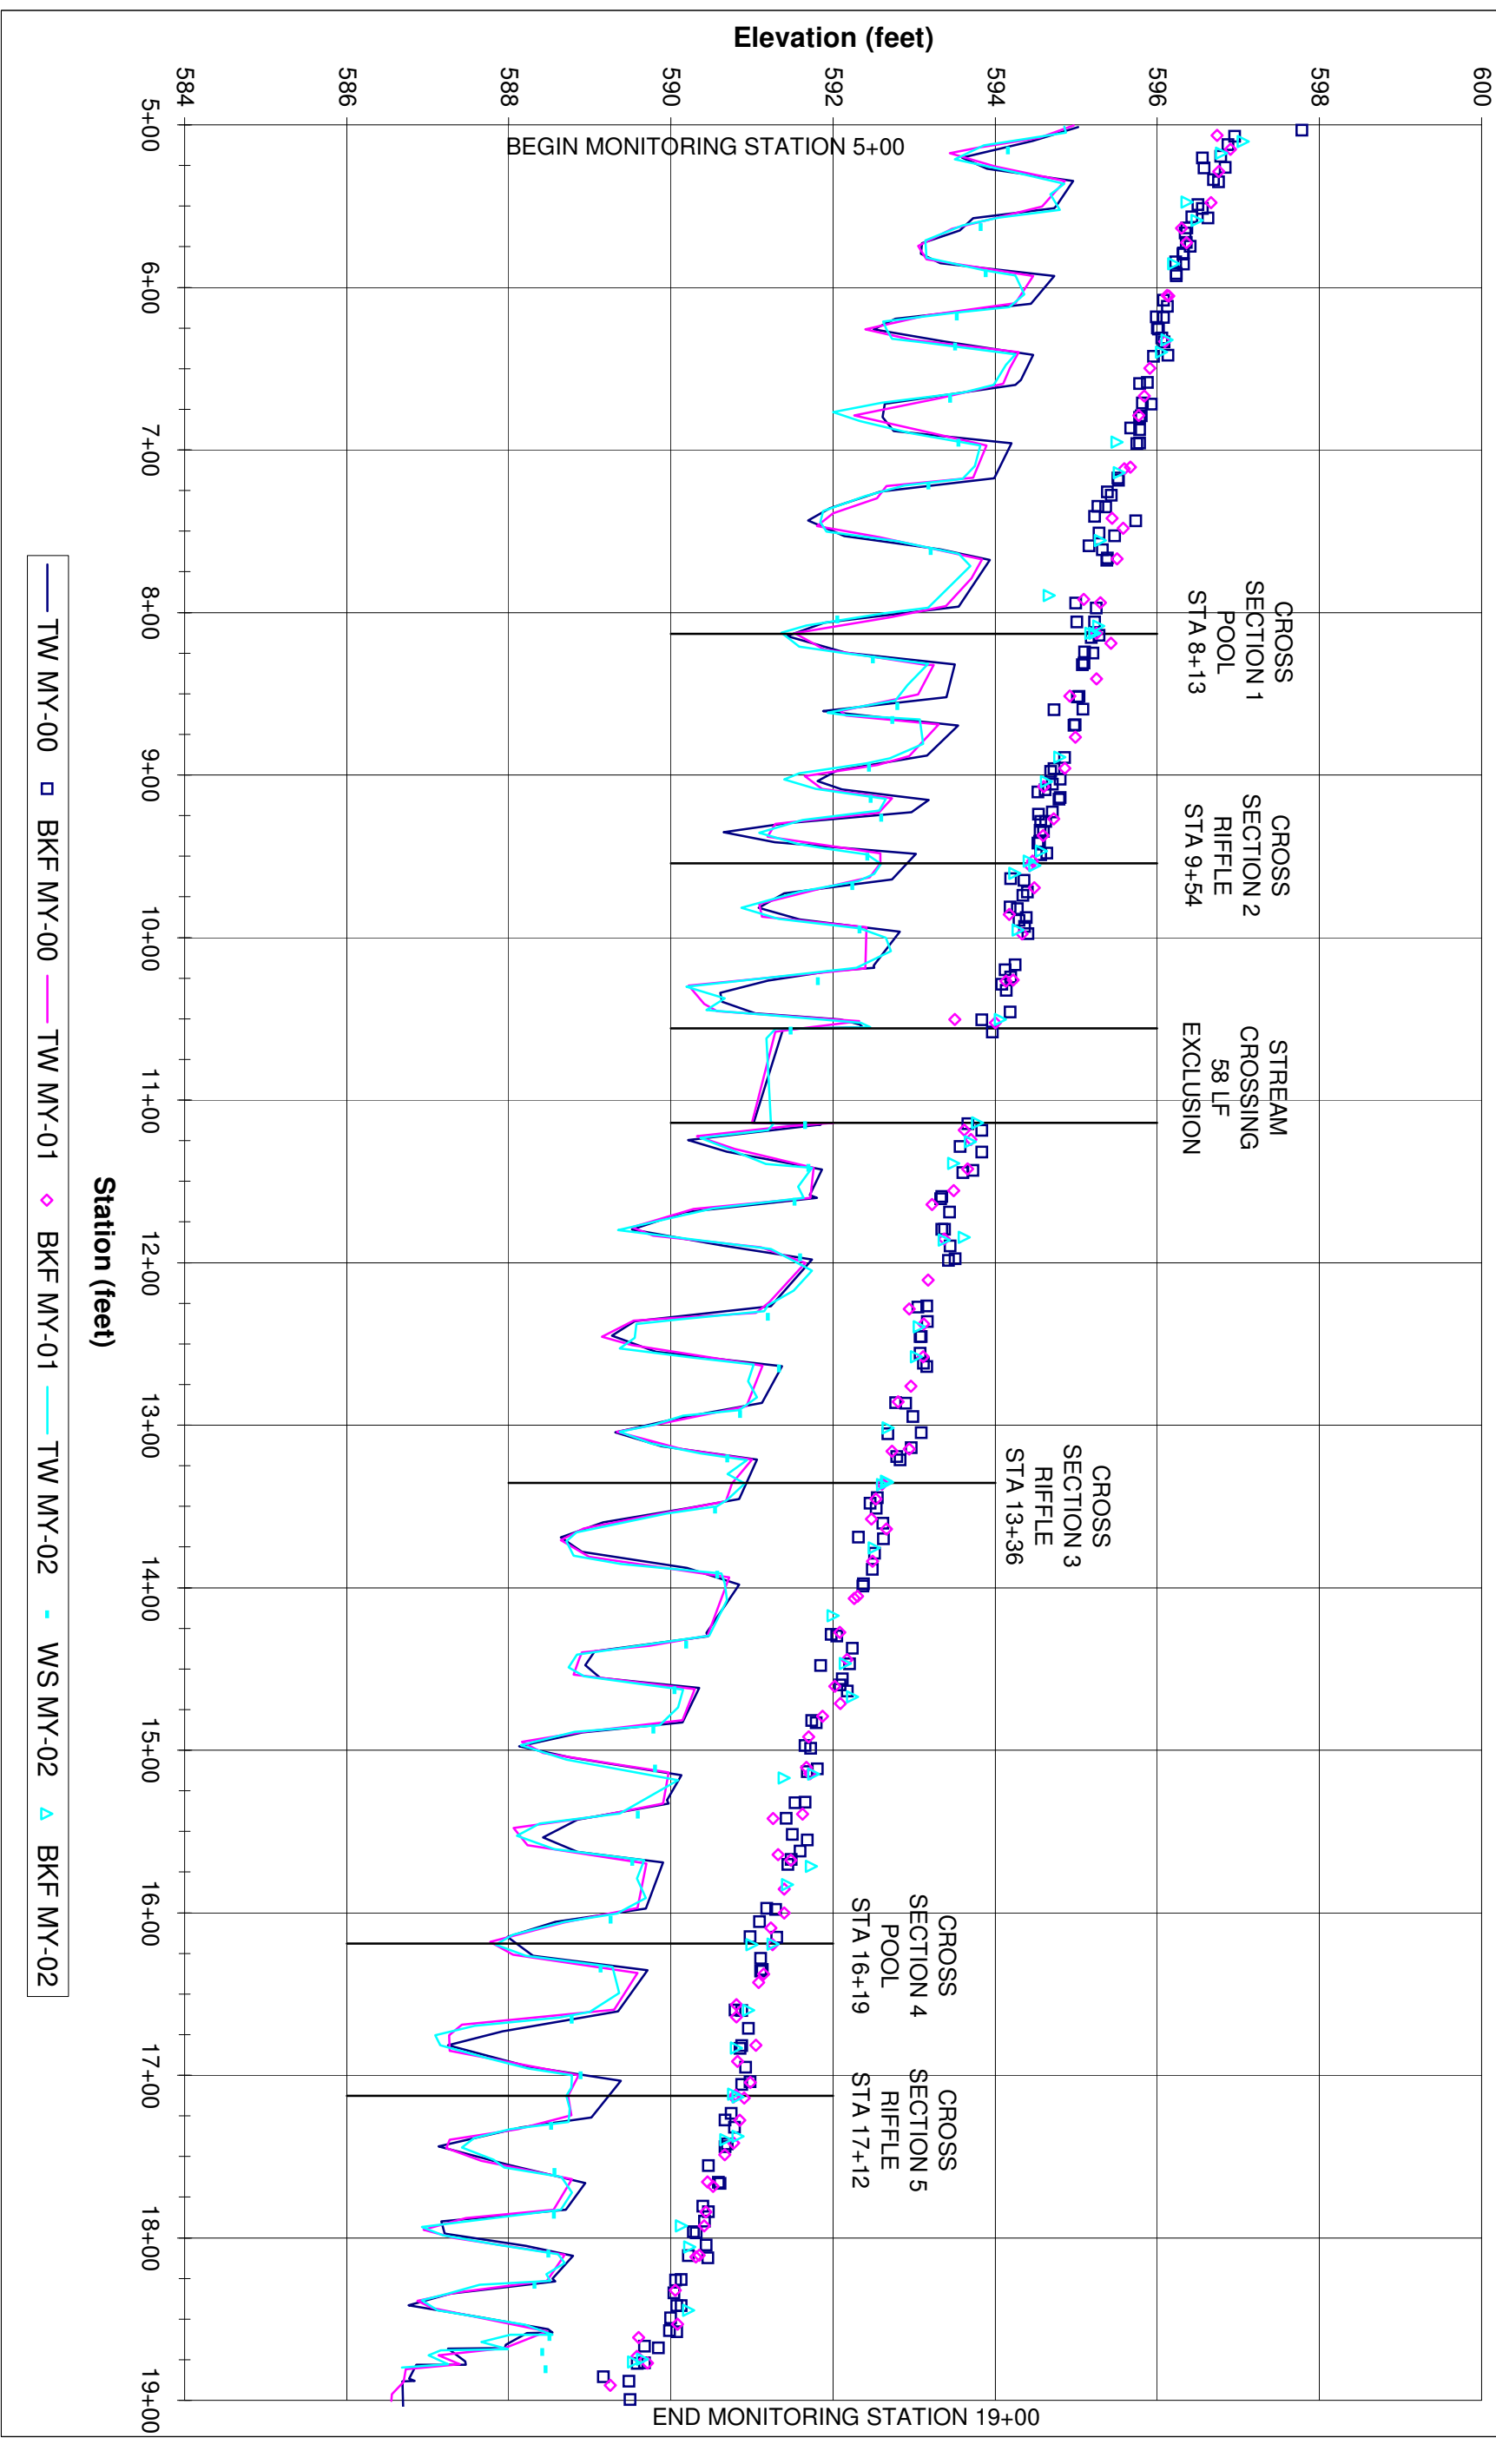
**Underwood Creek (Newtown)  
Longitudinal Profile  
Main: Station 5+00 - 19+00**

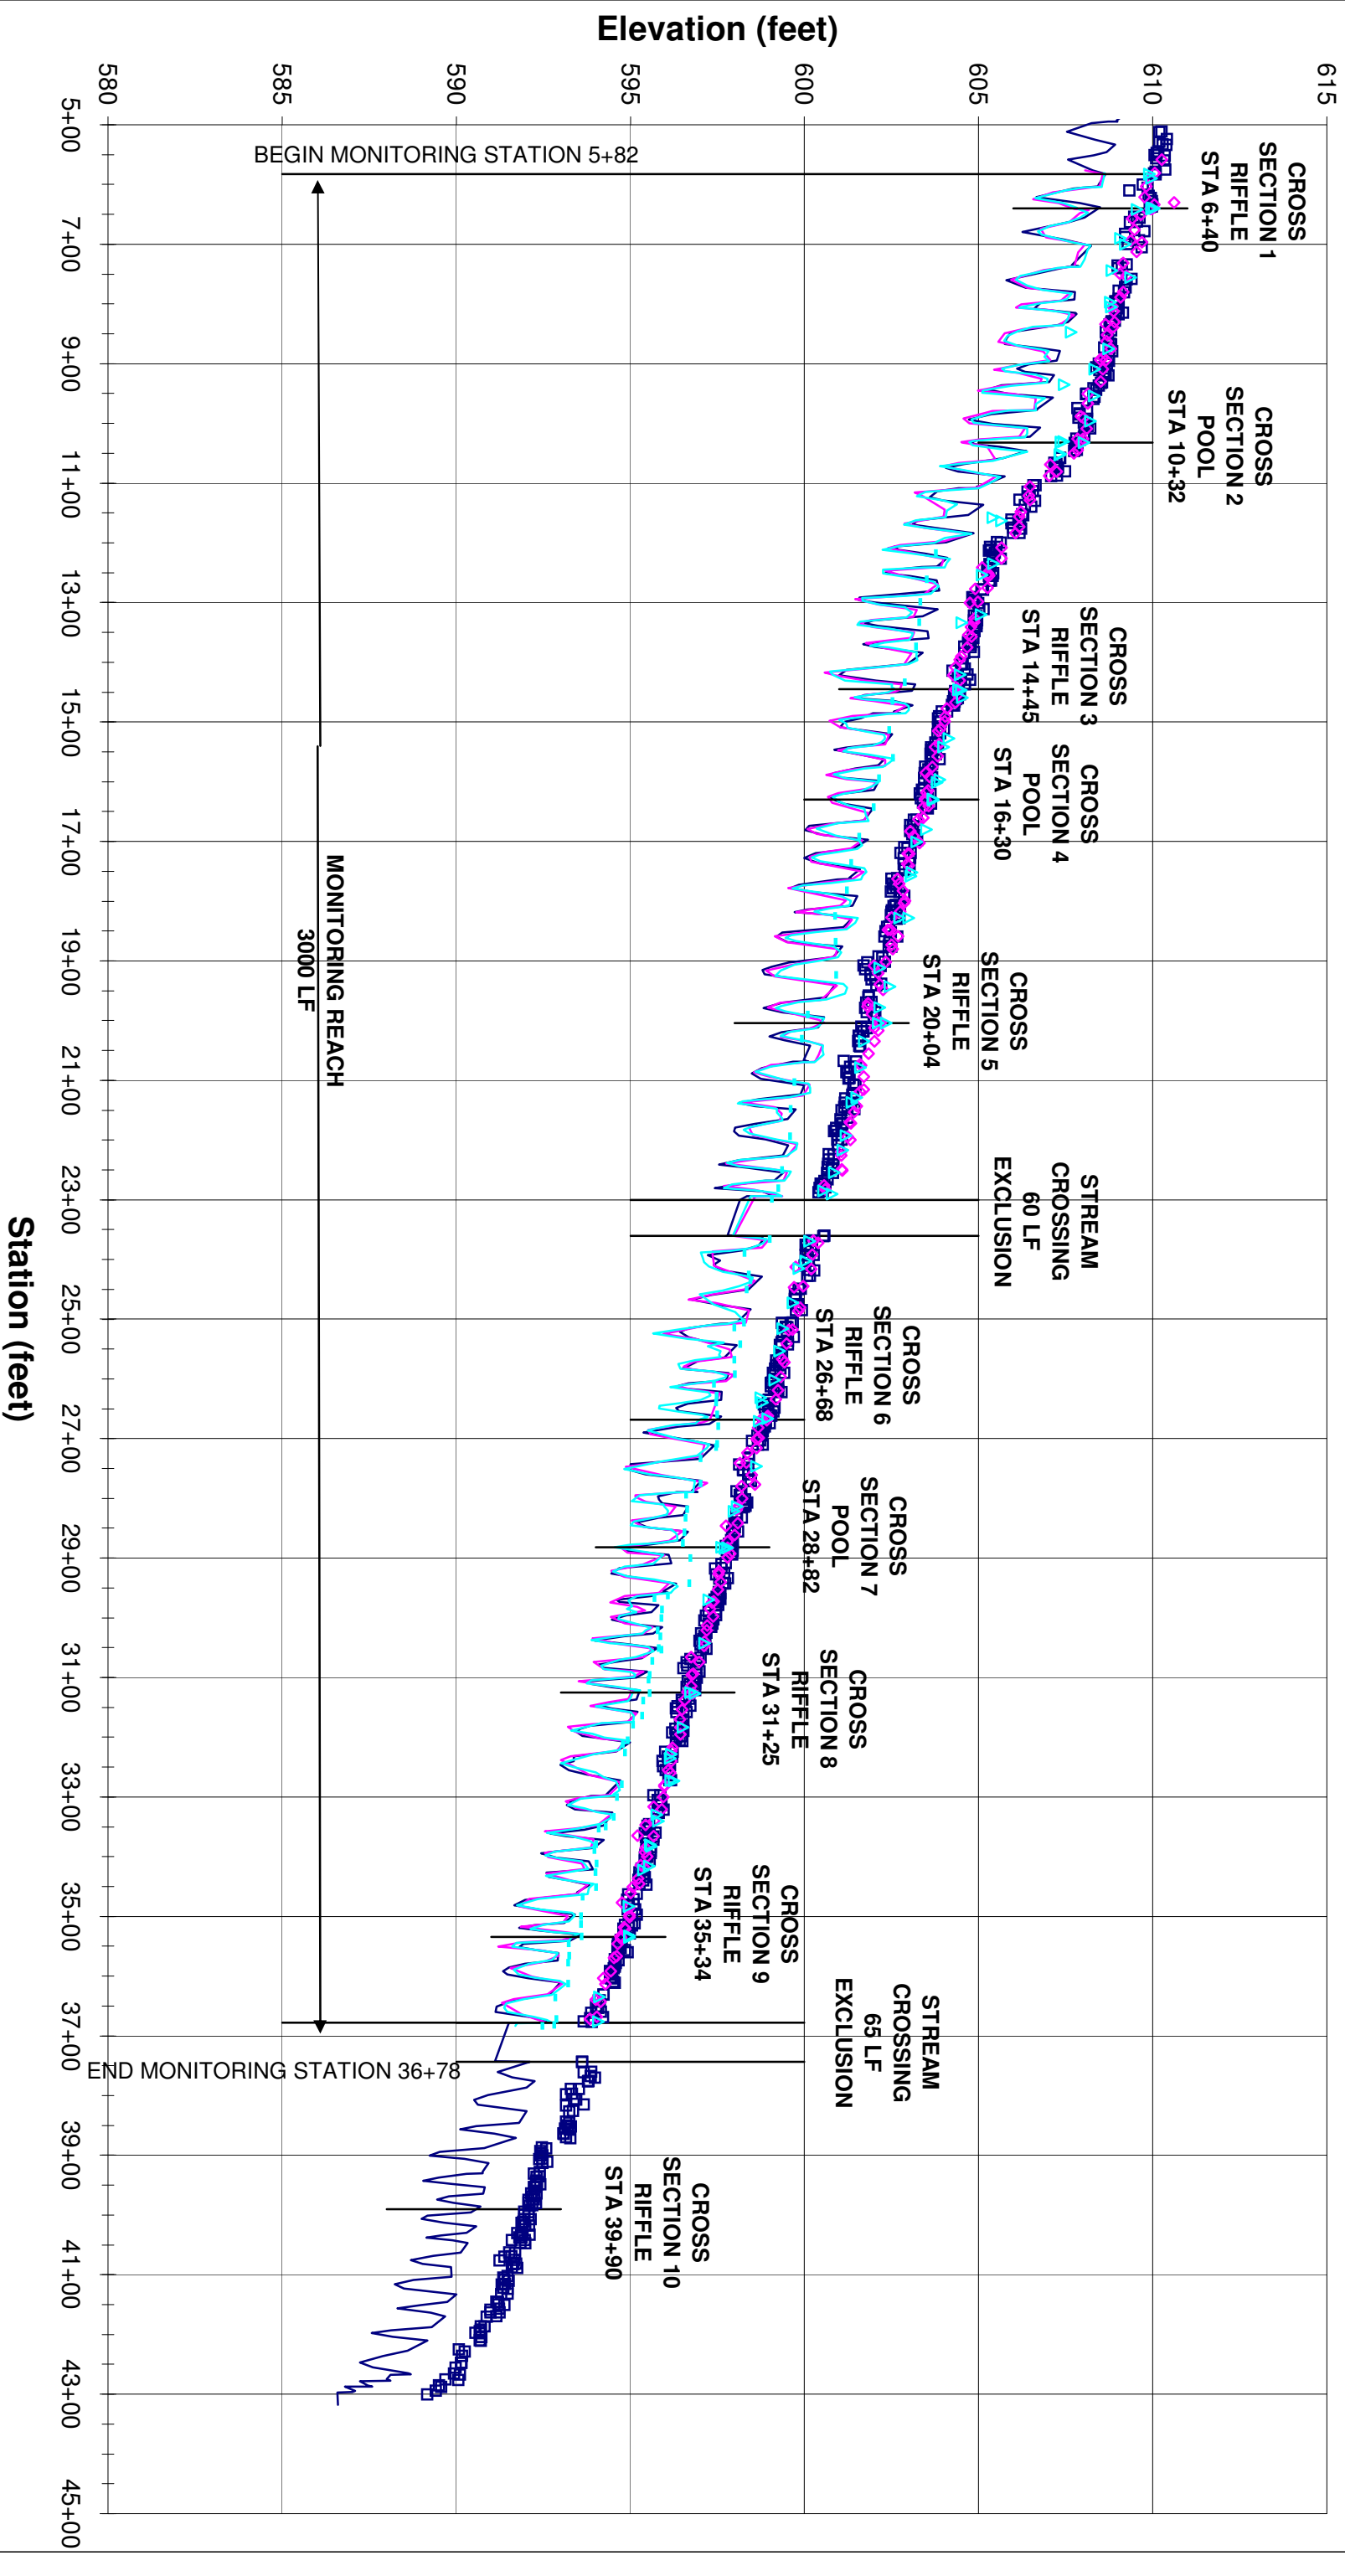
**UT to Underwood Creek (Newtown)**  
**Longitudinal Profile**  
**Tributary: Station 5+82 - 36+78**

— TW MY-00   
 □ BKF MY-00   
 — TW MY-01   
 ◇ BKF MY-01   
 — TW MY-02   
 - WS MY-02   
 △ BKF MY-02
