**Newtown Stream and Wetland  
Restoration Project  
Union County, North Carolina  
EEP Project #94150  
Contract No. 002025**

**MY-02 Monitoring Report**

Data Collected: September/October 2012  
Submitted: January 2013

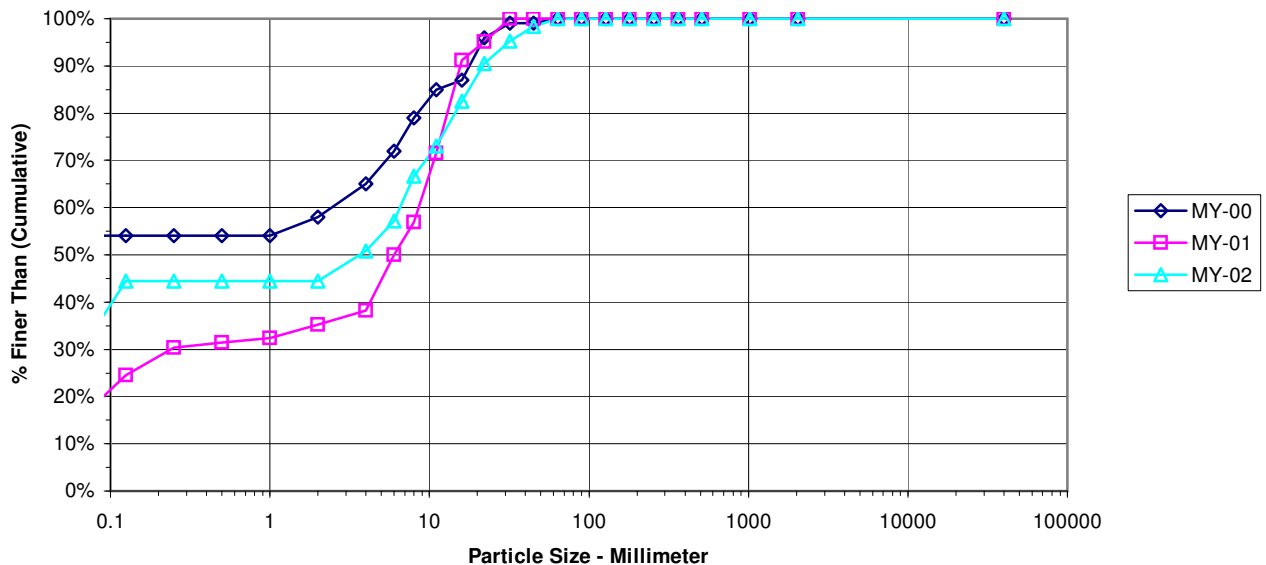
d16	d35	d50	d84	d95
0.1	0.1	3.8	17.1	31.5

**Bed Particle Size Distribution  
Cross Section 2: Riffle**
