NORKETT BRANCH STREAM MITIGATION SITE
Union County, NC
DENR Contract 004673
NCEEP Project Number 95360

Baseline Monitoring Document and As-Built Baseline Report
FINAL

NORKETT BRANCH STREAM MITIGATION SITE

Baseline Monitoring Document and As-Built Baseline Report

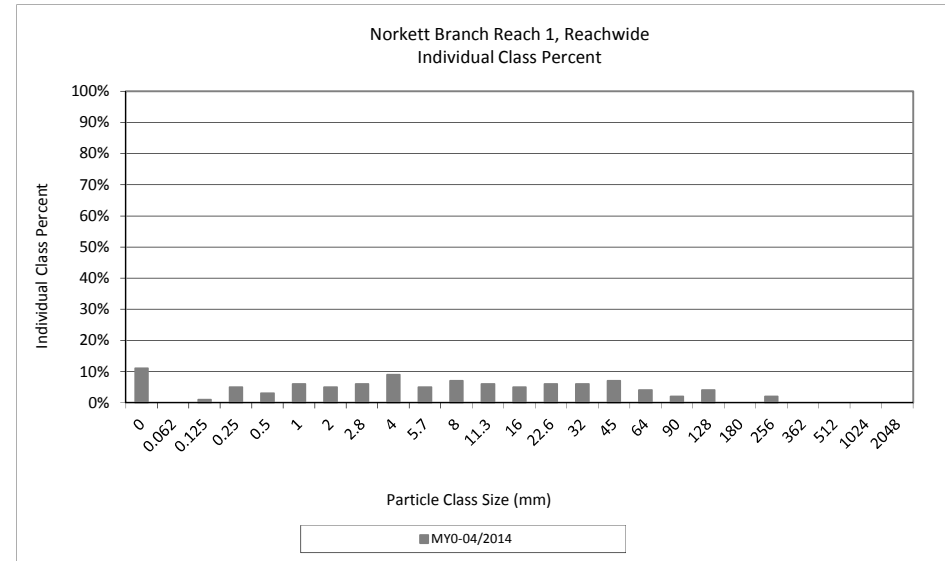
Reachwide and Cross-Section Pebble Count Plots
 Norkett Branch Stream Mitigation Site (NCEEP Project No. 95360)
 Norkett Branch Reach 1, Reachwide
 Monitoring Year 0

Reachwide	
Channel materials (mm)	
D ₁₆ =	0.4
D ₃₅ =	3.6
D ₅₀ =	7.4
D ₈₄ =	52.3
D ₉₅ =	139.4
D ₁₀₀ =	362.0

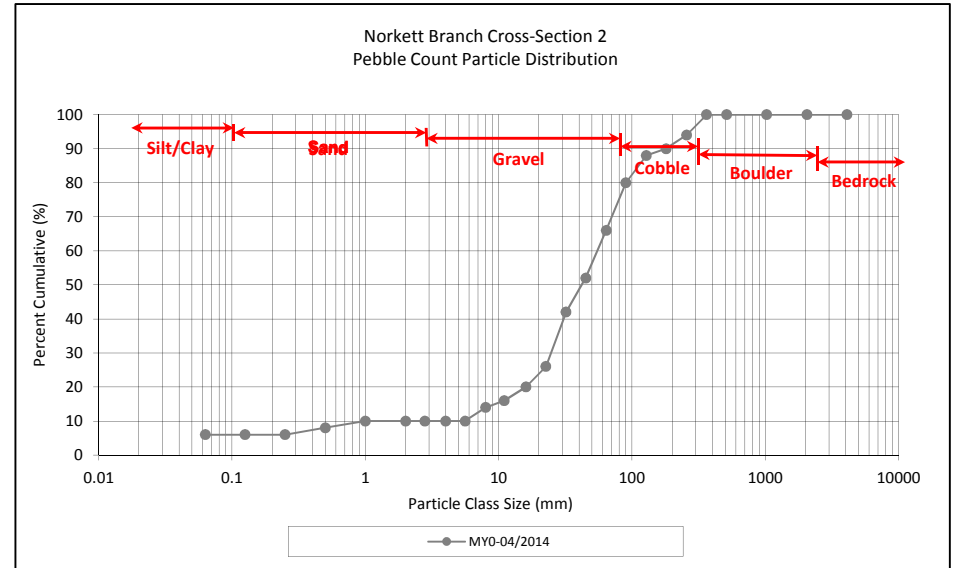
Reachwide and Cross-Section Substrate Plots
 Norkett Branch Stream Mitigation Site (NCEP Project No. 95360)
 Norkett Branch Reach 1, Cross-Section 2
 Monitoring Year 0

Cross-Section 2	
Channel materials (mm)	
D ₁₆ =	11.0
D ₃₅ =	27.5
D ₅₀ =	42.0
D ₈₄ =	107.3
D ₉₅ =	271.2
D ₁₀₀ =	362.0

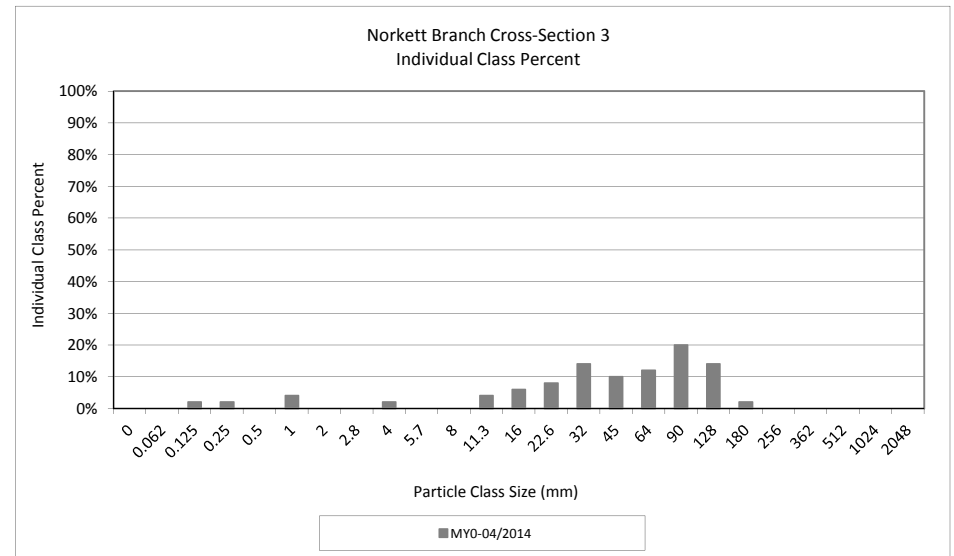
Reachwide and Cross-Section Substrate Plots
 Norkett Branch Stream Mitigation Site (NCEP Project No. 95360)
 Norkett Branch Reach 1, Cross-Section 3
 Monitoring Year 0

Cross-Section 2	
Channel materials (mm)	
D ₁₆ =	18.0
D ₃₅ =	37.9
D ₅₀ =	59.6
D ₈₄ =	128.0
D ₉₅ =	167.3
D ₁₀₀ =	256.0

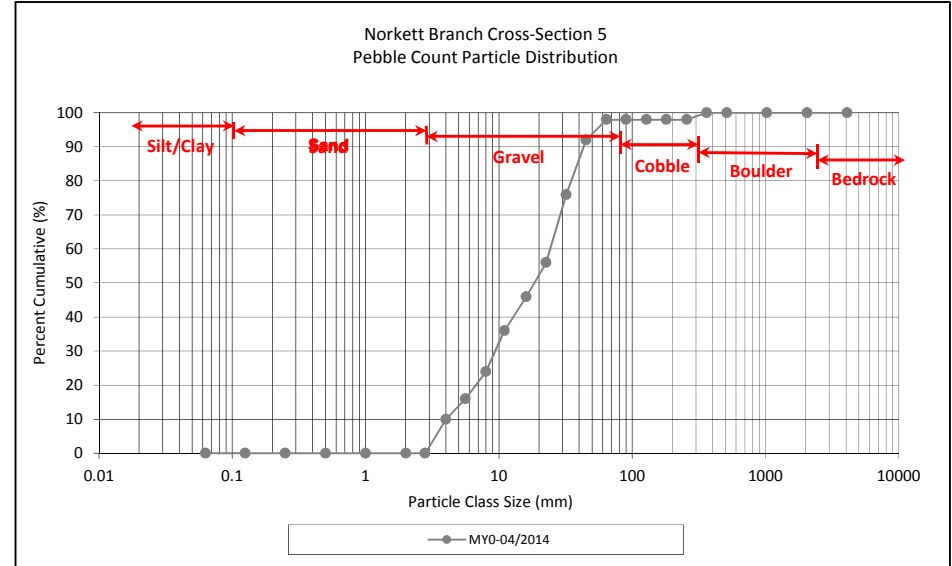
Reachwide and Cross-Section Substrate Plots
 Norkett Branch Stream Mitigation Site (NCEEP Project No. 95360)
 Norkett Branch Reach 1, Cross-Section 5
 Monitoring Year 0

Cross-Section 5	
Channel materials (mm)	
D ₁₆ =	5.6
D ₃₅ =	10.7
D ₅₀ =	18.4
D ₈₄ =	37.9
D ₉₅ =	53.7
D ₁₀₀ =	362.0

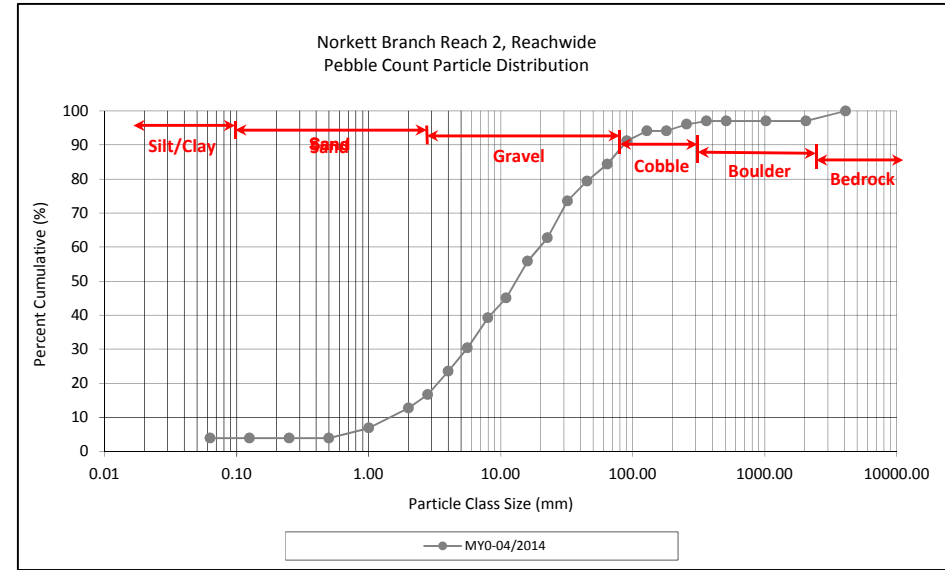
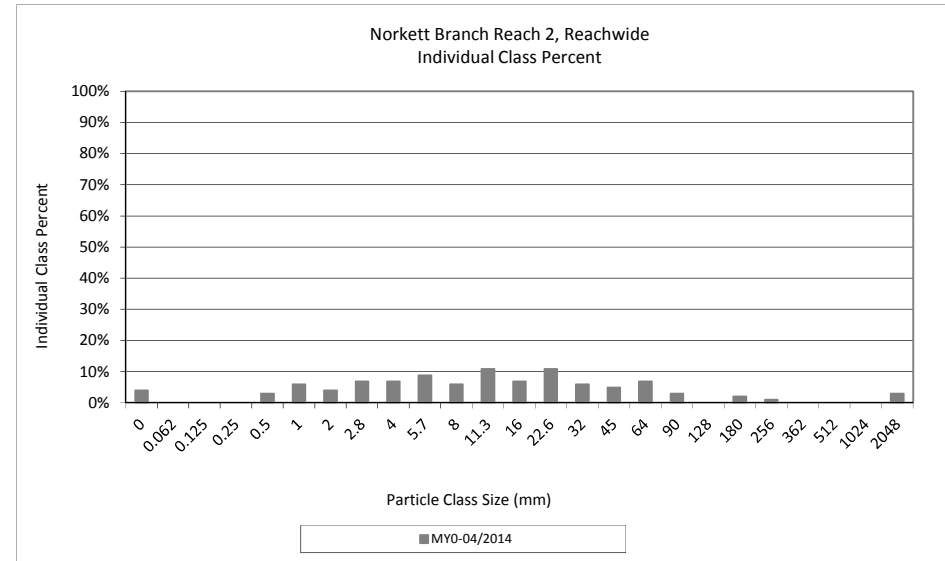
Reachwide and Cross-Section Pebble Count Plots
 Norkett Branch Stream Mitigation Site (NCEEP Project No. 95360)
 Norkett Branch Reach 2, Reachwide
 Monitoring Year 0

Reachwide Channel materials (mm)	
D ₁₆ =	2.6
D ₃₅ =	6.7
D ₅₀ =	13.0
D ₈₄ =	62.6
D ₉₅ =	210.9
D ₁₀₀ =	>2048

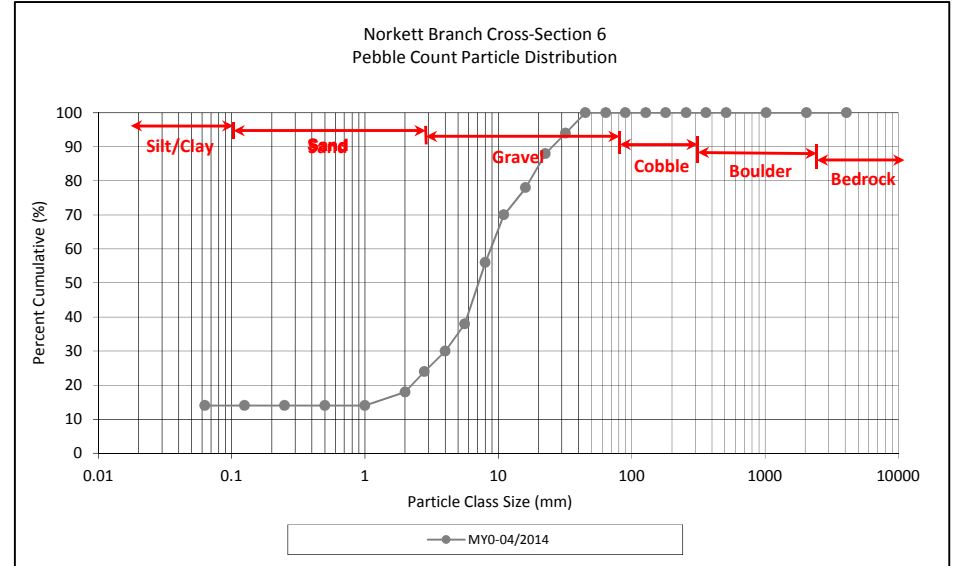
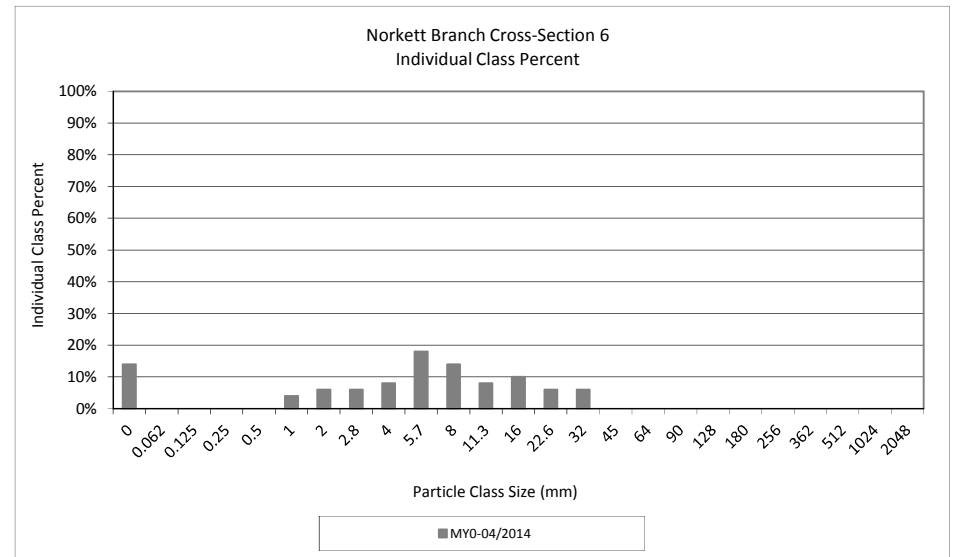
Reachwide and Cross-Section Substrate Plots
 Norkett Branch Stream Mitigation Site (NCEP Project No. 95360)
 Norkett Branch Reach 2, Cross-Section 6
 Monitoring Year 0

Cross-Section 1	
Channel materials (mm)	
D ₁₆ =	1.5
D ₃₅ =	5.2
D ₅₀ =	7.3
D ₈₄ =	21.5
D ₉₅ =	39.8
D ₁₀₀ =	>2048

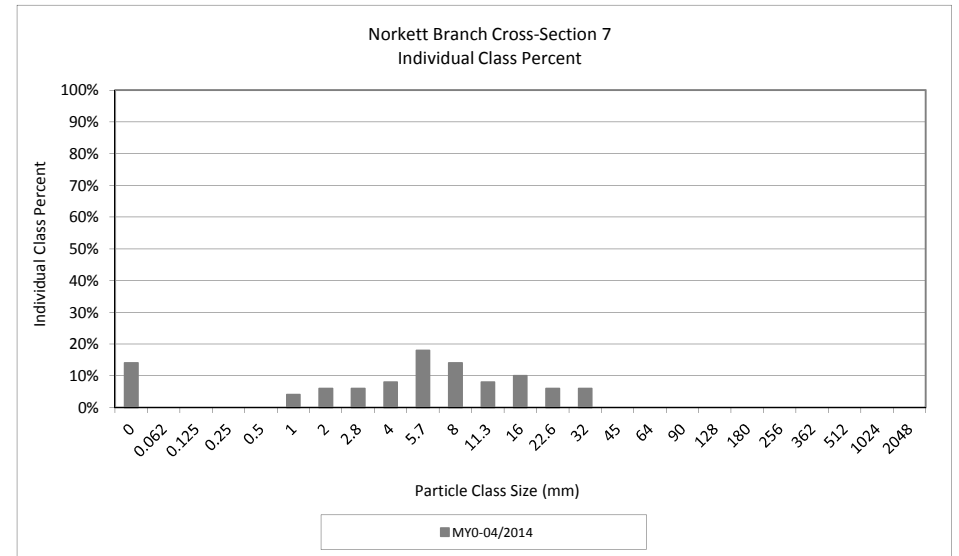
Reachwide and Cross-Section Substrate Plots
 Norkett Branch Stream Mitigation Site (NCEEP Project No. 95360)
 Norkett Branch Reach 2, Cross-Section 7
 Monitoring Year 0

Cross-Section 1	
Channel materials (mm)	
D ₁₆ =	3.1
D ₃₅ =	5.5
D ₅₀ =	9.9
D ₈₄ =	34.8
D ₉₅ =	60.4
D ₁₀₀ =	128.0

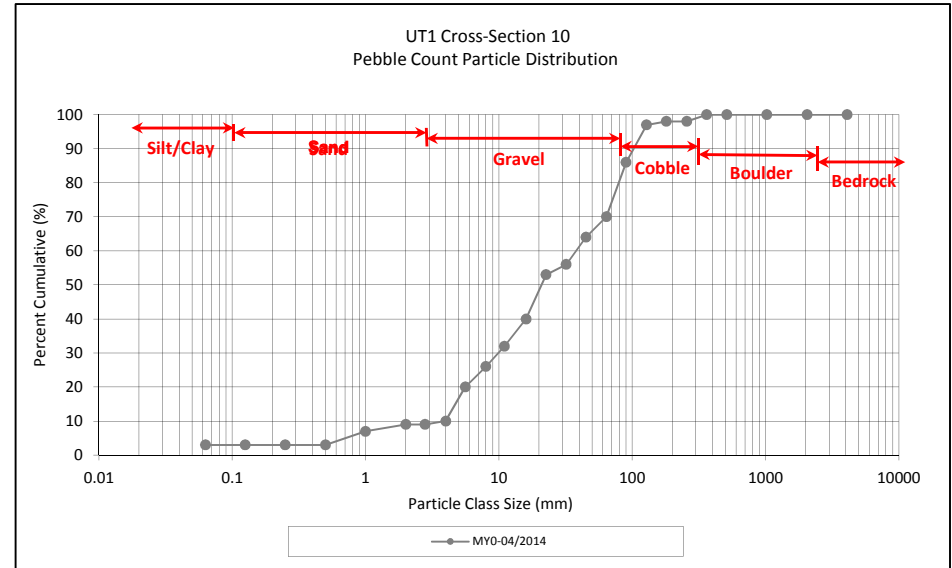
Reachwide and Cross-Section Substrate Plots
 Norkett Branch Stream Mitigation Site (NCEP Project No. 95360)
 UT1, Cross-Section 10
 Monitoring Year 0

Particle Class		Diameter (mm)		Particle Count	Cross-Section 10 Summary	
		min	max		Class Percentage	Percent Cumulative
SILT/CLAY	Silt/Clay	0.000	0.062	3	3	3
SAND	Very fine	0.062	0.125			3
	Fine	0.125	0.250			3
	Medium	0.250	0.500			3
	Coarse	0.5	1.0	4	4	7
	Very Coarse	1.0	2.0	2	2	9
GRAVEL	Very Fine	2.0	2.8			9
	Very Fine	2.8	4.0	1	1	10
	Fine	4.0	5.7	10	10	20
	Fine	5.7	8.0	6	6	26
	Medium	8.0	11.3	6	6	32
	Medium	11.3	16.0	8	8	40
	Coarse	16.0	22.6	13	13	53
	Coarse	22.6	32	3	3	56
	Very Coarse	32	45	8	8	64
	Very Coarse	45	64	6	6	70
COBBLE	Small	64	90	16	16	86
	Small	90	128	11	11	97
	Large	128	180	1	1	98
	Large	180	256			98
BOULDER	Small	256	362	2	2	100
	Small	362	512			
	Medium	512	1024			
	Large/Very Large	1024	2048			
BEDROCK	Bedrock	2048	>2048			
Total				100	100	100

Cross-Section 10	
Channel materials (mm)	
D ₁₆ =	4.9
D ₃₅ =	12.7
D ₅₀ =	20.9
D ₈₄ =	86.2
D ₉₅ =	120.1
D ₁₀₀ =	362.0

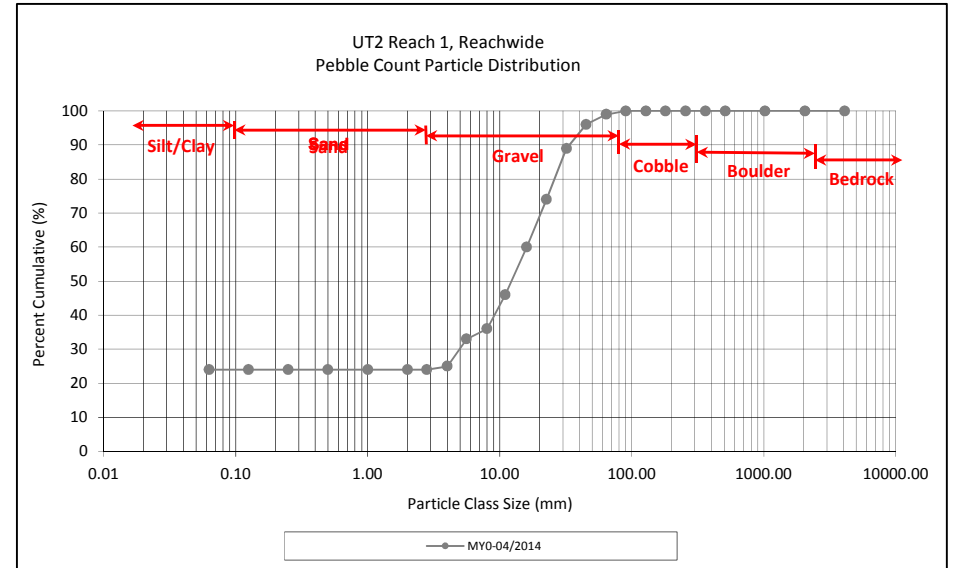
Reachwide and Cross-Section Pebble Count Plots
 Norkett Branch Stream Mitigation Site (NCEEP Project No. 95360)
 UT2 Reach 1, Reachwide
 Monitoring Year 0

Particle Class		Diameter (mm)		Particle Count			UT2 Reach 1 Summary	
		min	max	Riffle	Pool	Total	Class Percentage	Percent Cumulative
SILT/CLAY	Silt/Clay	0.000	0.062	4	20	24	24	24
SAND	Very fine	0.062	0.125			0	0	24
	Fine	0.125	0.250			0	0	24
	Medium	0.250	0.500			0	0	24
	Coarse	0.5	1.0			0	0	24
	Very Coarse	1.0	2.0			0	0	24
GRAVEL	Very Fine	2.0	2.8			0	0	24
	Very Fine	2.8	4.0		1	1	1	25
	Fine	4.0	5.7	2	6	8	8	33
	Fine	5.7	8.0	2	1	3	3	36
	Medium	8.0	11.3	5	5	10	10	46
	Medium	11.3	16.0	7	7	14	14	60
	Coarse	16.0	22.6	13	1	14	14	74
	Coarse	22.6	32	8	7	15	15	89
	Very Coarse	32	45	6	1	7	7	96
	Very Coarse	45	64	2	1	3	3	99
COBBLE	Small	64	90	1		1	1	100
	Small	90	128					
	Large	128	180					
	Large	180	256					
BOULDER	Small	256	362					
	Small	362	512					
	Medium	512	1024					
BEDROCK	Large/Very Large	1024	2048					
	Bedrock	2048	>2048					
Total				50	50	100	100	100

Reachwide Channel materials (mm)	
D ₁₆ =	Silt/Clay
D ₃₅ =	7.1
D ₅₀ =	12.2
D ₈₄ =	28.5
D ₉₅ =	42.9
D ₁₀₀ =	90.0

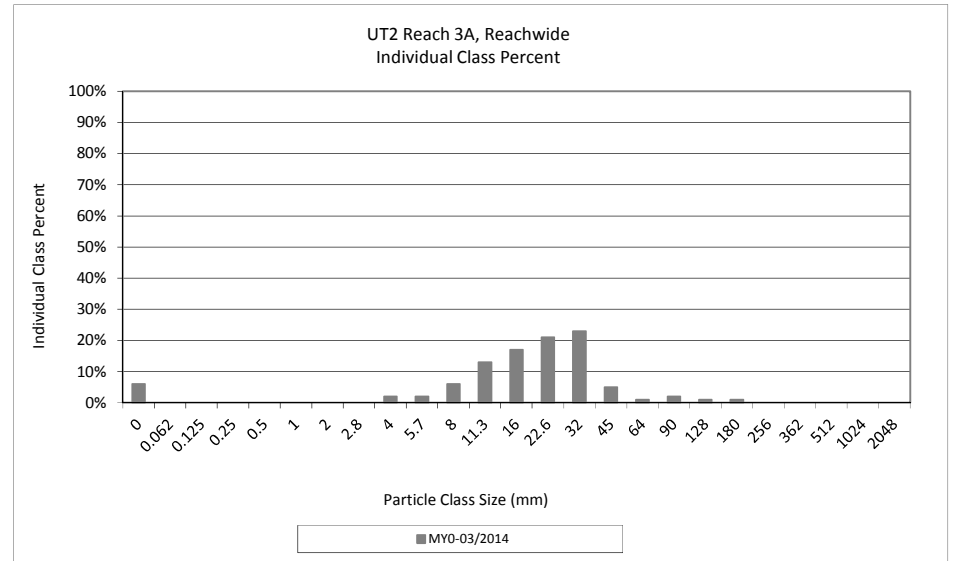
Reachwide and Cross-Section Pebble Count Plots
 Norkett Branch Stream Mitigation Site (NCEEP Project No. 95360)
 UT2 Reach 3a, Reachwide
 Monitoring Year 0

Particle Class		Diameter (mm)		Particle Count			UT2 Reach 3A Summary	
		min	max	Riffle	Pool	Total	Class Percentage	Percent Cumulative
SILT/CLAY	Silt/Clay	0.000	0.062	2	4	6	6	6
SAND	Very fine	0.062	0.125			0	0	6
	Fine	0.125	0.250			0	0	6
	Medium	0.250	0.500			0	0	6
	Coarse	0.5	1.0			0	0	6
	Very Coarse	1.0	2.0			0	0	6
GRAVEL	Very Fine	2.0	2.8			0	0	6
	Very Fine	2.8	4.0			0	0	6
	Fine	4.0	5.7		2	2	2	8
	Fine	5.7	8.0		2	2	2	10
	Medium	8.0	11.3	3	3	6	6	16
	Medium	11.3	16.0	3	10	13	13	29
	Coarse	16.0	22.6	11	6	17	17	46
	Coarse	22.6	32	11	10	21	21	67
	Very Coarse	32	45	15	8	23	23	90
	Very Coarse	45	64	2	3	5	5	95
COBBLE	Small	64	90		1	1	1	96
	Small	90	128	1	1	2	2	98
	Large	128	180	1		1	1	99
	Large	180	256	1	1	1	1	100
BOULDER	Small	256	362					
	Small	362	512					
	Medium	512	1024					
	Large/Very Large	1024	2048					
BEDROCK	Bedrock	2048	>2048					
Total				50	50	100	100	100

Reachwide Channel materials (mm)	
D ₁₆ =	11.0
D ₃₅ =	18.1
D ₅₀ =	24.1
D ₈₄ =	41.2
D ₉₅ =	64.0
D ₁₀₀ =	256.0

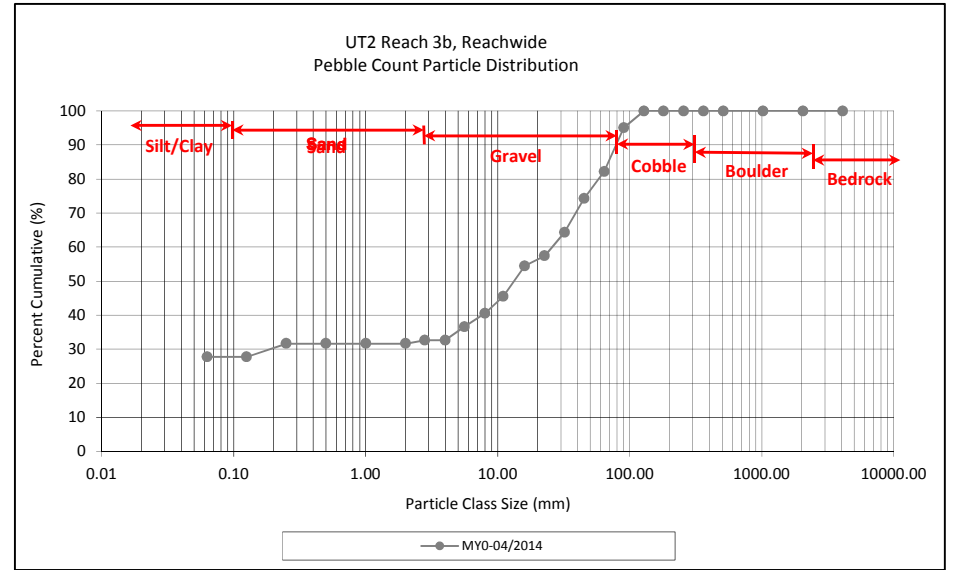
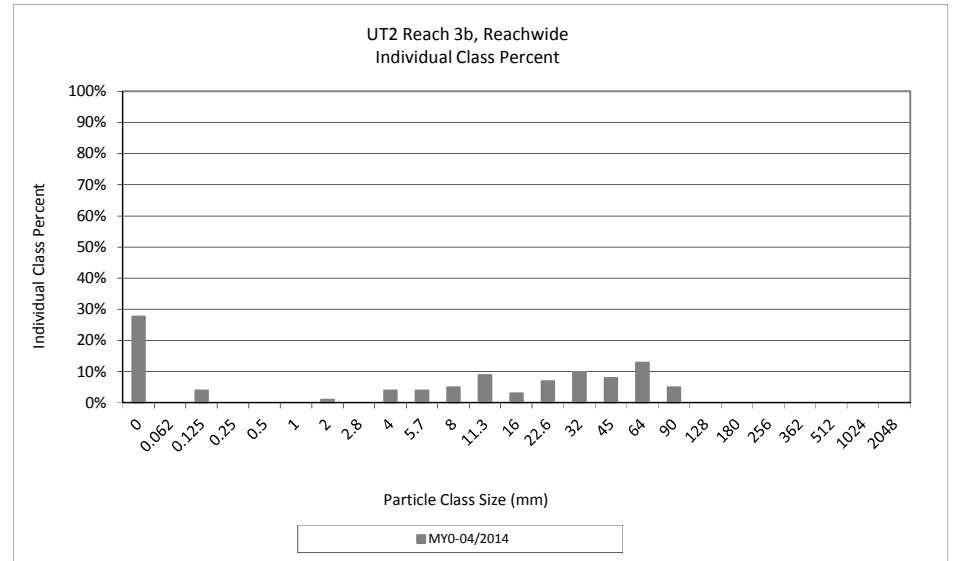
Reachwide and Cross-Section Pebble Count Plots
 Norkett Branch Stream Mitigation Site (NCEEP Project No. 95360)
 UT2 Reach 3b, Reachwide
 Monitoring Year 0

Particle Class		Diameter (mm)		Particle Count			BC2 Reach Summary	
		min	max	Riffle	Pool	Total	Class Percentage	Percent Cumulative
SILT/CLAY	Silt/Clay	0.000	0.062	8	20	28	28	28
SAND	Very fine	0.062	0.125			0	0	28
	Fine	0.125	0.250		4	4	4	32
	Medium	0.250	0.500			0	0	32
	Coarse	0.5	1.0			0	0	32
	Very Coarse	1.0	2.0			0	0	32
GRAVEL	Very Fine	2.0	2.8	1		1	1	33
	Very Fine	2.8	4.0			0	0	33
	Fine	4.0	5.7	2	2	4	4	37
	Fine	5.7	8.0	3	1	4	4	41
	Medium	8.0	11.3	5		5	5	46
	Medium	11.3	16.0	7	2	9	9	54
	Coarse	16.0	22.6	1	2	3	3	57
	Coarse	22.6	32	3	4	7	7	64
	Very Coarse	32	45	4	6	10	10	74
	Very Coarse	45	64	5	3	8	8	82
COBBLE	Small	64	90	10	3	13	13	95
	Small	90	128	2	3	5	5	100
	Large	128	180					
	Large	180	256					
BOULDER	Small	256	362					
	Small	362	512					
	Medium	512	1024					
BEDROCK	Large/Very Large	1024	2048					
	Bedrock	2048	>2048					
Total				51	50	101	100	100

Reachwide Channel materials (mm)	
D ₁₆ =	Silt/Clay
D ₃₅ =	4.9
D ₅₀ =	13.3
D ₈₄ =	67.2
D ₉₅ =	89.9
D ₁₀₀ =	128.0

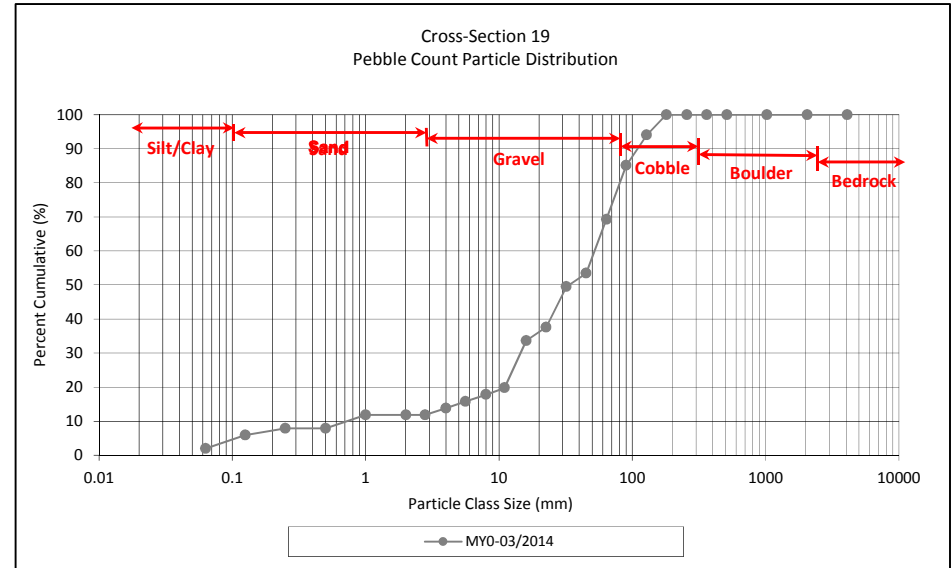
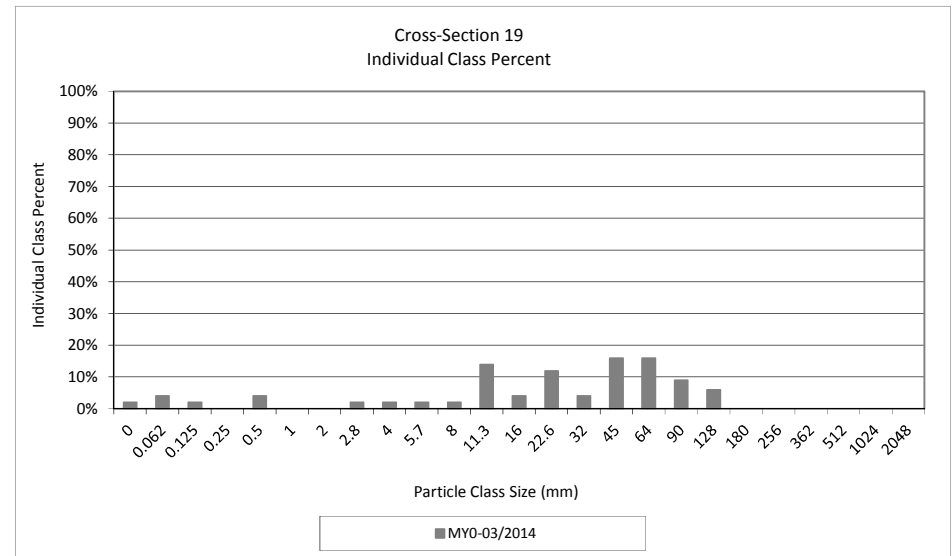
Reachwide and Cross-Section Substrate Plots
 Norkett Branch Stream Mitigation Site (NCEP Project No. 95360)
 UT2 Reach 3b, Cross-Section 19
 Monitoring Year 0

Particle Class		Diameter (mm)		Particle Count	Cross-Section 1 Summary	
		min	max		Class Percentage	Percent Cumulative
SILT/CLAY	Silt/Clay	0.000	0.062	2	2	2
SAND	Very fine	0.062	0.125	4	4	6
	Fine	0.125	0.250	2	2	8
	Medium	0.250	0.500			8
	Coarse	0.5	1.0	4	4	12
	Very Coarse	1.0	2.0			12
GRAVEL	Very Fine	2.0	2.8			12
	Very Fine	2.8	4.0	2	2	14
	Fine	4.0	5.7	2	2	16
	Fine	5.7	8.0	2	2	18
	Medium	8.0	11.3	2	2	20
	Medium	11.3	16.0	14	14	34
	Coarse	16.0	22.6	4	4	38
	Coarse	22.6	32	12	12	50
	Very Coarse	32	45	4	4	53
	Very Coarse	45	64	16	16	69
COBBLE	Small	64	90	16	16	85
	Small	90	128	9	9	94
	Large	128	180	6	6	100
	Large	180	256			
BOULDER	Small	256	362			
	Small	362	512			
BOULDER	Medium	512	1024			
	Large/Very Large	1024	2048			
BEDROCK	Bedrock	2048	>2048			
Total				101	100	100

Cross-Section 18	
Channel materials (mm)	
D ₁₆ =	5.8
D ₃₅ =	18.0
D ₅₀ =	33.4
D ₈₄ =	87.8
D ₉₅ =	135.1
D ₁₀₀ =	180.0

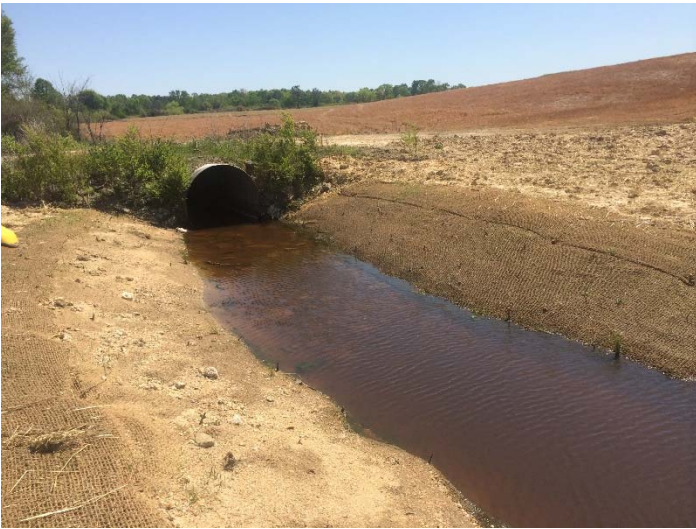
Photo Point 1 – looking upstream (04/23/2014)

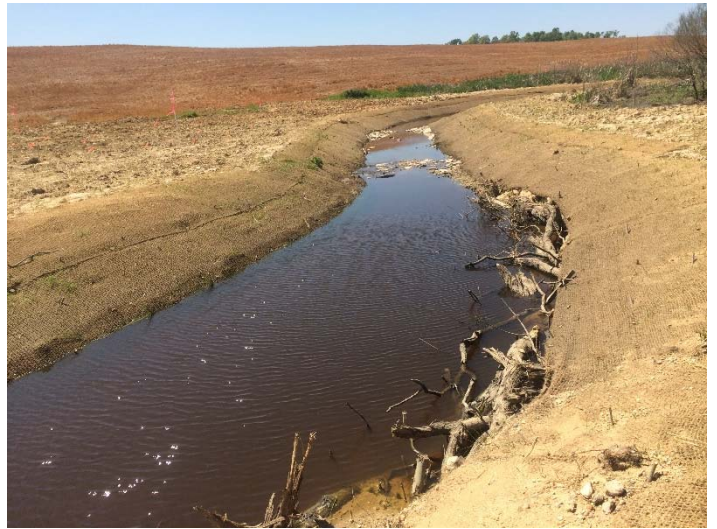
Photo Point 1 – looking downstream (04/23/2014)

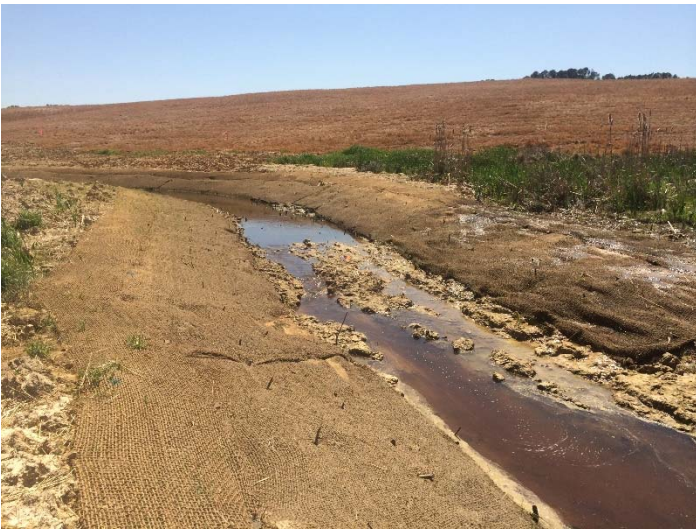
Photo Point 2 – looking upstream (04/23/2014)

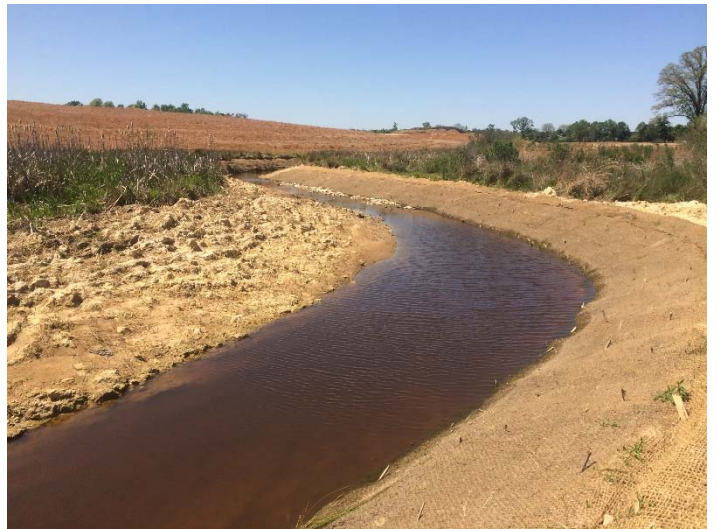
Photo Point 2 – looking downstream (04/23/2014)

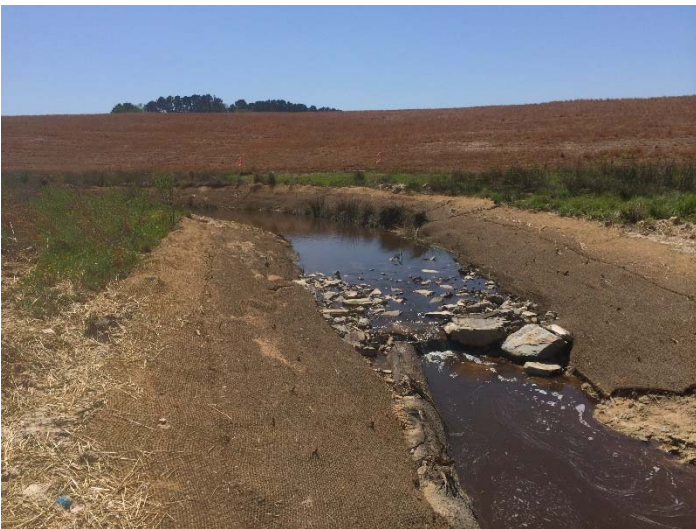
Photo Point 3 – looking upstream (04/23/2014)

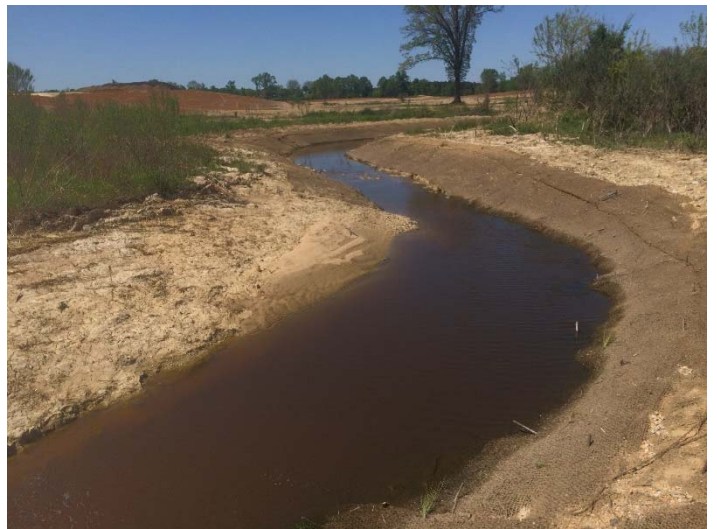
Photo Point 3 – looking downstream (04/23/2014)

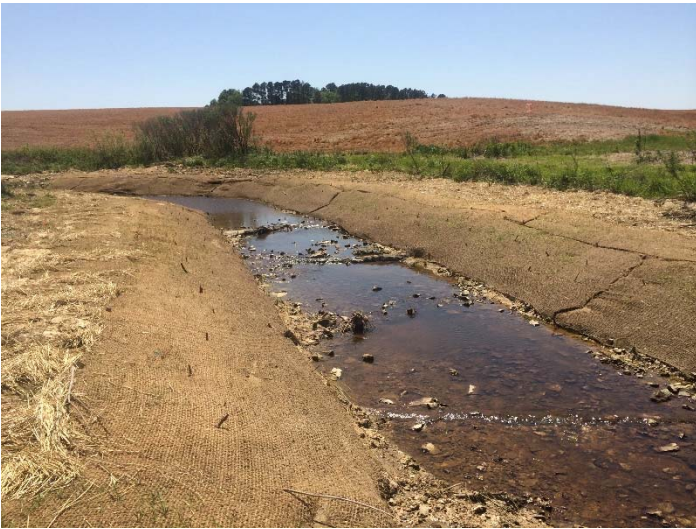
Photo Point 4 – looking upstream (04/23/2014)

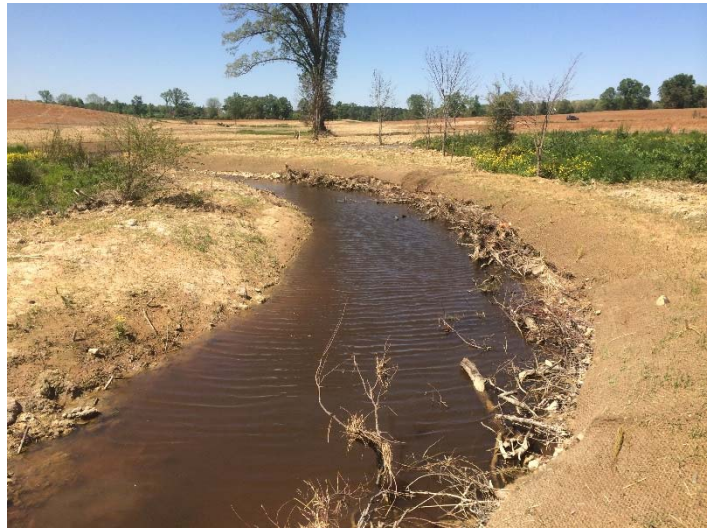
Photo Point 4 – looking downstream (04/23/2014)

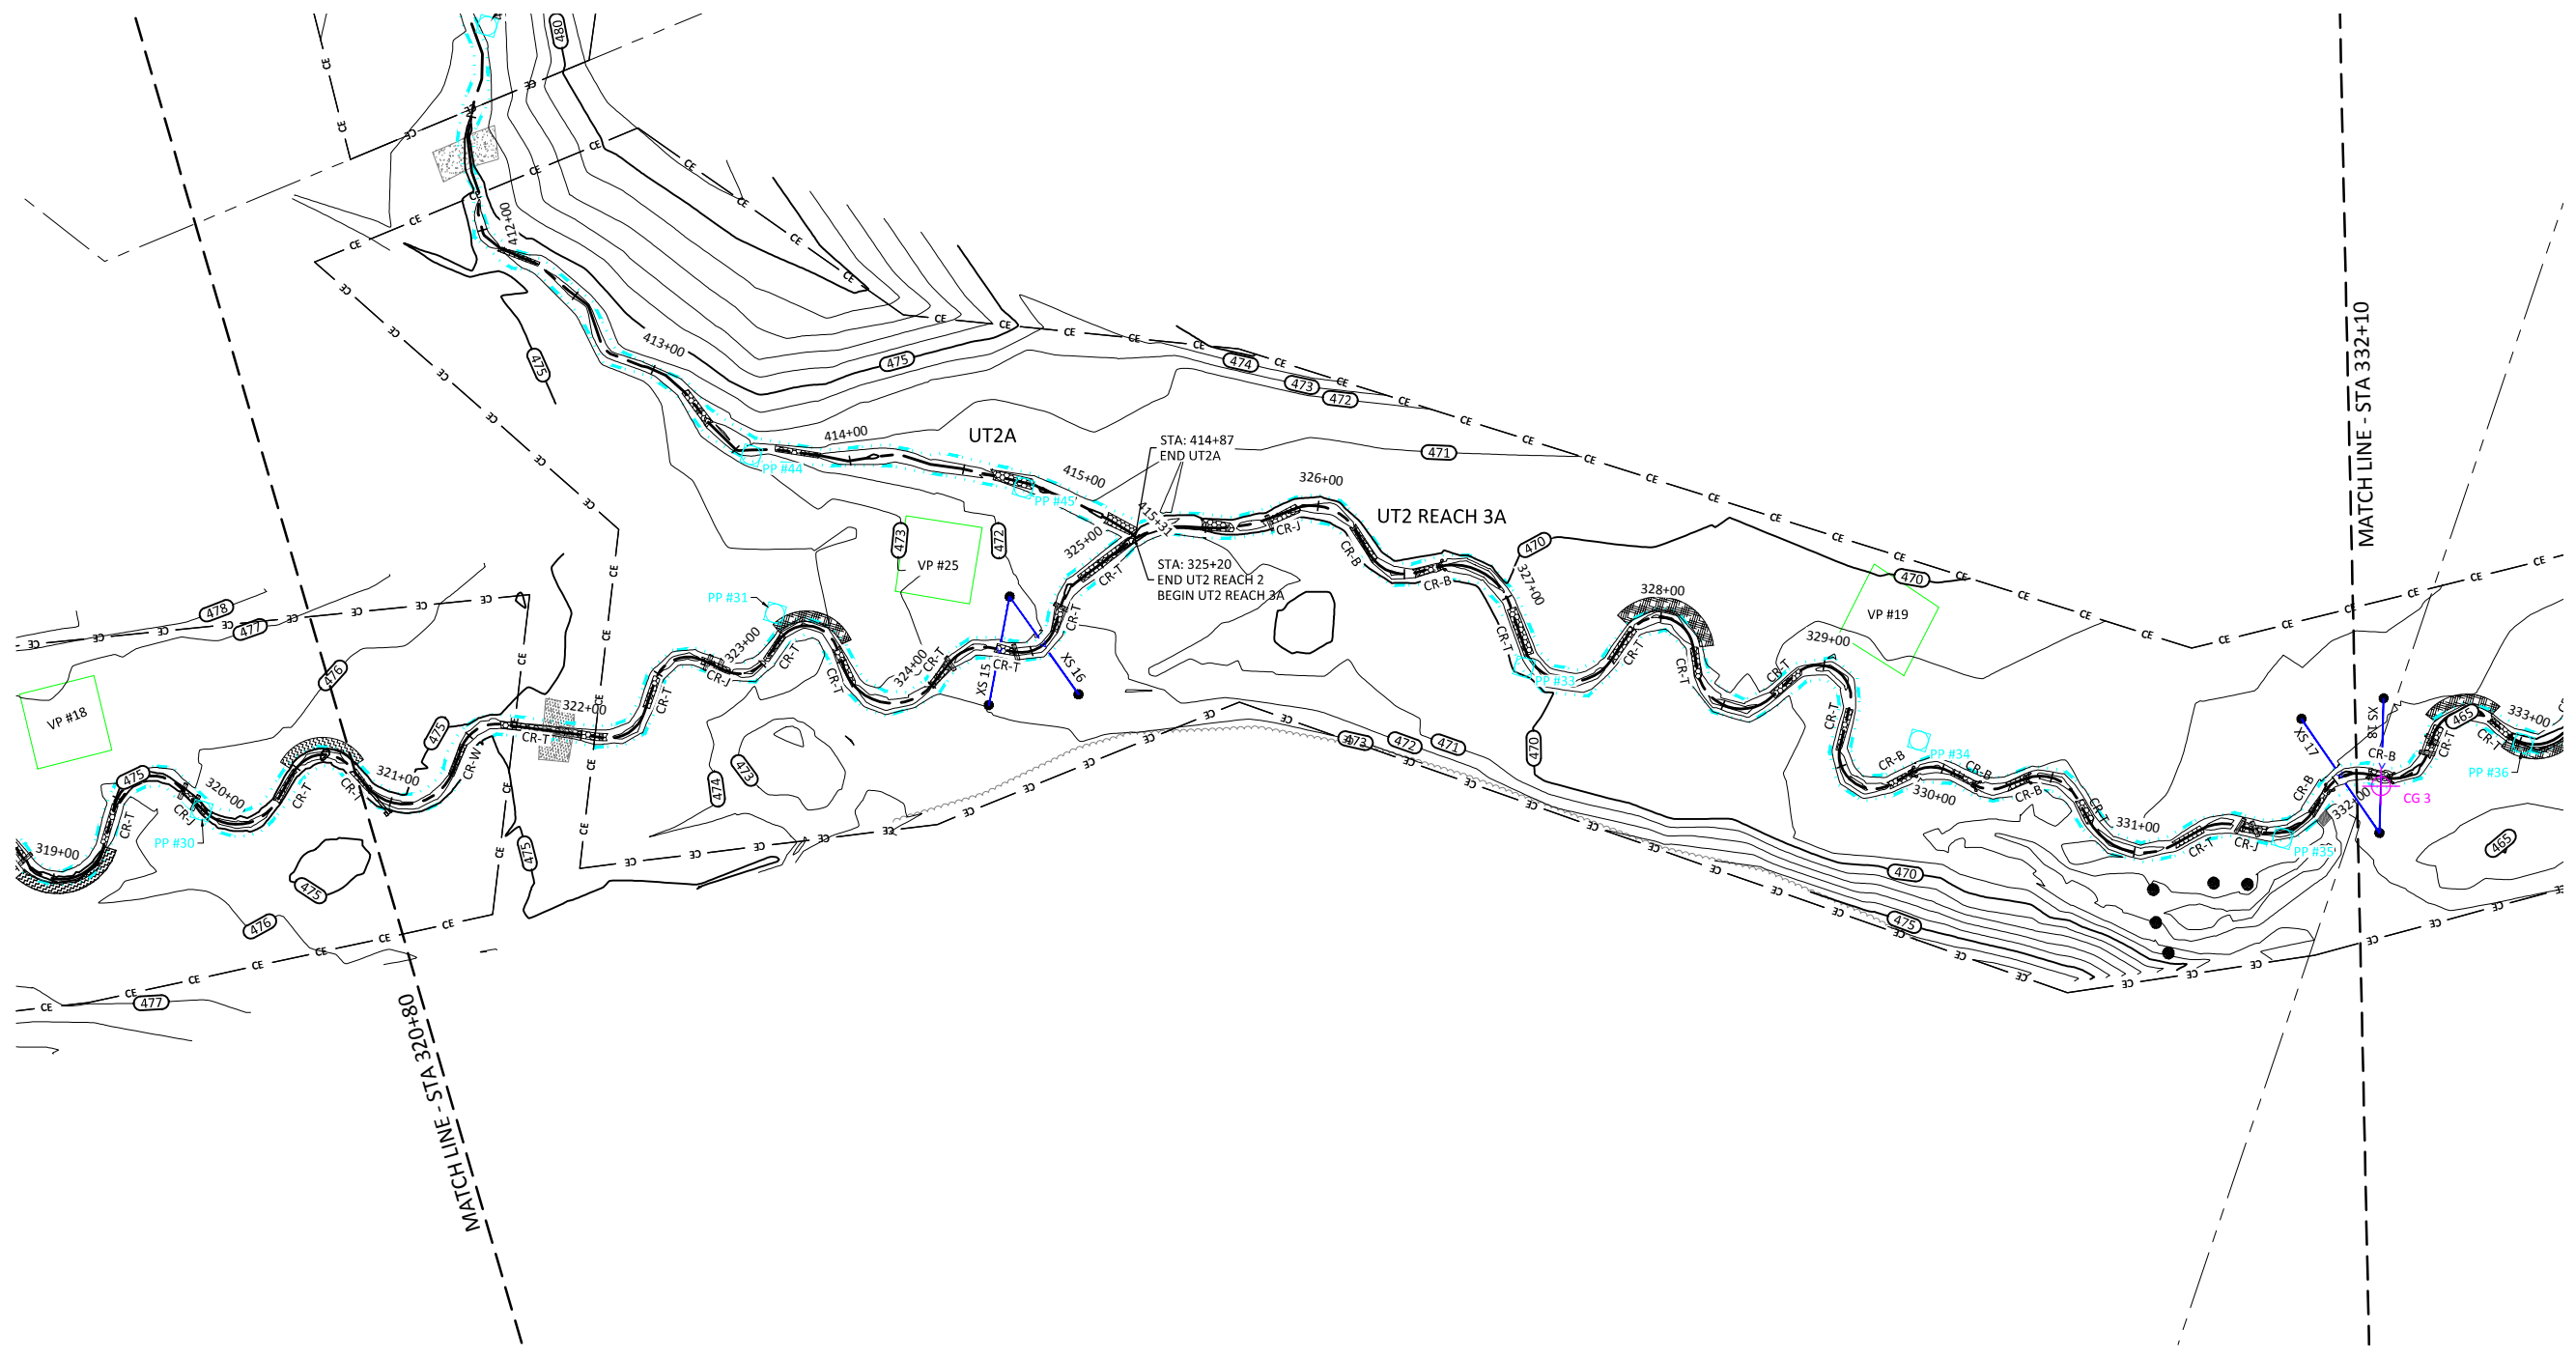
Norkett Branch Stream Mitigation Site
Union County, North Carolina
UT2 Reach 2 & Reach 3A
Baseline Drawings
