NORTH FORK MOUNTAIN CREEK
STREAM AND WETLAND RESTORATION

FINAL BASELINE MONITORING DOCUMENT AND AS-BUILT
BASELINE REPORT

Catawba County, North Carolina
EEP Project No. 94151

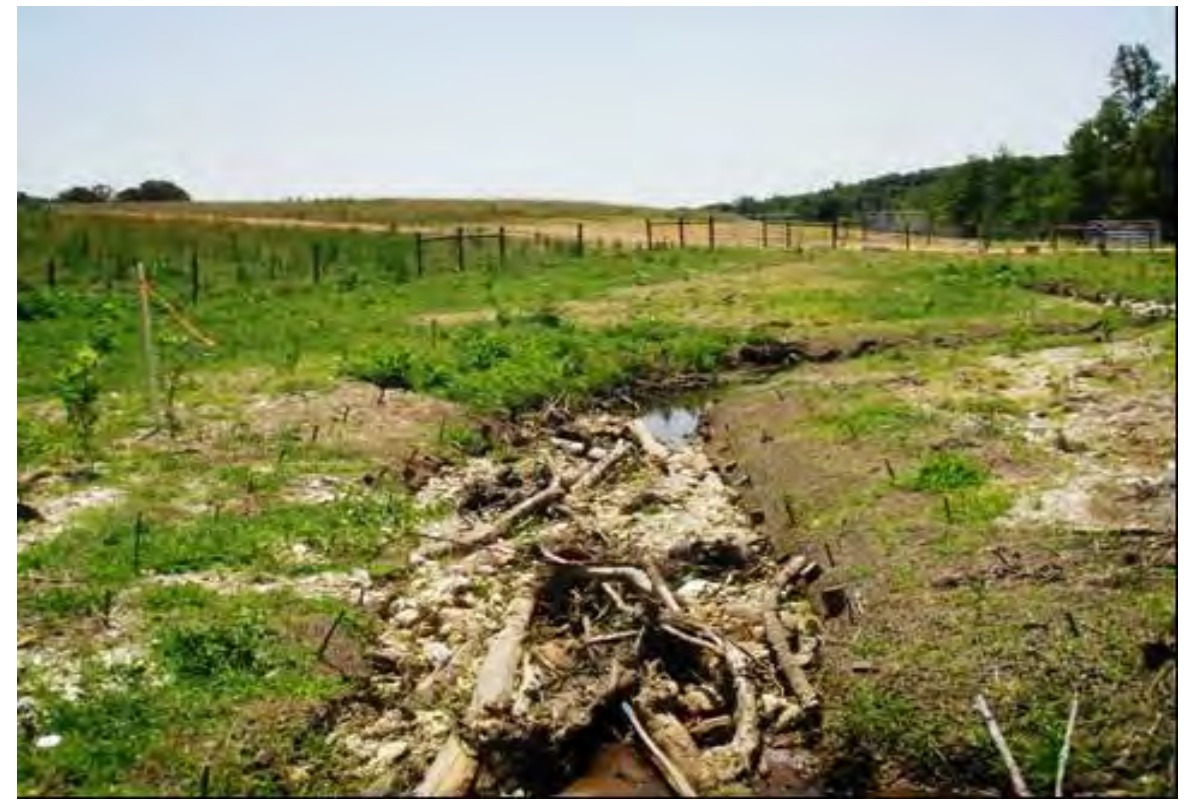
North Fork Mountain Creek - Reach 1
X-Section 1 Riffle, Station 101+45

Sta. 101+45 Looking Downstream

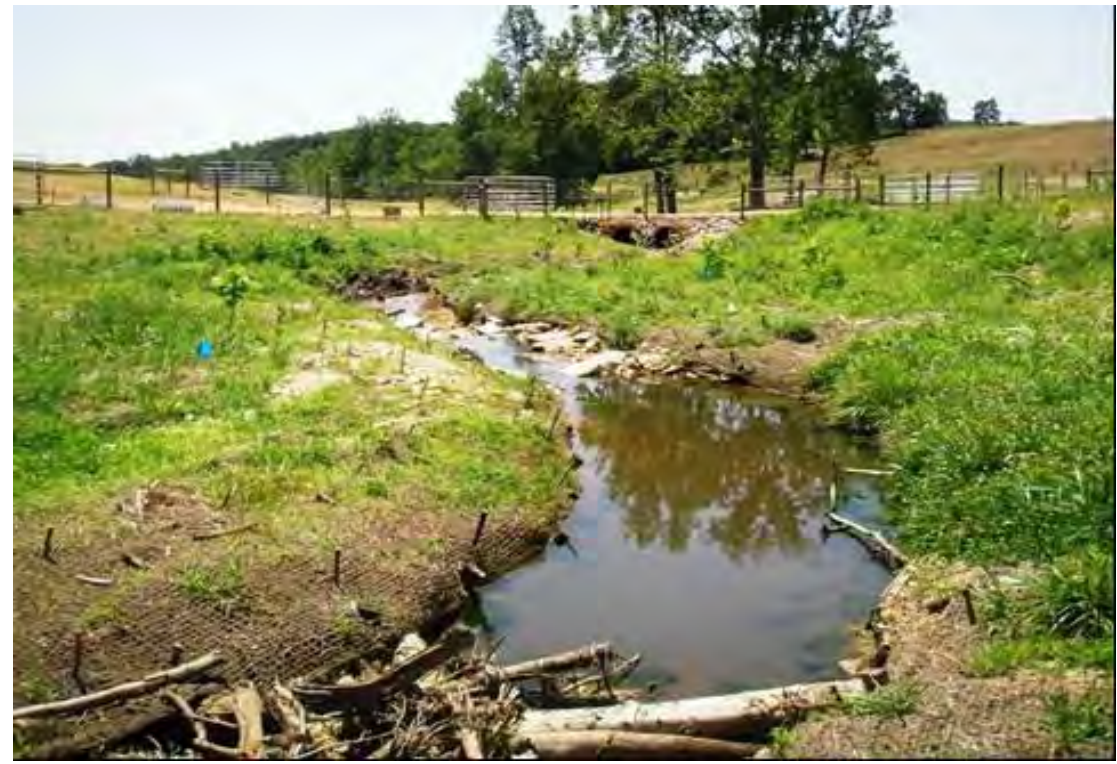
North Fork Mountain Creek - Reach 1
X-Section 2 Pool, Station 102+04

Sta. 102+04 Looking Downstream

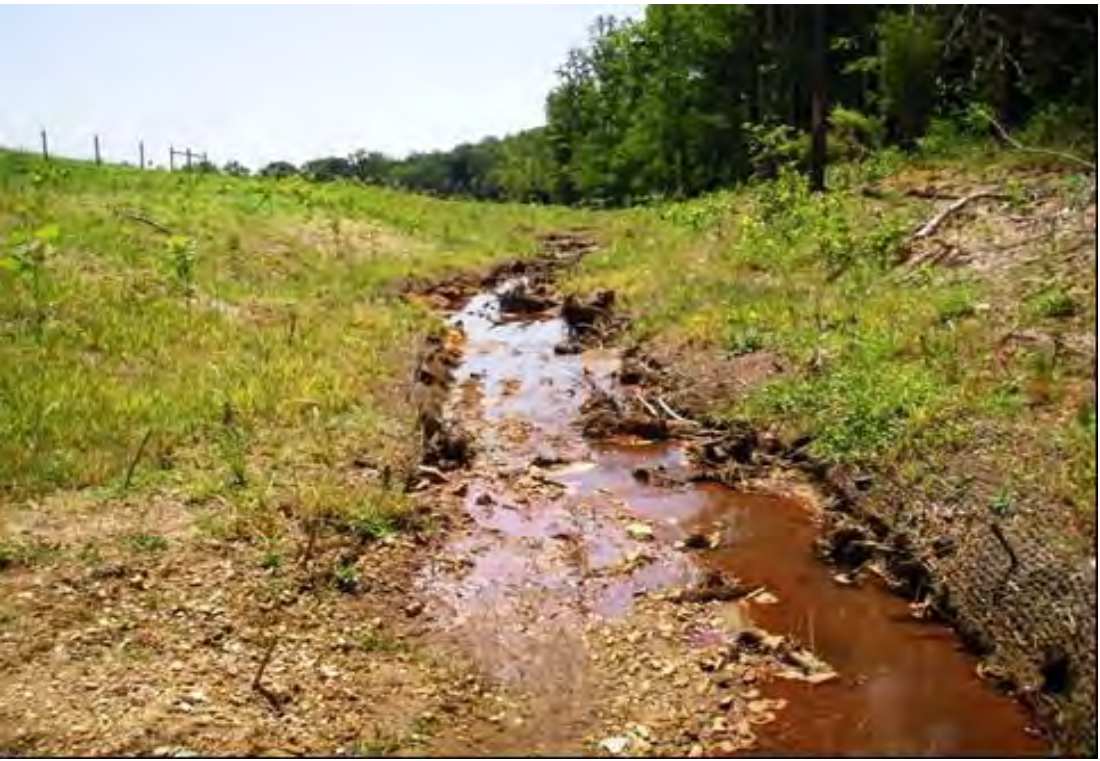
North Fork Mountain Creek - Reach 2
X-Section 3 Riffle, Station 107+28

Sta. 107+28 Looking Downstream

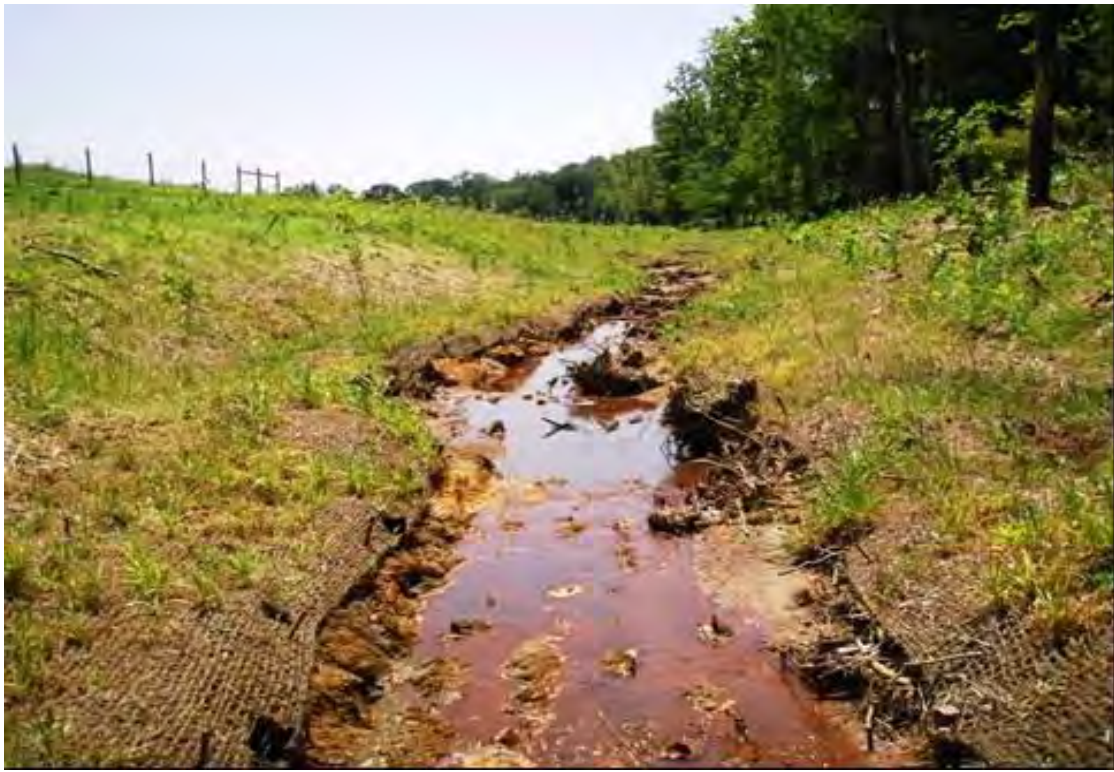
North Fork Mountain Creek - Reach 2
X-Section 4 Pool, Station 107+60

Sta. 107+60 Looking Downstream

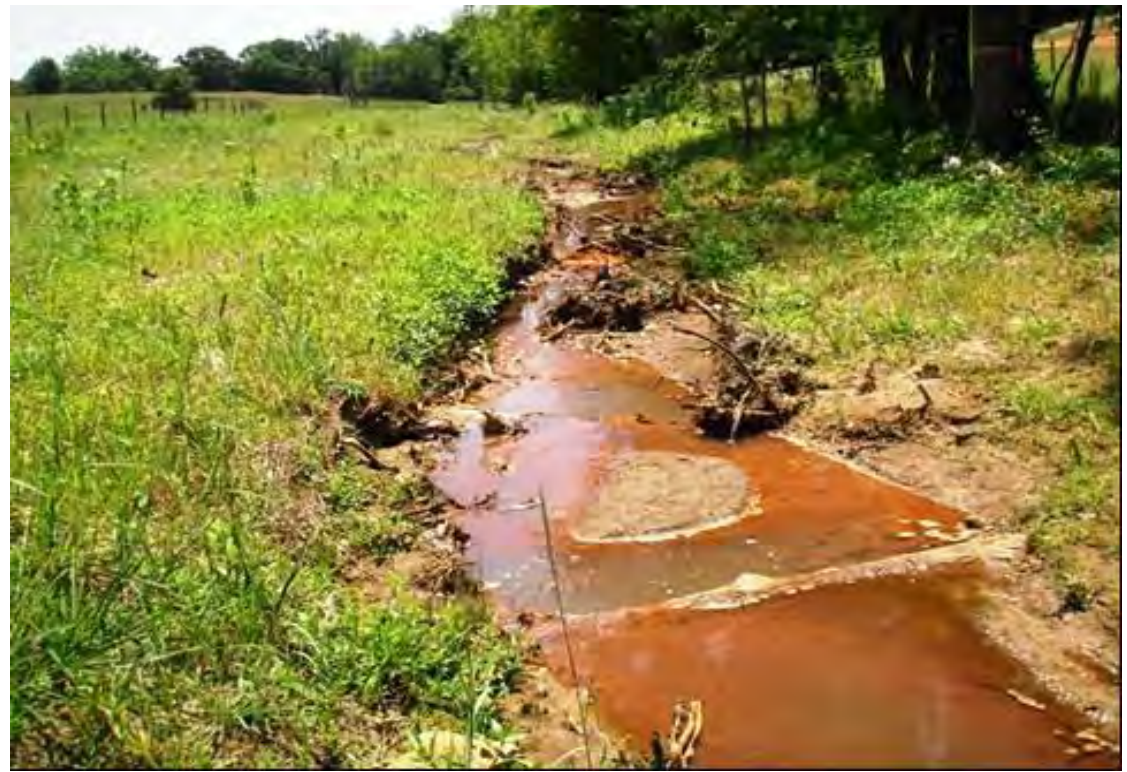
**North Fork Mountain Creek - Reach 2
X-Section 5 Pool, Station 112+05**

Sta. 112+05 Looking Downstream

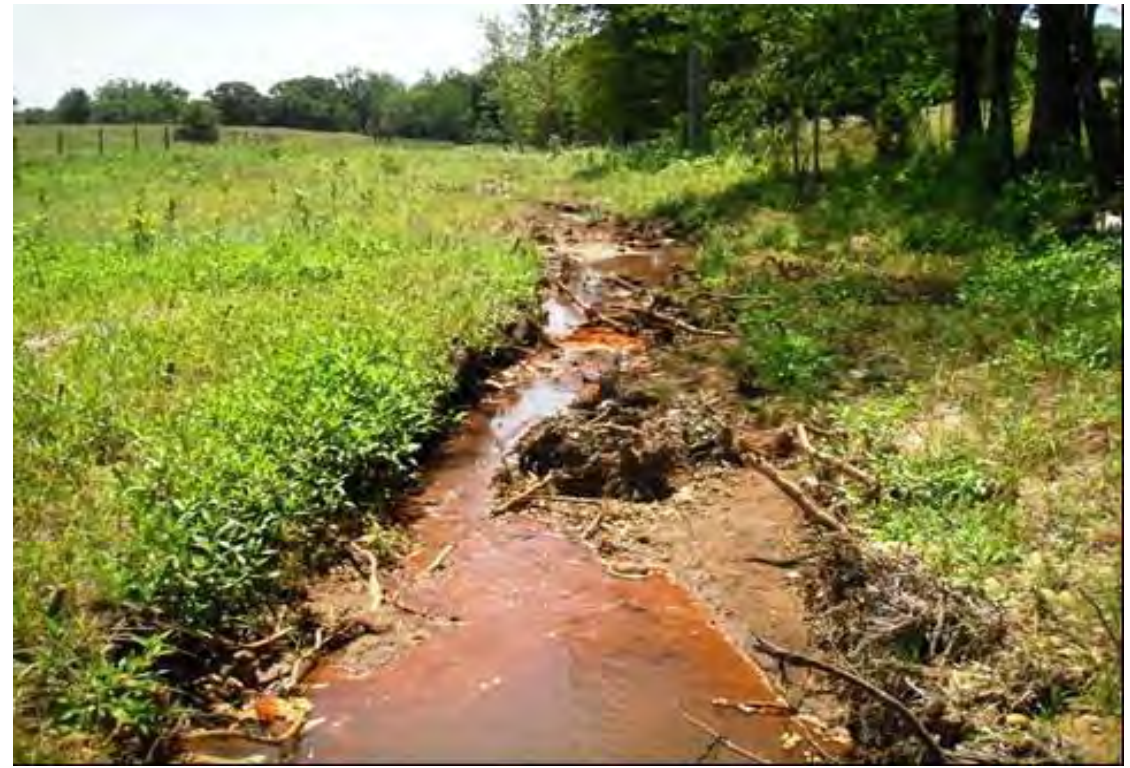
North Fork Mountain Creek - Reach 2
X-Section 6 Riffle, Station 112+22

Sta. 112+22 Looking Downstream

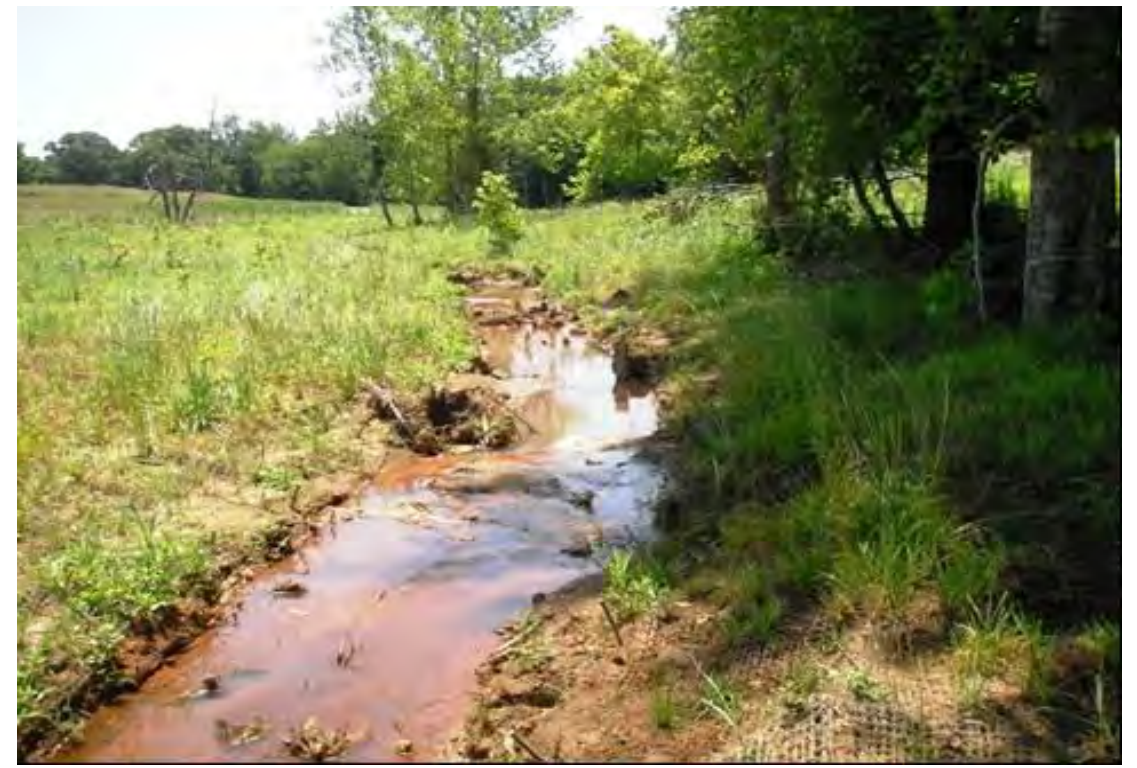
North Fork Mountain Creek - Reach 2
X-Section 7 Pool, Station 114+55

Sta. 114+55 Looking Downstream

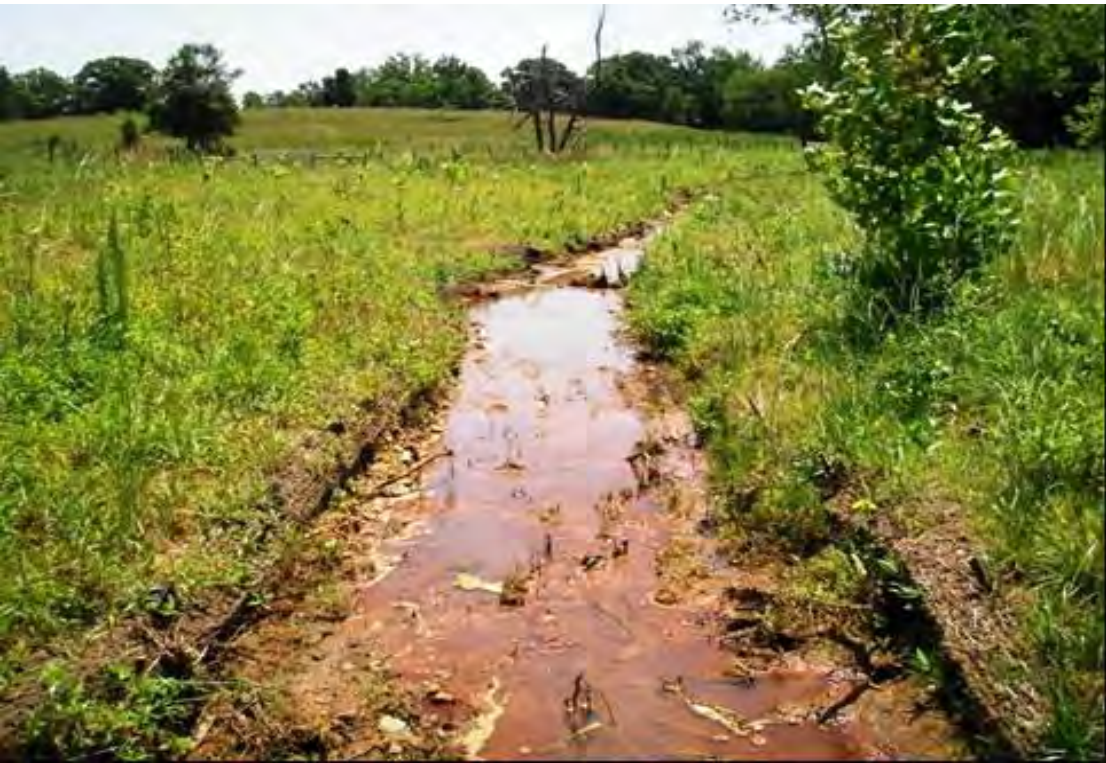
Sta. 115+16 Looking Downstream

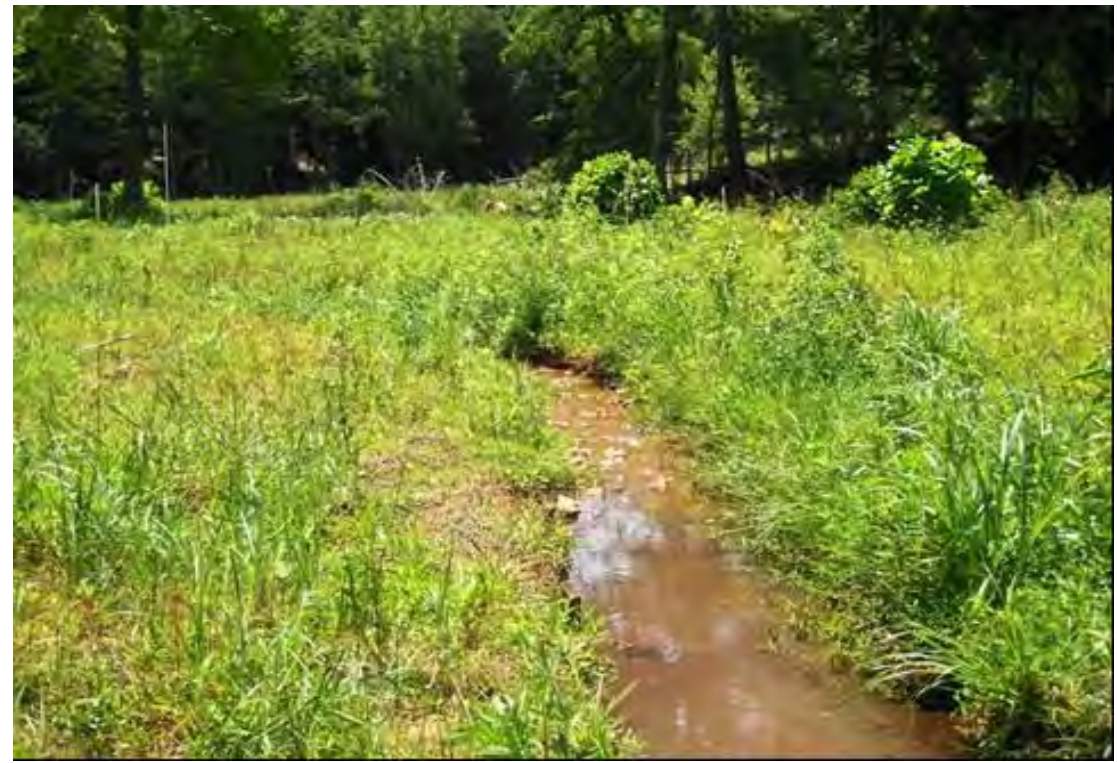
North Fork Mountain Creek - Reach 2
X-Section 9 Riffle, Station 117+94

Sta. 117+94 Looking Downstream

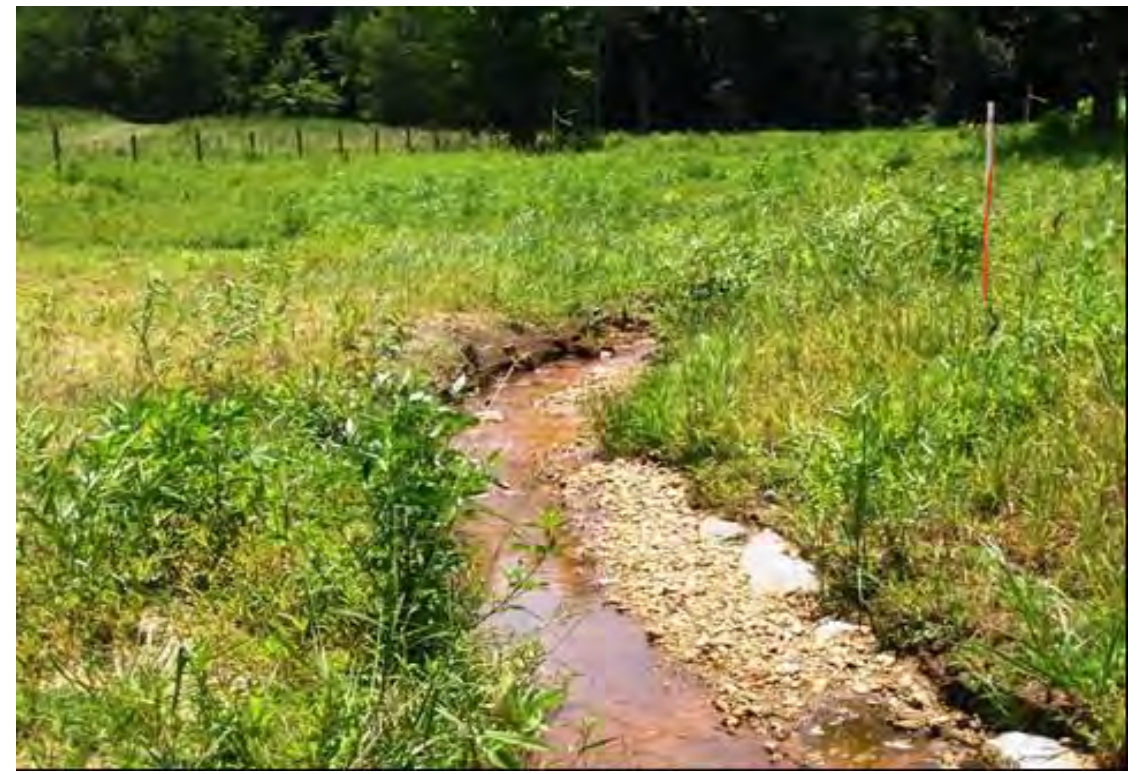
**North Fork Mountain Creek - Reach 2
X-Section 10 Pool, Station 118+53**

Sta. 118+53 Looking Downstream

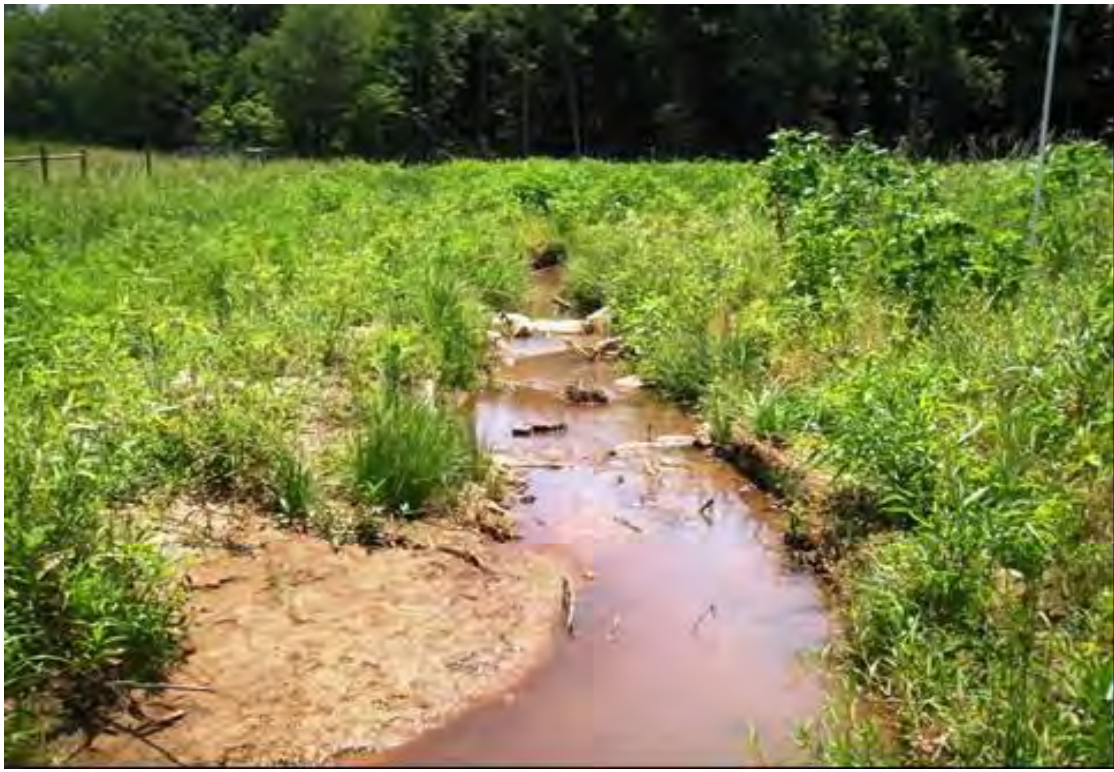
North Fork Mountain Creek - Reach 2
X-Section 11 Riffle, Station 120+73

Sta. 120+73 Looking Downstream

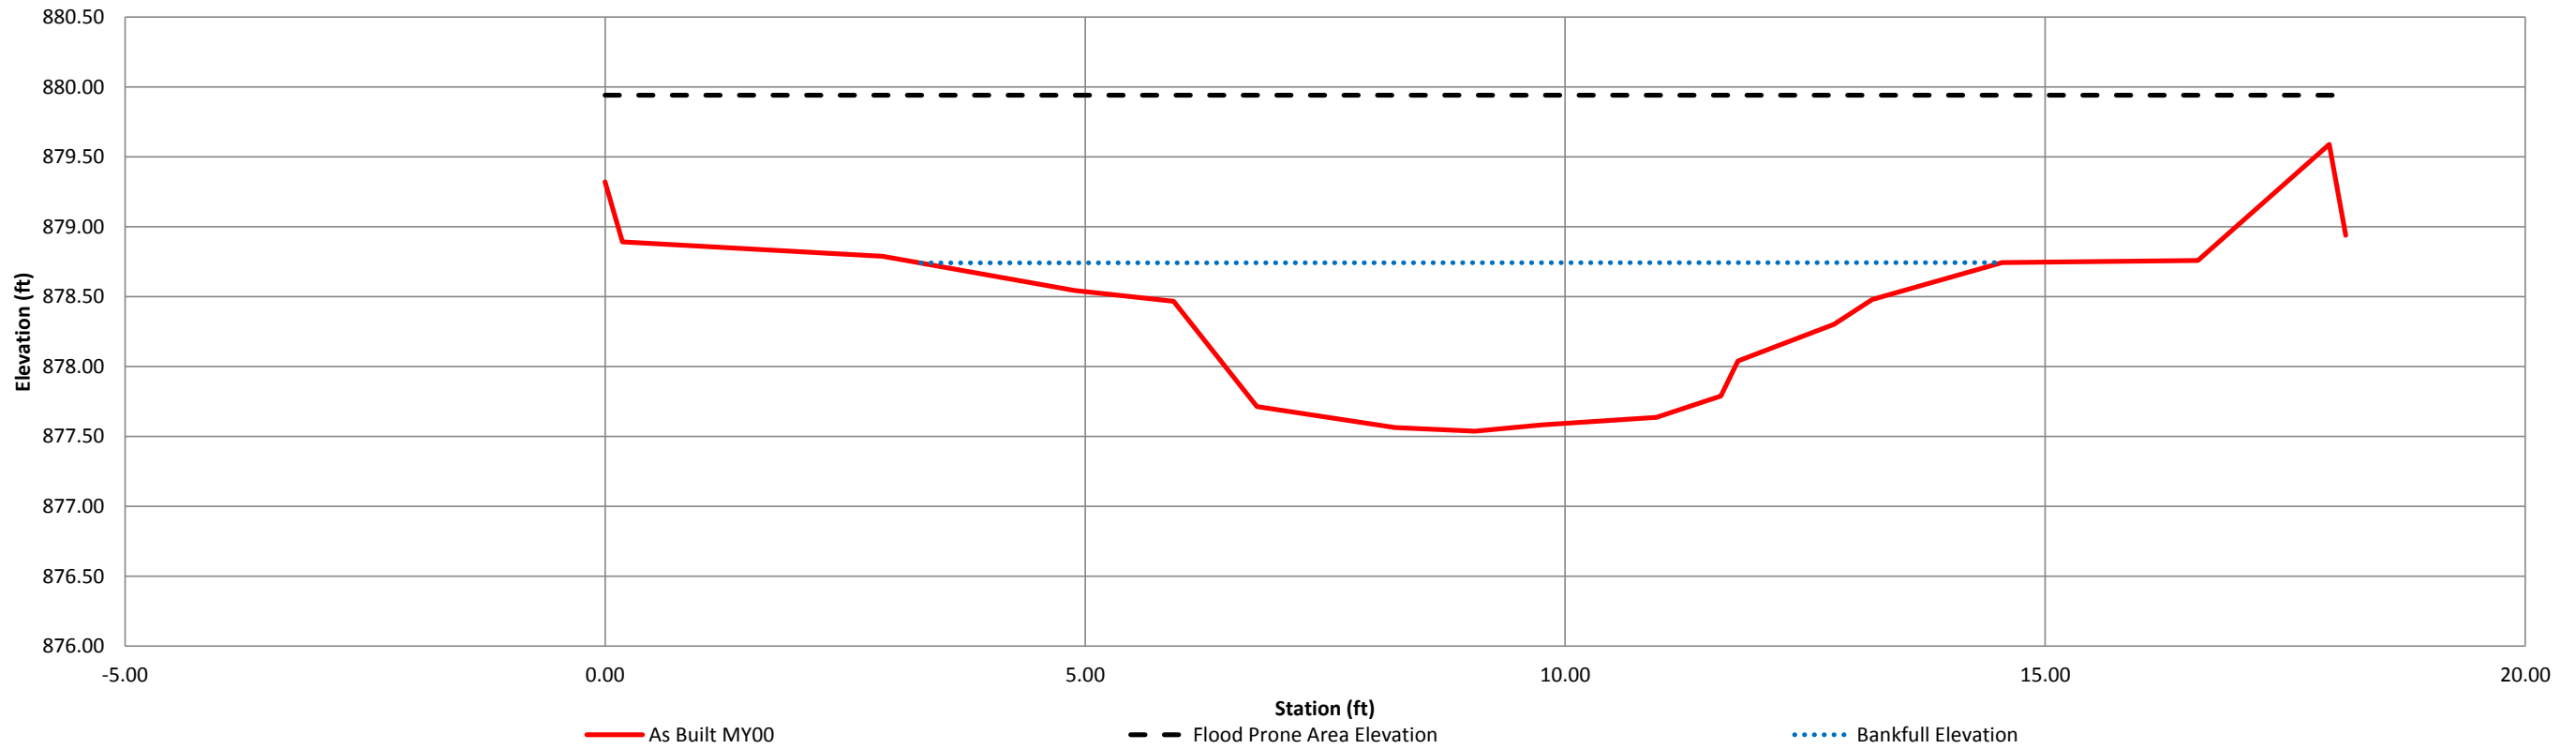
River Basin	Catawba River
Watershed	Lower Lake Norman
XS ID	XS-12, Riffle, STA 203+75
Drainage Area(sq. mi.)	0.06
Date	6/1/2012
Field Crew

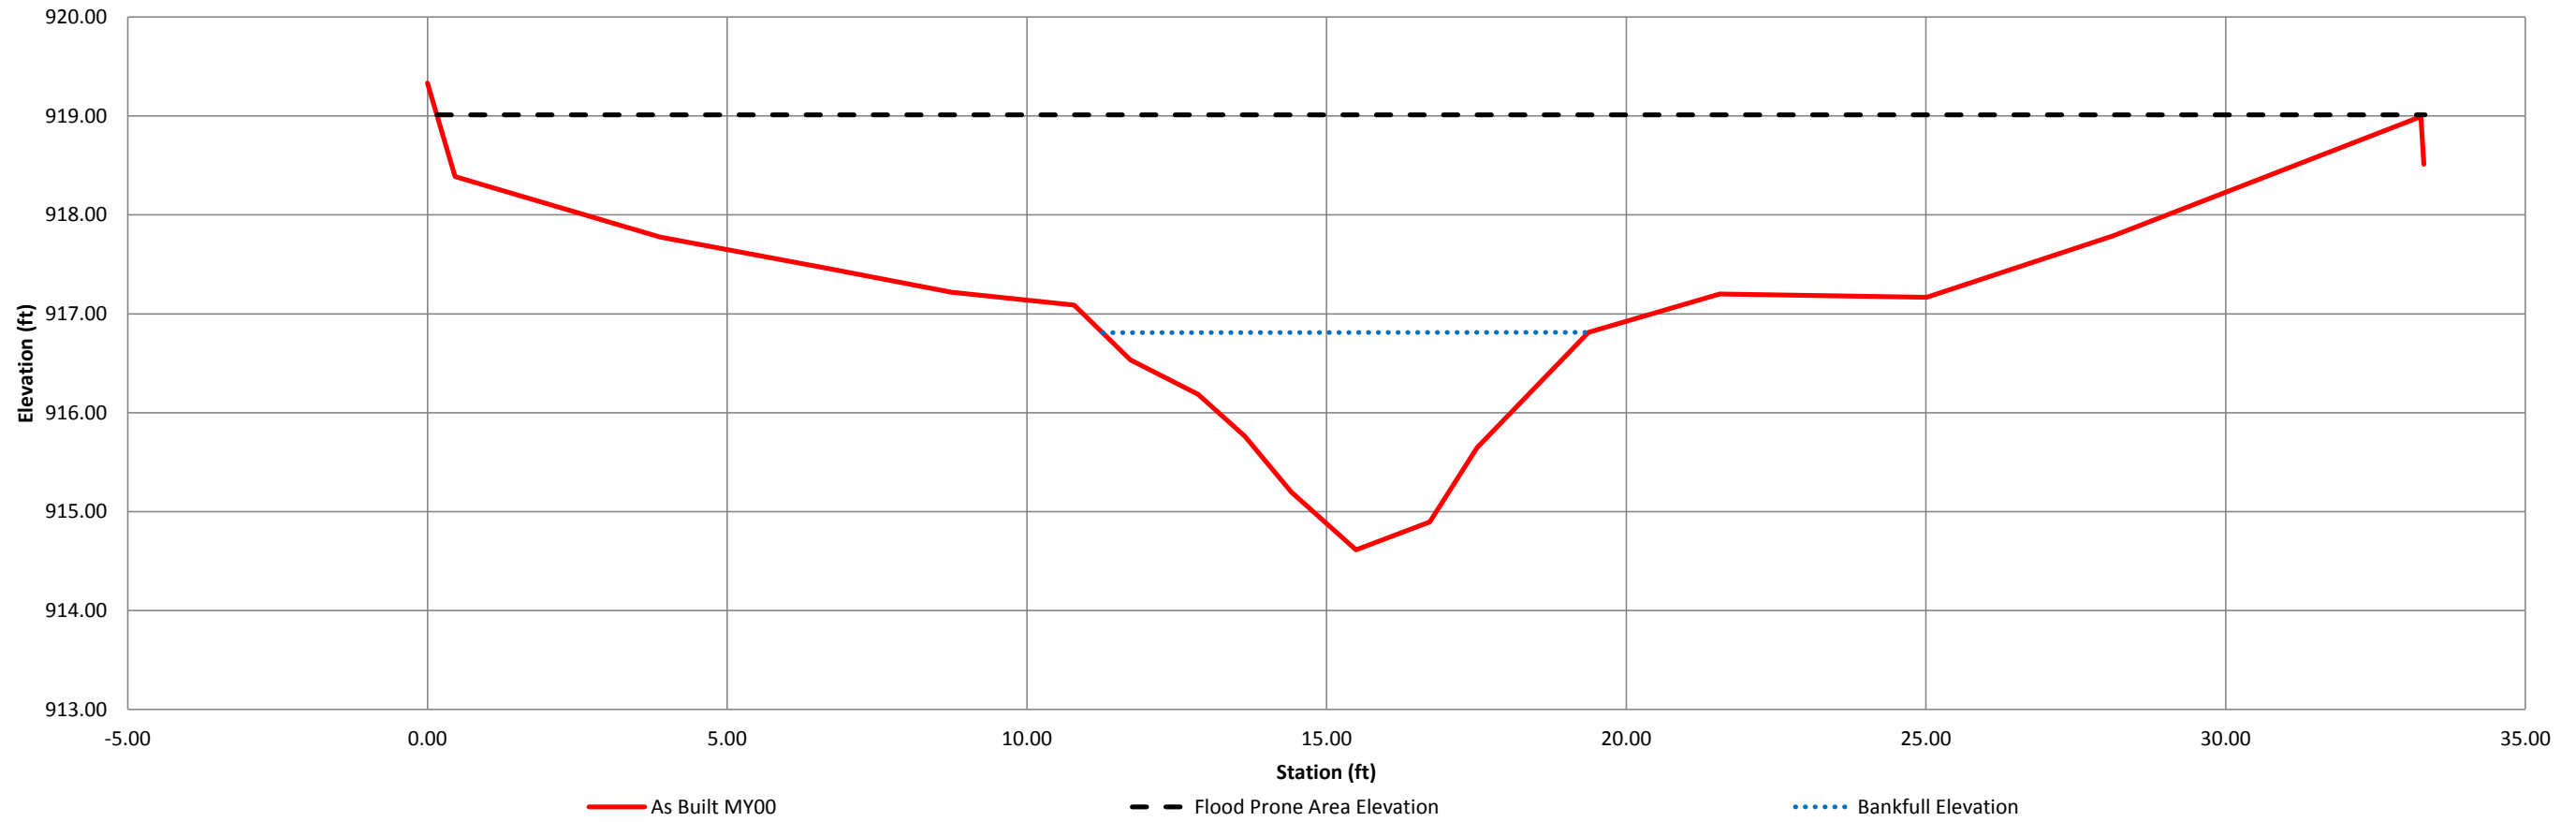
**North Fork Mountain Creek - Reach 3
X-Section 13 Pool, Station 204+01**

River Basin	Catawba River
Watershed	Lower Lake Norman
XS ID	XS-14, Pool, STA 301+18
Drainage Area(sq. mi.)	1.22
Date	6/1/2012
Field Crew

SUMMARY DATA	MY00
Bankfull Elevation	890.9
Bankfull Cross-Sectional Area	25.6
Bankfull Width	20.6
Flood Prone Area Elevation	894.0
Flood Prone Width	59
Max Depth at Bankfull	3.1
Mean Depth at Bankfull	1.2
W/D Ratio	16.6
Entrenchment Ratio	2.9
Bank Height Ratio	1.0
Stream Type	C

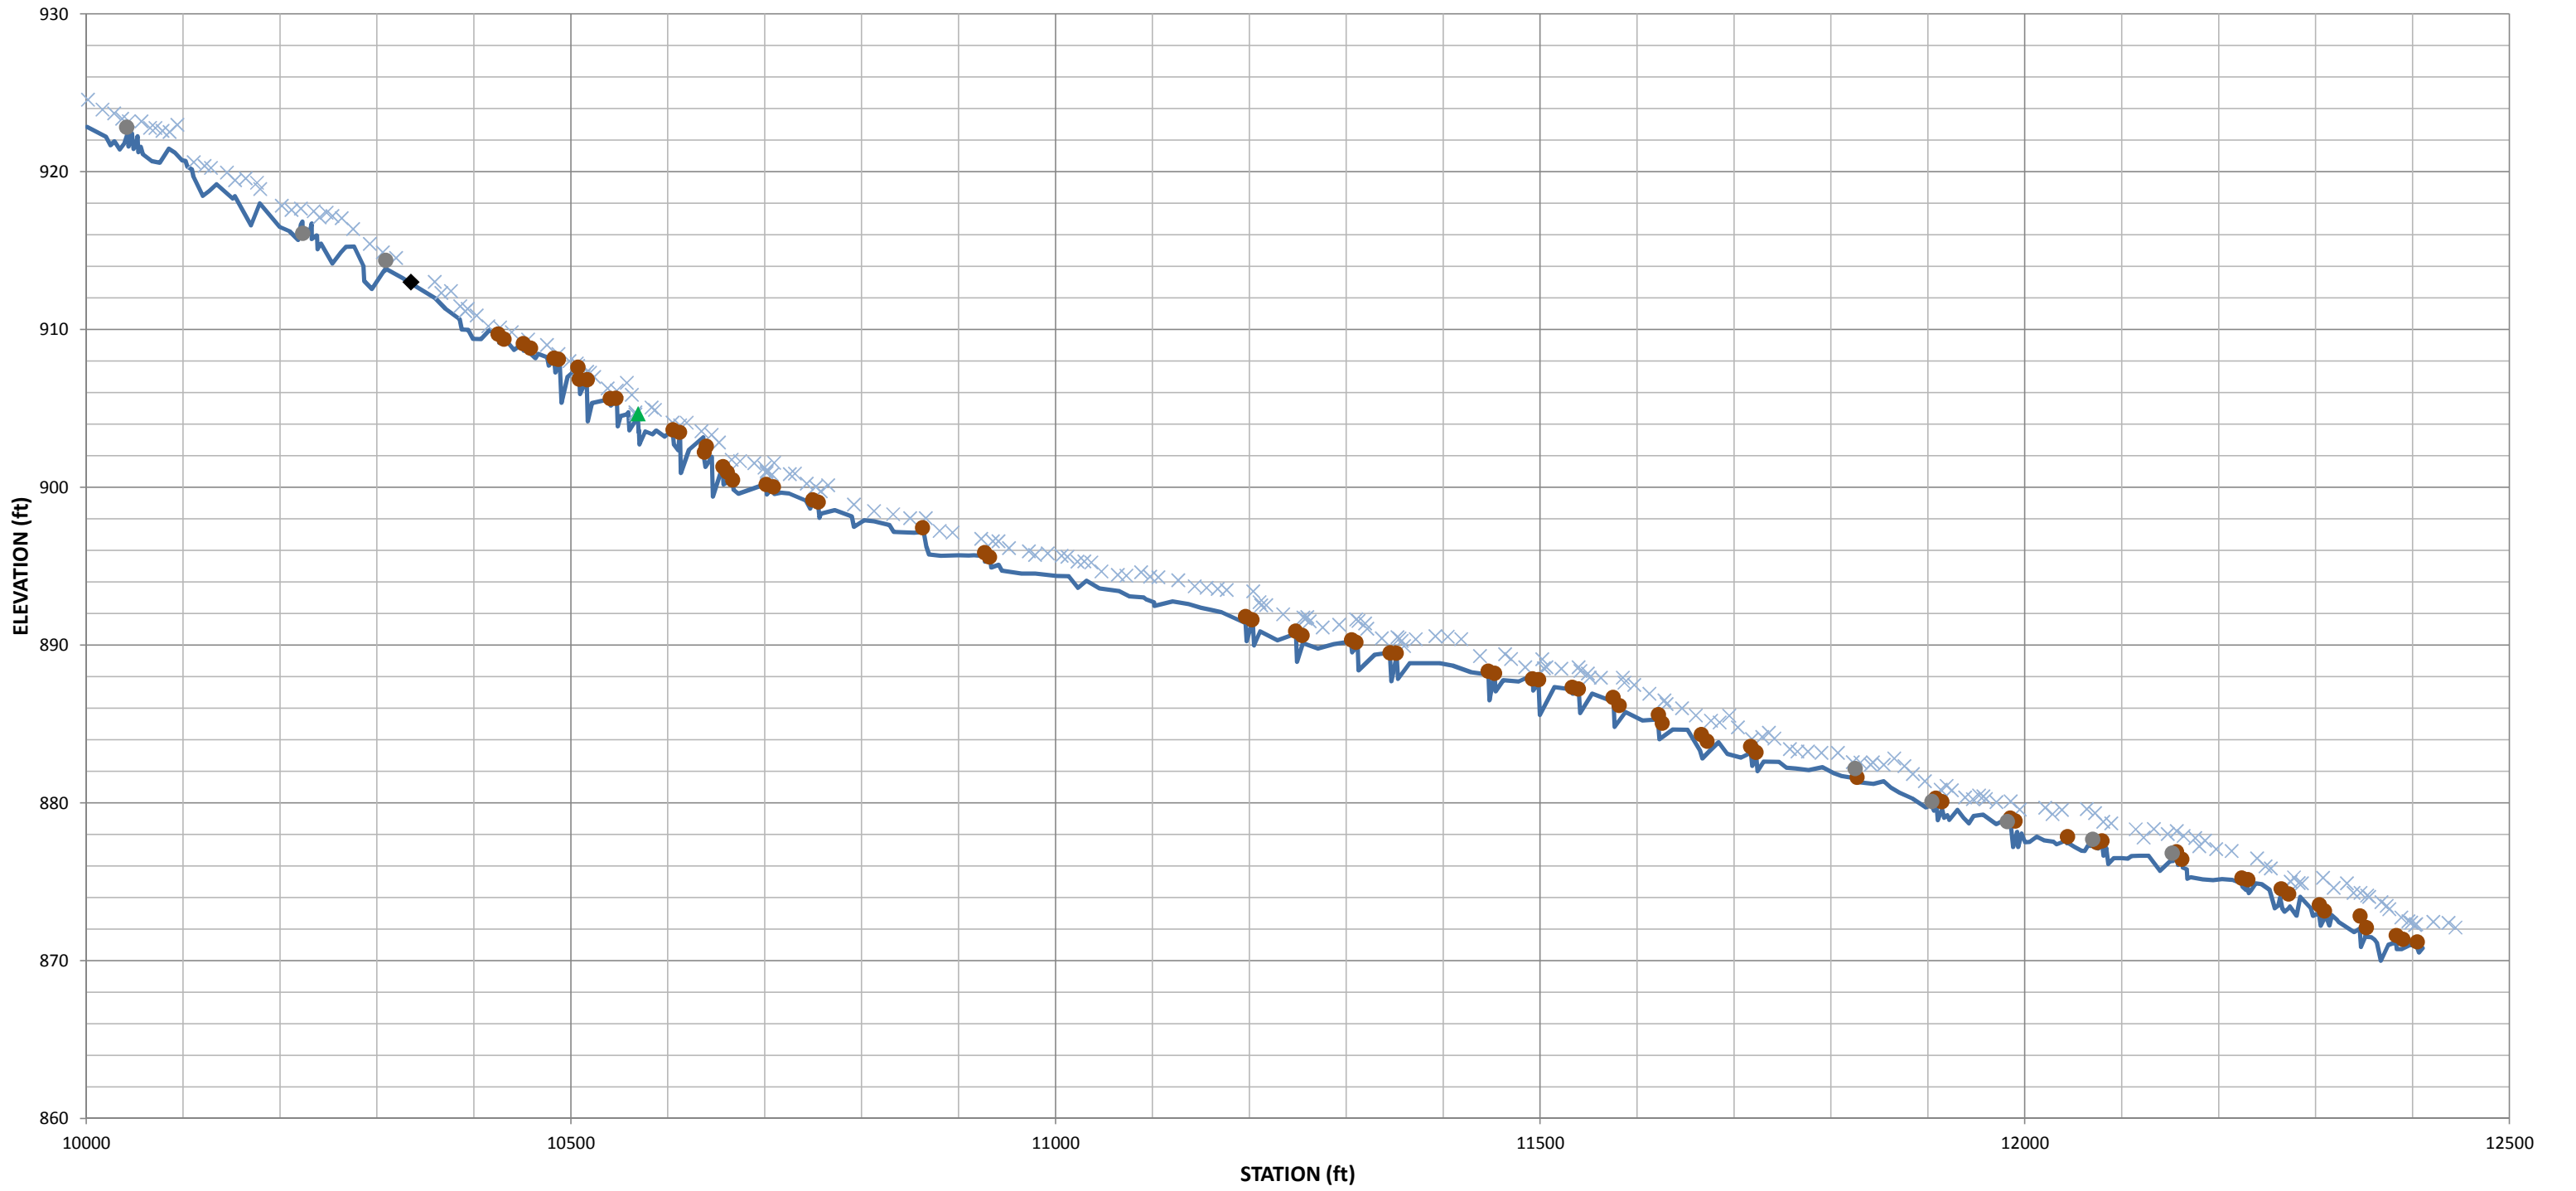
North Fork Mountain Creek, Reaches 1 and 2
Longitudinal Profile, As-built, STA 100+00 to 124+10

— MYO Thalweg × TOB ● Log ● Boulder Constructed Riffle ▲ Rock Cross Vane ◆ Culvert

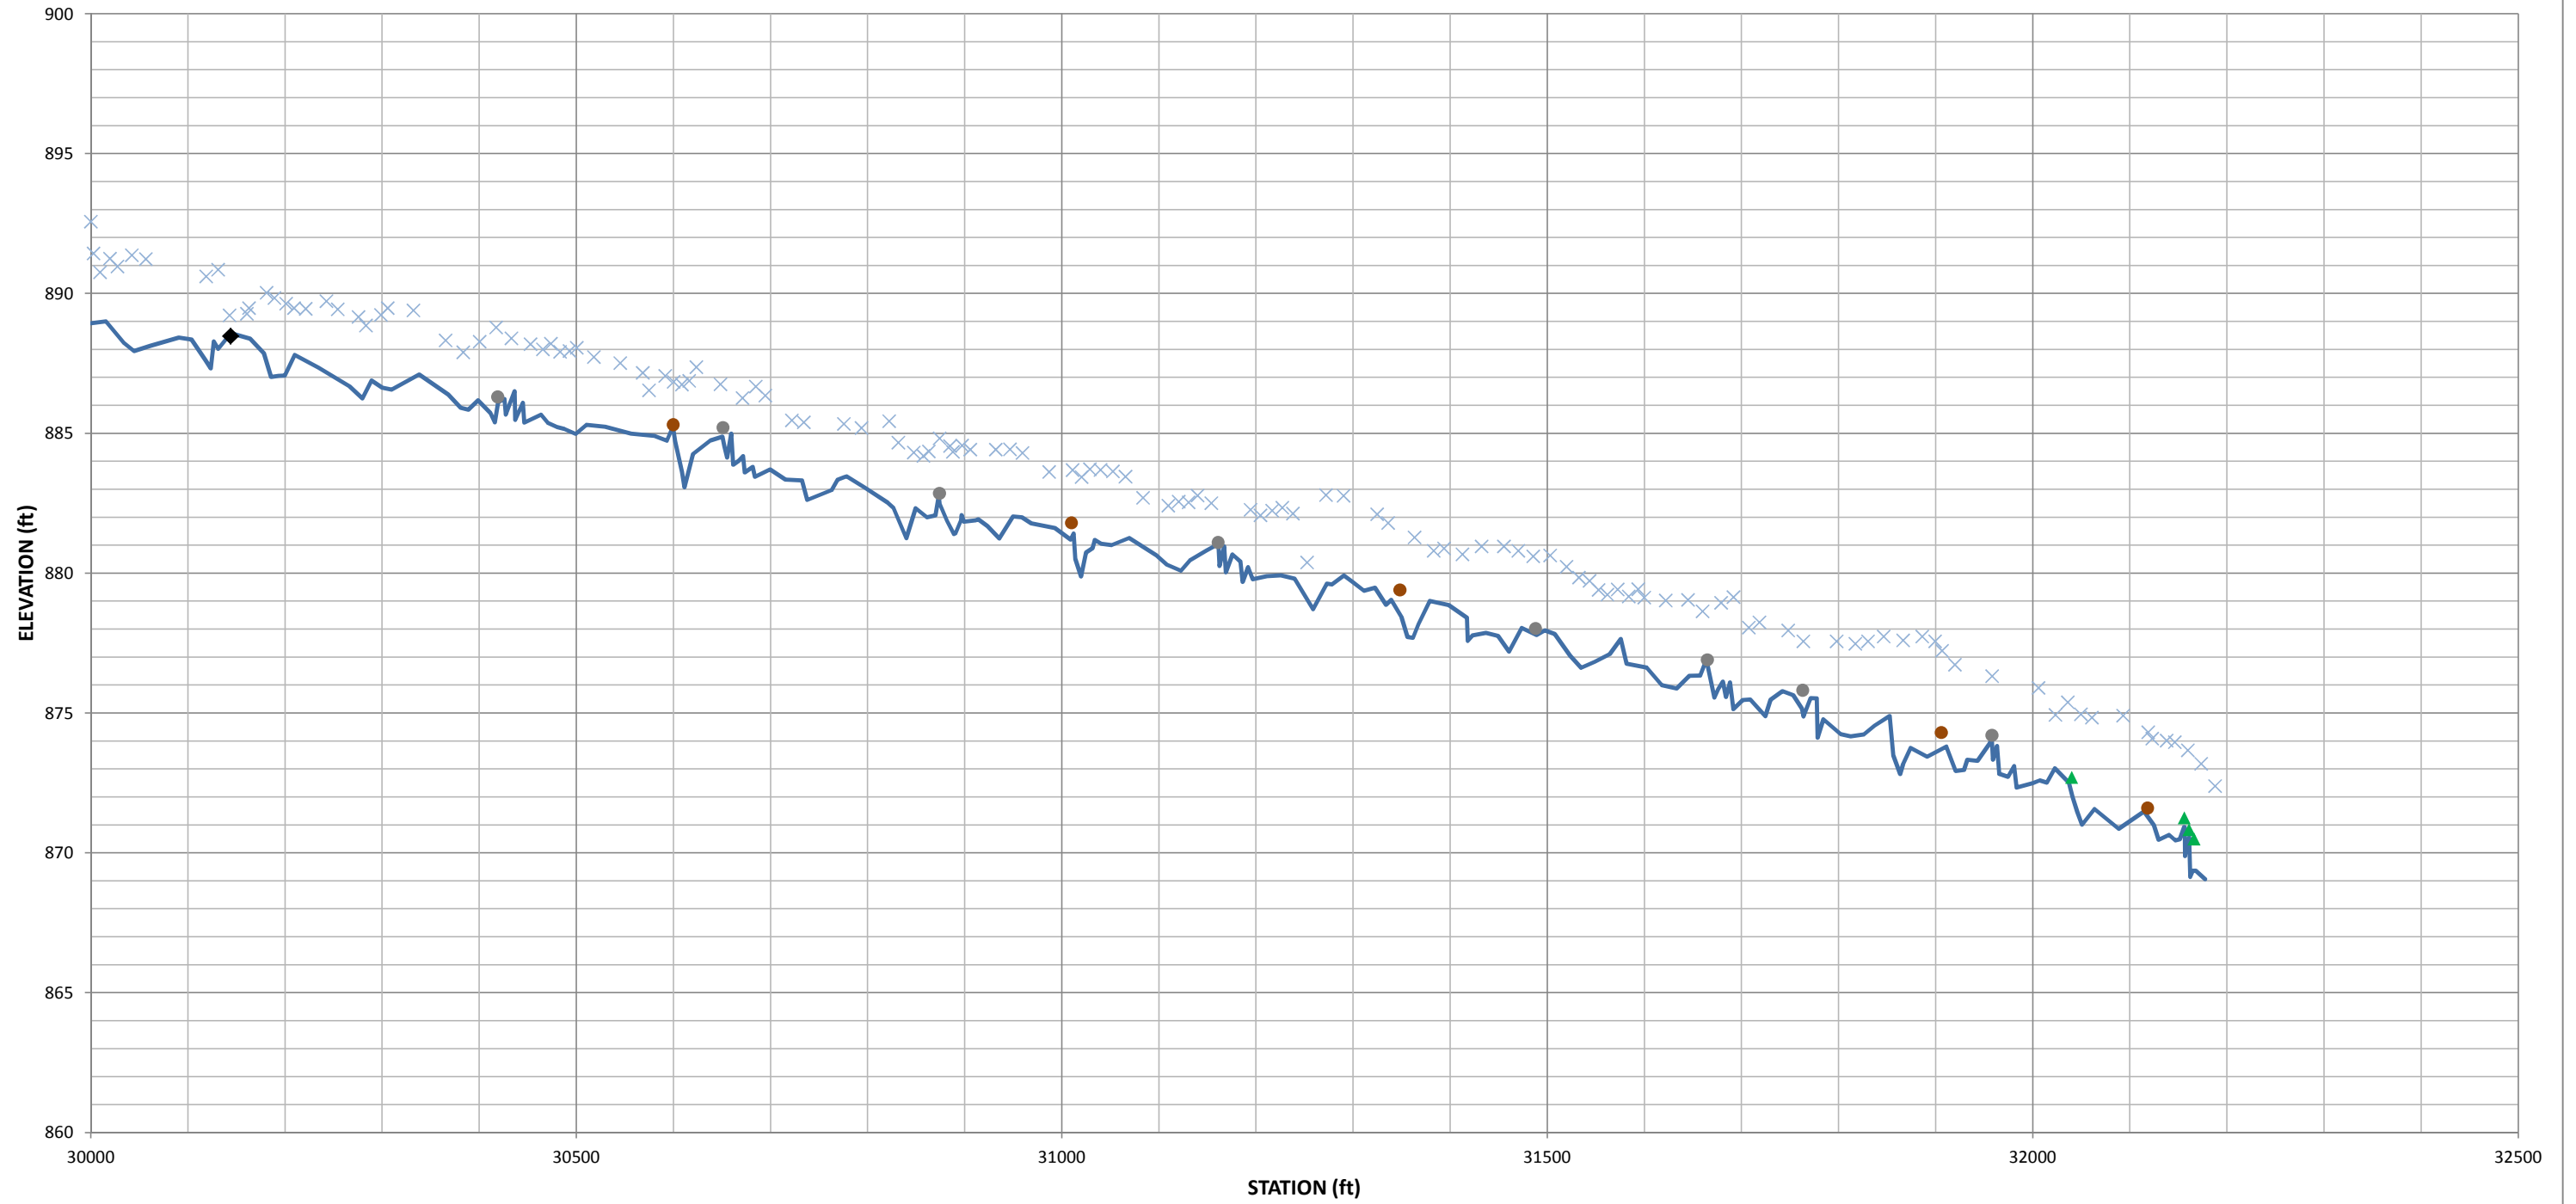
North Fork Mountain Creek, Reach 4
Longitudinal Profile, As-built, STA 300+00 to 321+77

— MYO Thalweg × TOB ● Log ● Boulder Constructed Riffles ▲ Rock Cross Vane ◆ Ford Crossing

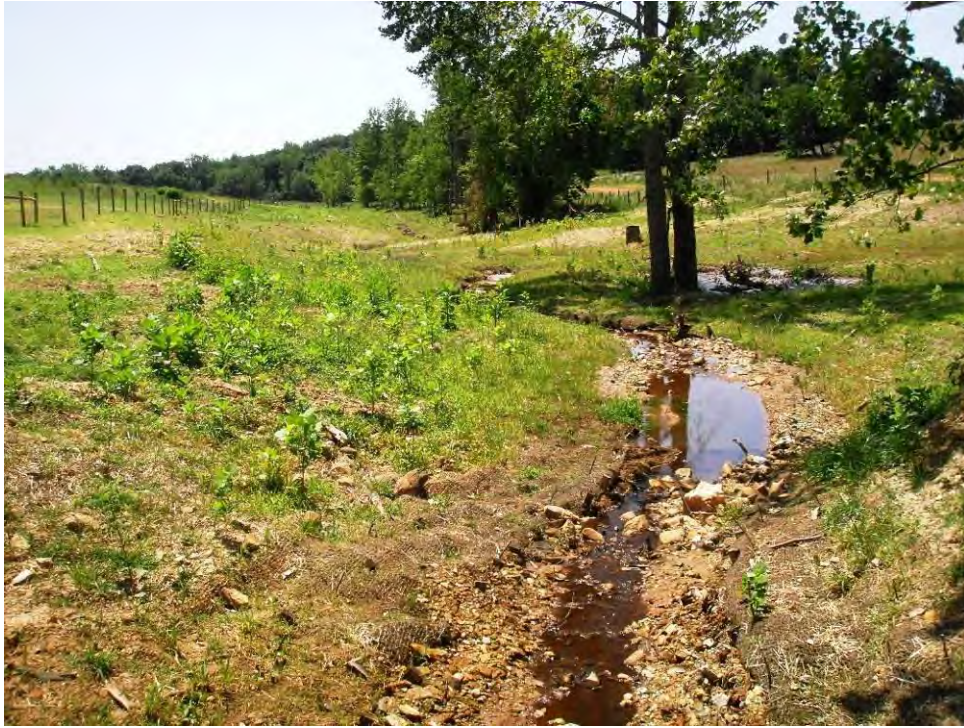
Photo B1 – Photo Station S1 Reach 1 crossing looking downstream (6/27/2012)

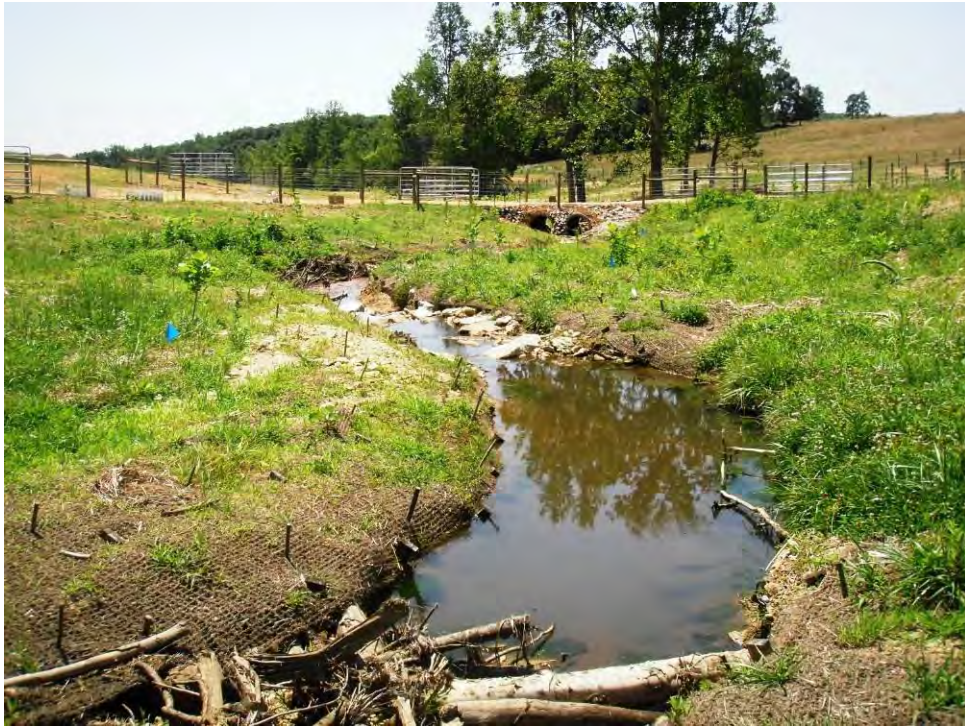
Photo B13 – Photo Station S13 Reach 1 cross-section 1 looking downstream (6/27/2012)

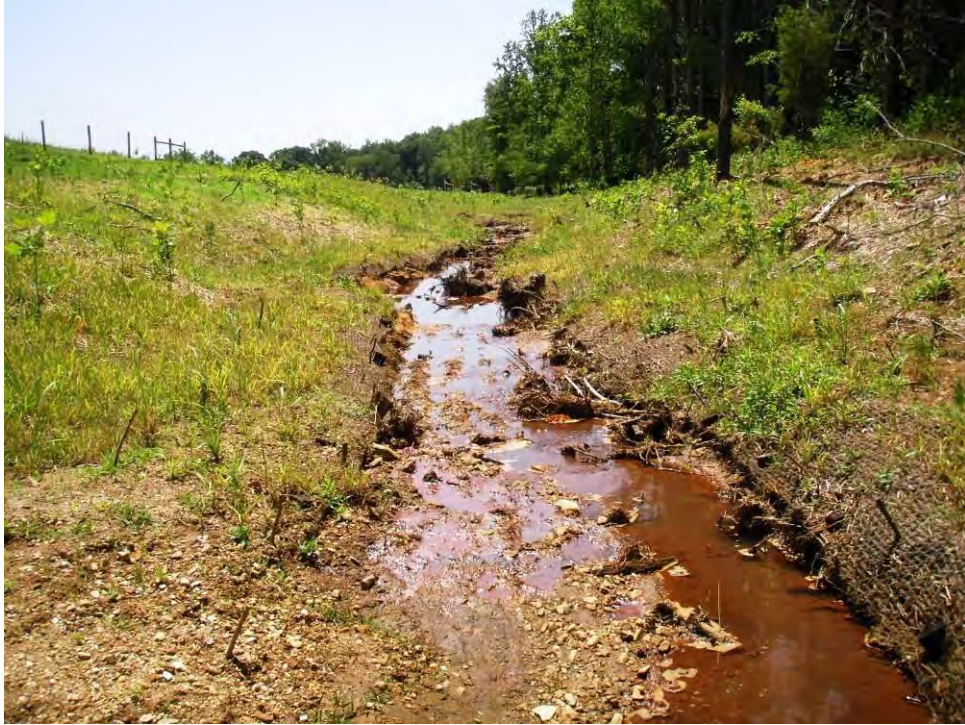
Photo B14 – Photo Station S14 Reach 1 cross-section 2 looking downstream (6/27/2012)

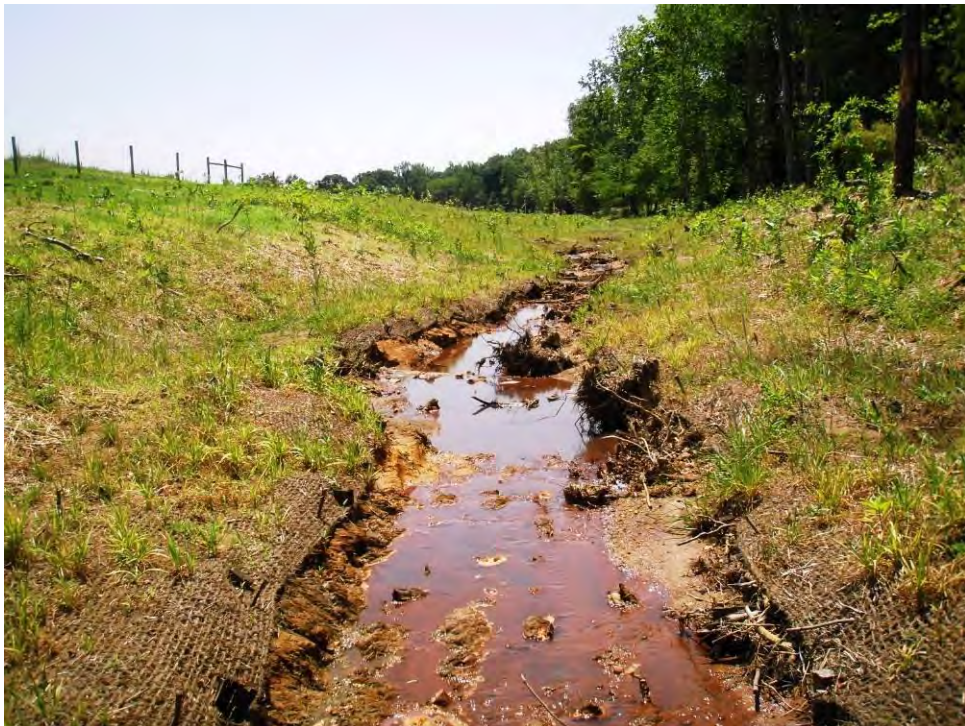
Photo B15 – Photo Station S15 Reach 2 cross-section 3 looking downstream (6/27/2012)
