NORTH FORK MOUNTAIN CREEK
STREAM AND WETLAND RESTORATION

FINAL BASELINE MONITORING DOCUMENT AND AS-BUILT
BASELINE REPORT

Catawba County, North Carolina
EEP Project No. 94151

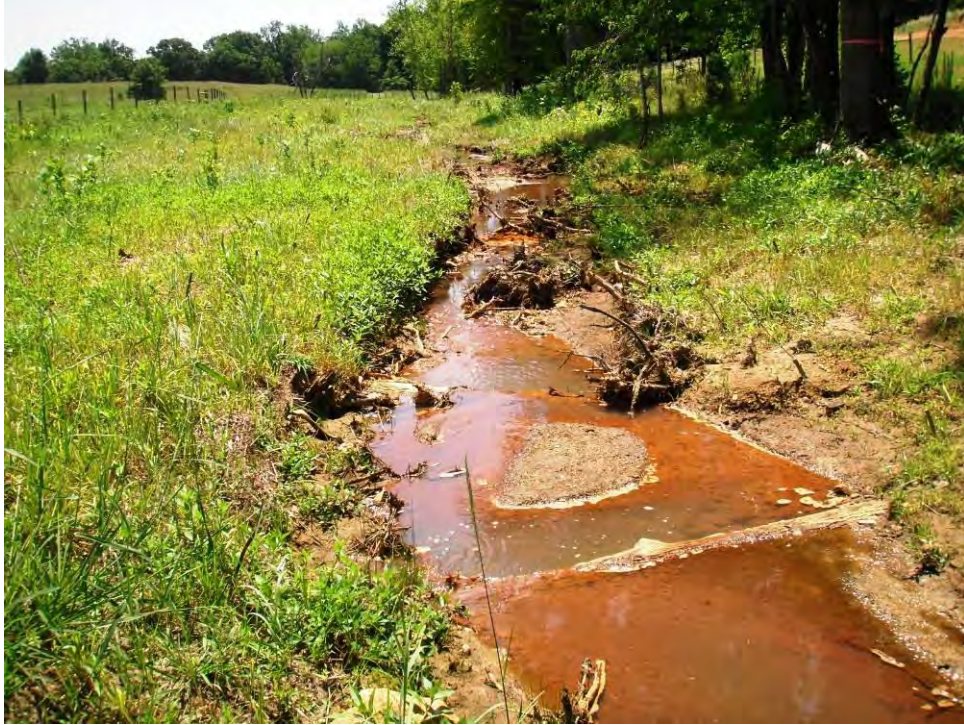
Photo B16 – Photo Station S16 Reach 2 cross-section 4 looking downstream (6/27/2012)

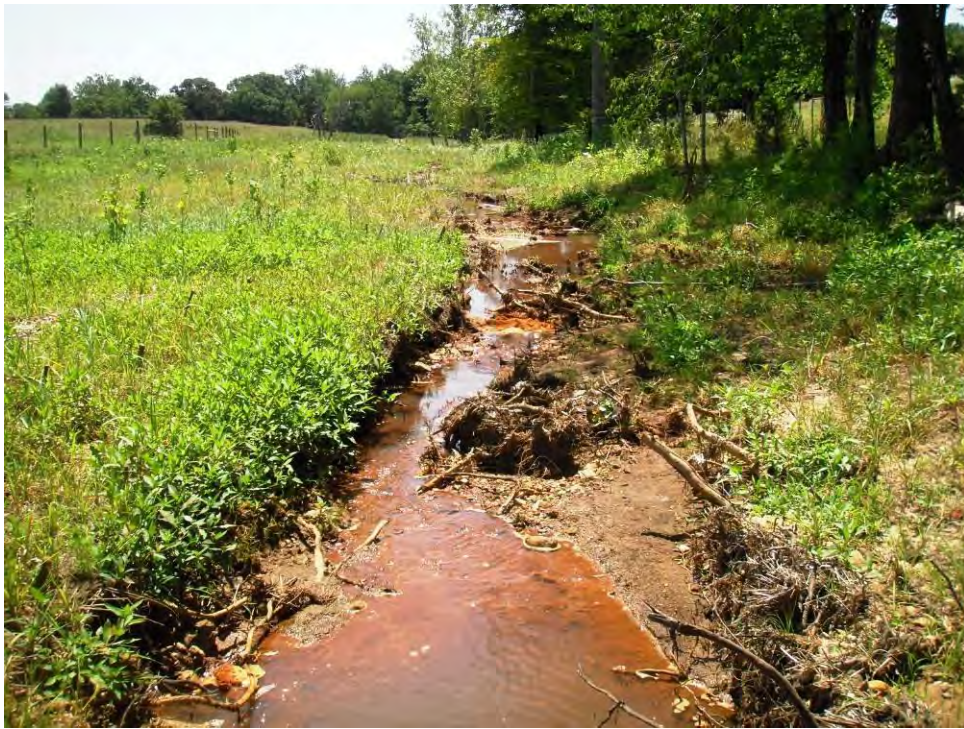
Photo B17 – Photo Station S17 Reach 2 cross-section 5 looking downstream (6/27/2012)

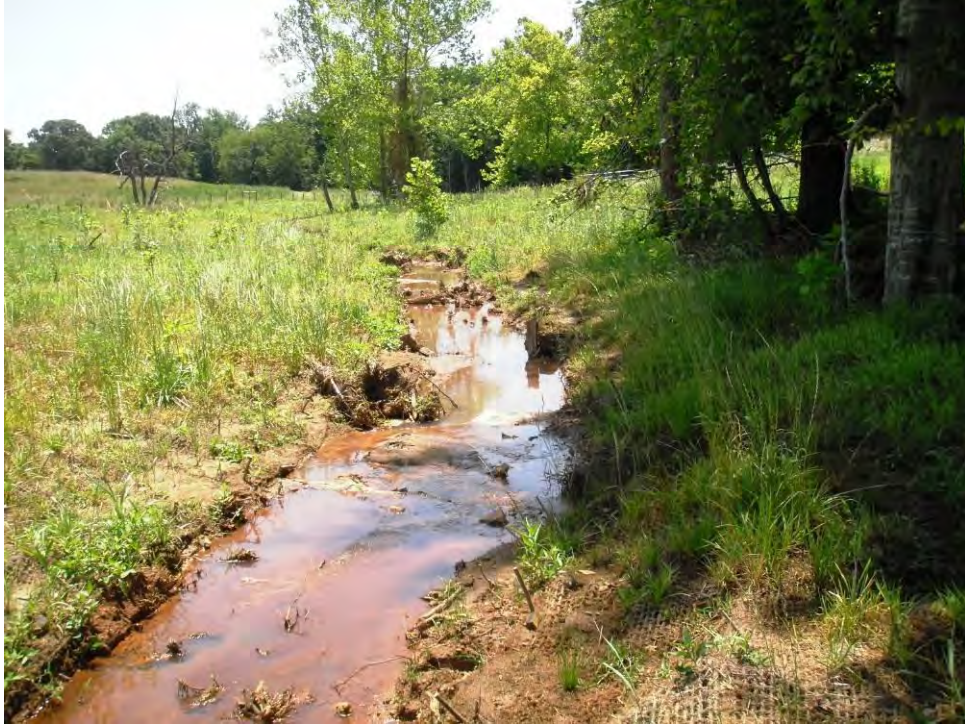
Photo B18 – Photo Station S18 Reach 2 cross-section 6 looking downstream (6/27/2012)

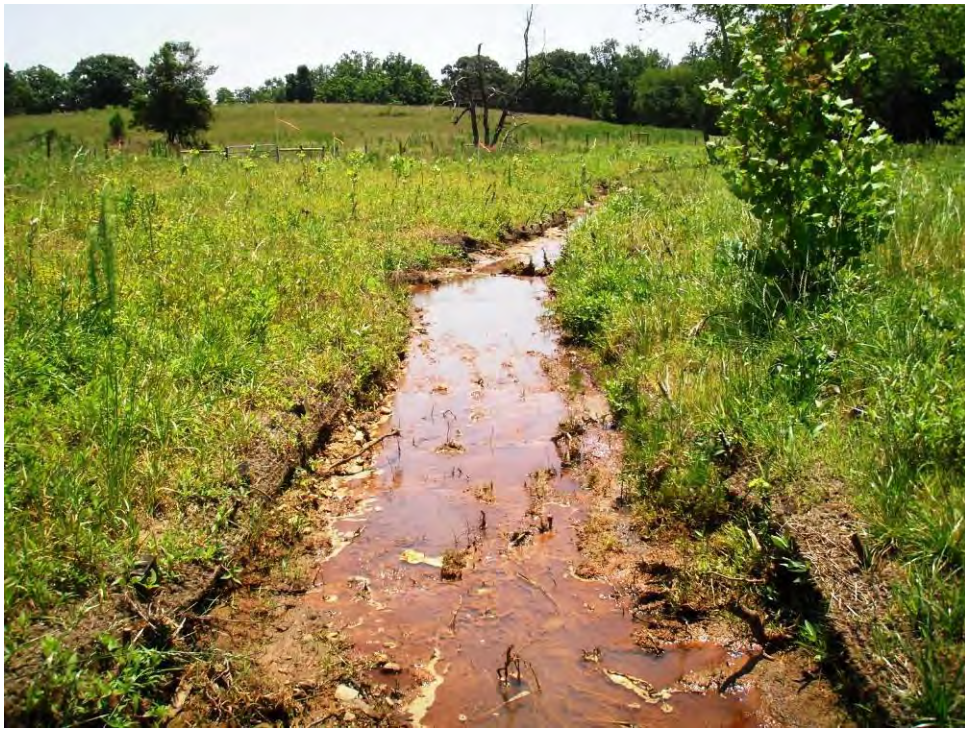
Photo B19 – Photo Station S19 Reach 2 cross-section 7 looking downstream (6/27/2012)

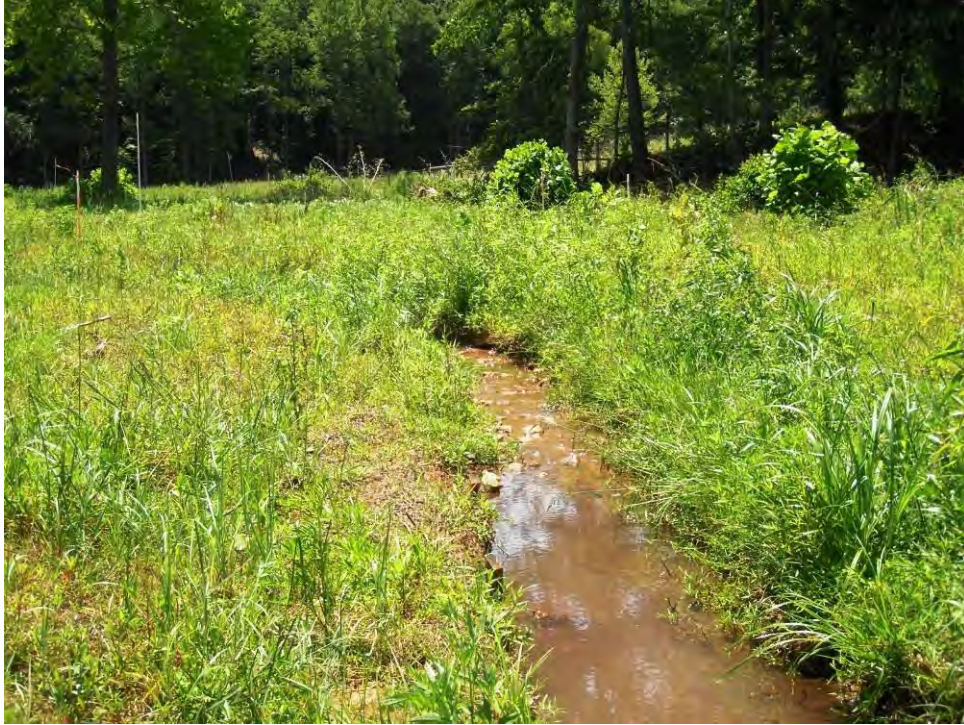
Photo B20 – Photo Station S20 Reach 2 cross-section 8 looking downstream (6/27/2012)

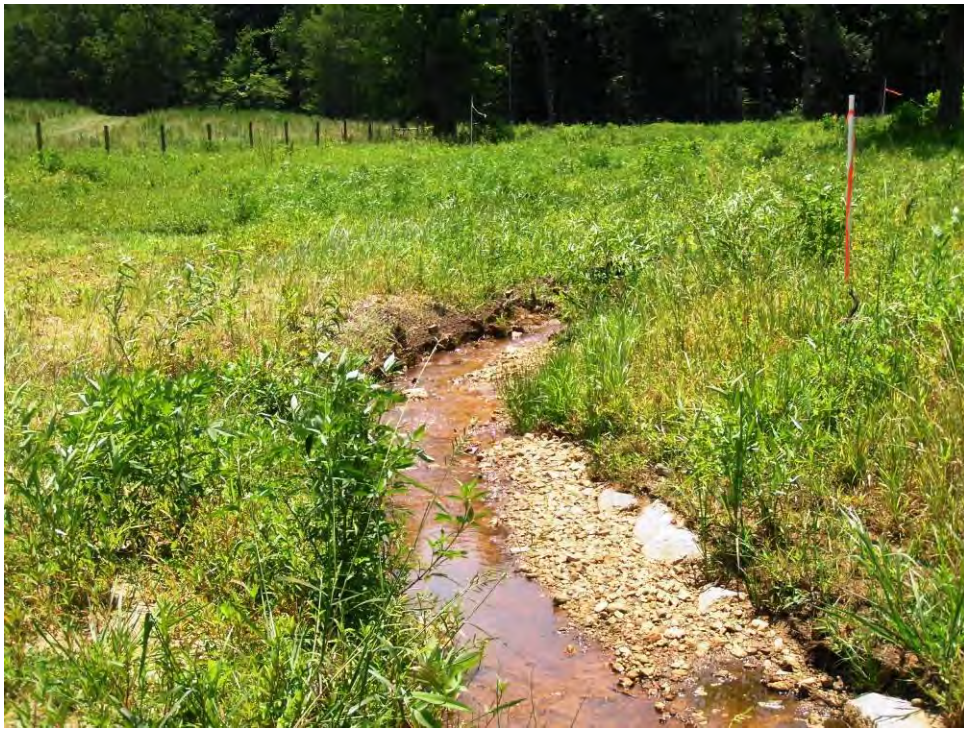
Photo B21 – Photo Station S21 Reach 2 cross-section 9 looking downstream (6/27/2012)

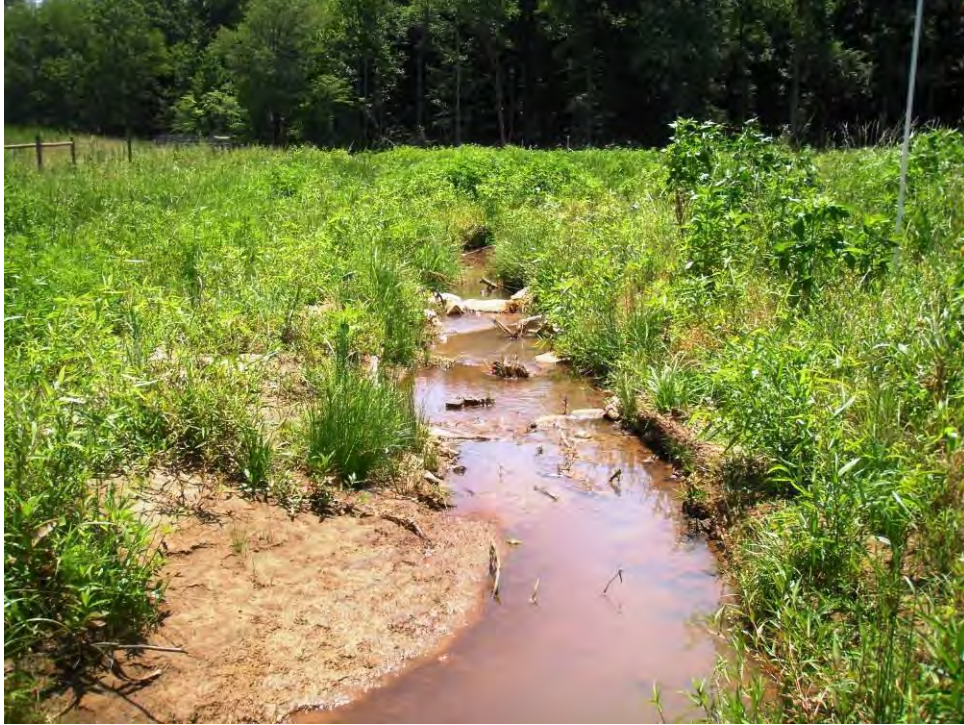
Photo B22 – Photo Station S22 Reach 2 cross-section 10 looking downstream (6/27/2012)

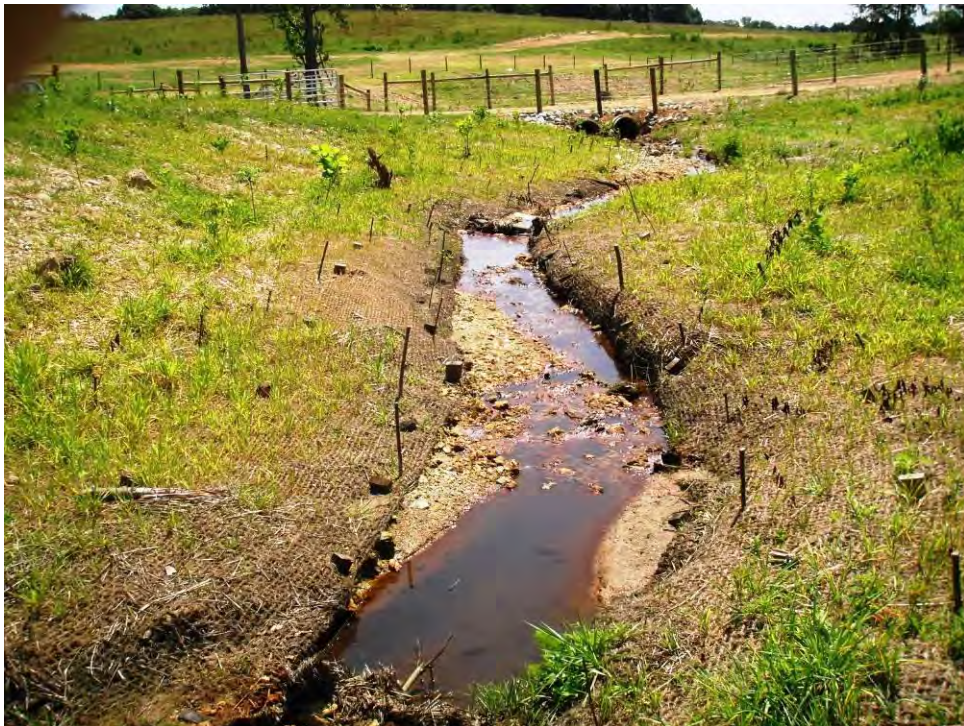
Photo B23 – Photo Station S23 Reach 2 cross-section 11 looking downstream (6/27/2012)

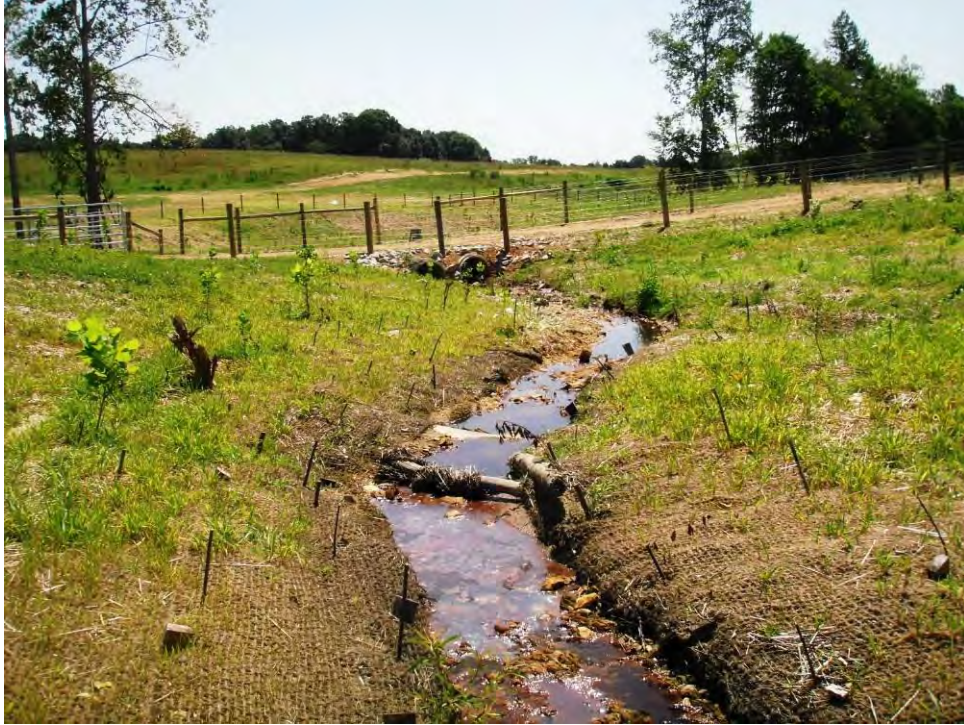
Photo B24 – Photo Station S24 Reach 3 cross-section 12 looking downstream (6/27/2012)

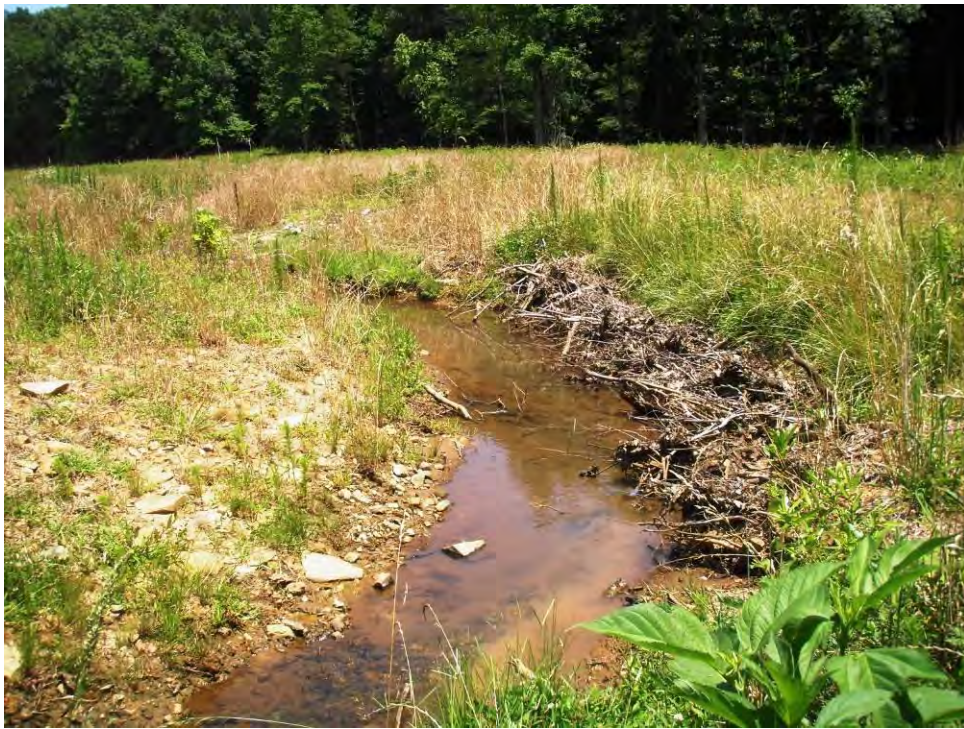
Photo B25 – Photo Station S25 Reach 3 cross-section 13 looking downstream (6/27/2012)

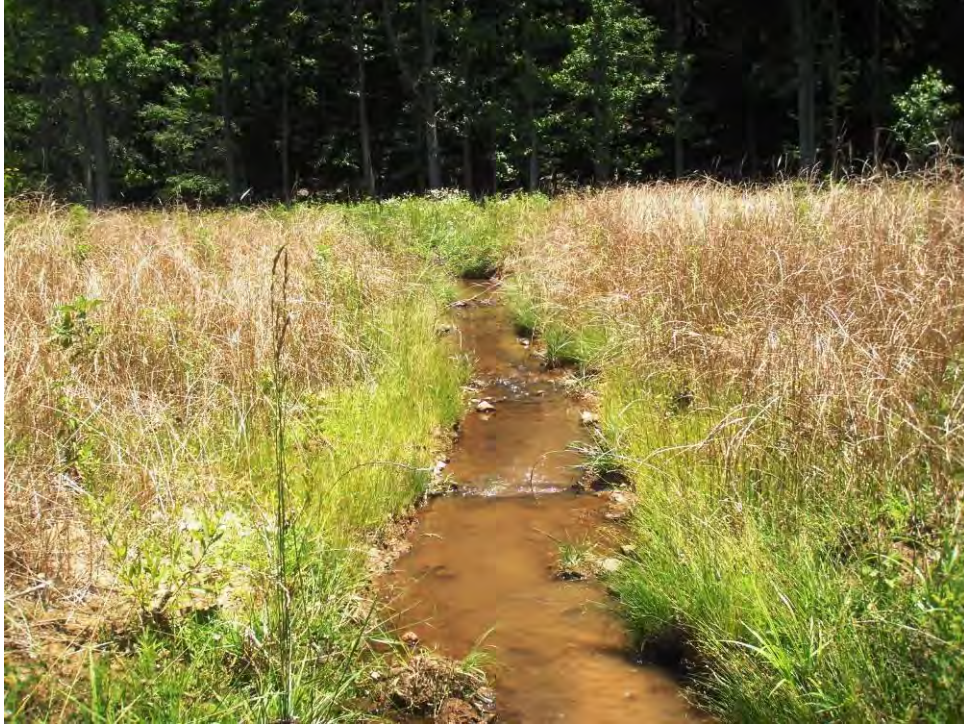
Photo B26 – Photo Station S26 Reach 4 cross-section 14 looking downstream (6/27/2012)

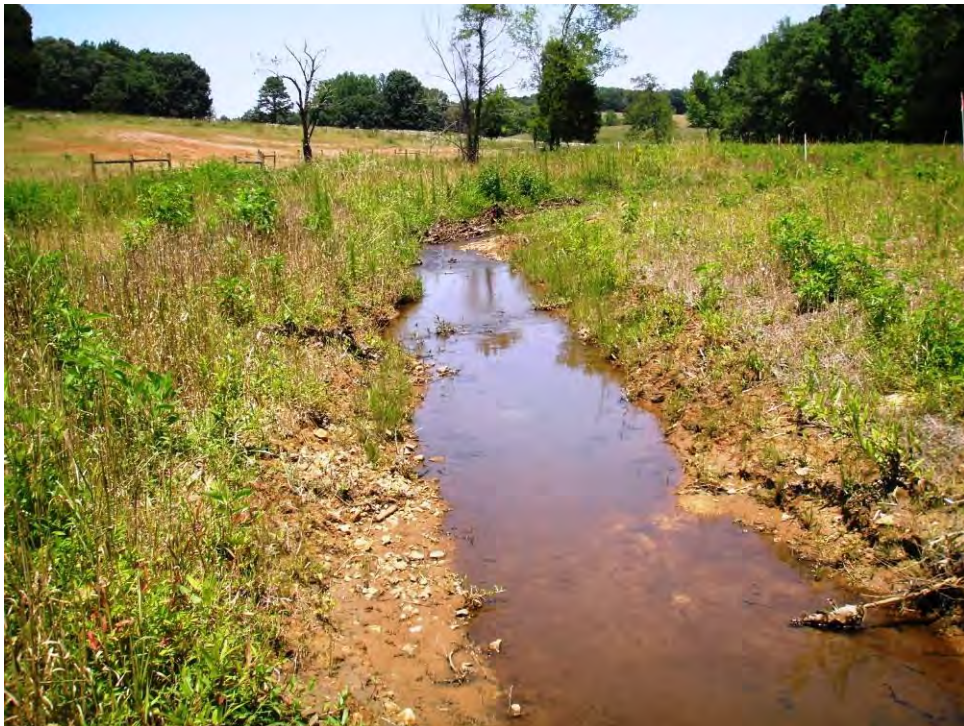
Photo B27 – Photo Station S27 Reach 4 cross-section 15 looking downstream (6/27/2012)

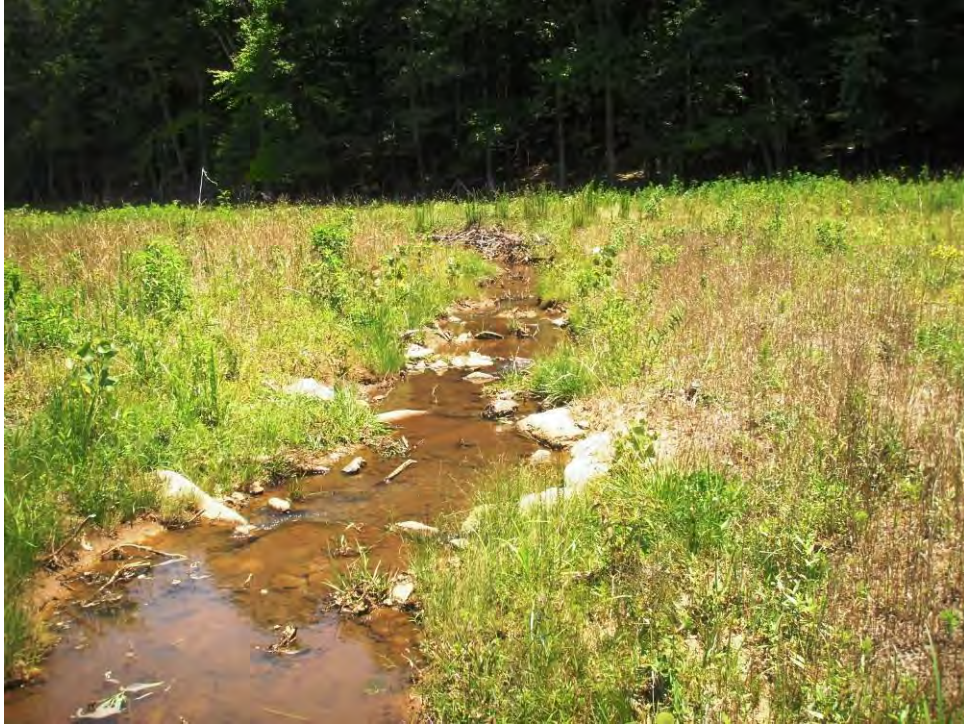
Photo B28 – Photo Station S28 Reach 4 cross-section 16 looking downstream (6/27/2012)

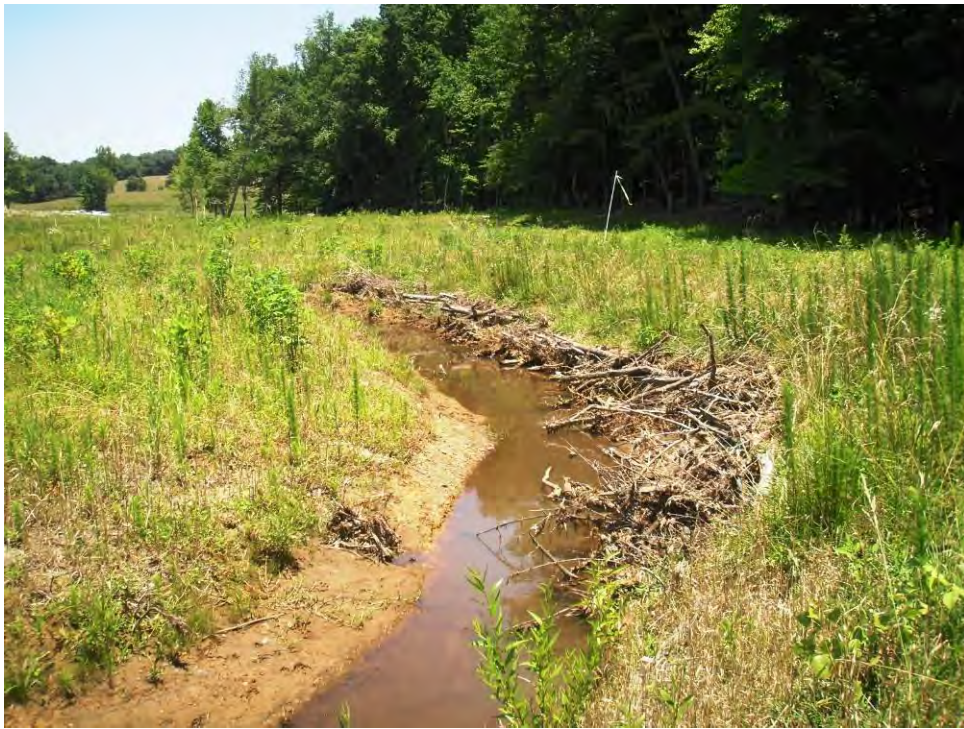
Photo B29 – Photo Station S29 Reach 4 cross-section 17 looking downstream (6/27/2012)

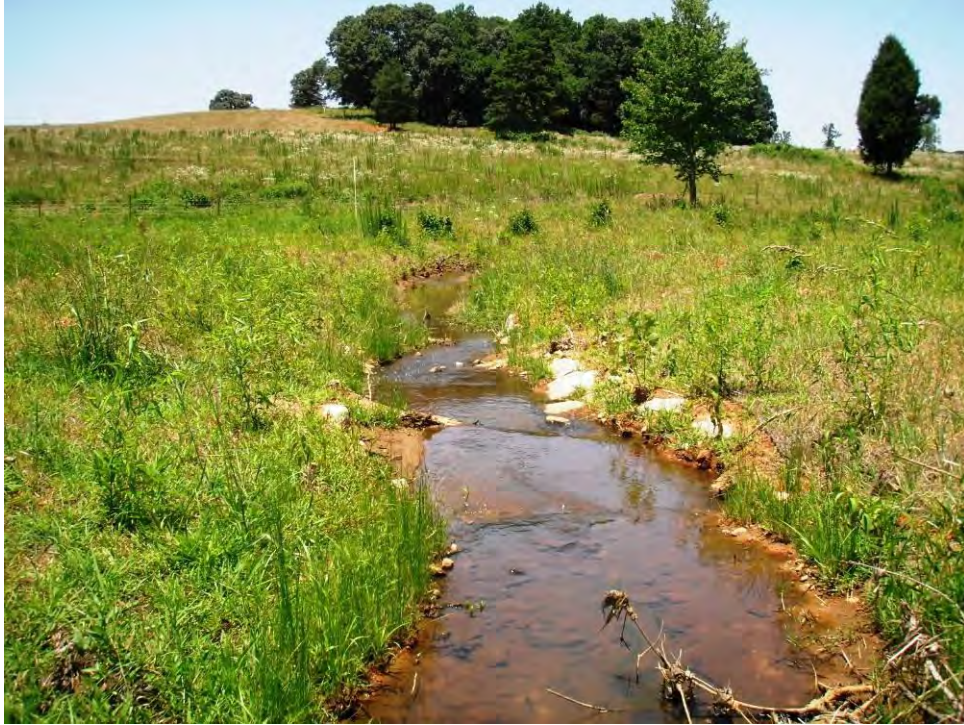
Photo B30 – Photo Station S30 Reach 4 cross-section 18 looking downstream (6/27/2012)

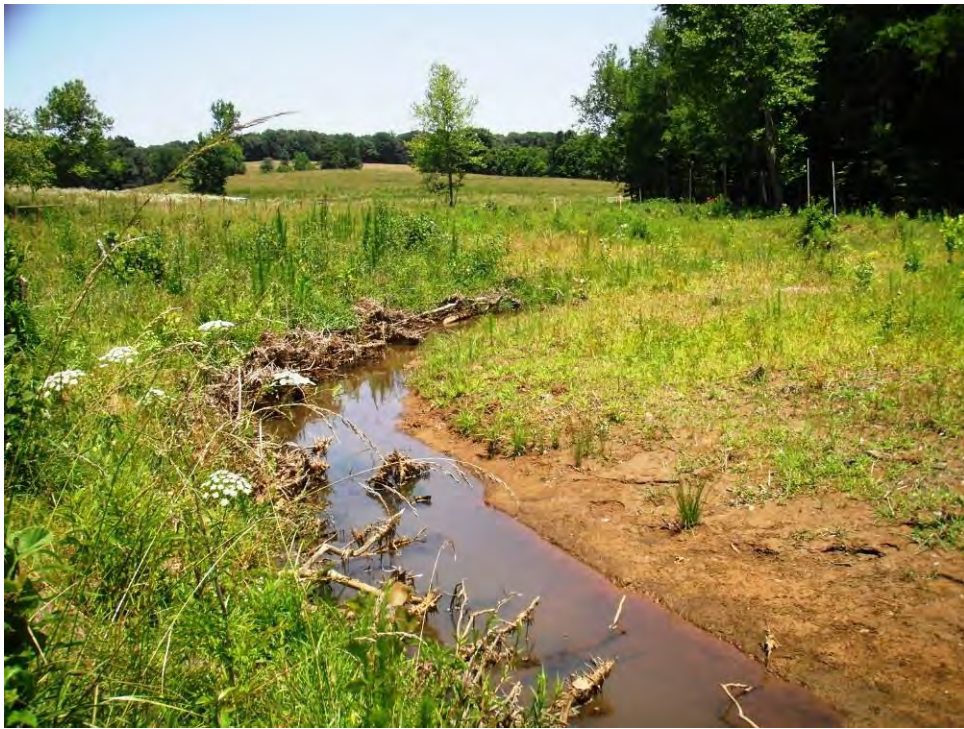
Photo B31 – Photo Station S31 Reach 4 cross-section 19 looking downstream (6/27/2012)

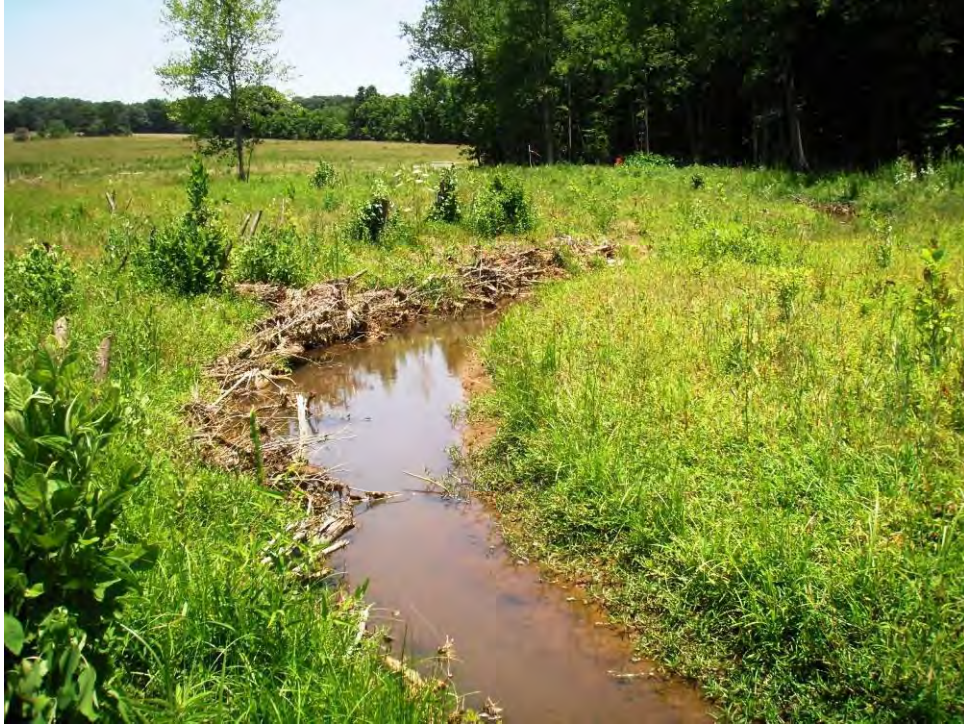
Photo B32 – Photo Station S32 Reach 4 cross-section 20 looking downstream (6/27/2012)

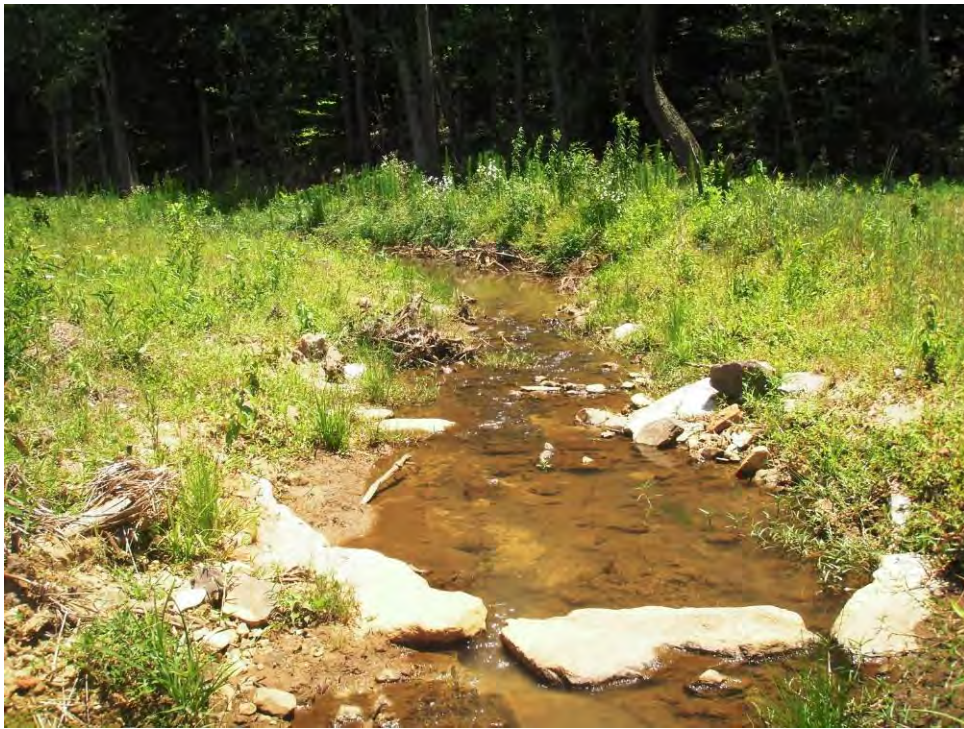
Photo B33 – Photo Station S33 Reach 4 cross-section 21 looking downstream (6/27/2012)

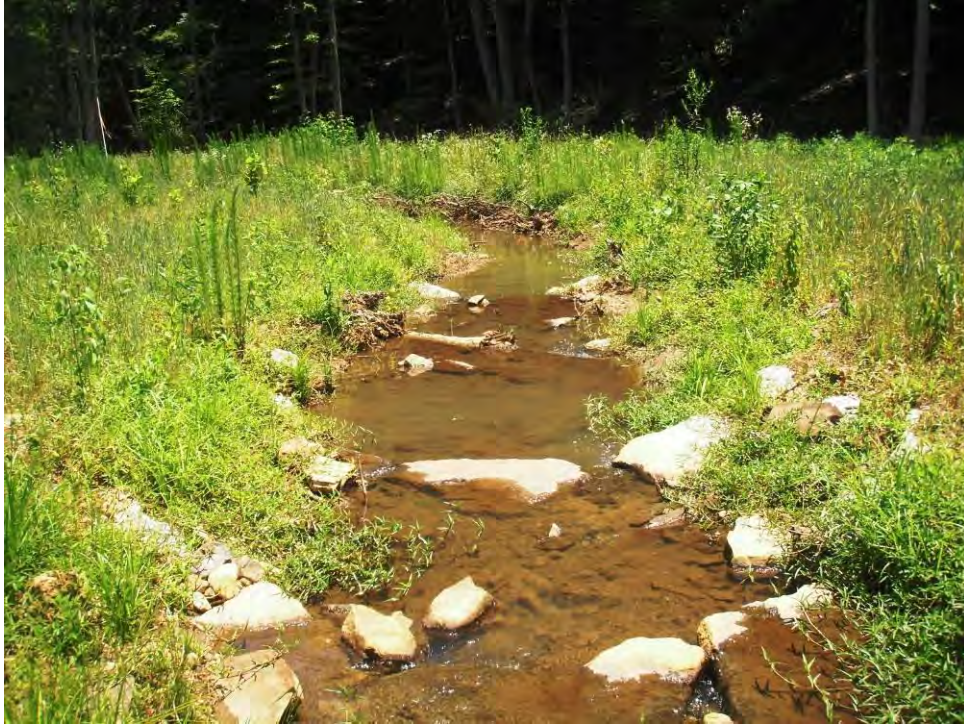
Photo B34 – Photo Station S34 Reach 4 cross-section 22 looking downstream (6/27/2012)

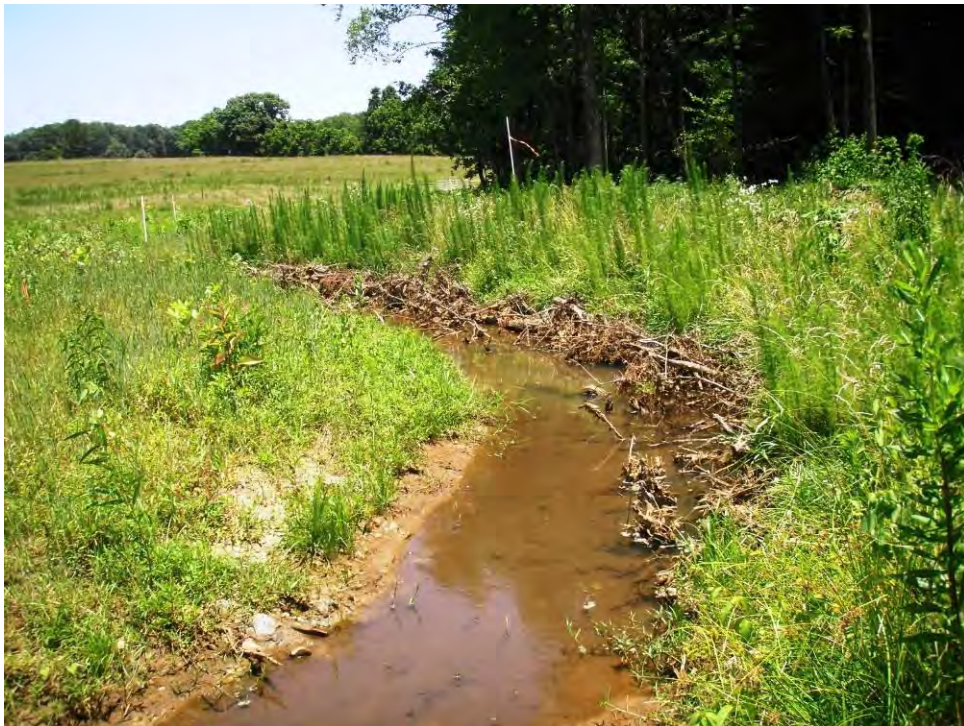
Photo B35 – Photo Station S35 Reach 4 cross-section 23 looking downstream (6/27/2012)

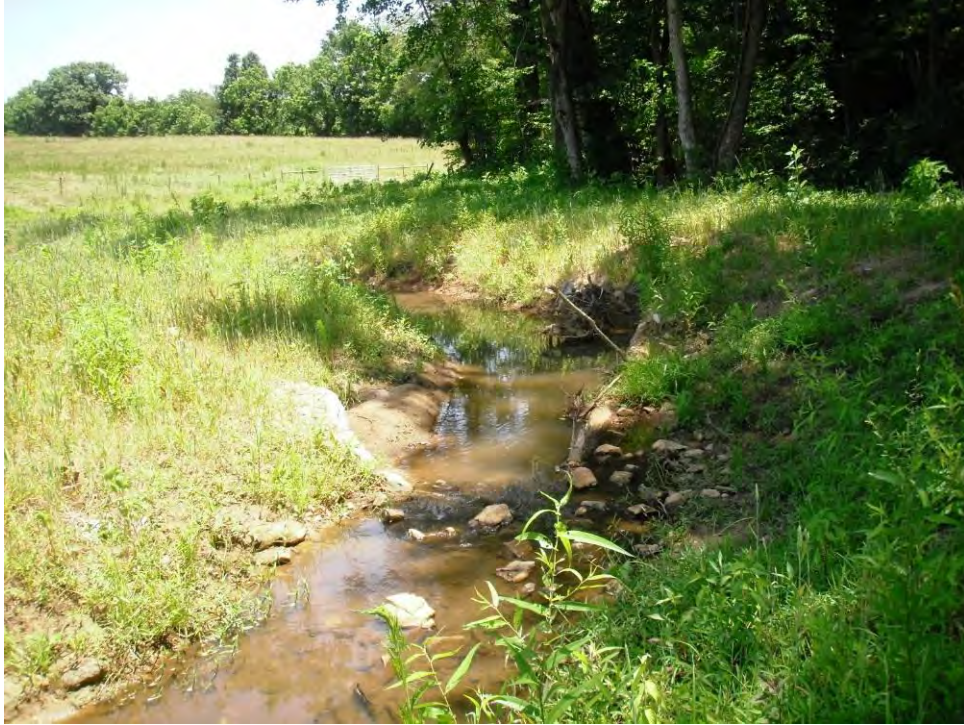
Photo B36 – Photo Station S36 Reach 4 cross-section 24 looking downstream (6/27/2012)

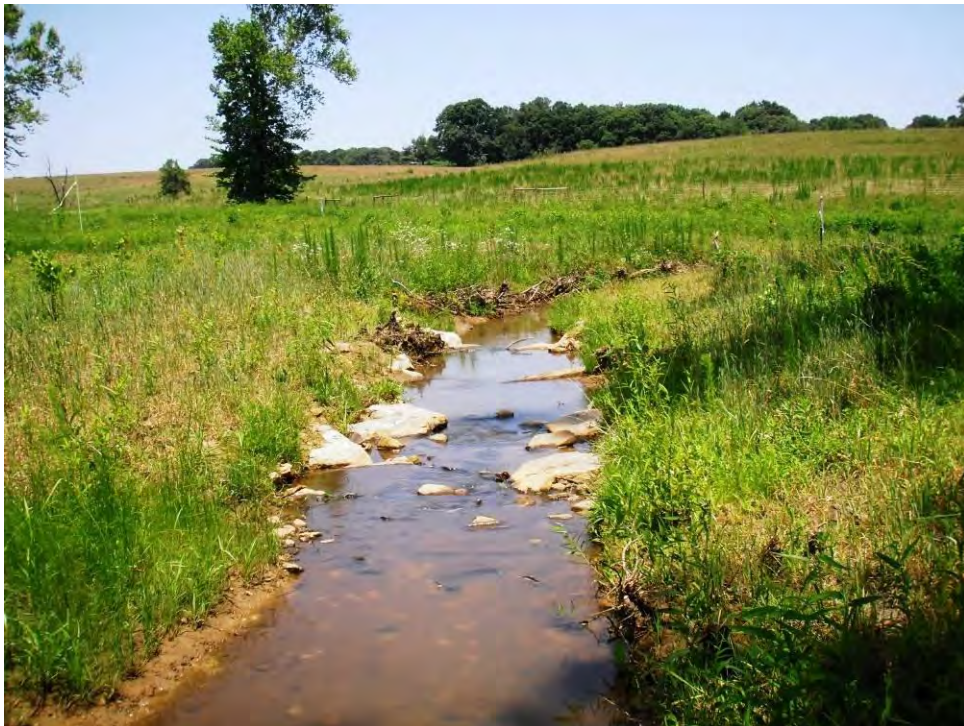
Photo B37 – Photo Station S37 Reach 4 cross-section 25 looking downstream (6/27/2012)

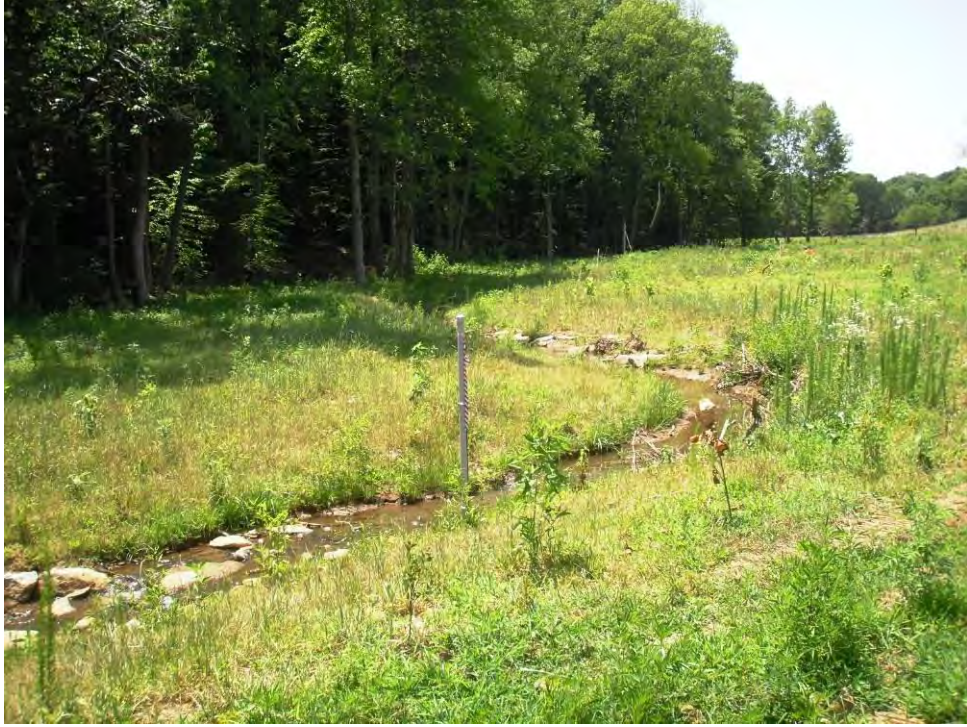
Photo B38 – Photo Station S38 Reach 4 cross-section 26 looking downstream (6/27/2012)

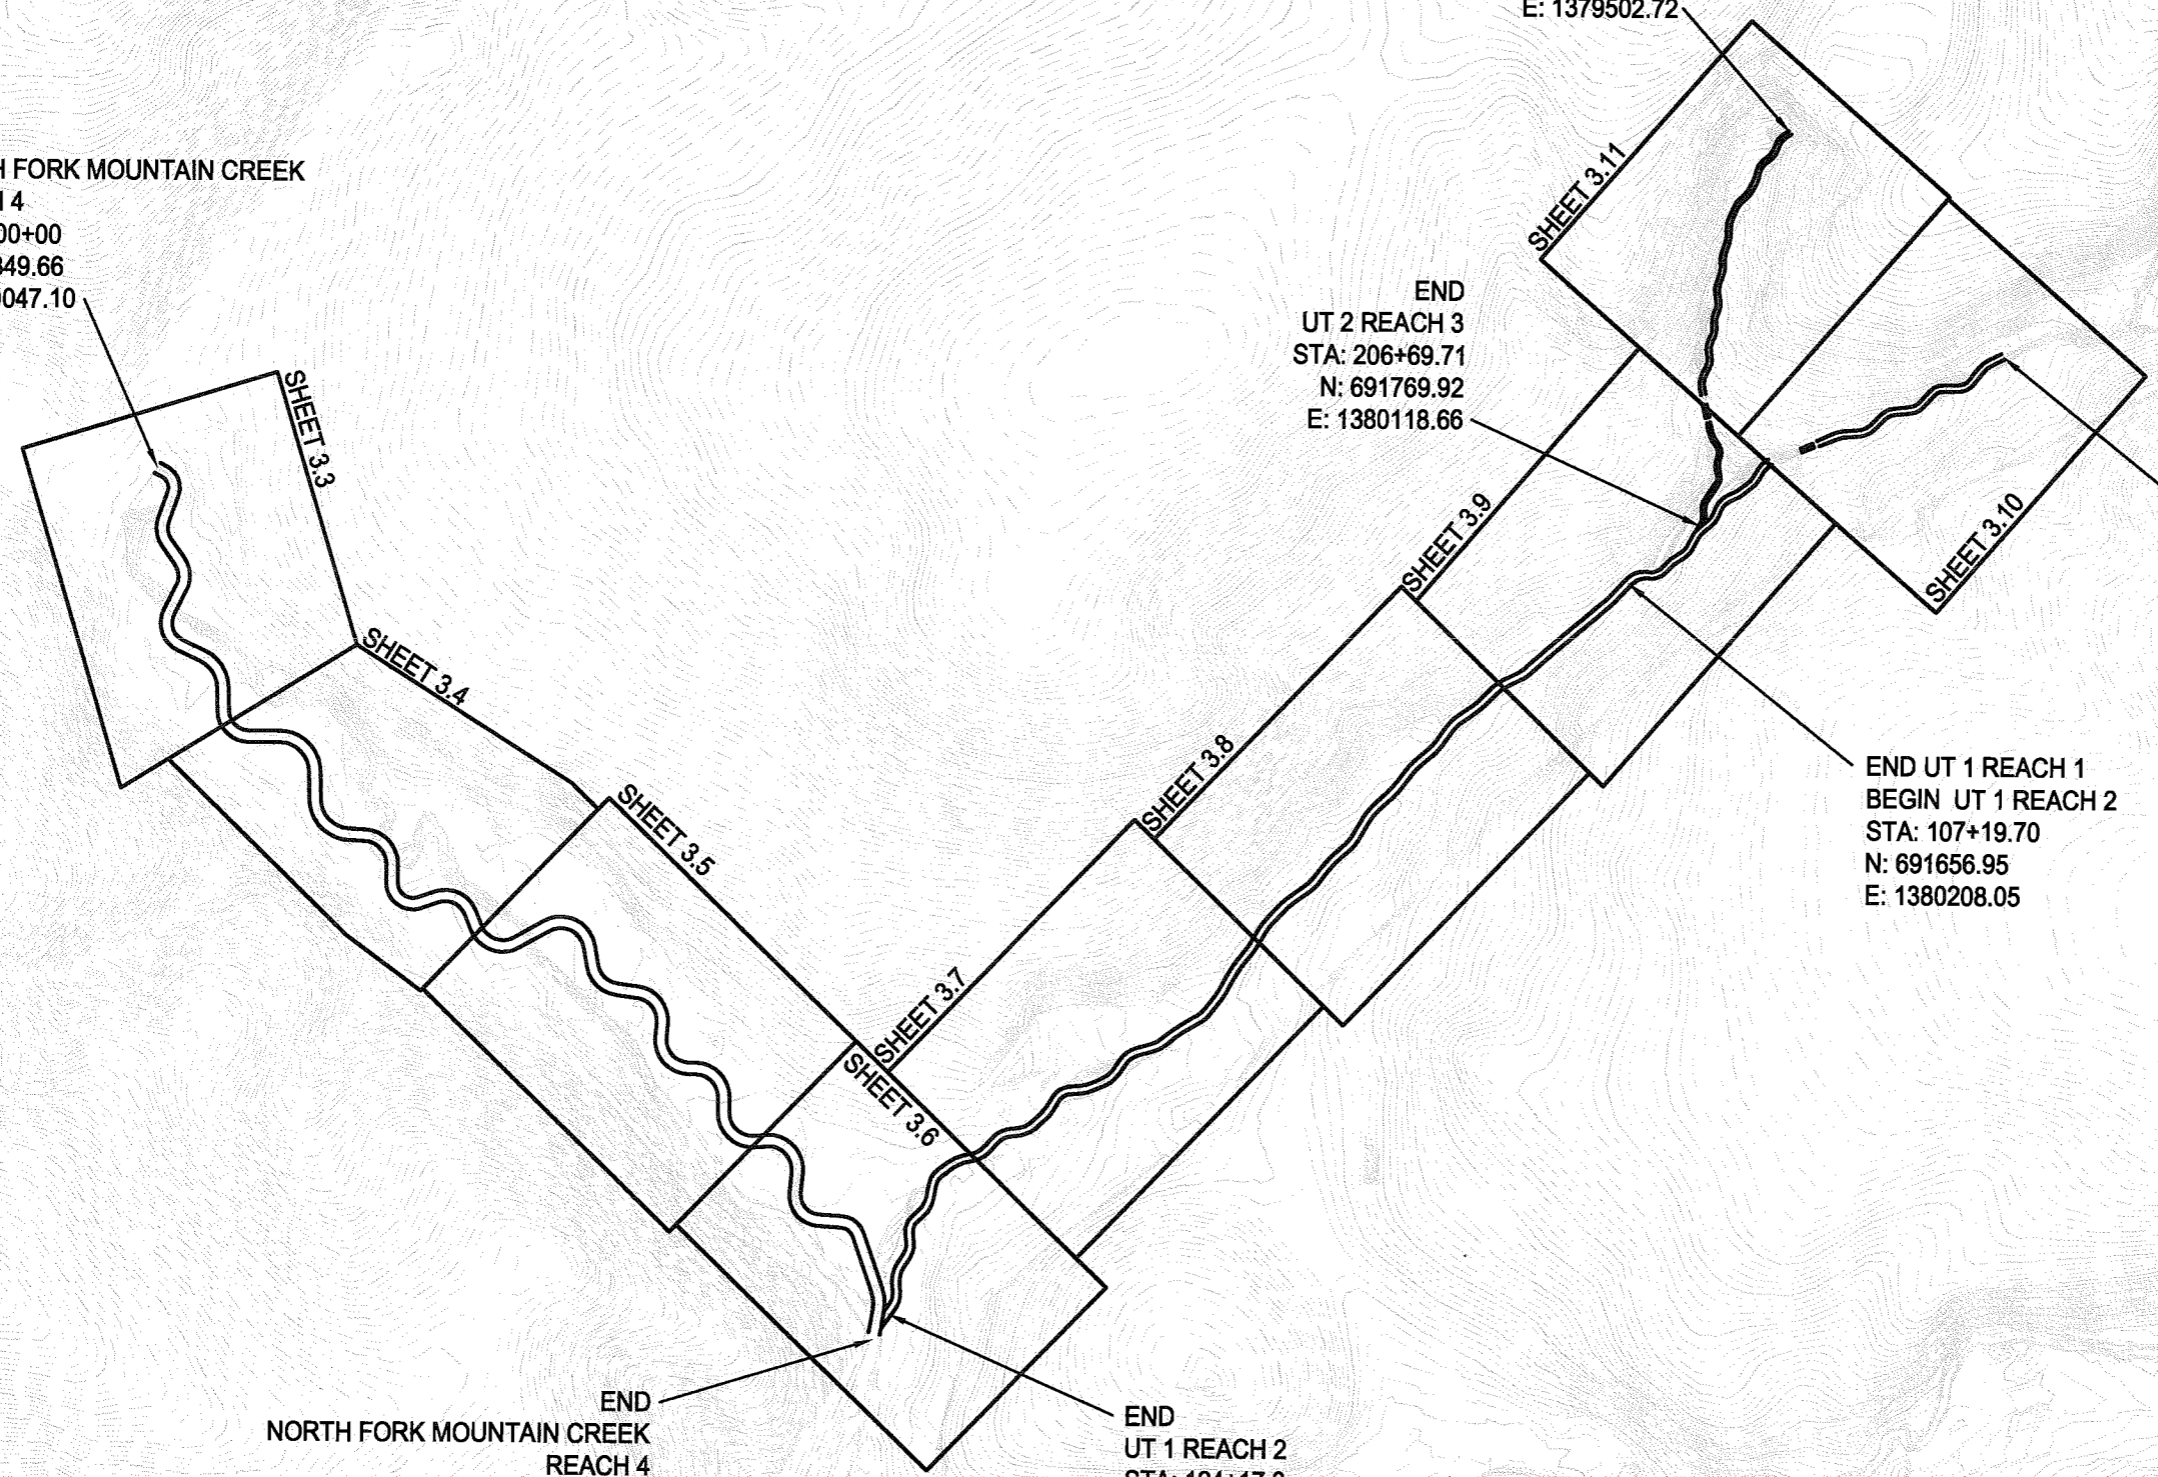
END
 UT 1 REACH 2
 STA: 124+17.8
 N: 690509.11
 E: 1381359.18

BEGIN
 NORTH FORK MOUNTAIN CREEK
 REACH 4
 STA: 300+00
 N: 689349.66
 E: 1380047.10

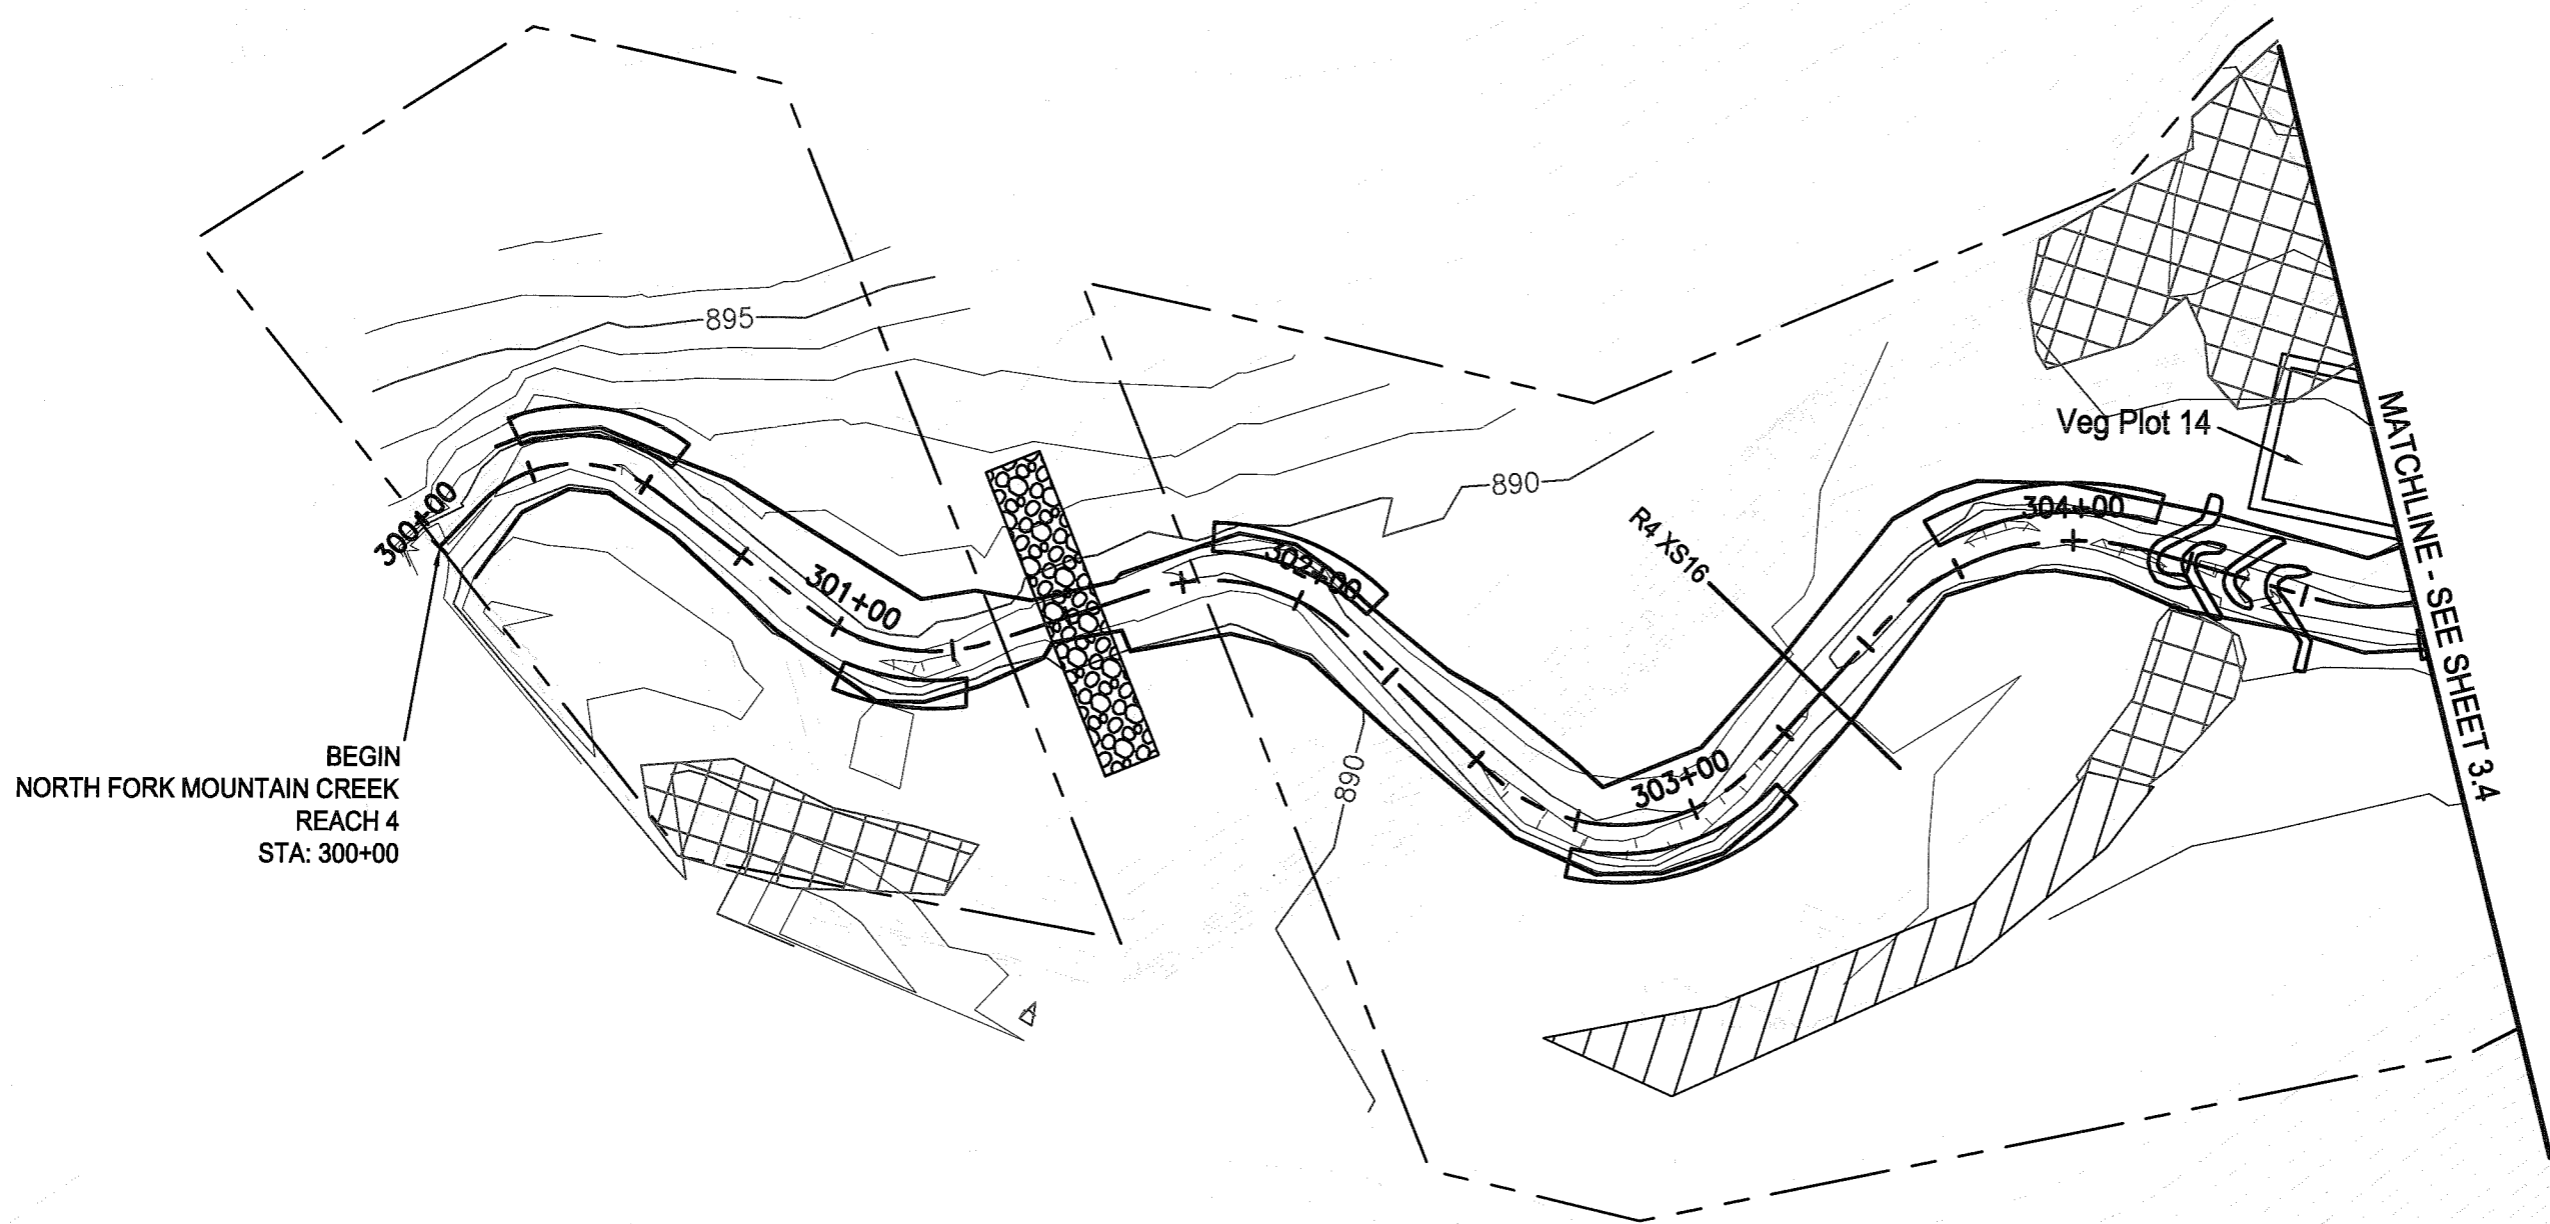
CADD PLOT:	SCALE: N/A	SHEET NO.
VOID PLOT:	DRAWN BY: R.R.P.	3.3
RELEASED TO CONSTRUCTION	DATE: 07-13-12	
	REVIEWED BY: T.T.

DRAWING TITLE
AS-BUILT PLAN SHEET

BEGIN
 NORTH FORK MOUNTAIN CREEK
 REACH 4
 STA: 300+00
