NORTH FORK MOUNTAIN CREEK
STREAM AND WETLAND RESTORATION

FINAL BASELINE MONITORING DOCUMENT AND AS-BUILT
BASELINE REPORT

Catawba County, North Carolina
EEP Project No. 94151

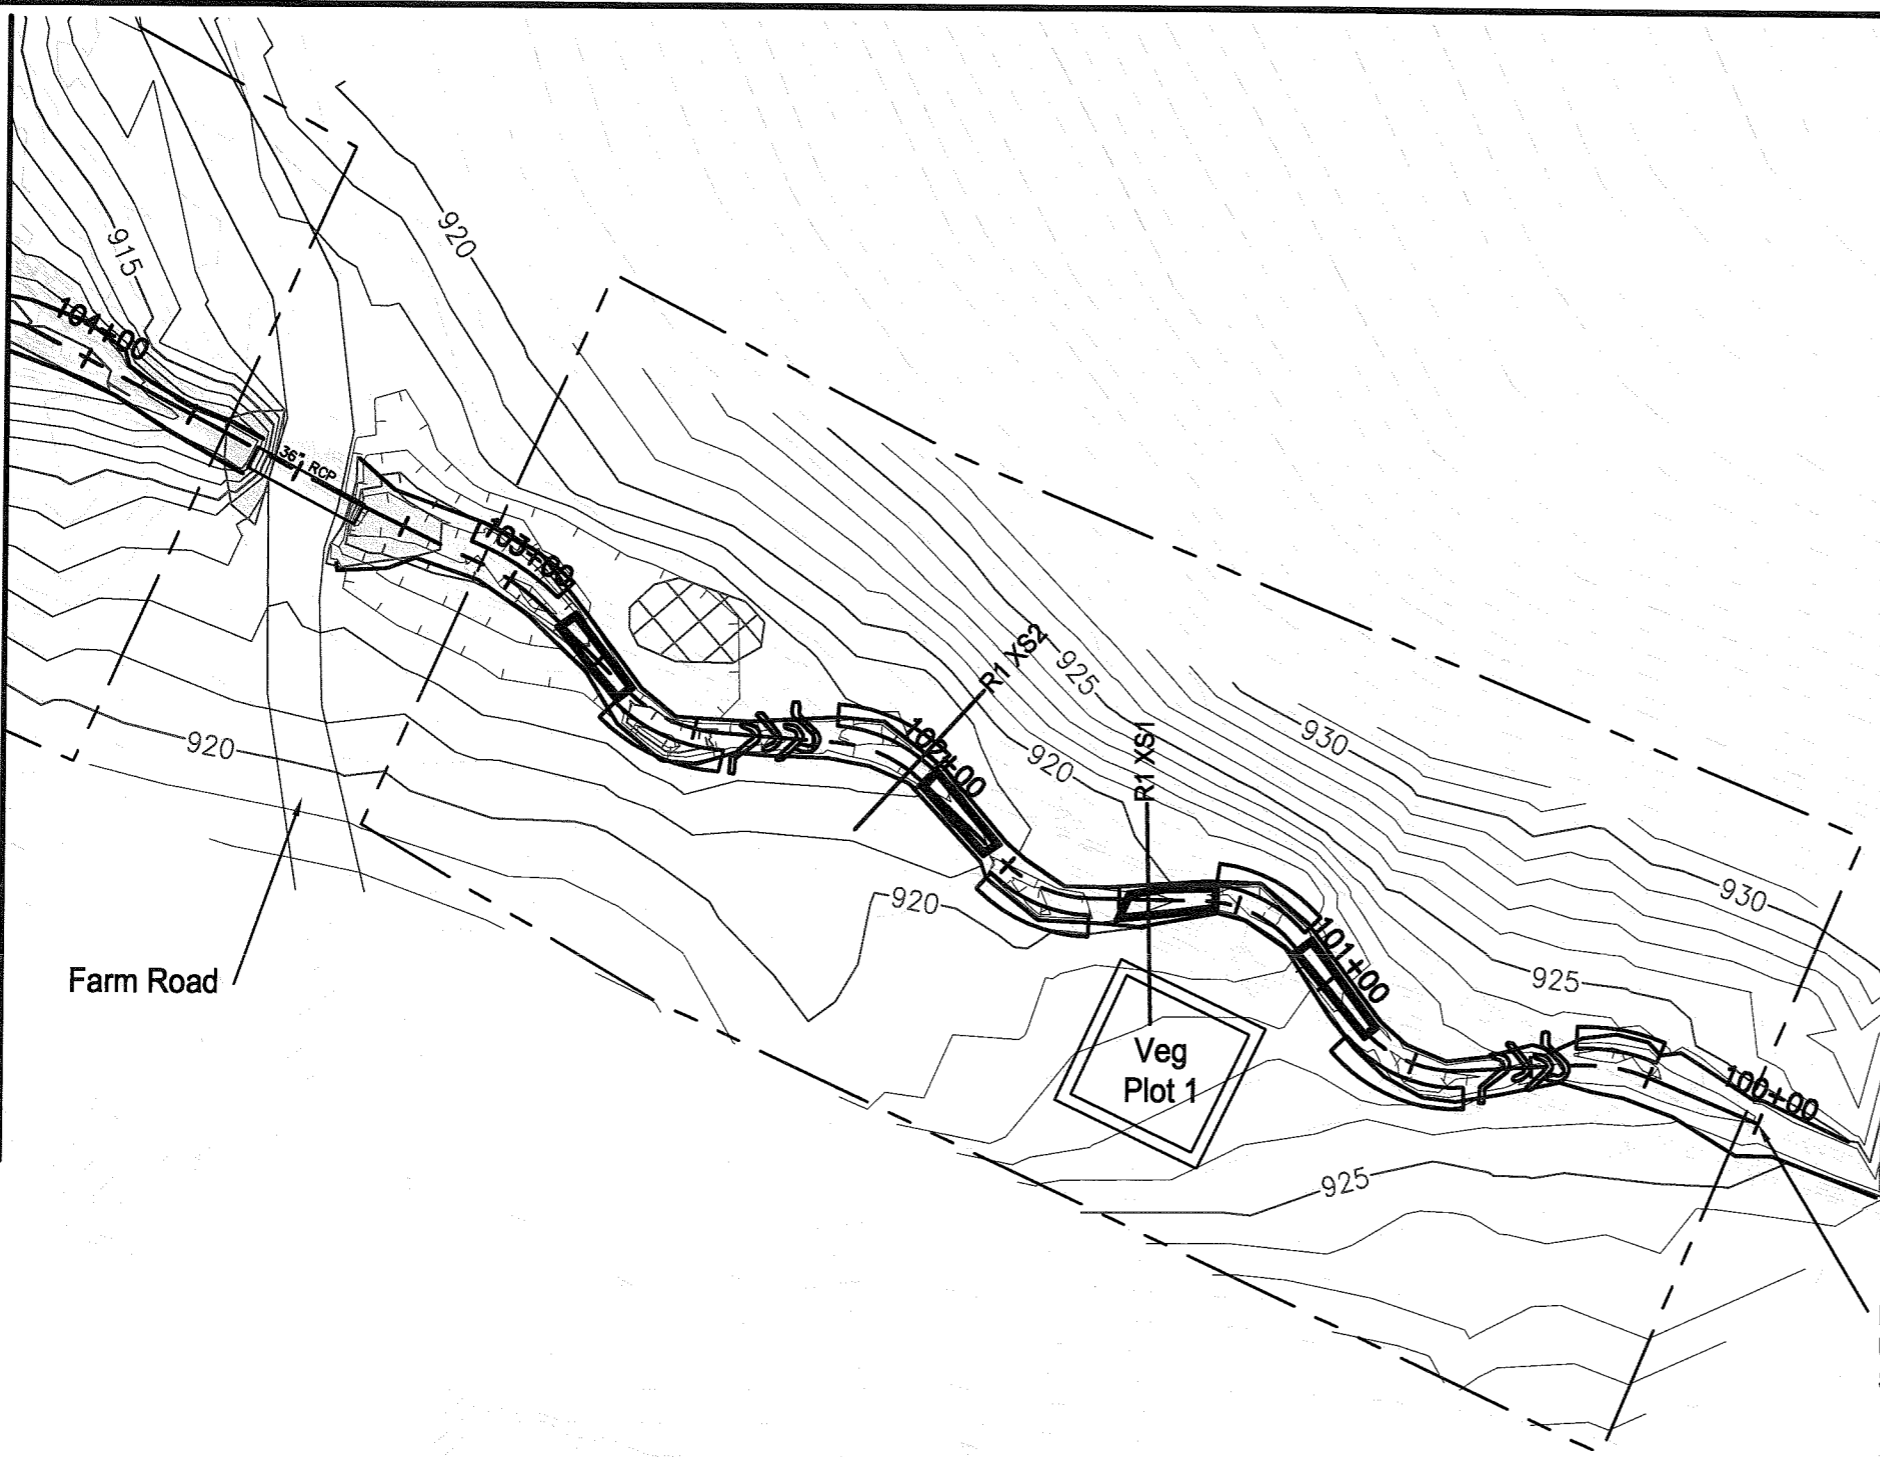
MATCHLINE - SEE SHEET 3.9

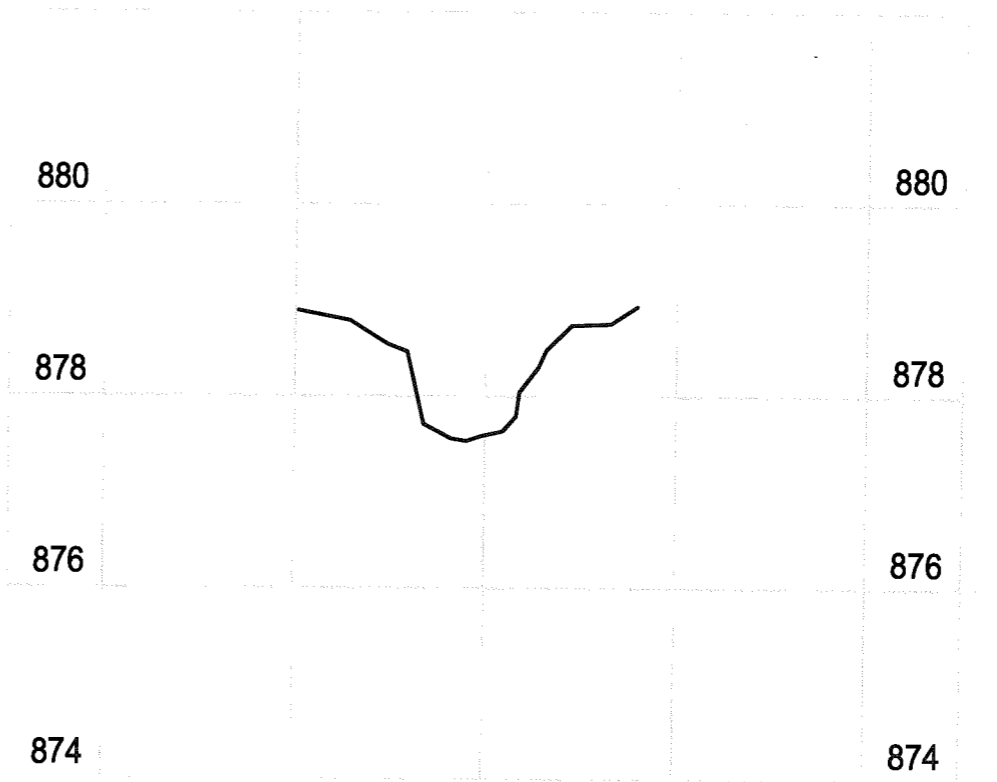
REACH 2 - XS11 - RIFFLE

SCALE: 1"=10' HORZ.
1"= 2' VERT.

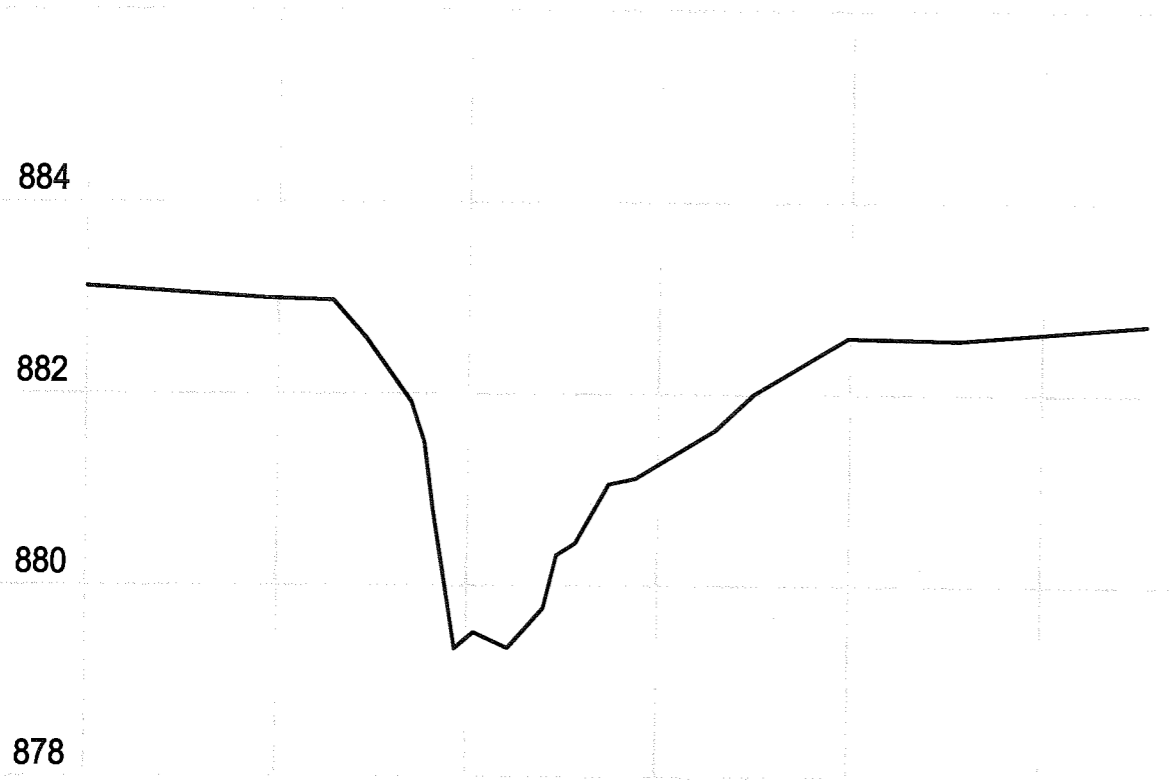
REACH 3 - XS12 - RIFFLE

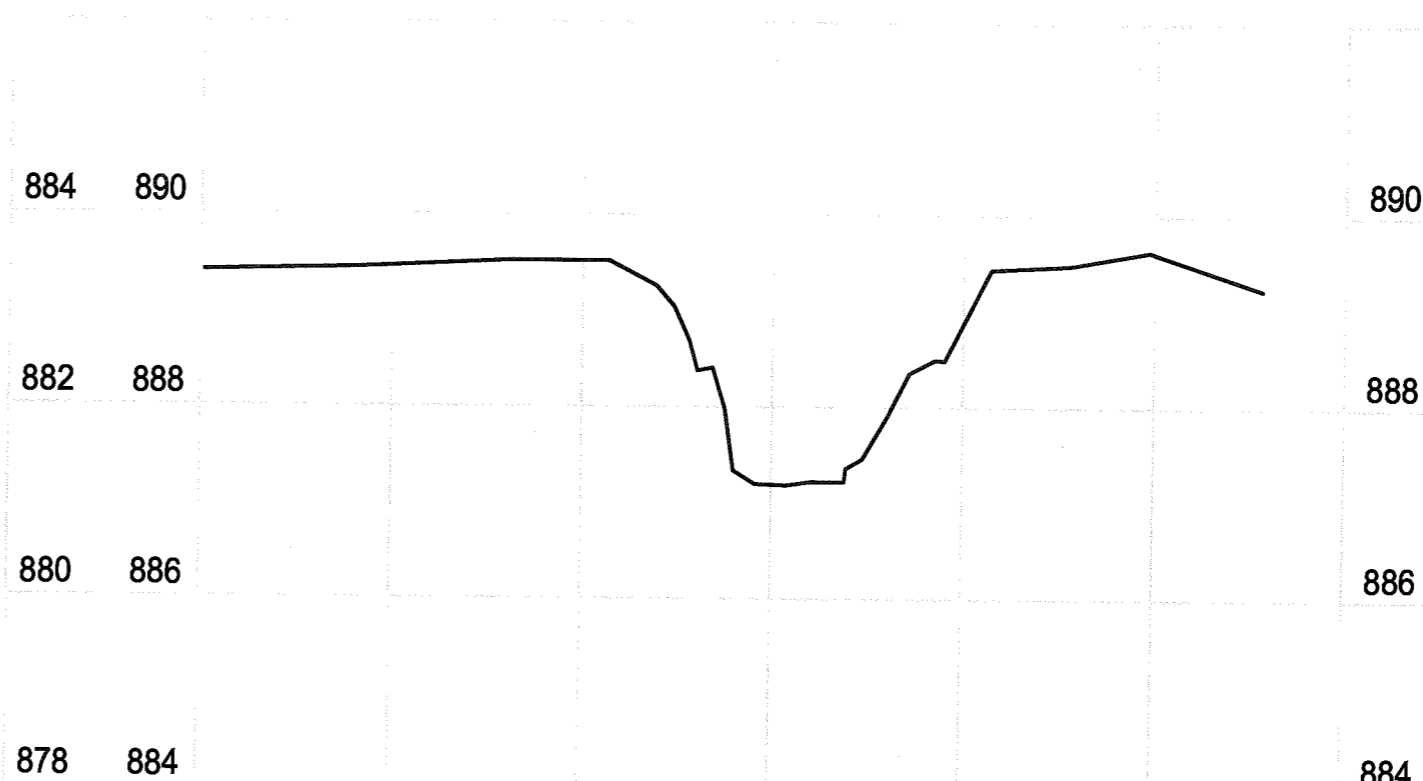
REACH 4 - XS20 - POOL
