**Northgate Park (Ellerbe Creek)
Stream Restoration Monitoring and
Baseline Report
EEP Project # 272
Monitoring Years – 00 and 01
2009**

April 2010

**NORTHGATE PARK (ELLERBE CREEK)
PROJECT #272 - MONITORING YEAR 01**
DURHAM, DURHAM COUNTY, NORTH CAROLINA
ELLERBE CREEK: STATION 17+40 TO STATION 26+25

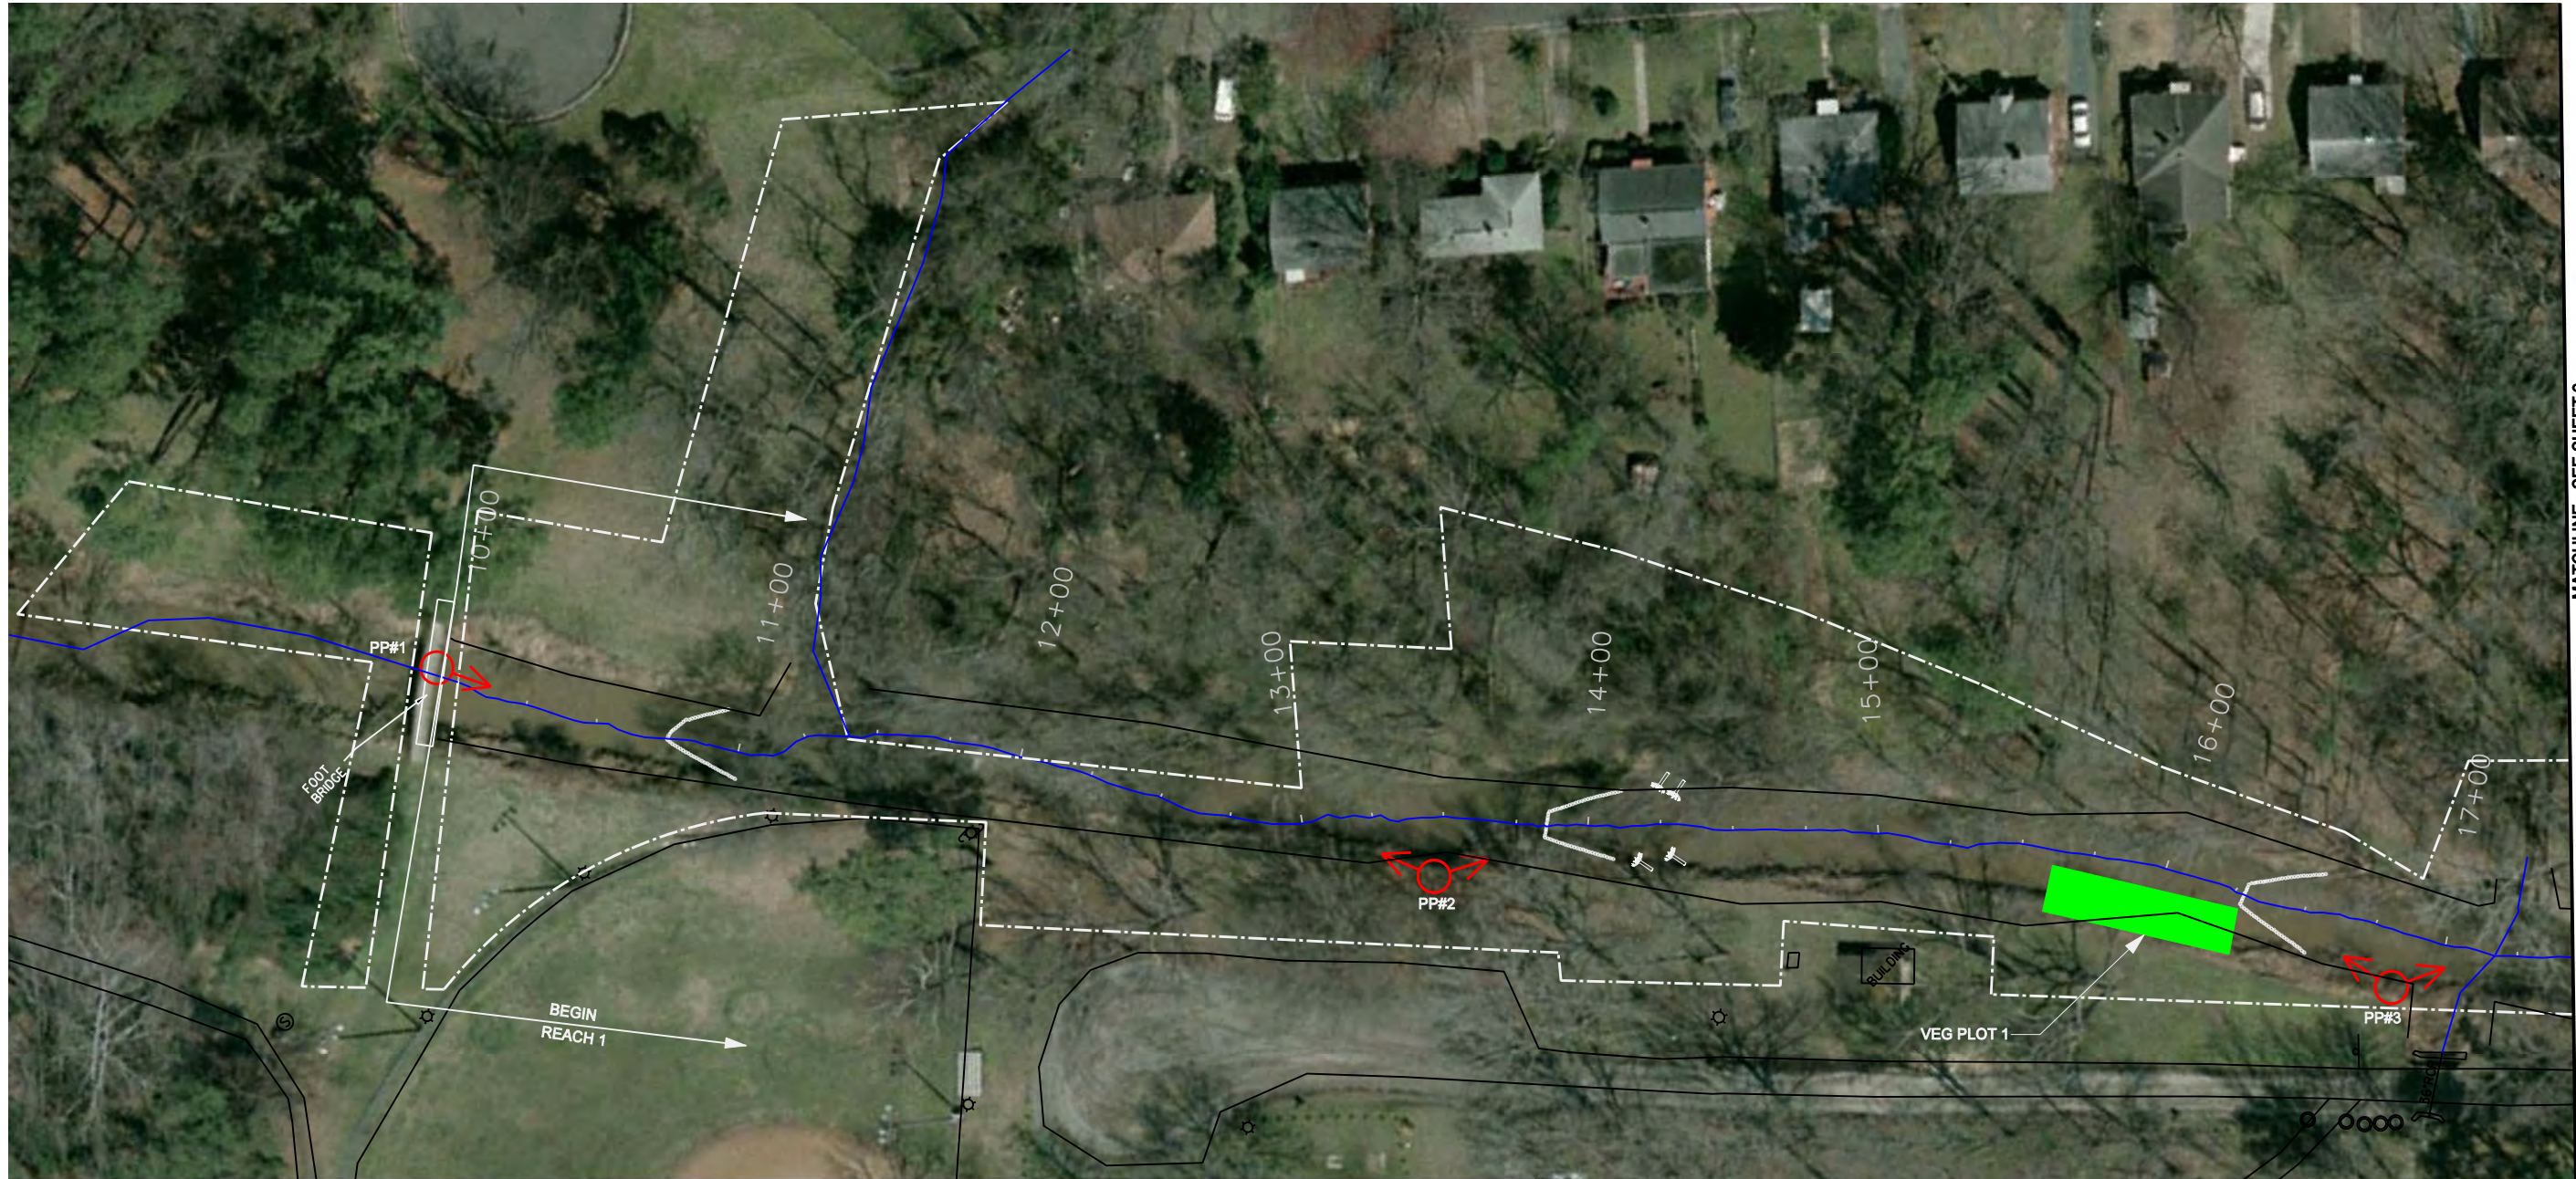
DATE: JAN 2010
SCALE: 1" = 60'
CURRENT CONDITION PLAN VIEW
SHEET 1 OF 3

| PROJECT CONDITION | |
|---|--|
| STREAM BED DEGRADATION | |

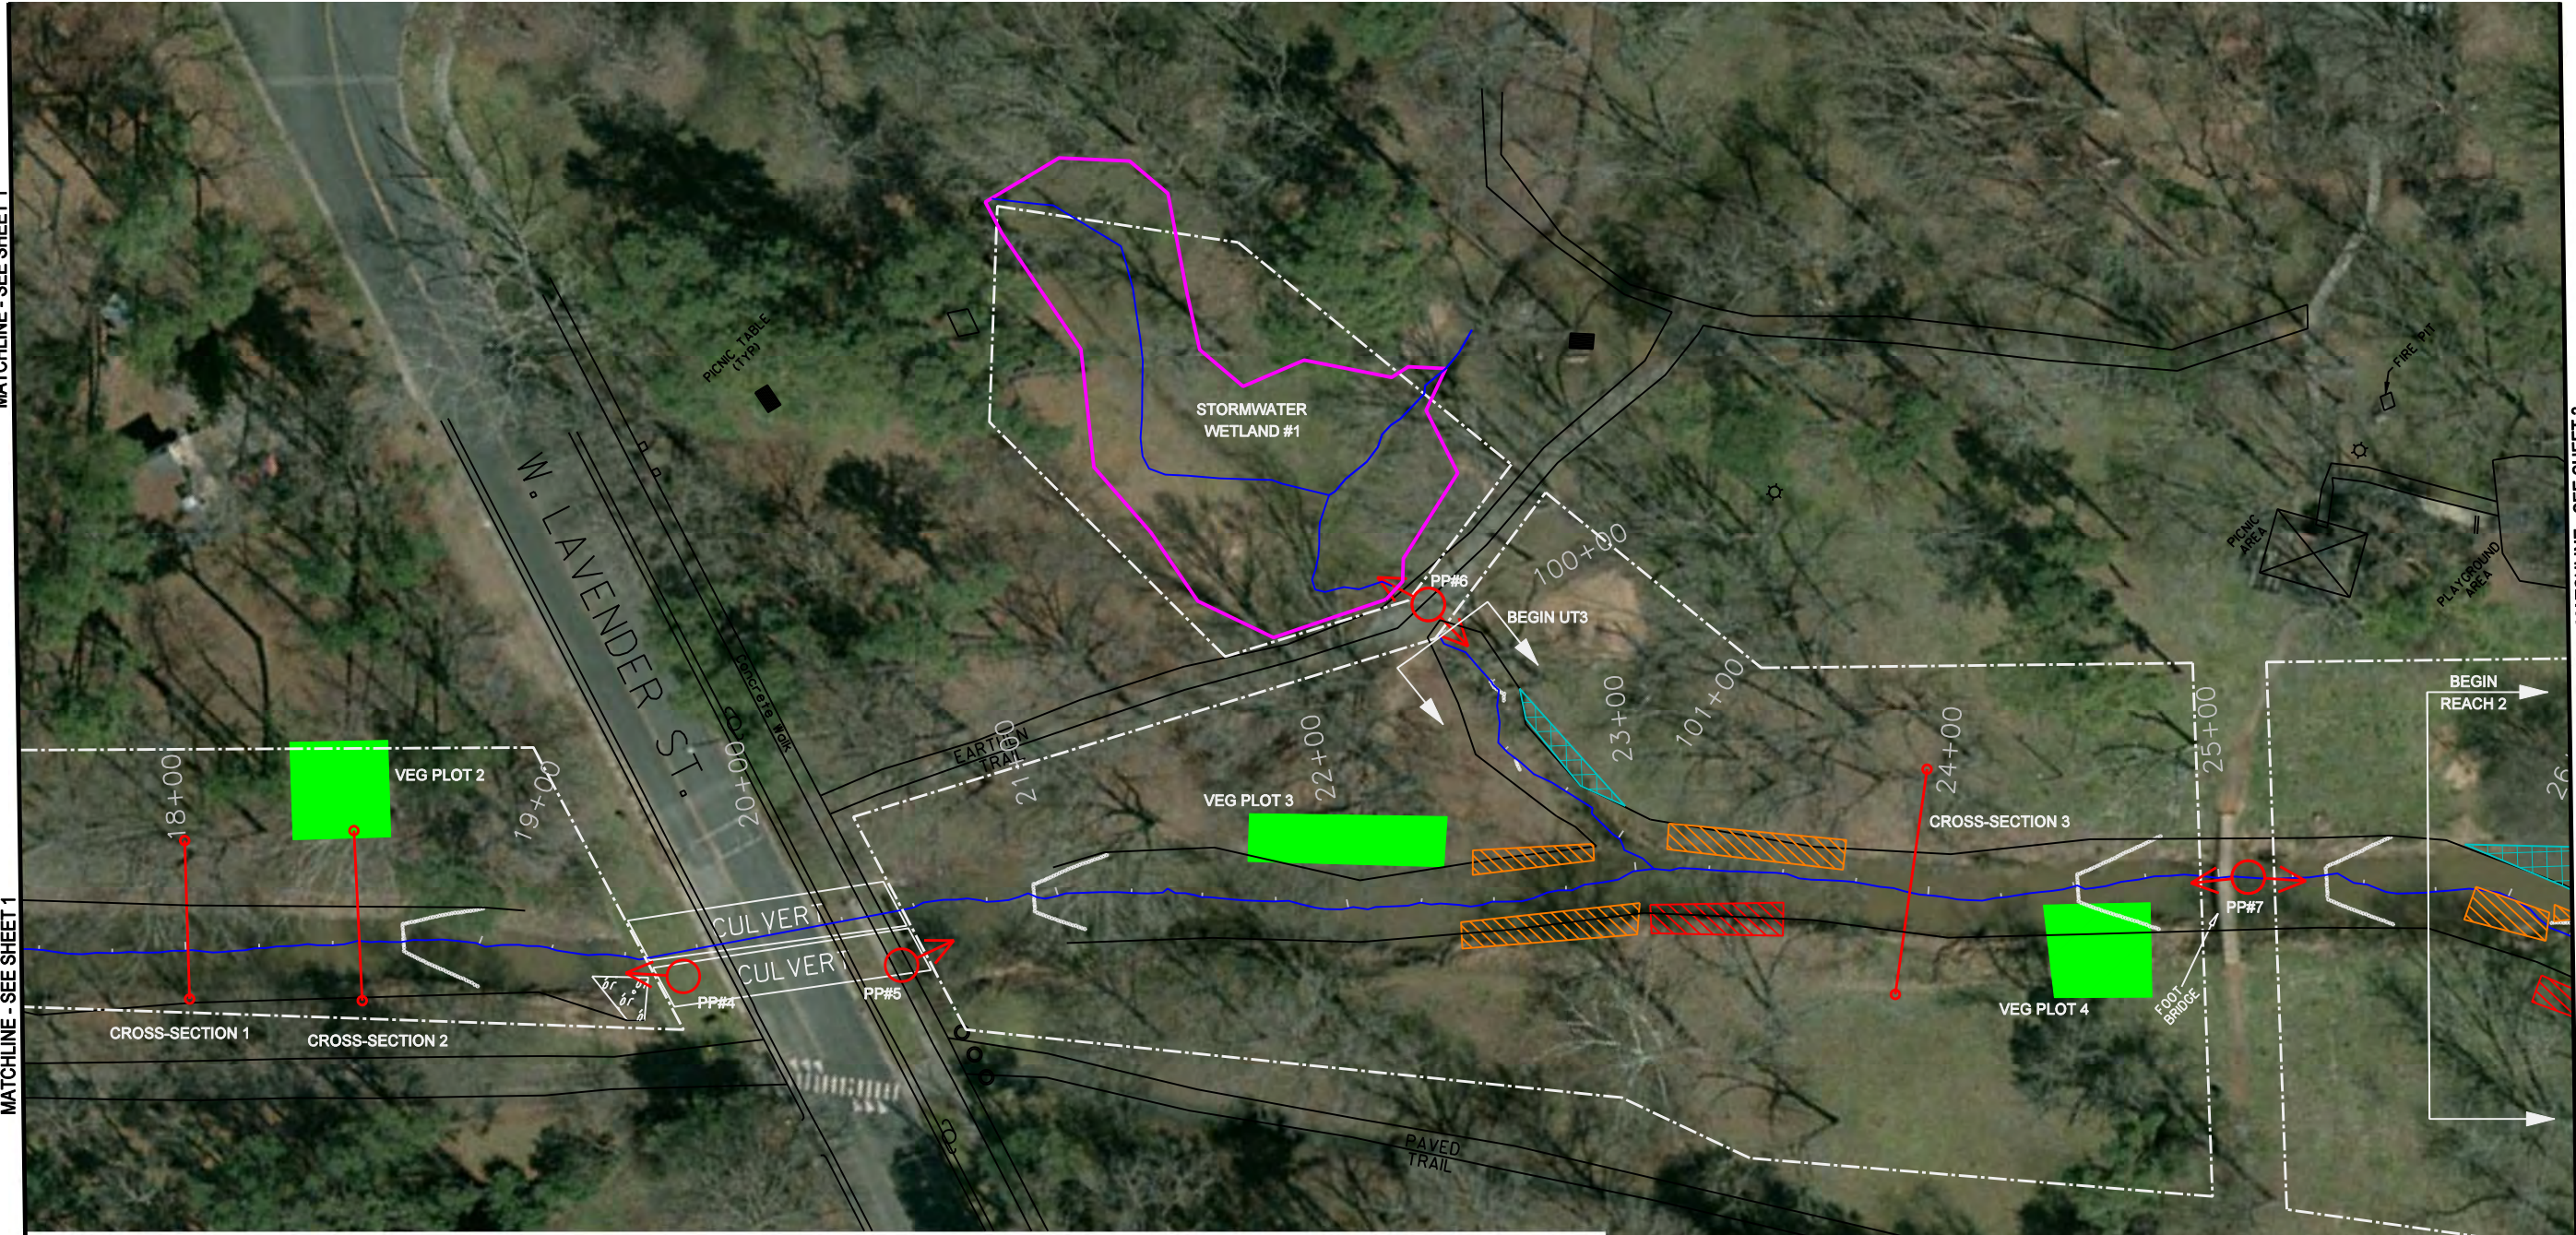
- STREAM BED DEGRADATION
- BANK EROSION
- UNDERCUT BANK
- MASS WASTING OF BANK
- VEG PLOT ACHIEVING DENSITY CRITERION
- VEG PLOT BELOW DENSITY CRITERION

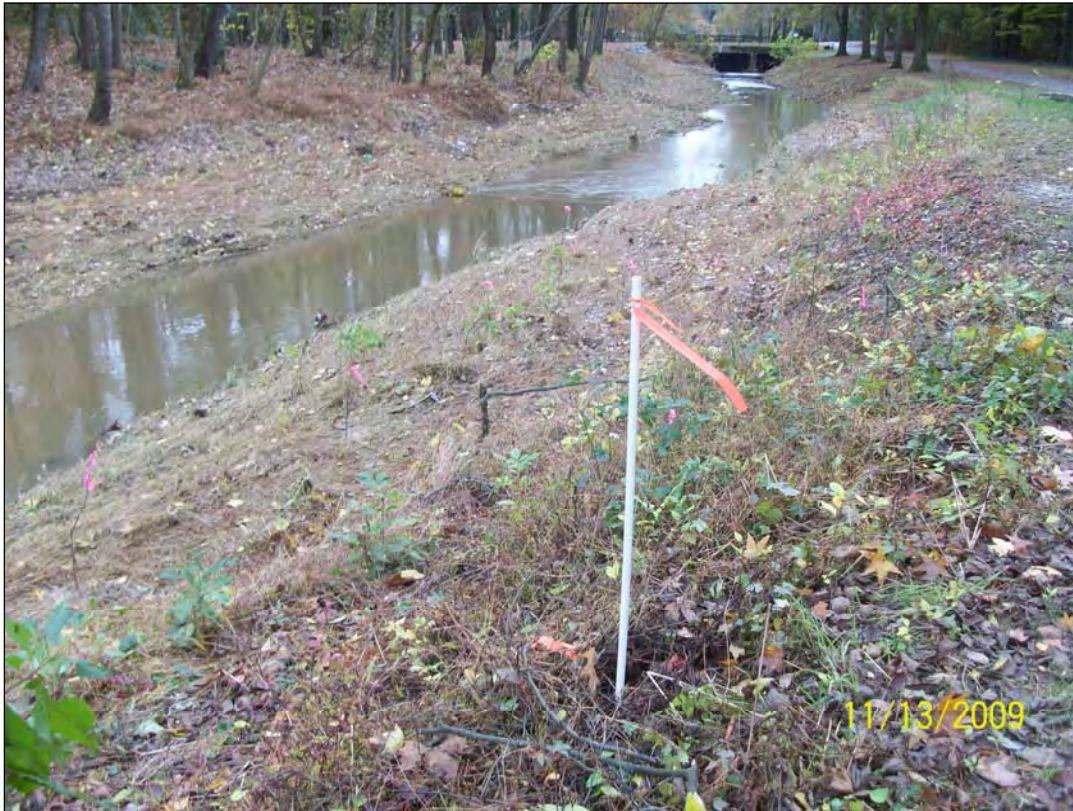
Plot 1 Photo – Taken looking southeast from the plot origin. 11/13/09 - MY 00

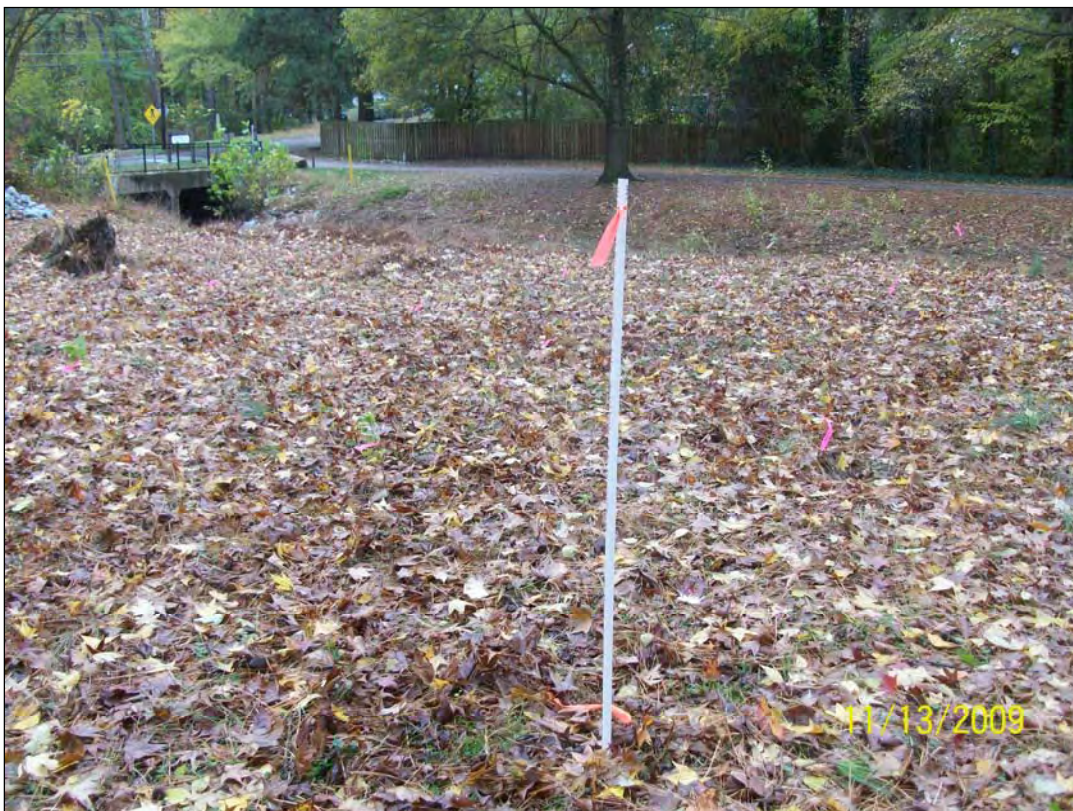
Plot 2 Photo – Taken looking south from the plot origin. 11/13/09 - MY 00

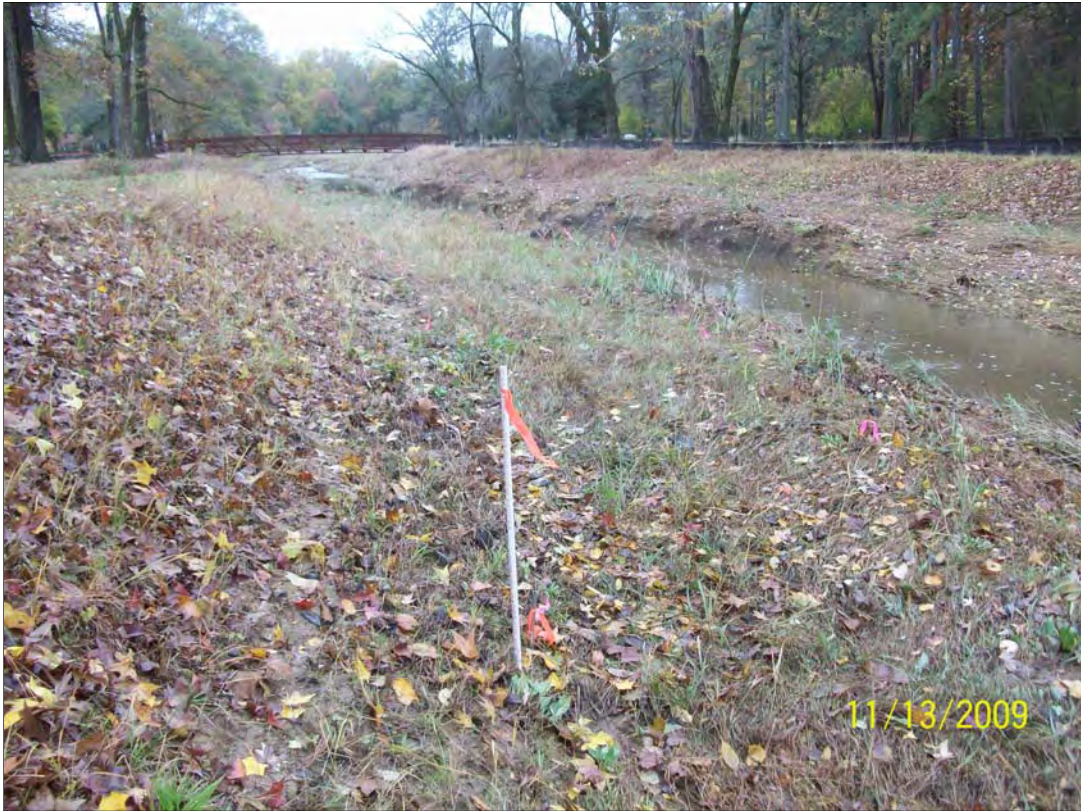
Plot 3 Photo – Taken looking east from the plot origin. 11/13/09 - MY 00

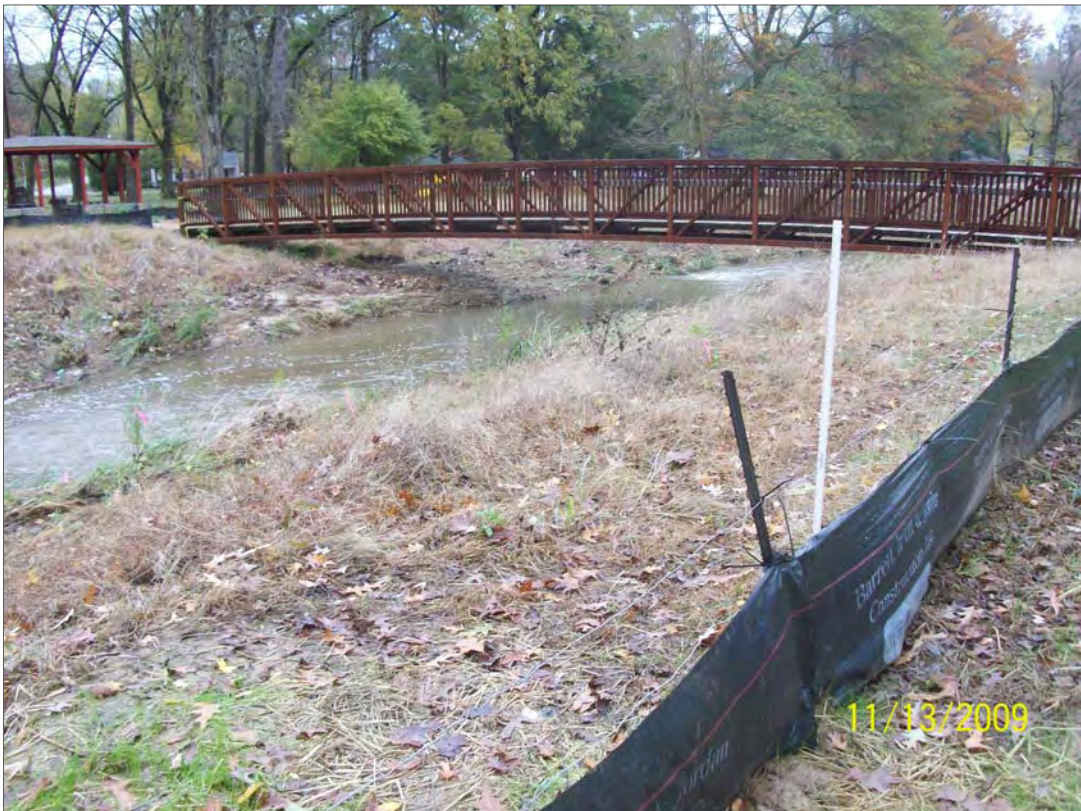
Plot 4 Photo – Taken looking south from the plot origin. 11/13/09 - MY 00

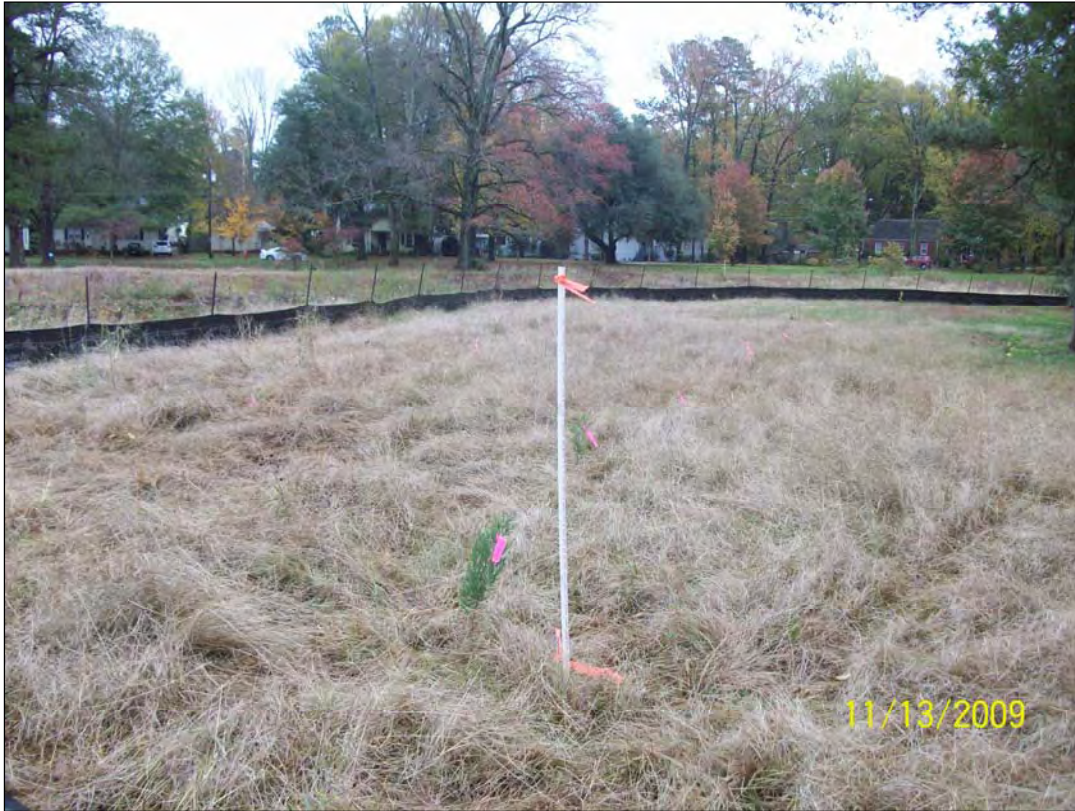
Plot 5 Photo – Taken looking east from the plot origin. 11/13/09 - MY 00

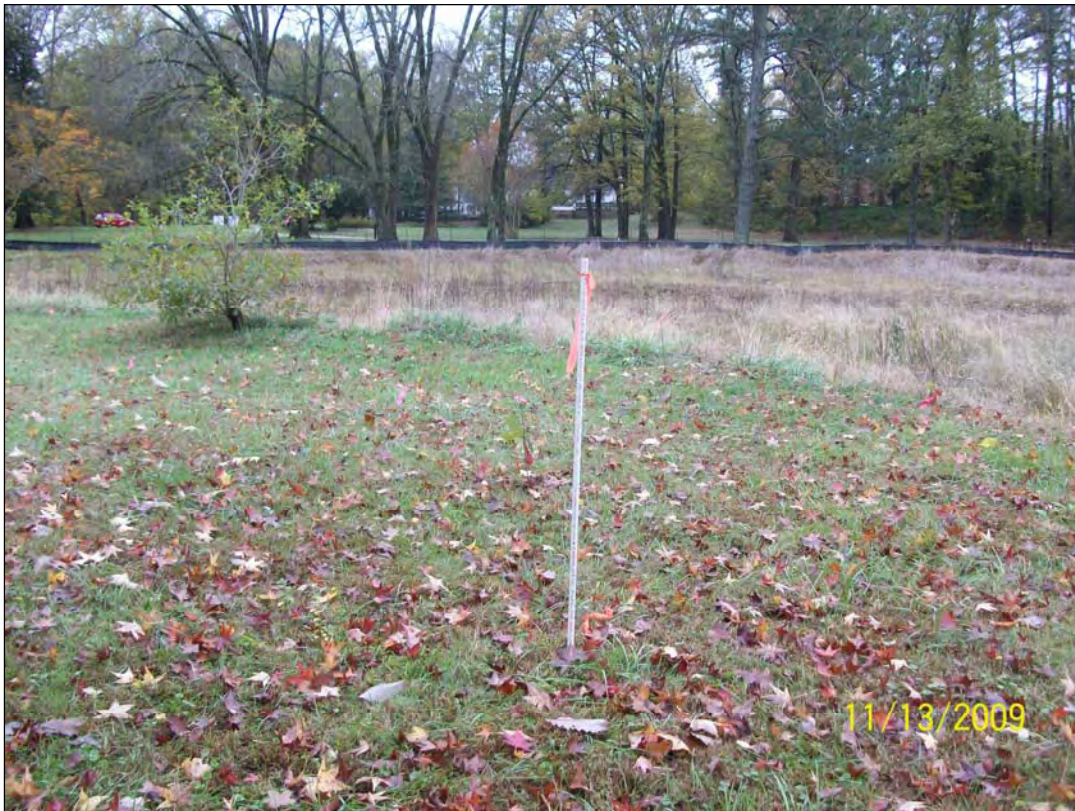
Plot 6 Photo – Taken looking south from the plot origin. 11/13/09 - MY 00

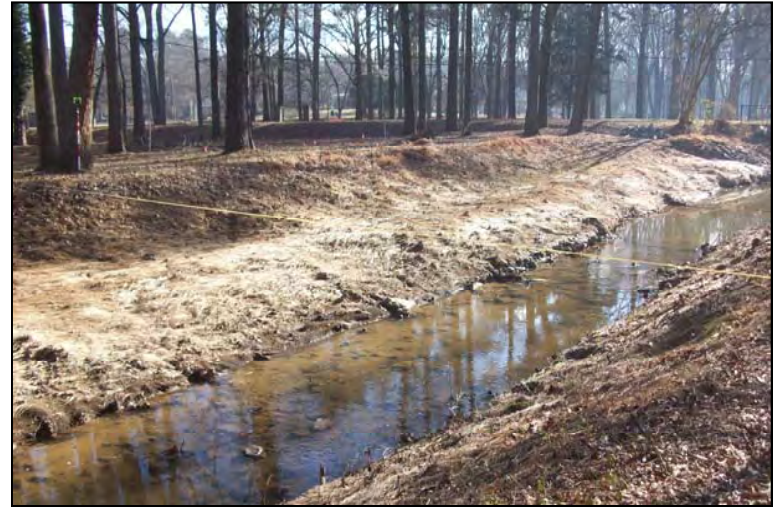
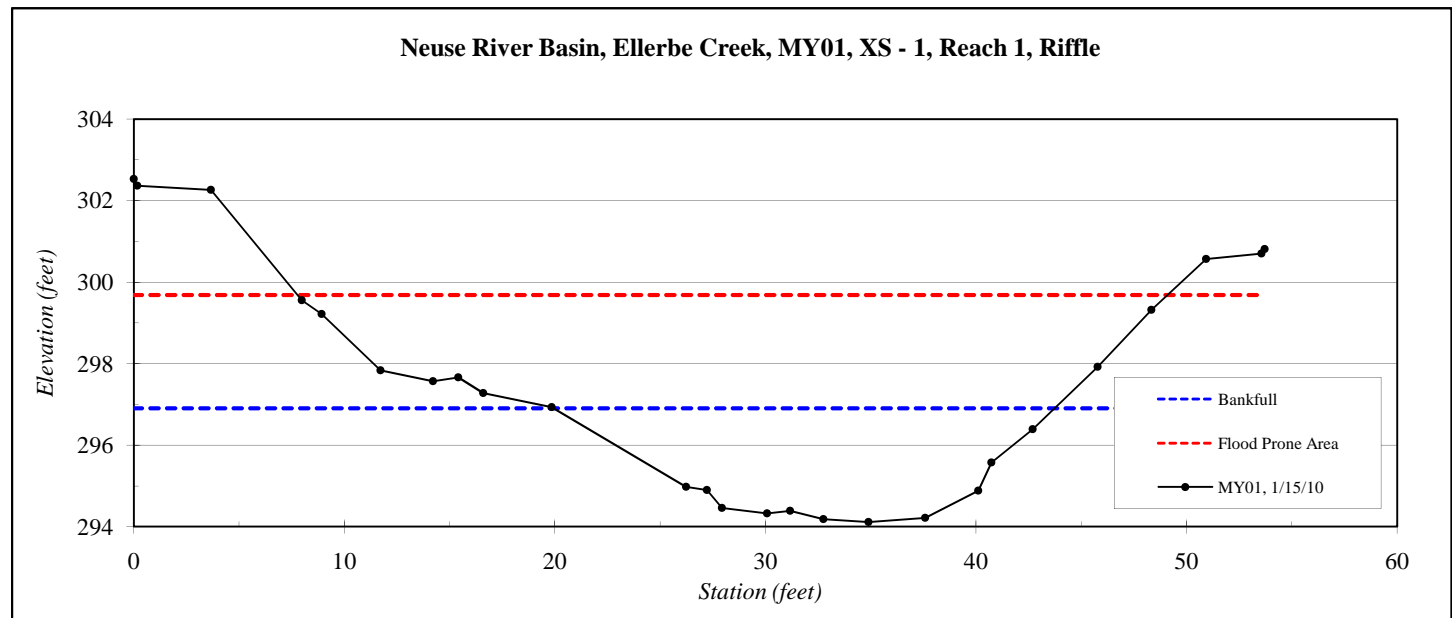
| SUMMARY DATA | |
|---|---|
| Entrenchment Ratio: | 1.8 |
| Bank Height Ratio: | 1.0 |

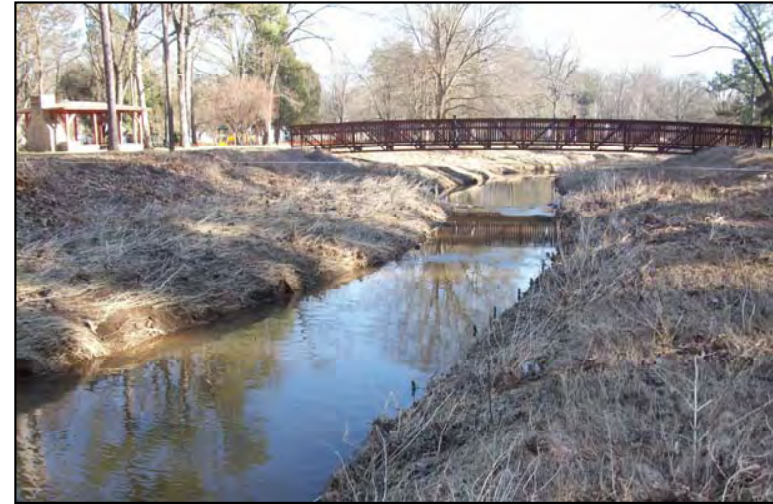
| SUMMARY DATA | |
|---|---|
| Entrenchment Ratio: | 2.5 |
| Bank Height Ratio: | 1.0 |

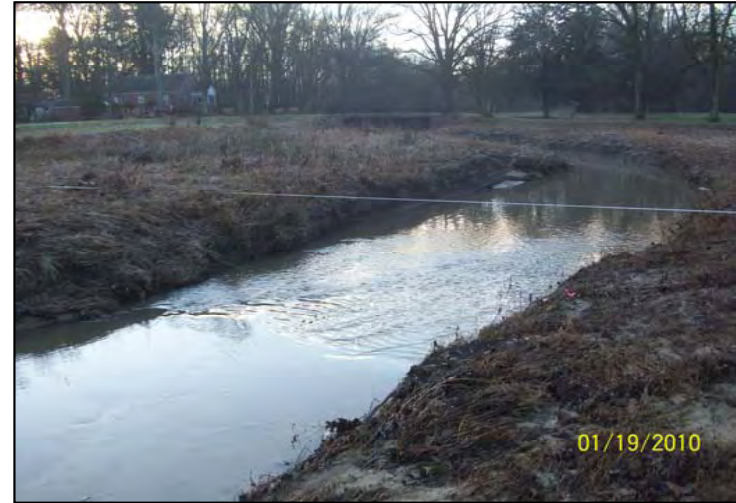
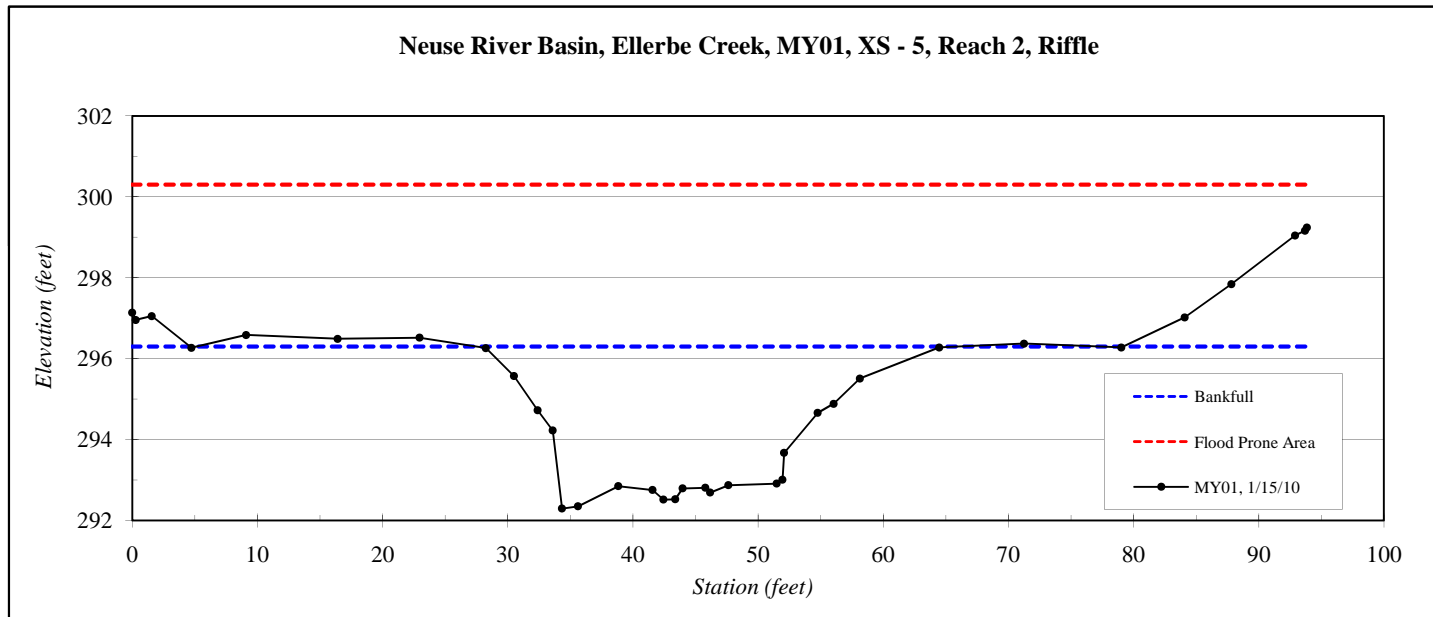
Neuse River Basin, Ellerbe Creek, MY01, XS - 5, Reach 2, Riffle

| SUMMARY DATA | |
|---|---|
| Bank Height Ratio: | 1.0 |
