Annual Monitoring Report

Project Name: Pee Dee Stream Restoration Site

1.0 PROJECT SUMMARY

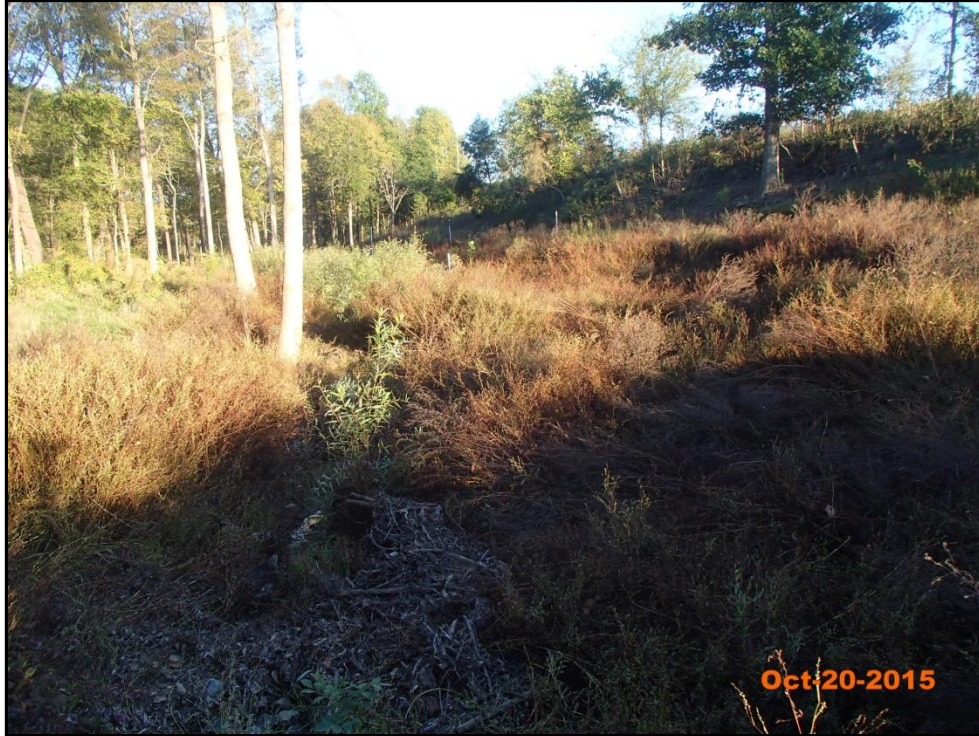
Jerry Branch – Permanent Photo Station 1
Station 300+25 - Downstream

For MY1, visual assessment was performed during the geomorphic and vegetation data collection event. For future monitoring years, visual assessment of the project will be performed at the beginning and end of the monitoring year. Permanent photo station photos were also collected during the geomorphic and vegetation data collection event; however for future monitoring years permanent photo station photos will be taken during the initial visual assessment during leaf-off conditions. Additional photos of vegetation or stream problem areas were documented with photographs throughout the project area.

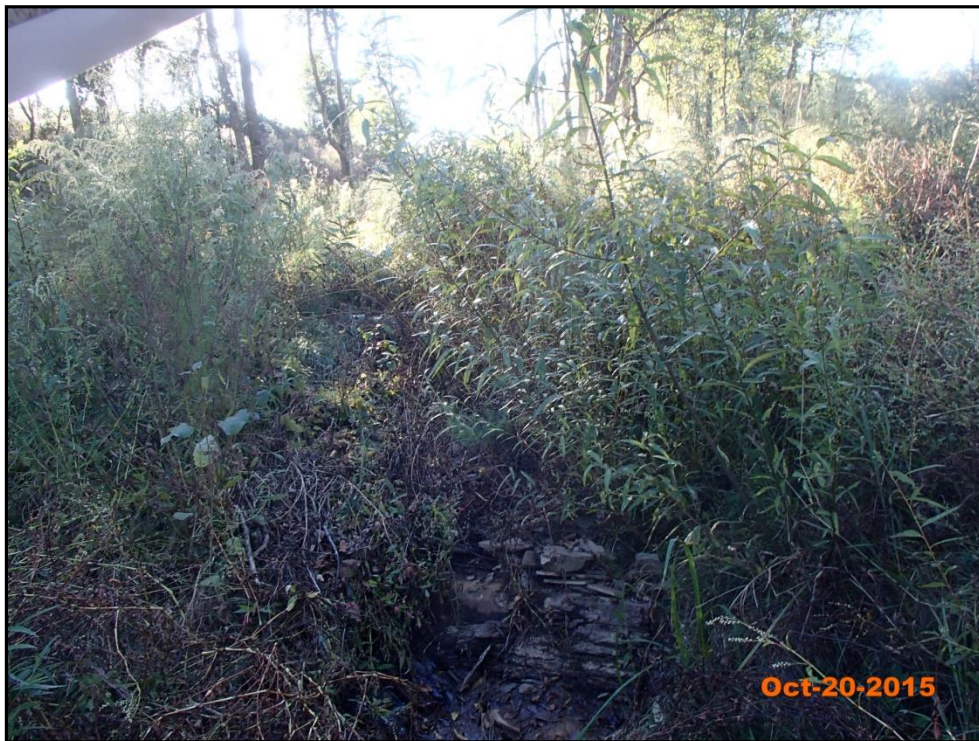
Jerry Branch – Permanent Photo Station 2
Station 305+04 - Upstream

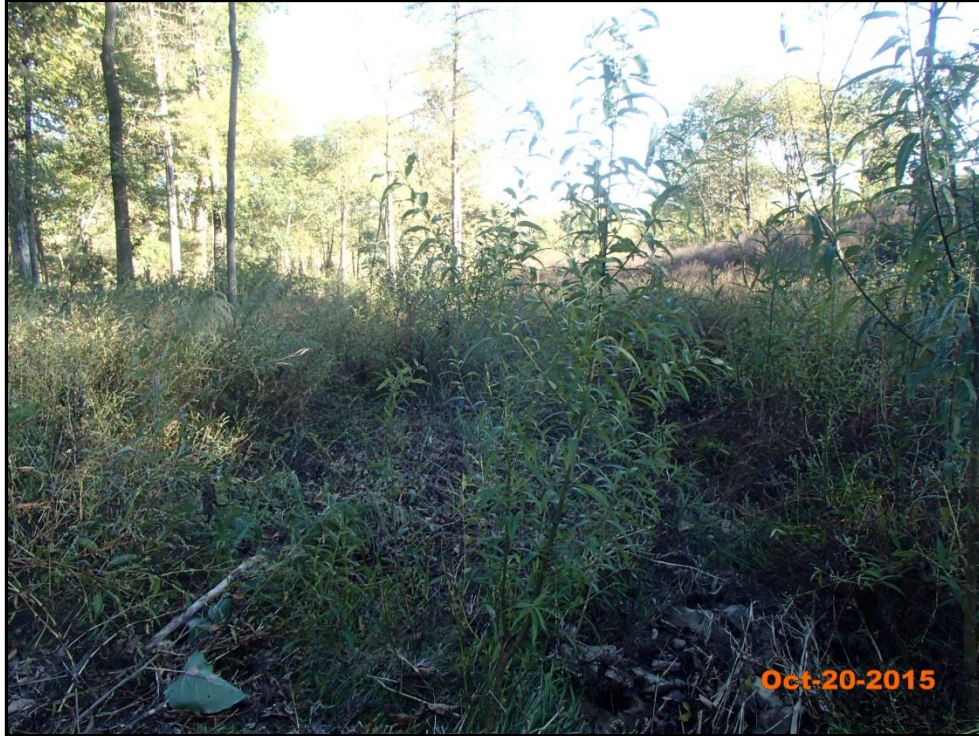
Jerry Branch – Permanent Photo Station 2
Station 305+04 - Downstream

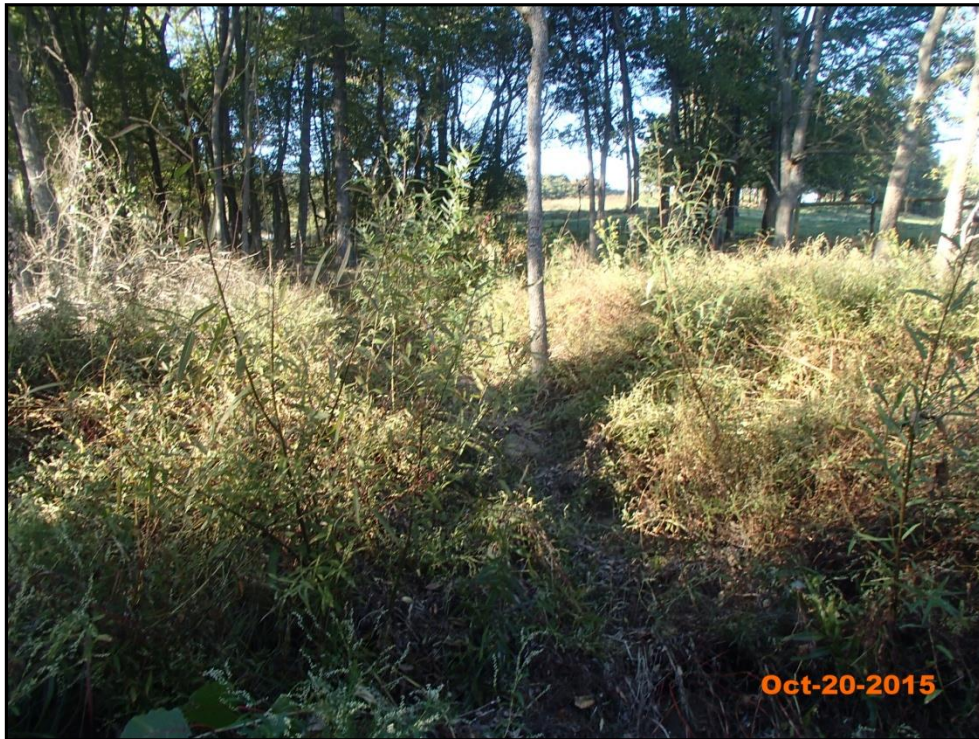
Hudson Branch – Permanent Photo Station 2
Station 305+04 – Looking Upstream from Confluence with Jerry Branch

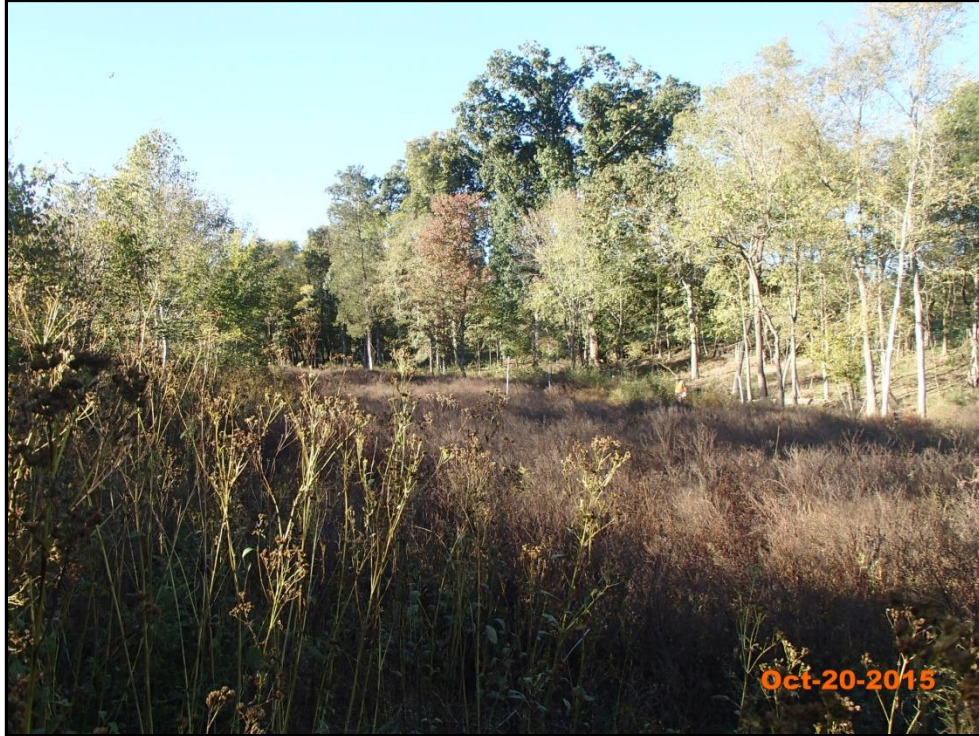
Jerry Branch – Permanent Photo Station 3
Looking North Northwest/Upstream Jerry Branch

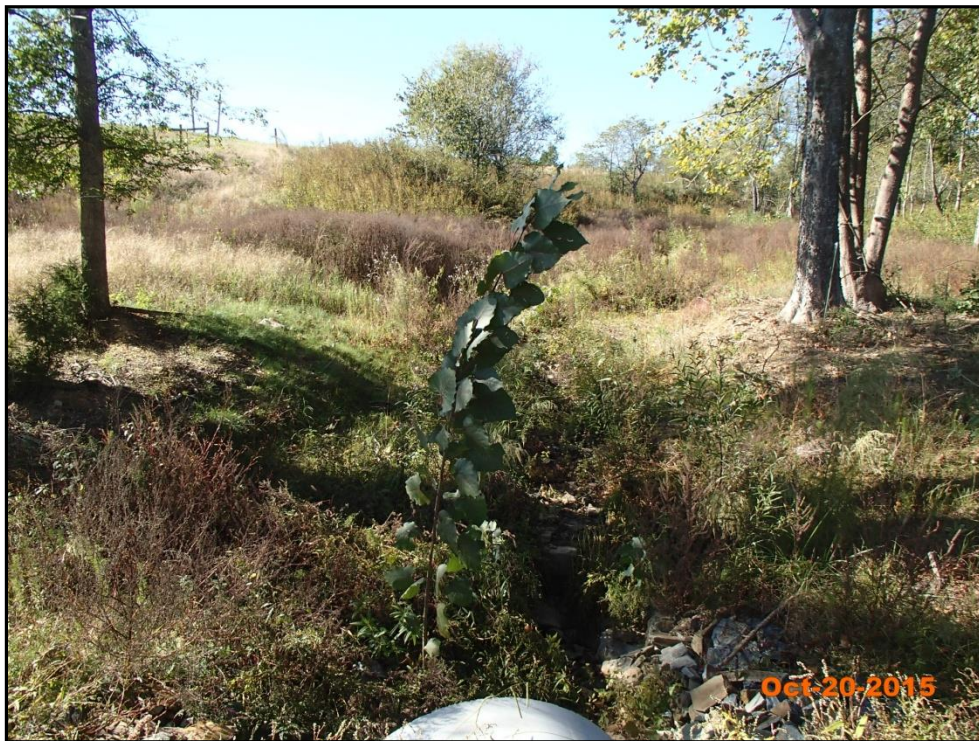
Jerry Branch – Permanent Photo Station 4
Station 304+80 - Upstream

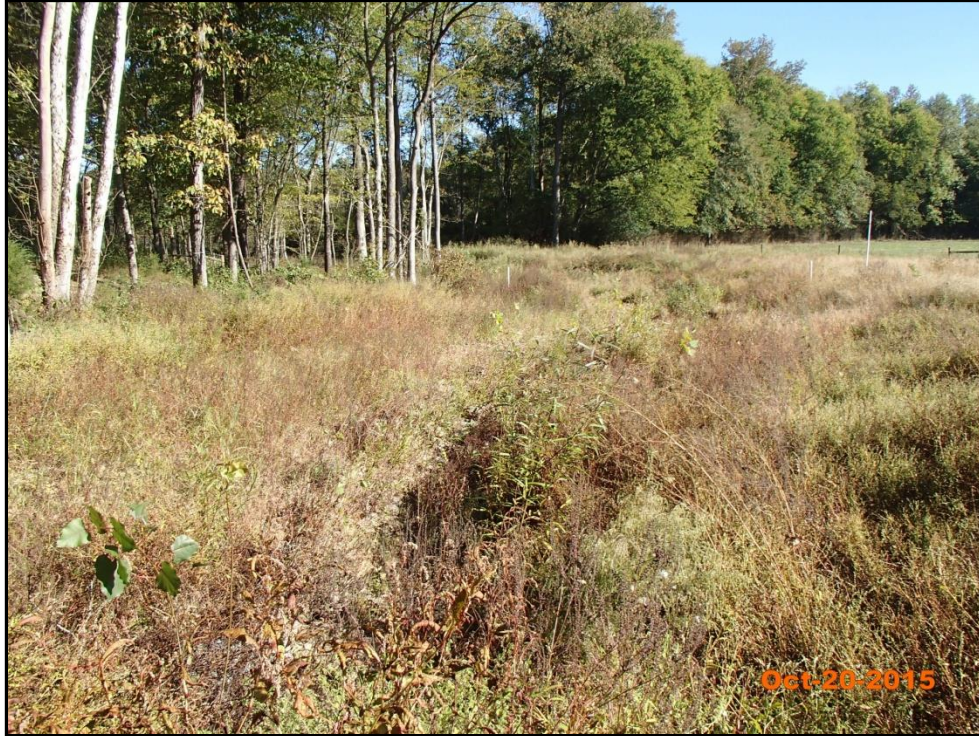
Jerry Branch – Permanent Photo Station 4
Station 304+80 - Downstream

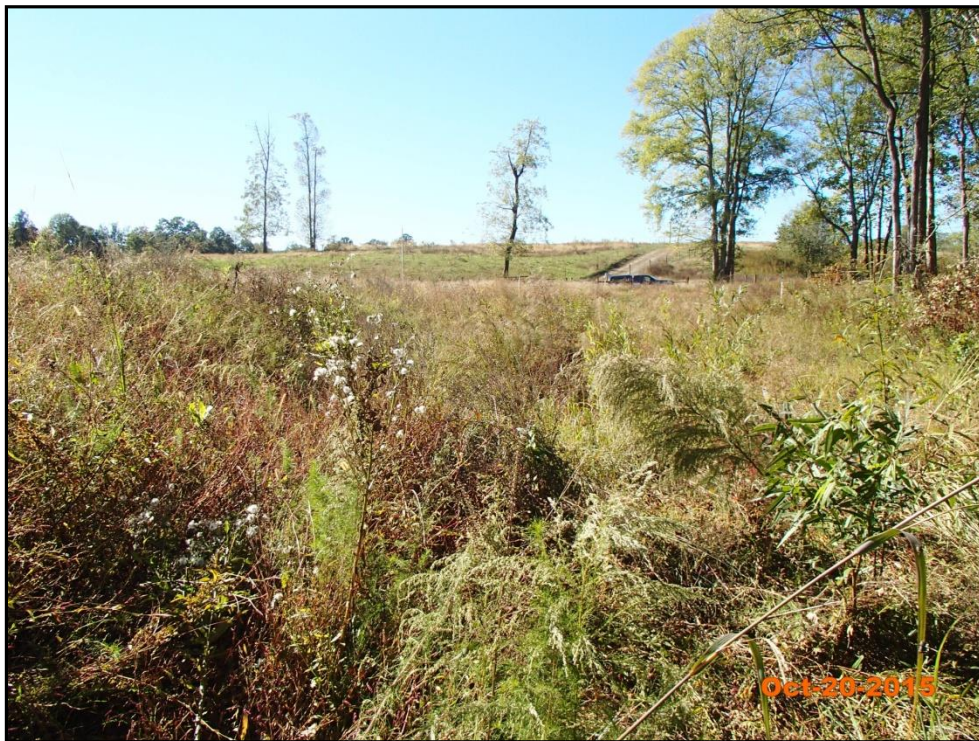
Jerry Branch – Permanent Photo Station 5
Station 316+95 - Upstream

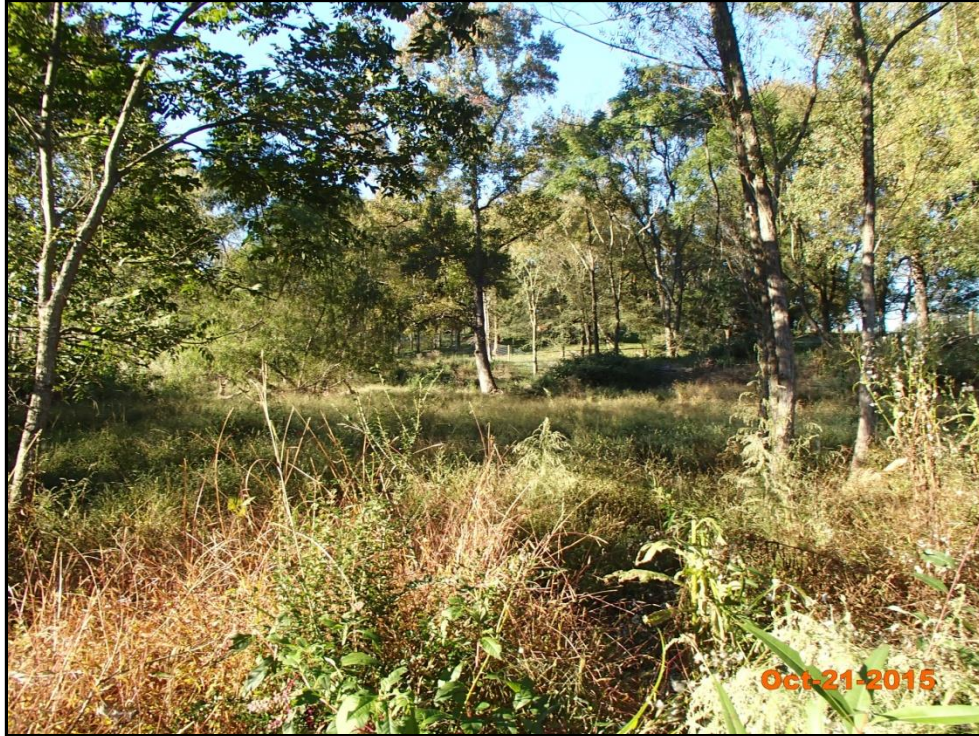
Dale Branch – Permanent Photo Station 6
Station 204+15 - Upstream

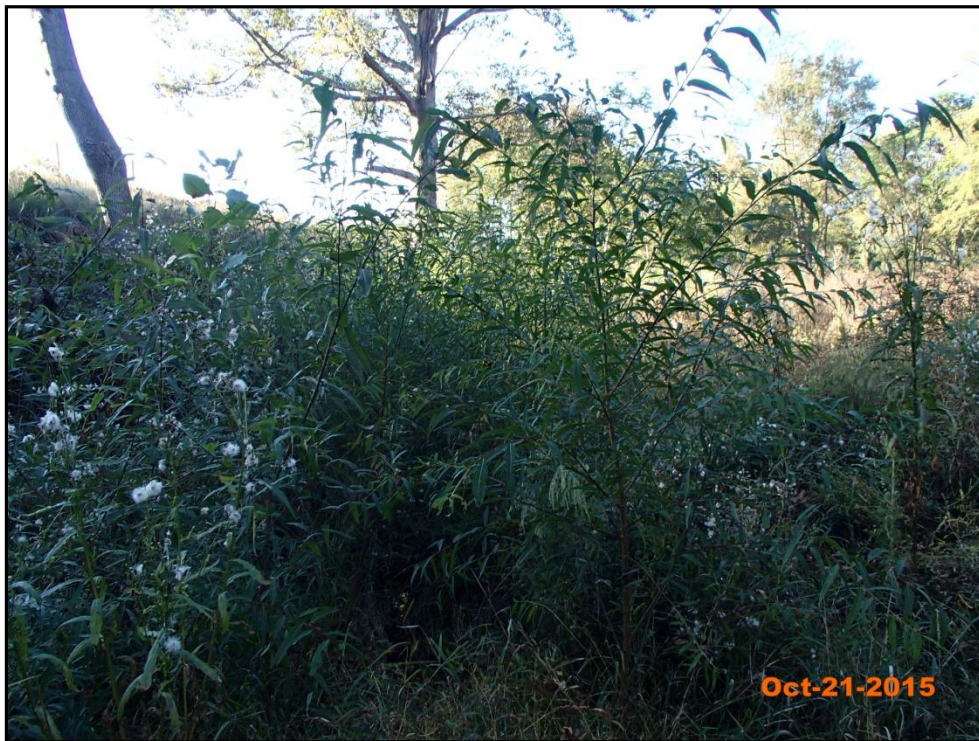
Dale Branch – Permanent Photo Station 7
Station 205+15 - Upstream

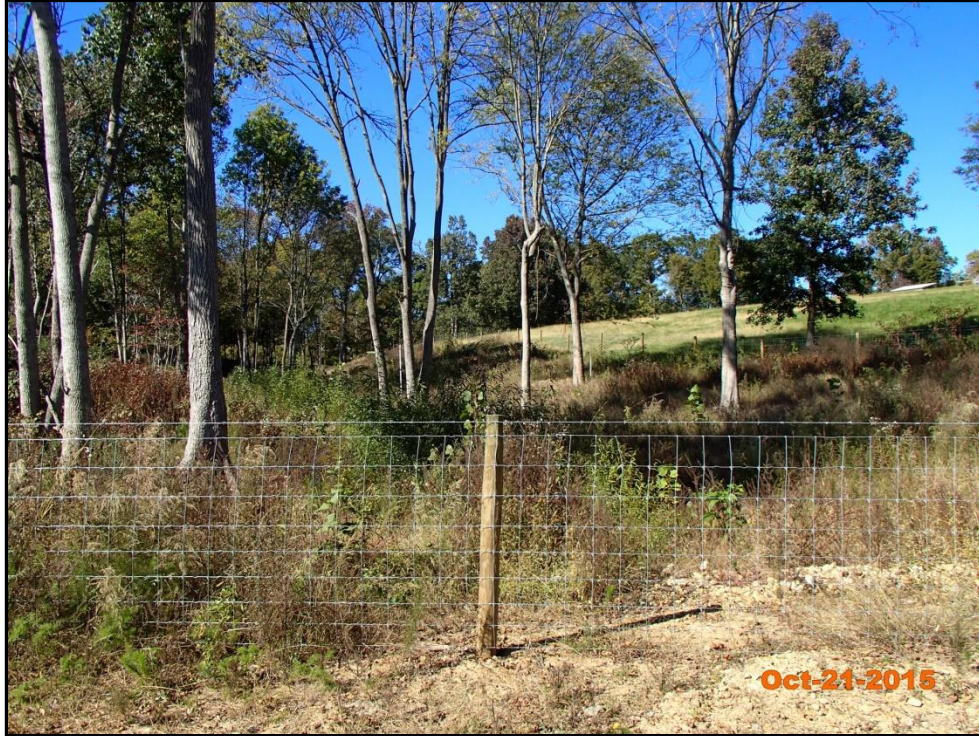
Dale Branch – Permanent Photo Station 8
Station 212+95 - Upstream

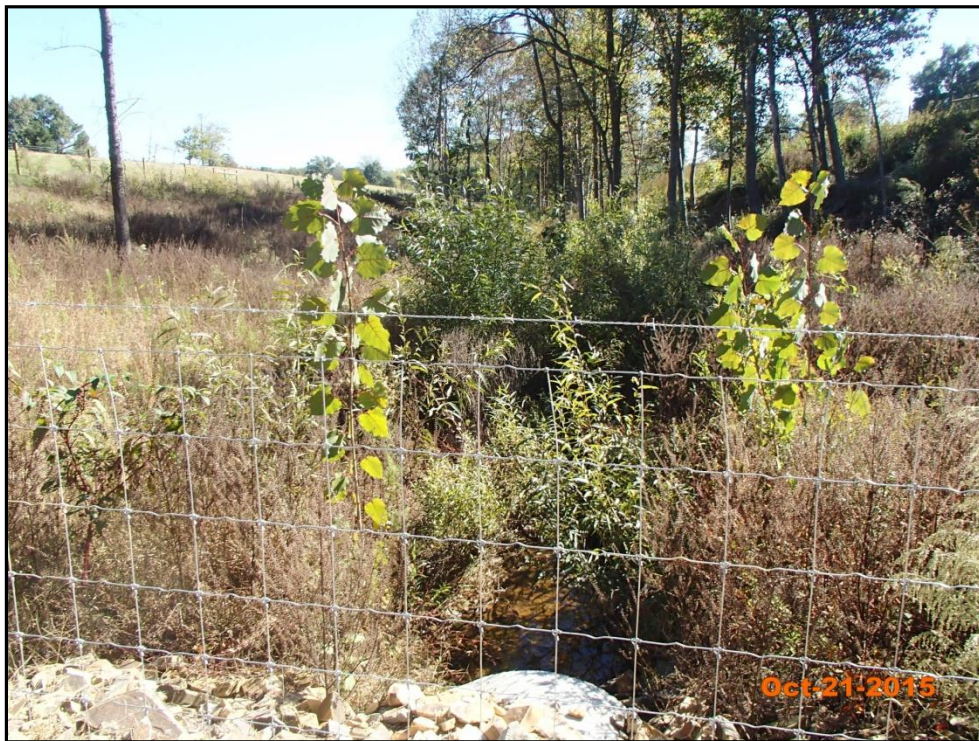
Dale Branch – Permanent Photo Station 8
Station 212+95 - Downstream

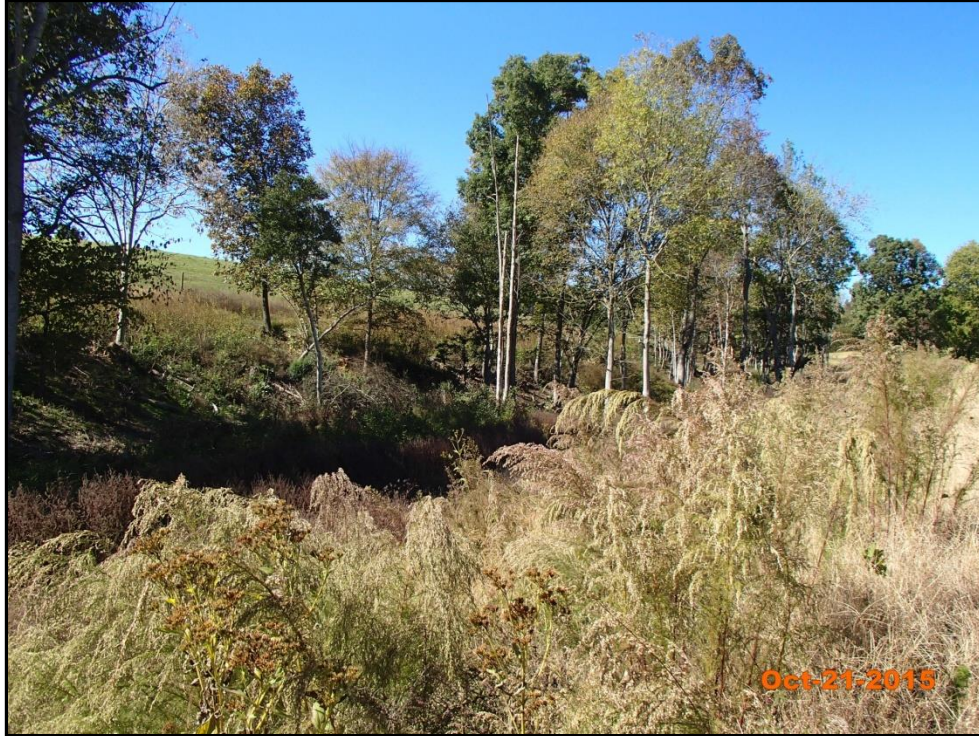
Dale Branch – Permanent Photo Station 9
Looking North Northwest – Upstream Dale

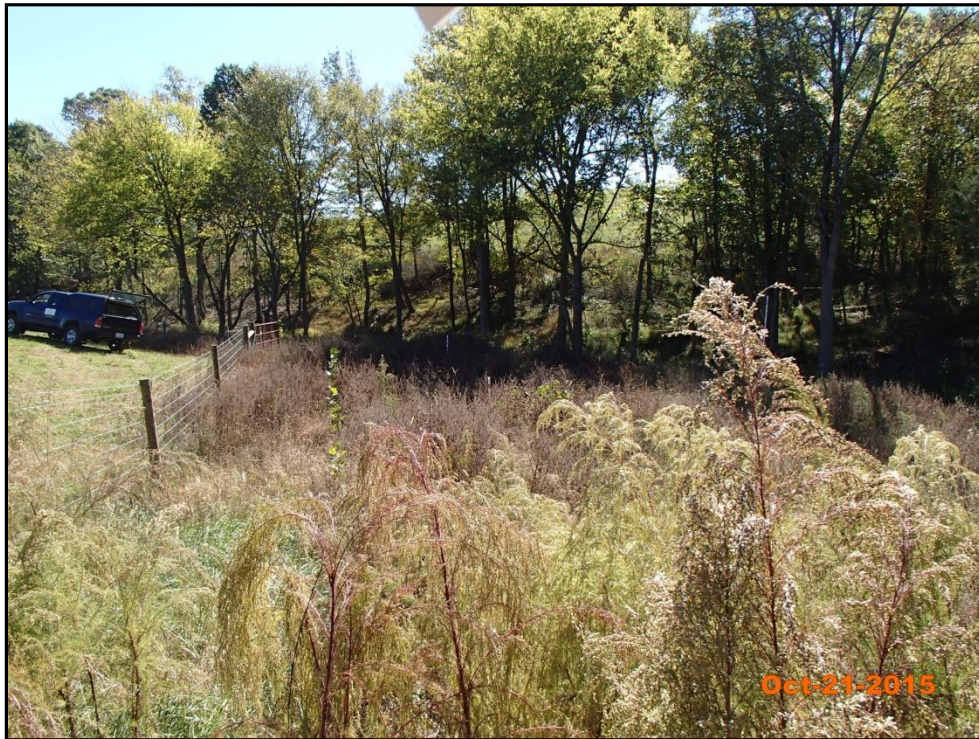
Dale Branch – Permanent Photo Station 9
Looking South Southeast- Downstream

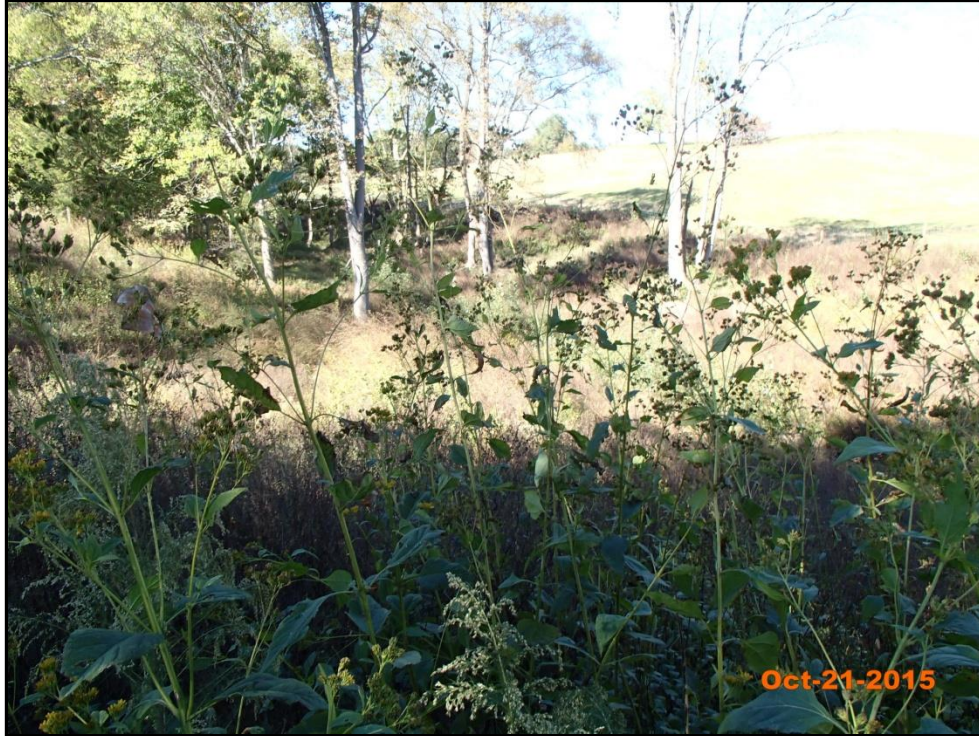
Dale Branch – Permanent Photo Station 10
Looking North Northeast – Upstream

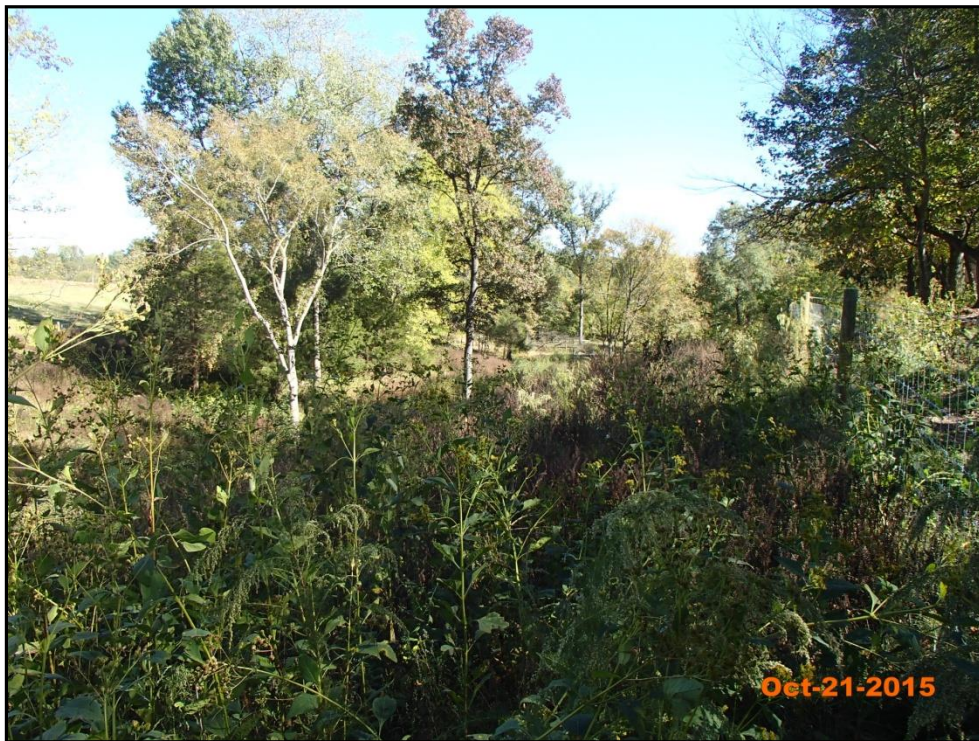
Dale Branch – Permanent Photo Station 10
Looking South Southwest – Downstream

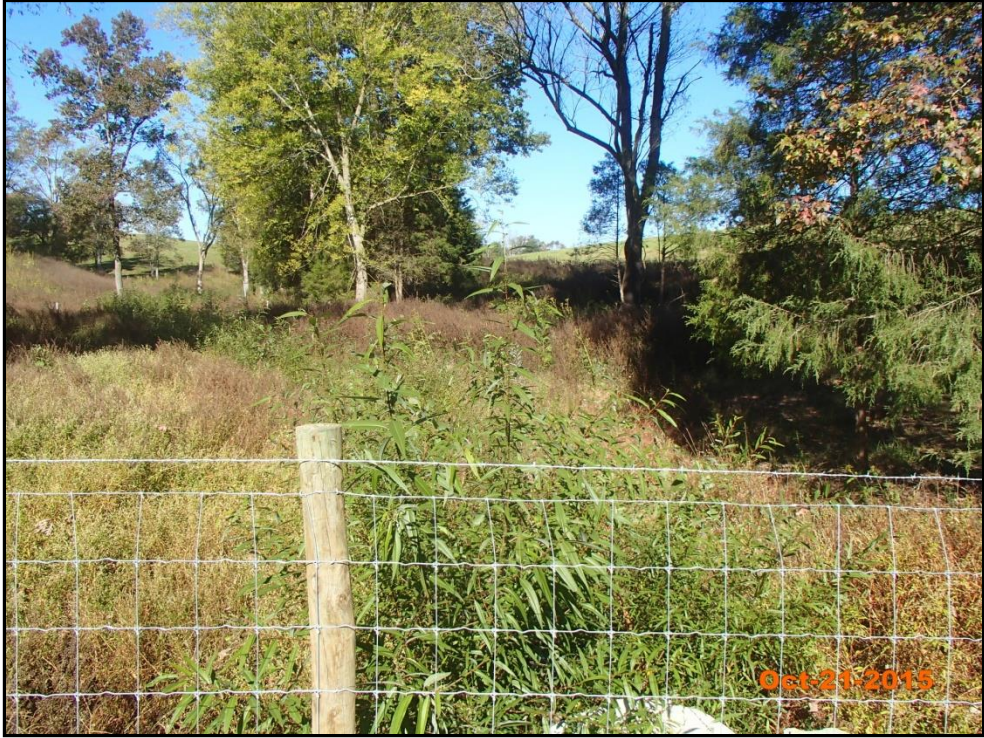
Dale Branch – Permanent Photo Station 11
Station 229+20 – Upstream

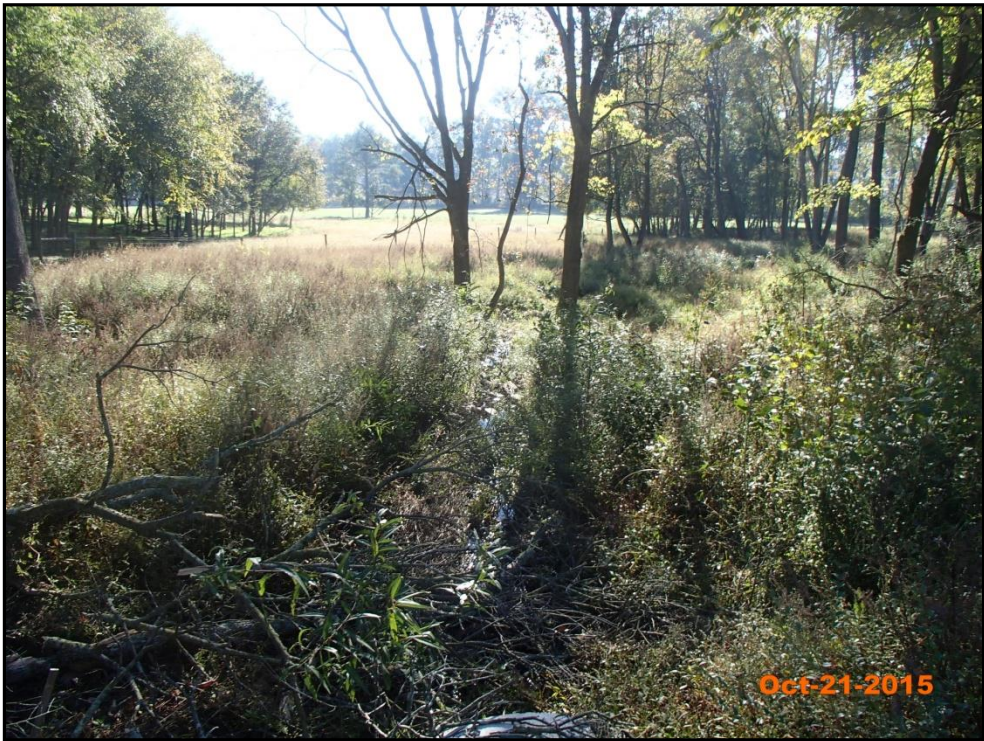
Dale Branch – Permanent Photo Station 11
Station 229+20 – Downstream

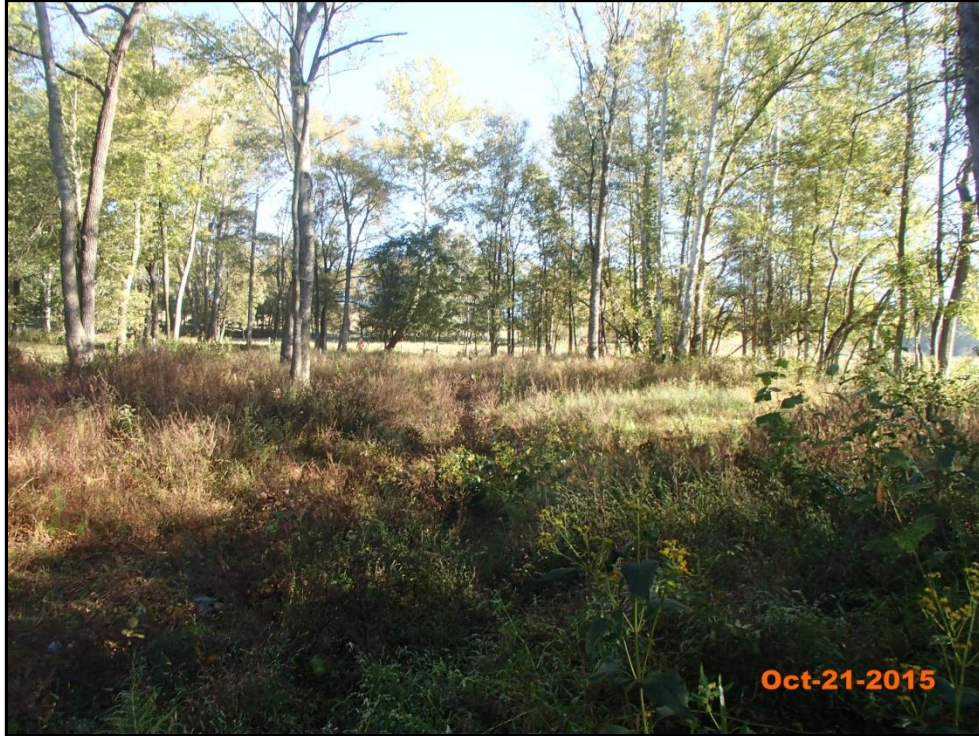
Dale Branch – Permanent Photo Station 12
Station 234+25 – Upstream

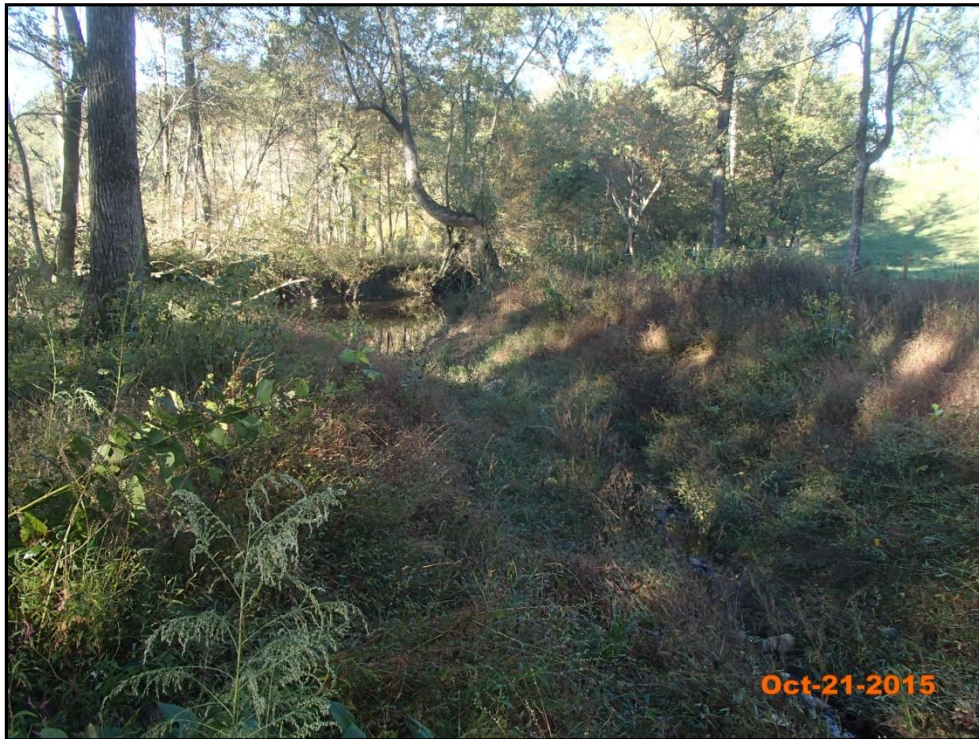
Dale Branch – Permanent Photo Station 12
Station 234+25 – Downstream

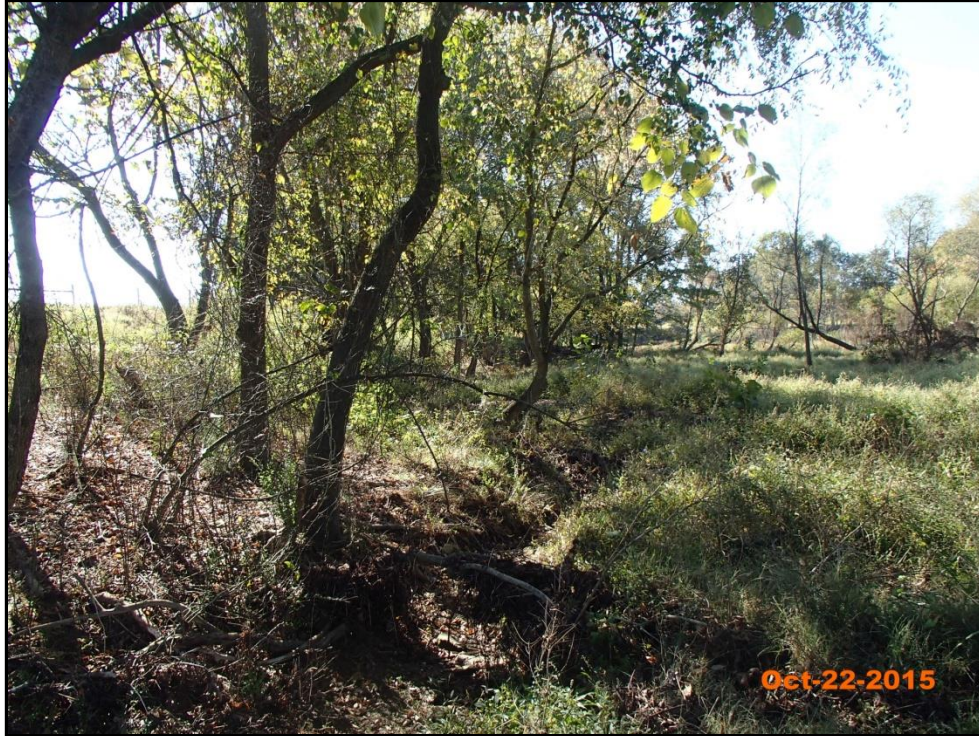
Thompson Branch – Permanent Photo Station 13
Station 101+15 – Downstream

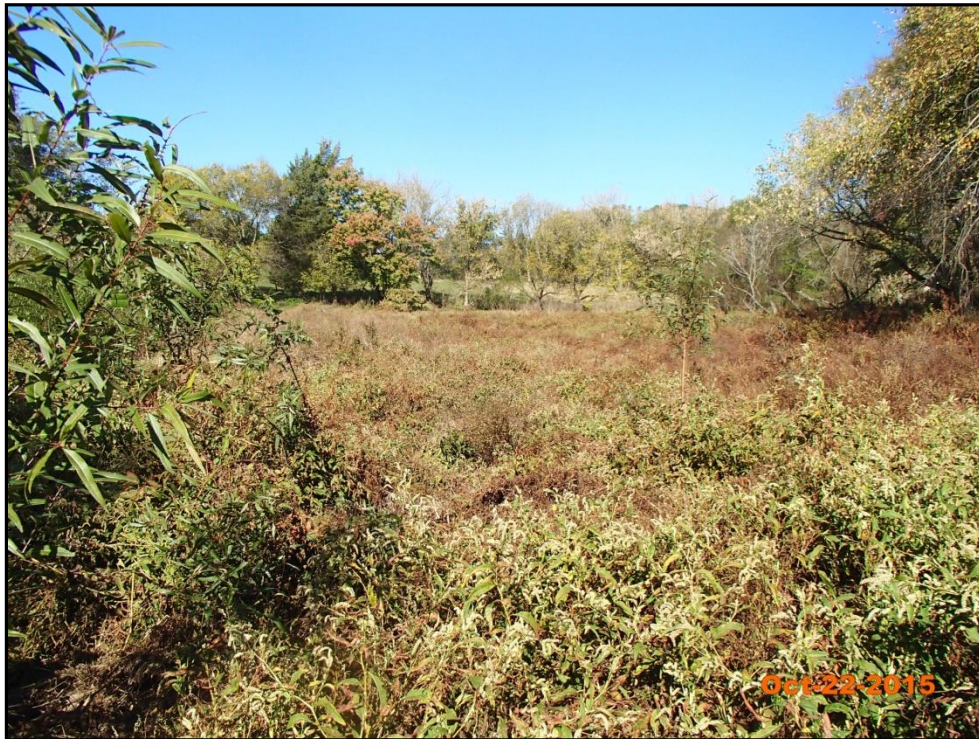
Thompson Branch – Permanent Photo Station 14
Station 105+25 – Upstream

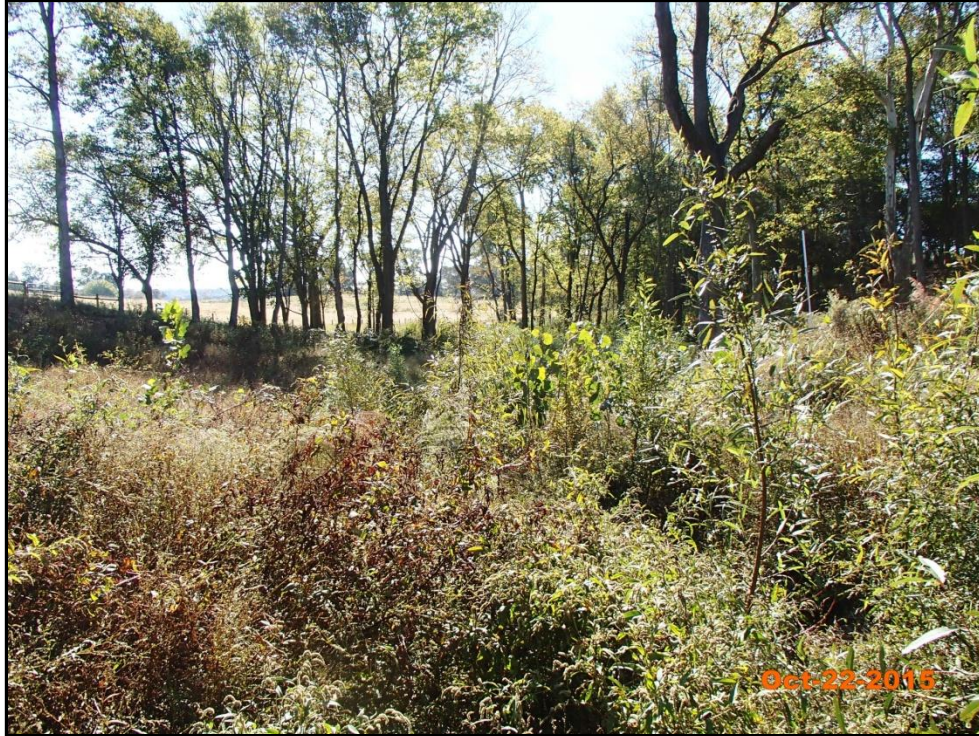
Thompson Branch – Permanent Photo Station 14
Station 105+25 – Downstream

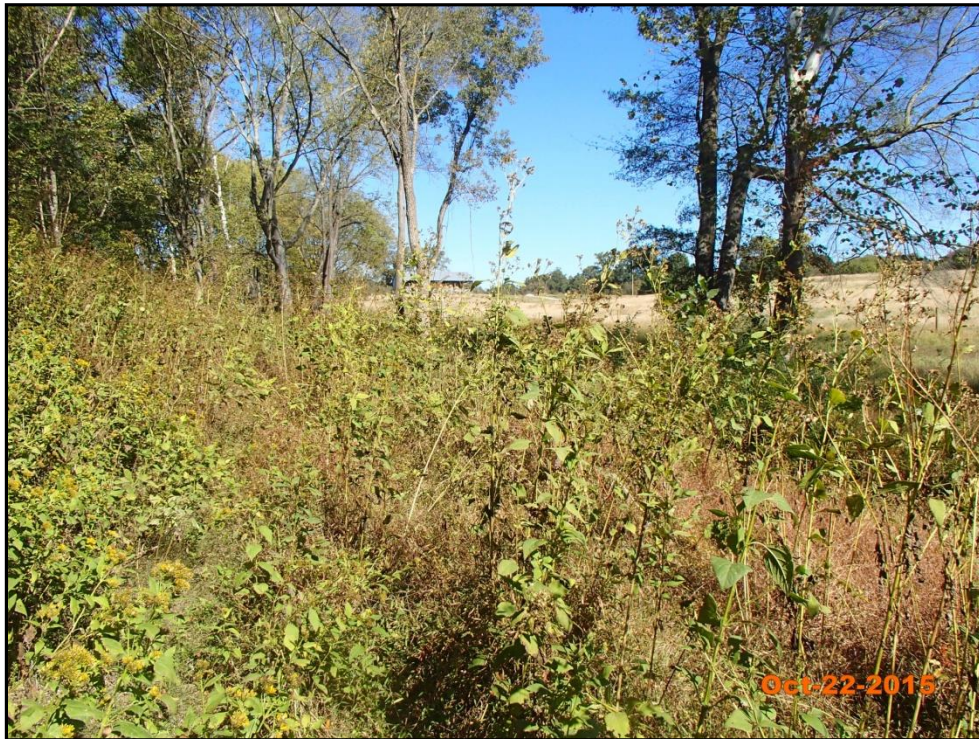
Thompson Branch – Permanent Photo Station 15
Station 115+50 – Upstream

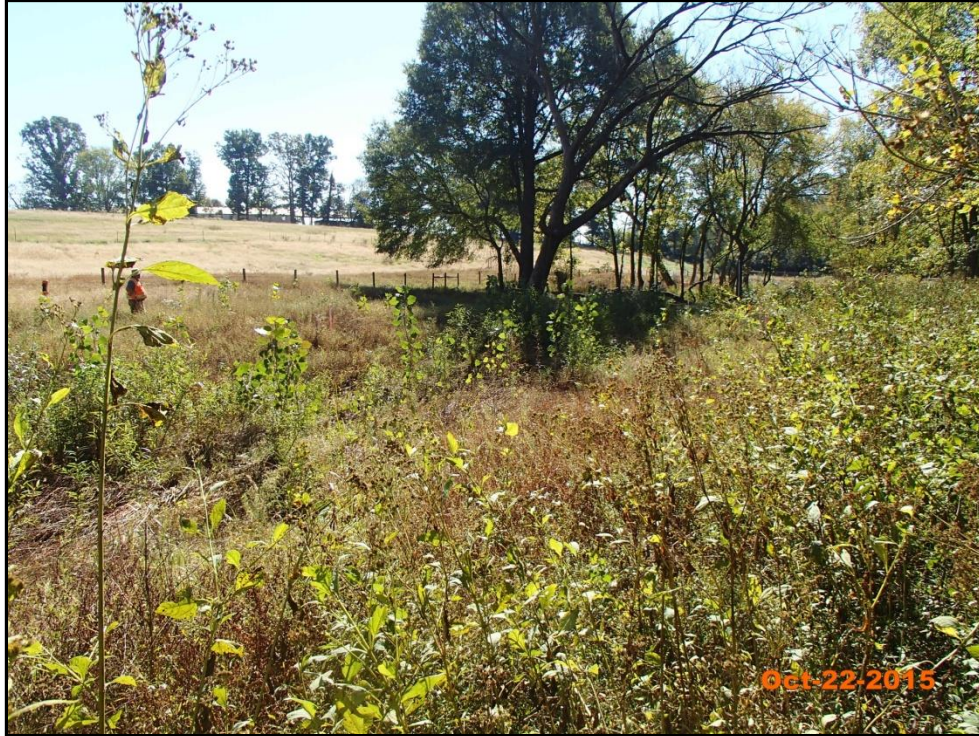
Thompson Branch – Permanent Photo Station 15
Station 111+50 – Downstream

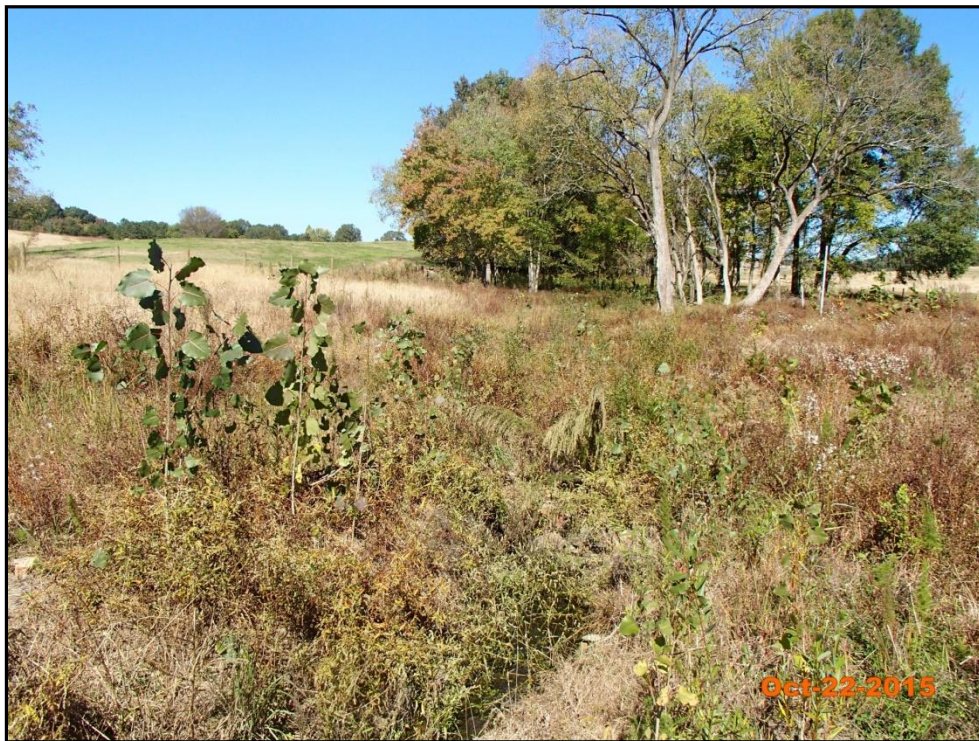
Thompson Branch – Permanent Photo Station 16
Station 115+85 – Upstream

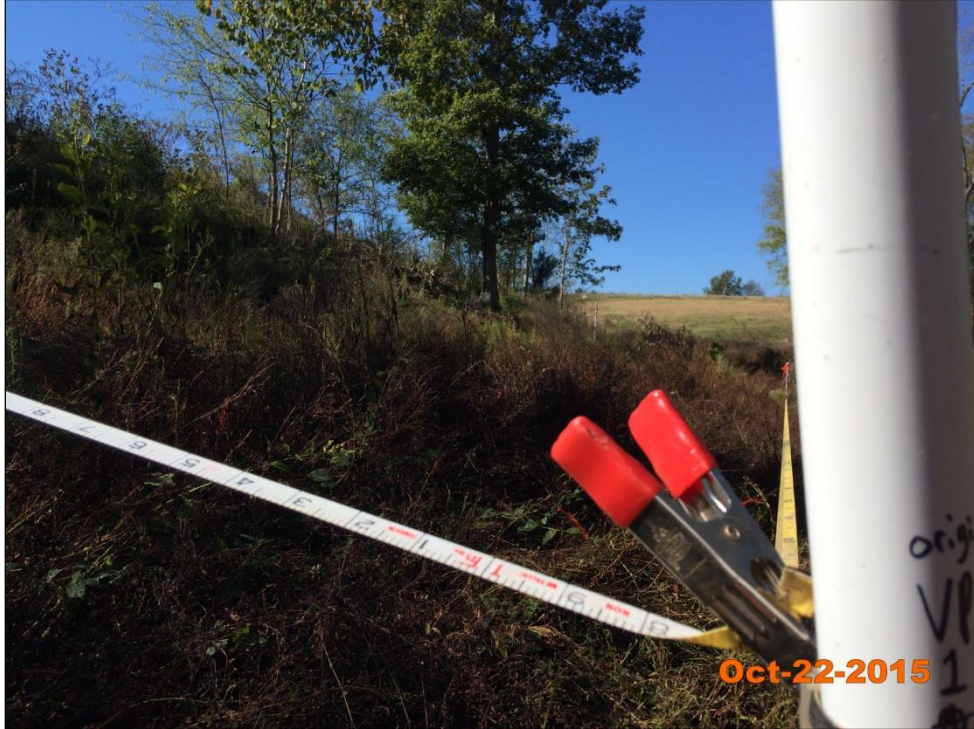
Pee Dee - Vegetation Monitoring Plot 1
October 22, 2015

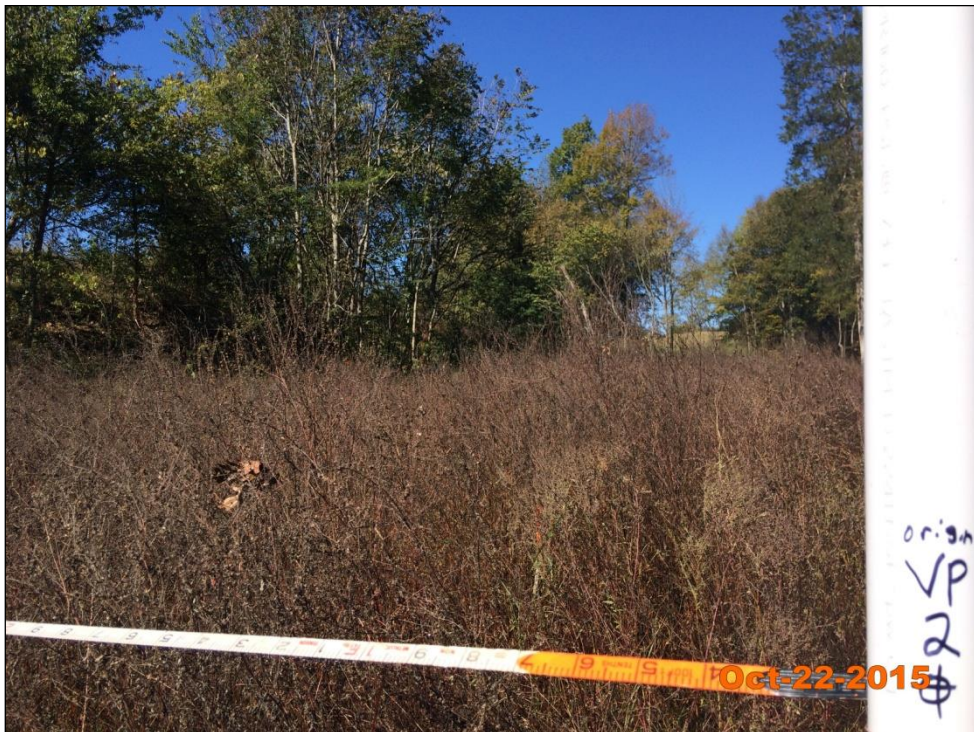
Pee Dee - Vegetation Monitoring Plot 2
October 22, 2015

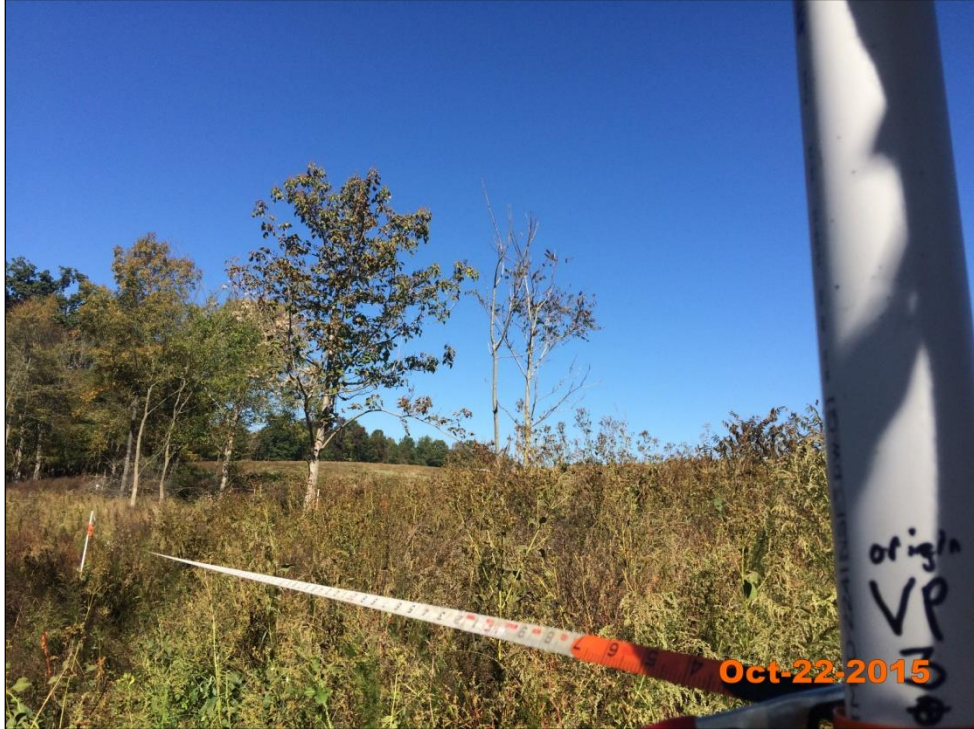
Pee Dee - Vegetation Monitoring Plot 3
October 22, 2015

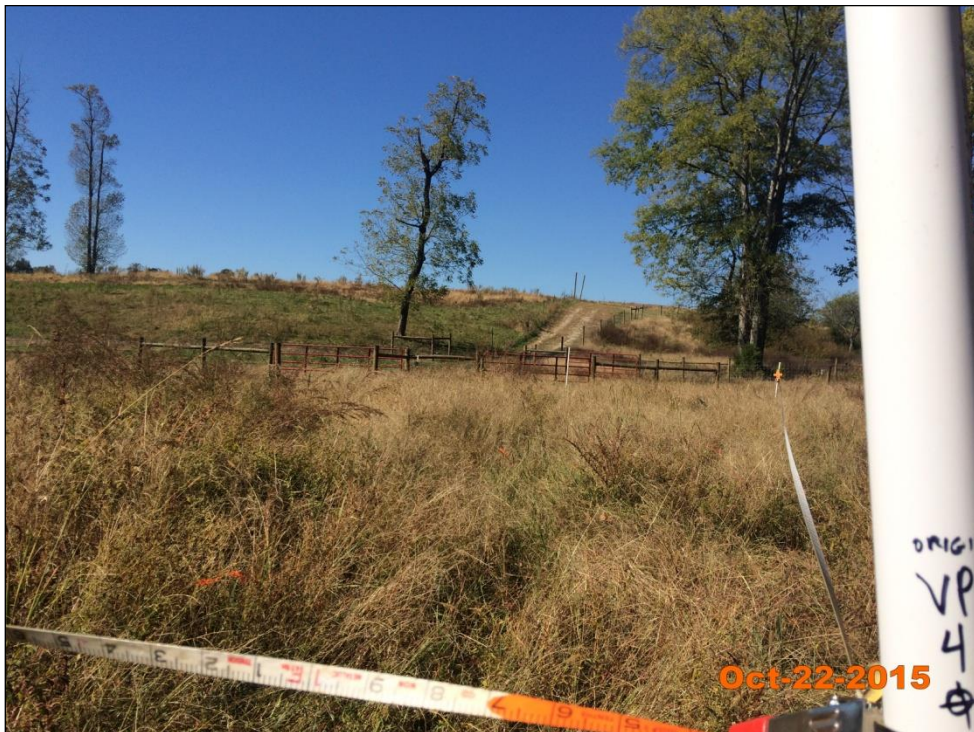
Pee Dee - Vegetation Monitoring Plot 4
October 22, 2015

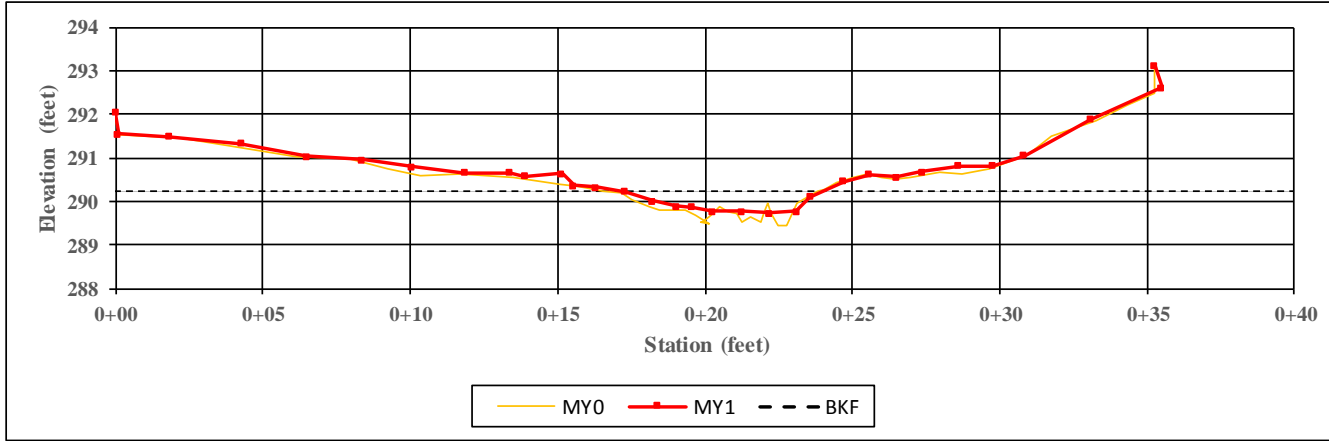
Reach Name: Jerry Branch 3

XS Type: Riffle

CHANNEL DIMENSIONS SUMMARY	MY0	MY1	MY2	MY3	MY4	MY5	MY6	MY7
Bankfull Width (ft)	7.2	6.7						
Floodprone Width (ft)	25.0	25.0						
Bankfull Mean Depth (ft)	0.4	0.3						
Bankfull Max Depth (ft)	0.8	0.5						
Bankfull Cross-Sectional Area (ft ²)	3.0	2.3						
Width/Depth Ratio	17.7	19.4						
Entrenchment Ratio	3.4	3.7						
Bank Height Ratio	1.0	1.0
