Annual Monitoring Report

Project Name: Pee Dee Stream Restoration Site

1.0 PROJECT SUMMARY

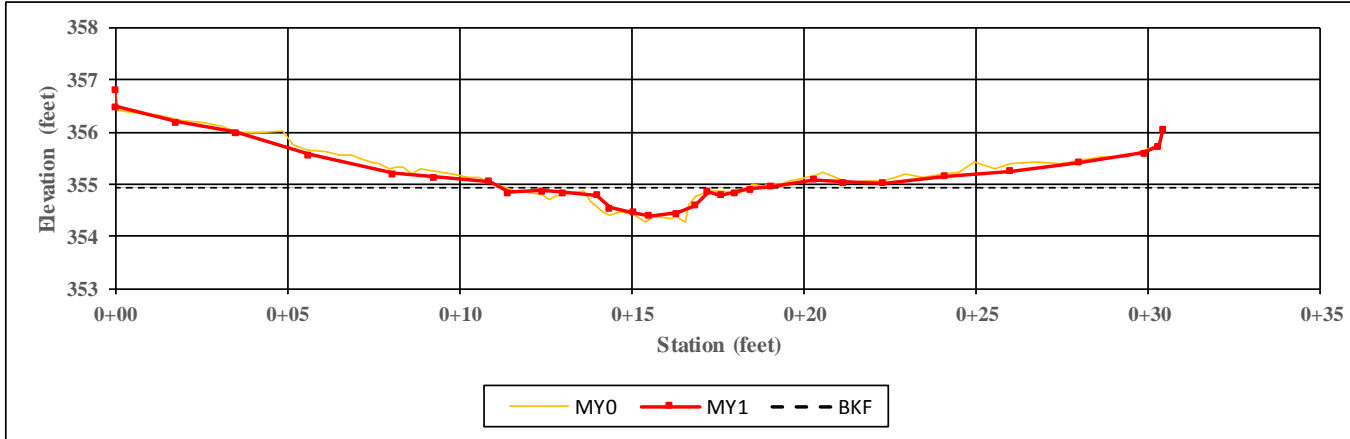
Reach Name: Dale Branch 2

XS Type: Riffle

CHANNEL DIMENSIONS SUMMARY	MY0	MY1	MY2	MY3	MY4	MY5	MY6	MY7
Bankfull Width (ft)	7.0	7.3						
Floodprone Width (ft)	25.0	25.0						
Bankfull Mean Depth (ft)	0.3	0.2						
Bankfull Max Depth (ft)	0.7	0.5						
Bankfull Cross-Sectional Area (ft ²)	2.0	1.7						
Width/Depth Ratio	24.6	30.6						
Entrenchment Ratio	3.6	3.4						
Bank Height Ratio	1.0	1.0

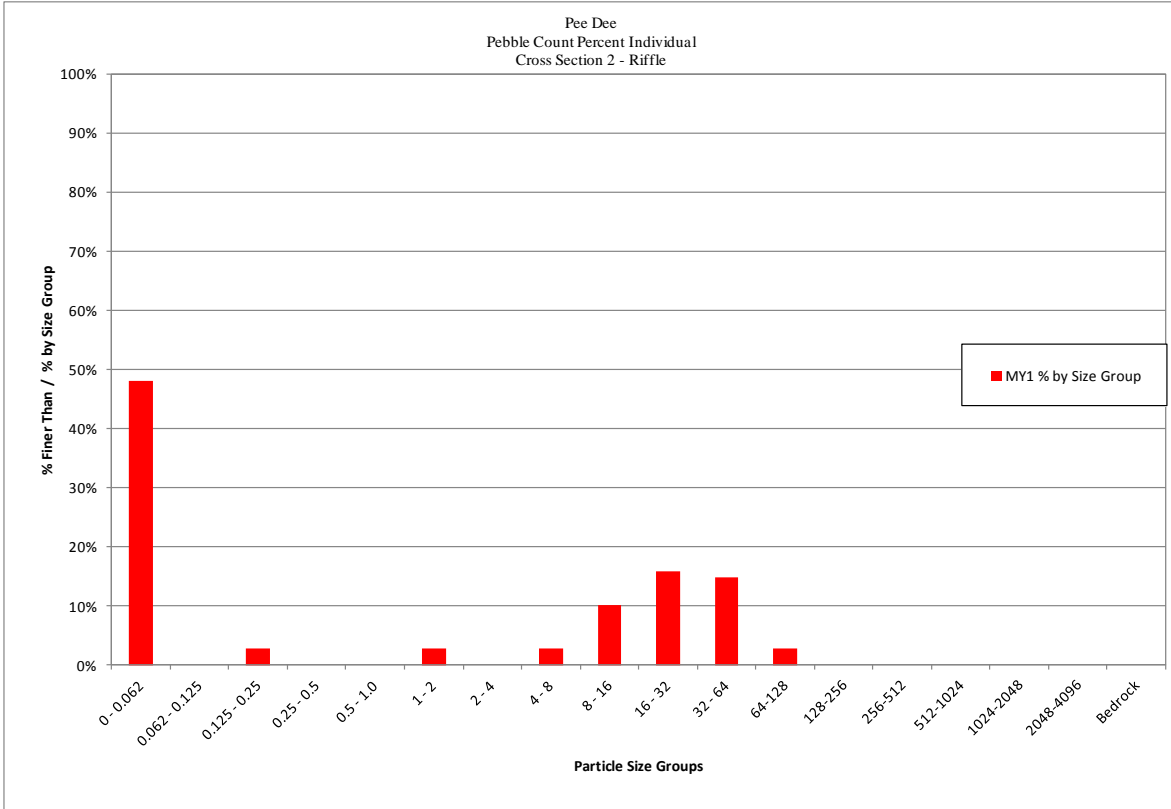
Pee Dee			
Cross Section 2 - Riffle			
Monitoring Year - 2015; MY1			
Bed Surface Material Particle Size Class (mm)	Number	% Individual	% Cumulative
0 - 0.062	52	48.1%	48%
0.062 - 0.125	0	0.0%	48%
0.125 - 0.25	3	2.8%	51%
0.25 - 0.5	0	0.0%	51%
0.5 - 1.0	0	0.0%	51%
1 - 2	3	2.8%	54%
2 - 4	0	0.0%	54%
4 - 8	3	2.8%	56%
8 - 16	11	10.2%	67%
16 - 32	17	15.7%	82%
32 - 64	16	14.8%	97%
64-128	3	2.8%	100%
128-256	0	0.0%	100%
256-512	0	0.0%	100%
512-1024	0	0.0%	100%
1024-2048	0	0.0%	100%
2048-4096	0	0.0%	100%
Bedrock	0	0.0%	100%
Total	108	100%	100%
		Summary Data	
		D50	0.2
		D84	34
		D95	54

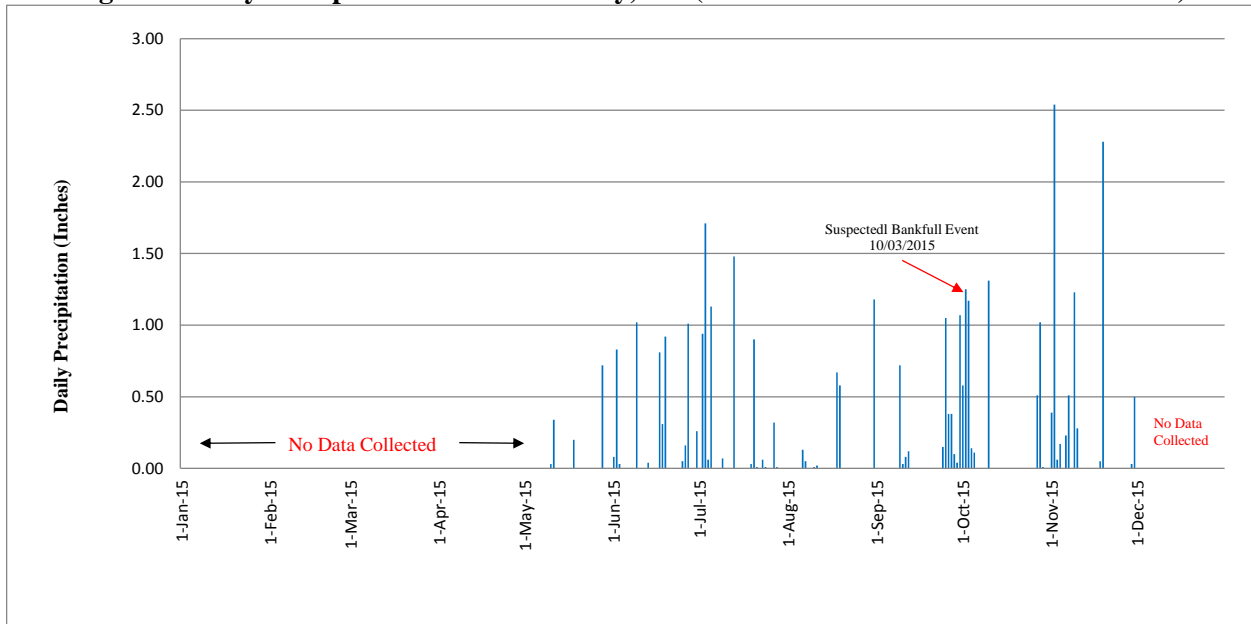
Figure 3. Daily Precipitation Totals for Troy, NC (CRONOS Station NUWH – Uwharrie)

¹Based on precipitation data, suggested date in 10/03/2015

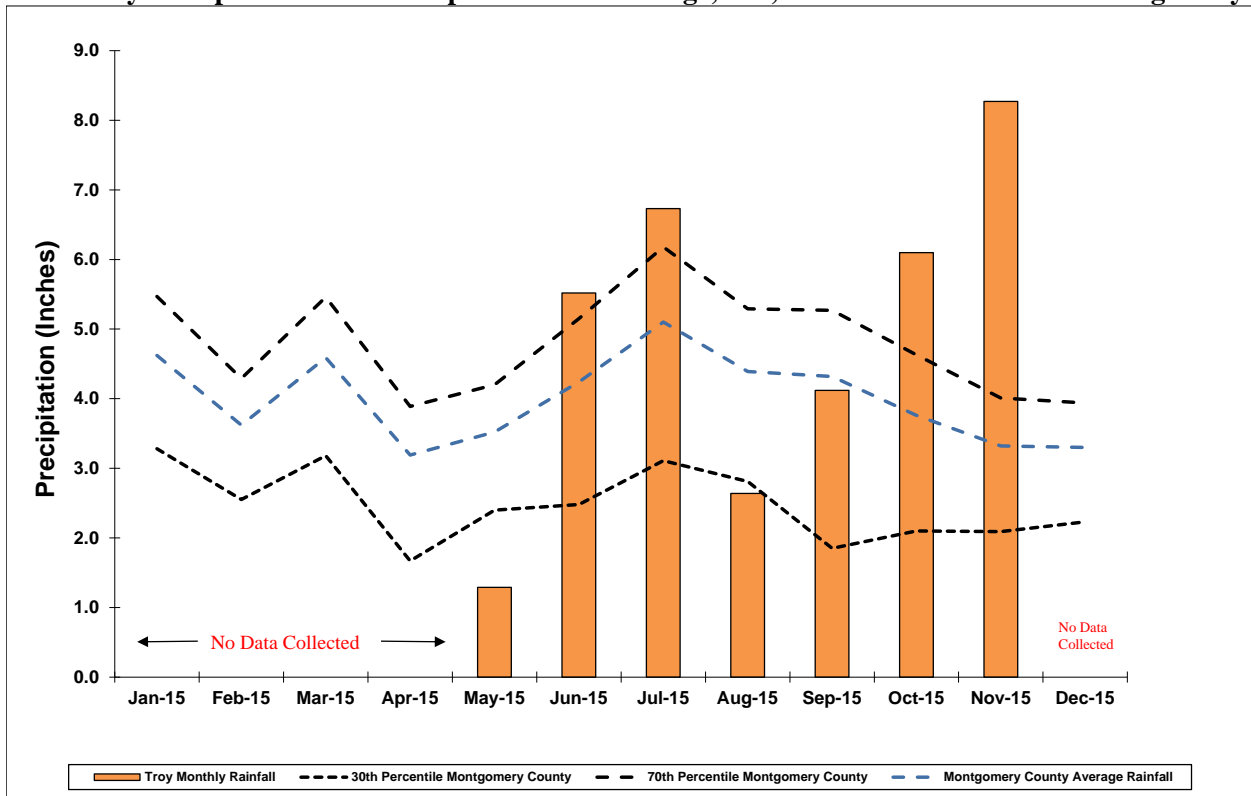
Figure 4. Monthly Precipitation Data Compared to the Average, 30th, and 70th Percentiles for Montgomery County
